Daily Report

Project:	Durham Meadows Pipeline Installation	Date:	June 29, 2020
Location:	Maiden Lane, Pickett Lane, and the Shared Access Driveway	Day of Week:	Monday
Project #:	AECOM: 6061487	Report No:	109
Contractor:	Ludlow Construction	Page:	1 of 19

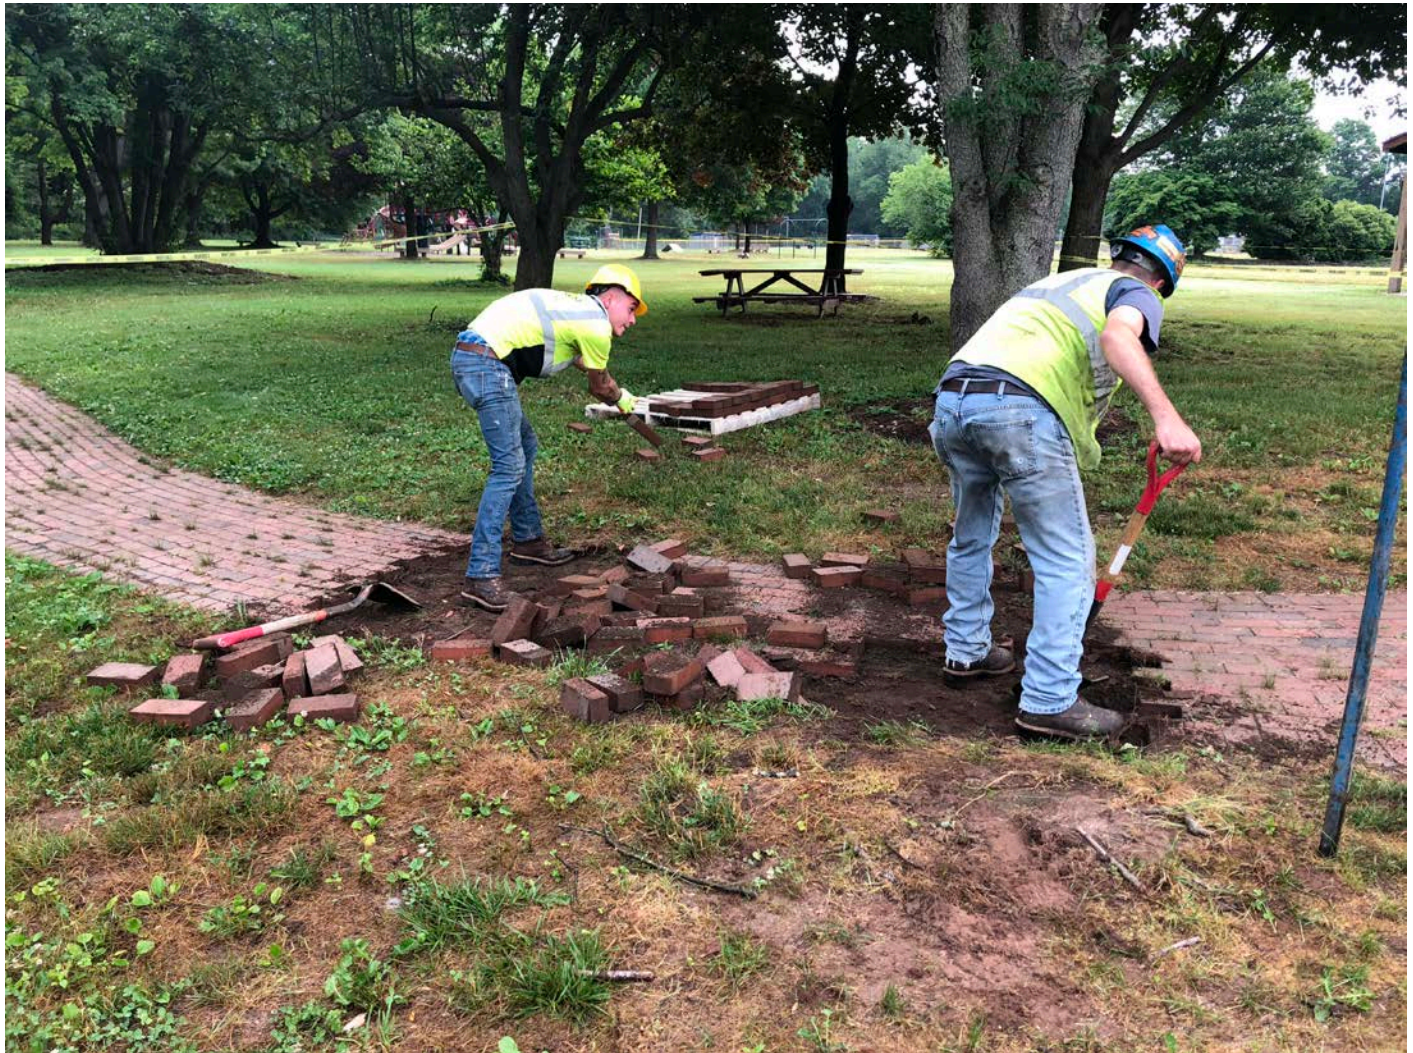
Picture 1: Ludlow removing brick walkway as part of stream crossing activities at Station ~511+00. Pickett Lane, Durham. View to the east.

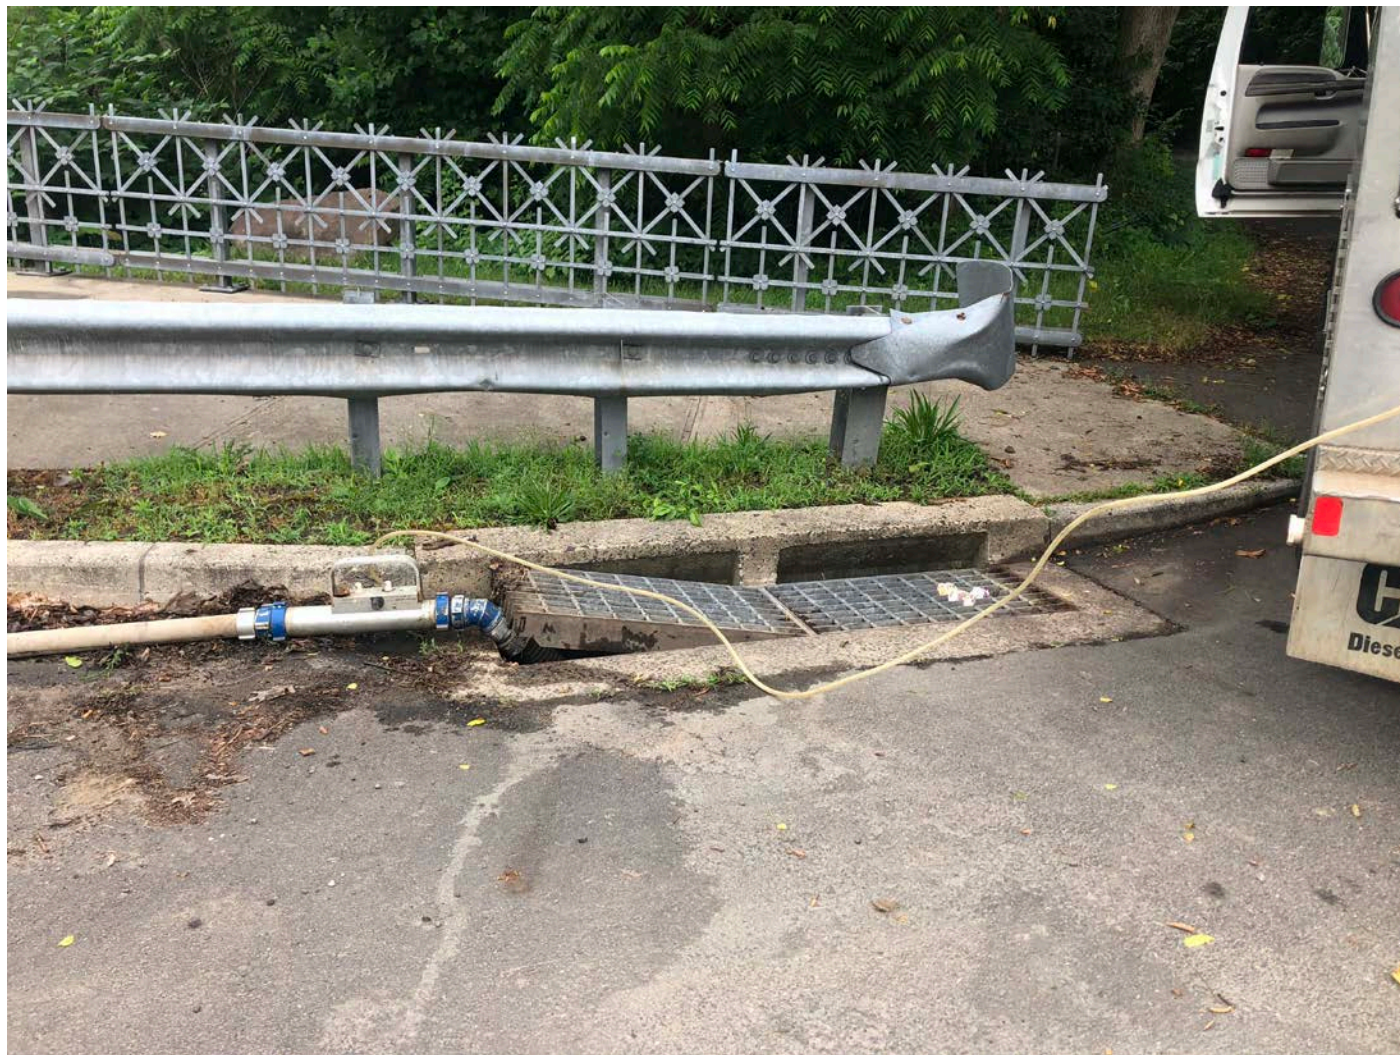
Picture 2: Ludlow dechlorinating the Main Street water line with calcium thiosulfate at the intersection of Main Street and Old Cemetery Road. View to the south.

0818: Ludlow and JMS Connections are at the intersection of Old Cemetery Road and Main Street, where they are adding calcium thiosulfate to dechlorinate the water in the Main Street water line from Winsome Road to Old Cemetery Road. There is one CT State Trooper present performing traffic management.

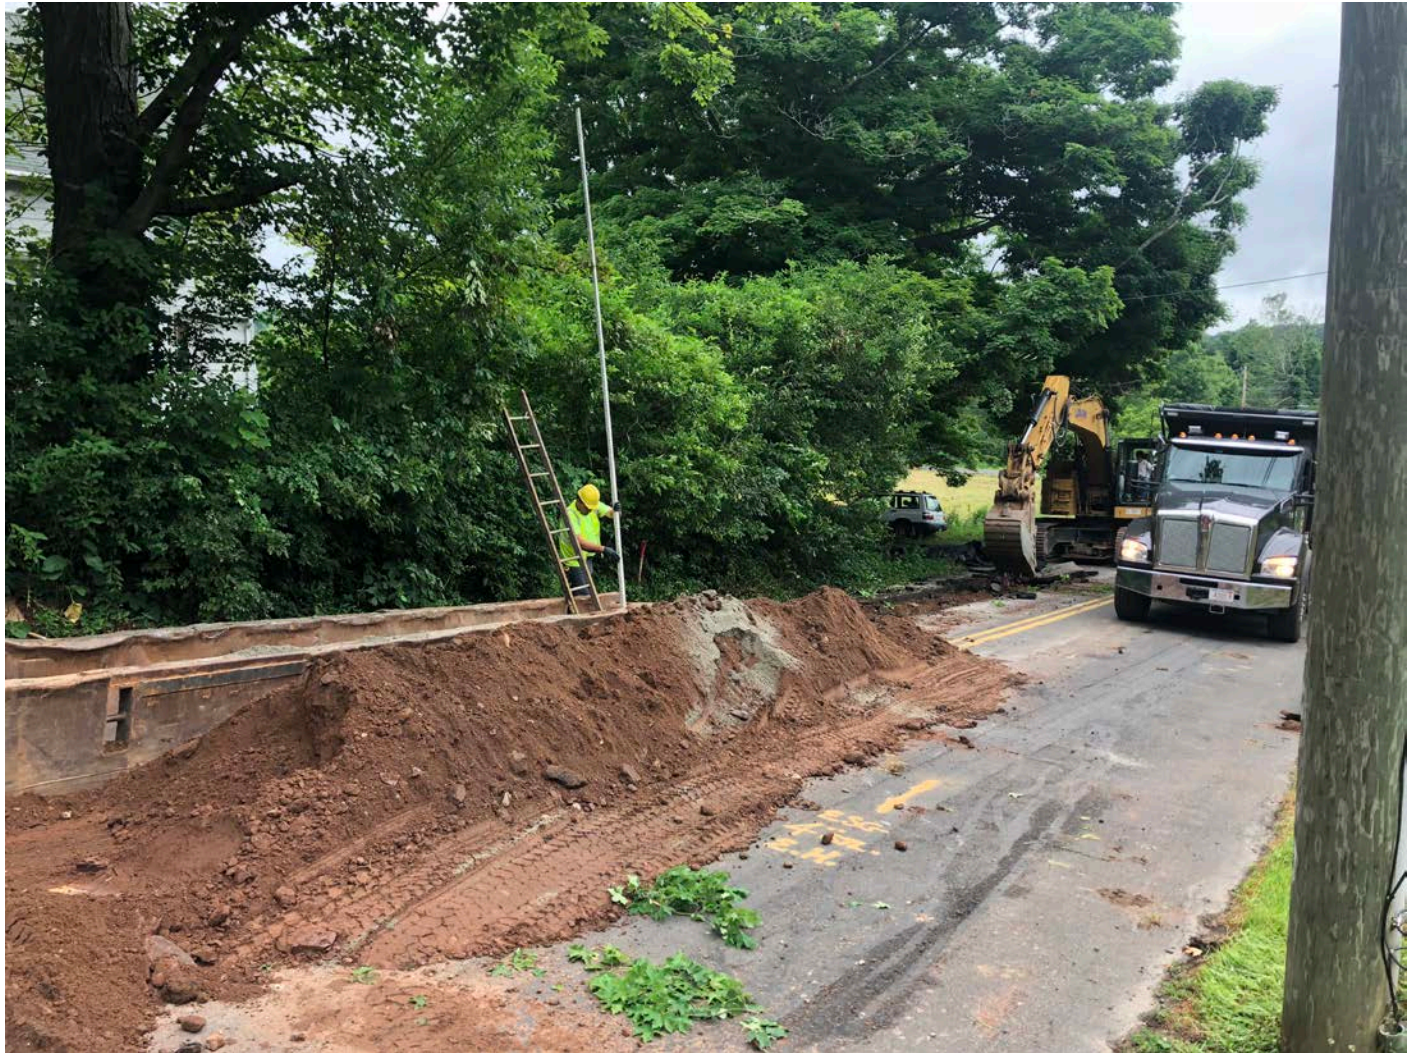
Picture 3: Ludlow installing 12" DIP at Station ~407+00. Maiden Lane, Durham. View to the northeast.

0855: Ludlow has 12" DIP installed up to Station 407+00.

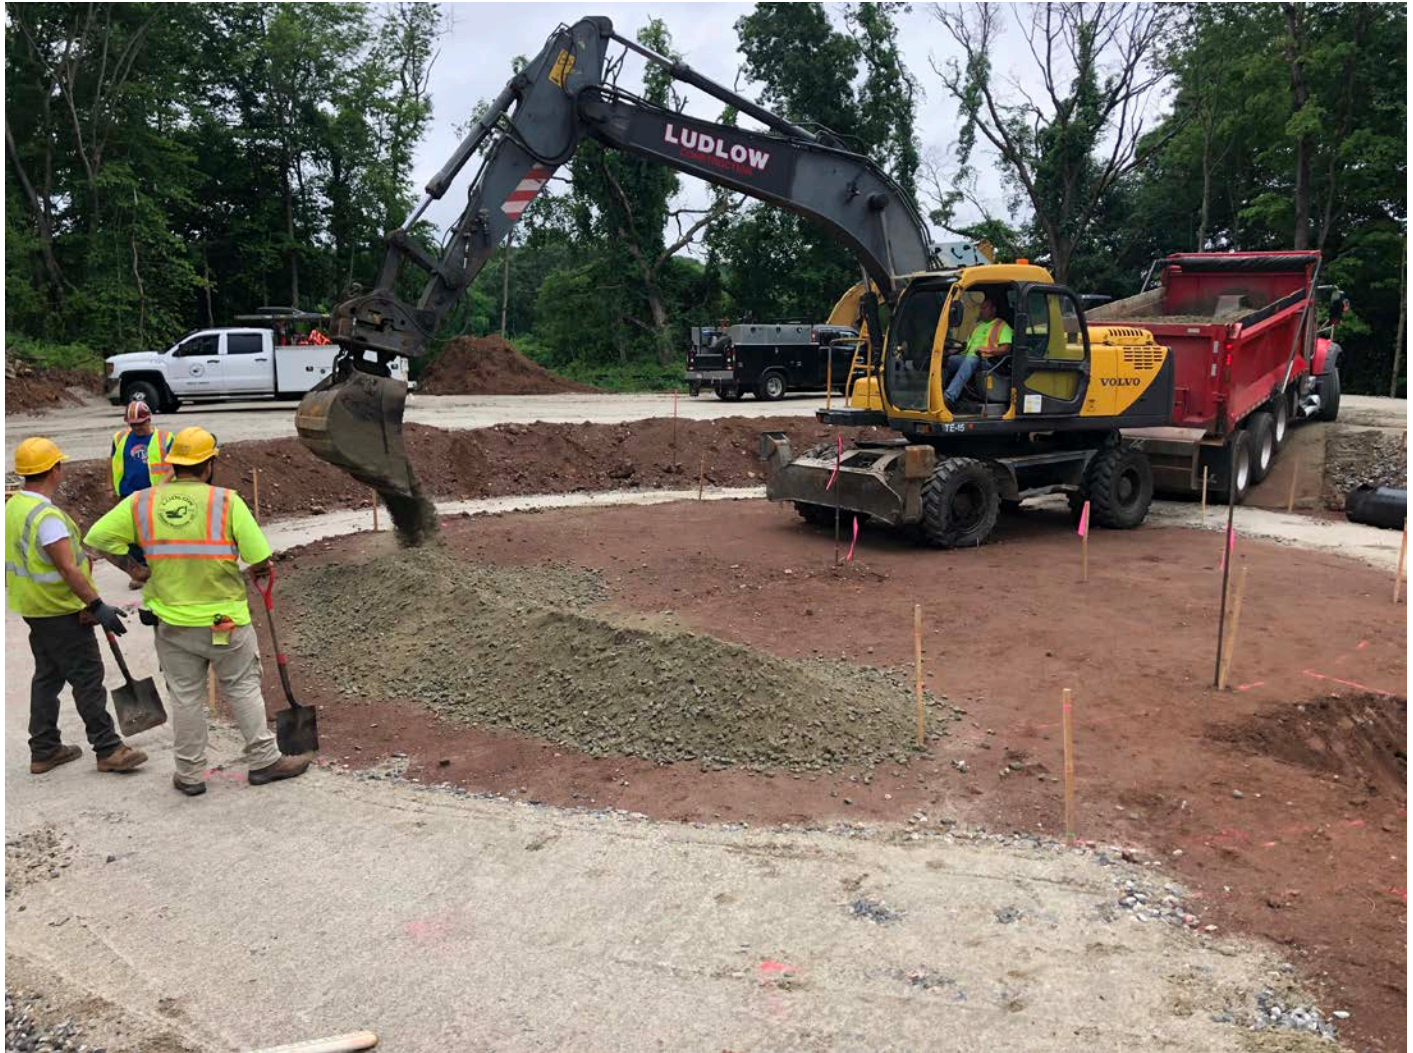
Picture 4: Ludlow placing 1.5" gravel at the water tank footprint. Shared Access Driveway, Middletown. View to the southeast.

0920: Ludlow is placing 1.5" gravel from elevation 435 to 439.67 within the water tank footprint. The material will be placed in 8" lifts and then compacted with a plate compactor.

0924: DN Tanks representative Scott Scopra arrives at the water tank footprint. Ludlow is not sure yet if compaction results taken from the tank footprint last week at elevation 437 passed using a new proctor. Ludlow is currently placing -1.5" gravel at the center of the water tank footprint.

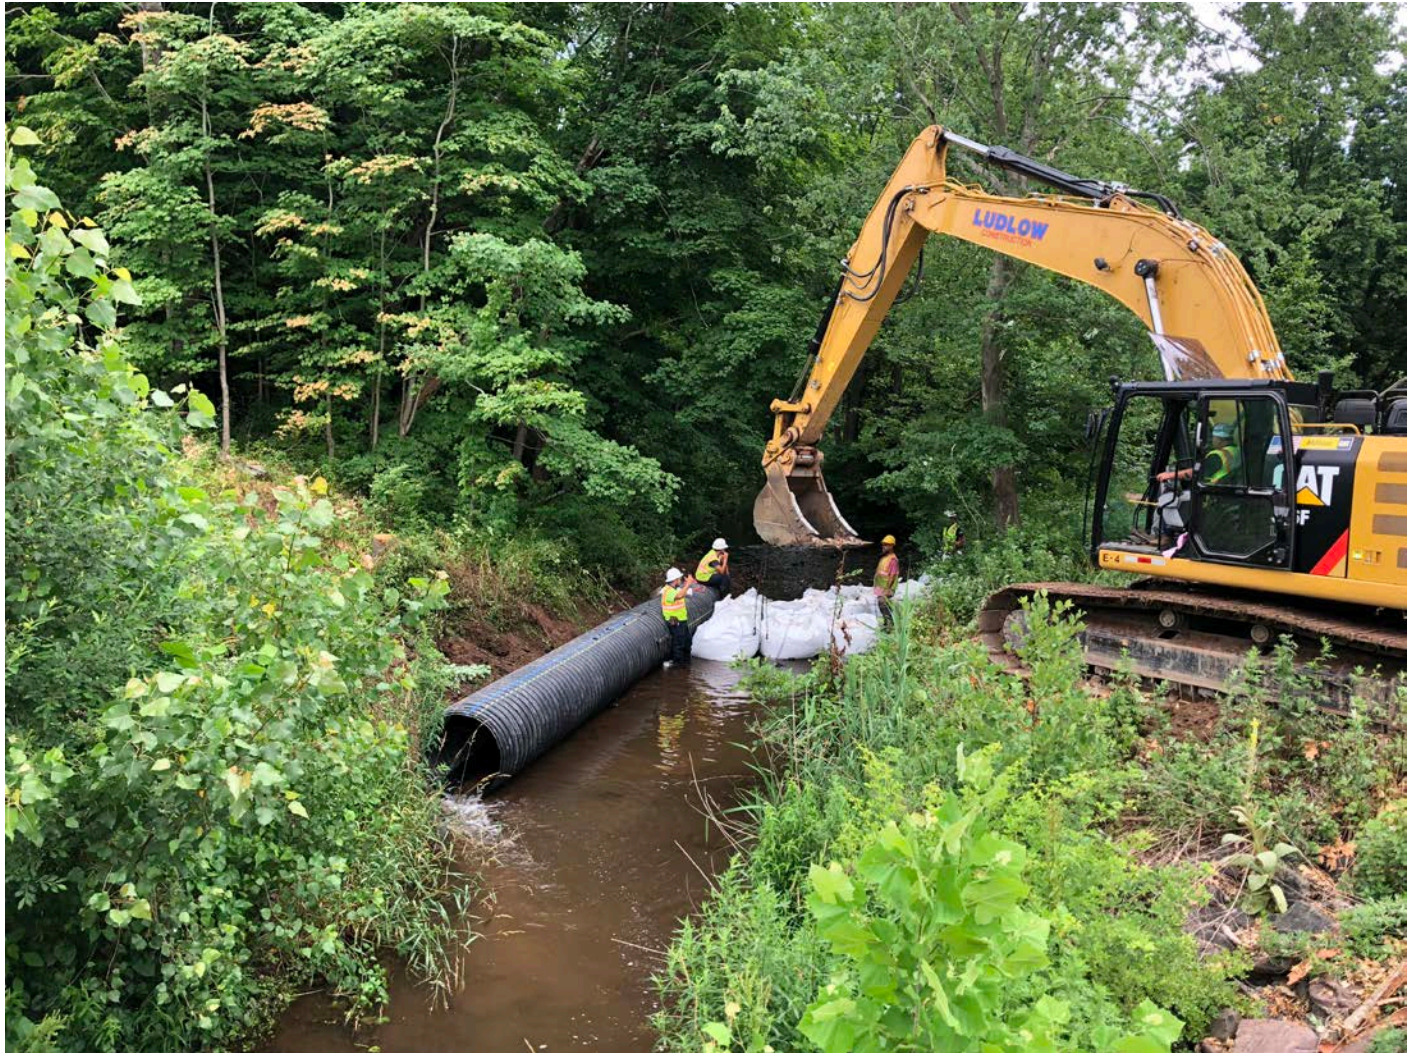
Picture 5: Ludlow installing 40" plastic culvert as a stream flow bypass for the stream crossing at Station ~511+00. Pickett Lane, Durham. View to the north.

0827: Ludlow is placing ~40" plastic corrugated PVC pipe in the streambed of Allyn Brook at Station ~511+00 to temporarily divert stream flow while they work to place 12" DIP across the stream.

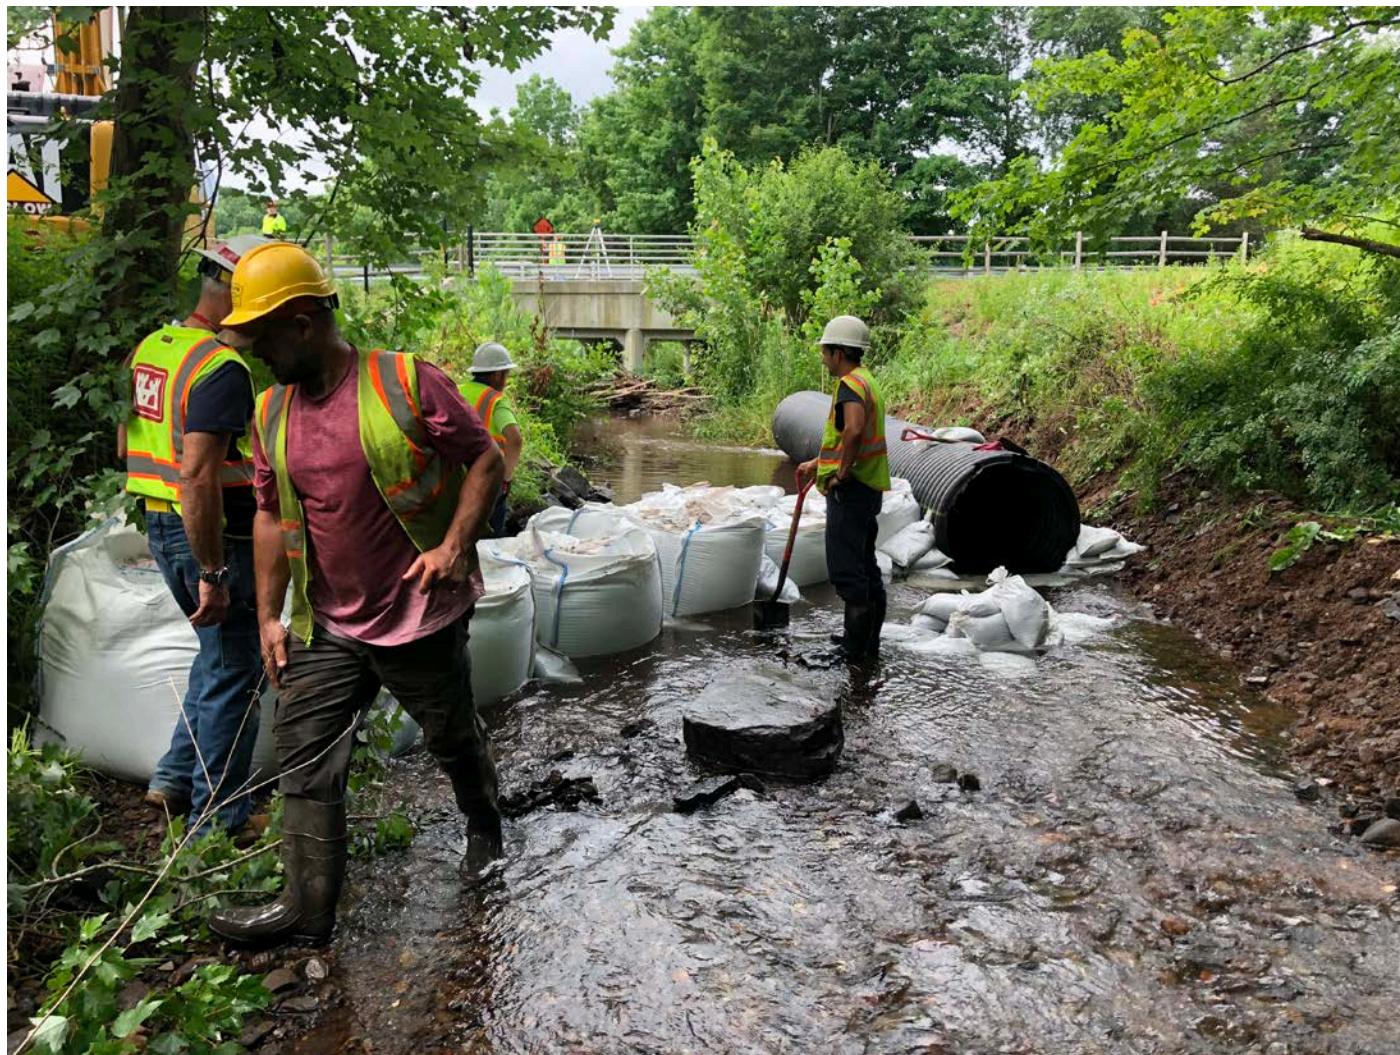
Picture 6: View of the 40" plastic culvert at Station ~511+00 with large and small sand bags placed to divert flow into pipe. View is downstream and to the south. Pickett Lane, Durham.

0944: Ludlow has ~40" corrugated plastic culvert in place in Allyn Brook (immediately upstream of the bridge where Pickett Lane crosses the brook) and are now using large and small sandbags to divert the stream flow into the upstream end of the plastic stream flow bypass culvert.

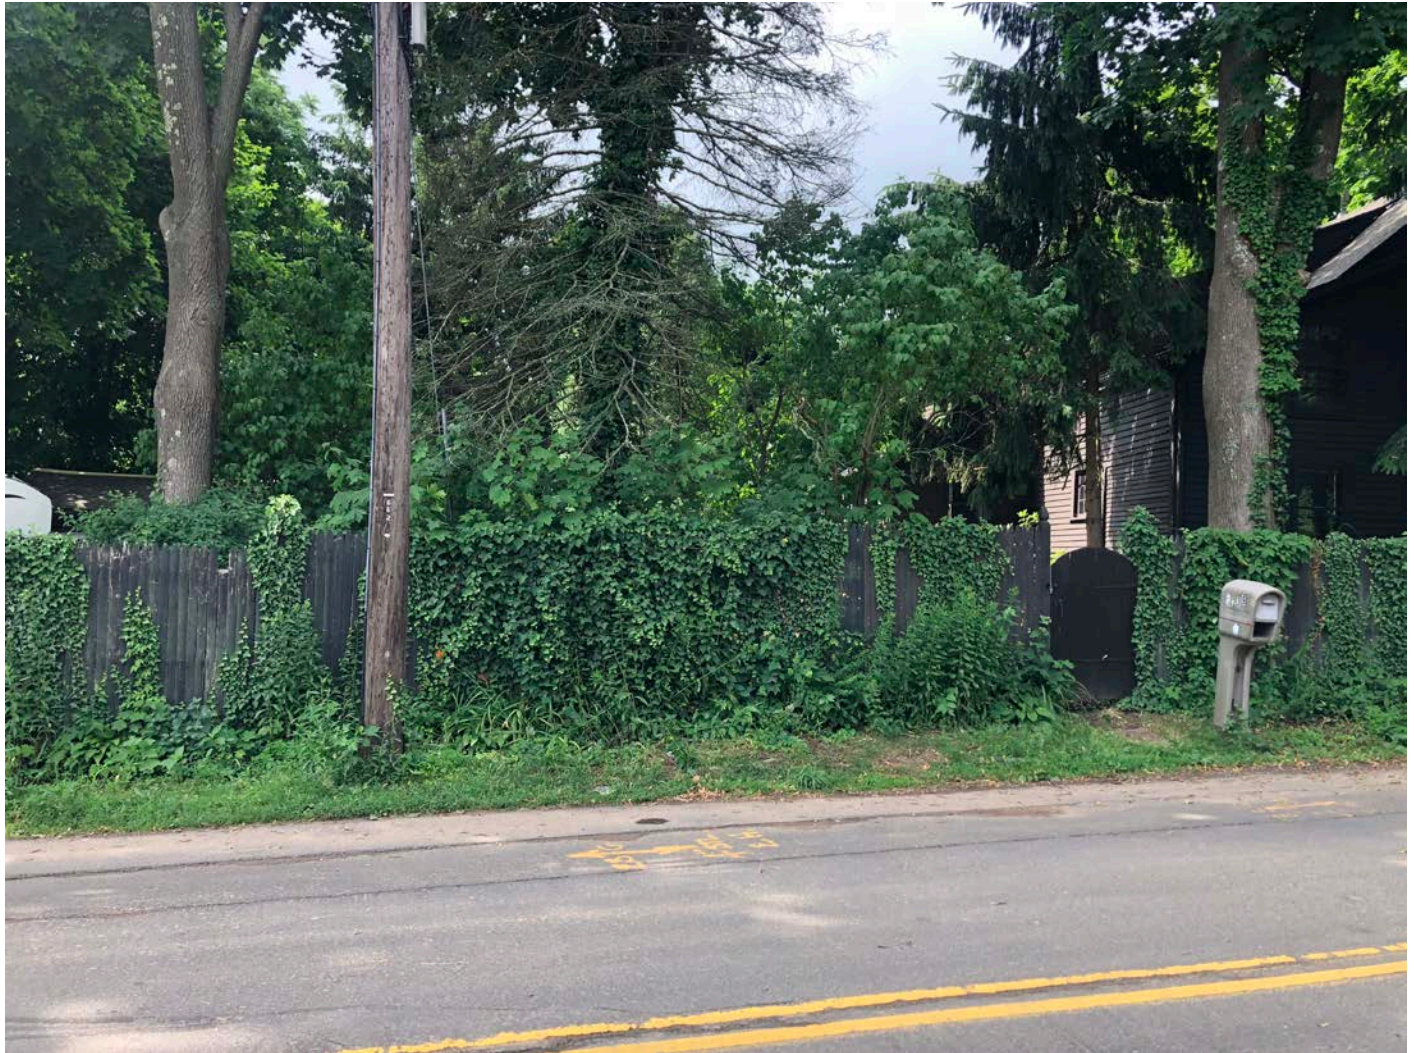
Picture 7: Durham Fire Chief selected the area immediately to the right of the telephone pole as the new location of a hydrant to be placed. This location is immediately north of 239 Main Street. Maiden Lane, Durham. View to the south.

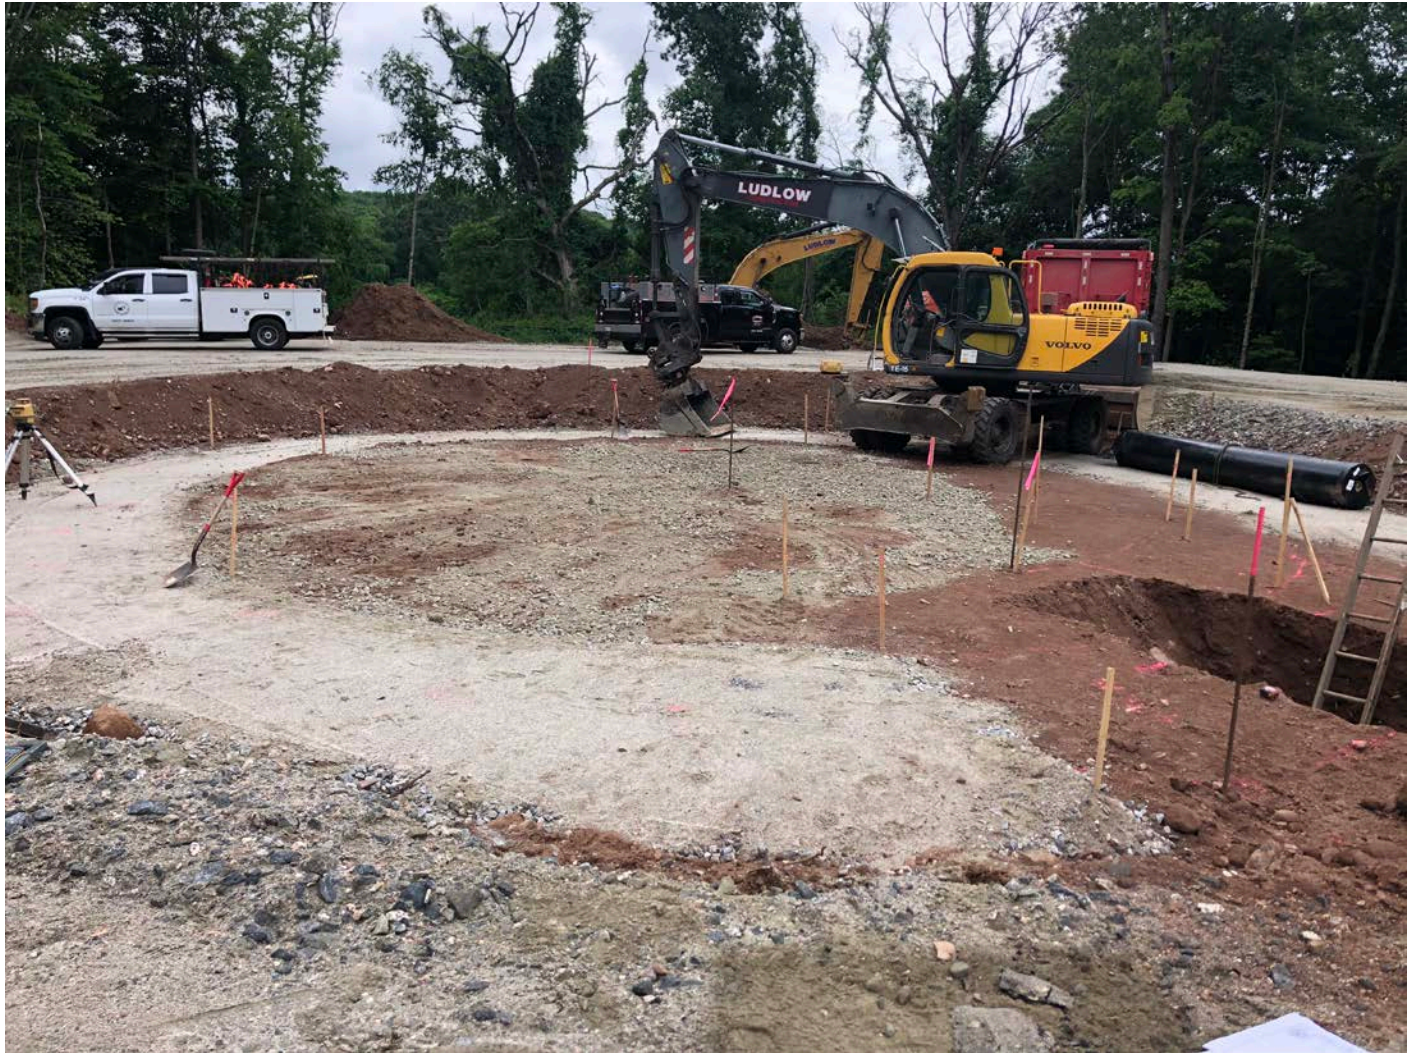
Picture 8: Water tank footprint after Ludlow removed the gravel they placed earlier today upon the advice of DN Tanks. Shared Access Driveway, Middletown. View to the southeast.

1021: Based upon input from DN Tanks, Ludlow has removed the gravel they placed on the water tank footprint this morning.

1108: AECOM spoke to Mike Pio of Ludlow about the tank pad footprint. Mike said that DN Tanks wants them to remove previously placed fill to elevation 435 and bring back up to 437 using the structural fill (1.25" gravel) that AECOM previously approved. Mike also said the compaction test taken last week failed using the new proctor.

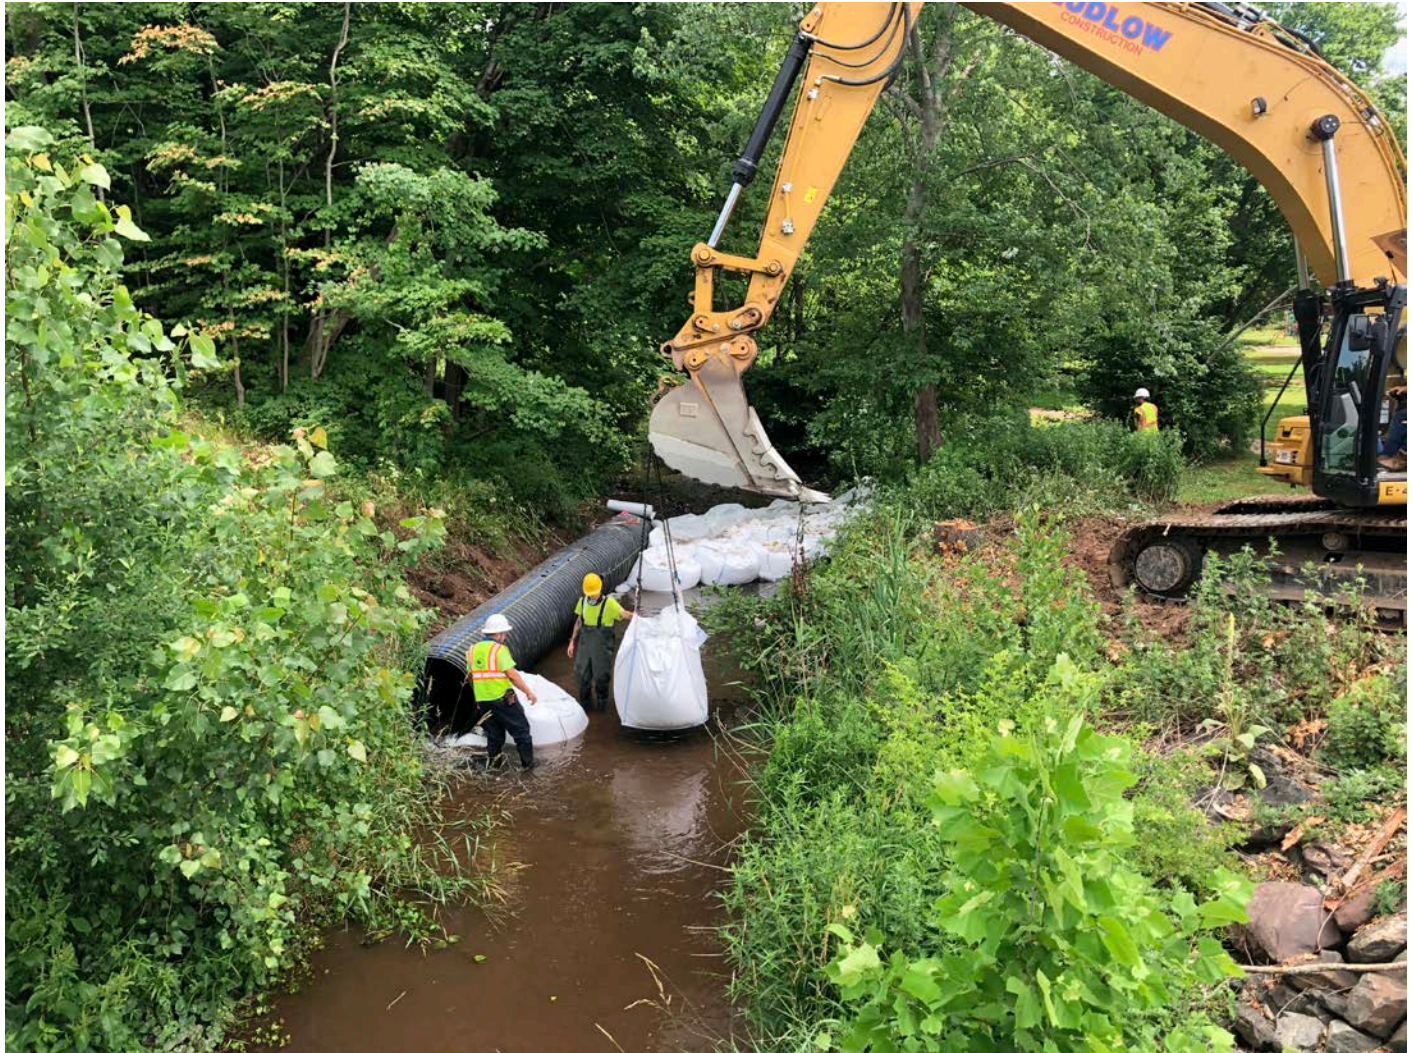
Picture 9: Ludlow placing large sand bag next to work zone for the stream crossing at Station ~511+00. View is upstream and to the north. Pickett Lane, Durham.

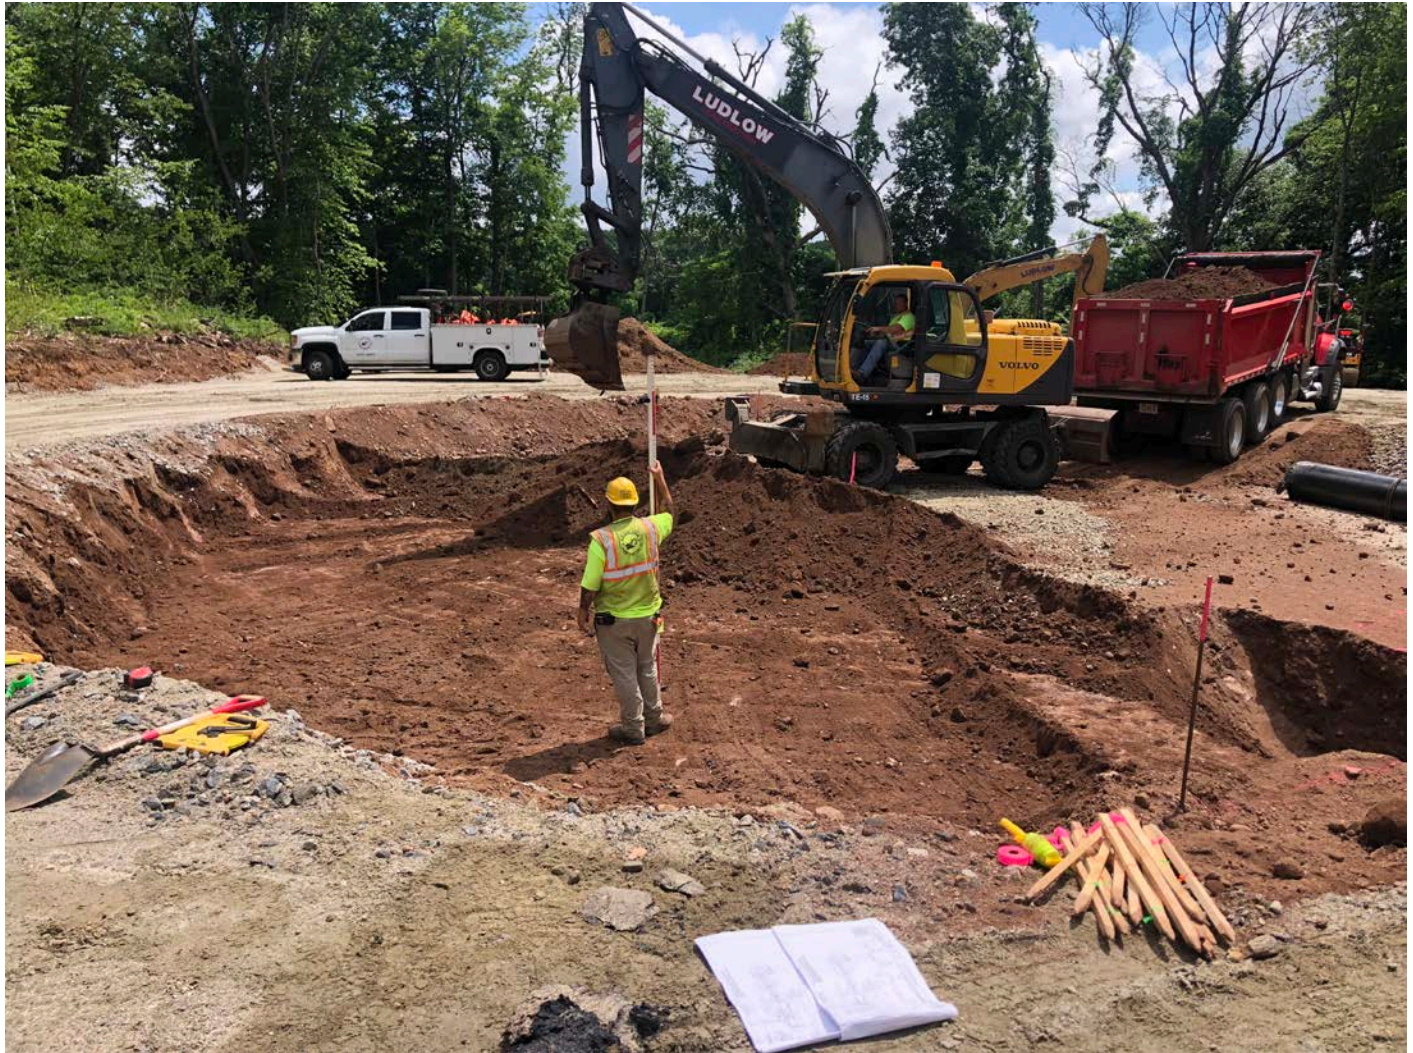
Picture 10: Water tank footprint as Ludlow removes fill down to elevation 435 today upon the advice of DN Tanks. Shared Access Driveway, Middletown. View to the southeast.

1130: Ludlow is removing previously placed fill on the water tank footprint down to elevation 435.

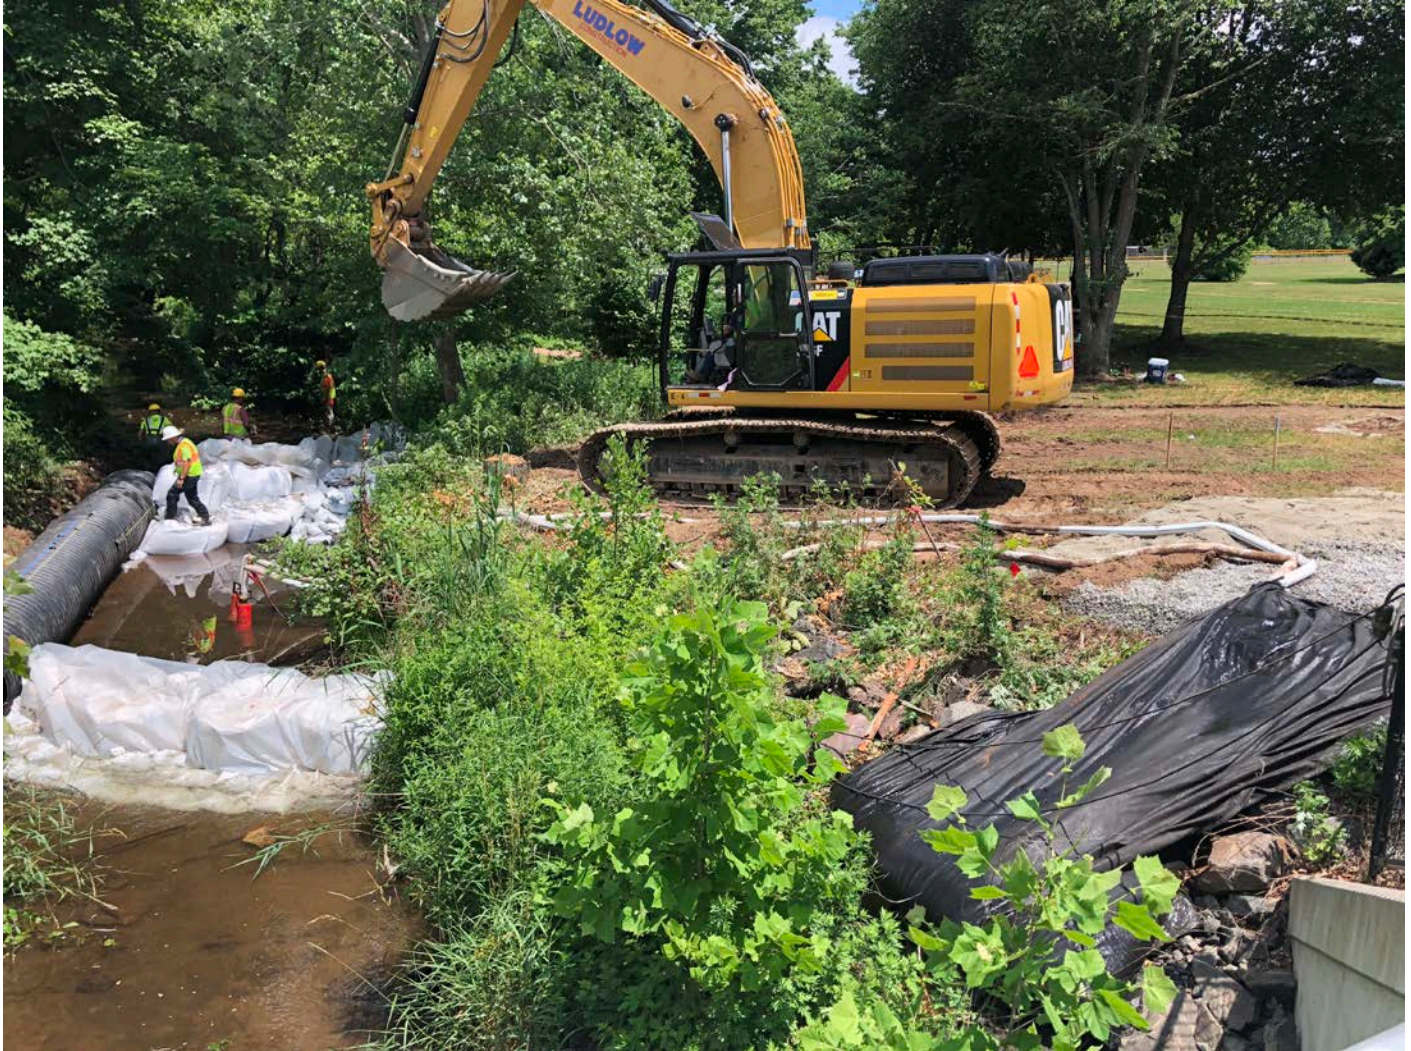
Picture 11: Allyn Brook looking upstream from Pickett Lane. Ludlow has bracketed the work zone for the stream crossing at Station ~511+00 with sand bags and has two pumps moving water from the zone and into the silt bag that is visible on the right hand side of the photo. View is upstream and to the north. Pickett Lane, Durham.

1200: Ludlow continues to work at the stream crossing at Station ~511+00. They have two pumps moving water from the work zone into a silt bag placed downstream on the stream bank.

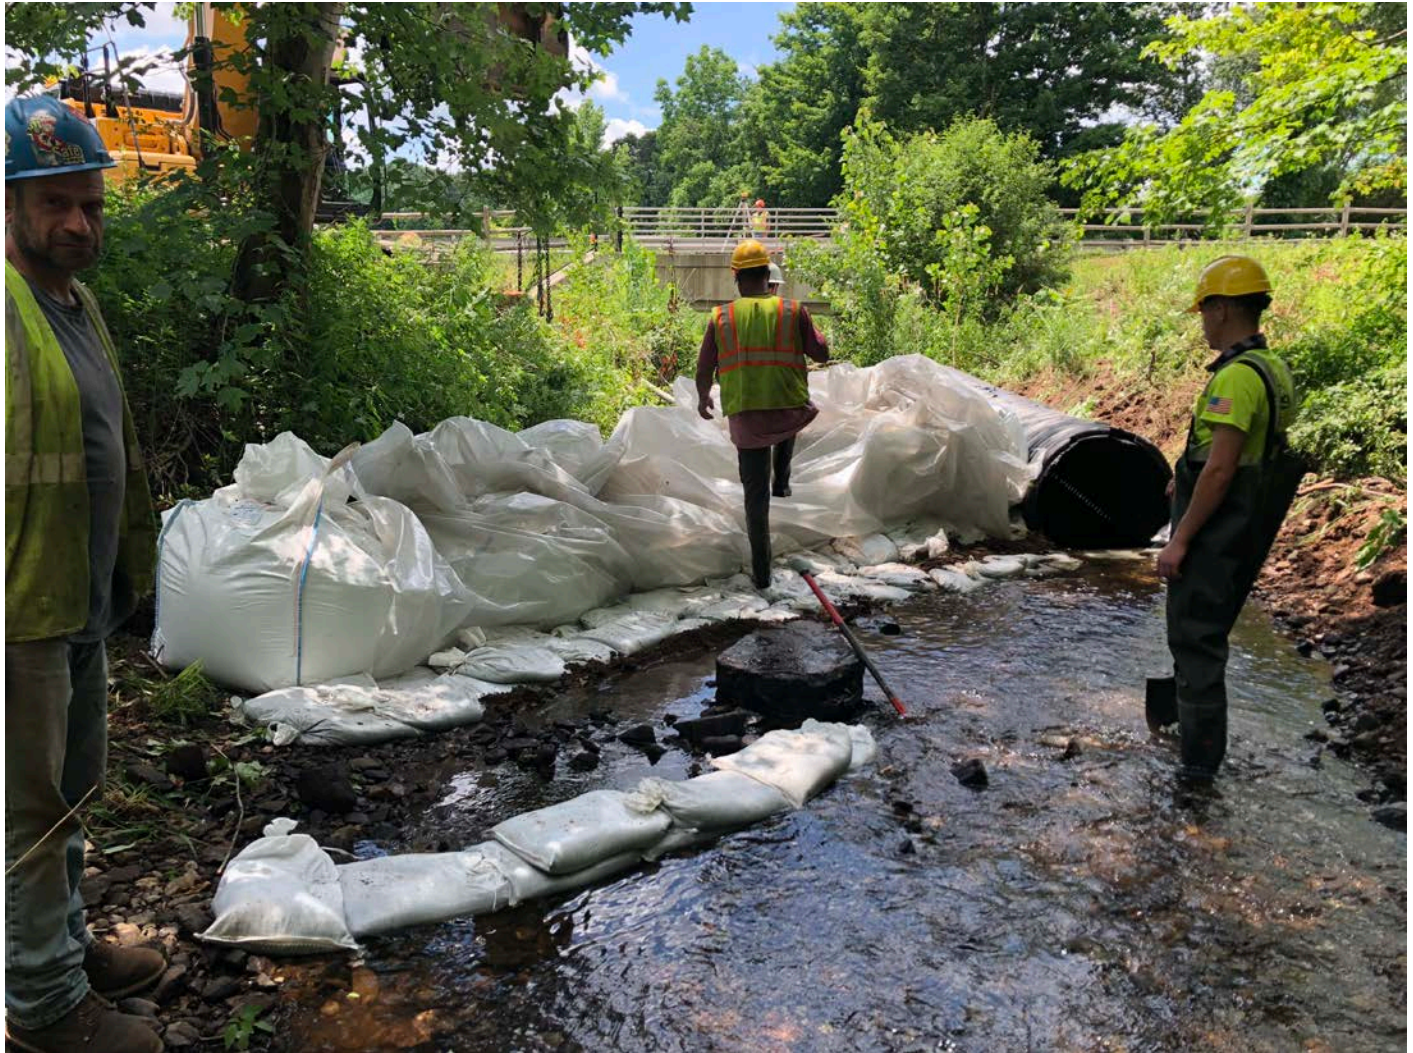
Picture 12: Allyn Brook looking downstream towards Pickett Lane. Ludlow has placed sand bags to divert stream flow into the 40" plastic culvert. Pickett Lane, Durham.

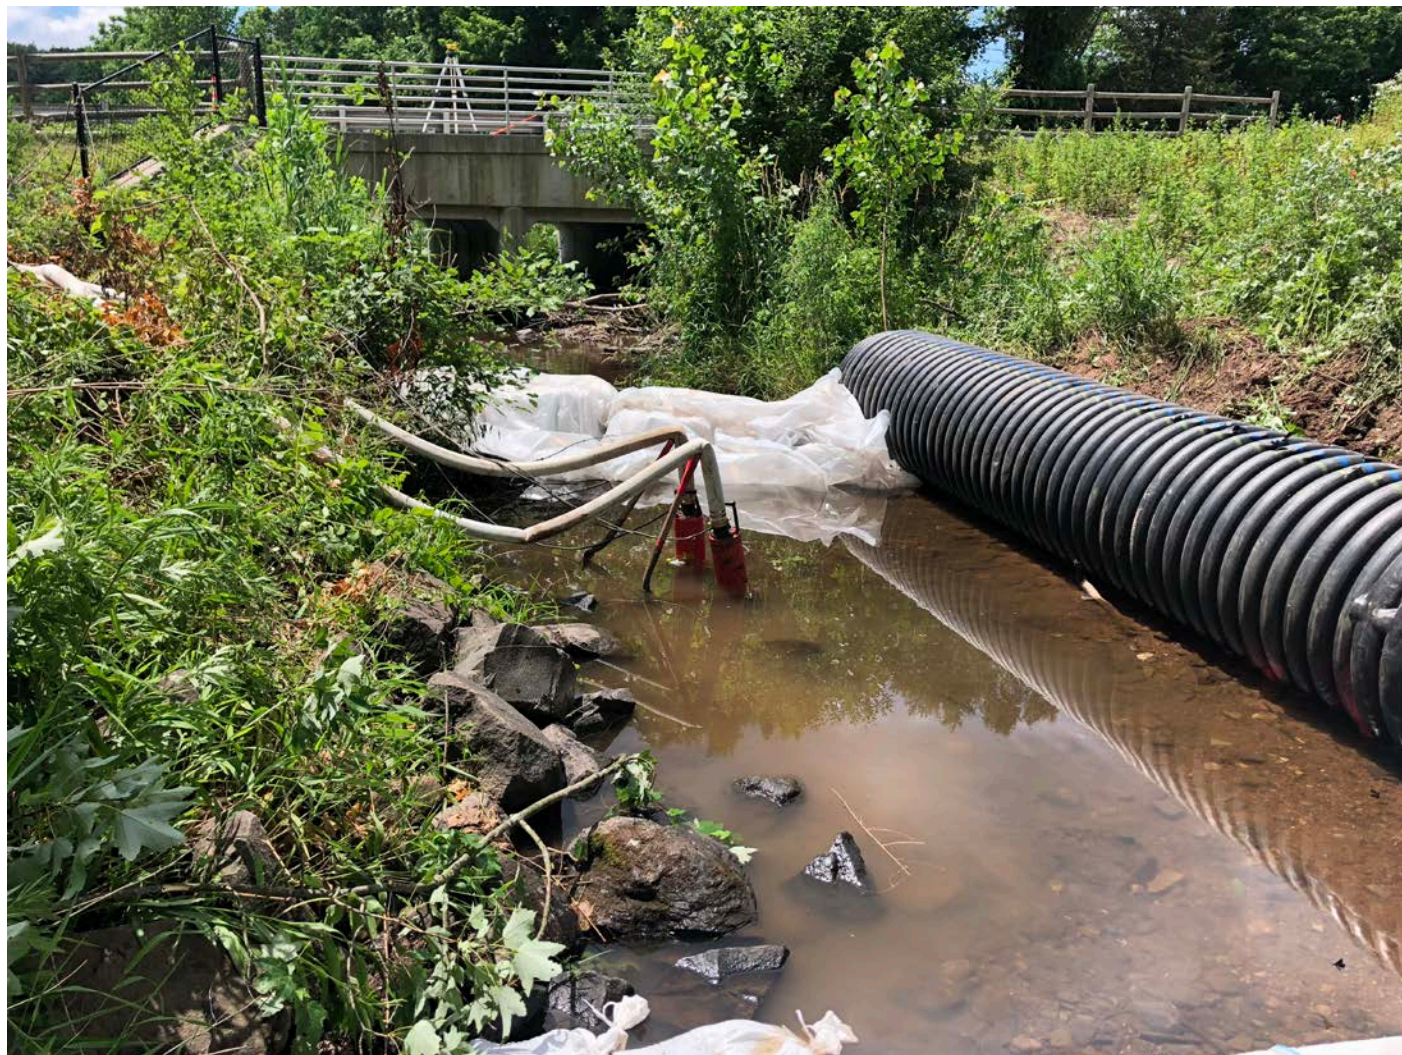
Picture 13: Allyn Brook looking downstream towards Pickett Lane. Ludlow has placed sand bags on the upstream and downstream sides of the stream crossing work zone and stream flow is diverted into the 40" plastic culvert visible on the right. Station ~511+00, Pickett Lane, Durham.

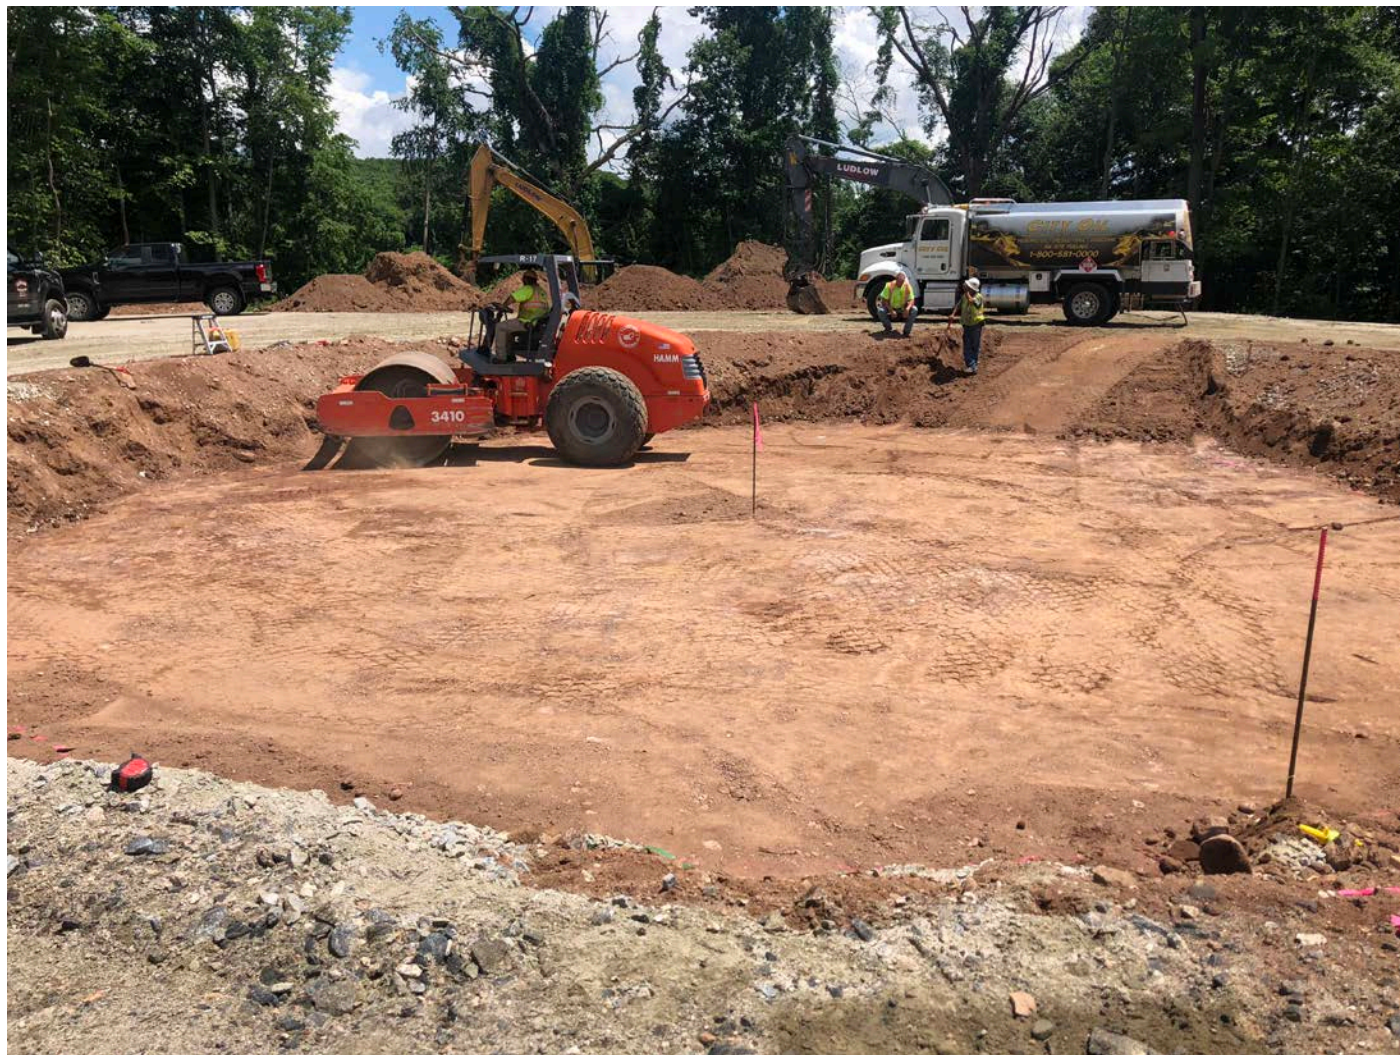
Picture 14: Ludlow compacting fill at elevation 435 at the water tank footprint. Shared Access Driveway, Middletown. View to the southeast.

1249: Ludlow has finished excavating material at the water tank footprint down to elevation 435 and is currently compacting the tank footprint with a roller.
