Daily Report

Project:	Durham Meadows Pipeline Installation	Date:	June 29, 2020
Location:	Maiden Lane, Pickett Lane, and the Shared Access Driveway	Day of Week:	Monday
Project #:	AECOM: 6061487	Report No:	109
Contractor:	Ludlow Construction	Page:	1 of 19

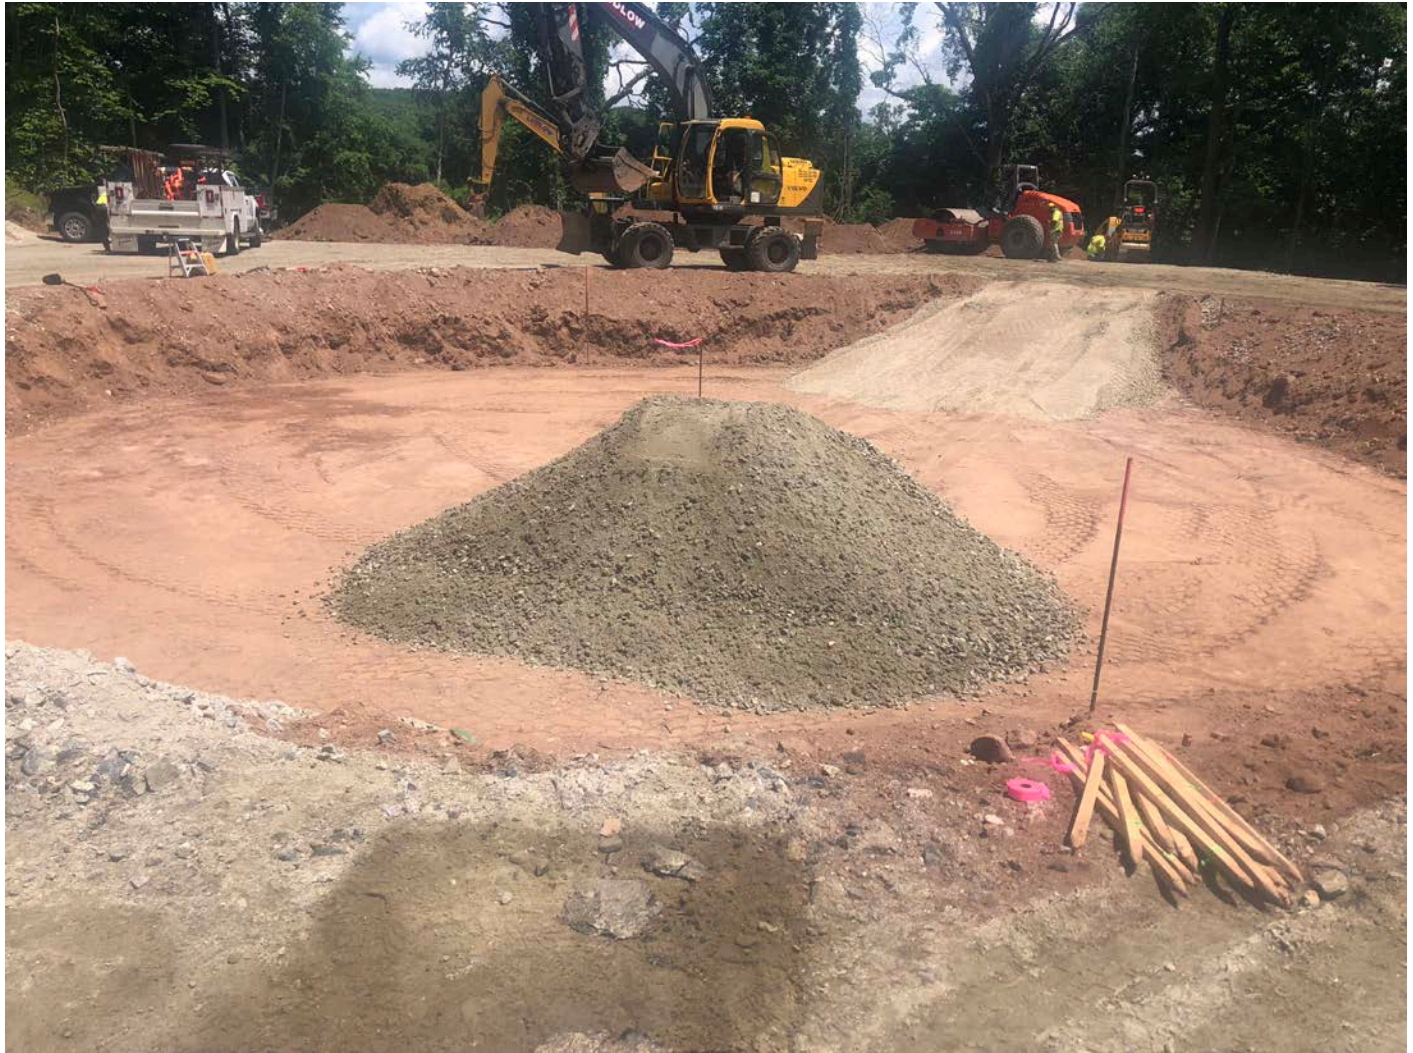
Picture 15: Ludlow placing structural fill on the water tank footprint. Shared Access Driveway, Middletown. View to the southeast.

1322: Ludlow has begun to place structural fill on the water tank footprint.

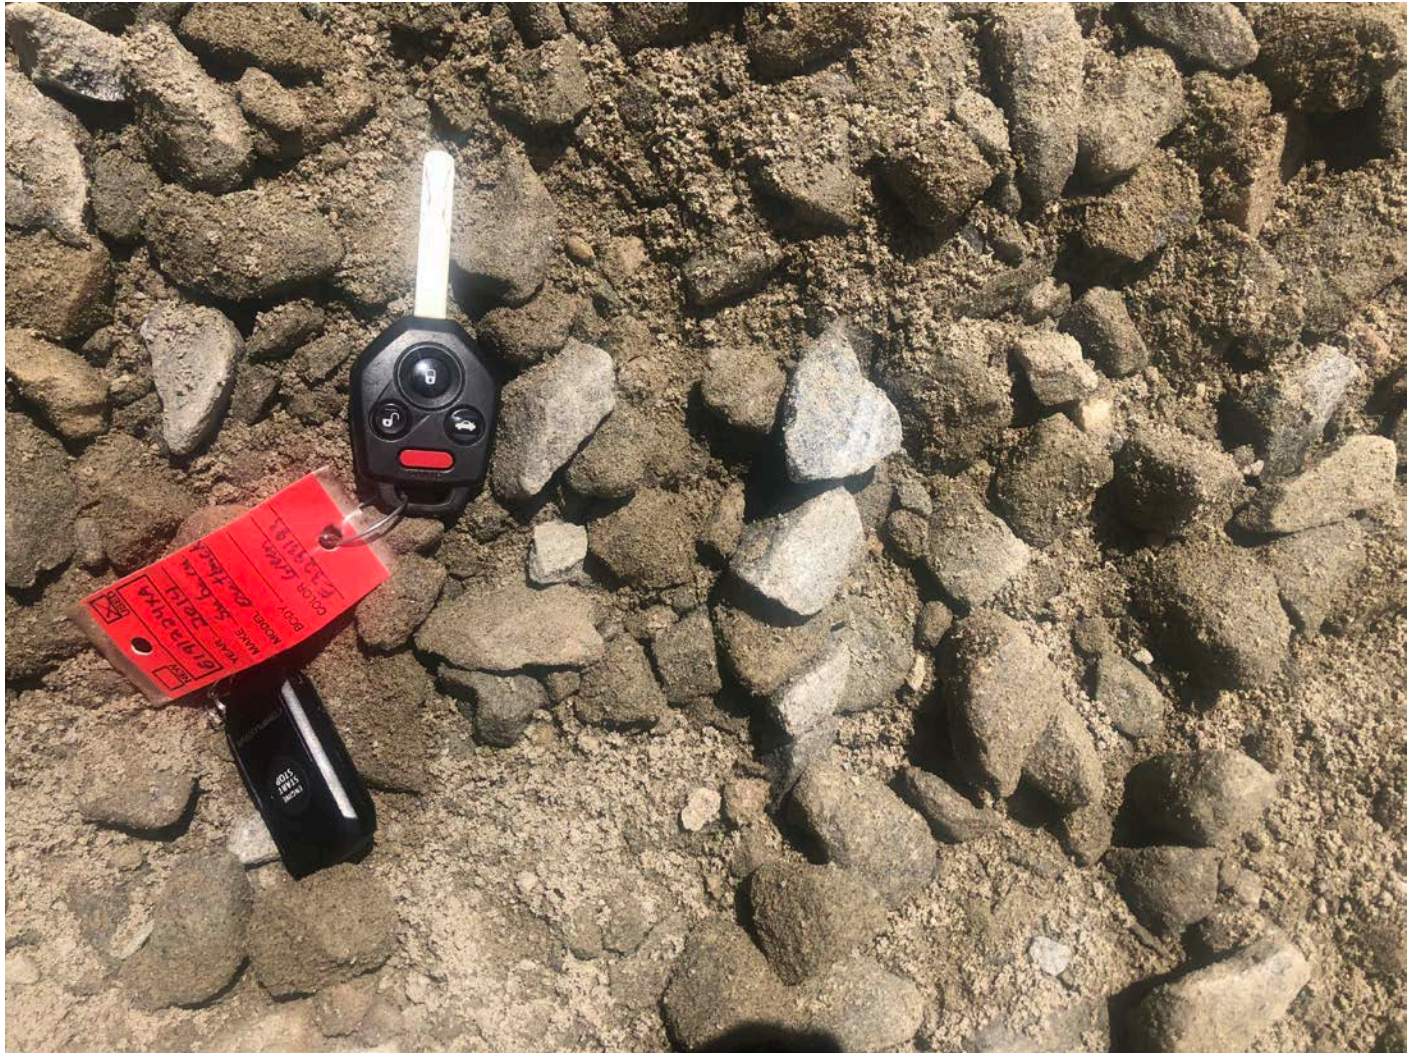
Picture 16: Closeup of structural fill placed on the water tank footprint with keys to provide scale. Shared Access Road, Middletown. View to the southeast.
