Daily Report

Project:	Durham Meadows Pipeline Installation	Date:	July 2, 2020
Location:	Maple Avenue, Pickett Lane, and the Shared Access Driveway	Day of Week:	Thursday
Project #:	AECOM: 6061487	Report No:	112
Contractor:	Ludlow Construction	Page:	1 of 16

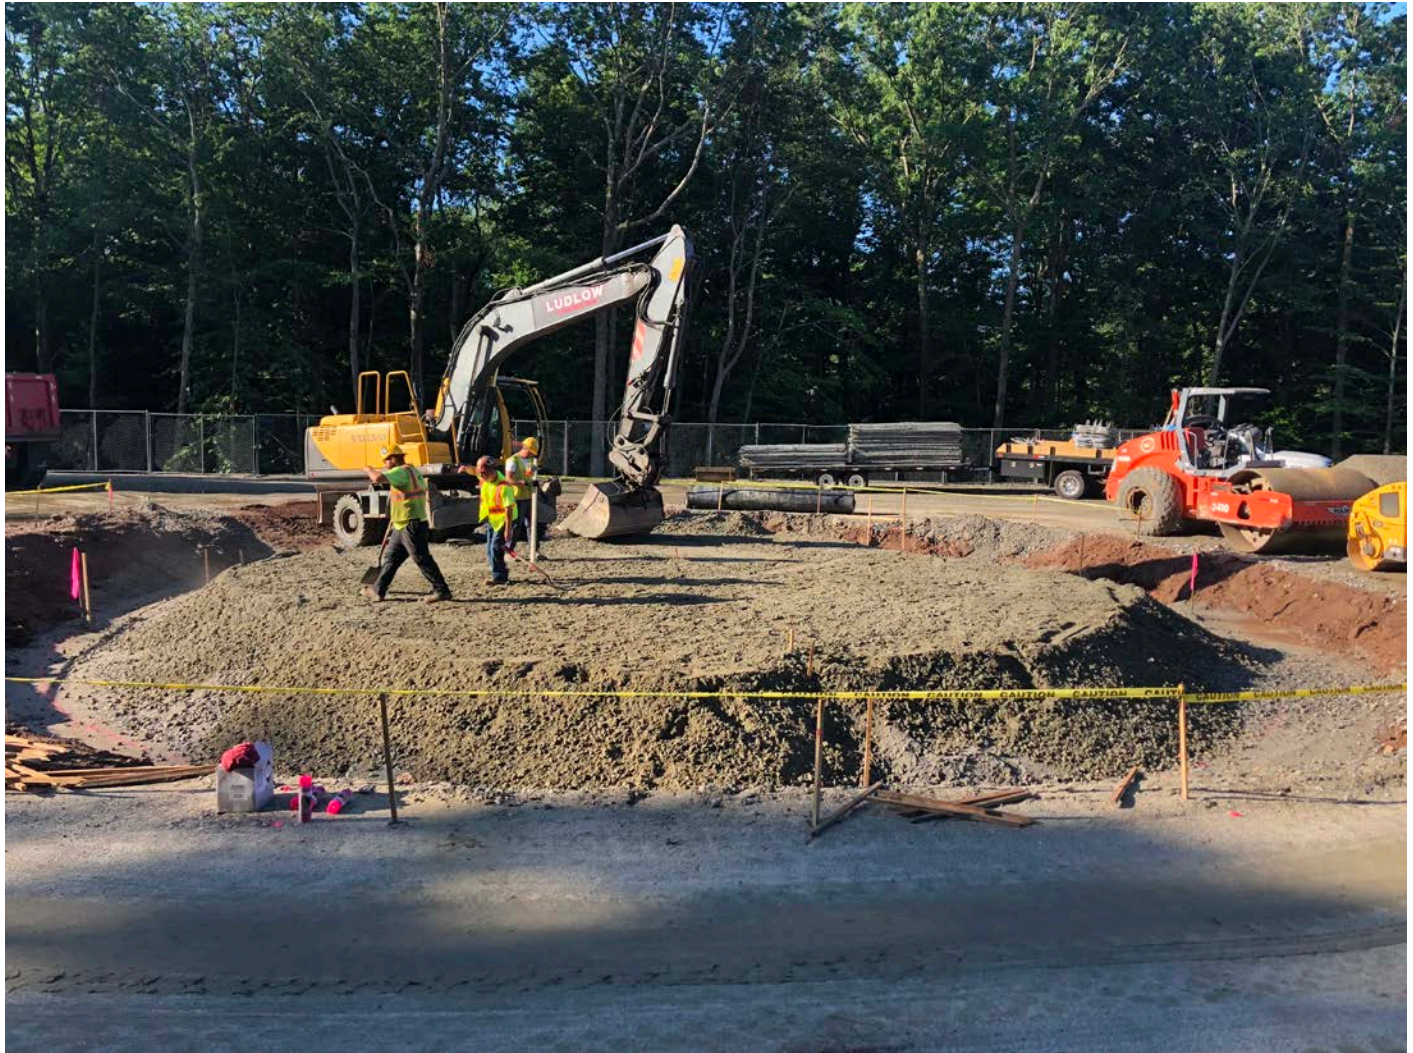
Picture 2: Ludlow placing structural fill at the water tank footprint on the Shared Access Driveway, Middletown, Durham. View to the south.

0802: Ludlow places another 8" lift of structural fill at the tank pad footprint, bringing the elevation up to 439.67.

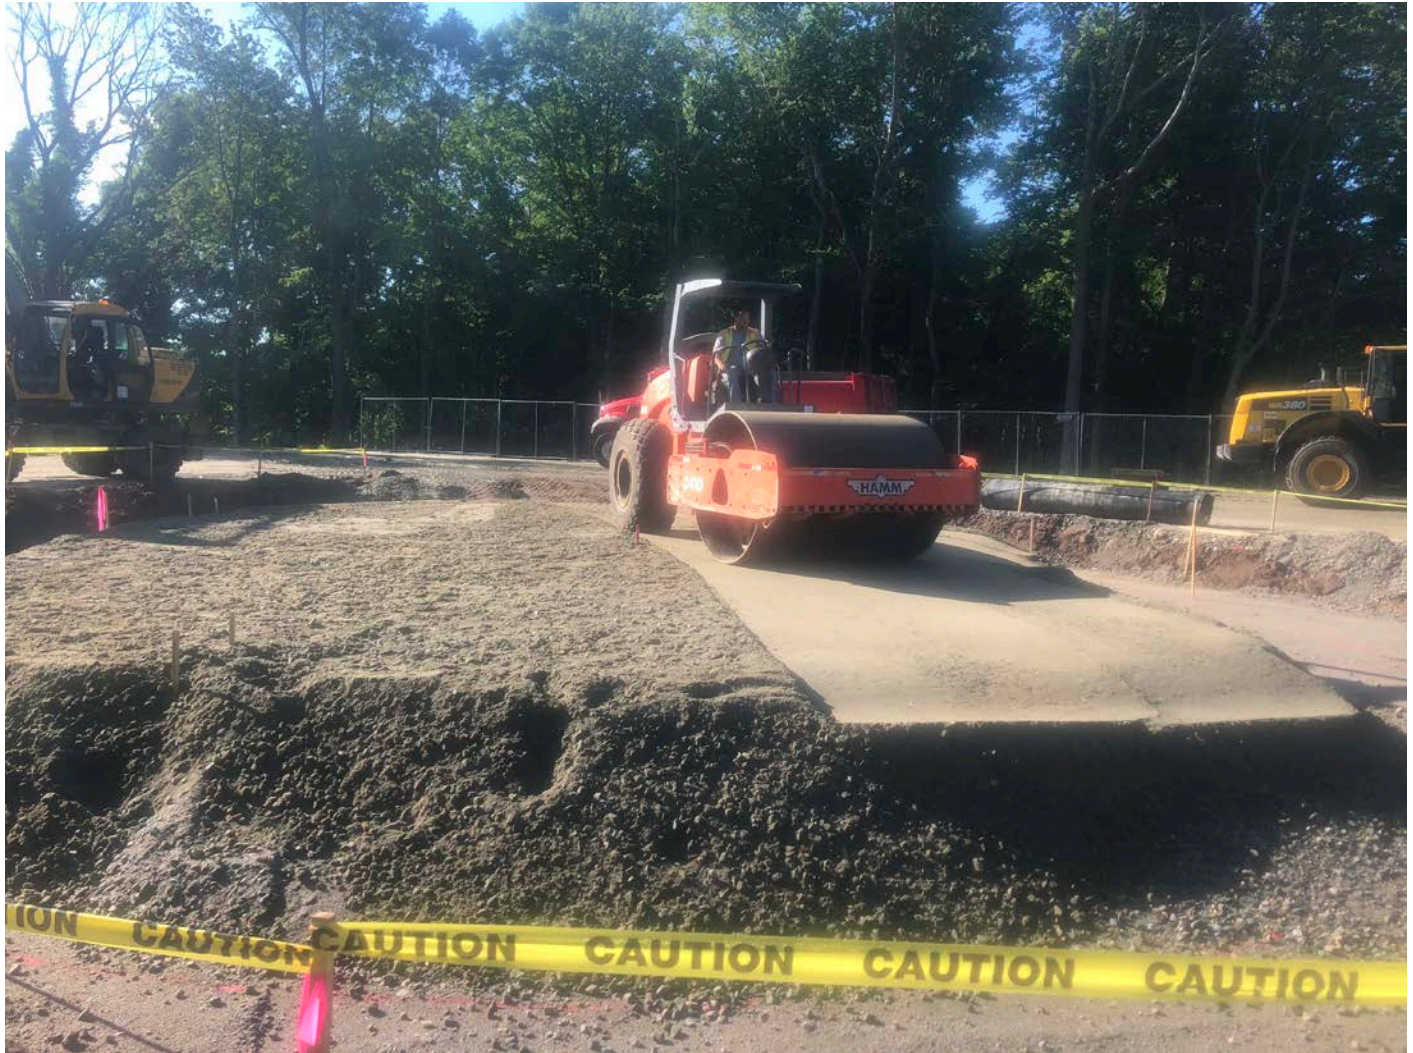
Picture 3: Ludlow compacting structural fill at the water tank footprint on the Shared Access Driveway, Middletown, Durham. View to the south.

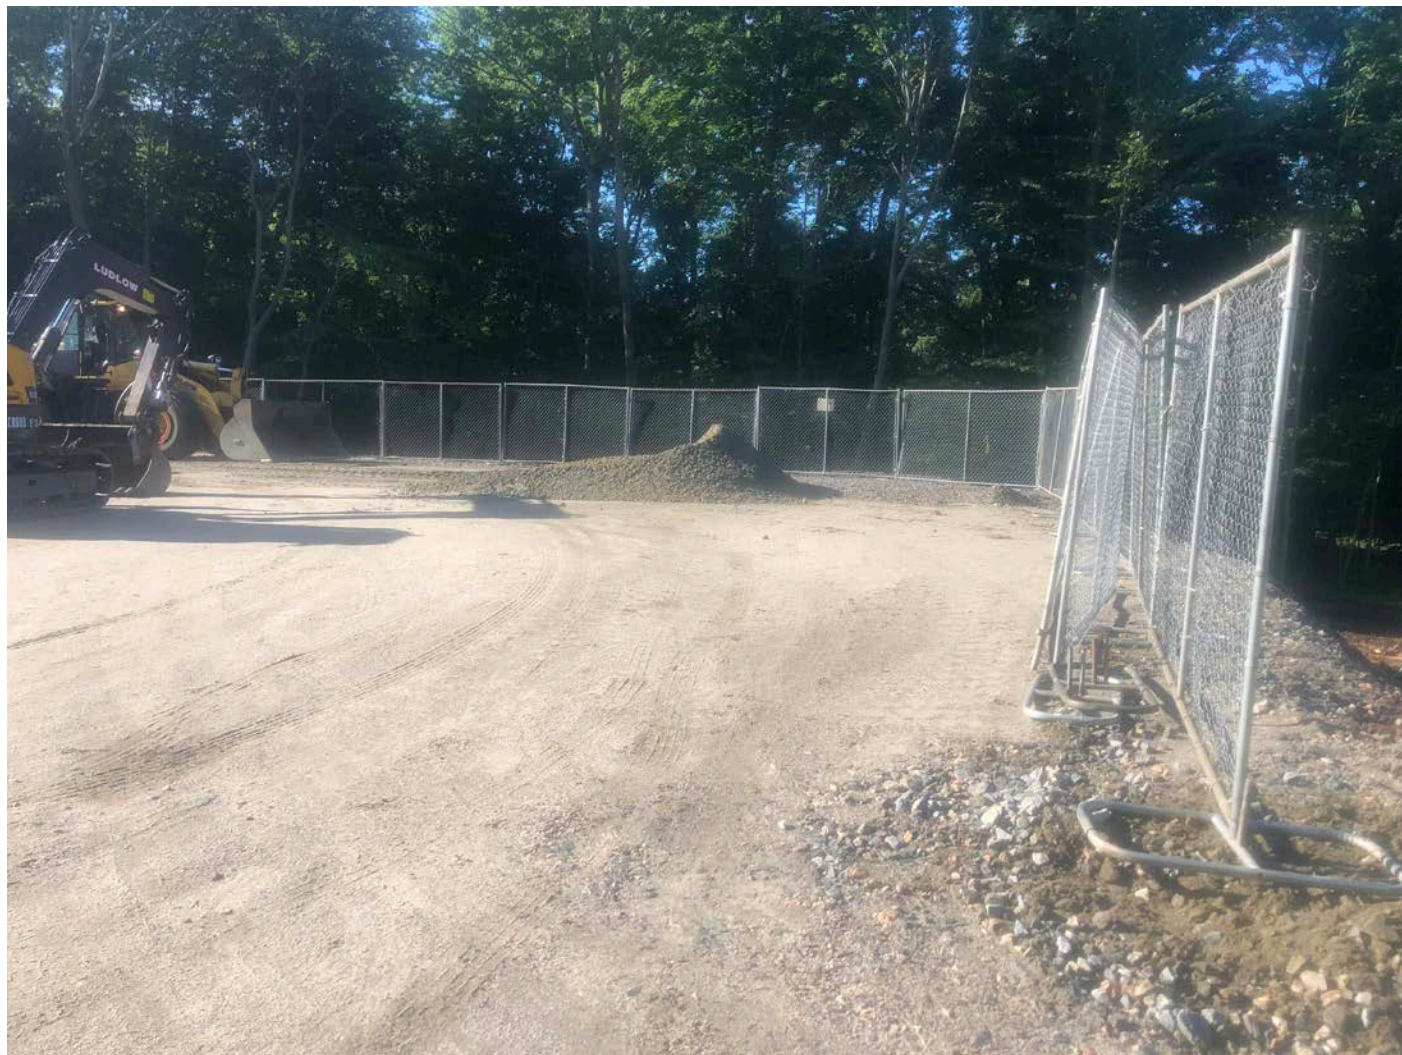
Picture 4: Temporary fencing erected around the water tank footprint at the Shared Access Driveway, Middletown, Durham. View to the south.

0930: Eagle Fence has finished installing temporary fencing around water tank footprint.

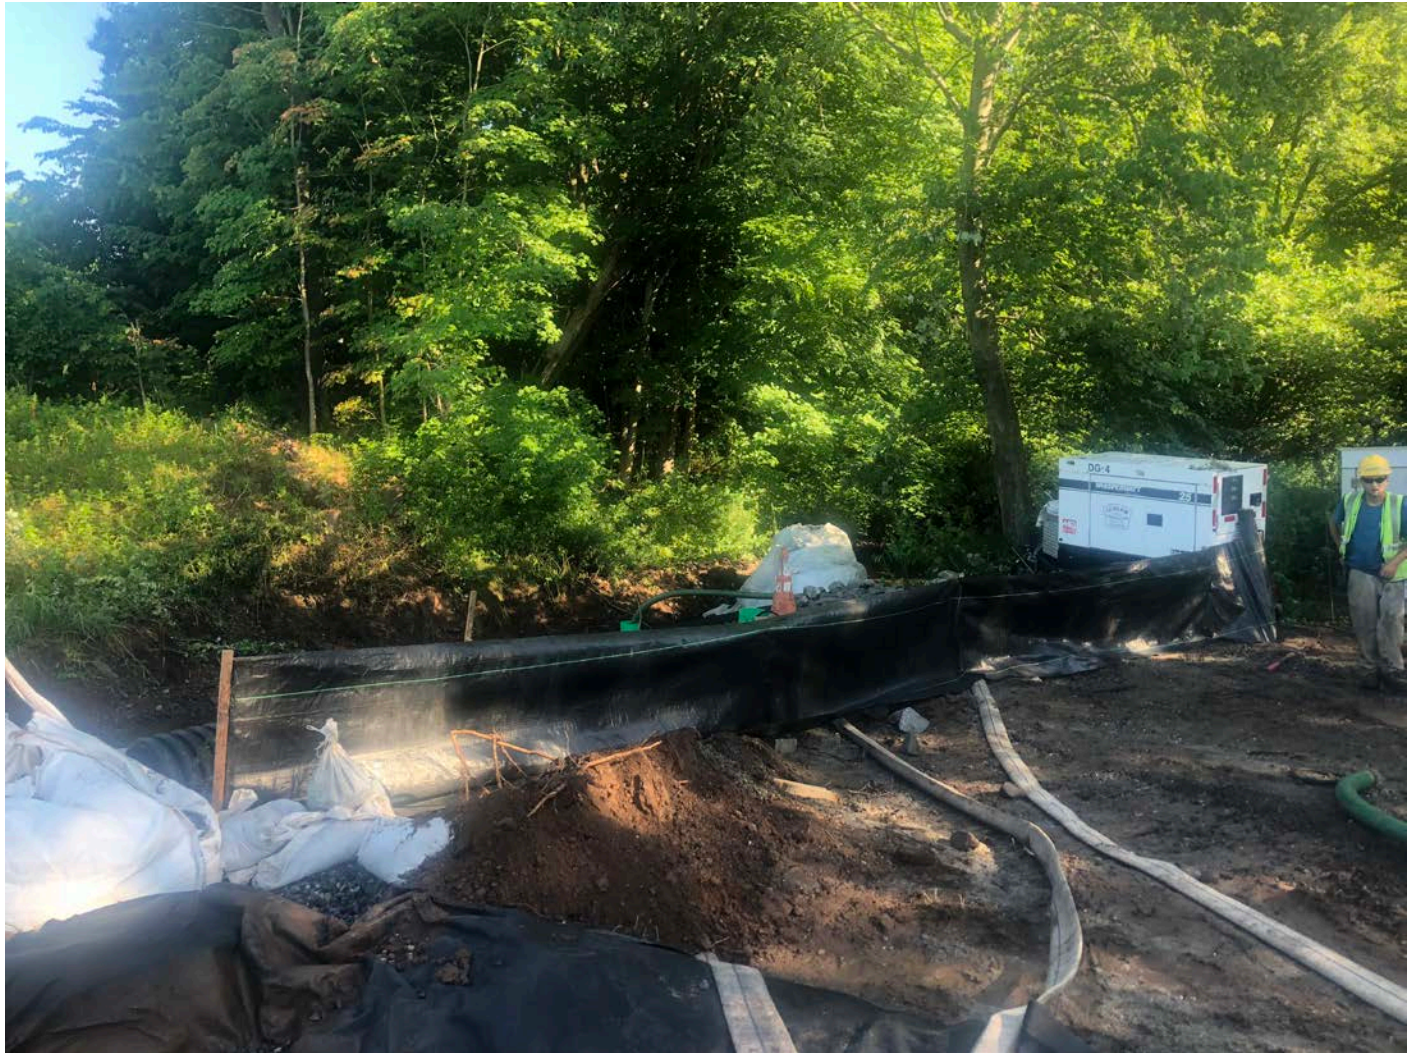
Picture 5: Silt fence installed along the east side of Allyn Brook at Station ~511+00. Pickett Lane, Durham. View to the northwest.

0814: Ludlow is placing silt fence at the top of the east bank of Allyn Brook next to the stream crossing.

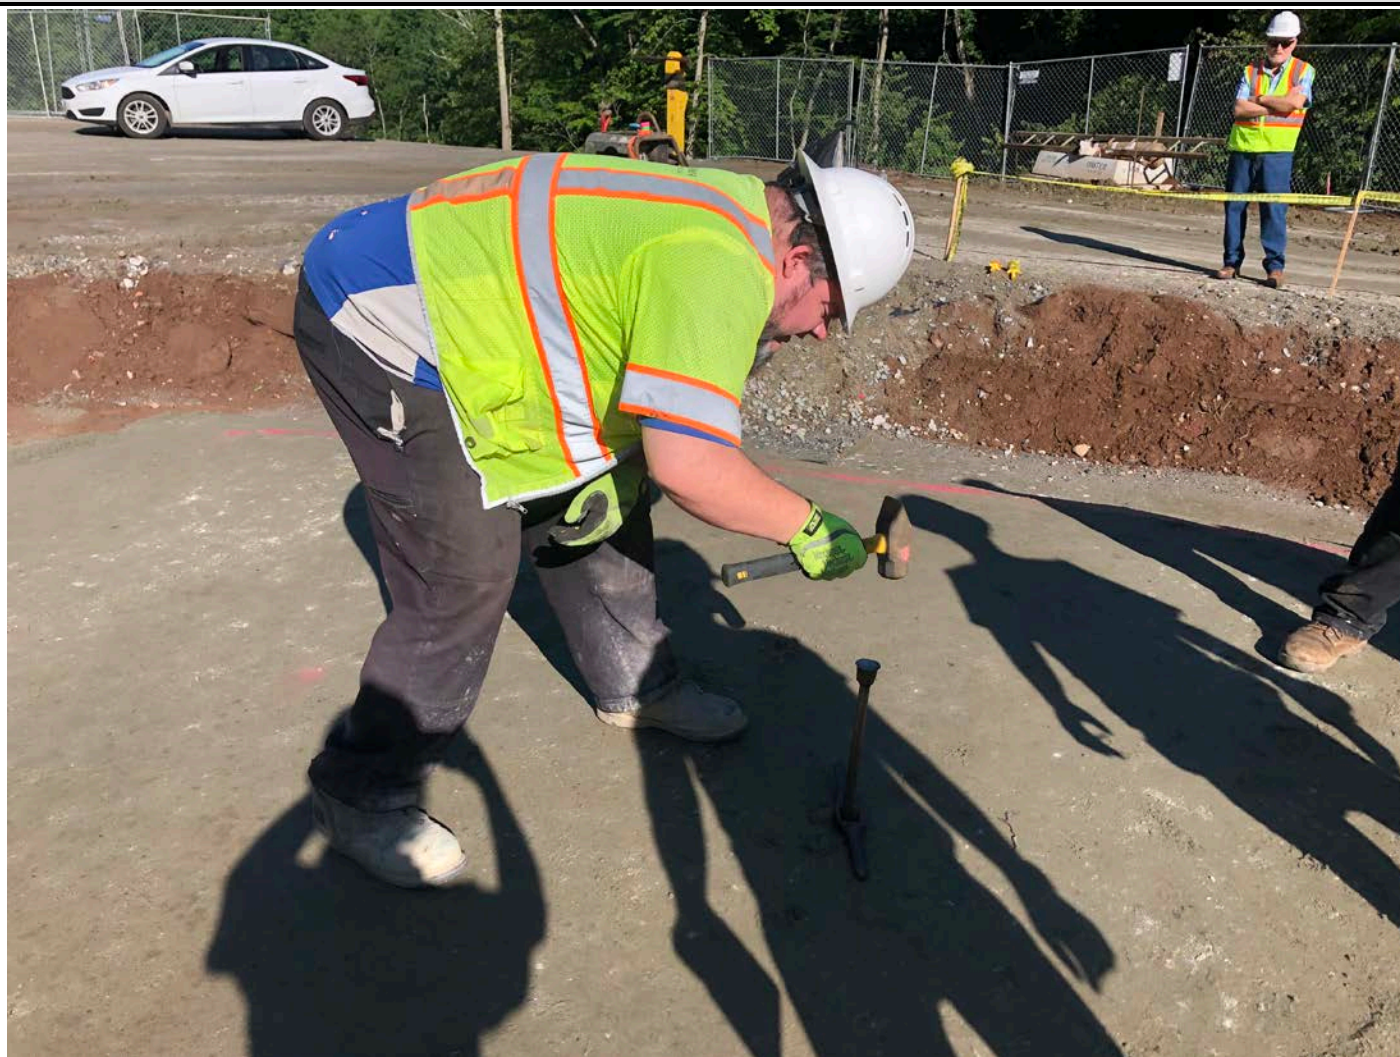
Picture 6: JTC preparing to collect soil compaction data at the water tank footprint at the Shared Access Driveway, Middletown, Durham. View to the west.

0822: JTC is present at tank pad footprint to perform soil compaction test on the elevation 439.67 lift of structural fill. JTC is going to collect 4 readings from this lift.

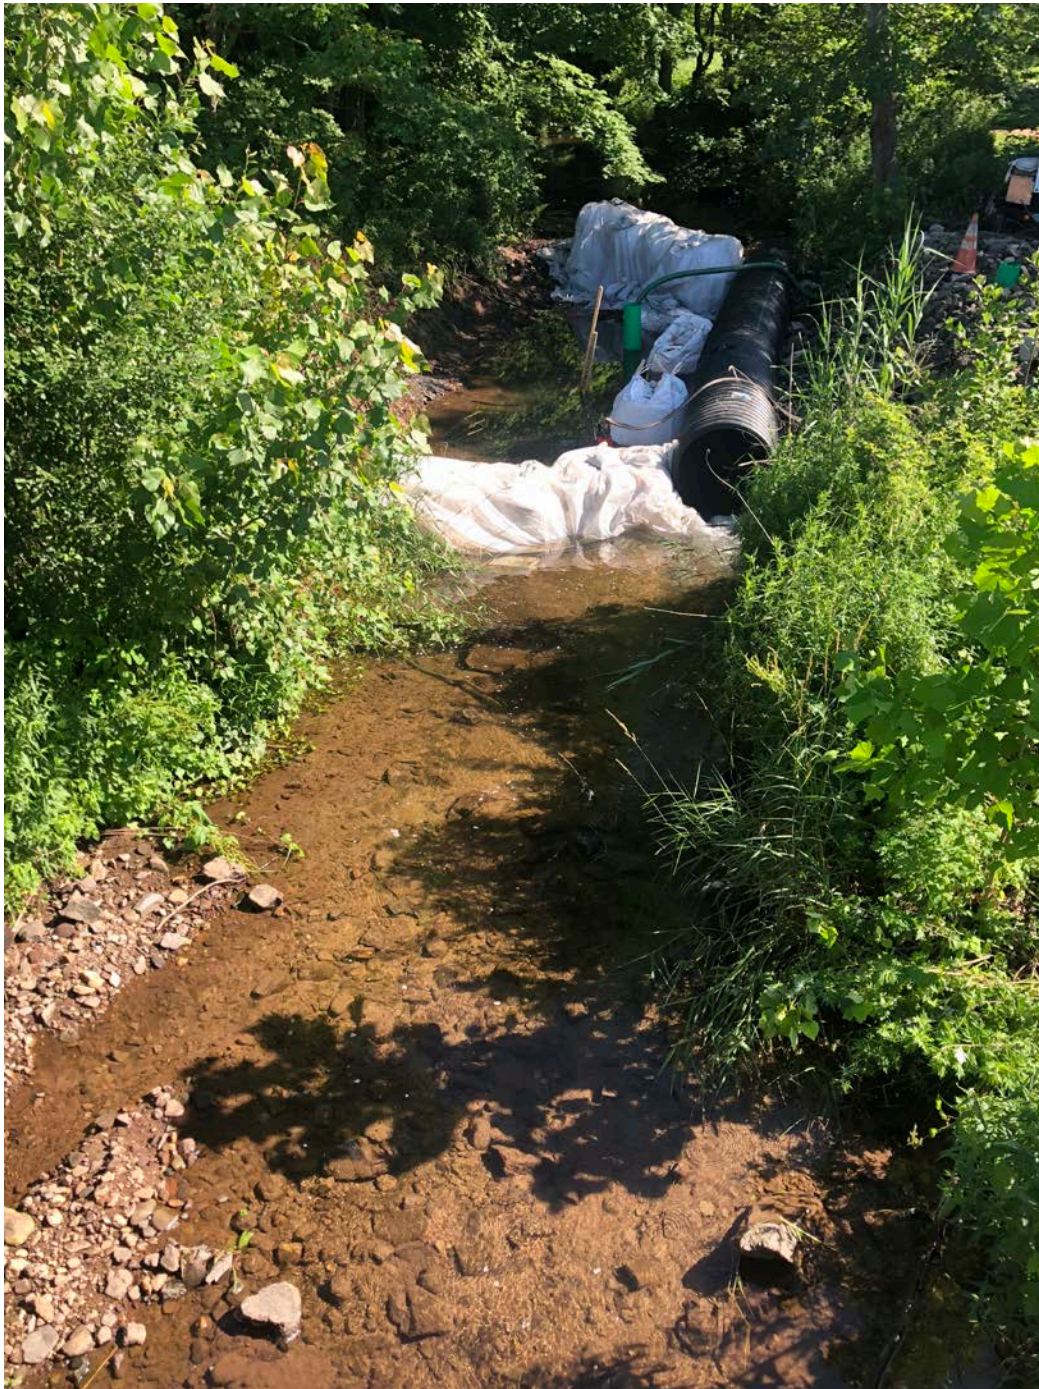
Picture 7: Stream crossing work zone at Allyn Brook at Station ~511+00. Pickett Lane, Durham. View to the north.

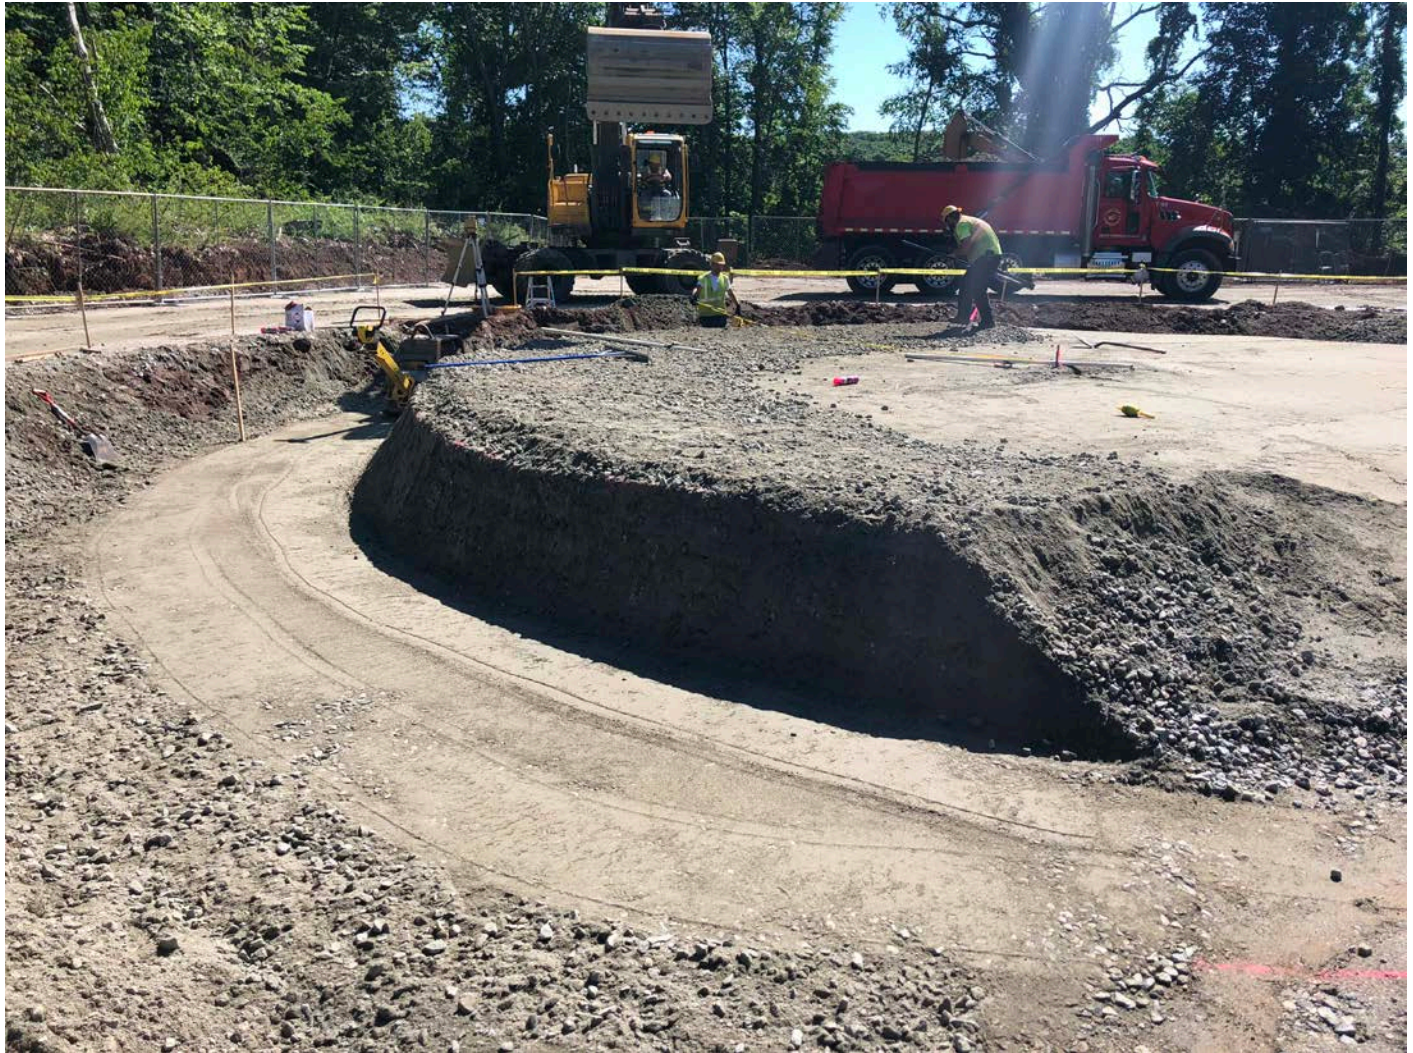
Picture 8: Ludlow shaping soils at elevation 437 and 439.67 at the water tank footprint. Shared Access Driveway, Middletown. View to the east.

1111: Ludlow continues to refine the platform of soil that has been built up within the footprint of the tank pad at elevation 439.67. The ring surrounding the platform (for the placement of the future lean concrete footing extension) is currently at elevation 437.

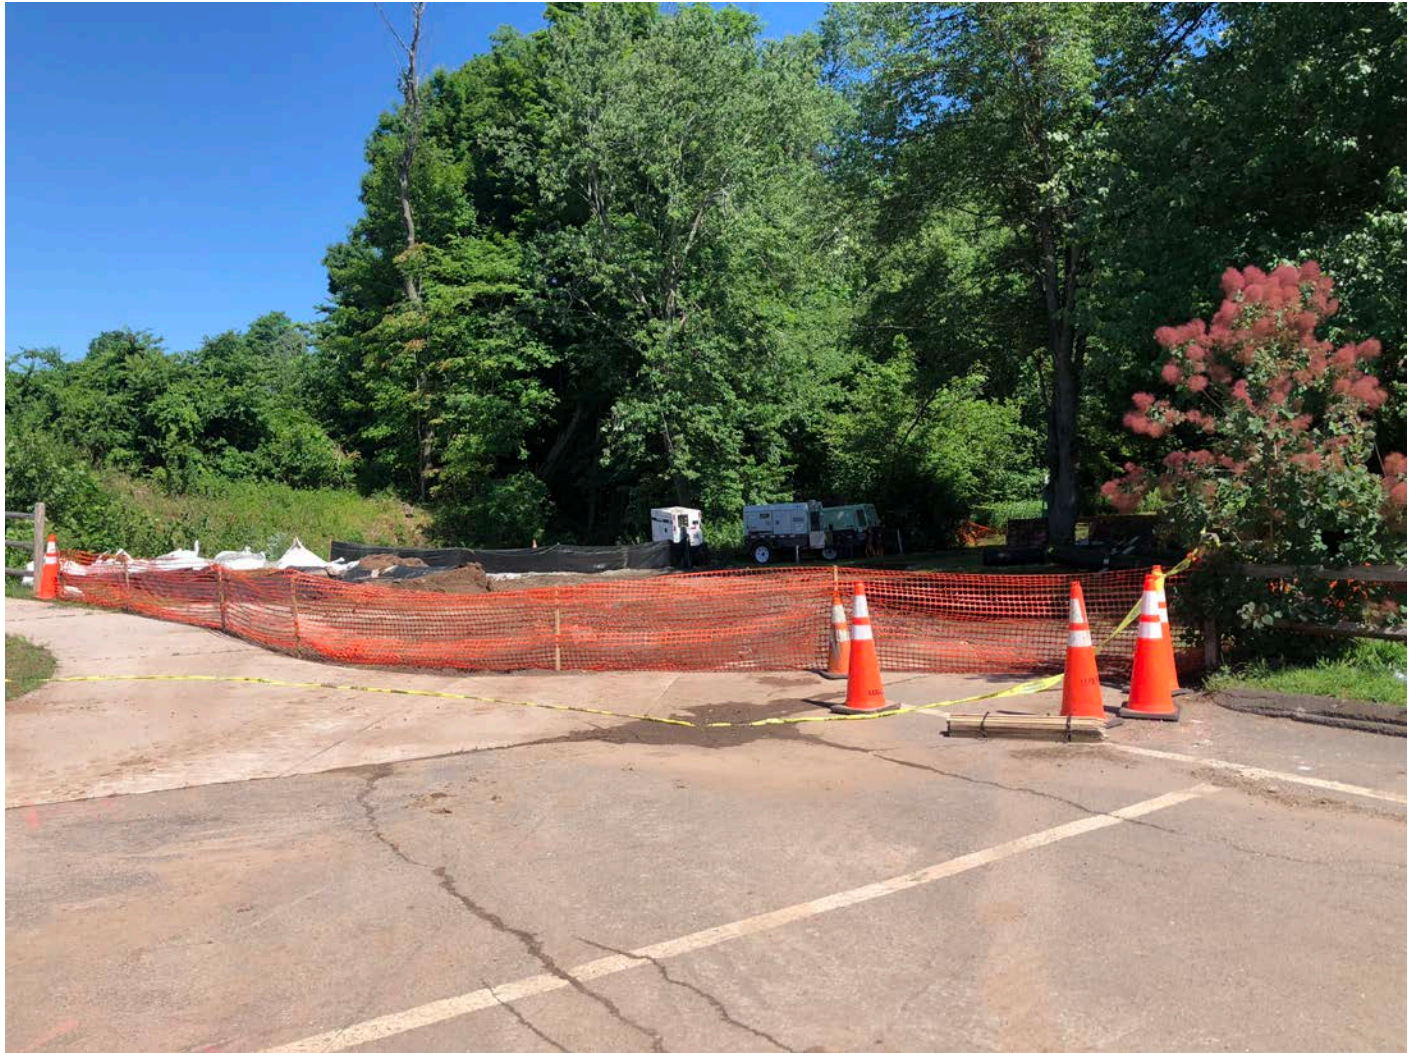
Picture 9: Snow fence placed around work zone on the east side of Allyn Brook at Station ~511+00. Pickett Lane, Durham. View to the northwest.

1035: Ludlow has the work zone on the east bank of Allyn Brook secured with orange snow fence.

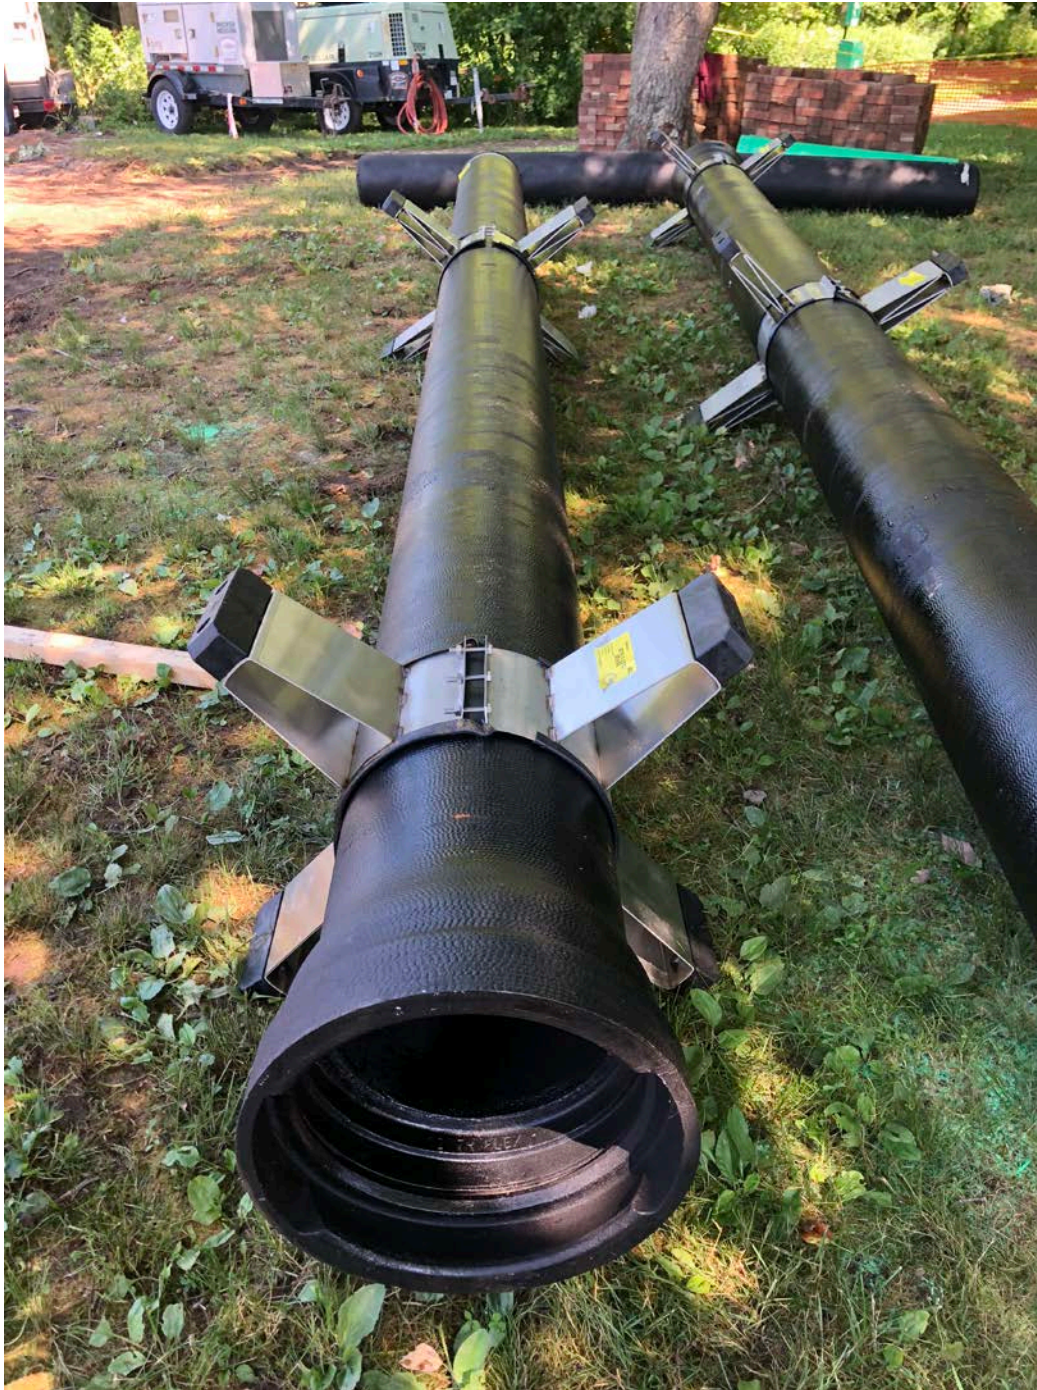
Picture 10: Spacers placed around 12" DIP for insertion into the 36" conduit Ludlow has placed beneath the stream bed of Allyn Brook at Station ~511+00. Pickett Lane, Durham.

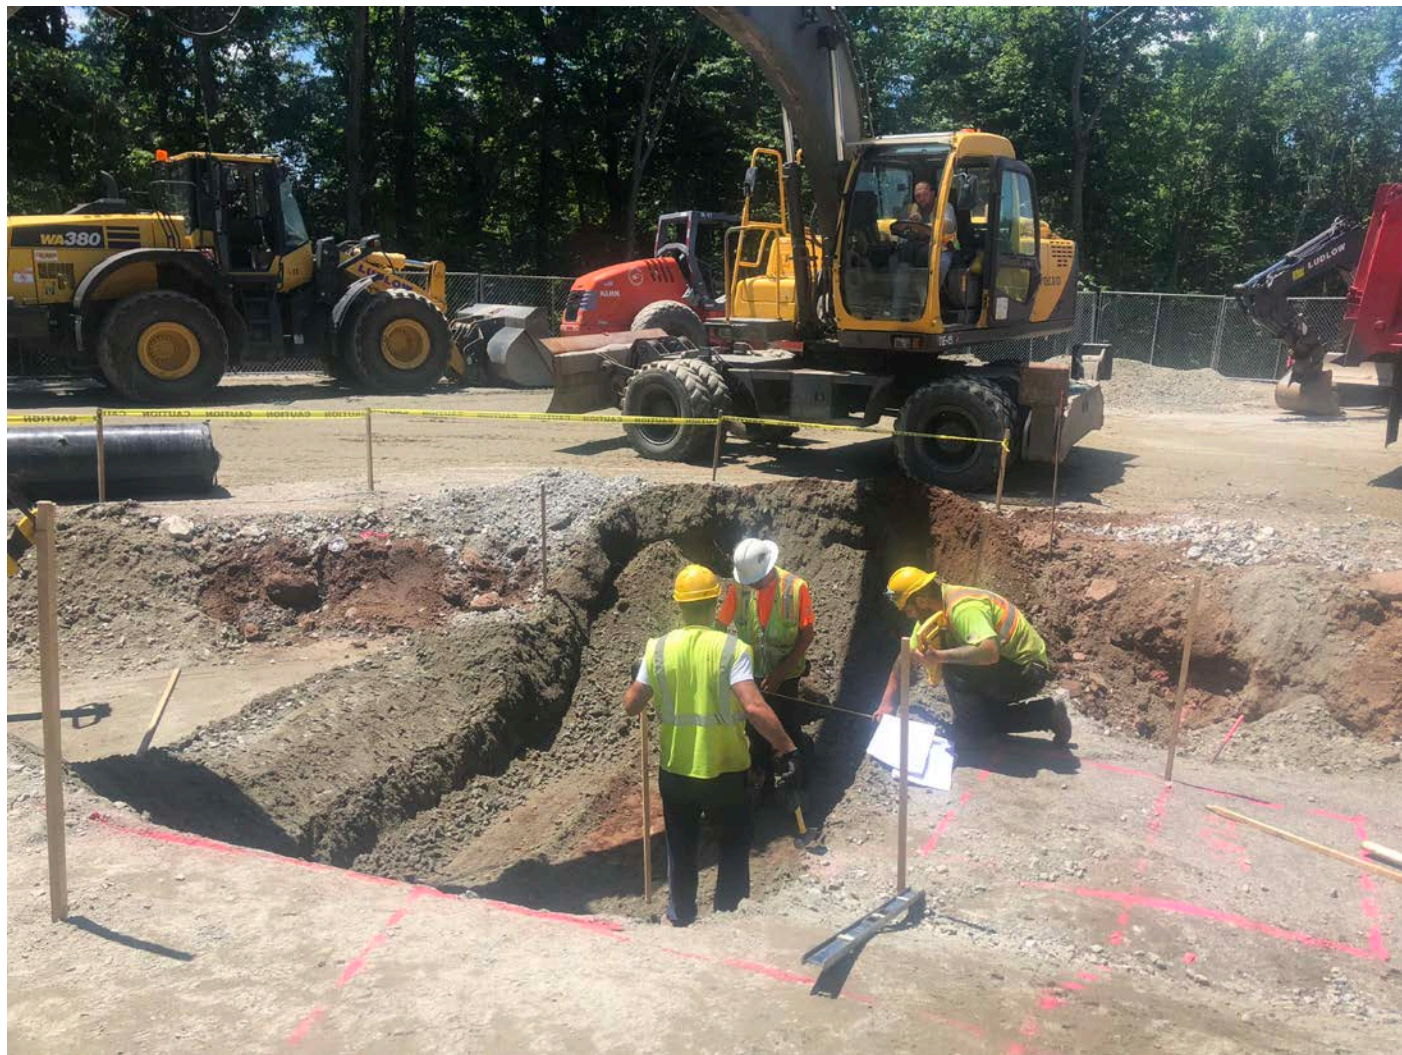
Picture 12: Ludlow excavating trench for the placement the water tank supply pipe at the water tank footprint. Shared Access Driveway, Middletown. View to the southwest.

1312: Ludlow is excavating a trench within the water tank footprint for the future installation of the water tank fill supply pipe.

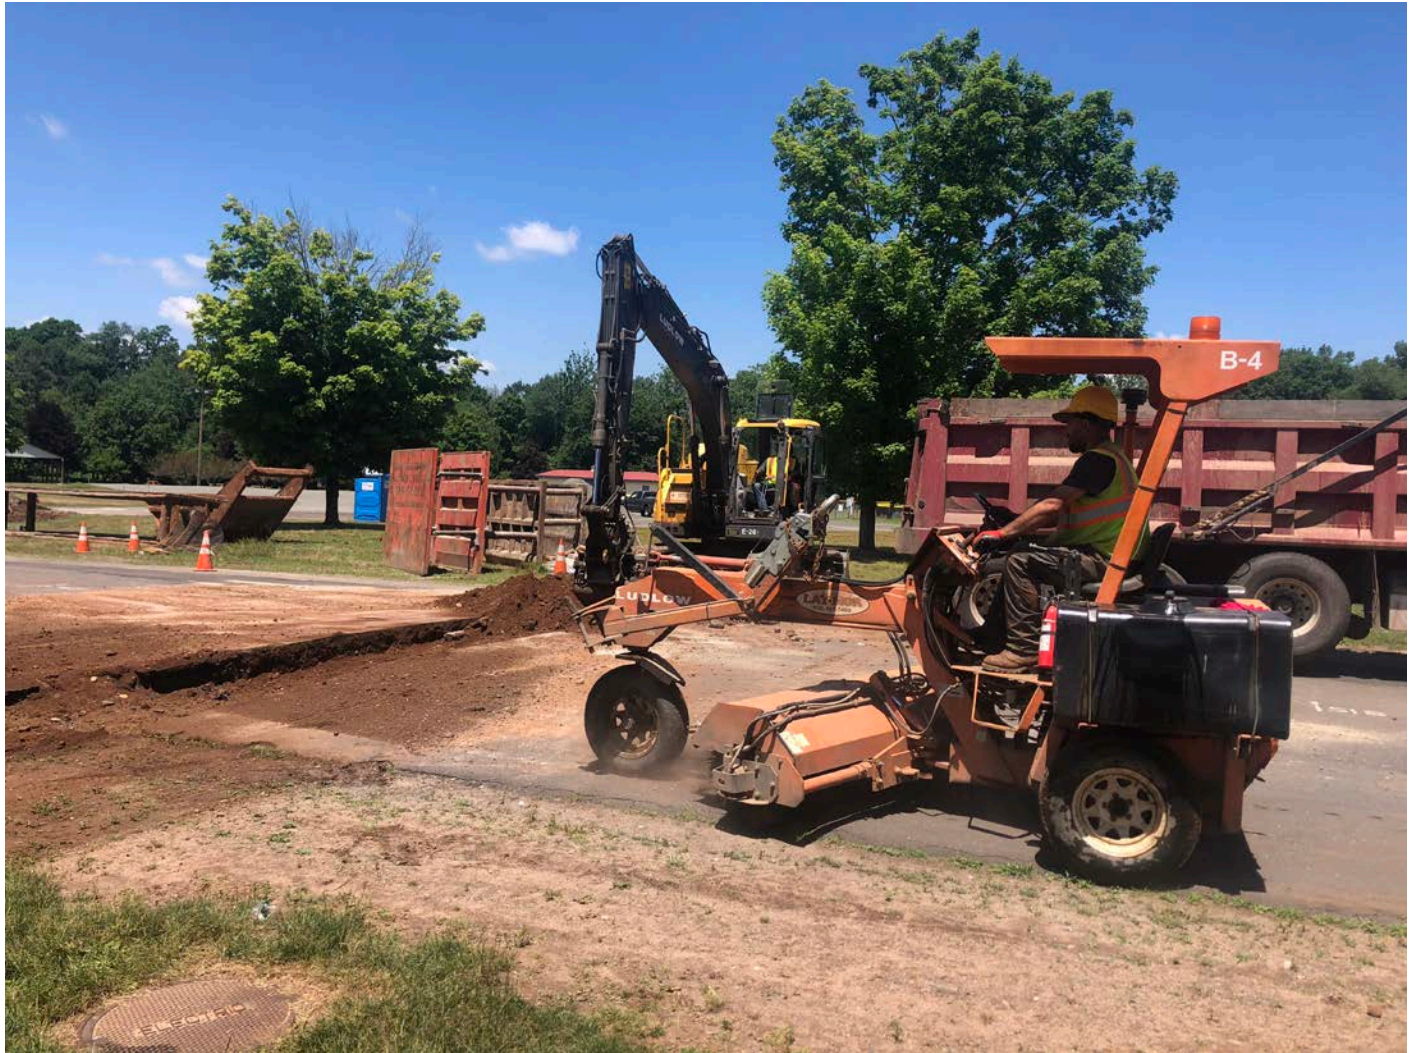
Picture 13: Ludlow cleaning up work zone at Station 517+75. Pickett Lane, Durham. View to the southeast.

1235: Ludlow cleaning up work zone at Station 517+75. The curb stop at has been placed 17' from edge of pavement.
