## Daily Report

<b>Project:</b>	Durham Meadows Pipeline Installation	<b>Date:</b>	July 14, 2020
<b>Location:</b>	Pickett Lane and Main Street, Durham	<b>Day of Week:</b>	Tuesday
<b>Project #:</b>	AECOM: 6061487	<b>Report No:</b>	119
<b>Contractor:</b>	Ludlow Construction	<b>Page:</b>	1 of 14

### Daily Activities – Stream Crossing, Hersig Brook, Durham

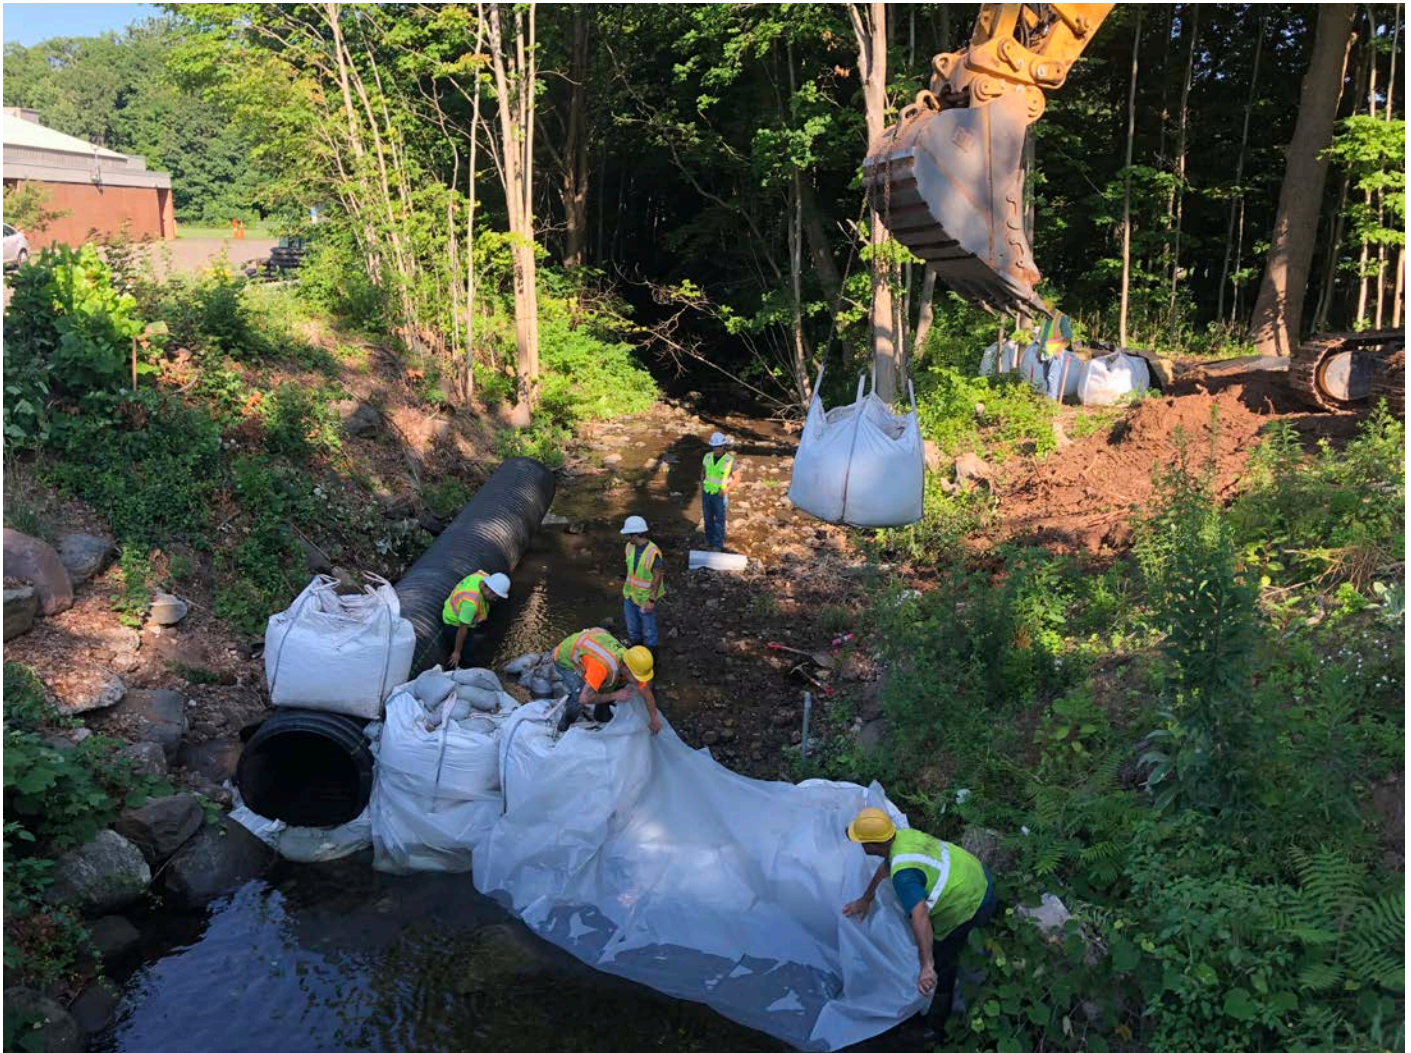
0838: Ludlow has placed a 40" corrugated plastic flow bypass culvert on the south side of the stream at Station ~532+00. Ludlow is currently placing a line of large sandbags on the upstream portion of the work zone in order to divert water into the bypass culvert. Work activities have created a small amount of turbidity in Hersig Brook.

**Picture 1: Ludlow placing large and small sandbags upstream of the Hersig Brook stream crossing work zone to direct stream flow into the 40" plastic corrugated flow bypass pipe placed on the south shore of the brook. View is to the west. Pickett Lane, Durham. Station ~532+00.**

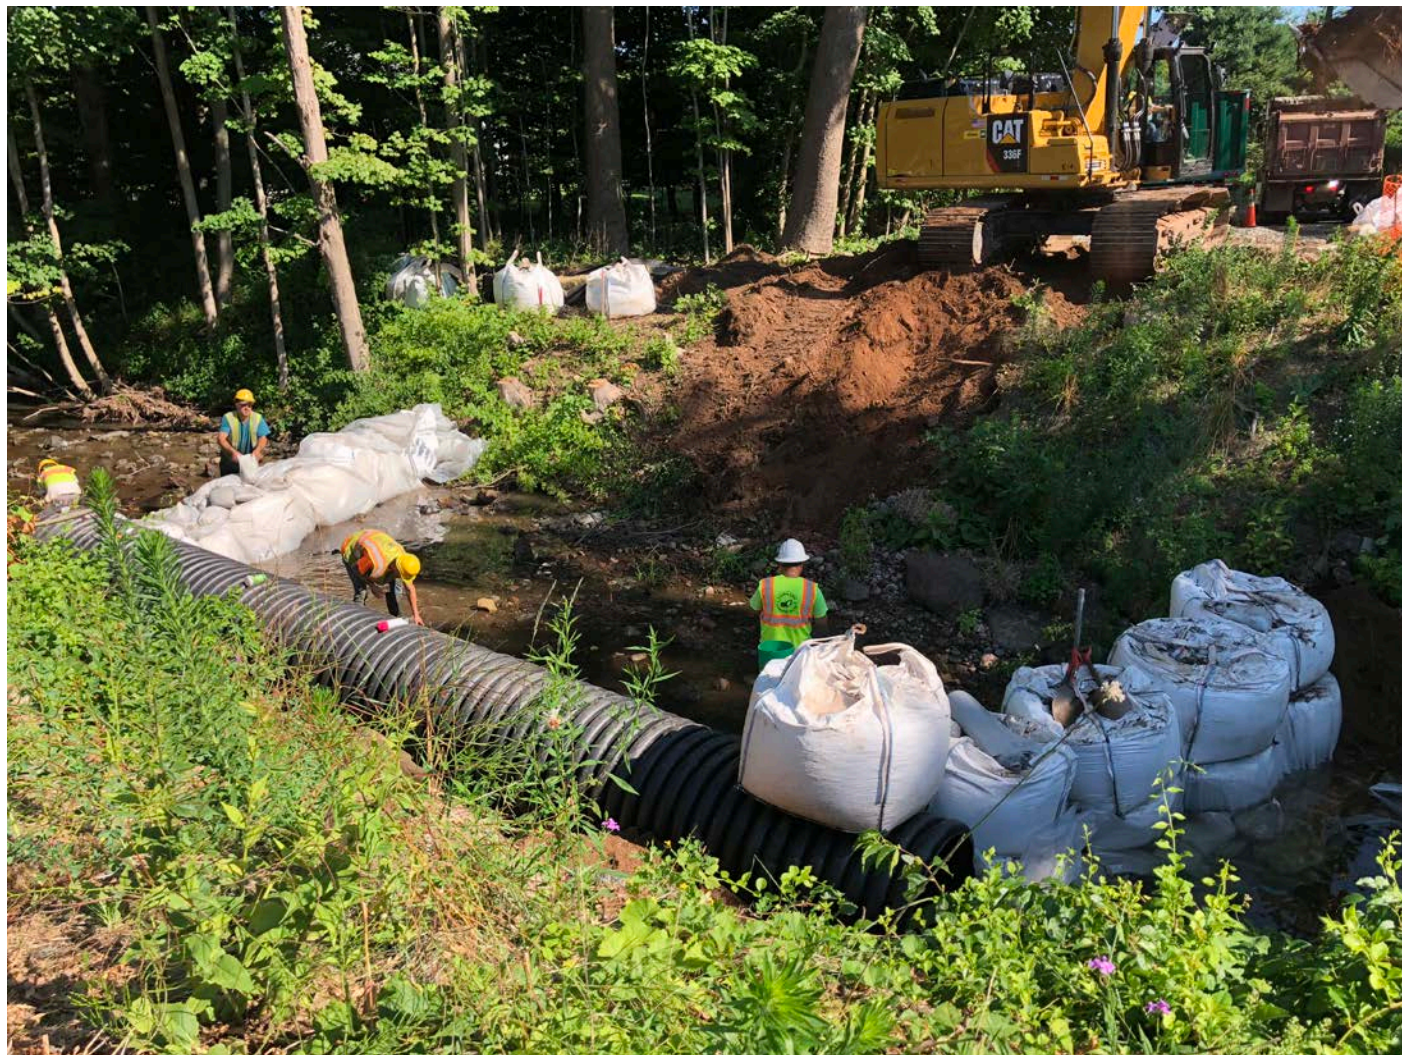
0955: Ludlow continues to work on placing sandbags upstream and downstream of the stream crossing work zone at Station ~532+00.

**Picture 2: Ludlow placing large and small sandbags downstream of the Hersig Brook stream crossing work zone. Pickett Lane, Durham. Station ~532+00. View to the northwest.**

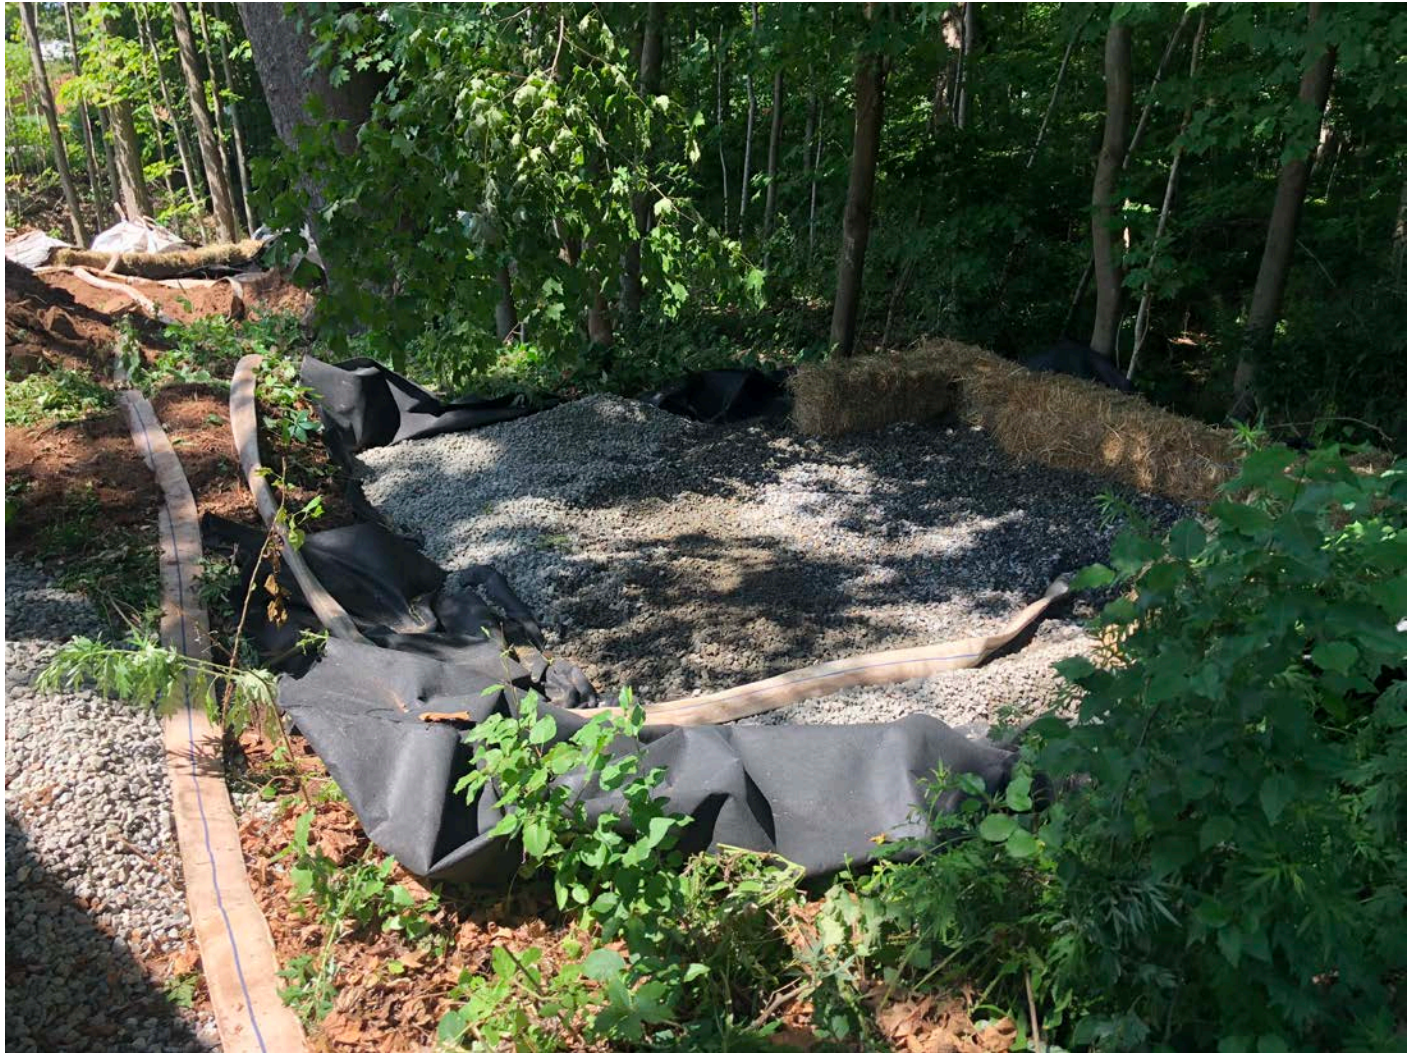
**Picture 4: One of two filter beds Ludlow constructed on the north side of Hersig Brook. View is to the west. Pickett Lane, Durham. Station ~532+00.**

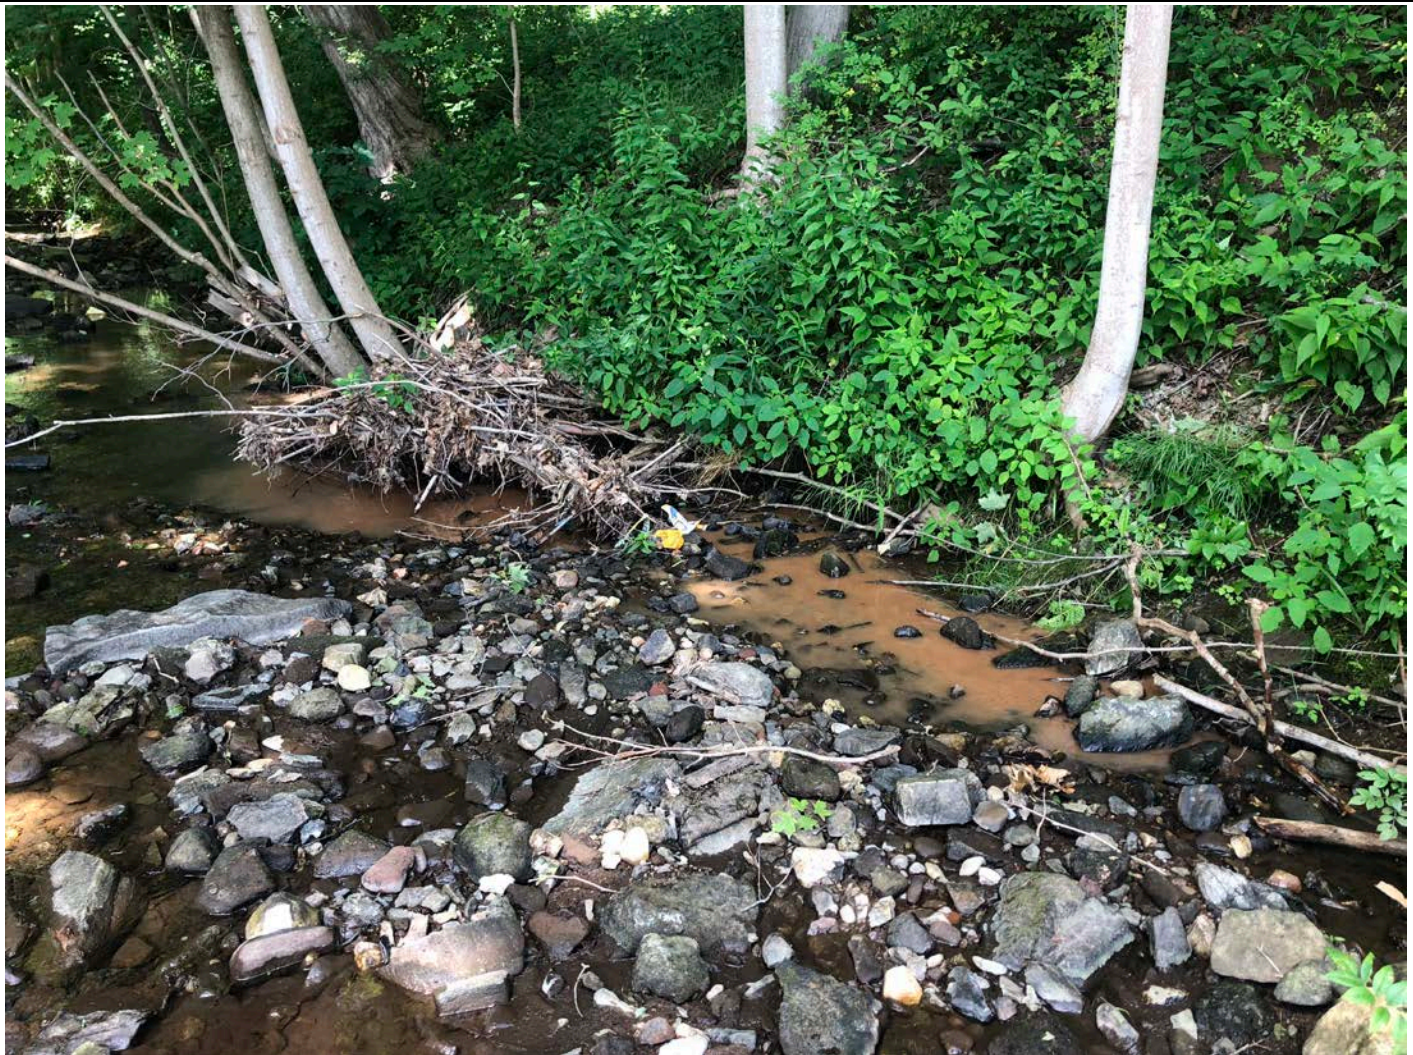
1217: A significant amount of turbidity is currently observed entering Hersig Brook downstream of work area. The turbidity is coming from water filtering through the filter bag/filter bed closest to the stream. Water is not currently being pumped into this bed; Ludlow is currently pumping water into the frac tank.

**Picture 5: Turbidity from water draining off the filter bed closest to the stream bank on Hersig Brook. View is to the northwest. Pickett Lane, Durham. Station ~532+00.**

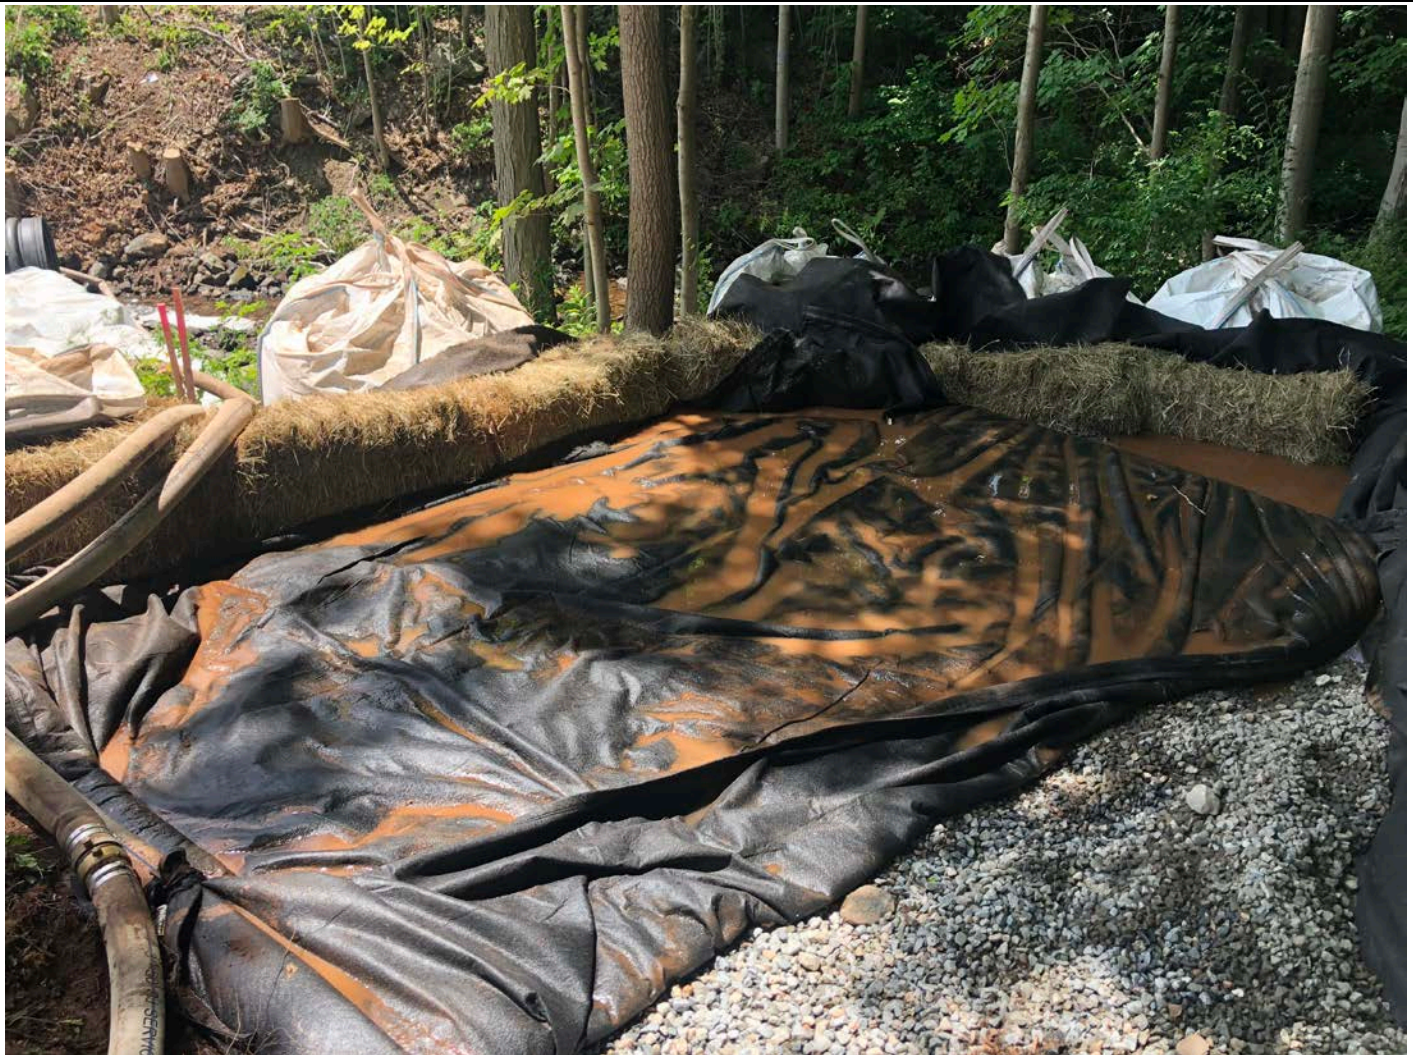
Picture 6: The filter bed Ludlow constructed closest to the stream bank of Hersig Brook. View is to the northwest. Pickett Lane, Durham. Station ~532+00.

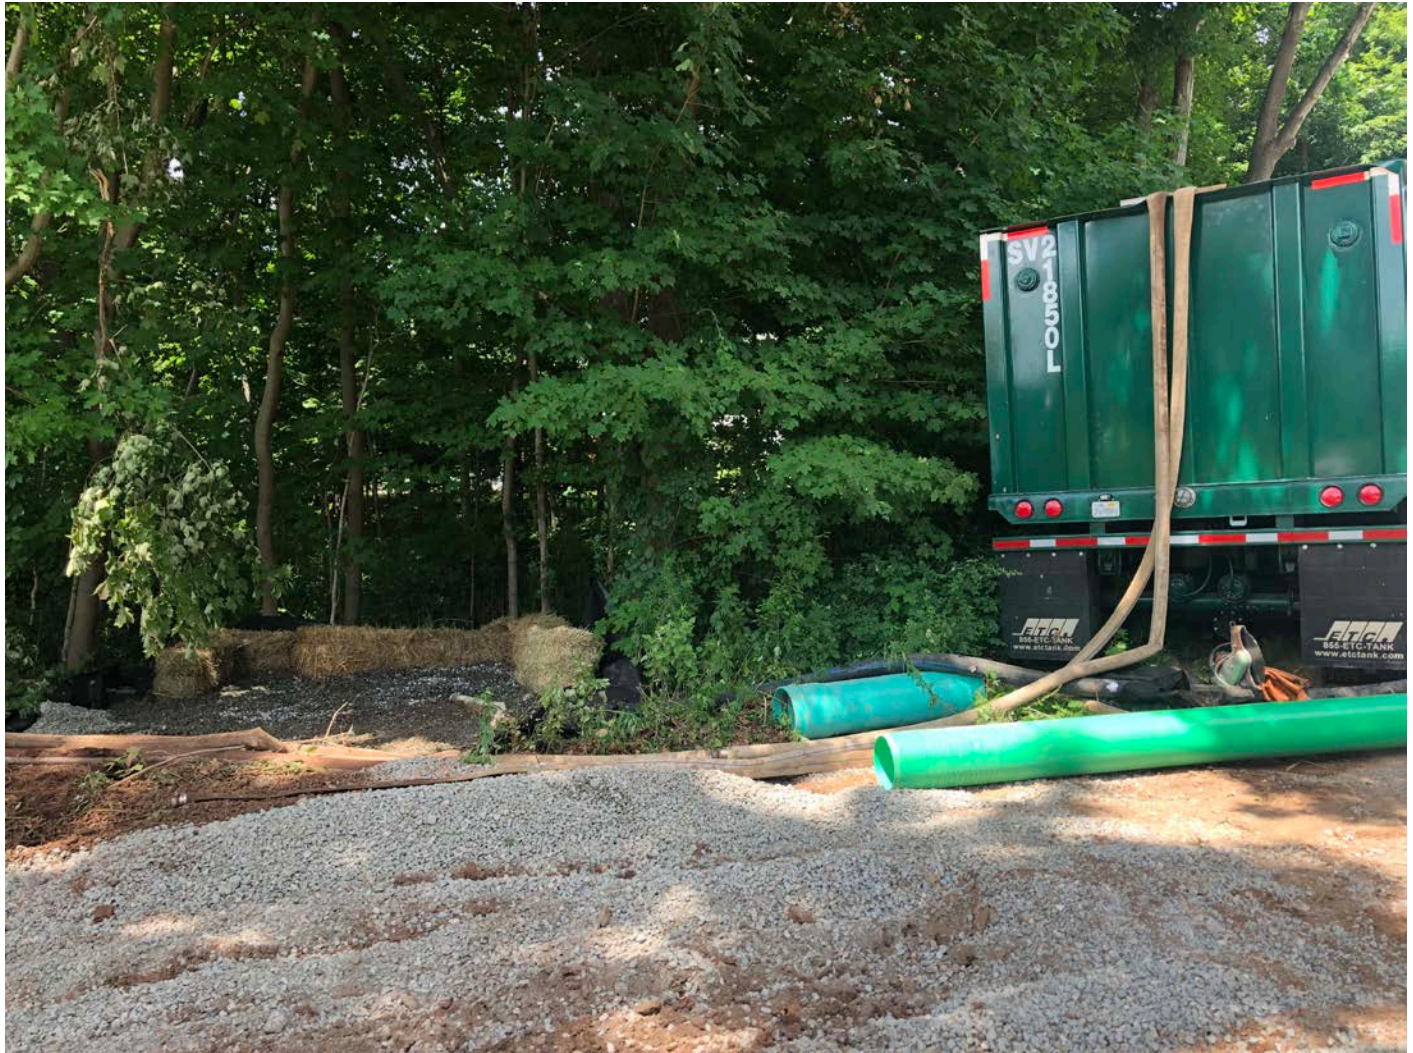
**Picture 7: The filter bed Ludlow constructed furthest from Hersig Brook. View is to the west. Pickett Lane, Durham. Station ~532+00.**

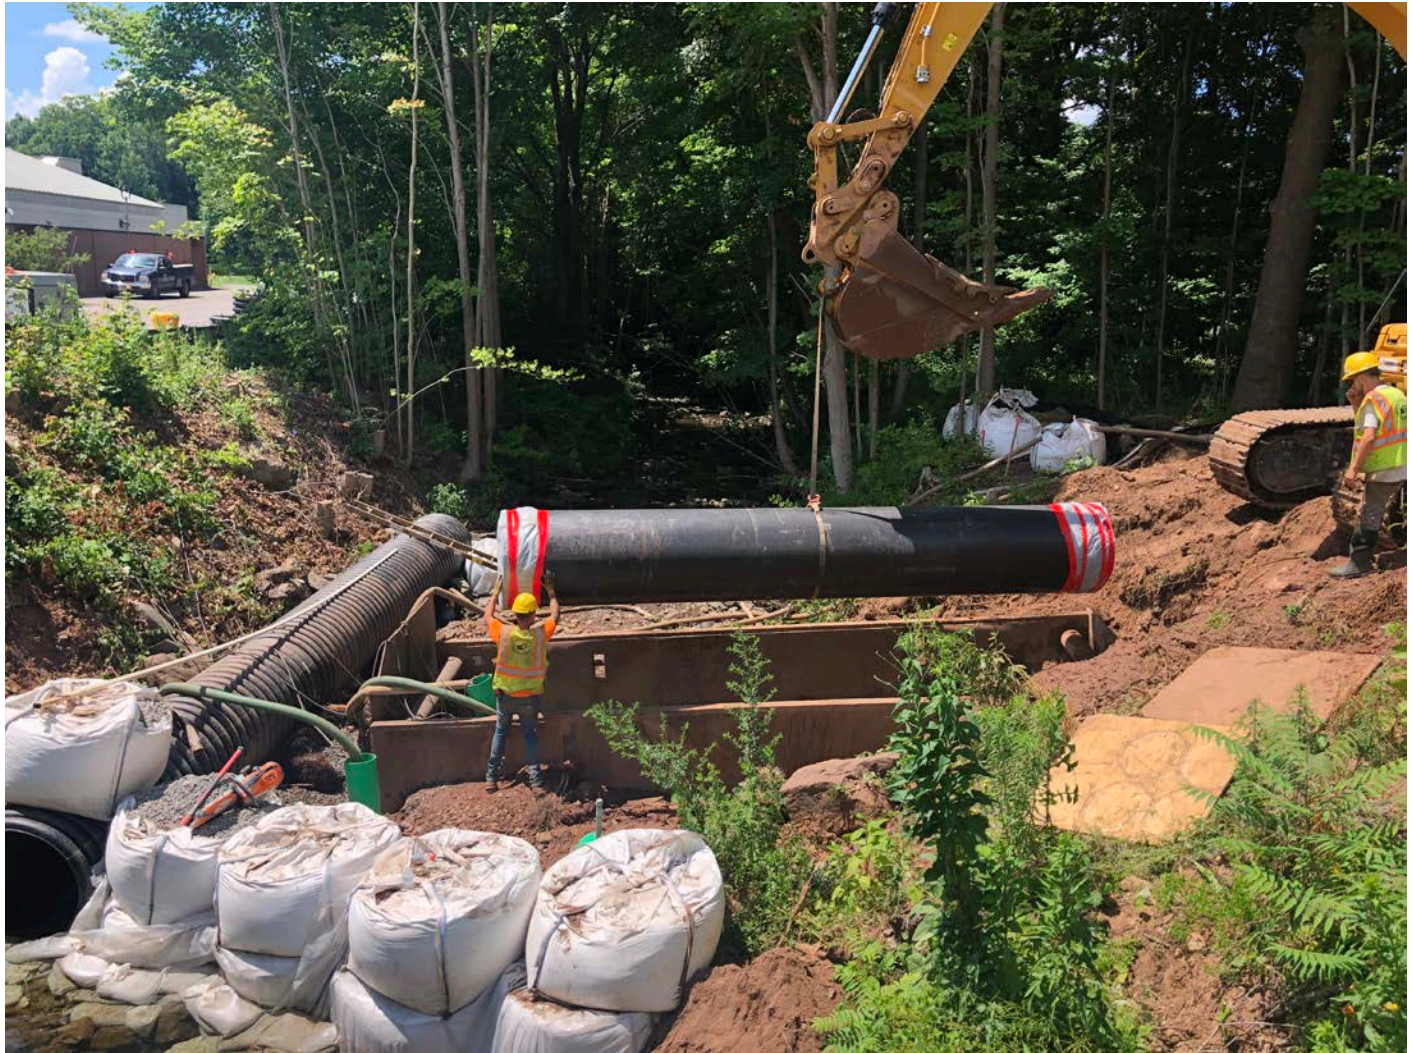
1347: Ludlow is placing 36" conduit in a place at the Hersig Brook stream crossing.

**Picture 8: Ludlow placing 36" pipe conduit in the bed of Hersig Brook. View to the west. Pickett Lane, Durham. Station ~532+00.**

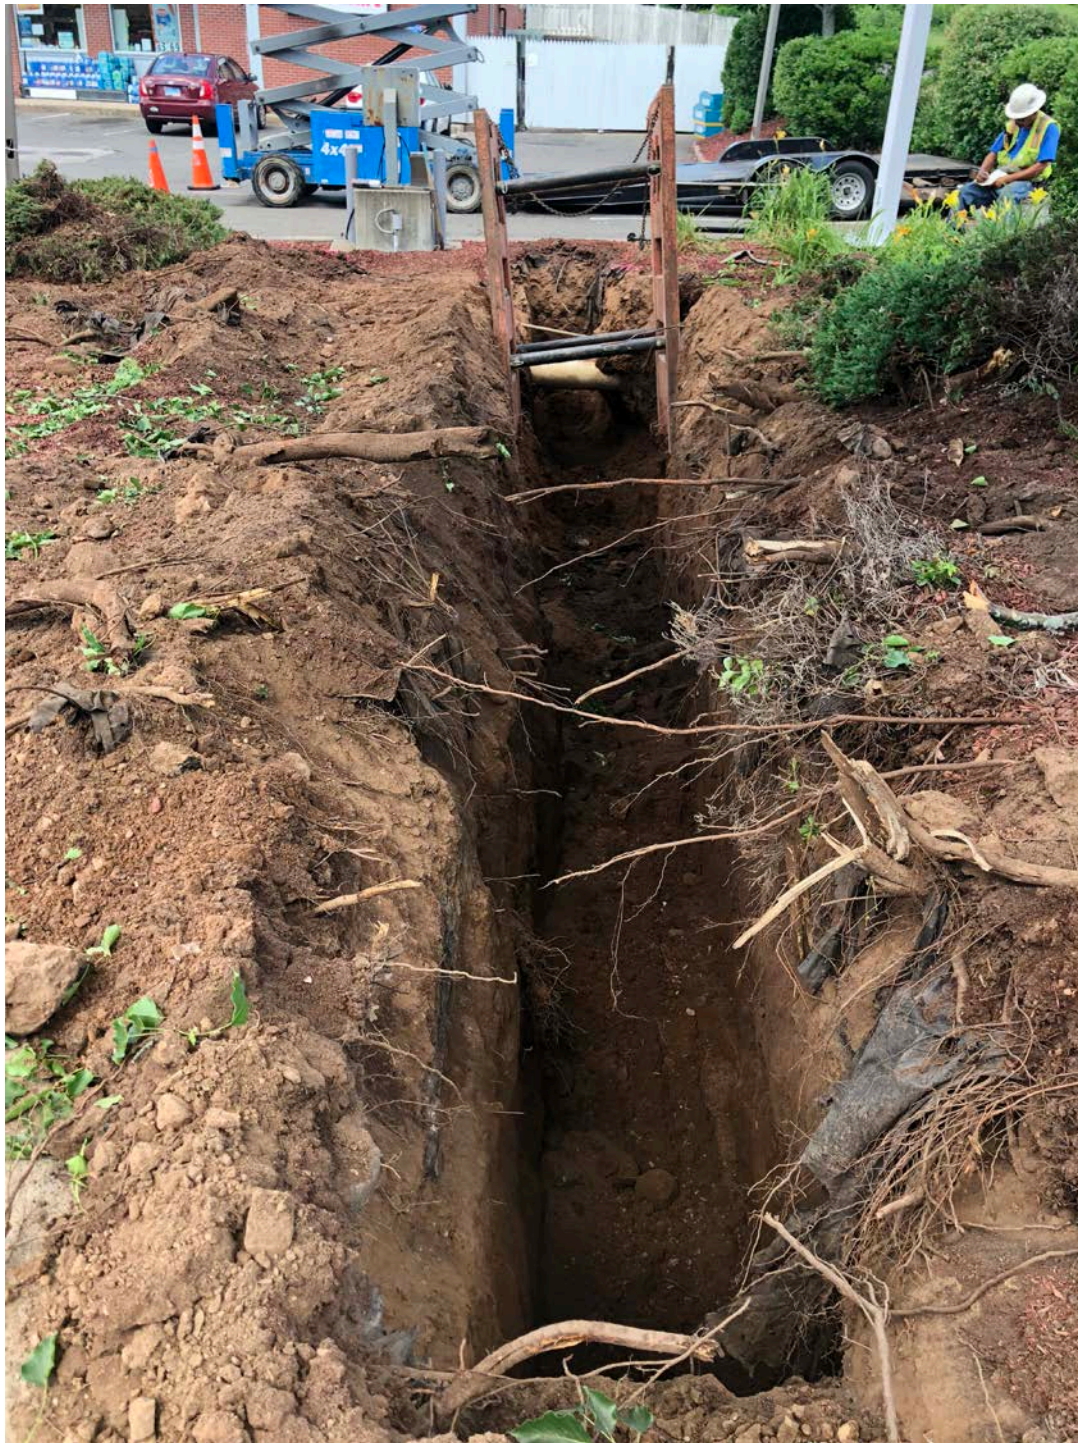
Picture 9: Partially excavated curb stop trench at Station 162+73, 384 Main Street, Durham. View to the west.

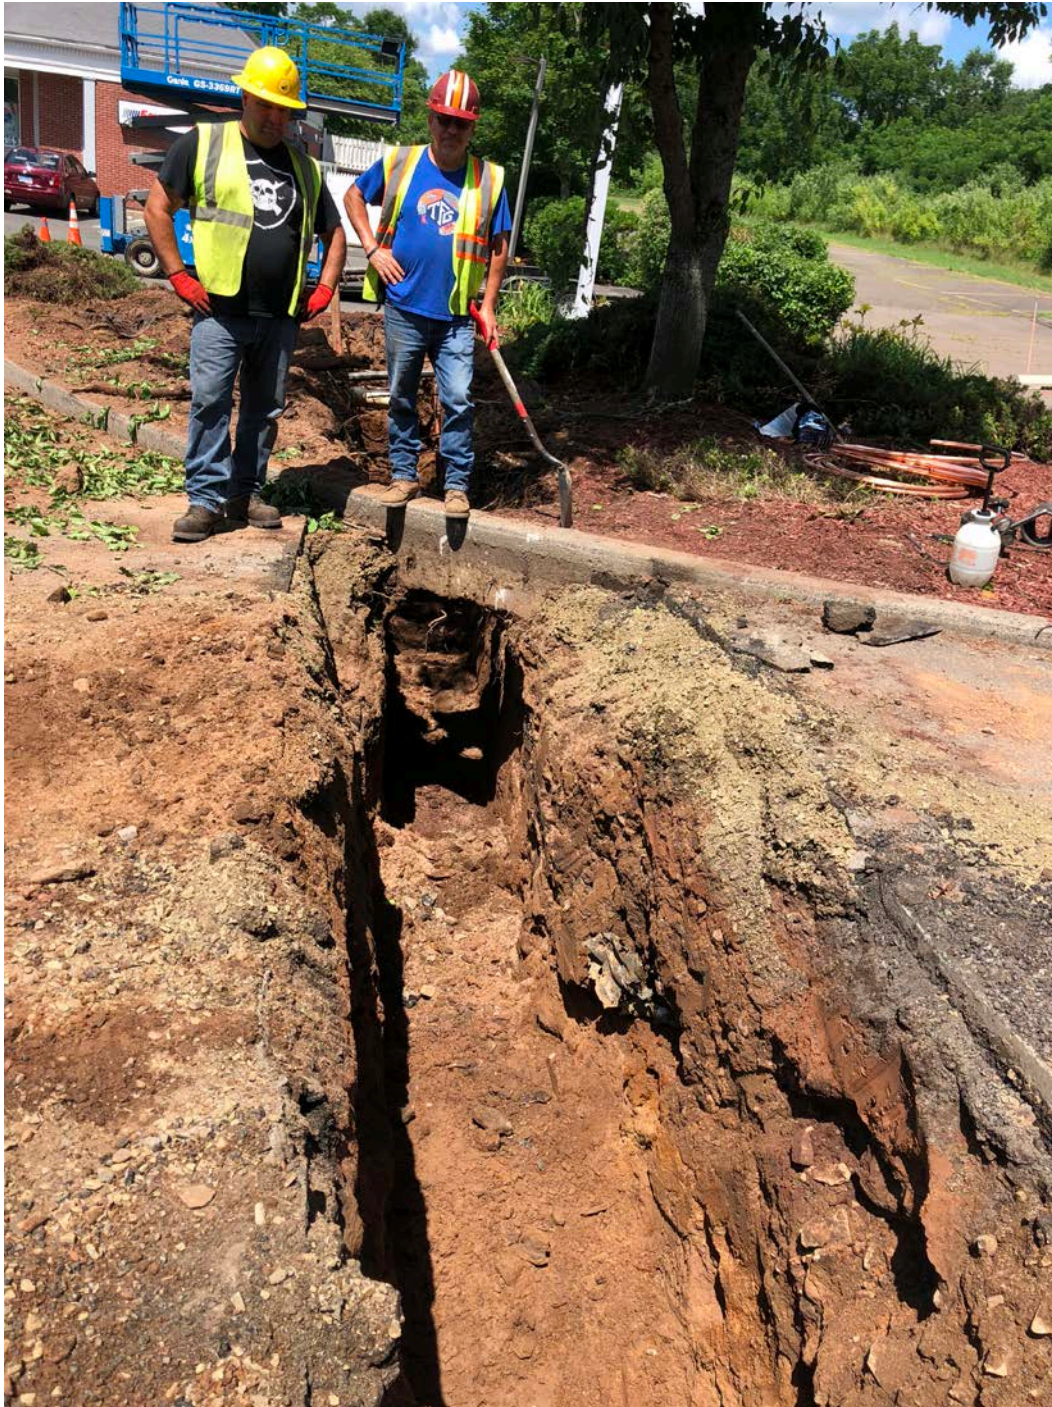
Picture 10: Trench at Station 162+73 excavated beneath curbing at 384 Main Street, Durham. View to the west.

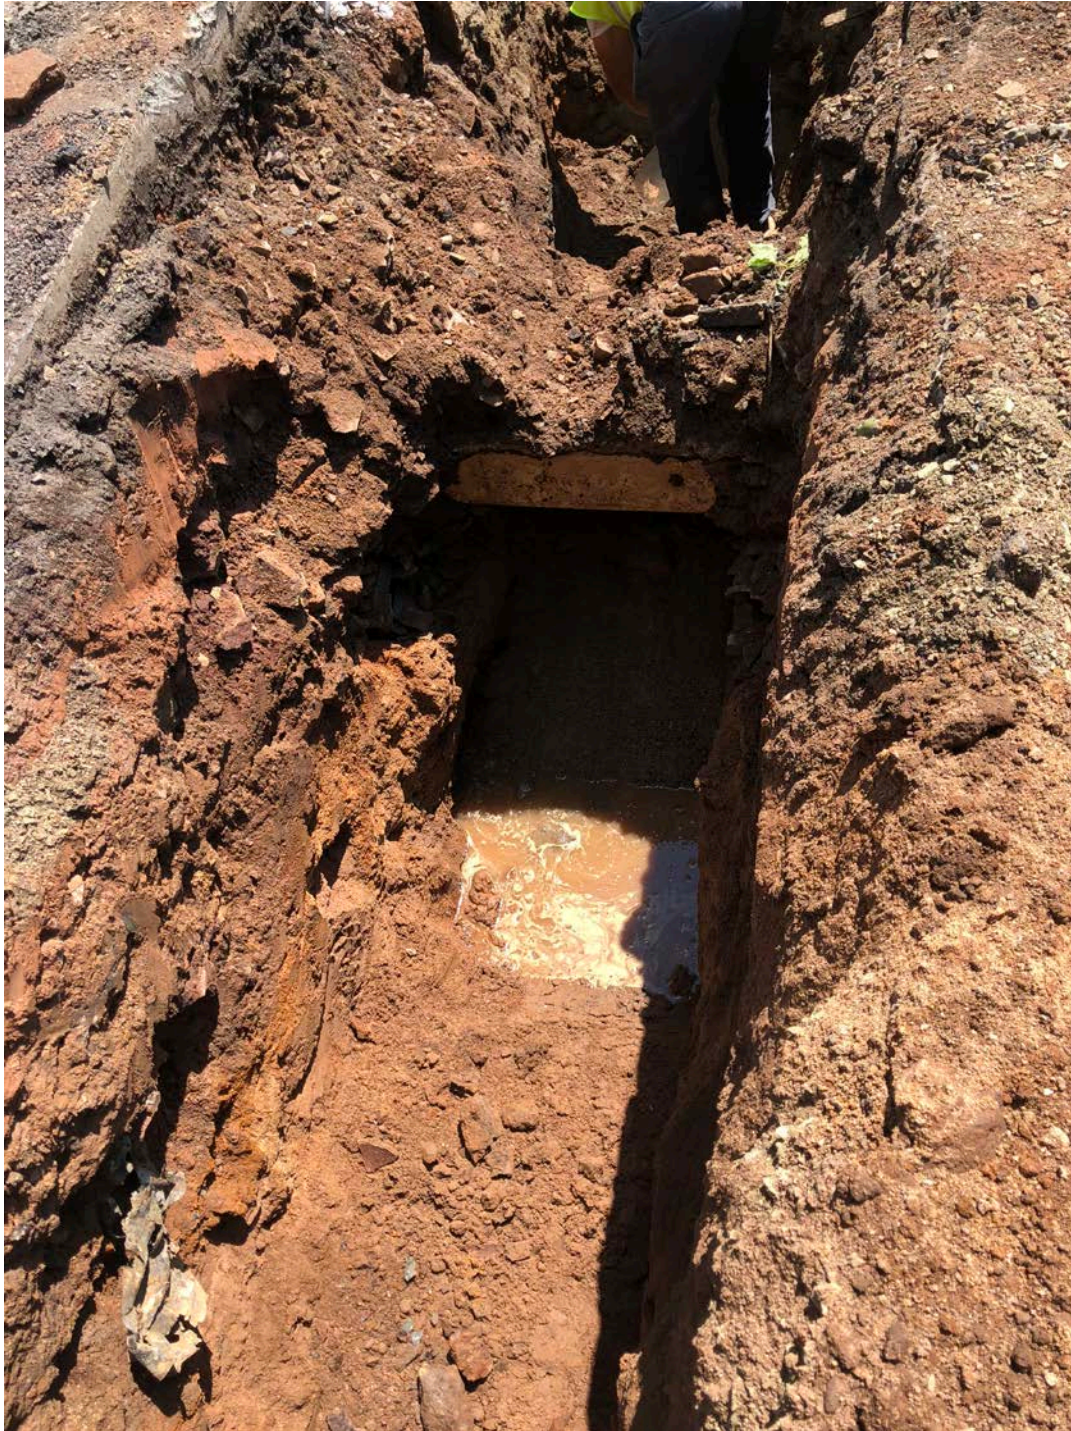
1135: Ludlow continues to work on the installation of a curb stop at Station 162+73. There's a small amount of water in the bottom of the trench. Ludlow is currently not pumping the water out of the trench.

Picture 11: Water observed in trench at Station 162+73, 384 Main Street, Durham. View to the west.
