Daily Report

Project:	Durham Meadows Pipeline Installation	Date:	July 17, 2020
Location:	Pickett Lane, Main Street, and the Shared Access Driveway	Day of Week:	Friday
Project #:	AECOM: 6061487	Report No:	122
Contractor:	Ludlow Construction	Page:	1 of 8

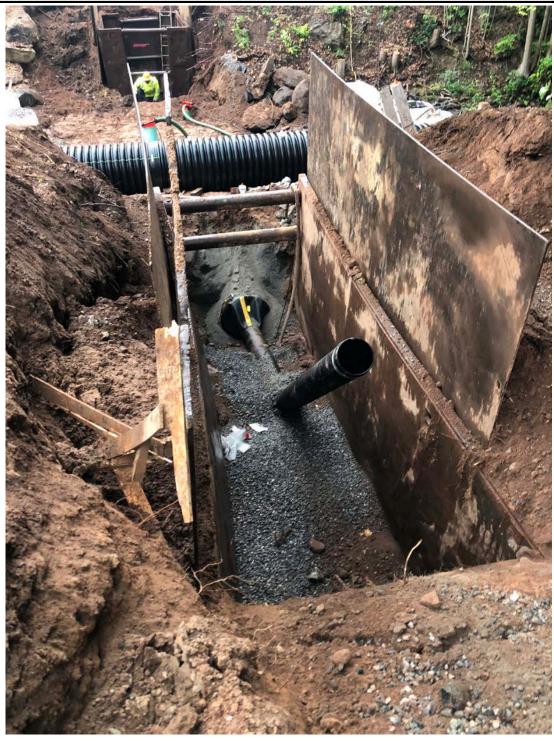
Picture 1: 12" DIP and 45° bend that Ludlow installed on the north side of the Hersig Brook stream crossing yesterday. Pickett Lane, Durham; Station ~532+00. View to the south.

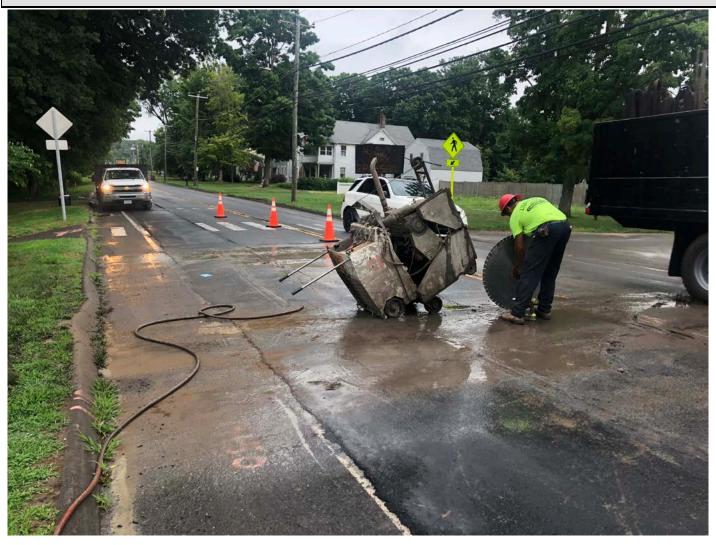
Picture 2: Ludlow preparing to saw cut pavement on Main Street, Durham. View to the north.

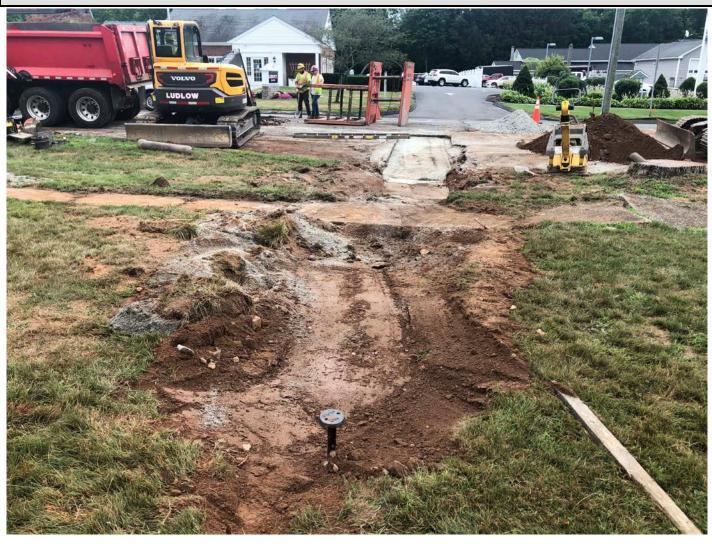
Picture 3: Curb stop installation at Station 161+81, Main Street, Durham. View to the east

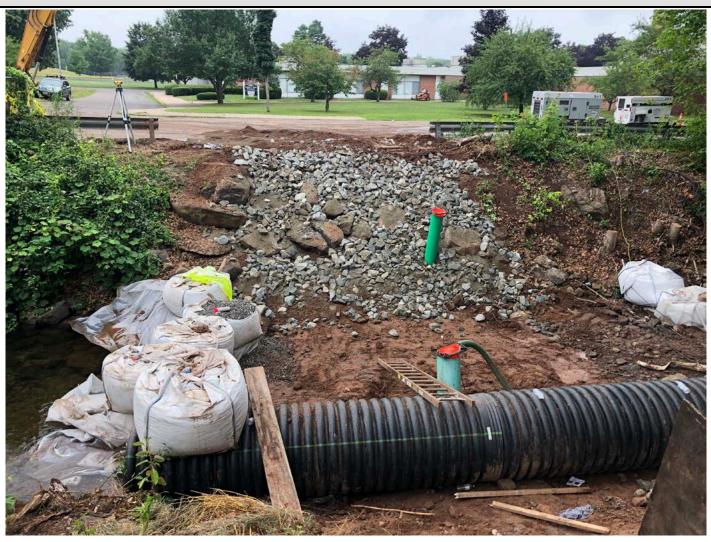
Picture 5: South bank of Hersig Brook after Ludlow placed riprap. View to the south. Station ~532+00, Pickett Lane, Durham.
