Daily Report

Project:	Durham Meadows Pipeline Installation	Date:	July 20, 2020
Location:	Pickett Lane, Main Street, and the Shared Access Driveway	Day of Week:	Monday
Project #:	AECOM: 6061487	Report No:	123
Contractor:	Ludlow Construction	Page:	1 of 10

Daily Activities – Stream Crossing, Hersig Brook, Durham

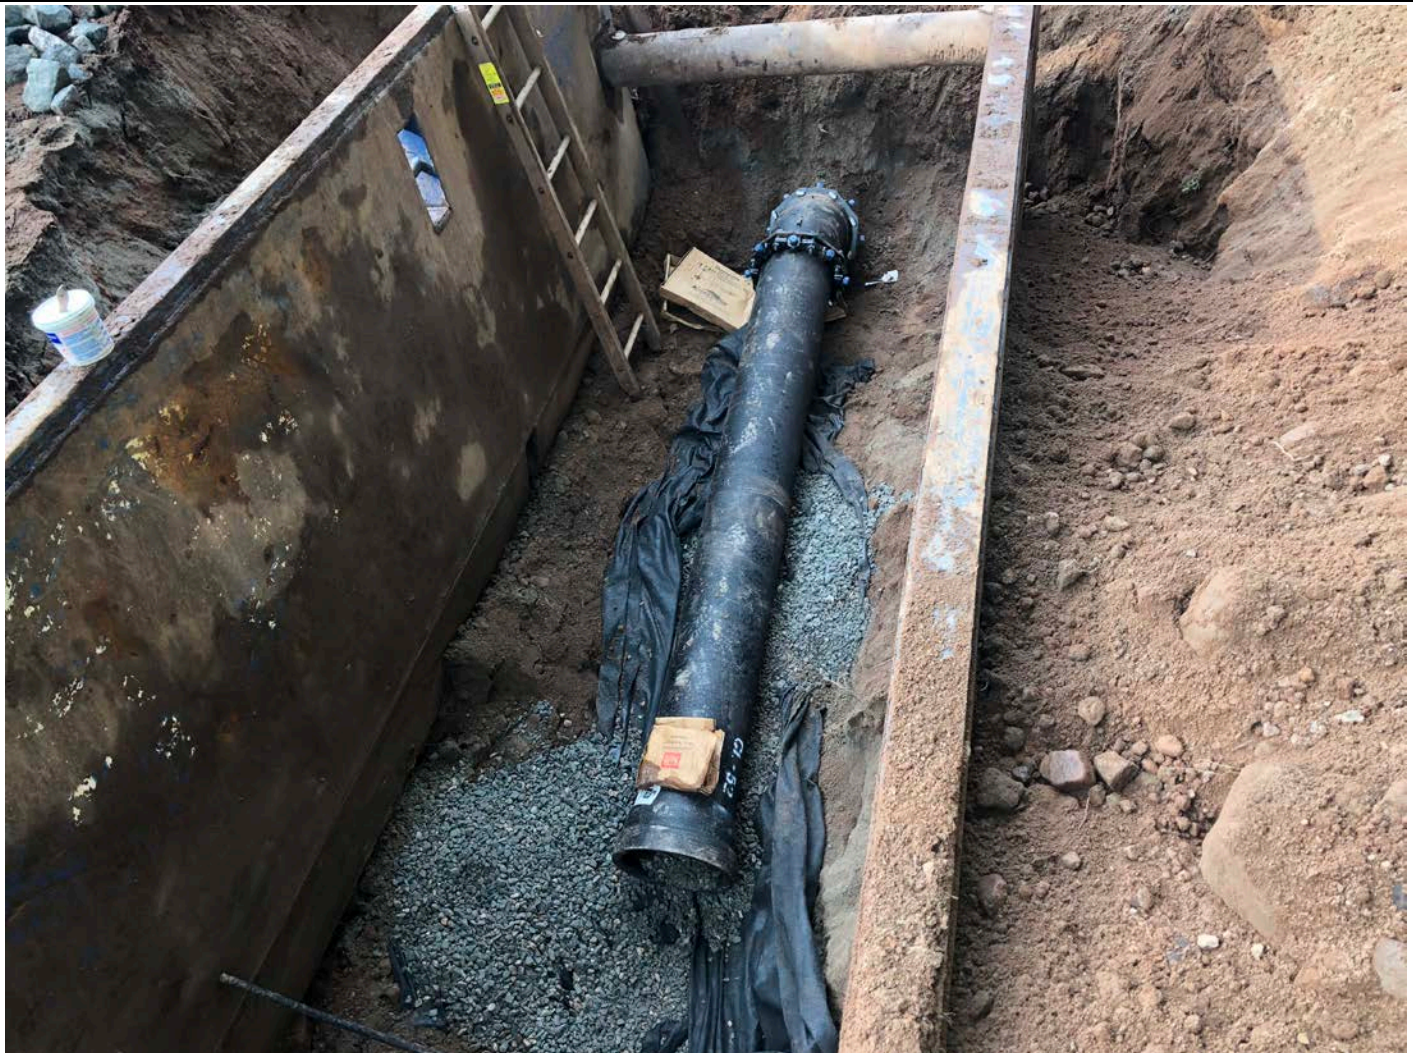
Picture 1: 9' section of 12" DIP and 45° bend that Ludlow installed on the north side of the Hersig Brook stream crossing. Pickett Lane, Durham; Station ~532+00.

0837: Ludlow has installed a 45° bend of 12" DIP, and has added a 9' section of 12' DIP to the 45° bend.

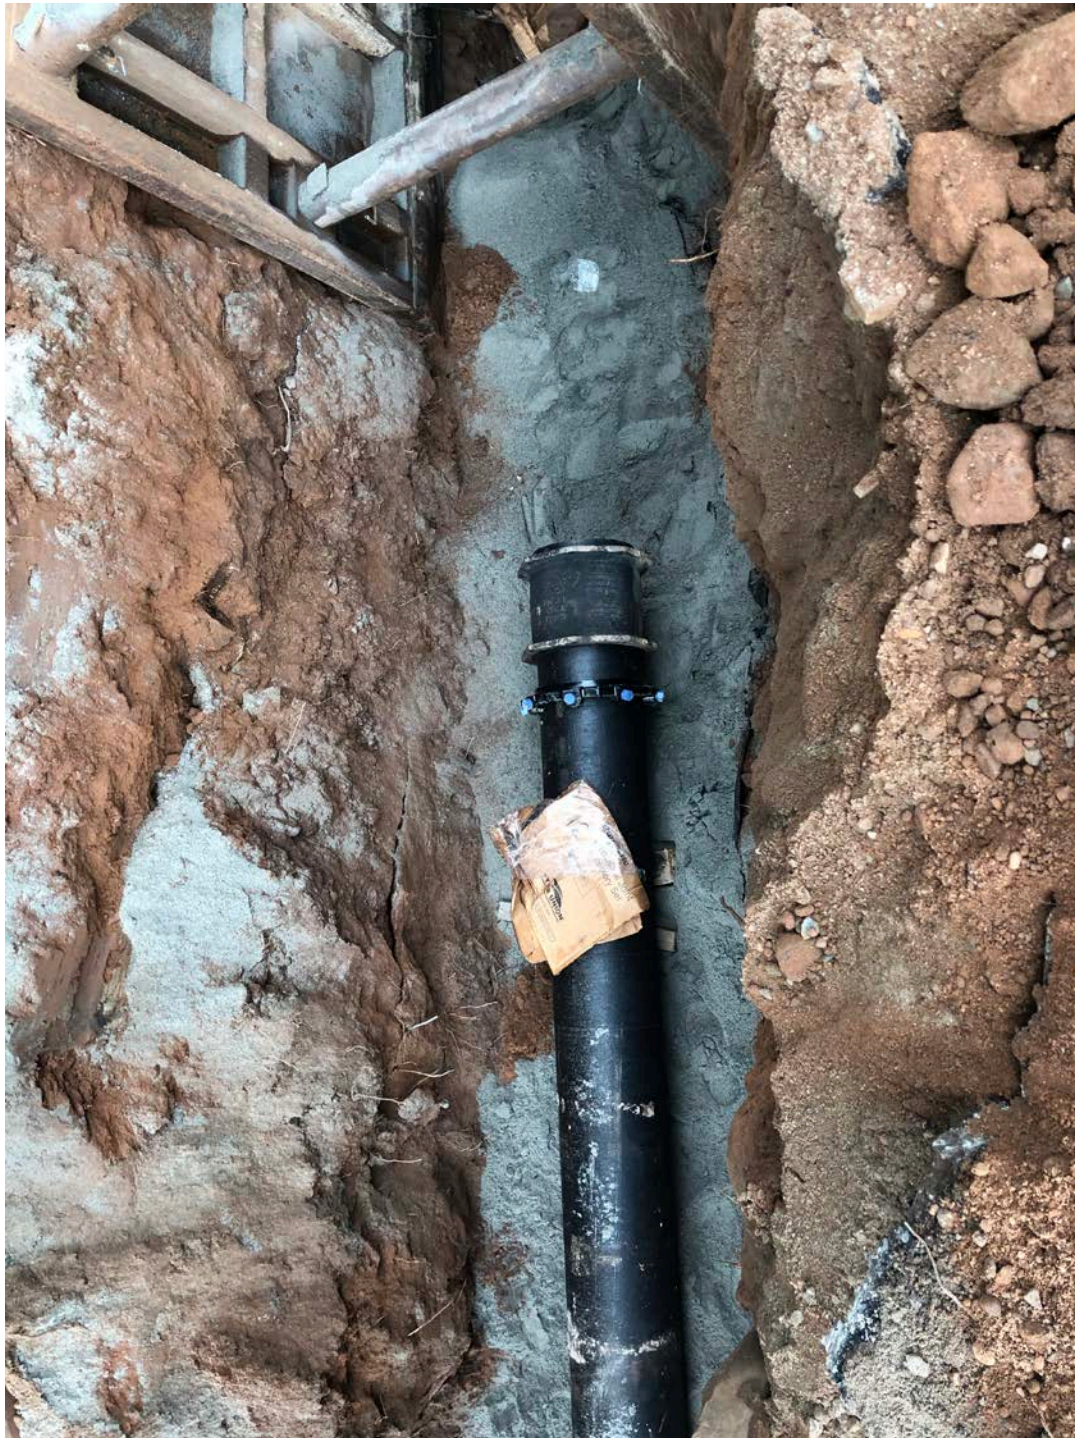
Picture 2: 20' section of 12" DIP and a female-female 12" DIP sleeve that Ludlow installed on the north side of the Hersig Brook stream crossing. Pickett Lane, Durham; Station ~532+00.

0850: Ludlow has just installed a 20' section of 12" DIP at the Hersig Brook stream crossing.

0859: Ludlow has added a female-female sleeve at the end of the 20' section of 12" DIP that they just installed.

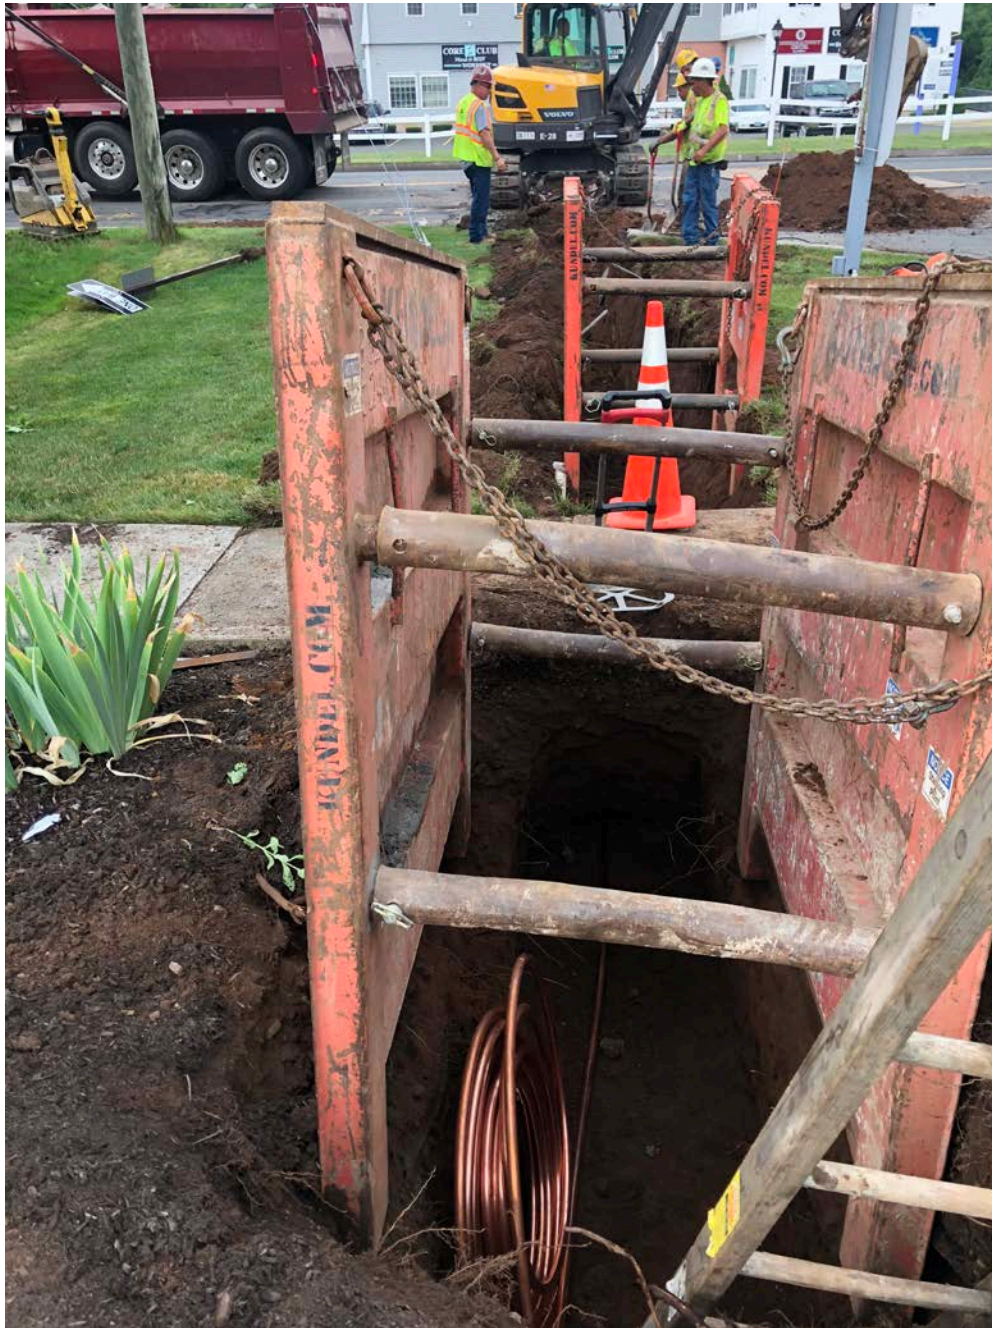
Picture 3: Curb stop installation underway at Station 171+22. Ludlow has 1" copper water line partially installed. View to the west. Main Street, Durham.

0913: Ludlow has excavated beneath the concrete sidewalk at Station 171+22 and has started laying out 1" copper line for the curb stop. Ludlow is currently excavating west toward Main Street.

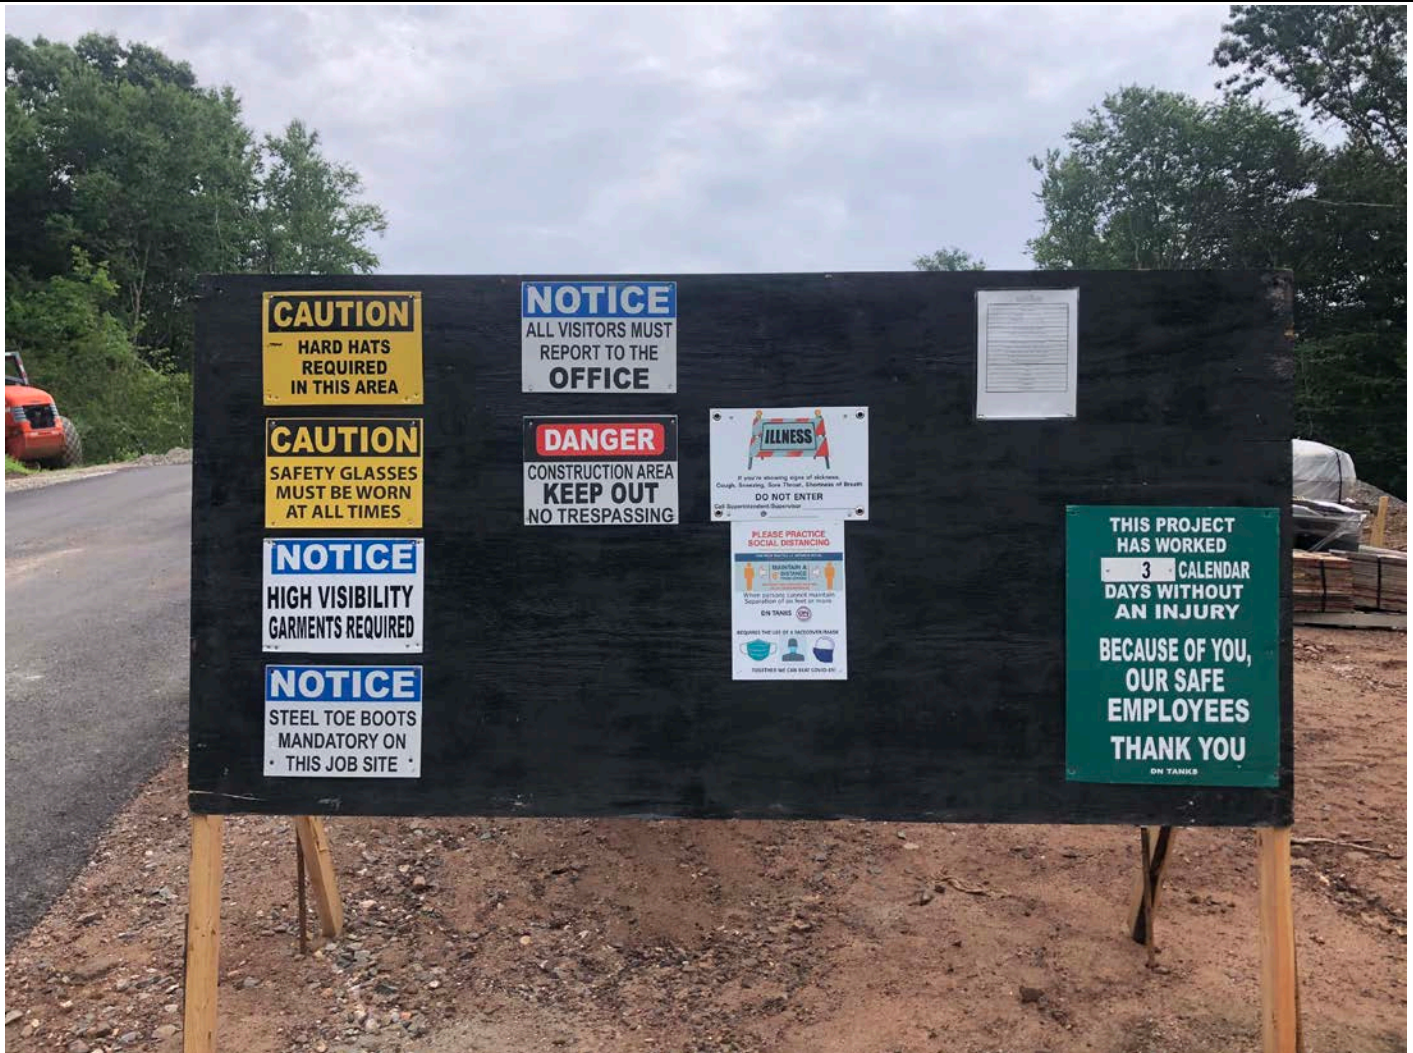
Picture 4: Sign board erected by DN Tanks on the Shared Access Driveway leading up to the water tank footprint. Middletown; view to the east.

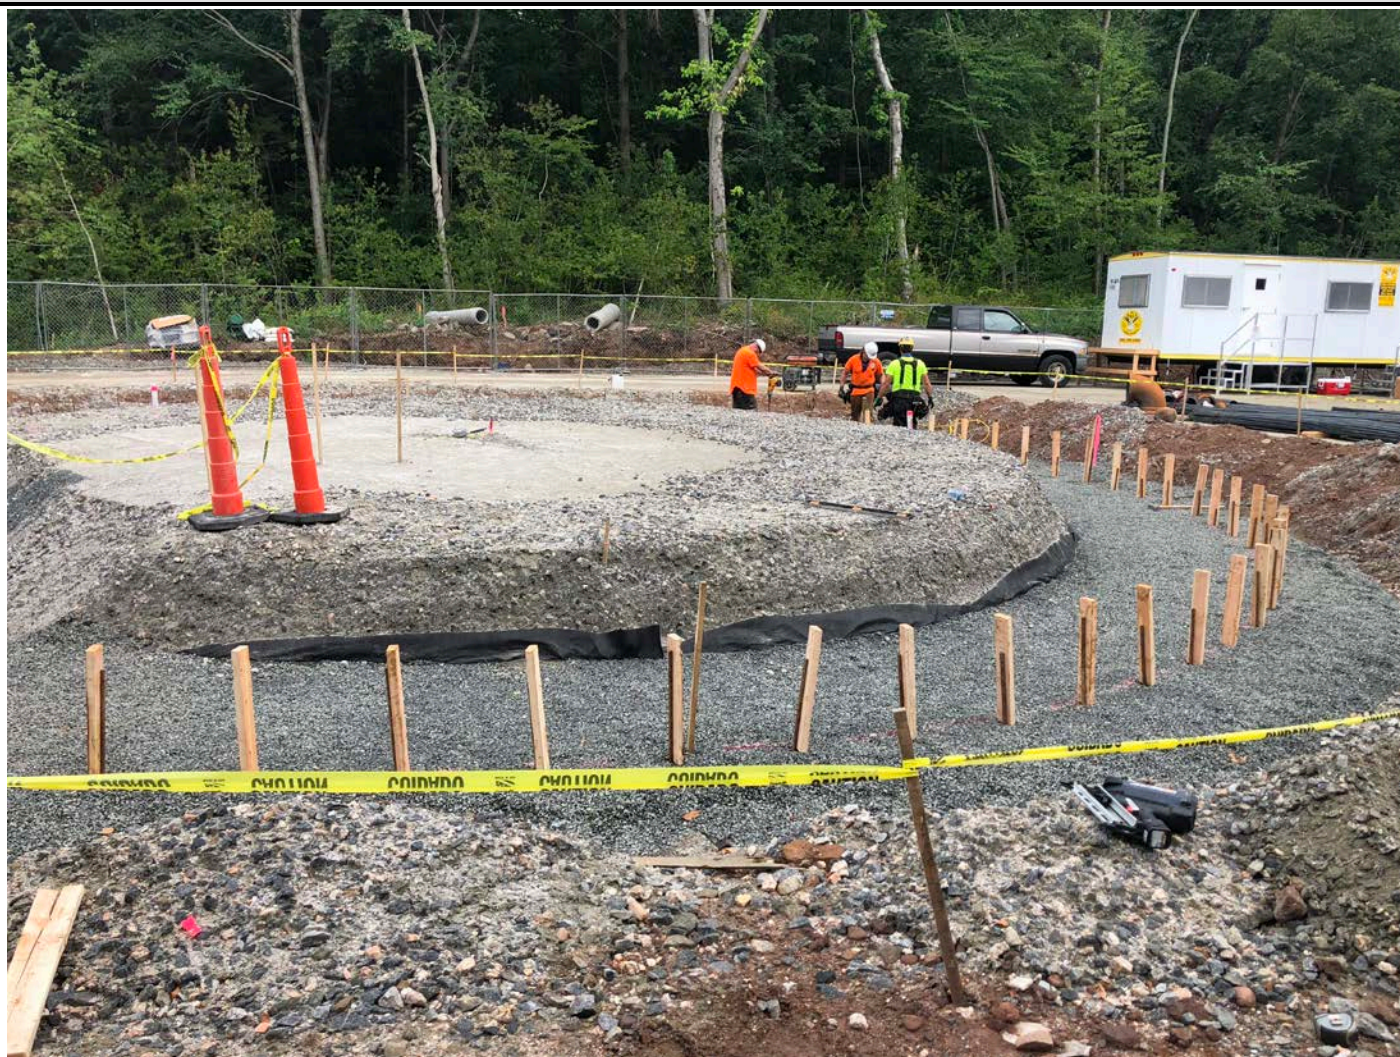
Picture 5: DN Tanks constructing cement form for the water tank frost wall. Shared Access Driveway, Middletown. View to the northeast.

0923: Ludlow subcontractor DN Tanks is starting to build a form for the water tank frost wall, fixing lumber and rebar around the periphery of the tank footprint. DN Tanks currently has 4 personnel working at the water tank pad.

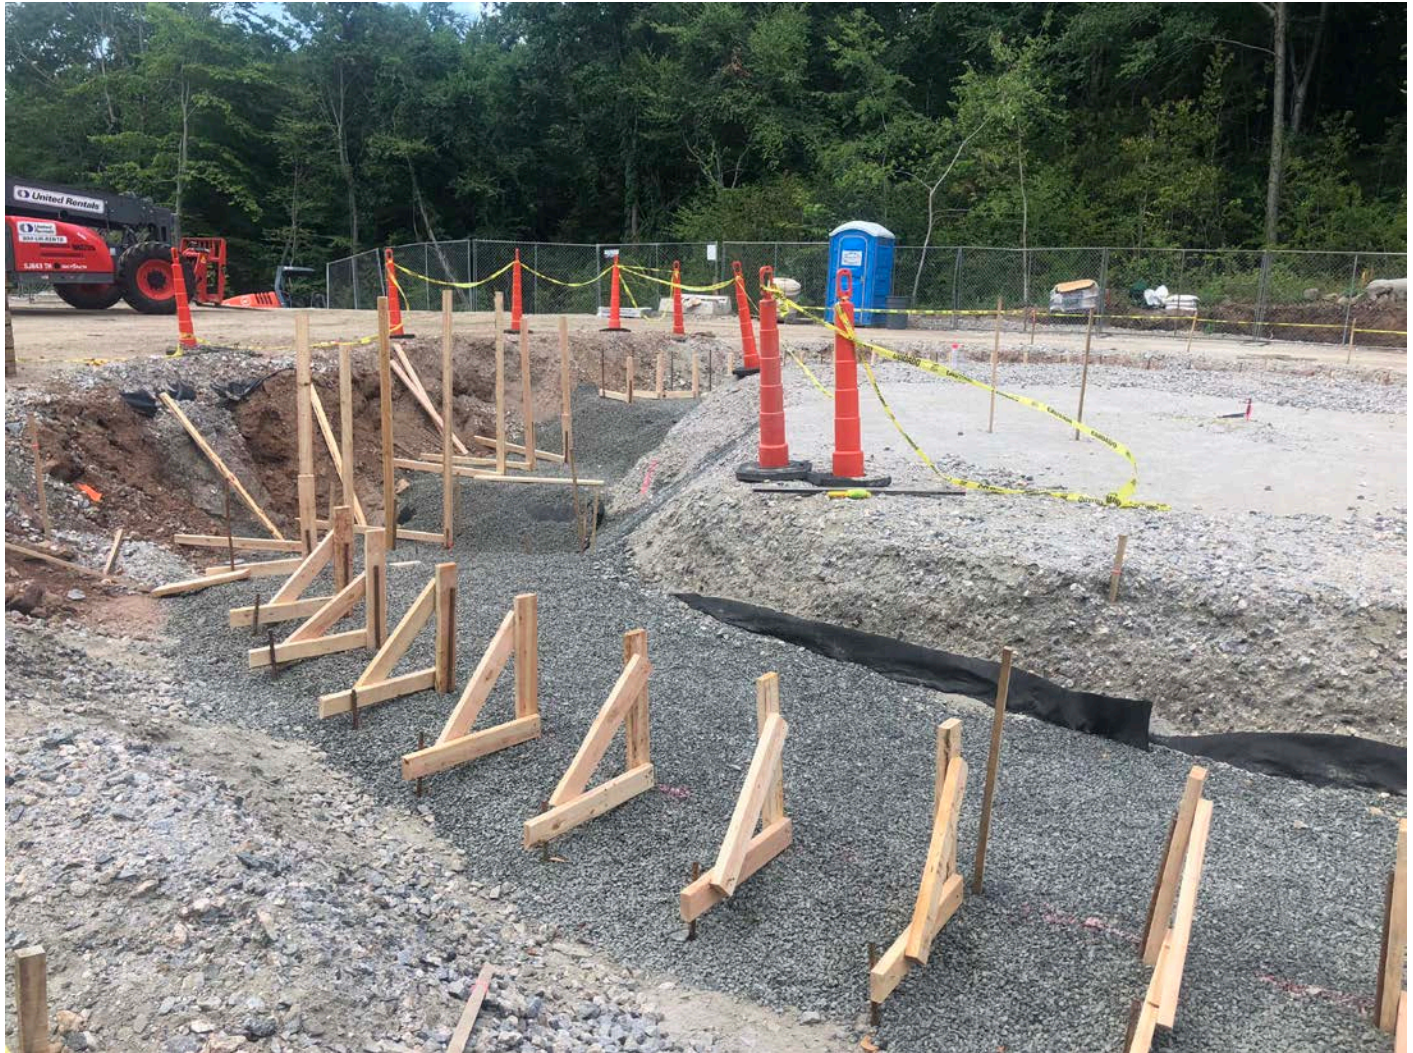
Picture 6: DN Tanks constructing cement form for the water tank frost wall. Shared Access Driveway, Middletown. View to the north.

1036: DN Tanks continues to build a concrete form for the frost wall at the tank pad footprint.

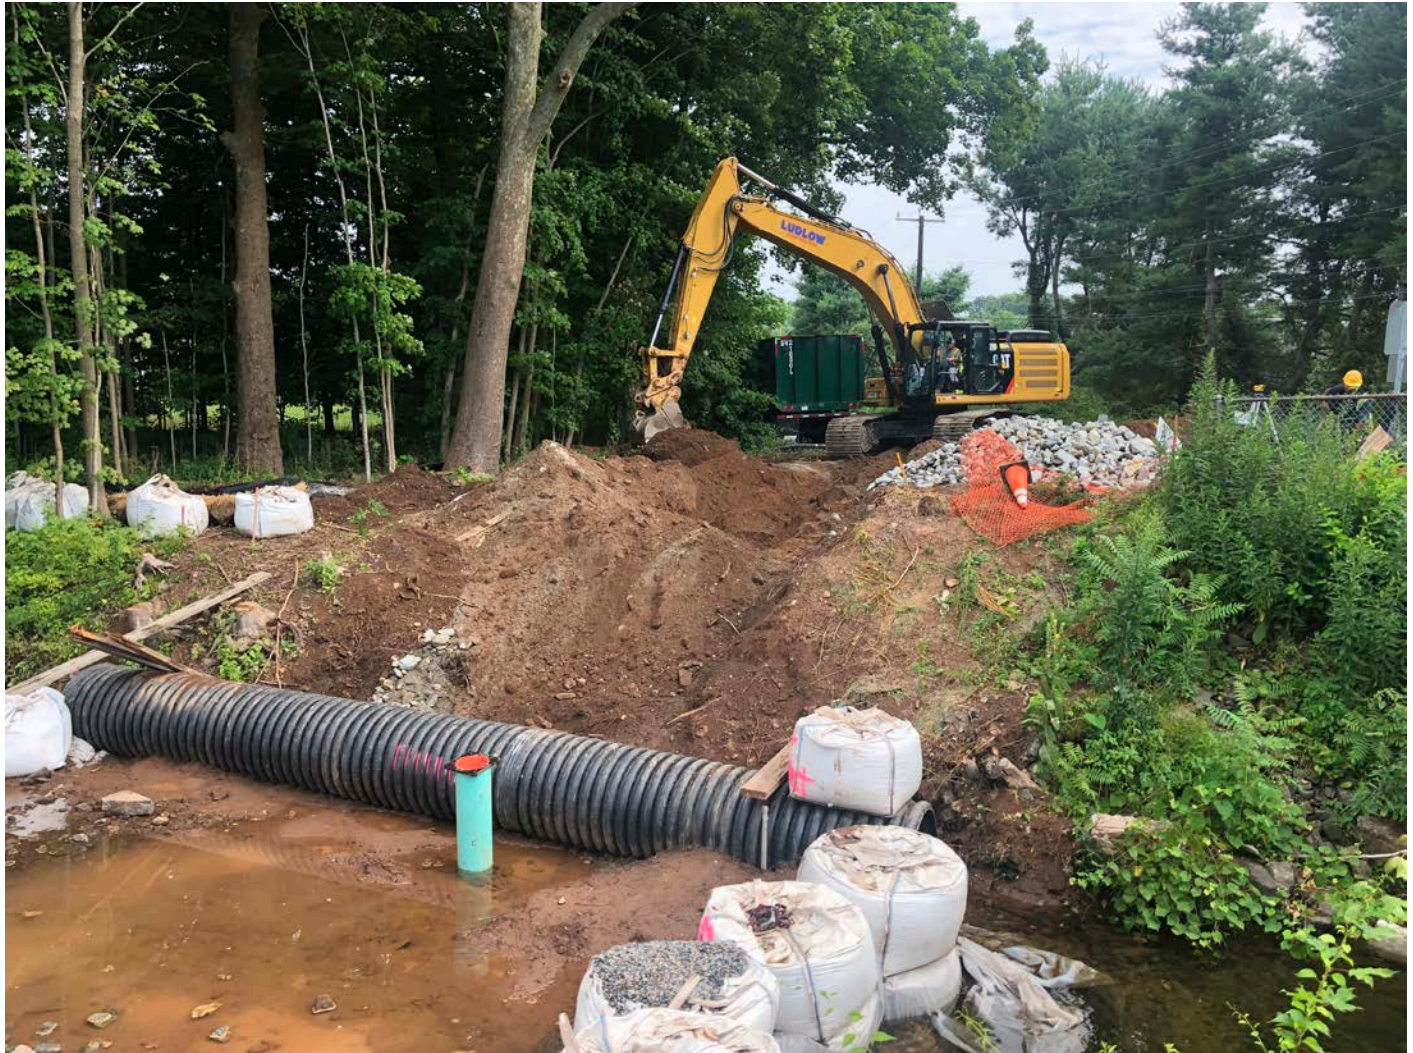
Picture 7: Ludlow backfilling trench on the north bank of Hersig Brook after the installation of 12" DIP. Pickett Lane, Durham; Station ~532+00. View to the northeast.

0948: Ludlow has connected 12" DIP coming from Hersig Brook stream crossing to the 12" DIP that was previously installed on Pickett Lane north of the brook. Ludlow is currently backfilling trench. Ludlow added a 12' section of 12" DIP and a 45° bend to connect to the 12" DIP on Pickett Lane.

1205: Ludlow has completely backfilled the trench on north side of the work zone at the Hersig Brook stream crossing. Ludlow is currently placing 6" stone on the north bank of the work zone. The 40" plastic corrugated flow bypass culvert has been removed from the streambed.
