Daily Report

Project:	Durham Meadows Pipeline Installation	Date:	July 22, 2020
Location:	Pickett Lane, Main Street, and the Shared Access Driveway	Day of Week:	Wednesday
Project #:	AECOM: 6061487	Report No:	125
Contractor:	Ludlow Construction	Page:	1 of 13

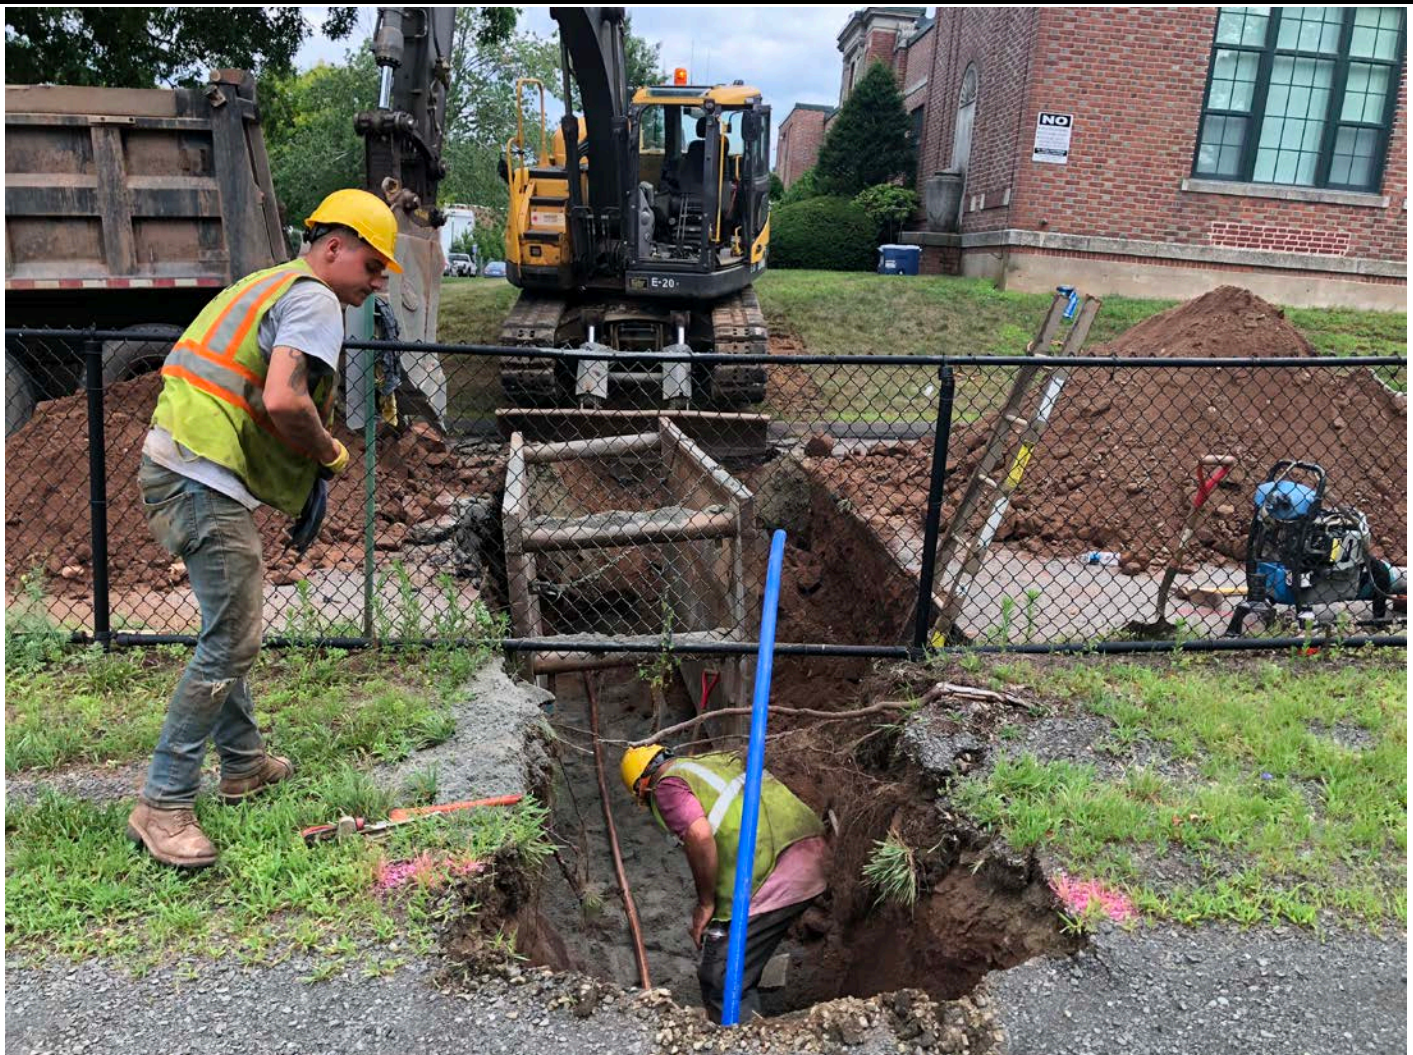
Picture 1: Ludlow installing 1" curb stop at Station 502+95. Pickett Lane, Durham. View to the north.

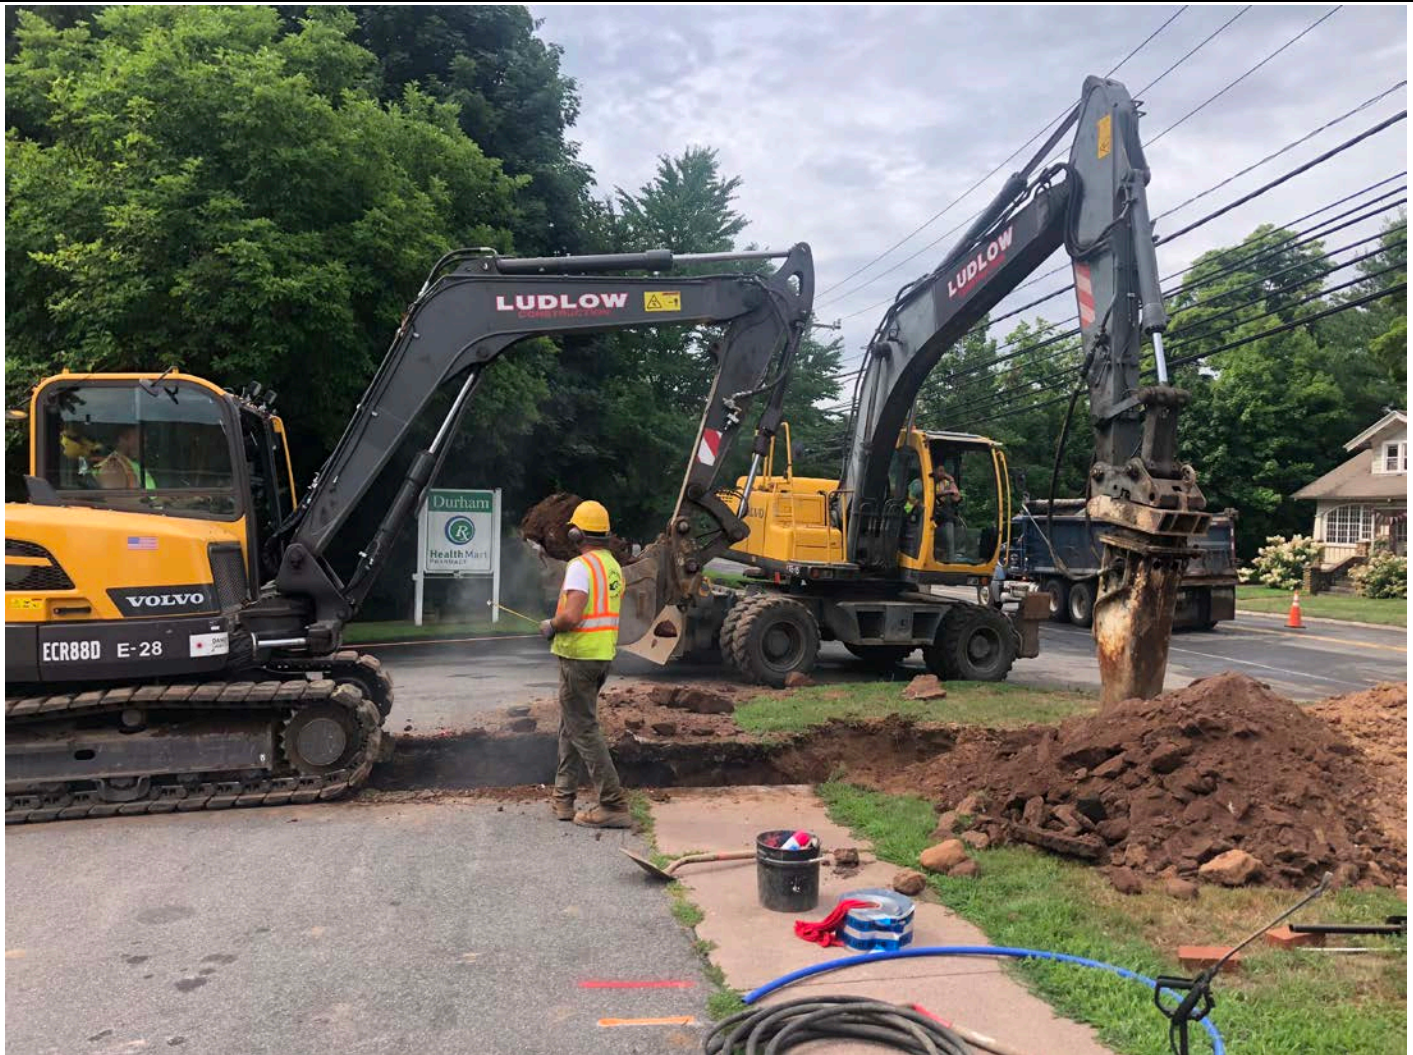
Picture 2: Ludlow hammering rock at Station 176+03. Main Street, Durham. View to the south.

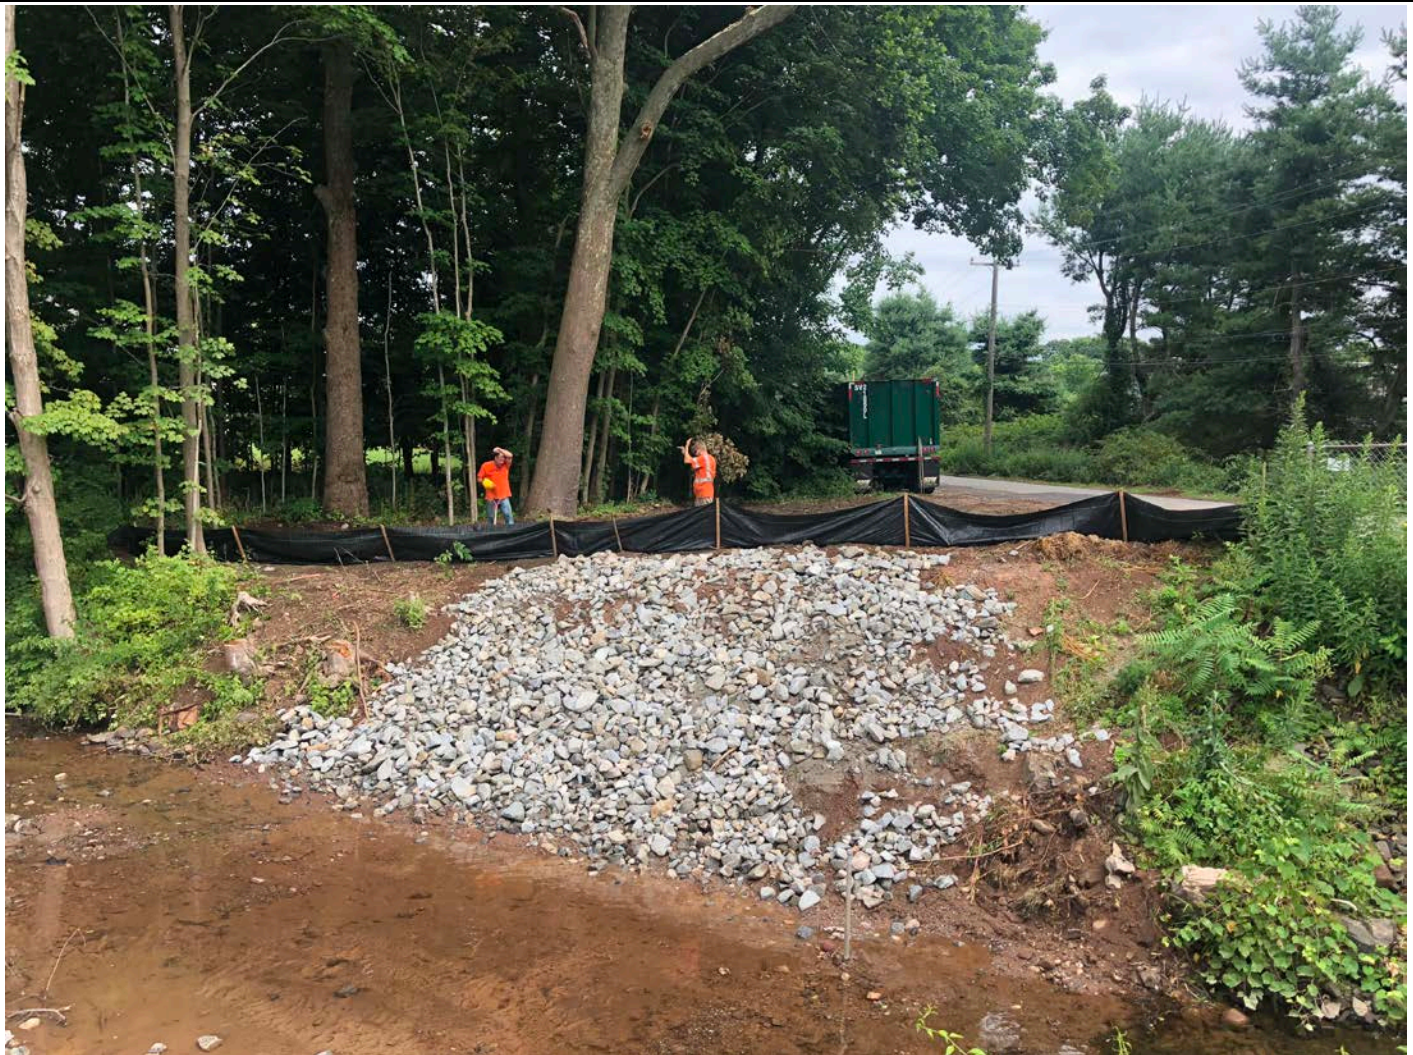
Picture 3: Ludlow installing silt fence on the north side of the Hersig Brook stream crossing. Pickett Lane, Durham. View to the north.

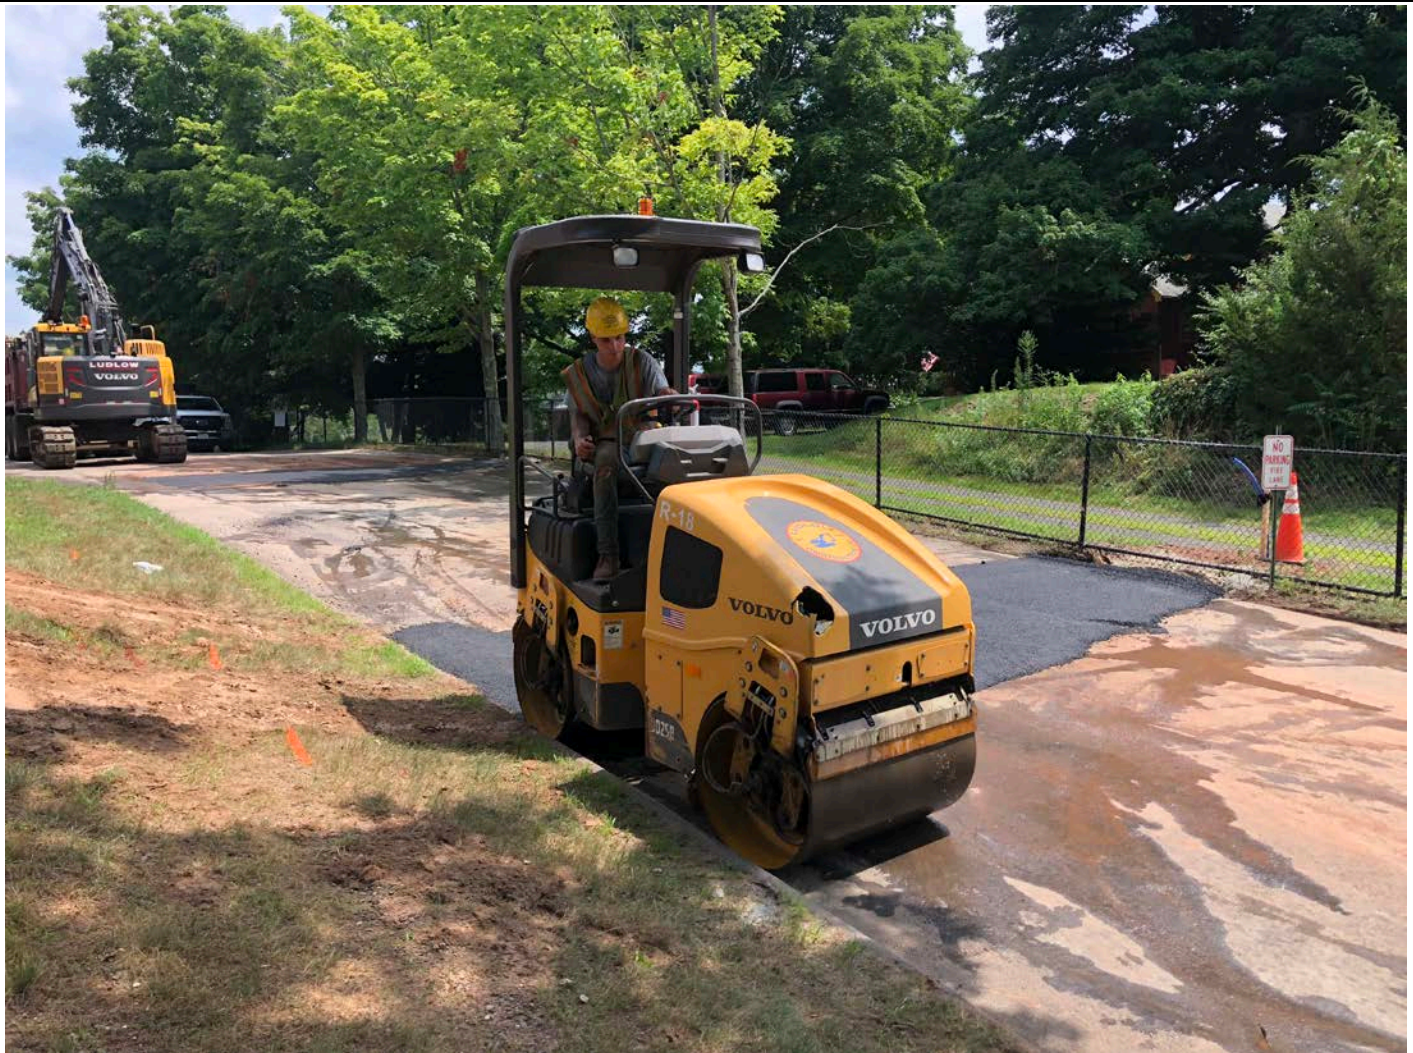
Picture 4: Ludlow compacting hot patch at Station 502+48. Pickett Lane, Durham. View to the east.

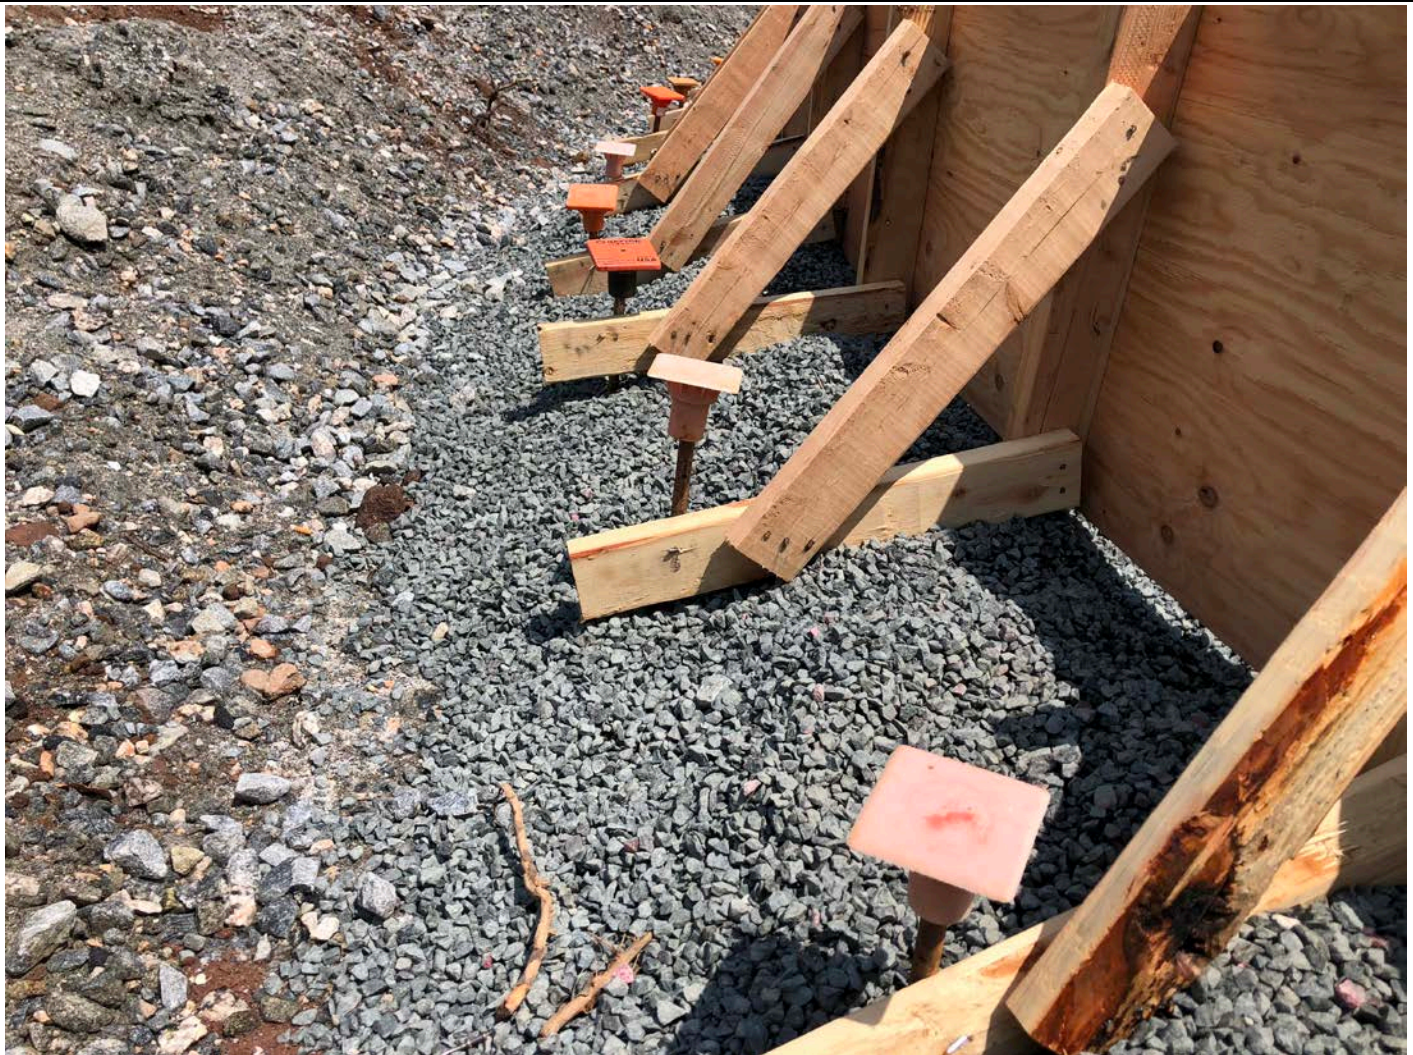
Picture 5: Safety caps that DN Tanks placed on exposed rebar ends. Water tank footprint, Shared Access Driveway, Middletown.

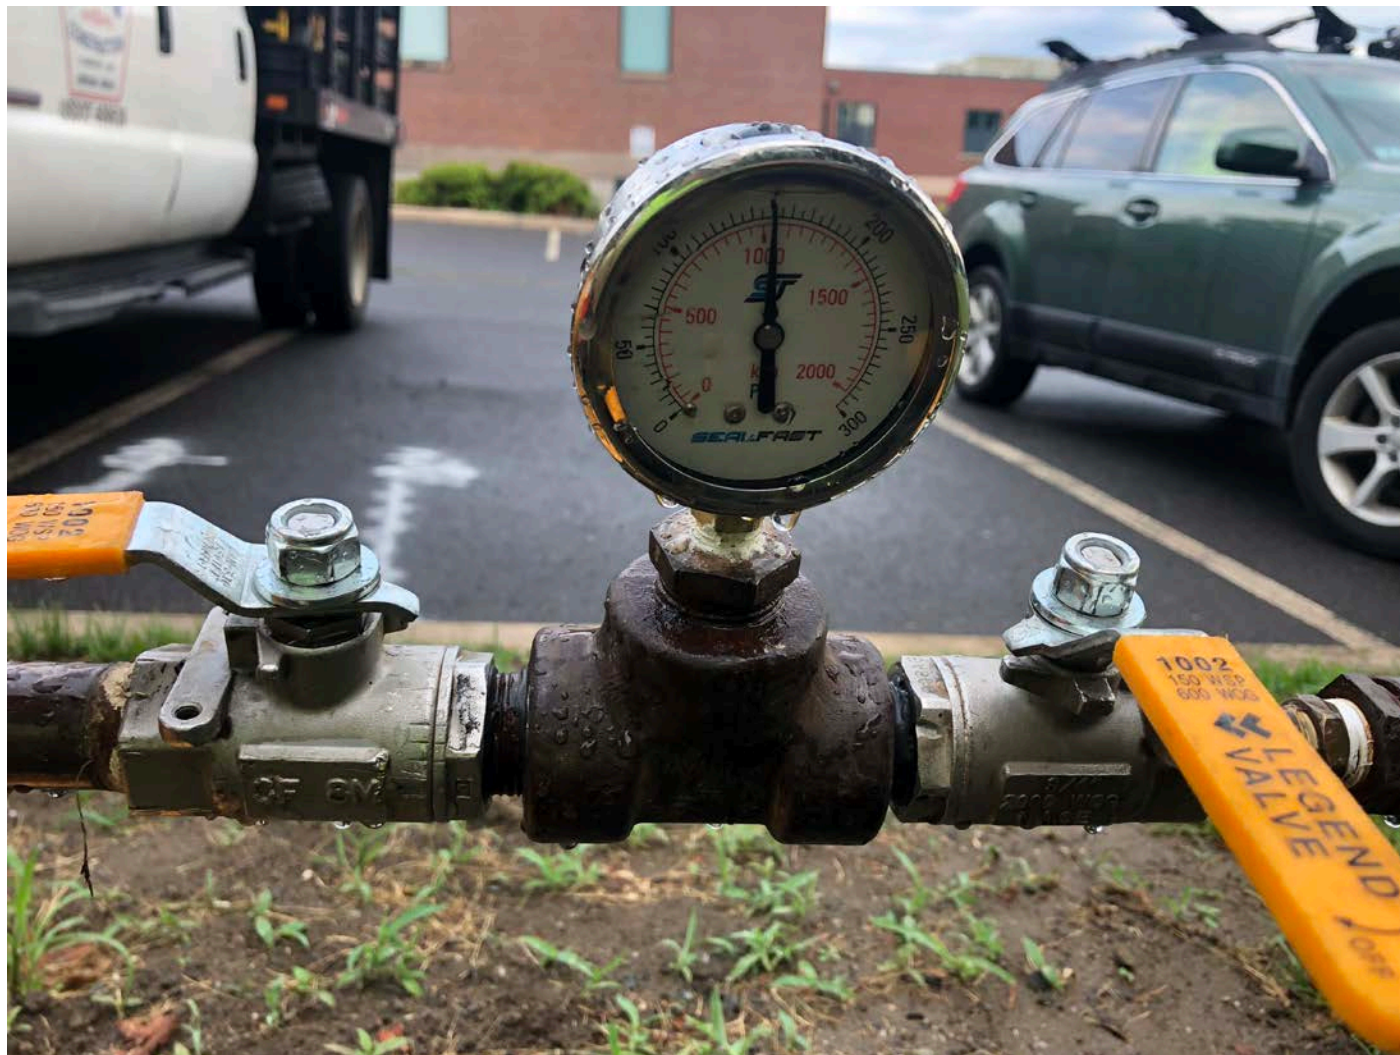
0825: Ludlow starts the pressure test. Starting pressure is 150 PSI.

Picture 6: Beginning pressure on the pressure test run on the Pickett Lane water line from Main Street to a valve located near Station 511+00. Pickett Lane, Durham.

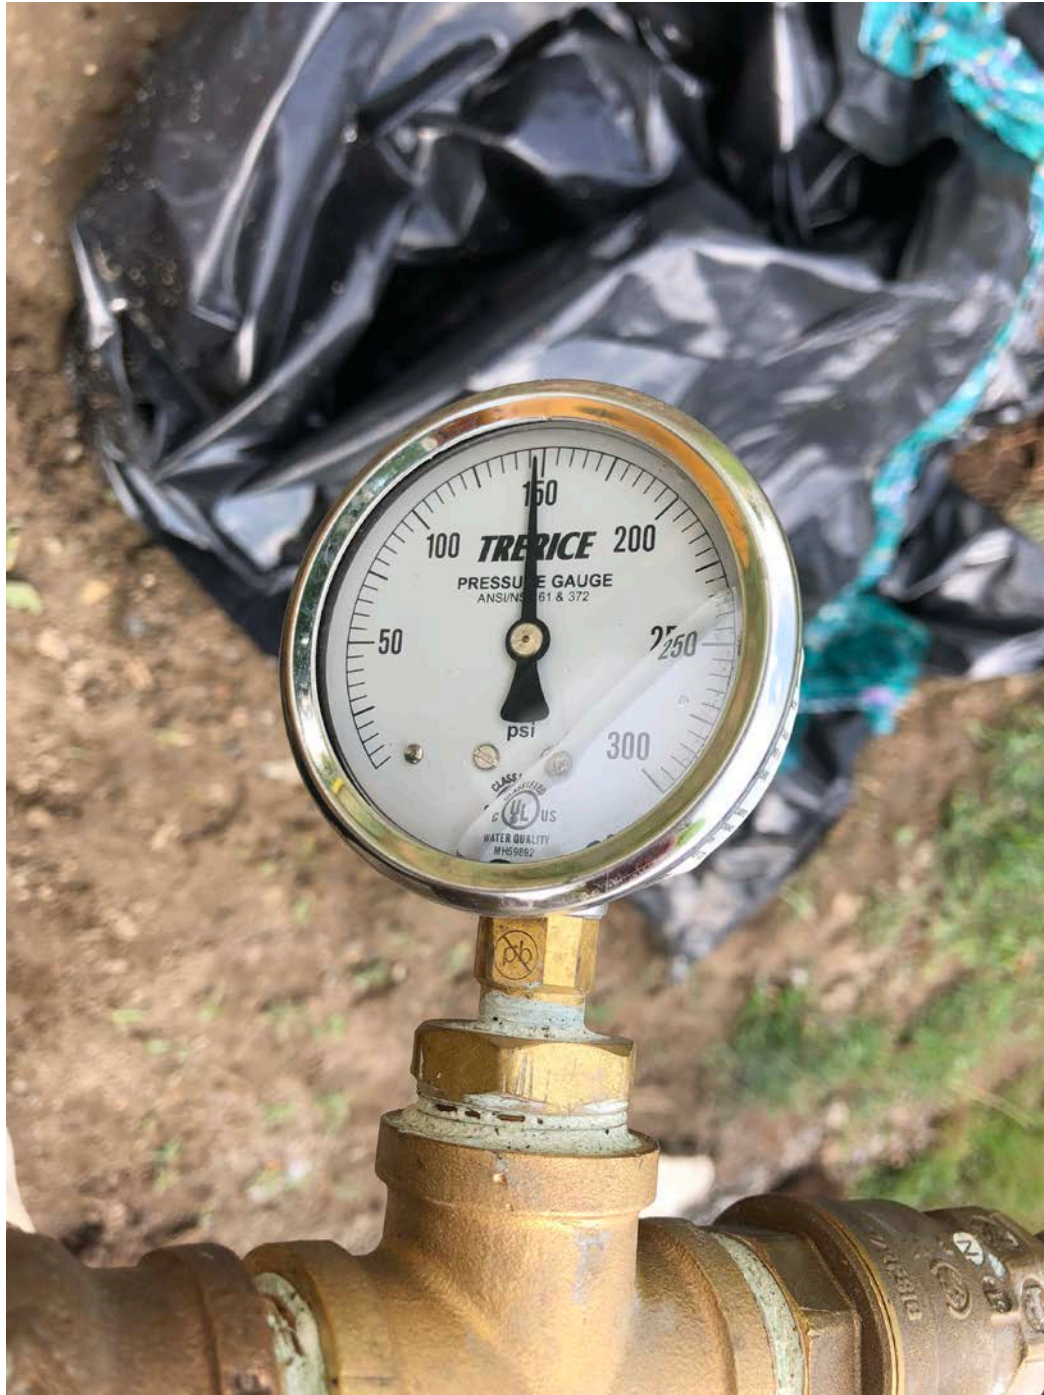
0948: Ludlow starts a second pressure test on Pickett Lane – this one testing the section of the water line from a gate valve near Station 511+00 to another valve near Station 530 (south side of the Hersig Brook bridge). Starting pressure is slightly less than 150 PSI.

Picture 8: Beginning pressure on the pressure test run on the Pickett Lane water line from a valve located near Station 511+00 to a valve located near Station 532+00. Pickett Lane, Durham.

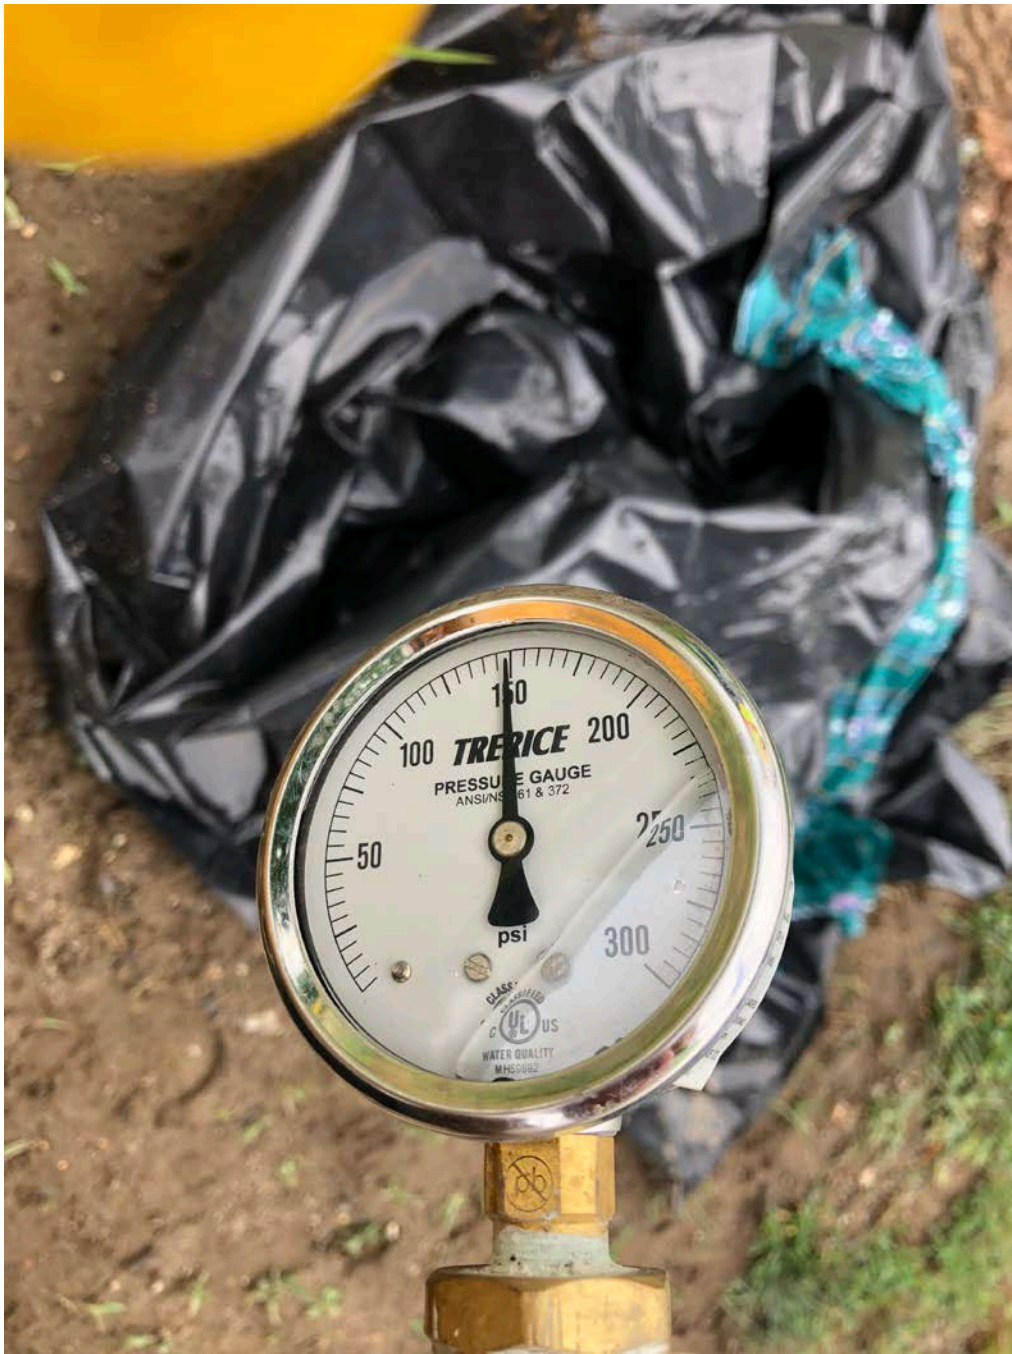
1150: The second pressure test on the water line on Pickett Lane was due to finish at 1148 hours. The pressure gauge attached to a hydrant between the valve near Station 511+00 and the valve near Station 531+00 reads 149.5 PSI.

Picture 9: End pressure on the pressure test run on the Pickett Lane water line from a valve located near Station 511+00 to a valve located near Station 532+00. Pickett Lane, Durham.
