## Daily Report

<b>Project:</b>	Durham Meadows Pipeline Installation	<b>Date:</b>	July 24, 2020
<b>Location:</b>	Pickett Lane, Main Street, and the Shared Access Driveway	<b>Day of Week:</b>	Friday
<b>Project #:</b>	AECOM: 6061487	<b>Report No:</b>	127
<b>Contractor:</b>	Ludlow Construction	<b>Page:</b>	1 of 16

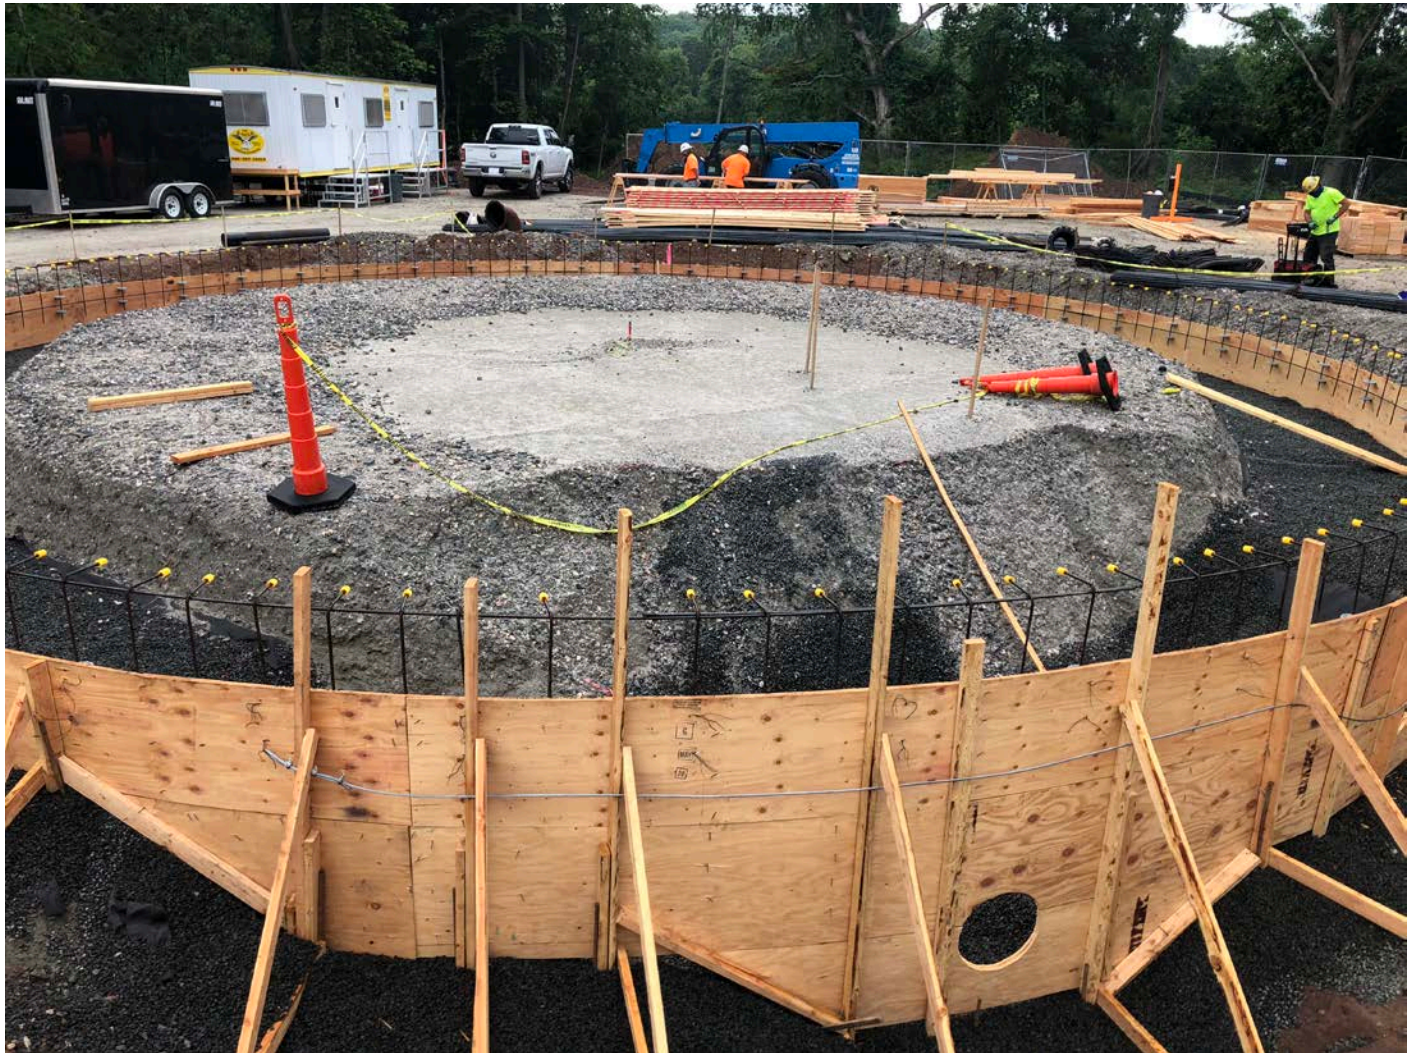
**Picture 1: Frost wall cement form at the water tank footprint, east end of the Shared Access Road, Middletown. View to the east.**

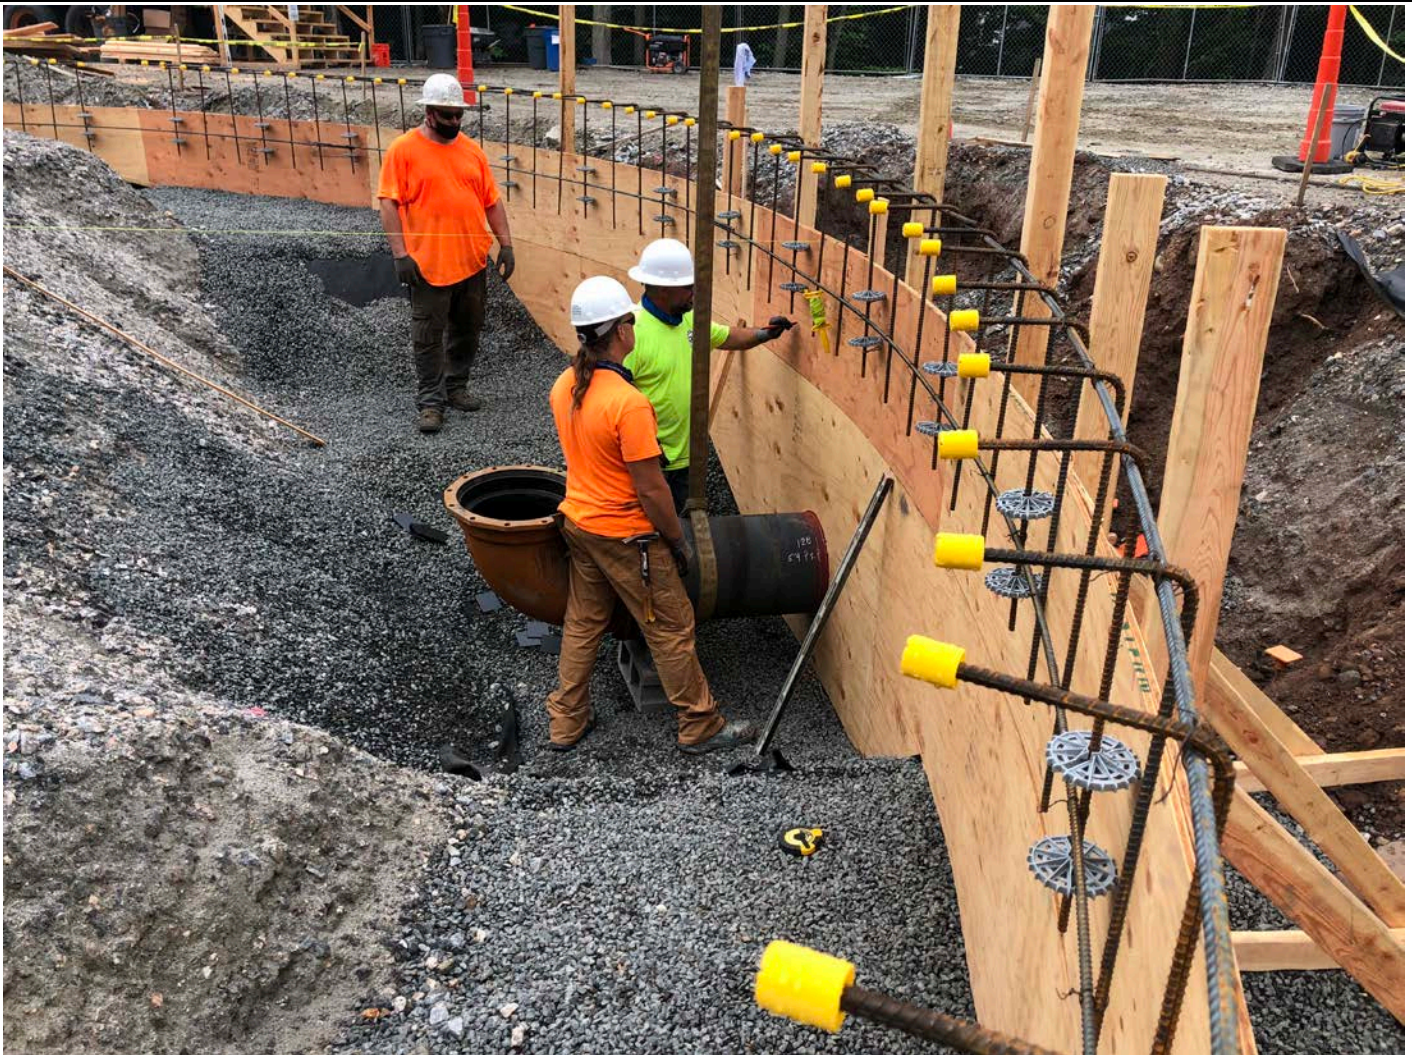
Picture 2: DN Tanks installing the water tank's main line through a hole cut through the wall of the concrete form for the frost wall. View to the south.

0850: DN Tanks is installing the water tank's main line through a hole cut through the wall of the concrete form for the frost wall.

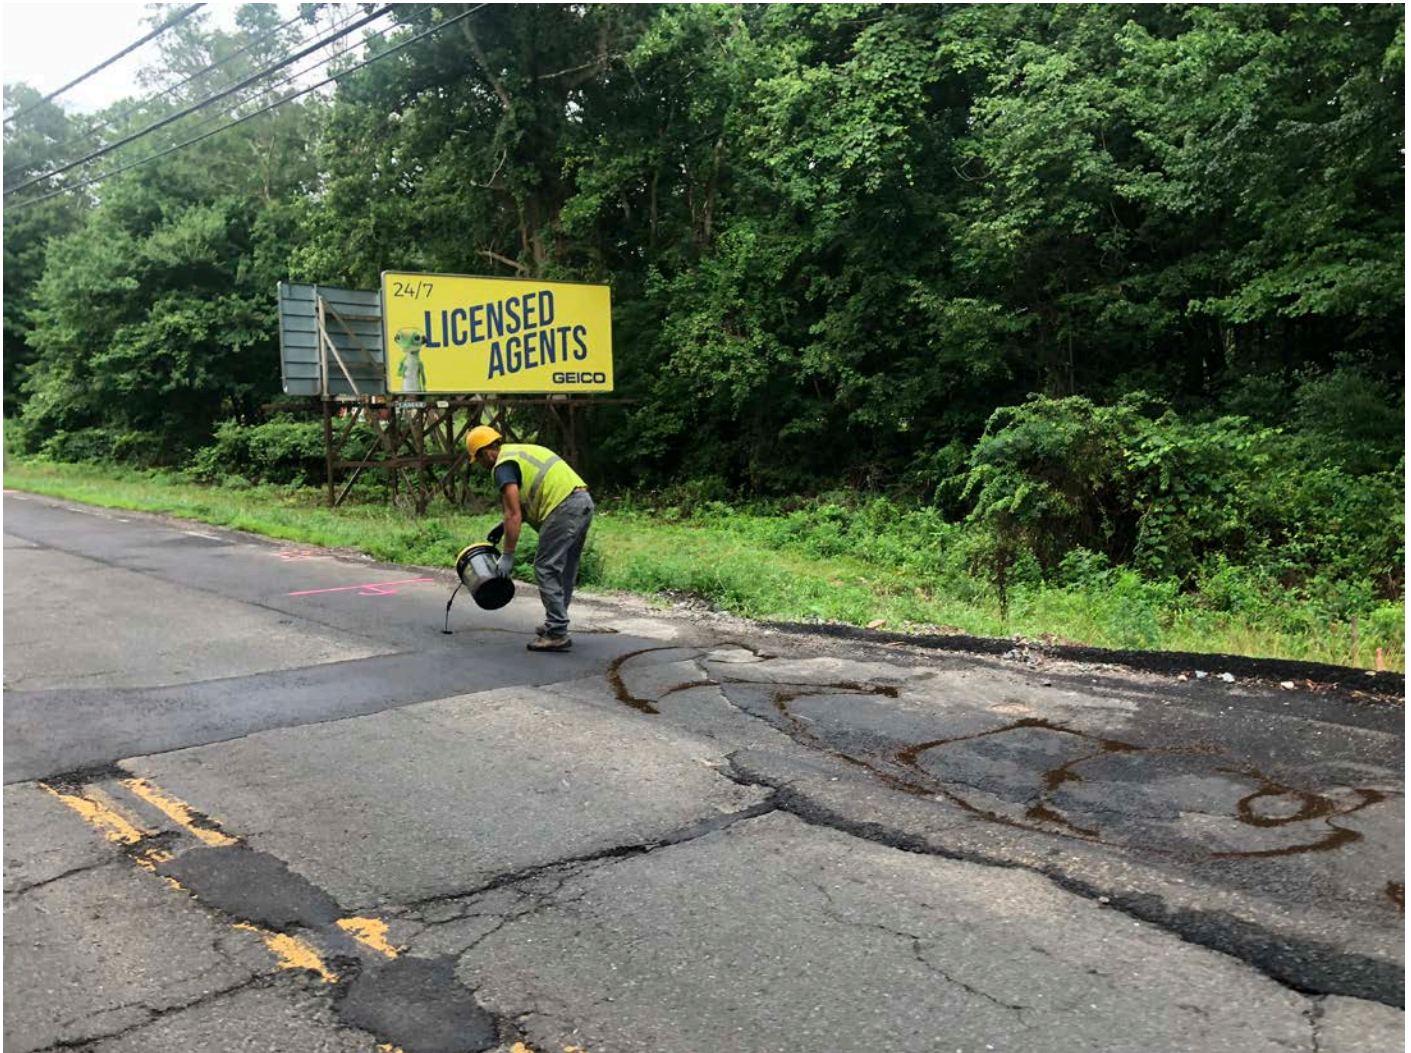
Picture 3: Ludlow applying tack coat to asphalt surface, preparing to shim coat trench footprint on S. Main Street in Middletown from Stations 136+50 to 138+00. View to the west.

0750: Ludlow is spreading tack coat on top of exiting asphalt on the water trench footprint on the southbound lane of S. Main Street from Stations 136+50 to 138+00.

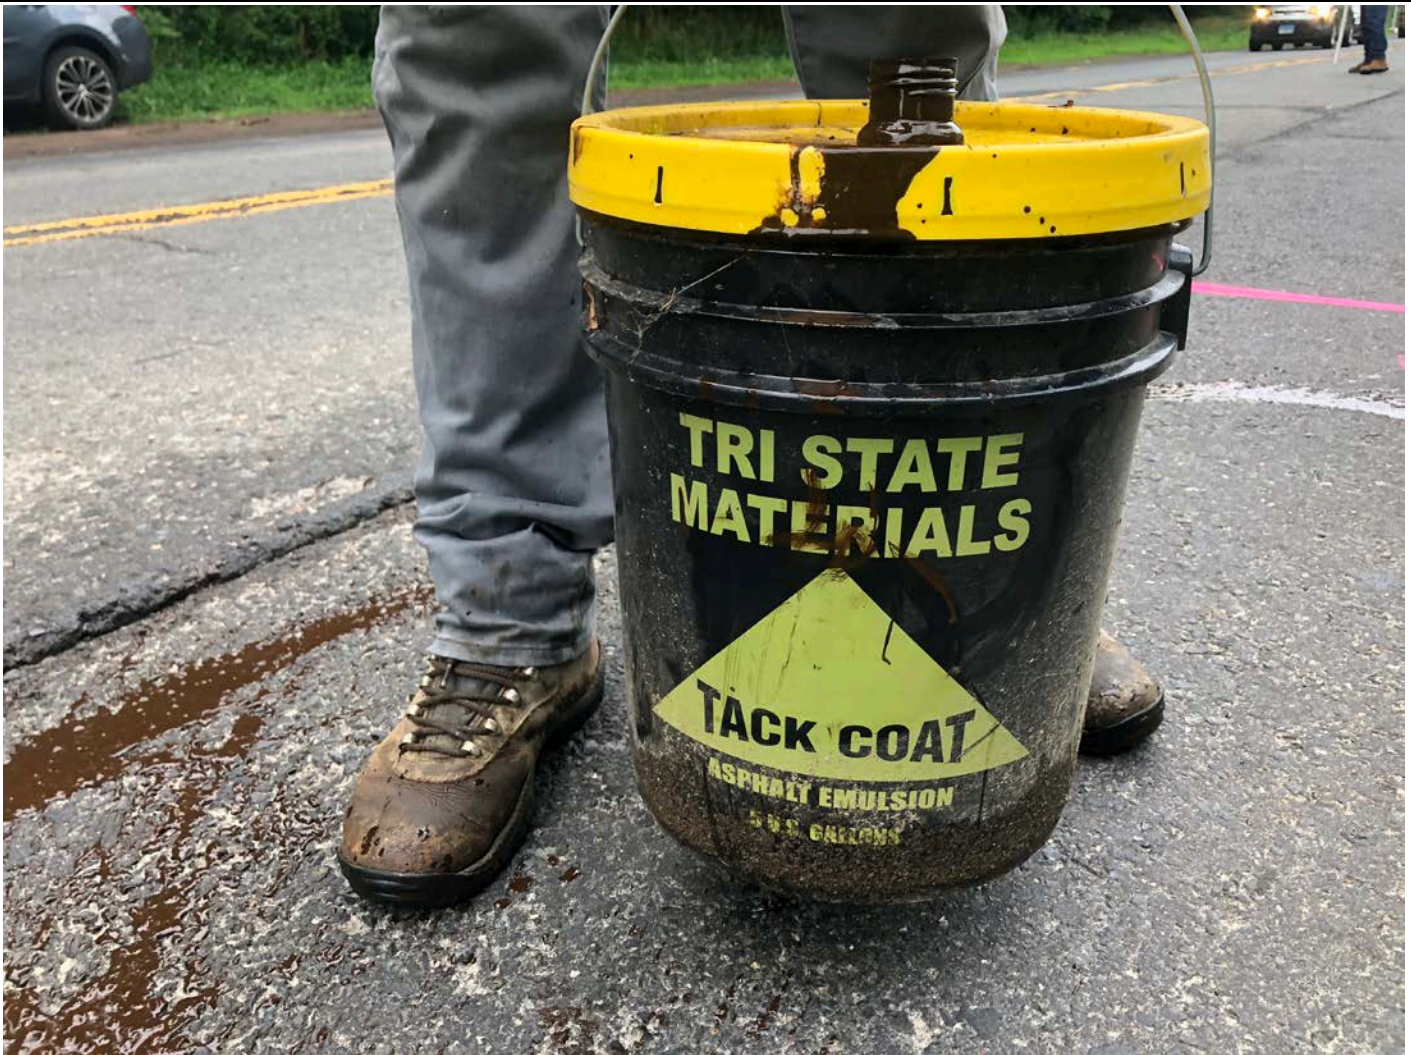
Picture 4: Tack coat applied prior to shim coating.

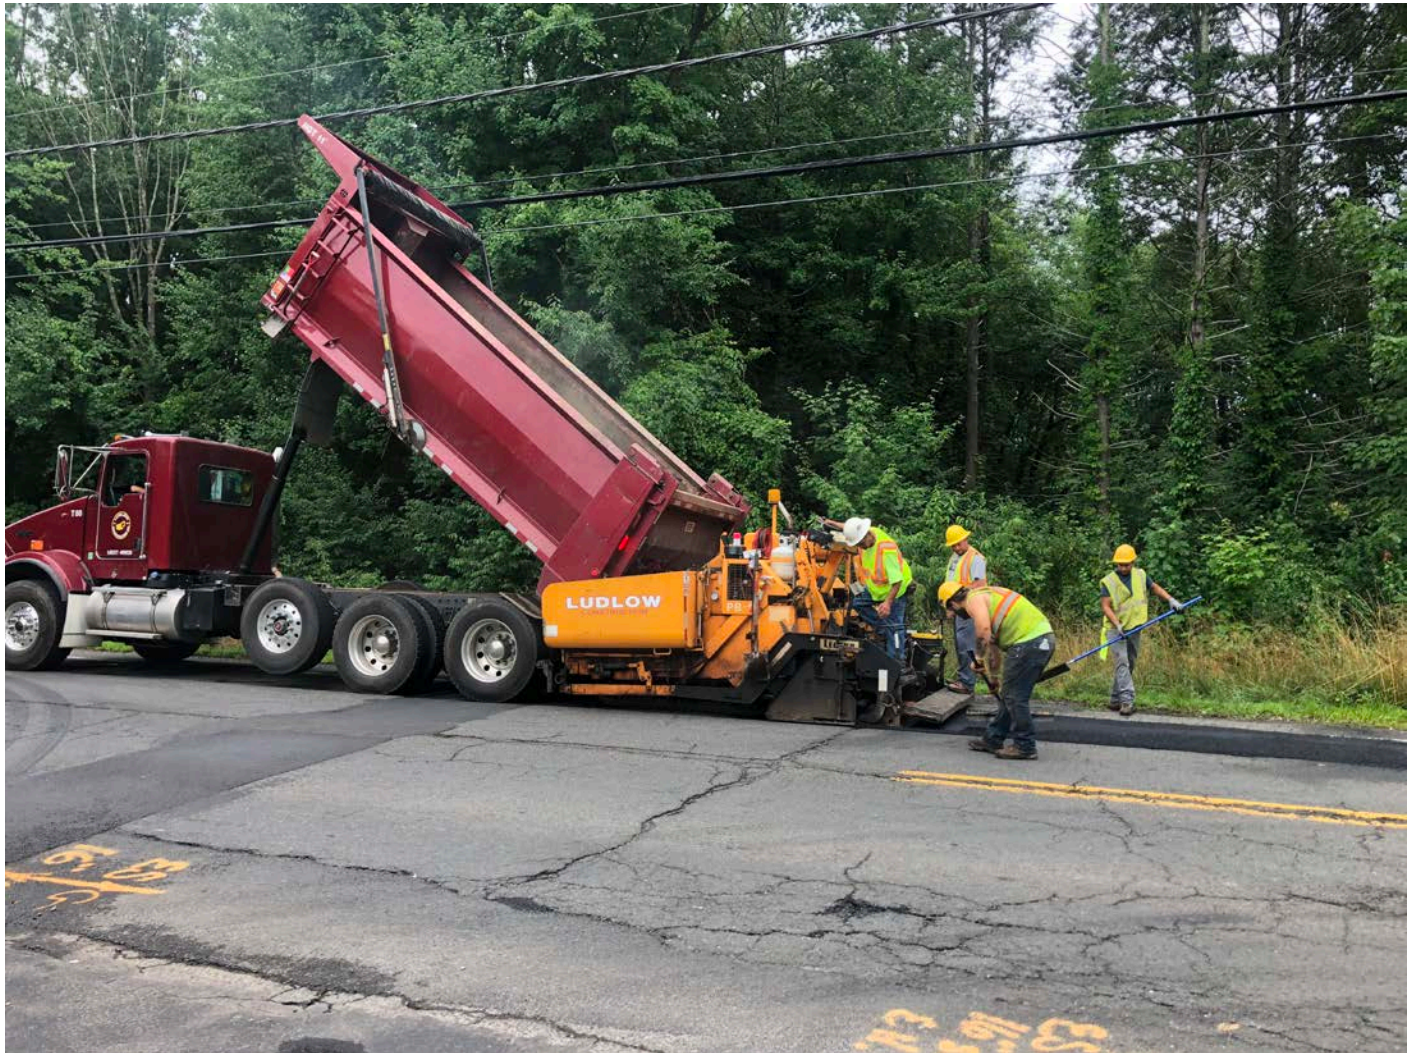
Picture 5: Ludlow begins to shim coat the southbound section of S. Main Street in Middletown from Stations 136+50 to 138+00. View to the west.

0809: Ludlow delivers hot patch to the work zone at the intersection of Royal Oak Drive and S. Main Street. Ludlow begins to shim coat the trench on the southbound lane of S. Main Street from Stations 136+50 to 138+00.

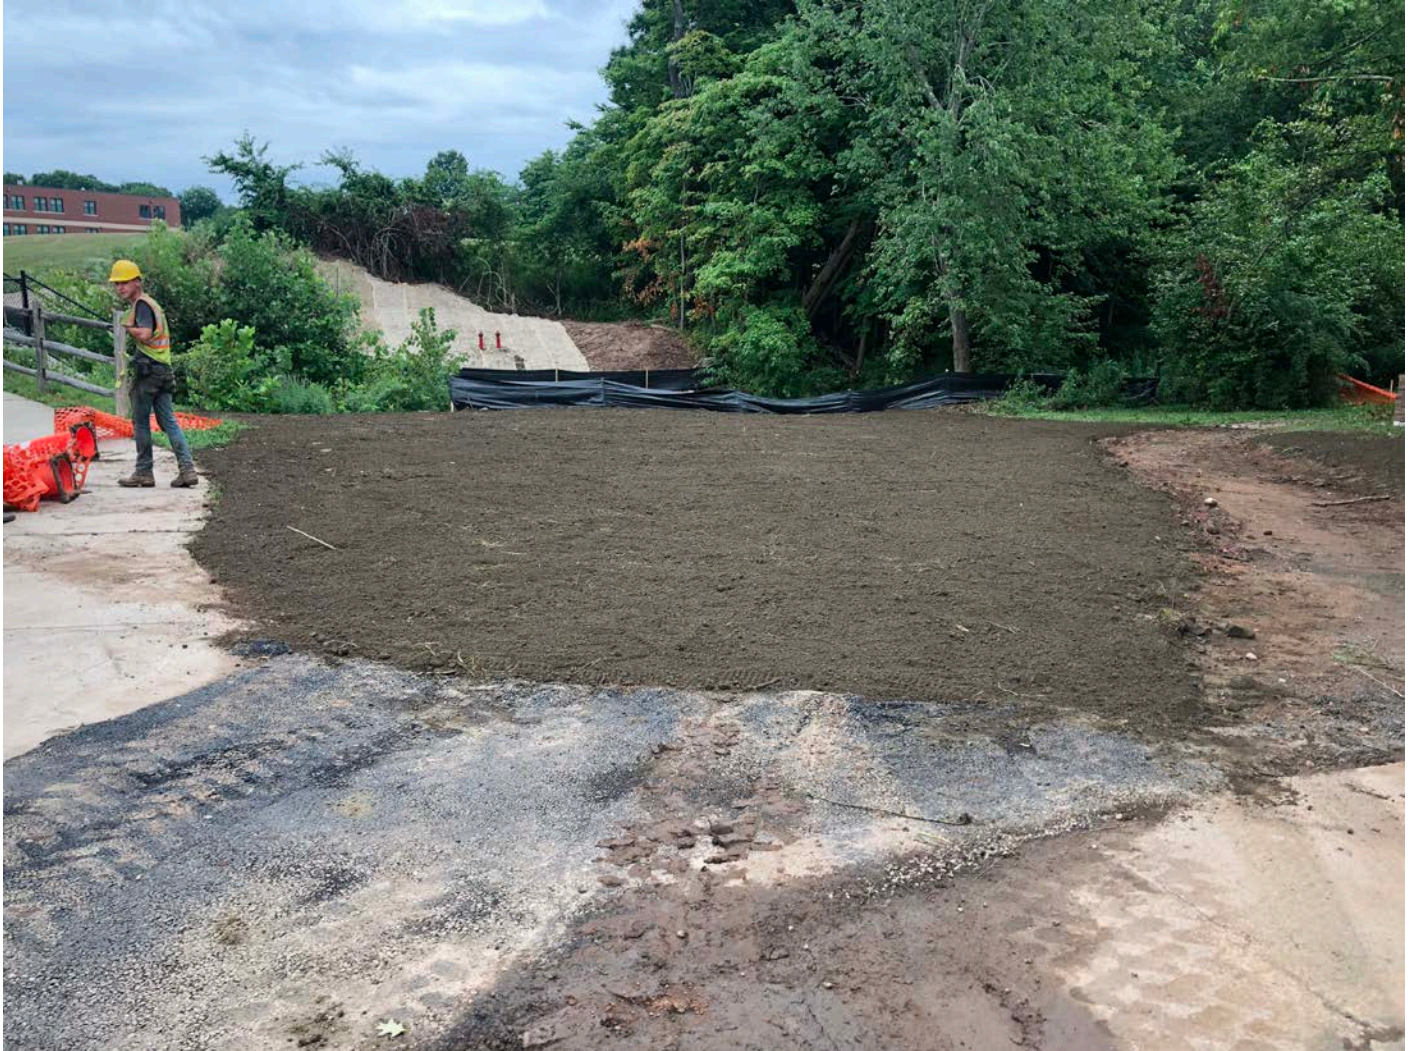
Picture 6: Ludlow loaming and seeding the work area located due east of the Pickett Lane stream crossing at Station ~511+00. View to the northwest.

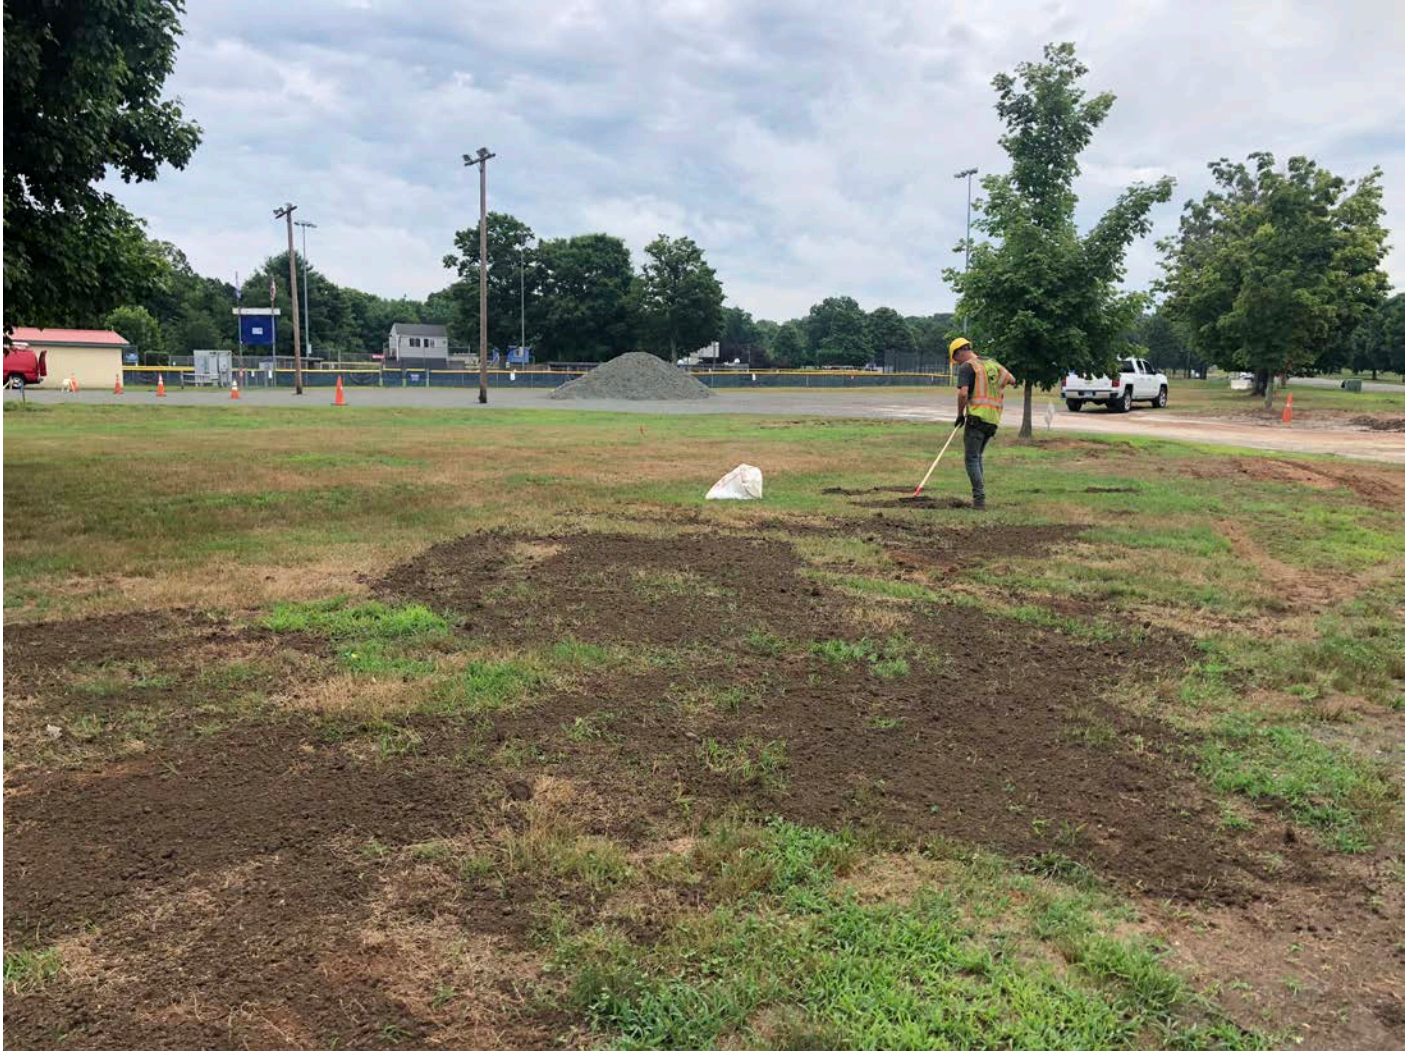
**Picture 7: Ludlow loaming and seeding at the Station 514+00 staging area on Pickett Lane, Durham. View to the northeast.**

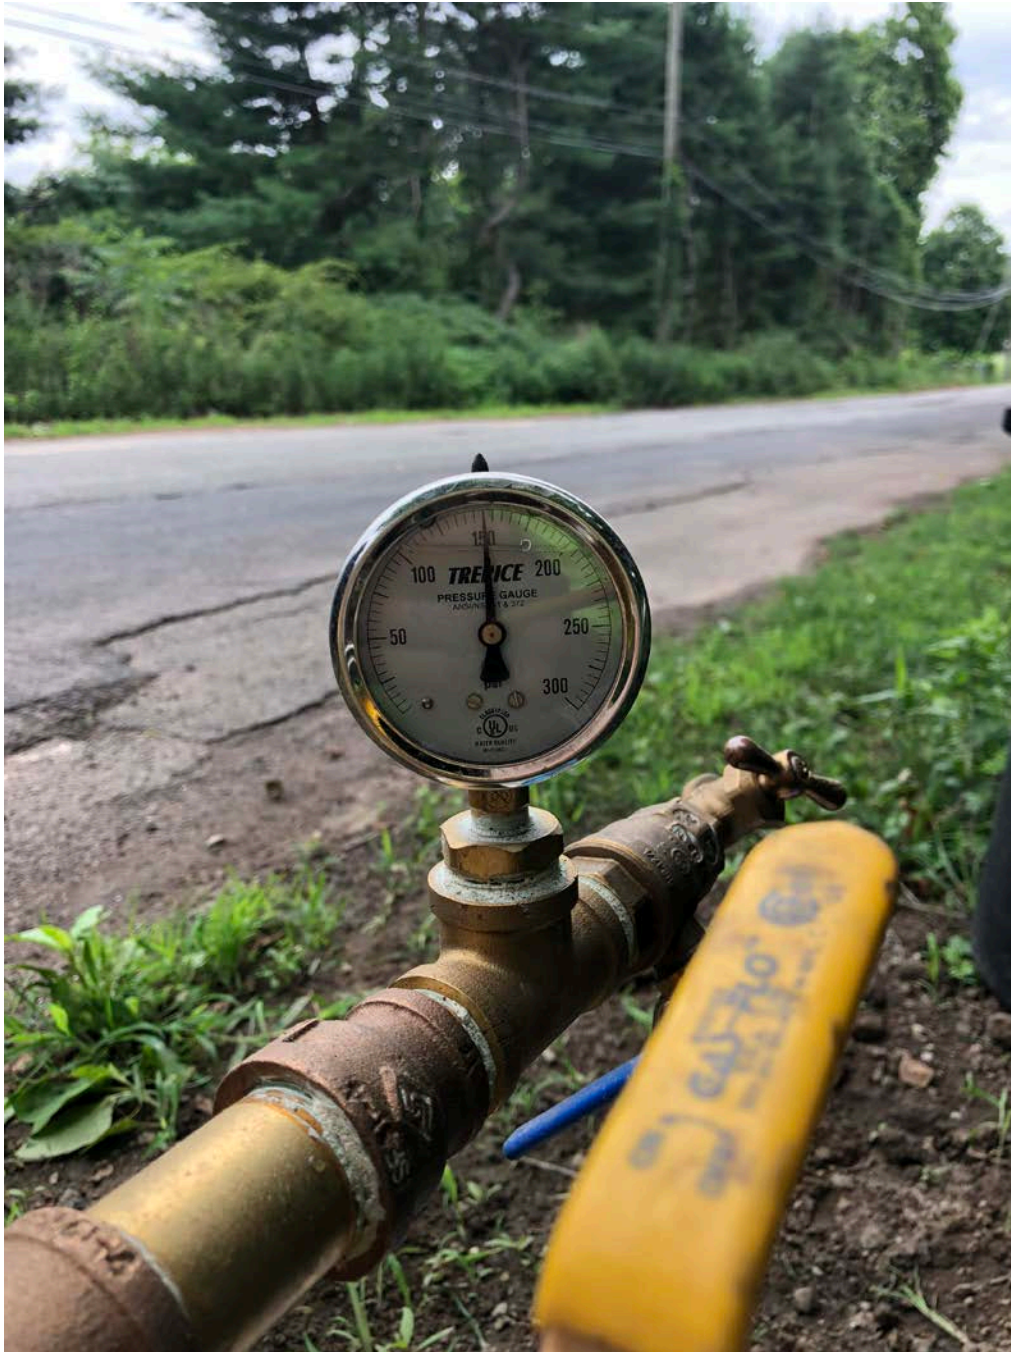
**Picture 8: Beginning pressure on the test performed on the Pickett Lane water line from a valve at Station 531+00 to a valve located at the intersection of Pickett Lane and Maiden Lane.**

1131: Ludlow starts a pressure test on Pickett Lane. The test is being run on the section of water line located between a valve at Station 531+00 and a valve located at the intersection of Pickett Lane and Maiden Lane.

1138: The reading for the pressure test being run on Pickett Lane is taken from a gauge that was placed on the hydrant located at 534+30.

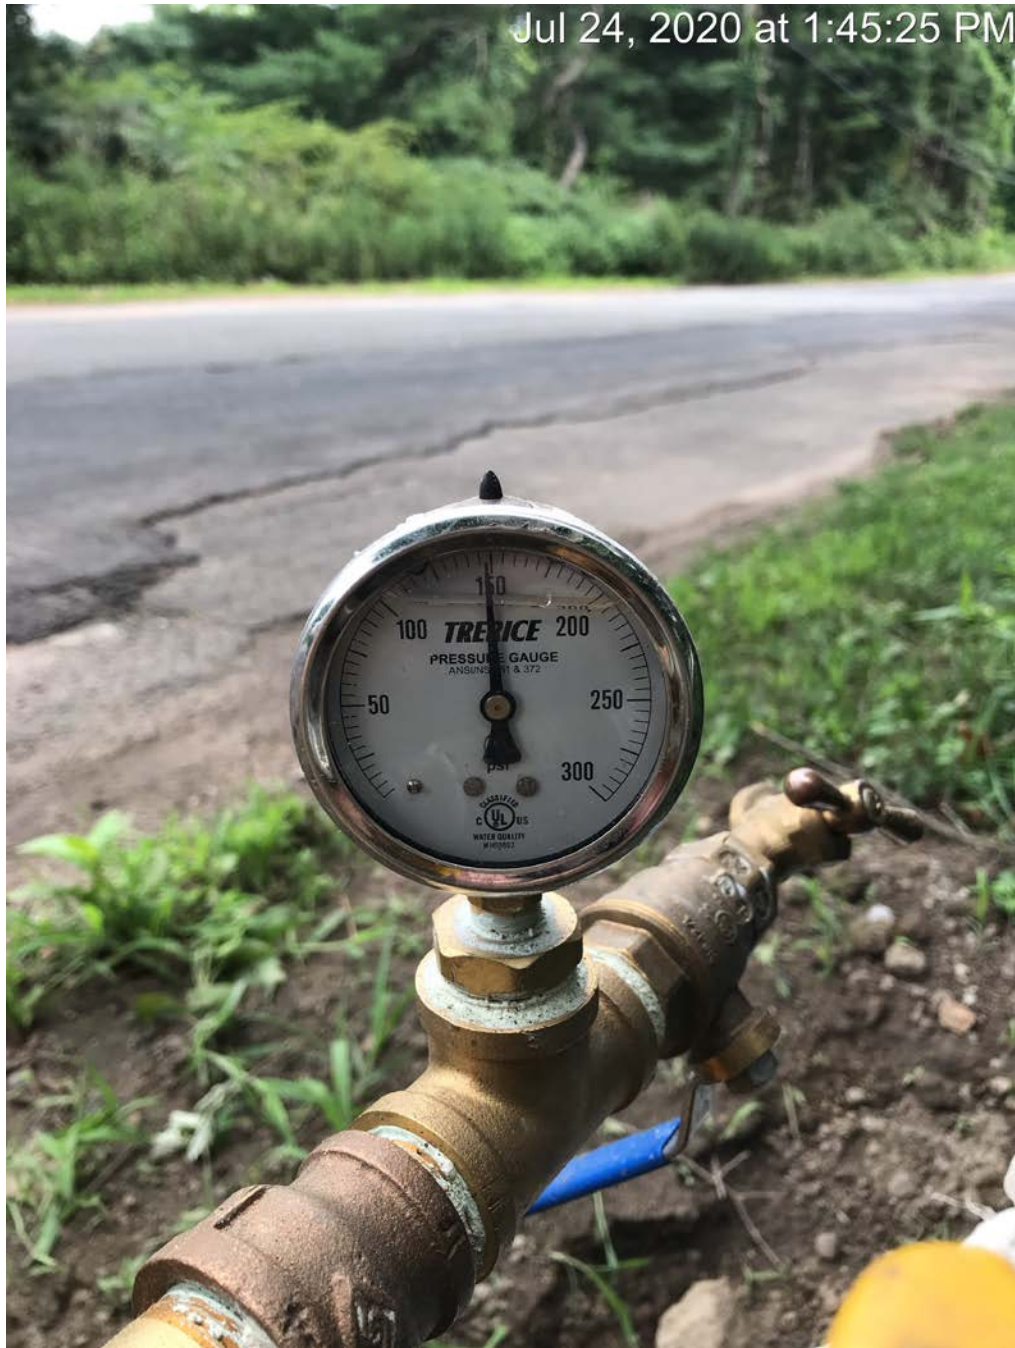
Picture 9: End pressure on the test performed on the Pickett Lane water line from a valve at Station 531+00 to a valve located at the intersection of Pickett Lane and Maiden Lane.

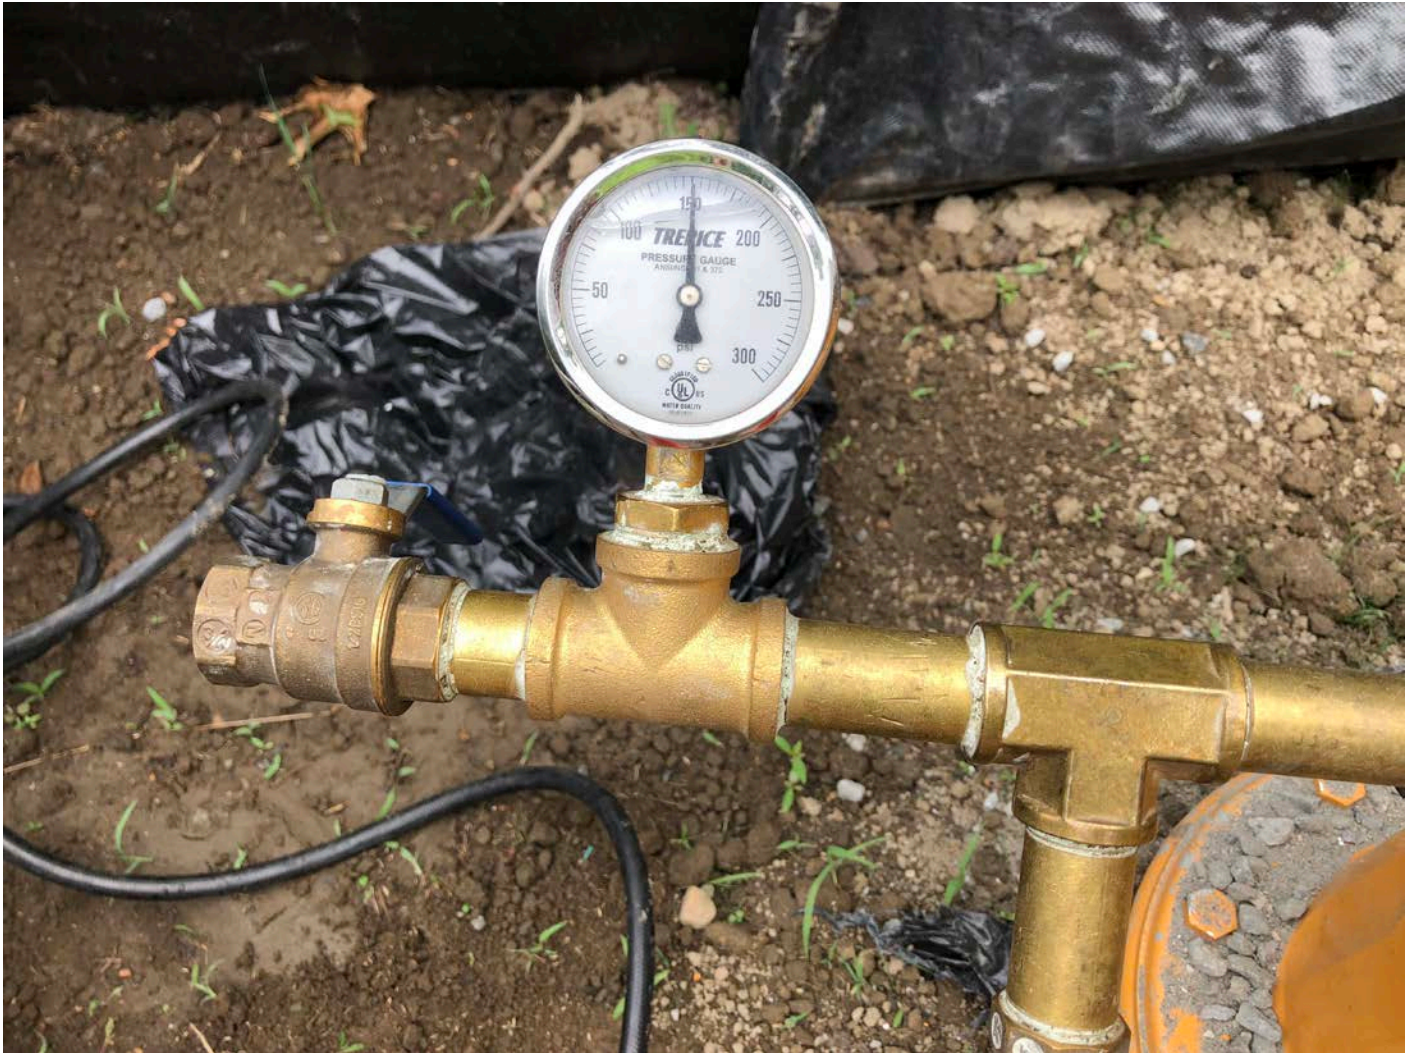
**Picture 10: Beginning pressure on the test performed on the Maiden Lane water line from a gate valve at Station 412+14 and gate valve at the intersection of Maiden Lane and Pickett Lane.**

1139: Ludlow starts a pressure test on Maiden Lane. The test is being run on the section of water line located between a gate valve at Station 412+14 and gate valve at the intersection of Maiden Lane and Pickett Lane. The pressure gauge for this test is on a hydrant located at Station 420+50.

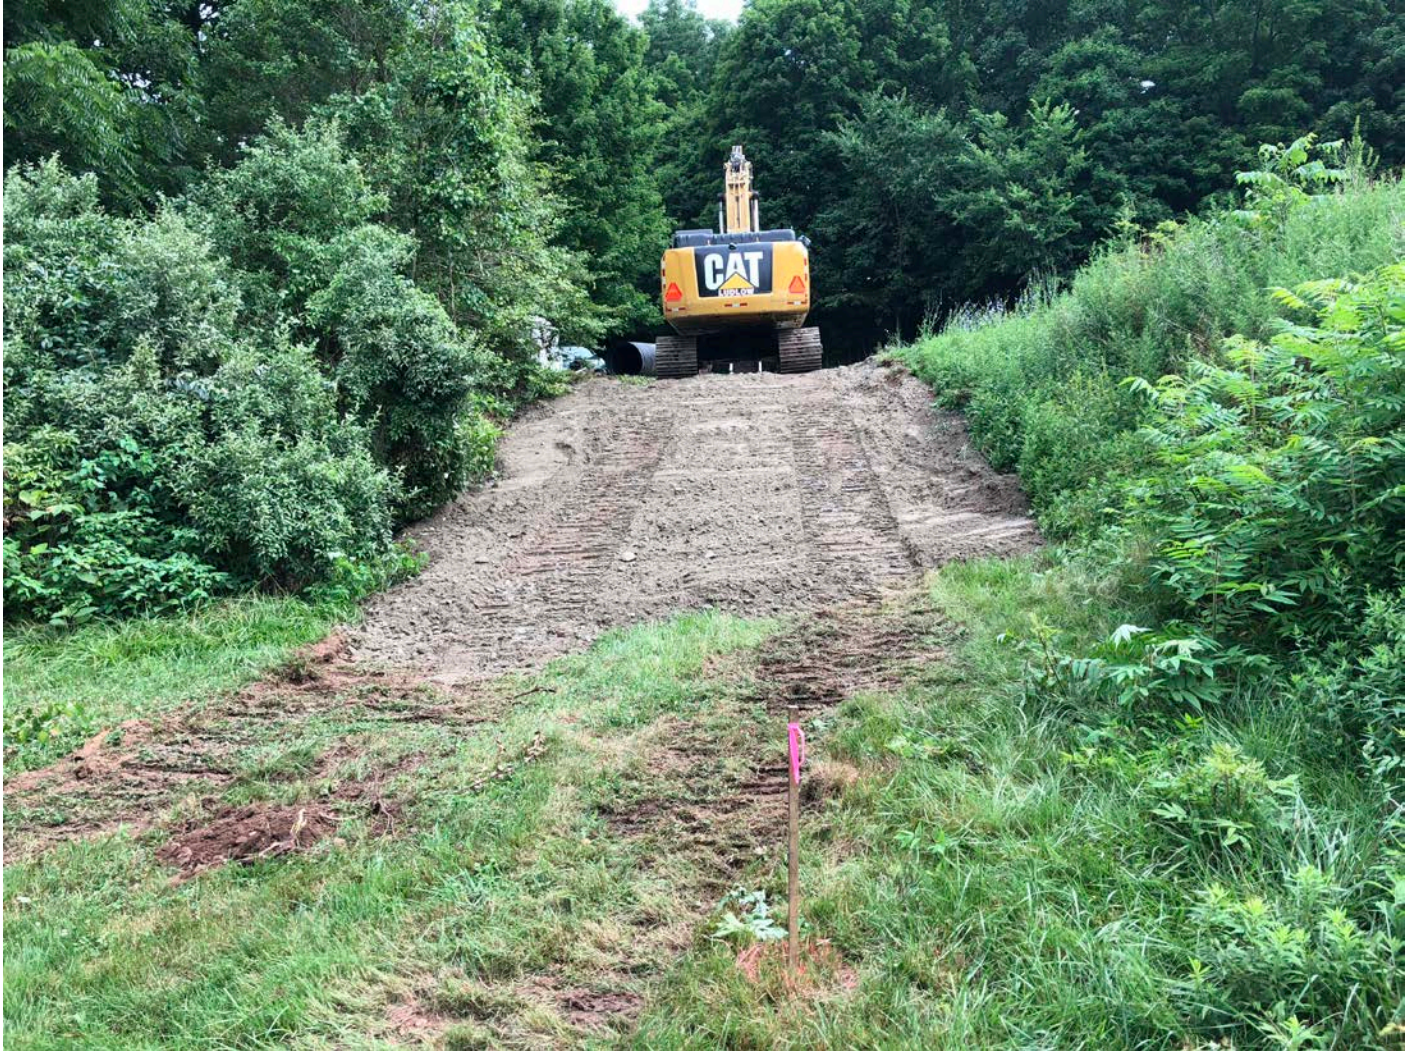
**Picture 12: View of where Ludlow cleared brush on the north side of the Allyn Brook stream crossing on Maple Avenue, Durham. View to the north.**

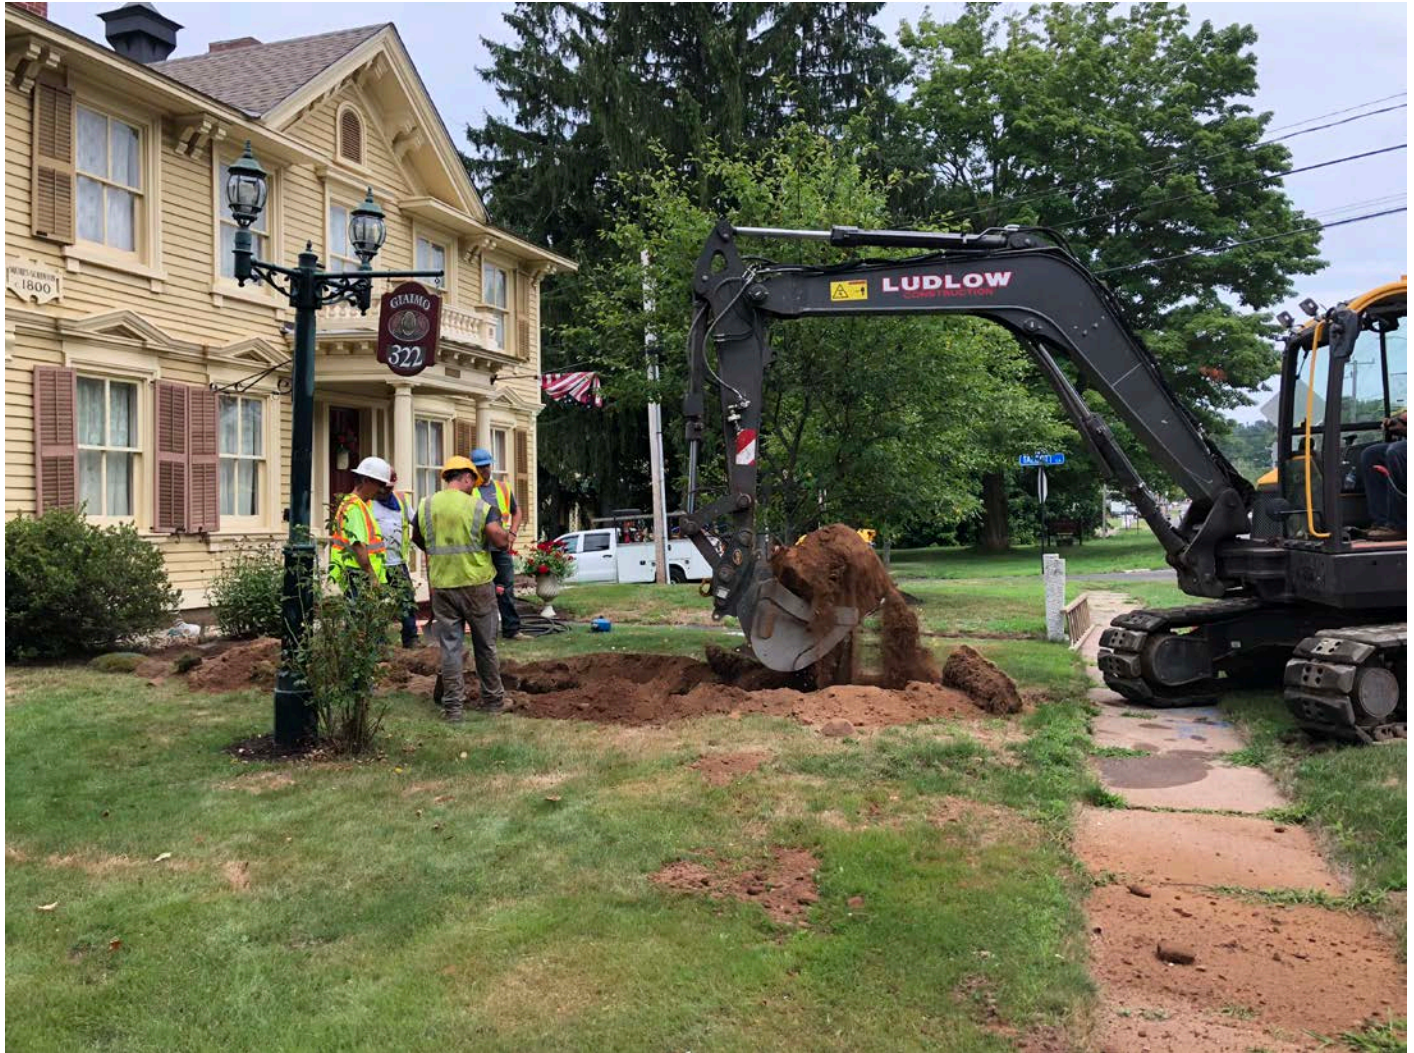
Picture 13: Ludlow installing a curb stop at 322 Main Street; Station 176+00. View to the north.

1029: Ludlow begins excavating for placement of a curb stop at Station 176+00. This will service the home at 322 Main Street, Durham. The trench for the 1" copper service line was curved to arc around the roots of a newly planted tree.

1128: The curb stop at 322 Main Street is set back 35.5' from the edge of pavement.
