Daily Report

Project:	Durham Meadows Pipeline Installation	Date:	July 28, 2020
Location:	Maple Avenue, Main Street, and the Shared Access Driveway	Day of Week:	Tuesday
Project #:	AECOM: 6061487	Report No:	129
Contractor:	Ludlow Construction	Page:	1 of 15

Daily Activities – Stream Crossing, Maple Avenue

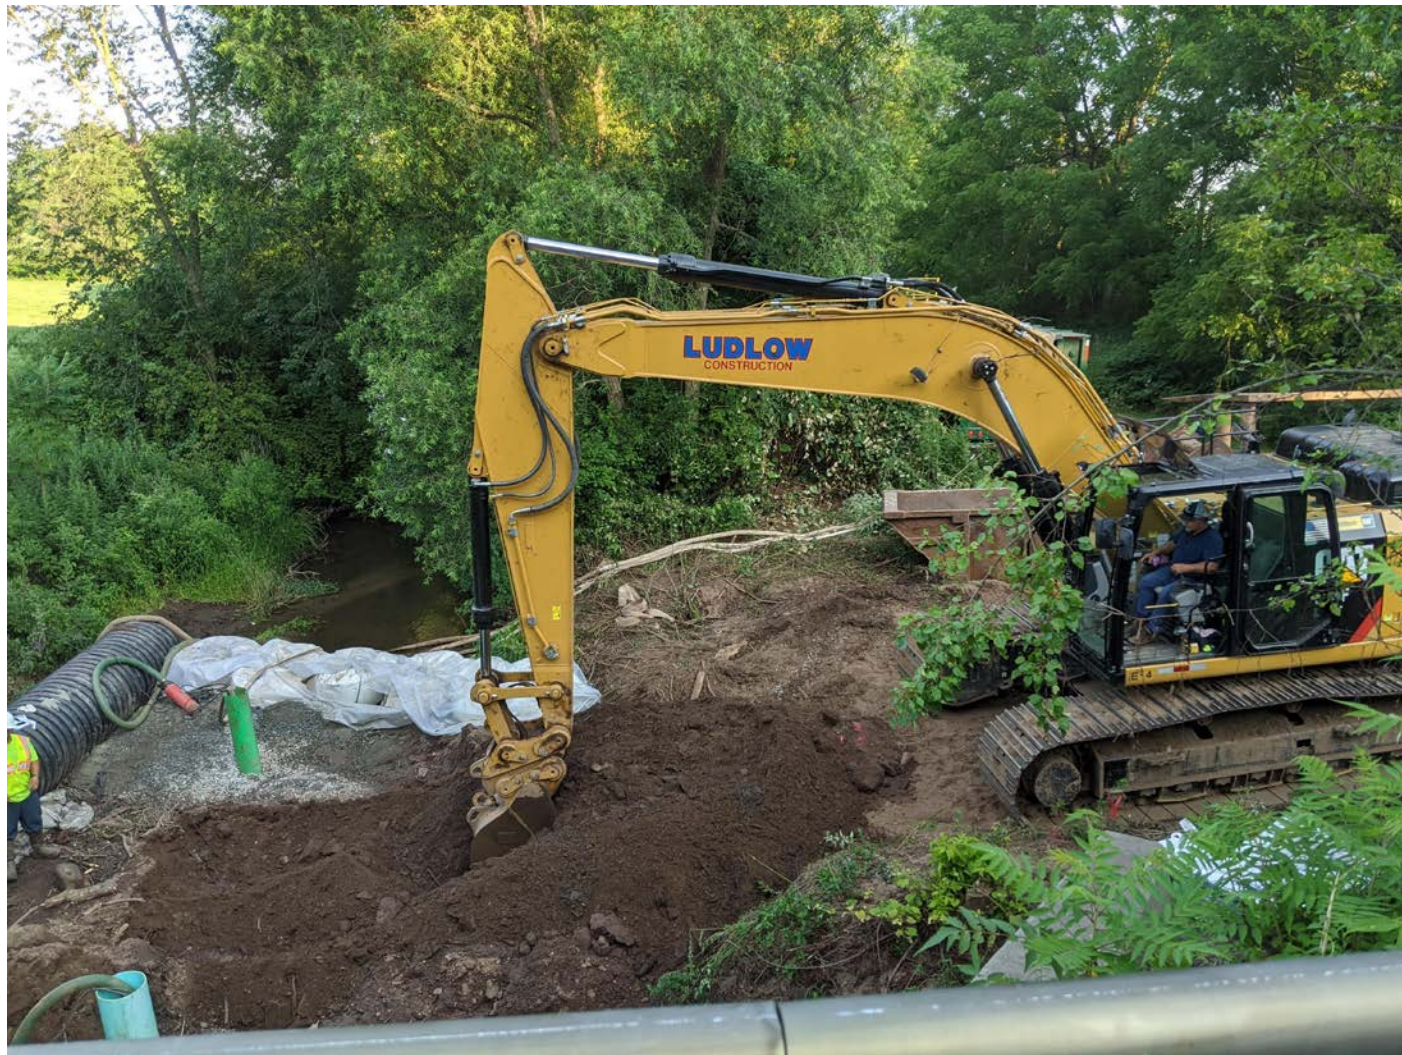
Picture 1: Ludlow construction removing soil from the stream bed, Maple Avenue, Station 905+00. View to the west.

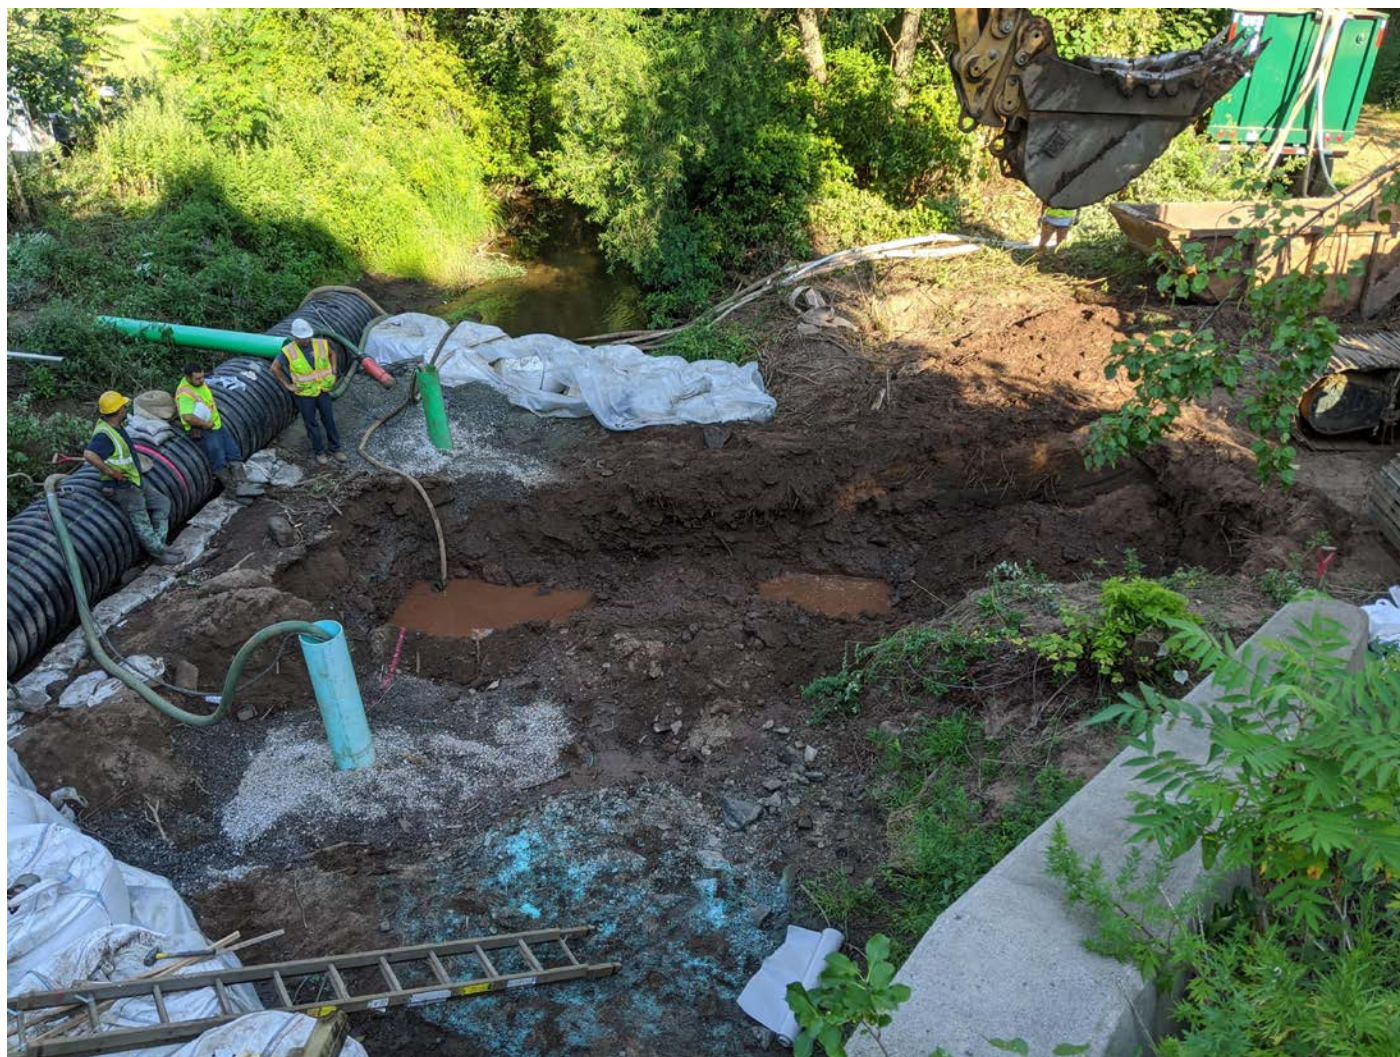
Picture 2: Ludlow construction pumping groundwater from the stream bed excavation, Maple Avenue, Station 905+00. View to the west.

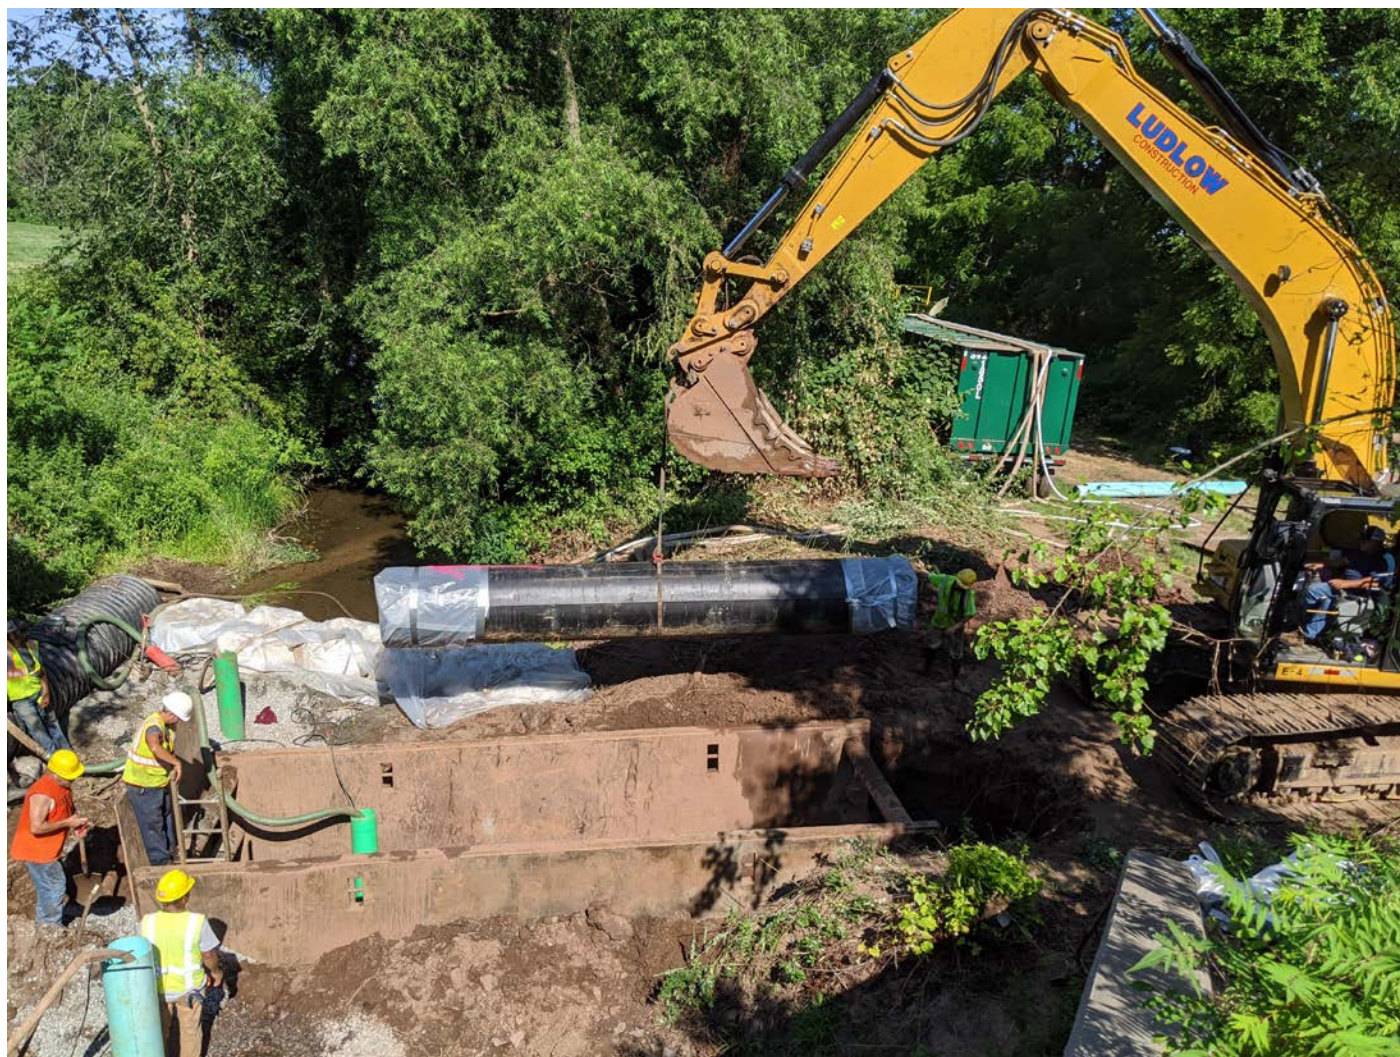
Picture 3: Ludlow construction installing 20' long 36" diameter casing into the stream bed excavation, Maple Avenue, Station 905+00. View to the west.

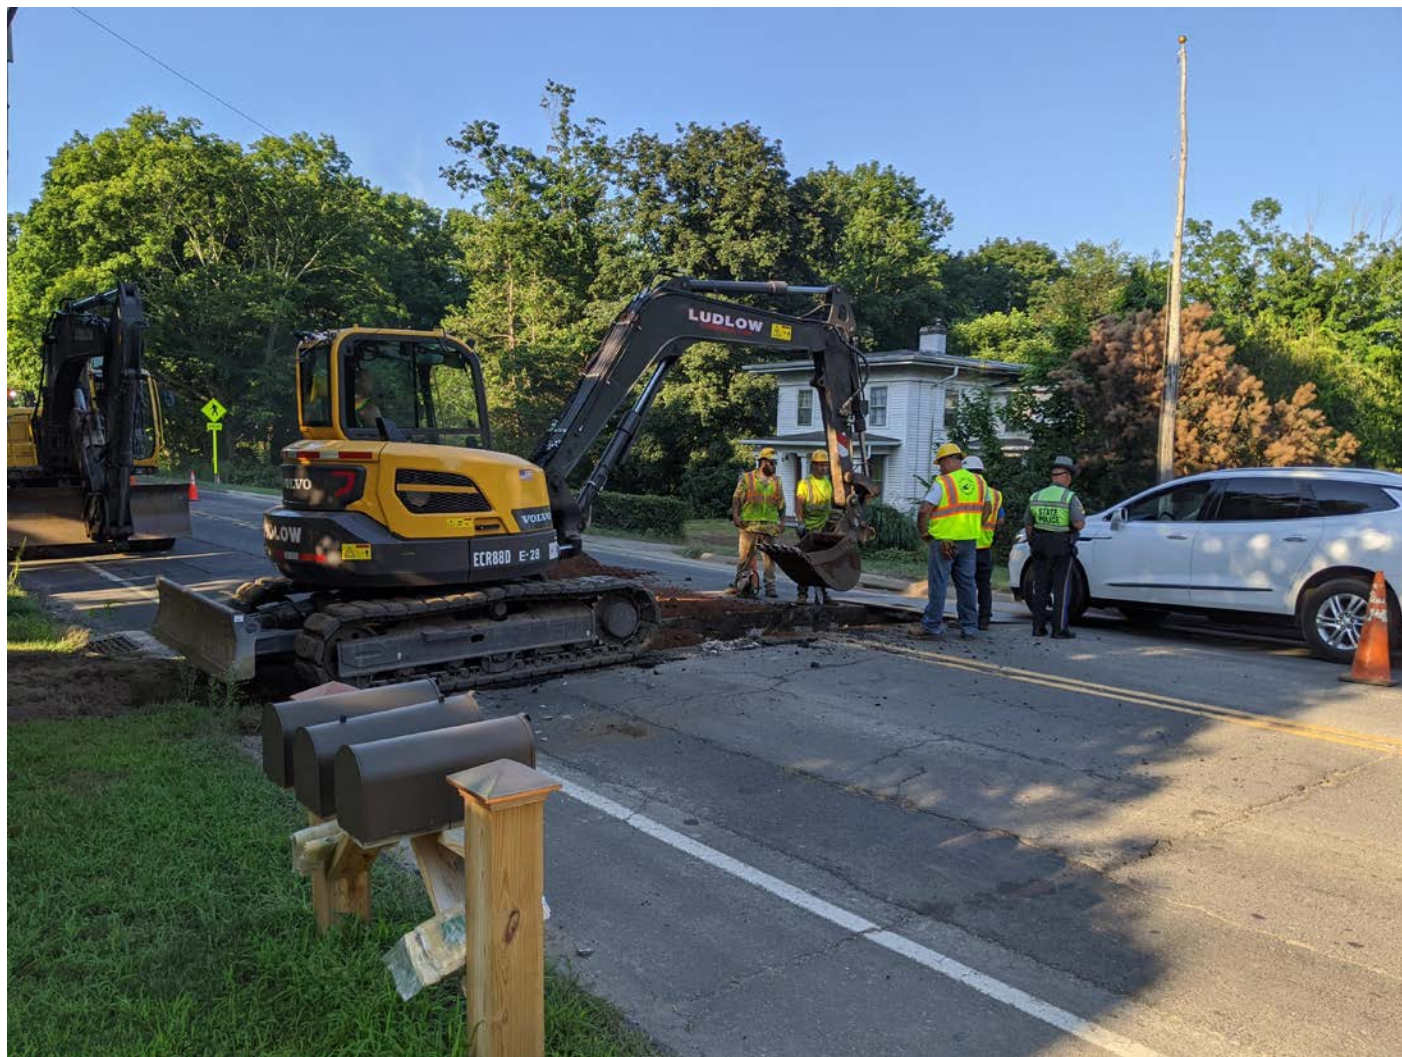
Picture 4: Ludlow construction digging a water service trench on Main Street, Main Street, Station 179+50. View to the southwest.

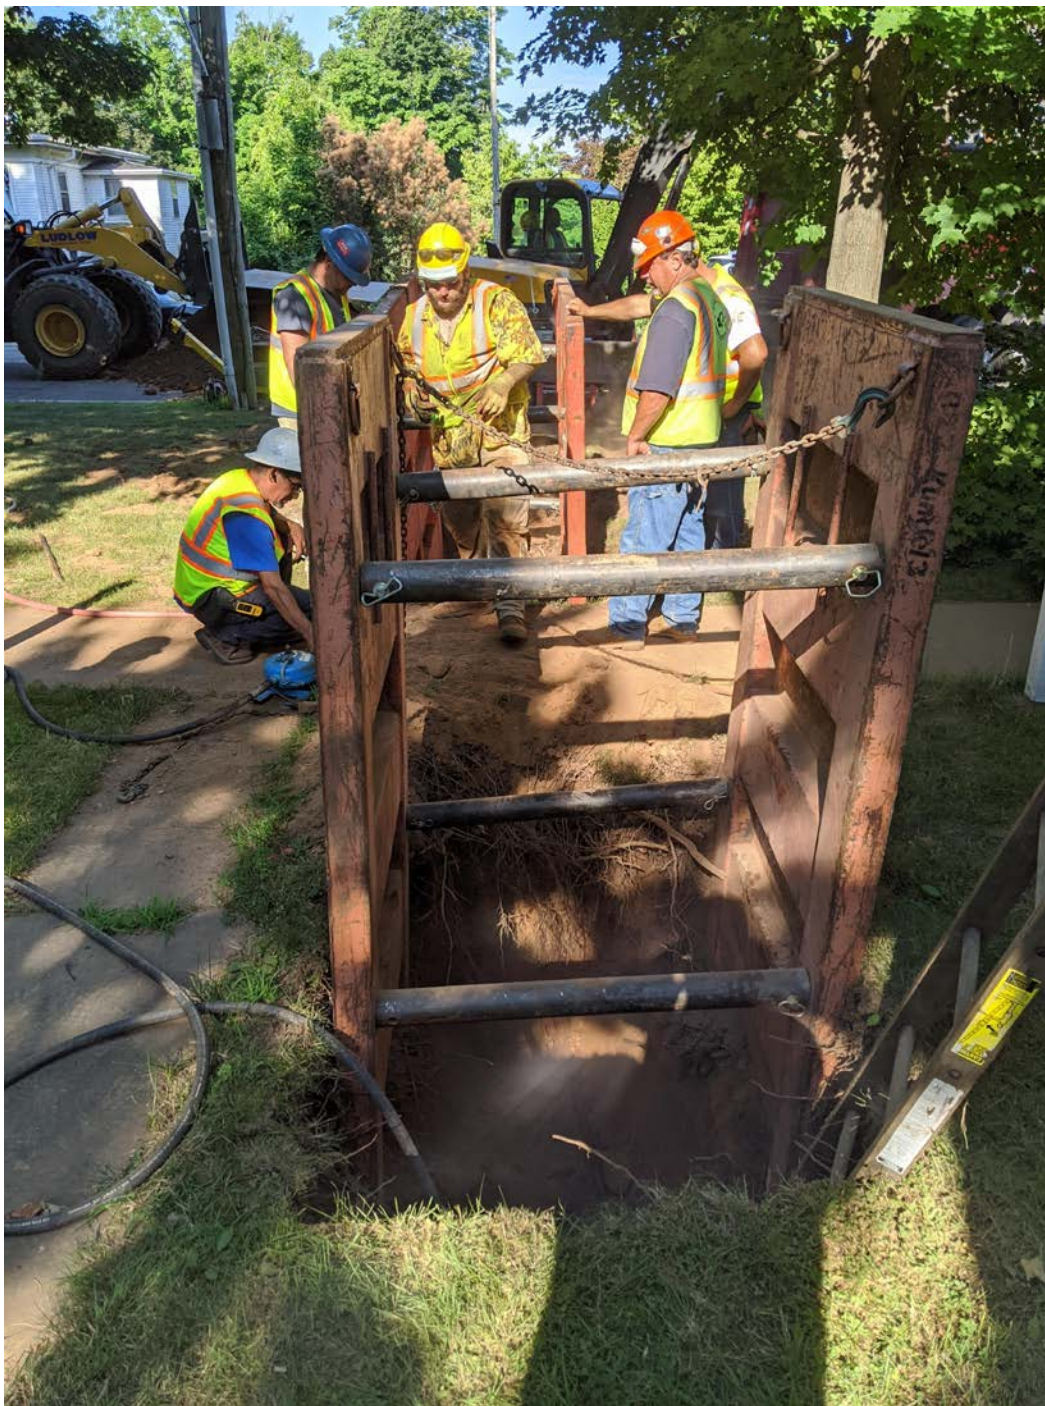
Picture 5: Ludlow construction using a pneumatic horizontal drill to install the service line for 303 Main Street, Main Street, Station 179+50. View to the west.

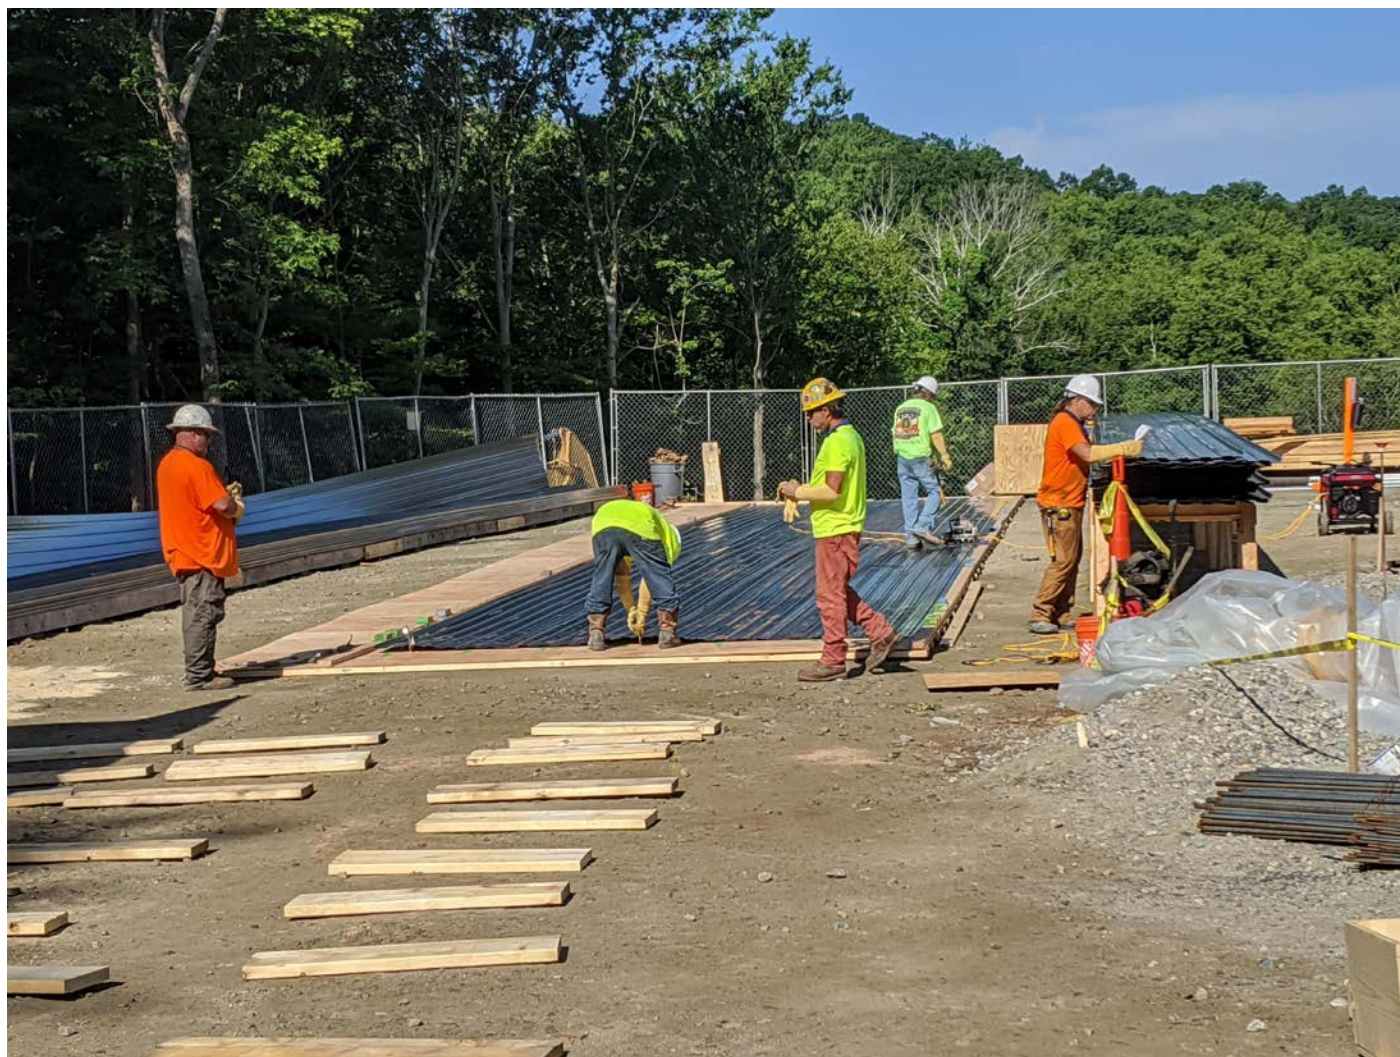
Picture 6: DN Tanks seaming together the sheet metal for the tank side panels, Shared access driveway. View to the south.

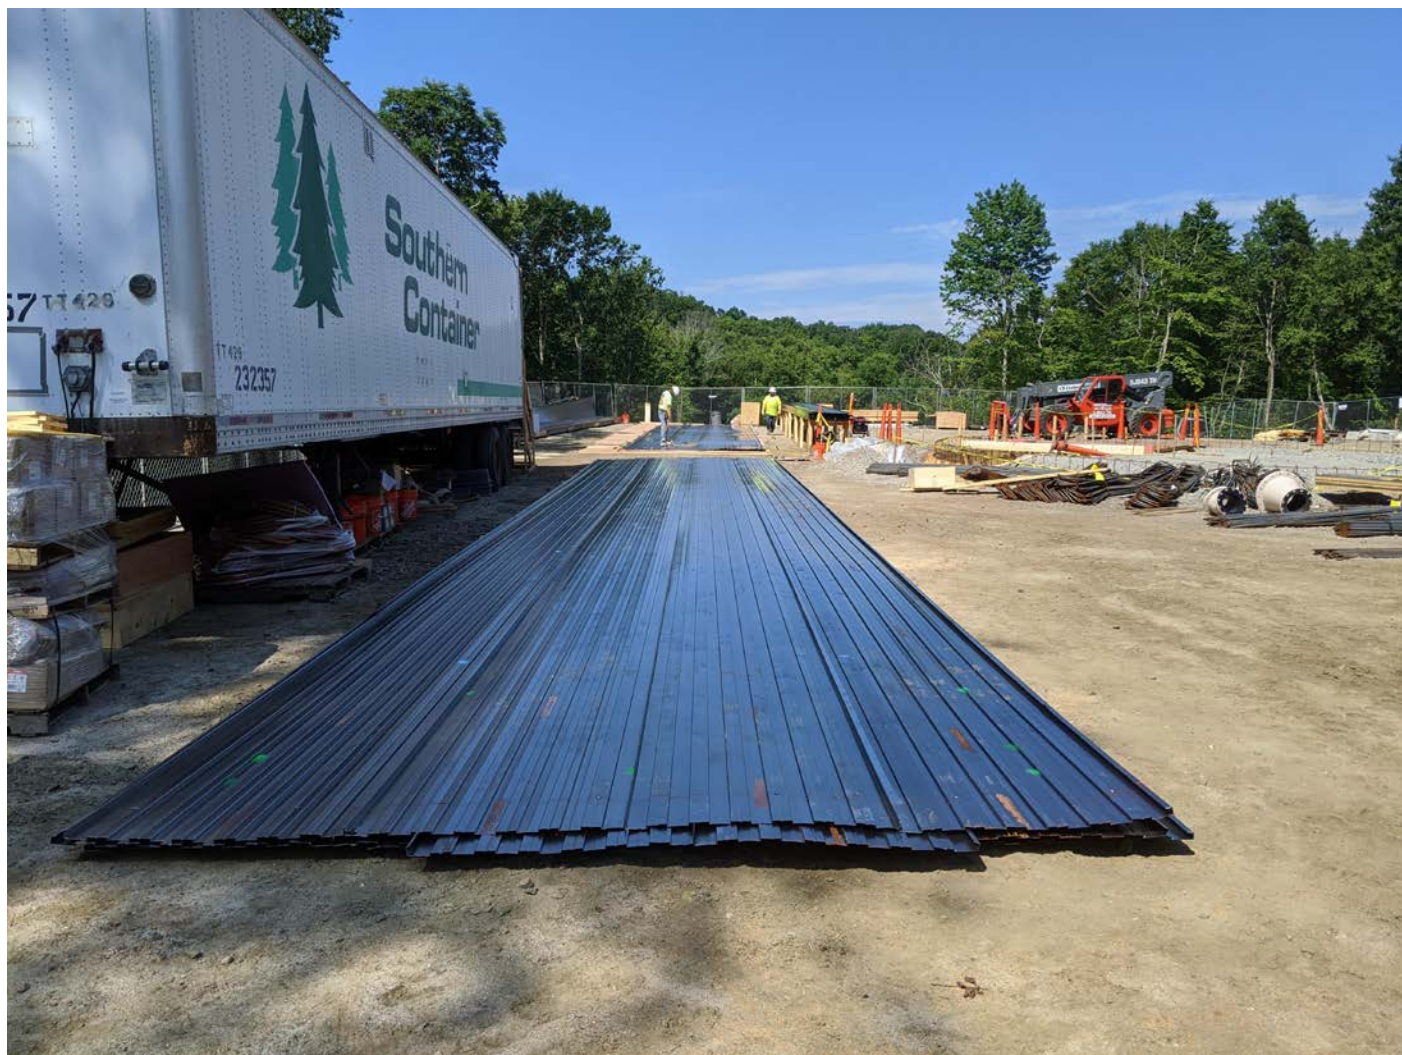
Picture 7: Stack of sheet metal for the water tank side panels, Shared access driveway. View to the south.

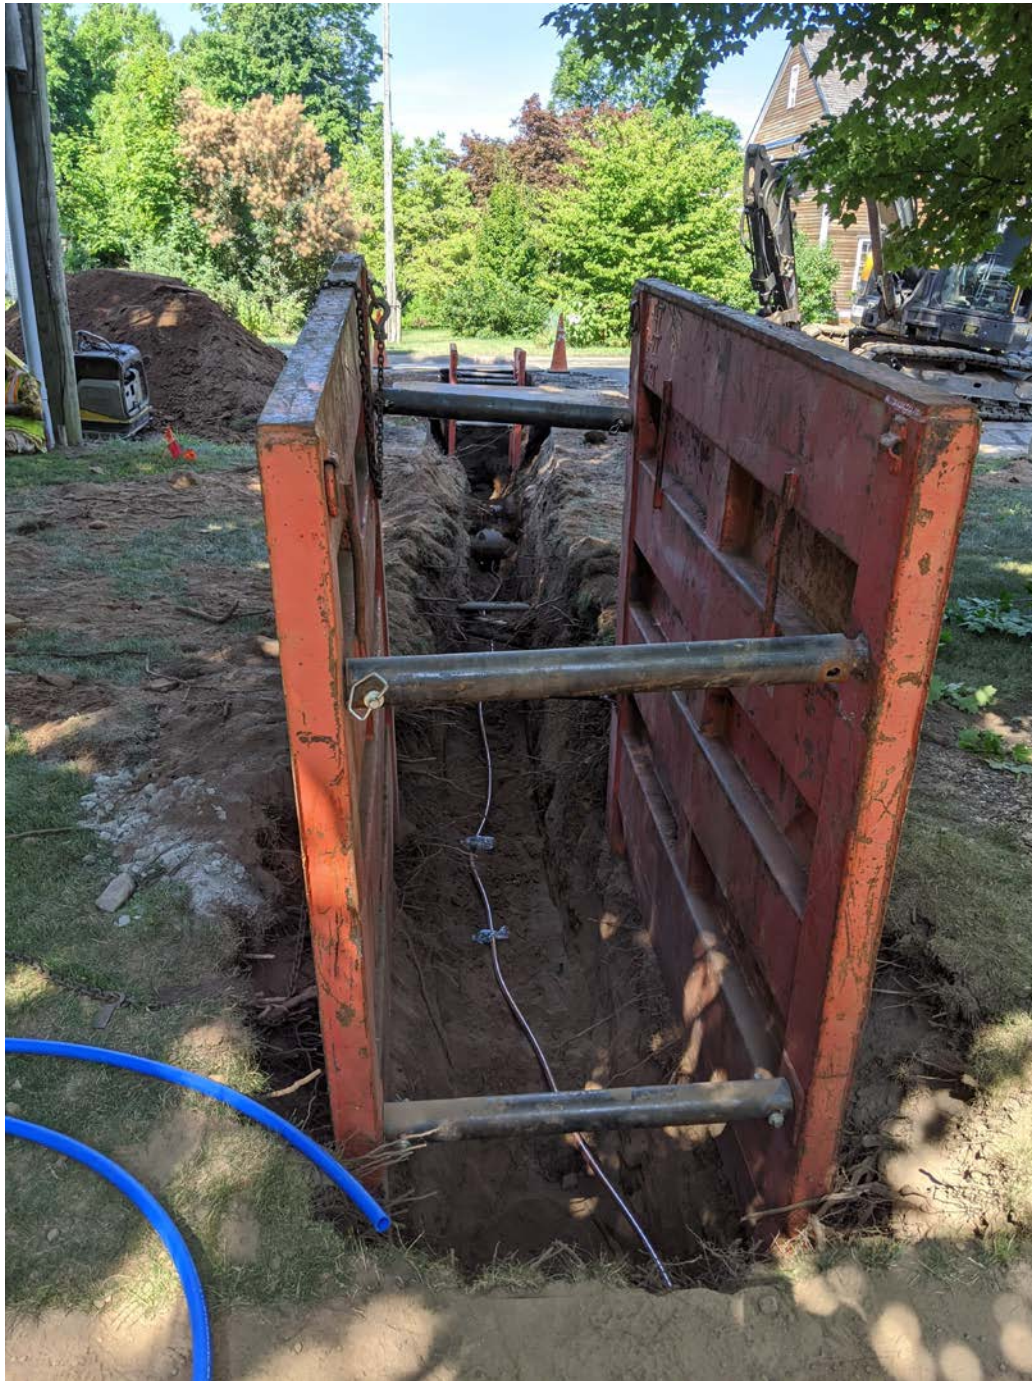
Picture 8: Trench showing service line running towards 305R Main Street, Shared access road. View to the west.

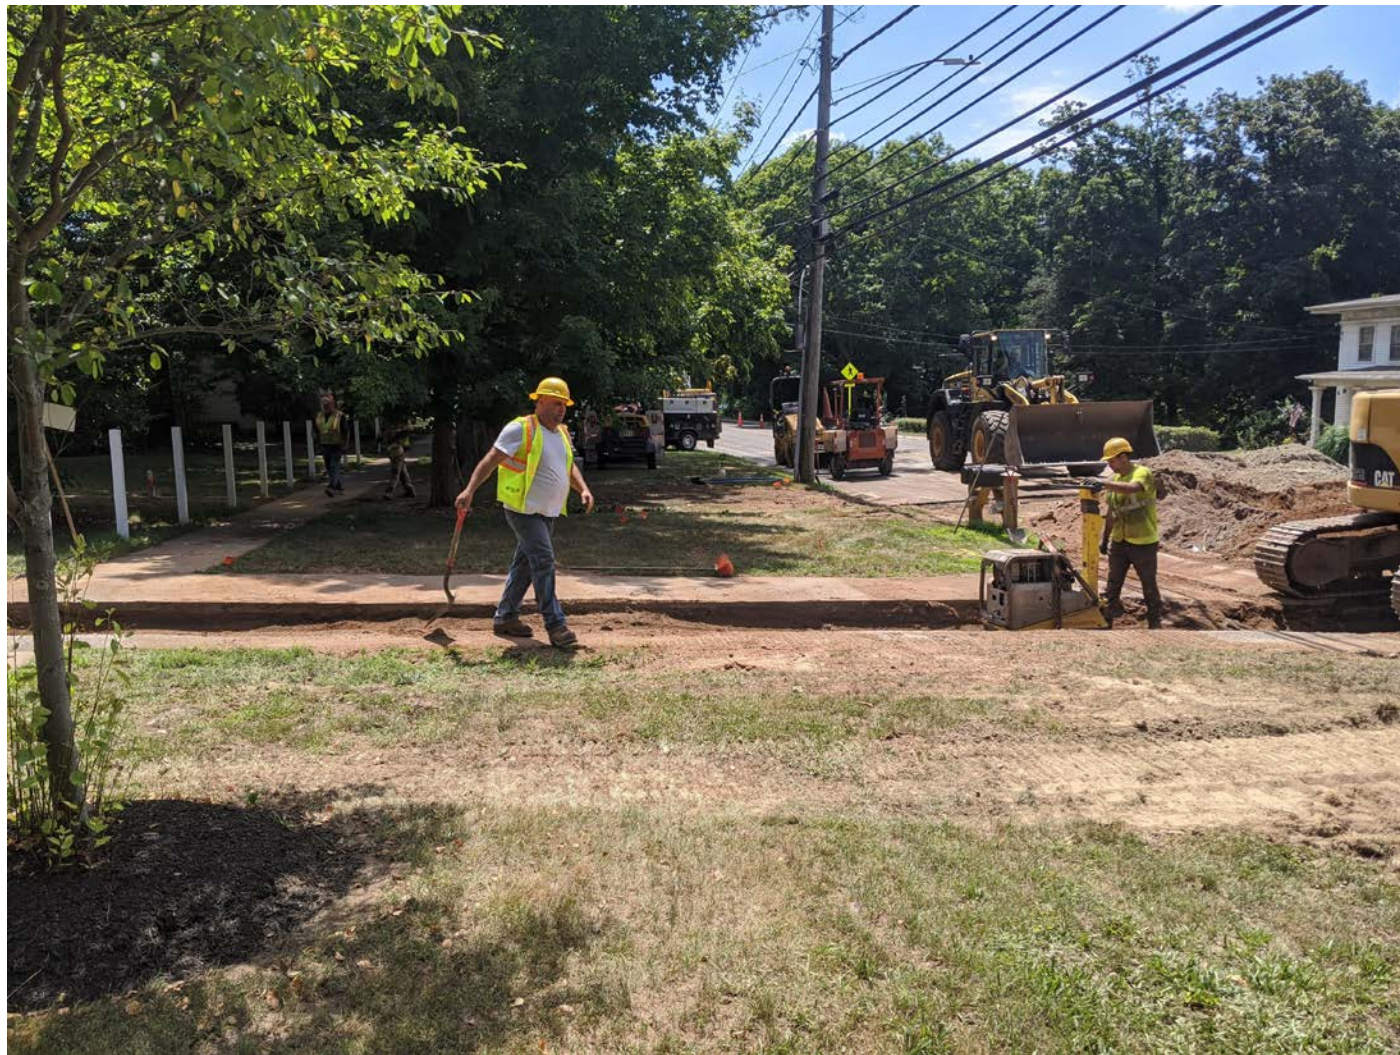
Picture 9: Ludlow Construction compacting the trench line to 303 Main Street, Main Street, Station 179+50. View to the south.

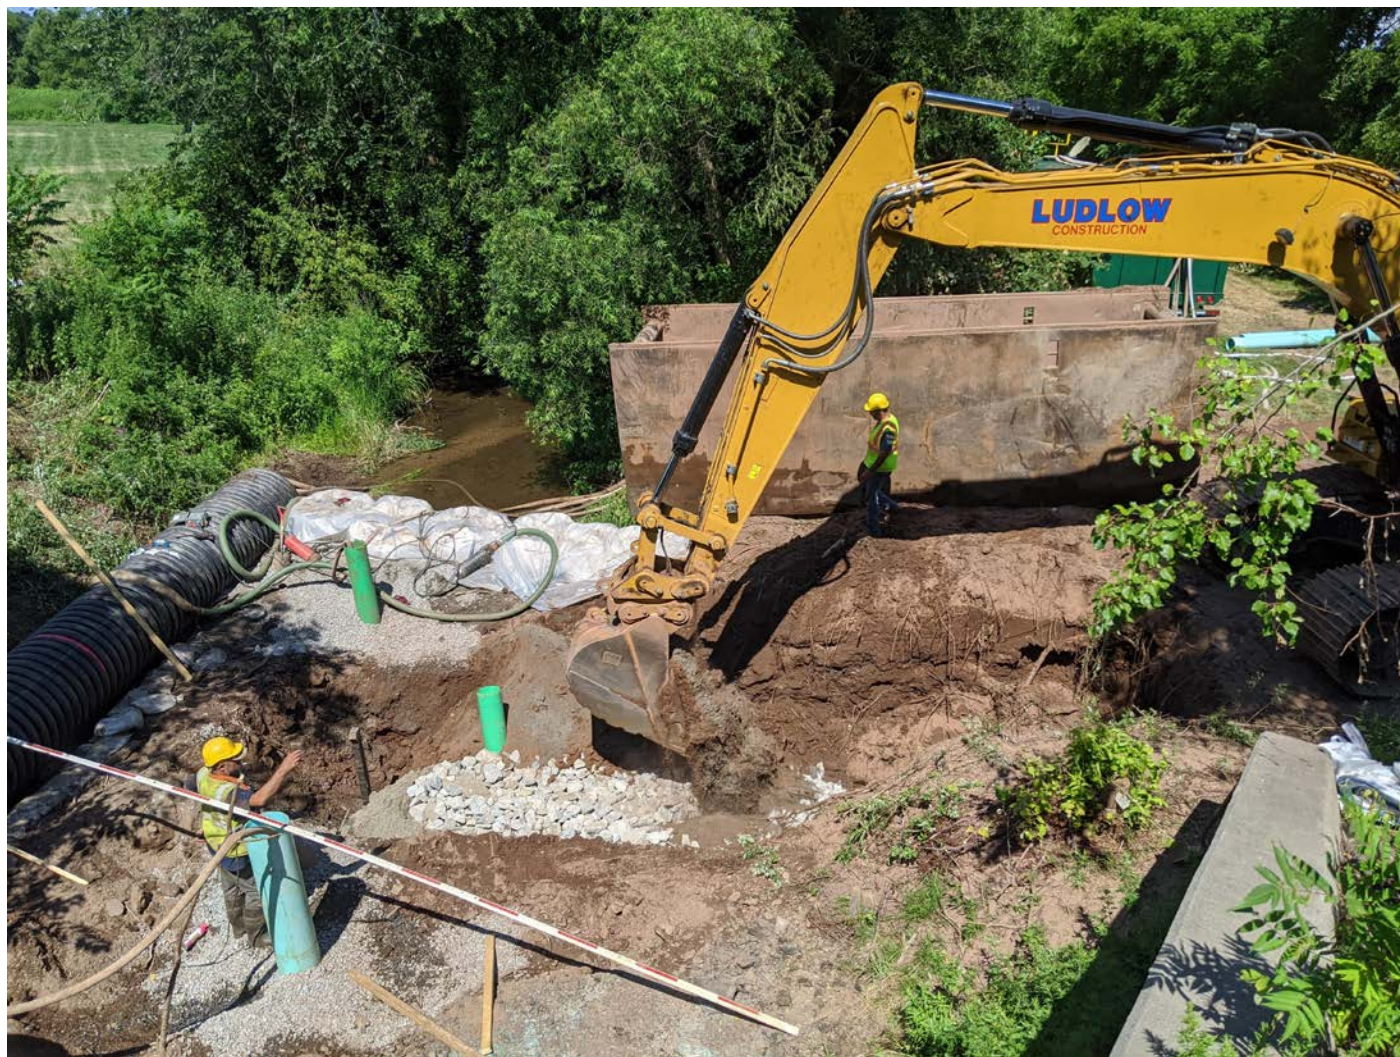
Picture 10: Ludlow Construction backfilling the stream bed excavation with soil and rip rap, Maple Avenue, Station 905. View to the west.

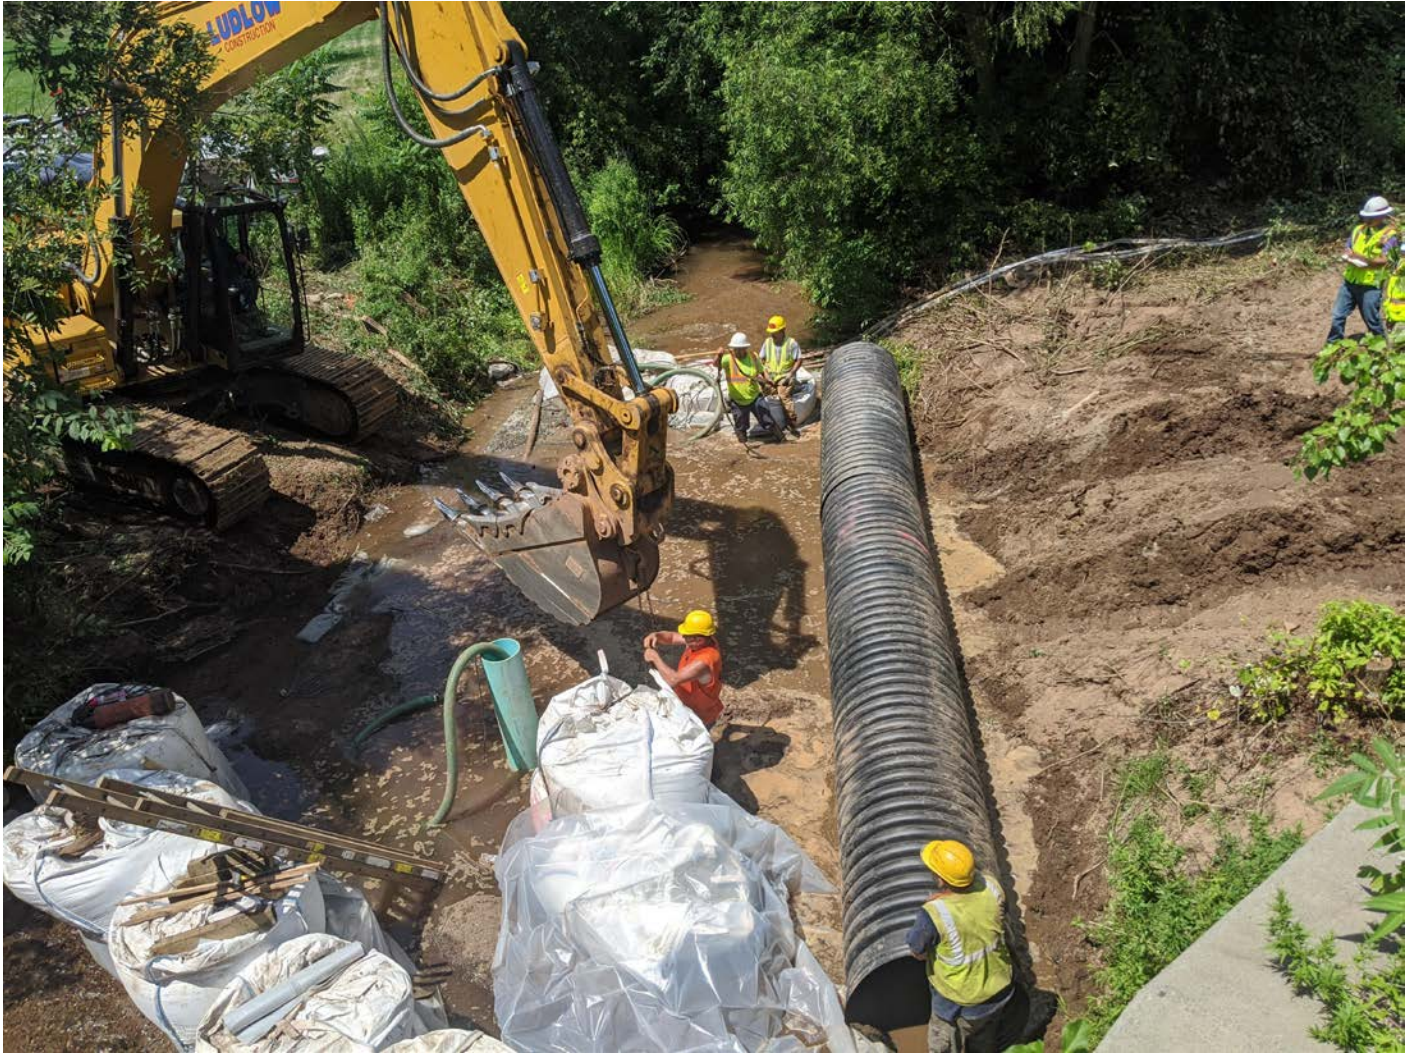
Picture 11: Ludlow construction moving the corrugated piping and sandbags to the other side of the stream, Maple Avenue, Station 905. View to the west.

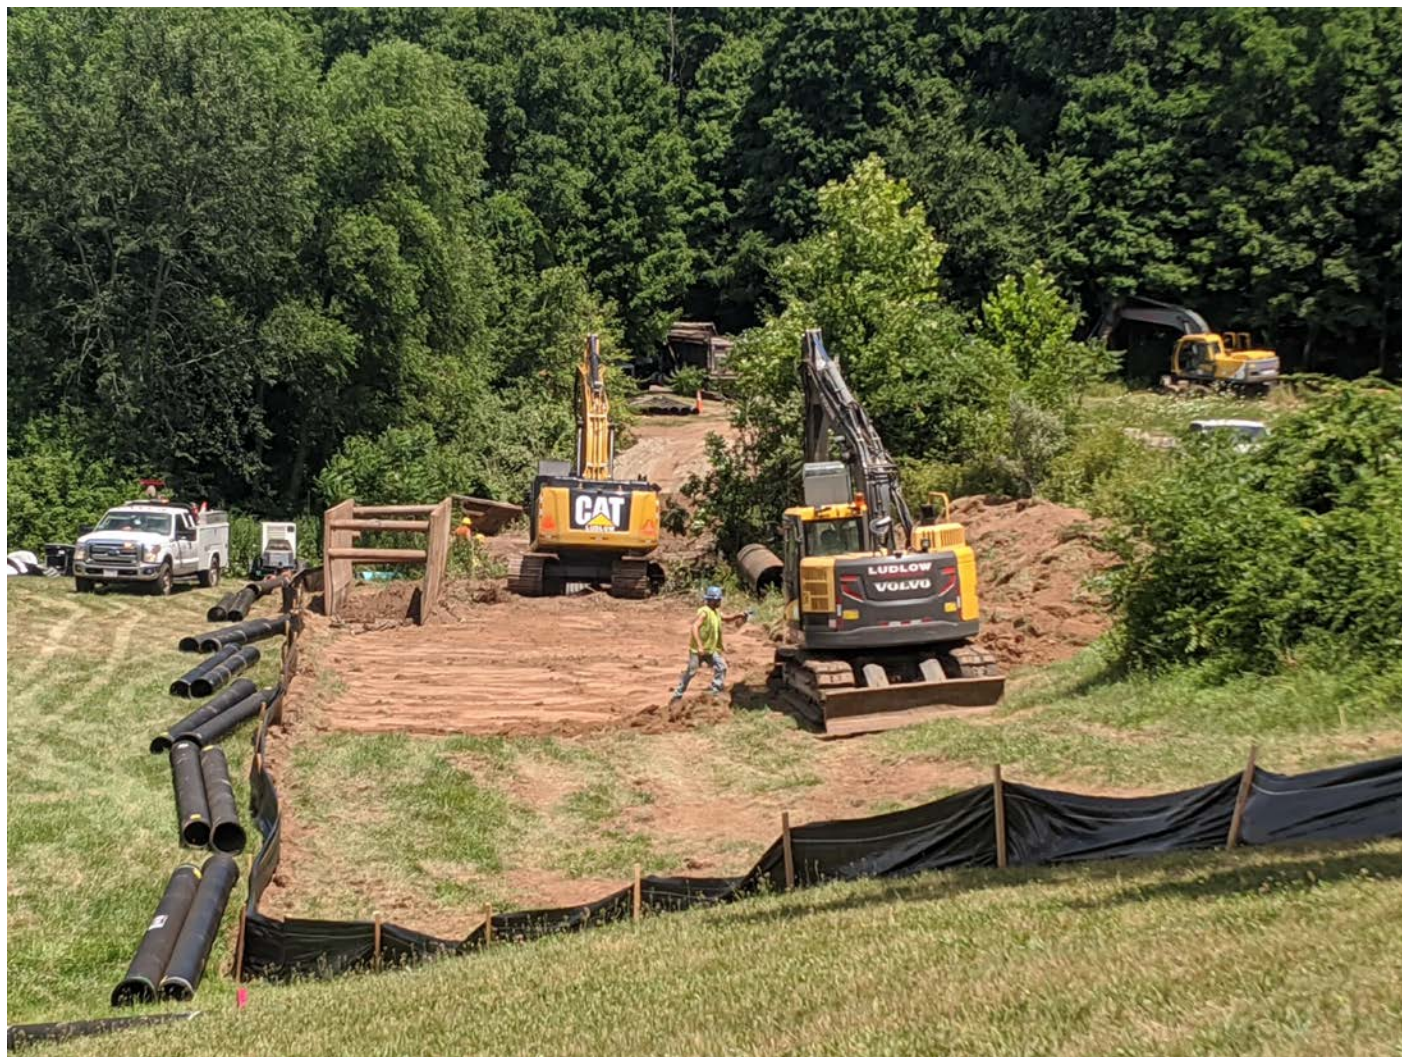
Picture 12: Ludlow construction removing topsoil in preparation for a piping run on the south side of Allyn Brook, Maple Avenue. View to the North.
