Daily Report

Project:	Durham Meadows Pipeline Installation	Date:	August 14, 2020
Location:	Maple Avenue and Main Street, Durham; Shared Access Driveway, Middletown	Day of Week:	Friday
Project #:	AECOM: 6061487	Report No:	138
Contractor:	Ludlow Construction	Page:	1 of 12

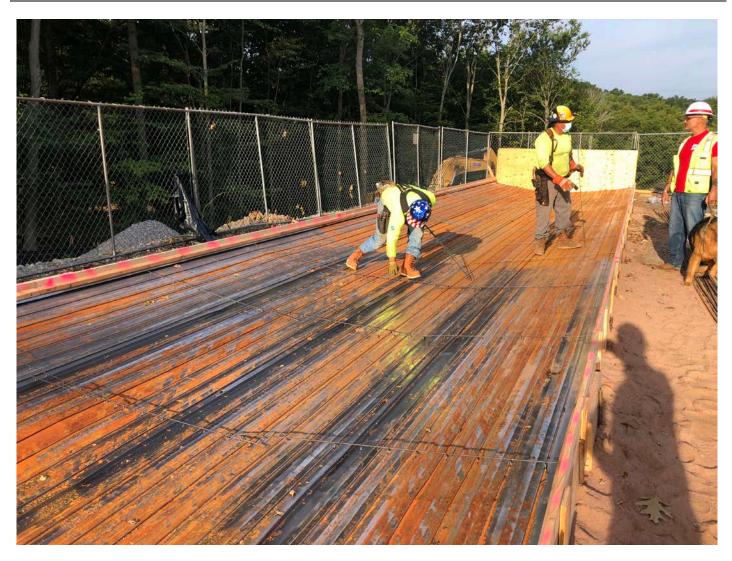
Picture 1: Northeastern Steel begins to lay out chairs on one of the water tank side panel concrete forms that rebar will be fastened onto. Water tank work zone, east of the Shared Access Road, Middletown. View to the west.

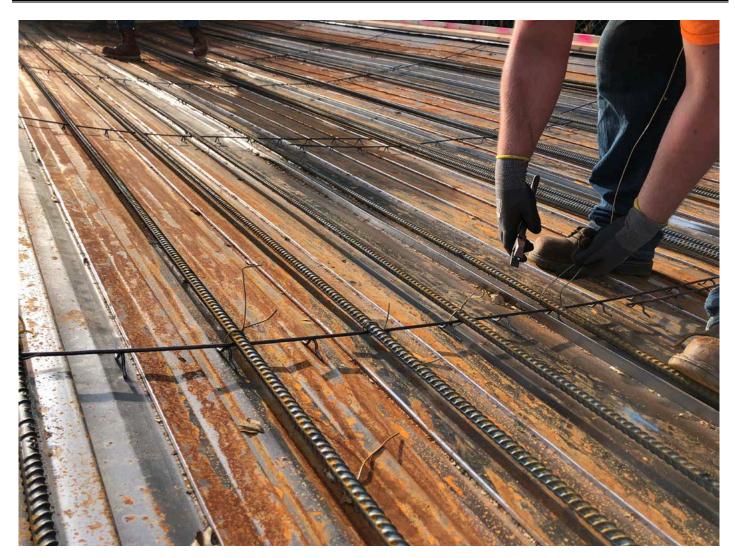
Picture 2: Northeastern Steel fastening rebar to chairs that have been placed on the first of two water tank side panel concrete forms. Water tank work zone, east of the Shared Access Driveway, Middletown. View to the east.

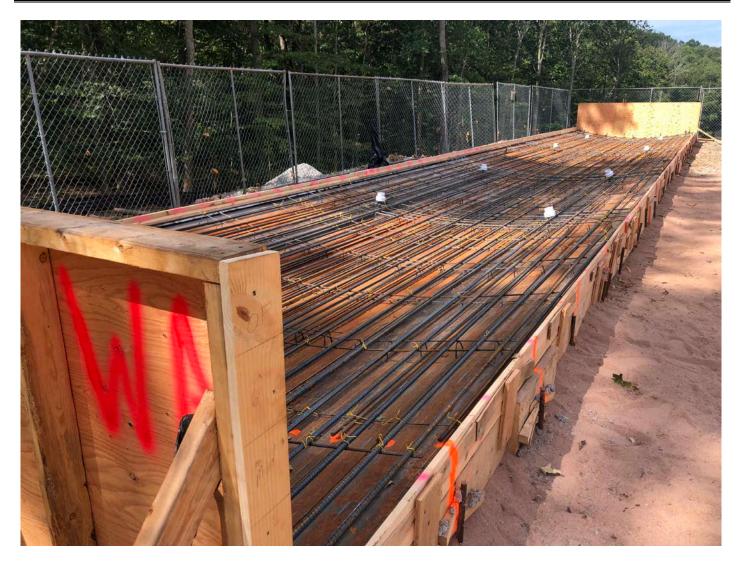
Picture 3: The first of two water tank side panel concrete forms where Northeastern Steel has finished fastening rebar to wire chairs in preparation of concrete being placed onto the form. Water tank work zone, east of the Shared Access Driveway, Middletown. View to the west.

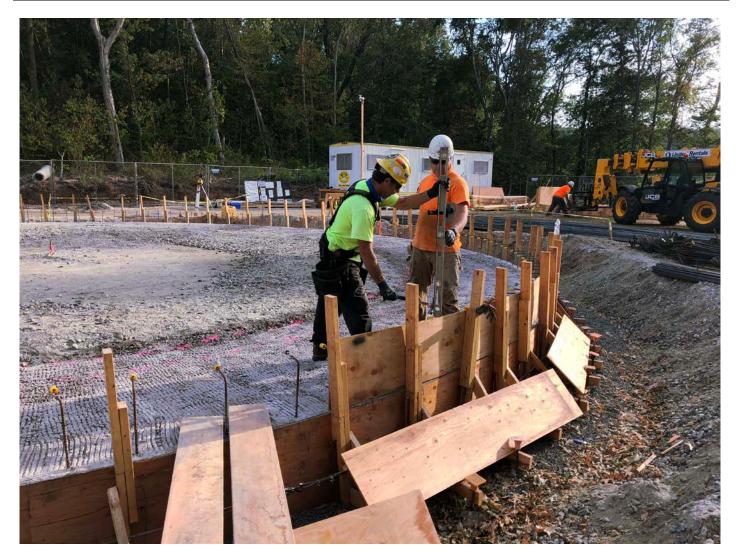
Picture 4: DN Tanks adding plywood to the form surrounding the water tank footprint. East of the Shared Access Driveway, Middletown. View to the northeast.

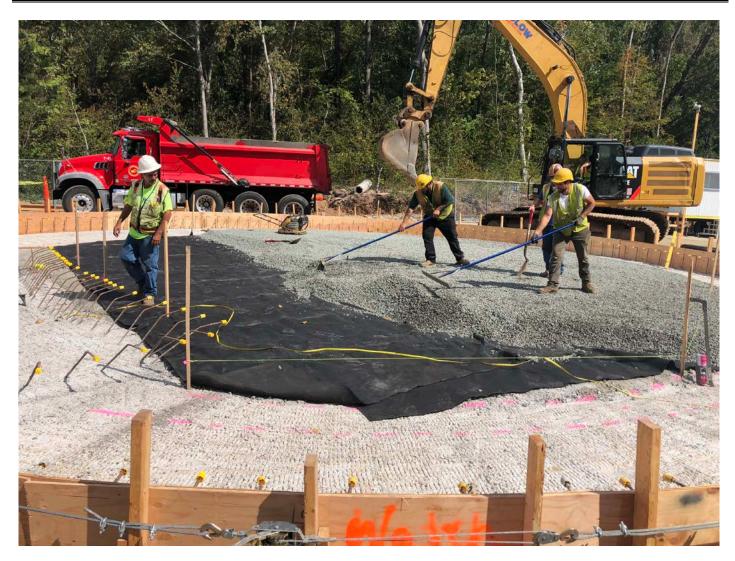
Picture 5: Ludlow placing and compacting $\frac{1}{2}$ " gravel on the water tank footprint. East of Shared Access Driveway, Middletown. View to the north.

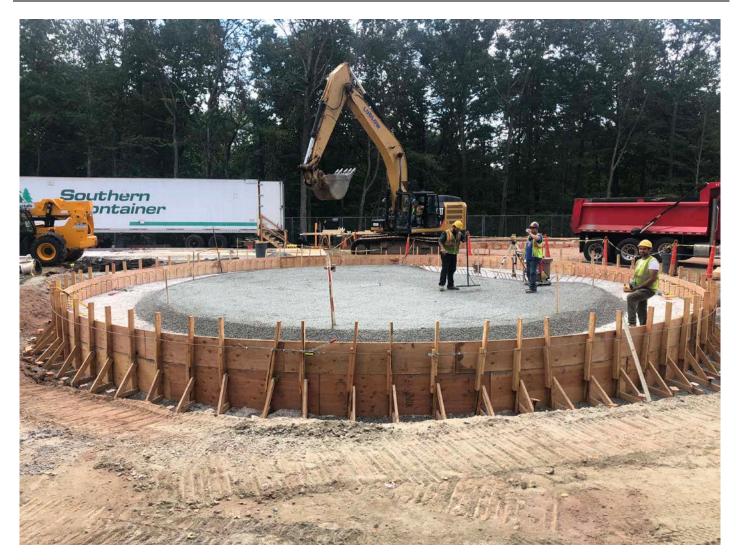
Picture 6: Ludlow finishing the placement and compaction of ½" gravel on the water tank footprint. East of Shared Access Driveway, Middletown. View to the south.

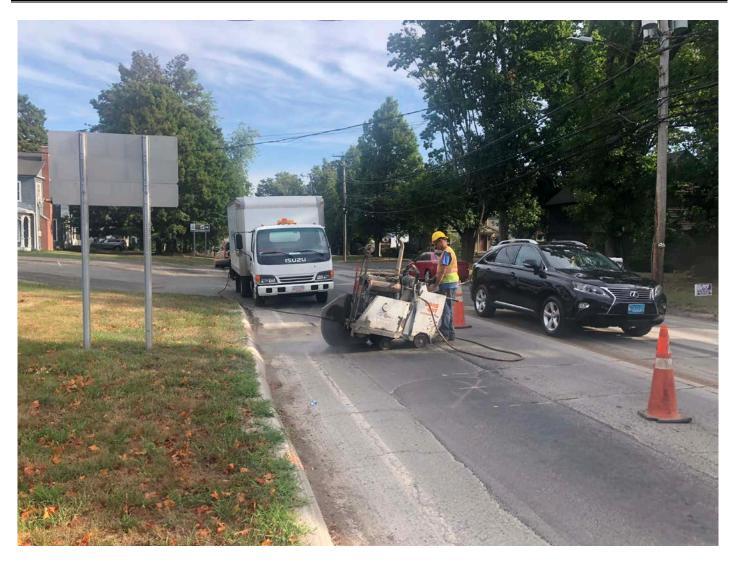
Picture 7: Ludlow saw cutting pavement on the southbound lane of Main Street, Durham, in front of 228 Main Street. View to the north.

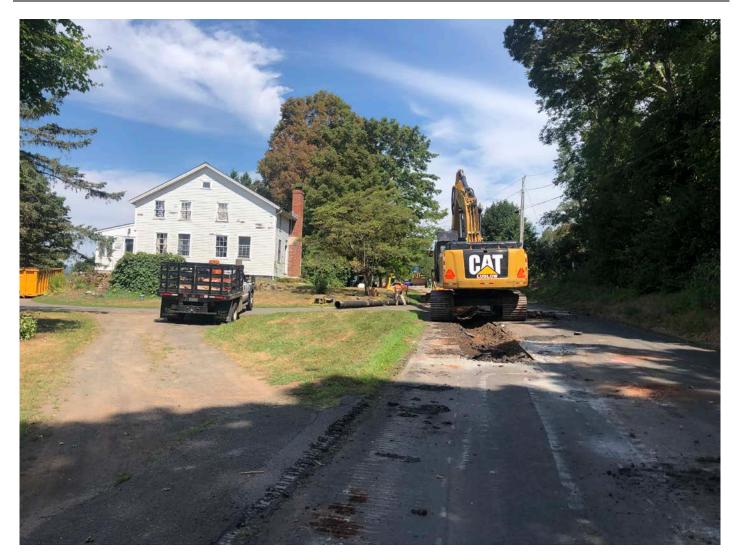
Picture 8: Ludlow trenching on the southbound lane of Maple Avenue, Durham (Station ~910+00) as they place 12" DIP while progressing in a southerly direction. View to the north.

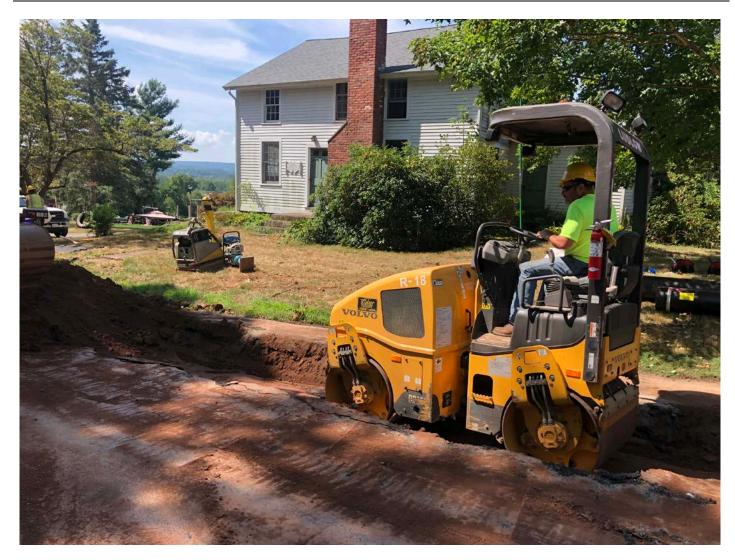
Picture 9: Ludlow compacting fill in trench at Station ~910+50 on the southbound lane of Maple Avenue, Durham. View to the southwest.
