Daily Report

Project:	Durham Meadows Pipeline Installation	Date:	August 26, 2020
Location:	Maple Avenue and Main Street, Durham; Shared Access Driveway, Middletown	Day of Week:	Wednesday
Project #:	AECOM: 6061487	Report No:	146
Contractor:	Ludlow Construction	Page:	1 of 13

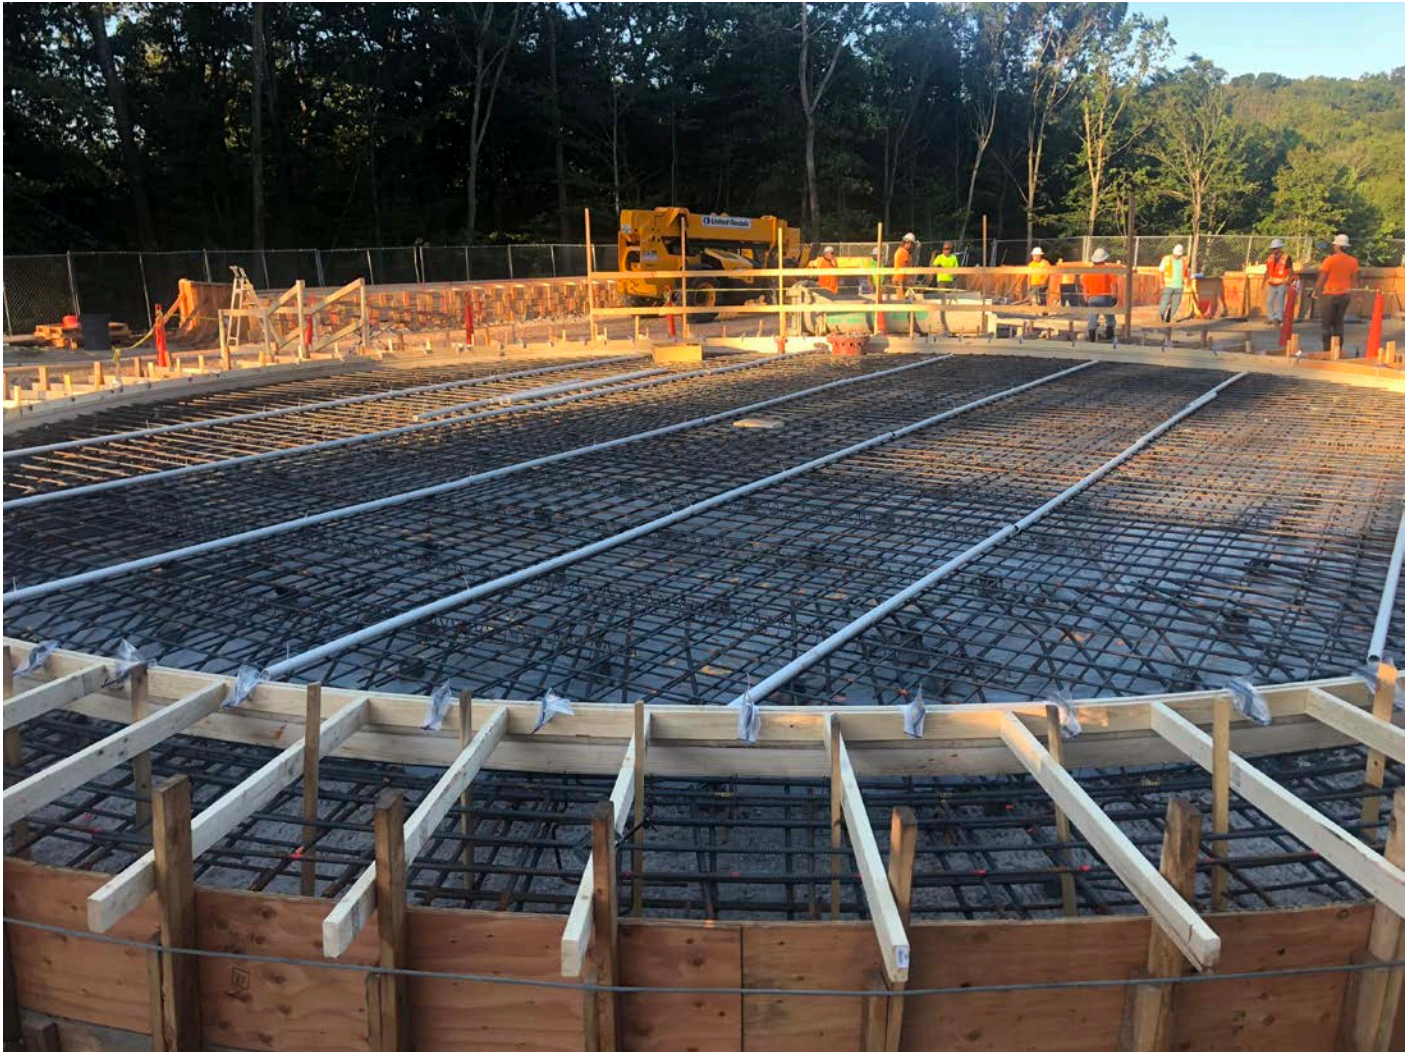
Picture 1: Water tank base laid out with rebar, water stop clamped in place, and PVC pipe temporarily placed to guide the power bull float once concrete has been poured. Water tank work zone, east of the Shared Access Driveway, Middletown. View to the west.

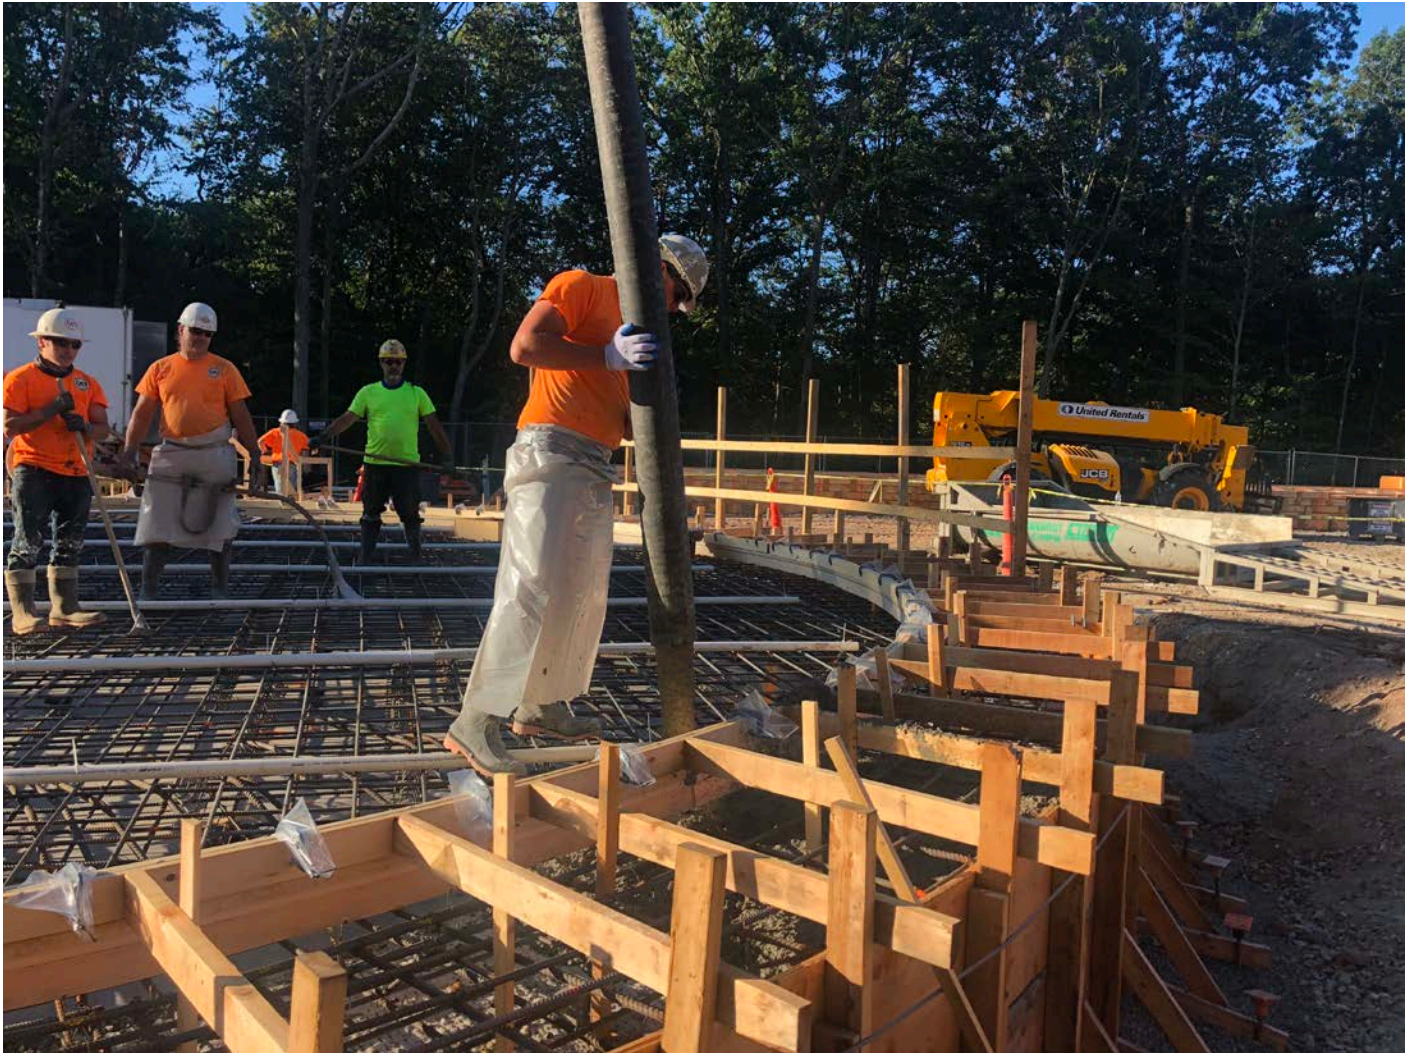
Picture 2: DN Tanks beginning to pour concrete for the water tank base. Water tank work zone, east of the Shared Access Driveway, Middletown. View to the south.

0745: DN Tanks begins to place concrete on the water tank footprint to form the tank base. The concrete is getting poured and vibrated on either side of PVC water stop.

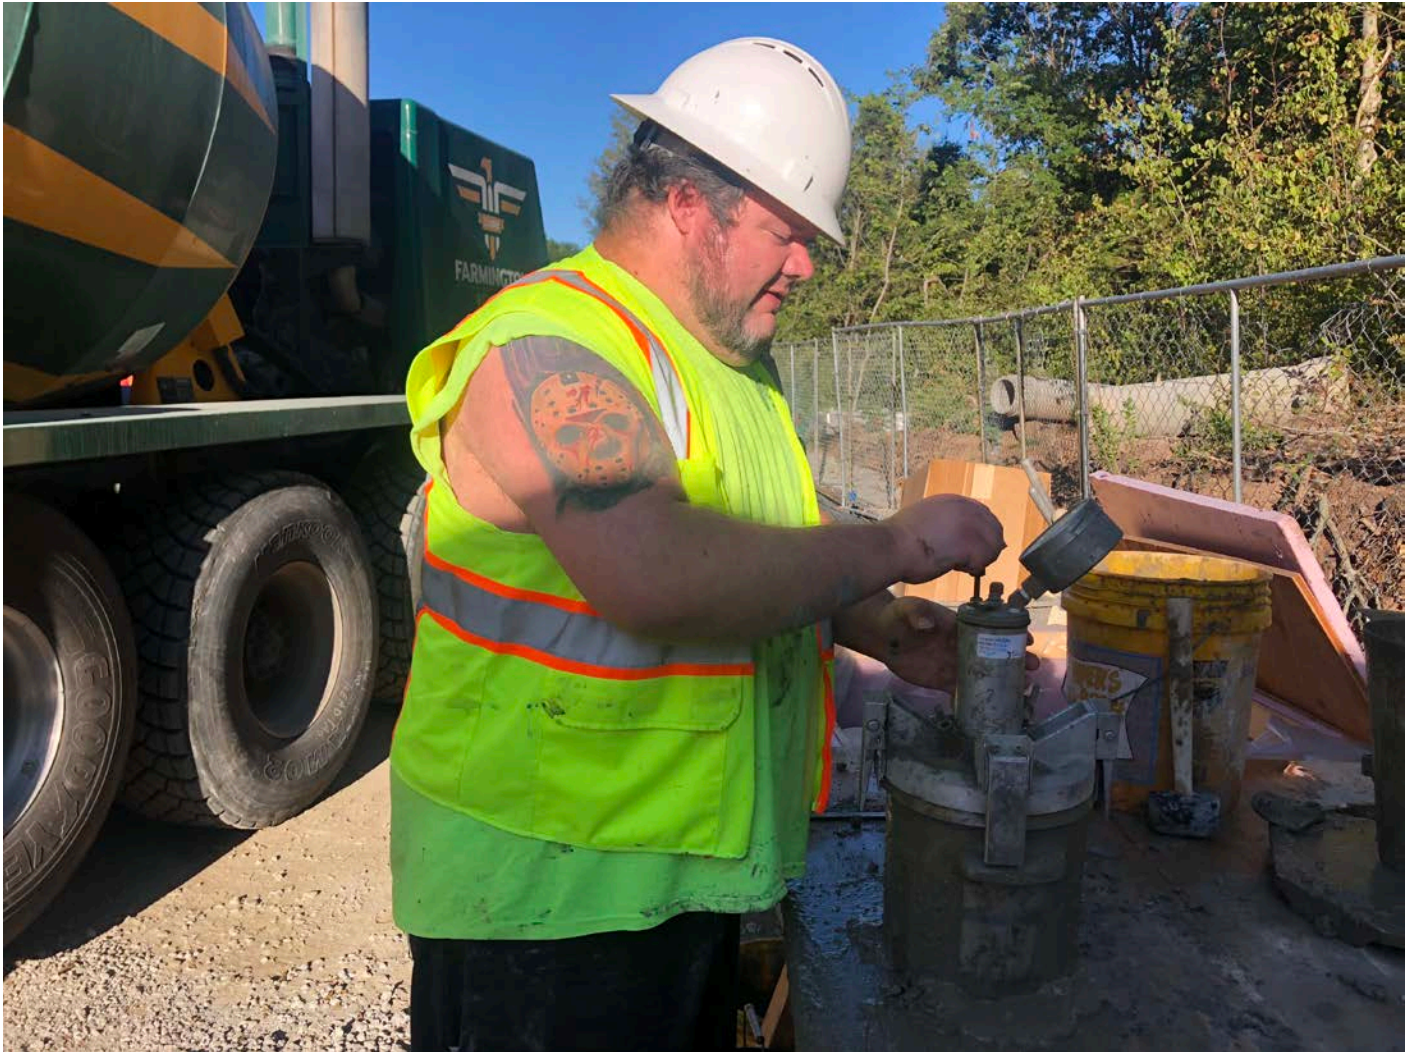
Picture 3: JTC performing percent air analysis on concrete that was just delivered to the water tank work zone. Water tank work zone, east of the Shared Access Driveway, Middletown. View to the west.

0758: DN Tanks is placing the second truckload of concrete for the water tank base. The first truck field tested at 2.5%; the second truck field tested at 2.2 % air.

0834: The fourth truck of concrete arrives on site from Farmington Ready Mix. JTC collects sample volume from this truck and gets a result of 1.7% air.

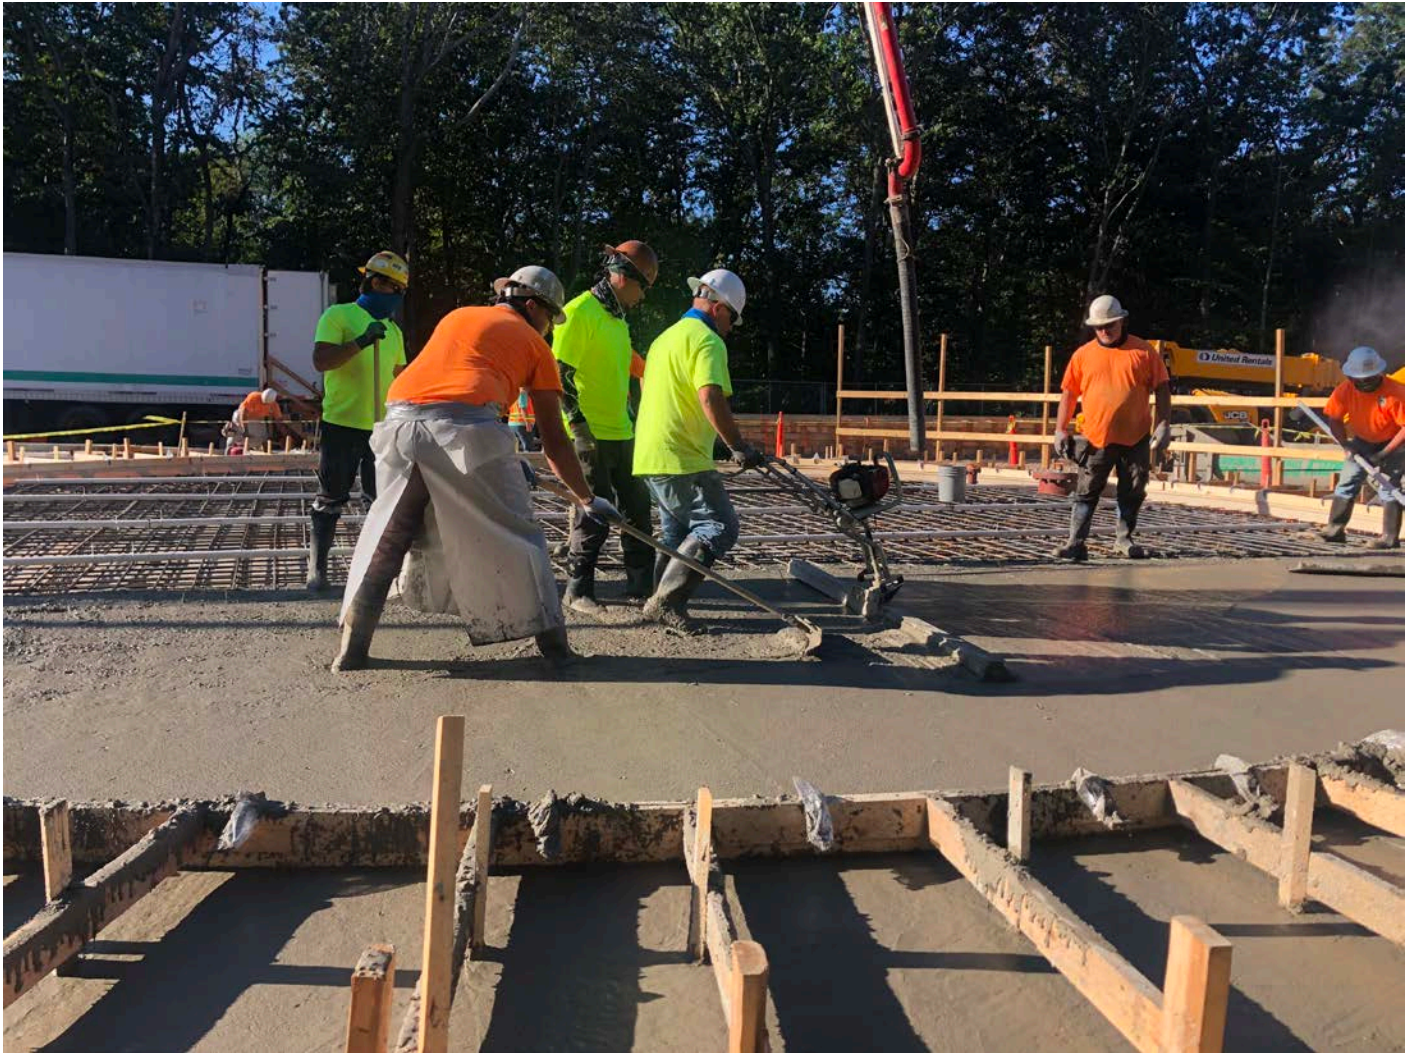
Picture 4: DN Tanks using the power bull float to smooth and level freshly-poured concrete for the water tank base. Water tank work zone, east of the Shared Access Driveway, Middletown. View to the south.

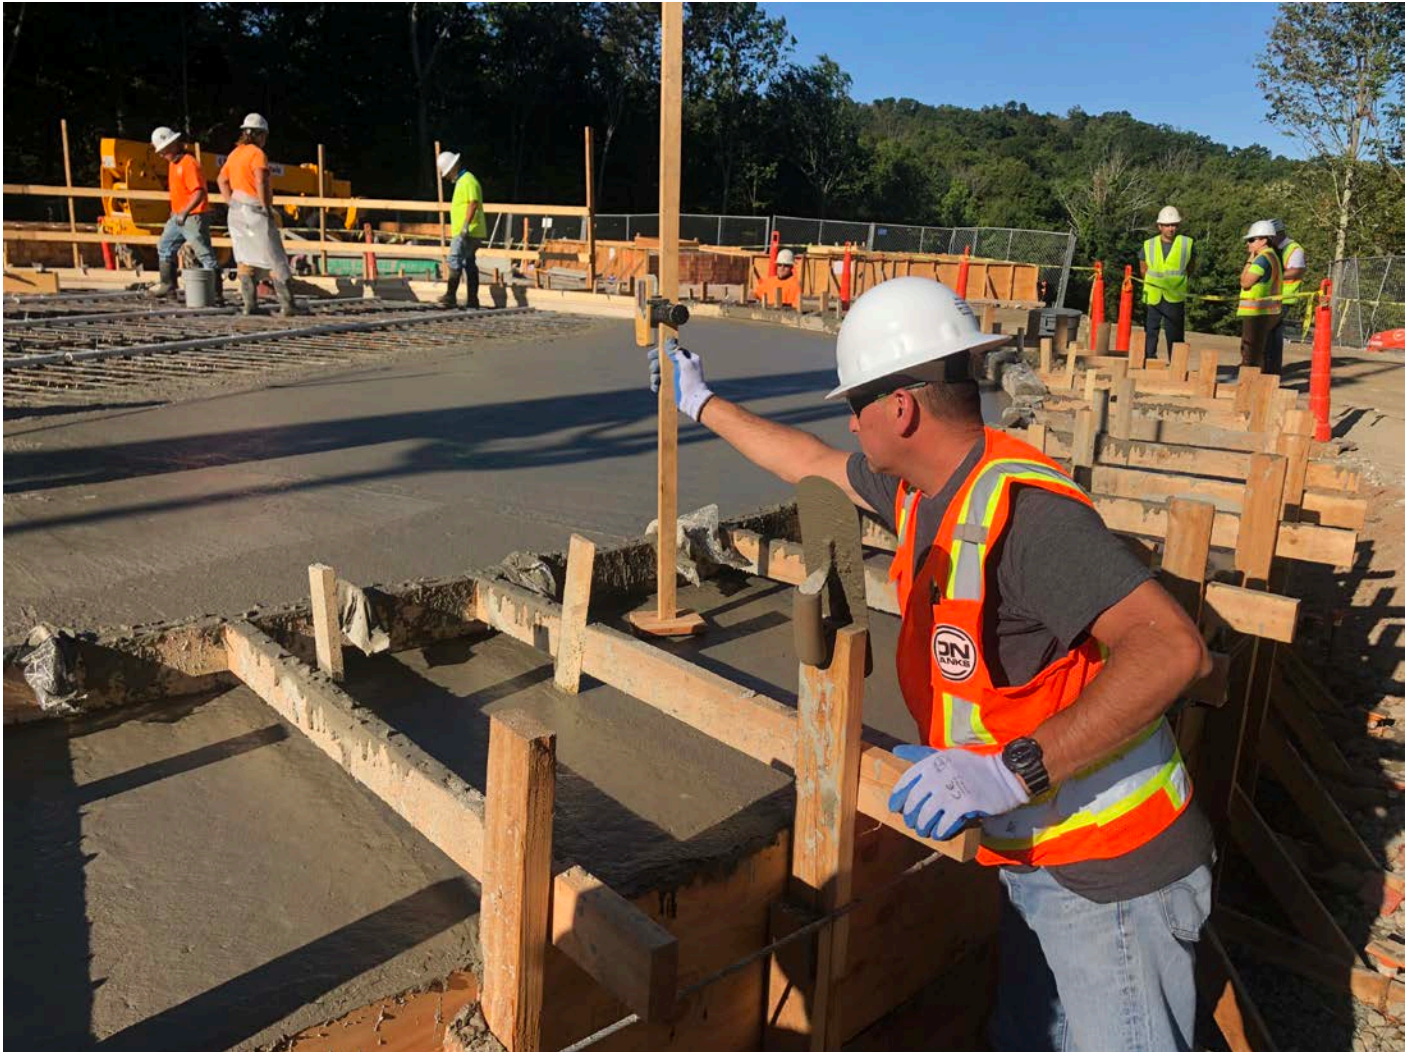
Picture 5: DN Tanks checks the elevation of the freshly-placed concrete for the water tank base. Water tank work zone, east of the Shared Access Driveway, Middletown. View to the south.

0831: DN Tanks is checking the elevation of the concrete surface around the entire periphery of the tank above the frost walls at 2-foot intervals.

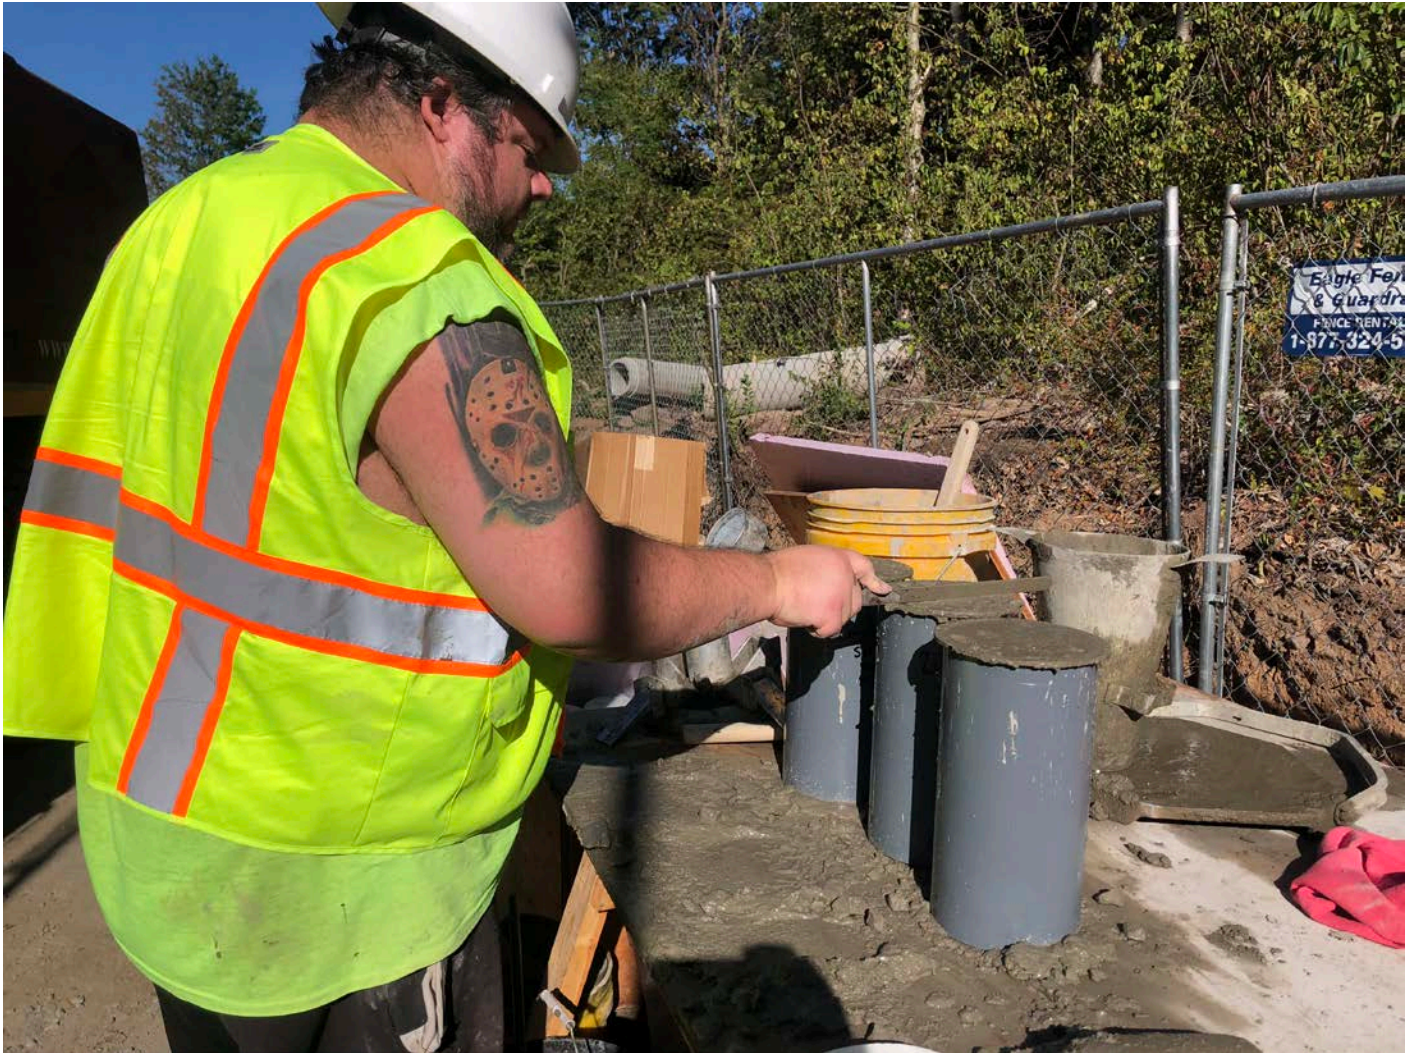
Picture 6: JTC collecting samples for laboratory analysis on concrete that was just delivered to the water tank work zone. Water tank work zone, east of the Shared Access Driveway, Middletown. View to the west.

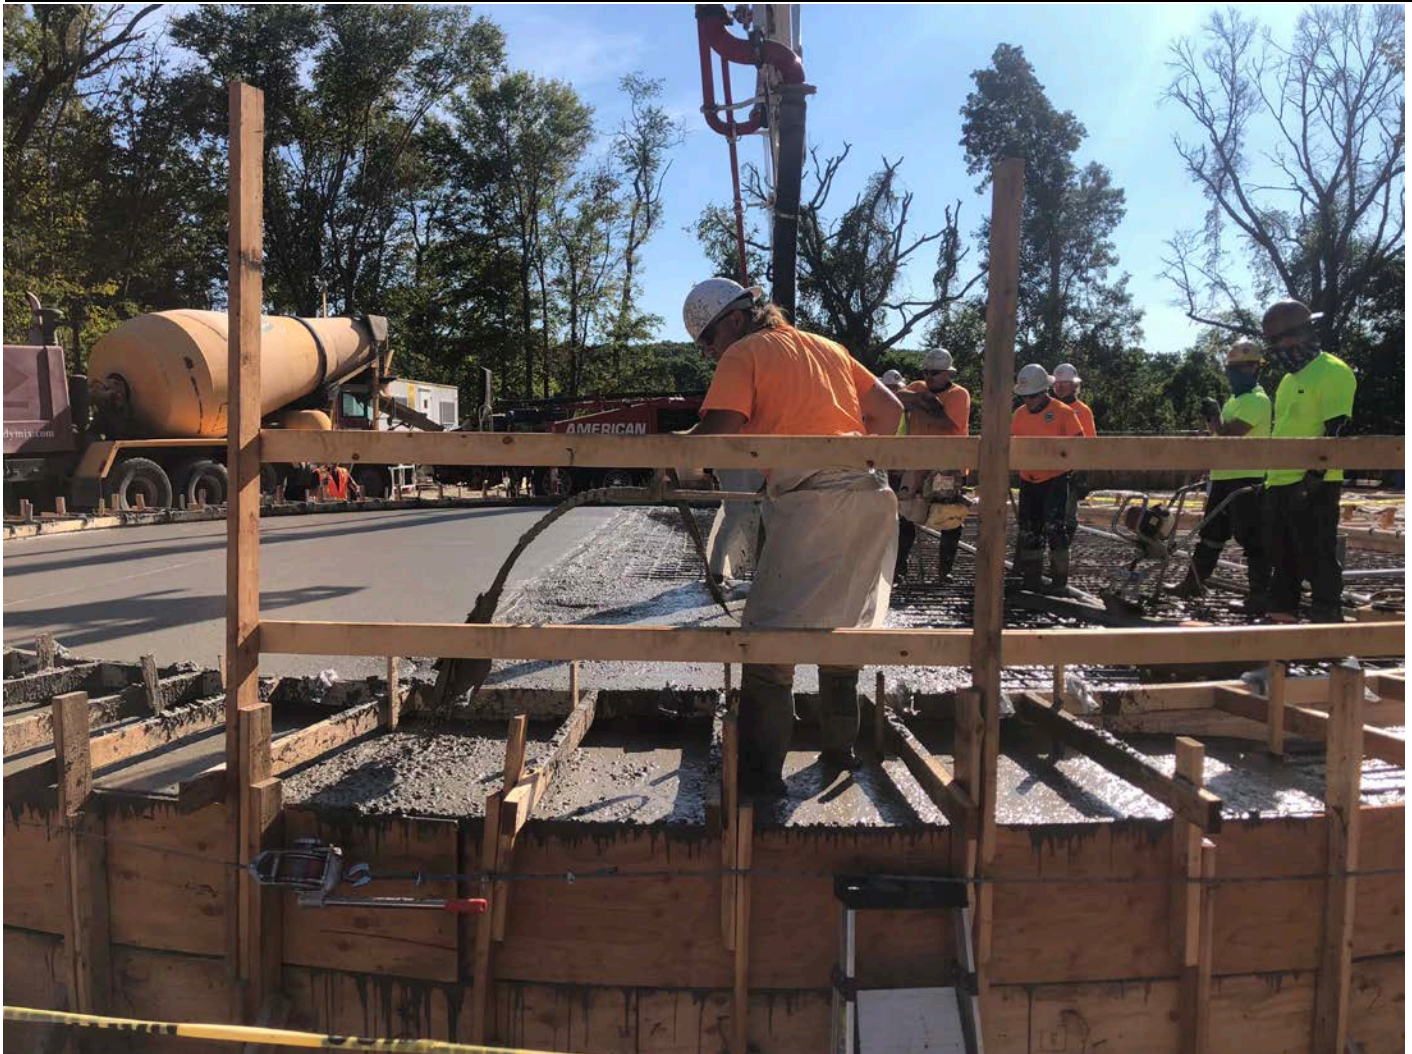
Picture 7: DN Tanks vibrating freshly-placed concrete at the water tank base. Water tank work zone, east of the Shared Access Driveway, Middletown. View to the east.

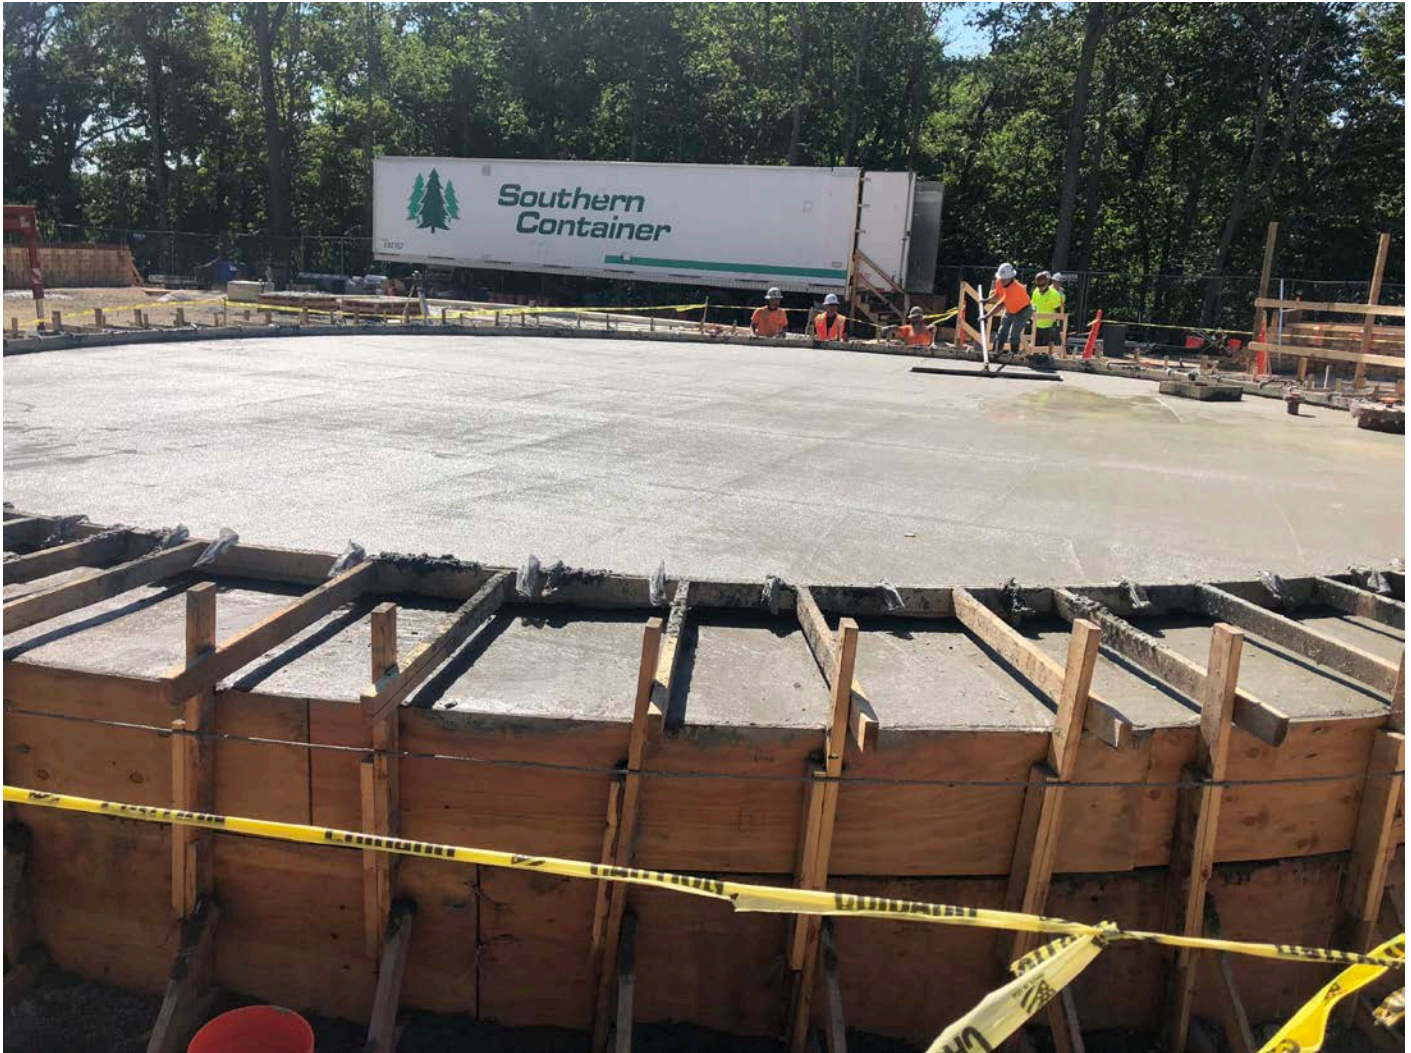
Picture 8: DN Tanks finishing smoothing of surface of the freshly-place concrete at the water tank base. Water tank work zone, east of the Shared Access Driveway, Middletown. View to the south.

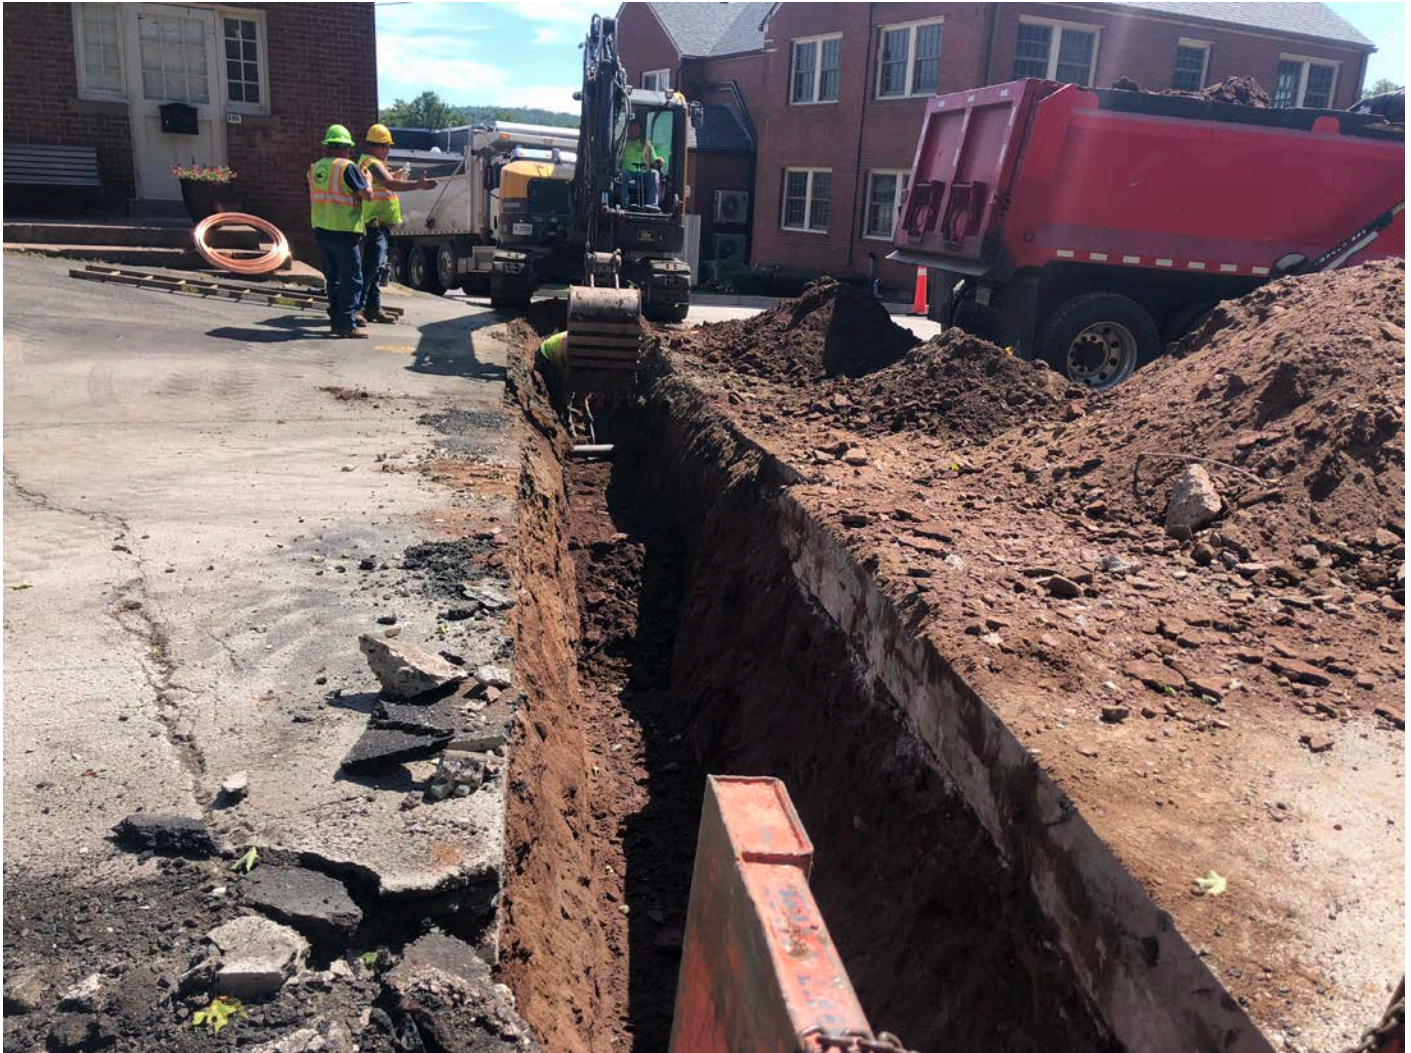
Picture 9: Ludlow installing a curb stop at 205 Main Street (Station 199+12). Main Street, Durham. View to the east.

1138: Ludlow is about the hammer rock for the curb stop trench at Station 199+12 (205 Main Street, Durham).

1250: Ludlow has the curb stop installed 19.5' from edge of pavement at 205 Main Street. Ludlow is currently backfilling the trench.

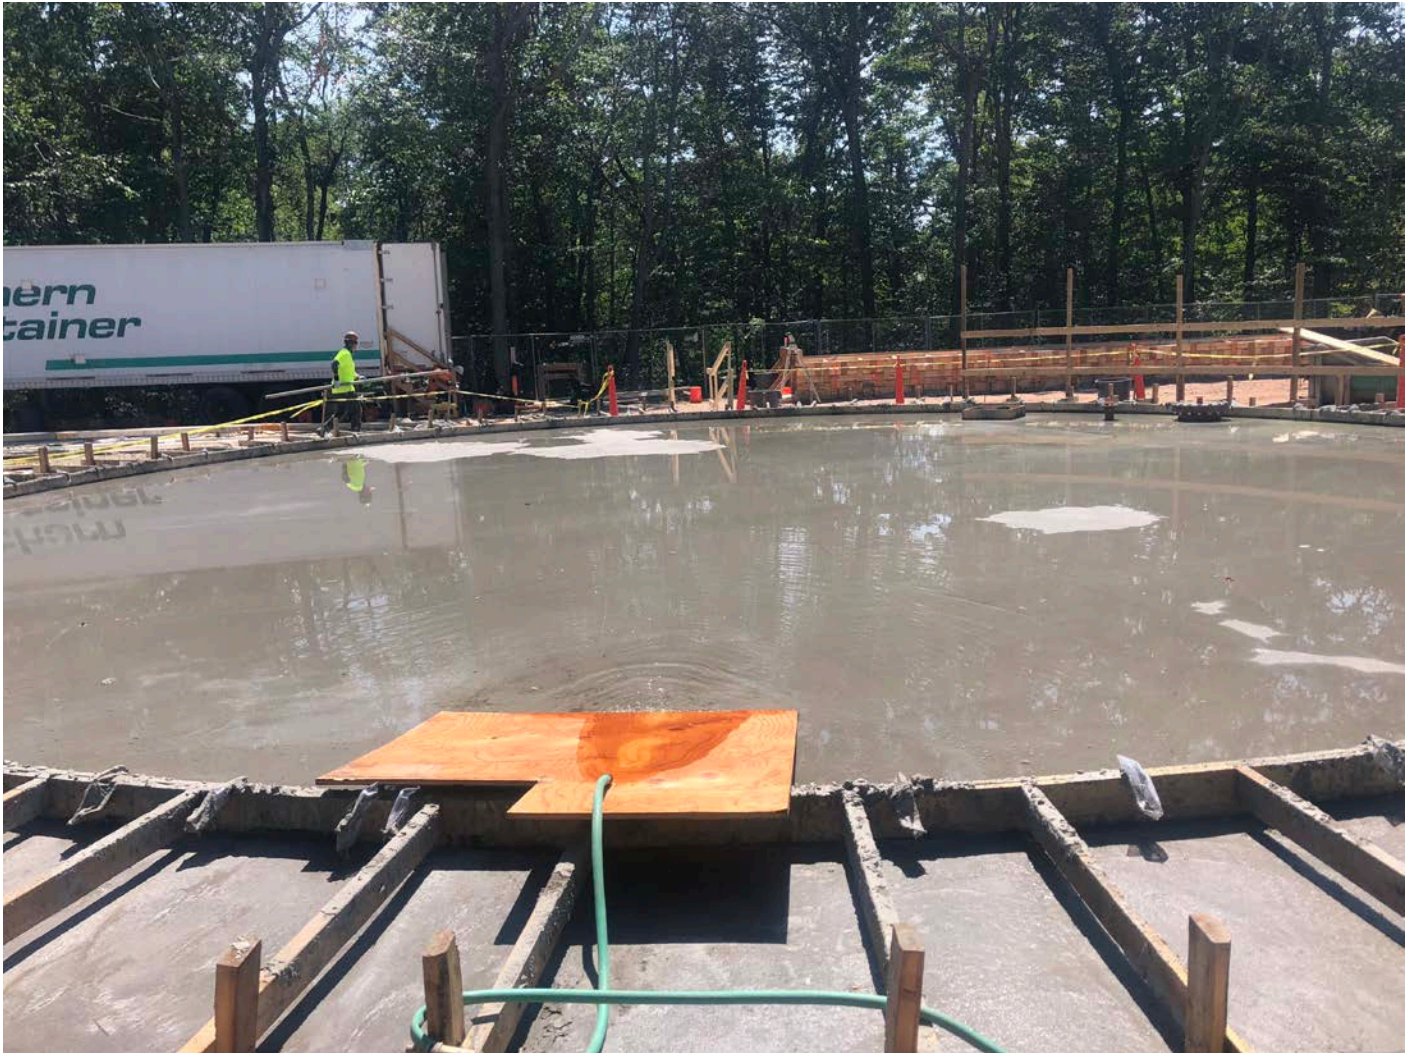
Picture 10: Freshly-placed concrete at the water tank base, with a layer of water placed over it in order to slow the cure. Water tank work zone, east of the Shared Access Driveway, Middletown. View to the south.
