Daily Report

Project:	Durham Meadows Pipeline Installation	Date:	September 11, 2020
Location:	Maple Avenue and Maiden Lane, Durham; Shared Access Driveway, Middletown, South Main Street, Middletown	Day of Week:	Friday
Project #:	AECOM: 60614871	Report No:	157
Contractor:	Ludlow Construction	Page:	1 of 25

Pipe Connections, Installations, and Other Work

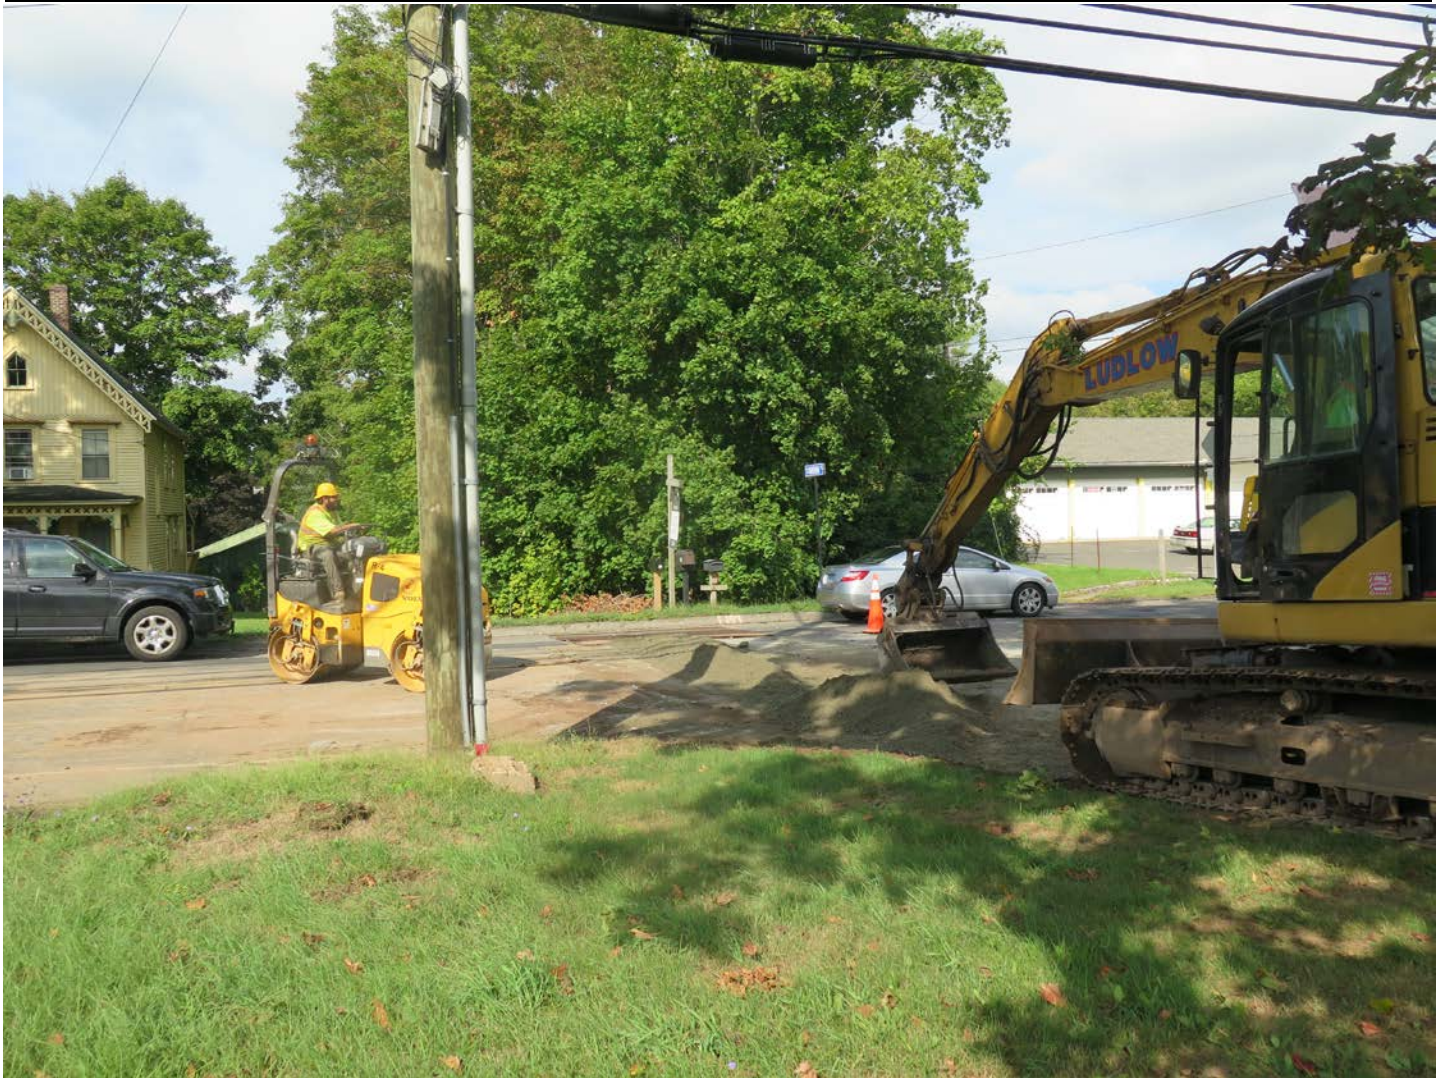
Picture 1: Backfilling curb stop at Station 1174+00 on Main Street, east side. View to the west.

0945: Ludlow backfilling curb stop at Station 1174+00, east side.

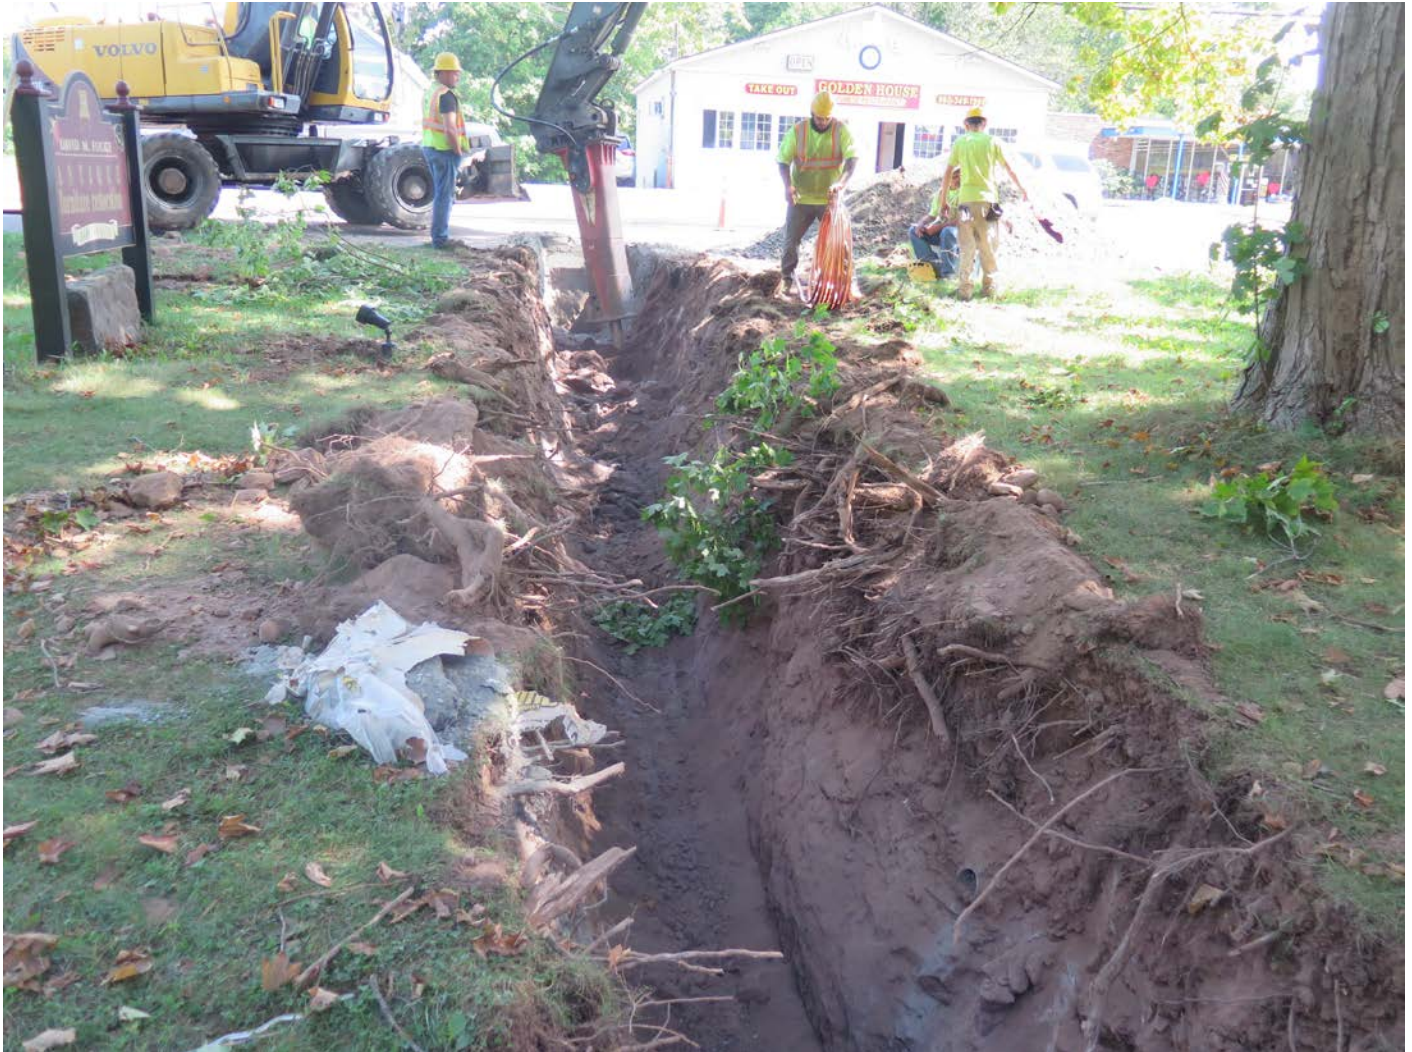
Picture 2: Installing curb stop at #328 Main Street, Durham, using hammer attachment to remove ledge. View to the east.

1250: Ludlow is installing curb stop at 328 Main Street (west side), between Stations 1174+50 and 1175+00. They are using a hammer attachment on the excavator to remove shallow ledge adjacent to the water main.

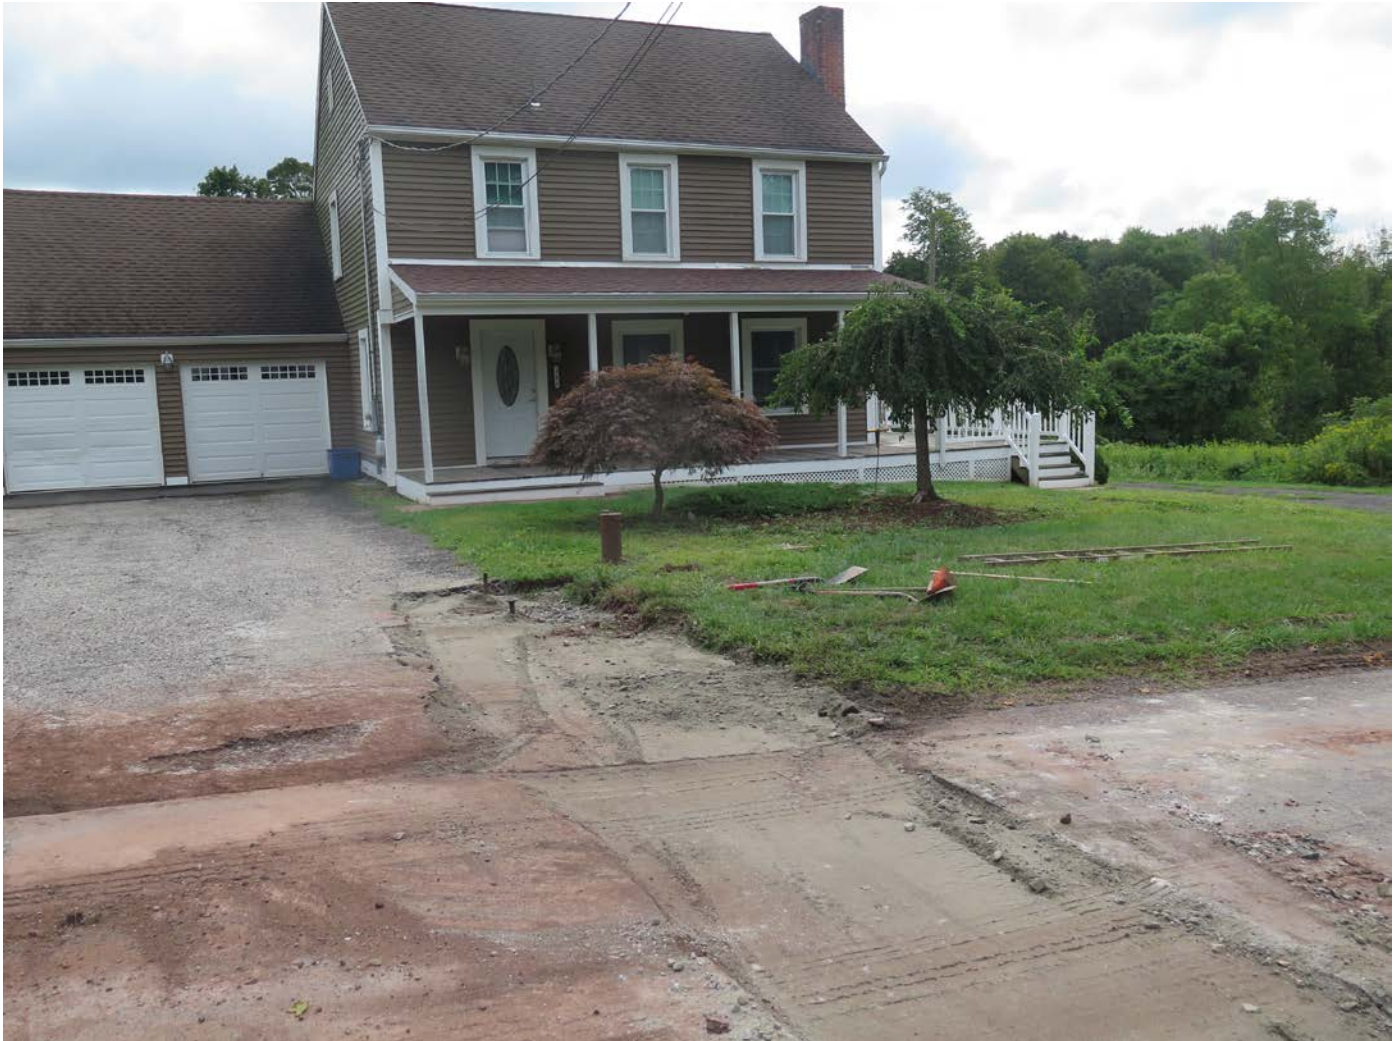
Picture 3: Backfilled curb stop at #245 Maple Street, Durham. View to the east.

1015: Ludlow has completed curb stops at #244 and #245 Maple Avenue. They will work on #235 Maple Avenue next.

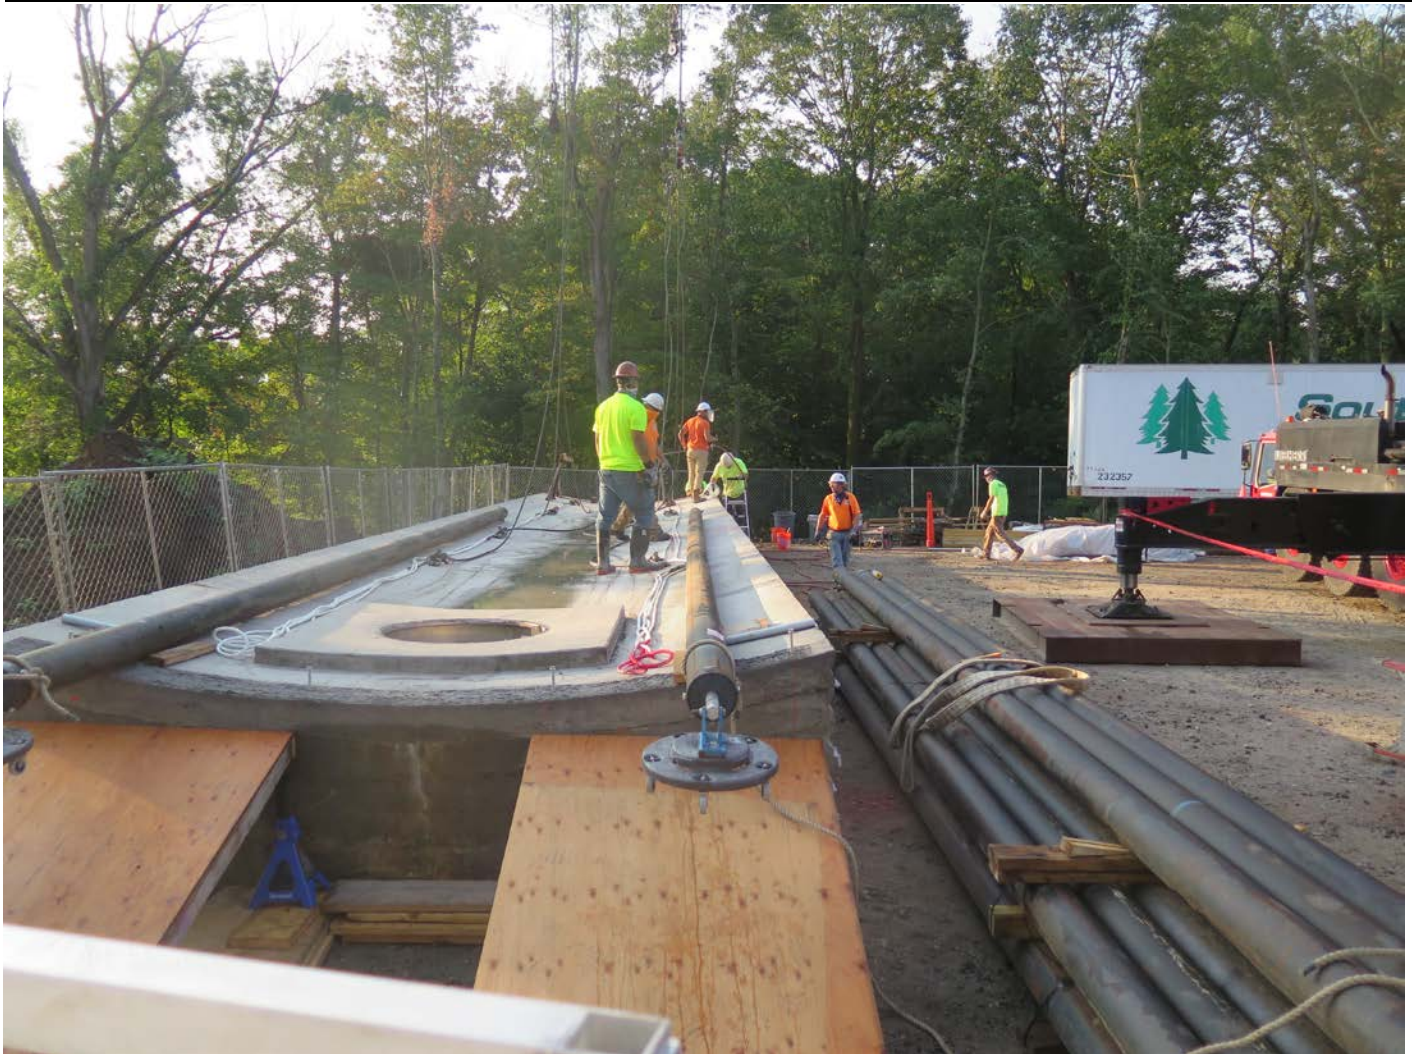
Picture 4: DN Tanks preparing the first tank wall panel for installation. Note rolling bases and guide ropes attached to bottoms of bracing poles, attached lifting cables with ropes for pulling release levers, and more bracing poles staged to the right of the stack of panels. Shared access driveway, Middletown; view to the south.

0830: DN Tanks preparing to lift first tank wall panel.

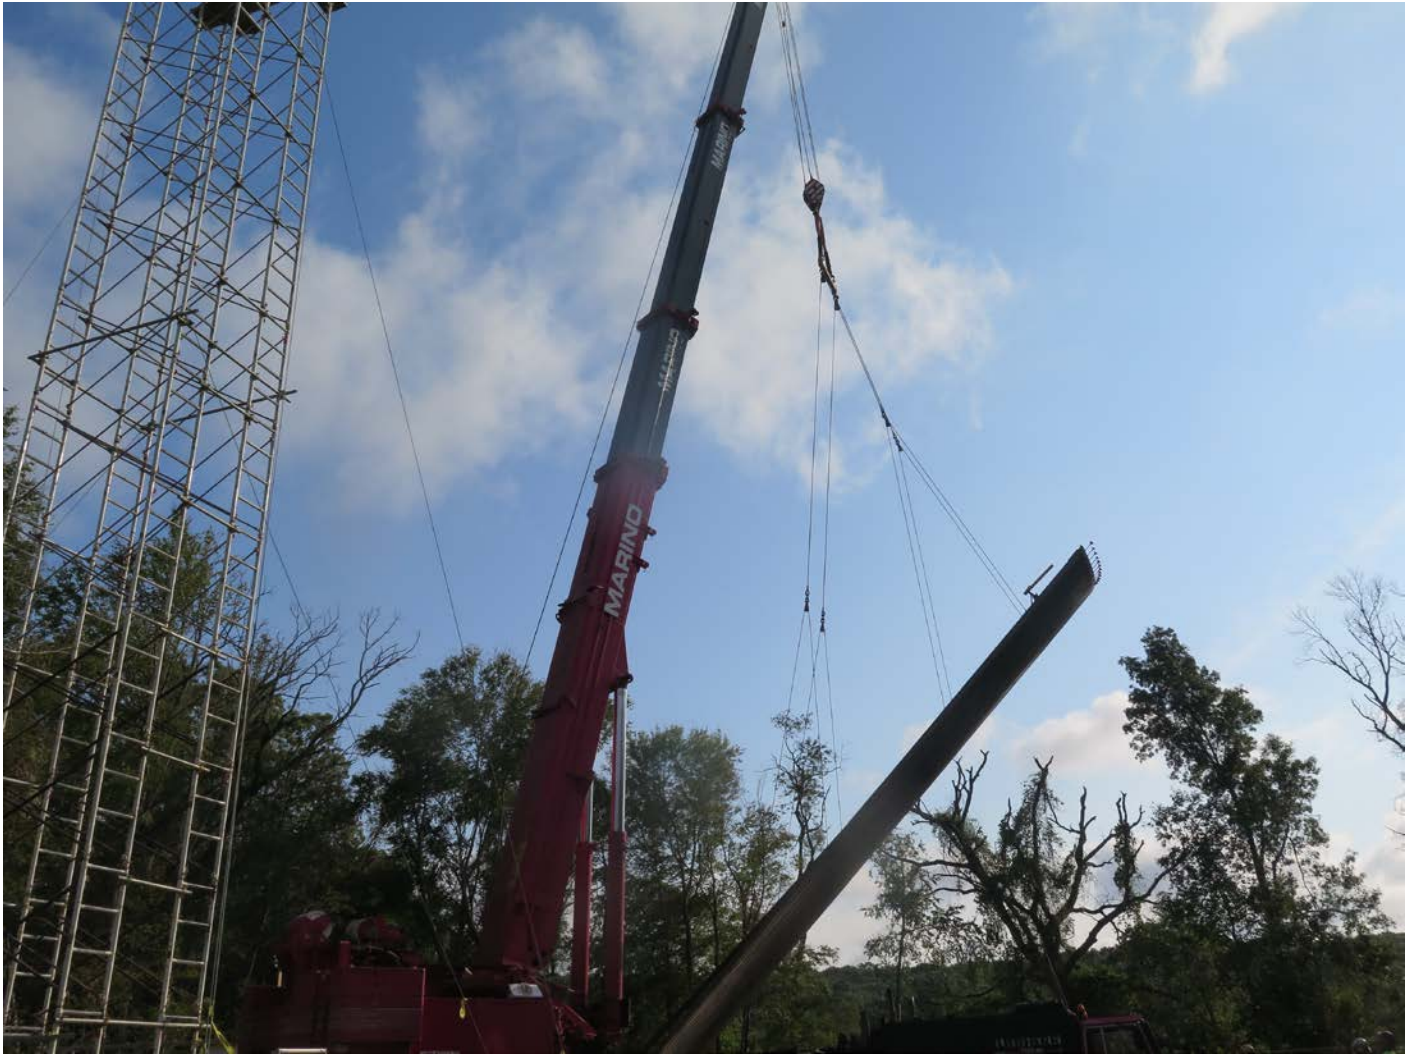
Picture 5: Lifting first tank wall panel. Shared access driveway, Middletown; view to the east.

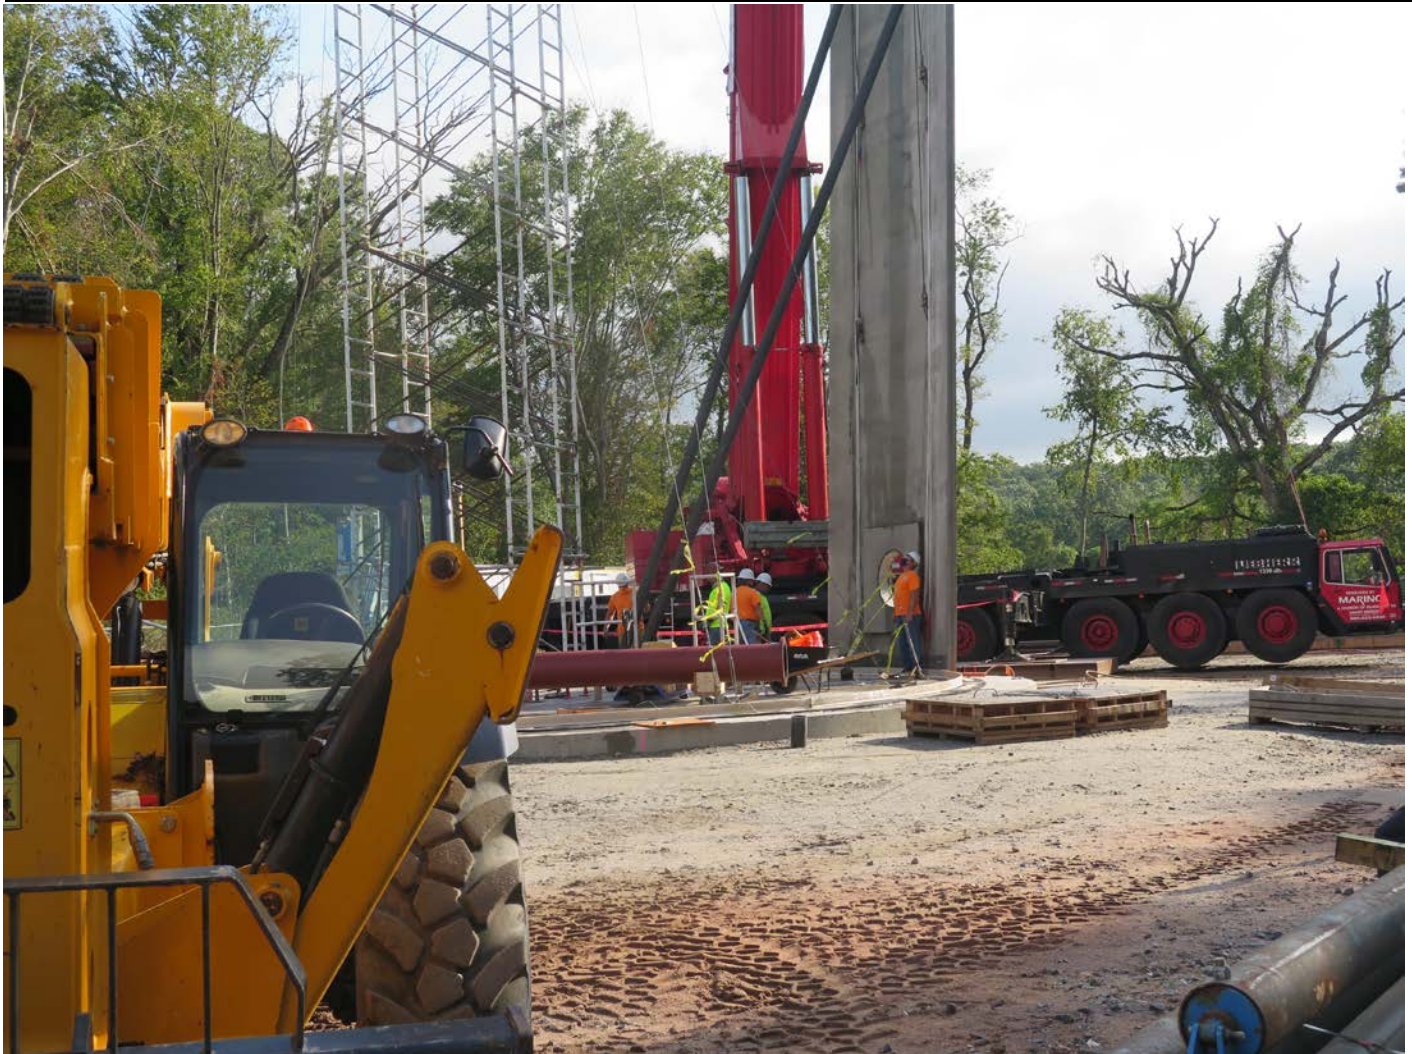
Picture 6: DN Tanks securing first tank wall panel. Note bracing poles tied into tank base slab. Shared access driveway, Middletown; view to the east.

1000: DN Tanks securing first tank wall panel in place.

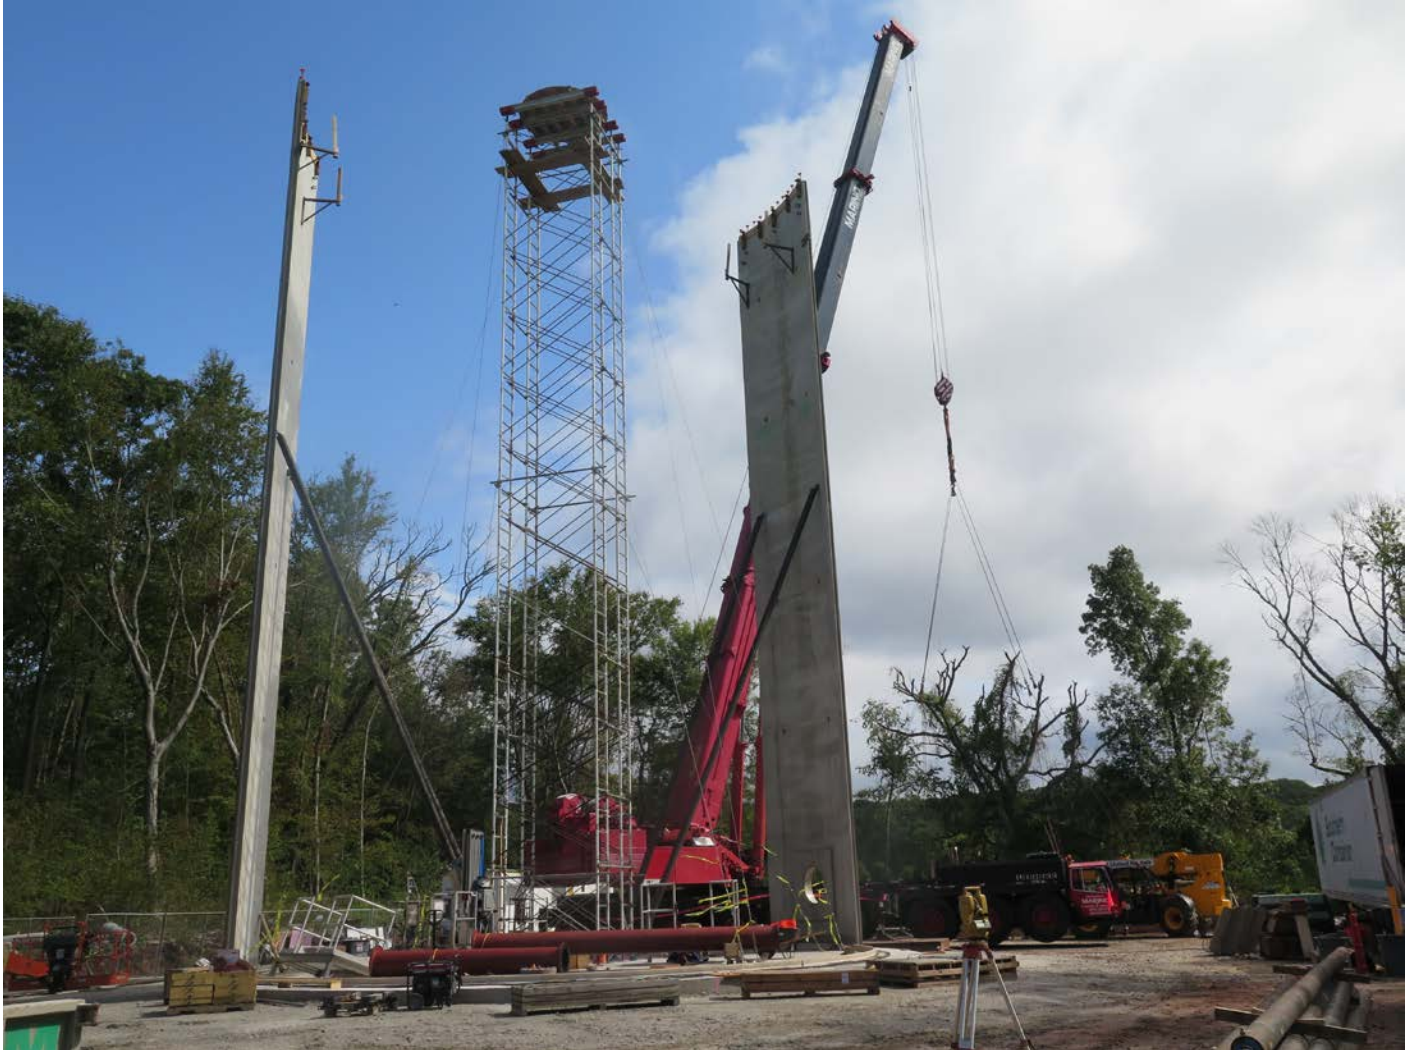
Picture 7: Second tank wall panel in place, DN Tanks preparing to lift third tank wall panel. Shared access driveway, Middletown; view to the east.

1100: Second tank wall panel secured in place, DN Tanks preparing to lift third tank wall panel.

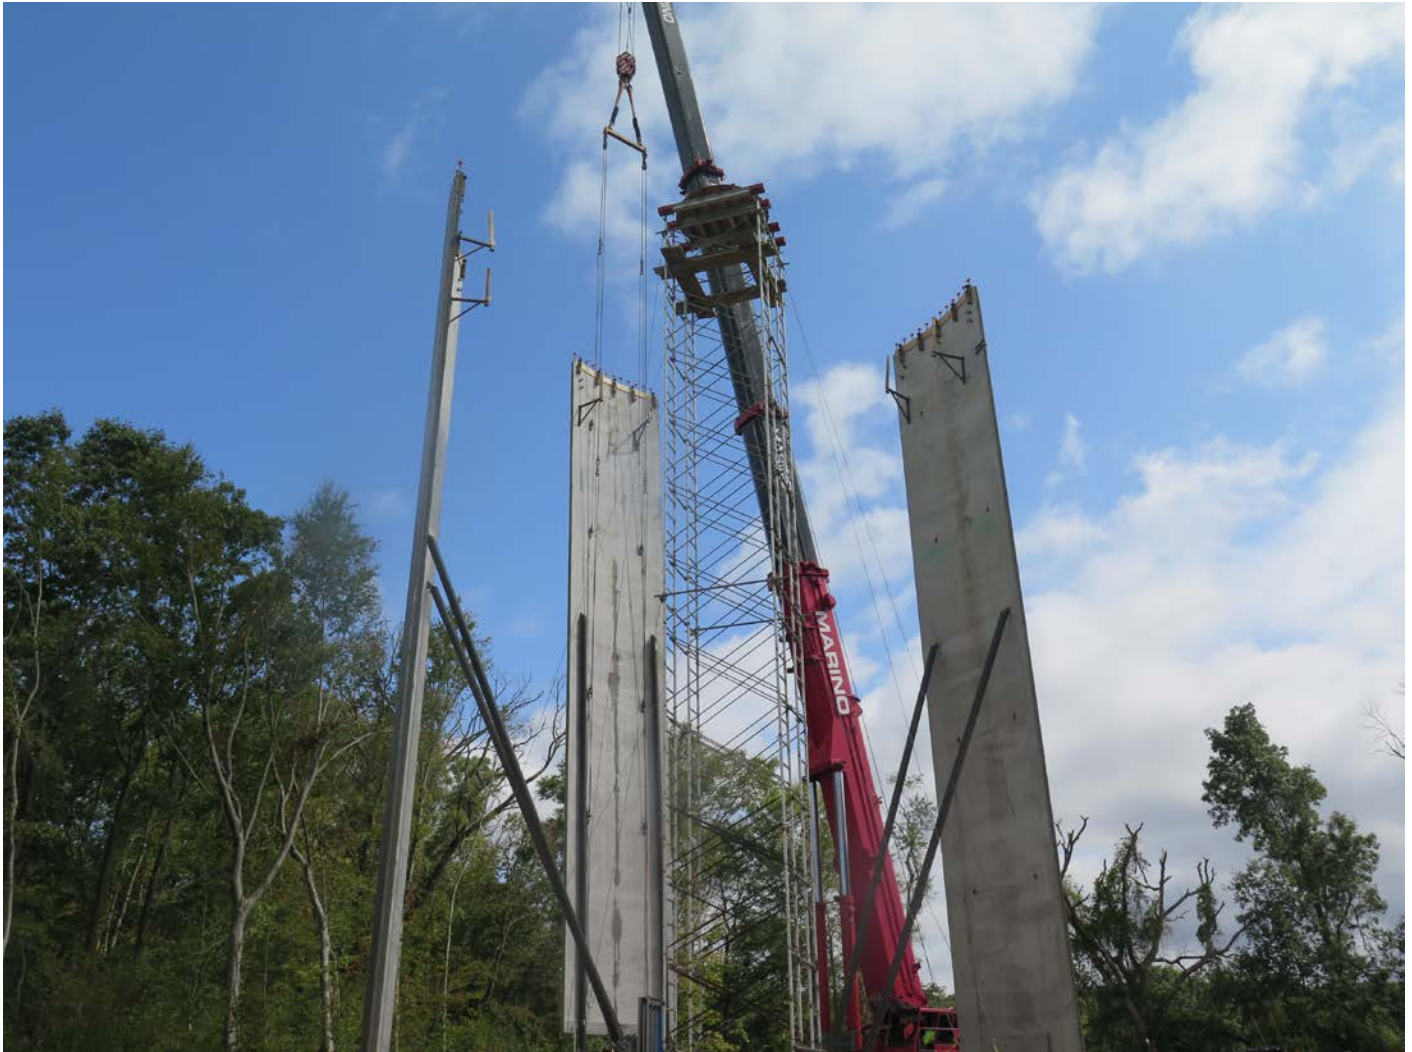
Picture 8: Moving third tank wall panel to tank base slab. Shared access driveway, Middletown; view to the northeast.

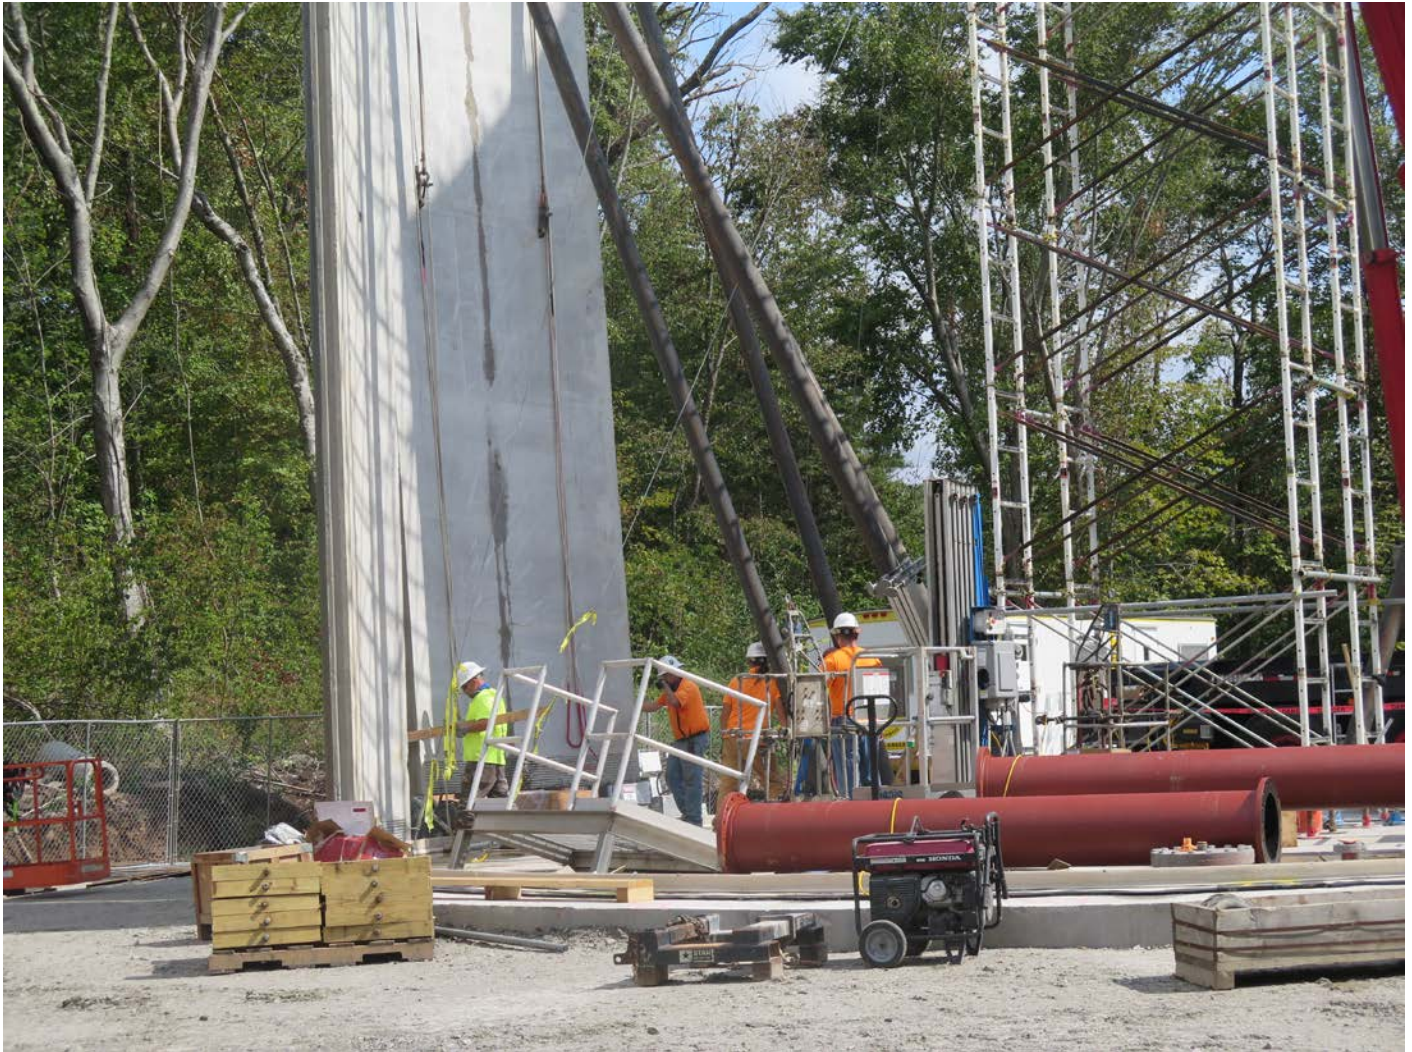
Picture 9: Securing base of third tank wall panel. Shared access driveway, Middletown; view to the northeast.

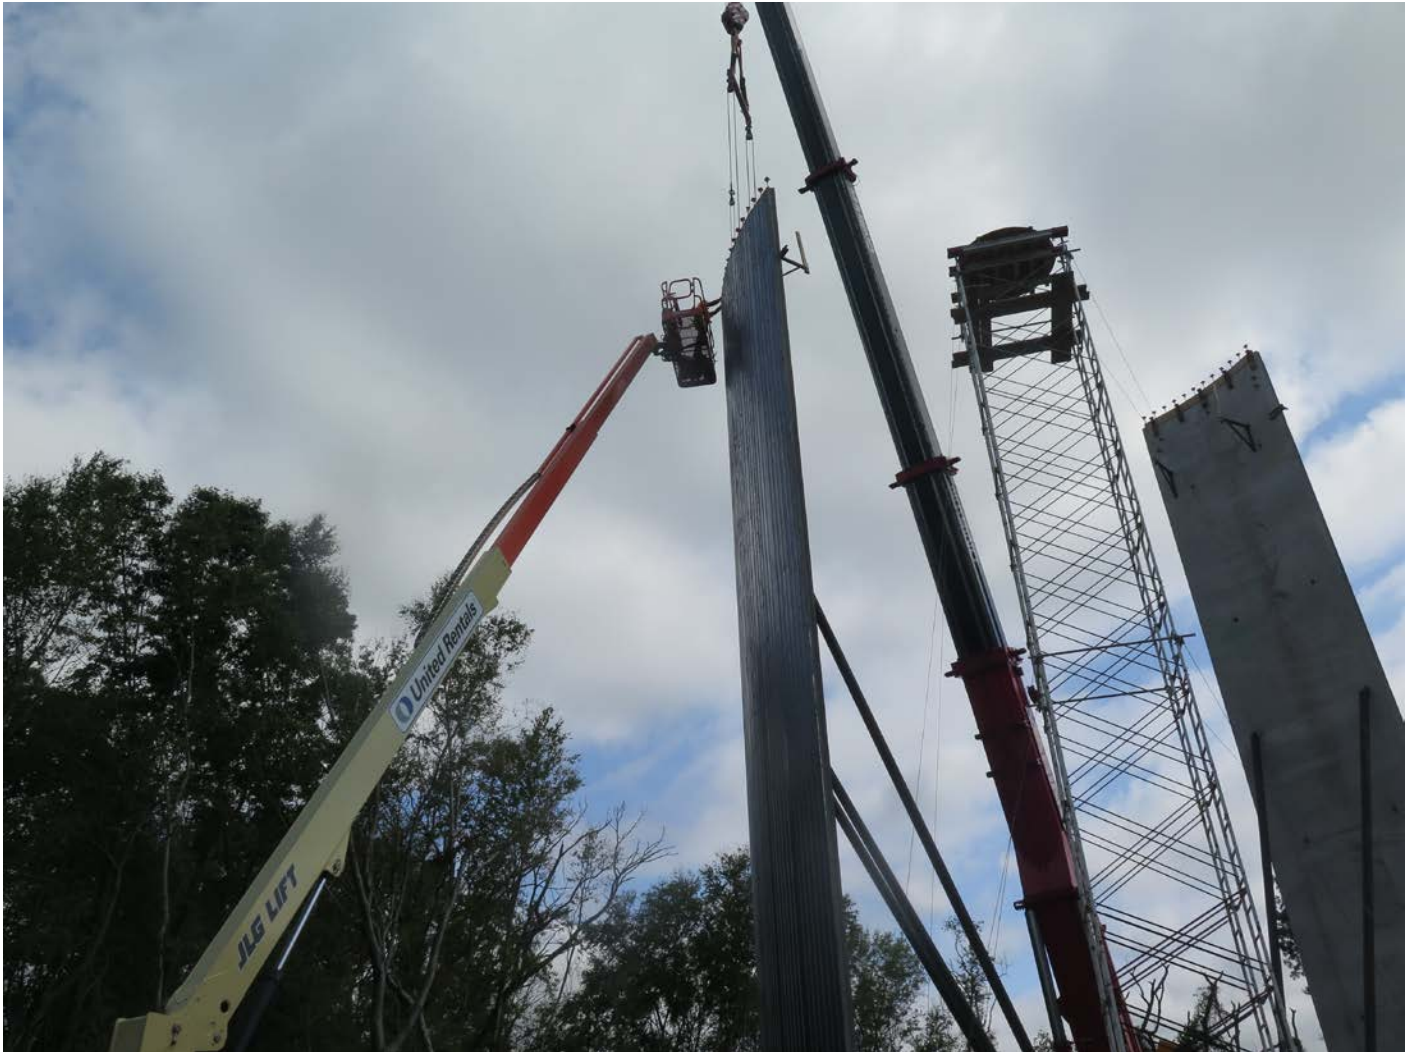
Picture 10: Worker on raised platform tying upper edges of second and third panels together. Shared access driveway, Middletown; view to the northeast.

1200: Third panel secured in place adjacent to second panel, temporary braces connecting the two panels. DN Tanks breaks for lunch.

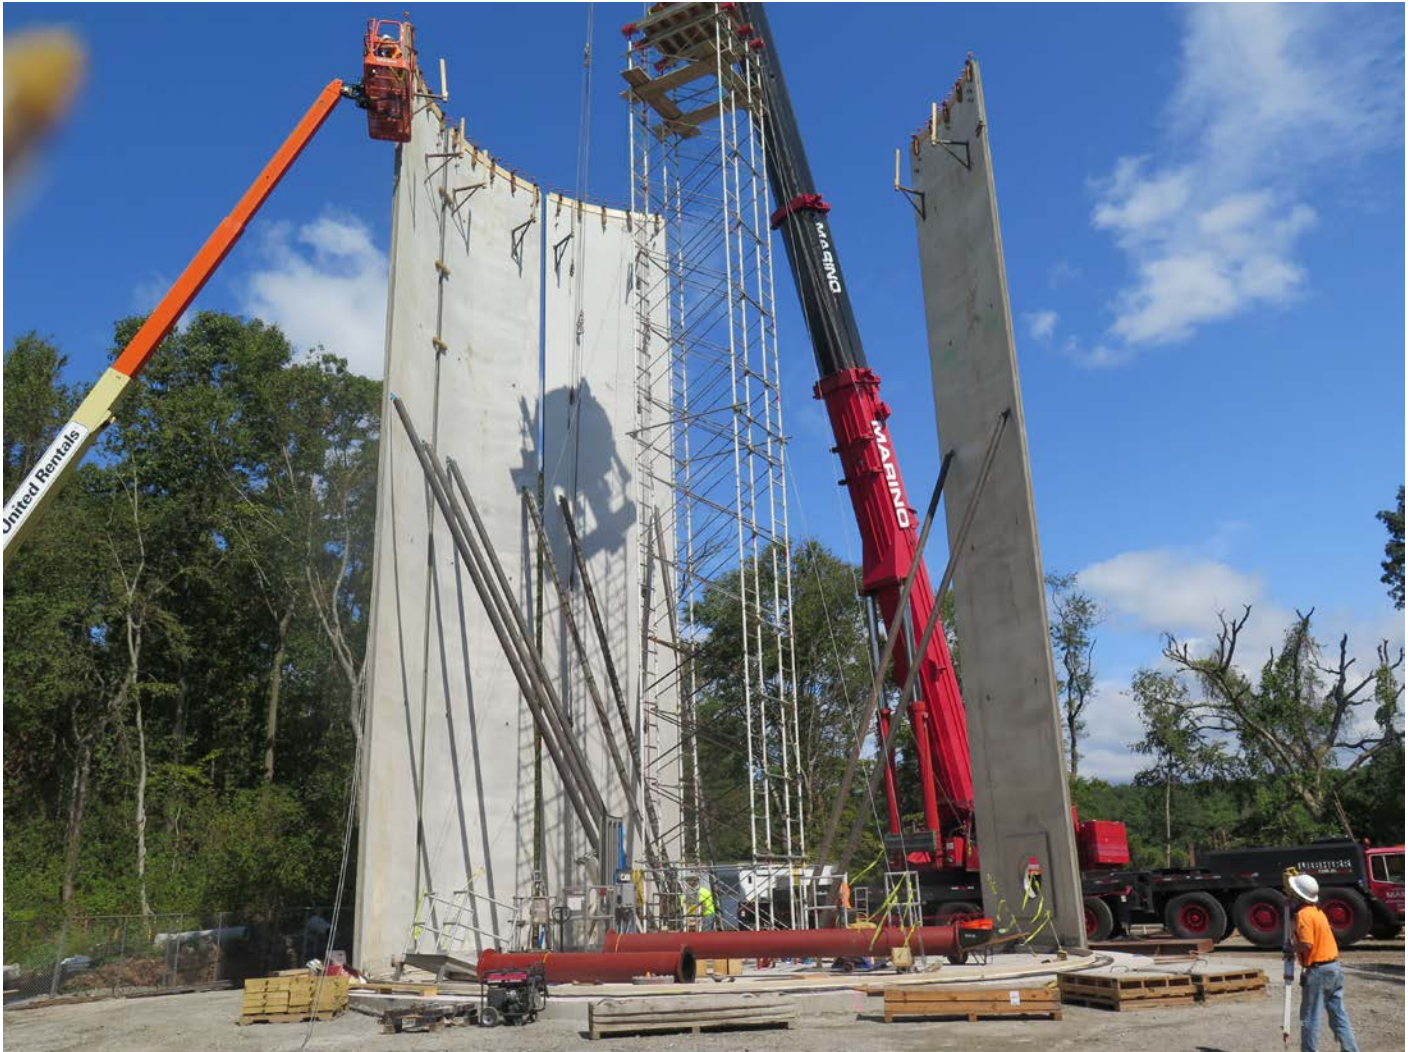
Picture 12: Fourth tank wall panel in place, preparing to secure upper edges to third panel. Note three bar clamps between second and third panels. Shared access driveway, Middletown; view to the northeast.

1320: Fourth panel in place, workers setting braces to secure it.

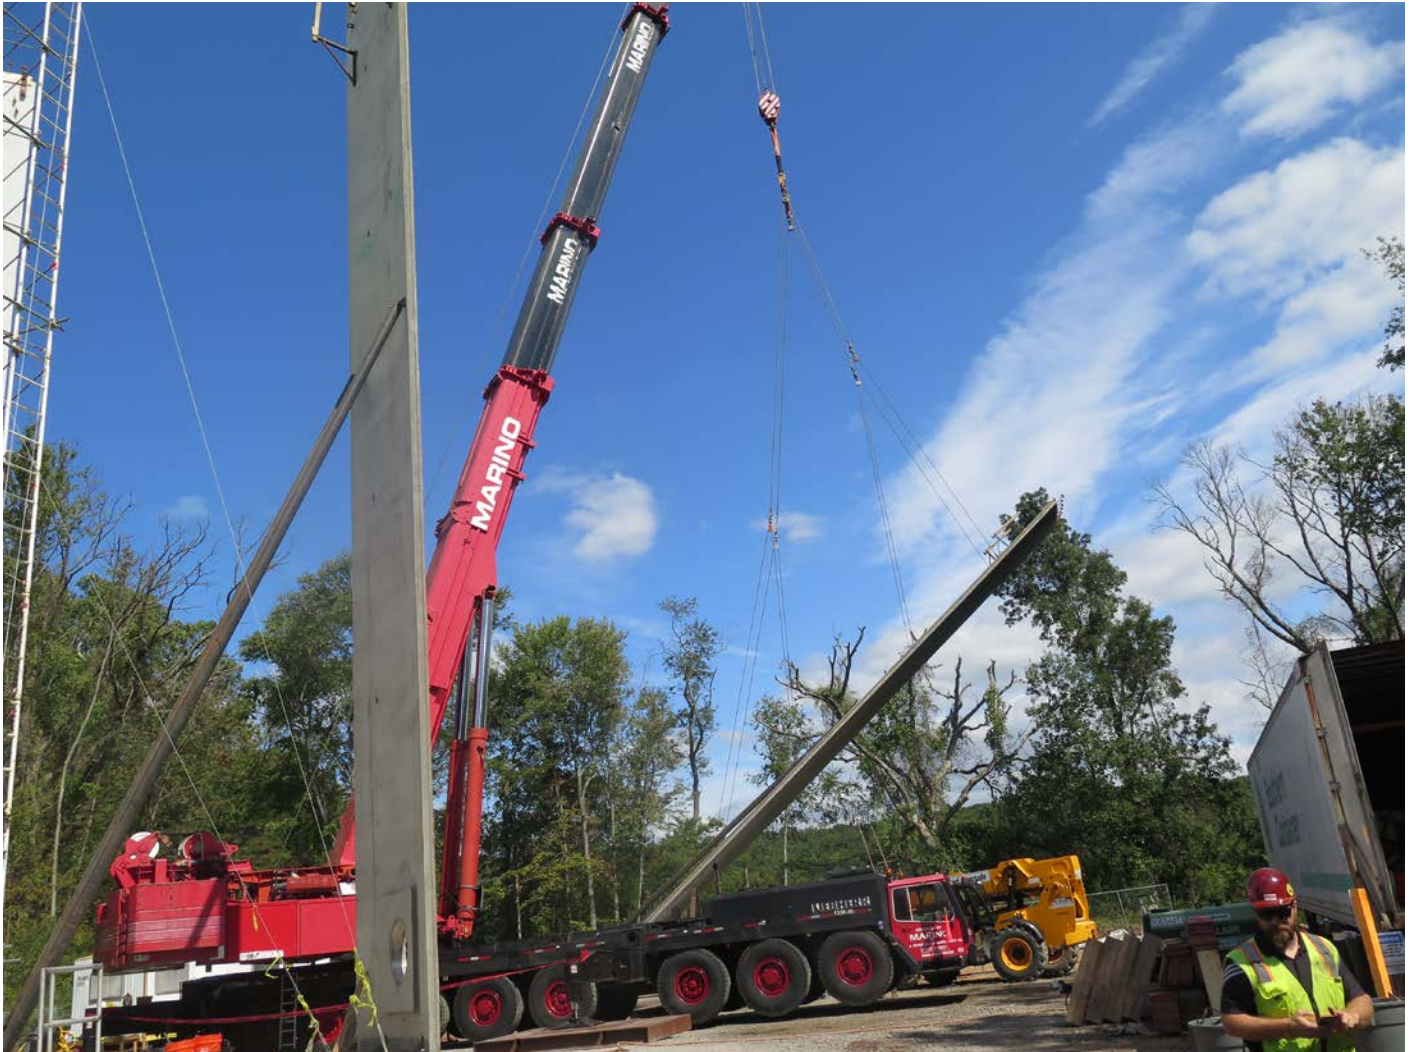
Picture 13: Lifting fifth tank wall panel. Shared access driveway, Middletown; view to the east.

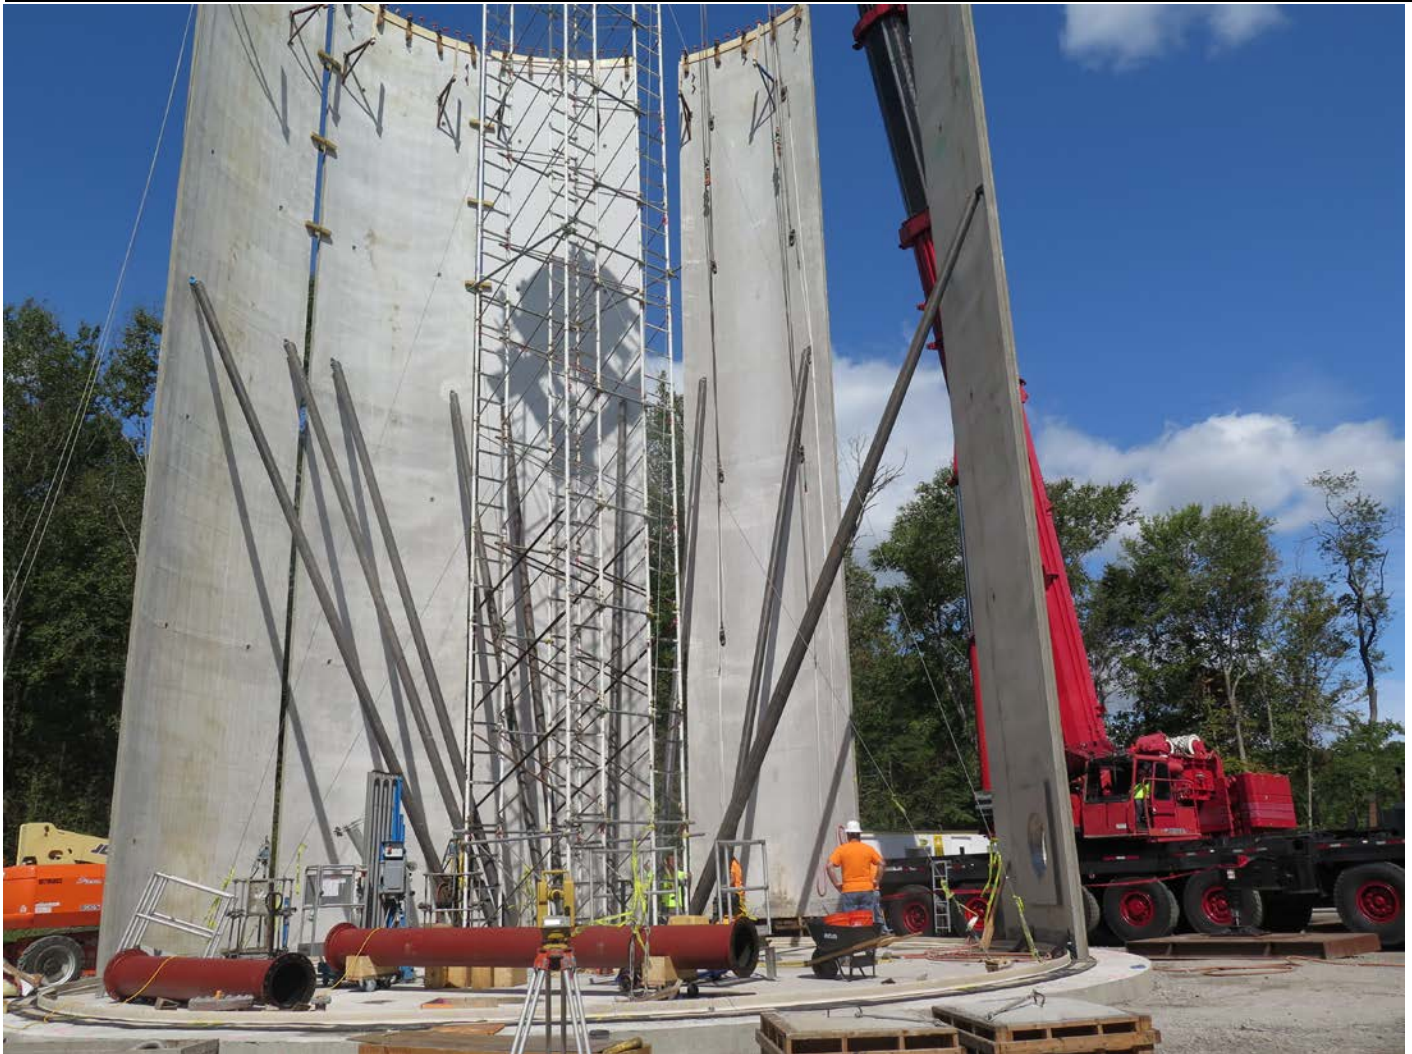
Picture 14: Placing fifth tank wall panel. Shared access driveway, Middletown; view to the northeast.

1350: Fifth panel secured, workers preparing sixth panel.

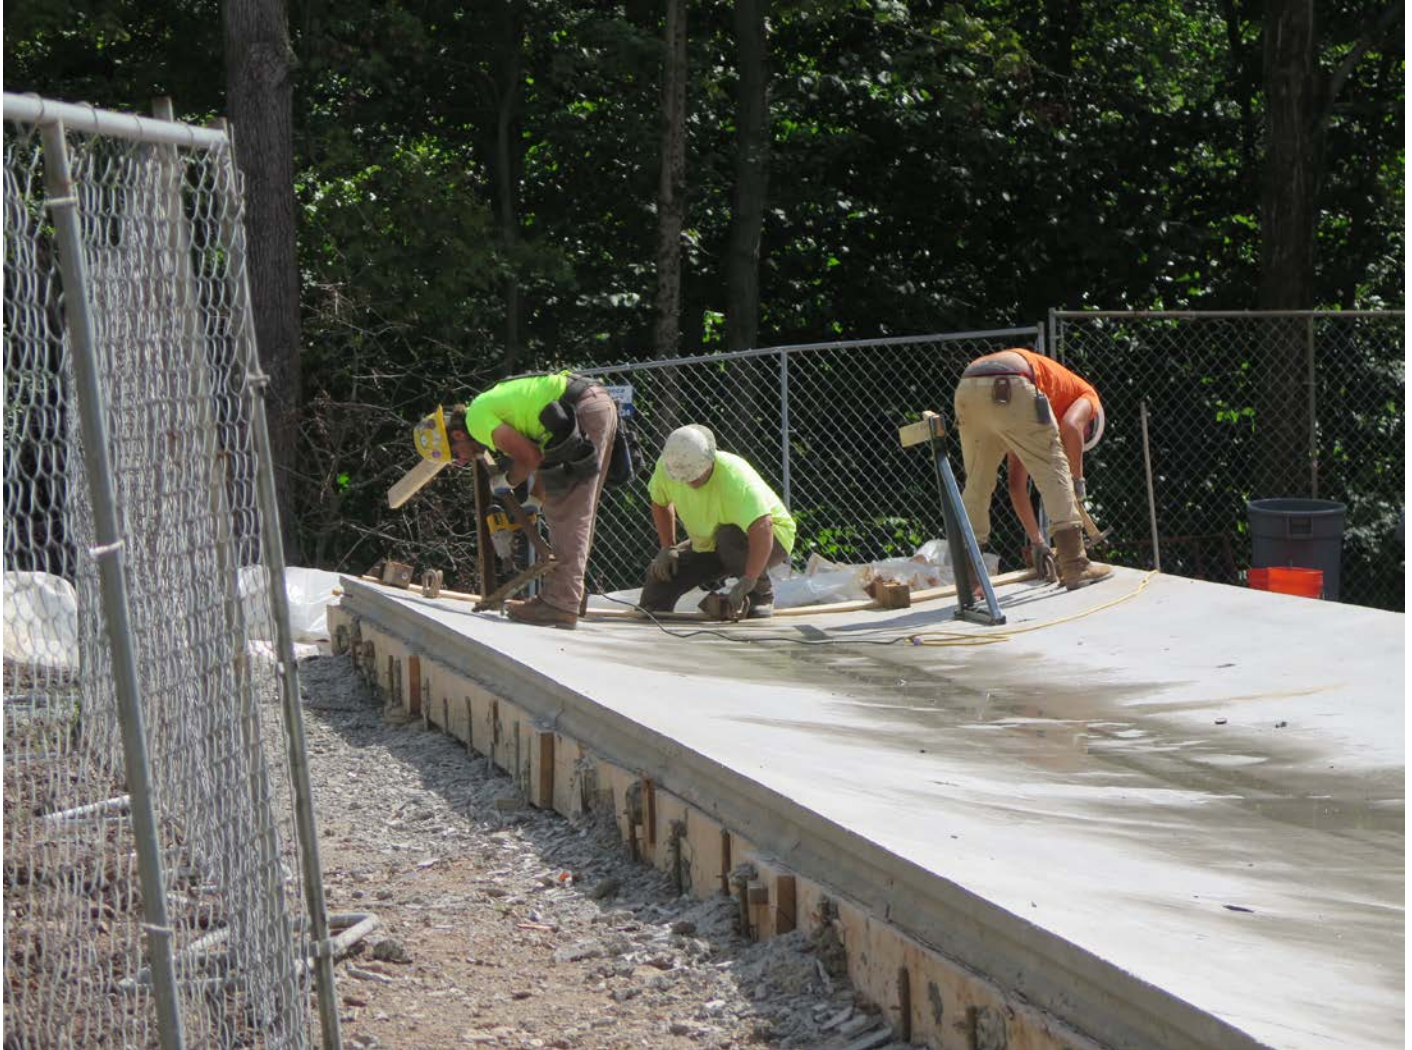
Picture 15: Adding supports to upper end of sixth tank wall panel. Shared access driveway, Middletown; view to the south.

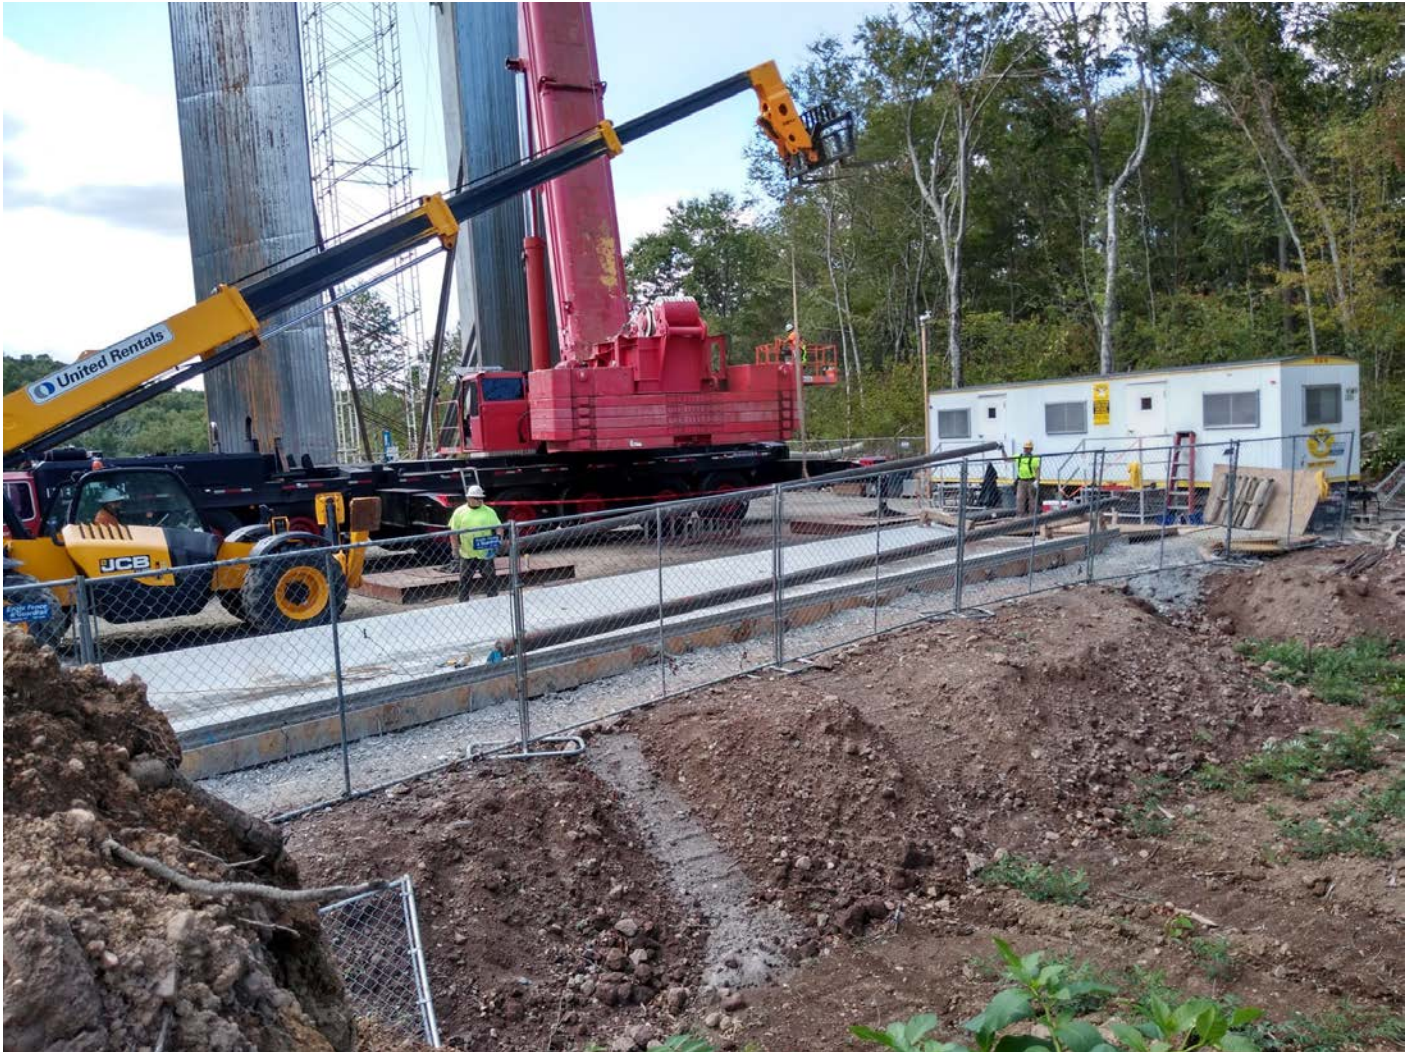
Picture 16: Attaching bracing poles to sixth tank wall panel. Shared access driveway, Middletown; view to the Northwest.
