Daily Report

Project:	Durham Meadows Pipeline Installation	Date:	September 11, 2020
Location:	Maple Avenue and Maiden Lane, Durham; Shared Access Driveway, Middletown, South Main Street, Middletown	Day of Week:	Friday
Project #:	AECOM: 60614871	Report No:	157
Contractor:	Ludlow Construction	Page:	1 of 25

Pipe Connections, Installations, and Other Work

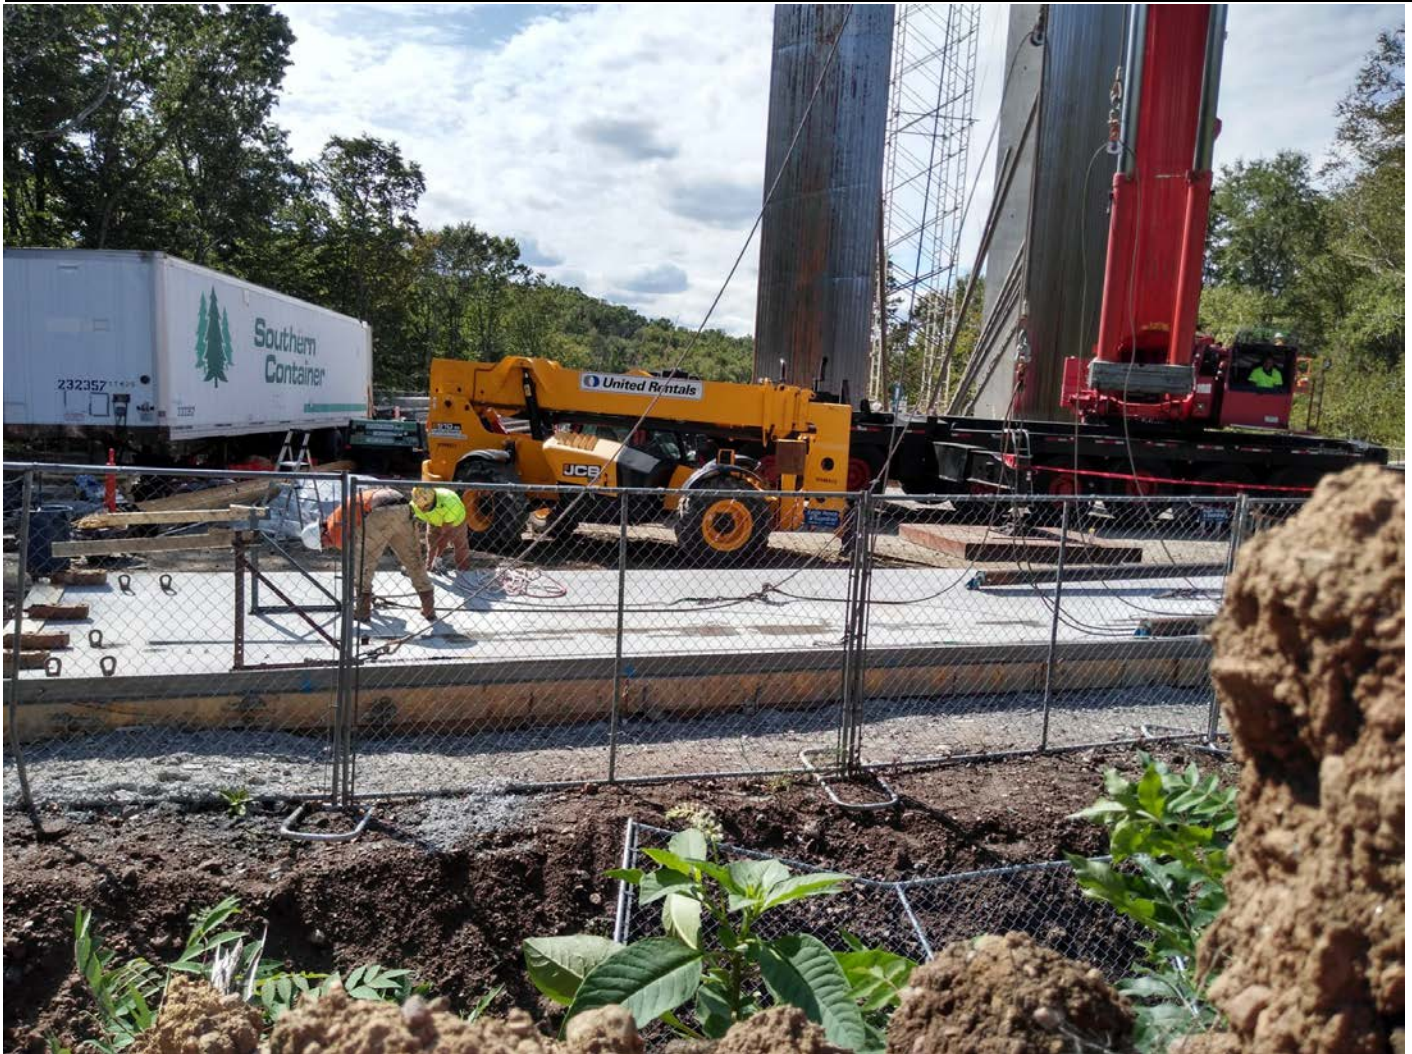
Picture 17: Attaching lifting cables to sixth tank wall panel. Shared access driveway, Middletown; view to the west.

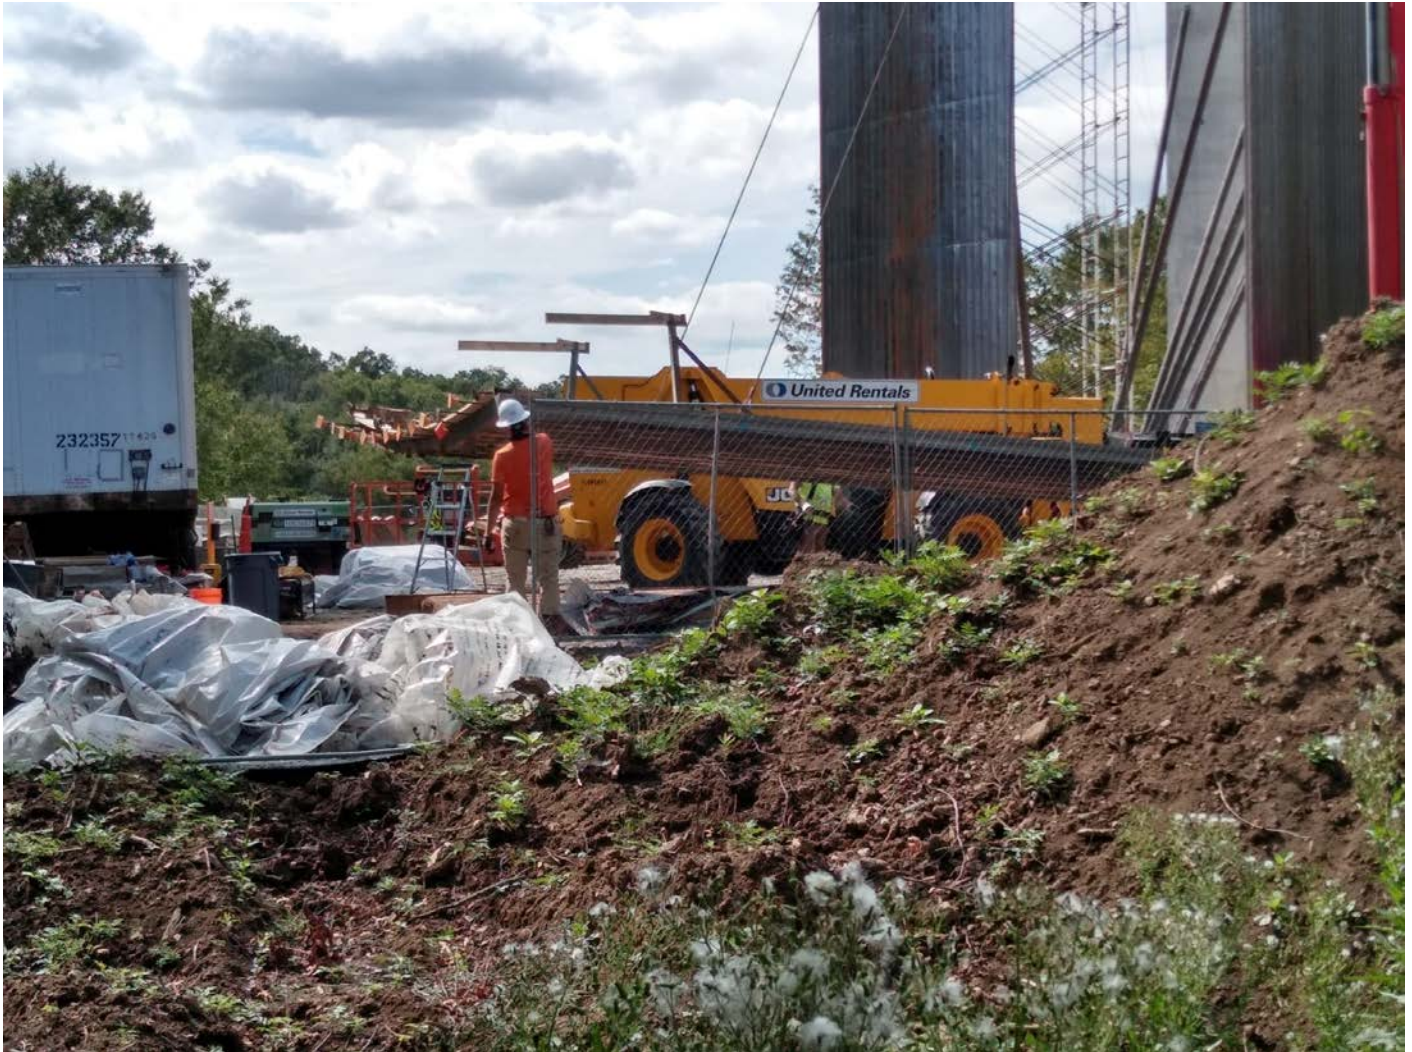
Picture 18: Hammering off loose flakes of concrete from edges of sixth tank wall panel. Shared access driveway, Middletown; view to the west.

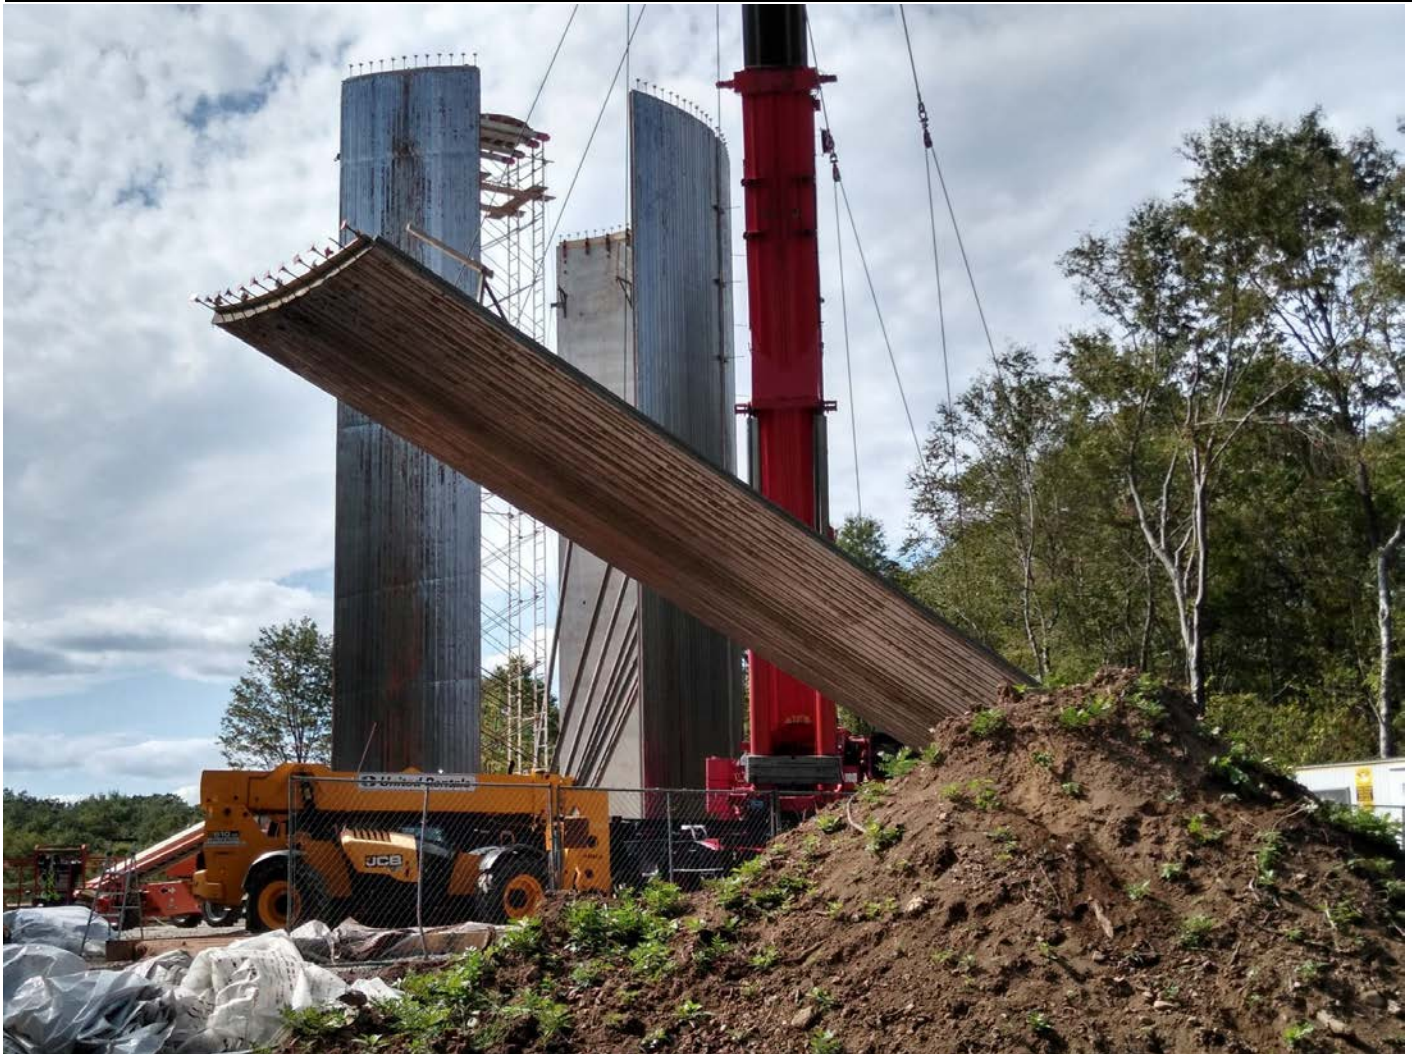
Picture 19: Beginning to lift sixth tank wall panel. Shared access driveway, Middletown; view to the west.

1445: Crane begins to lift sixth panel.

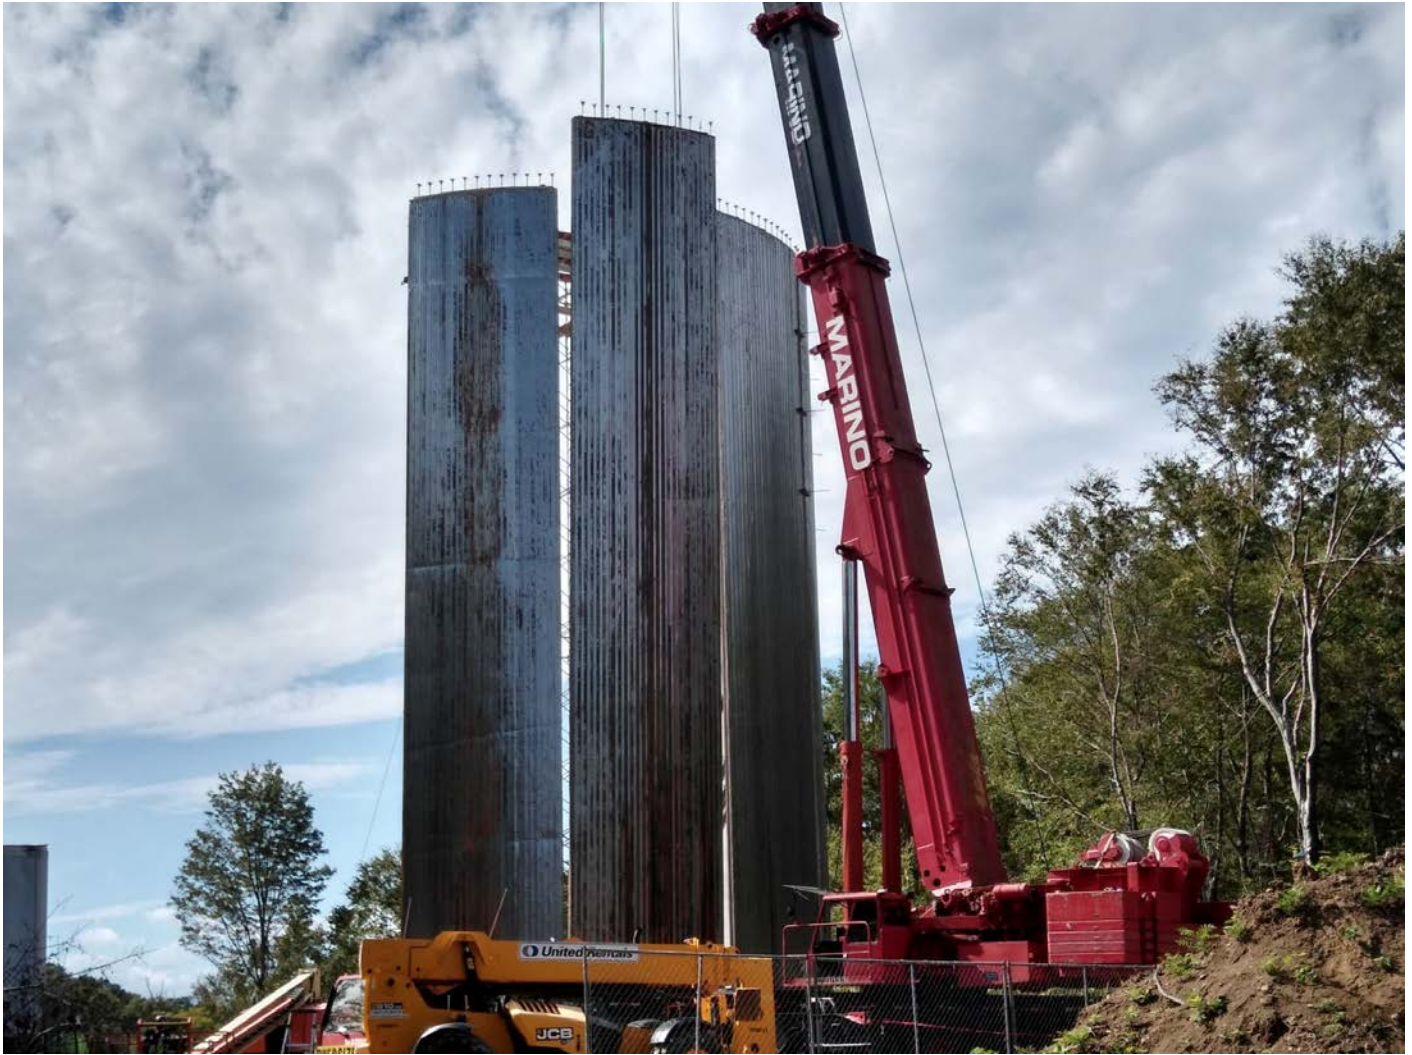
Picture 20: Positioning sixth tank wall panel on tank slab. Shared access driveway, Middletown; view to the west.

1510: Sixth panel in place, workers setting braces.

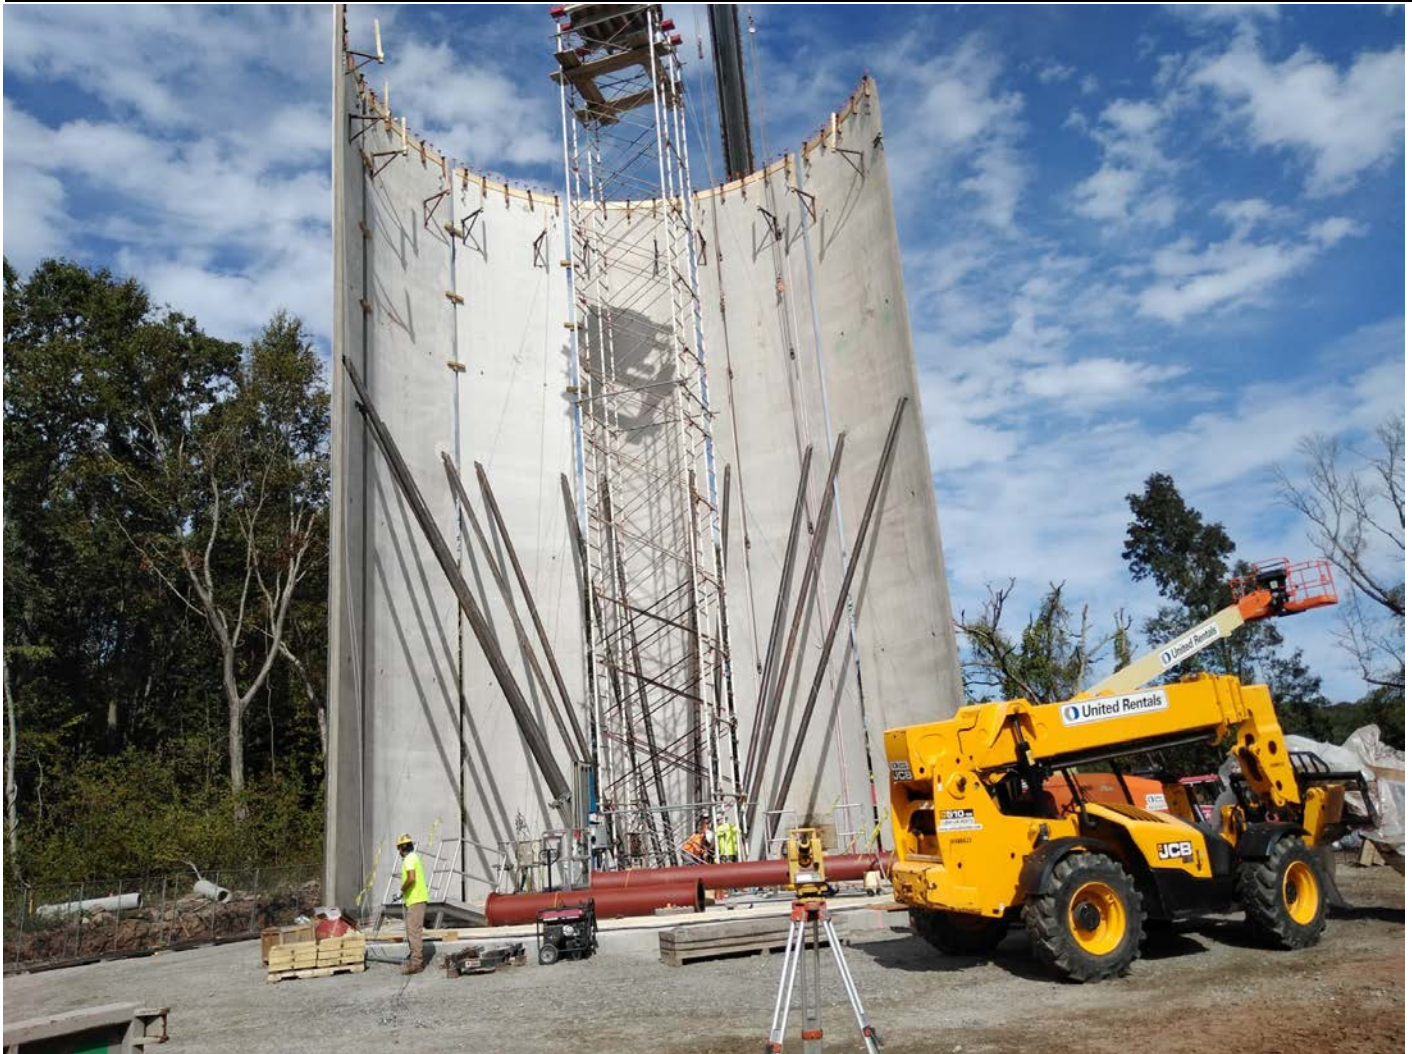
Picture 21: Securing bracing poles of sixth tank wall panel to tank slab. Shared access driveway, Middletown; view to the northeast.
