Daily Report

Project:	Durham Meadows Pipeline Installation	Date:	September 21, 2020
Location:	Main Street, Durham; S. Main Street and the Shared Access Driveway, Middletown	Day of Week:	Monday
Project #:	AECOM: 6061487	Report No:	163
Contractor:	Ludlow Construction	Page:	1 of 12

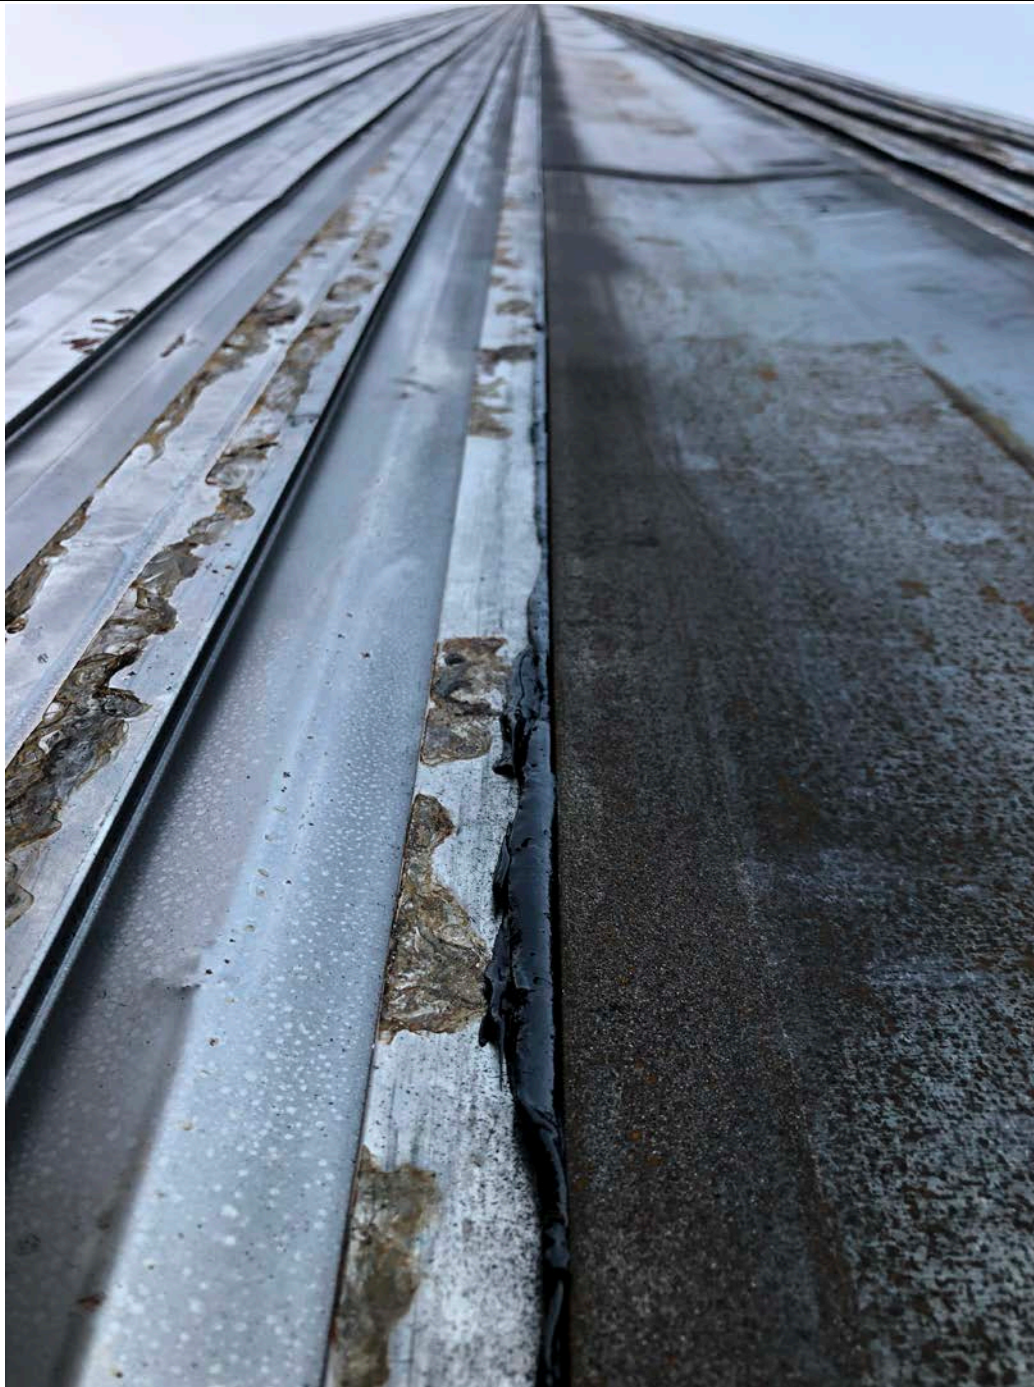
Picture 2: Closeup of caulk applied to seal a slot panel to the exterior of the water tank. Water tank work zone, east of the Shared Access Driveway, Middletown.

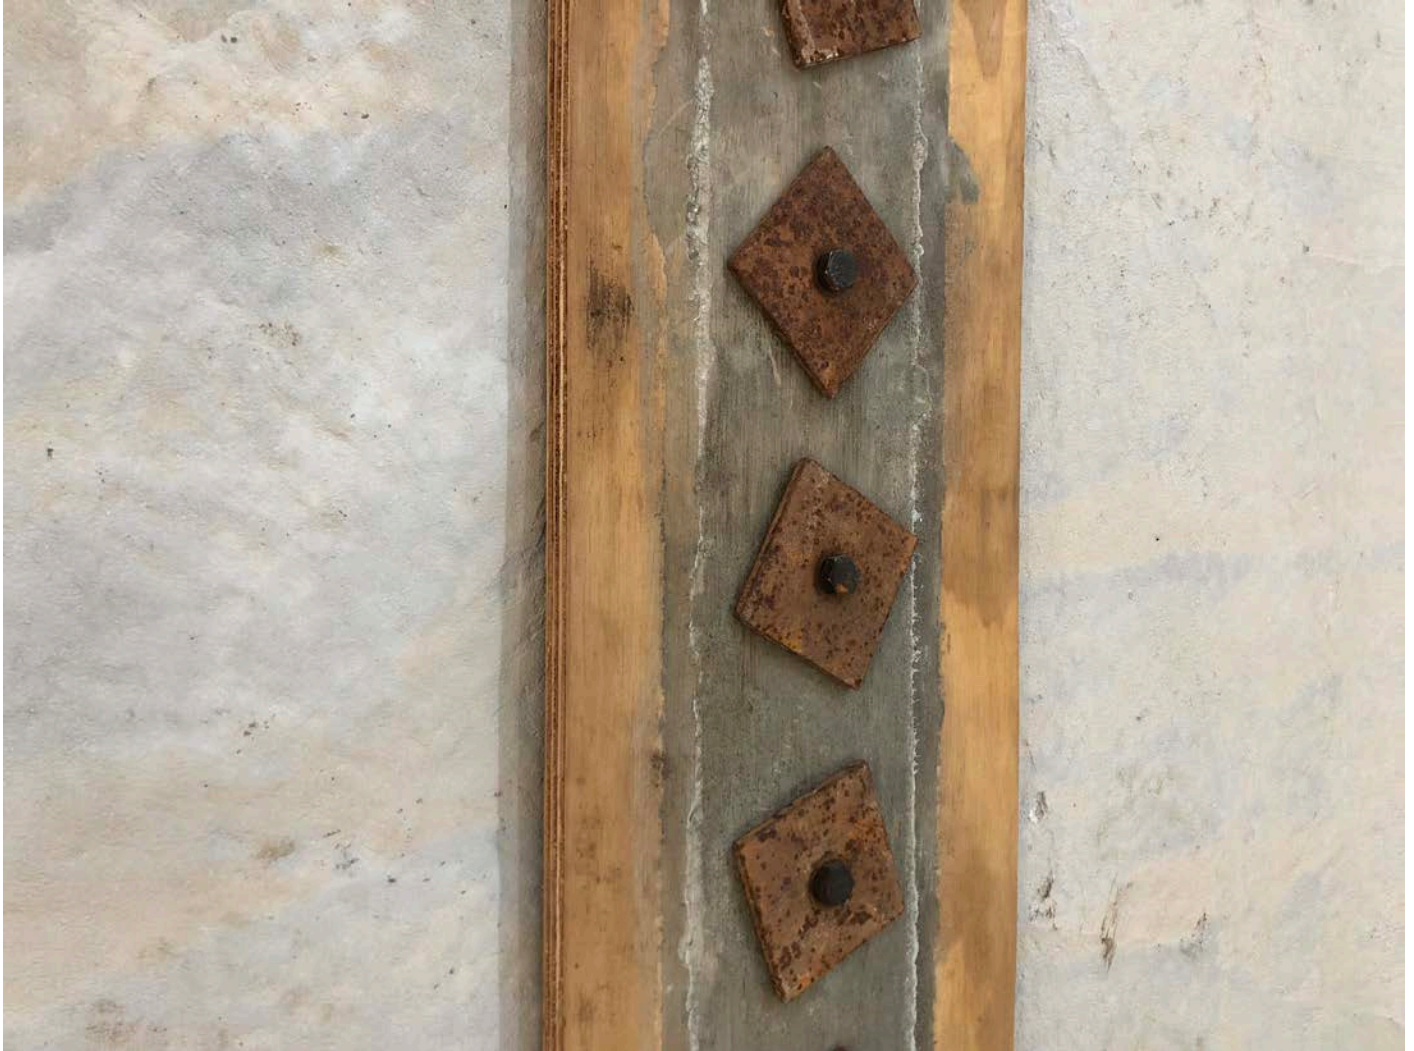
Picture 4: Closeup of plywood bolted to the back of a slot panel from the inside of the water tank. Water tank work zone, east of the Shared Access Driveway, Middletown.

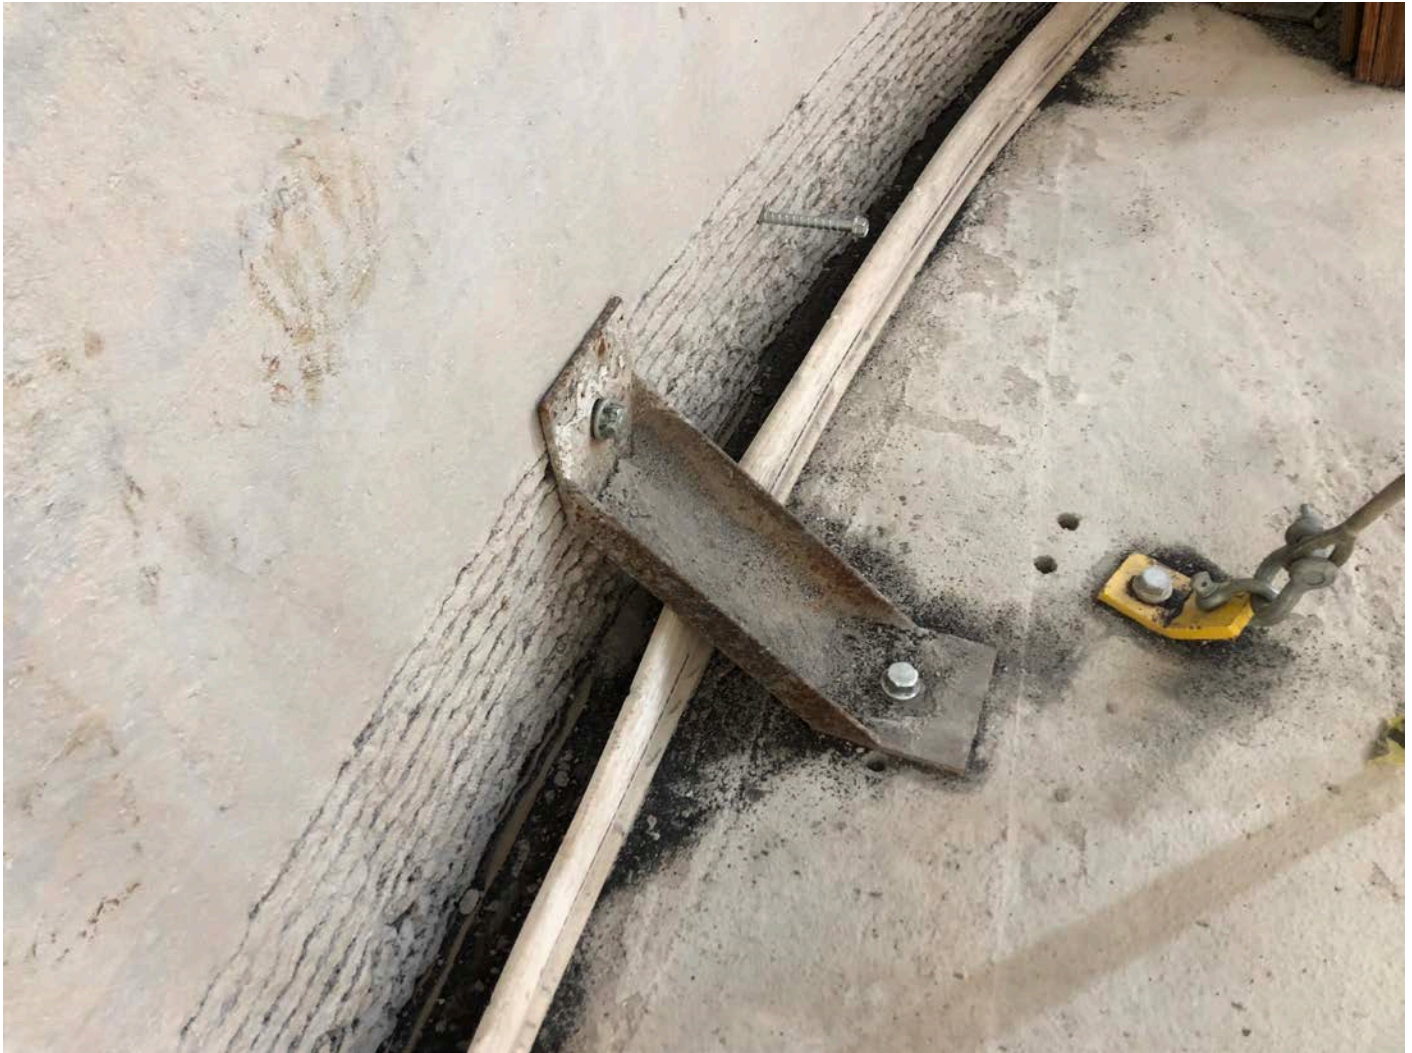
Picture 5: Brace anchoring water tank side panel to the base of the water tank. Water tank work zone, east of the Shared Access Driveway, Middletown.

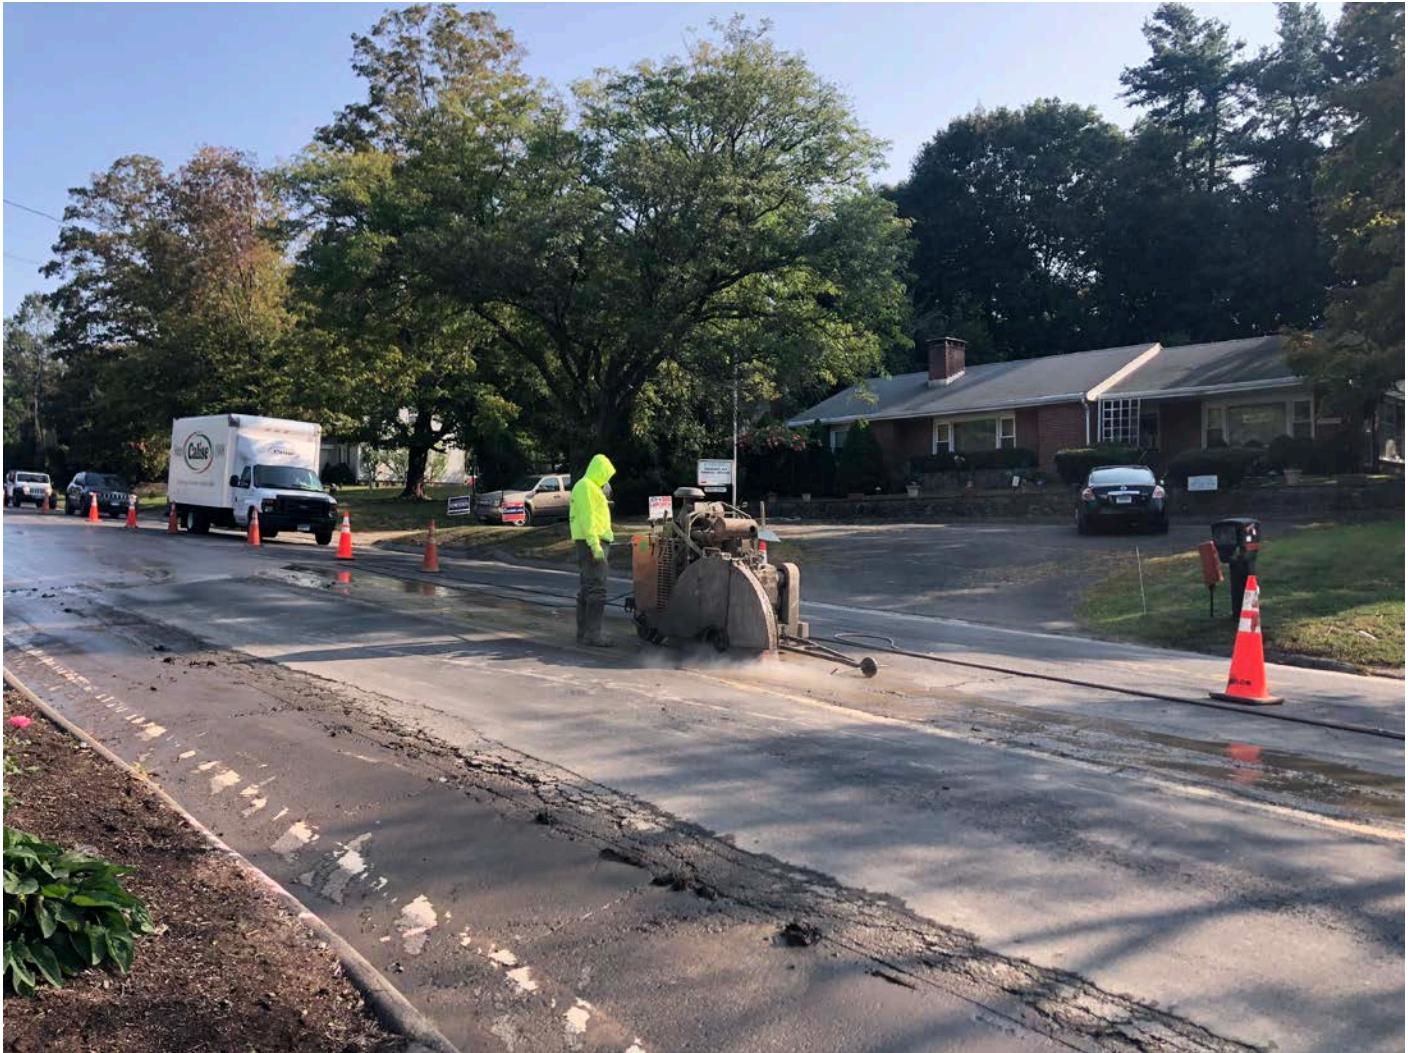
Picture 6: Veilleux saw cutting pavement at Station 155+00 on Main Street, Durham. View to the northeast.

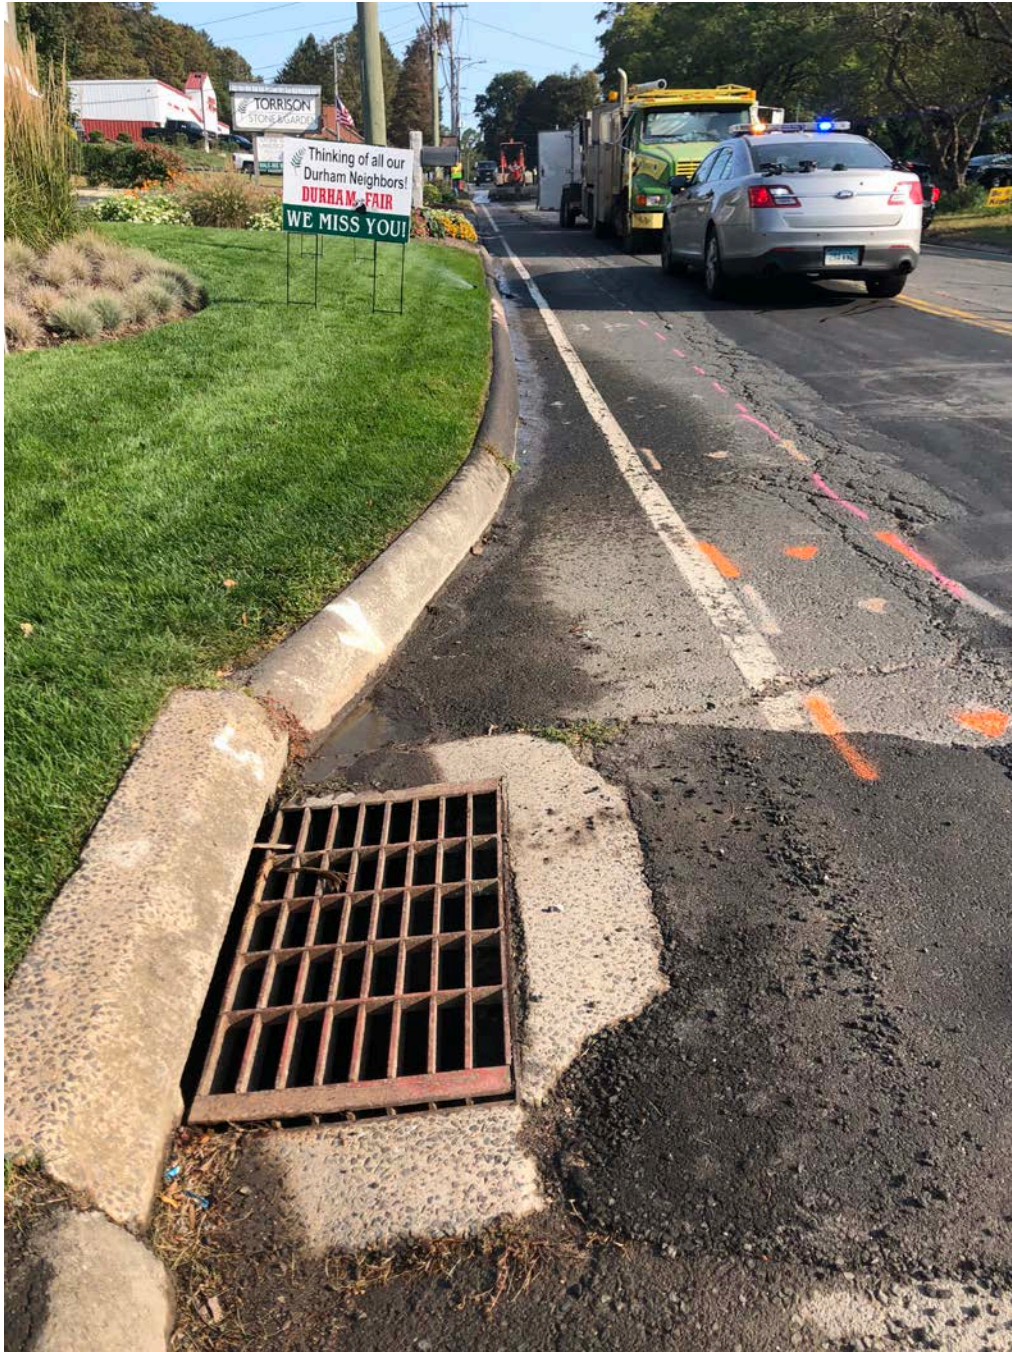
Picture 7: Catch basin without a silt sock located on the west side of Main Street, Durham, that is located downgradient of saw cutting activities being performed at Station 155+00. View to the north.

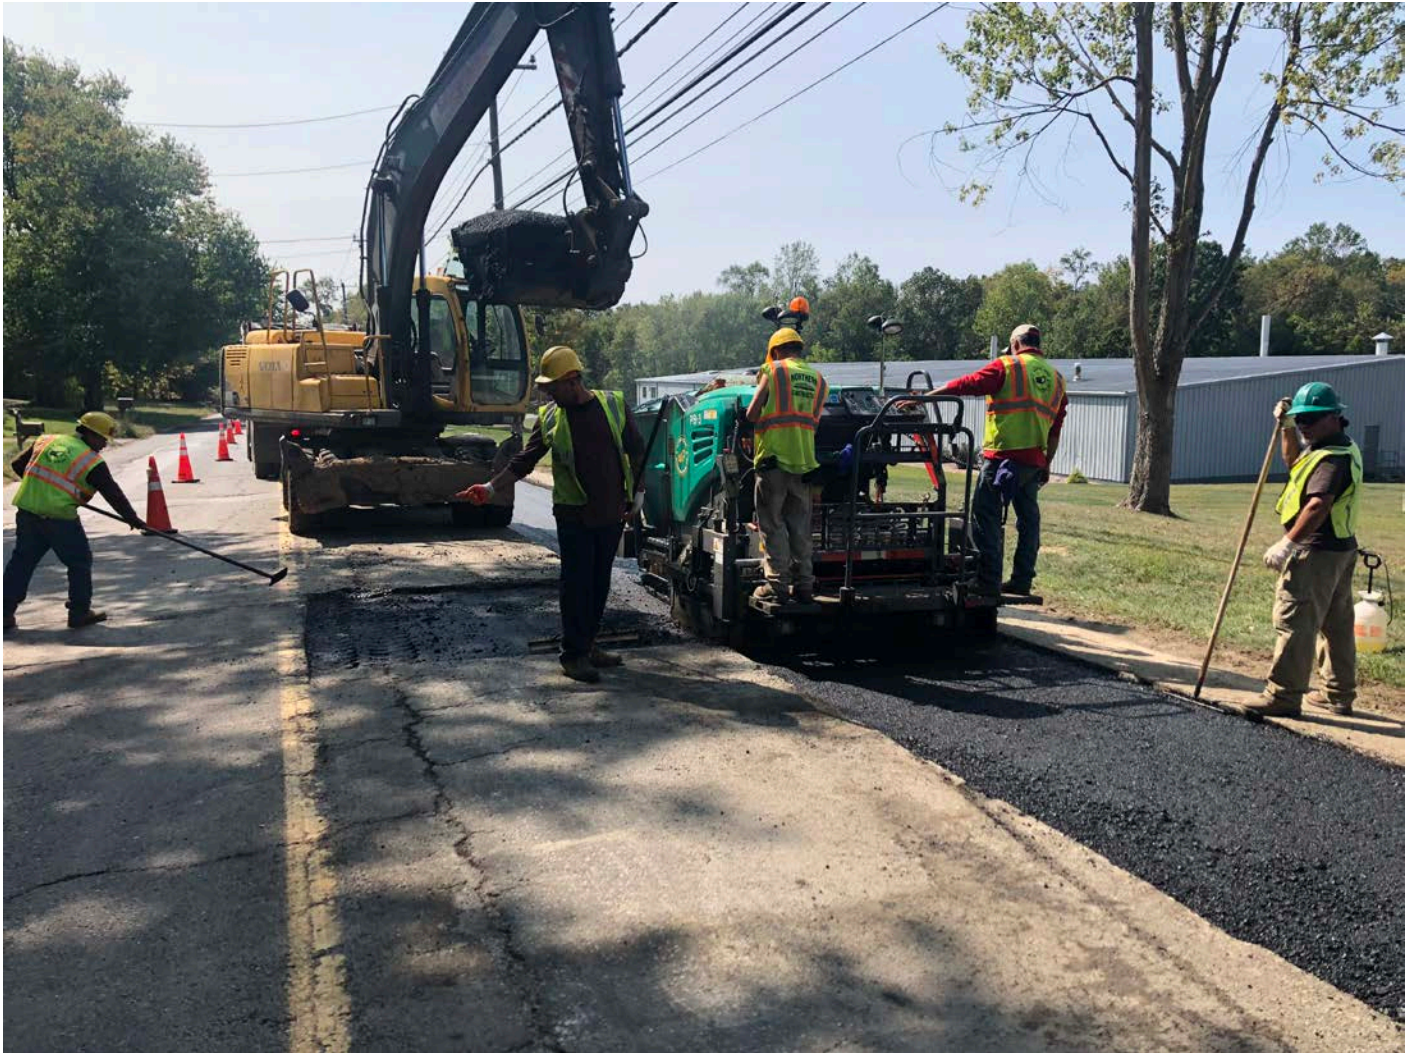
Picture 8: Ludlow applying the third 3" lift of asphalt at Station 177+00 as part of trench cutback paving activities on S. Main Street, Middletown. View to the south.

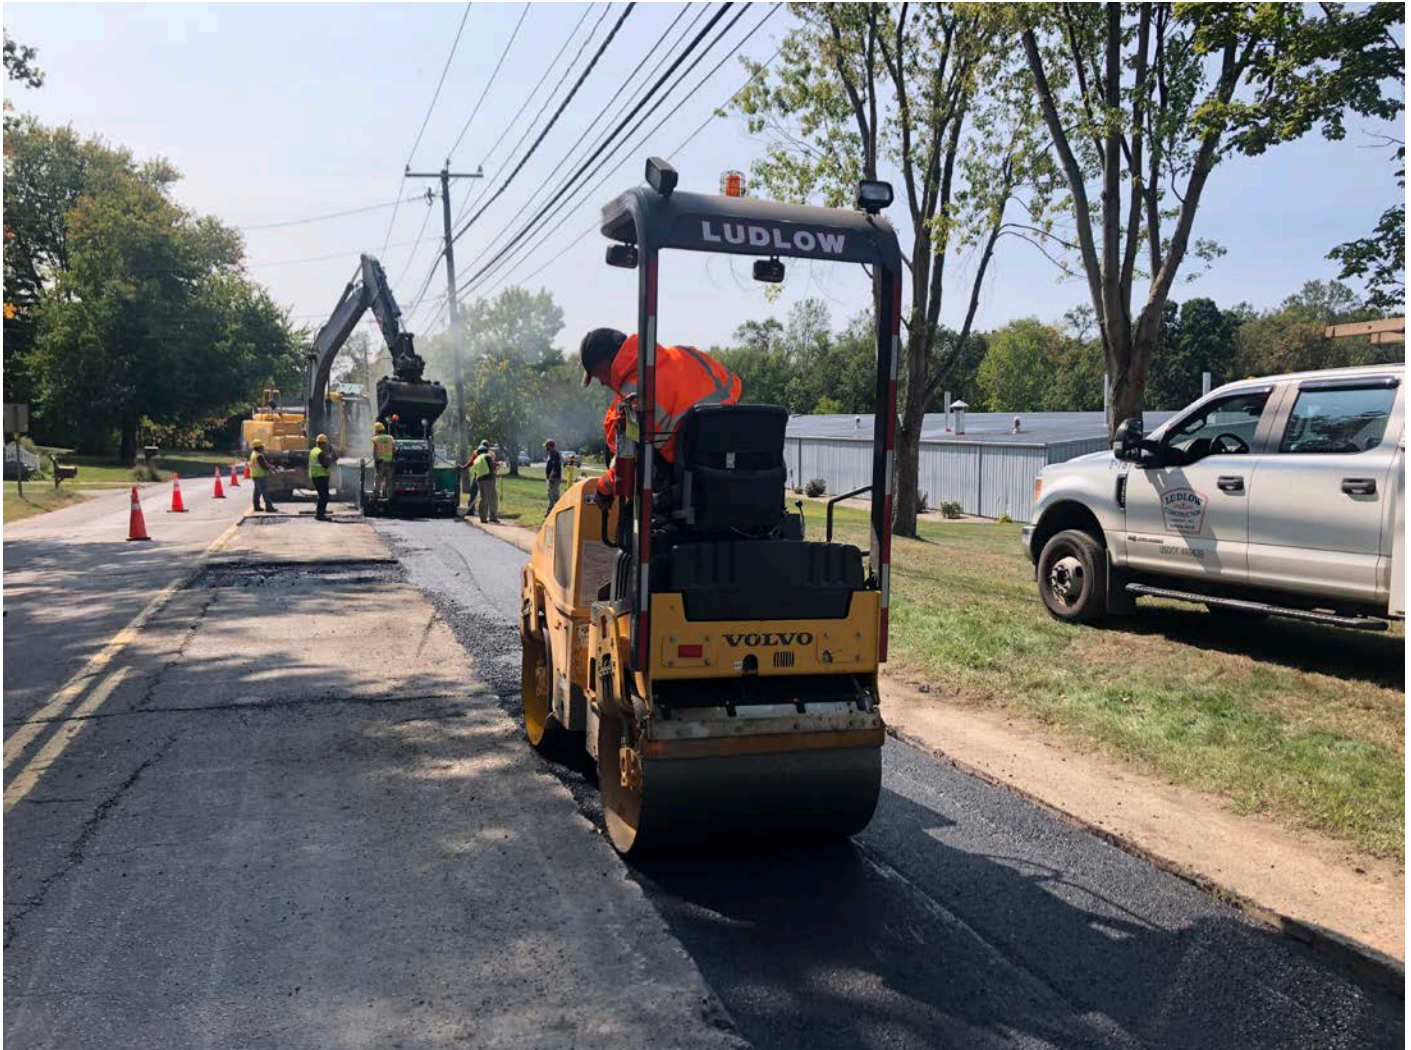
Picture 9: Ludlow compacting the third 3" lift of asphalt at Station 176+50 as part of trench cutback paving activities on S. Main Street, Middletown. View to the south.
