Daily Report

Project:	Durham Meadows Pipeline Installation	Date:	September 24, 2020
Location:	Main Street, Durham; S. Main Street and the Shared Access Driveway, Middletown	Day of Week:	Thursday
Project #:	AECOM: 6061487	Report No:	166
Contractor:	Ludlow Construction	Page:	1 of 13

Daily Activities – Water tank construction, Shared Access Driveway, Middletown

Daily Activities – Paving of trench cutbacks, S. Main Street, Middletown

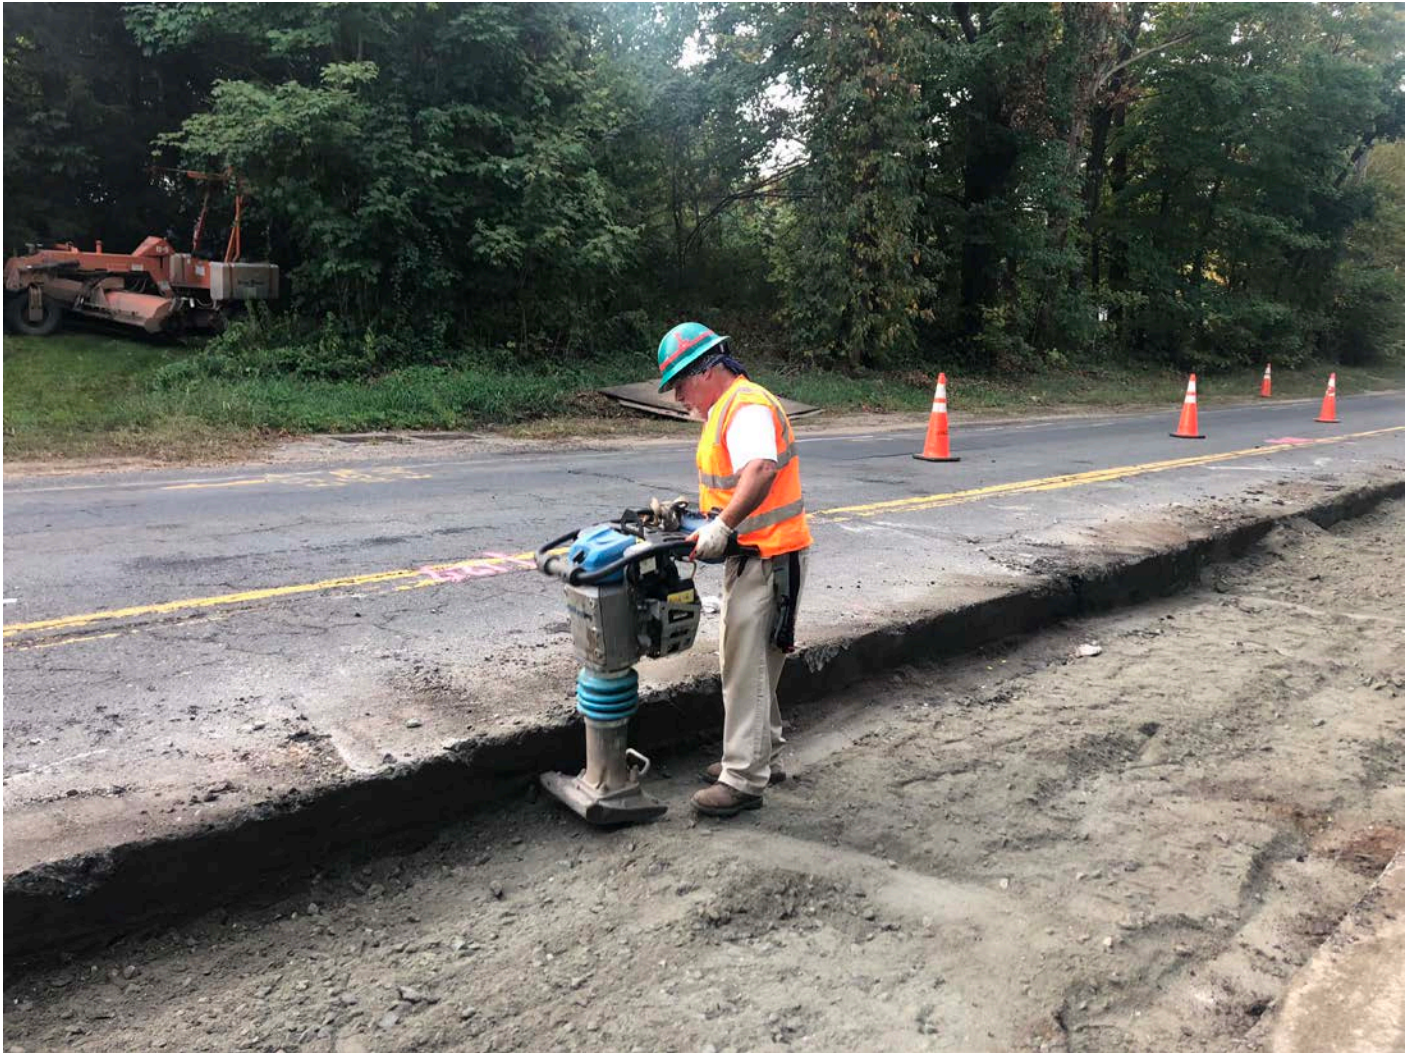
Picture 1: Ludlow using a jumping jack to compact 1.5" processed gravel along the edge of cut pavement as part of trench cutback paving activities on the southbound lane of S. Main Street, Middletown. View to the southeast.

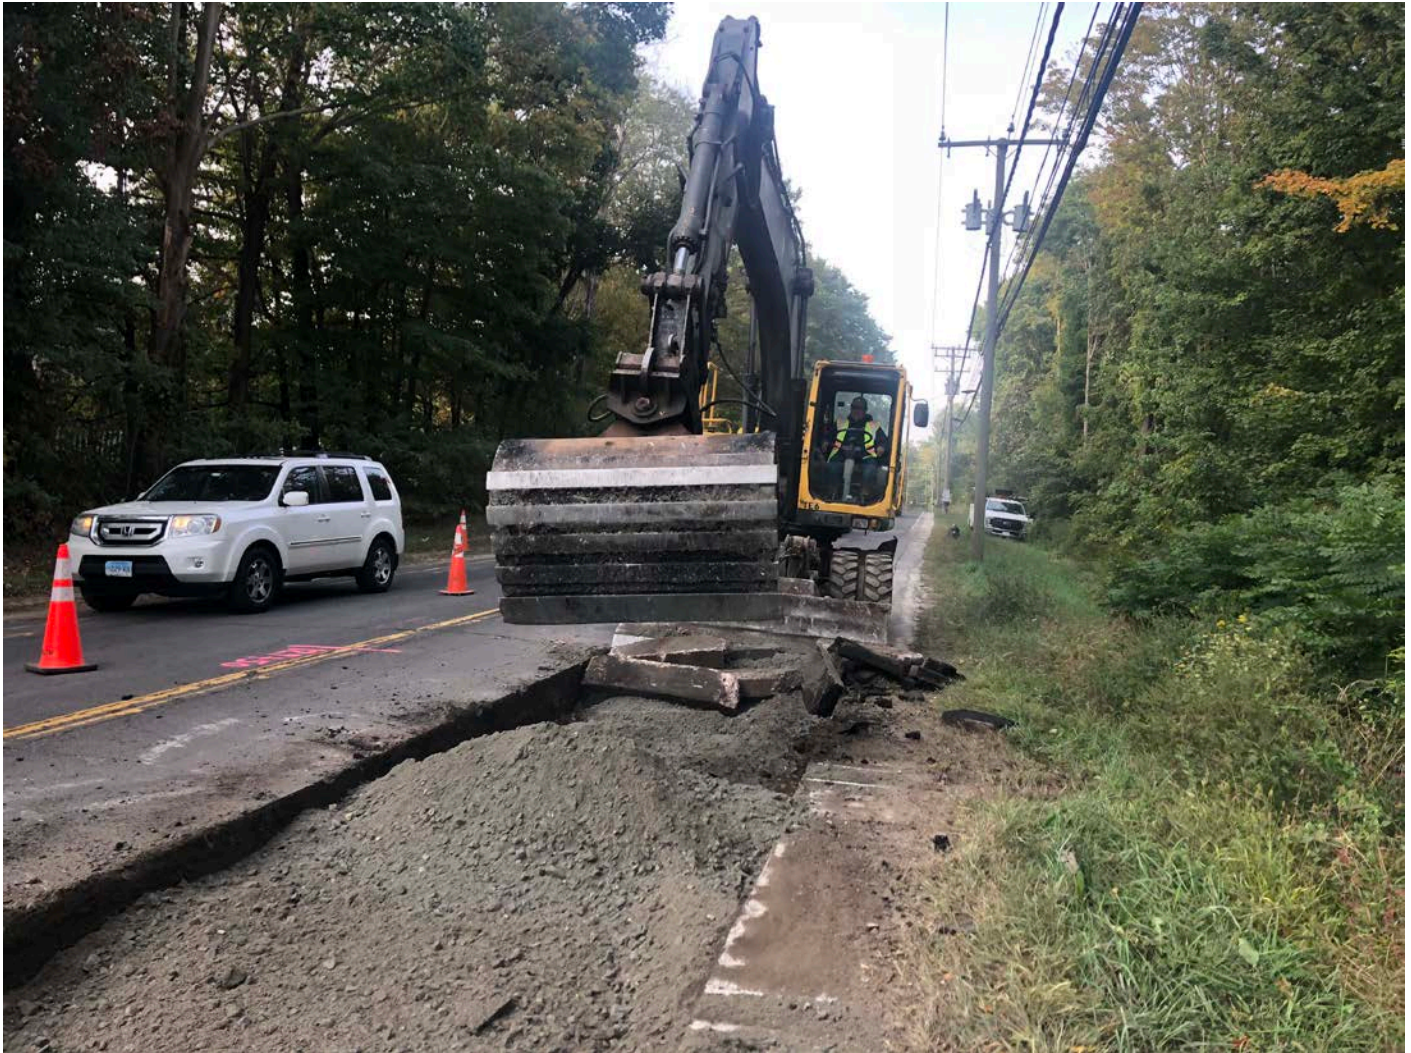
Picture 2: Ludlow removing pavement from Stations 126+00 to 130+00 as part of trench cutback paving activities on the southbound lane of S. Main Street, Middletown. View to the west.

0713: Ludlow has begun to strip pavement from the trench cutbacks starting at Station 126+00.

0801: Ludlow continues to strip pavement between Stations 126+00 and 130+00, moving south on the southbound lane of Main Street as part of trench cut back paving activities.

0930: Ludlow has all pavement stripped between Stations 126+00 and 130+00.

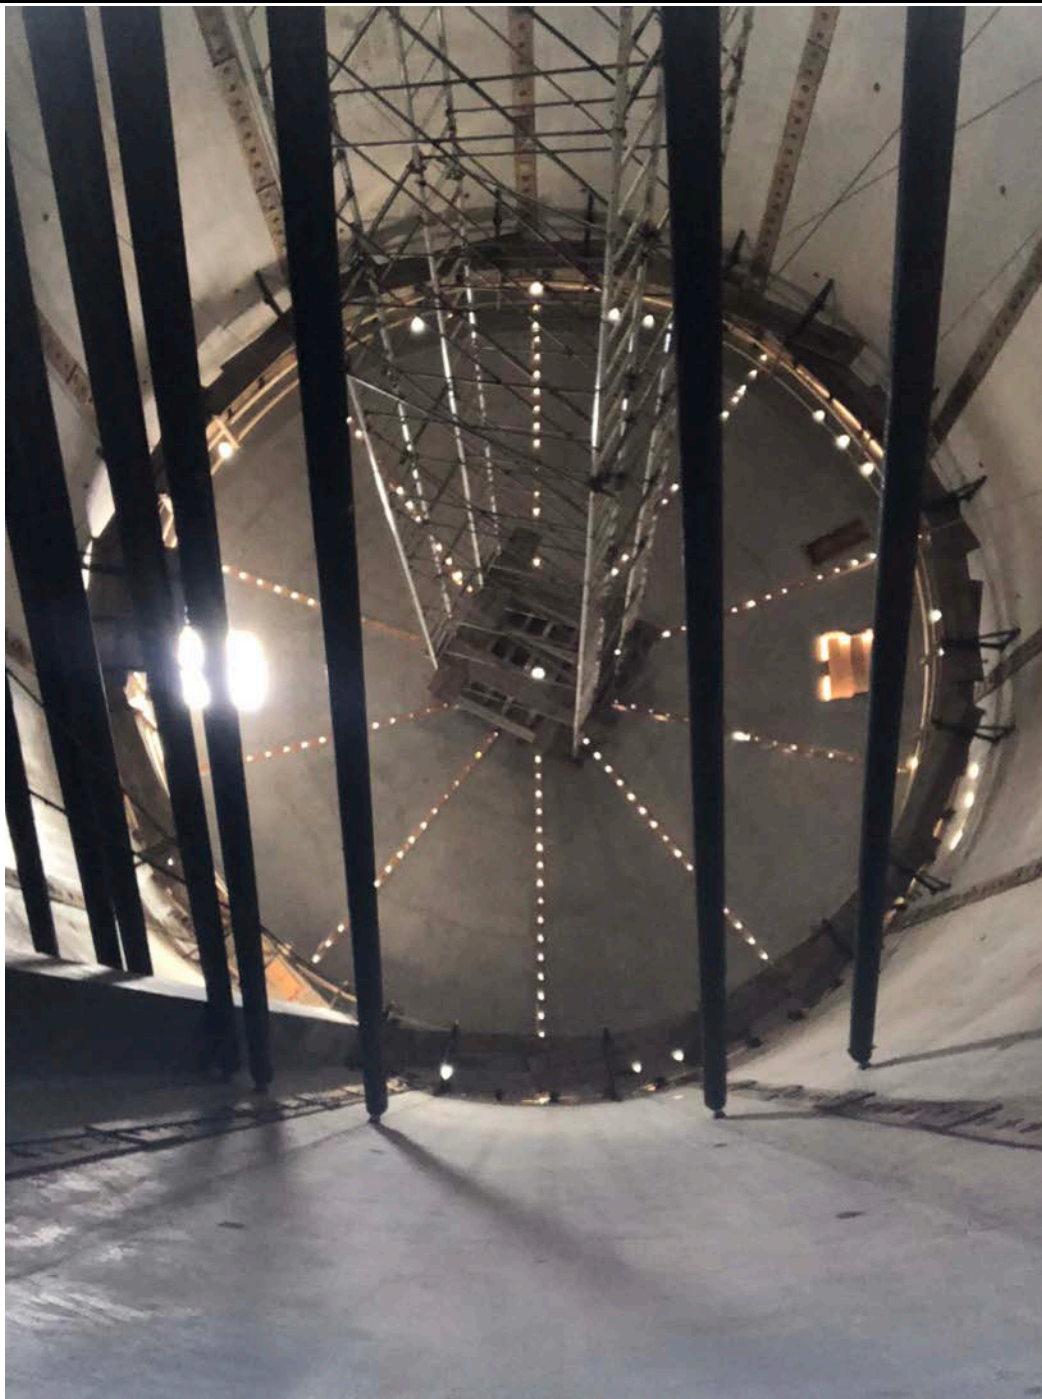
Picture 3: The water tank roof, viewed from the inside looking up. Water tank work zone, east of the Shared Access Driveway, Middletown.

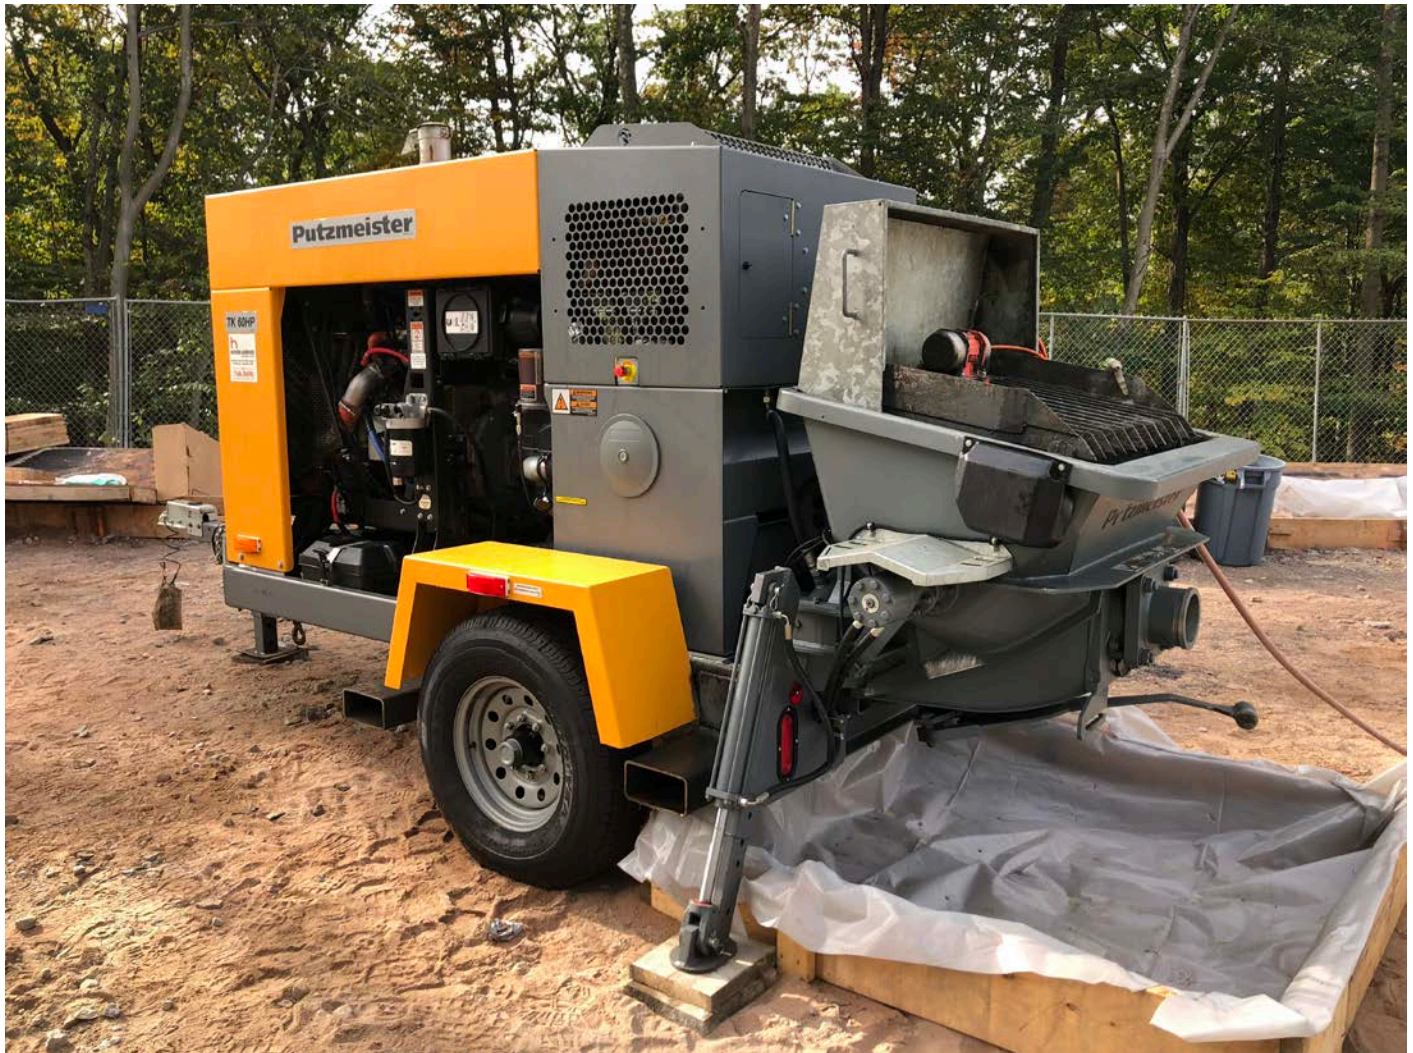
Picture 5: Pump trailer mobilized to the water tank work zone east of the Shared Access Driveway, Middletown in preparation of pumping grout into slot panels. View to the south.

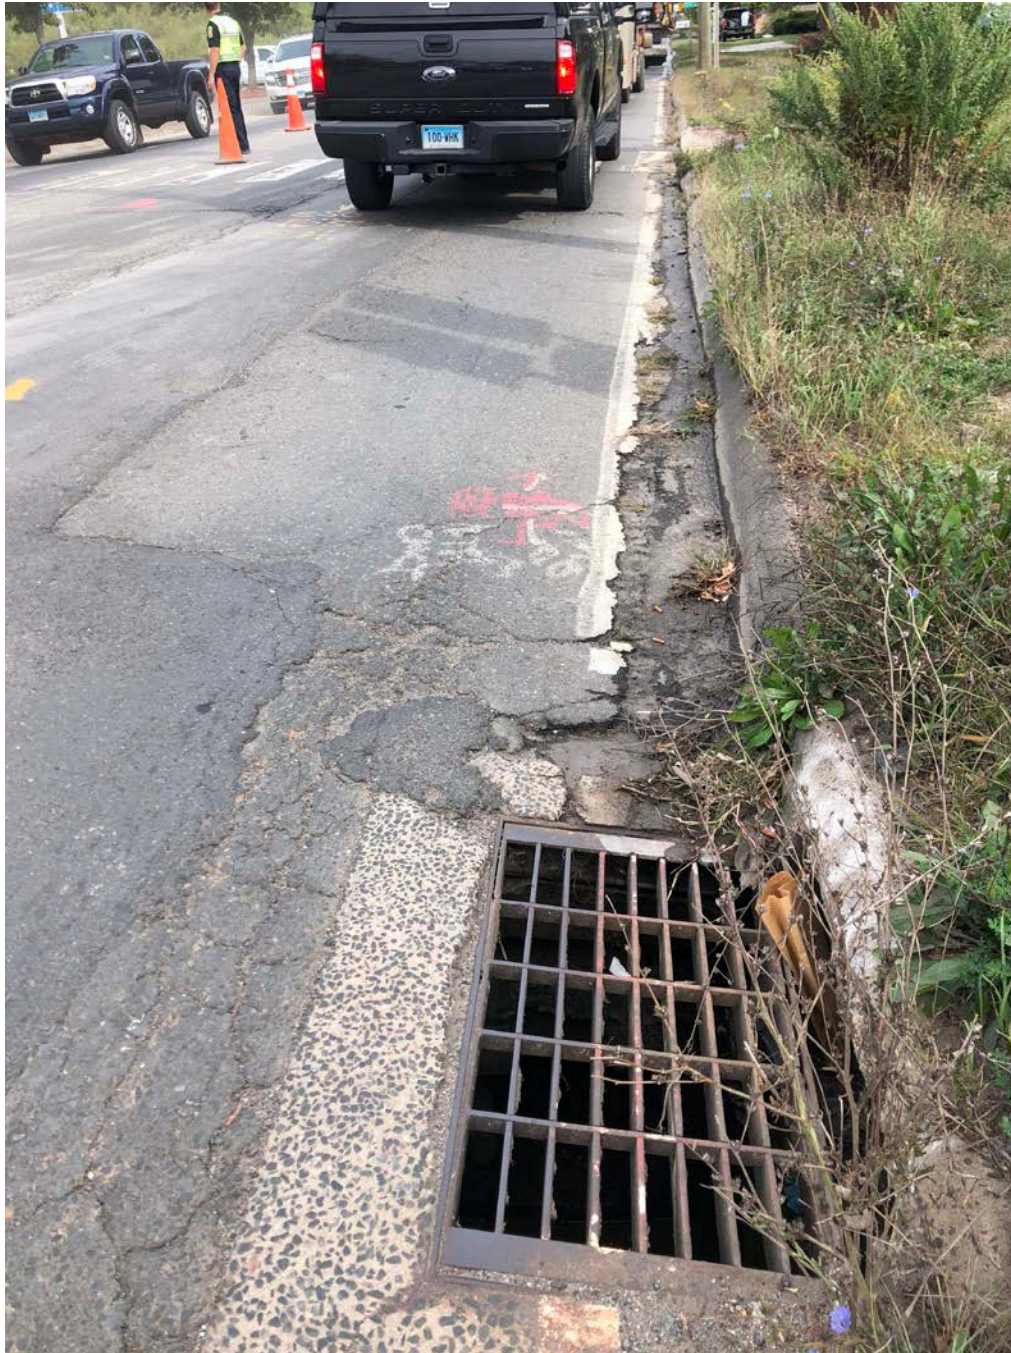
1032: Silt socks have been previously placed in the catch basins at Station 165+50 on both the east and west sides of the road. No silt sock has been installed in the catch basin located on east side of Main Street, Durham at Station 164+30, which is directly downgradient of saw cutting activities currently being performed on northbound lane. AECOM notified the USACE field engineer that Ludlow was asked by AECOM to address this issue.

Picture 6: Unprotected catch basin at Station 164+30 located downgradient of pavement saw cutting activities. Ludlow was notified of this condition and placed a silt sock into the catch basin. View to the north.

1053: Ludlow has placed a silt sock on the catch basin located at Station 164+30 on Main Street, Durham.

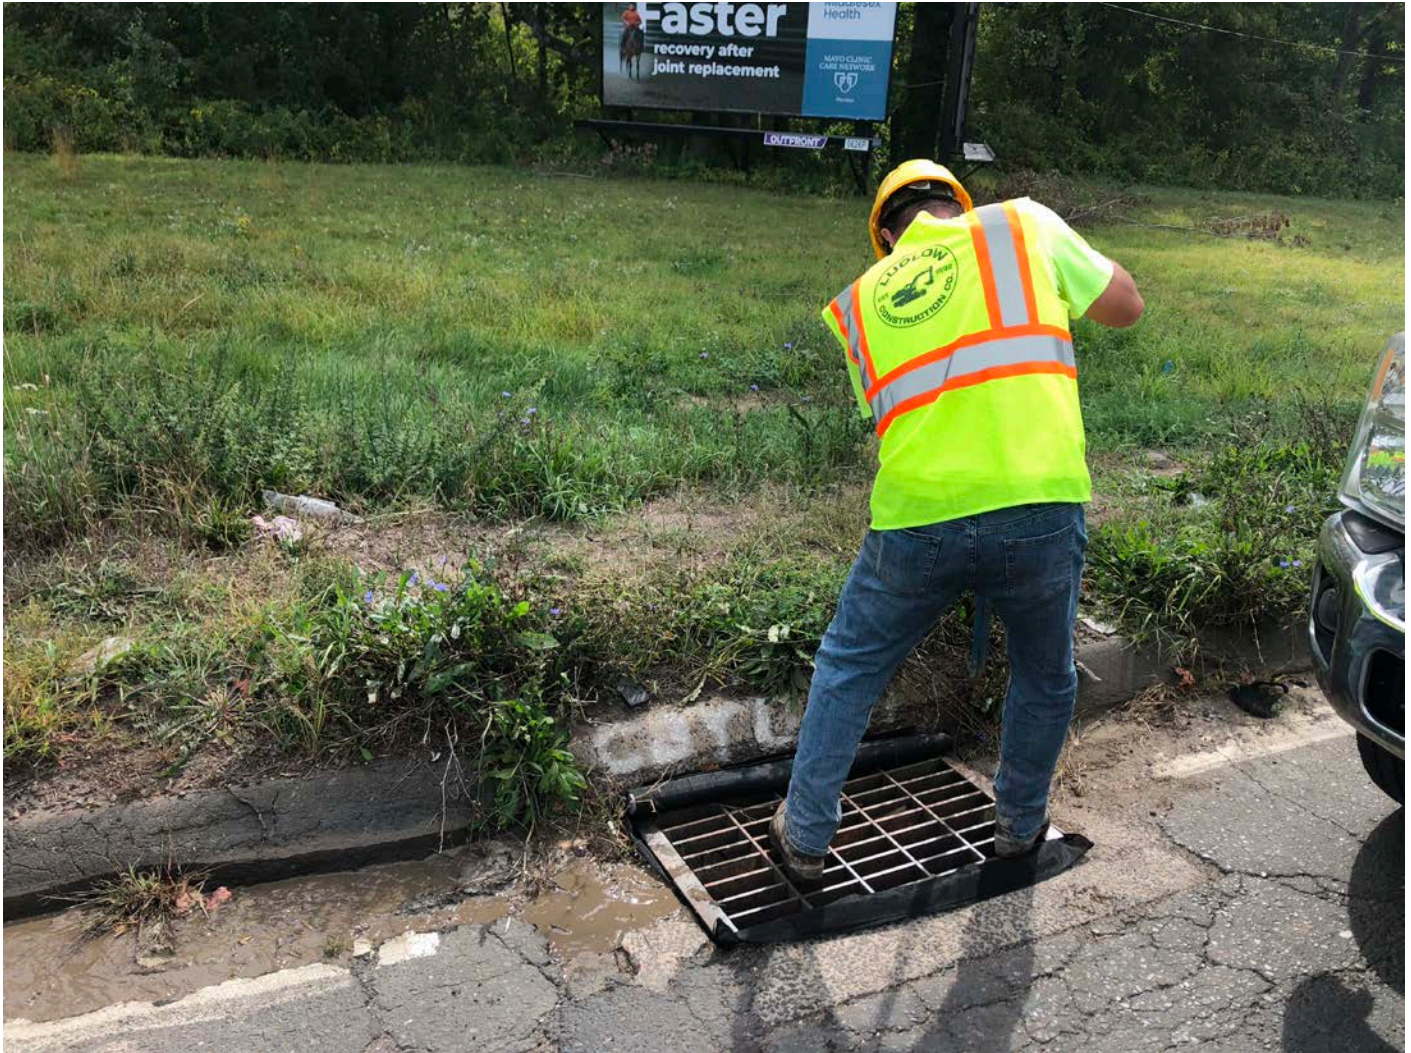
Picture 7: Ludlow installing a silt sock on the catch basin located at Station 164+30 on the northbound lane of Main Street, Durham. View to the north.

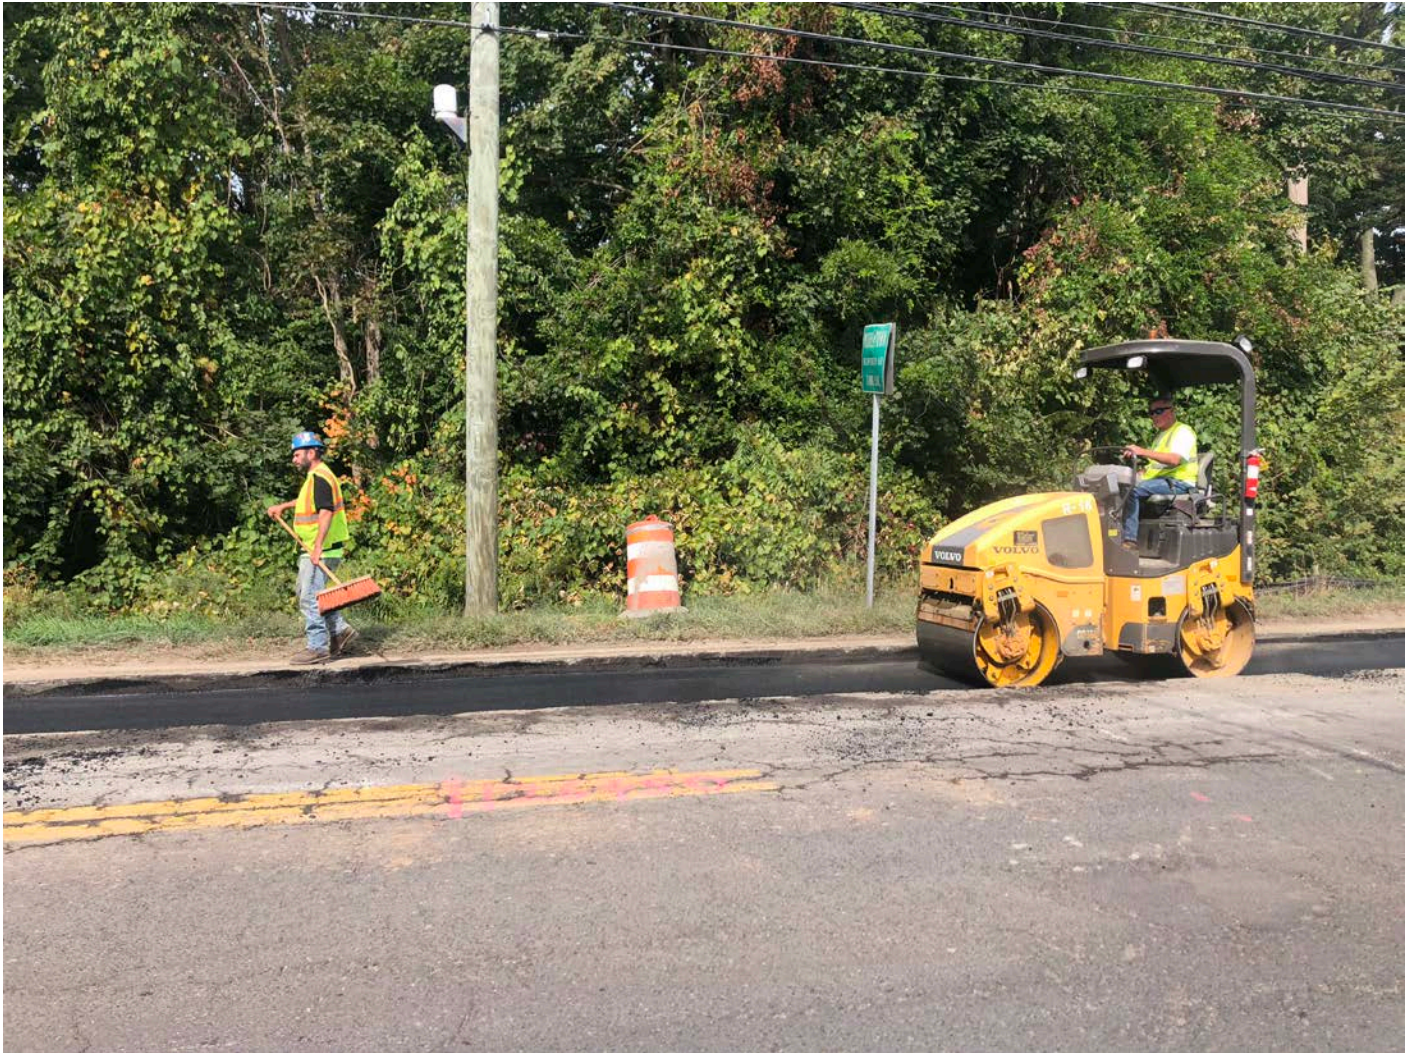
Picture 8: Ludlow compacting the first of three 3" lifts of asphalt between Stations 126+00 and 130+00 as part of trench cutback paving activities on the southbound lane of S. Main Street, Middletown. View to the west.

1109: Ludlow is placing tack coat along the edges of cut pavement and have started placing and compacting the first of three 3" lifts of asphalt. JTC is present to collect compaction data from the newly placed asphalt. Ludlow has paved between Stations 126+00 and 127+50 so far.

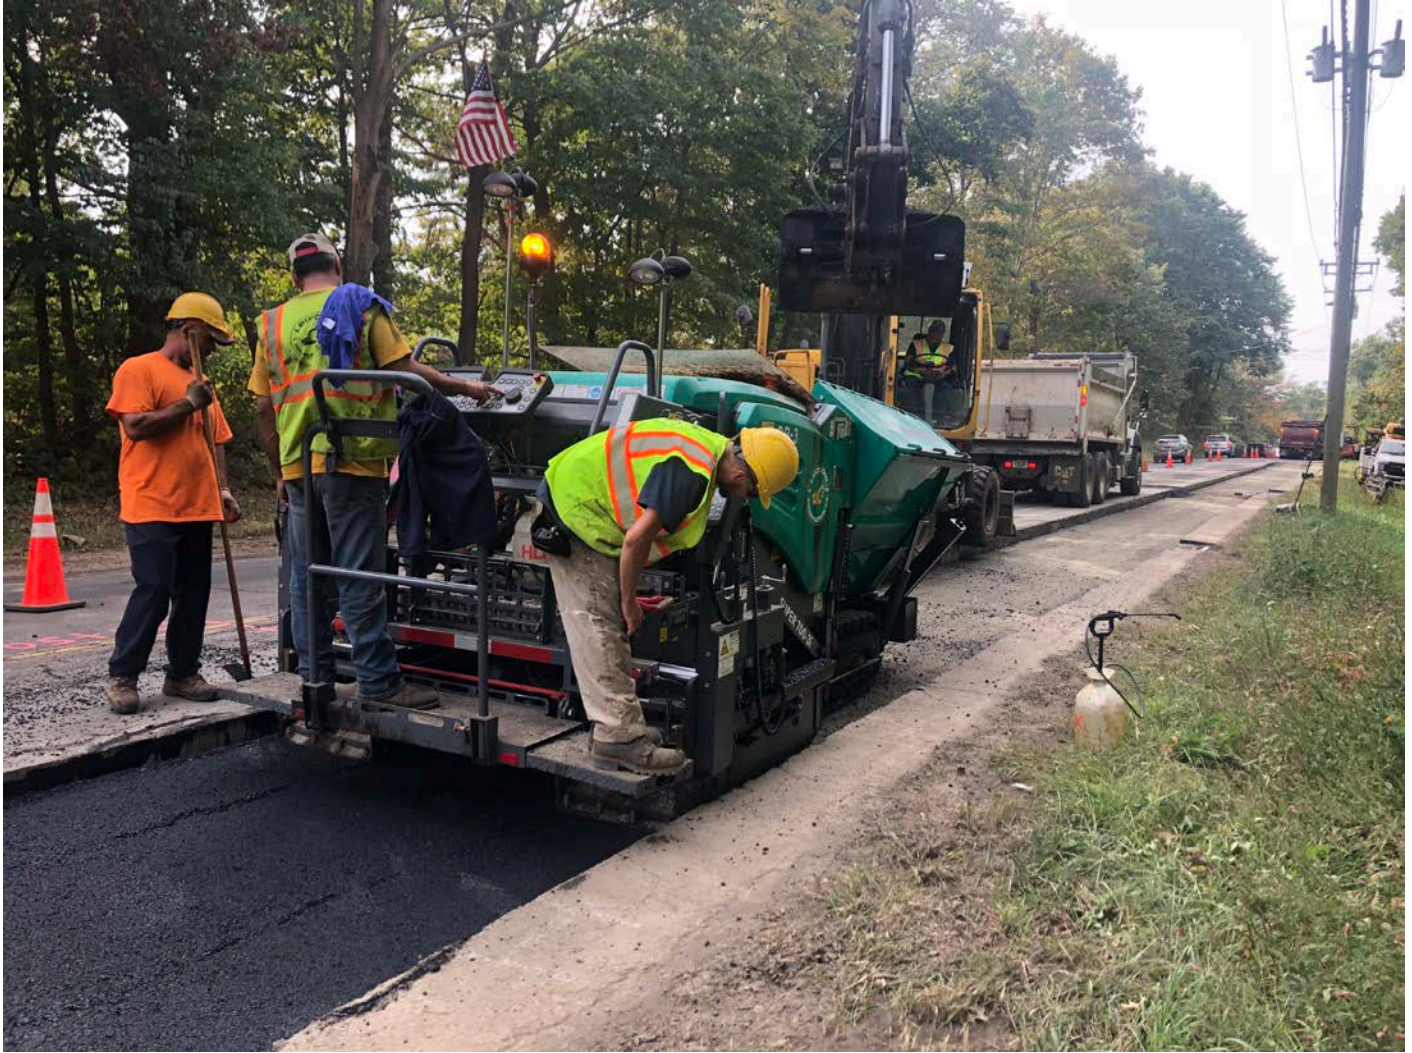
Picture 9: Ludlow placing the first of three 3" lifts of asphalt between Stations 126+00 and 130+00 as part of trench cutback paving activities on the southbound lane of S. Main Street, Middletown. View to the south.

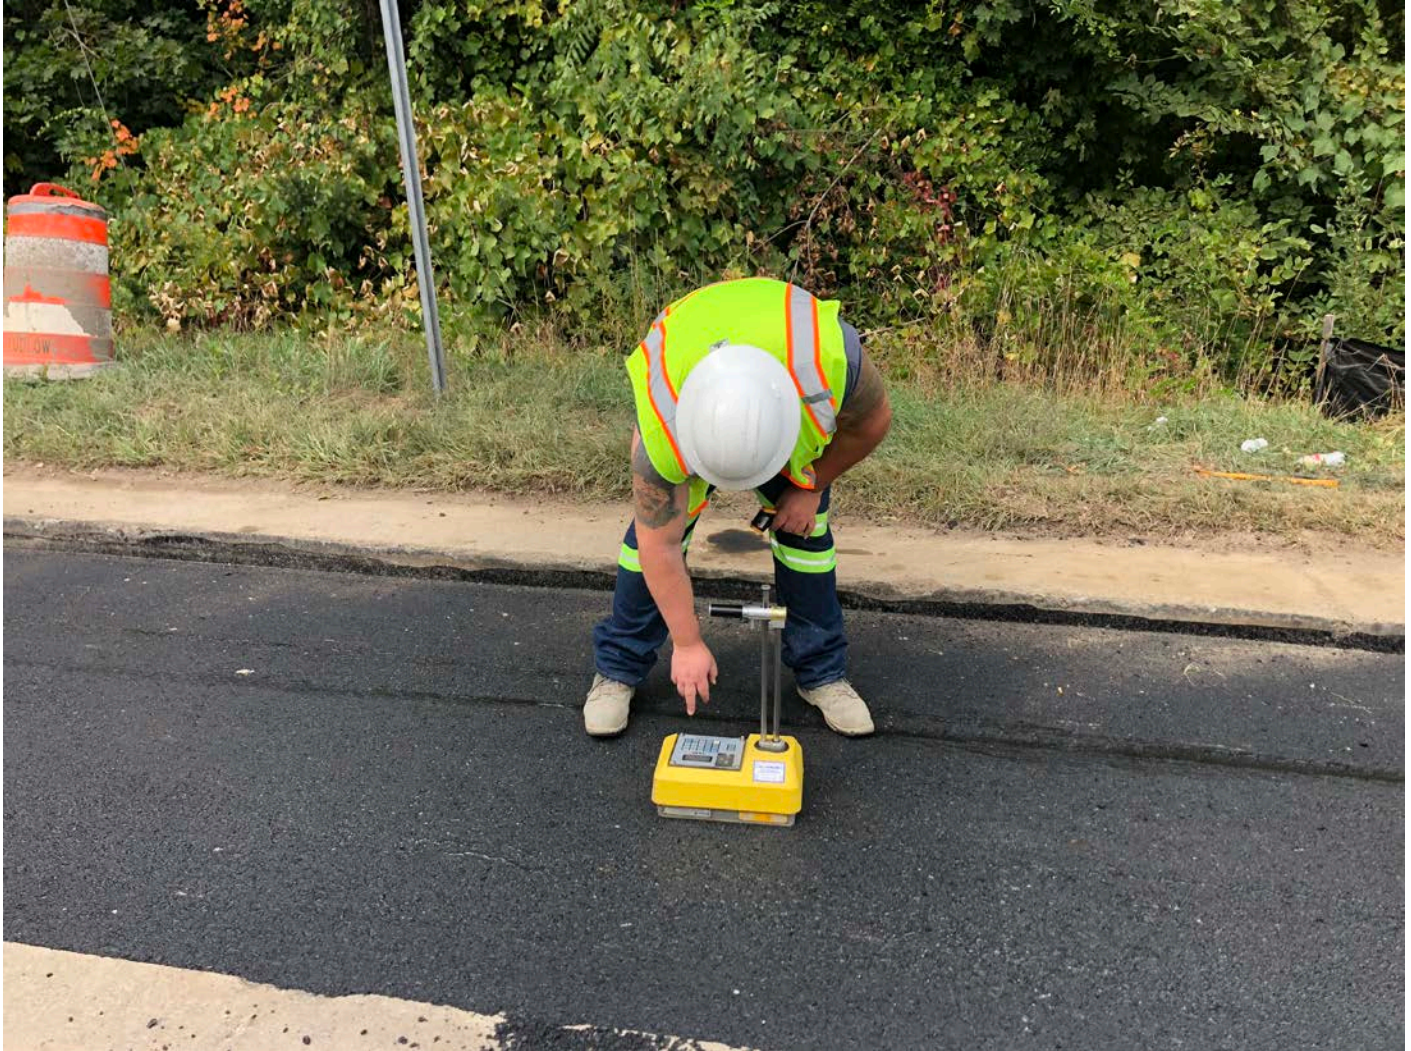
Picture 10: JTC collecting compaction data from the second of three 3" lifts of asphalt between Stations 126+00 and 130+00 on the southbound lane of S. Main Street, Middletown. View to the west.

1149: JTC collected compaction data from the first lift of asphalt placed between Stations 126+00 and 130+00.
