Daily Report

Project:	Durham Meadows Pipeline Installation	Date:	September 25, 2020
Location:	Main Street, Durham; S. Main Street and the Shared Access Driveway, Middletown	Day of Week:	Friday
Project #:	AECOM: 6061487	Report No:	167
Contractor:	Ludlow Construction	Page:	1 of 13

Daily Activities – Water tank construction, Shared Access Driveway, Middletown

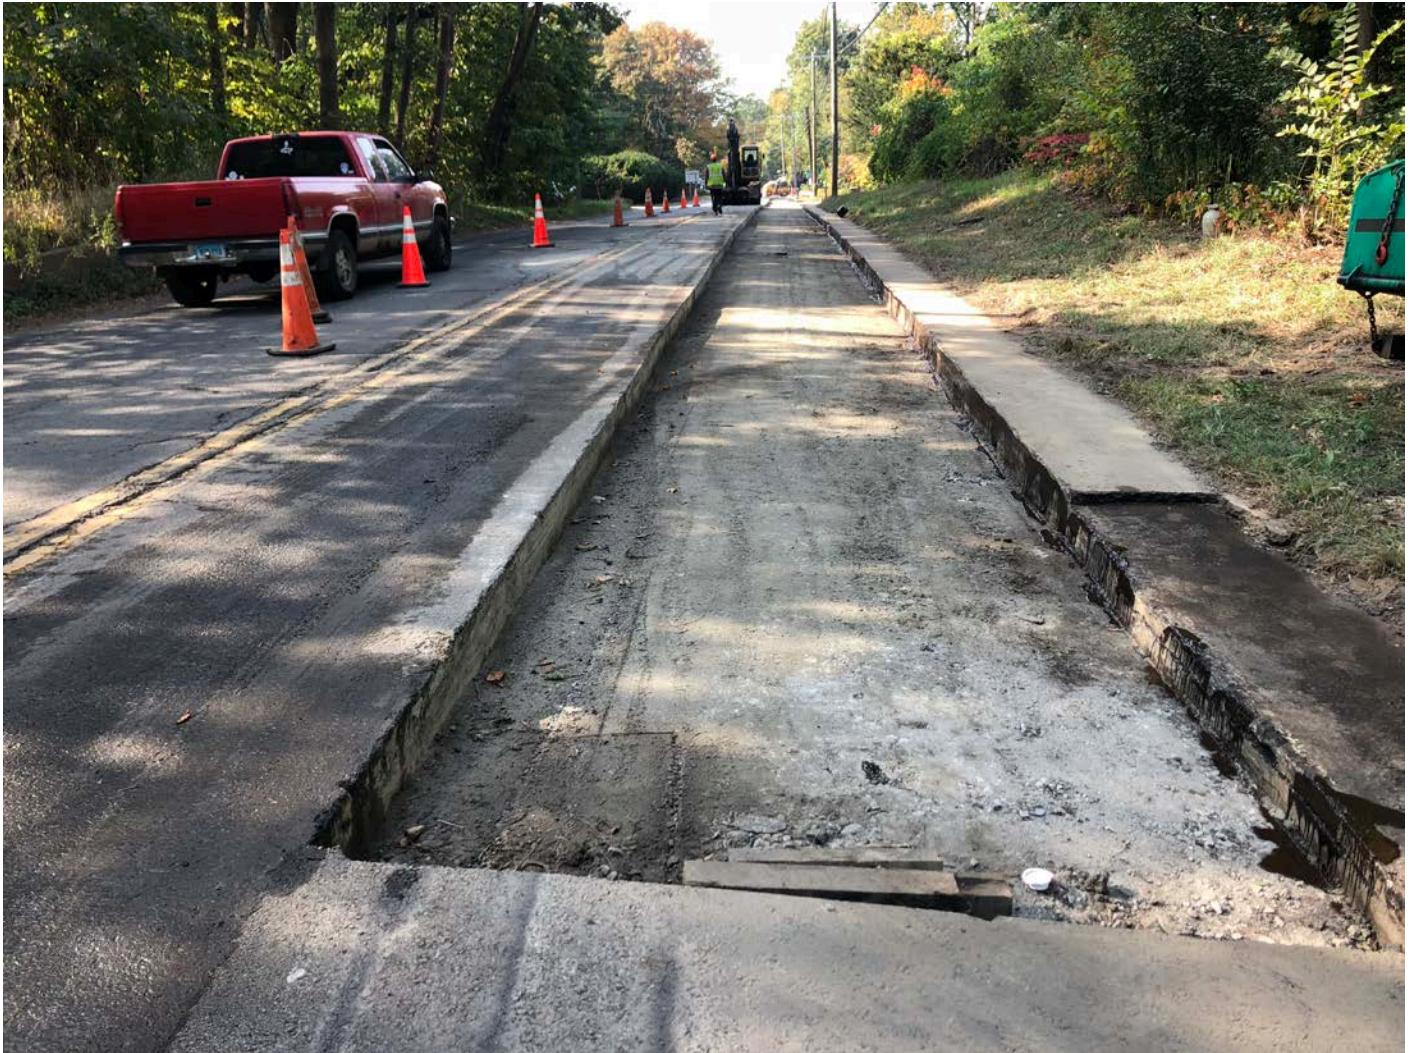
Picture 1: Ludlow removing pavement from the trench cutback zone on the southbound lane of S. Main Street, Middletown where they will pave later today. View to the south.

0710: Ludlow has begun to strip pavement from the trench cutbacks starting at Station 130+00.

0754: Ludlow continues to strip pavement between Stations 130+00 and 134+00, moving south on the southbound lane of Main Street as part of trench cut back paving activities.

0940: Ludlow has removed all pavement between Stations 130+00 and 134+00 on the trench cutback work zone on S. Main Street, Middletown.

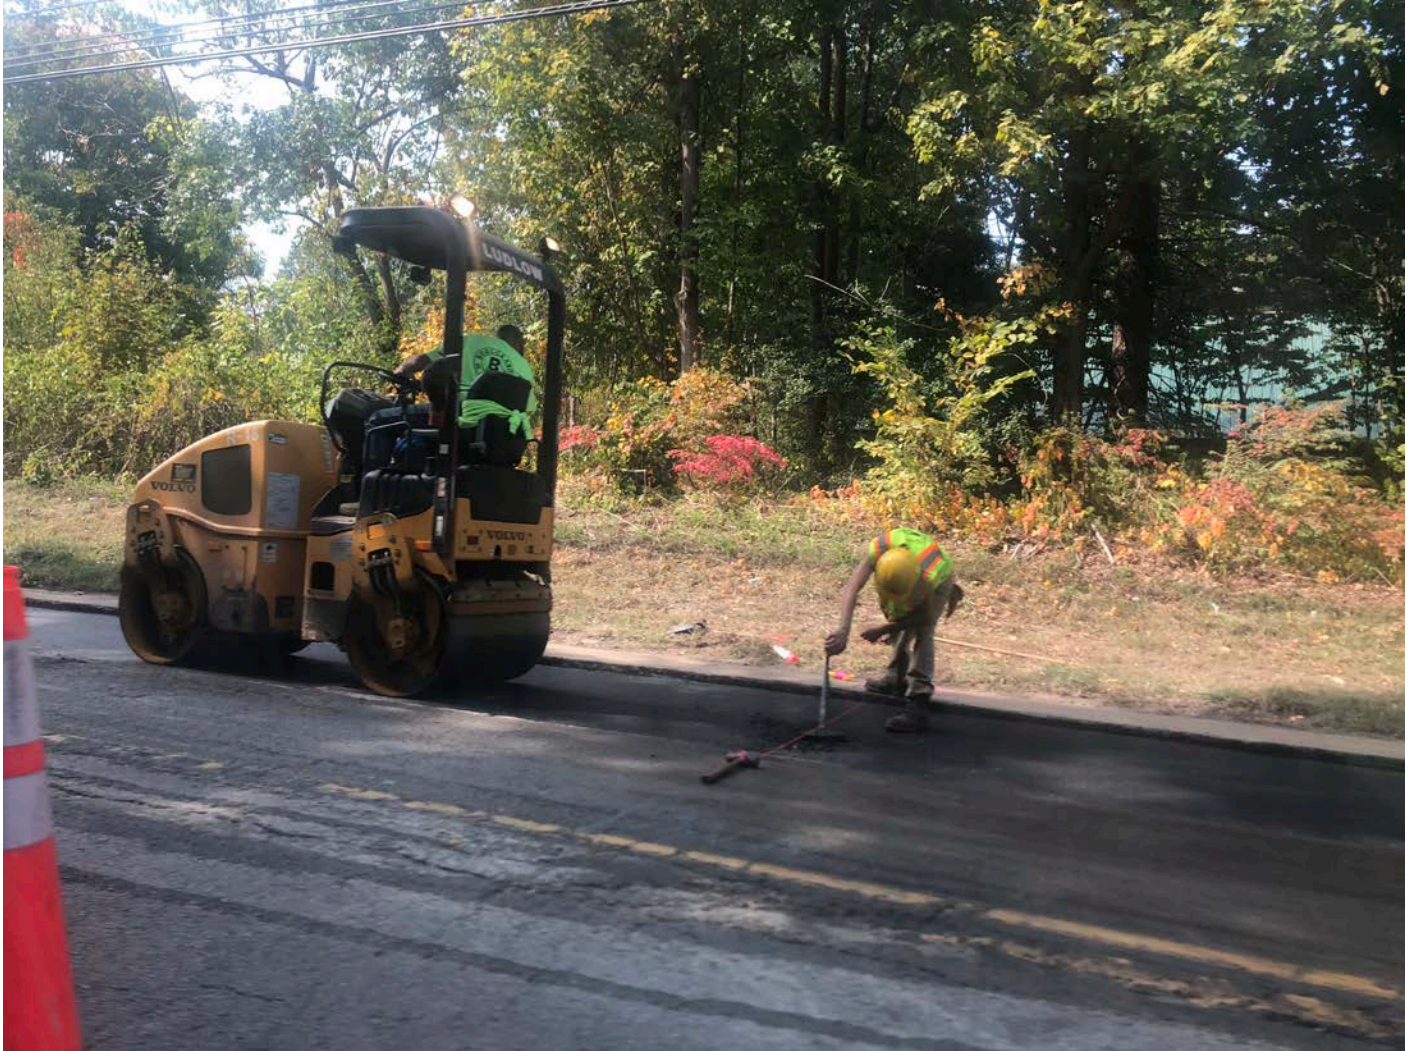
Picture 2: Ludlow raising a road box as they compact pavement between Stations 130+00 and 134+00 on the southbound lane of S. Main Street, Middletown. View to the southwest.

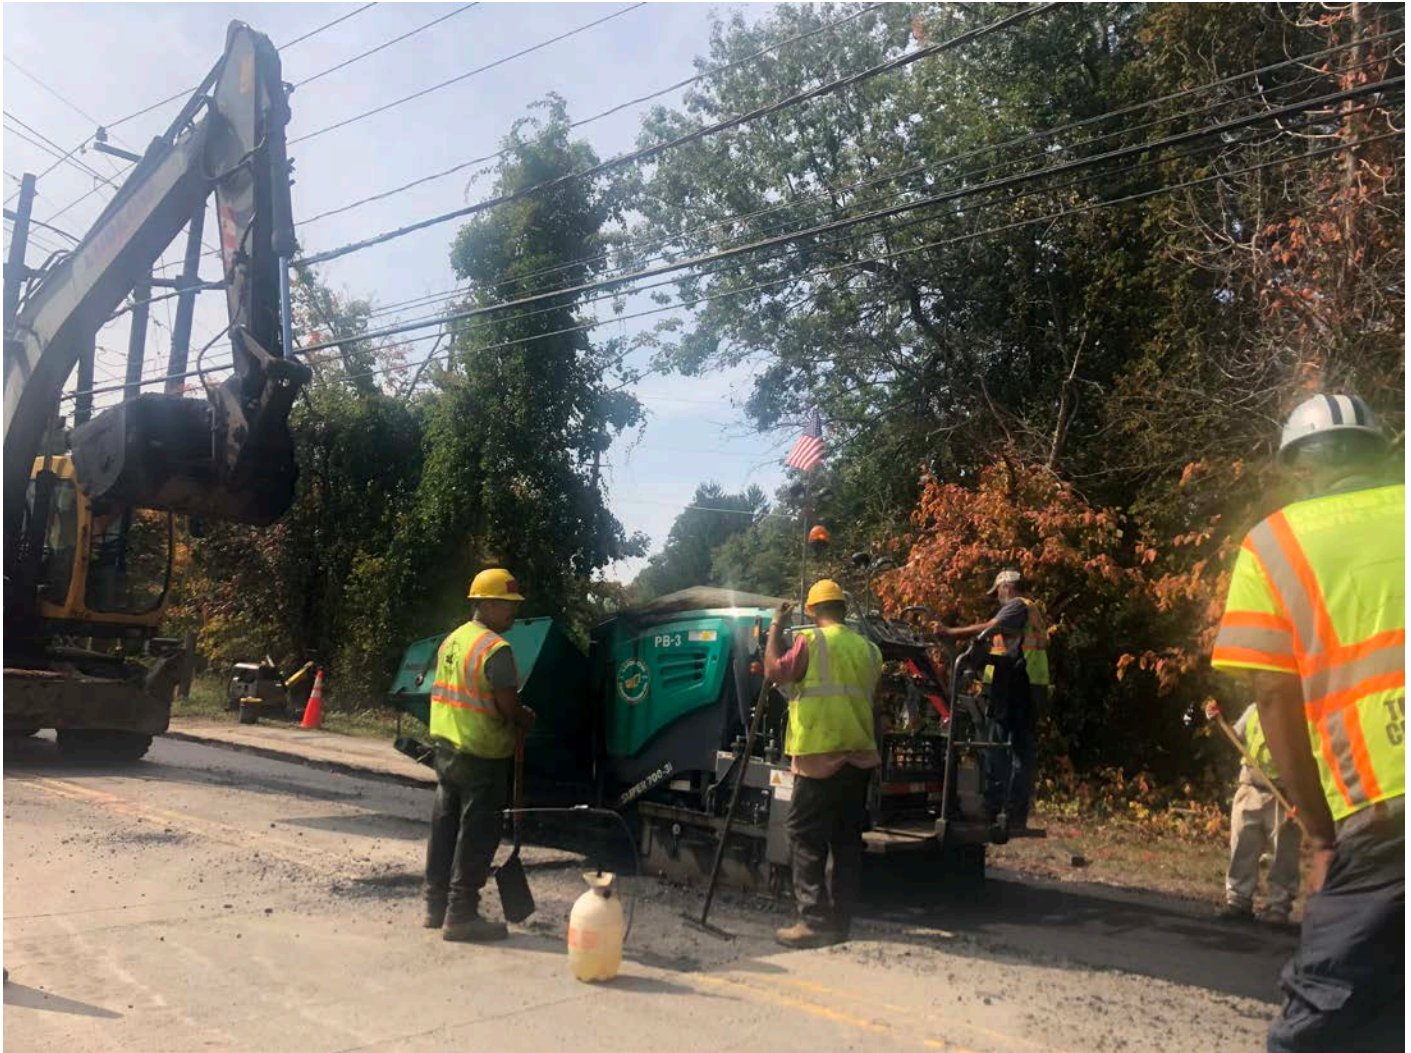
Picture 3: Ludlow placing the third of three 3" lifts of asphalt between Stations 130+00 and 134+00 as part of trench cutback paving activities on the southbound lane of S. Main Street, Middletown. View to the southwest.

1348: Ludlow is placing and compacting the third of three 3" lifts of asphalt between Stations 130+00 and 134+00.

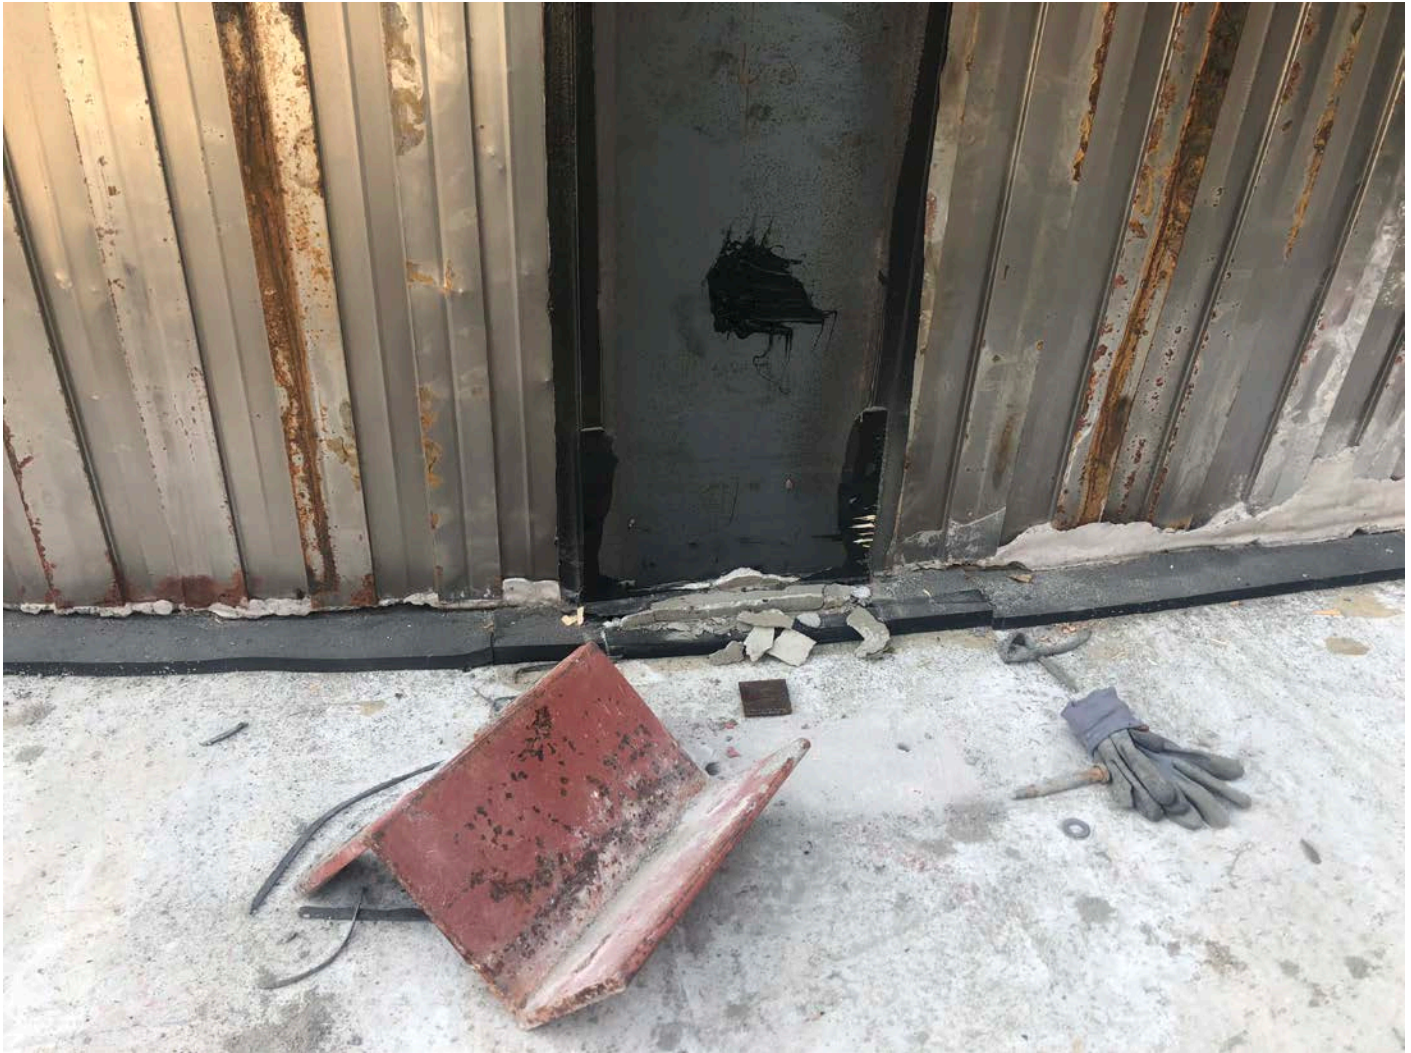
Picture 4: Brace removed from the toe of a slot panel on the water tank a day after grout was poured. Water tank work zone, east of the Shared Access Driveway, Middletown.

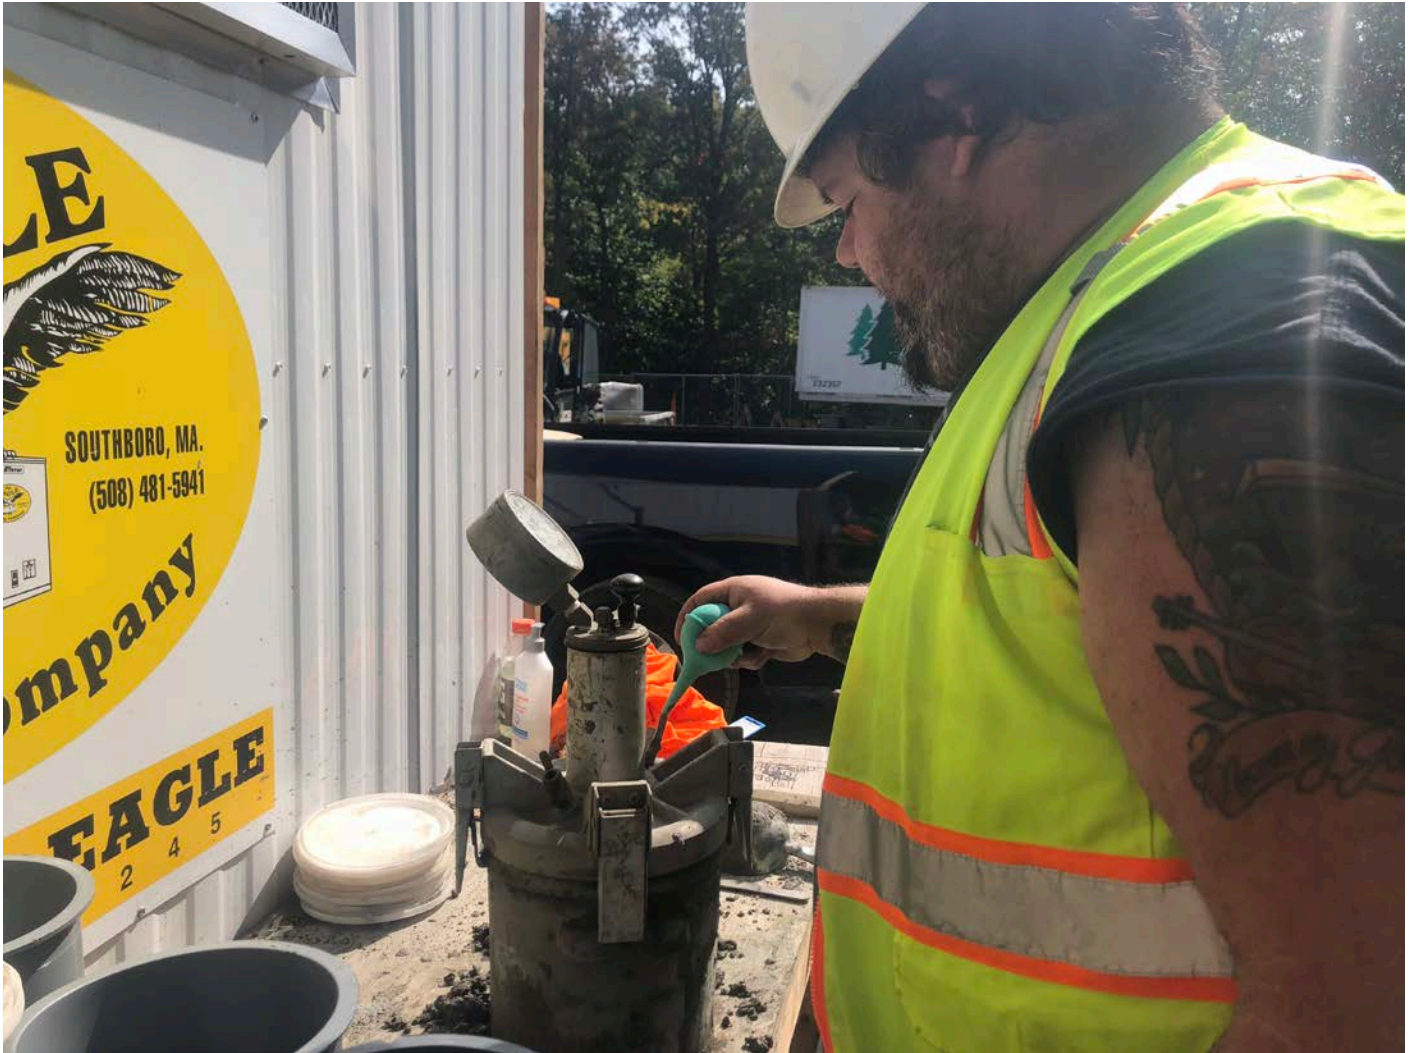
Picture 5: JTC performing air entrainment test on concrete brought to the site to be placed on top of the water tank today. Water tank work zone east of the Shared Access Driveway, Middletown.

1322: JTC collects field and laboratory samples of concrete brought to the water tank work zone for placement on the tank dome.

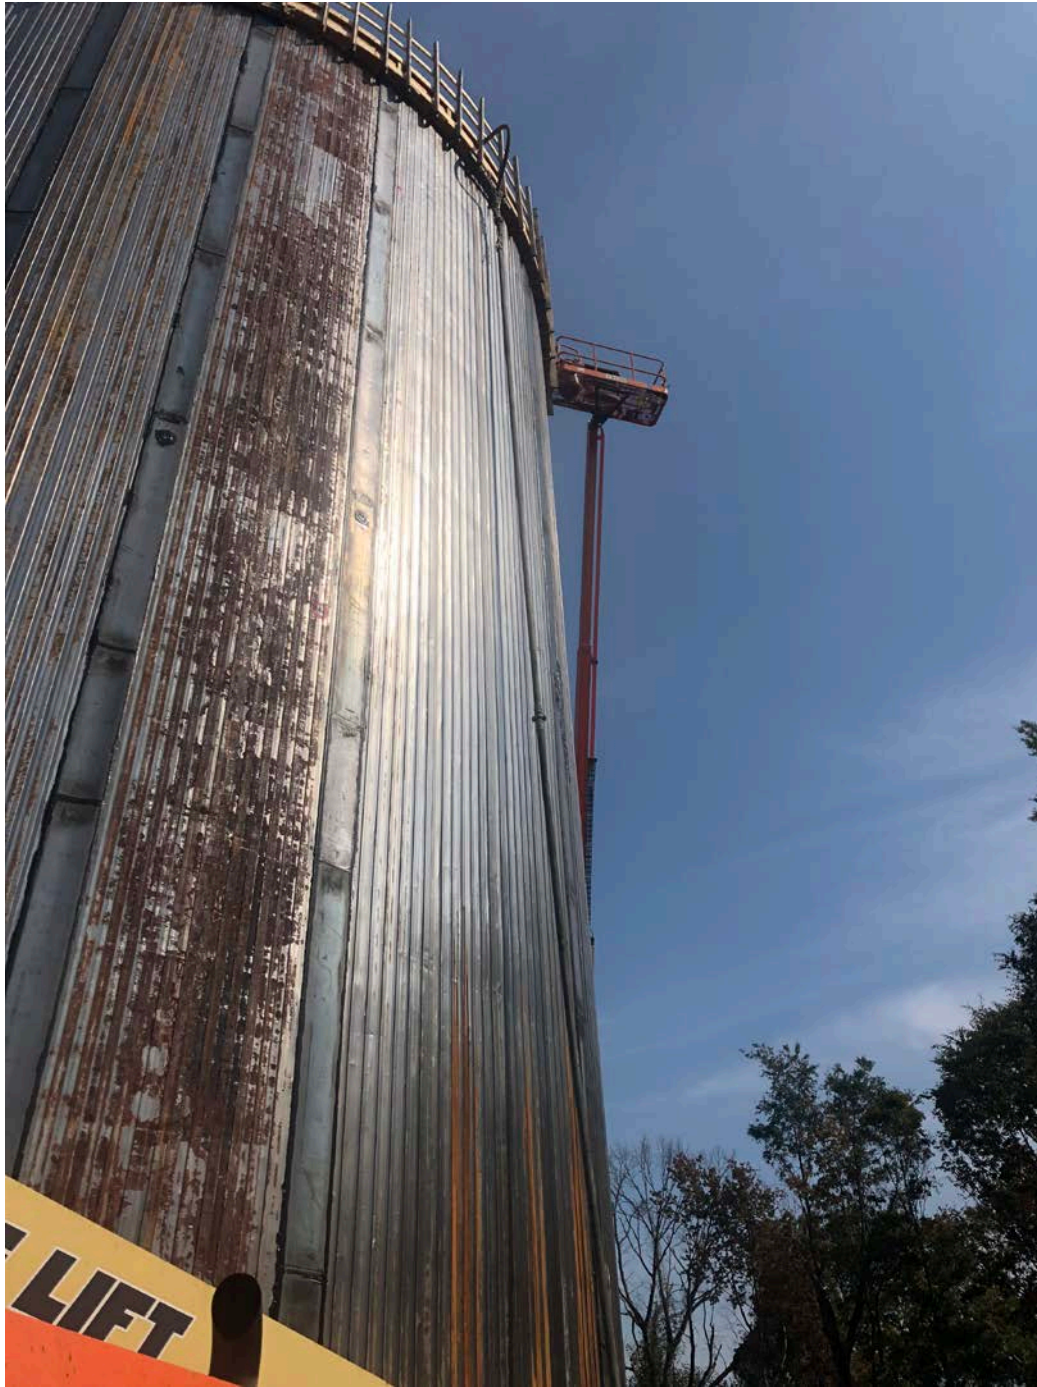
Picture 6: Hose run up the side of the water tank that was used in pumping concrete to top of the water tank today. Water tank work zone east of the Shared Access Driveway, Middletown. View to the southeast.

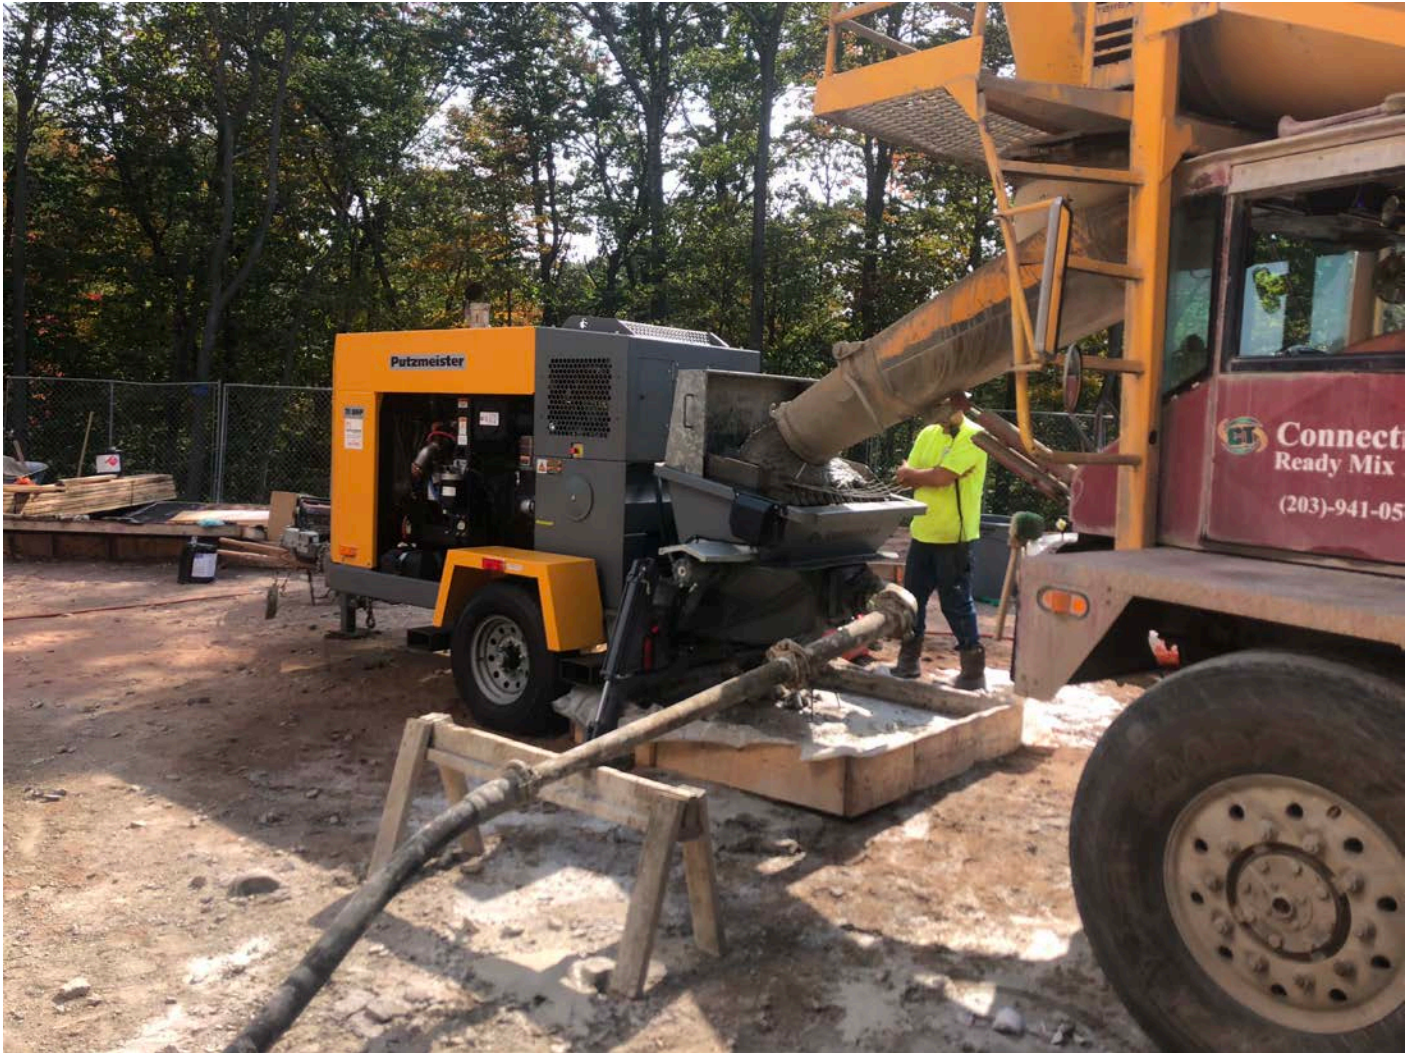
Picture 7: CT Ready Mix pumping concrete into a pump trailer that, in turn, is pumping concrete to the top of the water tower for a dome pour. Water tank work zone east of the Shared Access Driveway, Middletown. View to the south.

DN Tanks poured Mix C (4000 PSI) concrete on top of the water tank dome.

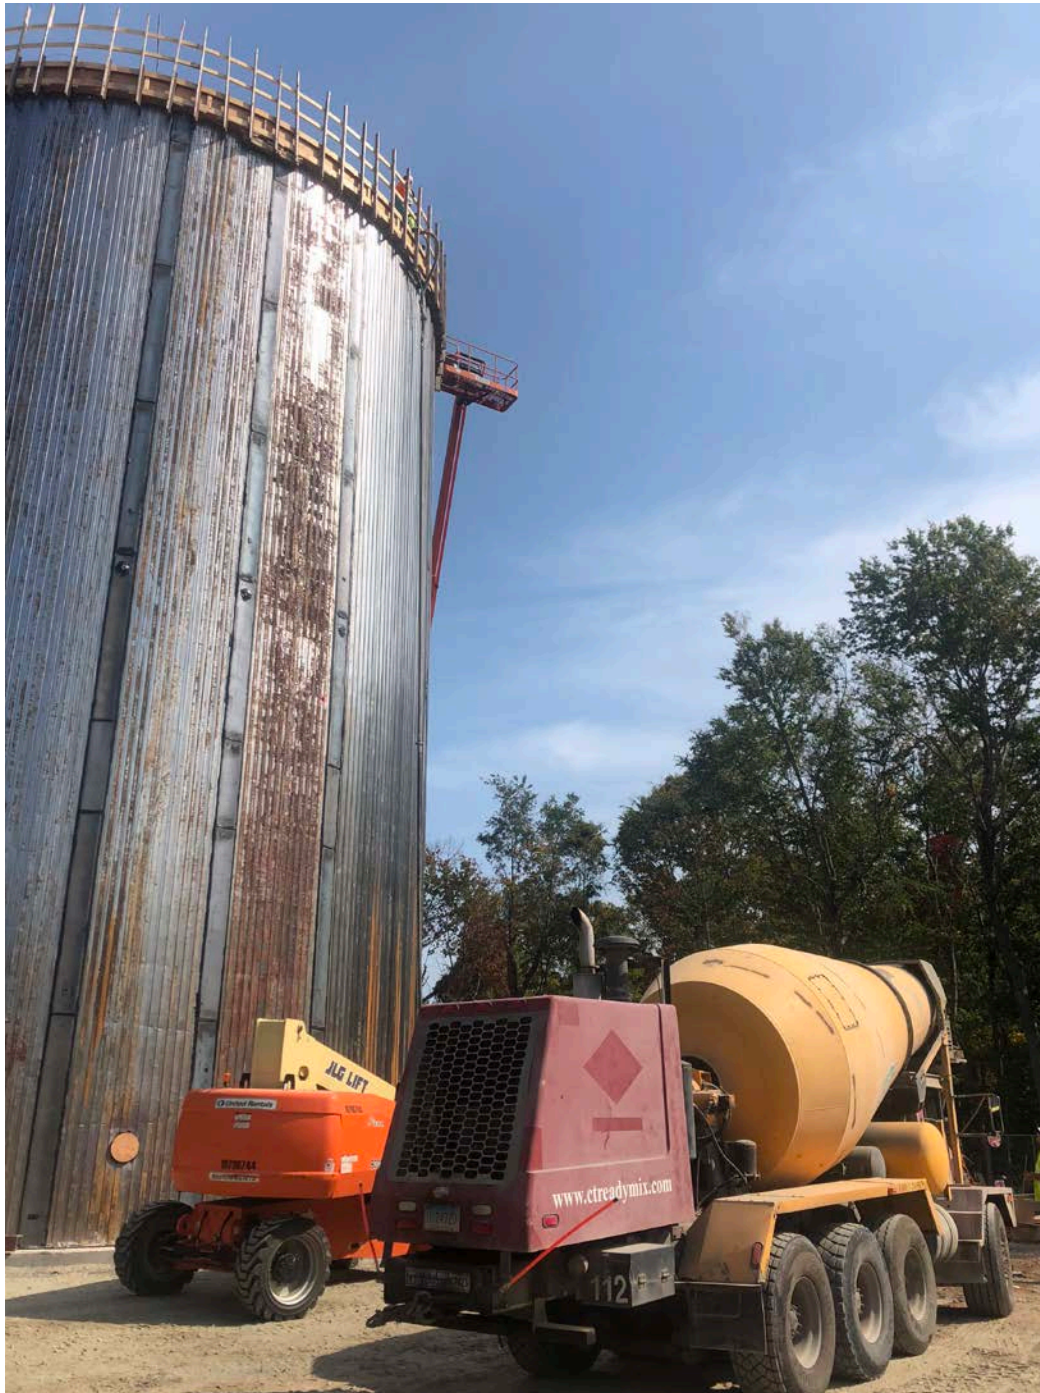
Picture 8: Overview of concrete being pumped to the top of the water tower for a dome pour. Water tank work zone east of the Shared Access Driveway, Middletown. View to the southeast.

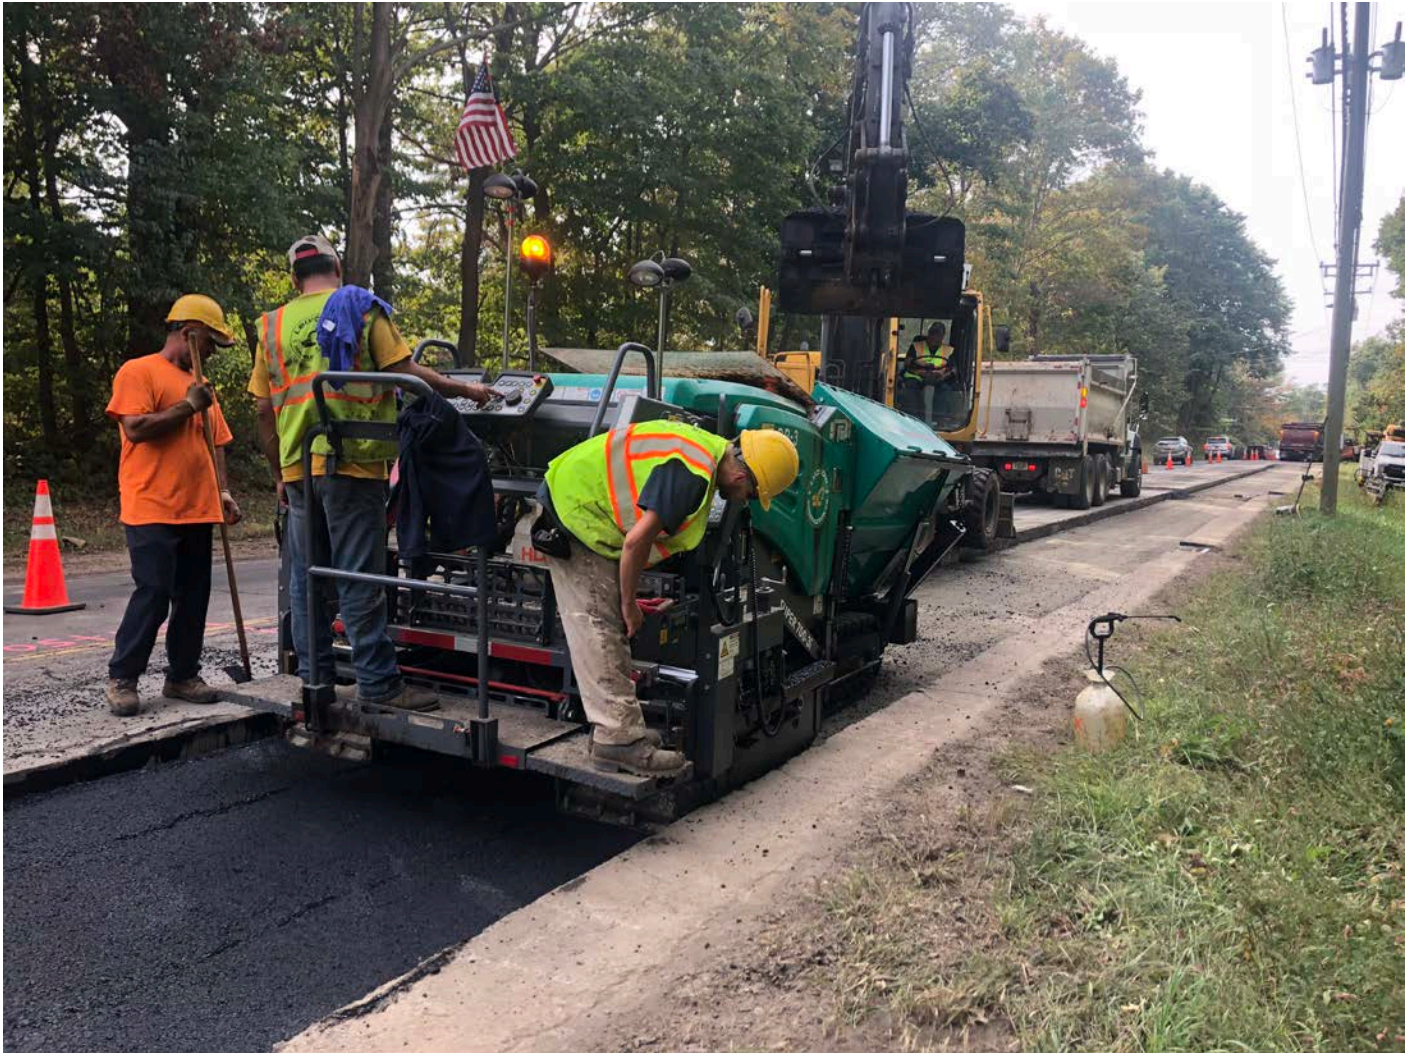
Picture 9: Ludlow placing the first of three 3" lifts of asphalt between Stations 126+00 and 130+00 as part of trench cutback paving activities on the southbound lane of S. Main Street, Middletown. View to the south.
