Daily Report

Project:	Durham Meadows Pipeline Installation	Date:	September 30, 2020
Location:	Main Street, Durham; Shared Access Driveway, Middletown	Day of Week:	Wednesday
Project #:	AECOM: 6061487	Report No:	170
Contractor:	Ludlow Construction	Page:	1 of 10

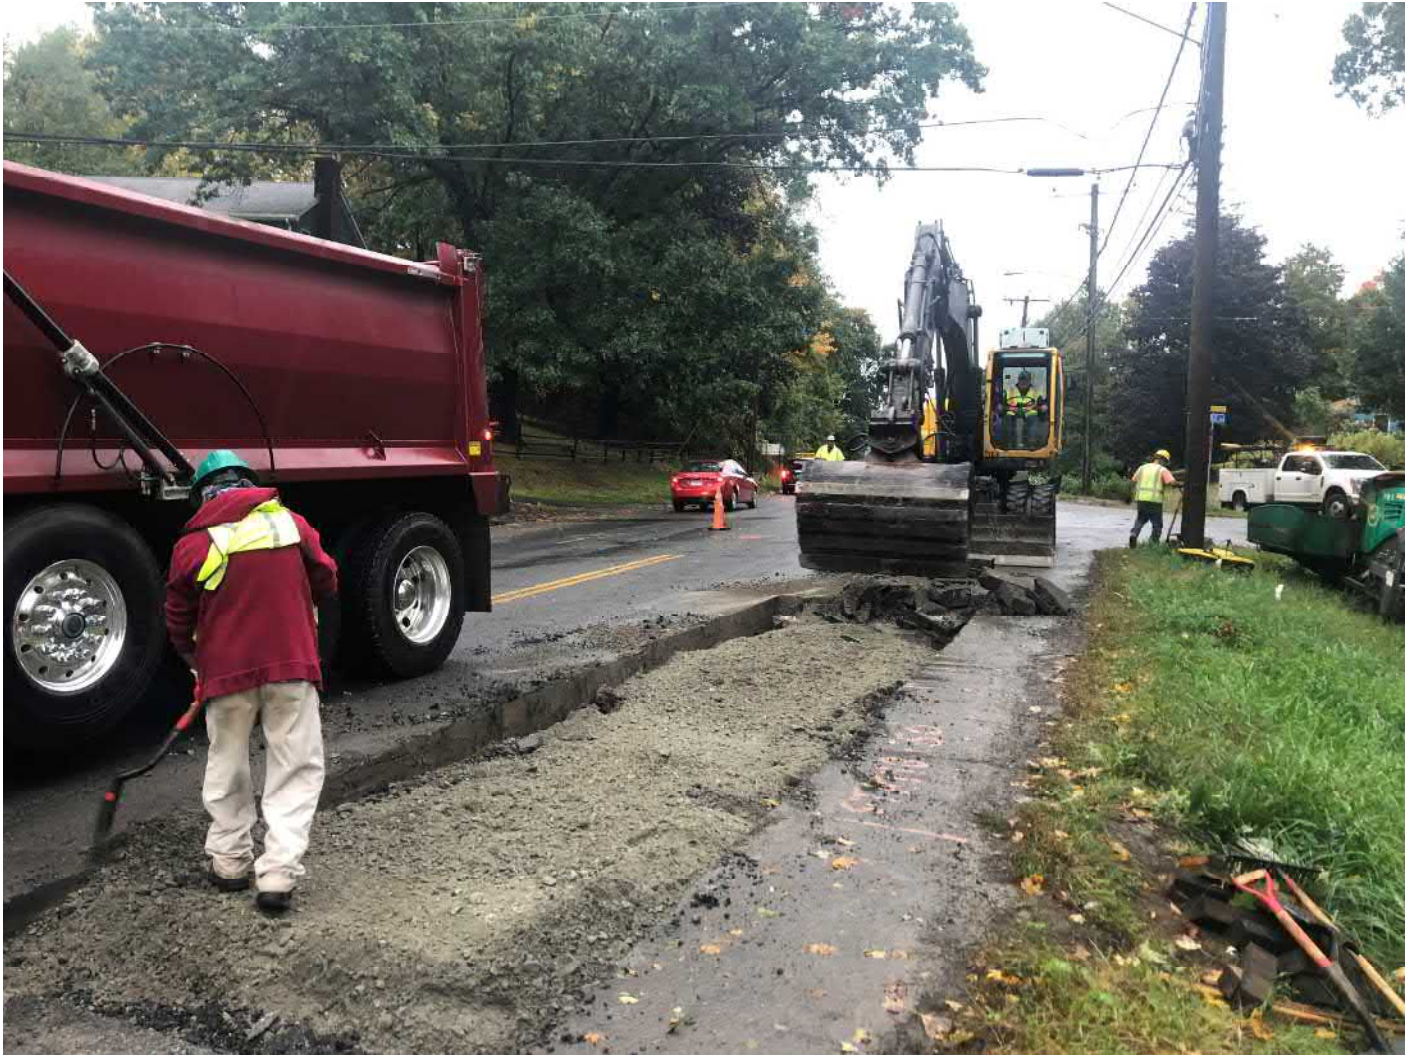
Picture 1: Ludlow in the process of stripping asphalt from trench overcuts as they prepare to place permanent paving on the southbound lane of Main Street, Durham from Stations 140+50 to 143+00. View to the south.

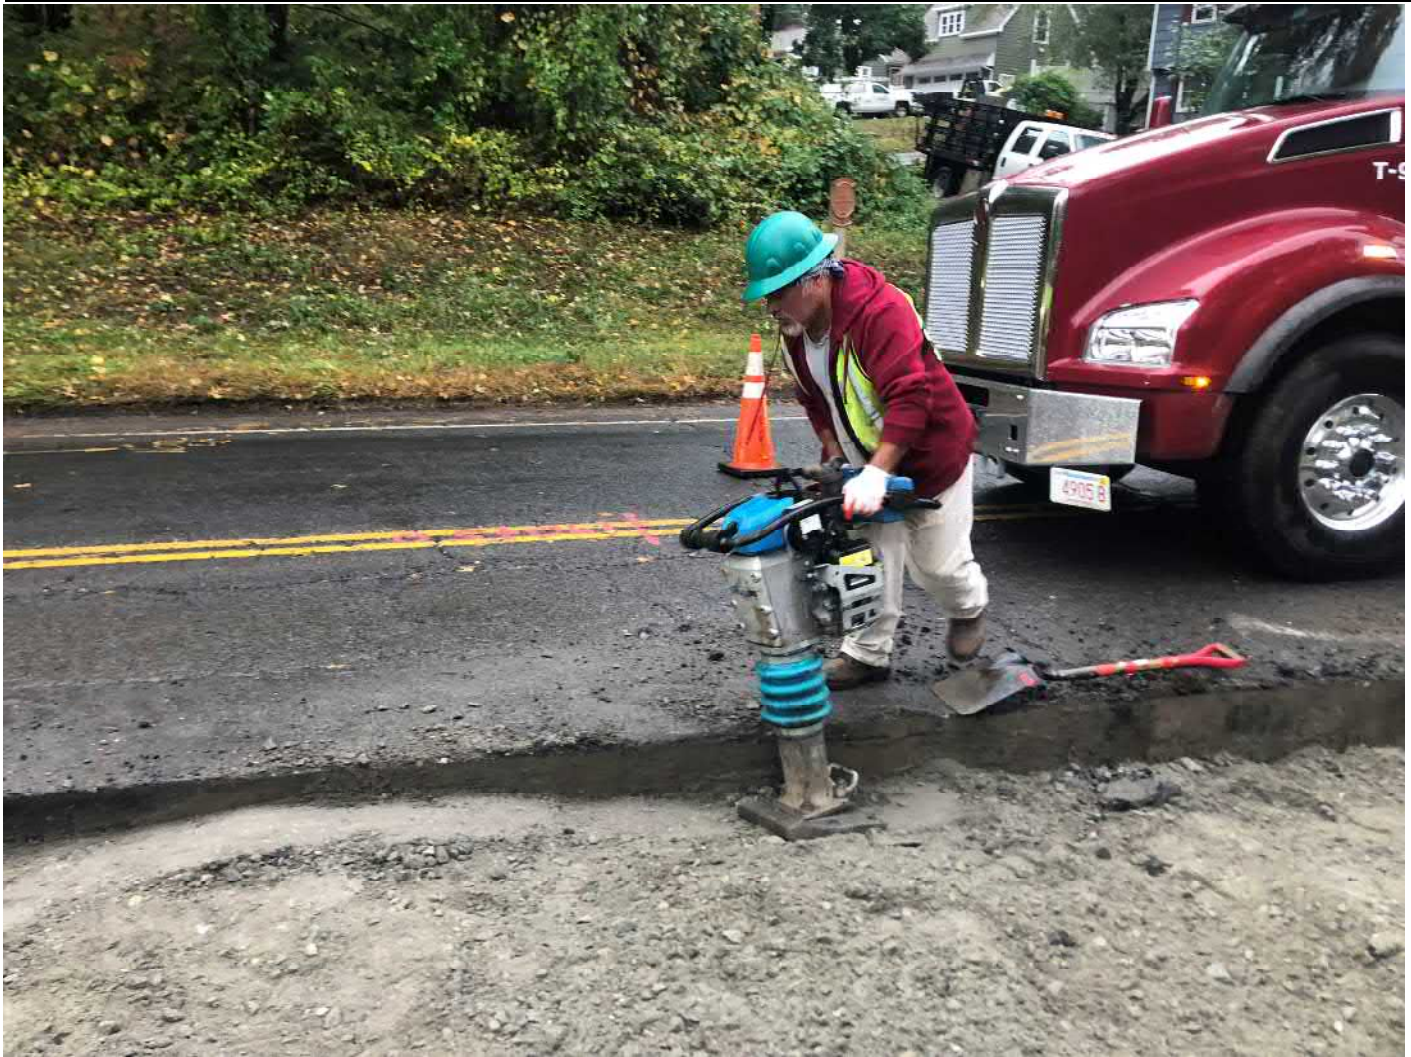
Picture 2: Ludlow compacting 1.5" processed gravel as they prepare to place permanent paving on the southbound lane of Main Street, Durham from Stations 140+50 to 143+00. View to the south.

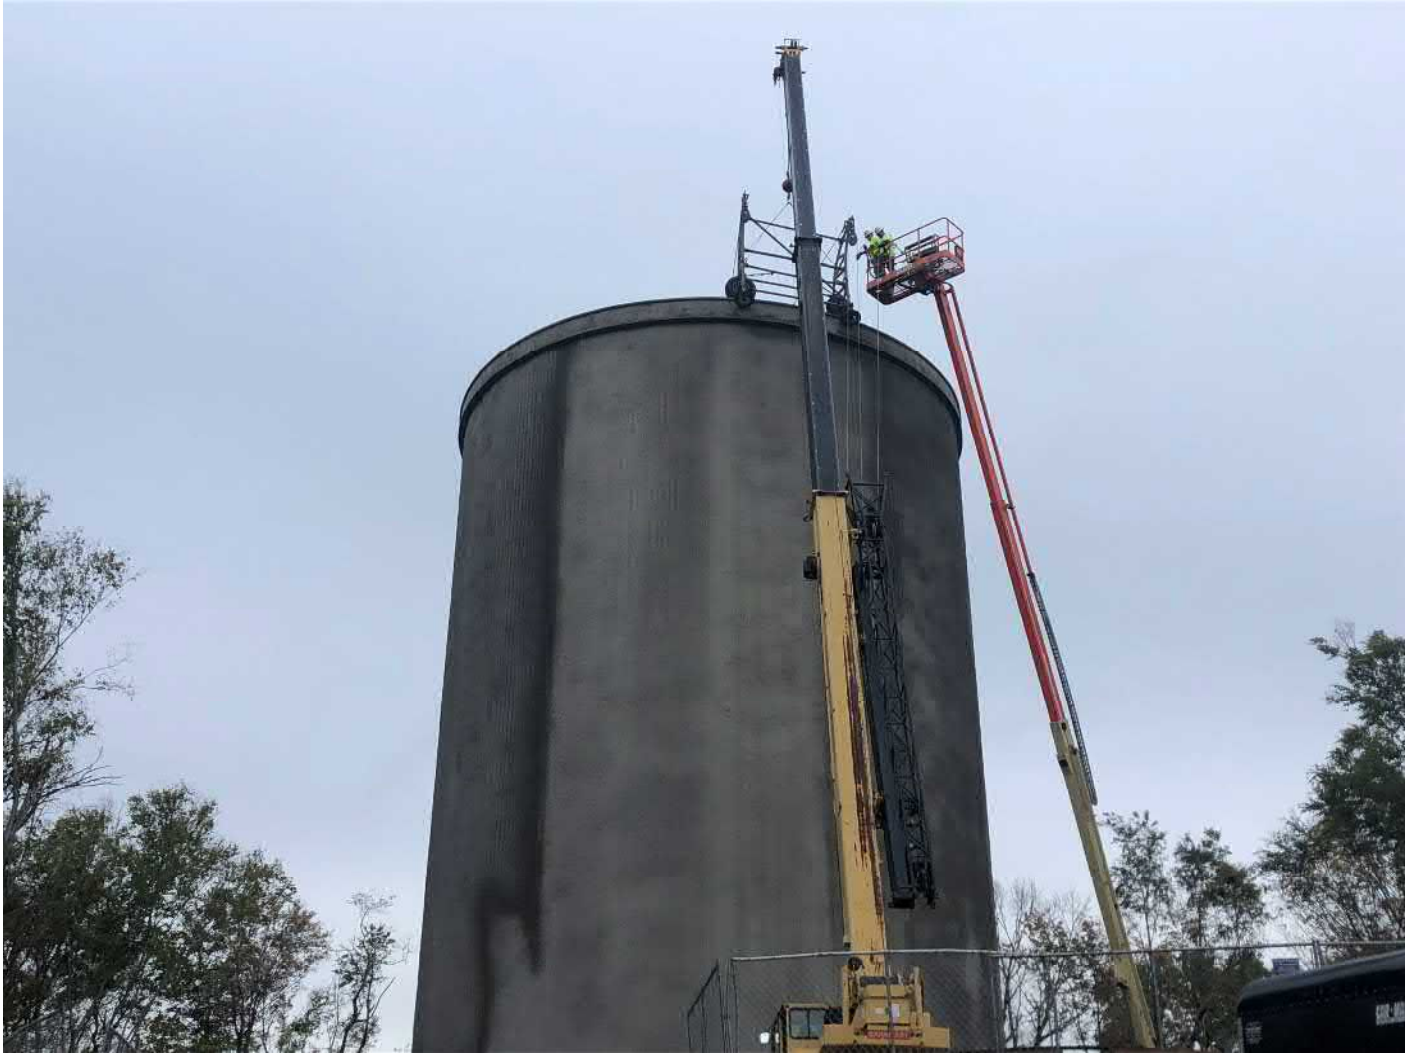
Picture 3: DN Tanks setting up to wrap prestressed wire around the sides of the water tank. Water tank work zone, east of the Shared Access Driveway, Middletown. View to the east.

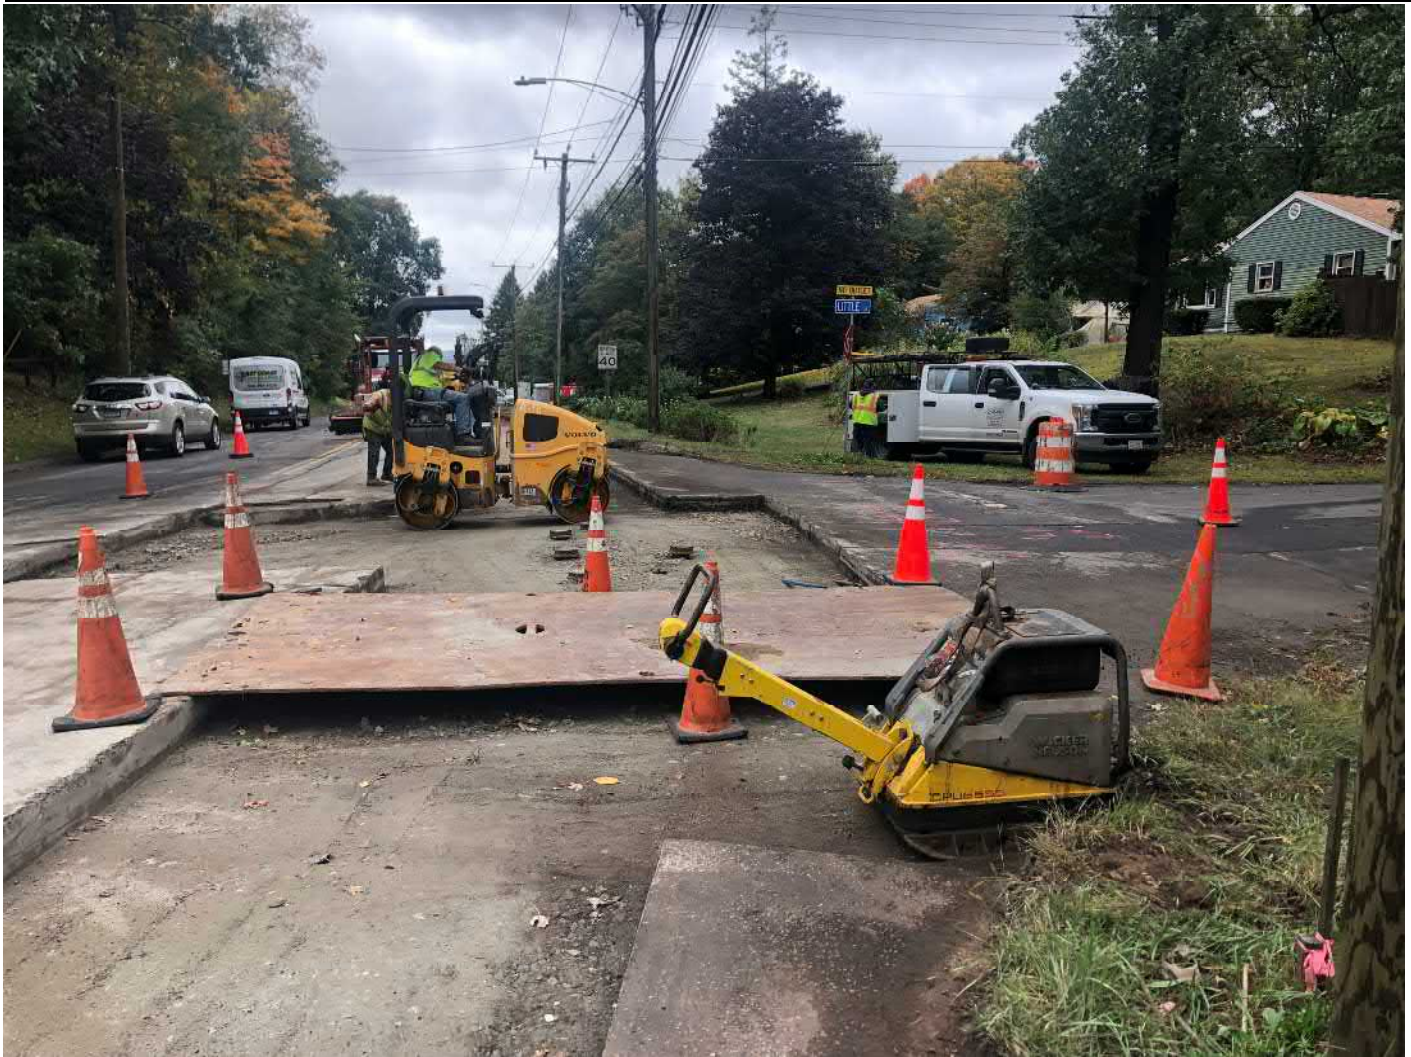
Picture 4: Ludlow compacting 1.5" processed gravel as they prepare to place permanent paving on the southbound lane of Main Street, Durham from Stations 140+50 to 143+00. View to the south.

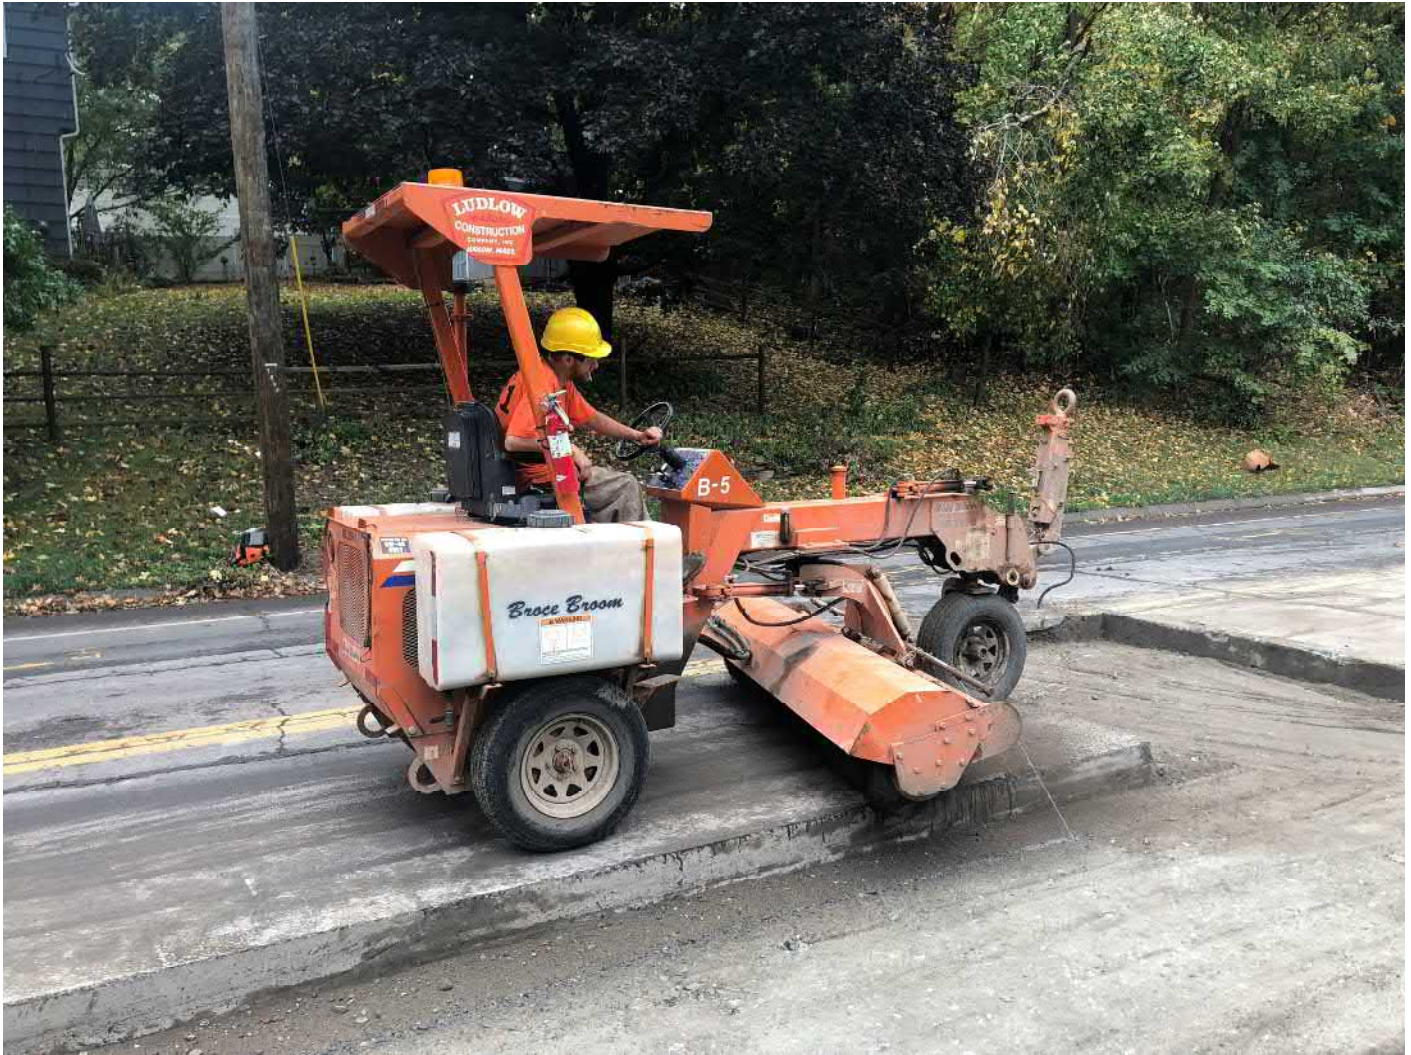
Picture 5: Ludlow using a Broce Broom to clean up the work zone as they prepare to place permanent paving on the southbound lane of Main Street, Durham from Stations 140+50 to 143+00. View to the southeast.

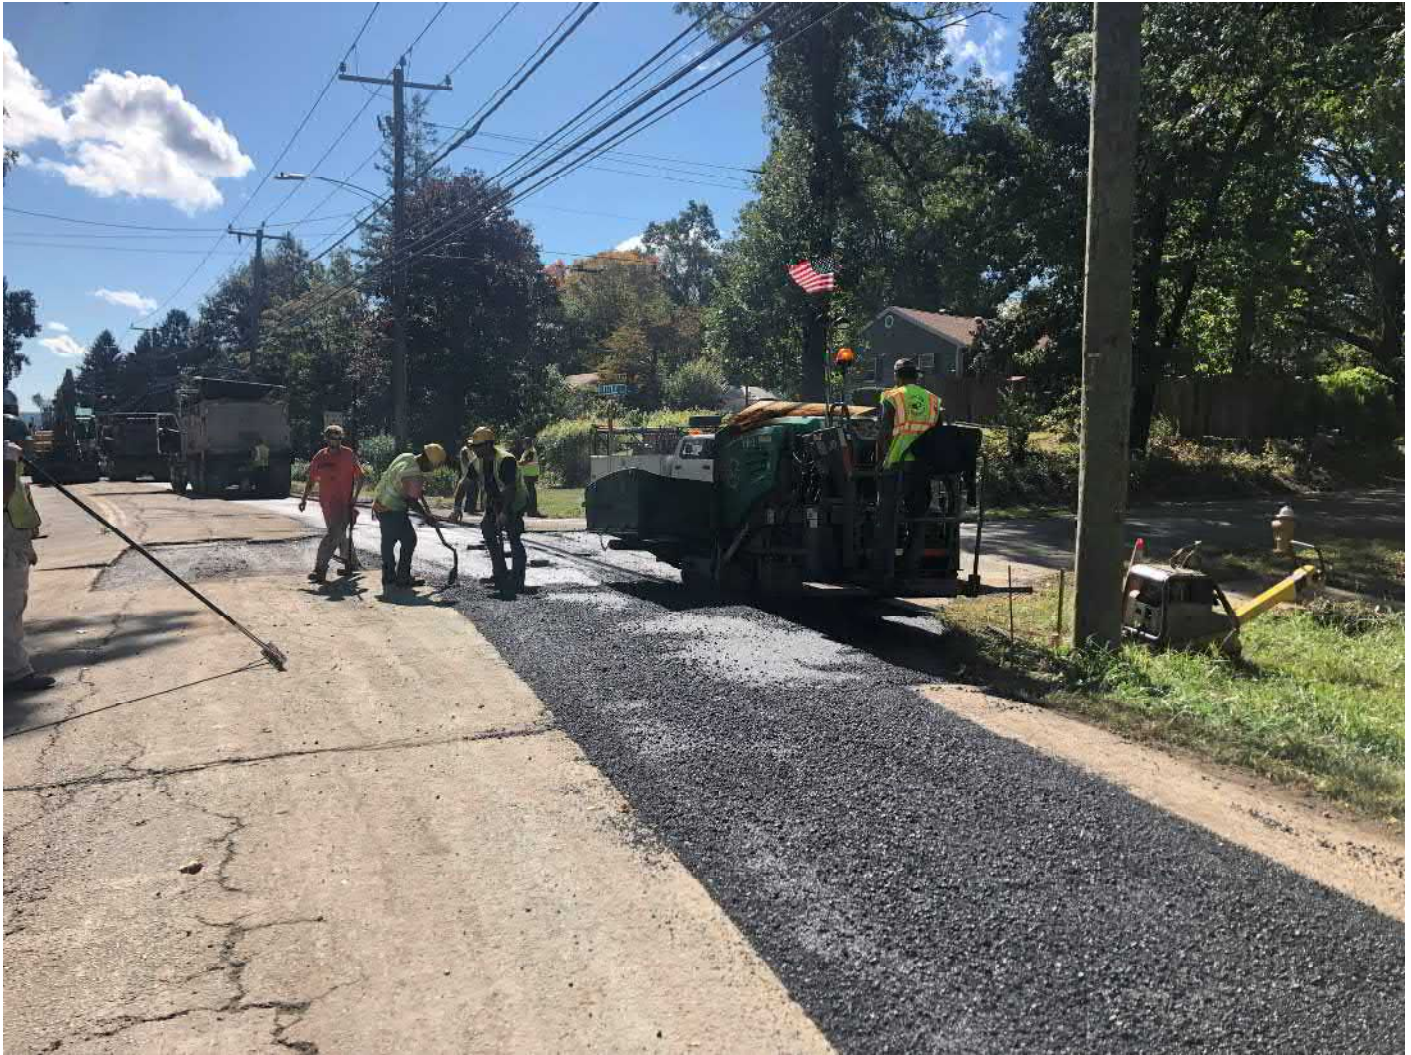
Picture 6: Ludlow placing and compacting the third of three 3" lifts of asphalt on the southbound lane of Main Street, Durham from Stations 140+50 to 143+00. View to the south.

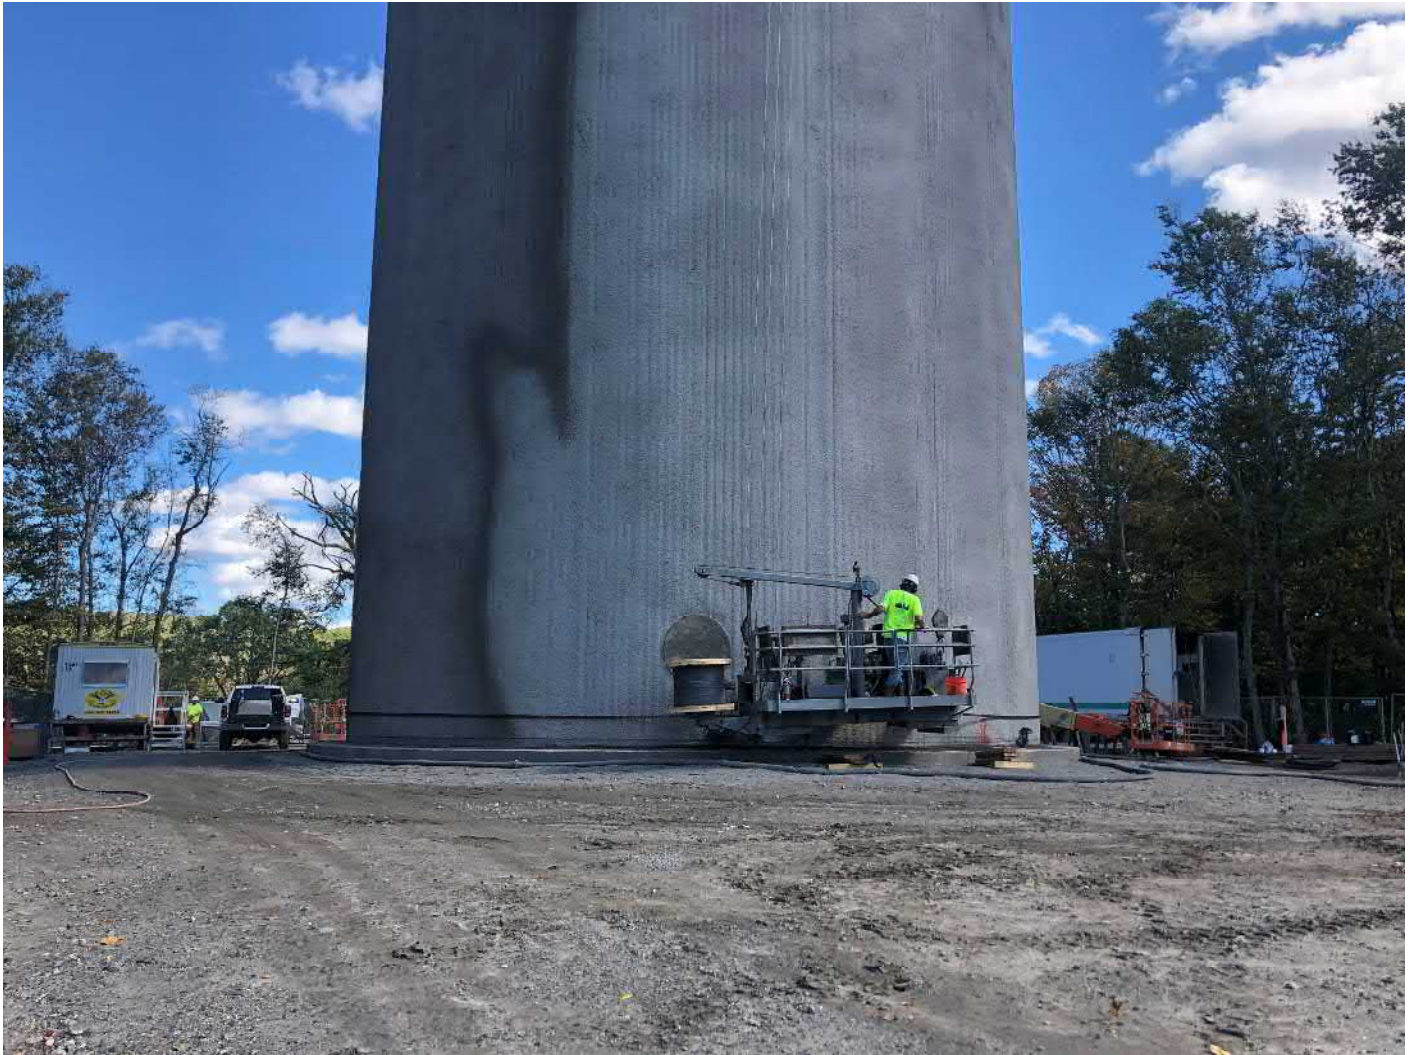
Picture 7: DN Tanks begins to wrap prestressed wire around the sides of the water tank. Water tank work zone, east of the Shared Access Driveway, Middletown. View to the east.
