Daily Report

Project:	Durham Meadows Pipeline Installation	Date:	October 1, 2020
Location:	Main Street, Durham; Shared Access Driveway, Middletown	Day of Week:	Thursday
Project #:	AECOM: 6061487	Report No:	170
Contractor:	Ludlow Construction	Page:	1 of 12

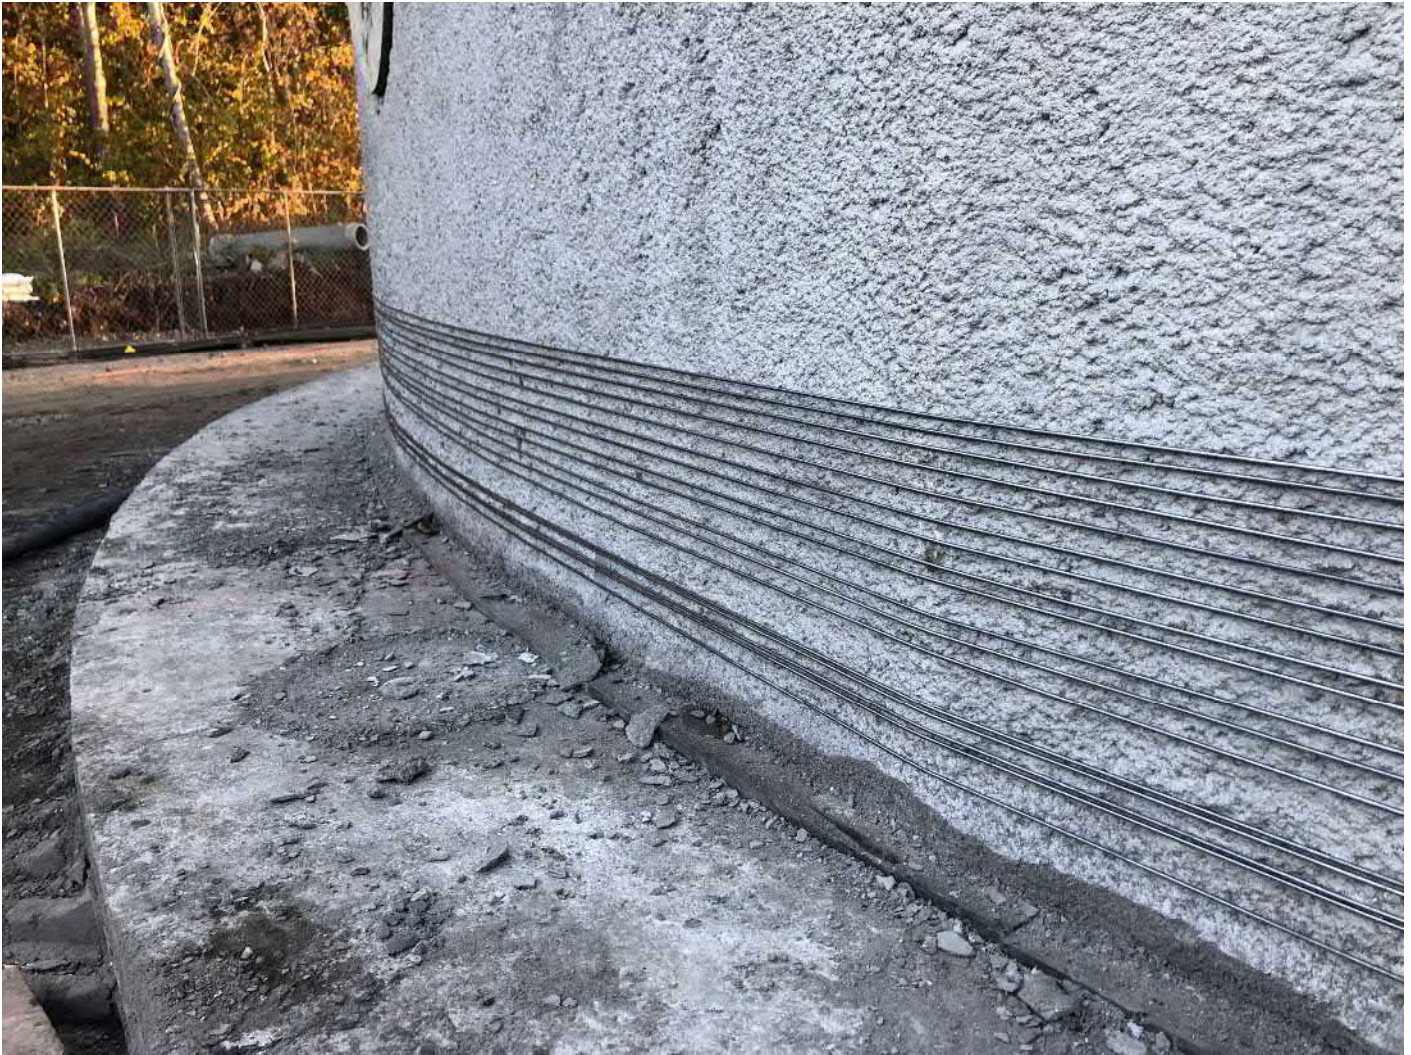
Picture 1: DN Tanks has wrapped prestressed wire around the sides of the water tank at the bottom. Water tank work zone, east of the Shared Access Driveway, Middletown. View to the northeast.

0716: DN Tanks has wrapped the first 14" of the bottom of the water tank with prestressed wire.

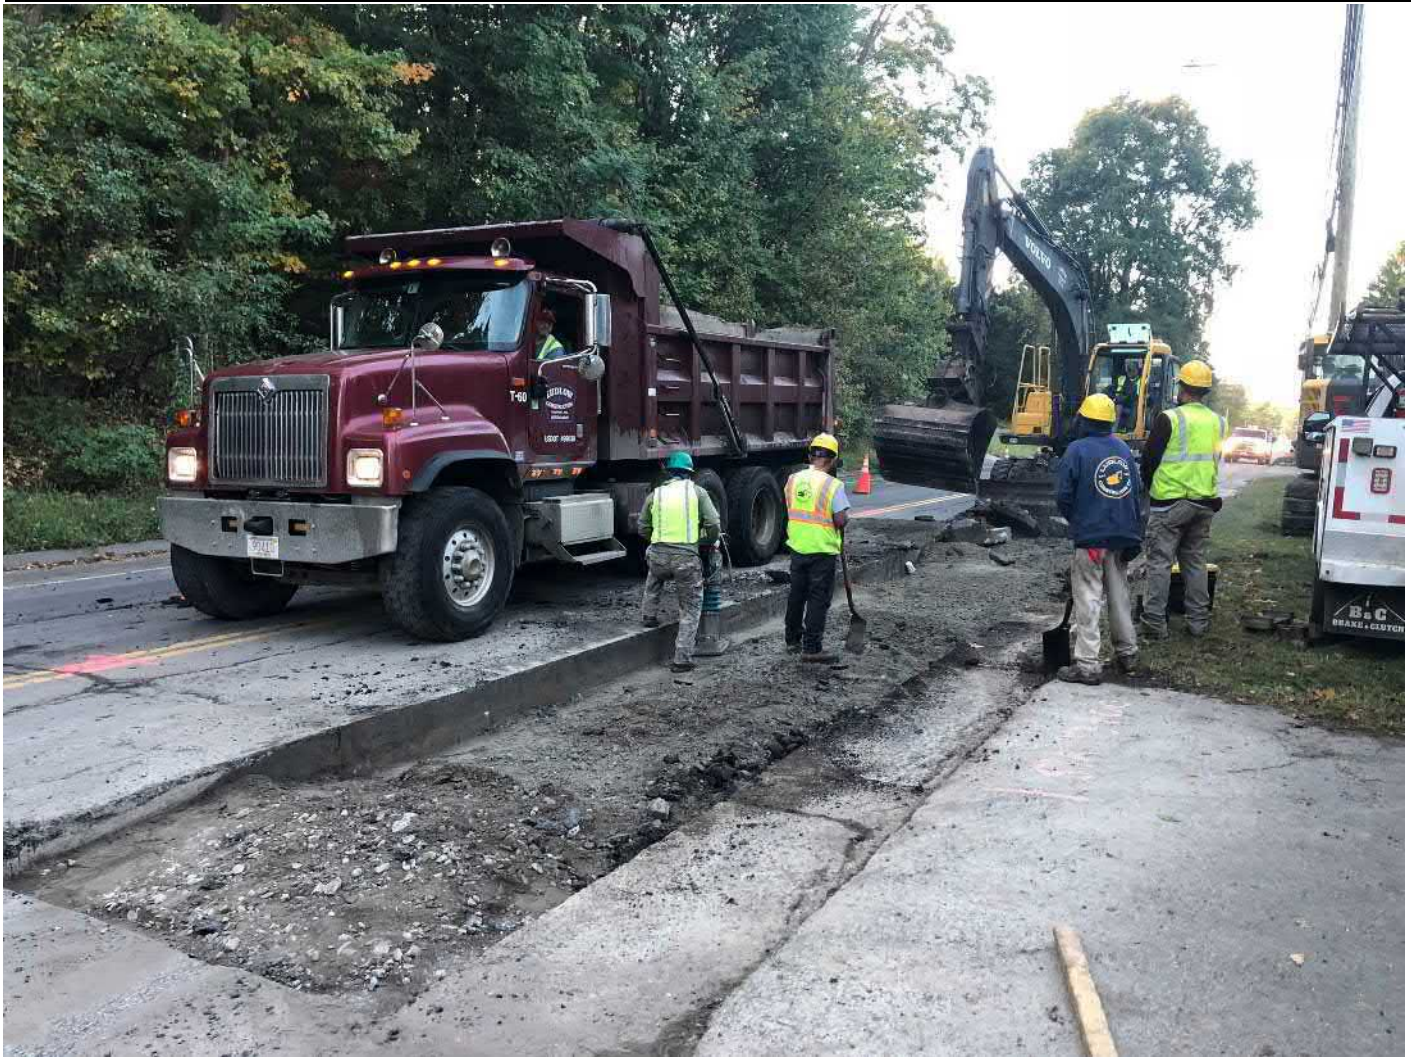
Picture 2: Ludlow stripping back asphalt as they prepare to place permanent paving on the southbound lane of Main Street, Durham from Stations 143+00 to 146+30. View to the south.

0826: Ludlow continues to strip asphalt from Station 143+00 to 146+30 on the southbound lane of Main Street, Durham.

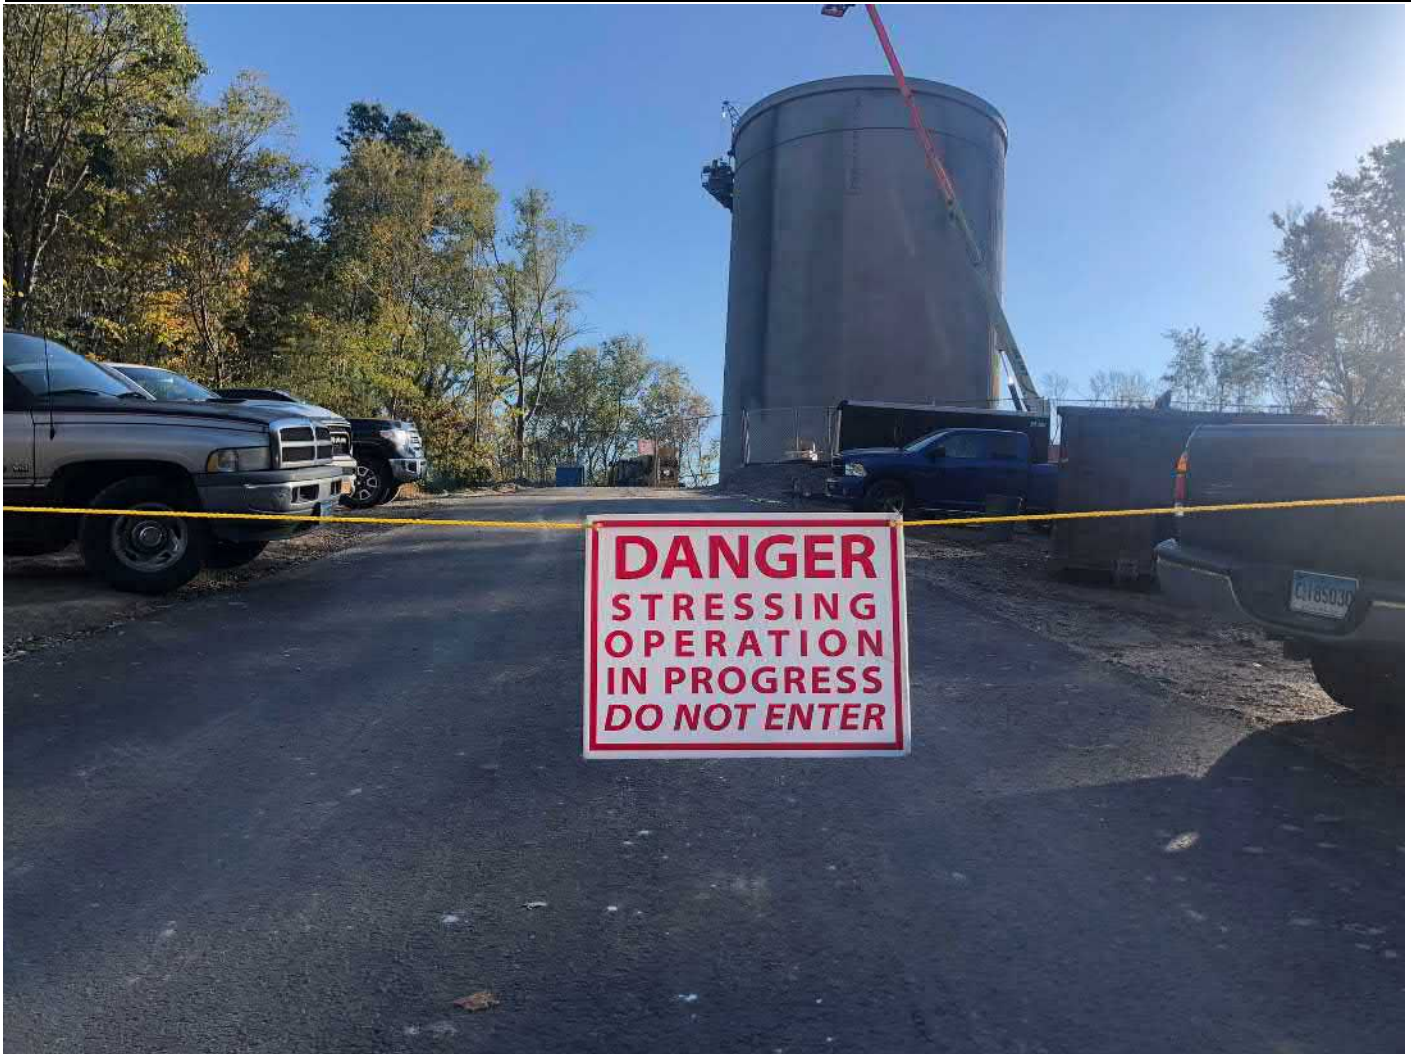
Picture 3: DN Tanks placed warning sign near the water tank work zone, east of the Shared Access Driveway, Middletown as they wrapped prestressed wire around the tank. View to the east.

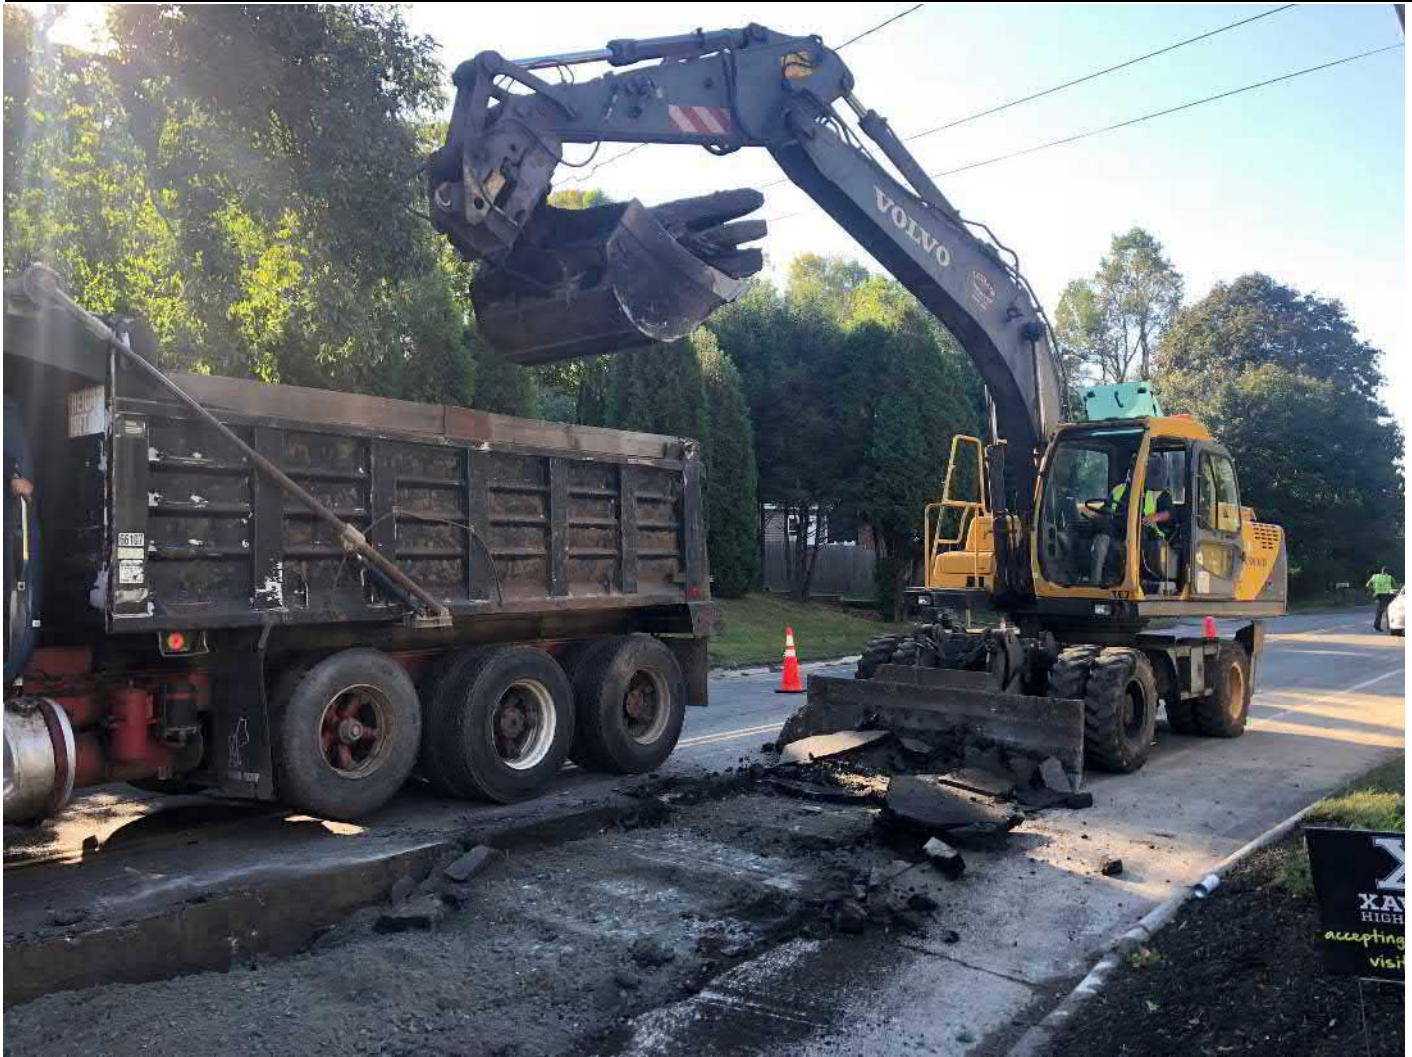
Picture 4: Ludlow stripping back asphalt as they prepare to place permanent paving on the southbound lane of Main Street, Durham from Stations 143+00 to 146+30. View to the southeast.

0910: Ludlow continues to strip asphalt from Station 143+00 to 146+30 on the southbound lane of Main Street, Durham.

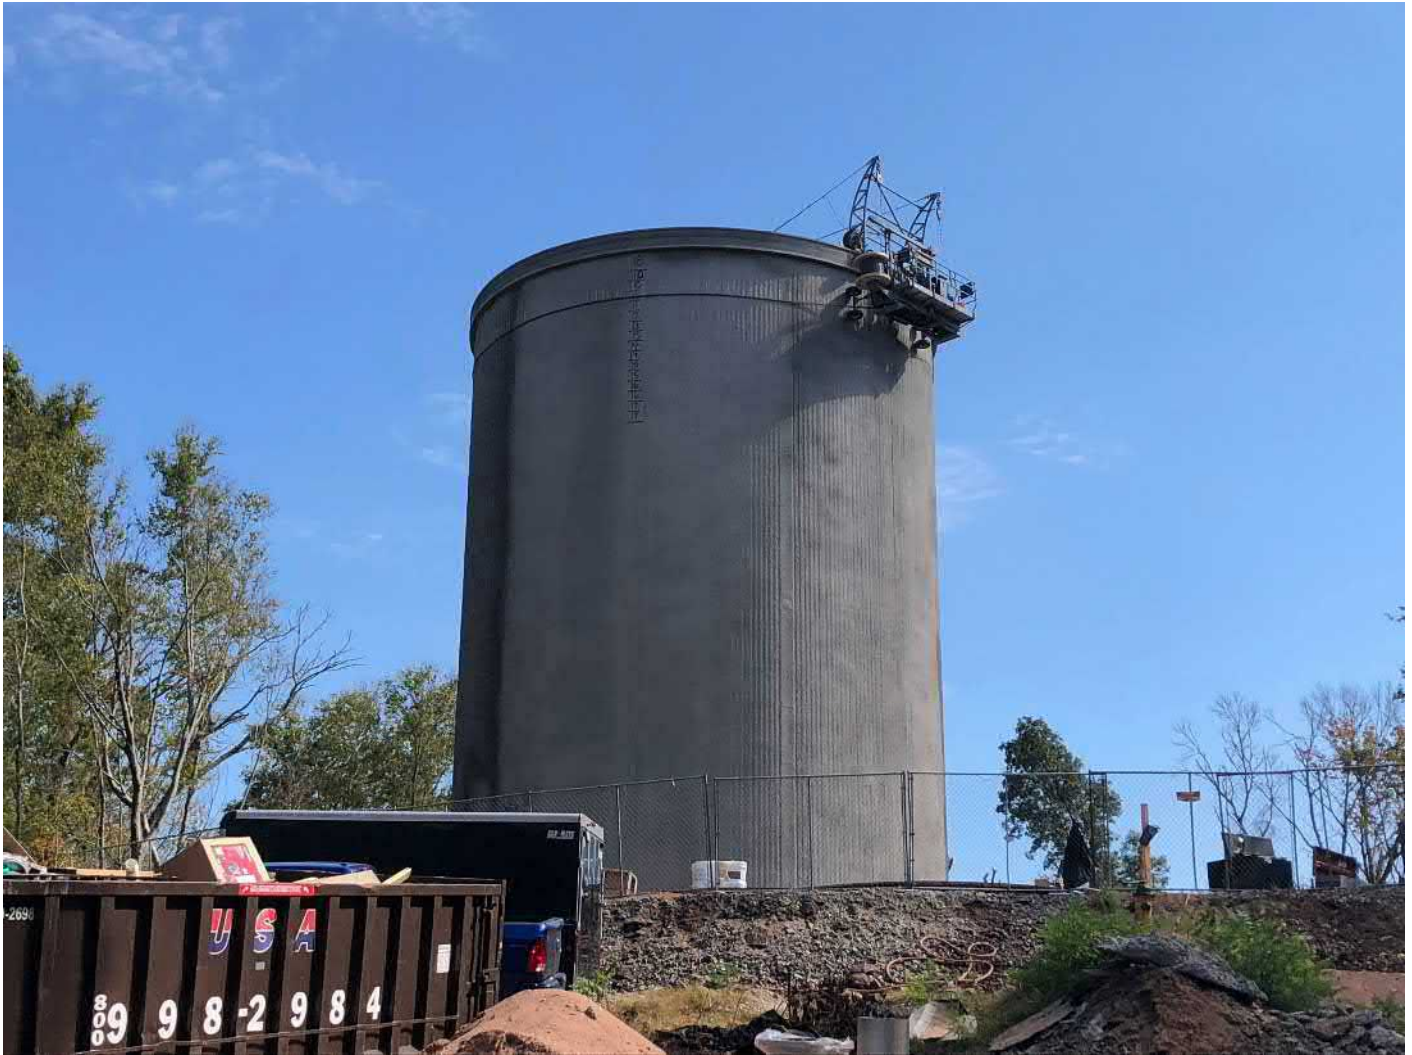
Picture 5: DN Tanks preparing to wrap prestressed wire around the sides of the water tank at the top of the tank. Water tank work zone, east of the Shared Access Driveway, Middletown. View to the northeast.

0853: DN Tanks has the wire wrapping cart positioned at the top of the water tank as they lay out the chain that the cart rides along as the wire is wrapped around the side of the tank.

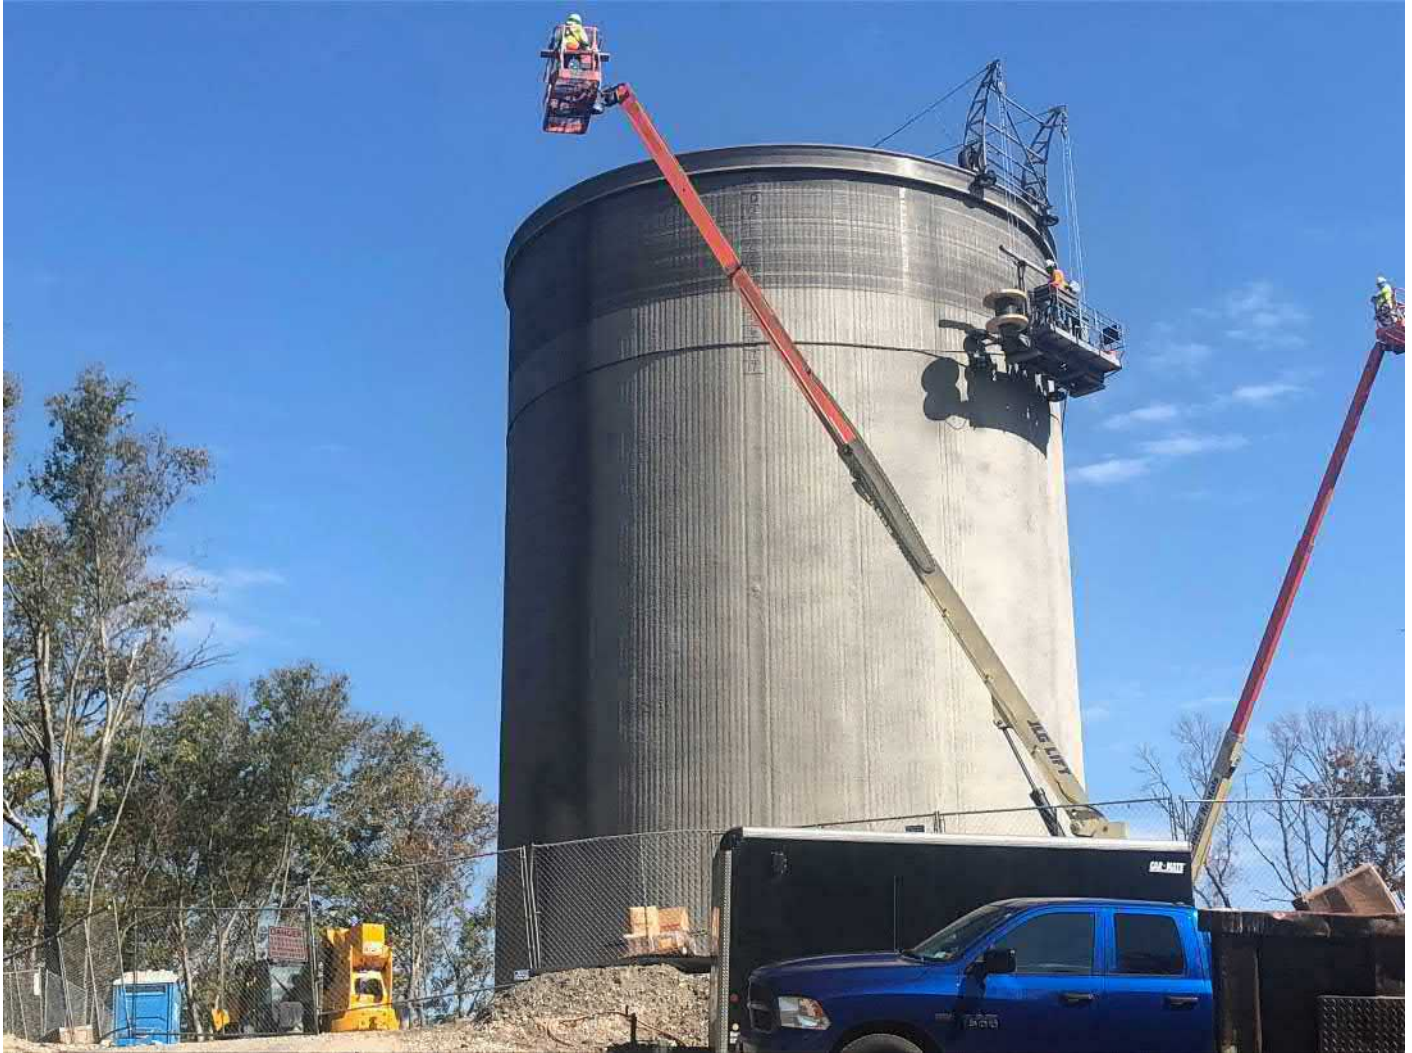
Picture 6: DN Tanks wrapping prestressed wire around the sides of the water tank at the top of the tank. Water tank work zone, east of the Shared Access Driveway, Middletown. View to the northeast.

1314: DN Tanks has wrapped prestressed wire around the dome rim of the water tank and is preparing to wind the same wire around the sides of the water tank, starting immediately below the dome rim.

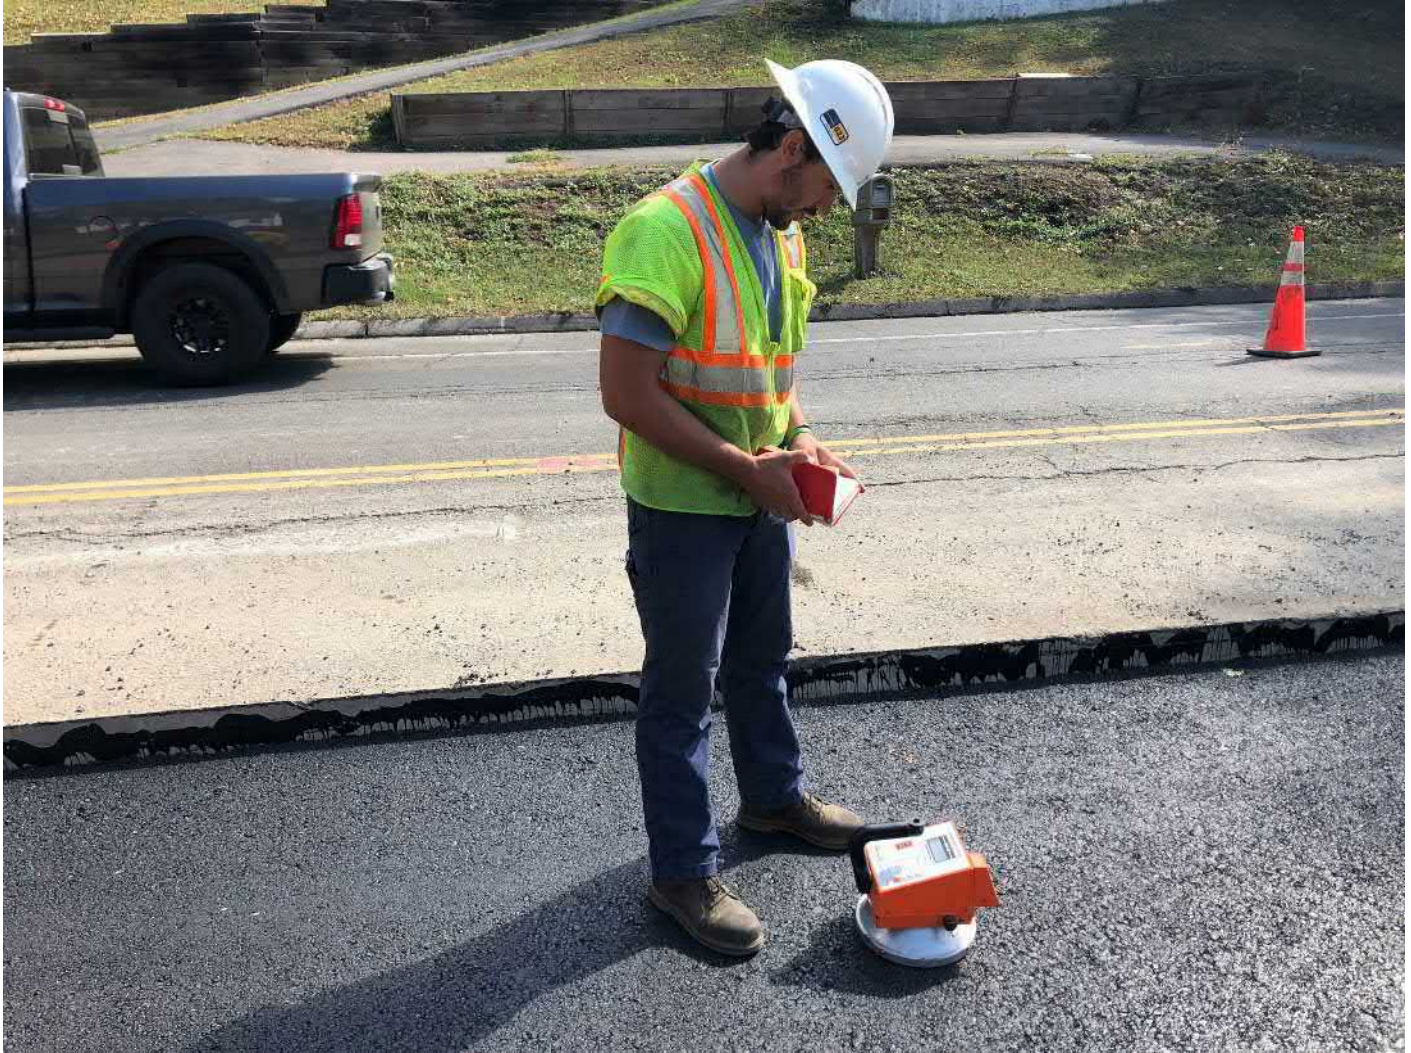
Picture 7: JTC collecting compaction data from the first of three 3" lifts of asphalt on the southbound lane of Main Street, Durham from Stations 143+00 to 146+30. View to the southeast.

1155: Ludlow continues to place the first lift of asphalt on the trench cutback on the southbound lane of Main Street, Durham from Stations 143+00 and 146+30. JTC is present to collect compaction data from the asphalt.

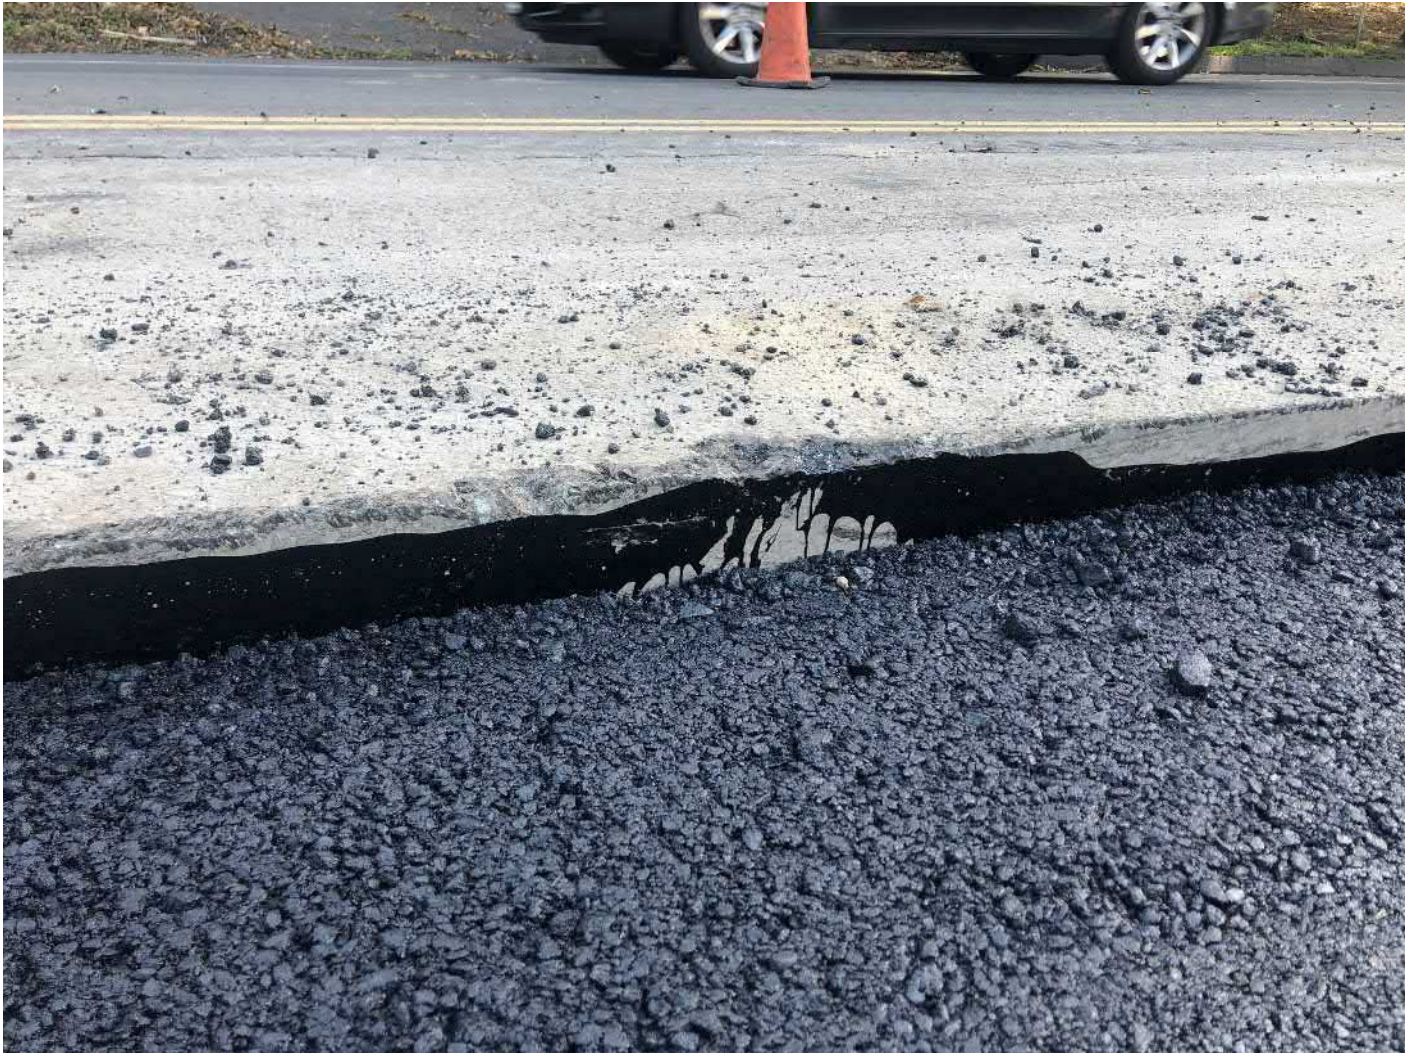
Picture 8: Tack coat applied to the sides of cut pavement as part of trench cutback paving activities on the southbound lane of Main Street, Durham from Stations 143+00 to 146+30.

1125: Ludlow is placing tack coat along the cut edges of pavement and they also place and compact the first of three 3" lifts of asphalt between Stations 143+00 and 146+30.

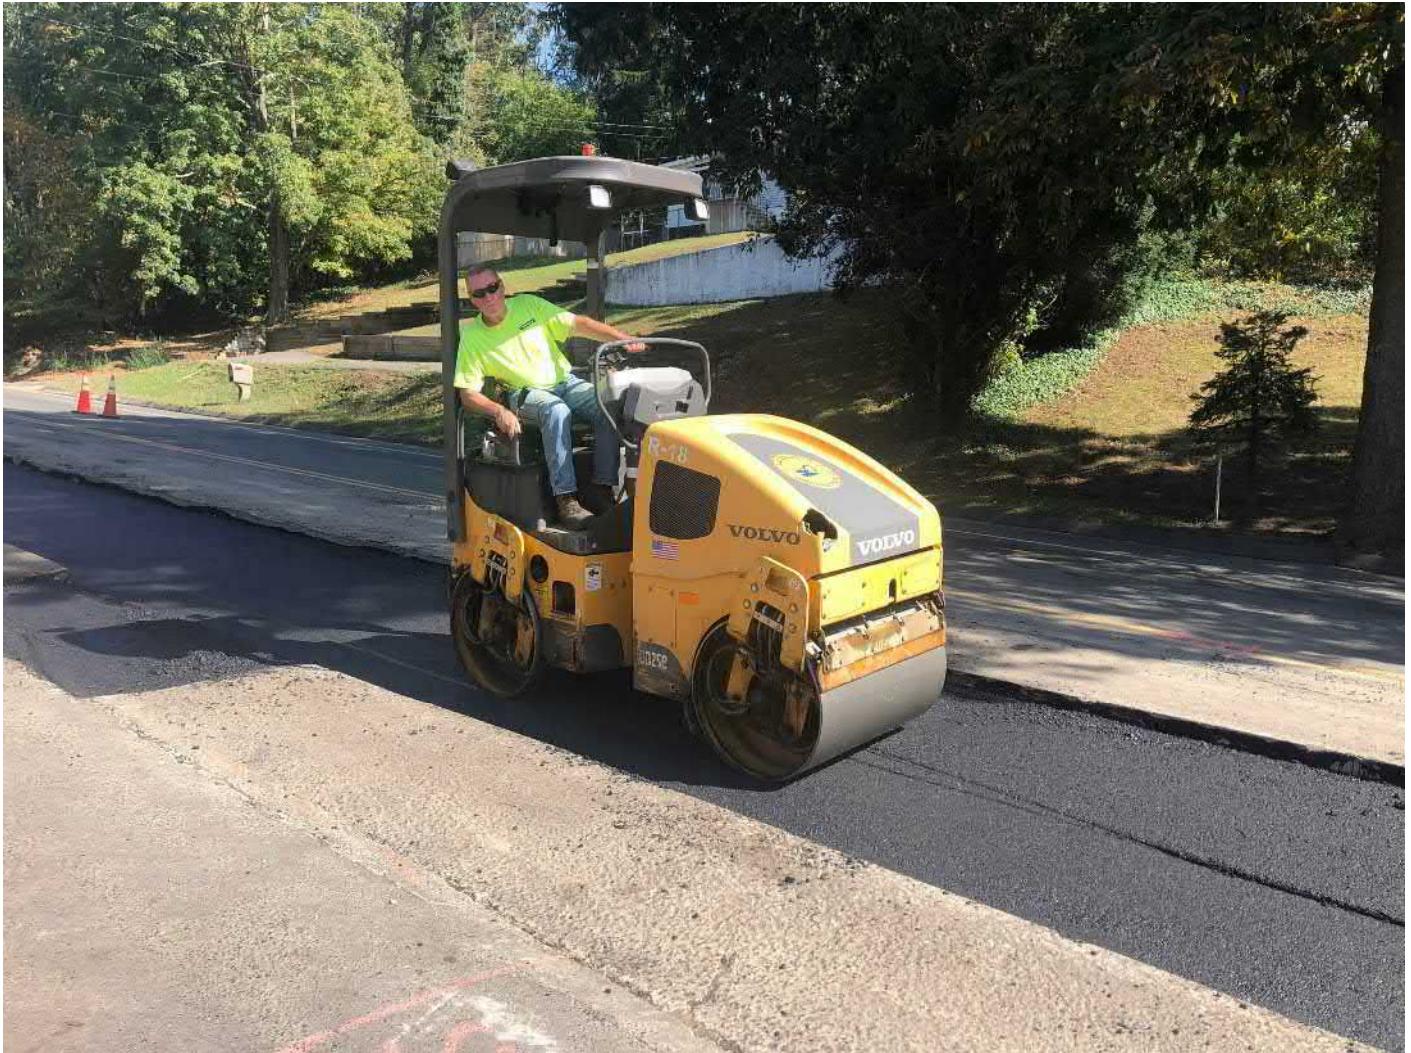
Picture 9: Ludlow compacting second lift of asphalt as part of trench cutback paving activities on the southbound lane of Main Street, Durham from Stations 143+00 to 146+30. View to the northeast.

1235: Ludlow is placing and compacting the second of three 3" lifts of asphalt between Stations 143+00 and 146+30.
