Daily Report

Project:	Durham Meadows Pipeline Installation	Date:	October 5, 2020
Location:	Main Street, Durham; Shared Access Driveway, Middletown	Day of Week:	Monday
Project #:	AECOM: 6061487	Report No:	172
Contractor:	Ludlow Construction	Page:	1 of 14

Daily Activities – Water tank construction, Shared Access Driveway, Middletown

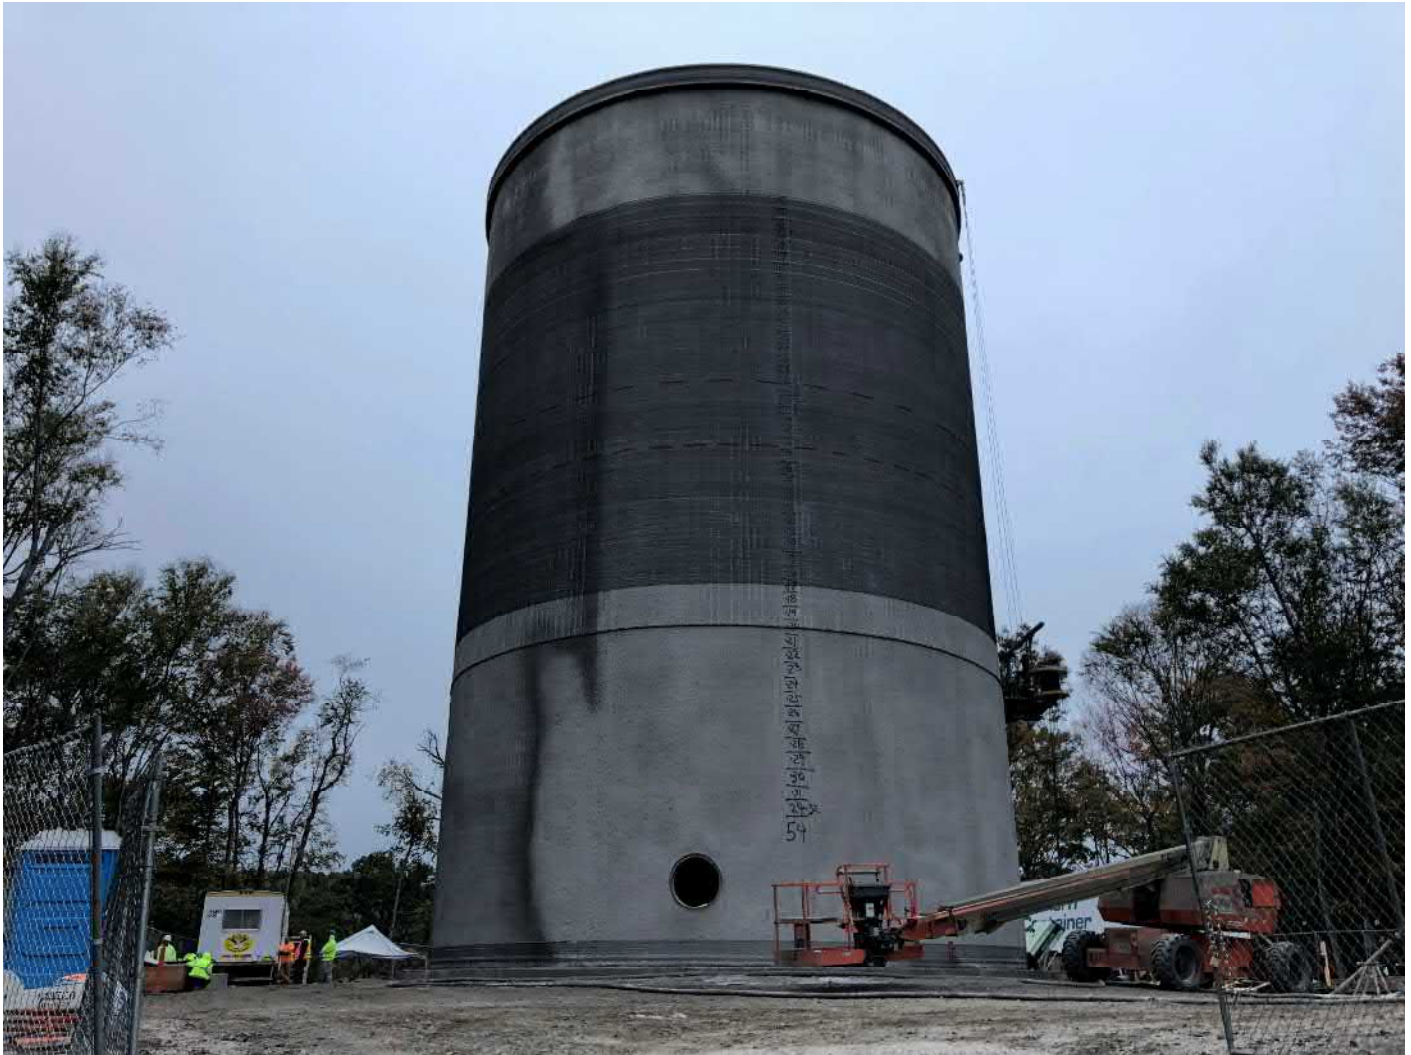
0710: DN Tanks has mobilized to the water tank work zone and is preparing to apply shotcrete to the prestressed wire they wrapped around the water tank sides and dome rim. Wire has been wrapped from the top of the tank moving down; a little more than half of the tank sides has been wrapped so far. The dome rim has been wrapped twice.

Picture 1: Water tank and the prestressed wire that has been wrapped around the sides of the tank. This is the tank before shotcrete was applied over the wire today. Water tank work zone, east of the Shared Access Driveway, Middletown. View to the east.

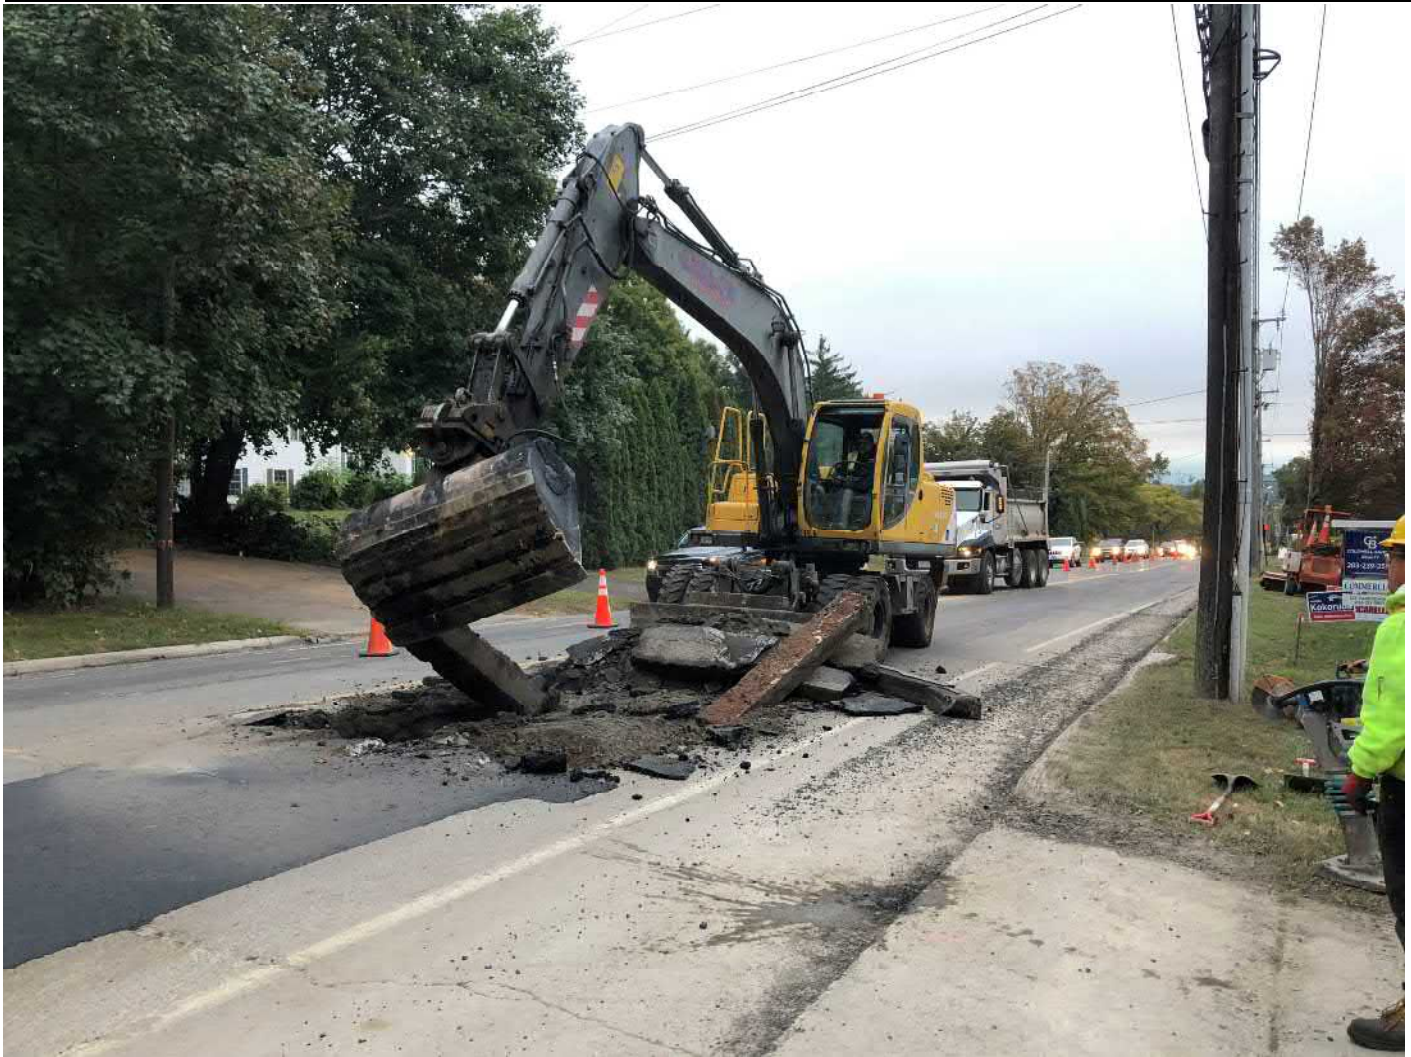
0717: Ludlow is resuming the removal of pavement for trench cutback permanent paving on the southbound lane of Main Street, starting at Station 148+65. One State Trooper and one private flagger are providing traffic management.

Picture 2: Ludlow stripping back asphalt as they prepare to place permanent paving on the southbound lane of Main Street, Durham from Stations 148+65 to 151+35. View to the southeast.

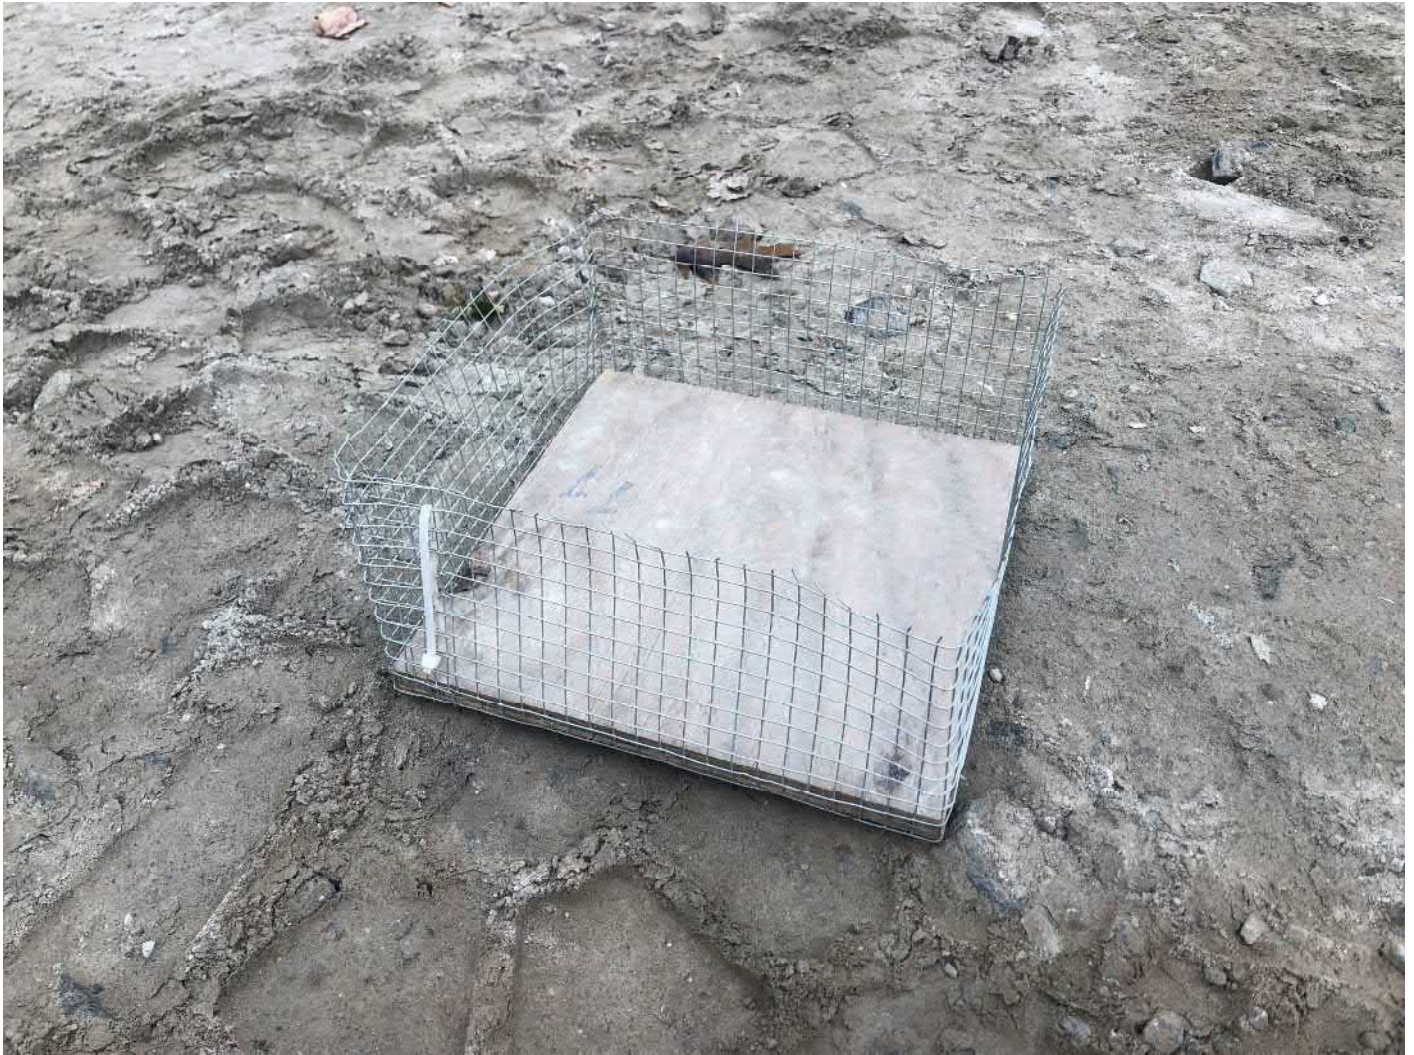
Picture 3: Basket used for the collection of a sample of shotcrete. Water tank work zone, east of the Shared Access Driveway, Middletown.

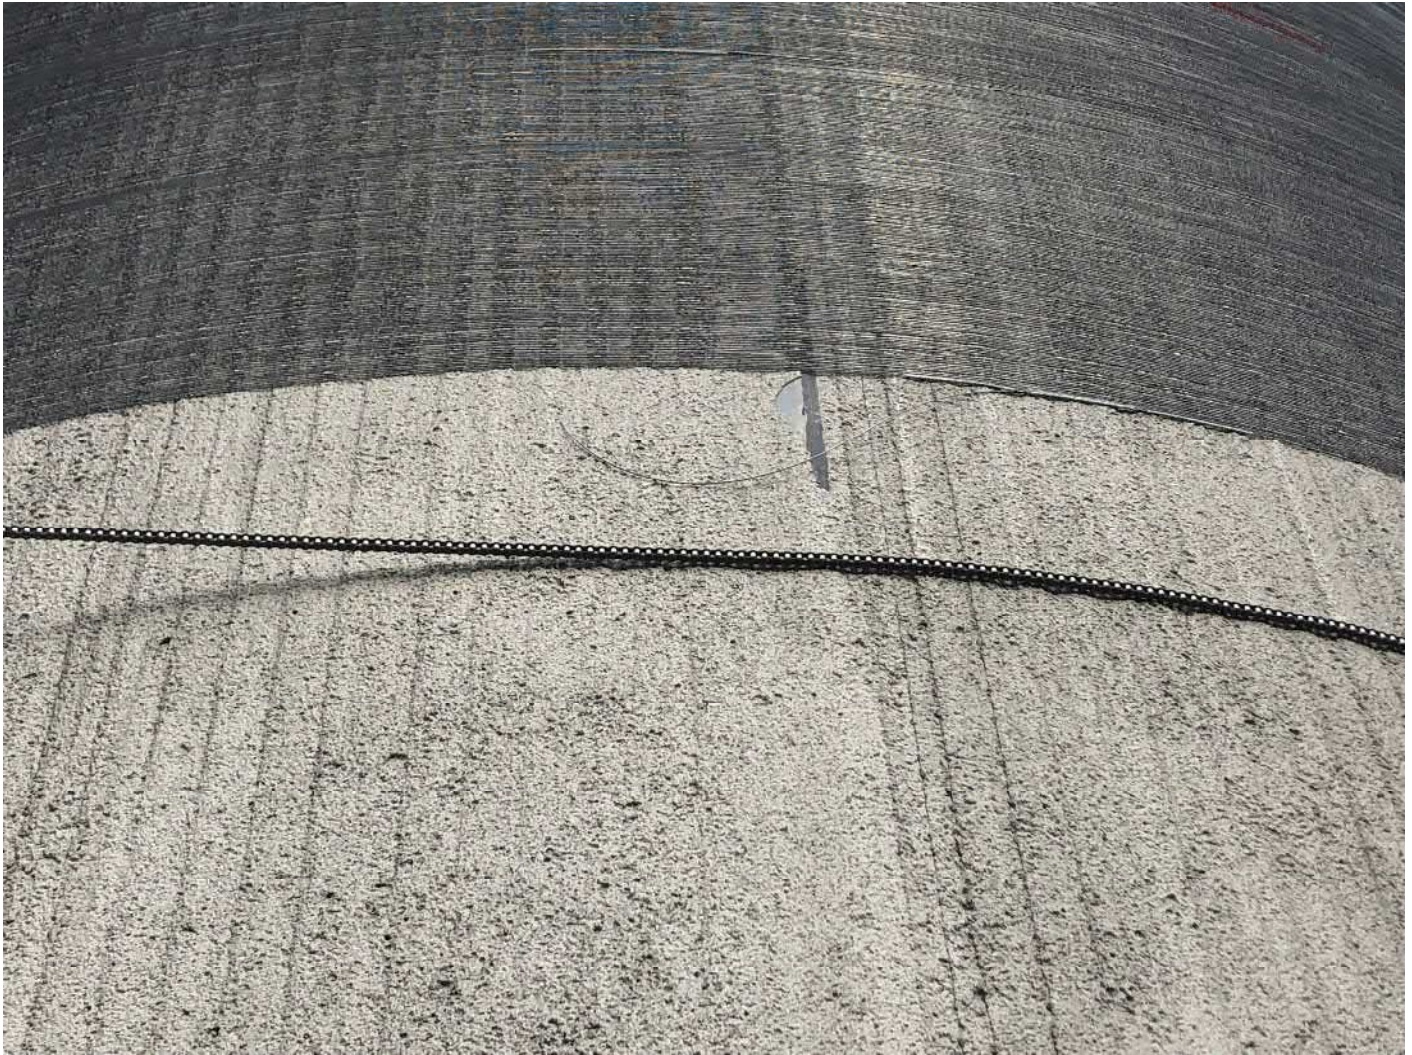
0922: Two spots on the steel diaphragm have patches approximately 4" x 12" where previously-applied shotcrete has chipped away, revealing bare metal. Ludlow states that DN Tanks will cover the bare spots with shotcrete today.

Picture 4: One of the two spots on the steel diaphragm where shotcrete has chipped away, revealing bare metal. DN Tanks later applied fresh shotcrete to these two areas. Water tank work zone, east of the Shared Access Driveway, Middletown. View to the north.

1340: DN Tanks has finished applying shotcrete to the water tank today. This includes covering the two bare spots where the steel diaphragm was exposed.

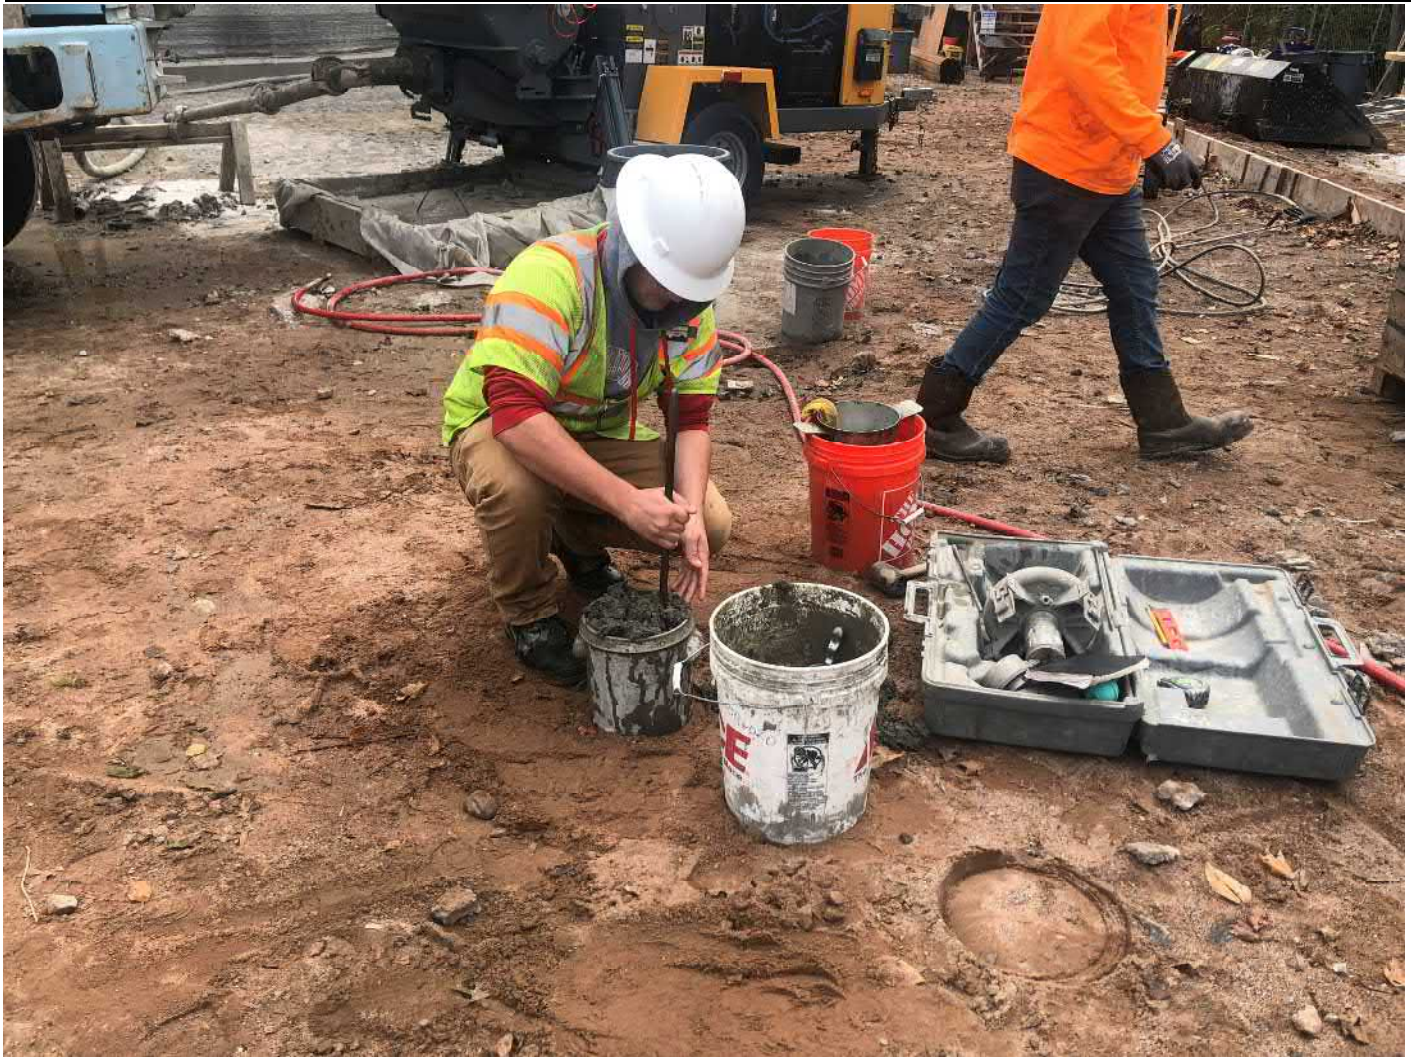
0951: The first of 3 trucks of shotcrete arrive at site from CT Ready Mix. JTC is in the process of preparing an-air entrainment sample.

Picture 5: JTC preparing an air entrainment sample from the first of three trucks of shotcrete delivered to the water tank work zone located to the east of the Shared Access Driveway, Middletown. View to the east.

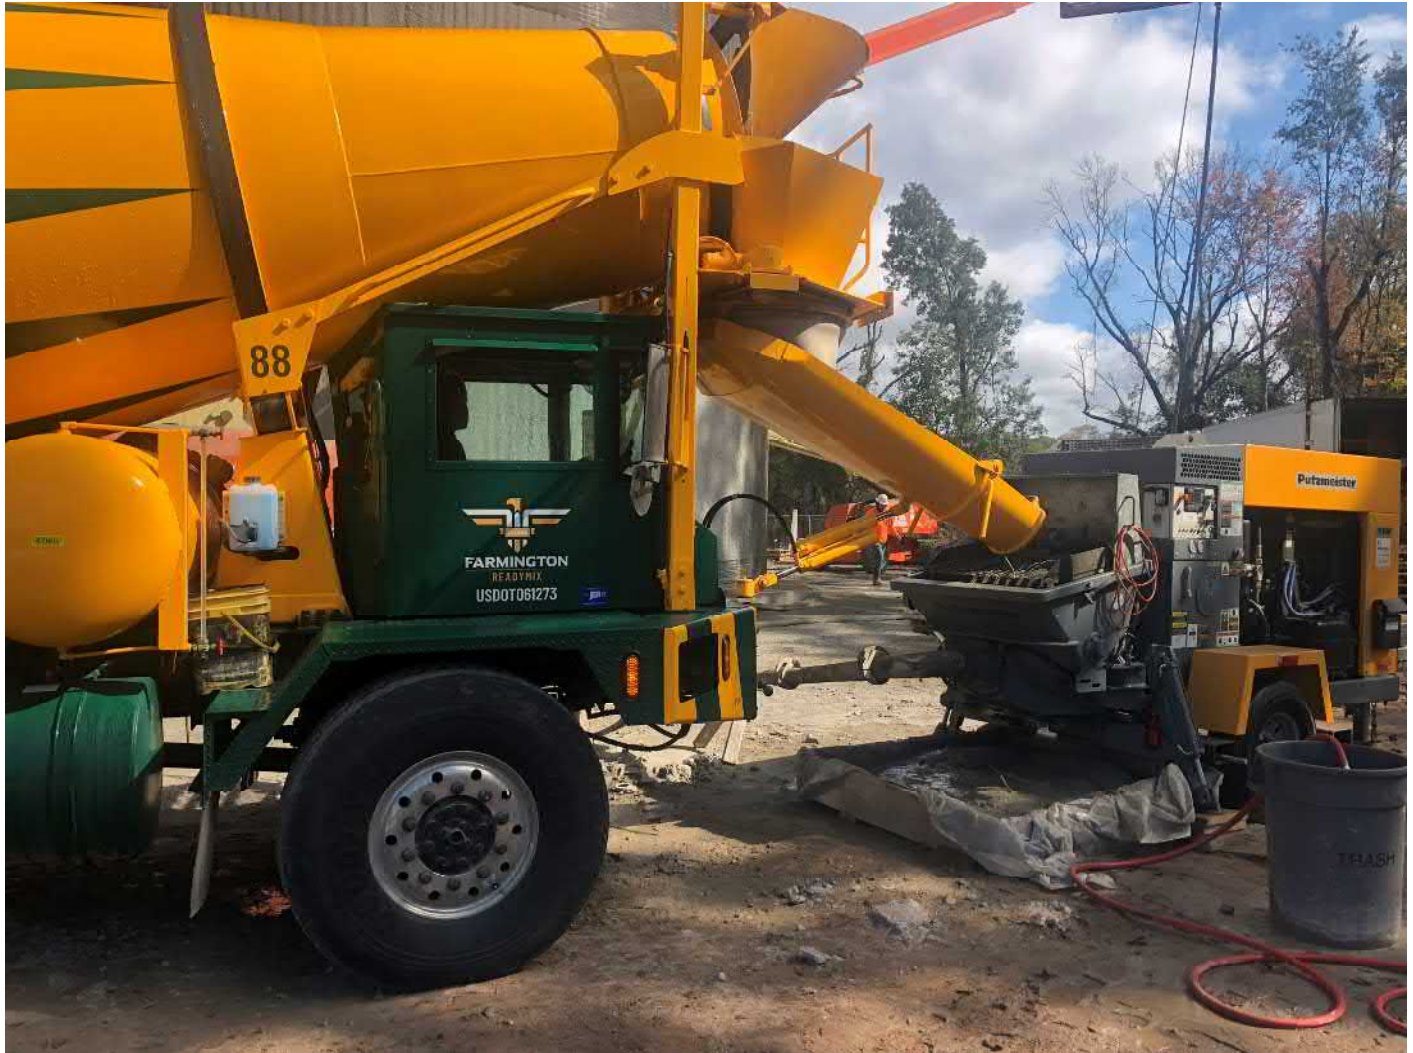
1159: A third truck of shotcrete from Farmington Ready Mix arrives to the water tank work zone as DN Tanks continues to apply shotcrete to the recently placed prestressed wire. No samples were collected from this truck by JTC.

Picture 6: The third of three trucks of shotcrete about to start transferring shotcrete into pumper/mixer. Water tank work zone located to the east of the Shared Access Driveway, Middletown. View to the east.

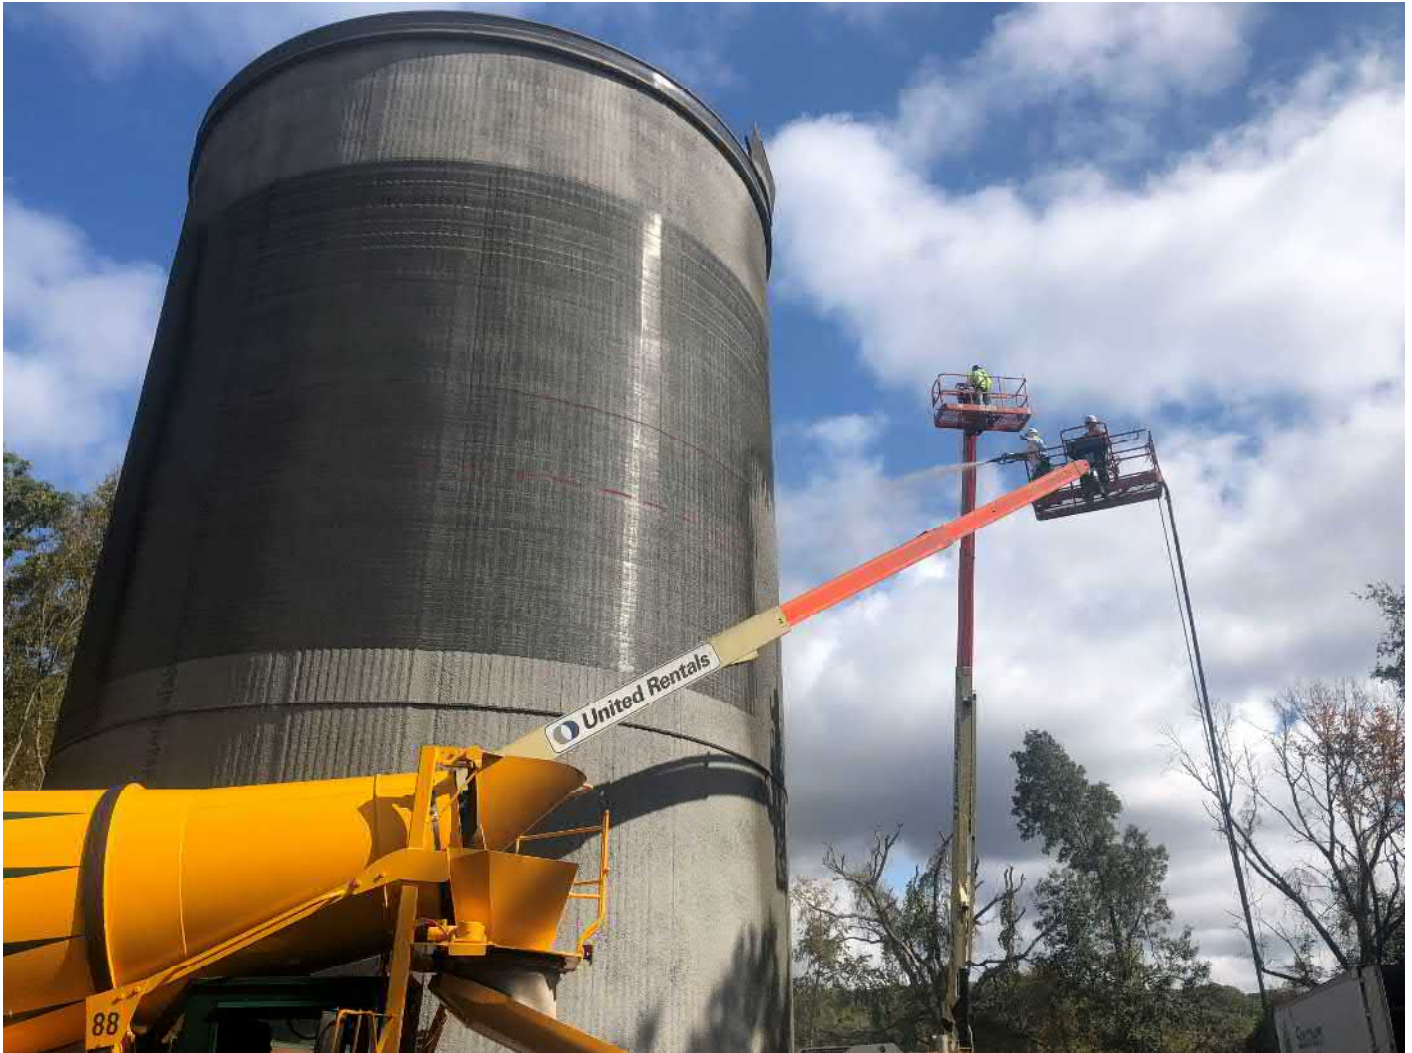
1020: DN Tanks begins to apply shotcrete to exposed prestressed wire on the sides of the water tank. They are also applying the shotcrete to the second layer of exposed prestressed wire on the tank's dome rim.

Picture 7: DN Tanks applying shotcrete to the side of the water tank. Water tank work zone located to the east of the Shared Access Driveway, Middletown. View to the east.

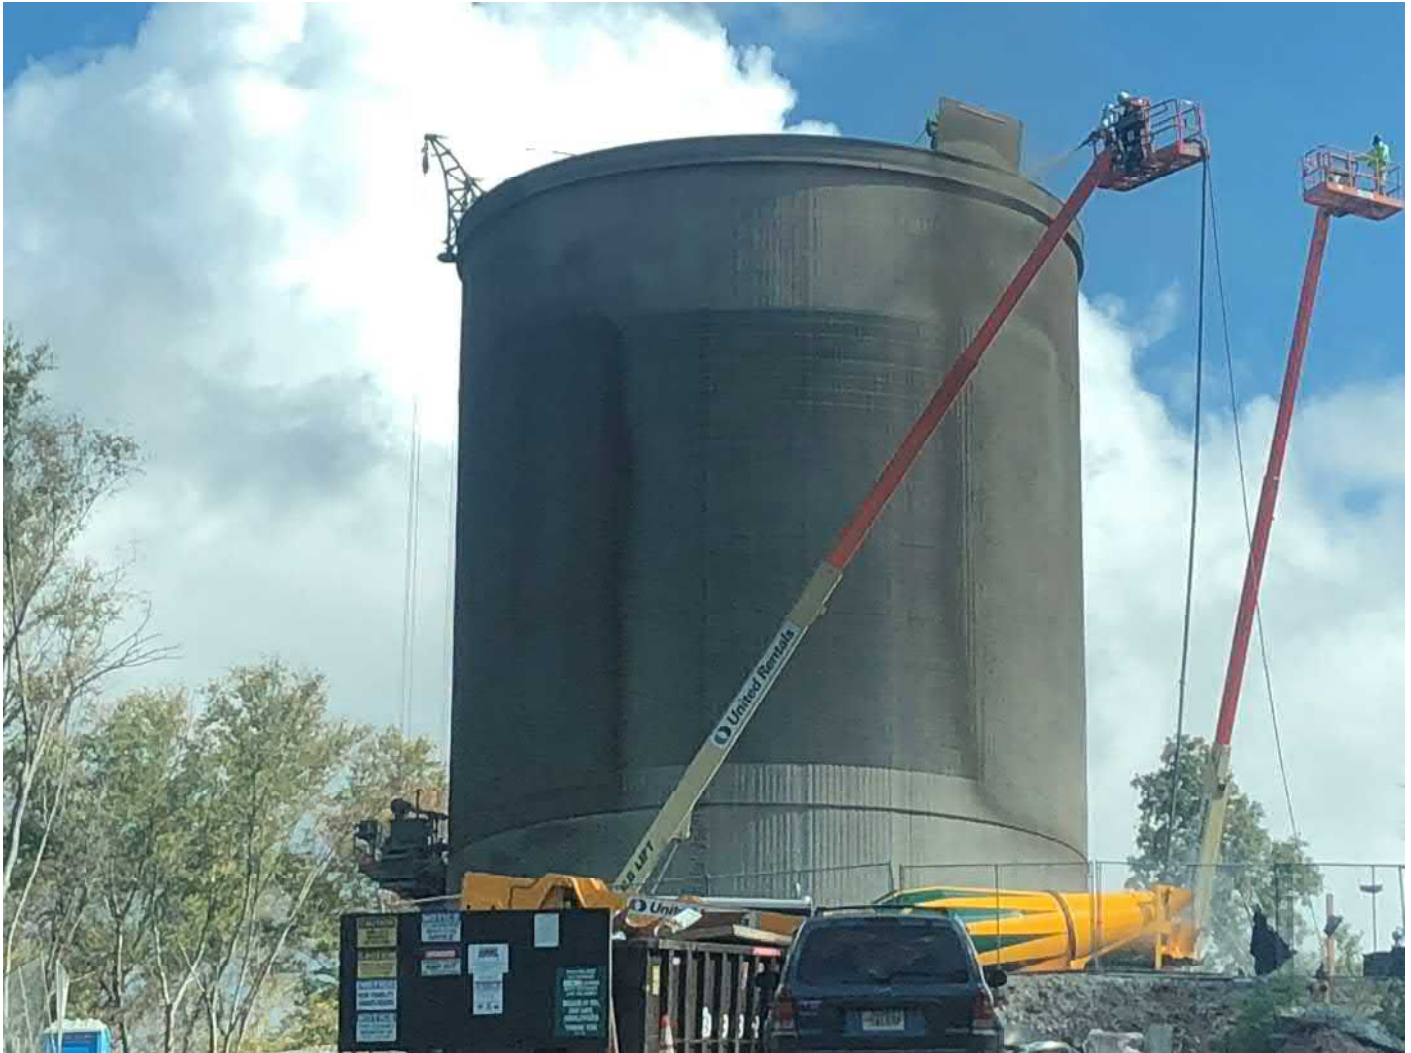
Picture 8: DN Tanks applying shotcrete to the dome rim of the water tank. Water tank work zone located to the east of the Shared Access Driveway, Middletown. View to the east.

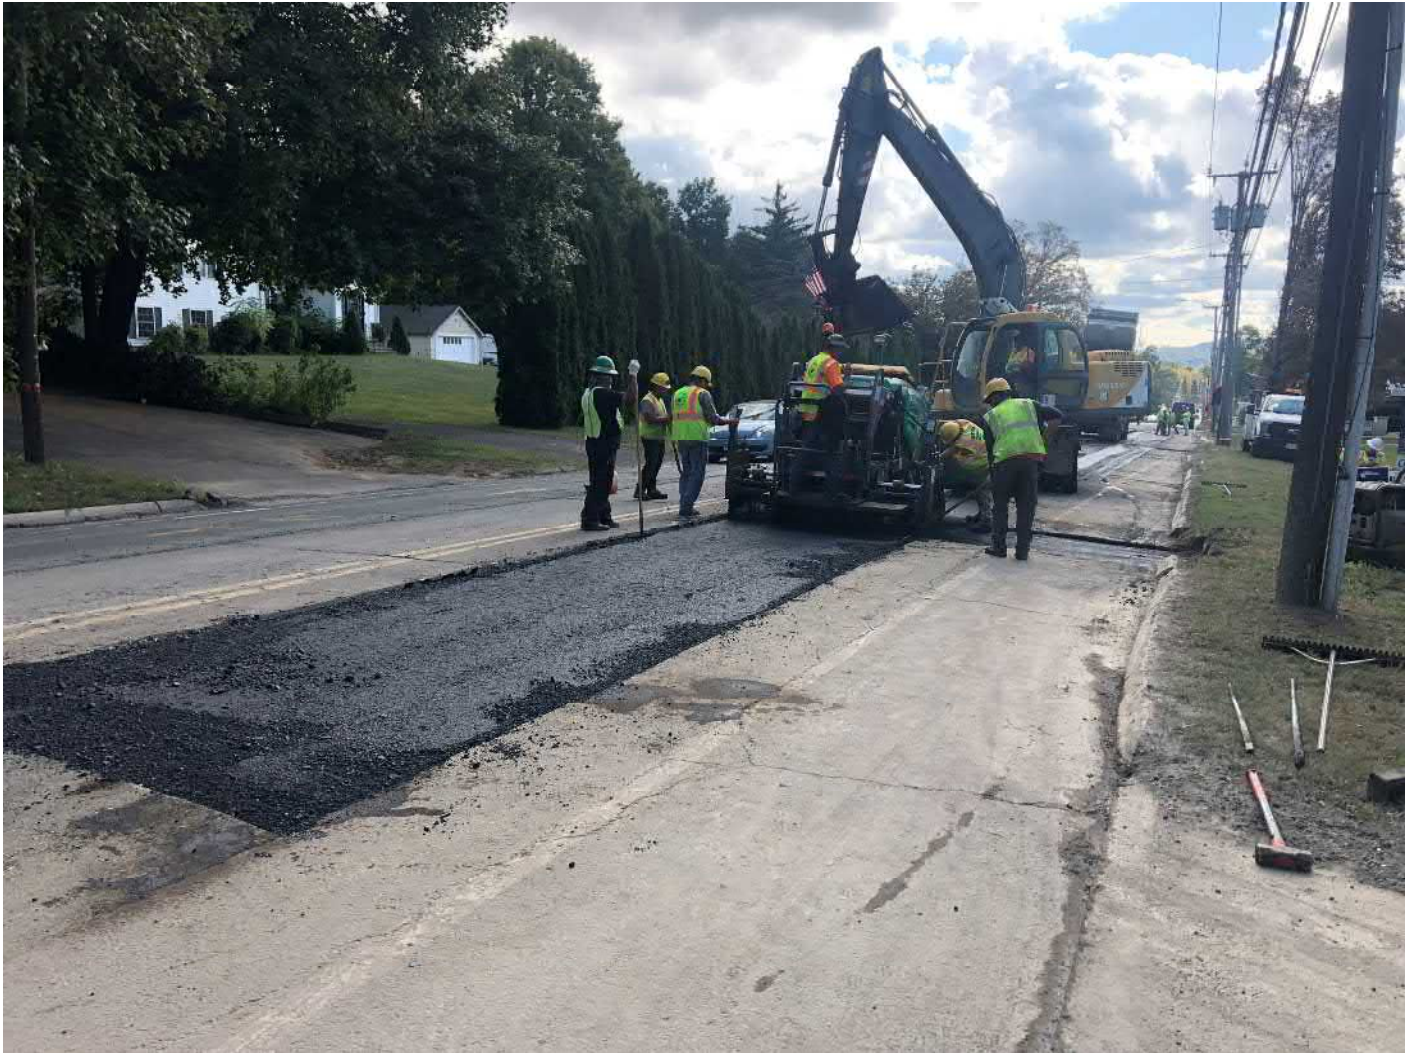
1254: Ludlow is applying the second of three 3" lifts of asphalt between Stations 148+65 and 151+35. JTC Is present waiting for to collect compaction data from the asphalt.

Picture 9: Ludlow placing the second of three 3" lifts of asphalt as part of permanent paving activities on the southbound lane of Main Street, Durham from Stations 148+65to 151+35. View to the southeast.

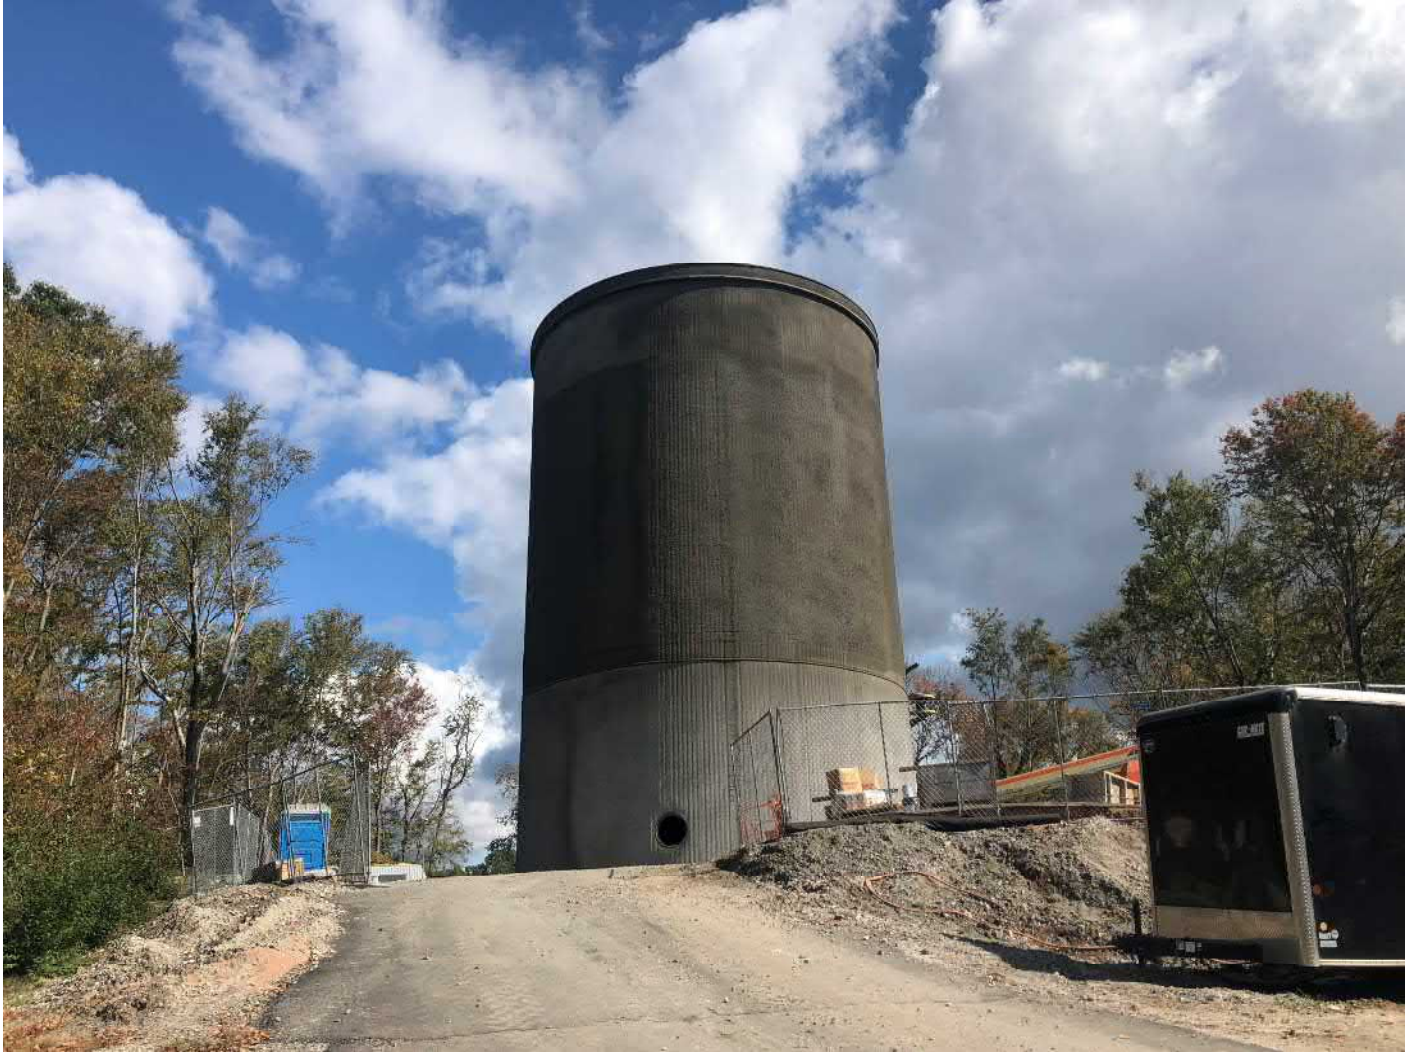
Picture 11: Overview of the water tank after DN Tanks applied shotcrete today. Water tank work zone located to the east of the Shared Access Driveway, Middletown. View to the east.
