Daily Report

Project:	Durham Meadows Pipeline Installation	Date:	October 6, 2020
Location:	Main Street, Durham; Shared Access Driveway, Middletown	Day of Week:	Tuesday
Project #:	AECOM: 6061487	Report No:	173
Contractor:	Ludlow Construction	Page:	1 of 13

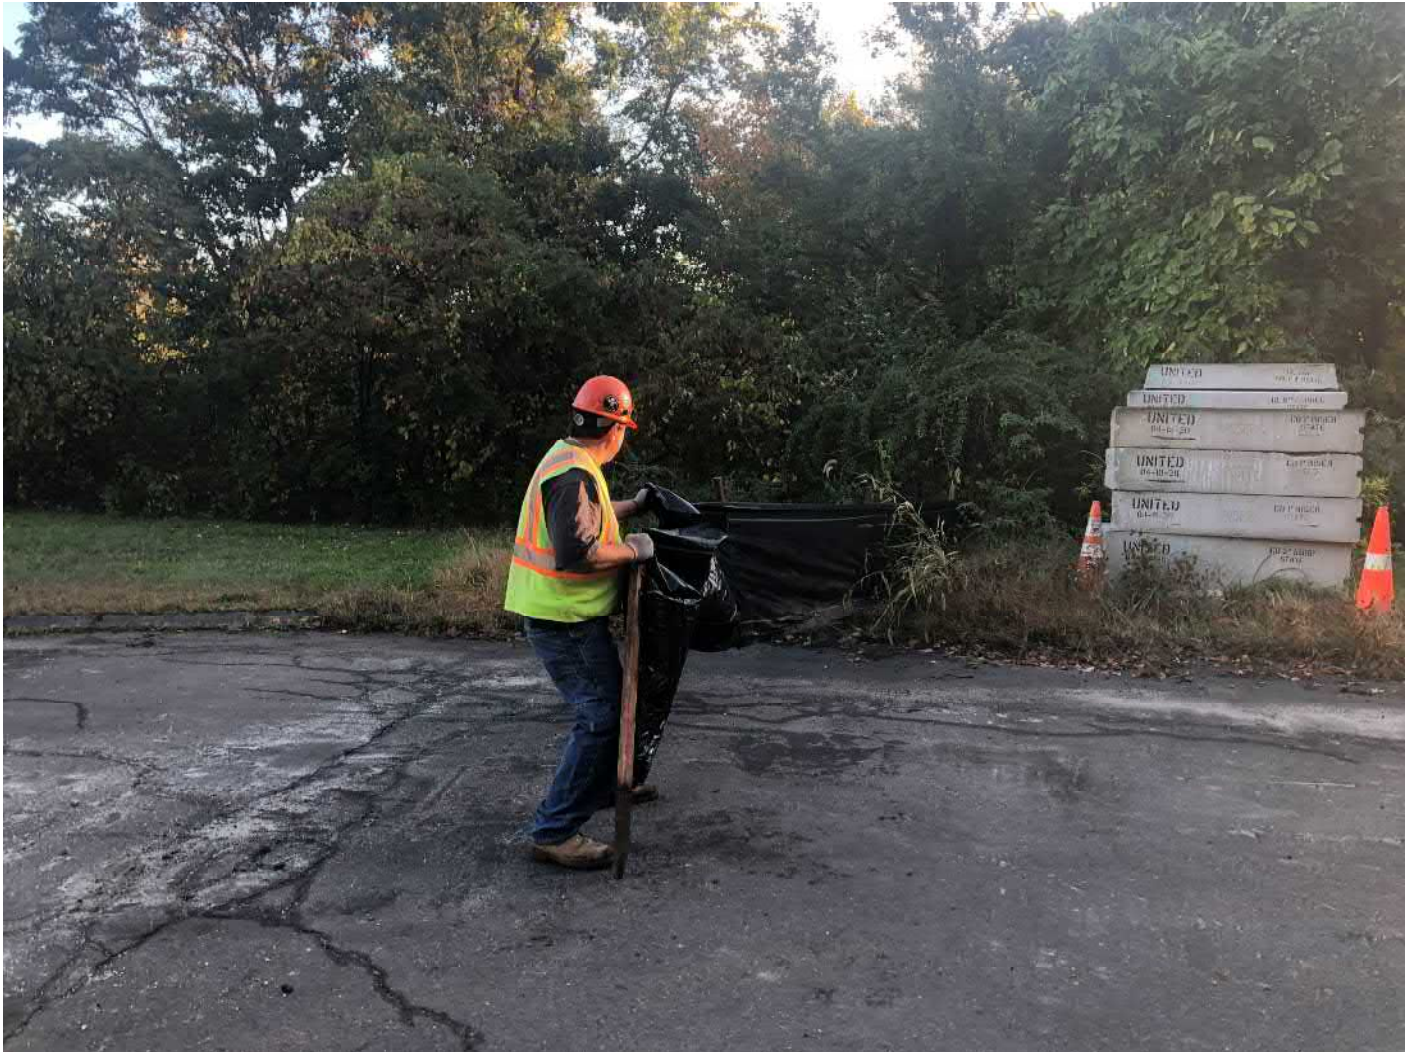
Picture 1: Ludlow removing silt fence from the Talcott Ridge Drive cul-de-sac and down along the Shared Access Driveway. View to the north.

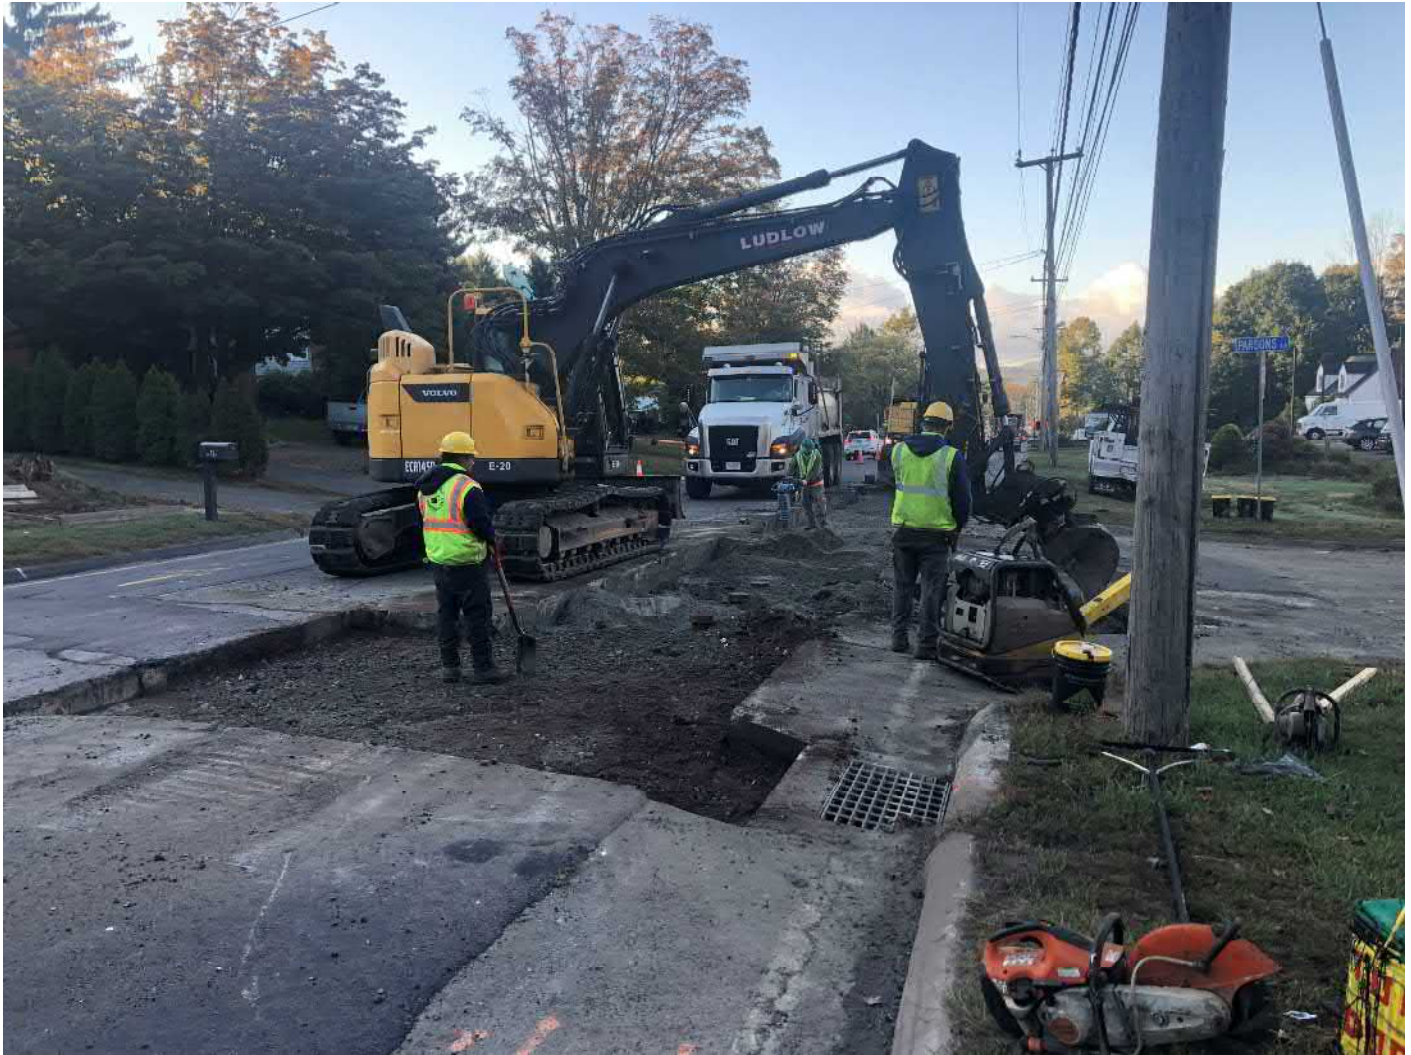
Picture 2: Ludlow stripping back asphalt as they prepare to place permanent paving on the southbound lane of Main Street, Durham from Stations 151+35 to 154+25. View to the south.

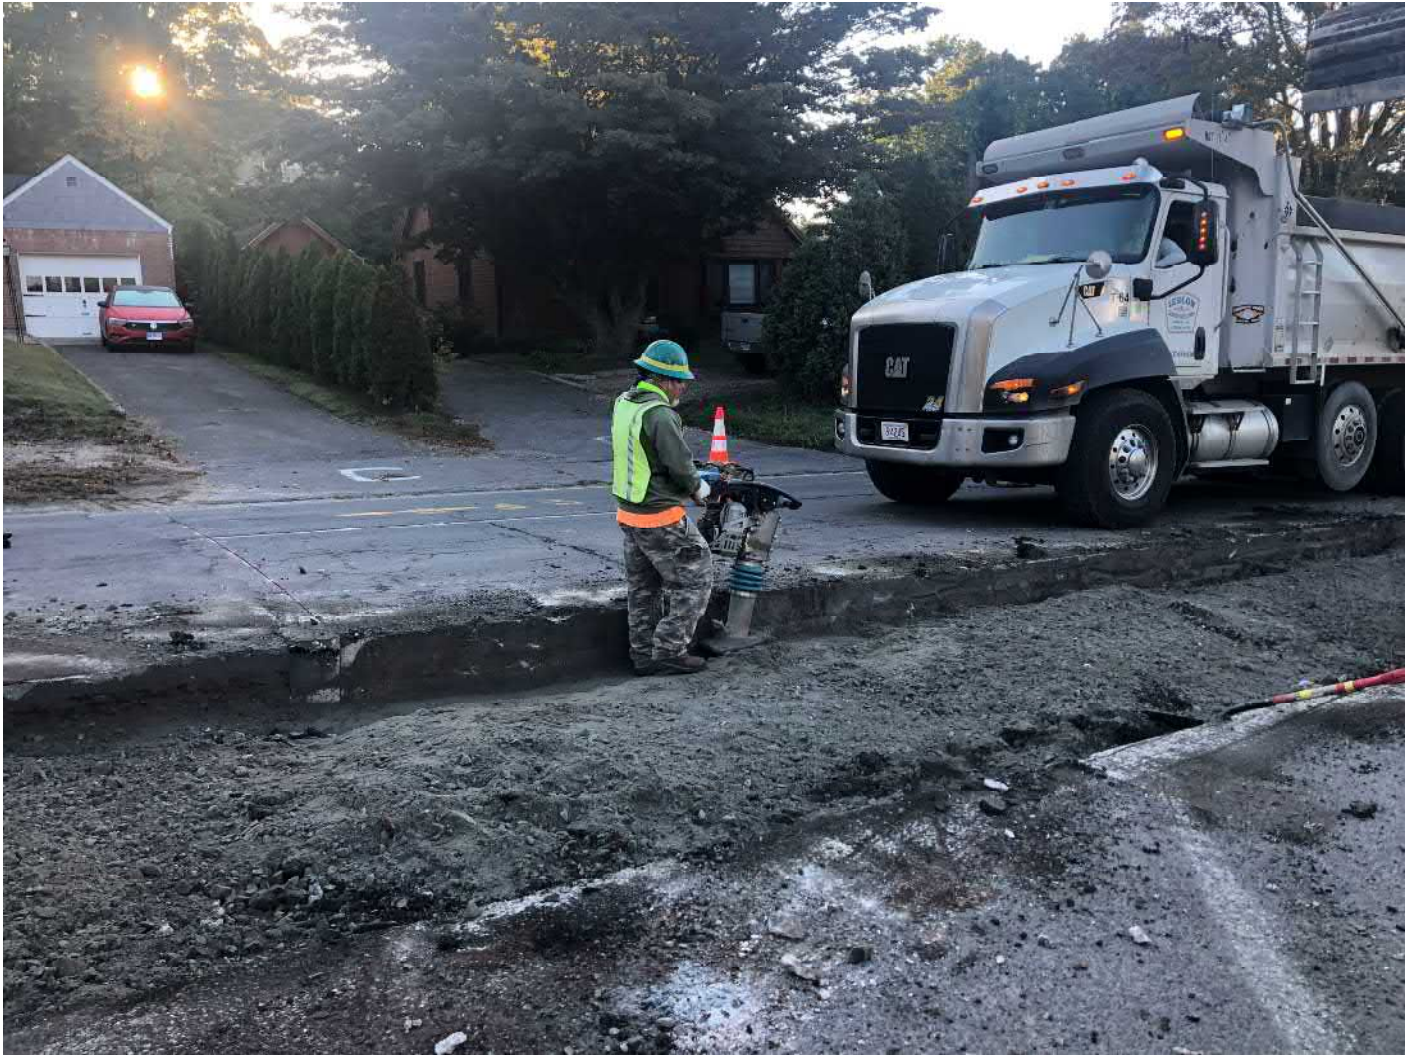
Picture 3: Ludlow using a Jumping Jack to compact 1.5" processed gravel along the edge of cut pavement as they prepare to place permanent paving on the southbound lane of Main Street, Durham from Stations 151+35 to 154+25. View to the southeast.

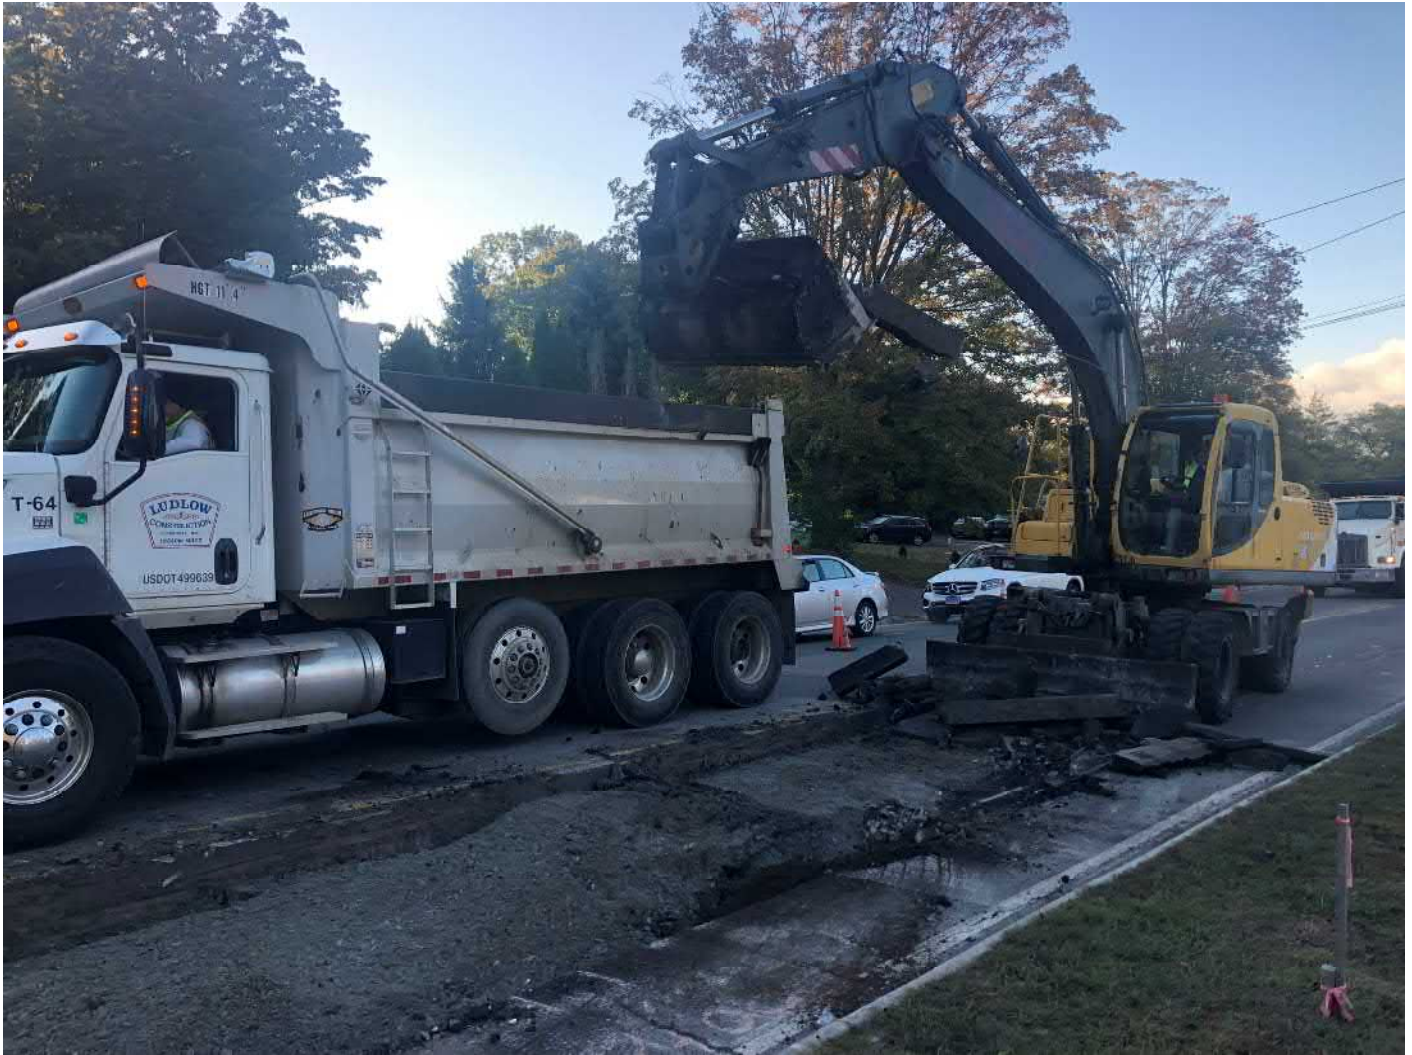
Picture 4: Ludlow loading asphalt and concrete into a dump truck as they strip back asphalt for permanent paving on the southbound lane of Main Street, Durham from Stations 151+35 to 154+25. View to the southeast.

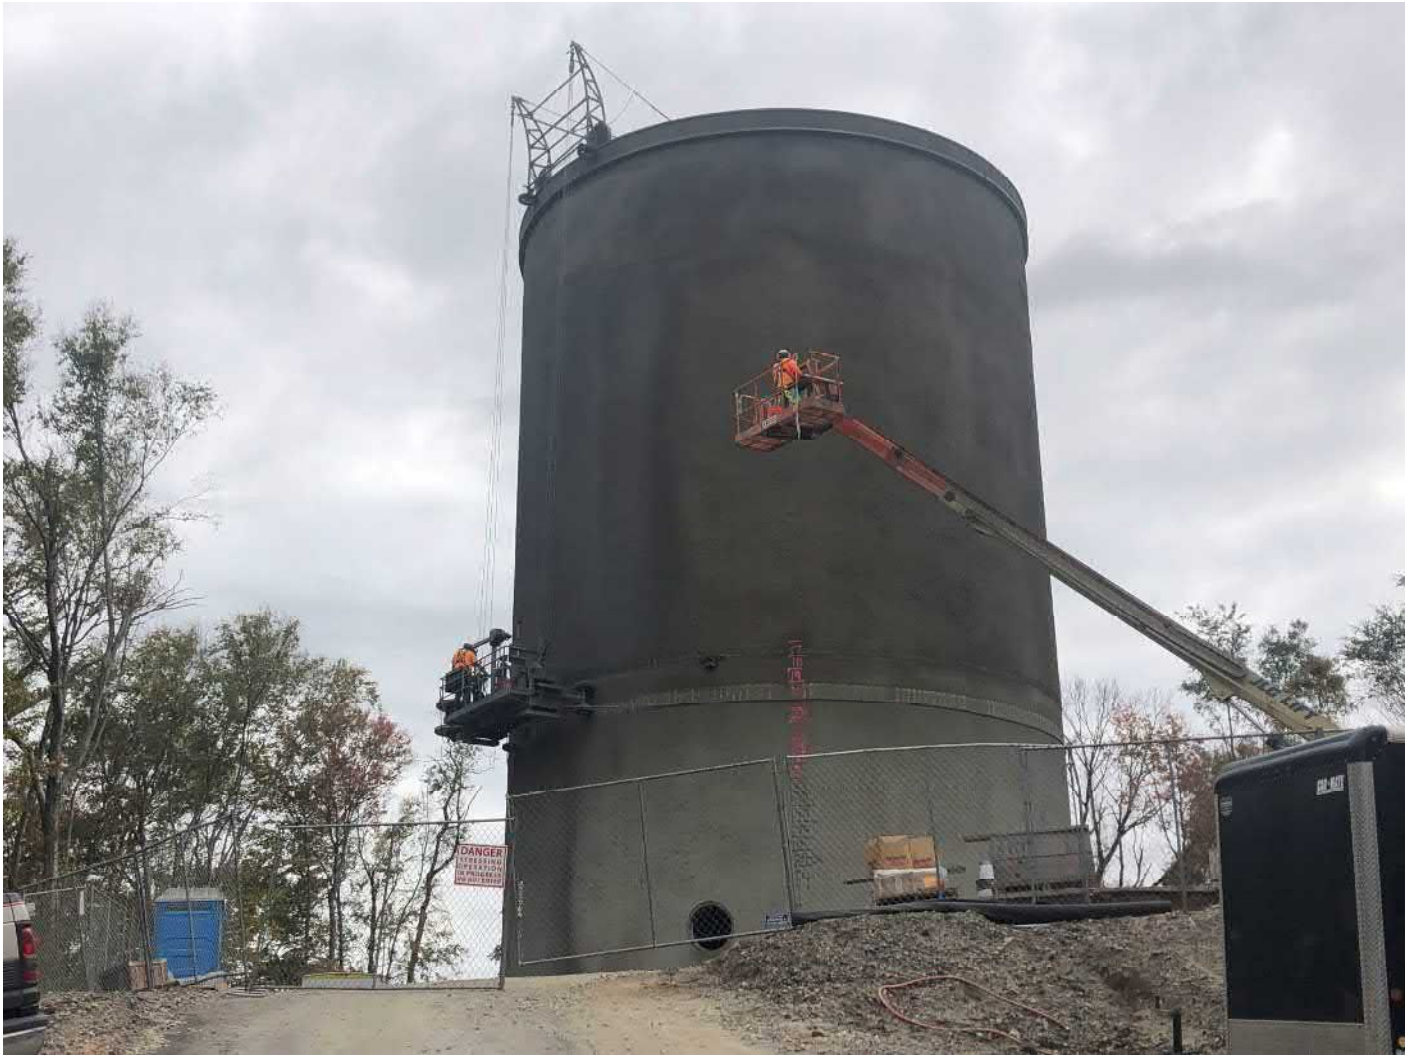
Picture 5: DN Tanks wrapping prestressed wire around the sides of the water tank. Water tank work zone located to the east of the Shared Access Driveway, Middletown. View to the east.

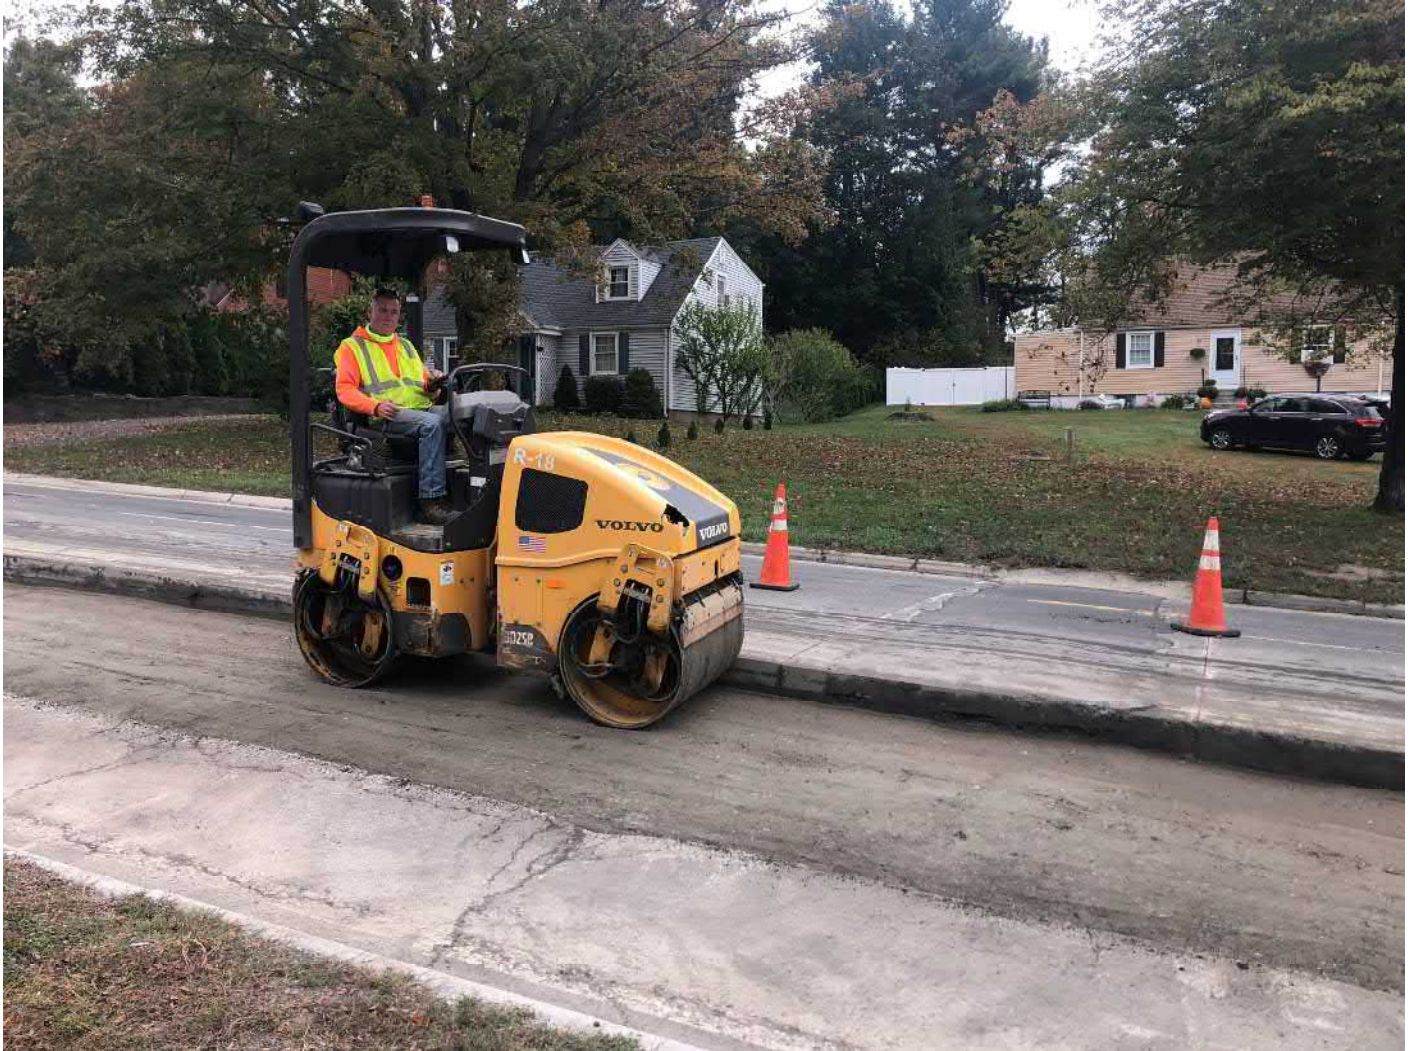
Picture 6: Ludlow is compacting 1.5" processed gravel as they prepare to place permanent paving on the southbound lane of Main Street, Durham from Stations 151+35 to 154+25. View to the east.

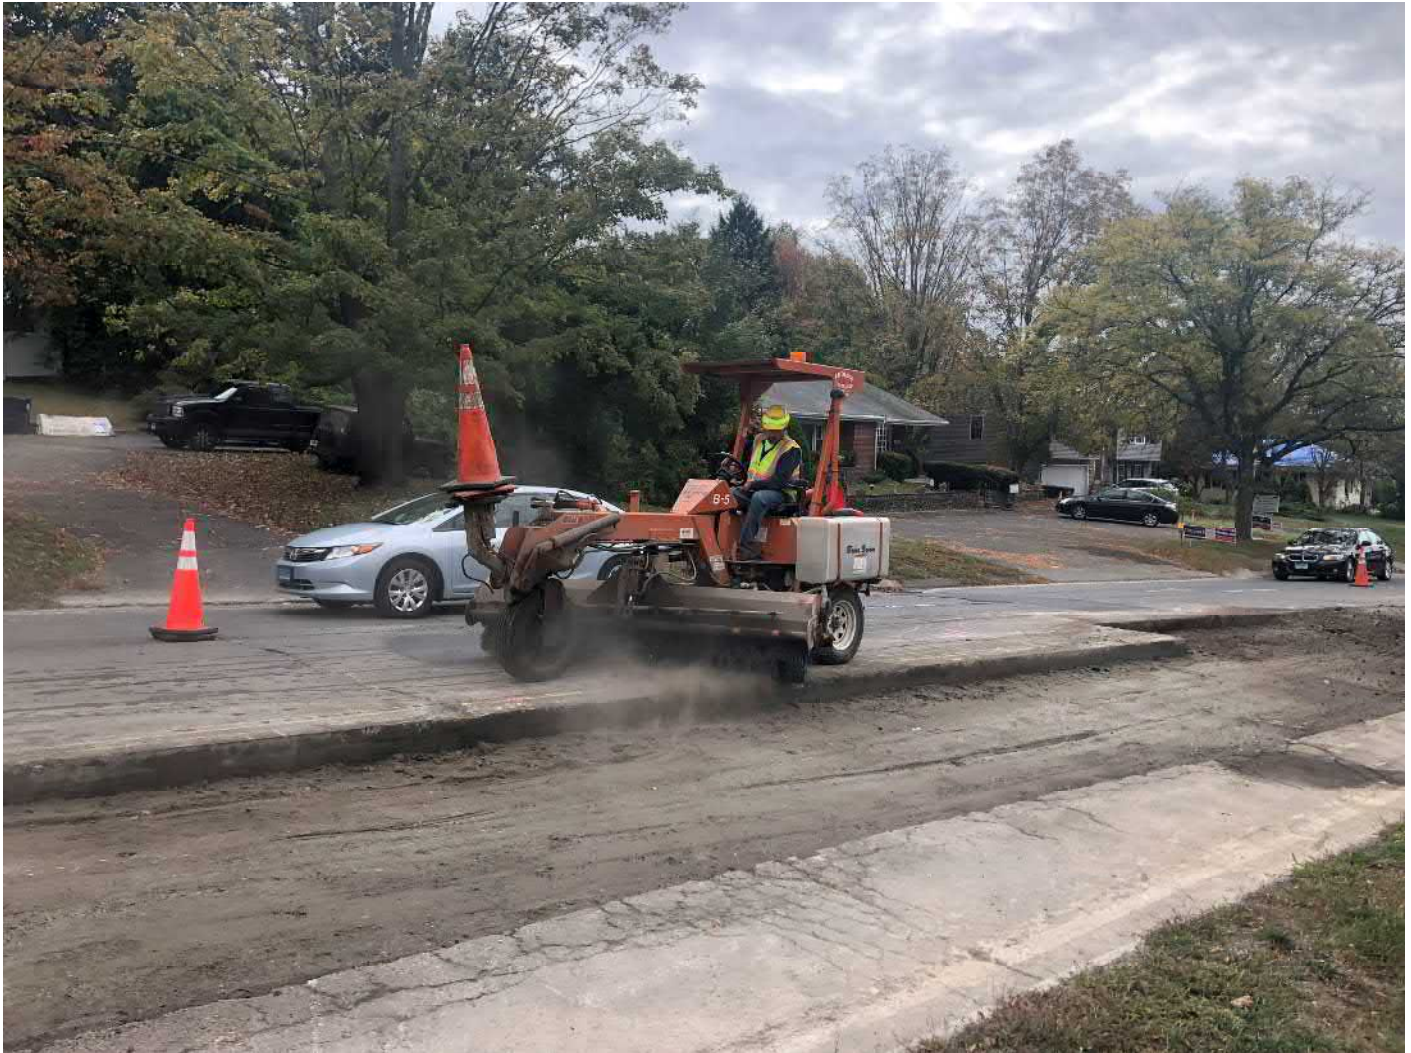
Picture 7: Ludlow cleaning work zone with the Broce Broom between Stations 151+35 to 154+25 as they prepare to place permanent paving on the southbound lane of Main Street, Durham. View to the southeast.

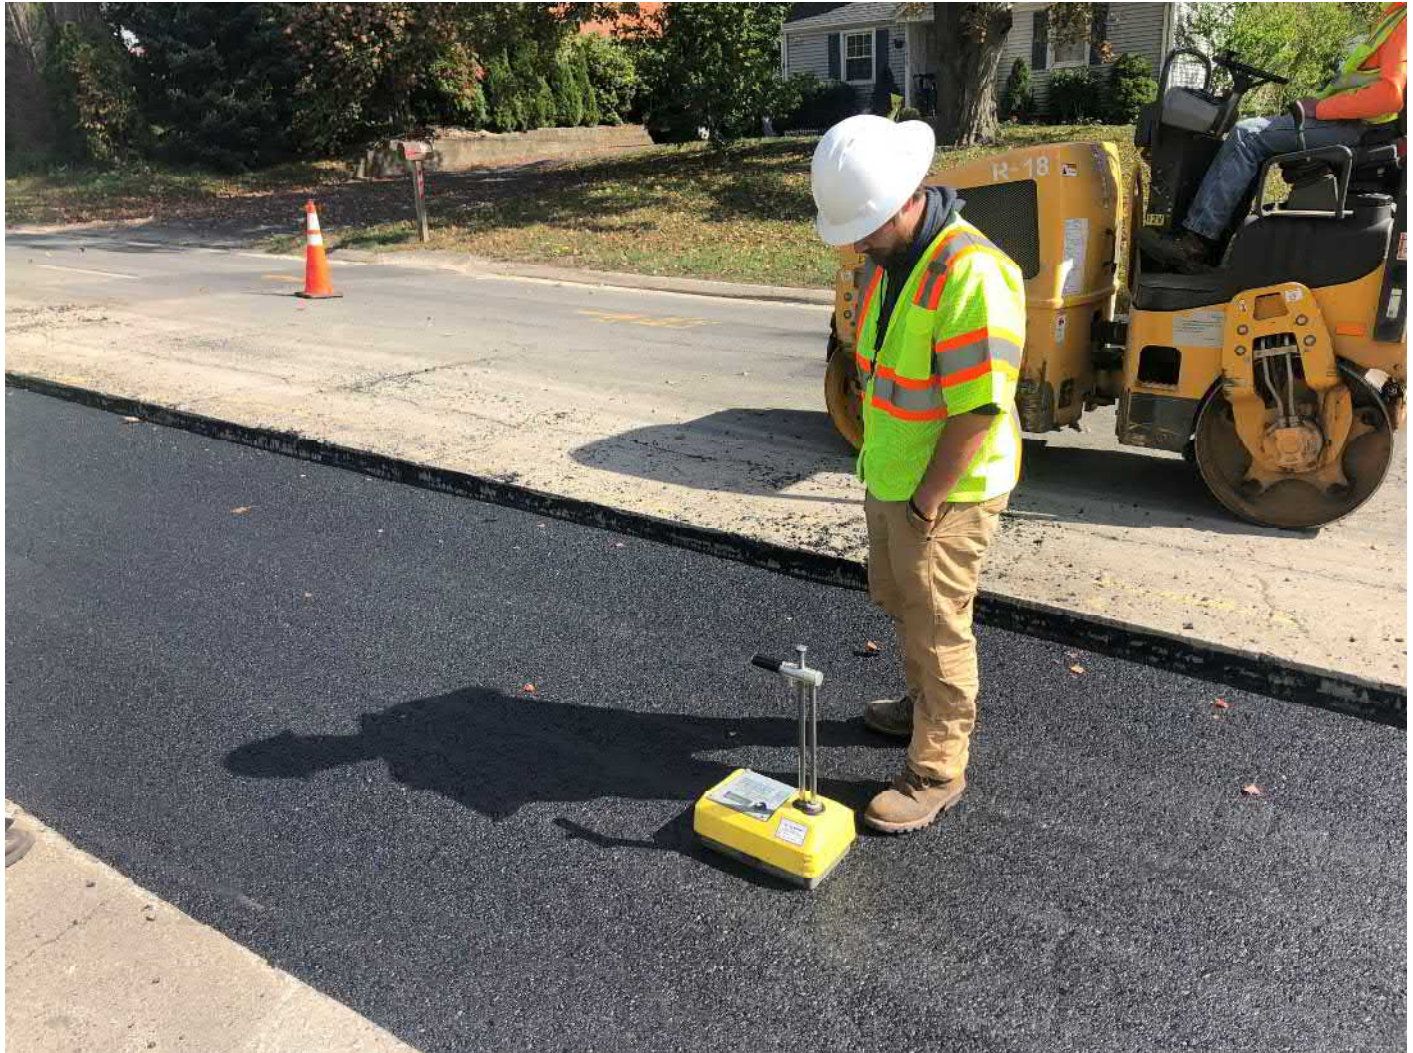
Picture 8: JTC is collecting compaction data from freshly placed and rolled asphalt between Stations 151+35 to 154+25 on the southbound lane of Main Street, Durham. View to the northeast.

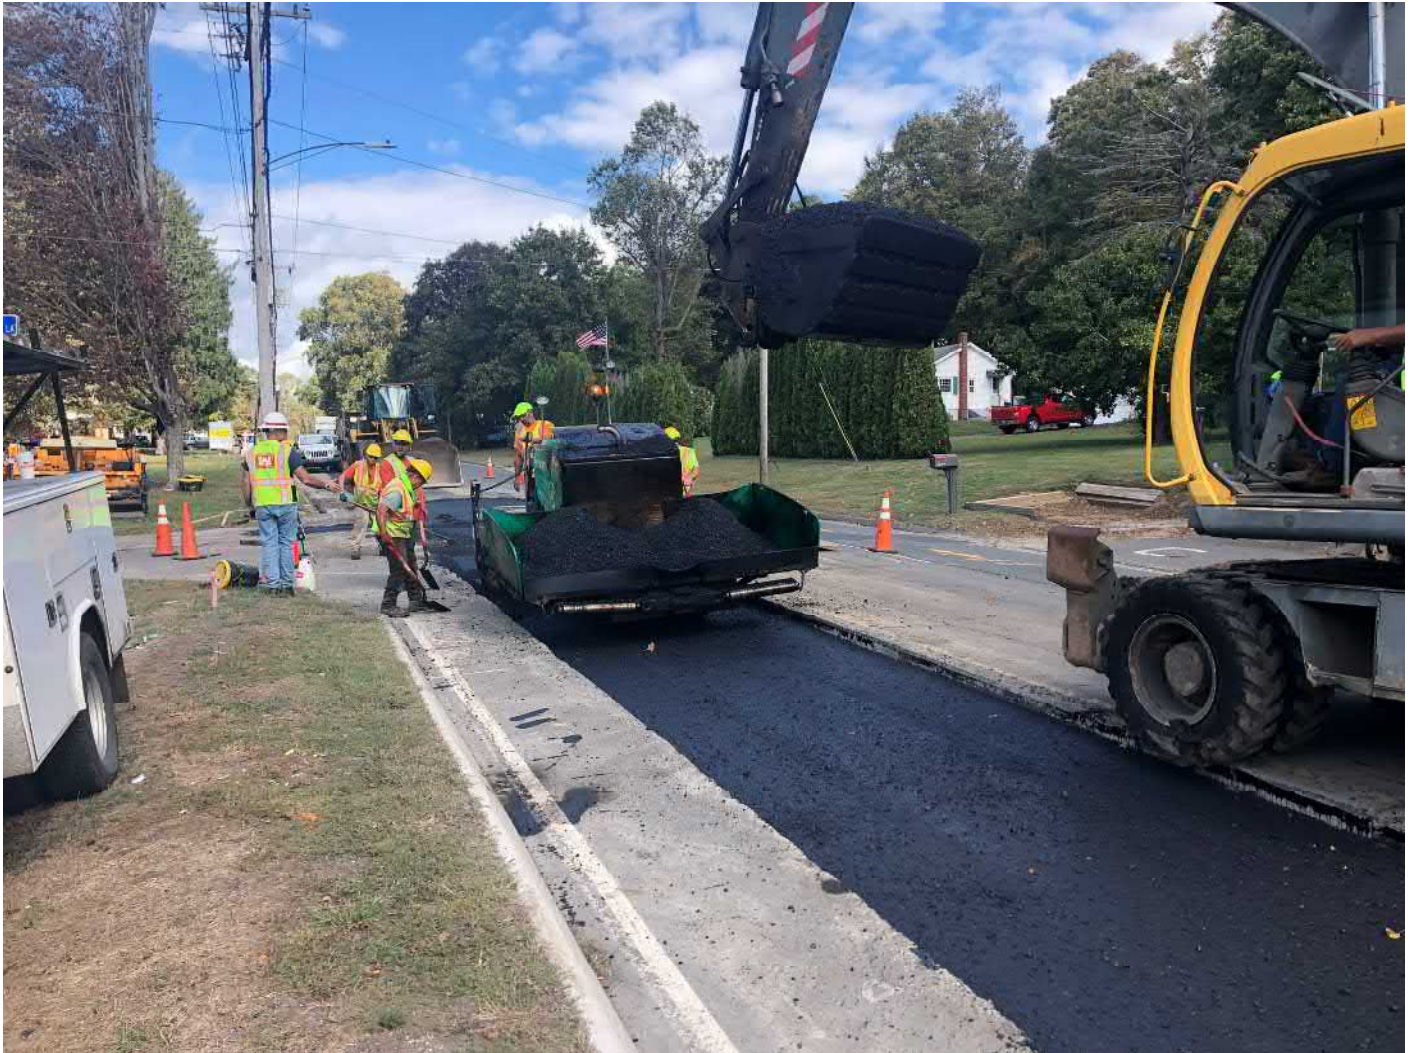
Picture 9: Ludlow placing the second of three 3" lifts of asphalt as part of permanent paving activities on the southbound lane of Main Street, Durham from Stations 151+35 to 154+25. View to the north.

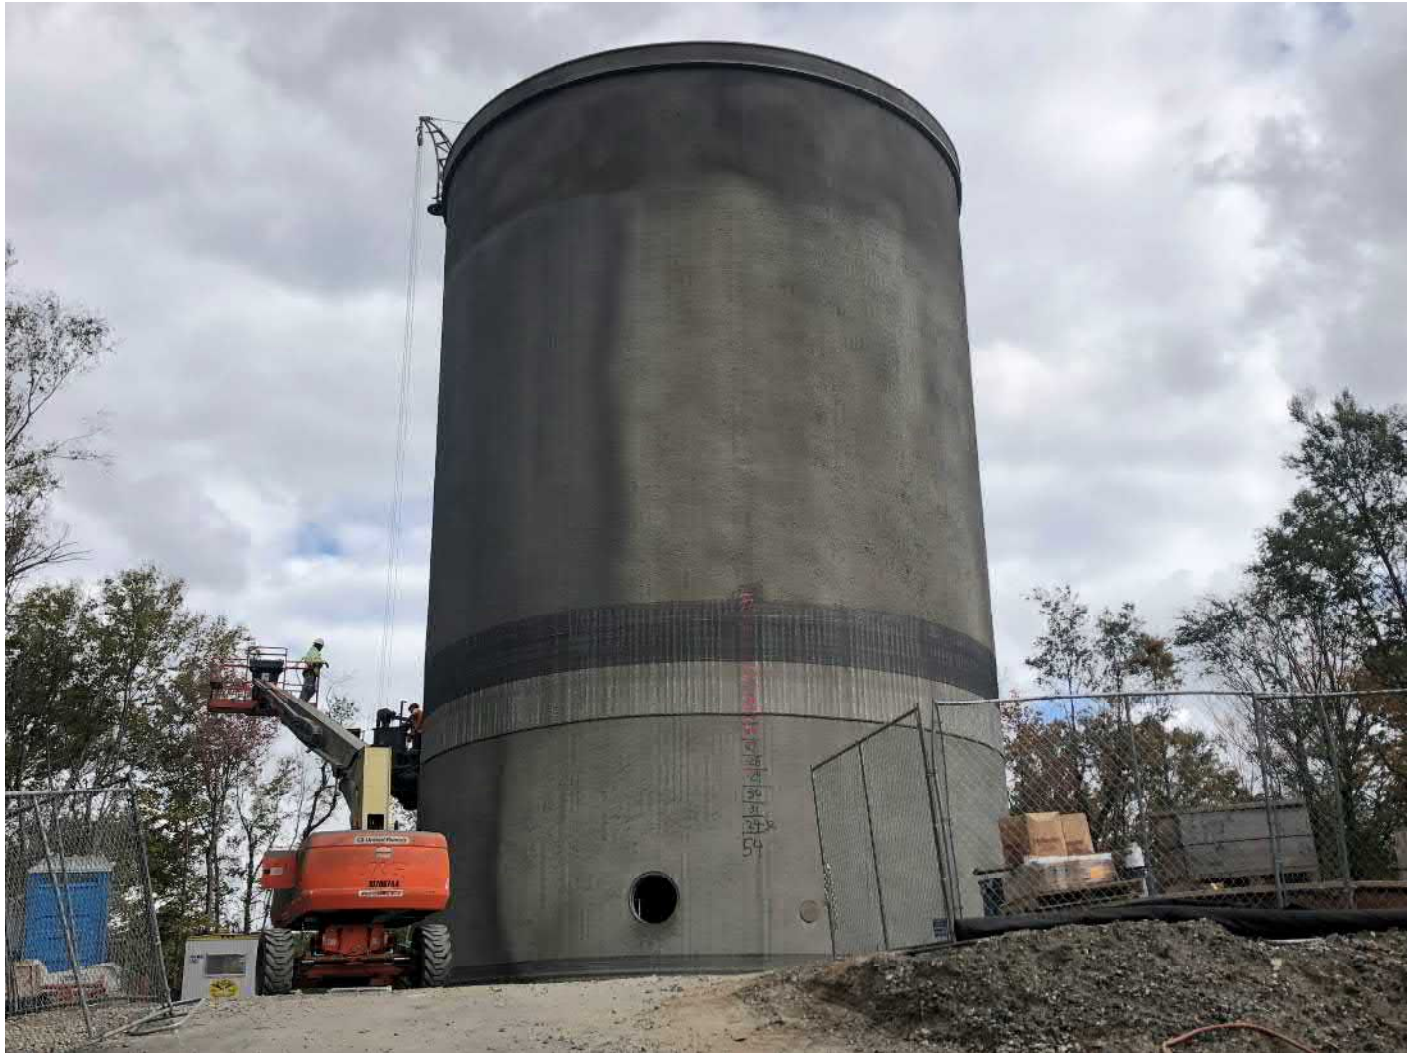
Picture 10: DN Tanks wrapping prestressed wire around the sides of the water tank. Water tank work zone located to the east of the Shared Access Driveway, Middletown. View to the east.
