## Daily Report

Project:	Durham Meadows Pipeline Installation	Date:	October 8, 2020
Location:	Main Street, Durham; Shared Access Driveway, Middletown	Day of Week:	Thursday
Project #:	AECOM: 6061487	Report No:	175
Contractor:	Ludlow Construction	Page:	1 of 12

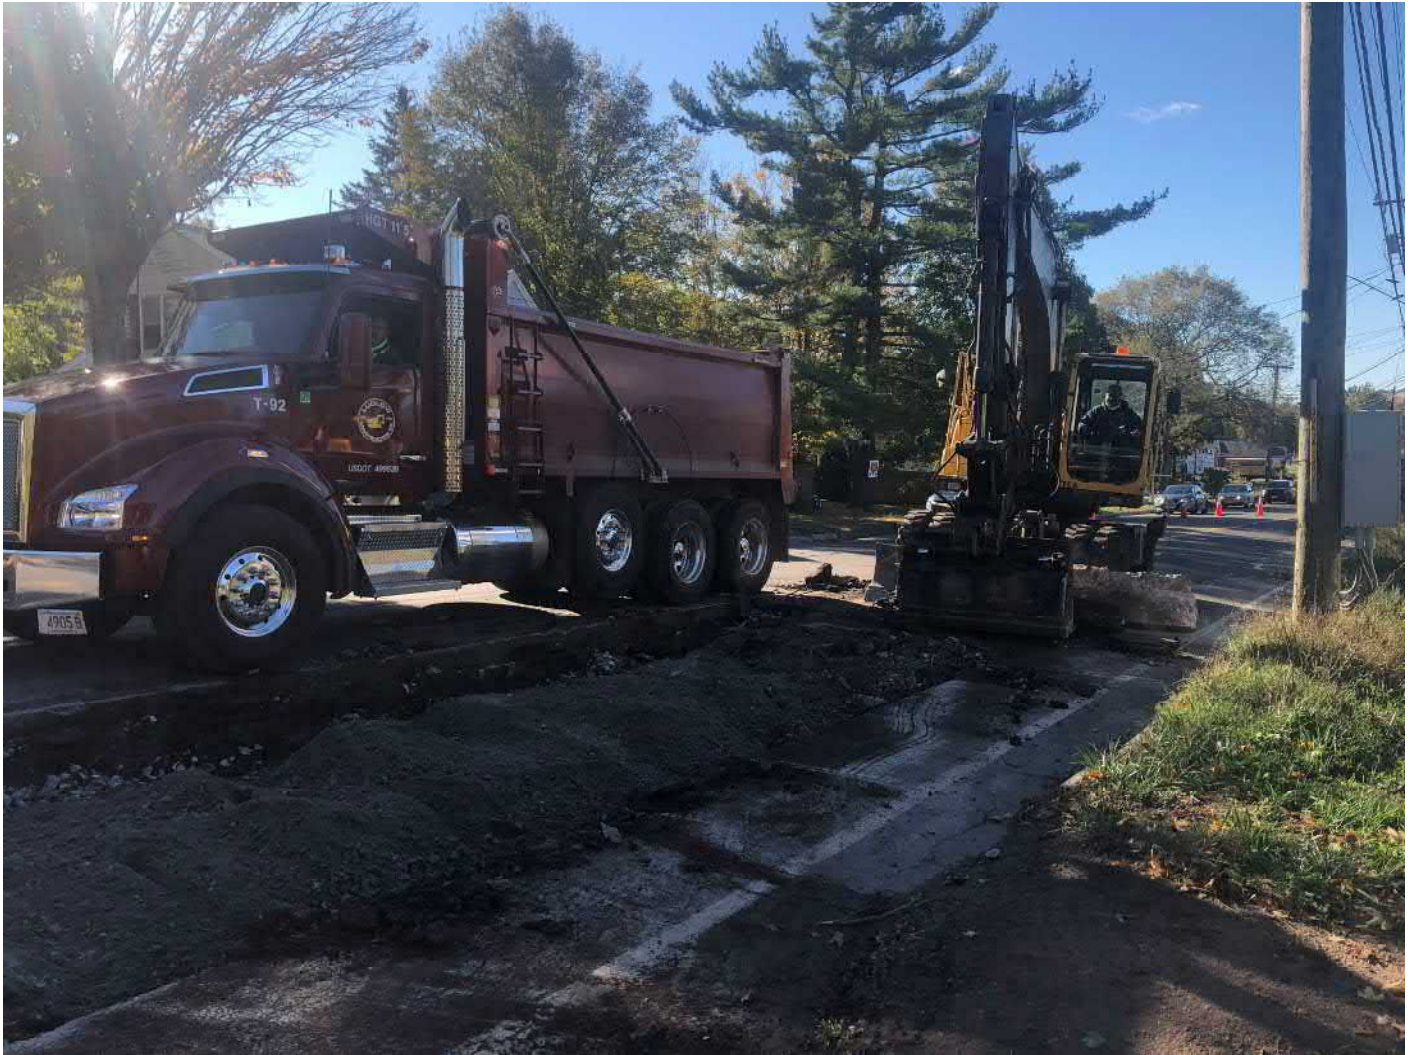
**Picture 2: Ludlow stripping back asphalt as they prepare to place permanent paving on the southbound lane of Main Street, Durham. View to the southeast.**

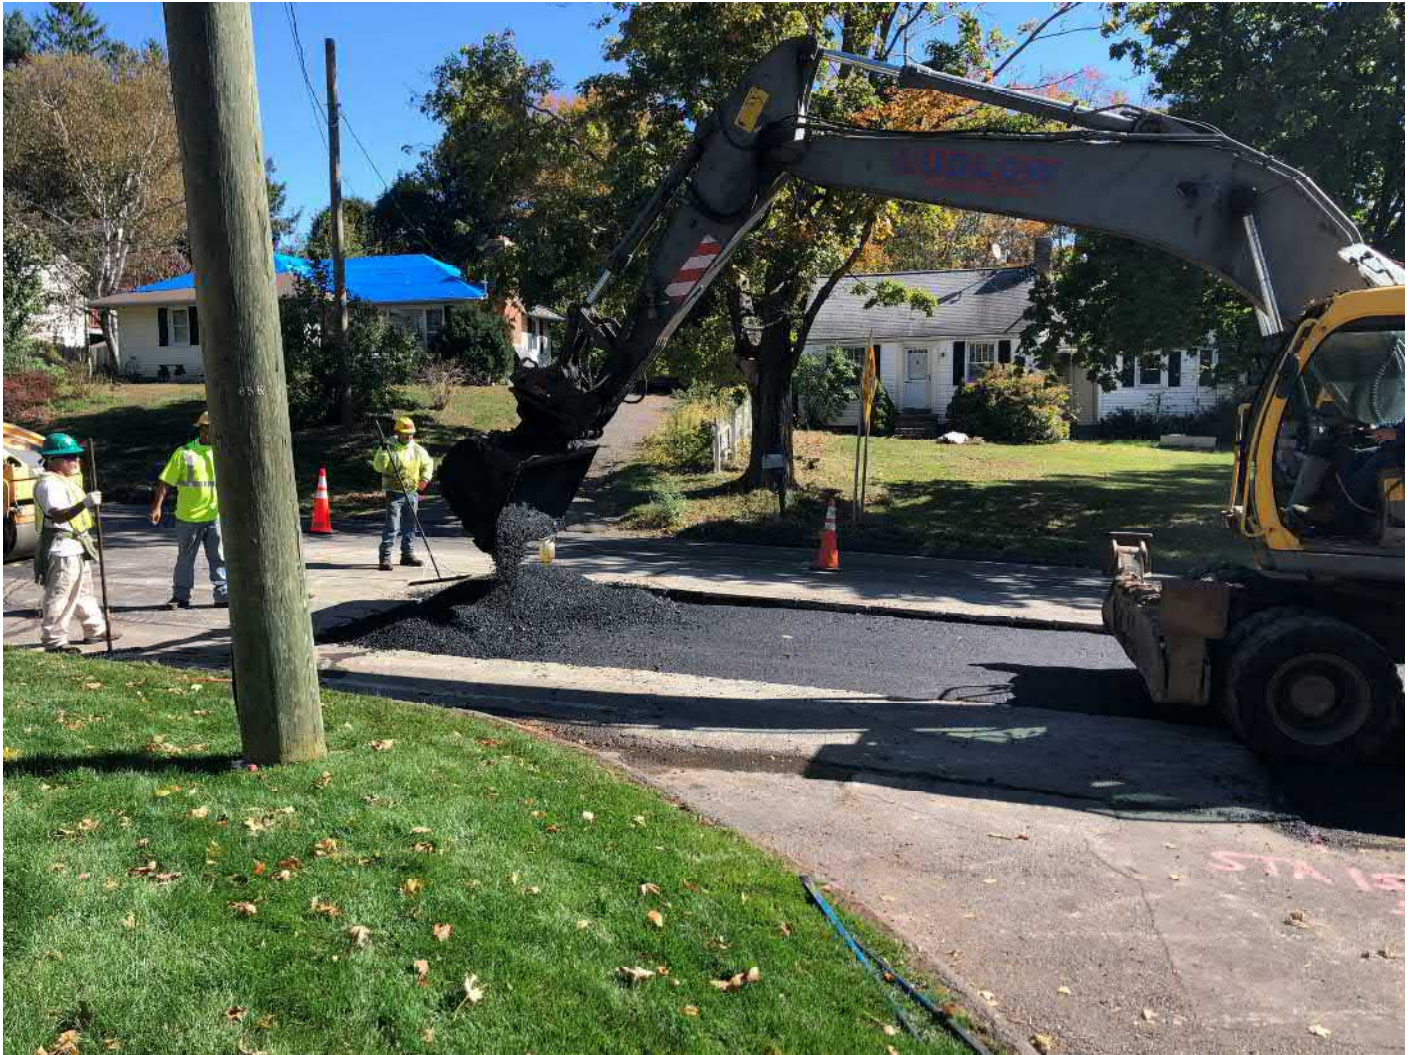
**Picture 3: Ludlow placing the first of three 3" lifts of asphalt on the southbound lane of Main Street, Durham between Stations 157+25 and 160+25. View to the east.**

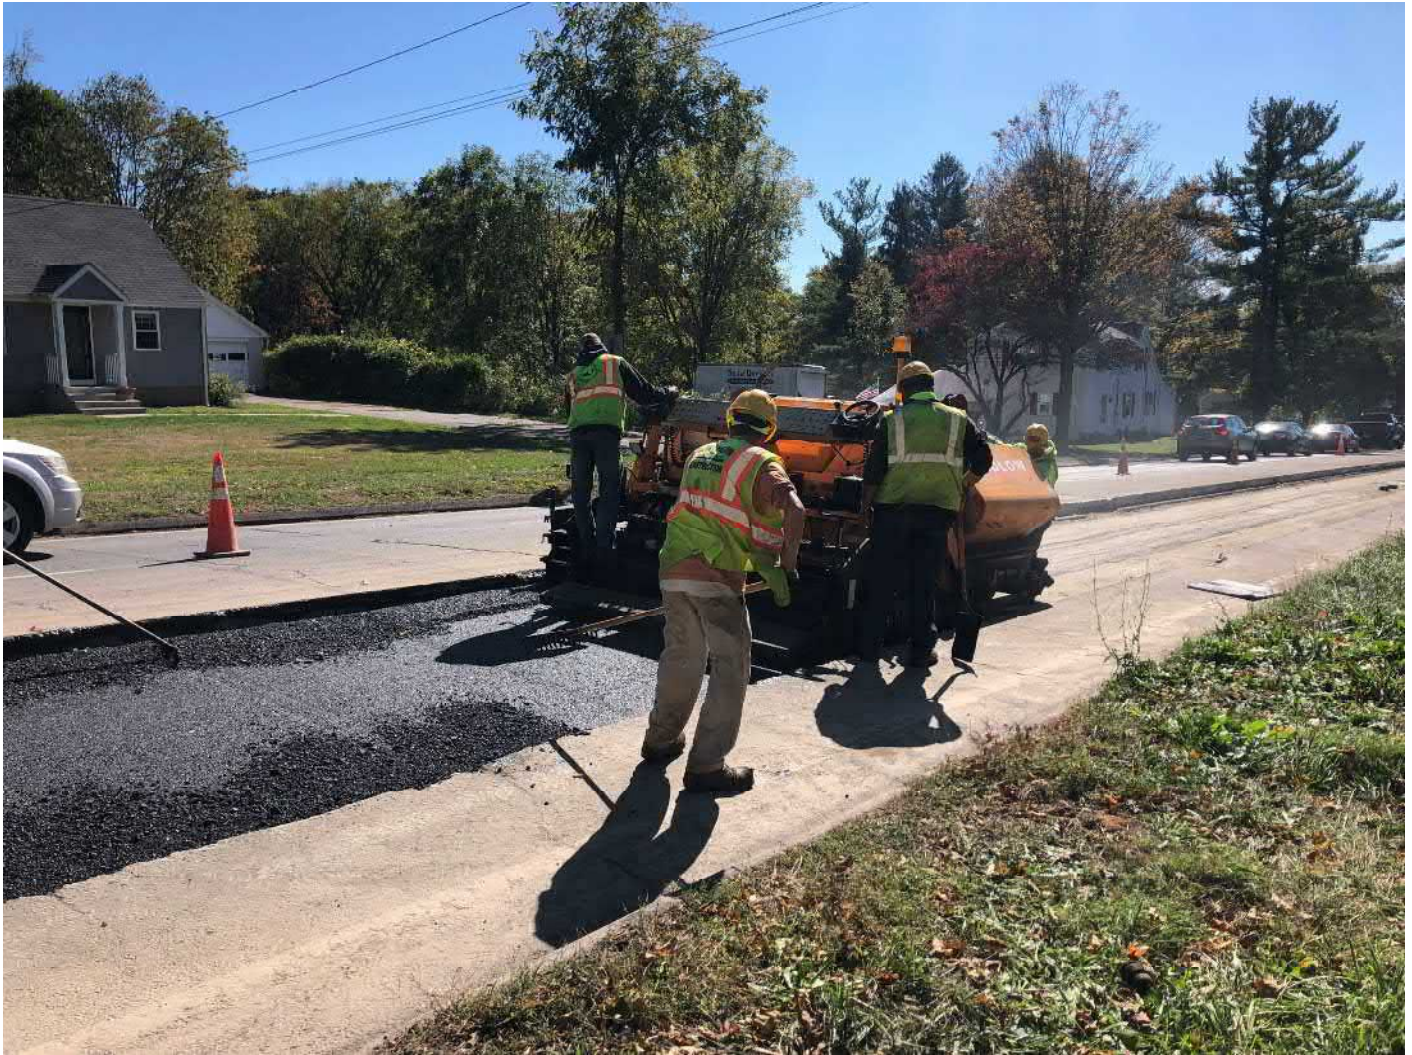
**Picture 4: Ludlow placing the first of three 3" lifts of asphalt on the southbound lane of Main Street, Durham between Stations 157+25 and 160+25. View to the southeast.**

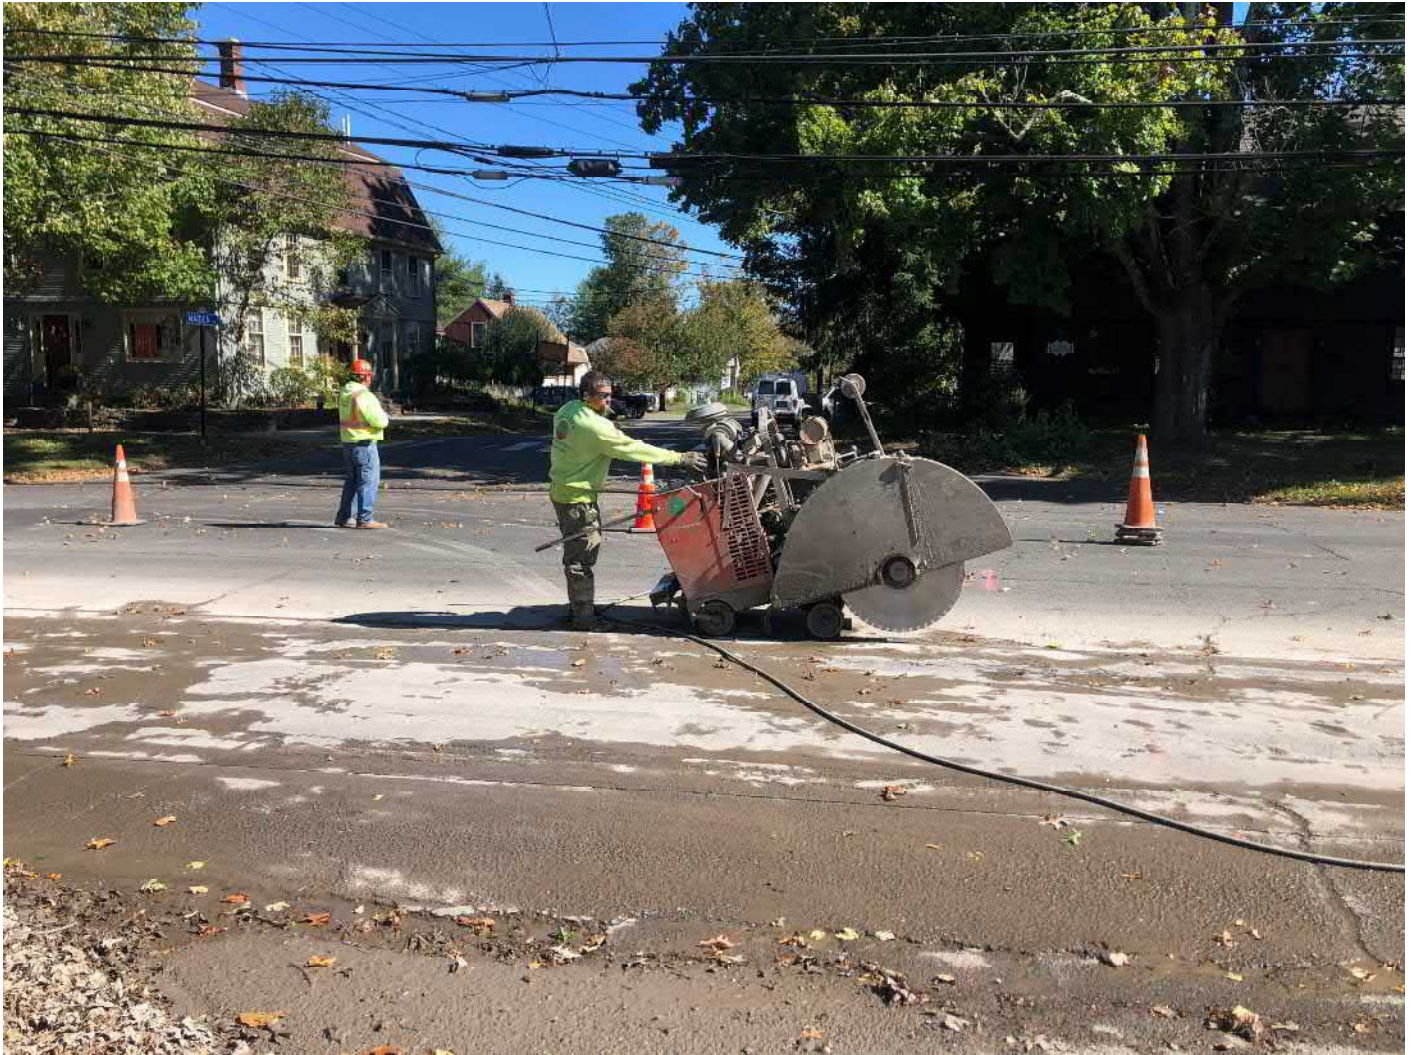
**Picture 5: Veilleux setting up to saw cut at Station 192+50 on the southbound lane of Main Street, Durham. View to the east.**

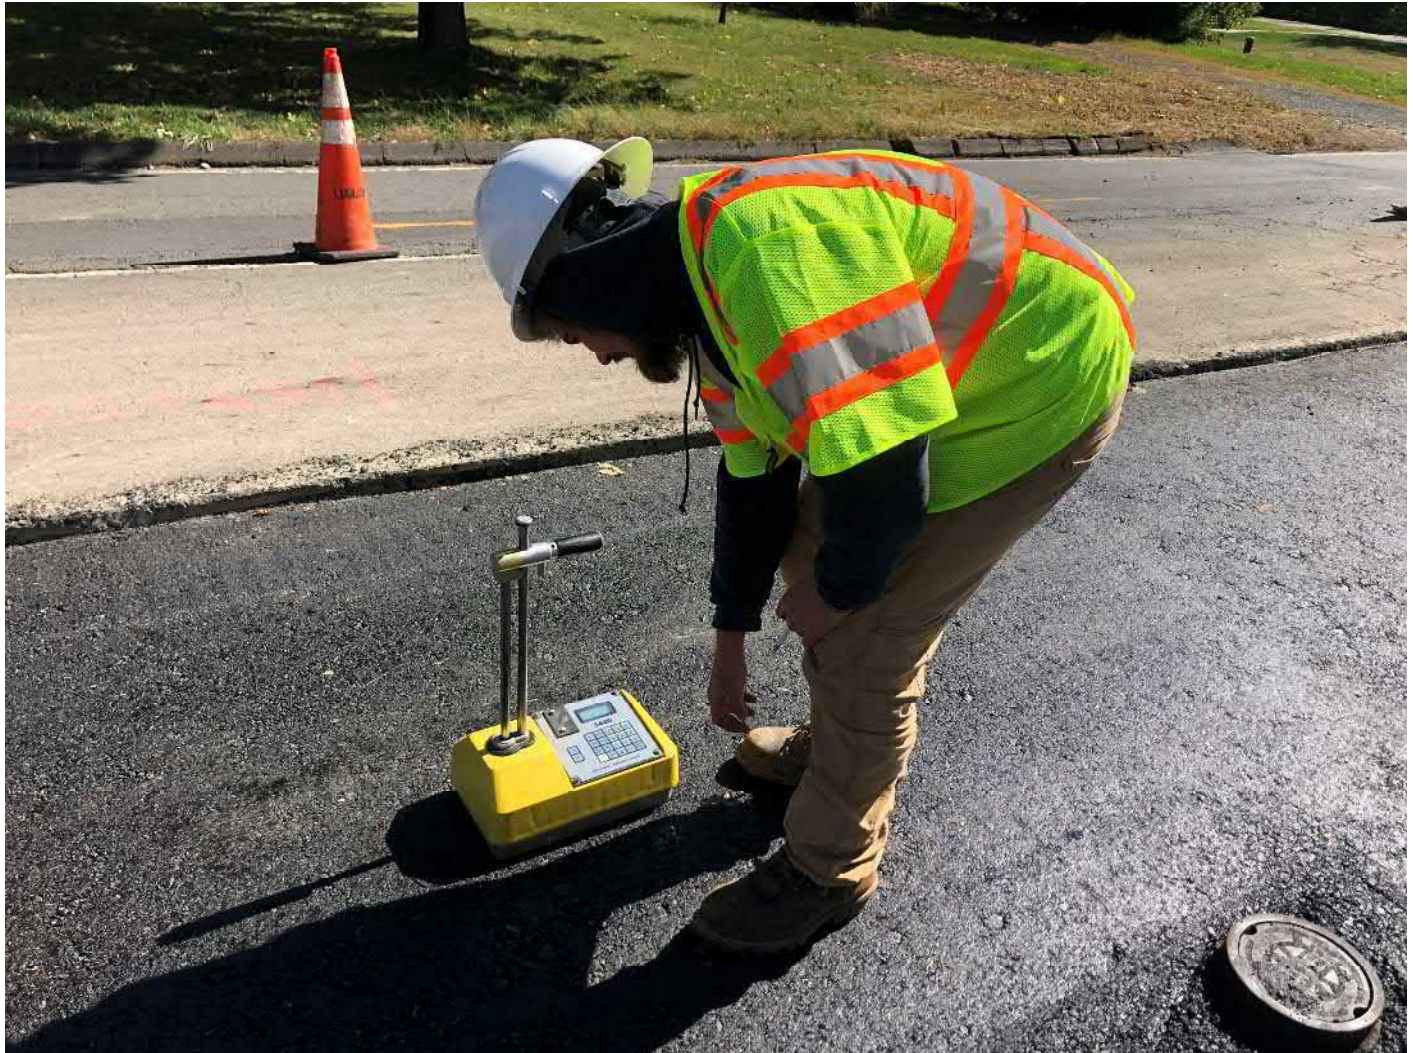
**Picture 6: JTC collecting compaction data from permanent paving at trench cutbacks between Stations 157+25 and 160+25 on the southbound lane of Main Street, Durham. View to the southeast.**

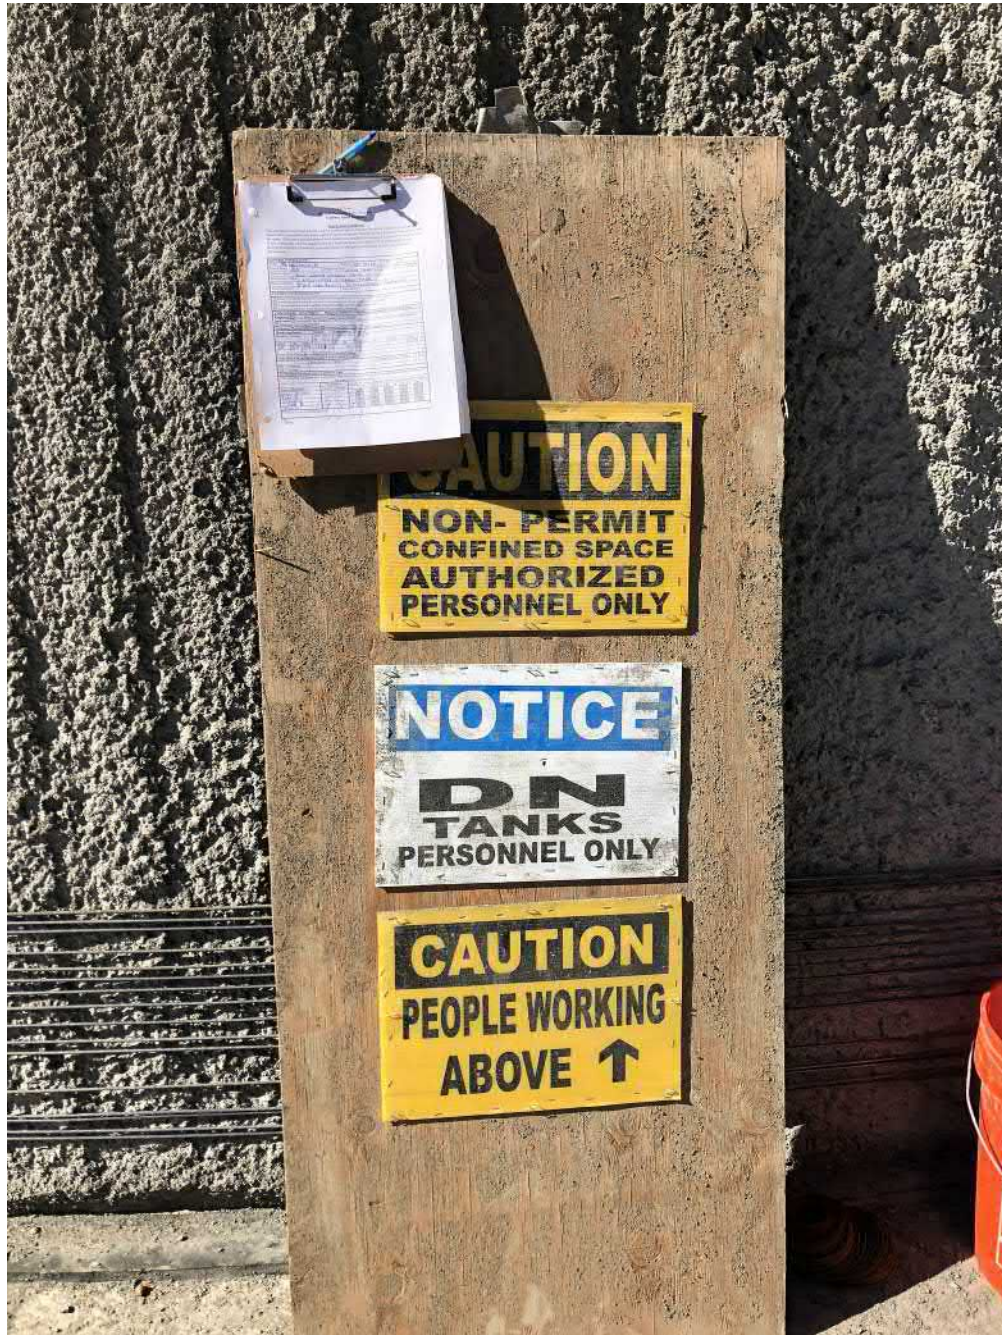
**Picture 7: Signage posted outside of the water tank as they prepare to remove knee braces from the water tank. Water tank work zone located to the east of the Shared Access Driveway, Middletown. View to the west.**

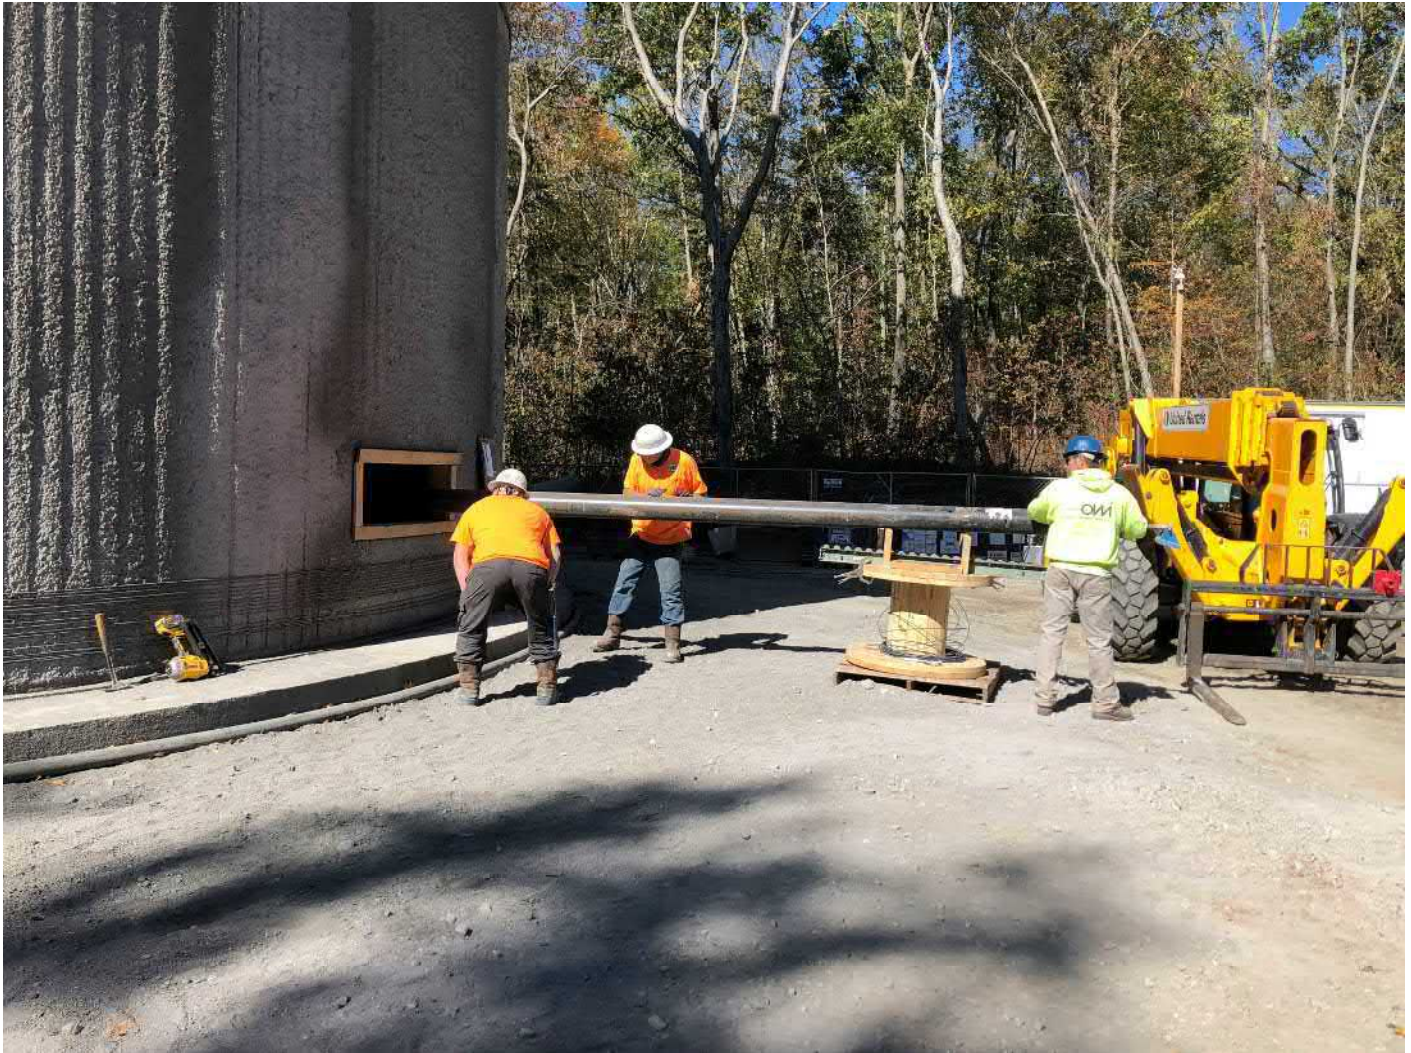
**Picture 9: Knee brace being removed from inside of the water tank. Water tank work zone located to the east of the Shared Access Driveway, Middletown. View to the north.**
