Daily Report

Project: Durham Meadows Pipeline Installation Date: October 9, 2020

Project #: AECOM: 6061487 Report No: 176
Contractor: Ludlow Construction Page: 1 of 10

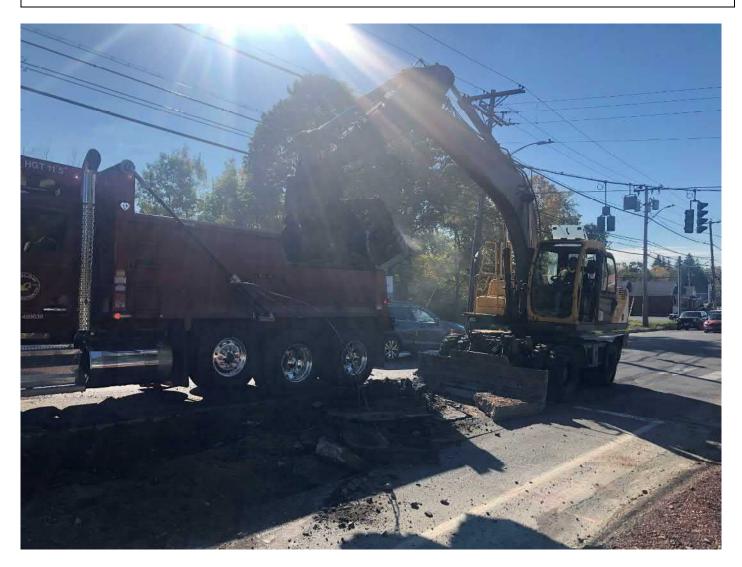
Picture 1: Ludlow stripping back asphalt as they prepare to place permanent paving between Stations 160+25 to 163+55 the southbound lane of Main Street, Durham. View to the southeast.

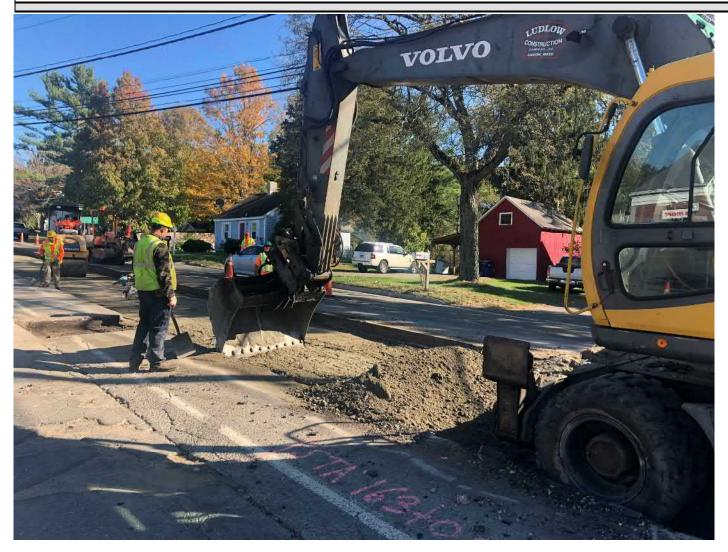
Picture 2: Ludlow grading and compacting 1.5" processed gravel between Stations 160+25 to 163+55 as they prepare to place permanent paving on the southbound lane of Main Street, Durham. View to the northeast.

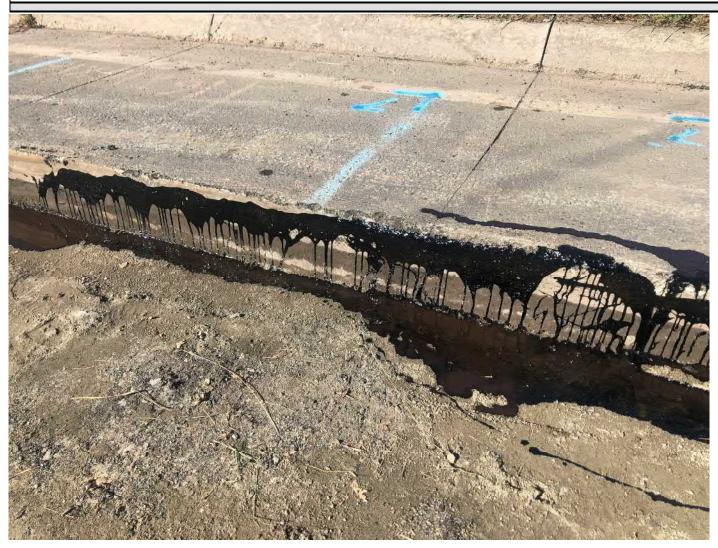
Picture 3: Tack coat that Ludlow has placed on the edges of cut pavement between Stations 160+25 to 163+55 as they prepare to place permanent paving on the southbound lane of Main Street, Durham. View to the west.

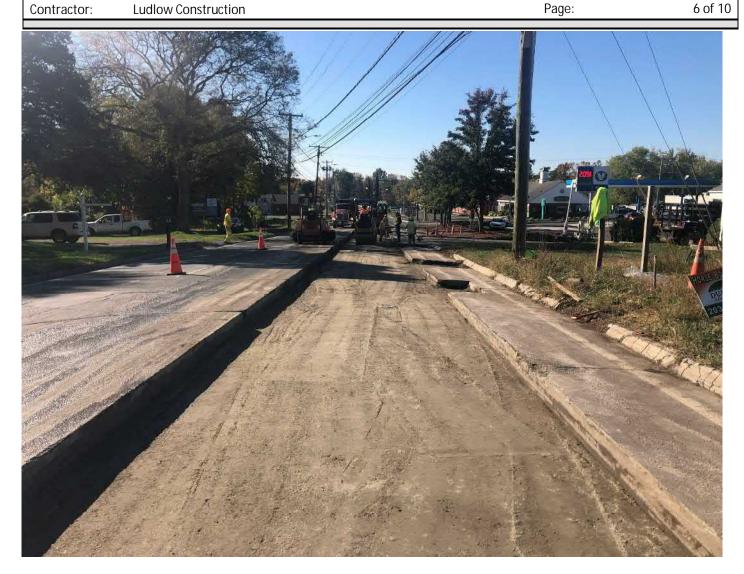
Picture 4: Ludlow stripping back asphalt as they prepare to place permanent paving between Stations 160+25 to 163+55 the southbound lane of Main Street, Durham. View to the south.

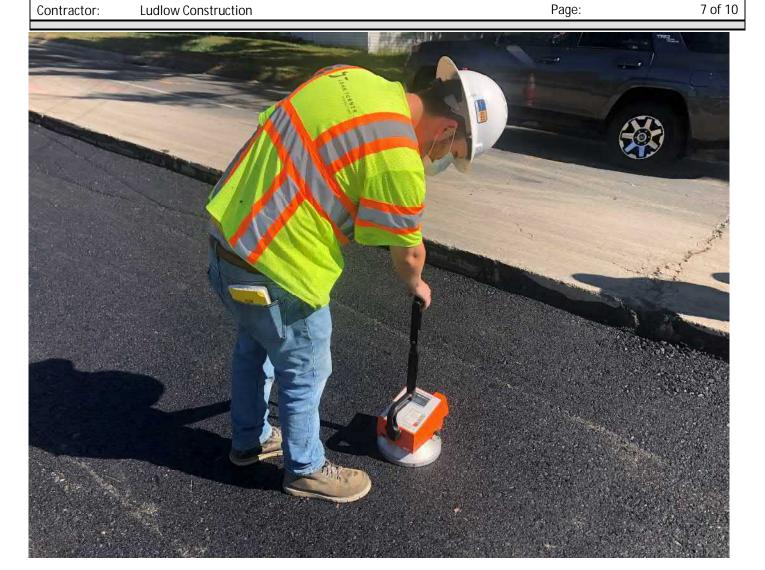
Picture 5: JTC collecting compaction data from permanent paving at trench cutbacks between Stations 160+25 and 163+55 on the southbound lane of Main Street, Durham. View to the northeast.

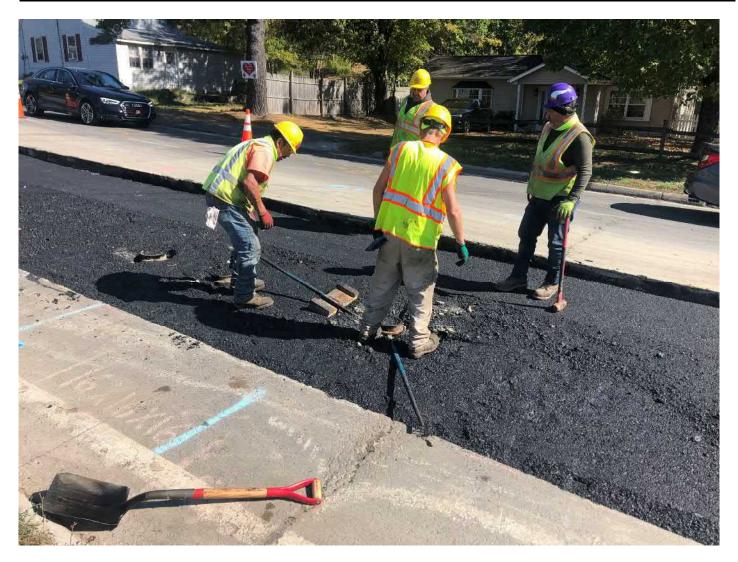
Picture 6: Ludlow raising a road box during permanent paving at trench cutbacks between Stations 157+25 and 160+25 on the southbound lane of Main Street, Durham. View to the east.

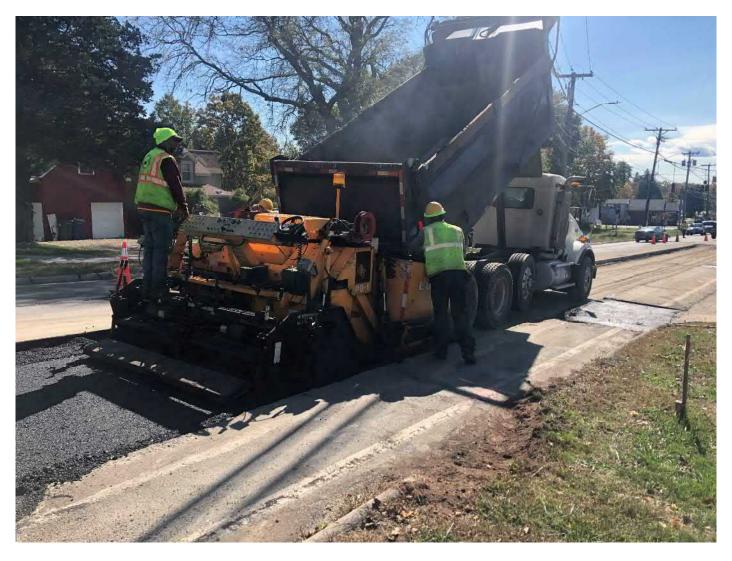
Picture 7: Ludlow placing and compacting the first of three 3" lifts of asphalt between Stations 160+25 to 163+55 as they prepare to place permanent paving on the southbound lane of Main Street, Durham. View to the southeast.

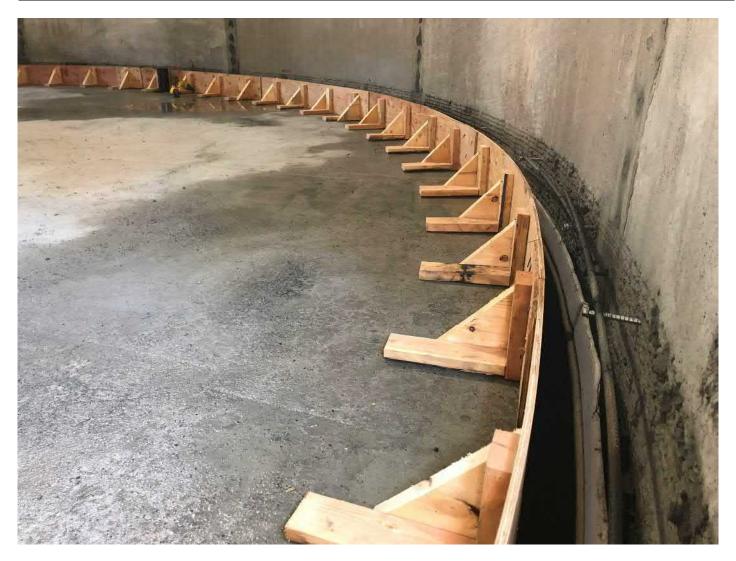
1154: DN Tanks is building a form on the inside perimeter of the water tank for creation of a C.I.P. cove that DN Tanks plans to pour on Monday. The C.I.P. cove will encase the PVC water stop located along the perimeter of the water tank where the tank wall meets the tank base.

Picture 8: Concrete form for the C.I.P cove on the inside of the water tank. Water tank work zone located to the east of the Shared Access Driveway, Middletown.
