Daily Report

Project:	Durham Meadows Pipeline Installation	Date:	October 12, 2020
Location:	Main Street, Durham; Shared Access Driveway, Middletown	Day of Week:	Monday
Project #:	AECOM: 6061487	Report No:	177
Contractor:	Ludlow Construction	Page:	1 of 12

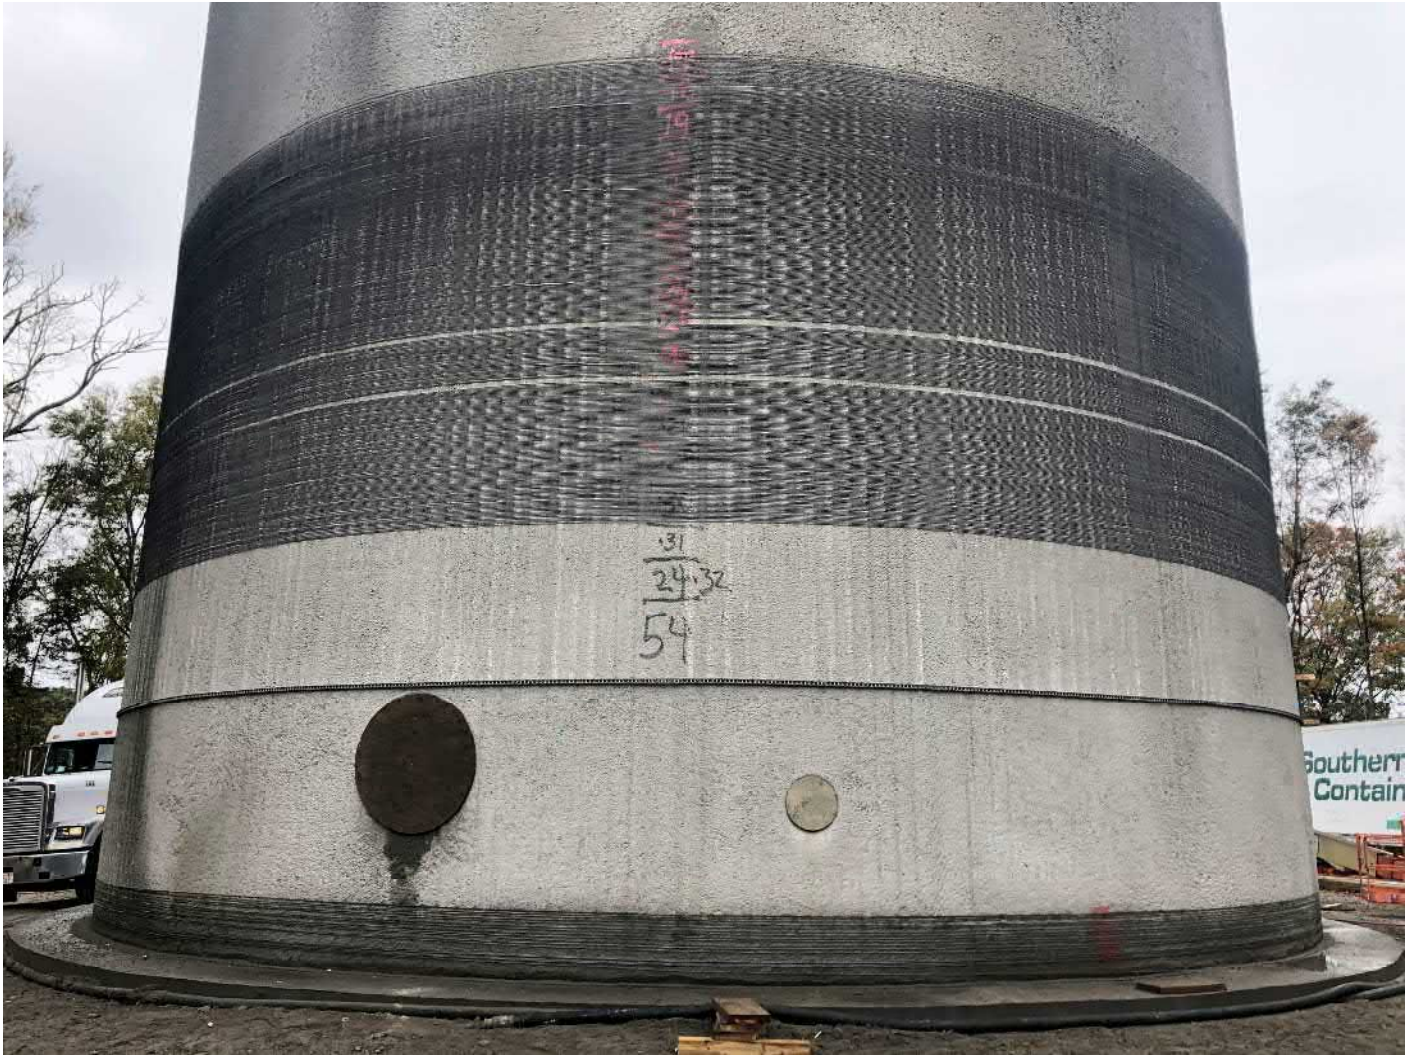
Picture 1: Prestressed wire that DN Tanks has wrapped around the exterior of the water tank located to the east of the Shared Access Driveway, Middletown. View to the east.

0752: DN Tanks is wrapping prestressed wire around the exterior of water tank located to the east of the Shared Access Driveway, Middletown.

1053: DN Tanks continues to wrap prestressed wire around the exterior of the water tank located east of the Shared Access Driveway, Middletown.

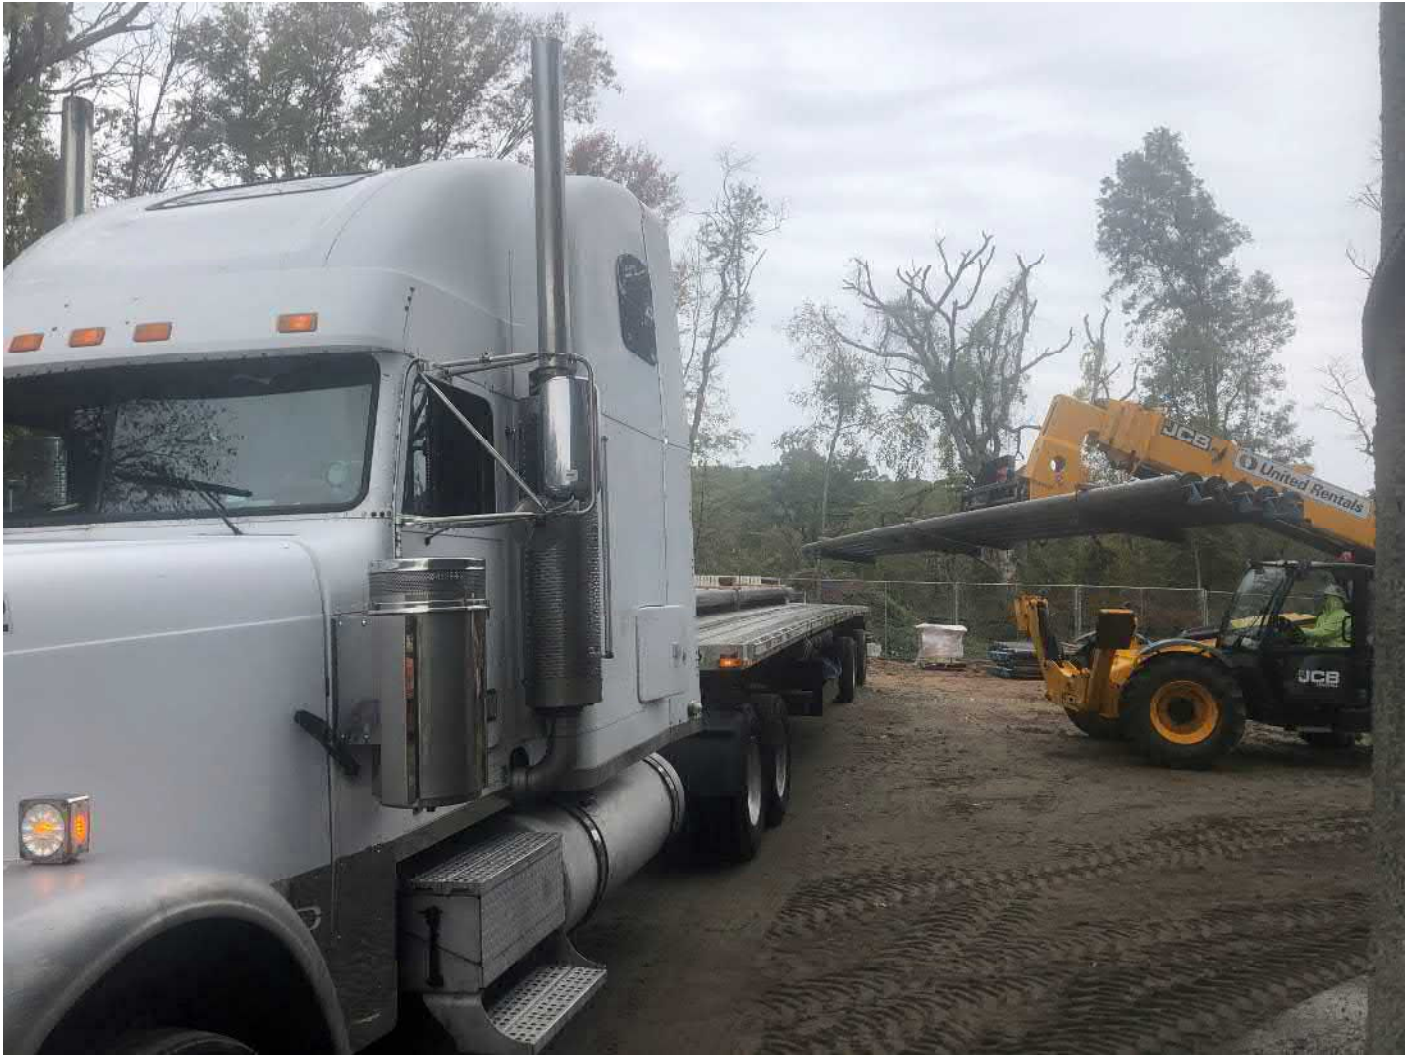
Picture 2: DN Tanks demobilizing knee braces from the water tank work zone located to the east of the Shared Access Driveway, Middletown. View to the east.

1111: DN Tanks is loading knee braces onto a trailer for removal from the water tank work zone and is continuing to wrap prestressed wire around the exterior of the water tank.

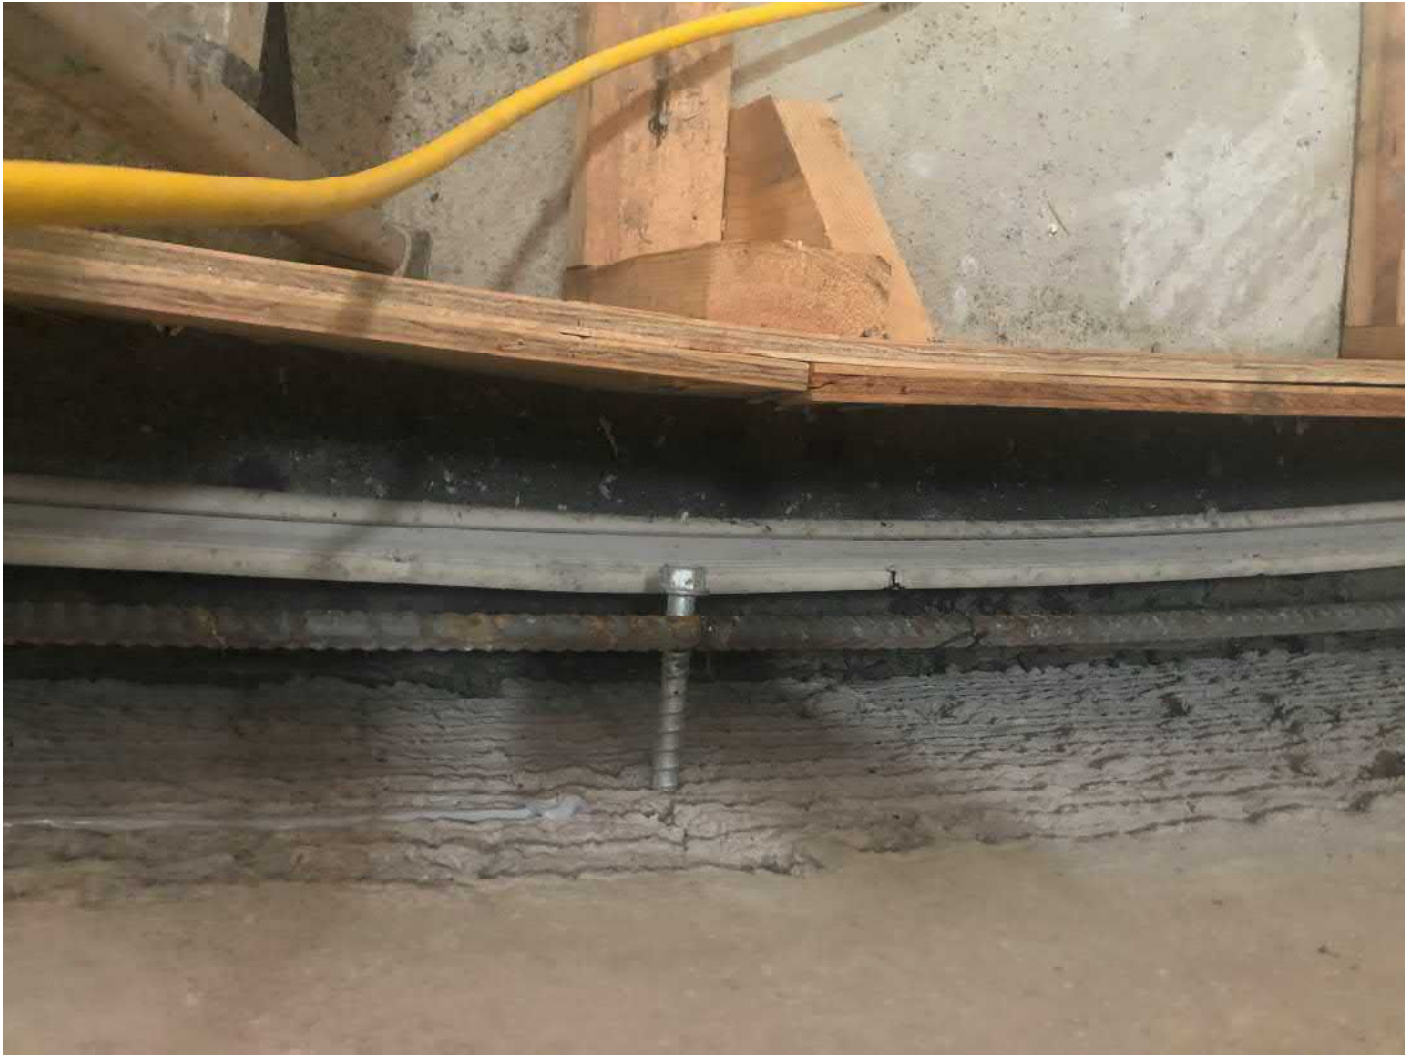
Picture 3: Concrete form for the C.I.P cove on the inside of the water tank with rebar set in place. Water tank work zone located to the east of the Shared Access Driveway, Middletown.

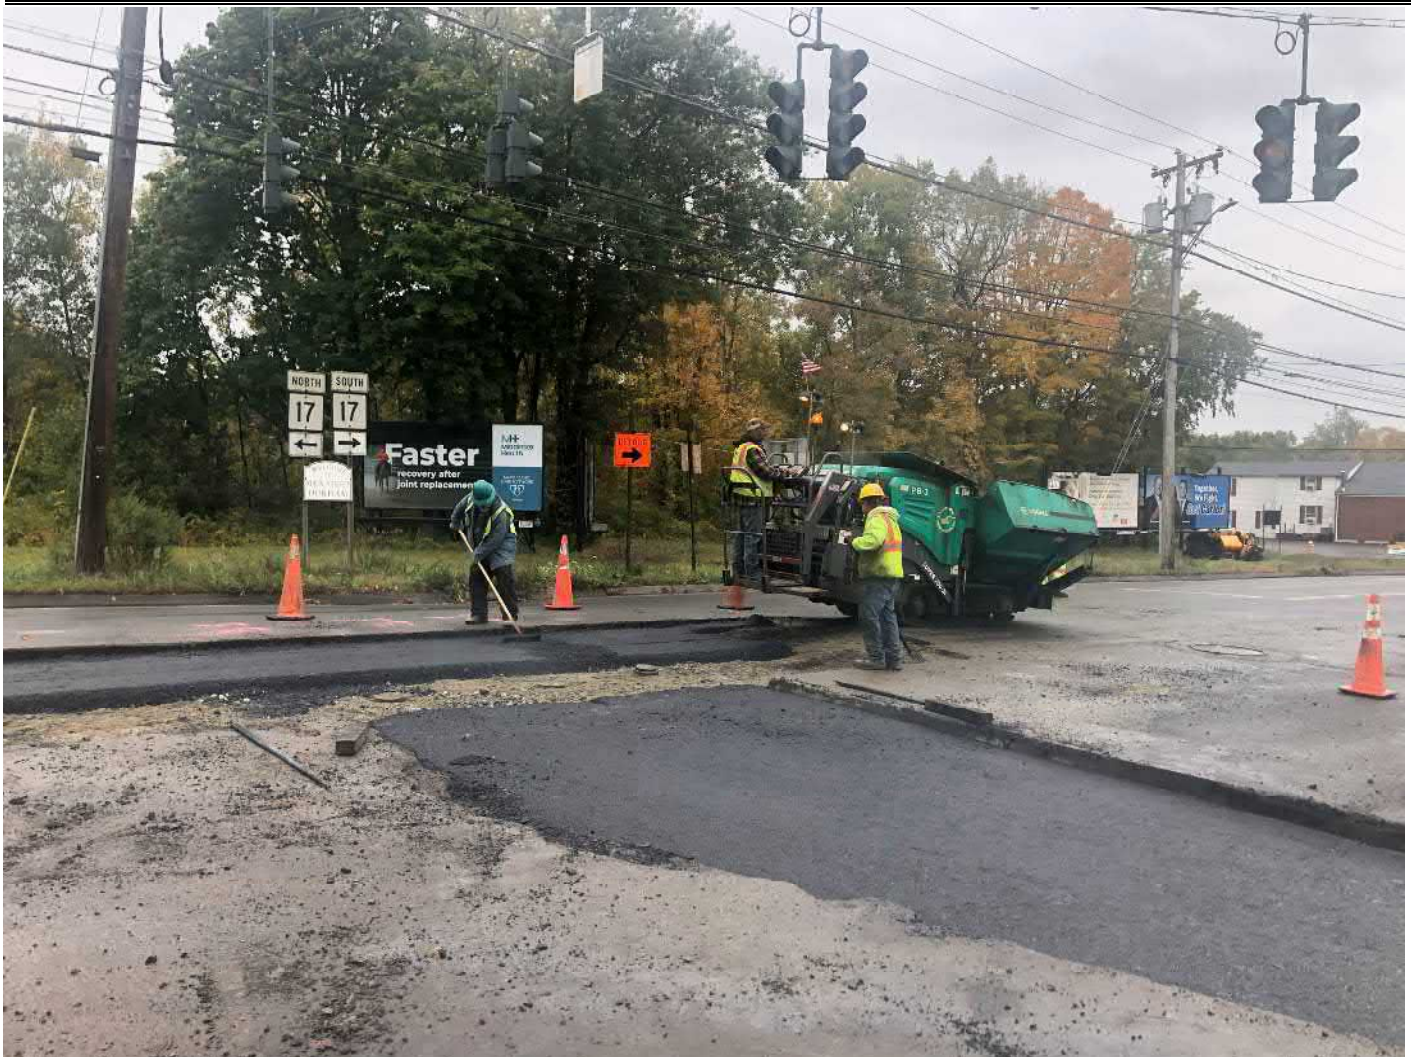
Picture 4: Intersection of Main Street and Route 147, where Ludlow is placing and compacting first lift of asphalt. This is the location where the USACE field engineer questioned Ludlow regarding the thickness of placed asphalt. View to the southeast.

1125: Ludlow has begun to place and compact the first of three 3" lifts of asphalt on the southbound lane of Main Street and the westbound lane of Route 147 at the intersection of Main Street and Route 147, Durham. Traffic control is being provided by one State Trooper, one private flagger, and one Ludlow laborer.

1154: Ludlow has begun to place and compact a second 3" lift of asphalt on Route 147 near the intersection of Main Street. The USACE field engineer questioned Ludlow regarding the fact that there didn't seem to be sufficient room between the top of existing pavement and the top of the first lift to accommodate two additional 3" lifts at the intersection of Route 147 and Main

Street. Ludlow explained that this section of the trench acts as a ramp to assist trucks with entering the trench to deliver asphalt to the paver. Ludlow stated that this portion of the ramp is cut back each morning to where a full 9" of asphalt was encountered.

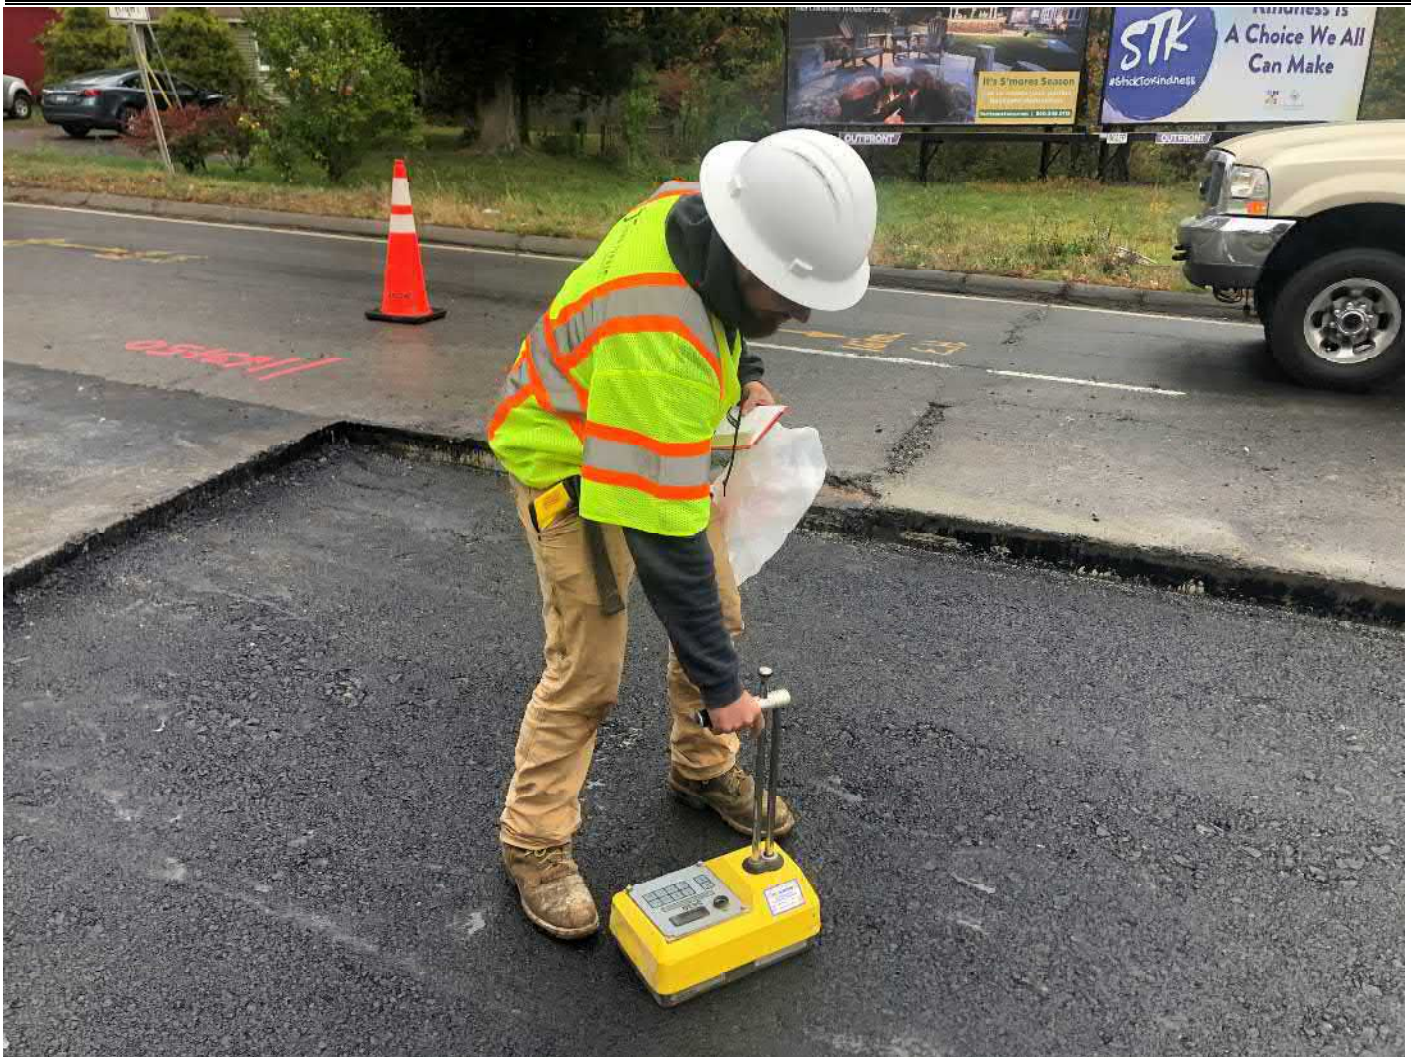
Picture 5: JTC collecting compaction data from permanent paving at trench cutbacks at Station 163+60 on the southbound lane of Main Street, Durham. View to the northeast.

1150: JTC is preparing to collect compaction data from first lift of asphalt placed and compacted by Ludlow on the southbound lane of Main Street, Durham just north of the intersection with Route 147.

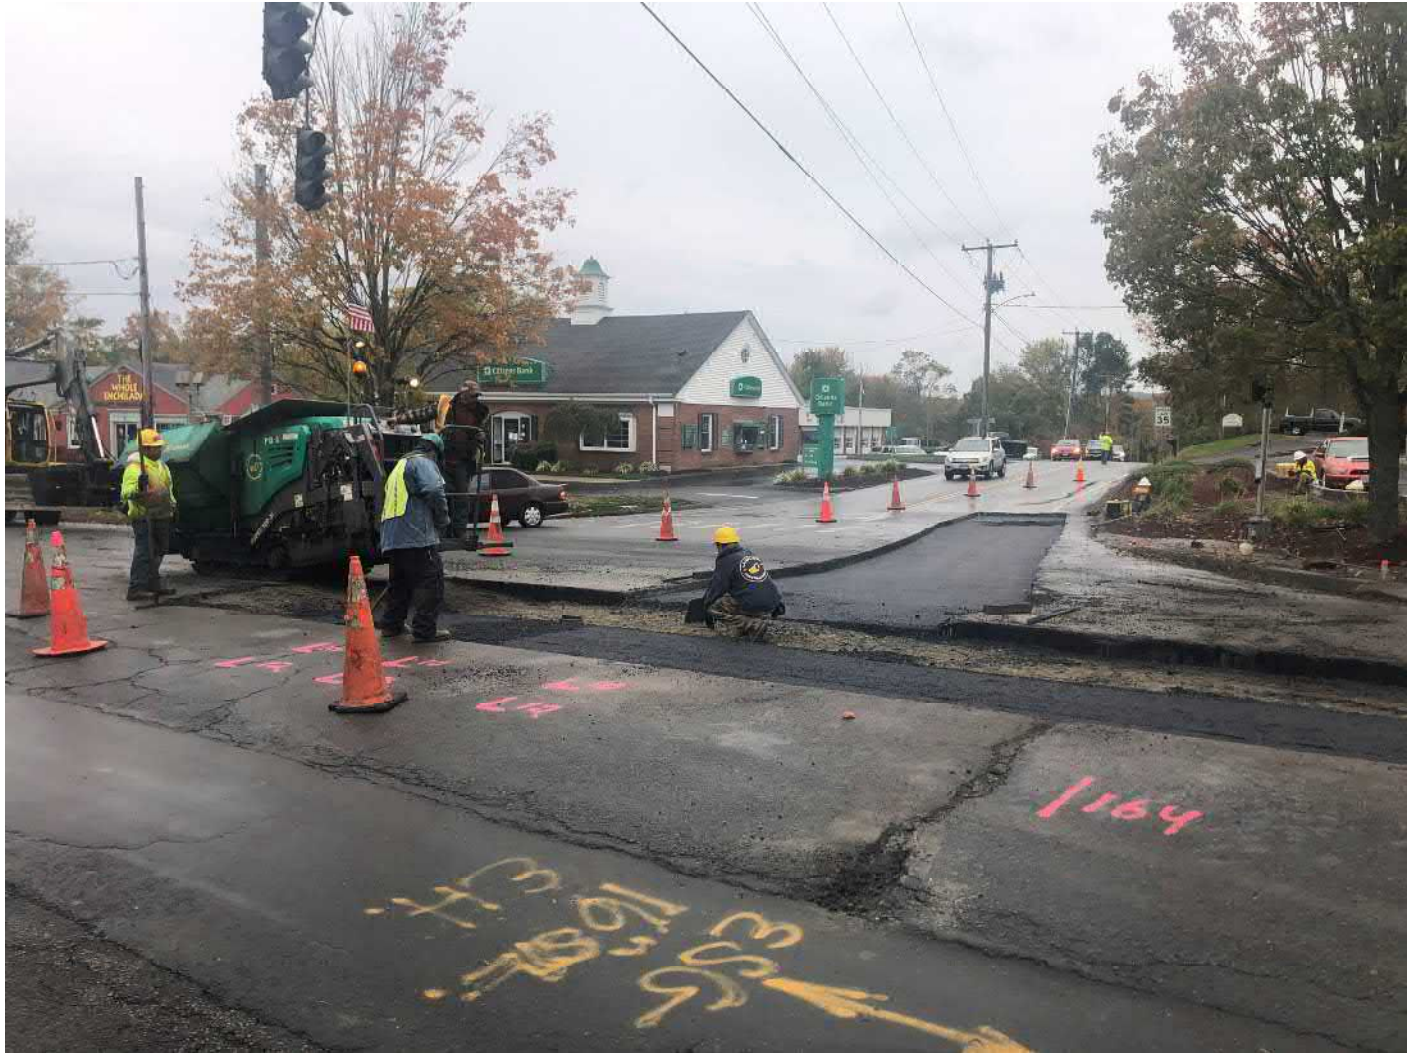
Picture 6: Overview of Route 147 permanent paving on trench cutbacks. View to the southwest.

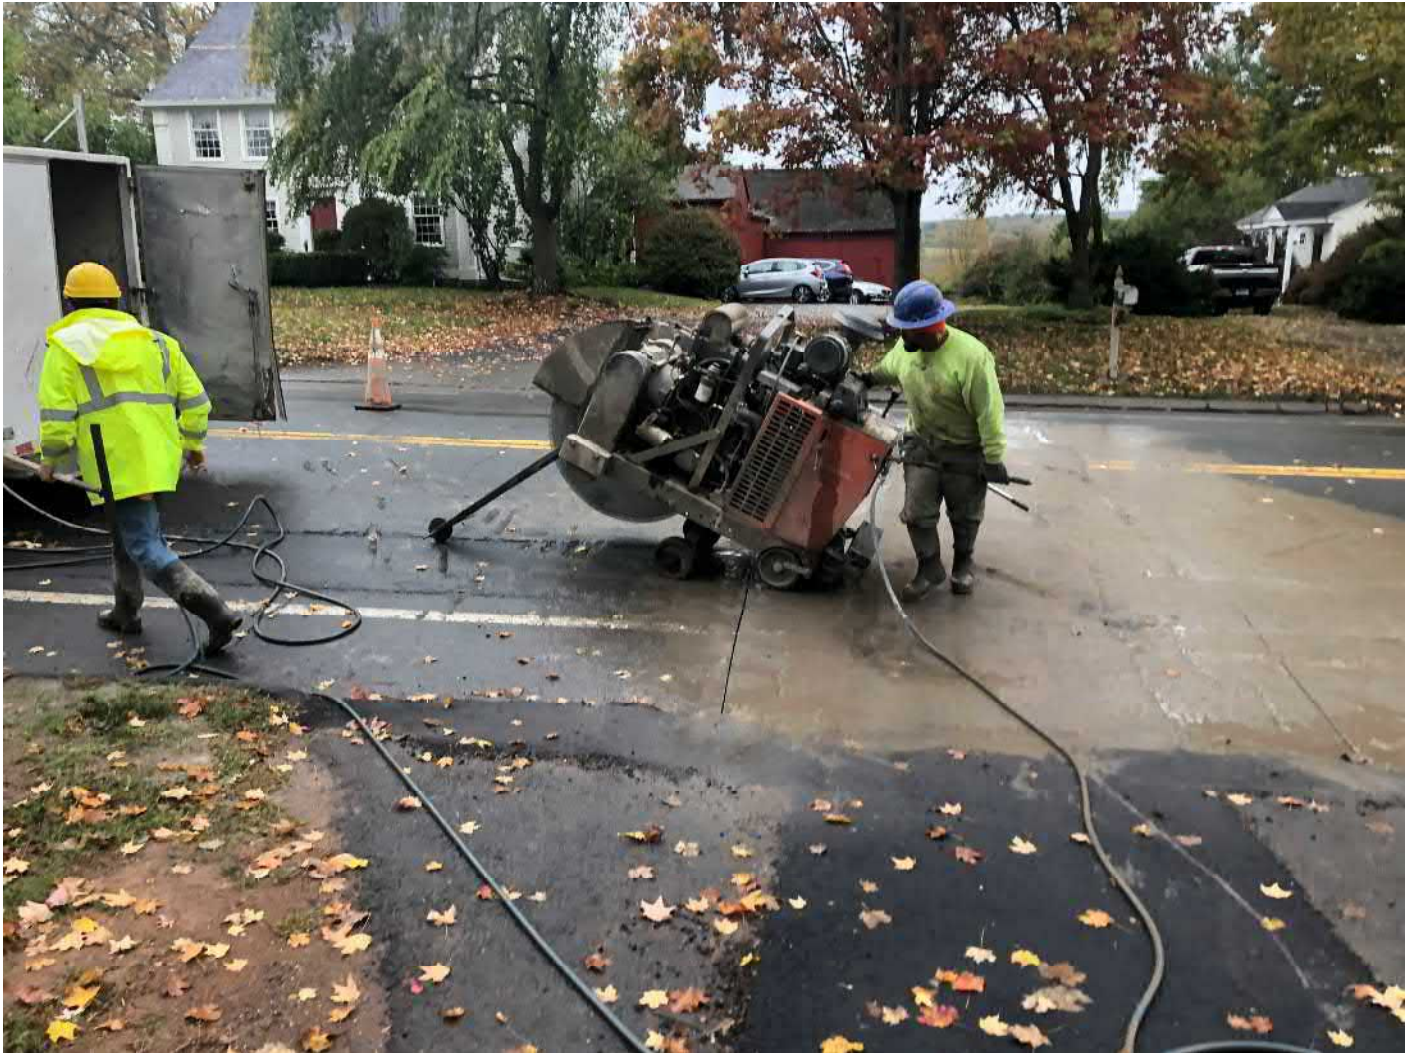
Picture 7: Veilleux saw cutting curb stop cutbacks on the northbound lane of Main Street. View to the southeast.

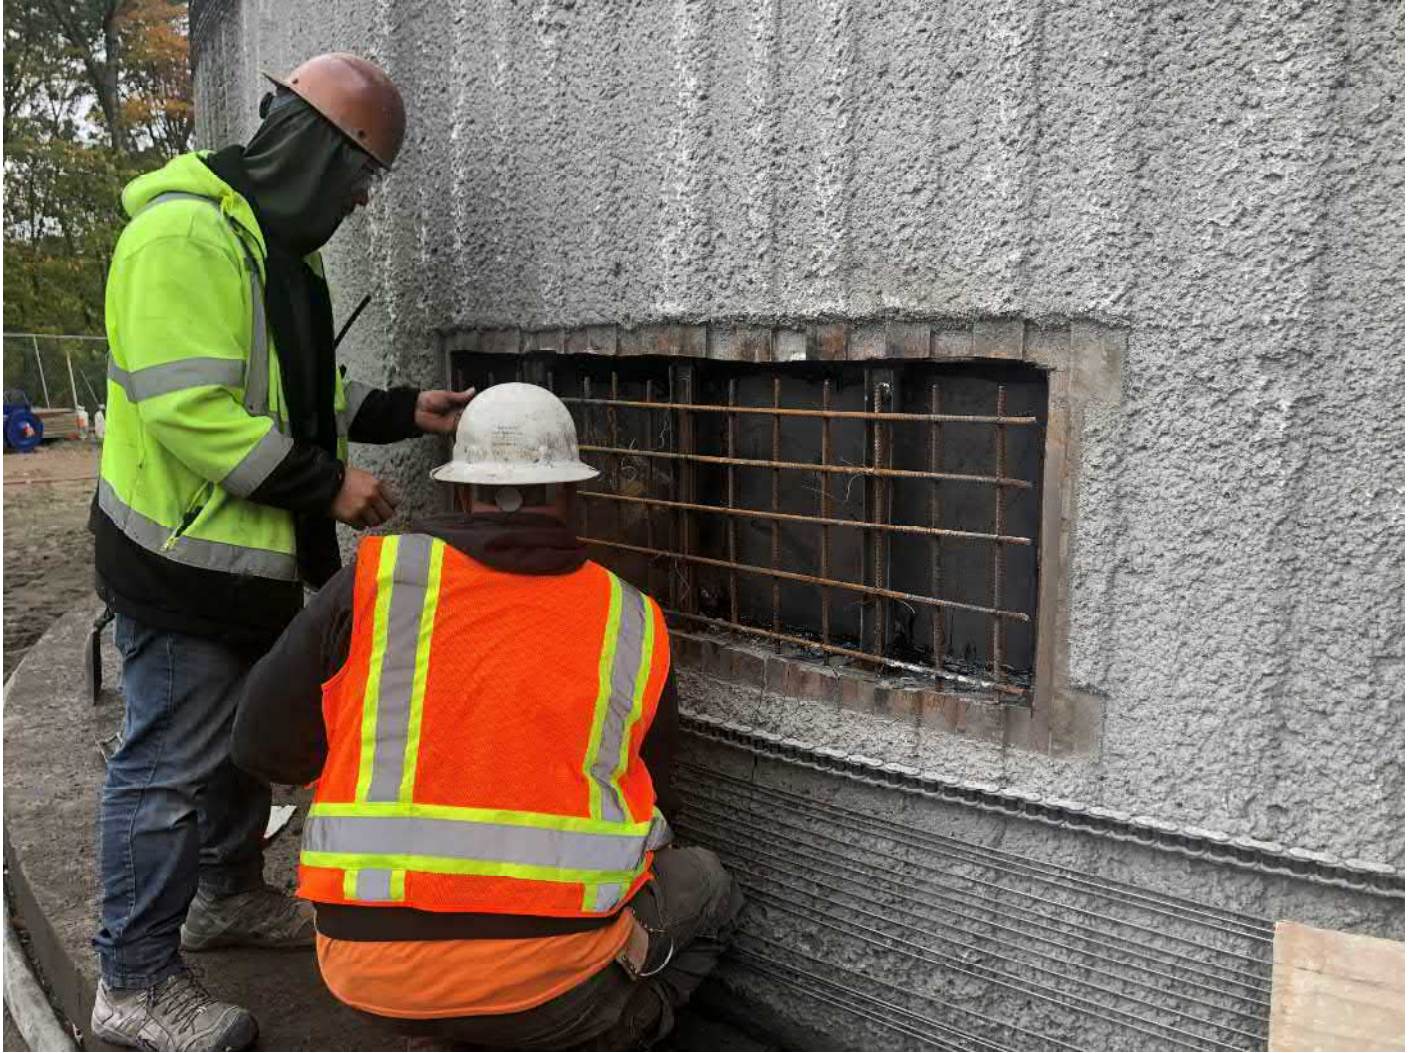
Picture 8: DN Tanks preparing to seal off a temporary entrance to the water tank. Water tank work zone located to the east of the Shared Access Driveway, Middletown.

1237: DN Tanks is working on securing the temporary manways into the water tank and preparing for a delivery of shotcrete to place over exposed prestressed wire that has been wrapped around the sides of the water tank.

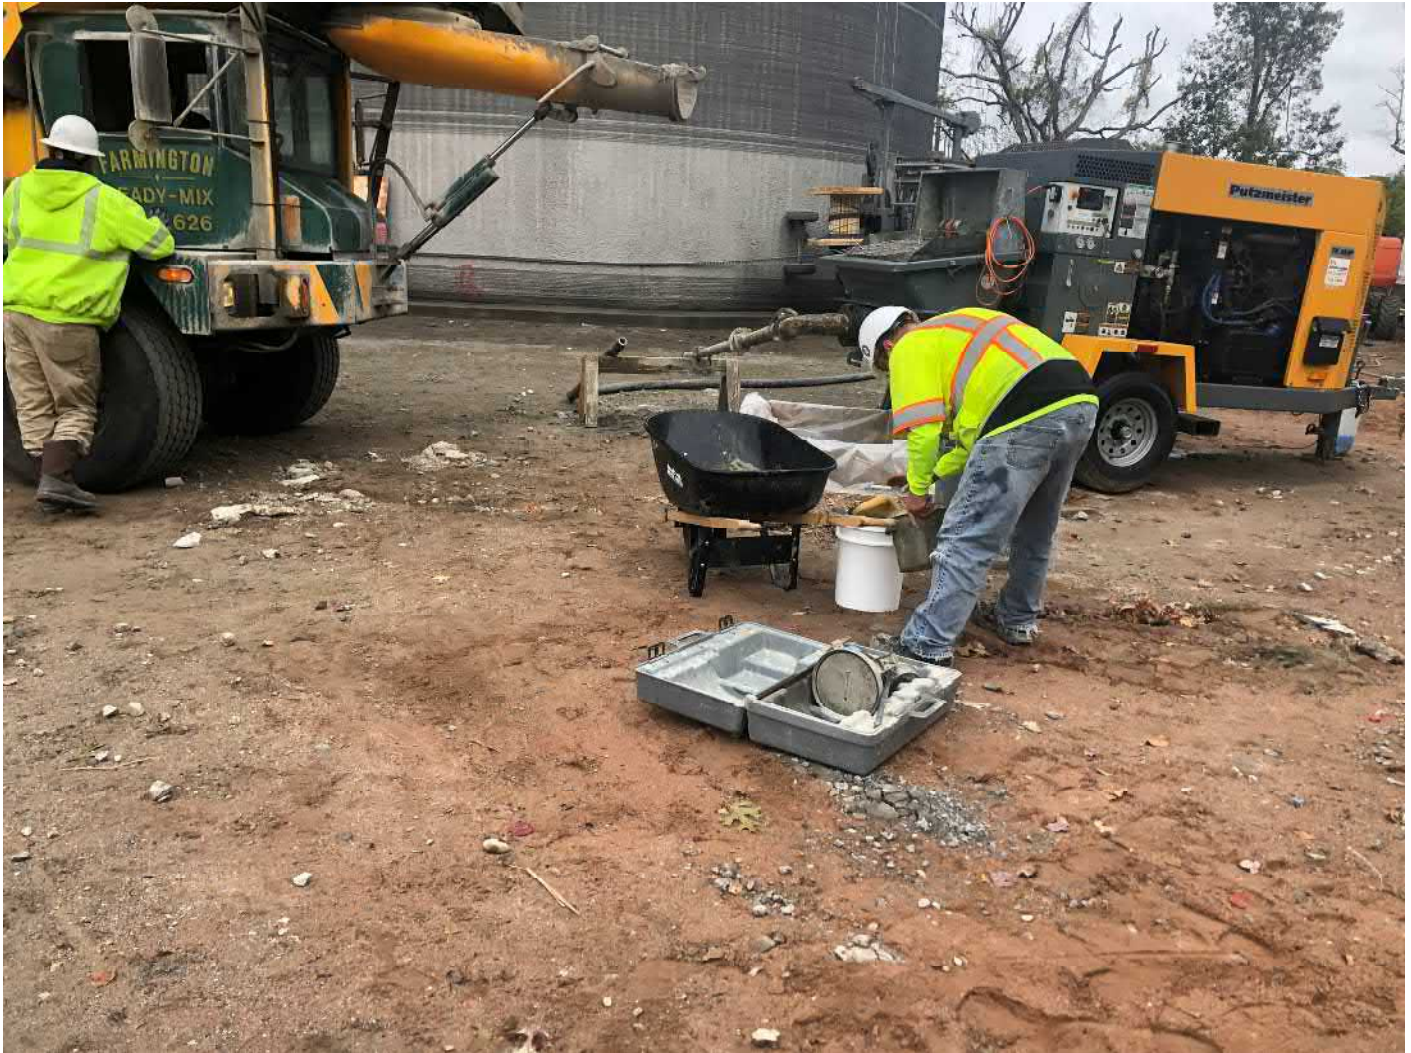
Picture 9: JTC preparing an air entrainment sample from a truckload of shotcrete that DN Tanks is about to apply to exposed prestressed wire on the exterior of the water. Water tank work zone located to the east of the Shared Access Driveway, Middletown.

1410: DN Tanks prepares to apply a truckload of shotcrete to the exterior of the water tank that has just arrived from Farmington Ready Mix.
