Daily Report

Project:	Durham Meadows Pipeline Installation	Date:	October 14, 2020
Location:	Main Street, Durham; Shared Access Driveway, Middletown	Day of Week:	Wednesday
Project #:	AECOM: 6061487	Report No:	179
Contractor:	Ludlow Construction	Page:	1 of 10

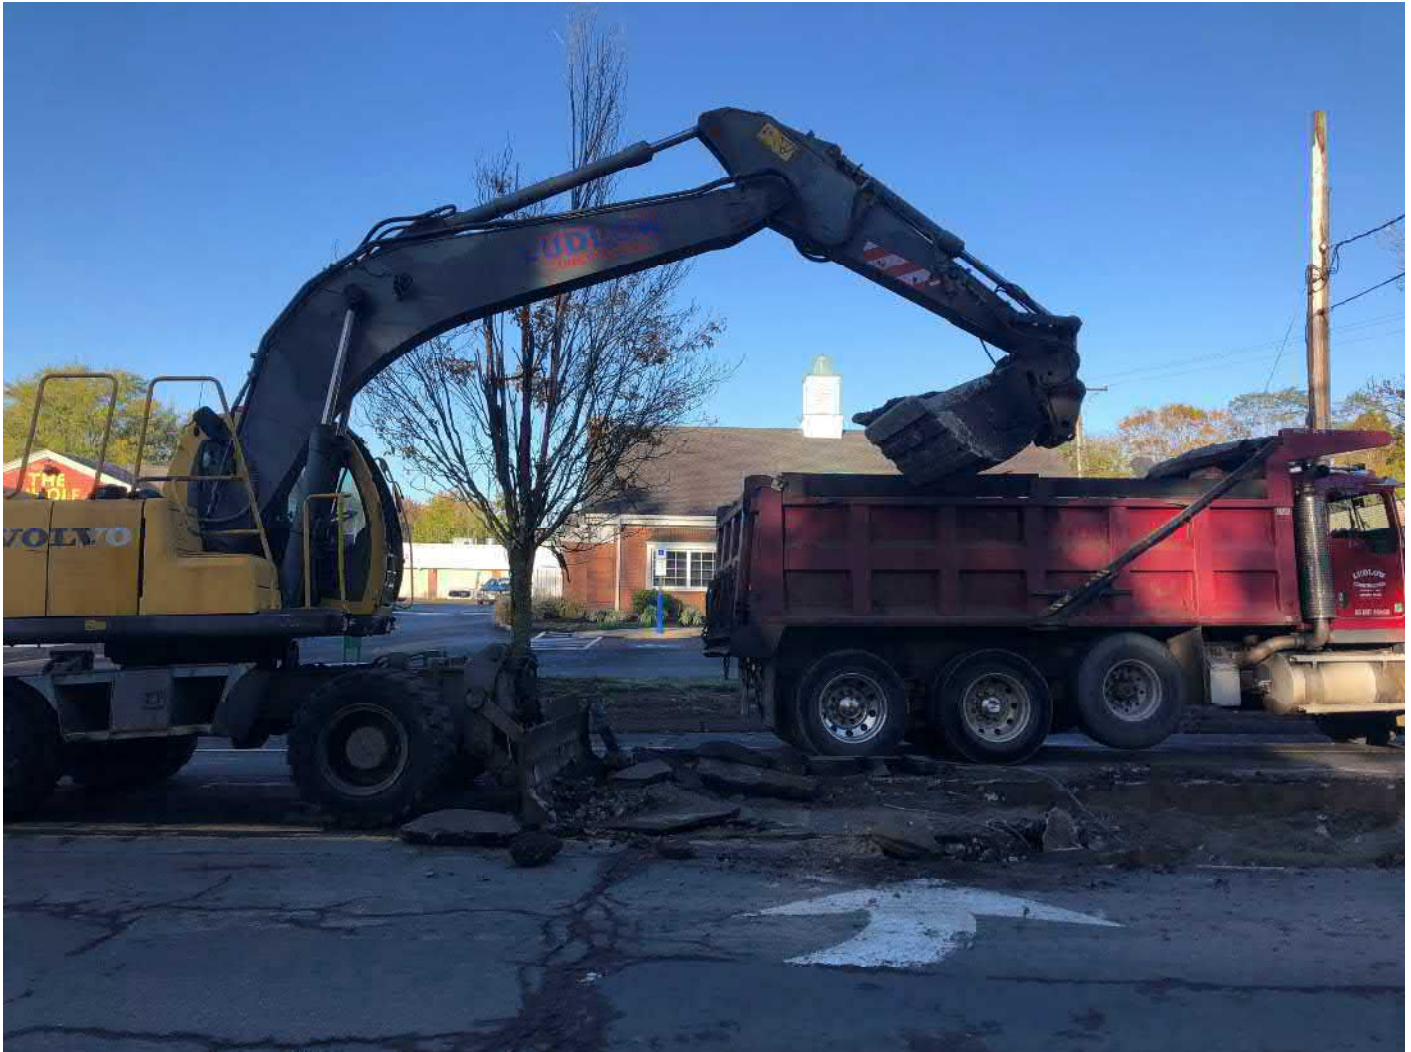
Picture 1: Ludlow excavating pavement on the trench overcuts for permanent paving on the southbound lane of Main Street, Durham, between Stations 164+25 to 167+30. View to the west.

0820: Ludlow is stripping asphalt for trench overcuts on the southbound lane of Main Street, starting at the intersection of Route 147 and Main Street, moving south on Main Street. Traffic management is being provided by two flaggers and one Ludlow labor.

1025: Ludlow is almost finished stripping pavement on trench overcuts between Stations 164+25 to 167+30 on the southbound lane of Main Street, Durham.

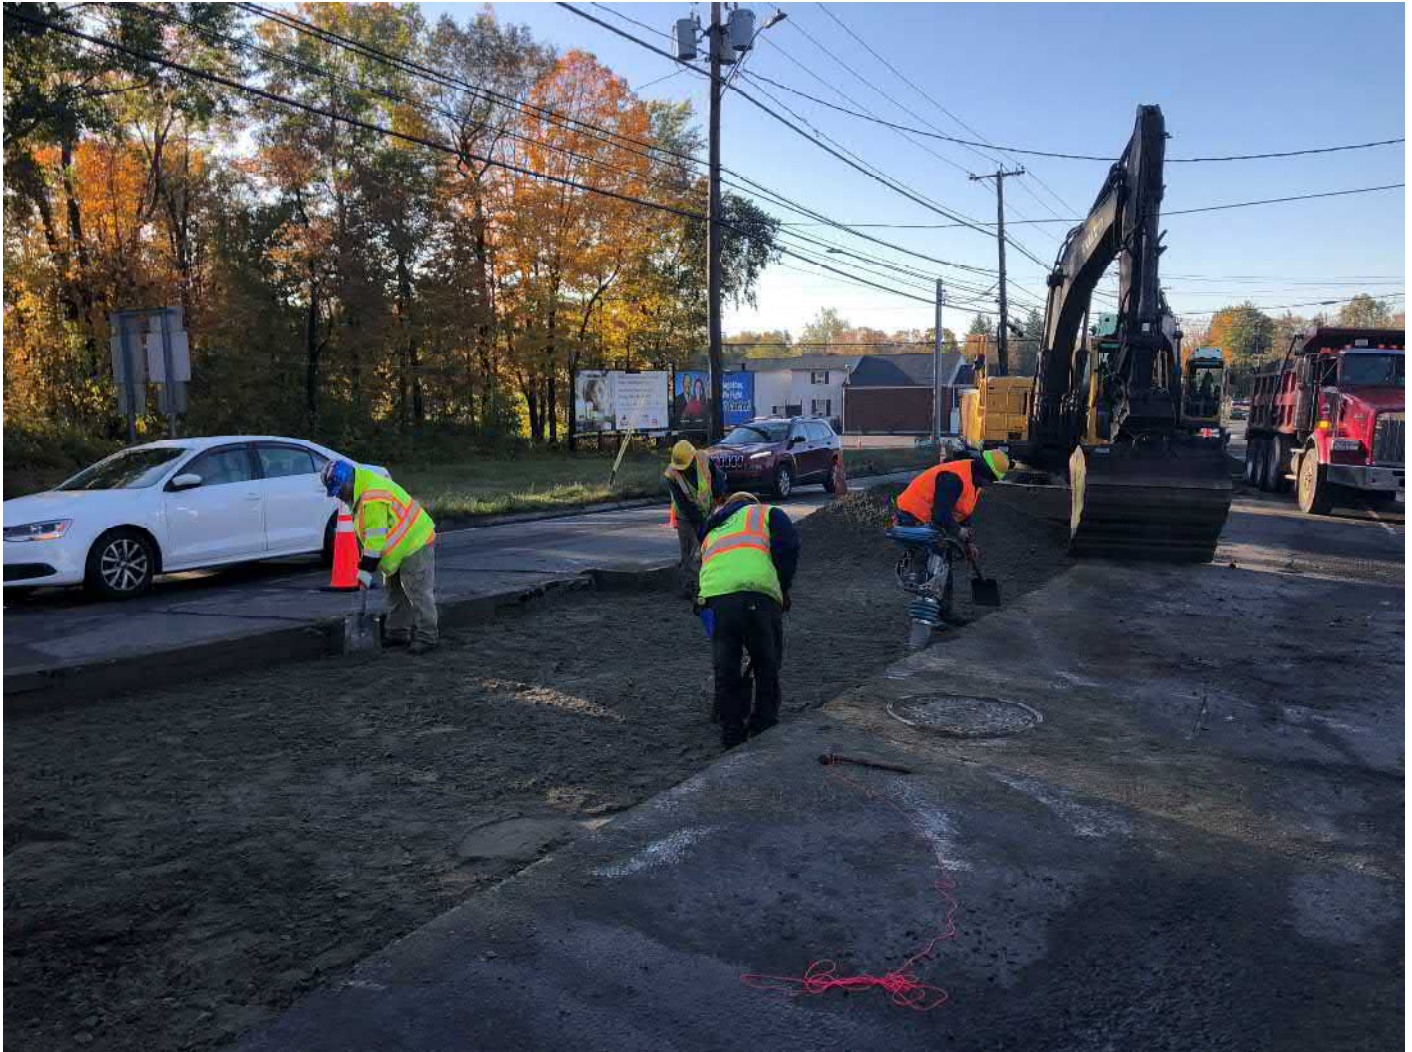
Picture 2: Ludlow grading 1.5" processed gravel as part of trench overcut permanent paving activities on the southbound lane of Main Street, Durham, between Stations 164+25 to 167+30. View to the south.

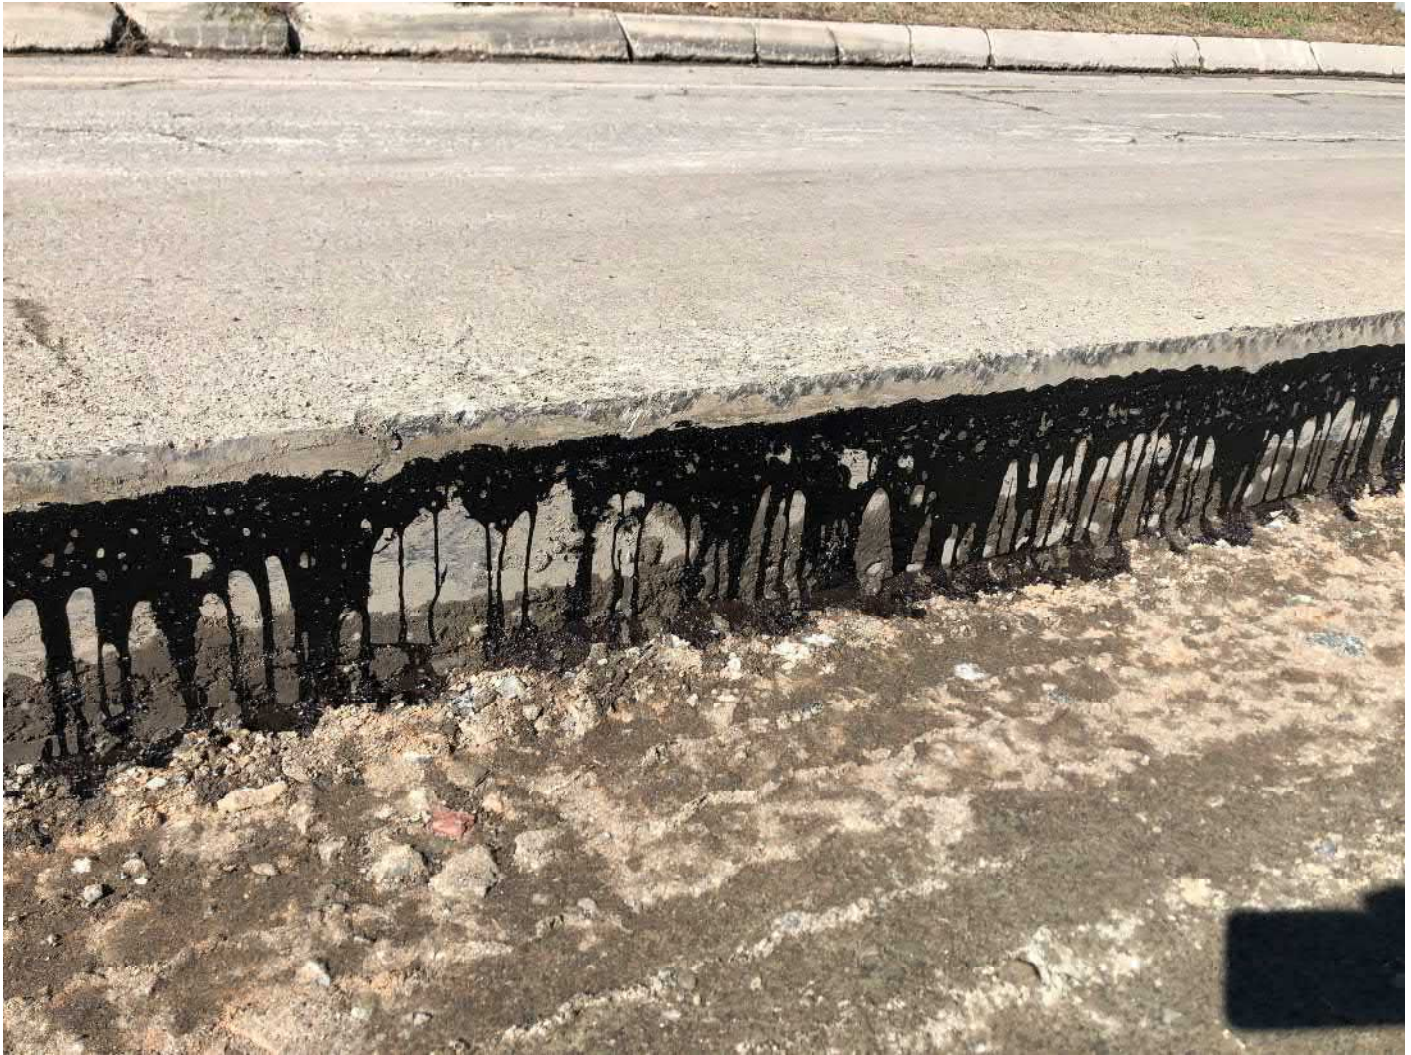
Picture 3: Tack coat that Ludlow has applied to the edge of cut pavement on the trench overcuts for permanent paving on the southbound lane of Main Street, Durham, between Stations 164+25 to 167+30.

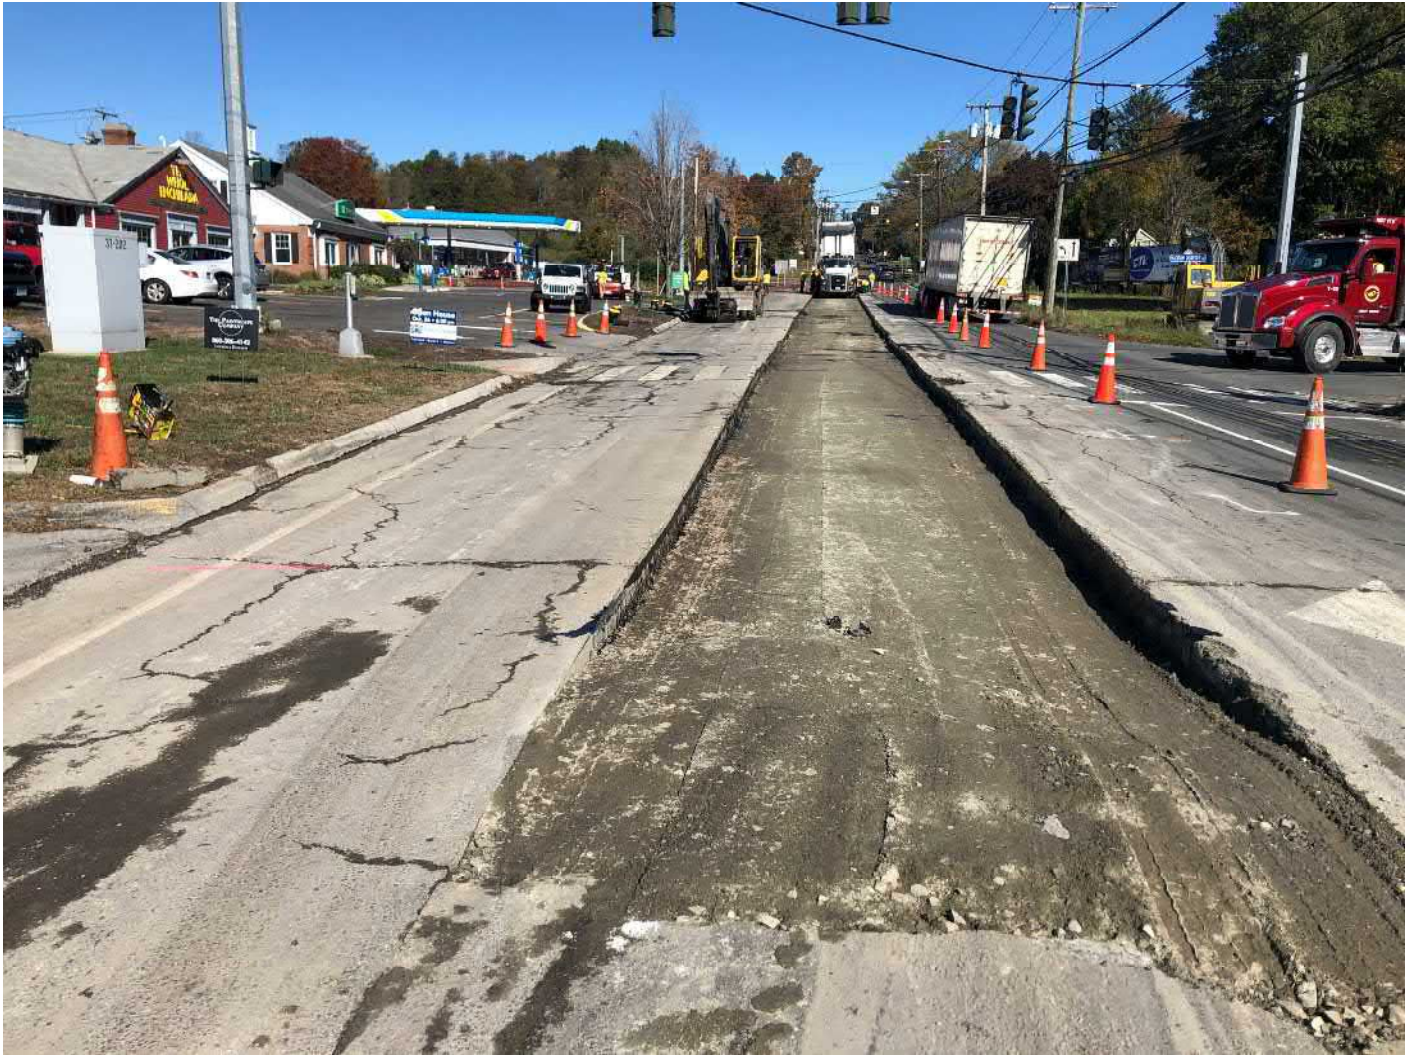
Picture 4: Pavement stripped back between Stations 164+25 to 167+30 as part of trench overcut permanent paving activities on the southbound lane of Main Street, Durham, between. View to the north.

1131: Ludlow has removed pavement on the trench overcuts between Stations 164+25 to 167+30 on the southbound lane of Main Street, Durham. Ludlow has just started applying the first lift of asphalt moving north to south on the southbound lane of Main Street, Durham. JTC is present to collect compaction data once the asphalt has been placed, compacted, and has cooled to 180°.

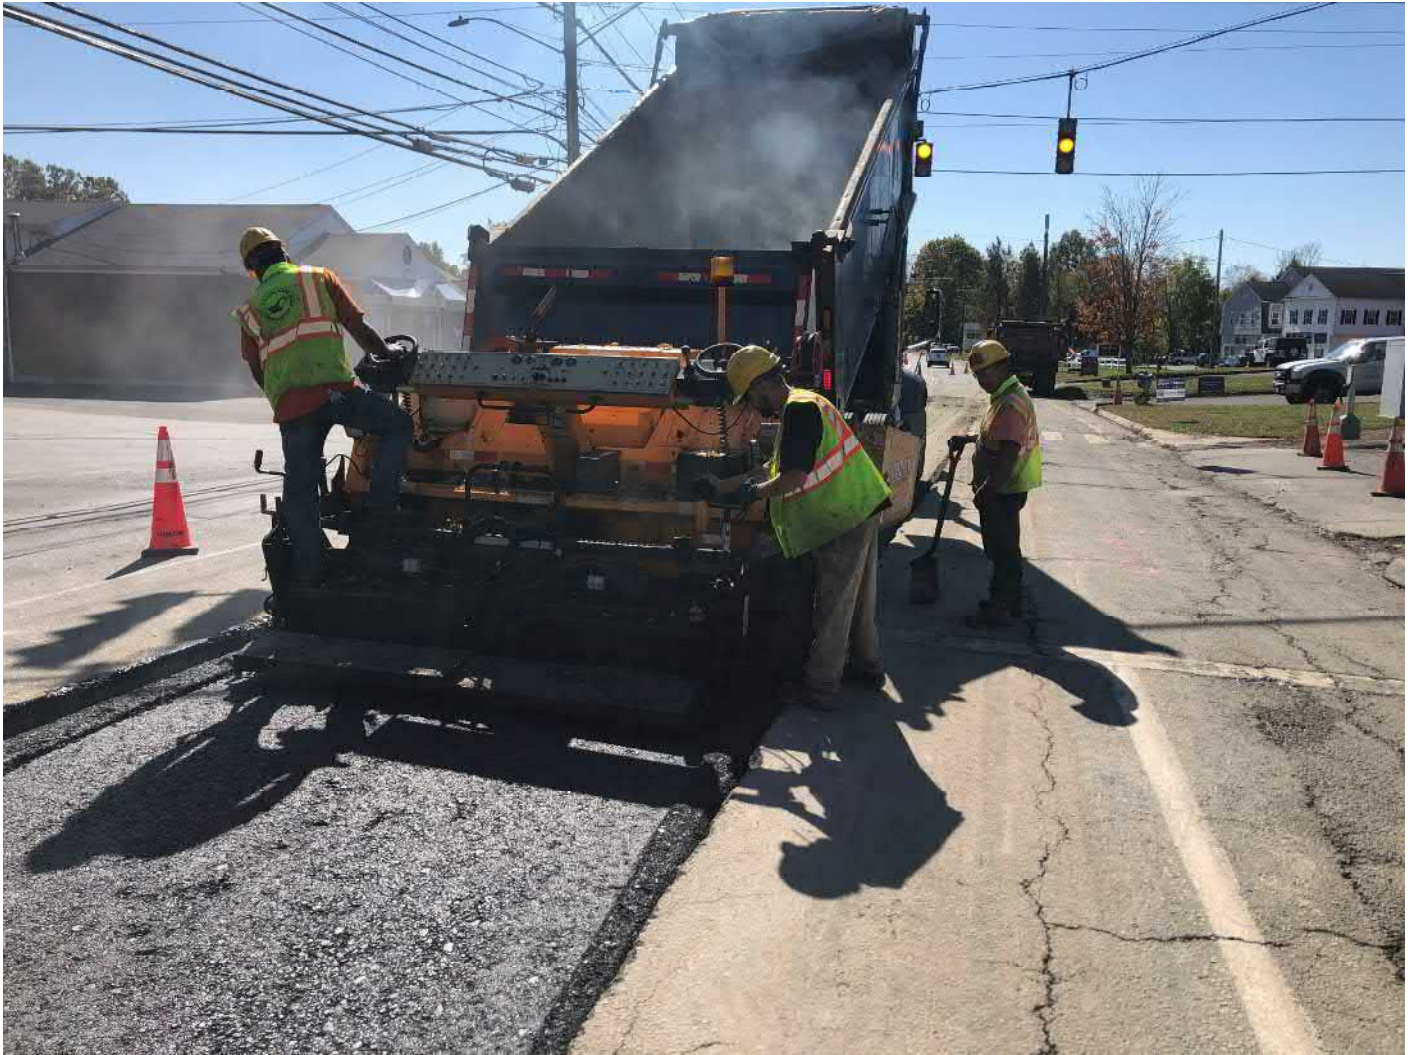
Picture 5: Ludlow placing the first of three 3" lifts on the southbound lane of Main Street, Durham between Stations 164+25 to 167+30. View to the south.

1224: Ludlow is close to finishing with the placement and compaction of the second of three 3" lifts of asphalt between Stations 164+25 to 167+30 on the southbound lane of Main Street, Durham.

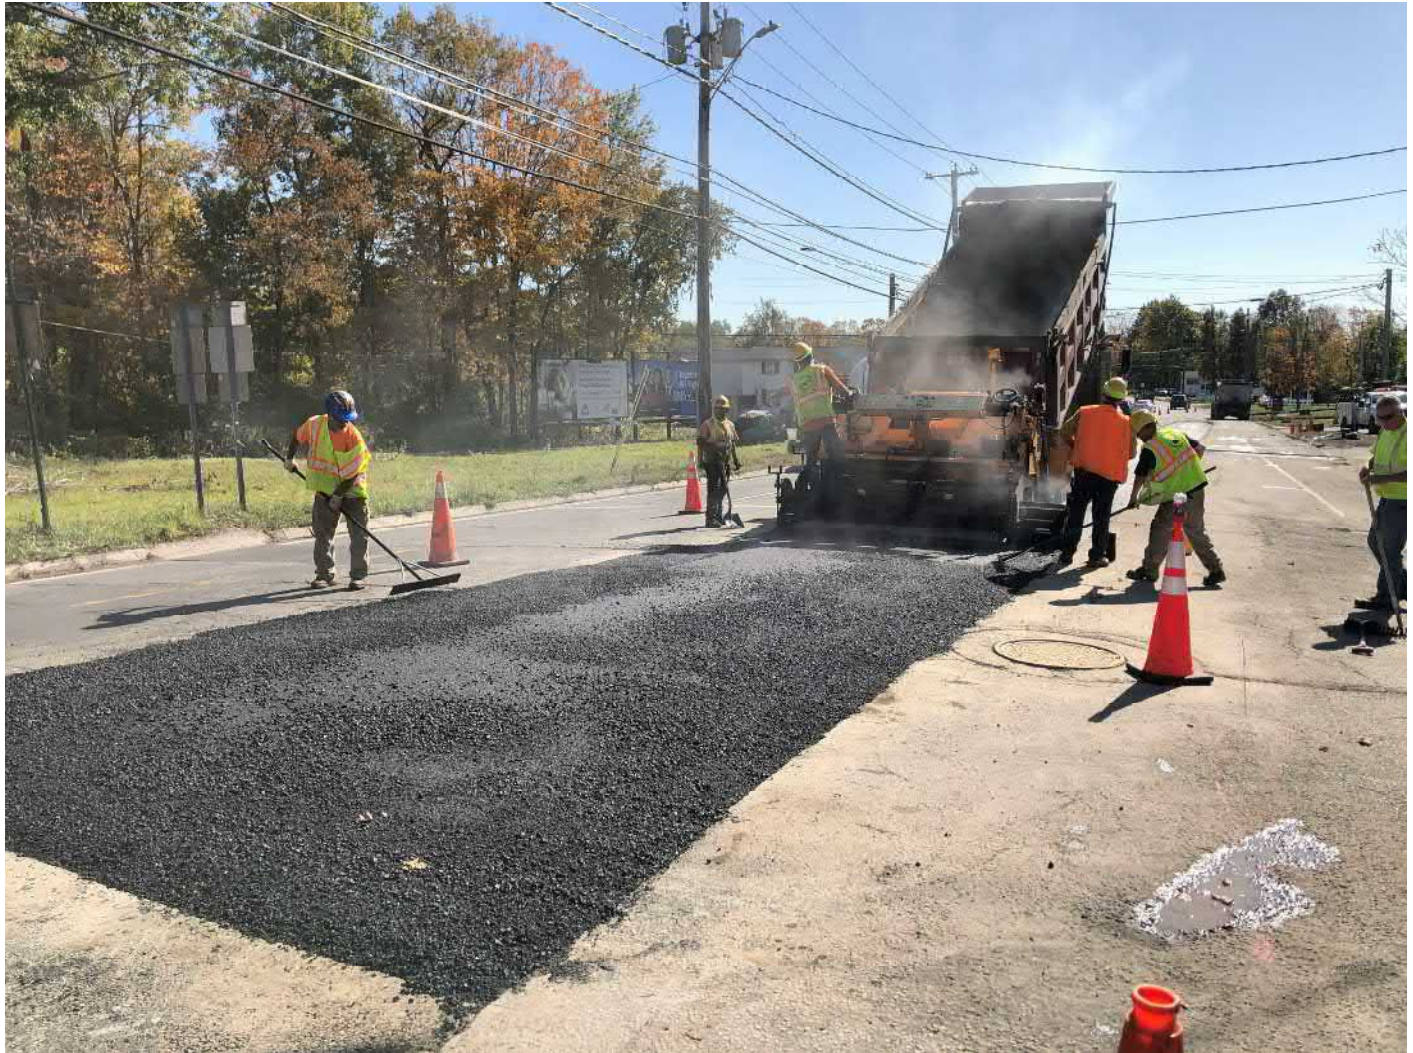
Picture 6: Ludlow placing the third of three 3" lifts on the southbound lane of Main Street, Durham between Stations 164+25 to 167+30. View to the southeast.

1346: Ludlow is placing a third 3" lift of asphalt between Stations 164+25 to 167+30 on the southbound lane of Main Street, Durham.

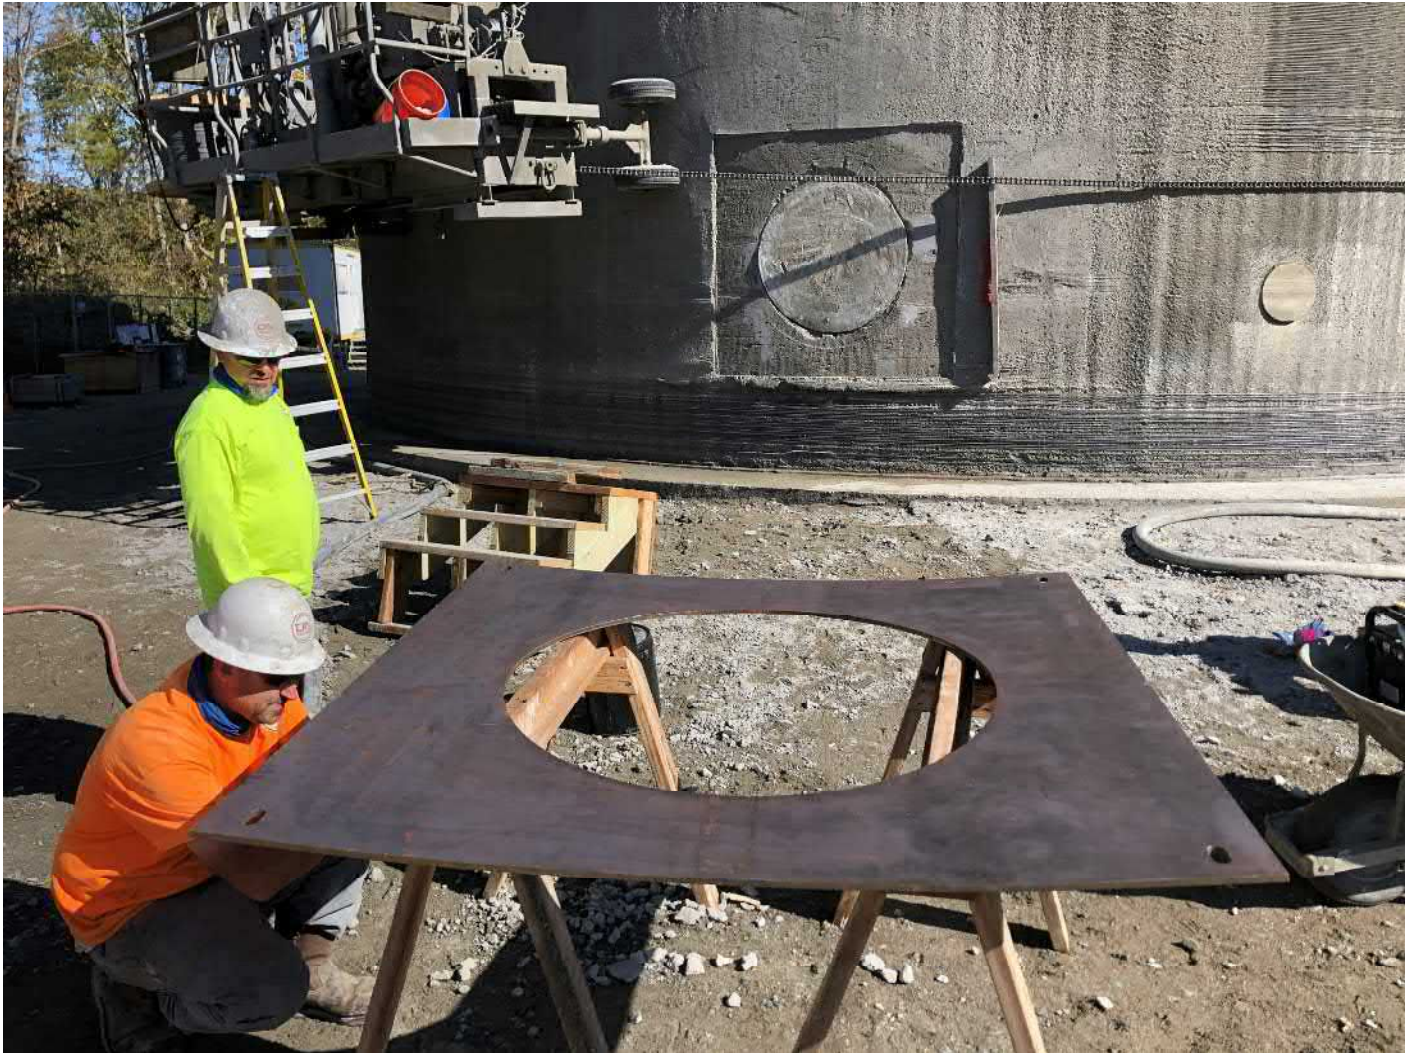
Picture 7: Stress plate that DN Tanks is preparing to place around one of the two manways of the water tank. Water tank work zone located east of the Shared Access Driveway, Middletown. View to the east.

1352: DN Tanks has placed additional wire around the exterior the water tank near the base. They are currently working on placing a stress plate around the manway located on the west side of the tank. DN Tanks stated that a similar stress plate will be placed on the manway located on the east side of the water tank tomorrow morning.
