Daily Report

Project:	Durham Meadows Pipeline Installation	Date:	October 16, 2020
Location:	Main Street, Durham; Shared Access Driveway, Middletown; South Main Street, Middletown	Day of Week:	Friday
Project #:	AECOM: 60614871	Report No:	181
Contractor:	Ludlow Construction	Page:	1 of 7

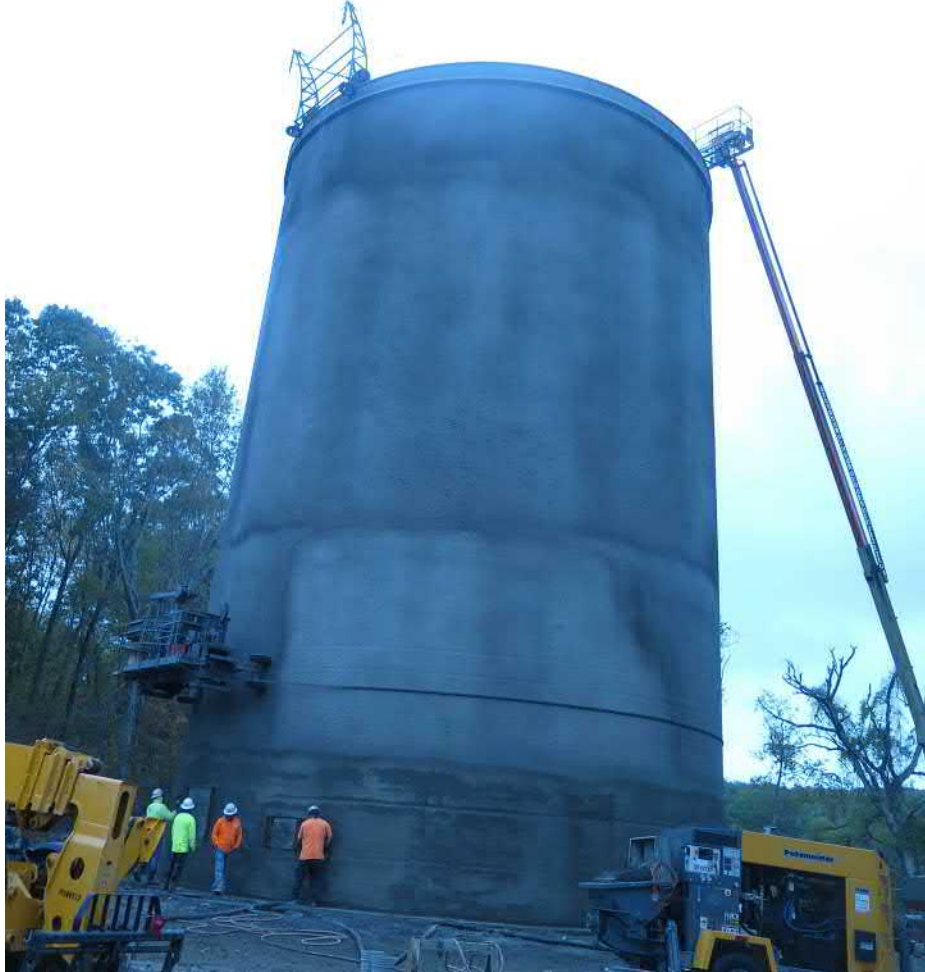
Picture 1: DN Tanks performing final tightening of wire clamps on overflow penetration. Water tank work zone located to the east of the Shared Access Driveway, Middletown. View to the east.

0720: DN Tanks performing final tightening of bolts on wire clamps with a torque wrench on northwest-facing manway and overflow penetration.

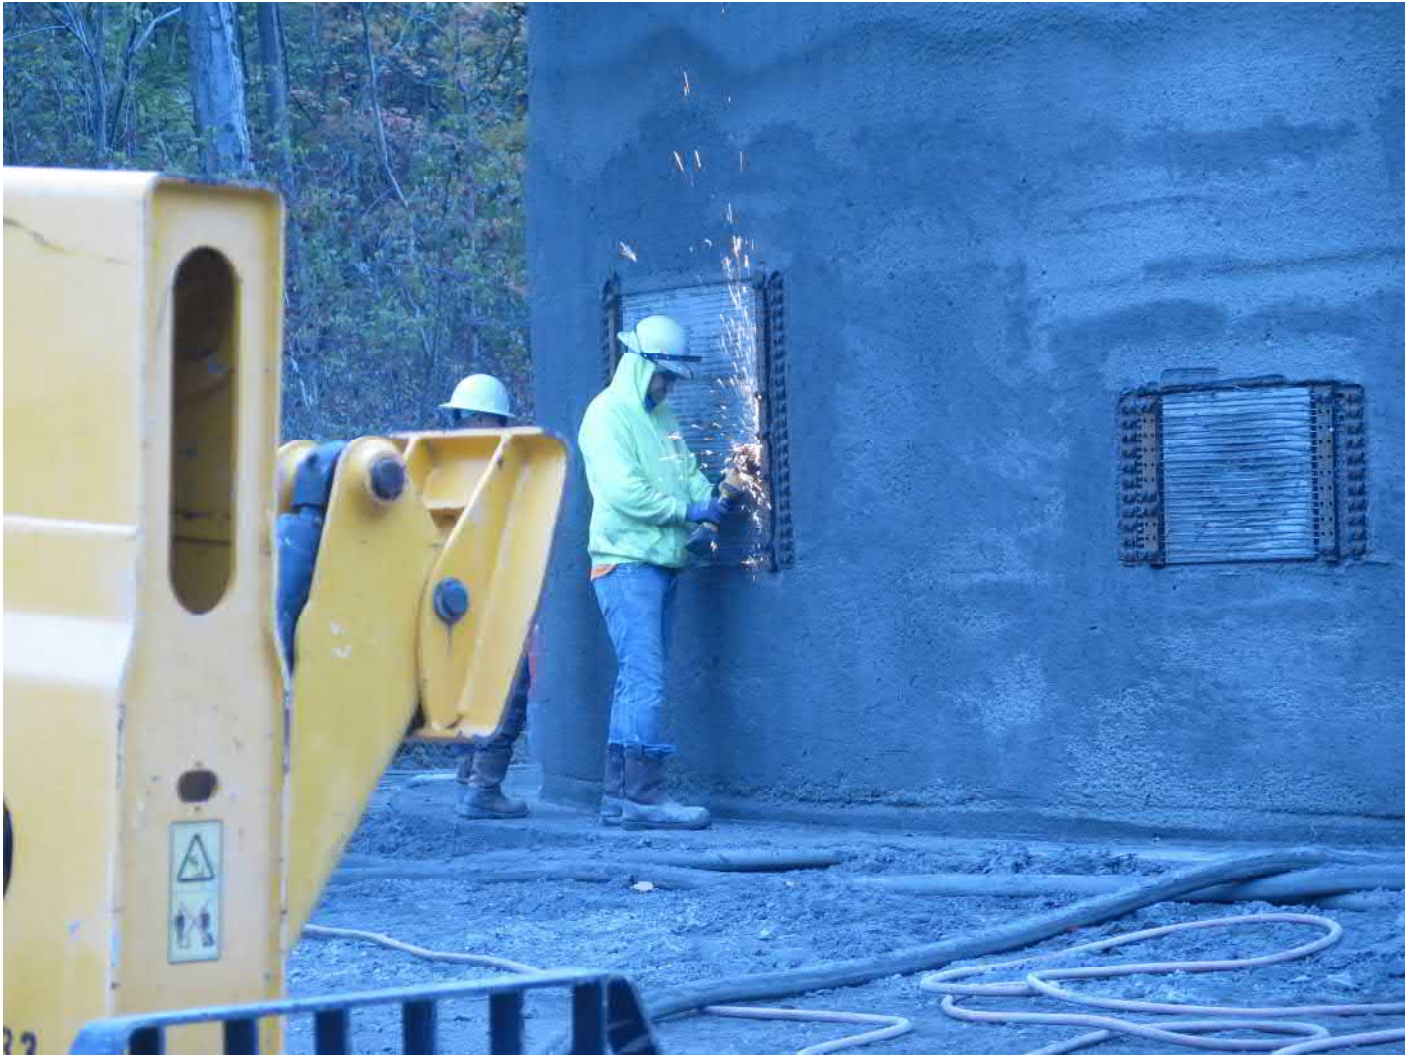
Picture 2: DN Tanks cutting pre-stress wires between clamps on the northwest manway. Water tank work zone located to the east of the Shared Access Driveway, Middletown. View to the northeast.

0730: DN Tanks cutting wires between clamps on northwest manway.

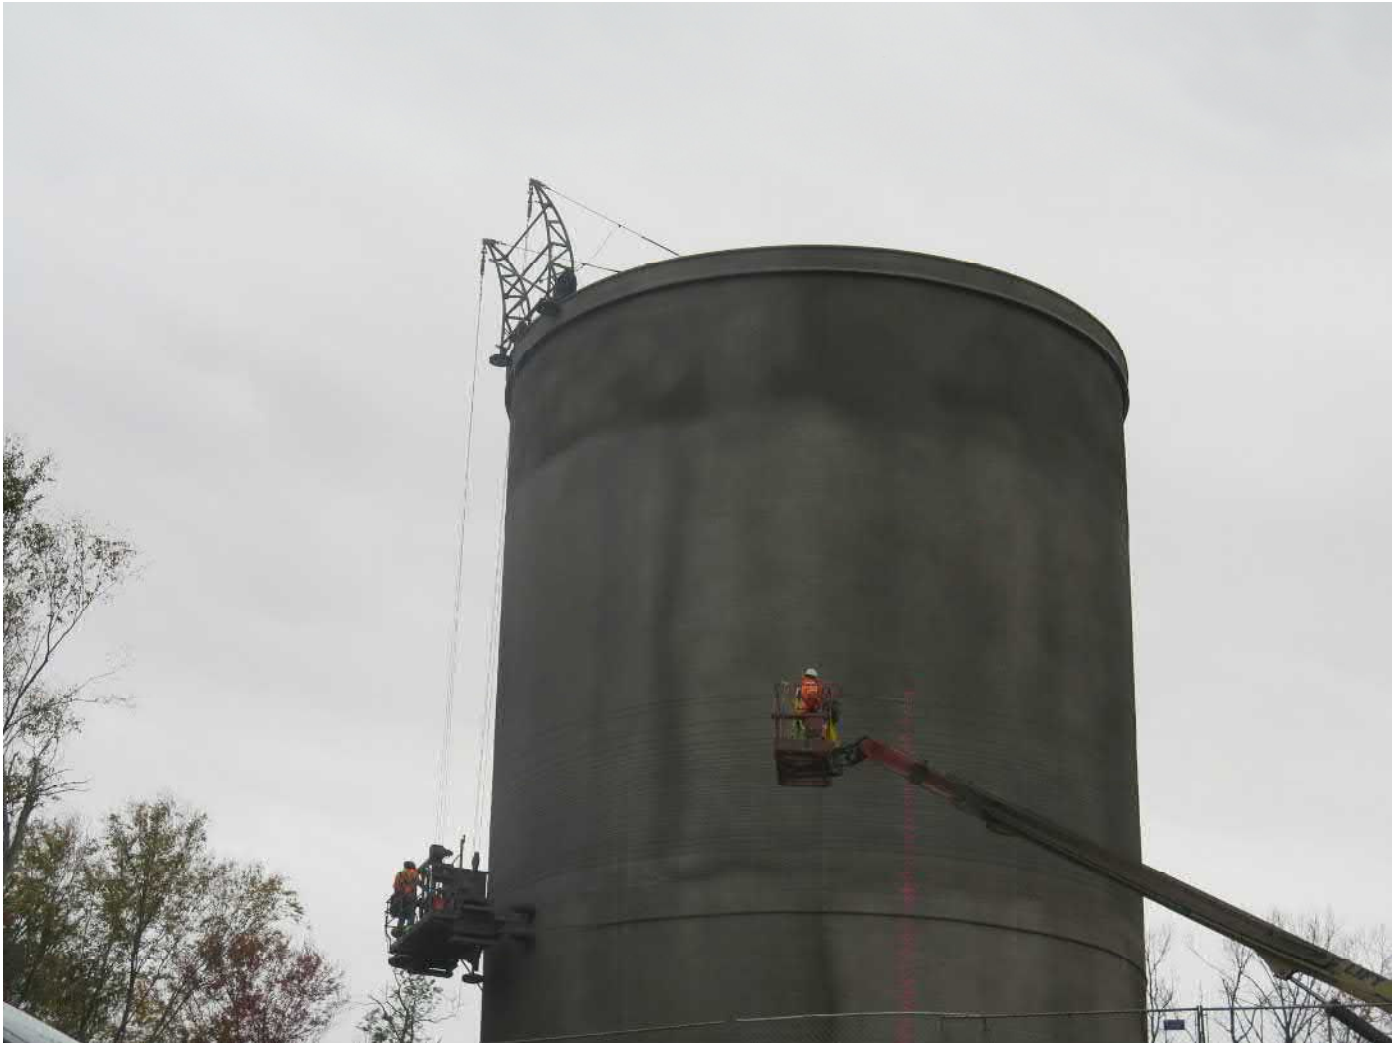
Picture 3: DN Tanks applying pre-stress wire to middle portion of tank wall. Water tank work zone located to the east of the Shared Access Driveway, Middletown. View to the east.

1000: DN Tanks winding pre-stress wire around middle portion of tank.

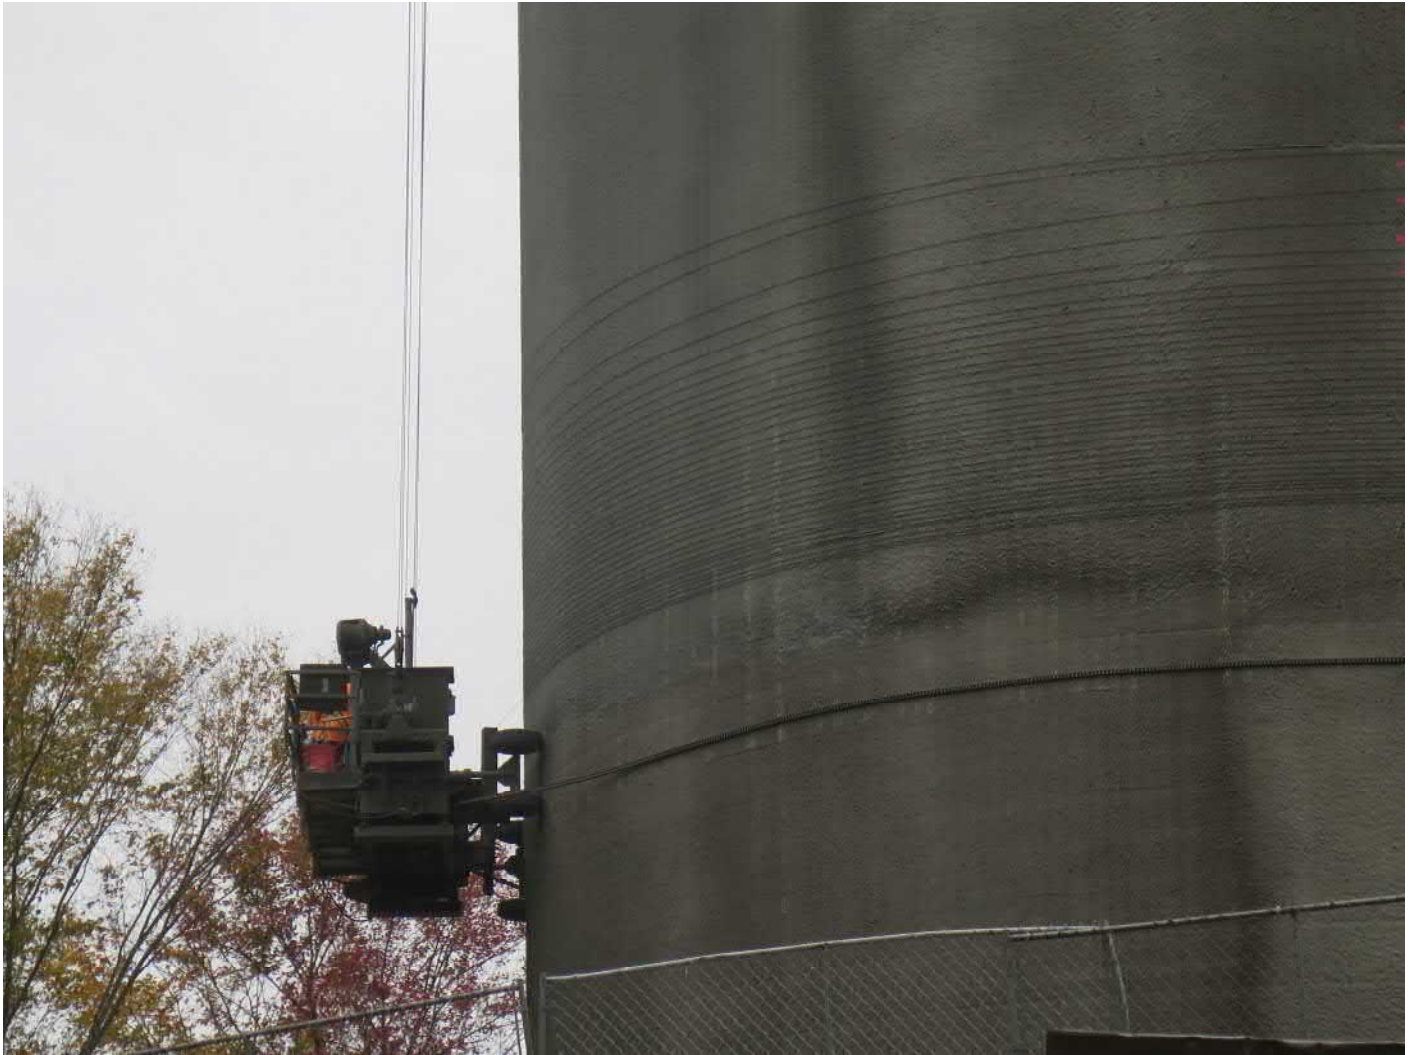
Picture 4: Close-up of wire application on tank wall. Water tank work zone located to the east of the Shared Access Driveway, Middletown. View to the east.

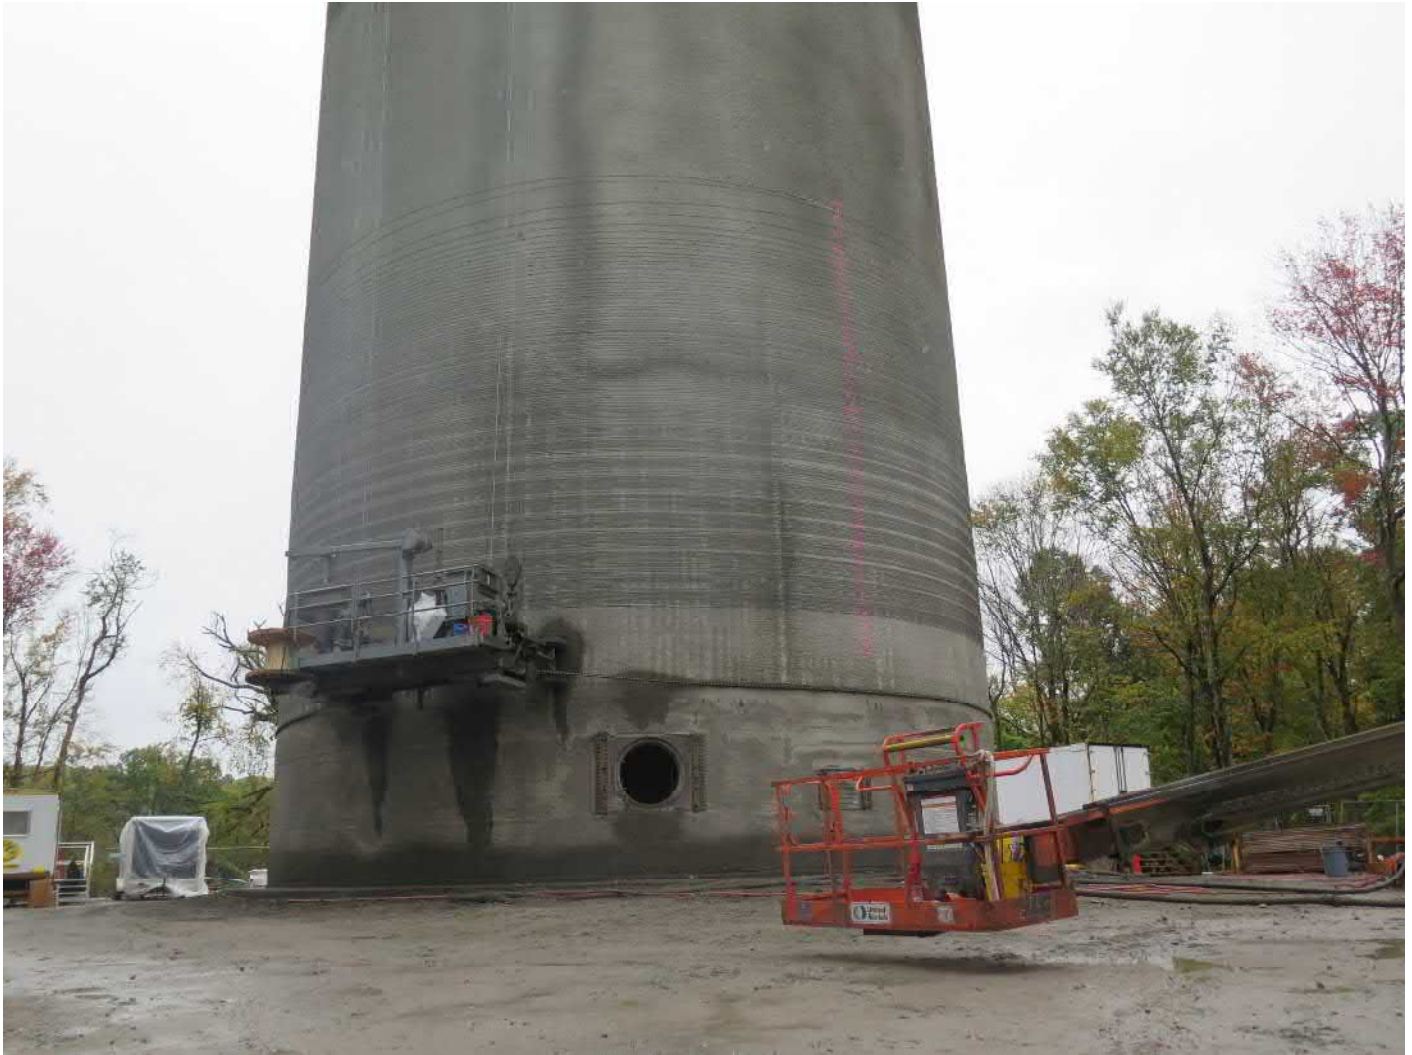
Picture 5: Extent of wire wrap completed today; within approximately 6 feet of top of manway. Water tank work zone located to the east of the Shared Access Driveway, Middletown. View to the east.

1300: Rain; DN Tanks has left for the day. Wire wrapping partially completed.
