Daily Report

Project:	Durham Meadows Pipeline Installation	Date:	October 26, 2020
Location:	Main Street, Durham; Shared Access Driveway, Middletown	Day of Week:	Monday
Project #:	AECOM: 6061487	Report No:	187
Contractor:	Ludlow Construction	Page:	2 of 8

Daily Activities – Water tank construction, Shared Access Driveway, Middletown

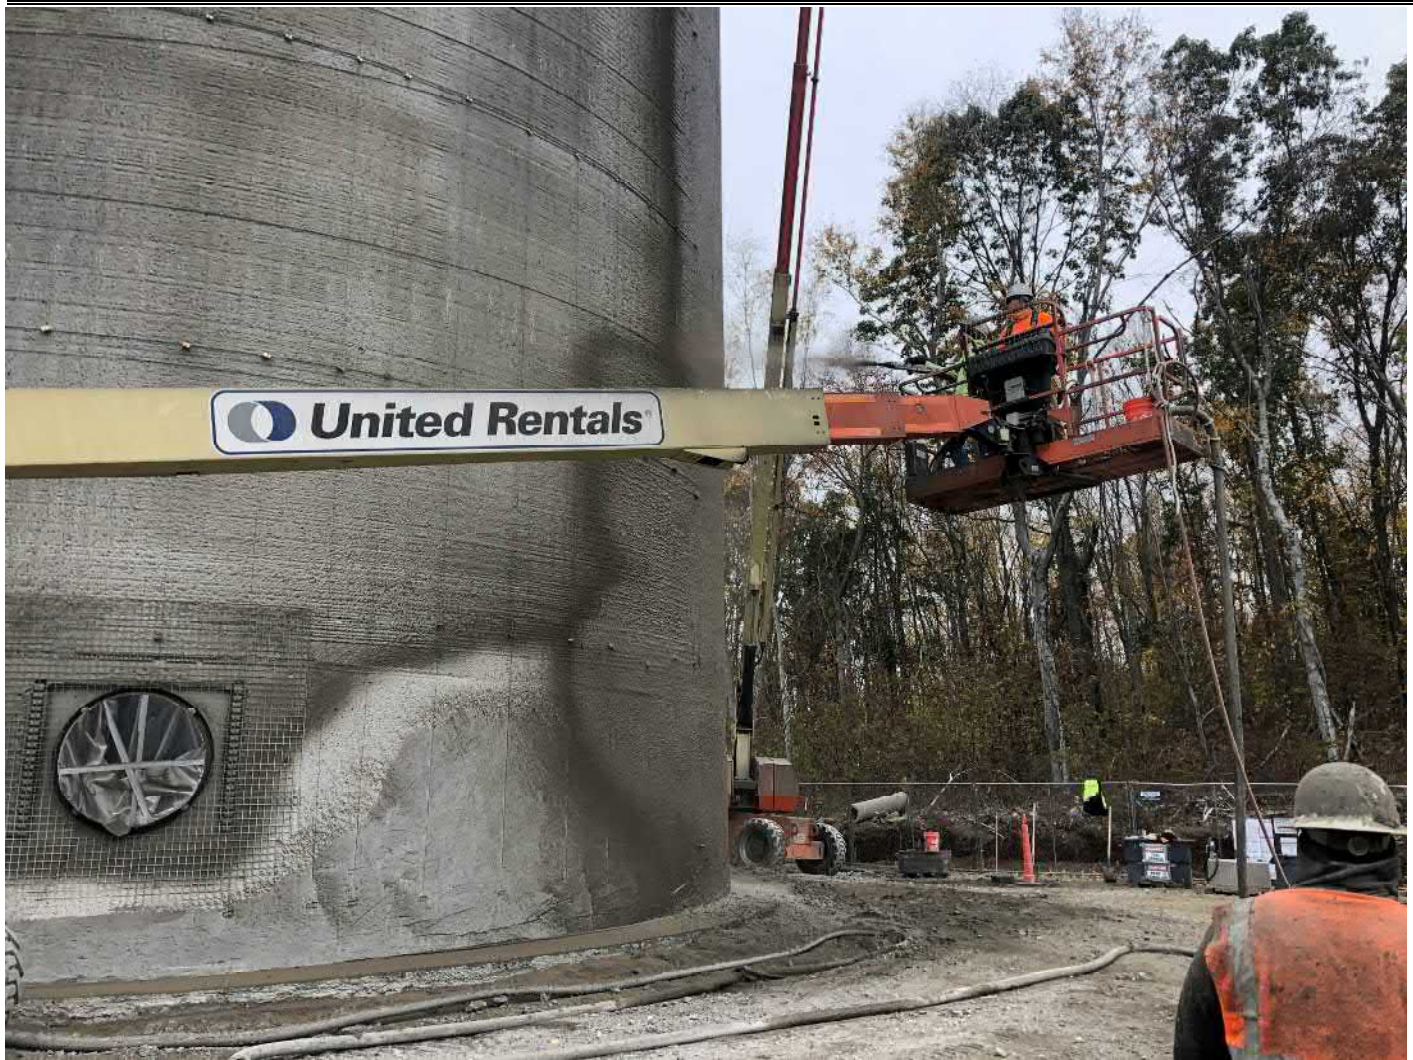
Picture 1: DN Tanks applying shotcrete to the northeast side of the water tank. Water tank work zone located east of the Shared Access Driveway, Middletown. View to the north.

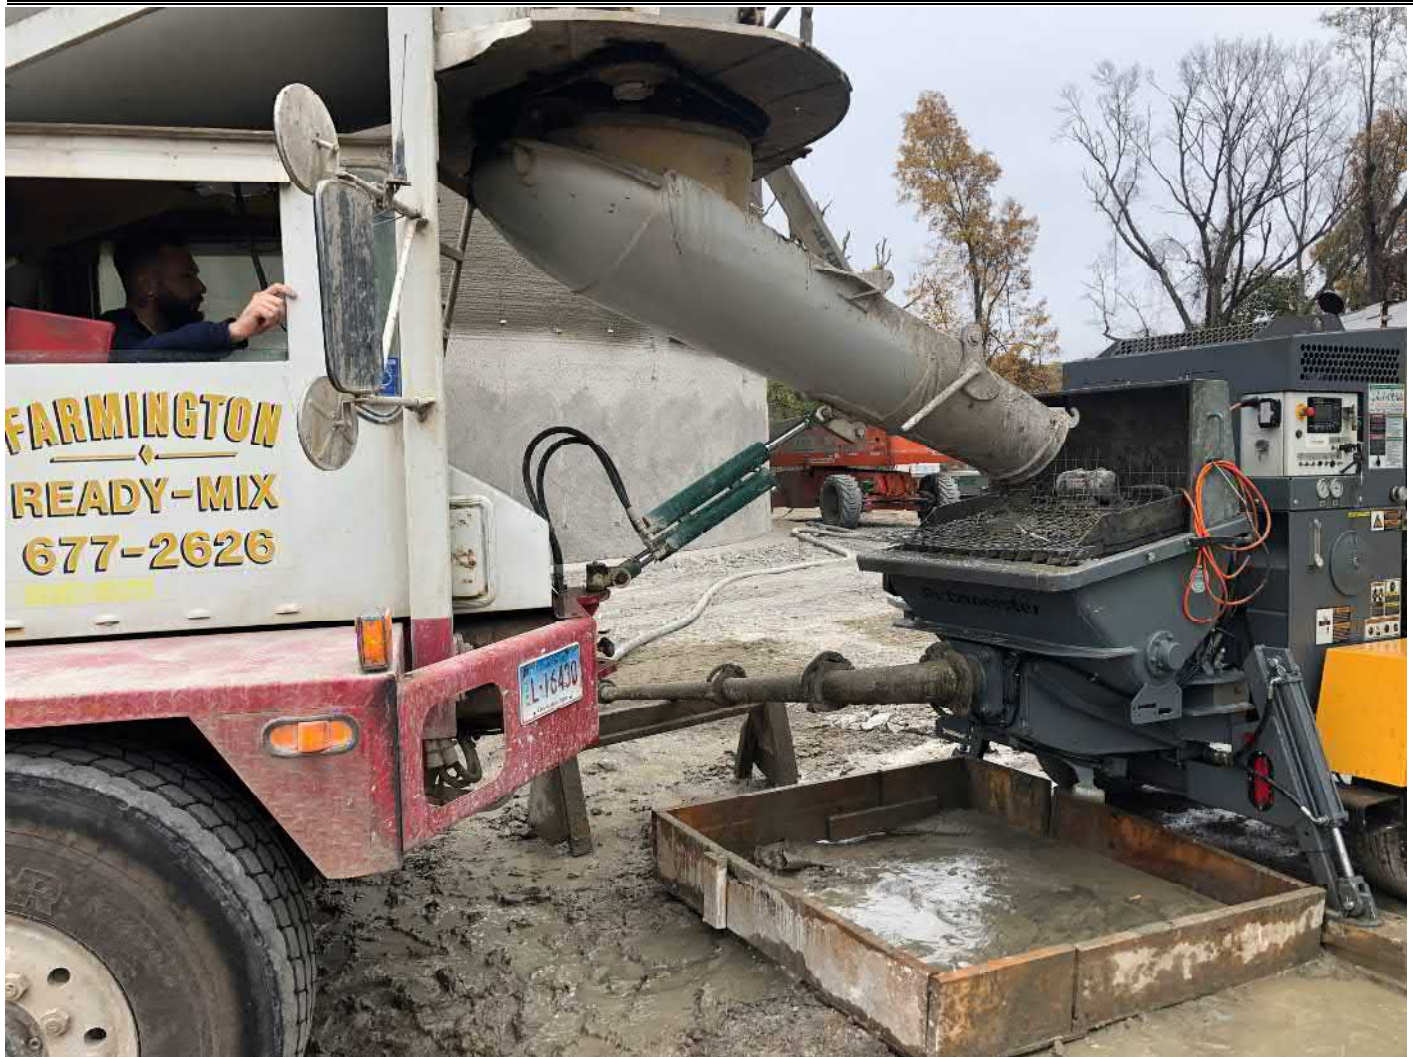
Picture 2: Farmington Ready Mix feeding shotcrete into pumper/mixer as DN Tanks applies the shotcrete to the exterior of the water tank. Water tank work zone located east of the Shared Access Driveway, Middletown.

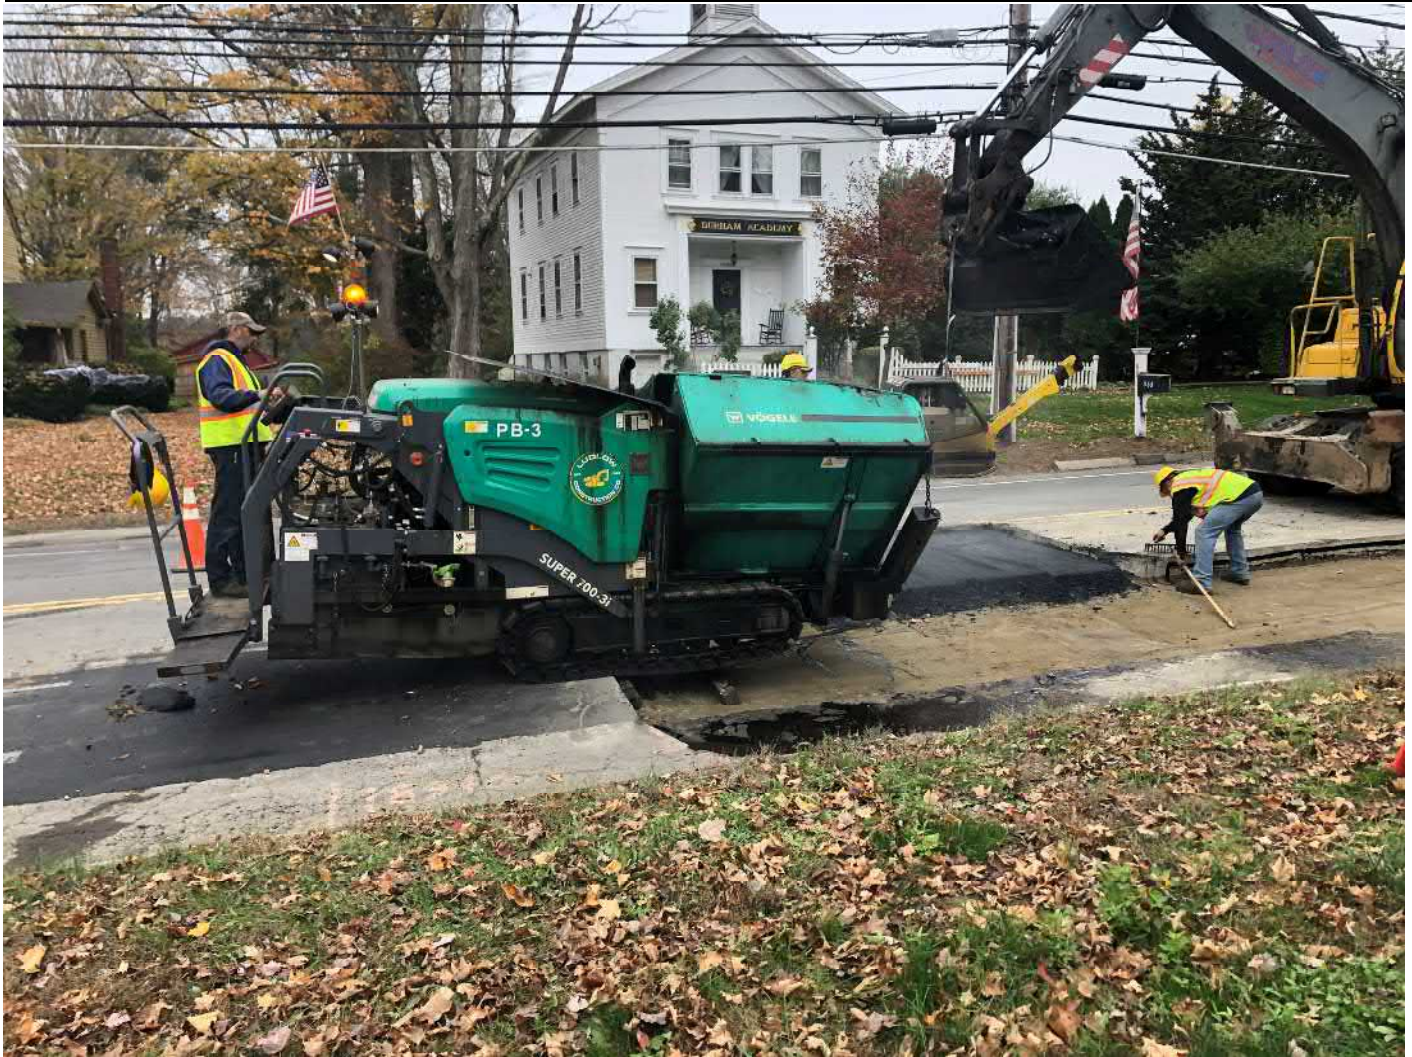
Picture 3: Ludlow preparing to place first of three 3" lifts of asphalt between Stations 189+00 and 192+70 on the southbound lane of Main Street, Durham. View to the east.

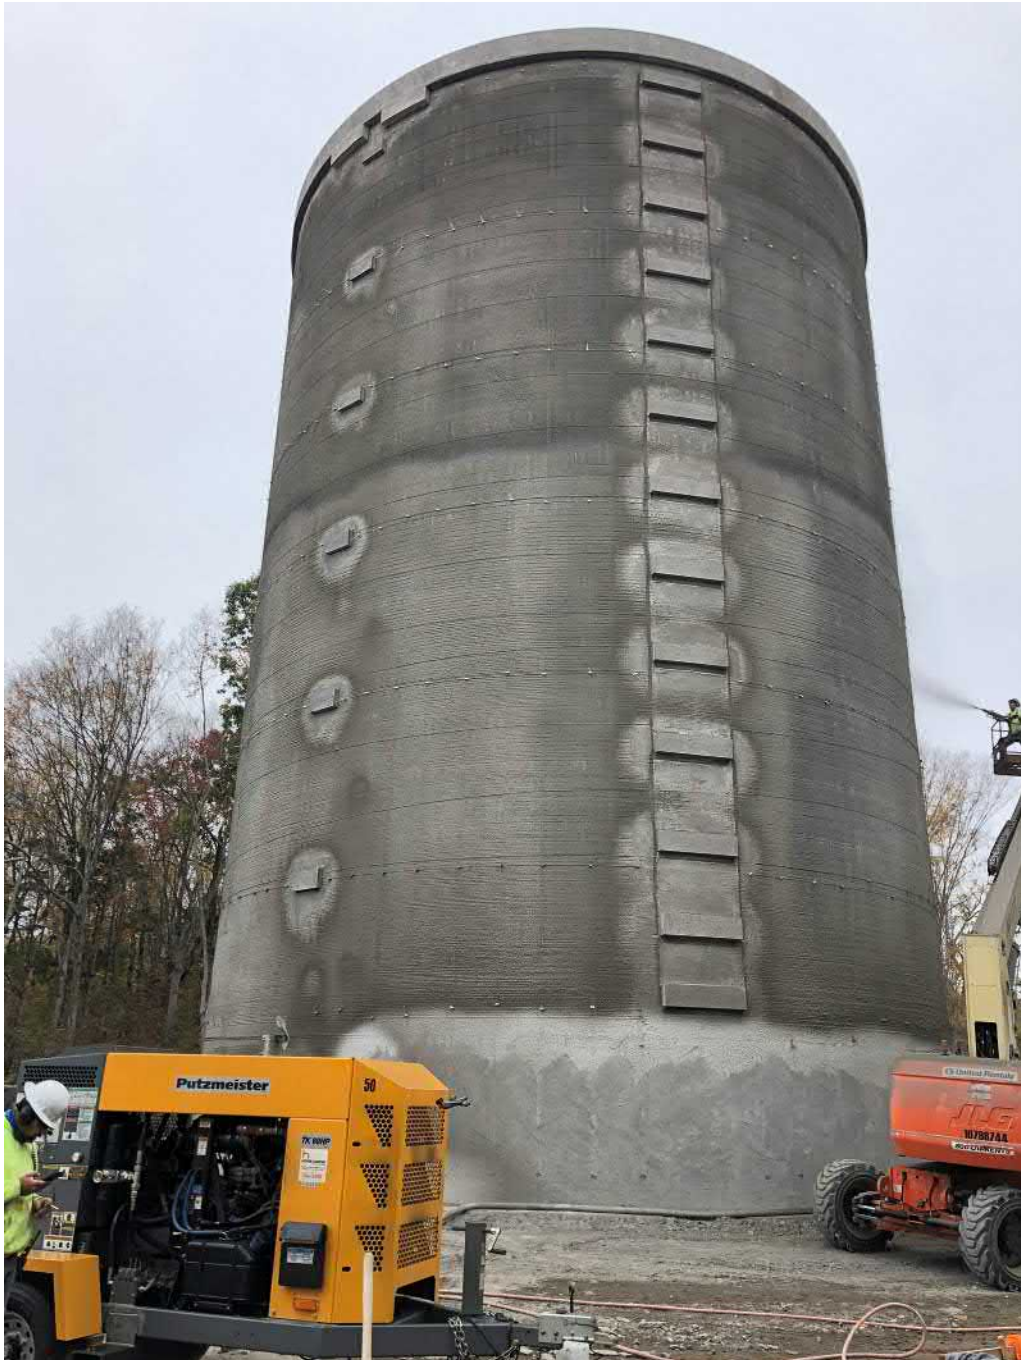
Picture 4: View of radio antennae supports (left) and ladder supports (right) after application of shotcrete last week. Water tank work zone located east of the Shared Access Road, Middletown.

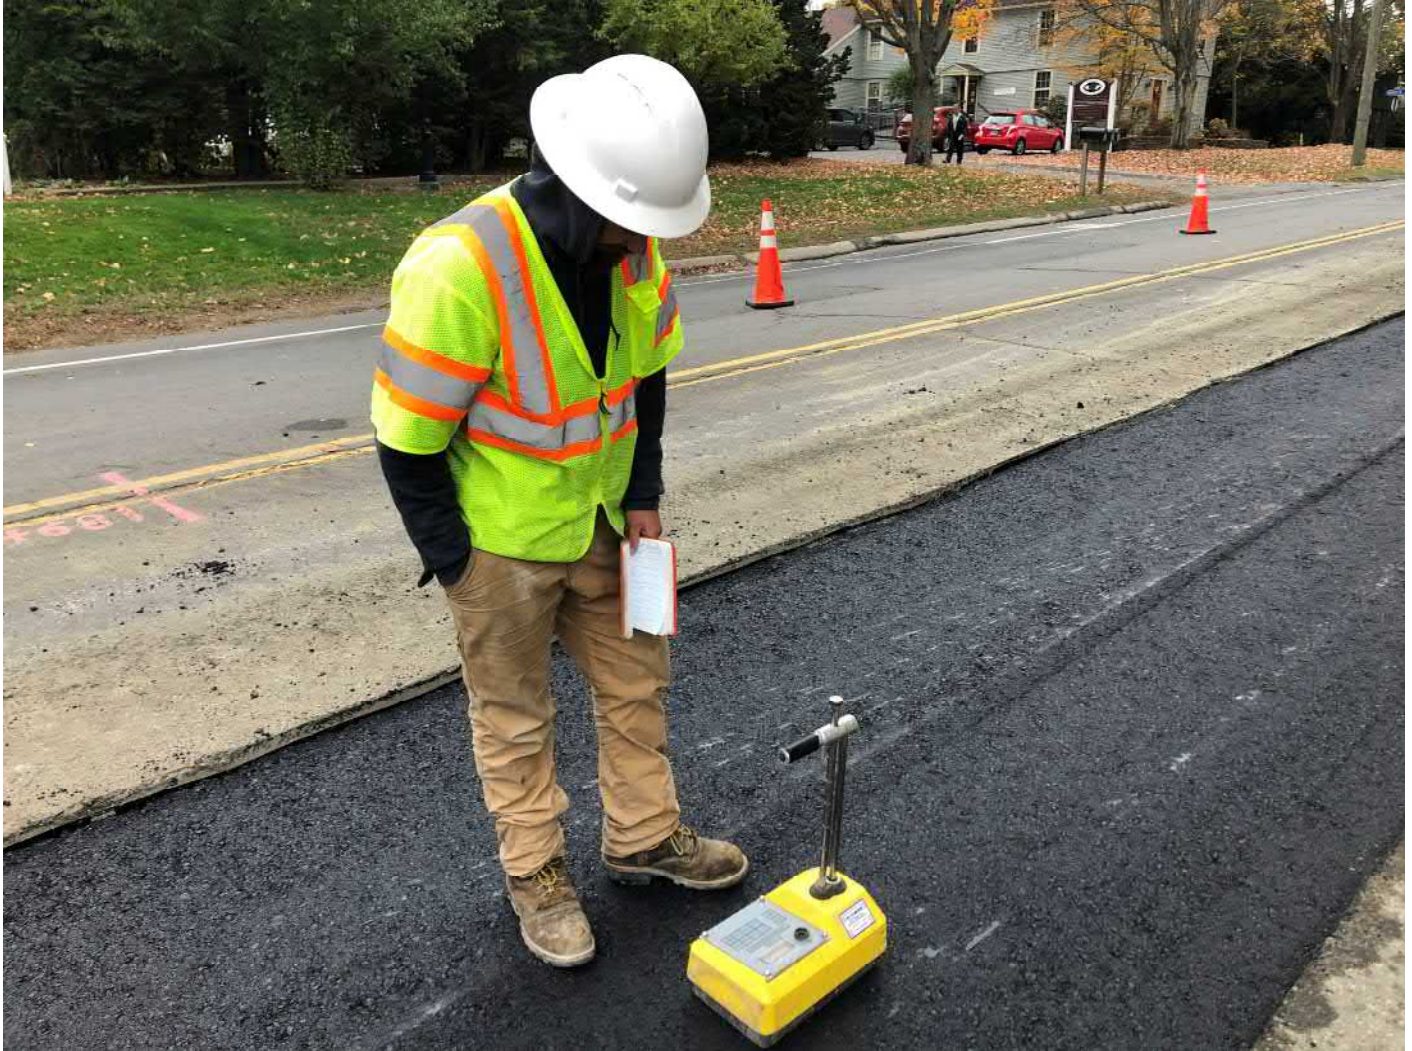
Picture 5: JTC collecting compaction data from the second lift of asphalt that Ludlow placed and compacted between Stations 189+00 and 192+70 on the southbound lane of Main Street, Durham. View to the southeast.
