Daily Report

| Project: | Durham Meadows Pipeline Installation | Date: | December 04, 2020 |
| Project #: | AECOM: 6061487 | Report No: | 212 |
| Contractor: | Ludlow Construction | Page: | 1 of 13 |

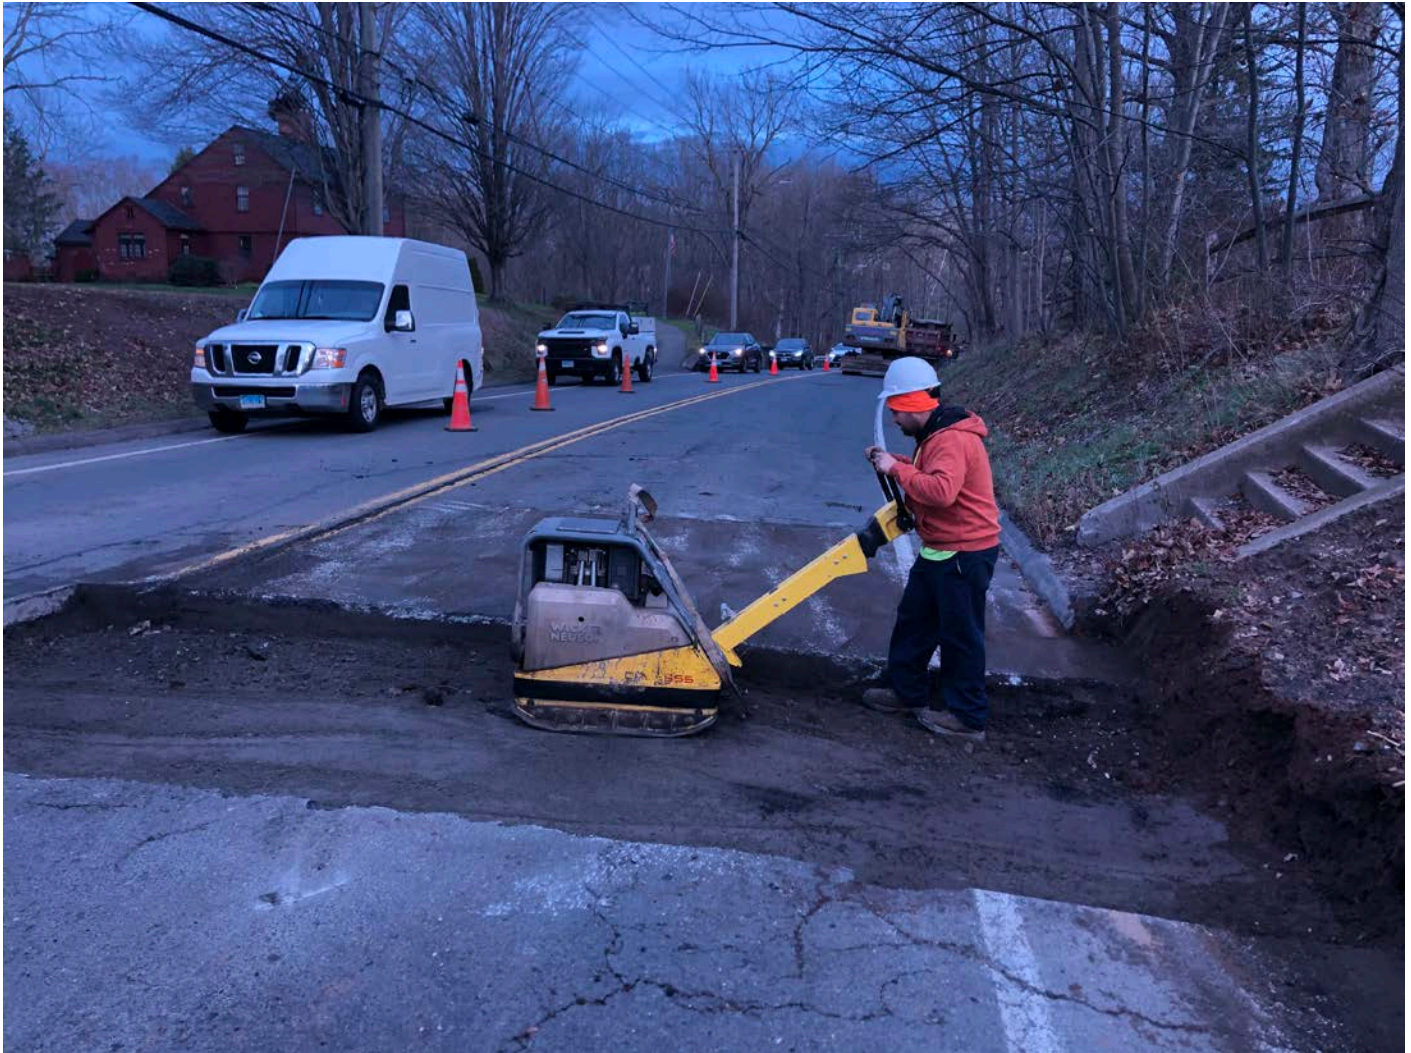
Picture 1: Ludlow compacting 1.5" processed gravel at the curb stop overcut on the northbound lane at 127 Main Street, Durham. View to the north.

0753: Ludlow is compacting 1.5" processed gravel after having removed pavement on a curb stop overcut on the northbound lane of Main Street, Durham at 119 Main Street.

0922: Ludlow has removed asphalt on the northbound lane of Main Street from the curb stop overcut at 127 Main Street. Ludlow has also compacted the underlying 1.5" processed gravel. The curb stop overcut is ready for the placement of the three 3" lifts of asphalt that Ludlow will place and compact as part of permanent paving activities.

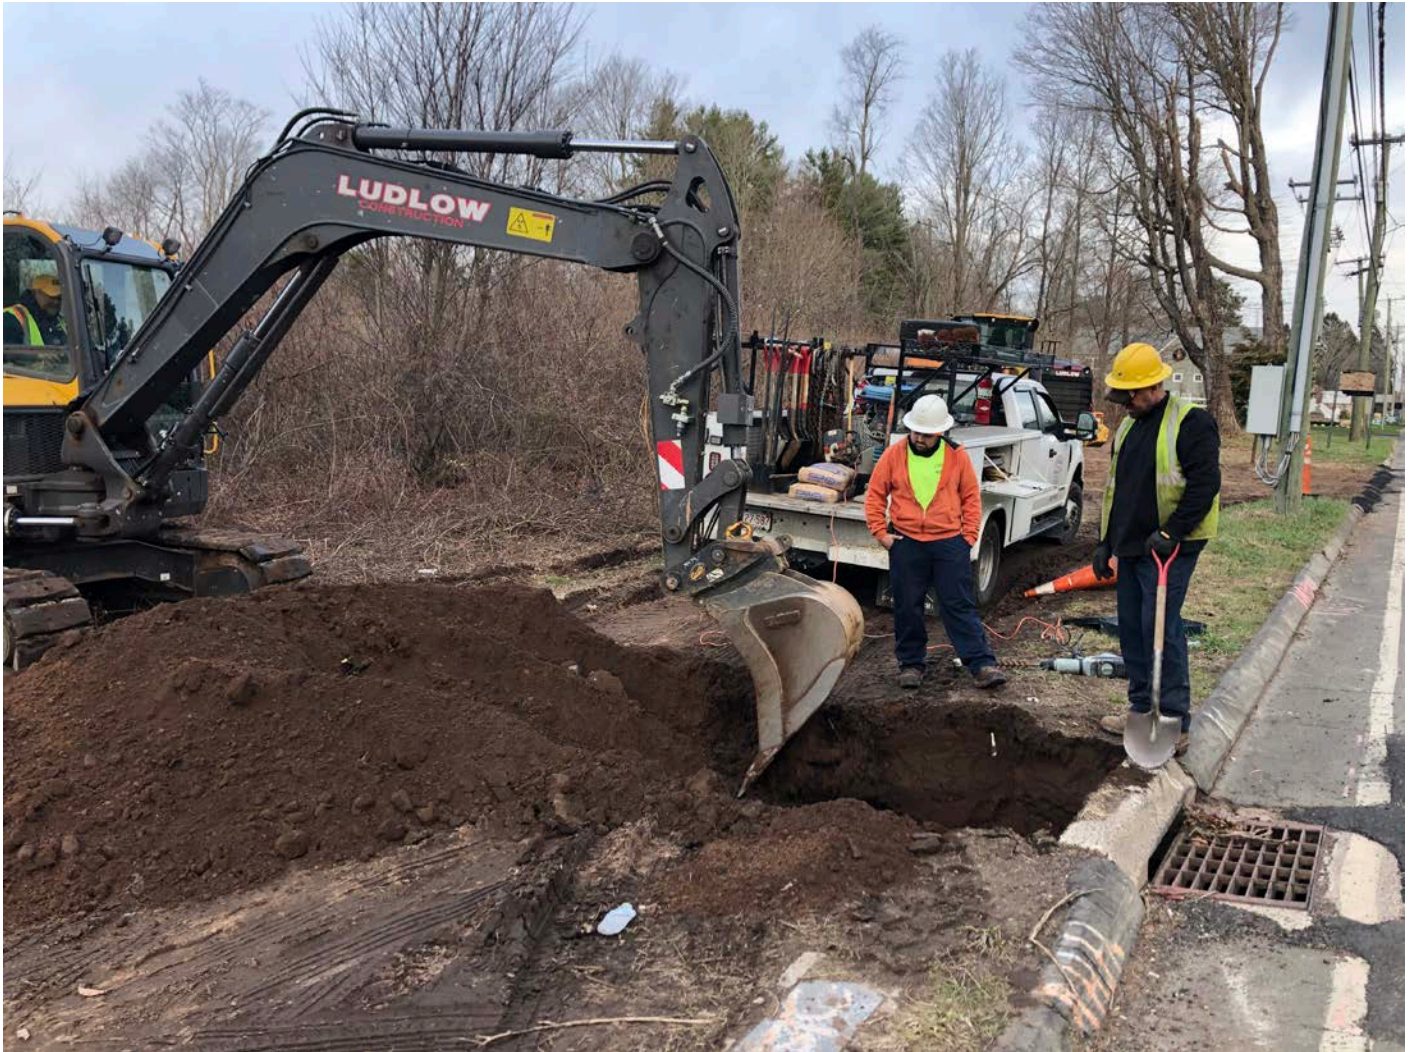
Picture 2: Ludlow excavating at ~Station 161+20 as they begin the installation of a 2" PVC drain line that will connect the PRV vault sump to the storm drain line that is connect to the catch basin depicted above. View to the north.

0823: Ludlow is excavating west of Main Street in front of the storm drain located at ~Station 160+20 as they prepare to install a 2" PVC drain line that will connect the sump in the PRV vault to the storm drainage line.

0904: Ludlow continues to excavate west of Main Street, Durham at Station 160+20 as they prepare to install a 2" PVC drain line that will connect the sump in the PRV vault to the storm drainage line.

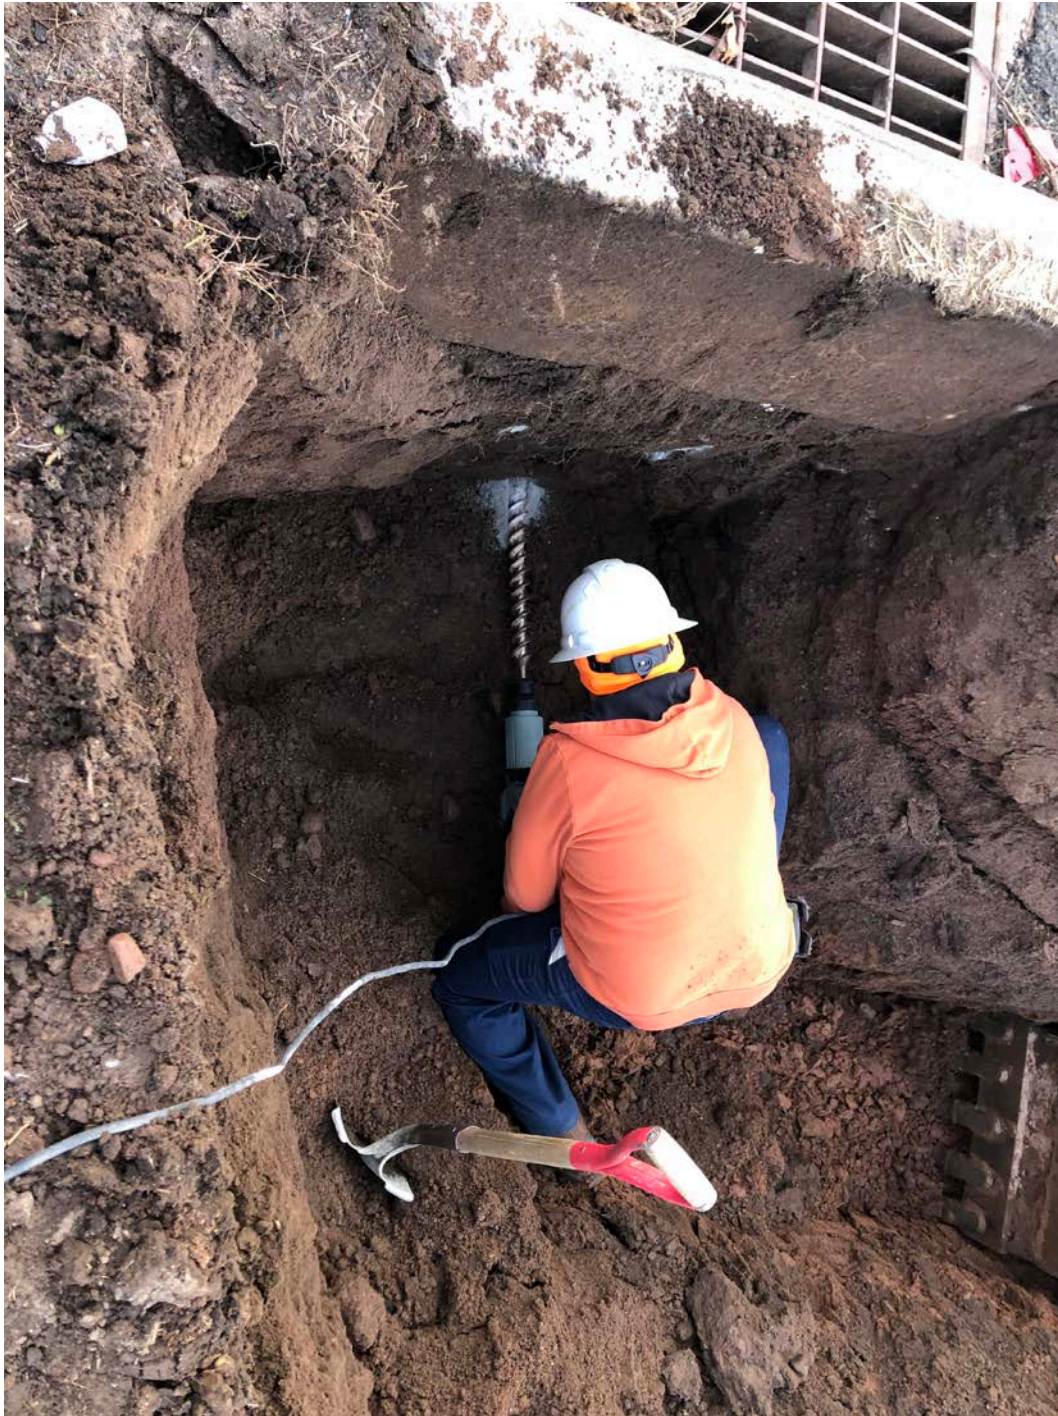
Picture 3: Ludlow drilling into the storm drain line located at Station 161+20 as they prepare to install a 2" PVC drain line that will connect the PRV vault sump to the storm drain line. View to the east.

0835: Ludlow is drilling into the existing storm drain at ~Station 160+20 for the installation of a 2" PVC drain line that will connect the sump in the PRV vault to the storm drainage line.

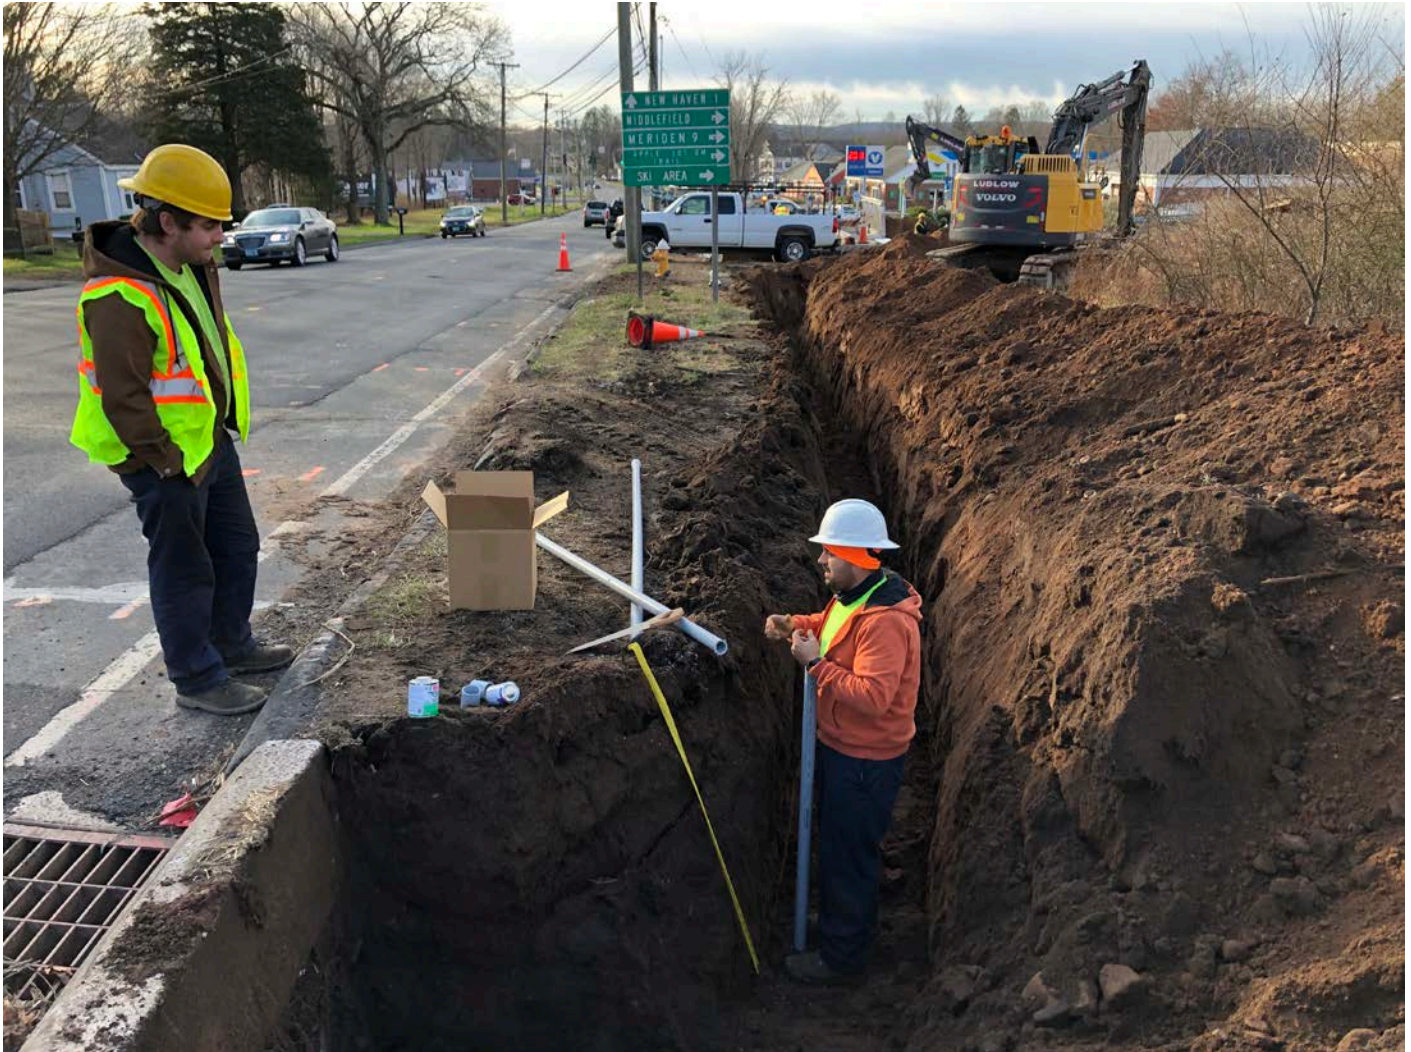
Picture 4: Ludlow in the process of installing a 2" PVC drain line that will connect the PRV vault sump to the storm drain line located at Station 161+20 on the west side of Main Street. View to the south.

1211: Ludlow has finished with the installation of a 2" PVC drain line that connects the sump in the PRV vault to the storm drainage line on the west side of Main Street, Durham at ~Station 161+20. United Concrete continues to work inside of the PRV Vault.

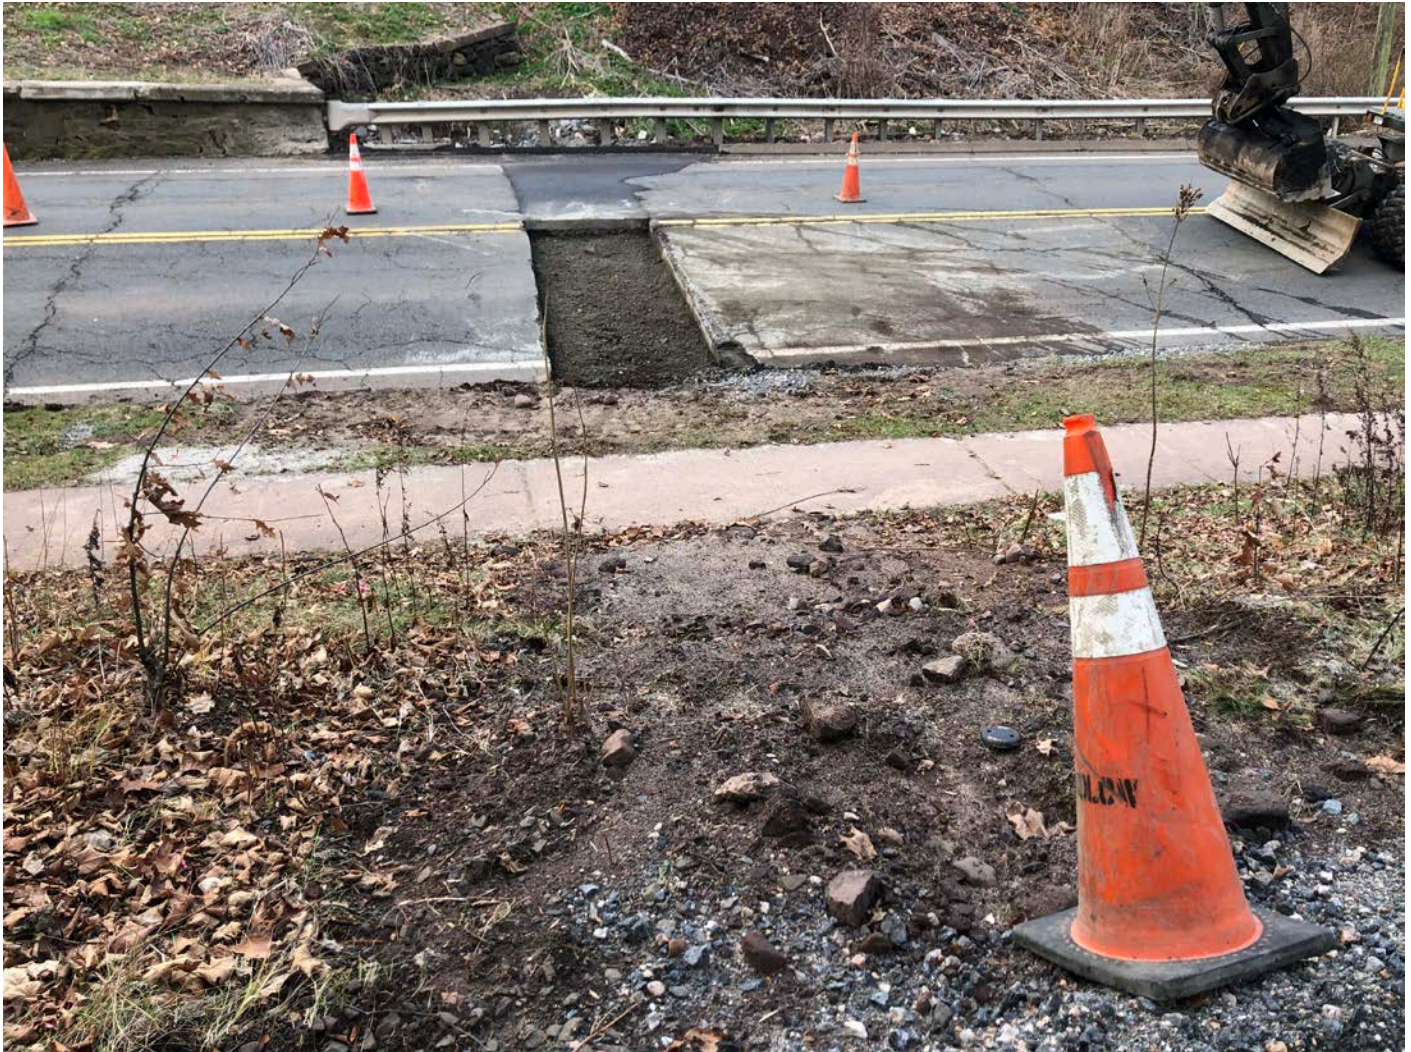
Picture 5: Curb stop overcut that is ready for permanent paving, located at 119 Main Street, Durham. View to the west.

0733: Ludlow has excavated a curb stop overcut at 119 Main Street, Durham for permanent paving.

1034: Ludlow is placing the third 3" lift of asphalt on the curb stop over cuts at 119 and 127 Main Street on the northbound lane of Main Street as part of permanent paving activities.

1102: Ludlow has finished permanent paving on the curb stop overcuts located at 127 and 119 Main Street, Durham.

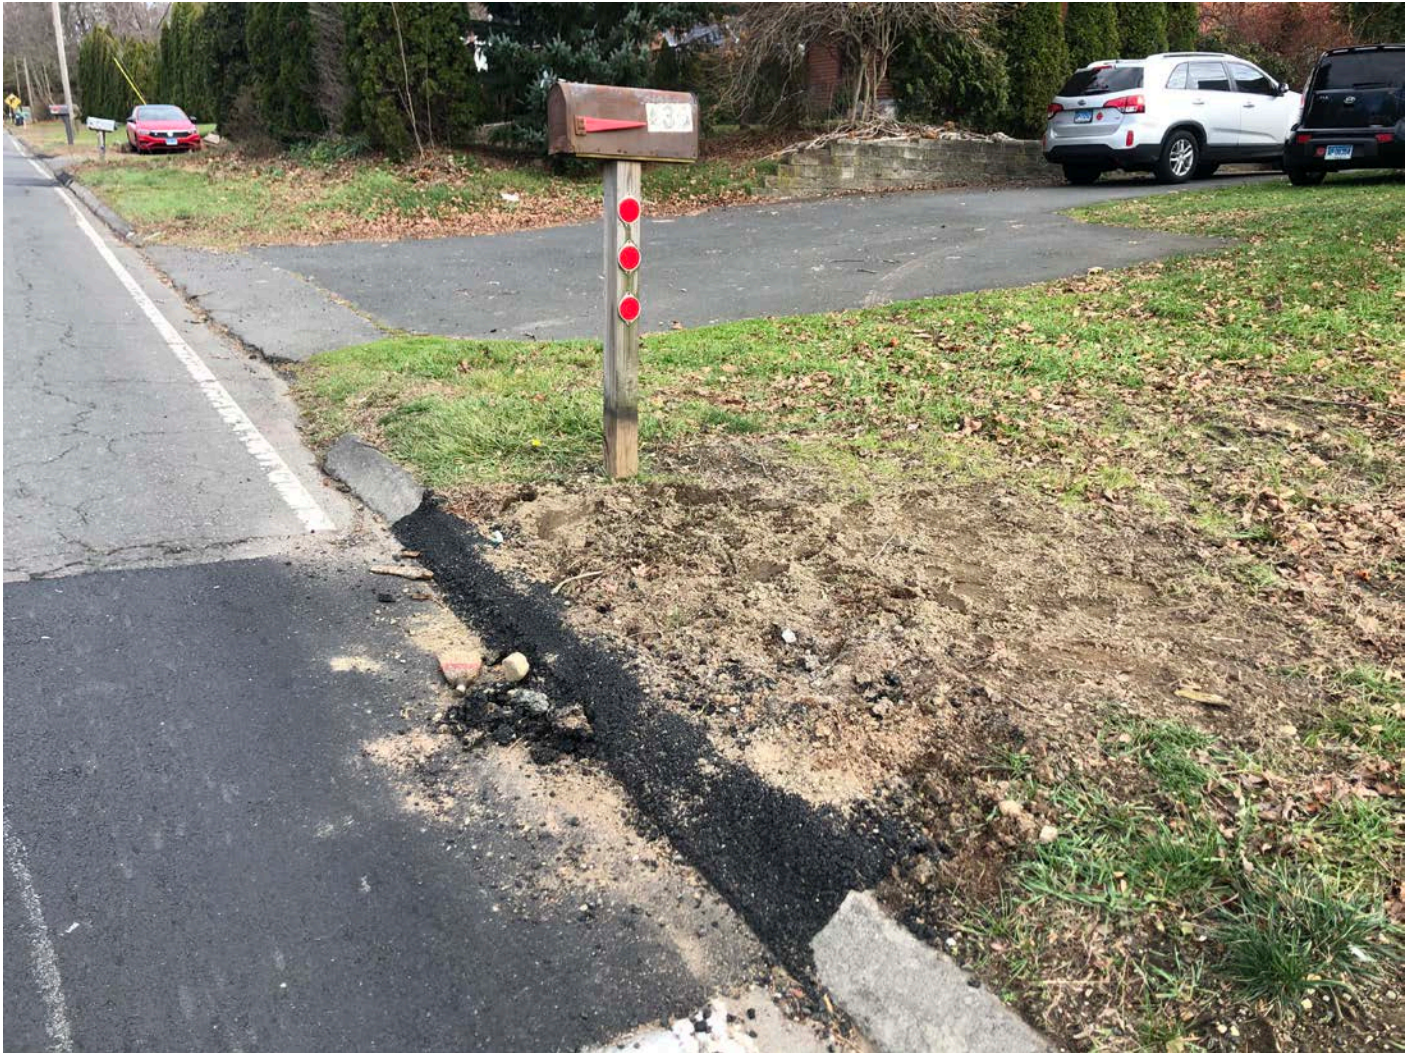
1335: A complaint came in a resident at 435 Main Street, Durham, where Ludlow had previously performed a temporary repair of the curbing that was disturbed during the installation of a curb stop. The area was inspected by Ludlow, USACE, and AECOM

independently: asphalt patching that was used in the repair of the curbing has been pushed into the road. In addition, the area to the east of the curbing repair was found to be in need of a small amount of additional Loam. Ludlow addressed these minor issues.

Picture 6: Temporary curb patch located at 435 Main Street, Durham that was the subject of a complaint. Ludlow removed the asphalt that was pushed into the road and added additional loam to the east of the curb. View to the northeast.

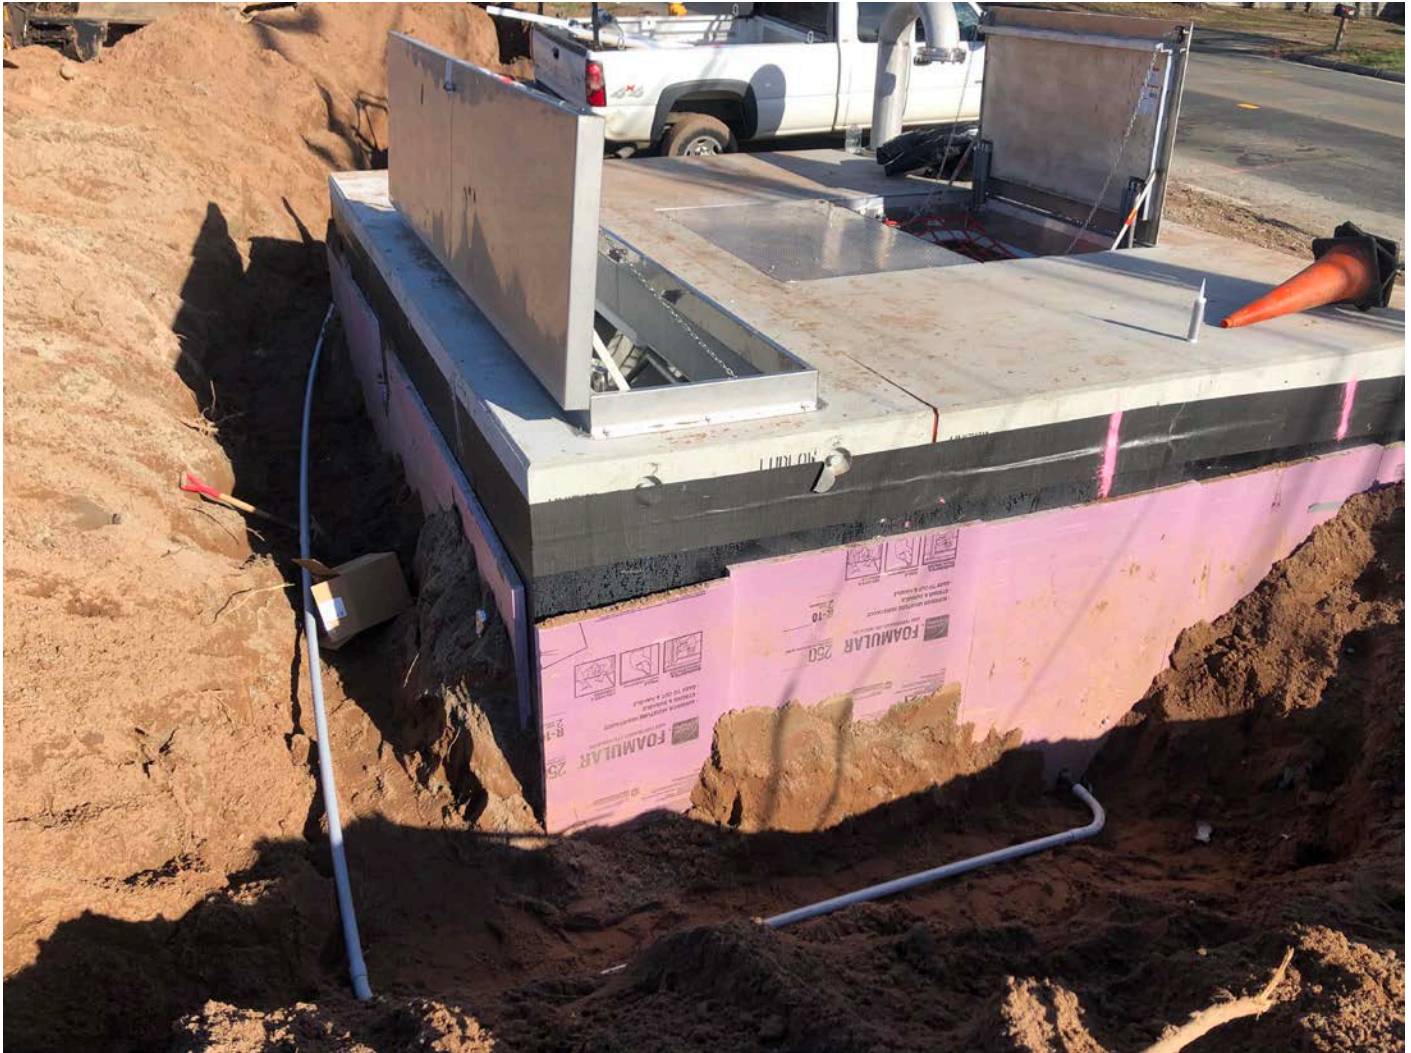
Picture 7: PVC drain line that has been connected to the south side of the PRV vault located at ~161+30 to the west of Main Street, Durham. View to the northeast.

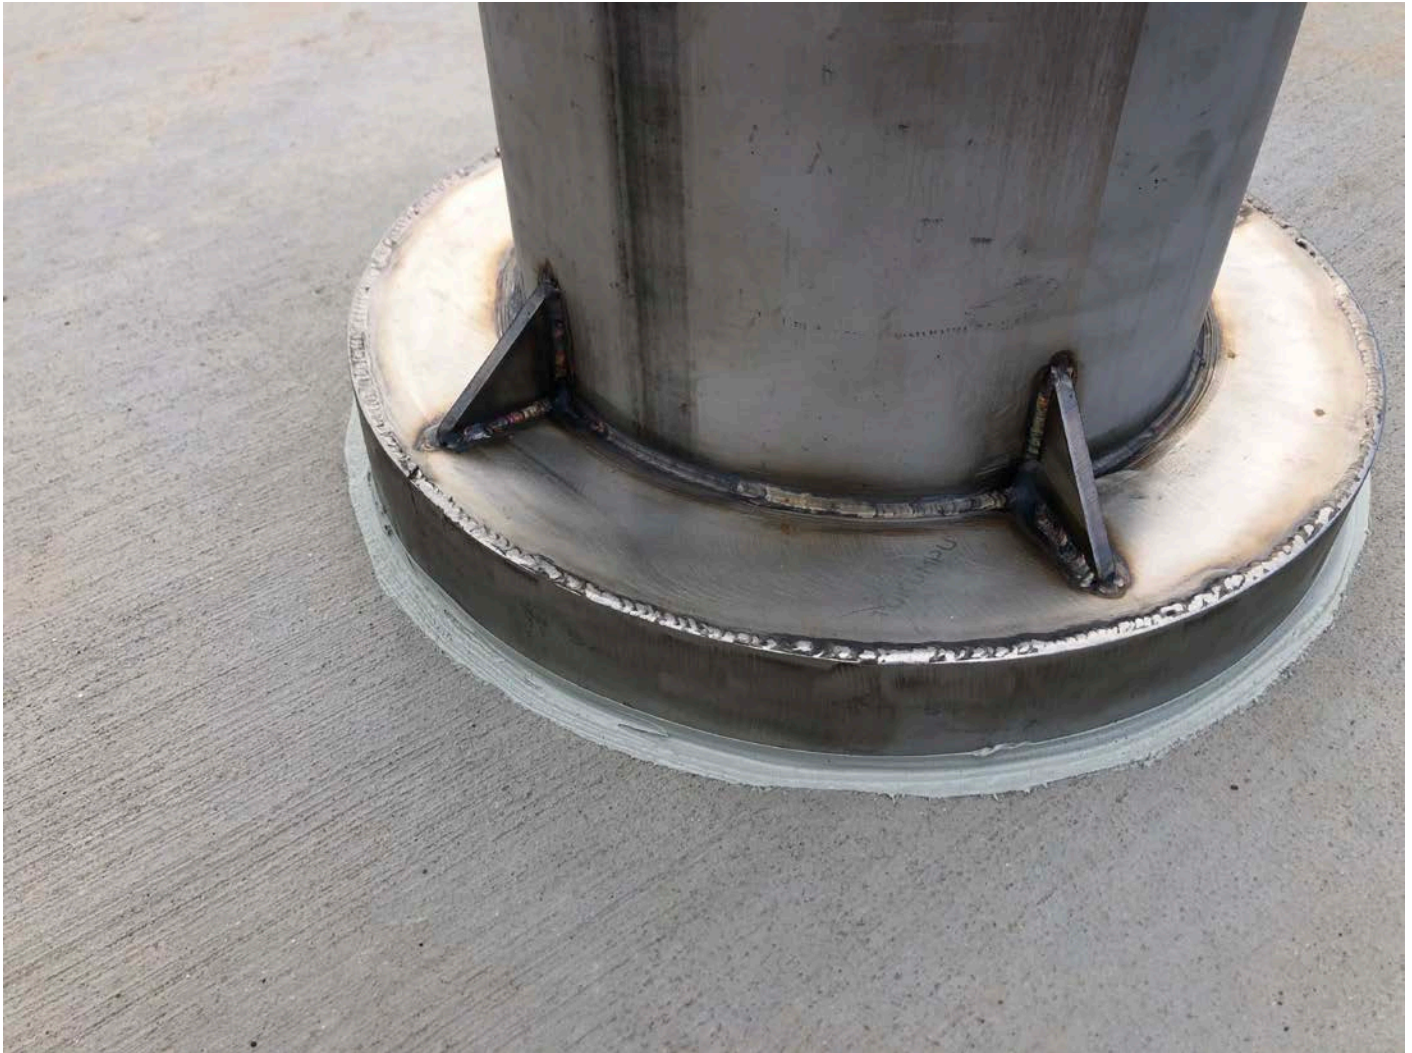
Picture 8: Seam between the PRV vault roof and the vent pipe located on the northeast corner of the vault that United Concrete sealed today. View to the southwest.

1318: United Concrete is working on the exterior of the PRV vault, sealing wall seams and penetrations of the vault walls and roof. Ludlow has finished backfilling over the PVC discharge pipe for the PRV vault's floor drain sump. There is still approximately 15" of the vault that is standing above surface grade.

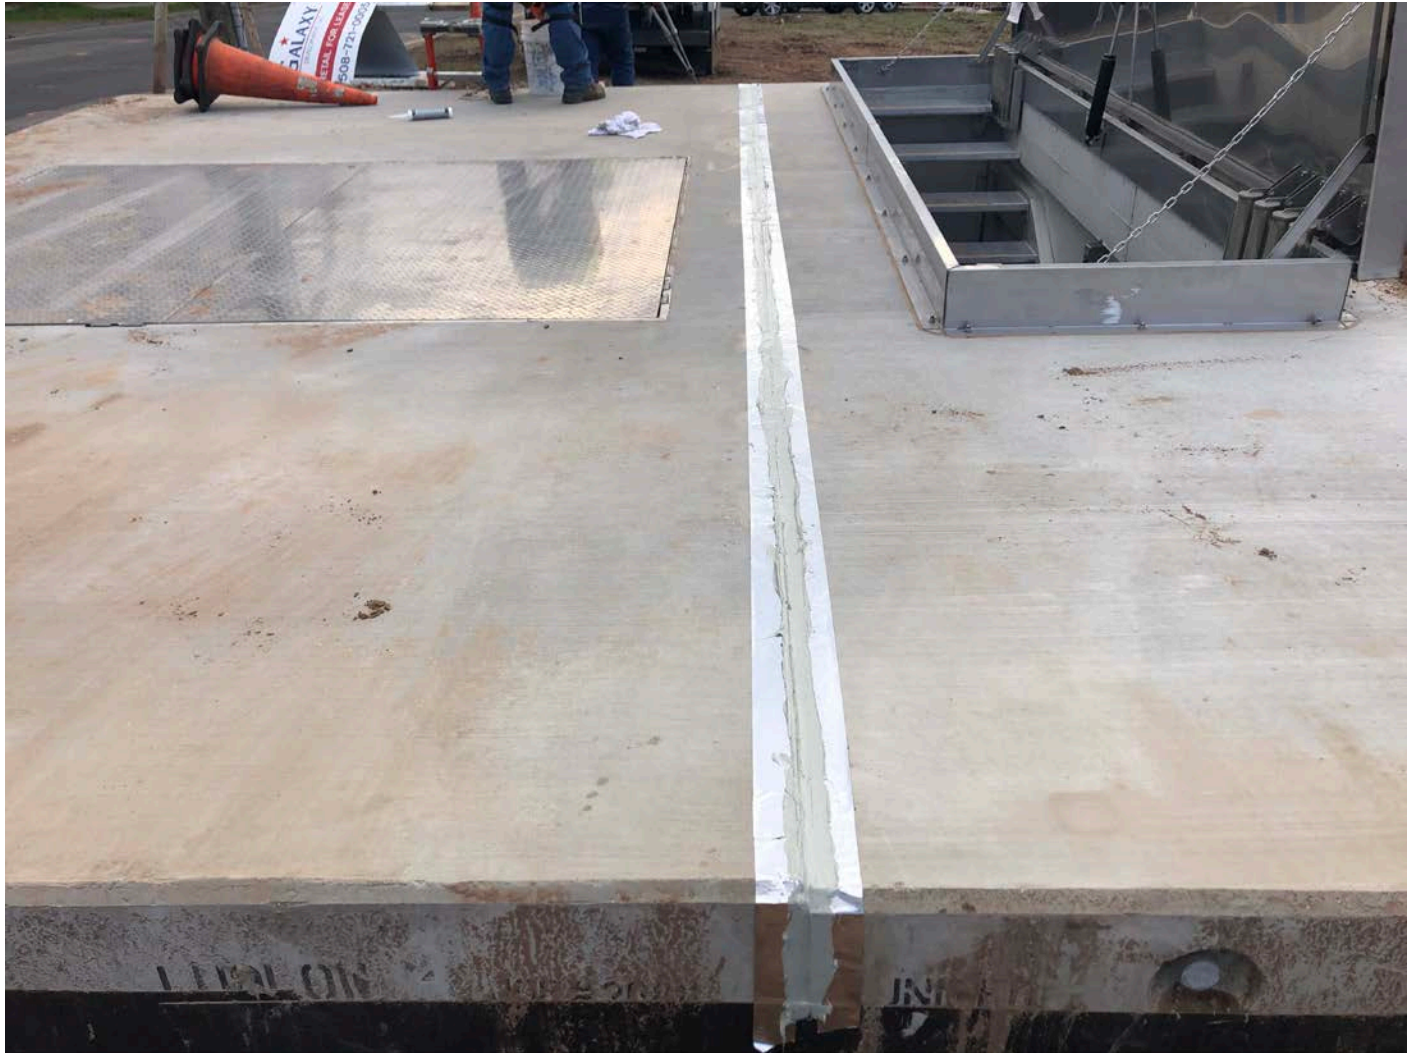
Picture 9: Seam between PRV vault roof sections that United Concrete sealed today (tape was removed once caulk set). View to the south.

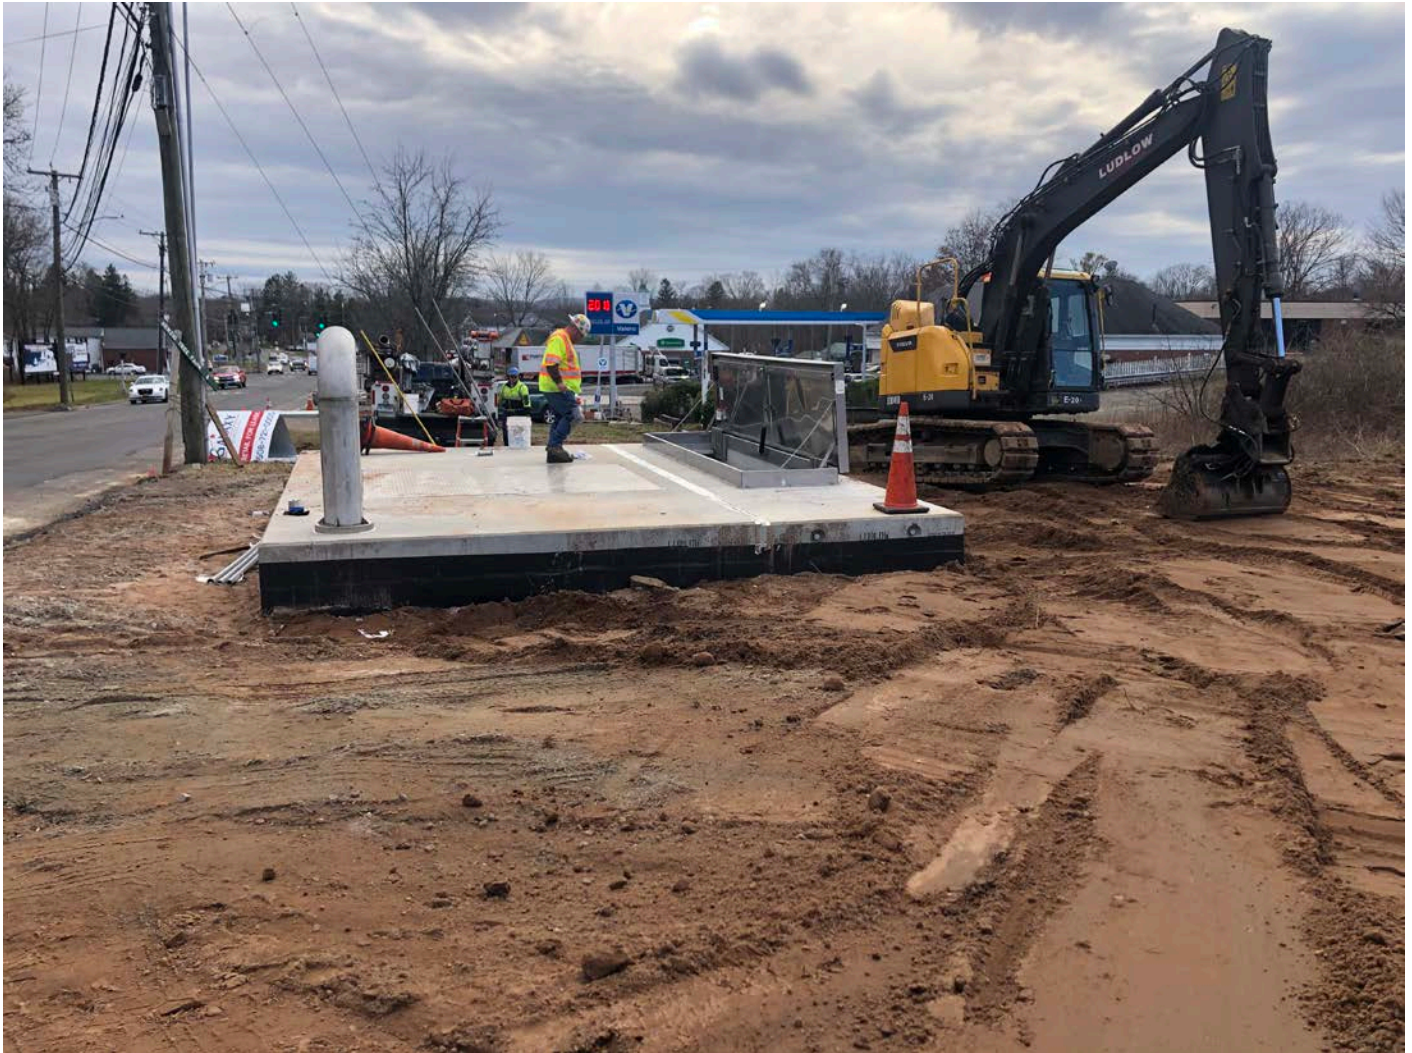
Picture 10: PRV vault after Ludlow backfilled around it after installing a PVC drain line from the vault to a storm drain located at Station ~161+20. View to the south.
