## Daily Report

<b>Project:</b>	Durham Meadows Pipeline Installation	<b>Date:</b>	April 6, 2021
<b>Location:</b>	Main Street, Durham; Shared Access Driveway, Middletown	<b>Day of Week:</b>	Tuesday
<b>Project #:</b>	AECOM: 6061487	<b>Report No:</b>	215
<b>Contractor:</b>	Ludlow Construction	<b>Page:</b>	1 of 9

### Pipe Connections, Installations, and Other Work

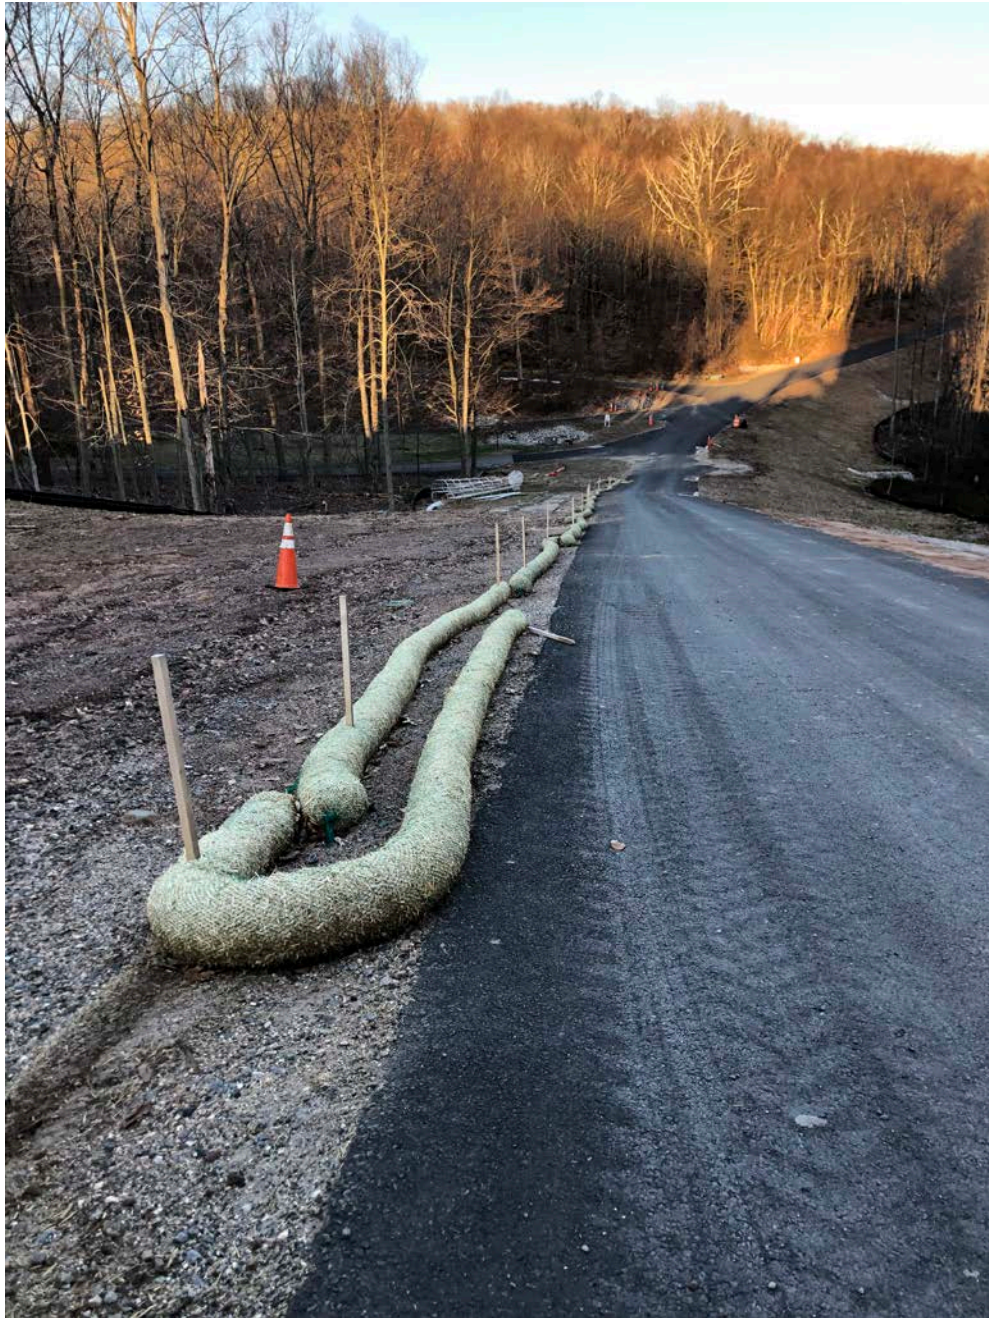
**Picture 1: Straw wattles that Ludlow placed for erosion control on the southern/upslope side of the Shared Access Driveway. View to the west.**

0708: Ludlow has mobilized some slide rail components to the north side of the Shared Access Driveway. There are several pieces of yellow iron staged next to the water tank. No personnel are currently on site. Wattles are present along the south edge of the Shared Access Driveway immediately west of the water tank. A small amount of erosion (several 1"-3" deep rills) were observed on the south side of the Shared Access Driveway, immediately south of the wattles.

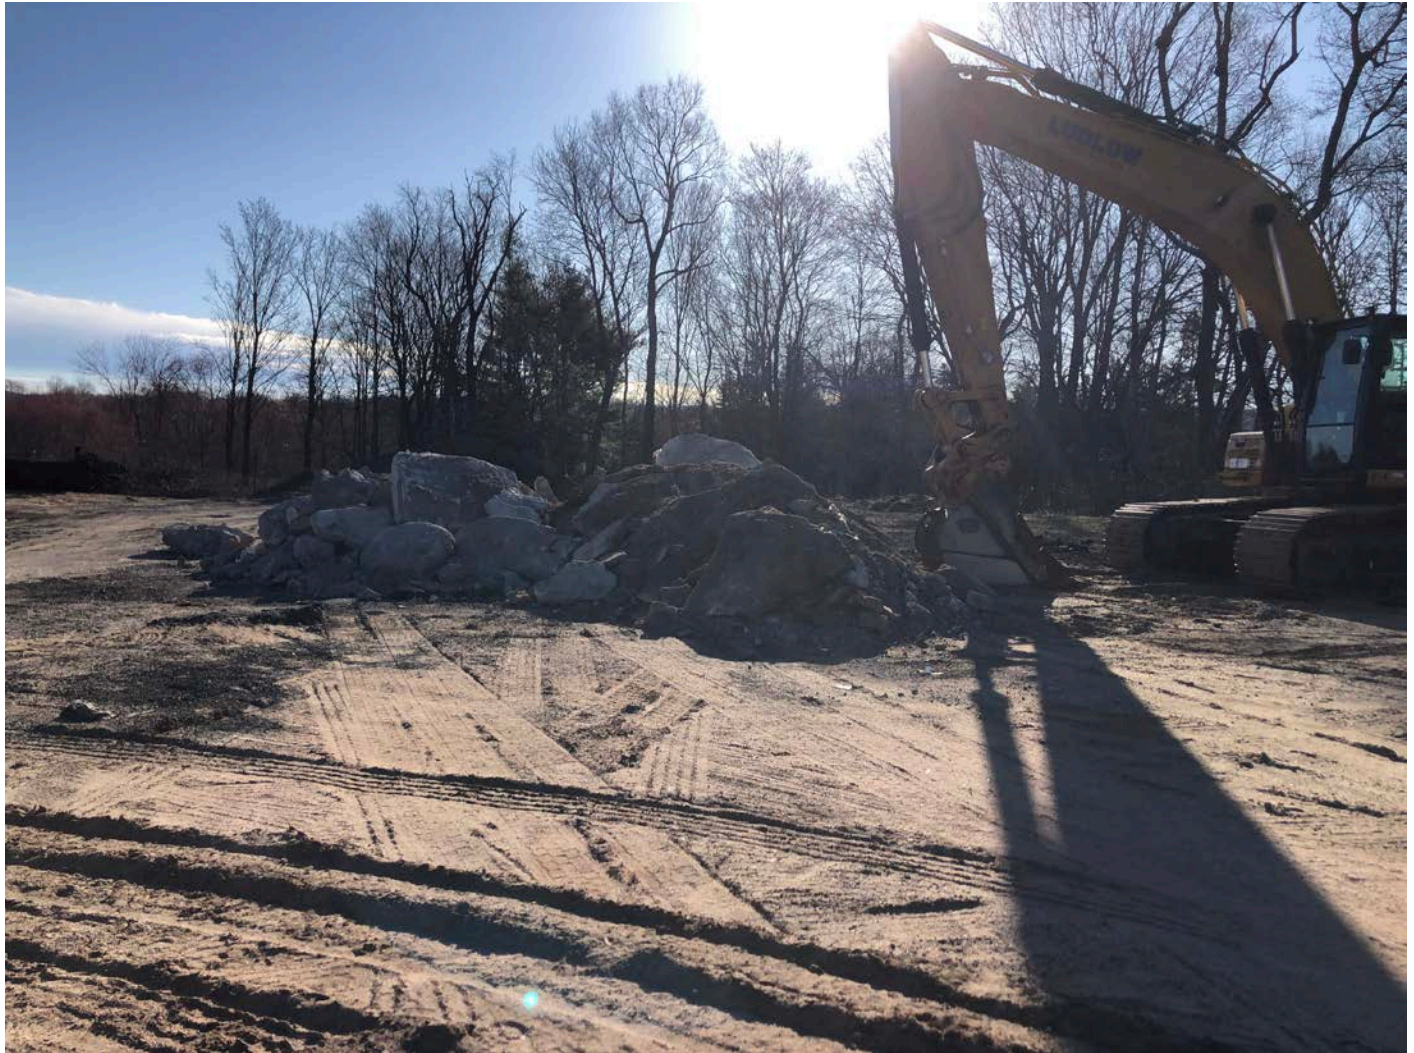
**Picture 3: Waste concrete that was left at the water tank construction zone last year that Ludlow moved to the 281 Main Street, Durham property. View to the east.**

0755: Ludlow is cleaning up around the water tank located east of the Shared Access Driveway in Middletown. Waste concrete leftover from the construction of the water tank will be staged at the 281 Main Street, Durham property.

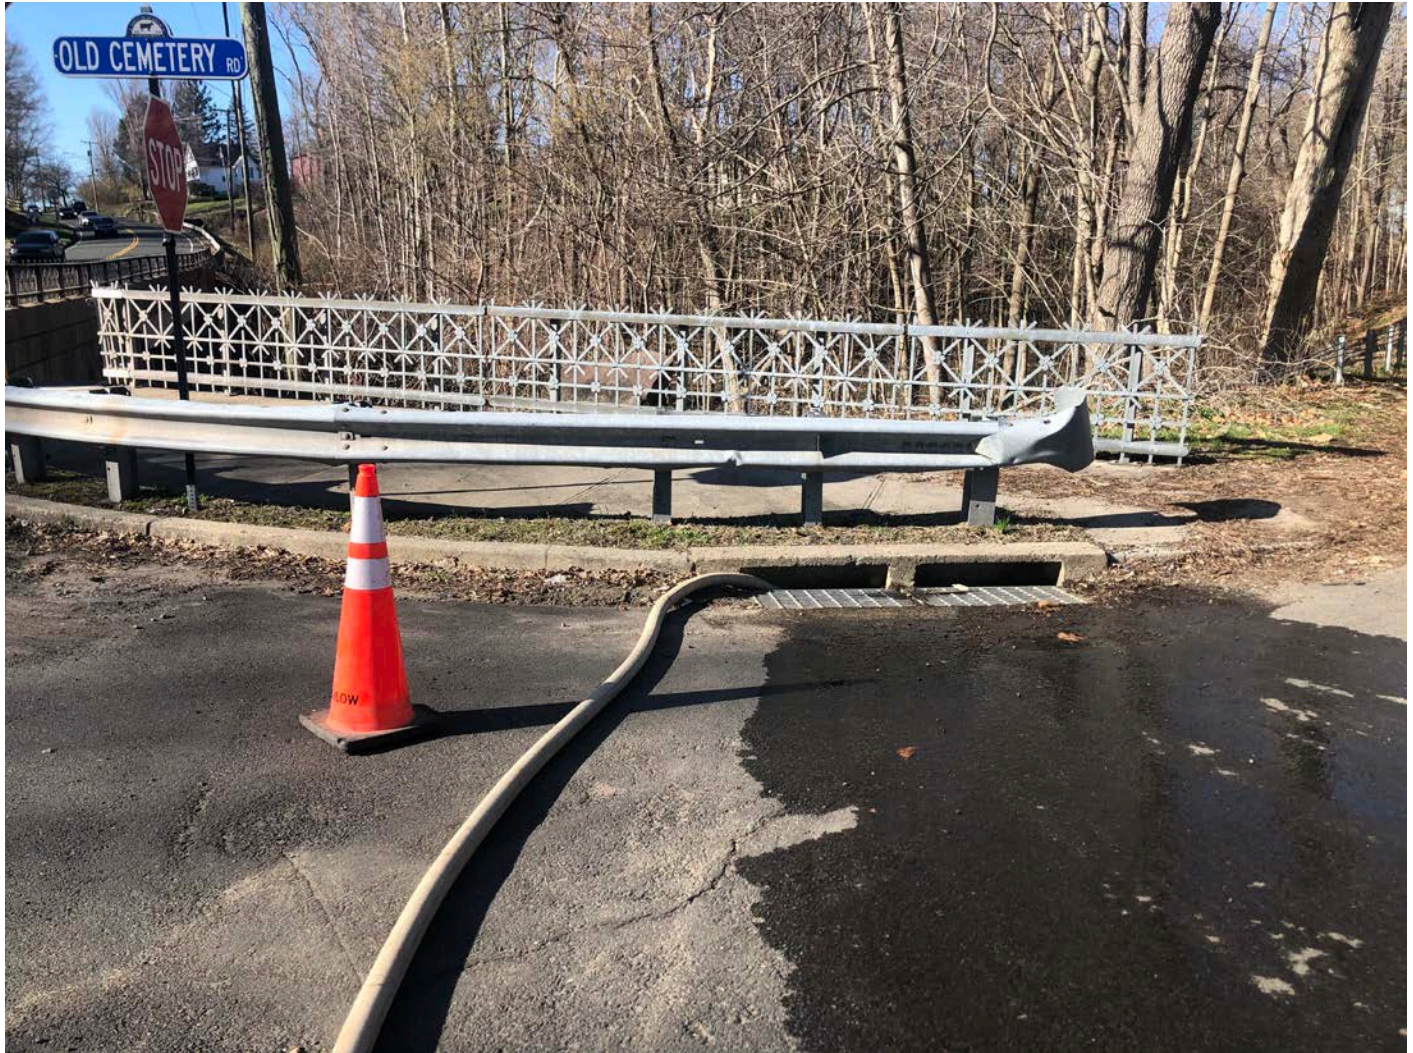
Picture 4: Ludlow directing water purged from the 16" water line on Main Street from Talcott Lane to Cemetery Road, Durham. View to the south.

Ludlow flushed the 16" DIP water line on Main Street in Durham from Talcott Lane south to Old Cemetery Road. Water was discharged to the storm drain located on the south side of the intersection of Main Street and Old Cemetery Road.

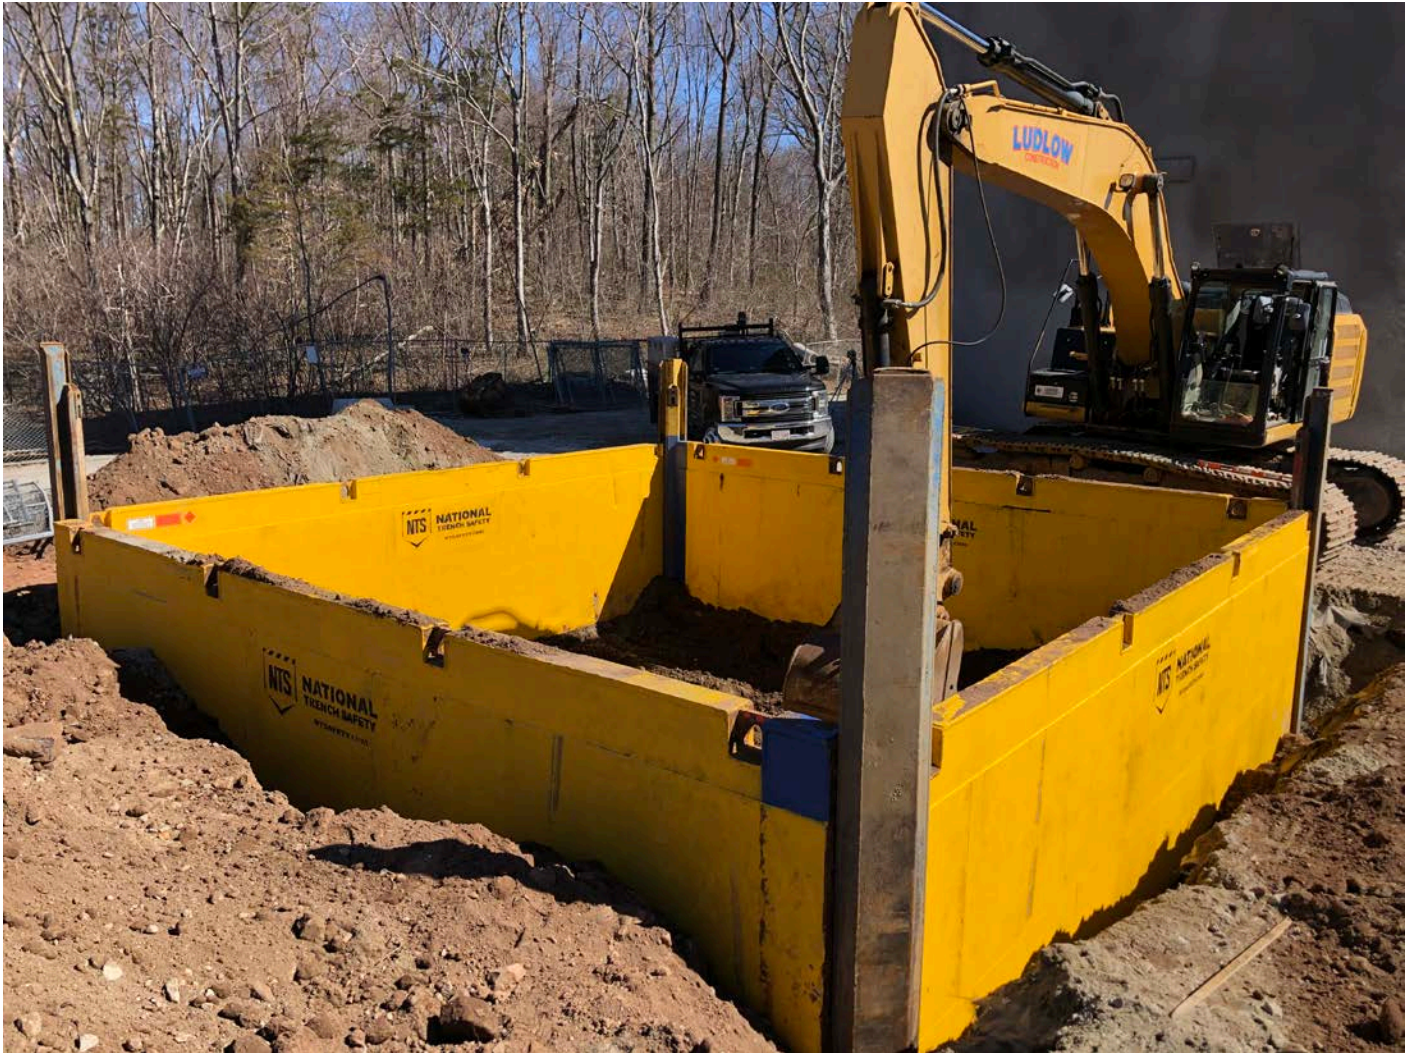
**Picture 5: Trench box that Ludlow installed around the Altitude Valve Vault excavation, east of the Shared Access Driveway, Middletown. View to the south.**

0837: Ludlow is placing slide rails together to form a trench box for the installation of altitude valve vault adjacent to and directly west of the water tank in Middletown.

1043: Ludlow has completed the placement of the slide rails to form a trench box in the altitude valve vault excavation.

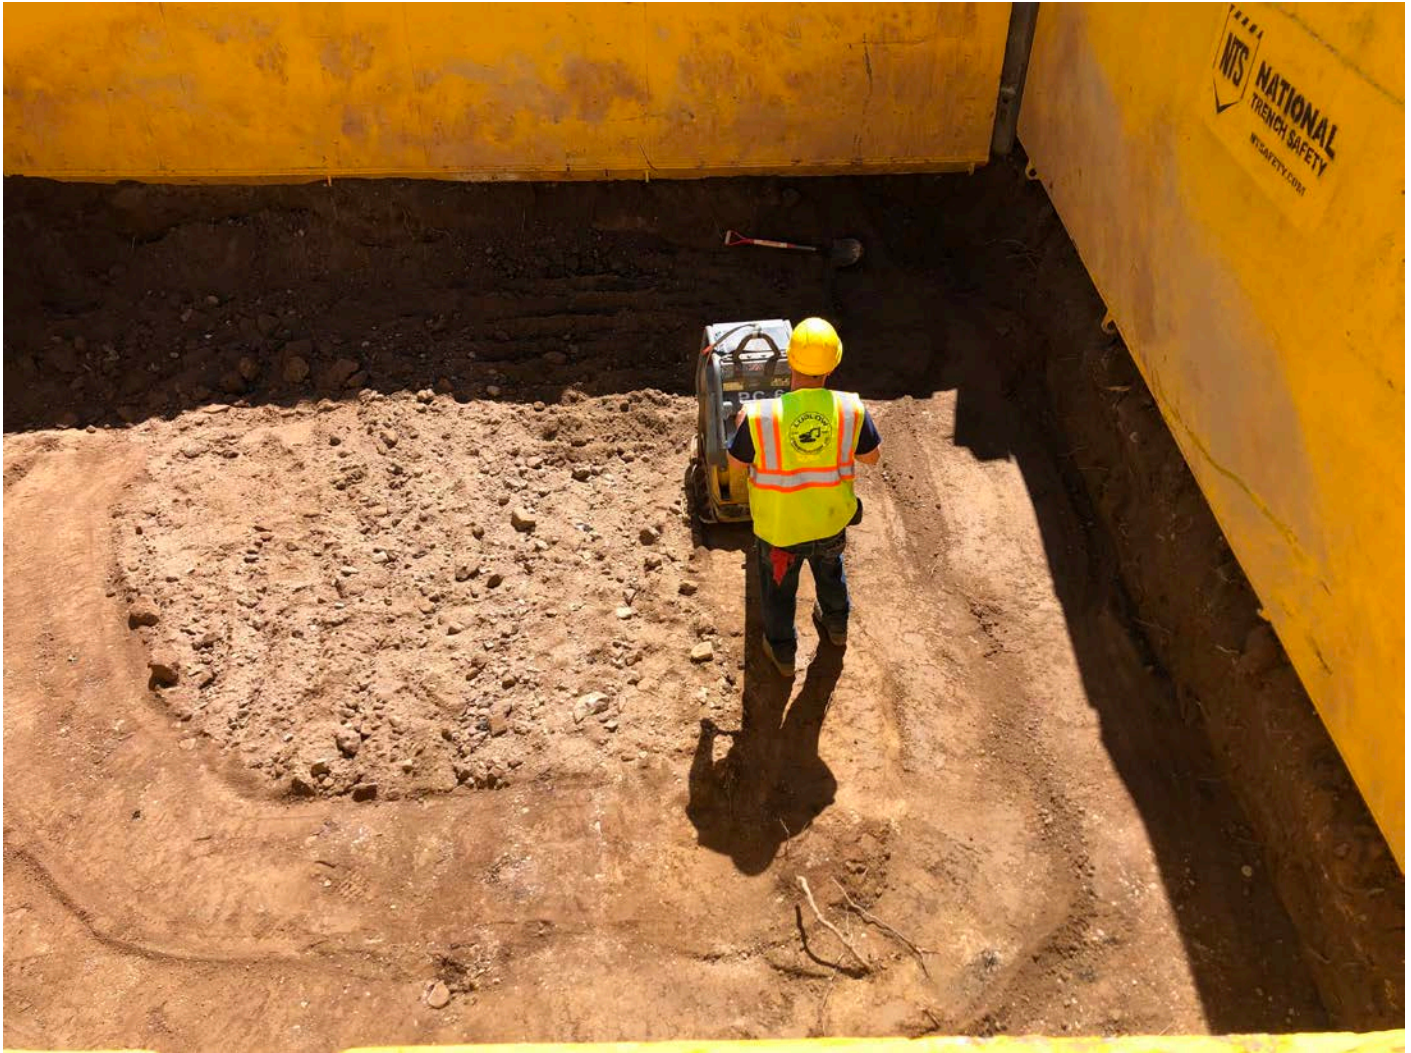
Picture 6: Ludlow compacting native earth at the bottom of the altitude valve vault excavation using a plate compactor. View to the south.

1247: Ludlow is compacting native earth at the bottom of the altitude valve vault excavation using a plate compactor.

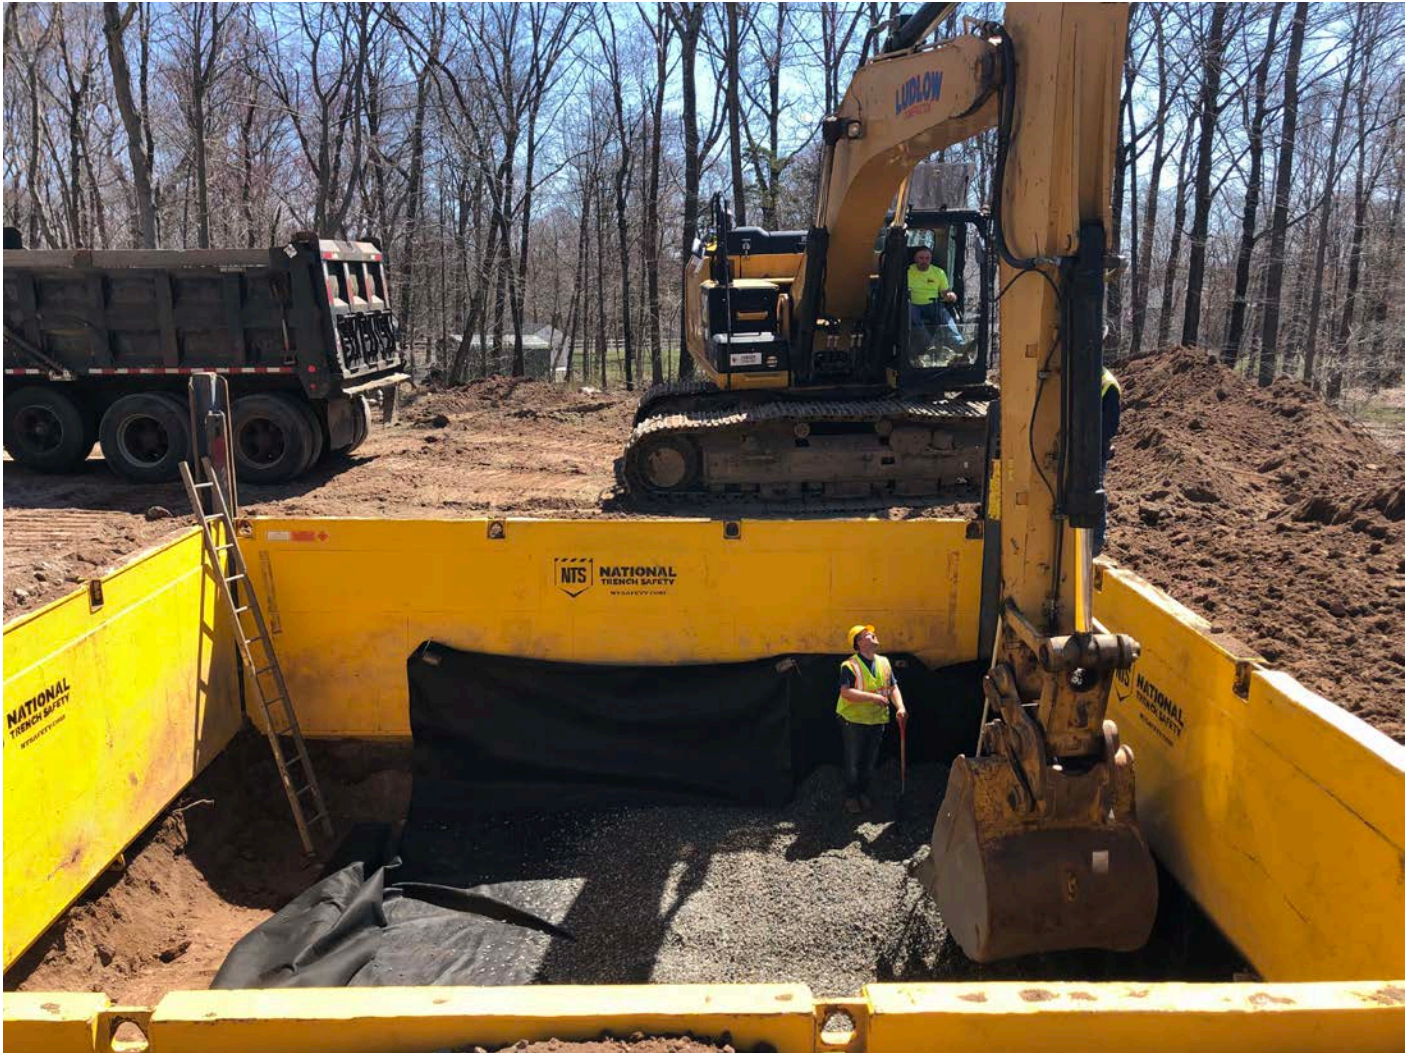
**Picture 7: Ludlow placing ¾" stone on top of black geofabric at the bottom of the altitude valve vault excavation. View to the south.**

1310: Ludlow is placing black geofabric on the bottom of the altitude valve vault excavation and has pinned it to the sides of the trench box using magnets.

1325: Ludlow has geofabric in place and is beginning to backfill the altitude valve vault excavation with 1' of ¾" stone.
