Daily Report

Project:	Durham Meadows Pipeline Installation	Date:	April 13, 2021
Location:	S. Main Street and the Shared Access Driveway, Middletown	Day of Week:	Tuesday
Project #:	AECOM: 6061487	Report No:	220
Contractor:	Ludlow Construction	Page:	1 of 13

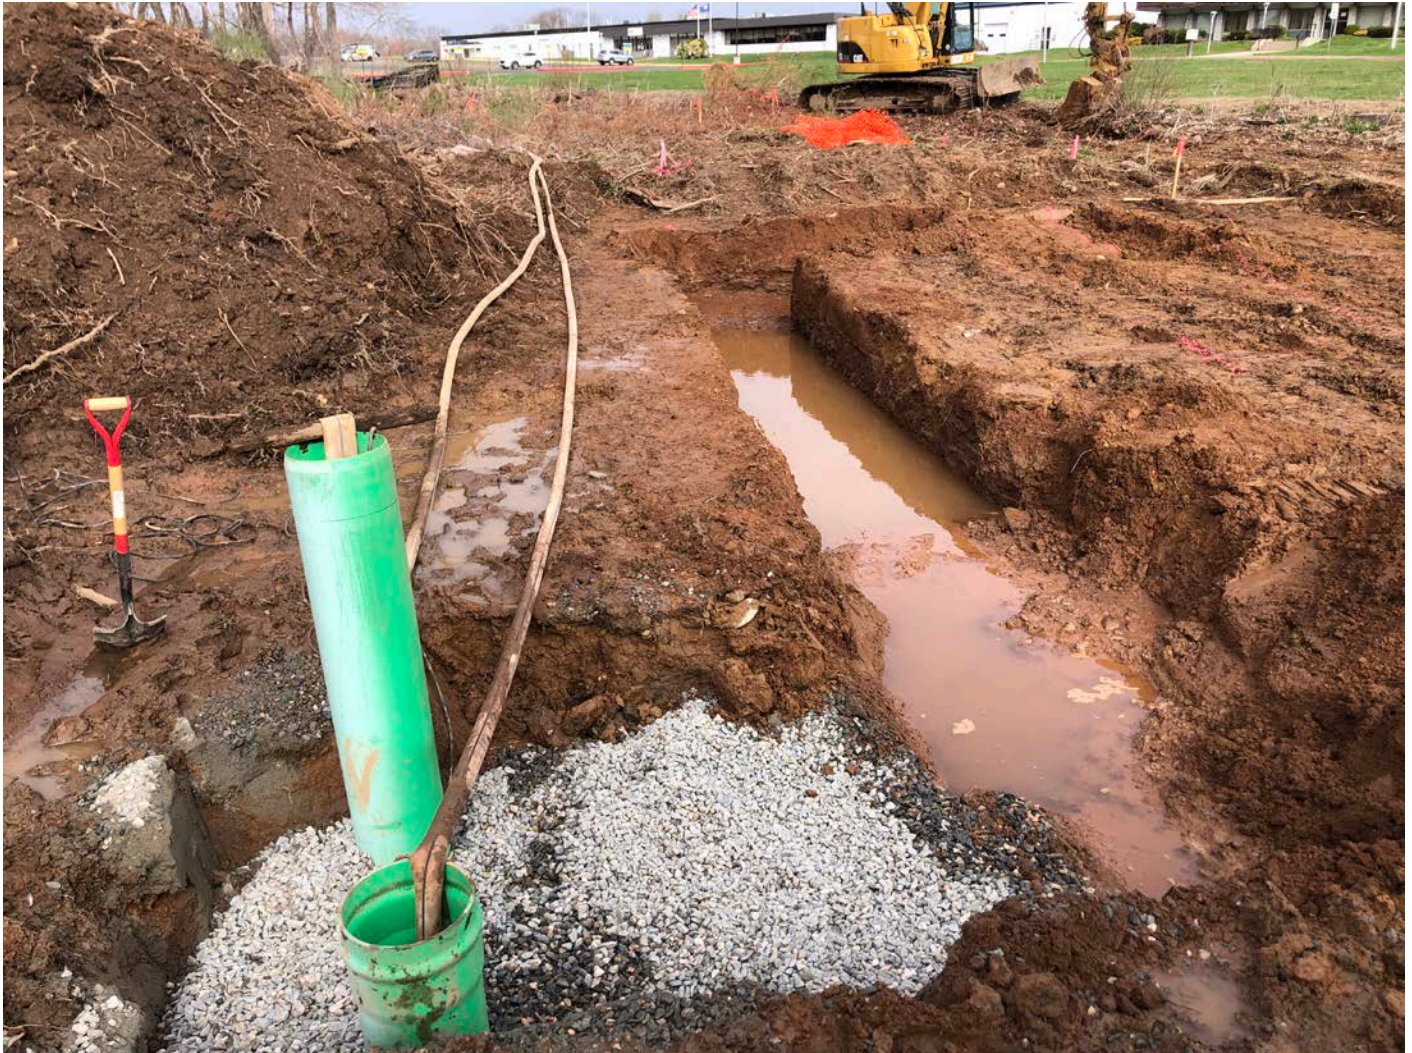
0917: Ludlow continues with site preparation activities for the installation of the booster station at Station 750+63, Middletown. Ludlow has installed two dewatering wells at the southeast corner of the booster station footprint. The groundwater is being discharged into the adjacent woods through a piece of filter fabric, approximately 50 yards west of the booster station.

Picture 1: Two dewatering wells that Ludlow placed at the southeast corner of the booster station footprint.

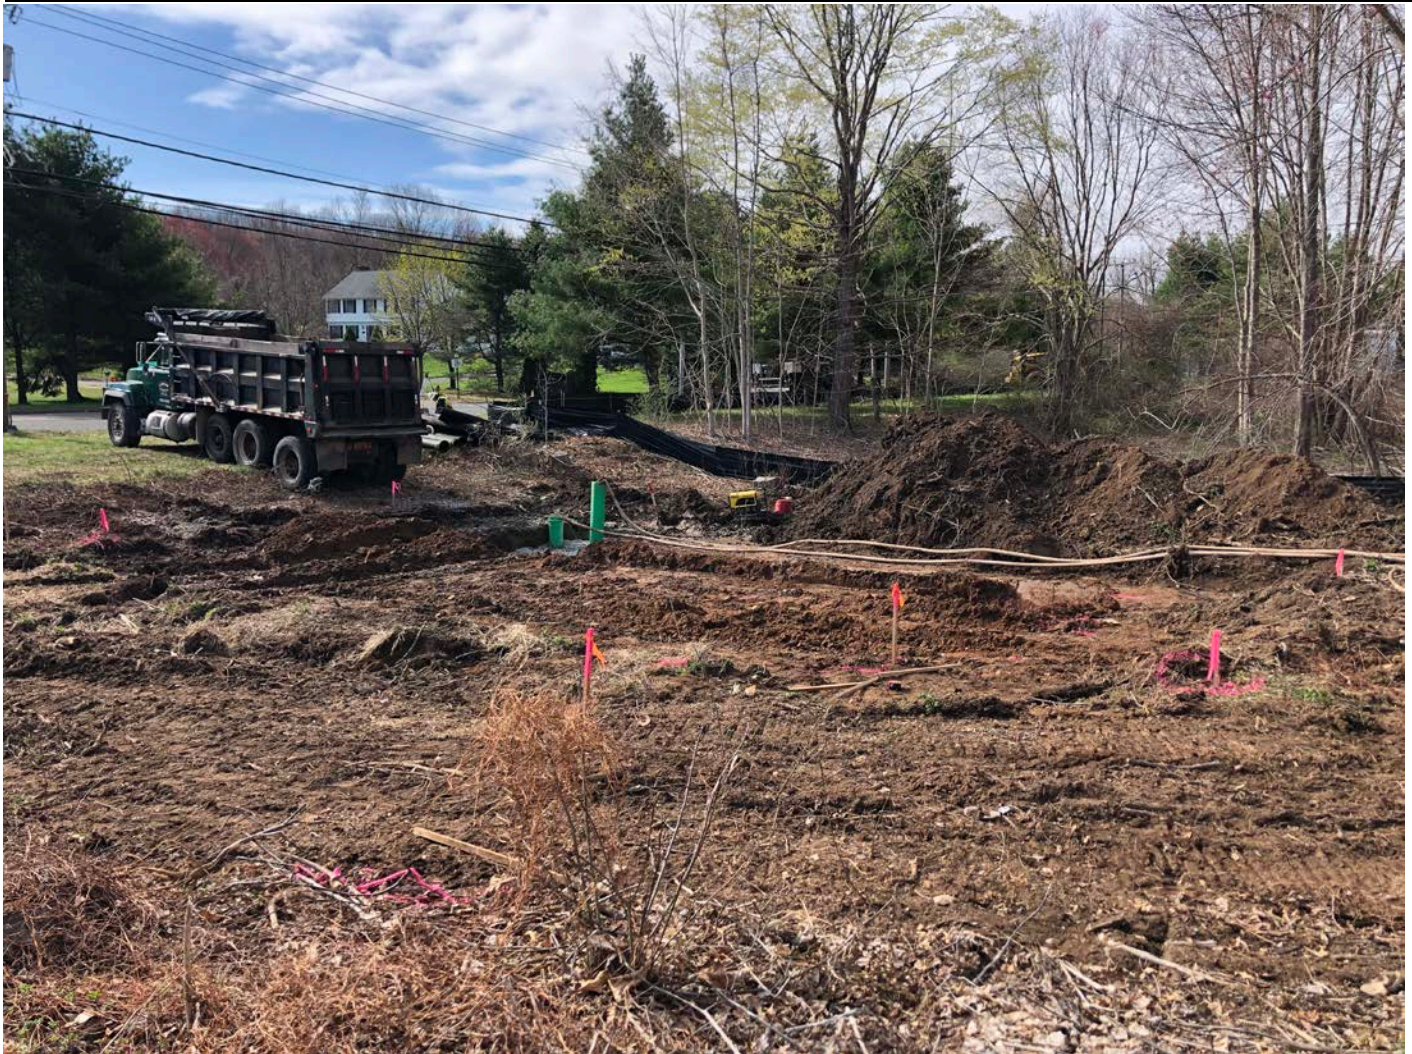
Picture 2: Overview of the booster station work zone at Station 750+63 in Middletown, looking to the southeast.

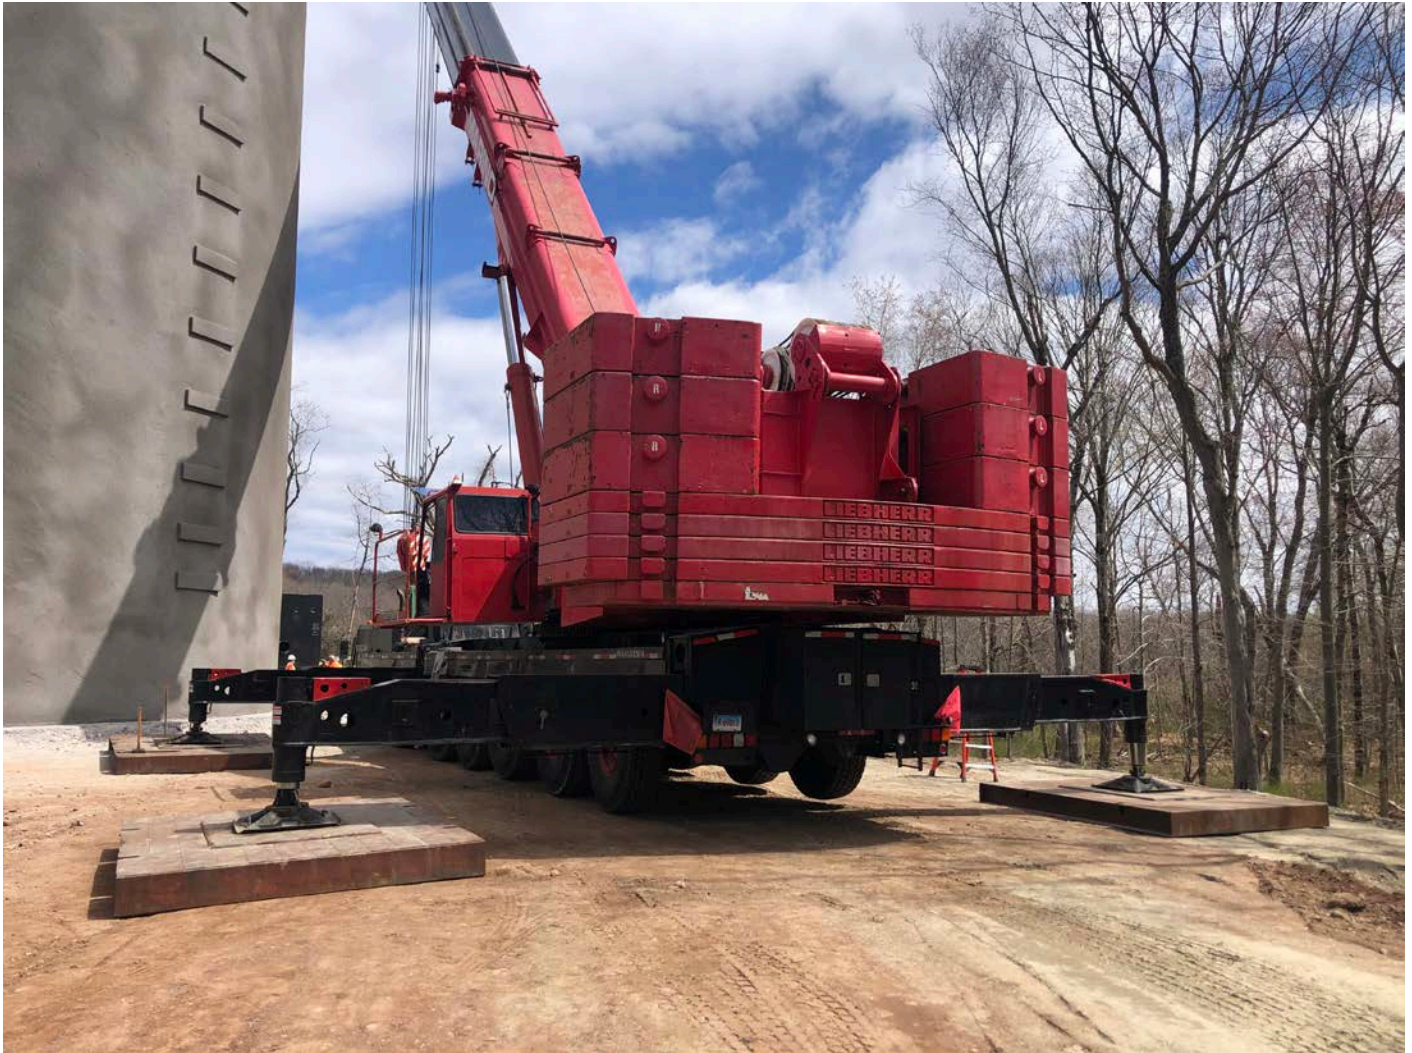
Picture 3: Barnhart/Marino crane staged on the southwest side of the water tank located east of the Shared Access Driveway as they prepare to lift the pieces of the altitude valve vault as they prepare to install them. View to the east.

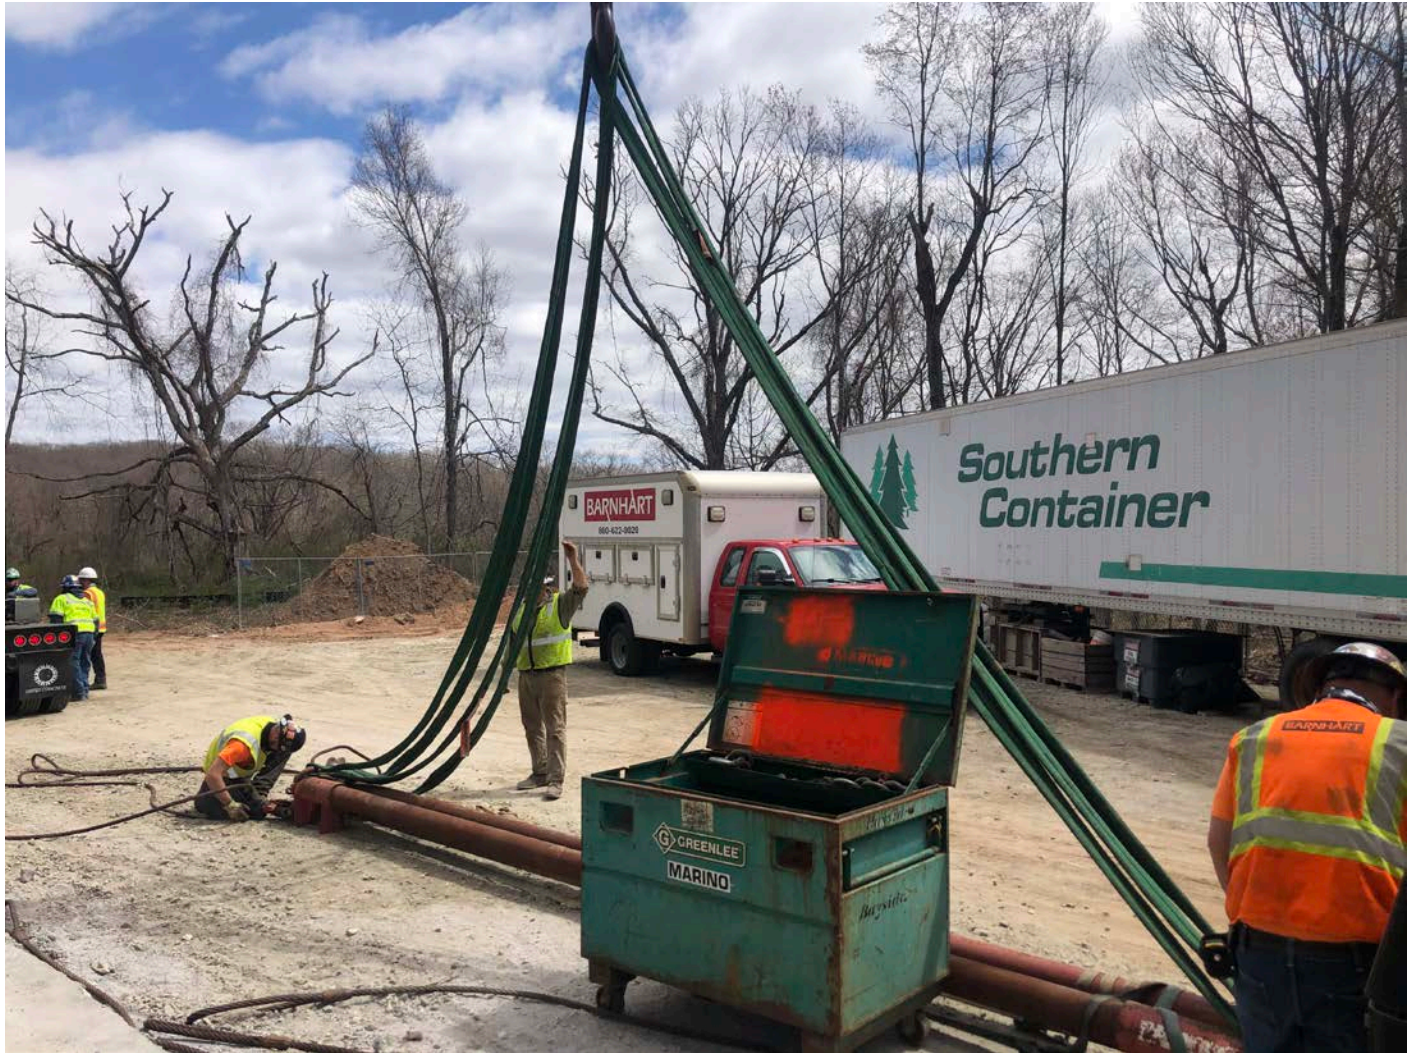
Picture 4: Barnhart preparing the sling that will be used to hoist pieces of the altitude valve vault into place during the vault installation to the east of the Shared Access Driveway. View to the southeast.

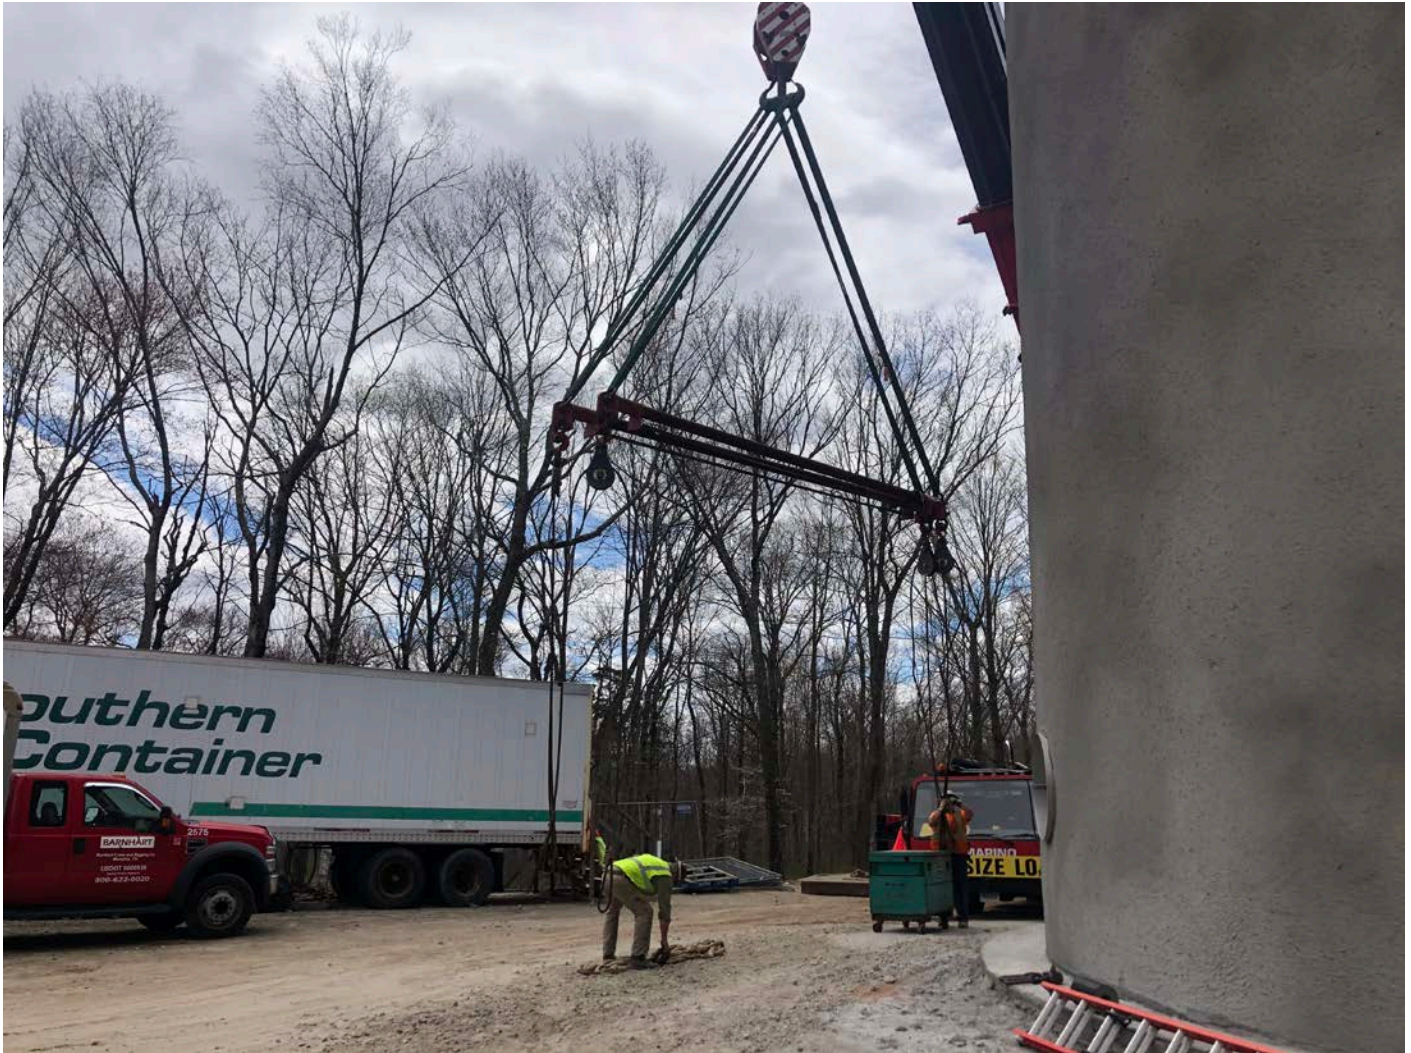
Picture 6: Barnhart adding lift hardware to the lift sling that will be used to hoist pieces of the altitude valve vault into place during the vault installation to the east of the Shared Access Driveway. View to the southwest.

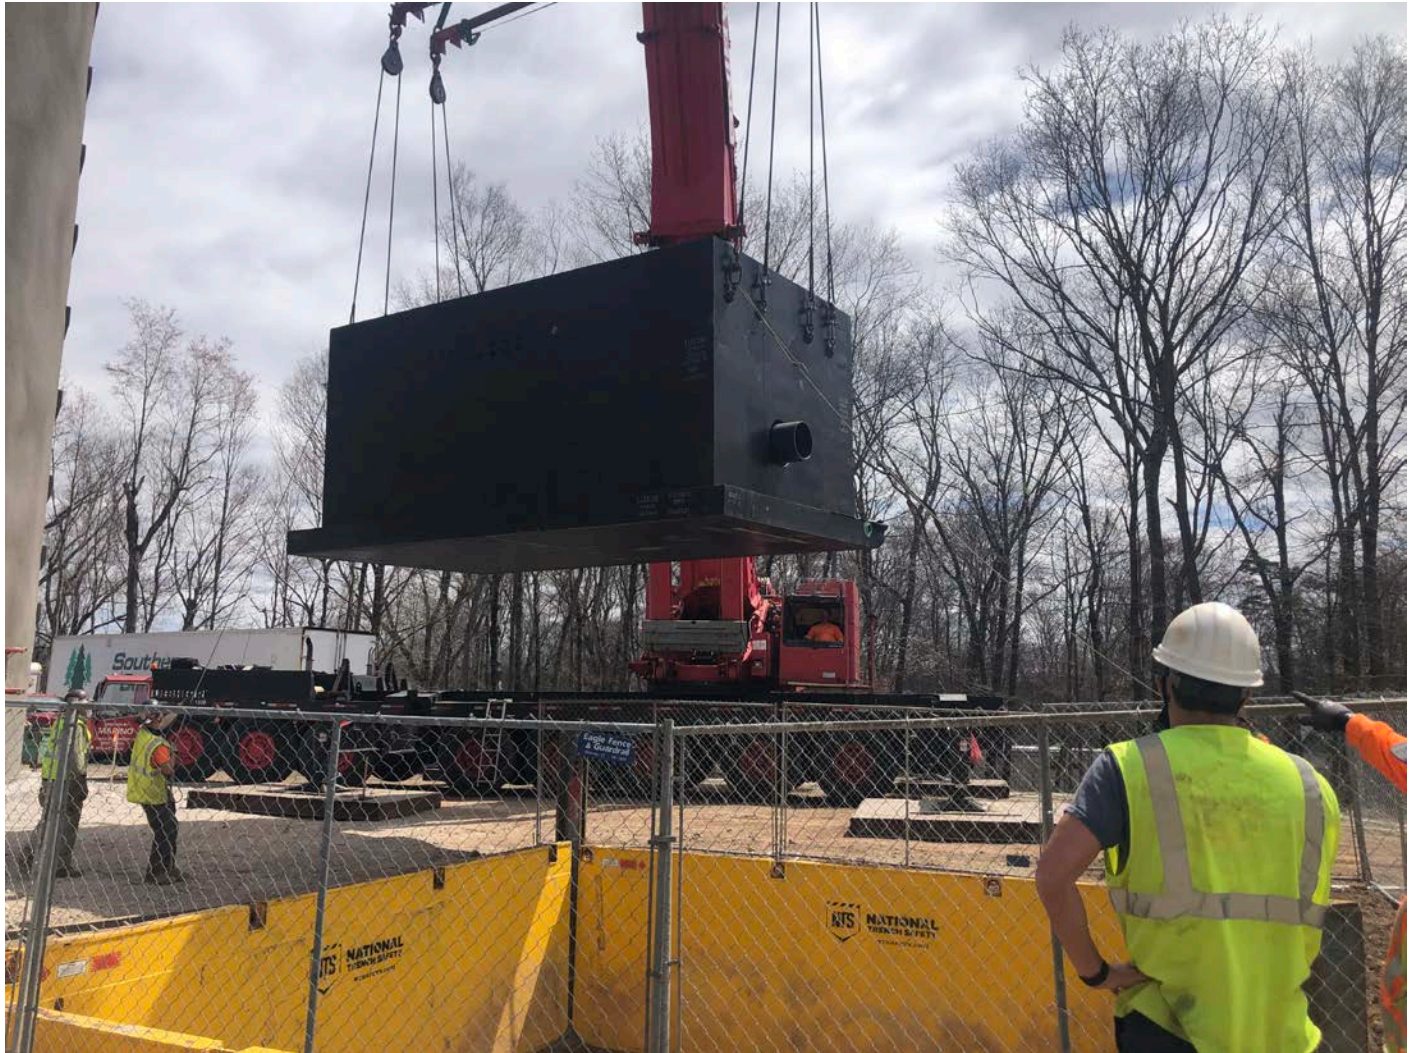
1301: Barnhart begins to lift the first half of the altitude valve vault off the flatbed and into the excavation east of the Shared Access Driveway.

Picture 7: Barnhart lifting the first of the two halves of the altitude valve vault as they prepare to lower it into the trench box. East of the Shared Access Driveway, Middletown. View to the southeast.

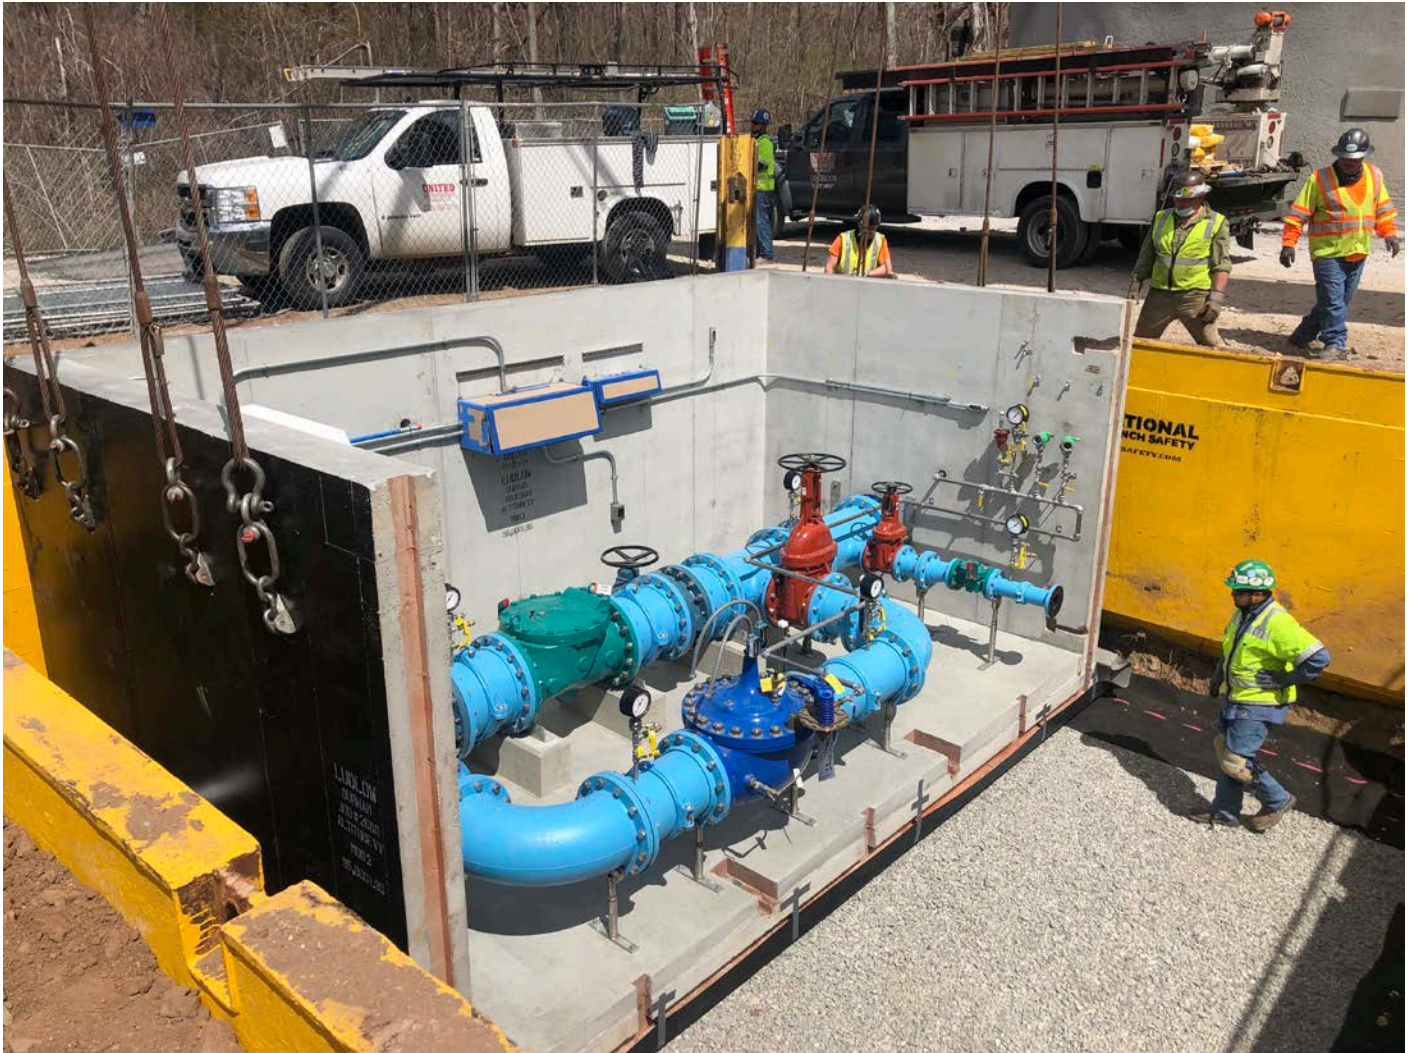
Picture 8: The project field team fine-tuning the placement of the first of the two halves of the altitude valve vault east of the Shared Access Driveway, Middletown. View to the southeast.

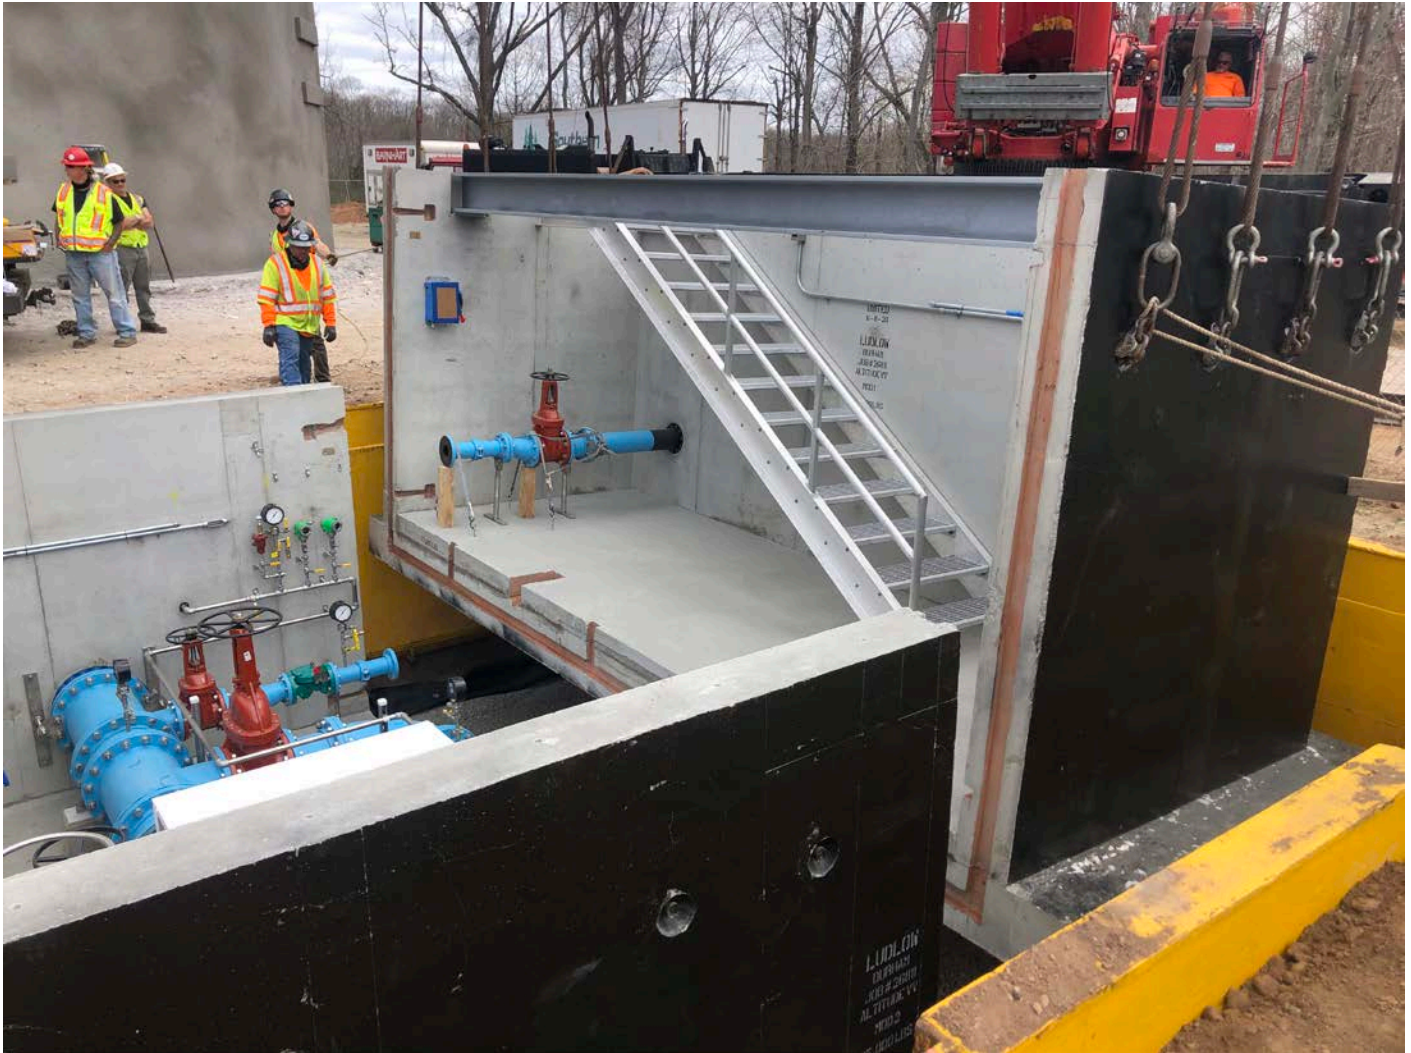
1345: The project team has just placed the second piece of the altitude valve vault into the excavation.

Picture 9: Barnhart lowering the second of the two halves of the altitude vault into place; east of the Shared Access Driveway, Middletown. View to the southeast.

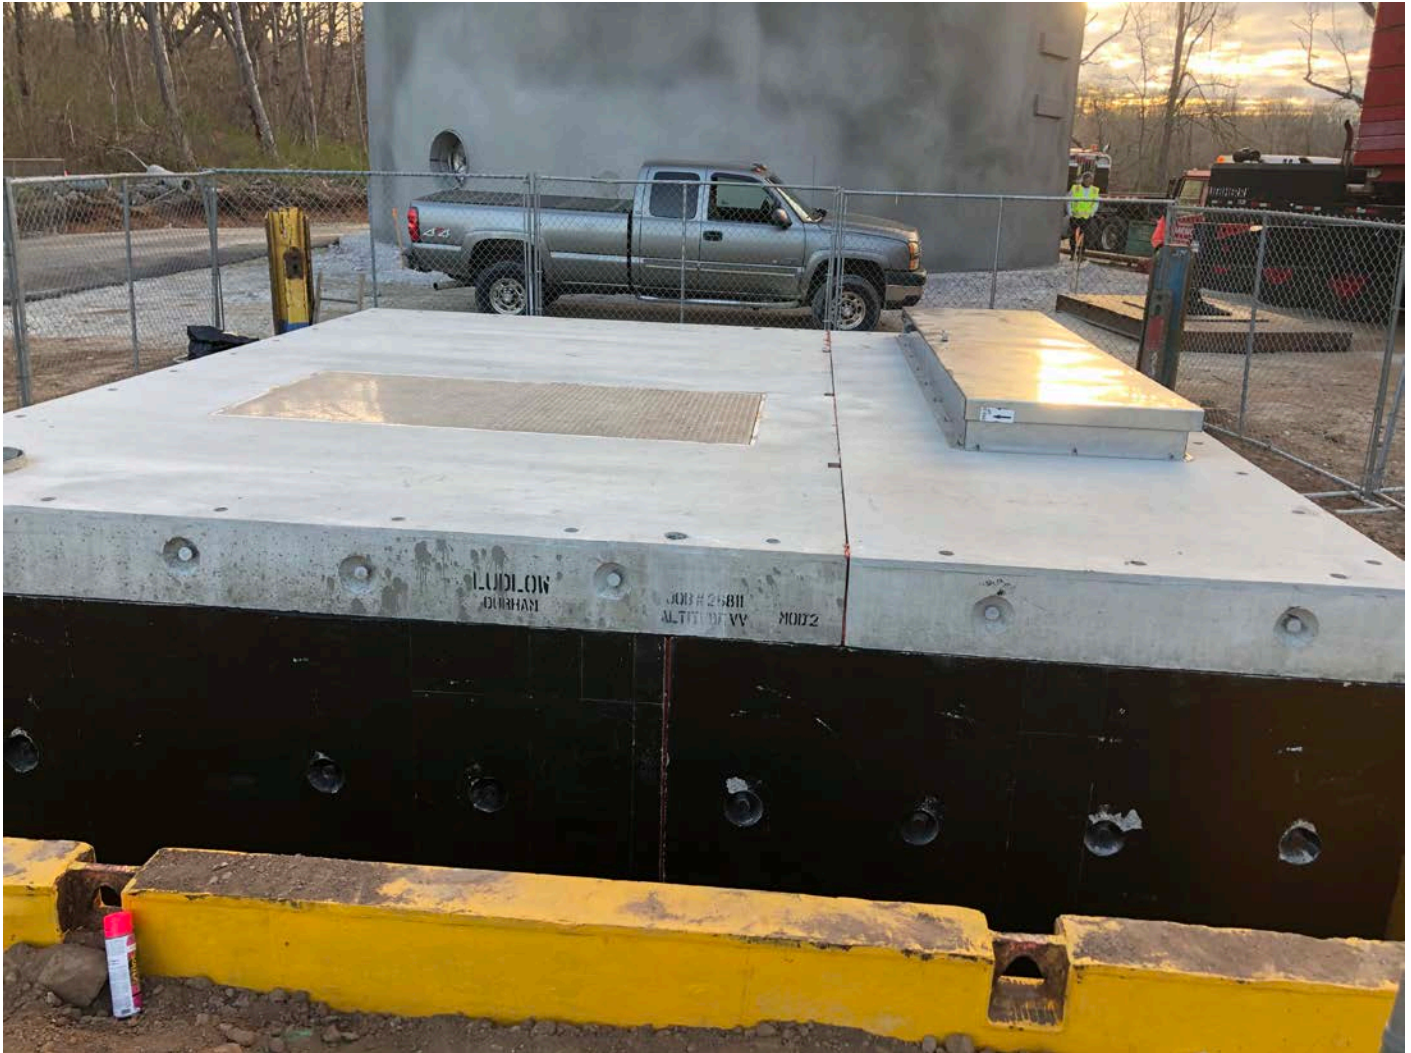
Picture 10: View of the altitude valve vault with both sections of the roof installed; east of the Shared Access Driveway, Middletown. View to the east.
