## Daily Report

<b>Project:</b>	Durham Meadows Pipeline Installation	<b>Date:</b>	April 14, 2021
<b>Location:</b>	S. Main Street and the Shared Access Driveway, Middletown Main Street, Durham	<b>Day of Week:</b>	Wednesday
<b>Project #:</b>	AECOM: 6061487	<b>Report No:</b>	221
<b>Contractor:</b>	Ludlow Construction	<b>Page:</b>	1 of 16

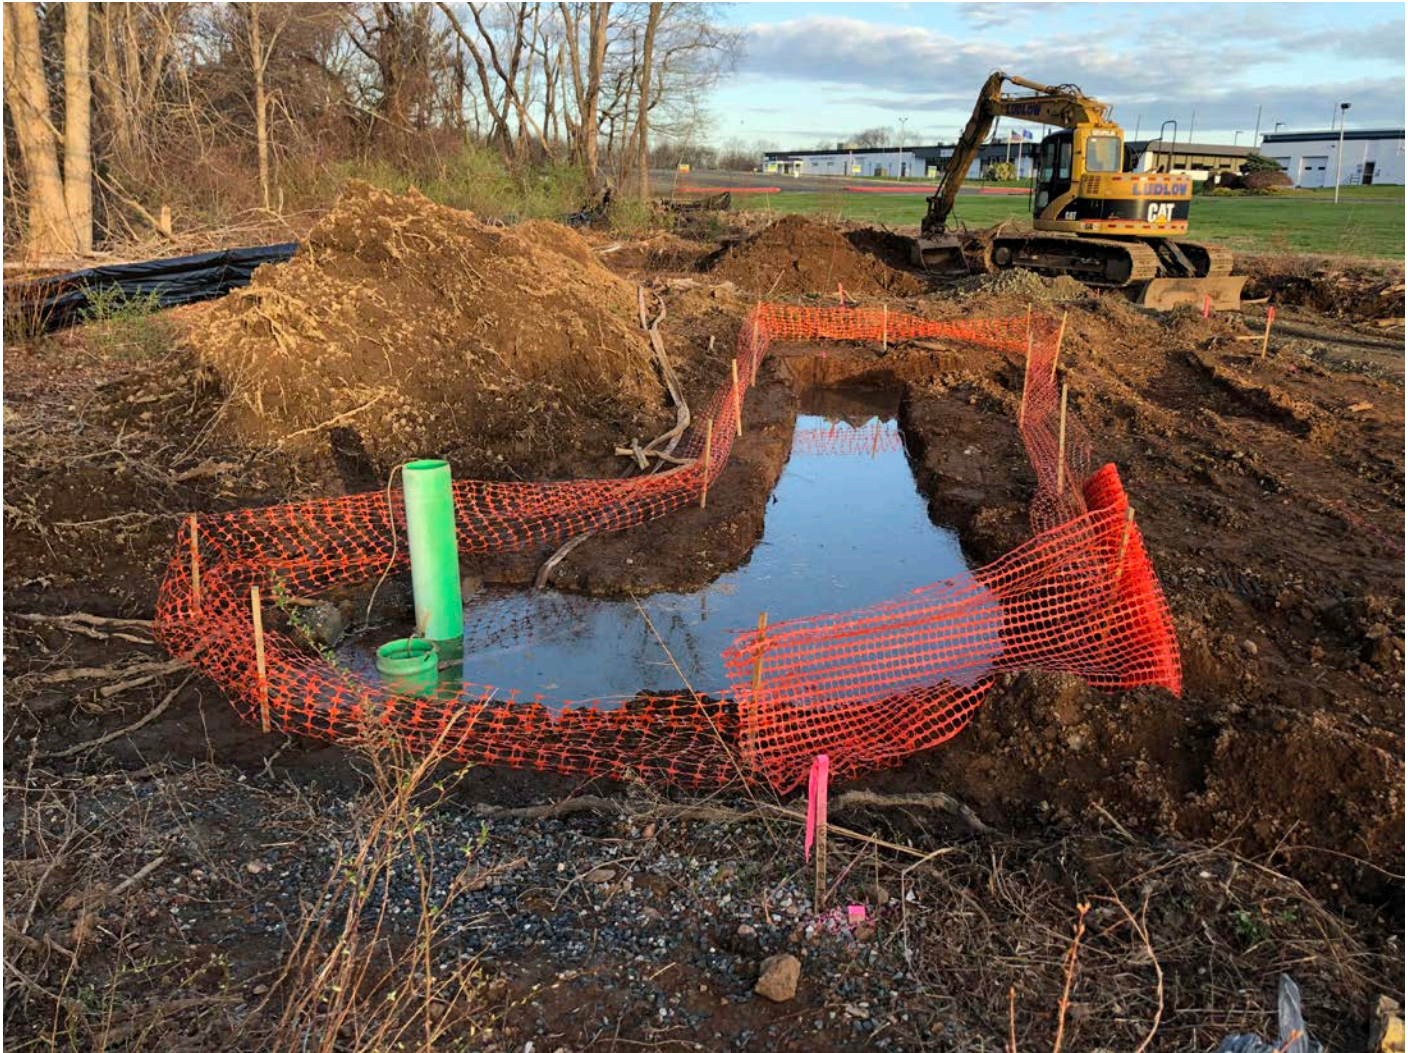
**Picture 1: View of the booster station footprint located at Station 750+63 in Middletown. The dewatering pumps were not operating at the time the picture was taken. View to the west.**

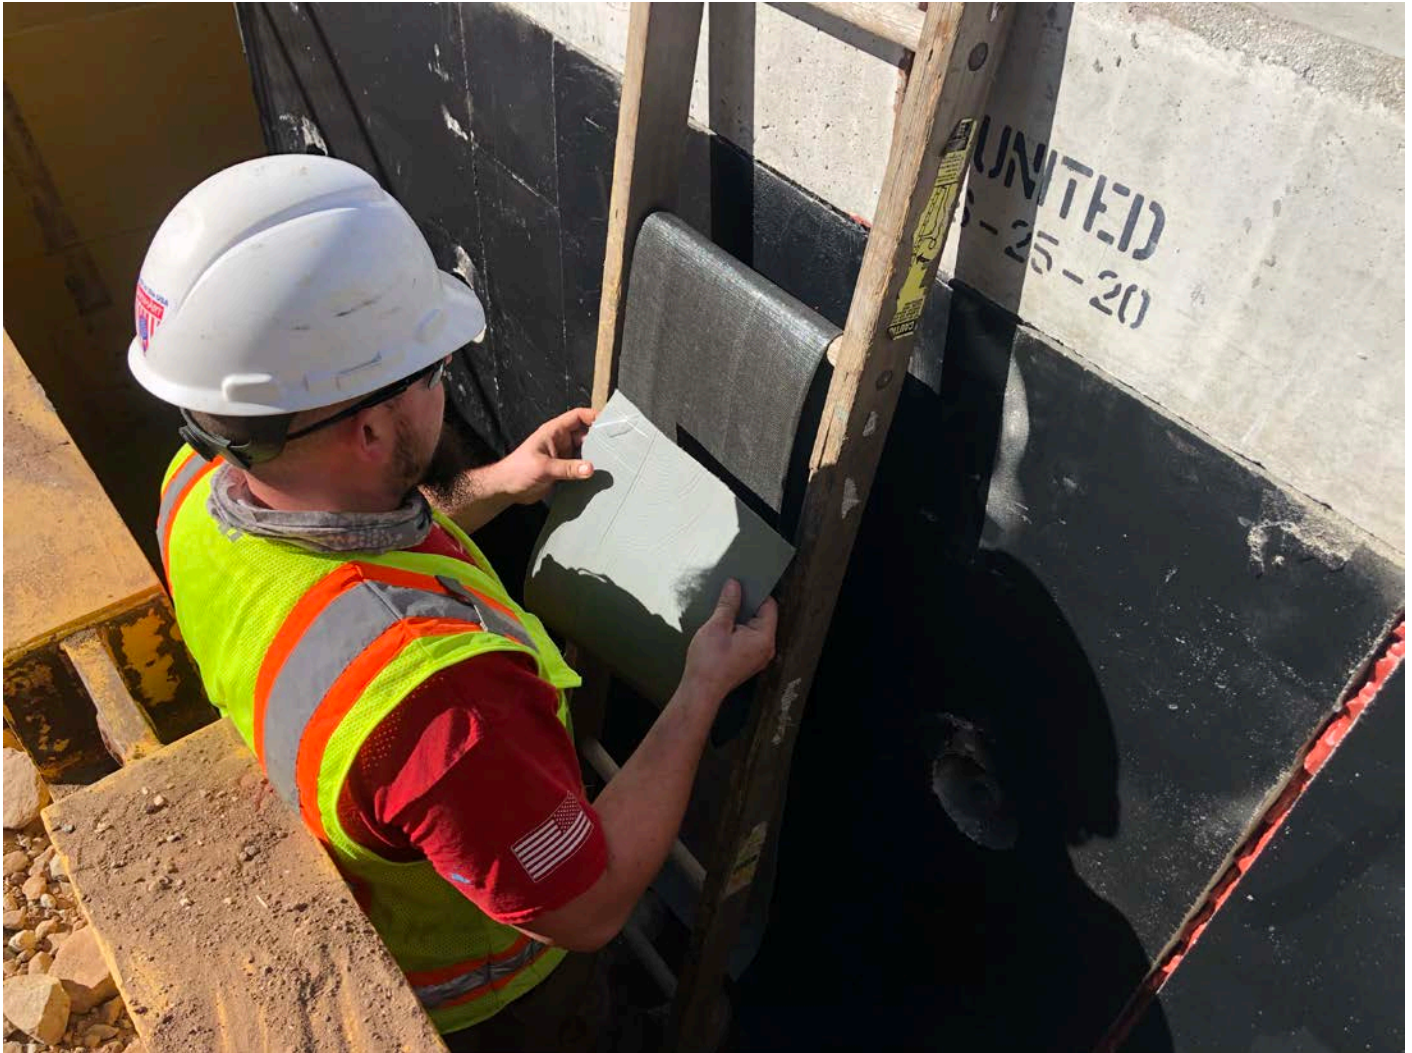
0929: United Concrete is applying Boa tape (the same Kevlar-based tape they used to join the bottom of the two halves of the altitude vault together yesterday) to the side seams between the two halves of the vault. United Concrete is also getting ready to apply grout to the altitude valve vault.

**Picture 4: United Concrete applying Boa tape to the side joints of the altitude valve vault walls. East of the Shared Access Driveway, Middletown. View to the southwest.**

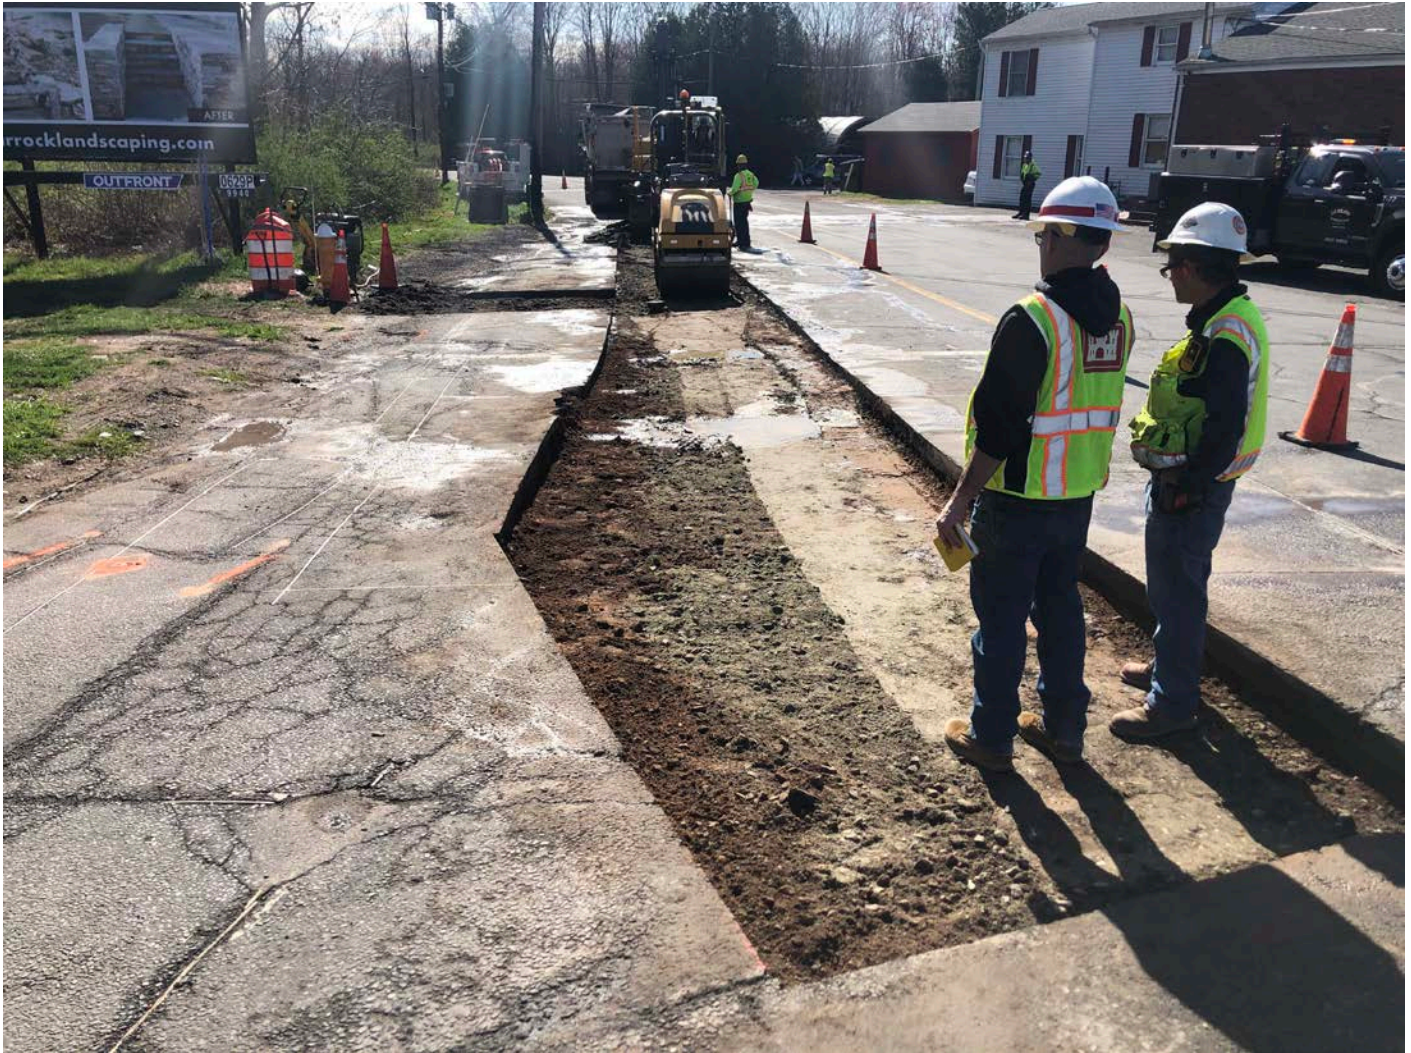
0943: Ludlow is stripping pavement away after they saw cut trench overcuts on the north side of Haddam Quarter Road near the intersection of Main Street. This was performed as part of permanent paving activities. Ludlow has a single private flagger providing traffic detail.

Picture 5: Asphalt that Ludlow stripped away on Haddam Quarter Road, Durham, as part of permanent paving activities. View to the east.

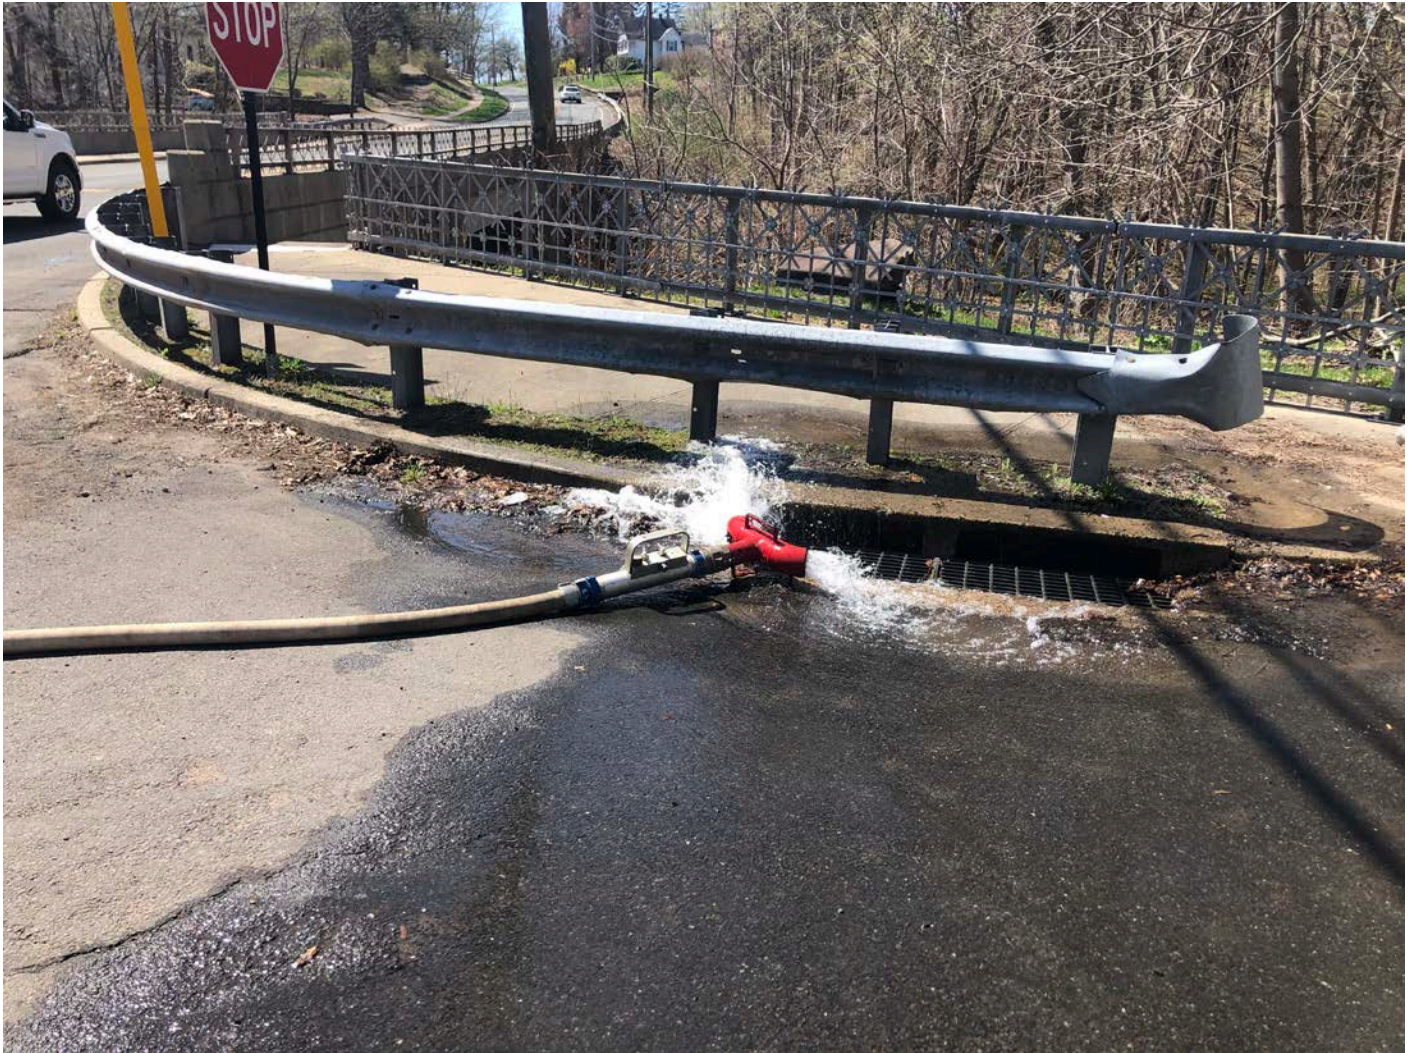
1016: Ludlow and JMS are flushing water from the section of 16" DIP waterline that runs between 327 Main Street and Old Cemetery Road in Durham. The water is being treated with calcium thiosulphate and JMS is testing for any residual chlorine.

**Picture 6: Ludlow and JMS discharging water that they are flushing from the 16" DIP waterline from 327 Main Street to the intersection of Main Street and Old Cemetery Road, Durham. View to the south.**

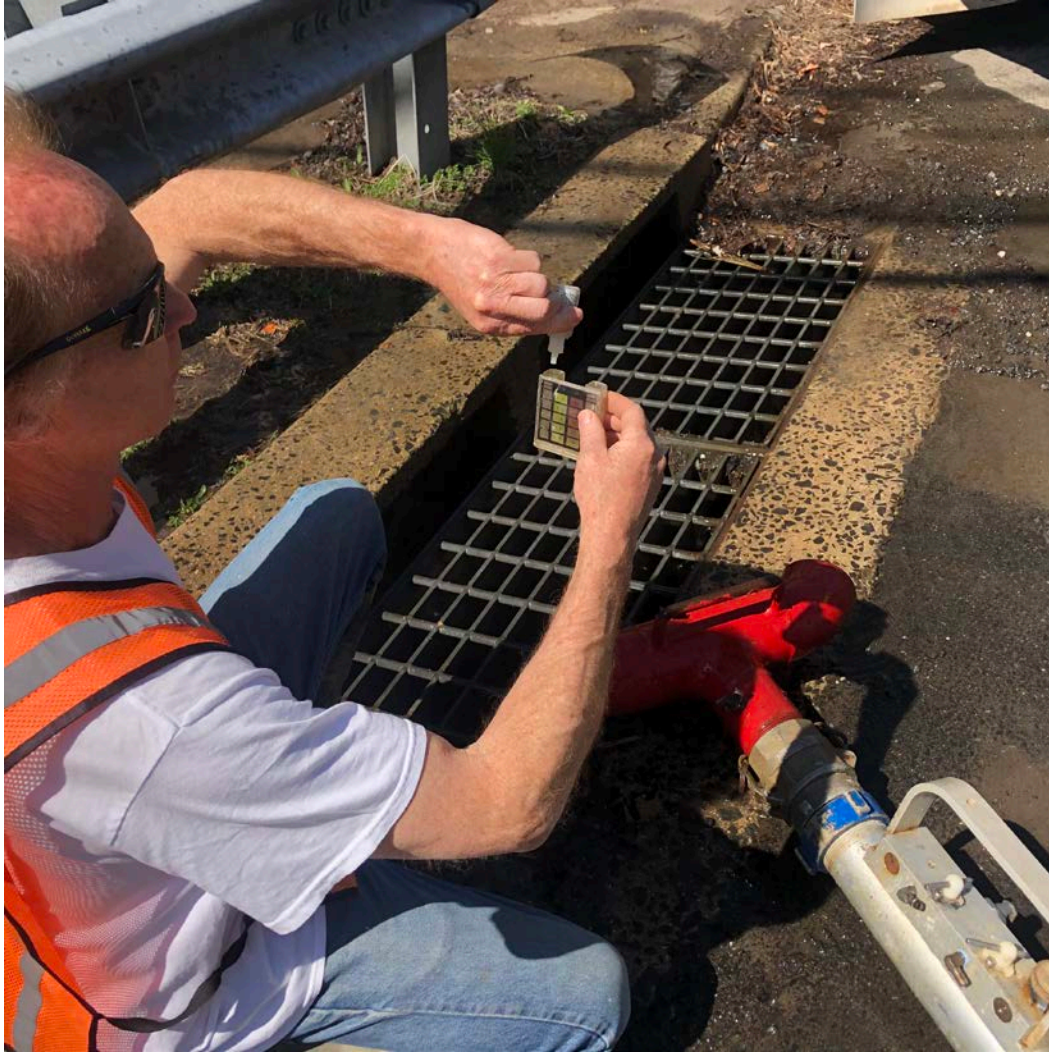
Picture 7: JMS is dechlorinating water that is being purged from the Main Street water line with calcium thiosulphate prior to discharging it and is testing the water frequently for residual chlorine.

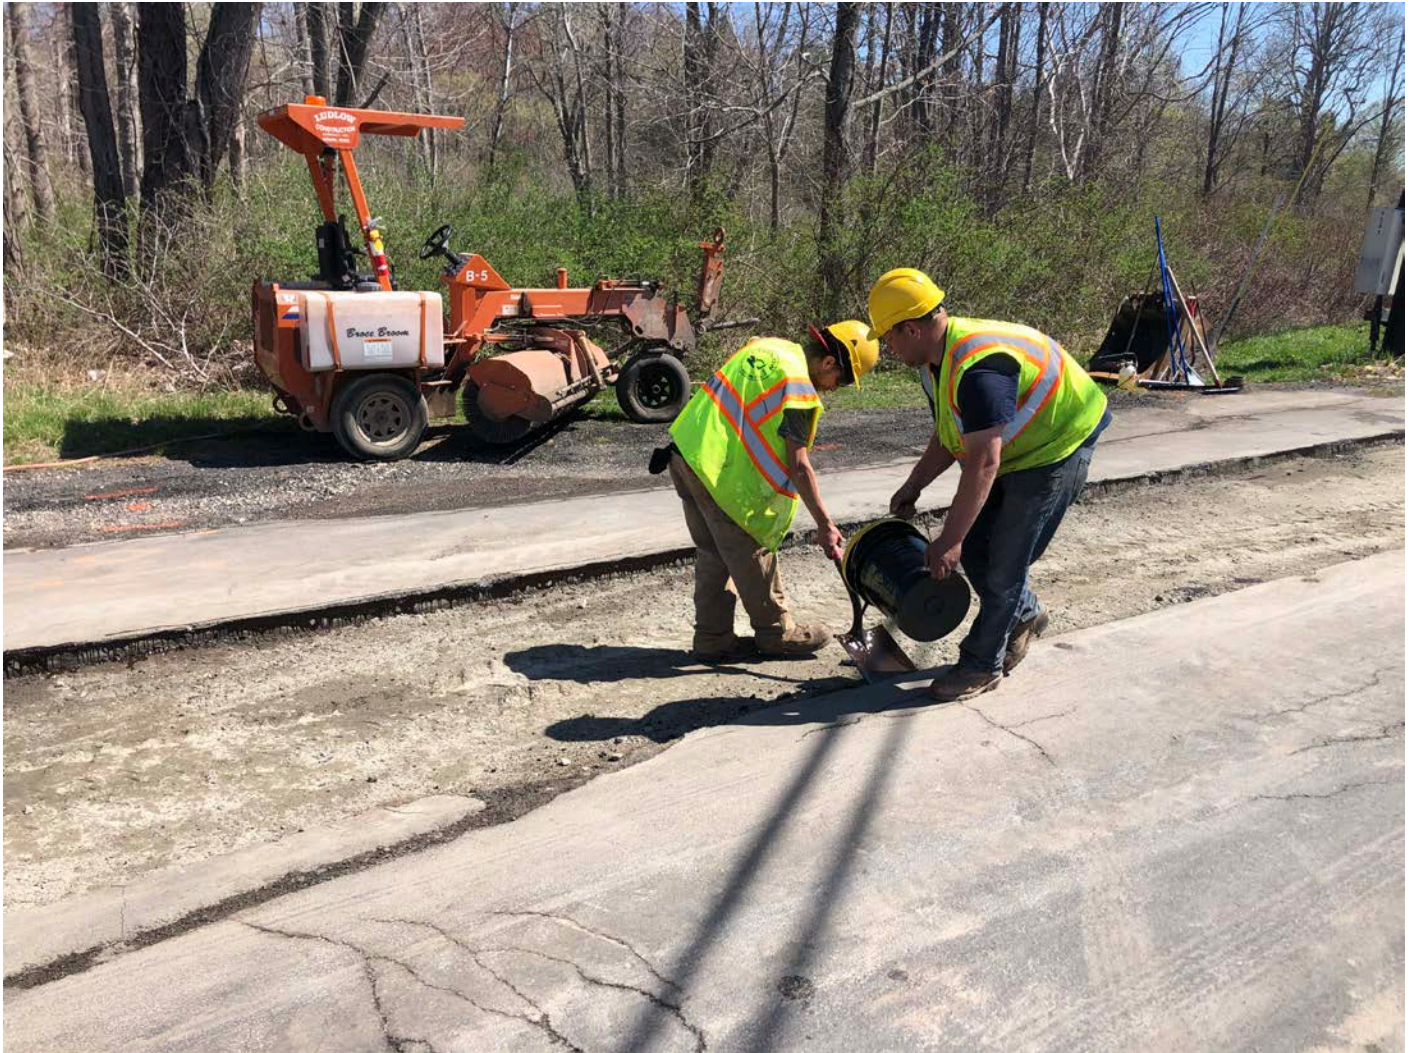
1136: Ludlow is applying tack coating to the cut edges of cut pavement as part of permanent paving activities at Haddam Quarter Road, Durham. Ludlow has just delivered a load of asphalt to the work zone.

Picture 8: Ludlow placing tack coating on the cut edges of pavement as part of permanent paving activities on Haddam Quarter Road, Durham. View to the northeast.

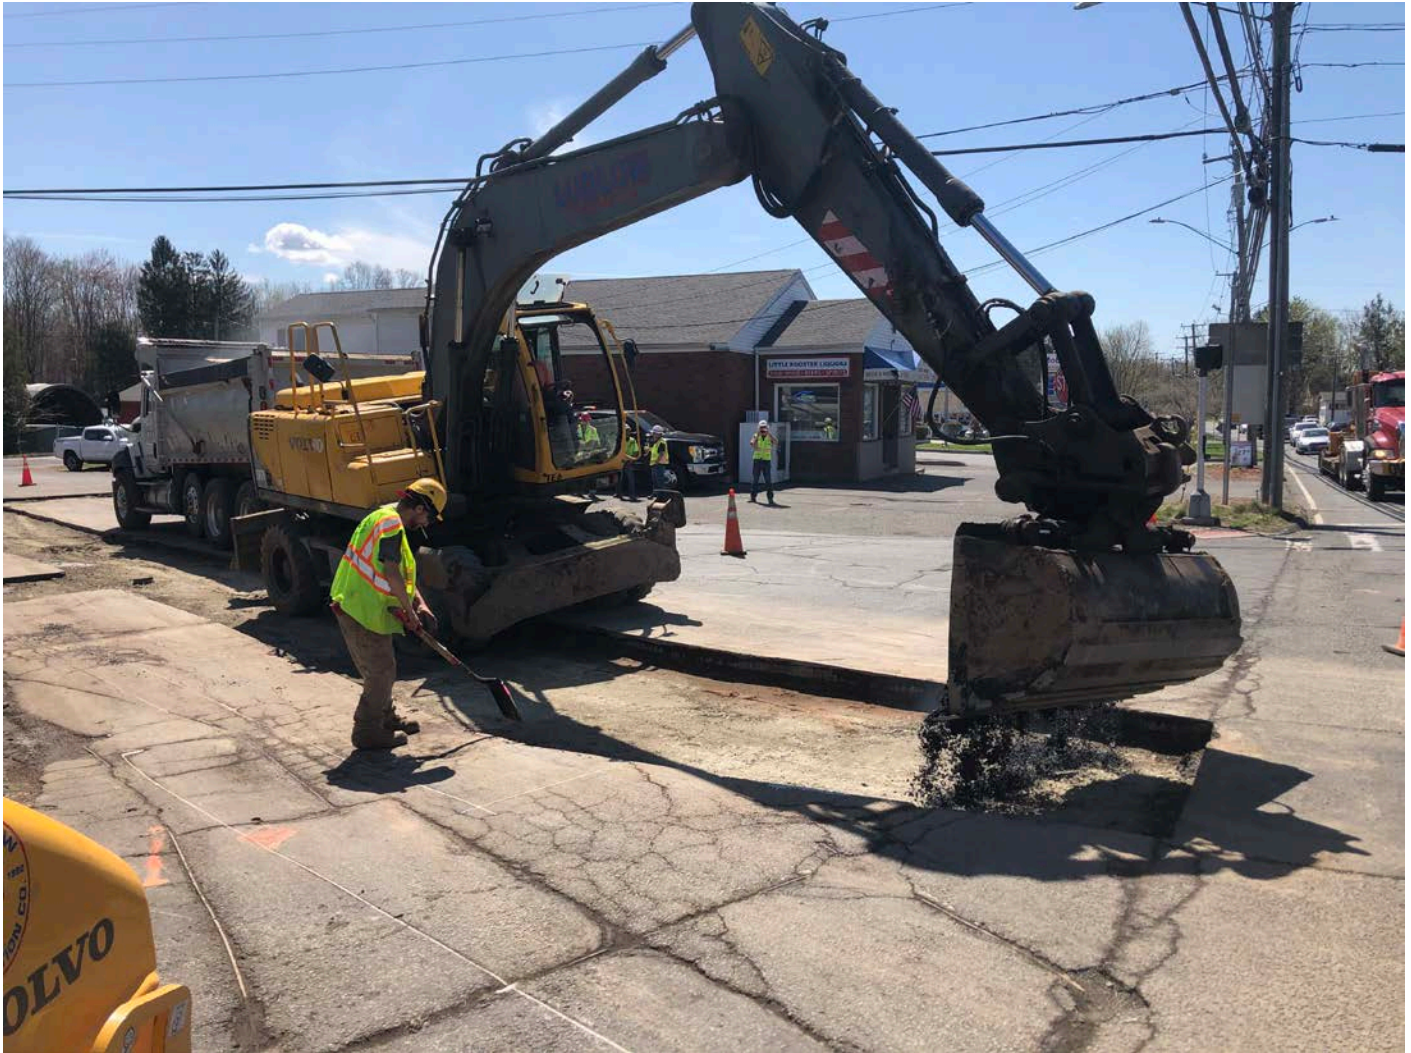
1244: Ludlow has placed and compacted the first lift of asphalt on Haddam Quarter Road, Durham as part of permanent paving activities.

Picture 9: Ludlow placing the first lift of asphalt as part of permanent paving activities on Haddam Quarter Road, Durham. View to the southeast.

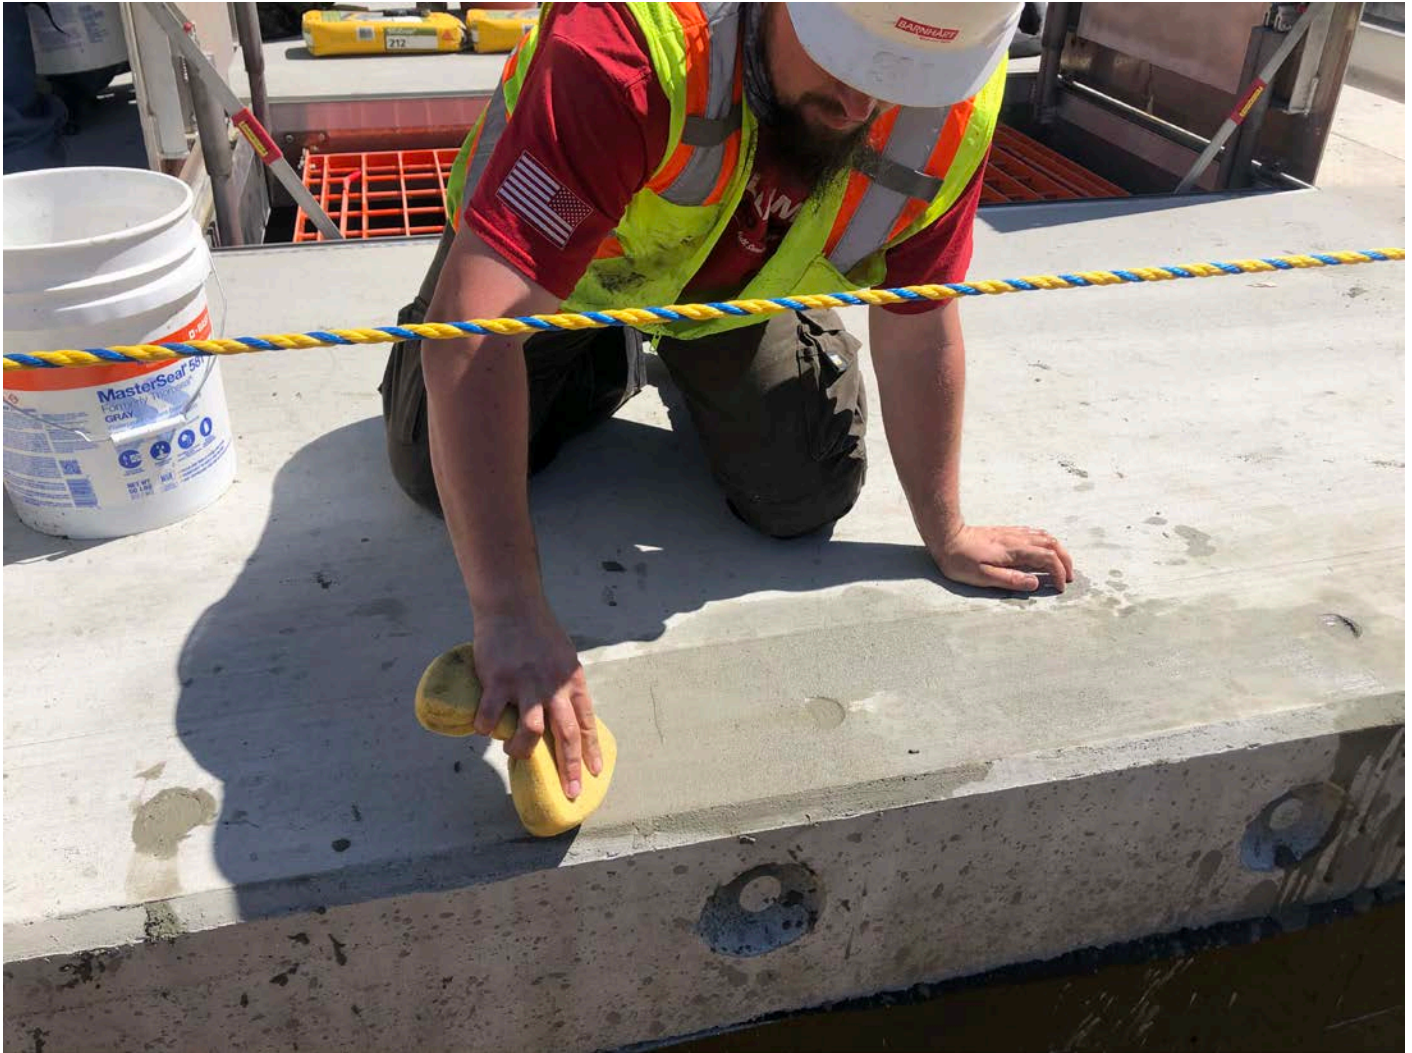
1142: United Concrete is placing grout and rebar through the altitude valve vault lid to connect the lid to the top of the vault walls.

**Picture 10: United Concrete cleaning away excess grout that was poured over the rebar sections that were secured with Hilti epoxy on the altitude valve vault located east of the Shared Access Driveway, Middletown.**

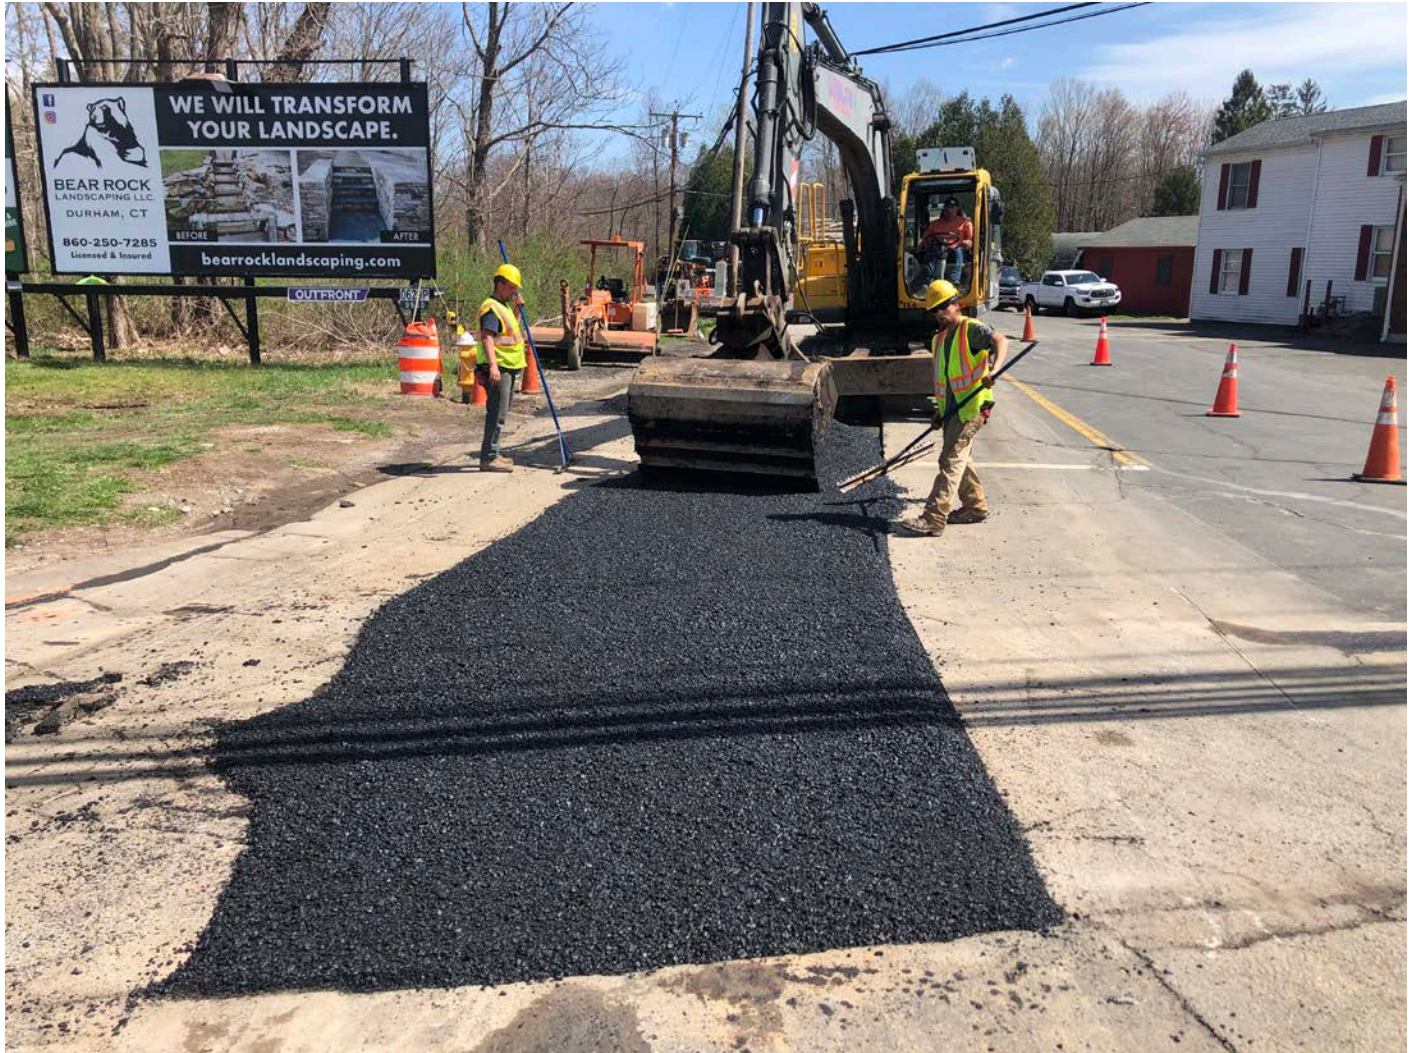
Picture 11: Ludlow placing asphalt on trench overcut on Haddam Quarter Road in Durham as part of permanent paving activities. View to the east.

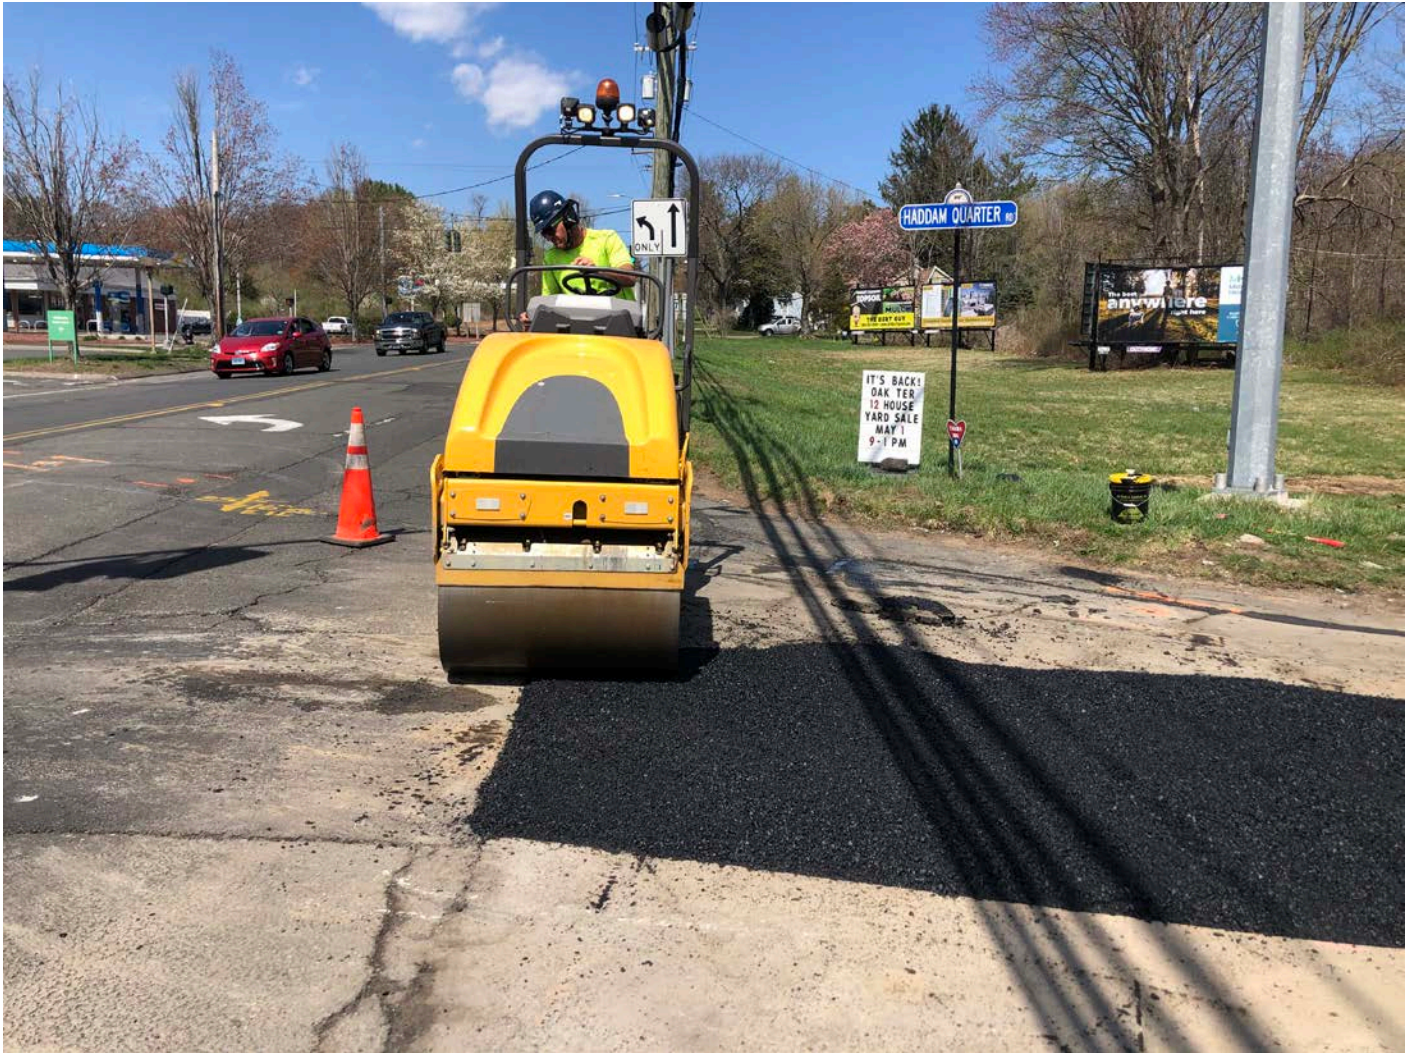
Picture 12: Ludlow compacting asphalt on the trench overcut on Haddam Quarter Road in Durham as part of permanent paving activities. View to the north.

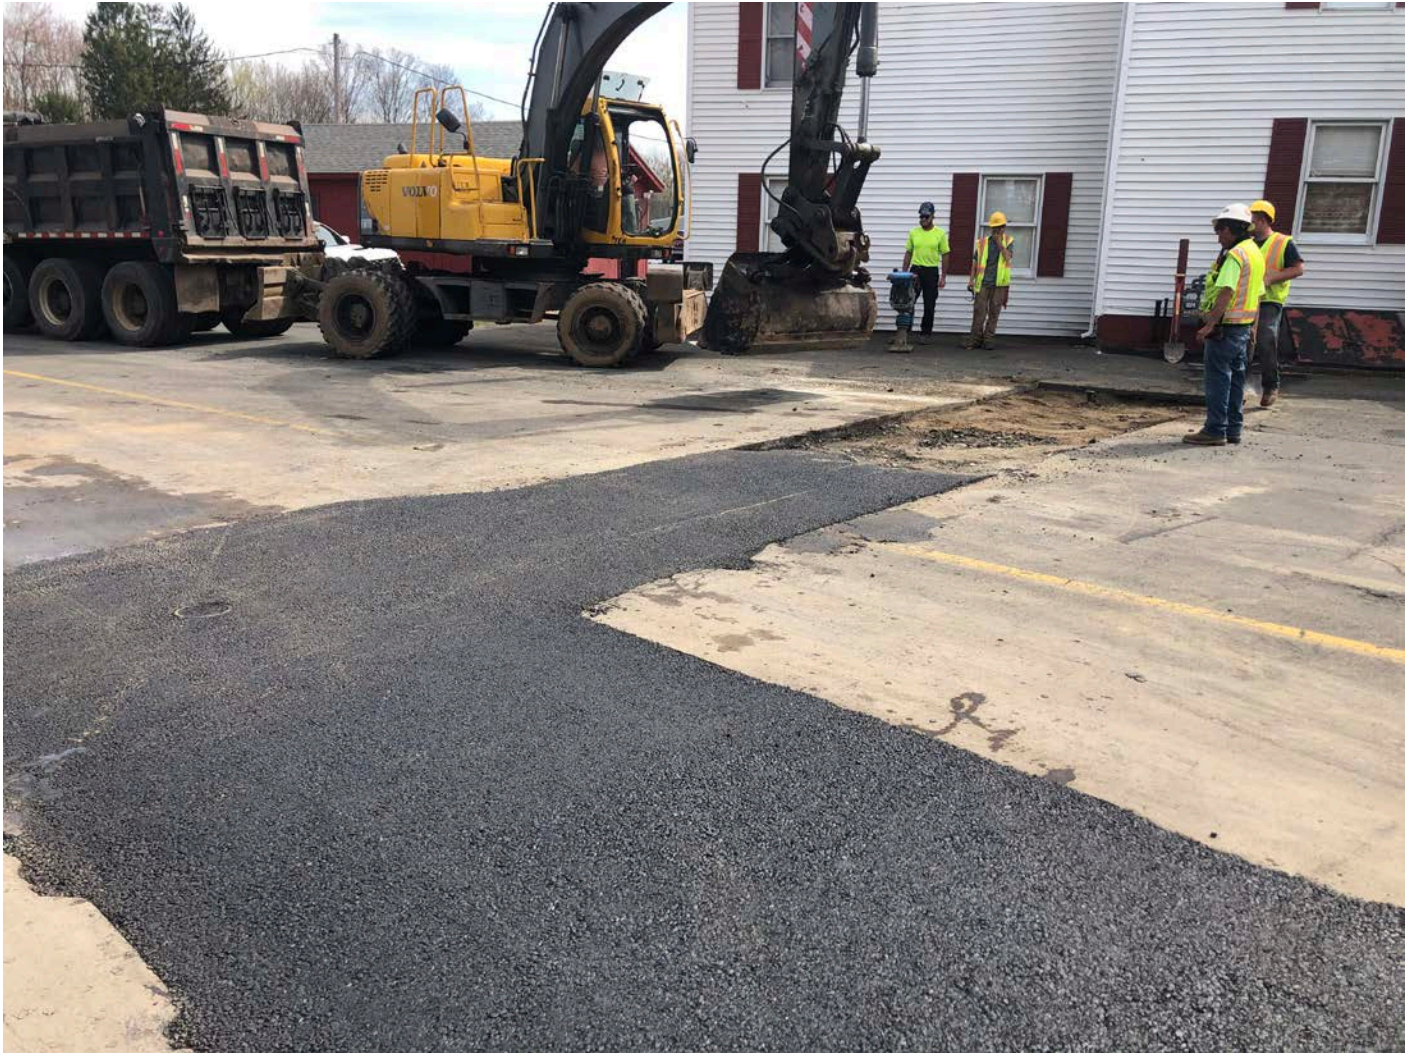
1436: Ludlow is stripping pavement across Haddam Quarter Road, Durham, perpendicular to Rooster Liquors as they prepare for permanent paving activities on the trench for the curb stop that services Rooster Liquors.

Picture 13: Ludlow placing asphalt on the curb stop trench overcut on Haddam Quarter Road in Durham as part of permanent paving activities. Rooster Liquors visible in the rear. View to the southeast.
