Daily Report

Project:	Durham Meadows Pipeline Installation	Date:	April 21, 2021
Location:	Shared Access Driveway, Middletown	Day of Week:	Wednesday
Project #:	AECOM: 6061487	Report No:	226
Contractor:	Ludlow Construction	Page:	1 of 8

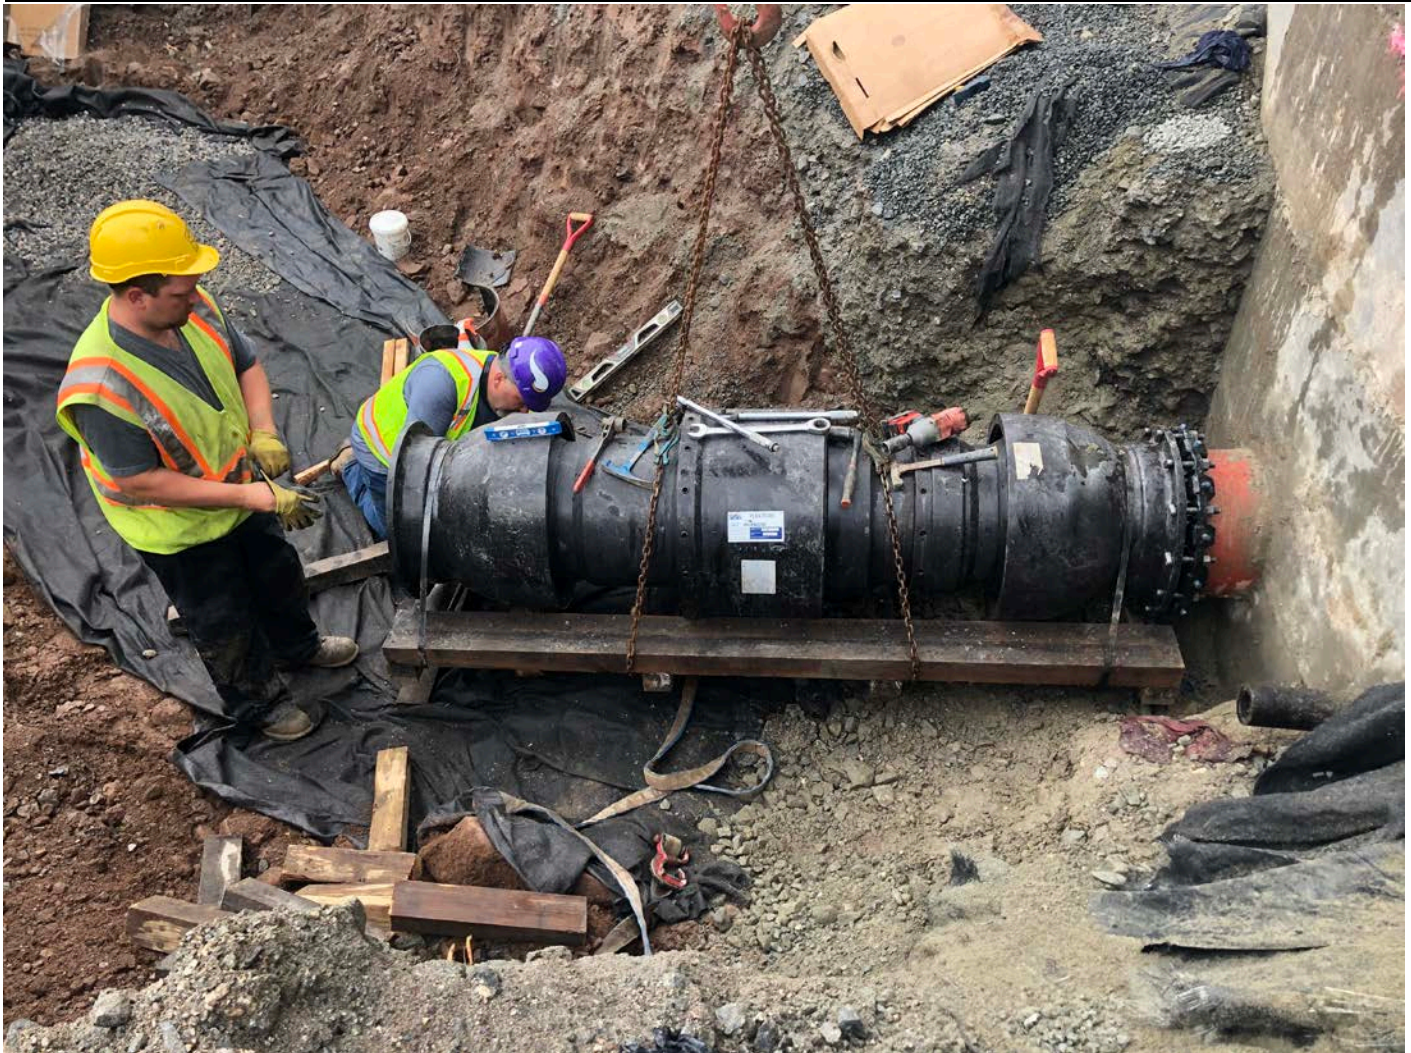
Picture 1: 16" FLEX-TEND piping assembly onto the 16" DIP protruding from the west side of the water tank located east of the Shared Access Road in Middletown. View to the north.

1232: Ludlow is installing the 16" FLEX-TEND piping assembly onto the 16" DIP protruding from the west side of the water tank located east of the Shared Access Driveway in Middletown.

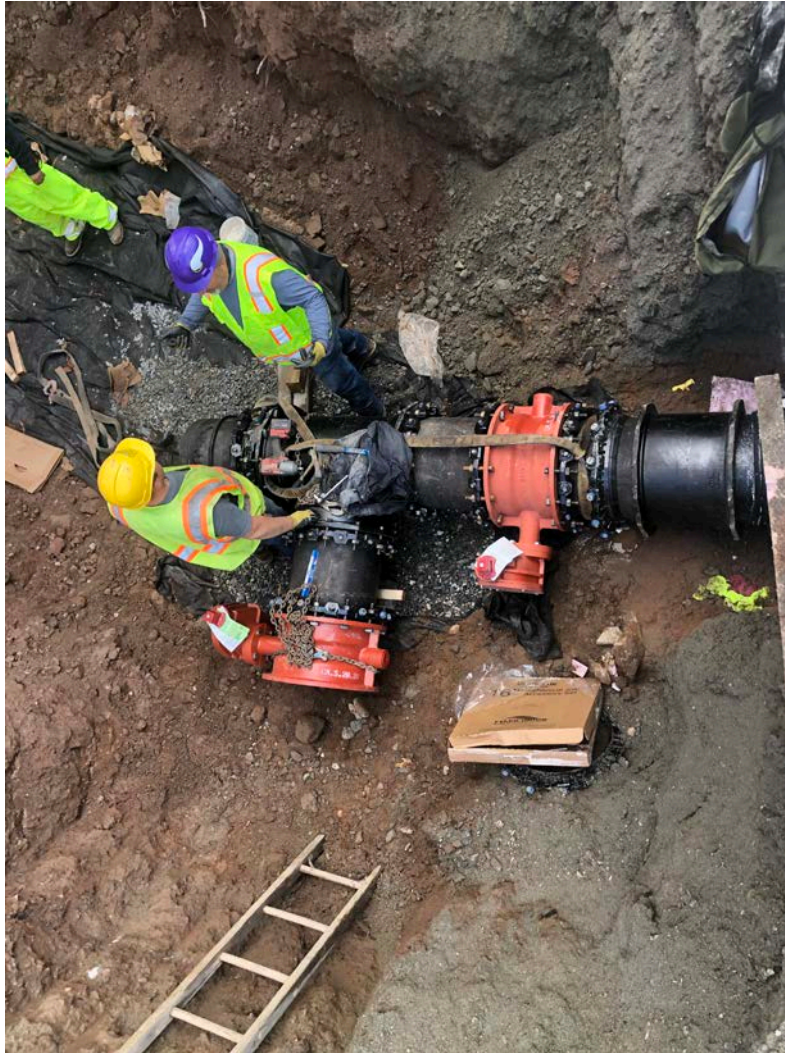
0818: Ludlow is looking to reconfigure the piping between the water tank and the altitude valve vault because the 16" DIP protruding from the base of the water tank does not align with the 16" DIP protruding from the east side of the altitude valve vault.

Picture 2: Ludlow dry-fitting 16" DIP and associated appurtenances on the east side of the altitude valve vault located east of the Shared Access Driveway in Middletown. Ludlow subsequently reconfigured this section using foster adapters.

1043: AECOM and Ludlow discuss how to connect the altitude valve vault to the water tank located east of the Shared Access Driveway given that the 16" DIP protruding from the base of the water tank does not align with the 16" DIP protruding from the east side of the altitude valve vault. It was decided that Ludlow will use foster adapters and possibly move some of the pipe components to make the connection.

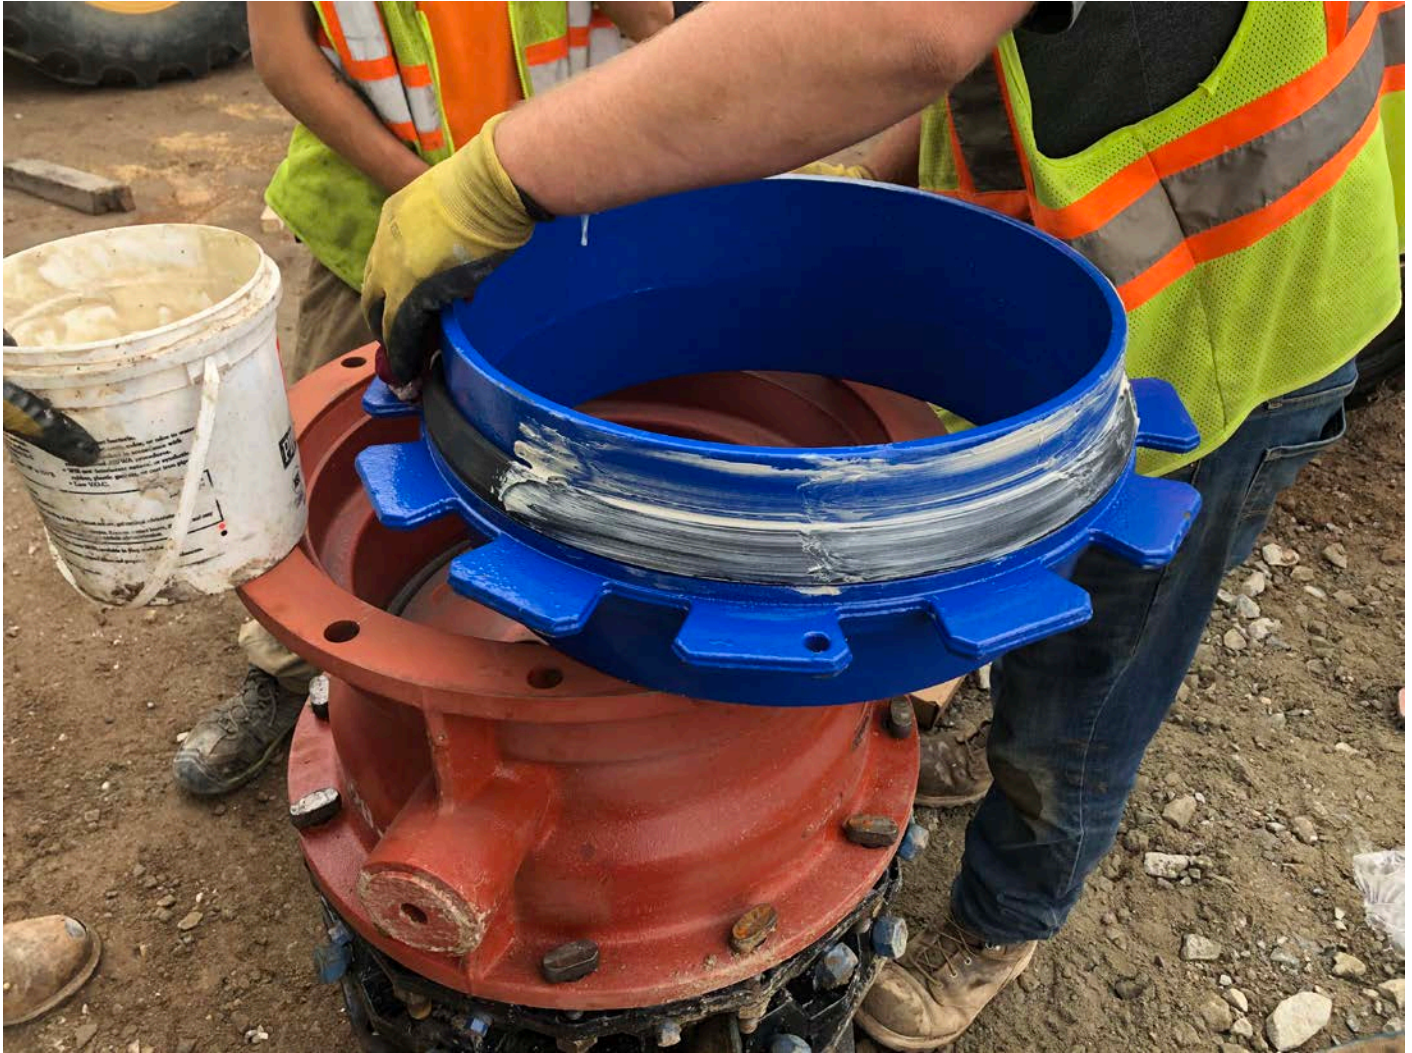
Picture 3: One of the 16" foster adapters that Ludlow used today while connecting the altitude valve vault to the water tank located east of the Shared Access Driveway in Middletown.

1123: AECOM spoke with Ludlow: they have five 16" foster adapters being delivered to the water tank work zone so they can reconfigure the connection between the tank and the altitude valve vault.

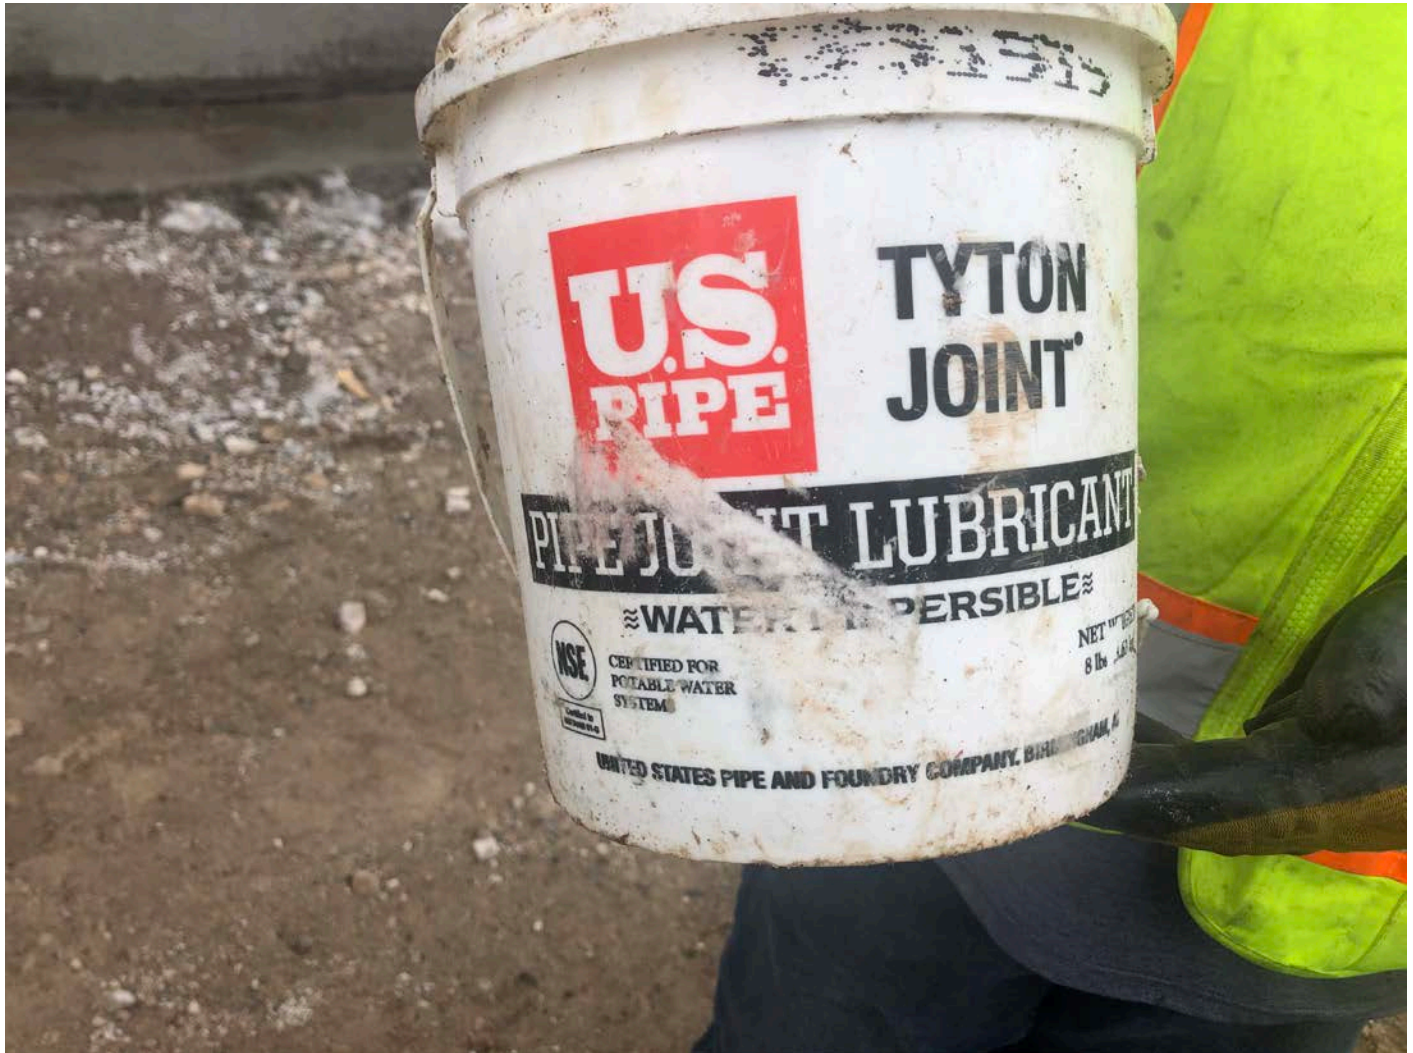
Picture 4: Pipe joint lubricant that Ludlow uses with the foster adapters and megalug connectors while connecting the altitude valve vault to the water tank located to the east of the Shared Access Driveway in Middletown.

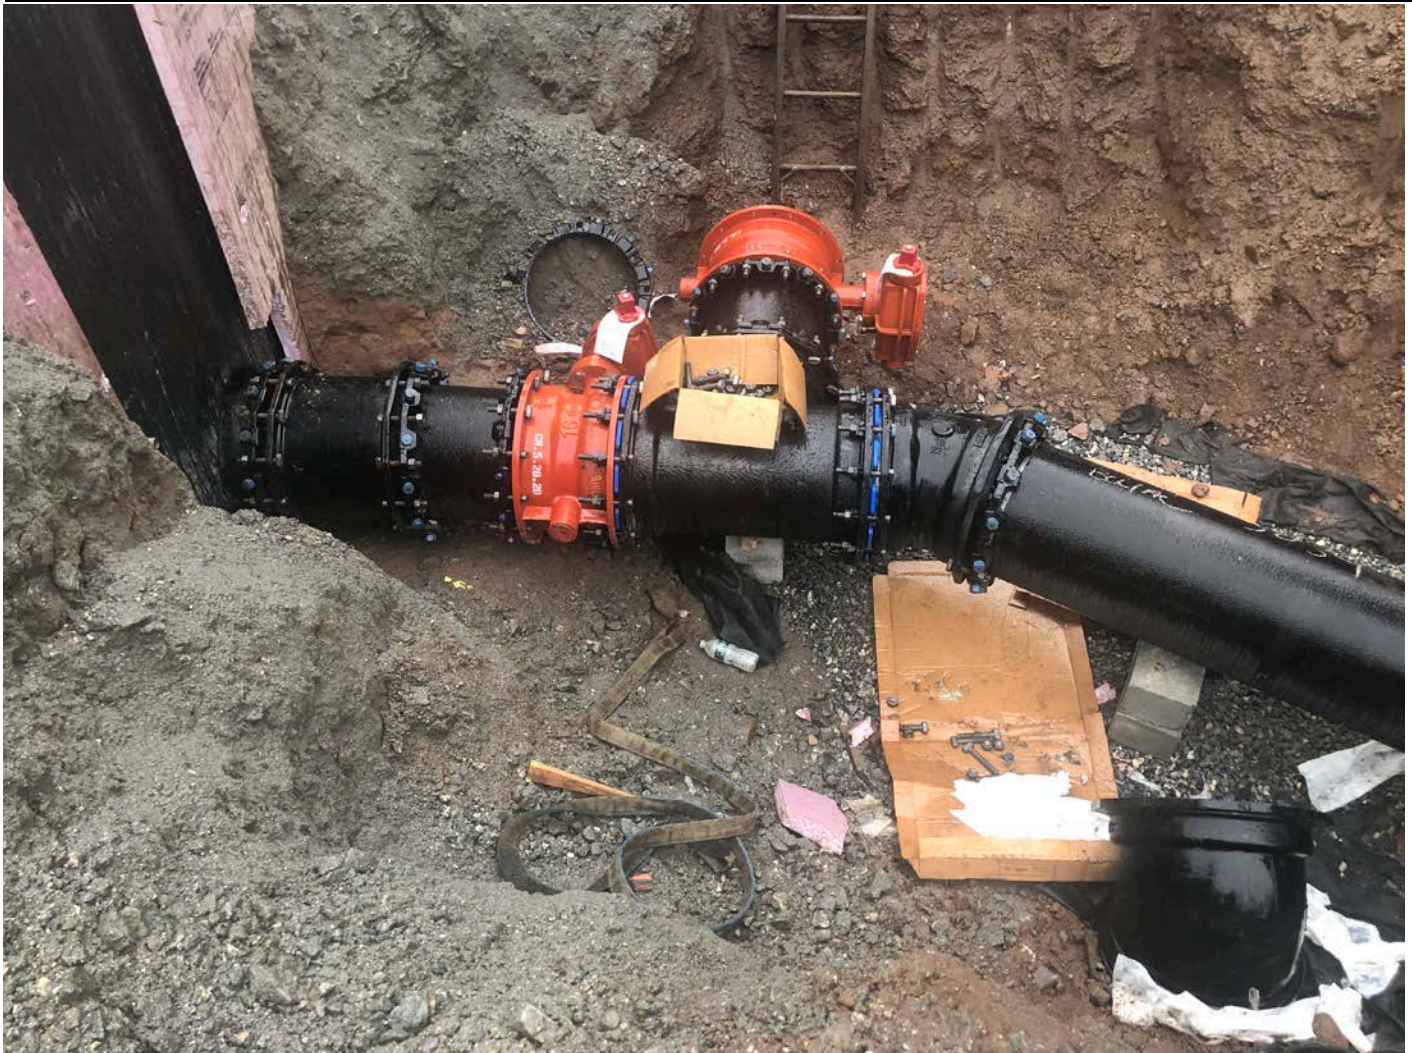
Picture 5: Final configuration of the 16" DIP that Ludlow attached to the east side of the altitude valve vault located east of the Shared Access Driveway in Middletown. Note foster adapters on either side of the 16"x16"x16" Tee. View to the north/northeast.

1539: Ludlow is placing 16" DIP between the altitude valve vault and the water tank. They have installed 4 foster adapters so far: one on either side of the 16"x16"x16" Tee coming off the east side of the altitude valve vault, and another two foster adapters installed on either side of the 16" butterfly valve that Ludlow attached immediately west of the 16" FLEX-TEND piping assembly that was attached to the 16" DIP that is protruding from the west side of the water tank.

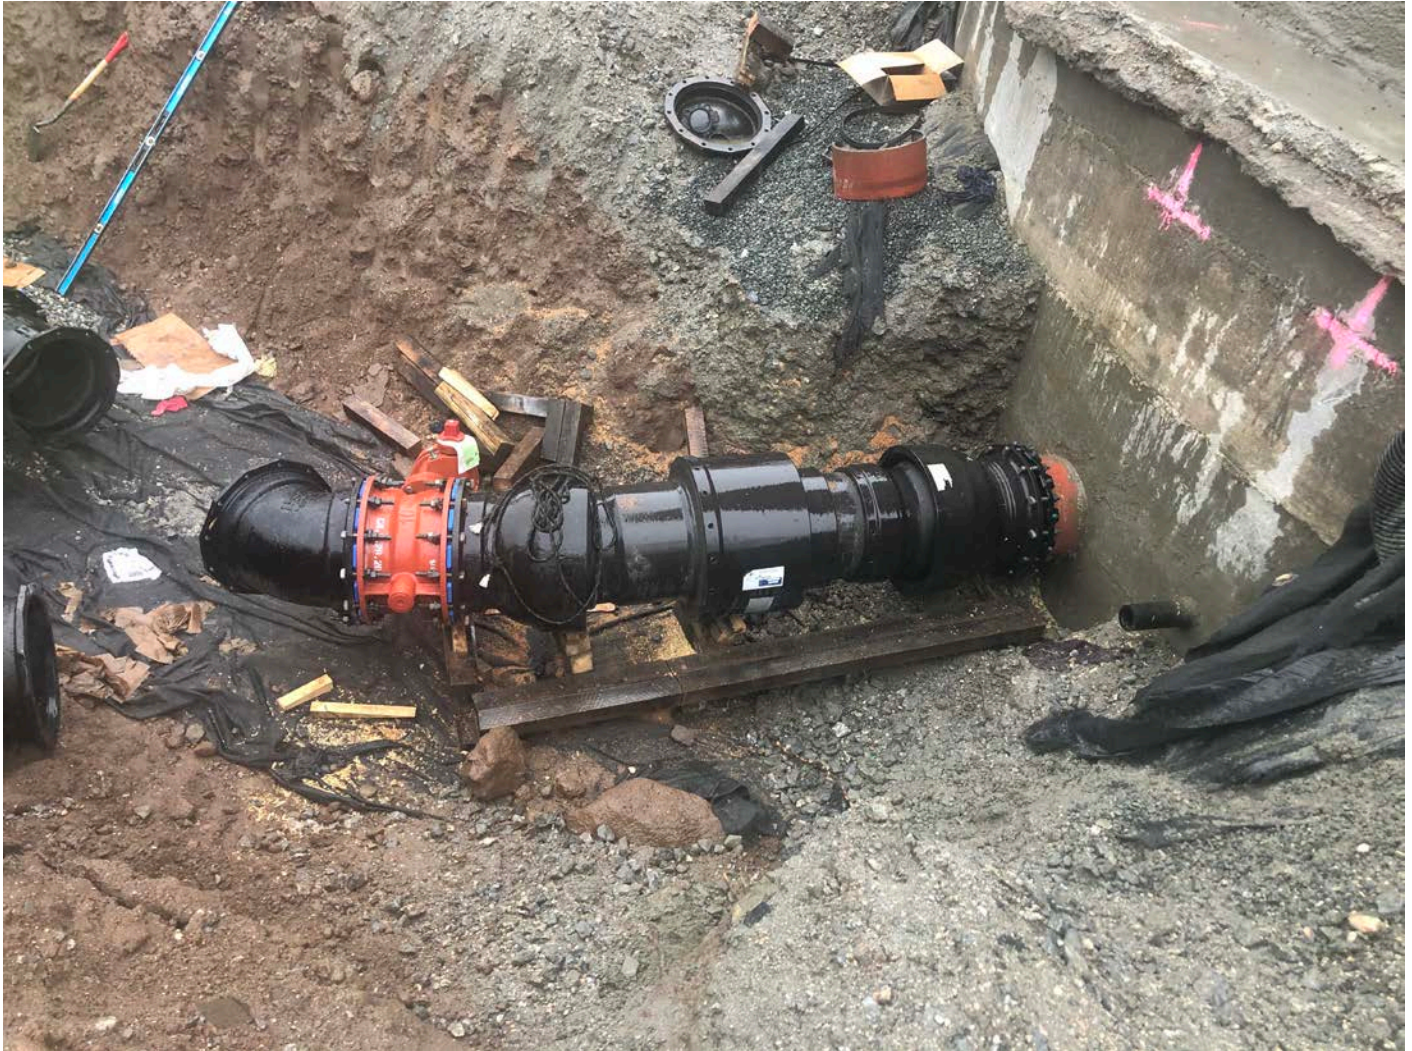
Picture 6: Final configuration of the 16" FLEX-TEND piping assembly with a foster adapter placed on either side of the 16" butterfly valve that was installed onto the 16" DIP protruding from the west side of the water tank. Water tank work zone located east of the Shared Access Driveway, Middletown. View to the north.
