Daily Report

Project:	Durham Meadows Pipeline Installation	Date:	April 22, 2021
Location:	Shared Access Driveway, Middletown	Day of Week:	Thursday
Project #:	AECOM: 6061487	Report No:	227
Contractor:	Ludlow Construction	Page:	1 of 10

Ludlow finished installing the 16" DIP between the altitude valve vault and the water tank located east of the Shared Access Driveway in Middletown.

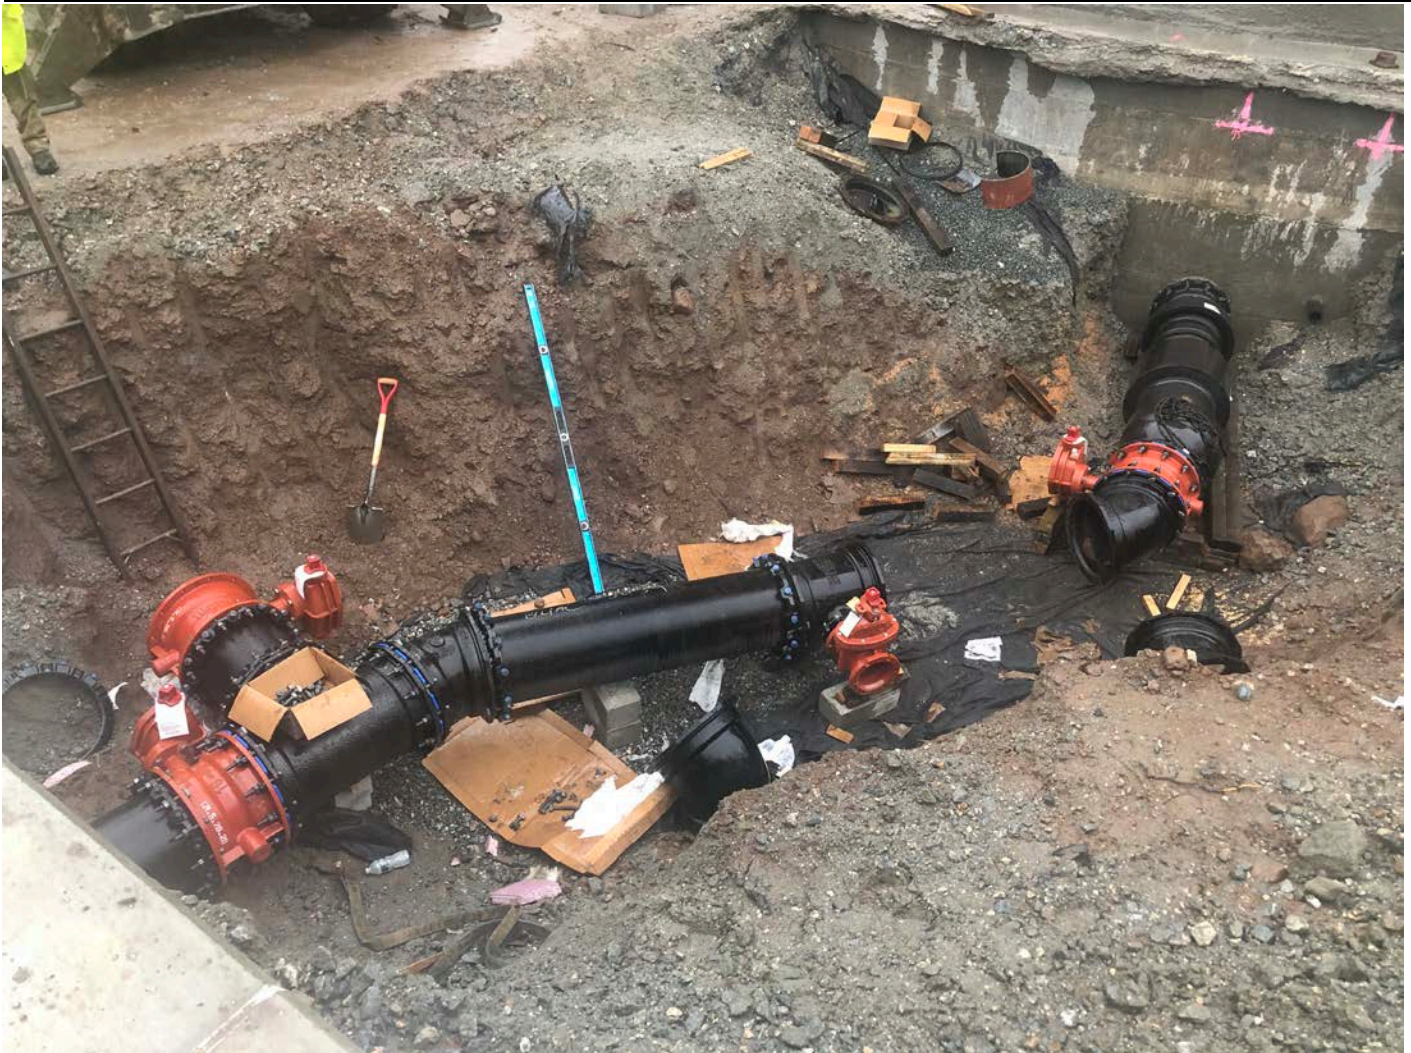
Picture 1: View of the piping that Ludlow installed yesterday between the altitude valve vault and the water tank located east of the Shared Access Driveway in Middletown. View to the northeast.

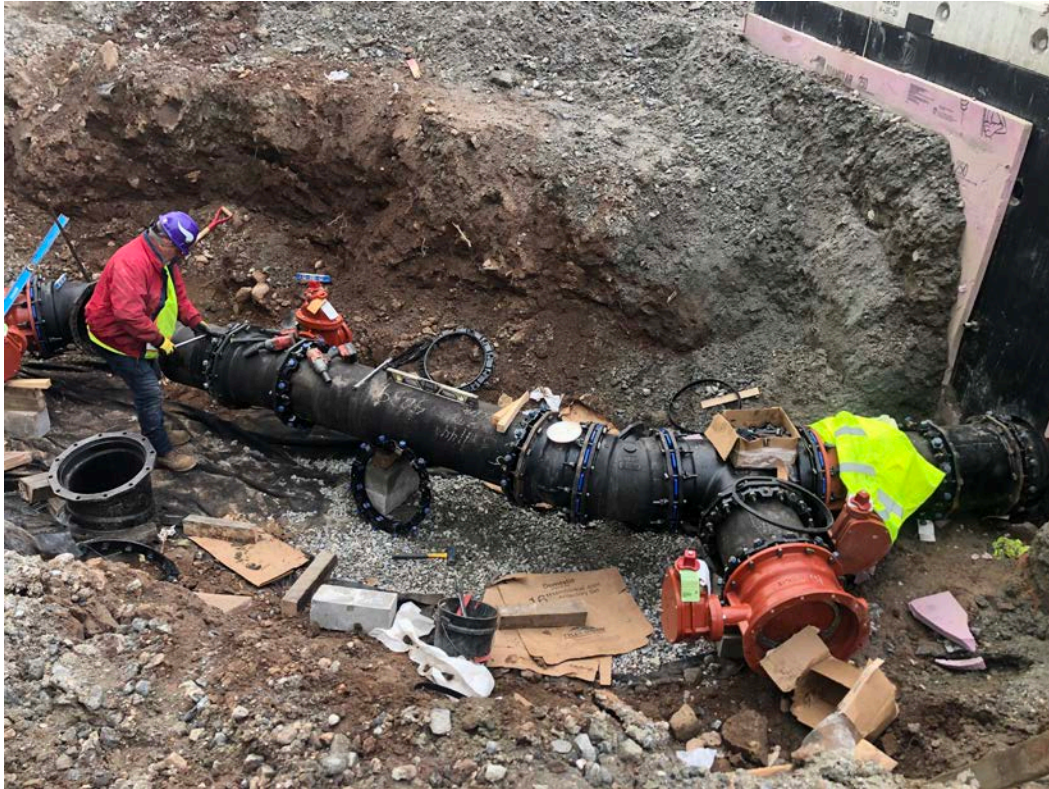
Picture 2: Ludlow tightening the bolts on a megalug restrained connection as they continue to install 16" DIP between the altitude valve vault and the water tank located east of the Shared Access Driveway in Middletown. View to the south.

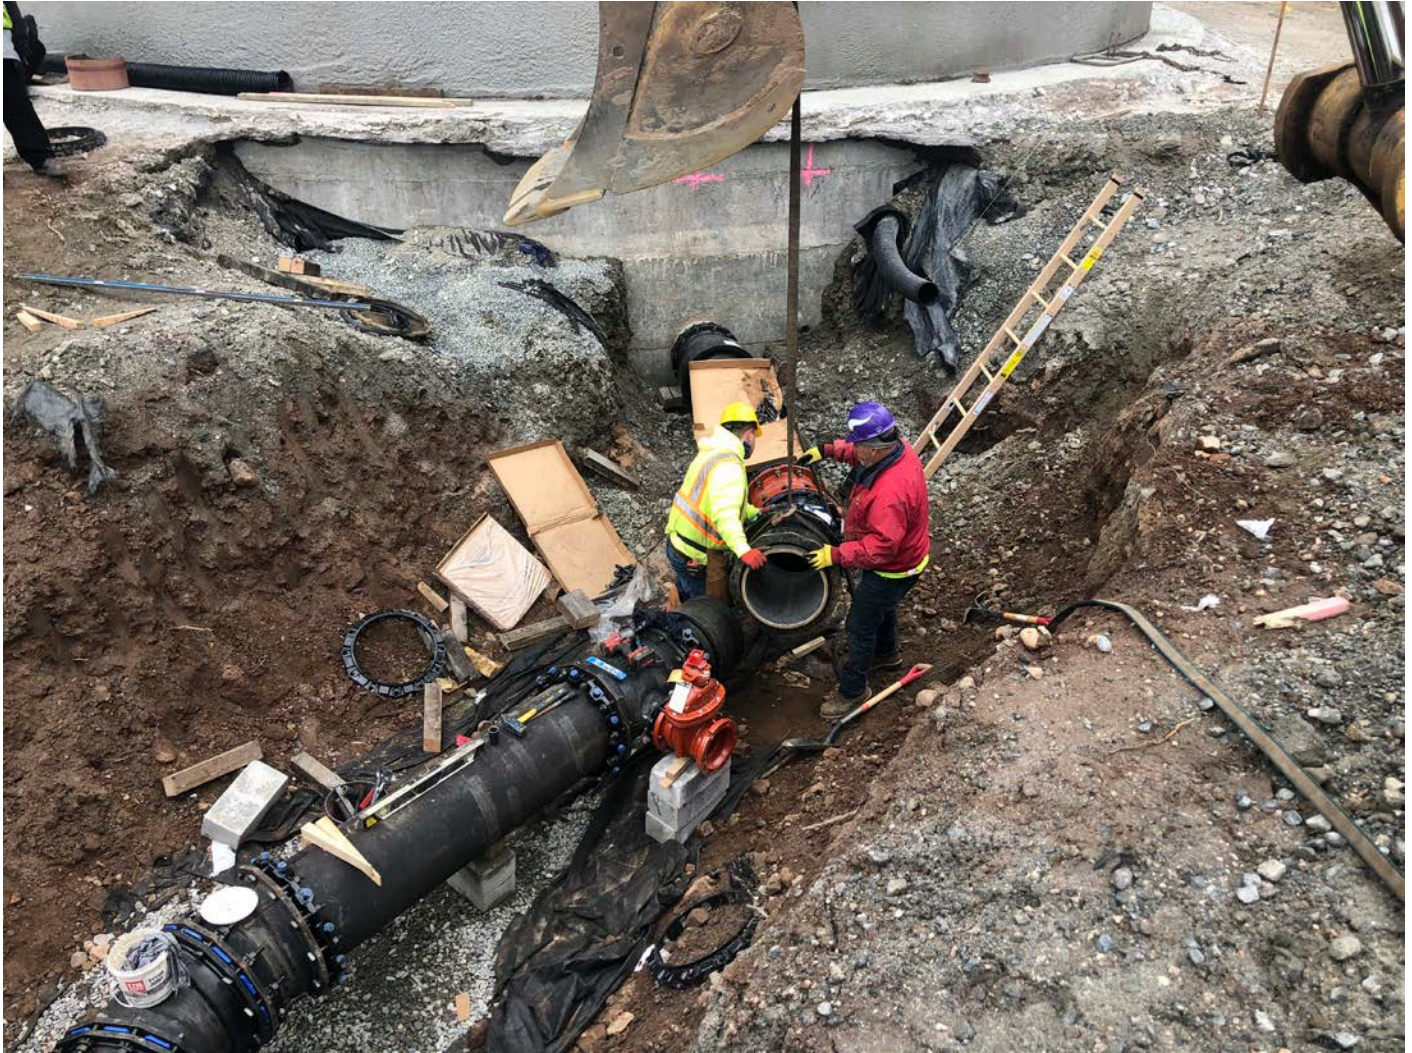
Picture 3: Ludlow continuing to install 16" DIP between the altitude valve vault and the water tank located east of the Shared Access Driveway in Middletown. View to the east.

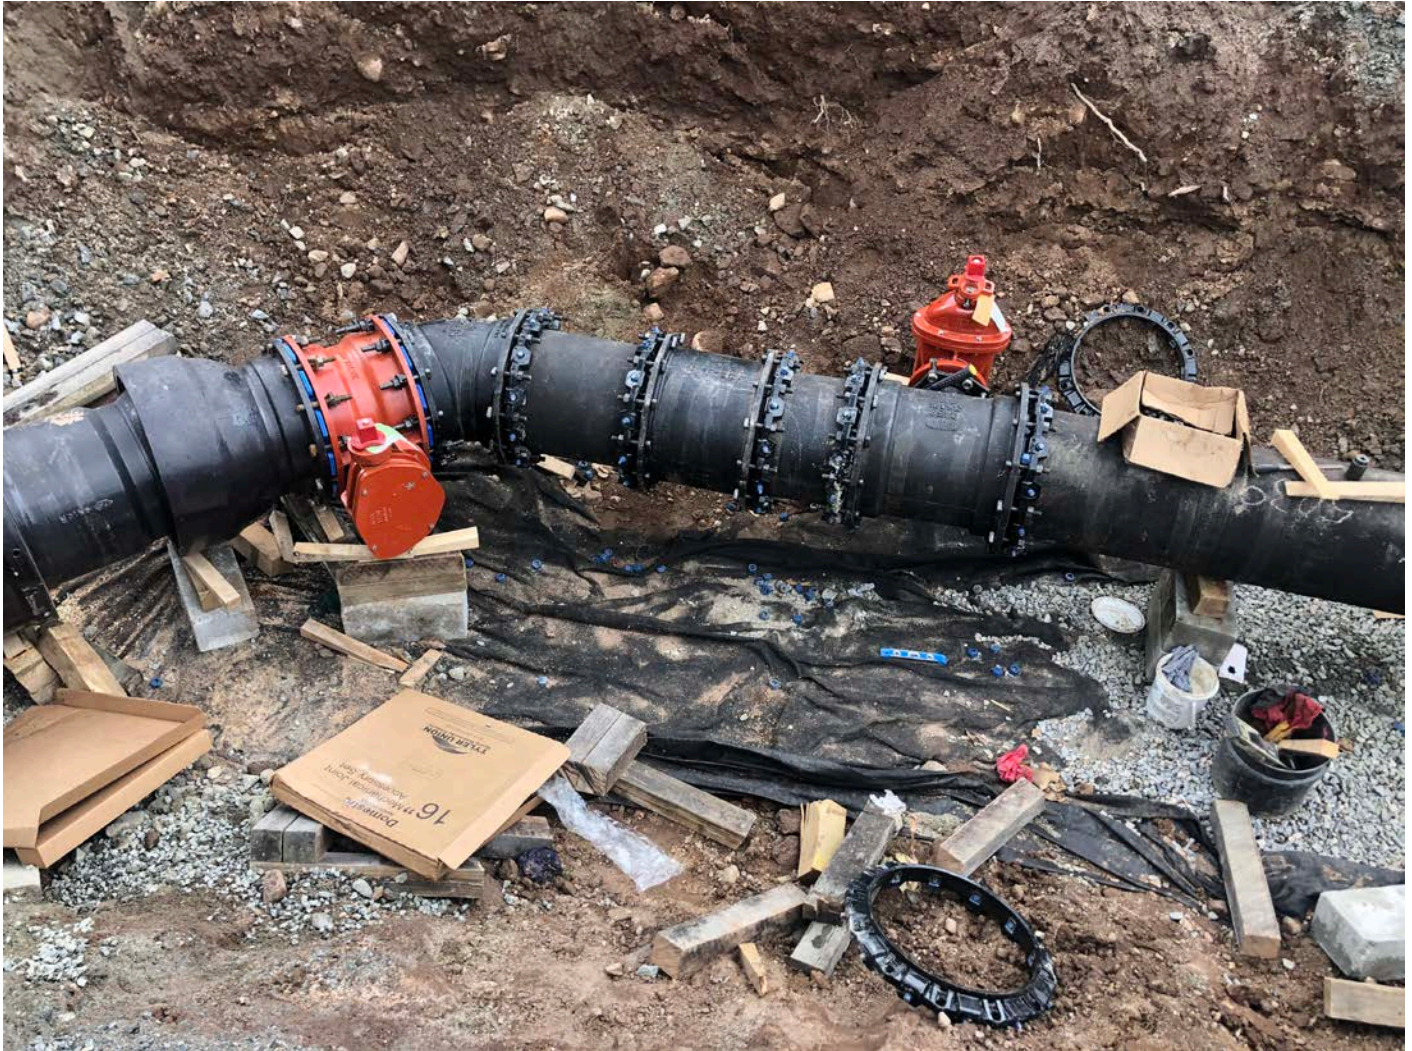
Picture 4: The last section of 16" DIP that Ludlow installed between the altitude valve vault to the water tank located to the east of the Shared Access Driveway in Middletown. View to the south.

1051: Ludlow has completed installing the 16" DIP to connect the altitude valve vault and the water tank.

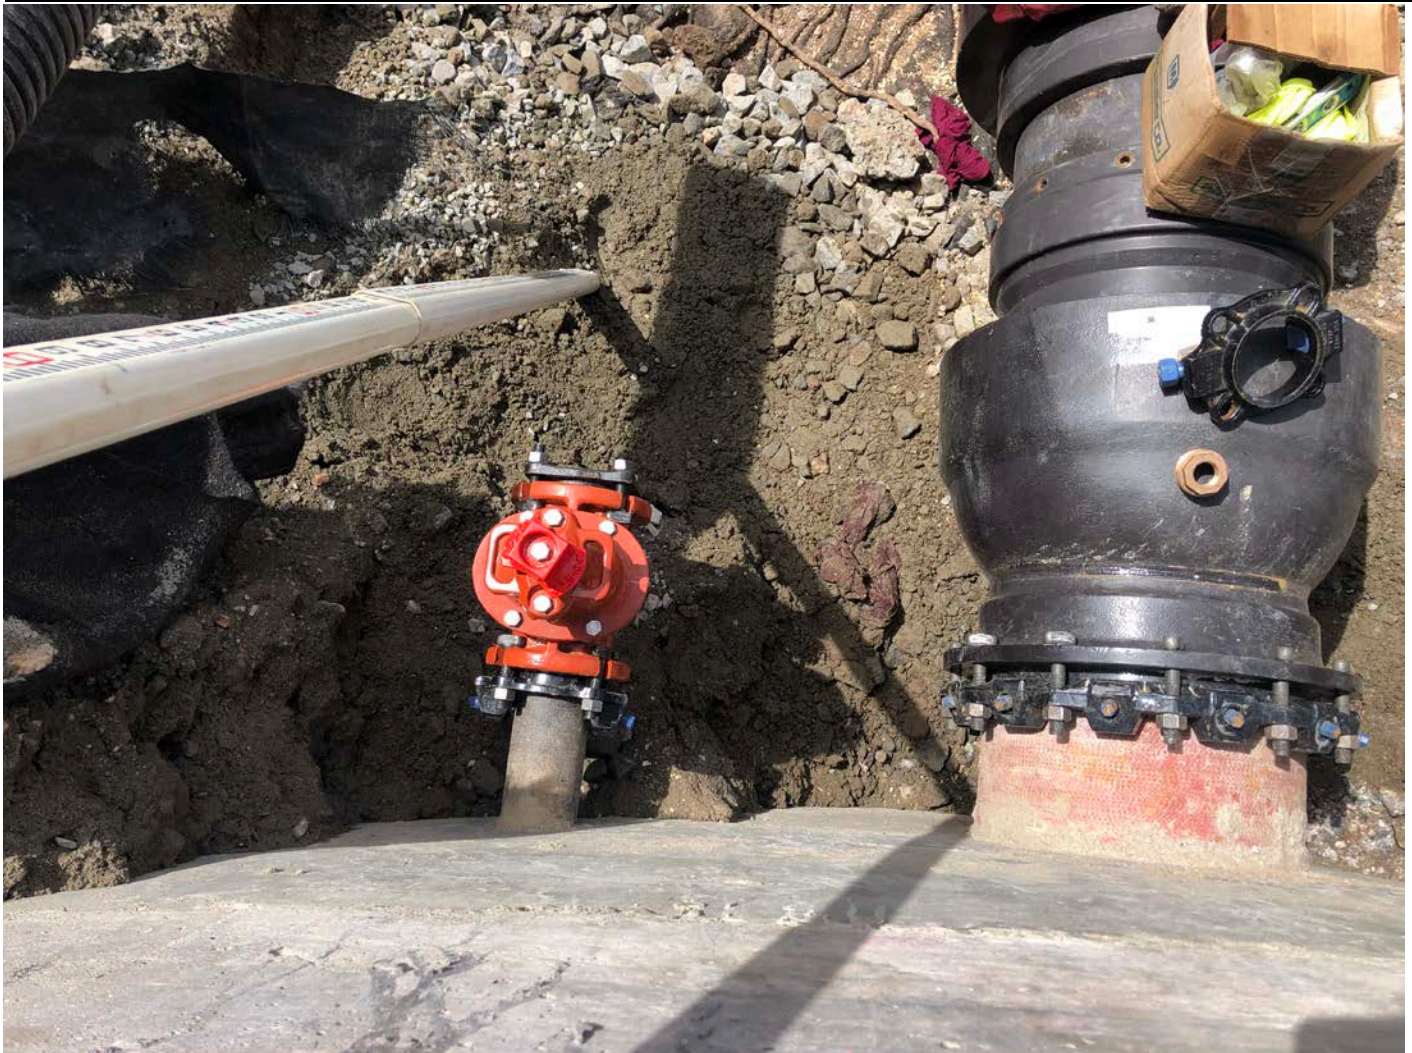
Picture 5: 3" gate valve that Ludlow has attached to the 3" DI tank level sensor line that protrudes from the west side of the water tank located east of the Shared Access Driveway in Middletown. View to the west.

1226: Ludlow is in the process of surveying the 16" DIP they installed between the altitude valve vault and the water tank for an as-built record. Ludlow is also installing a 3" gate valve right up against the water tank on the 3" DIP tank level sensor line that protrudes from the west side of the tank (about 3' south of where the 16" DIP protrudes from the west side of the water tank).

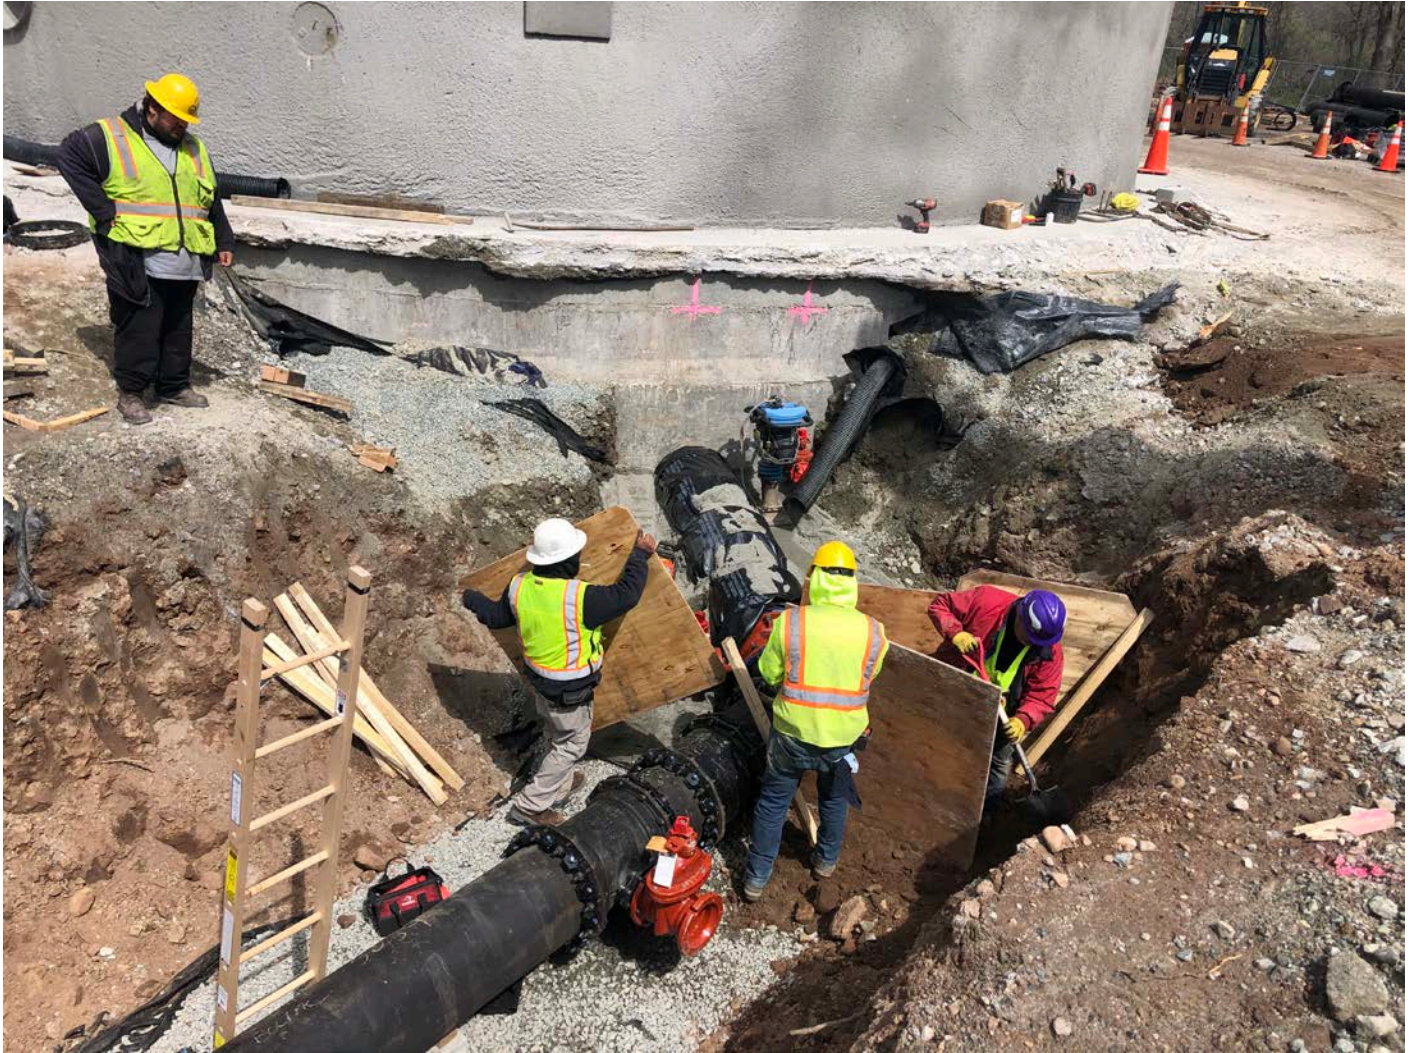
Picture 6: Ludlow building a form for concrete that will be poured to form a thrust block for the first bend of the 16" DIP located west of the 16" FLEX-TEND piping assembly. View to the east.

1417: Ludlow has finished backfilling underneath the 16" FLEX-TEND piping assembly that was attached to the west side of the water tank. Ludlow is currently building a form for concrete that will be poured to form a thrust block for the first bend of the 16" DIP located west of the 16" FLEX-TEND piping assembly.

1442: Ludlow is currently building a form for concrete that will be poured to form a thrust block for the first bend of the 16" DIP located west of the 16" FLEX-TEND piping assembly.

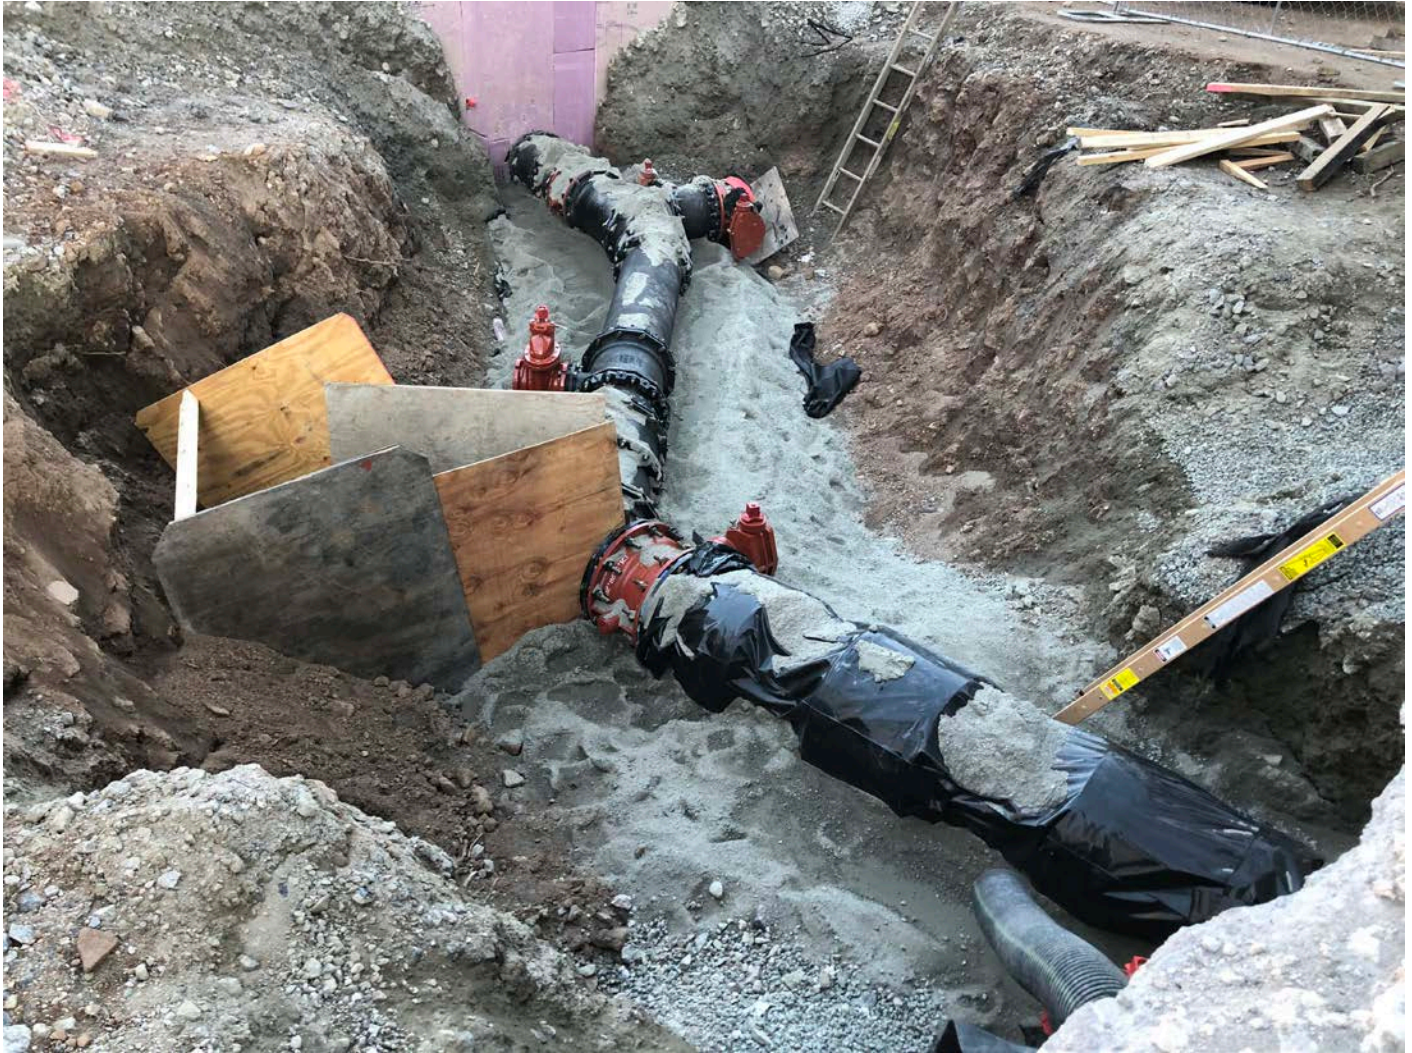
Picture 7: 16" DIP after Ludlow completed connecting the water tank to the altitude valve vault and placed geofabric, $\frac{3}{4}$ ' gravel, and sand beneath the pipe. View to the west.

1329: Ludlow is in the process of backfilling underneath the 16" FLEX-TEND piping assembly that was attached to the west side of the water tank. Geofabric has been placed on top of fill, followed by 6" of ¾" gravel, followed by another layer of geofabric. Sand will then be placed on top of the top layer of geofabric and brought up to the invert of the 16" FLEX-TEND piping assembly, with at least 3" of sand placed beneath said assembly.

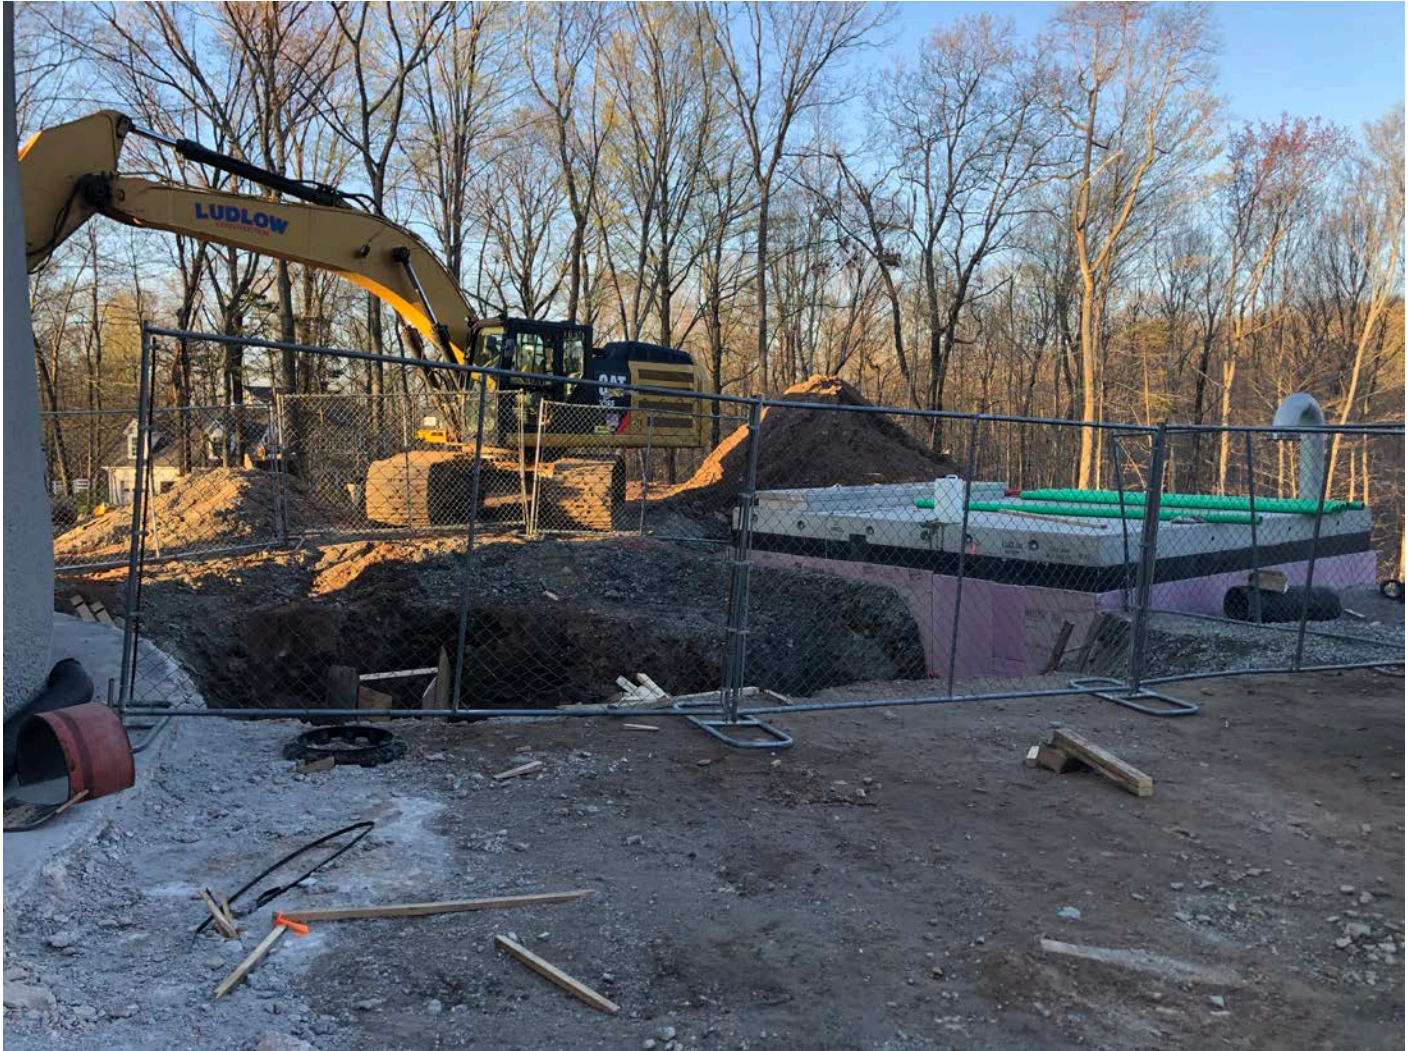
Picture 8: Excavation between the water tank to the altitude valve vault located east of the Shared Access Driveway, Middletown. Fencing was placed around the excavation at the end of the workday for security. View to the south.
