Daily Report

Project:	Durham Meadows Pipeline Installation	Date:	April 23, 2021
Location:	Shared Access Driveway, Middletown, Wallingford Road, Durham	Day of Week:	Friday
Project #:	AECOM: 6061487	Report No:	228
Contractor:	Ludlow Construction	Page:	1 of 10

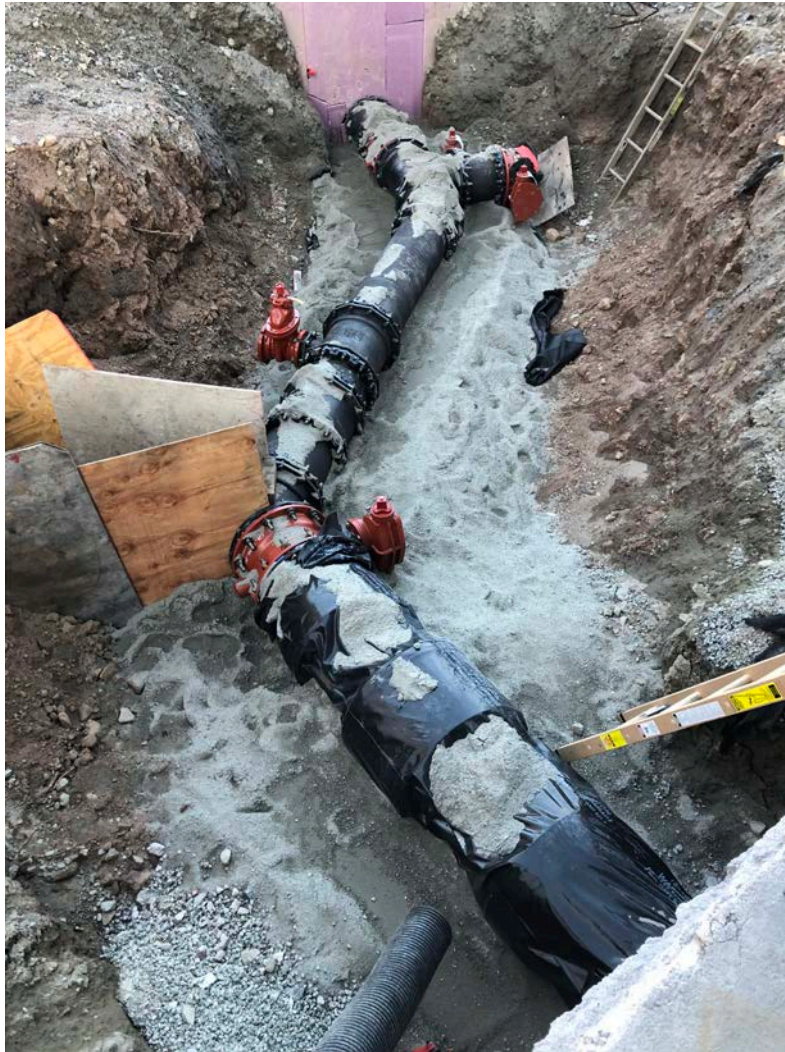
Picture 1: View of the 16" DIP that Ludlow installed between the altitude valve vault and the water tank located east of the Shared Access Driveway in Middletown. View to the west.

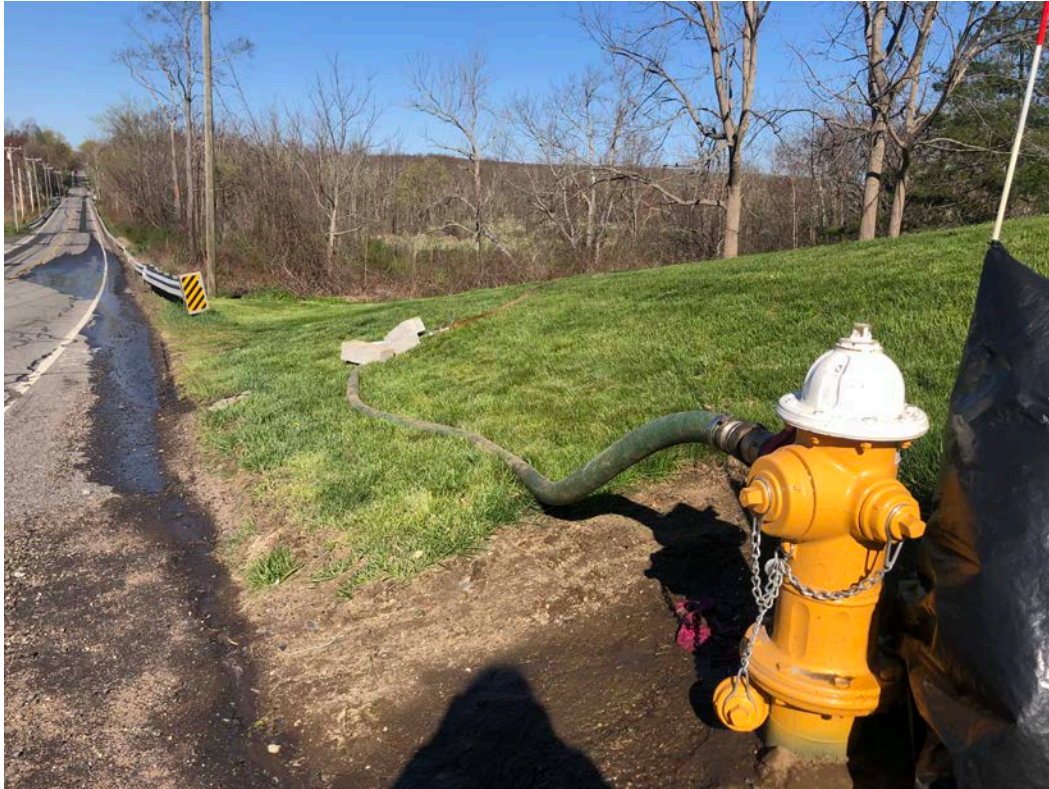
Picture 2: Ludlow flushing the 8" and 12" DIP waterline on Wallingford Road between Main Street and 47 Wallingford Road in Durham. Water is discharging into the adjoining wetland to the north of Wallingford Road. View to the west.

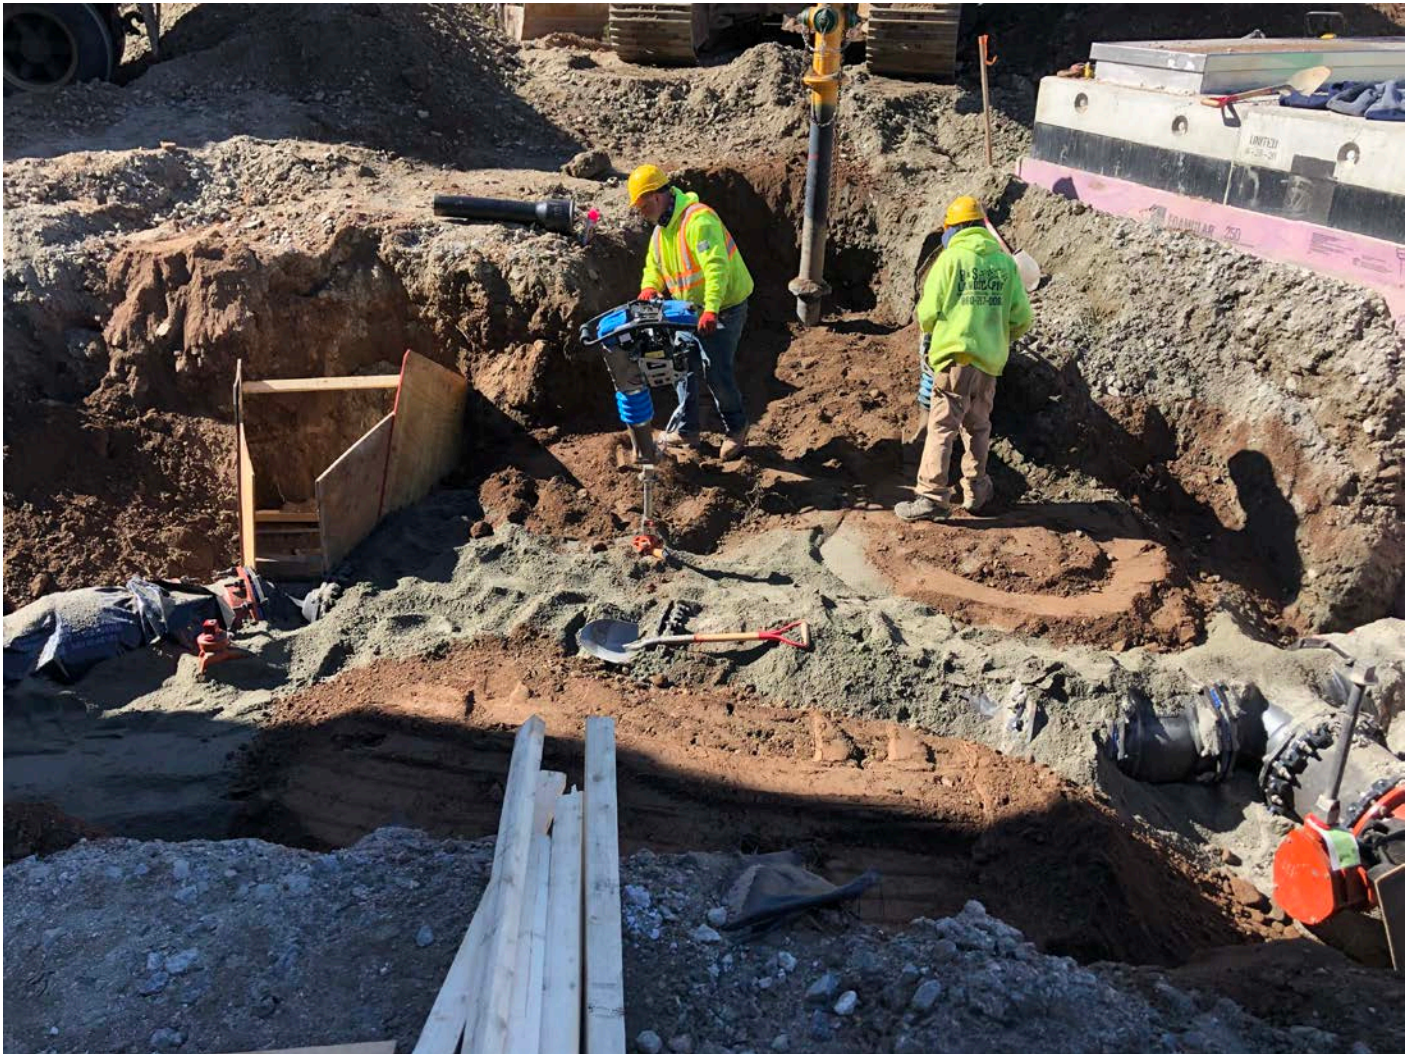
Picture 3: Ludlow compacting fill next to the hydrant they just installed with a jumping jack. Water tank work zone located east of the Shared Access Driveway in Middletown. View to the south.

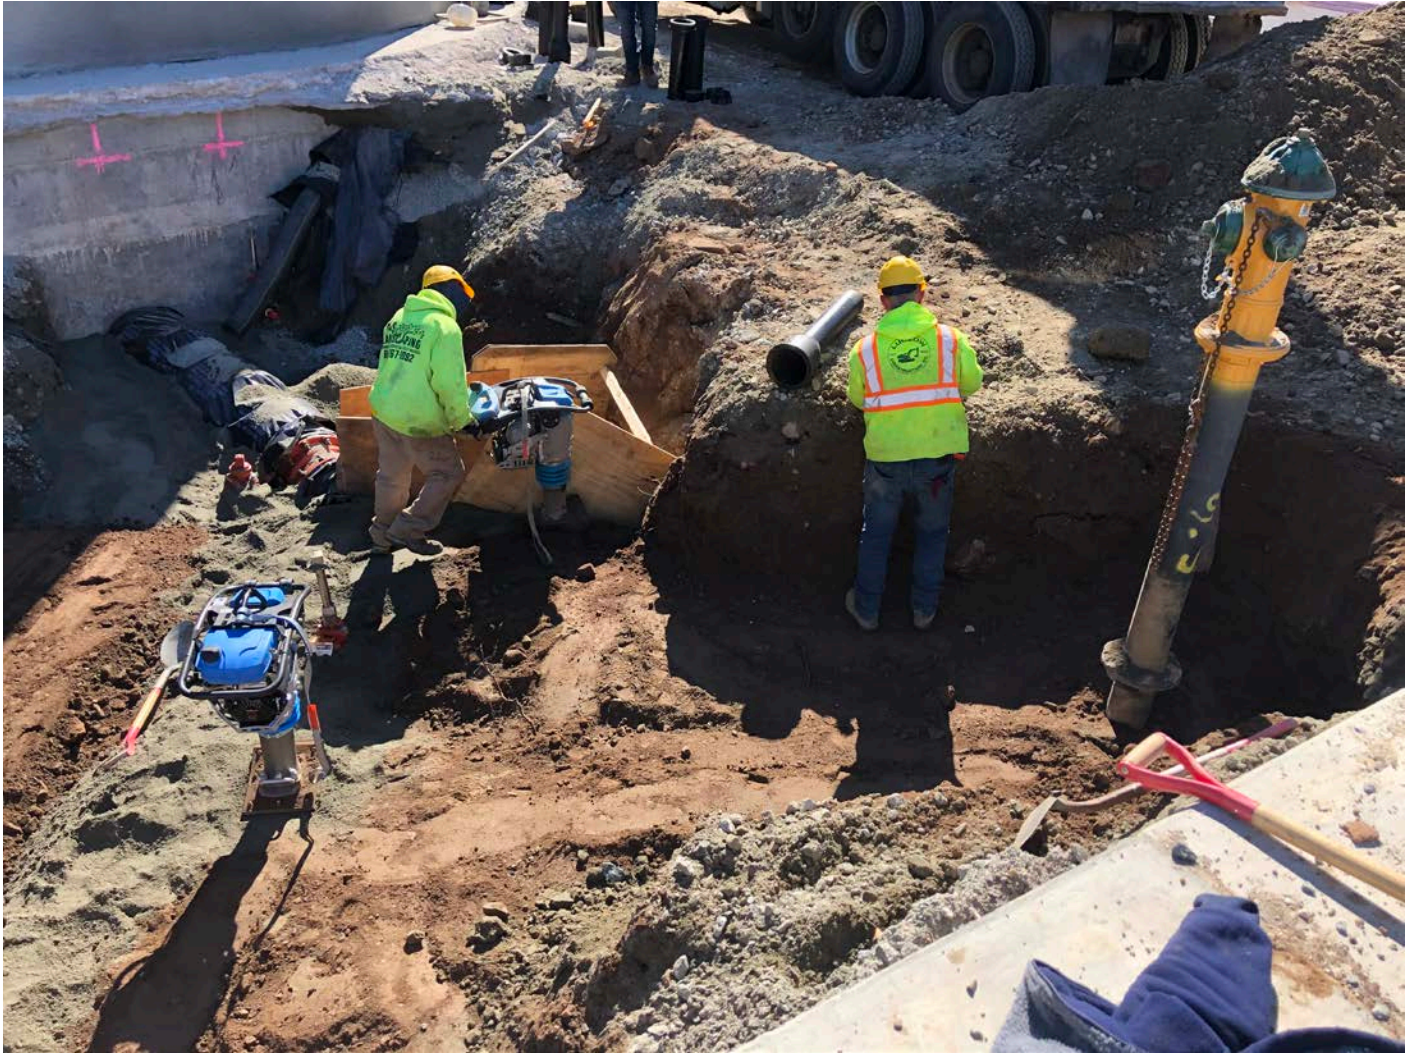
Picture 4: Ludlow compacting fill with a jumping jack next to the thrust block concrete form located between the altitude valve vault and the water tank. Water tank work zone located east of the Shared Access Driveway in Middletown. View to the southeast.

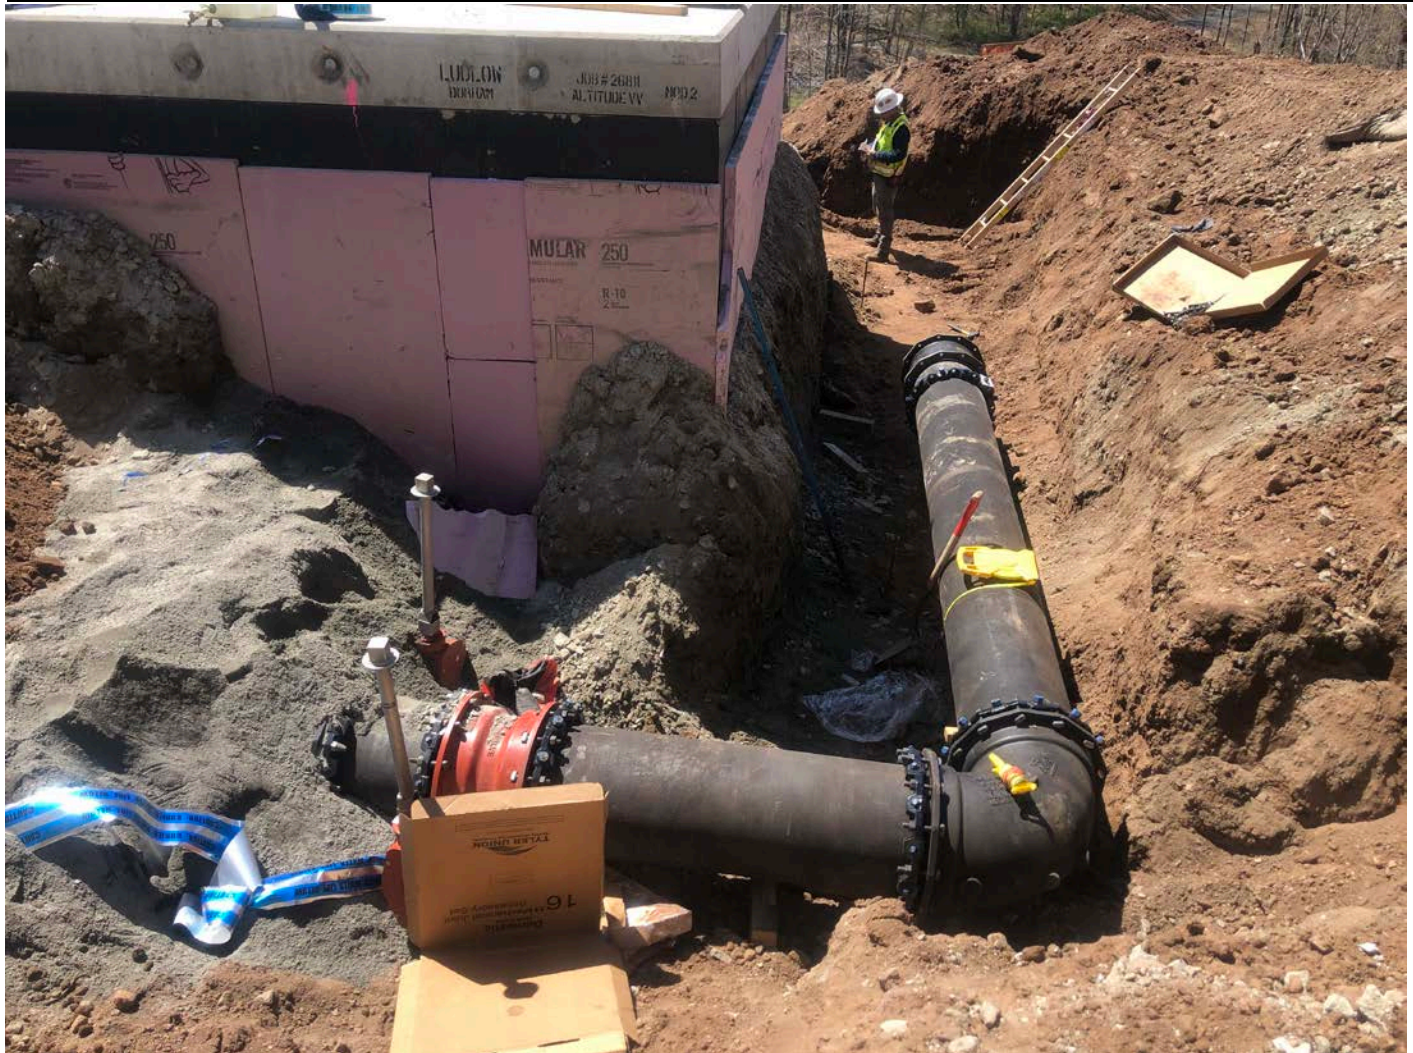
Picture 5: Ludlow in the process of installing 16" DIP for the bypass pipe that goes around the altitude valve vault to the north. Water tank work zone located east of the Shared Access Driveway in Middletown. View to the west.

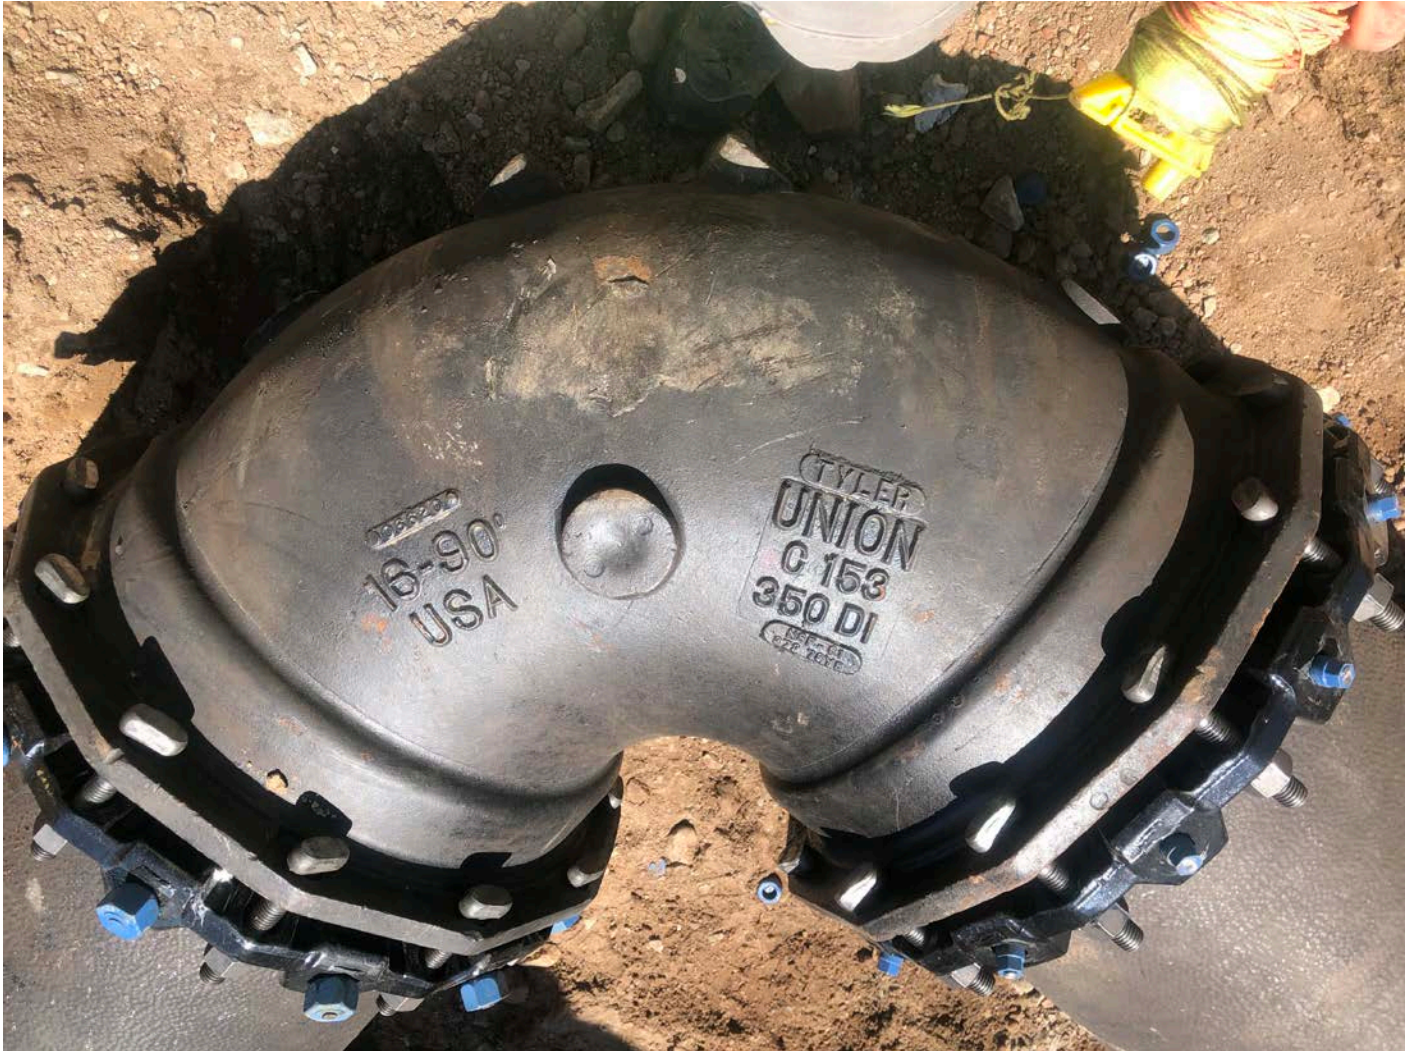
Picture 6: 90° elbow used in installing the 16" DIP used for the bypass pipe that goes around the altitude valve vault to the north. Water tank work zone located east of the Shared Access Driveway in Middletown.

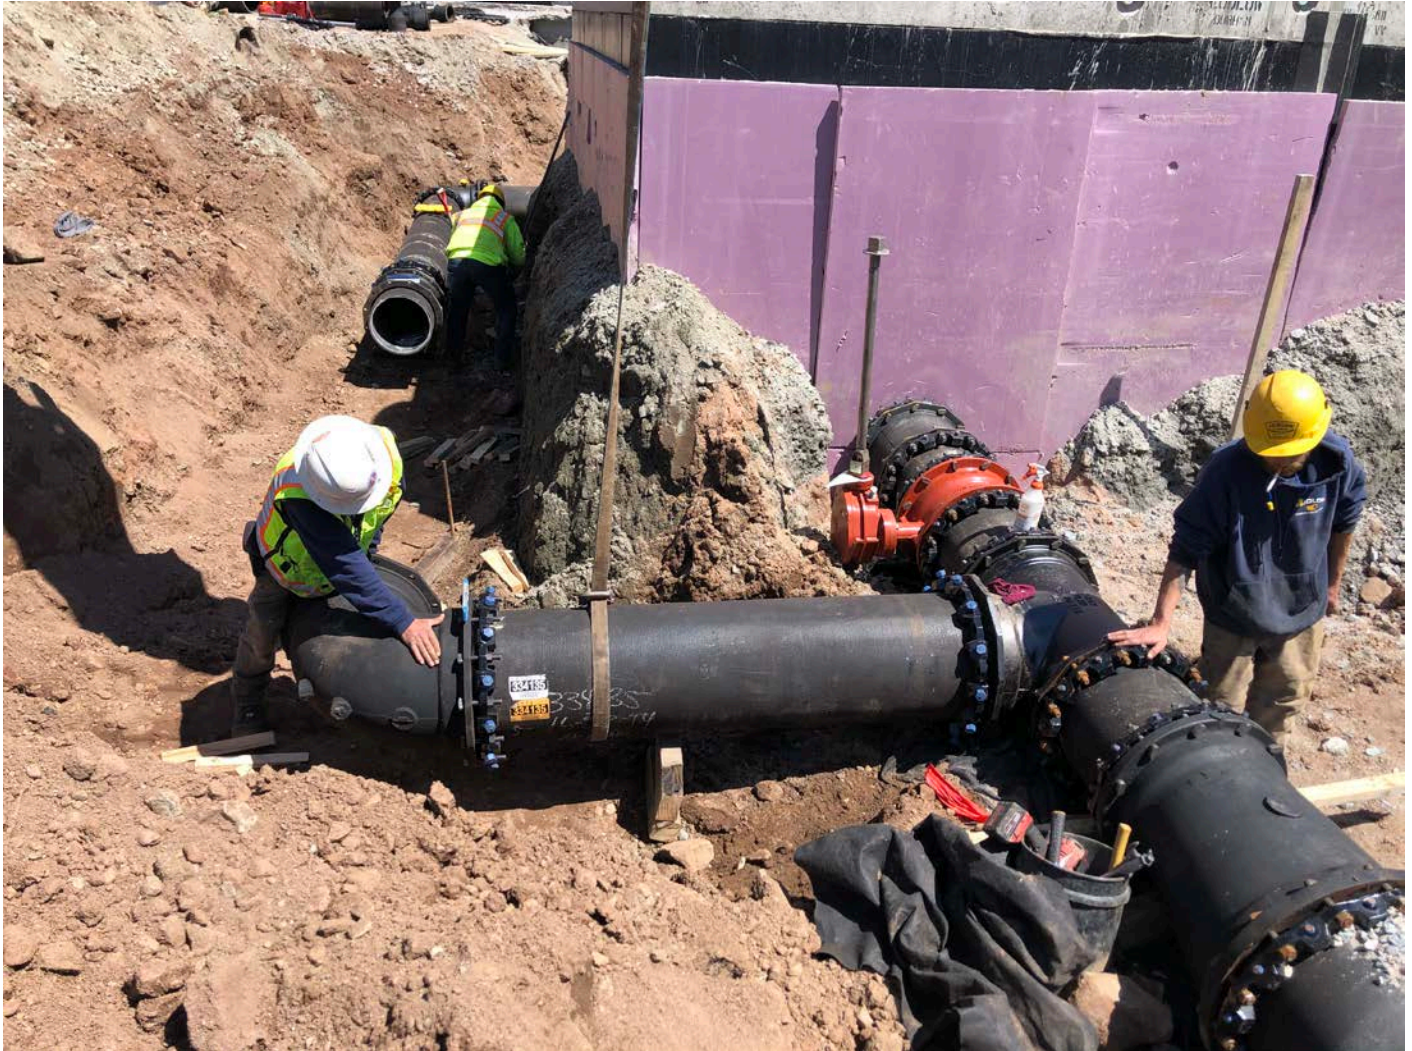
Picture 7: Ludlow working at the northwest corner of the altitude vault, installing 16" DIP for the bypass pipe that goes around the altitude valve vault to the north. Water tank work zone located east of the Shared Access Driveway in Middletown. View to the east.

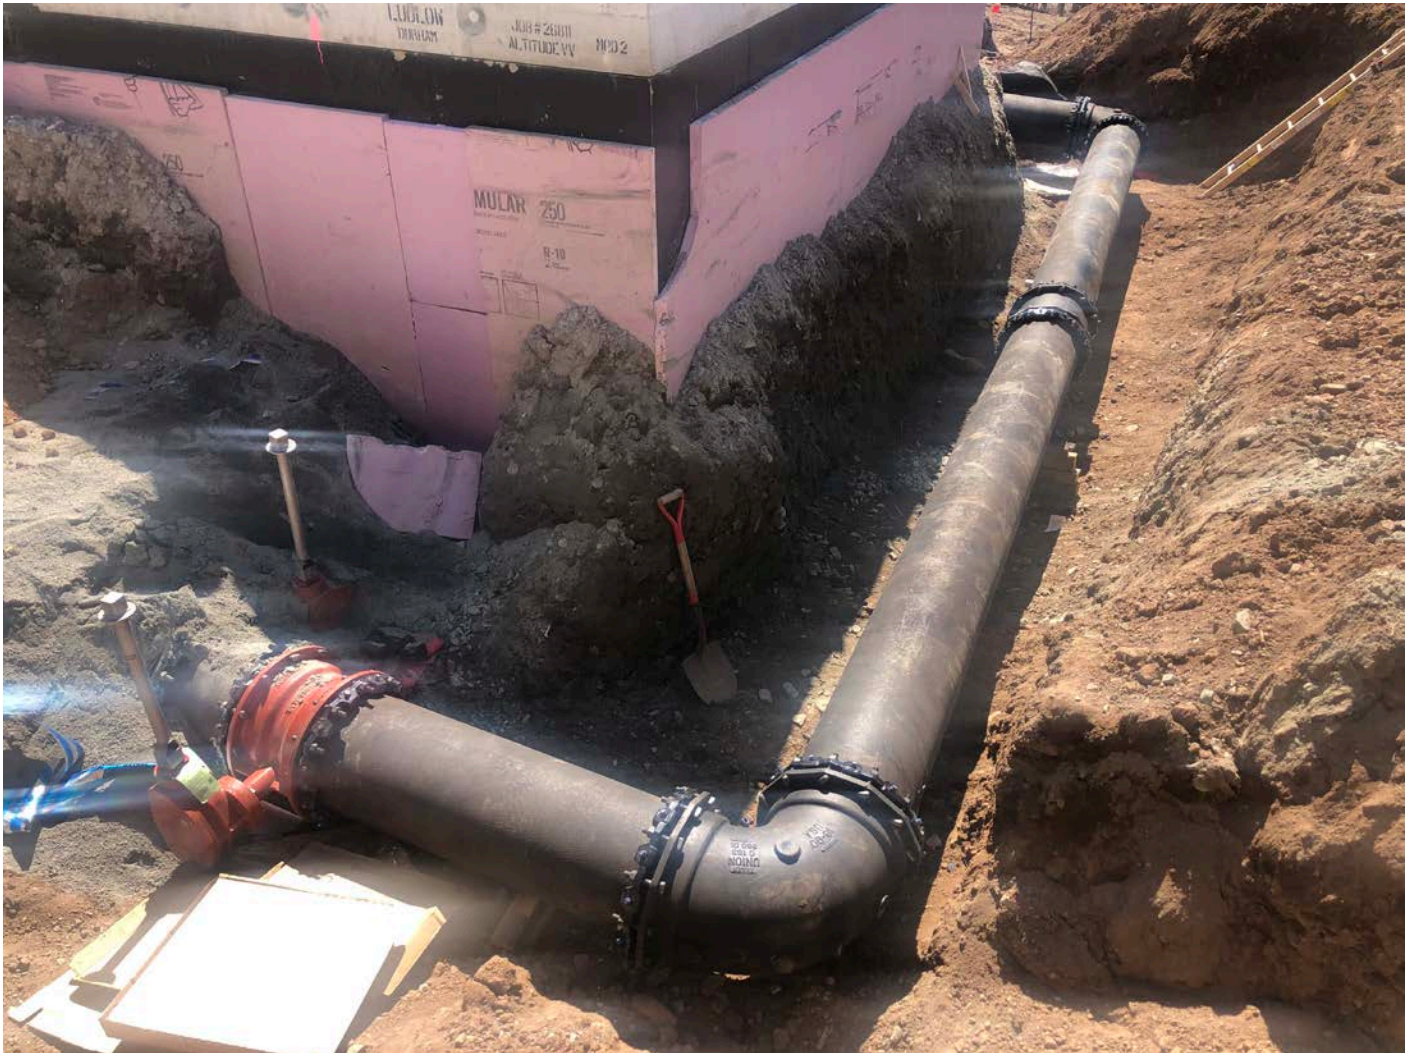
Picture 8: 16" DIP bypass pipe that Ludlow has installed around the north side of the altitude valve vault. Water tank work zone located east of the Shared Access Driveway in Middletown. View to the west.
