Daily Report

Project:	Durham Meadows Pipeline Installation	Date:	April 28, 2021
Location:	Main Street, Maple Avenue, Wallingford Road, Talcott Lane, Durham; Booster Station Site, South Main St. Middletown	Day of Week:	Wednesday
Project #:	AECOM: 6061487	Report No:	231
Contractor:	Ludlow Construction	Page:	1 of 9

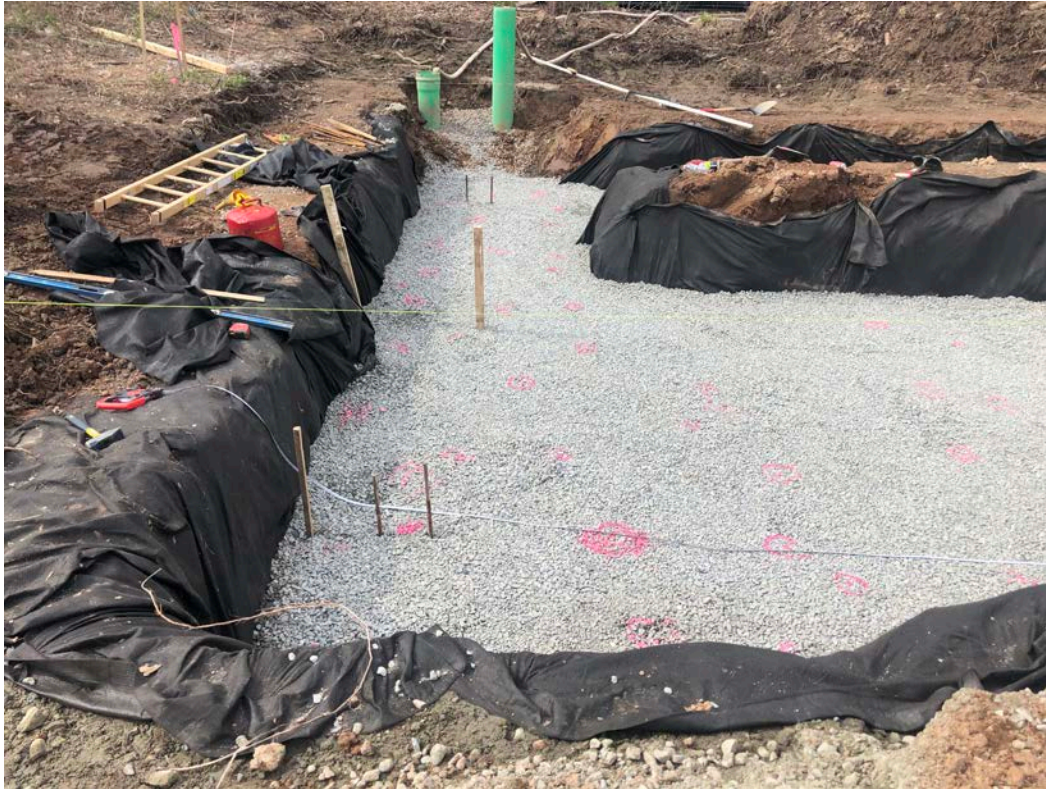
Picture 2: View of the booster station footprint with 3/4" gravel and geofabric in place. Station 750+63; view to the south.

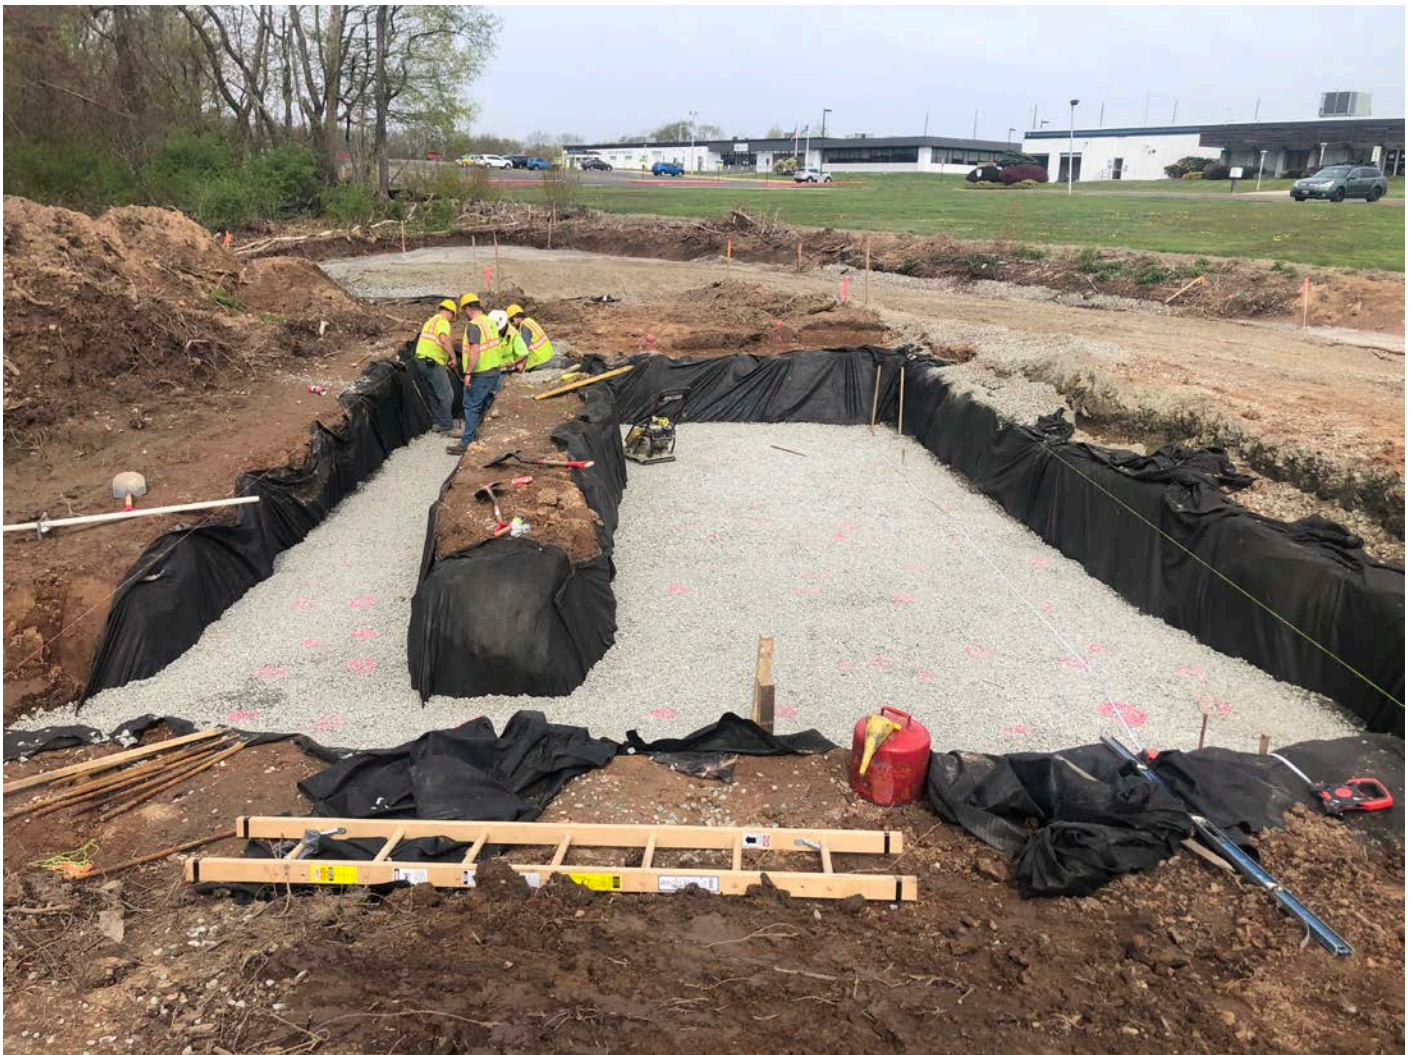
Picture 3: View of the booster station footprint with $\frac{3}{4}$ " gravel and geofabric in place. Station 750+63; view to the west.

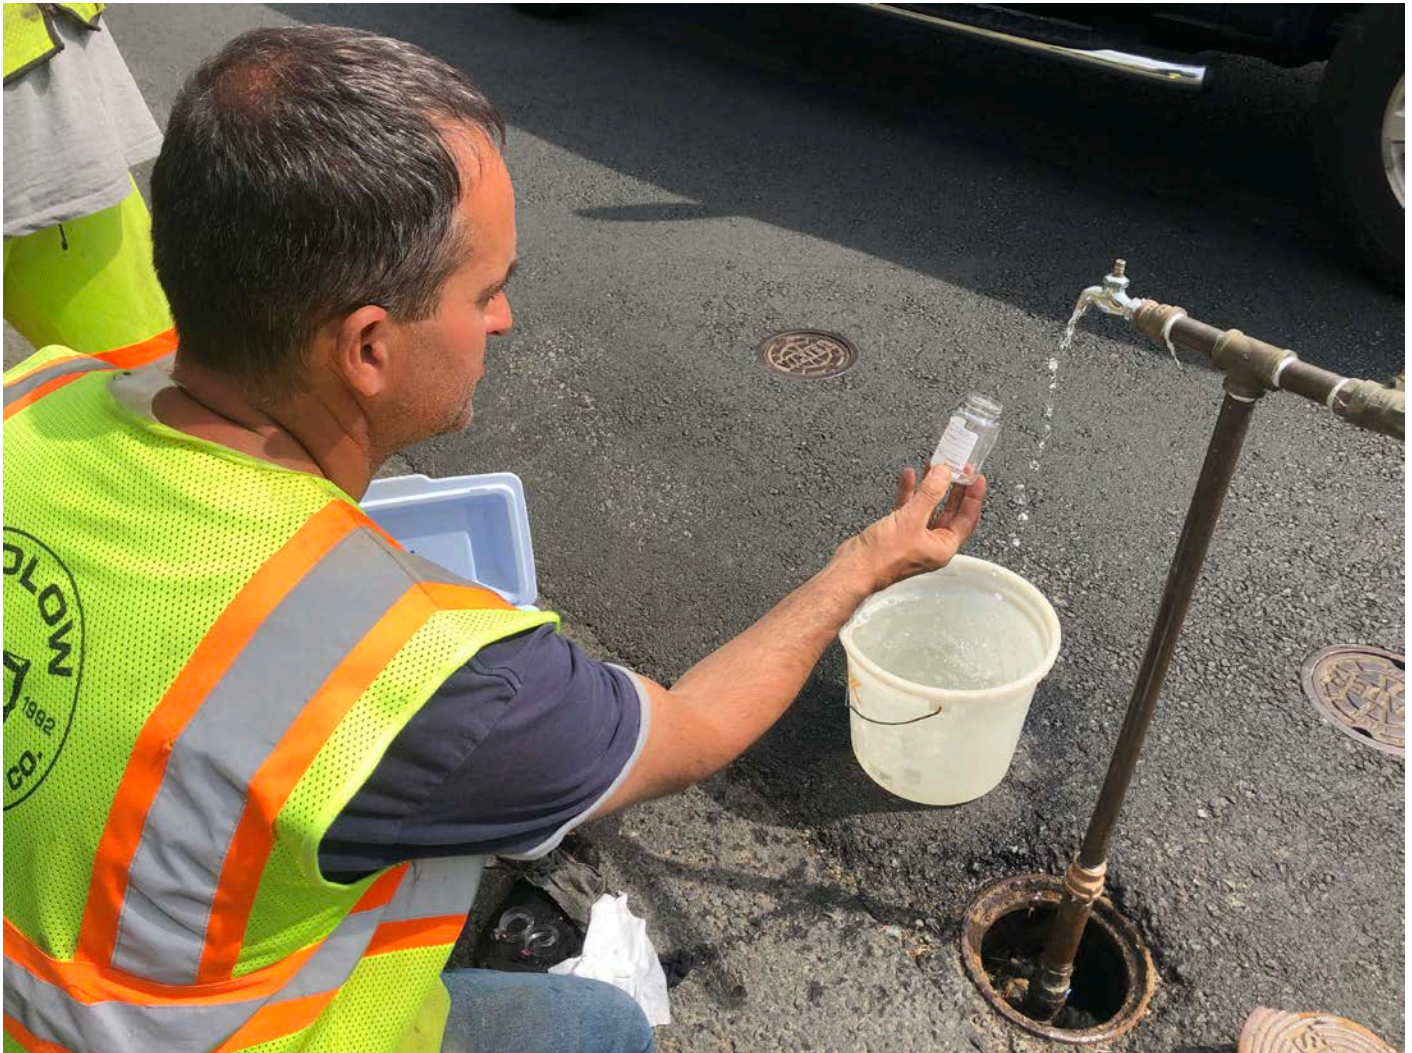
1044: Ludlow is preparing to collect two water samples for laboratory analysis for residual chlorine. The samples are being collected from the intersection of Talcott Lane and Main Street, Durham.

Picture 4: Ludlow collecting a water sample for submittal to a laboratory for analysis of residual chlorine from the intersection of Talcott Lane and Main Street, Durham.

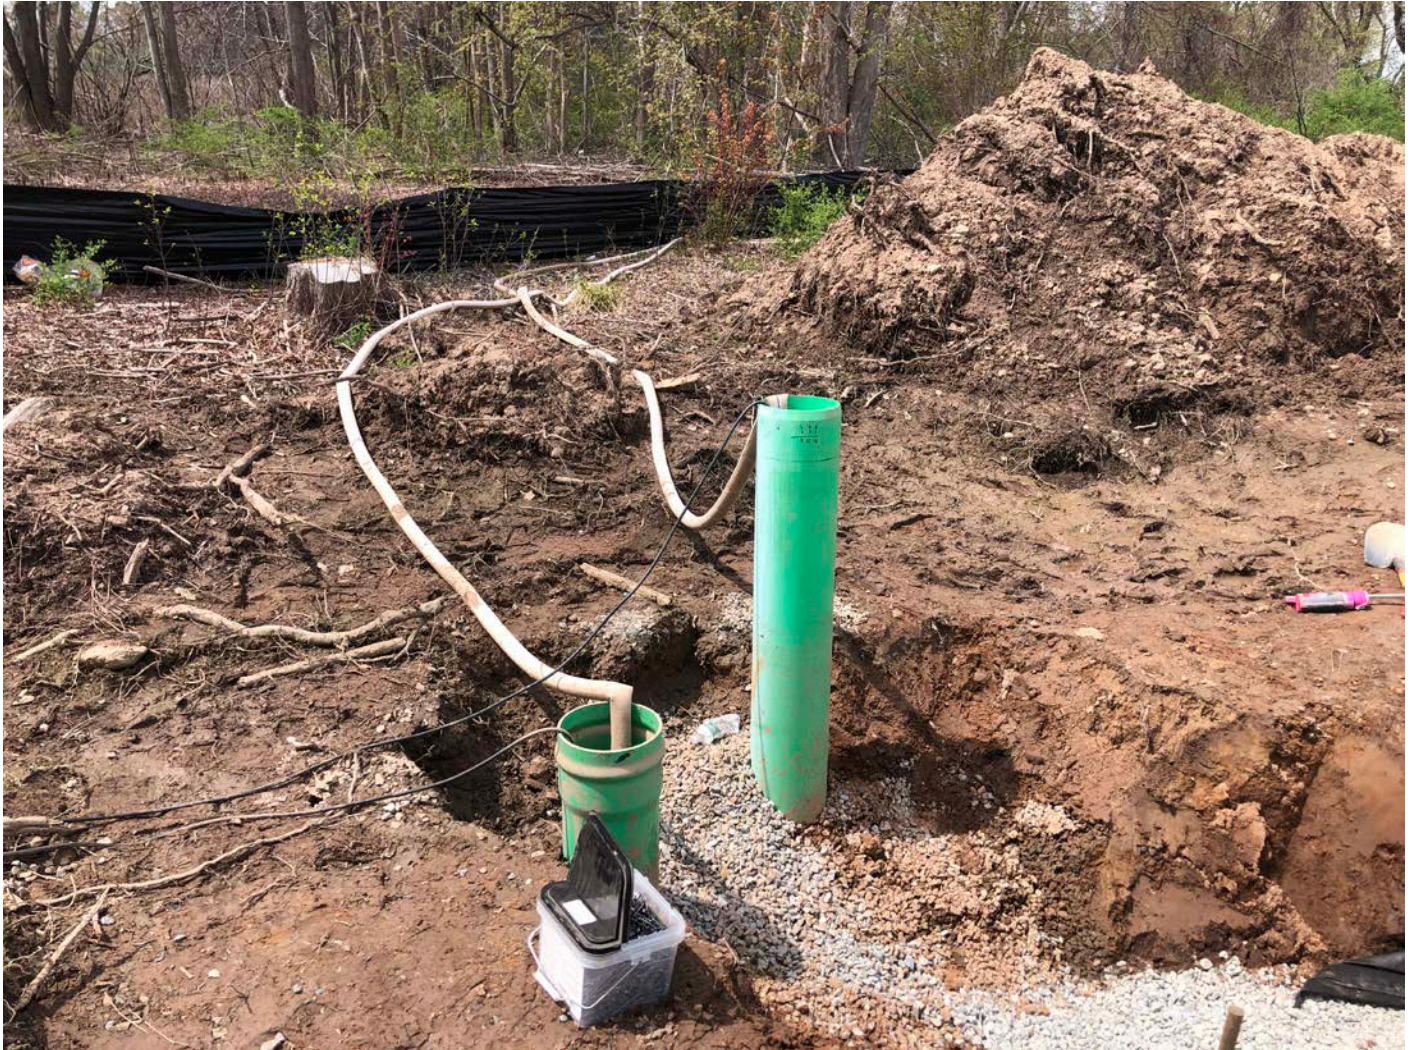
Picture 5: Dewatering wells that Ludlow is using to lower the water table on the southeast corner of the booster station footprint located at 750+63 in Middletown. View to the southwest.

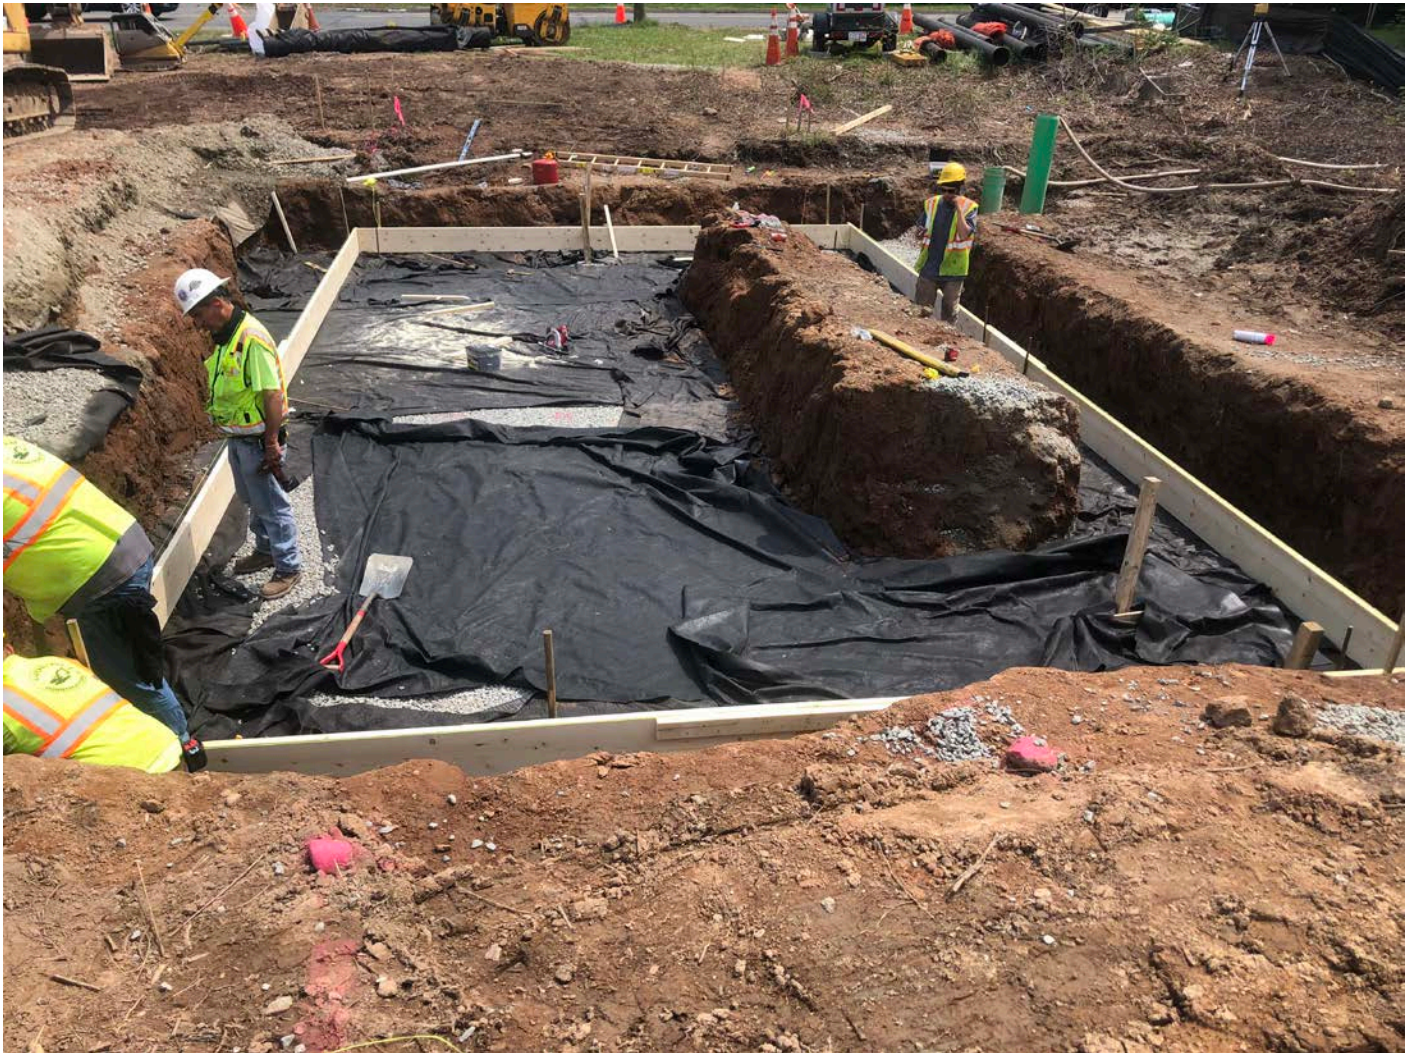
Picture 6: View of the booster station footprint depicting progress of the construction of the forms for the booster station footing. Station 750+63, Middletown. View to the west.

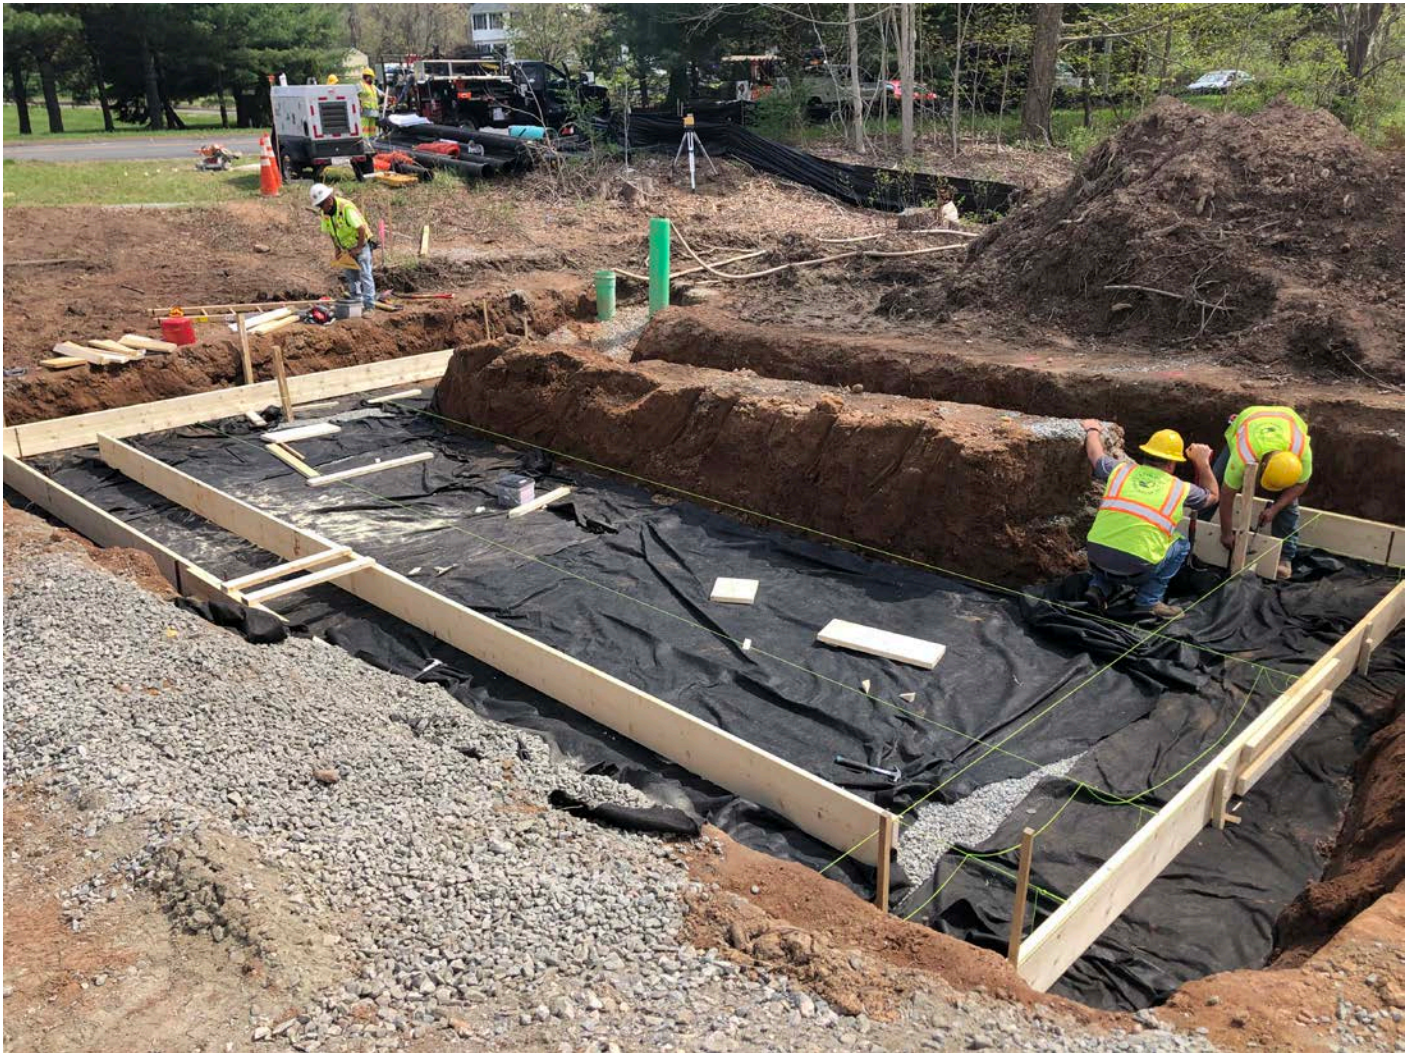
Picture 7: View of the booster station footprint depicting progress of the construction of the forms for the booster station footing. Station 750+63, Middletown. View to the southeast.
