Daily Report

Project:	Durham Meadows Pipeline Installation	Date:	April 30, 2021
Location:	Booster Station Site, South Main Street, Middletown	Day of Week:	Friday
Project #:	AECOM: 6061487	Report No:	233
Contractor:	Ludlow Construction	Page:	1 of 12

Daily Activities – Booster Station, S. Main Street, Middletown

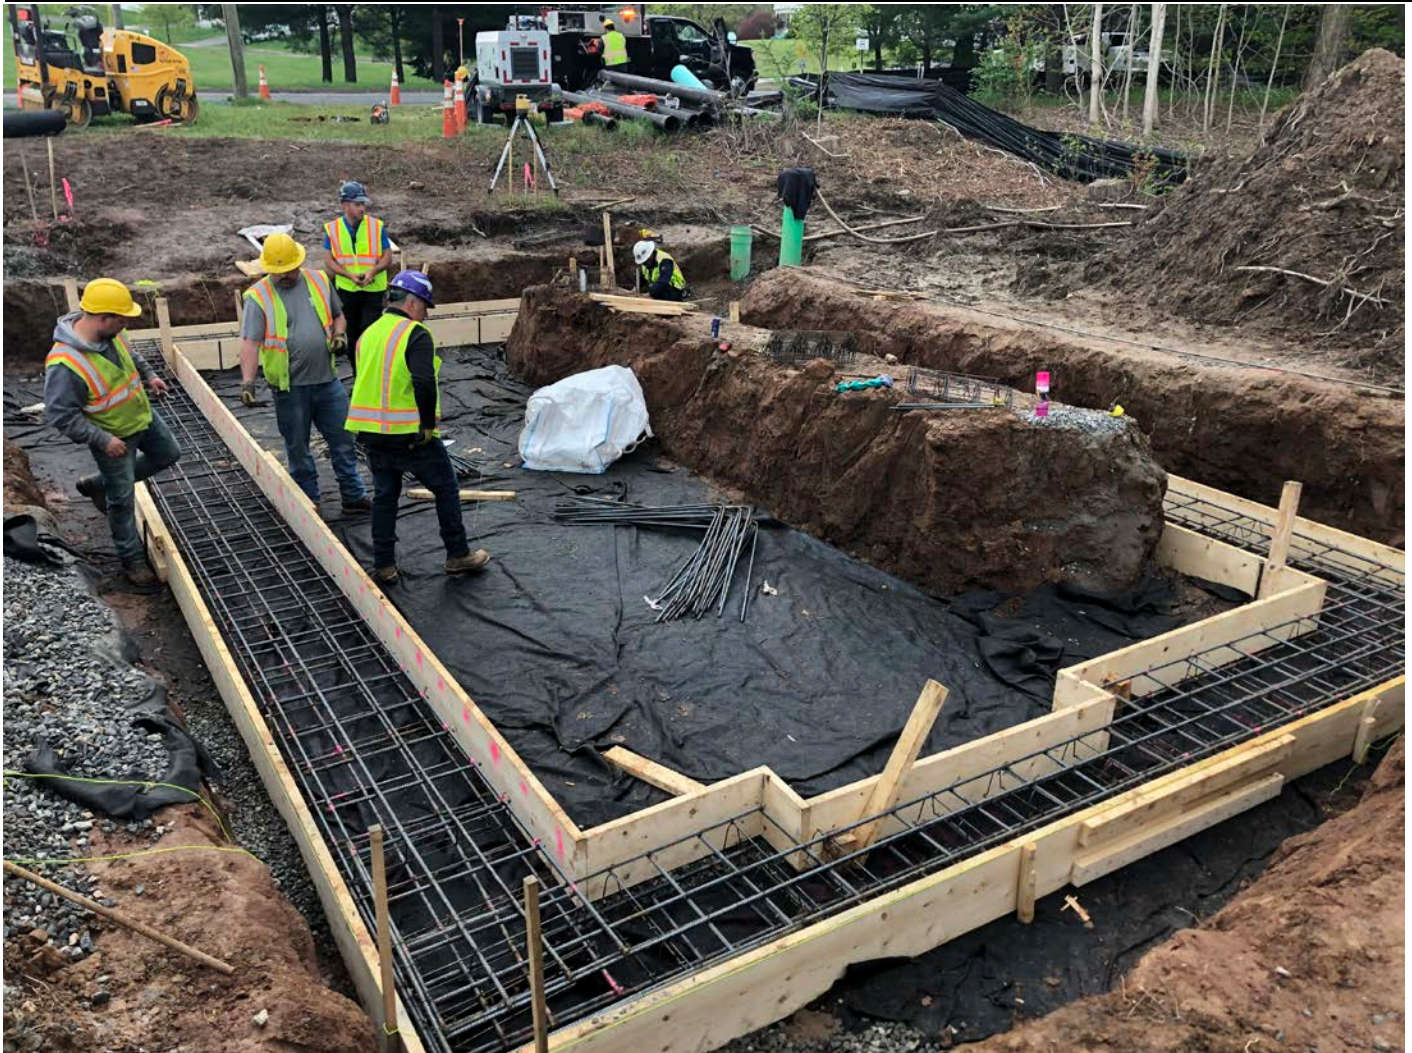
Picture 1: View of the booster station footprint as Ludlow continues to place and secure rebar within the concrete forms of the footings for the booster station located at Station 750+63 in Middletown. View to the east.

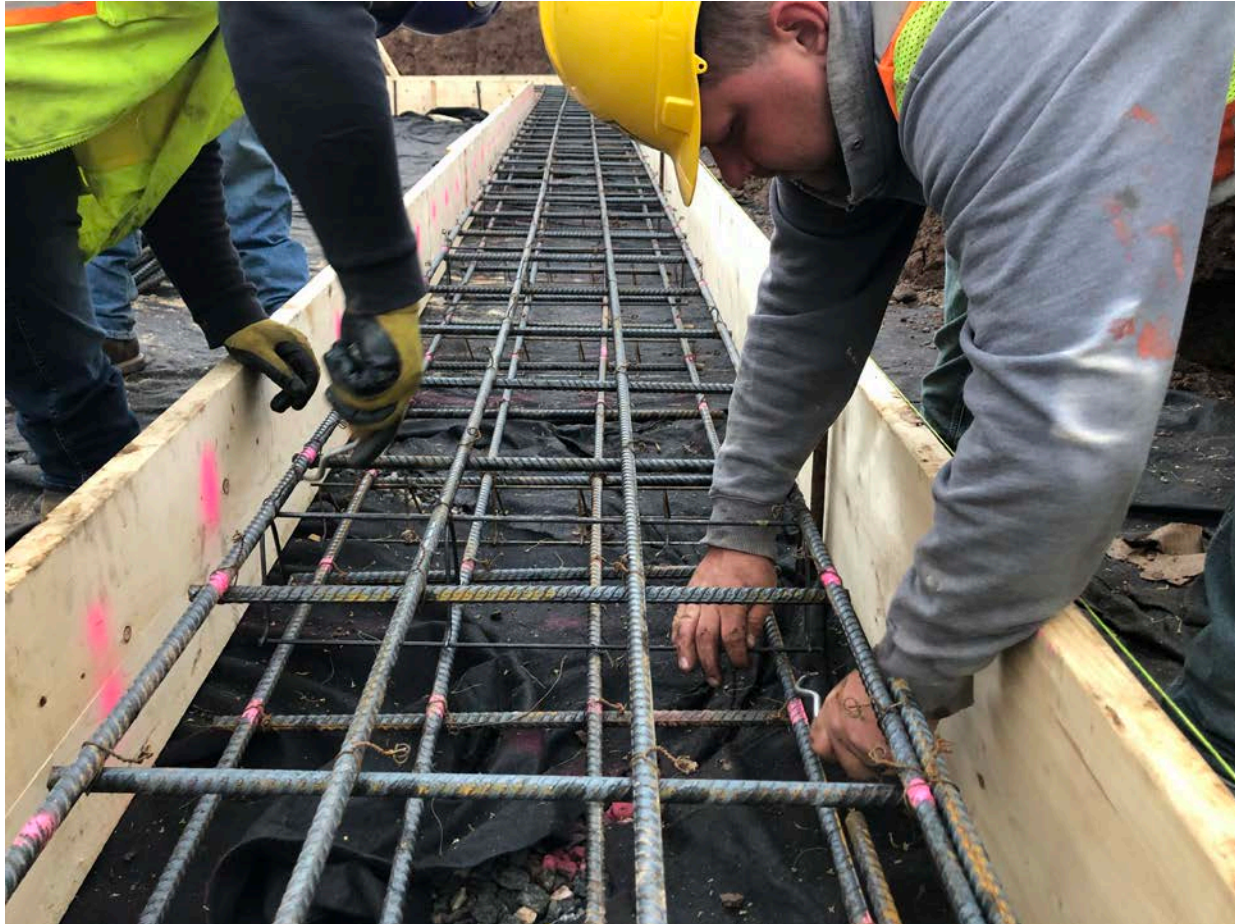
Picture 2: Ludlow twisting wire around intersecting pieces of rebar within the concrete forms for the footings of the booster station located at Station 750+63 in Middletown.

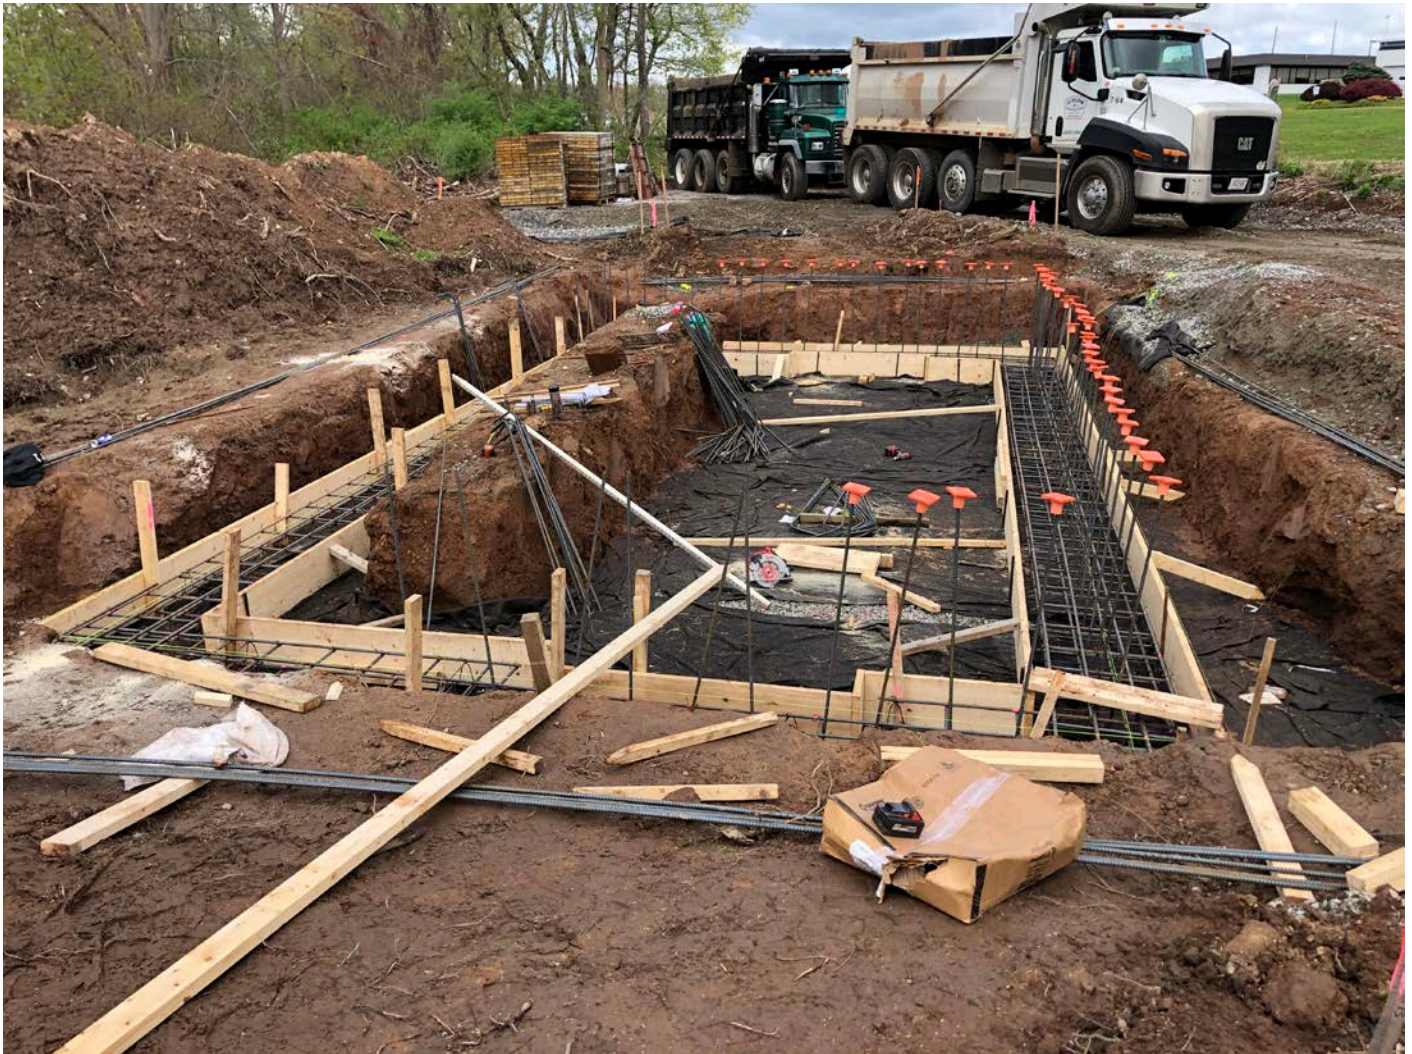
Picture 3: View of the booster station footprint as Ludlow begins to place and secure vertical sections of rebar for the frost wall associated with the construction of the booster station located at Station 750+63 in Middletown. View to the west.

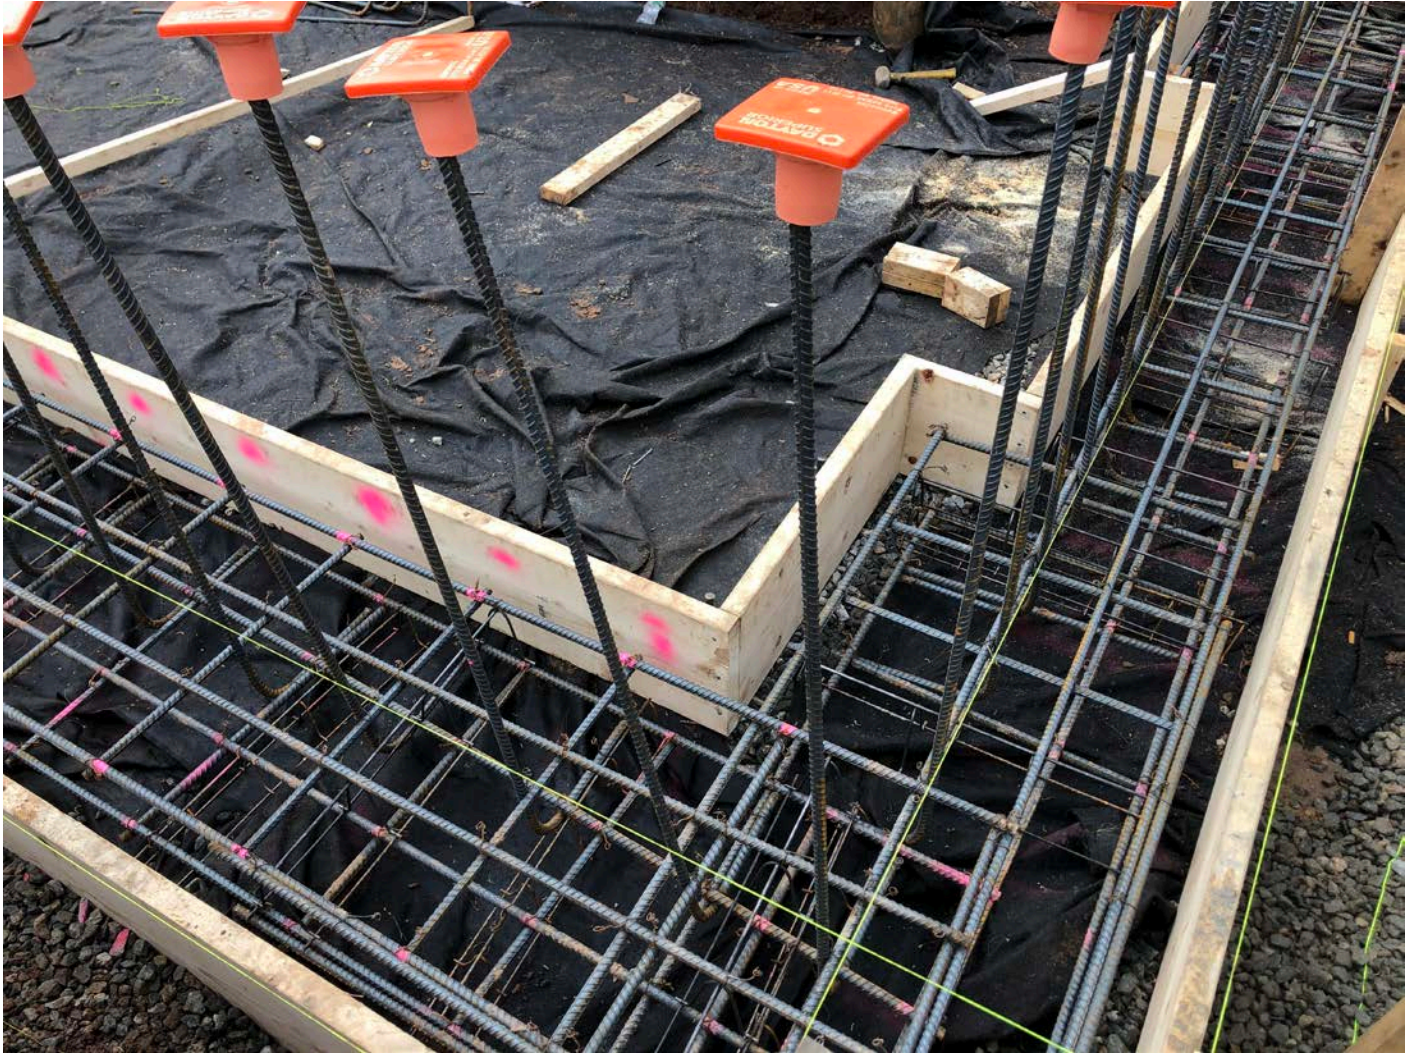
Picture 4: Vertical sections of rebar that have been placed within the concrete forms for the booster station frost wall. Station 750+63, Middletown; view to the south.

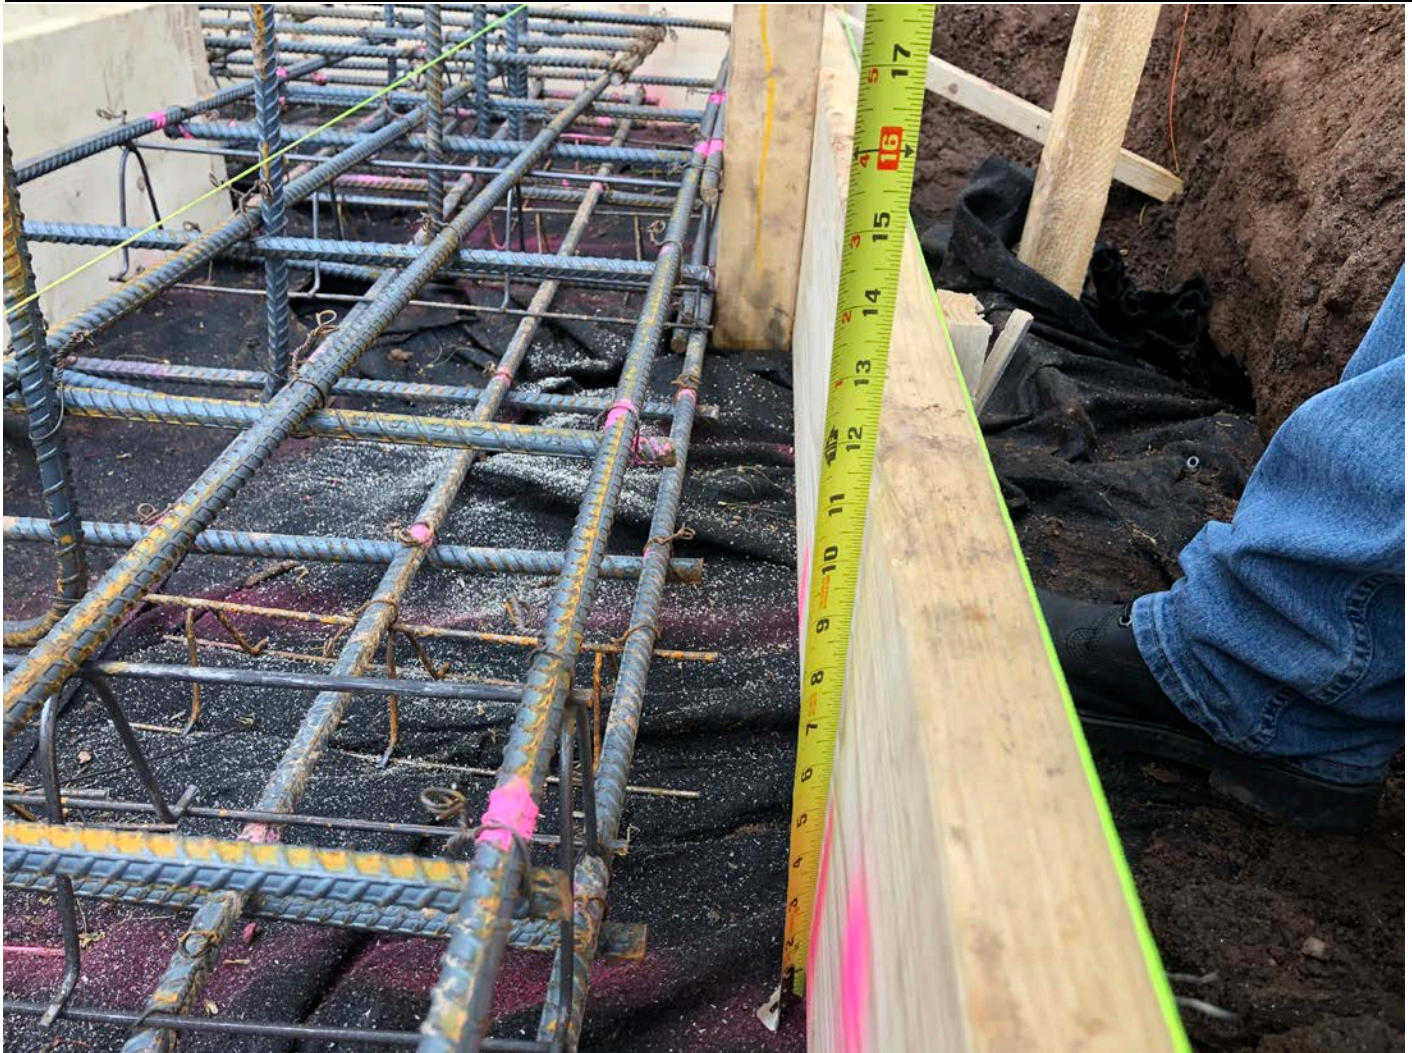
Picture 5: View of the side of one of the concrete forms for the booster station footings, showing 12" of height per specifications. Station 750+63, Middletown.

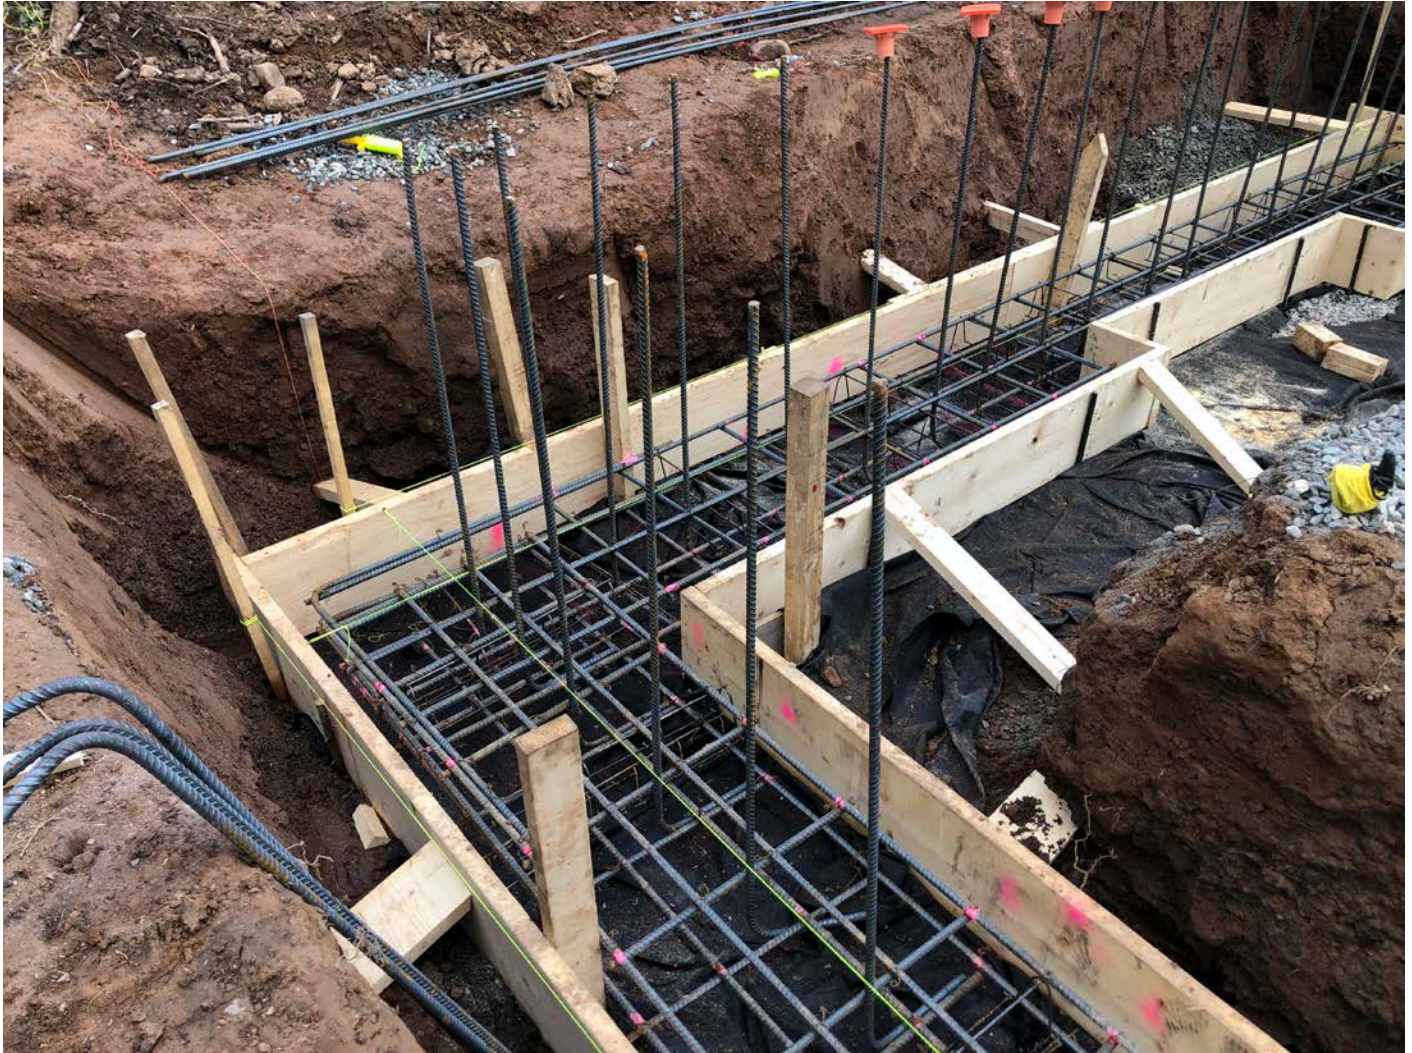
Picture 6: Vertical sections of rebar that have been placed within southeast corner of the concrete forms for the booster station frost wall. Station 750+63, Middletown; view to the southwest.

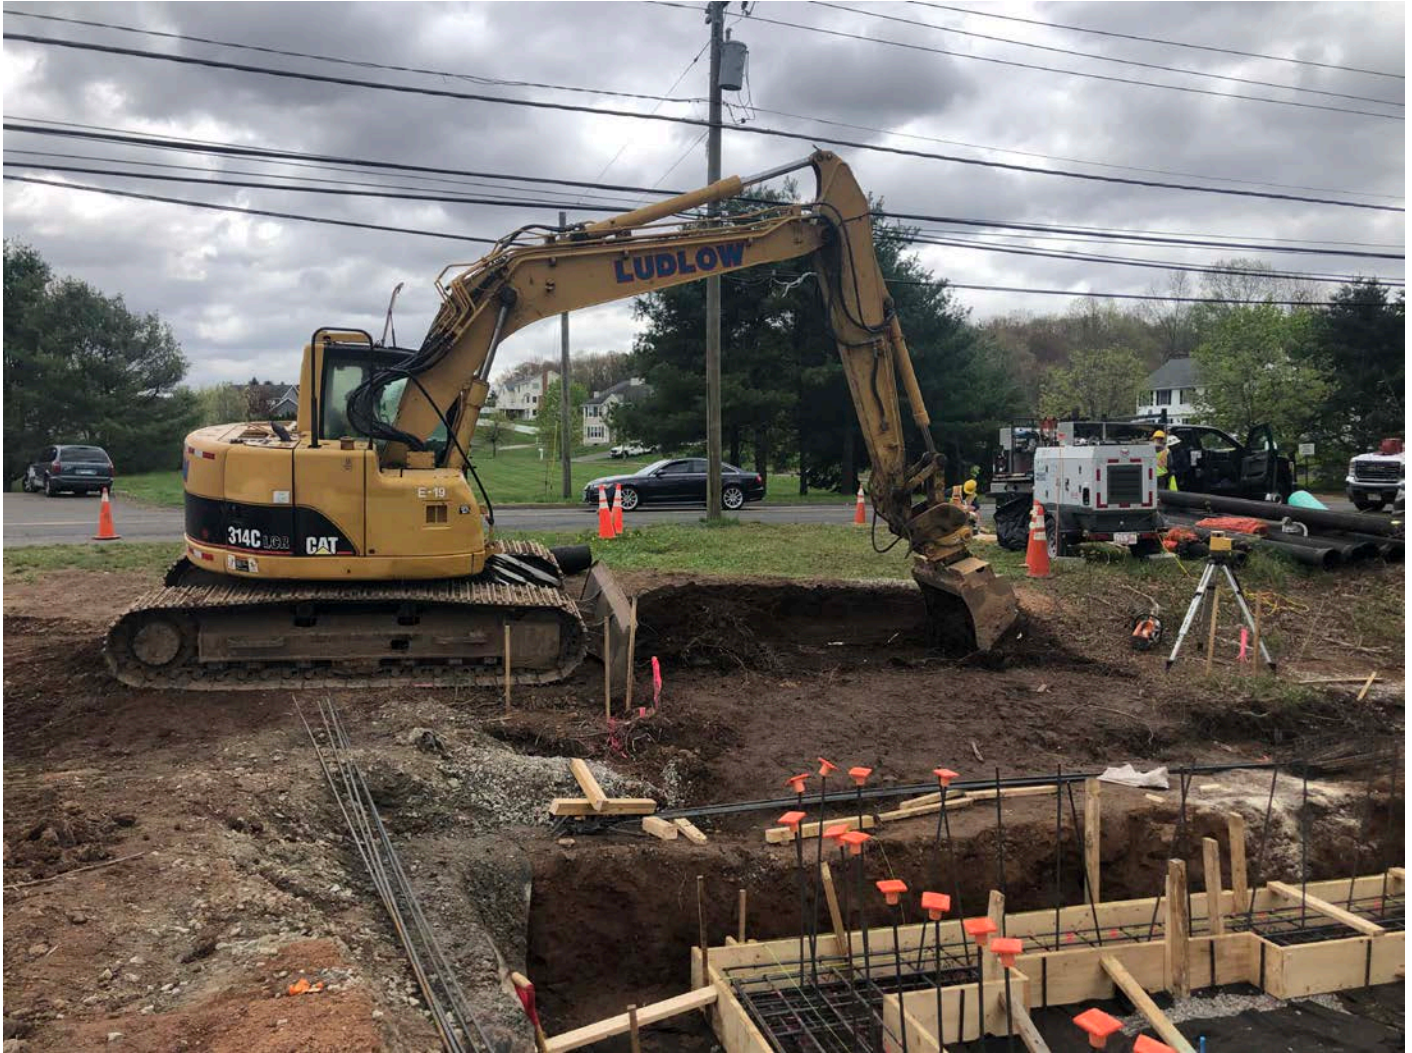
1207: Ludlow continues to place the vertical sections of rebar for the booster station frost wall. Ludlow has carved a section of native soil out from the east side of the booster station footprint and replaced it with gravel which they are currently compacting with a roller. This is to provide a more stable platform for the concrete truck to stage upon for the concrete pour on Monday, May 3, 2021.

Picture 7: Ludlow excavating soil east of the booster station footprint for the placement of a compacted pad made of 1.5" gravel. Station 750+63; view to the east.

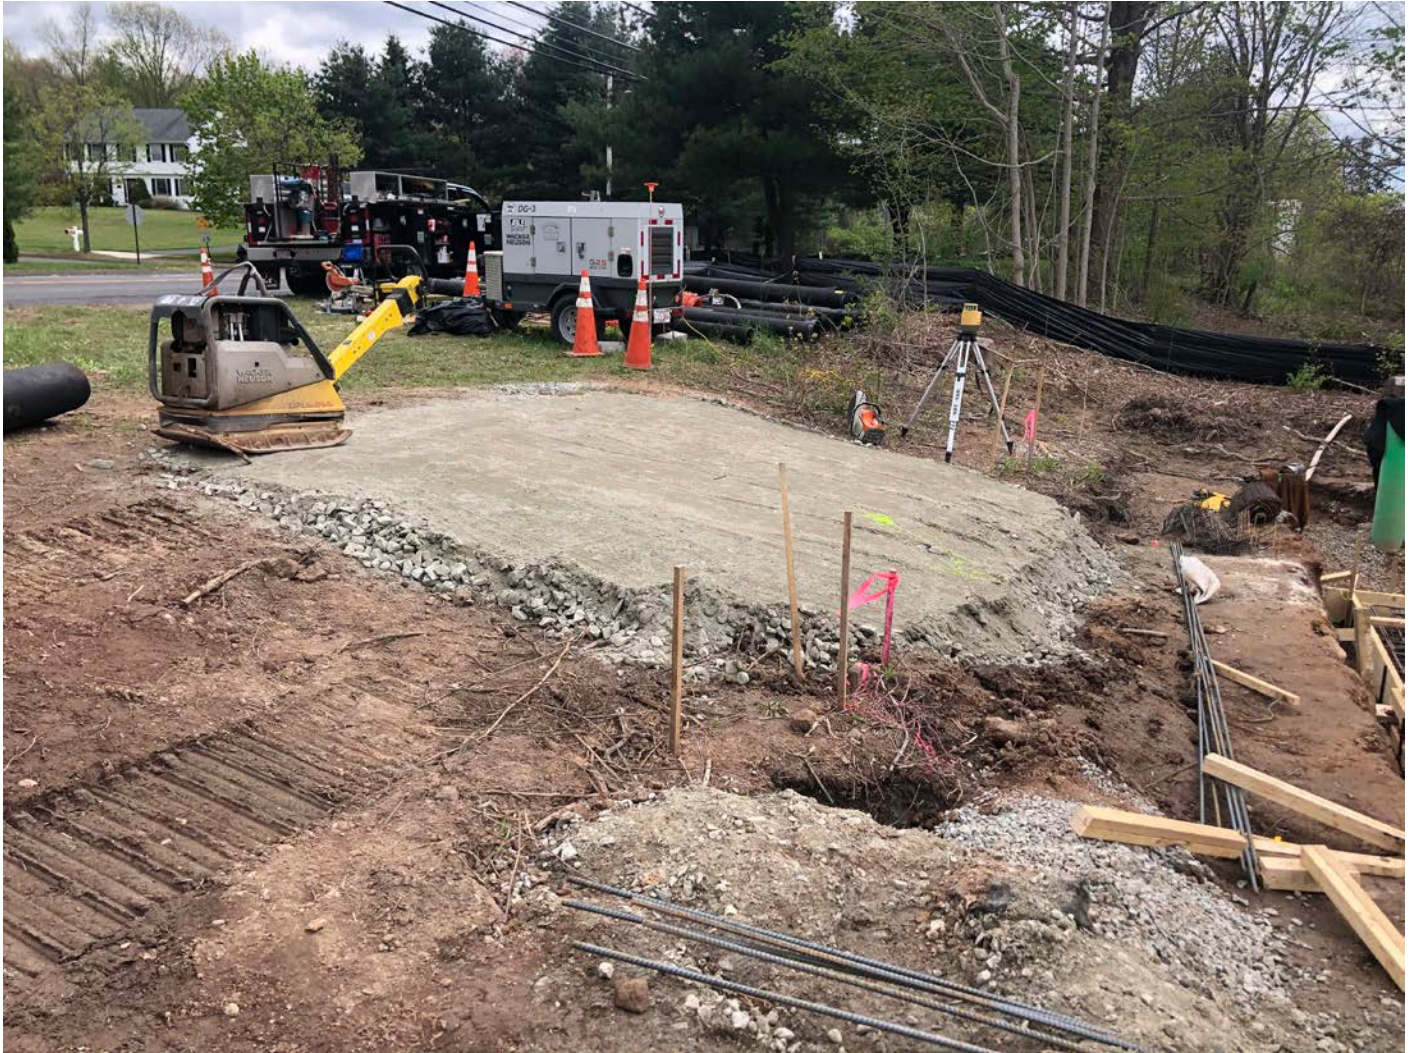
Picture 8: Pad comprised of 1.5" compacted gravel located on the east side of the booster station footprint. The pad will serve as a more stable platform for the concrete truck to stage upon when concrete gets poured into the forms for the booster station footings on Monday, May 3, 2021. Station 750+63, Middletown; view to the south.

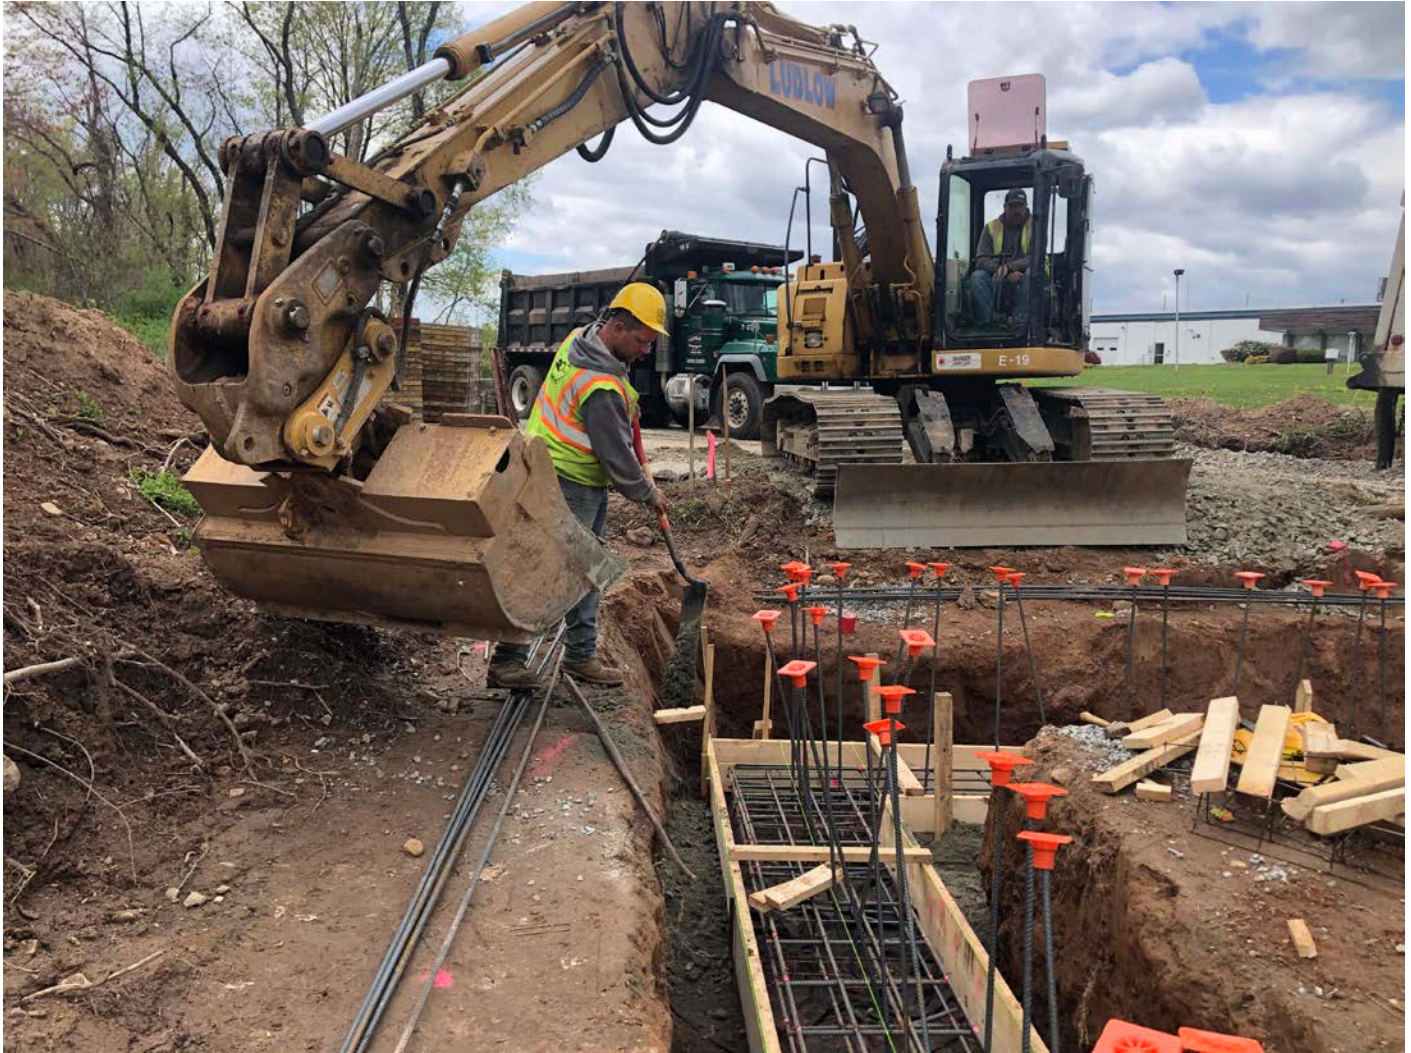
1337: Ludlow is placing and compacting 1.5" gravel on the bottom exterior of the concrete form for the footings at the booster station. This is to ensure that the concrete that will be poured won't blow out of the bottom of the forms.

Picture 9: Ludlow placing 1.5" gravel on the exterior of the concrete forms for the booster station footings to prevent the concrete that will be poured on May 3, 2021, from blowing out from beneath the forms. Station 750+63, Middletown; view to the west.

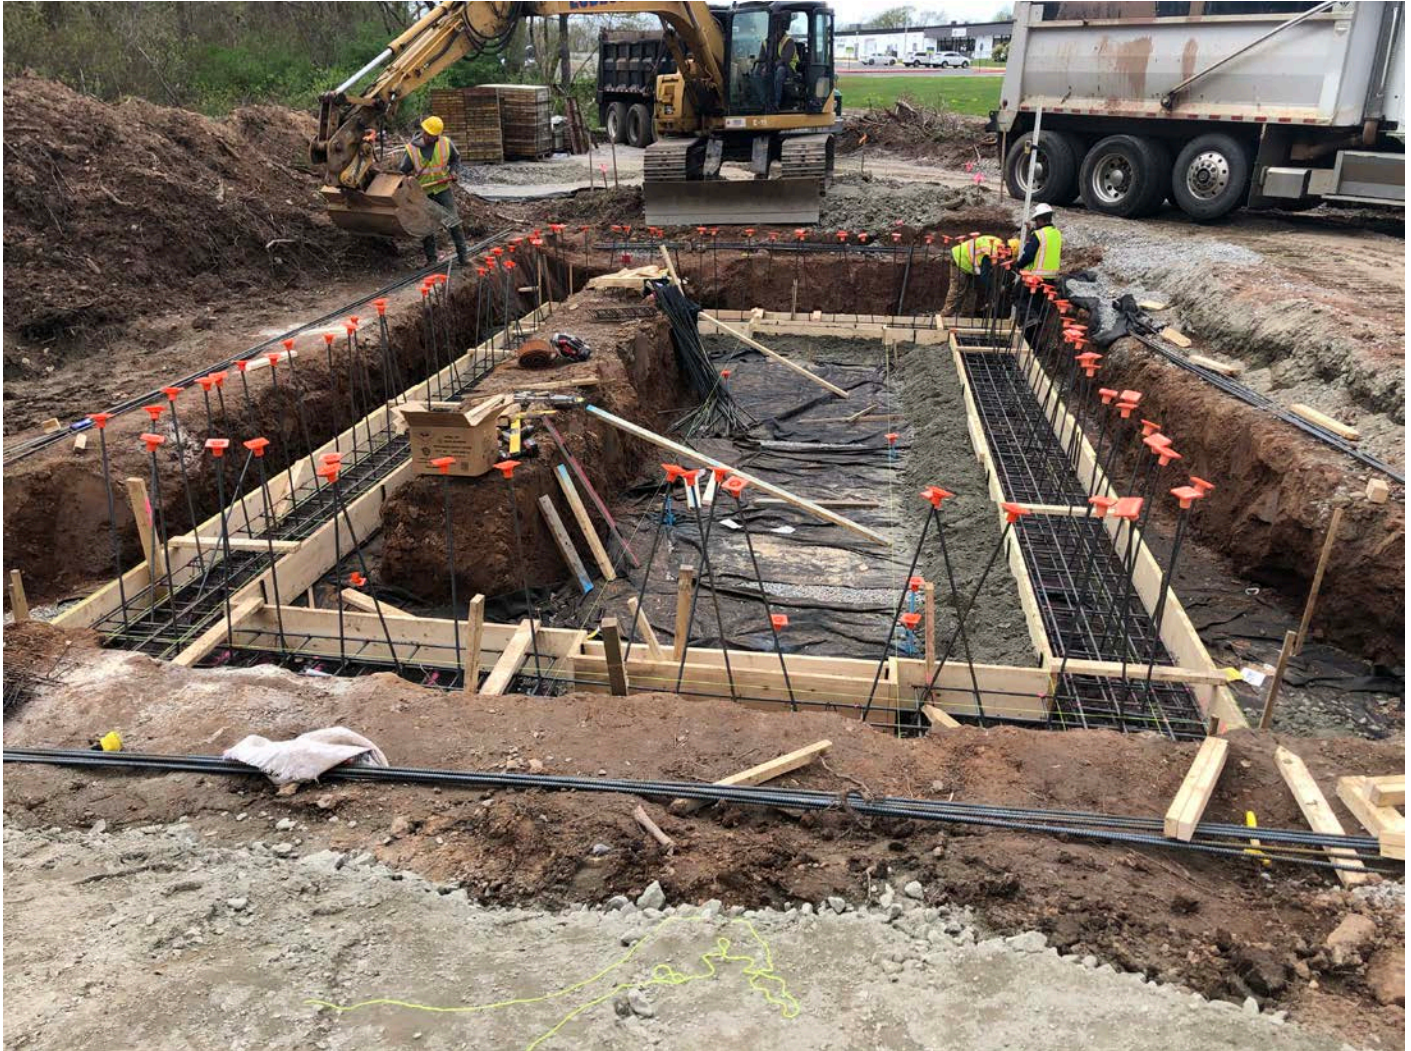
Picture 10: View of the booster station footprint as Ludlow continues to place and secure vertical pieces of rebar for the frost wall associated with the booster station. Station 750+63, Middletown. View to the west.
