Daily Report

Project:	Durham Meadows Pipeline Installation	Date:	May 4, 2021
Location:	Shared Access Driveway, Middletown	Day of Week:	Tuesday
Project #:	AECOM: 6061487	Report No:	235
Contractor:	Ludlow Construction	Page:	1 of 11

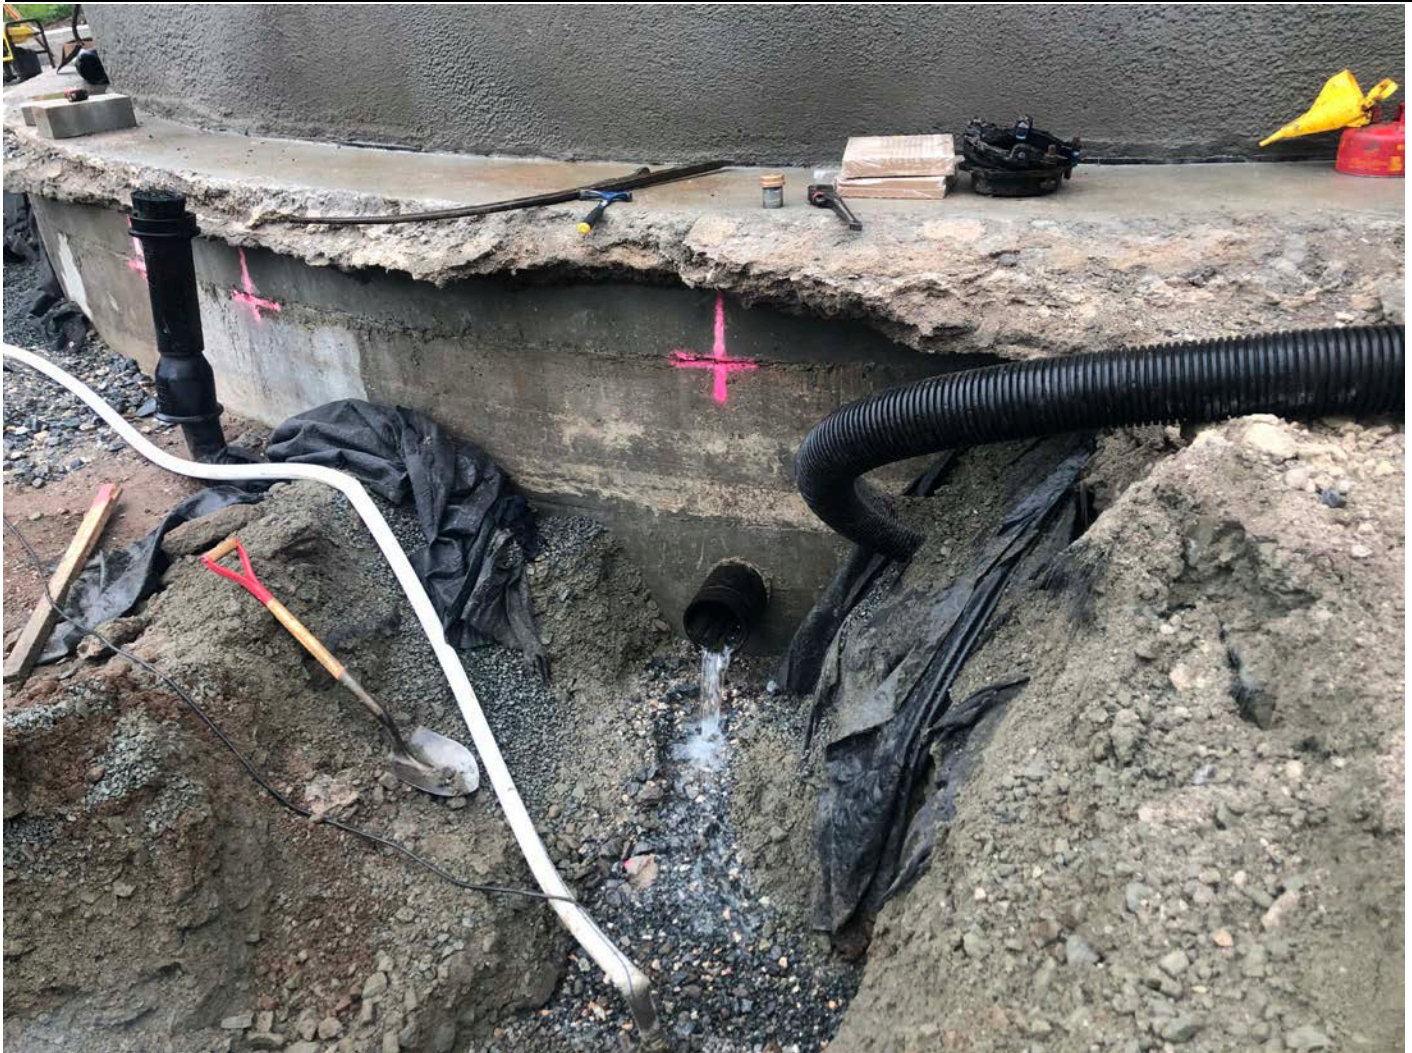
Picture 1: View of the 8" DIP water tank drain line that protrudes from the southwest side of the water tank located east of the Shared Access Driveway in Middletown. Ludlow daylighted the pipe in order to attach 8" DIP to it as they begin to install the tank drain line that will run south of the altitude valve vault. View to the east/northeast.

0921: Ludlow is excavating between the water tank and the altitude valve vault just east of the Shared Access Driveway in Middletown. They are pumping water that is draining out of the 8" DIP that protrudes from the southwest side of the tank into the catch basin located ~50' to the northwest of the water tank.

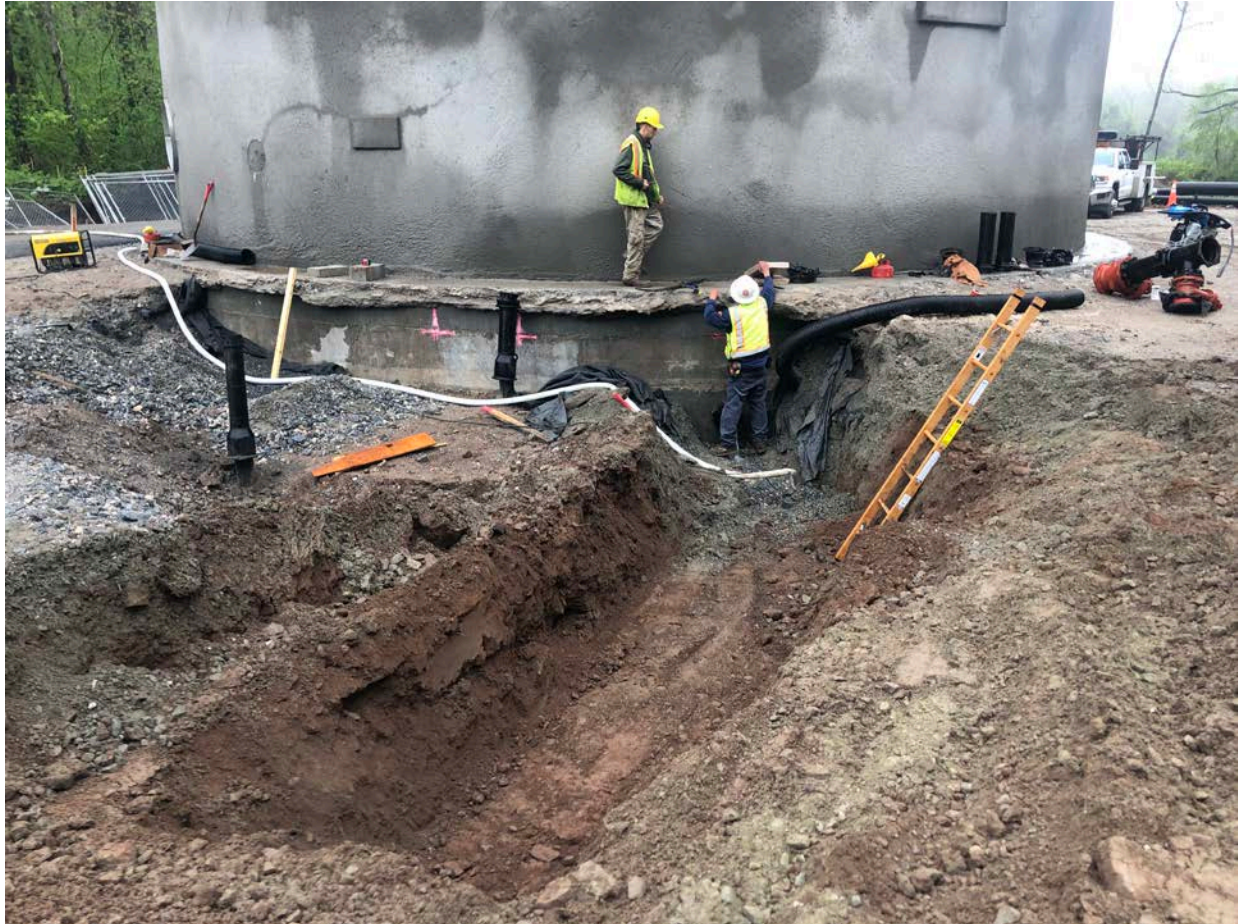
Picture 2: Trench that Ludlow excavated west of the water tank as they begin to install the tank drain line that will run south of the altitude valve vault. View to the east/northeast.

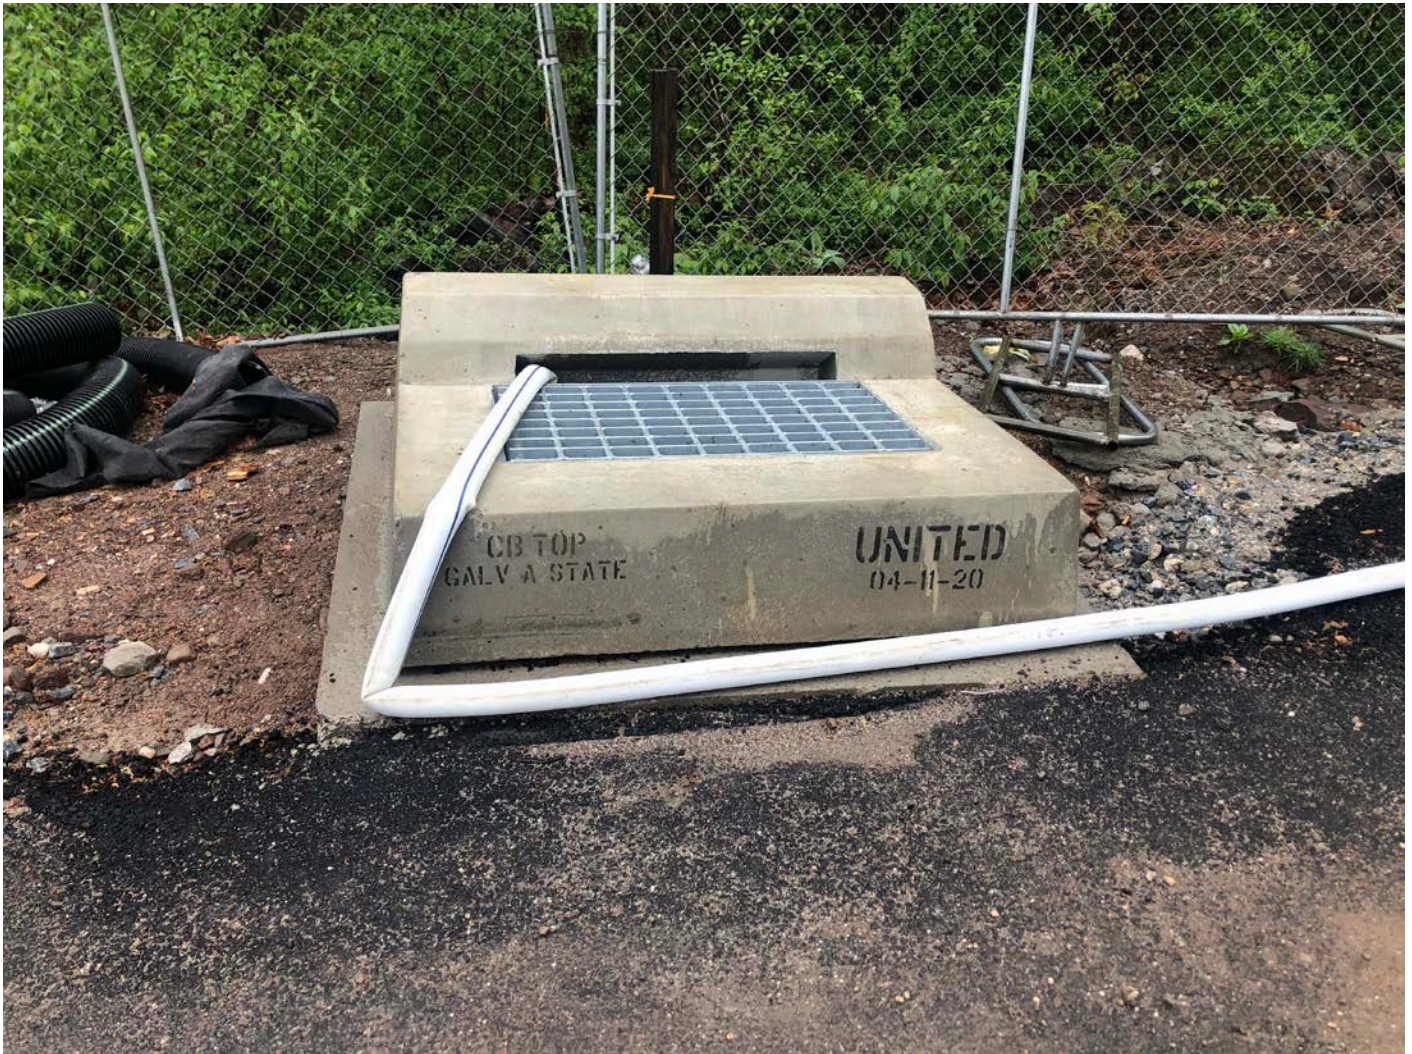
Picture 3: Catch basin that Ludlow is using to discharge water that drained out of the tank from the 8" DIP line that protrudes from the southwest side of the water tank as Ludlow installs the 8" tank drain line that will run south of the altitude valve vault. View to the north.

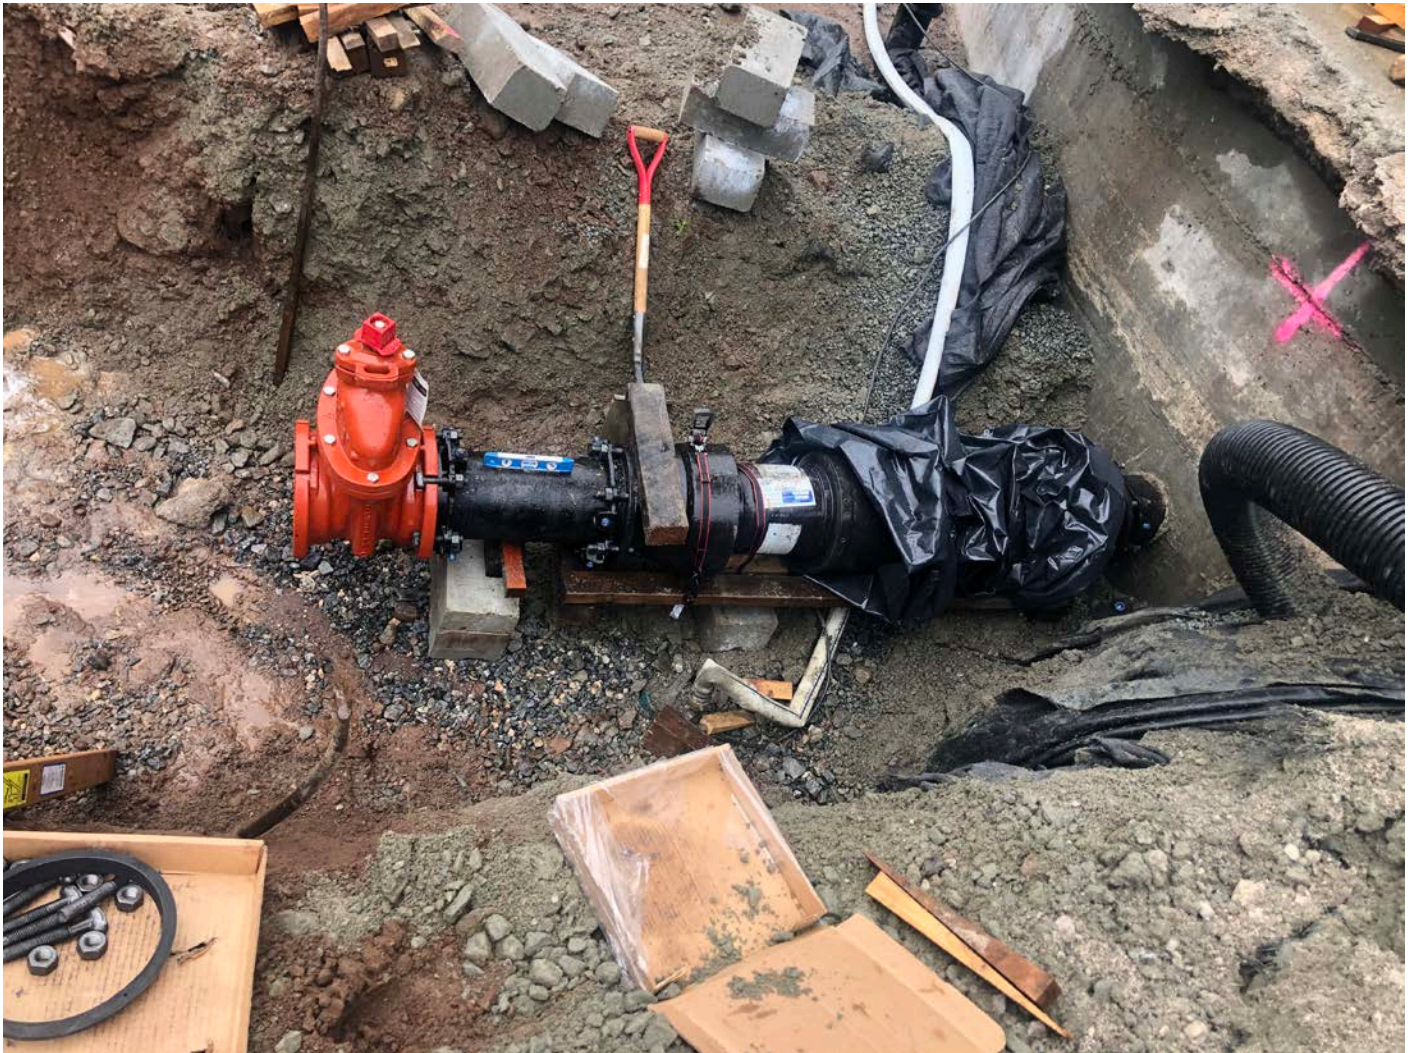
Picture 4: 8" MJ gate valve with flexible fitting that Ludlow has just connected to the 8" DIP drain line that protrudes from the water tank located east of the Shared Access Driveway in Middletown. View to the north.

1018: Ludlow has just finished installing a flexible fitting coming off the 8" DIP that protrudes from the southwest side of the water tank, including an 8" gate valve.

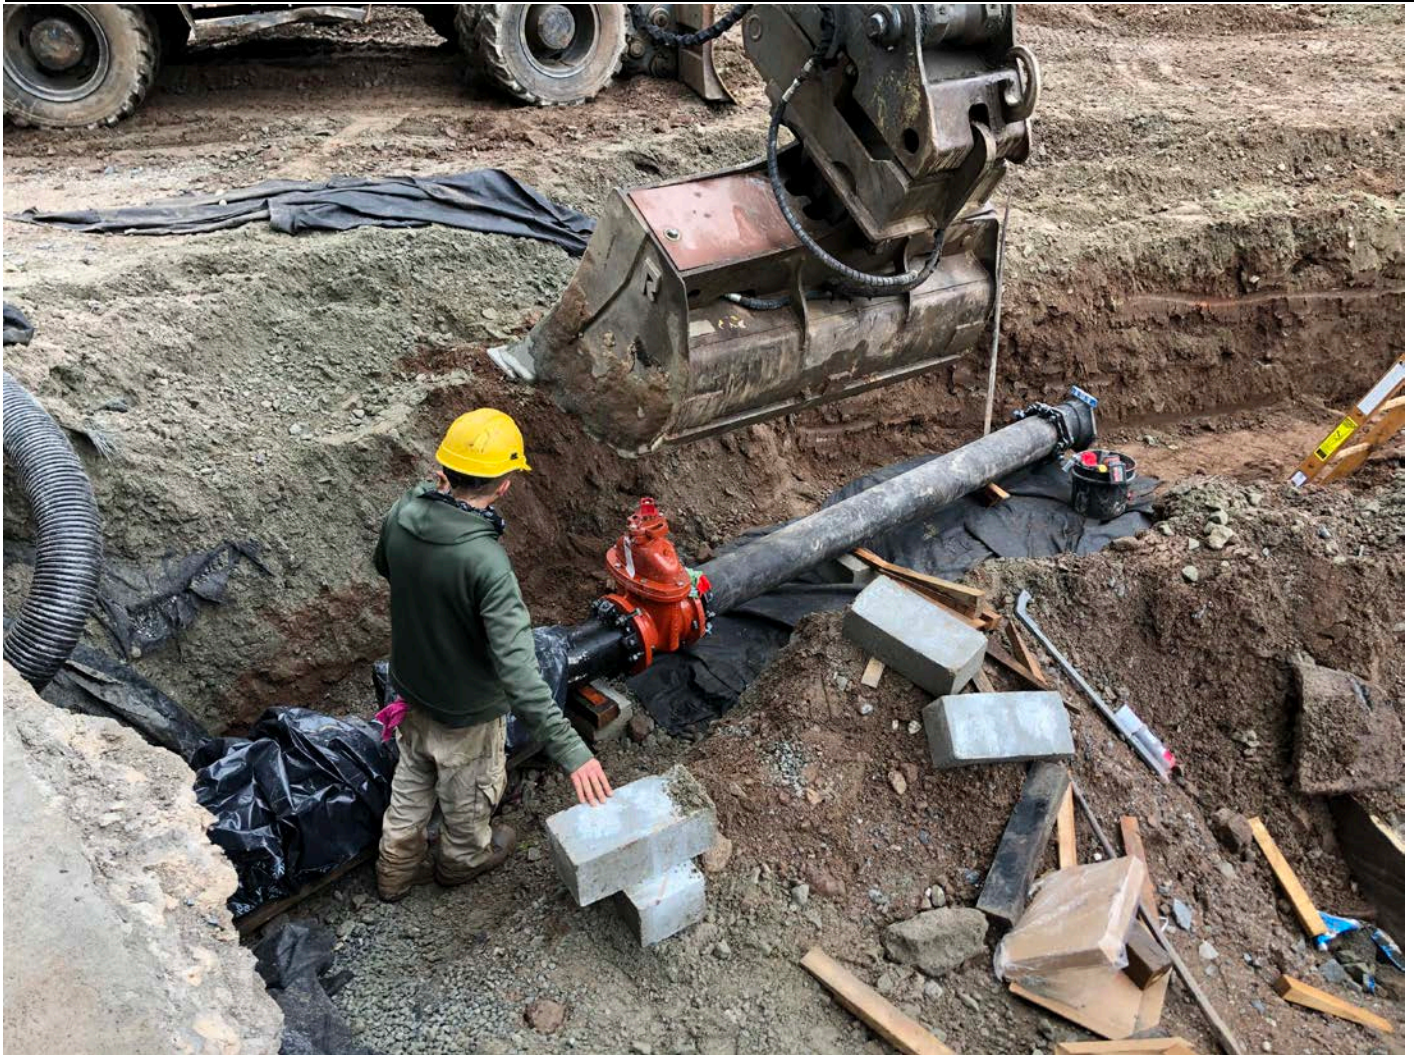
Picture 5: Ludlow in the process of installing a section of 8" DIP to the west of the 8" gate valve they just installed as part of the 8" DIP drain line that they are installing off the southwest side of the water tank. Shared Access Driveway, Middletown.

1103: Ludlow is in the process of installing a section of 8" DIP to the 8" gate valve they just attached to the flexible fitting coming off the 8" DIP that protrudes from the southwest side of the water tank

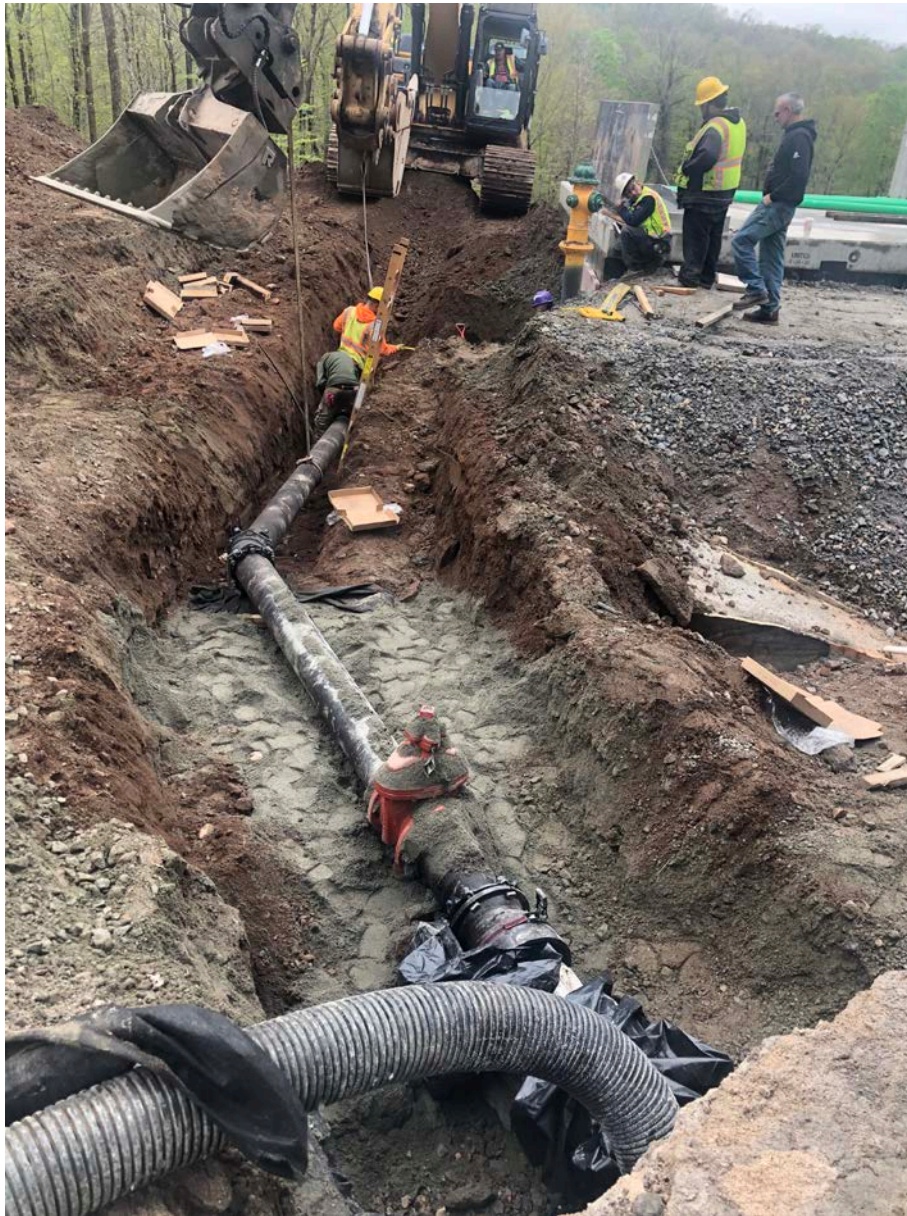
Picture 6: Overview of the 8” drain line that Ludlow is installing between the water tank and the headwall located south of the Shared Access Driveway at Station 11+70. View to the west.

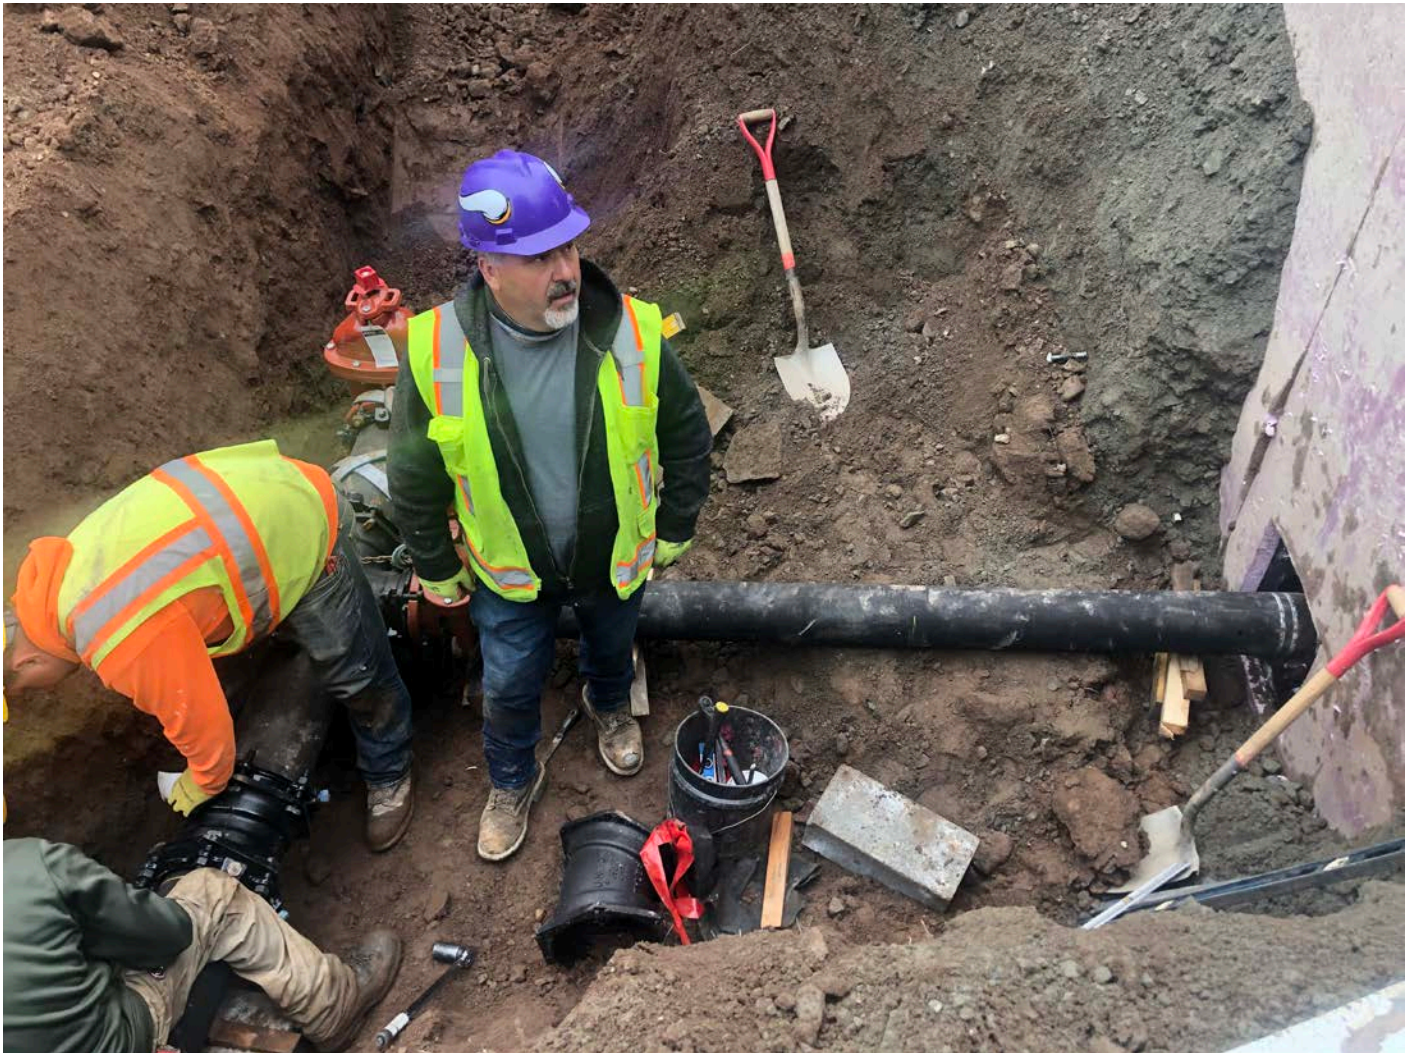
Picture 7: Section of 6" DIP that Ludlow placed temporarily between the altitude valve vault and the 8" water tank drain line to assist in the correct placement of the 6" gate valve they attached to the 8"x8"x6" M.J. TEE on the 8" drain line. View to the west.

1331: Ludlow has made a temporary connection between the 8" DIP drain line and the altitude vault with 6" DIP. This was done to assist Ludlow in placing the 6" gate valve that they installed on the 8"x8"x6" MJ TEE.

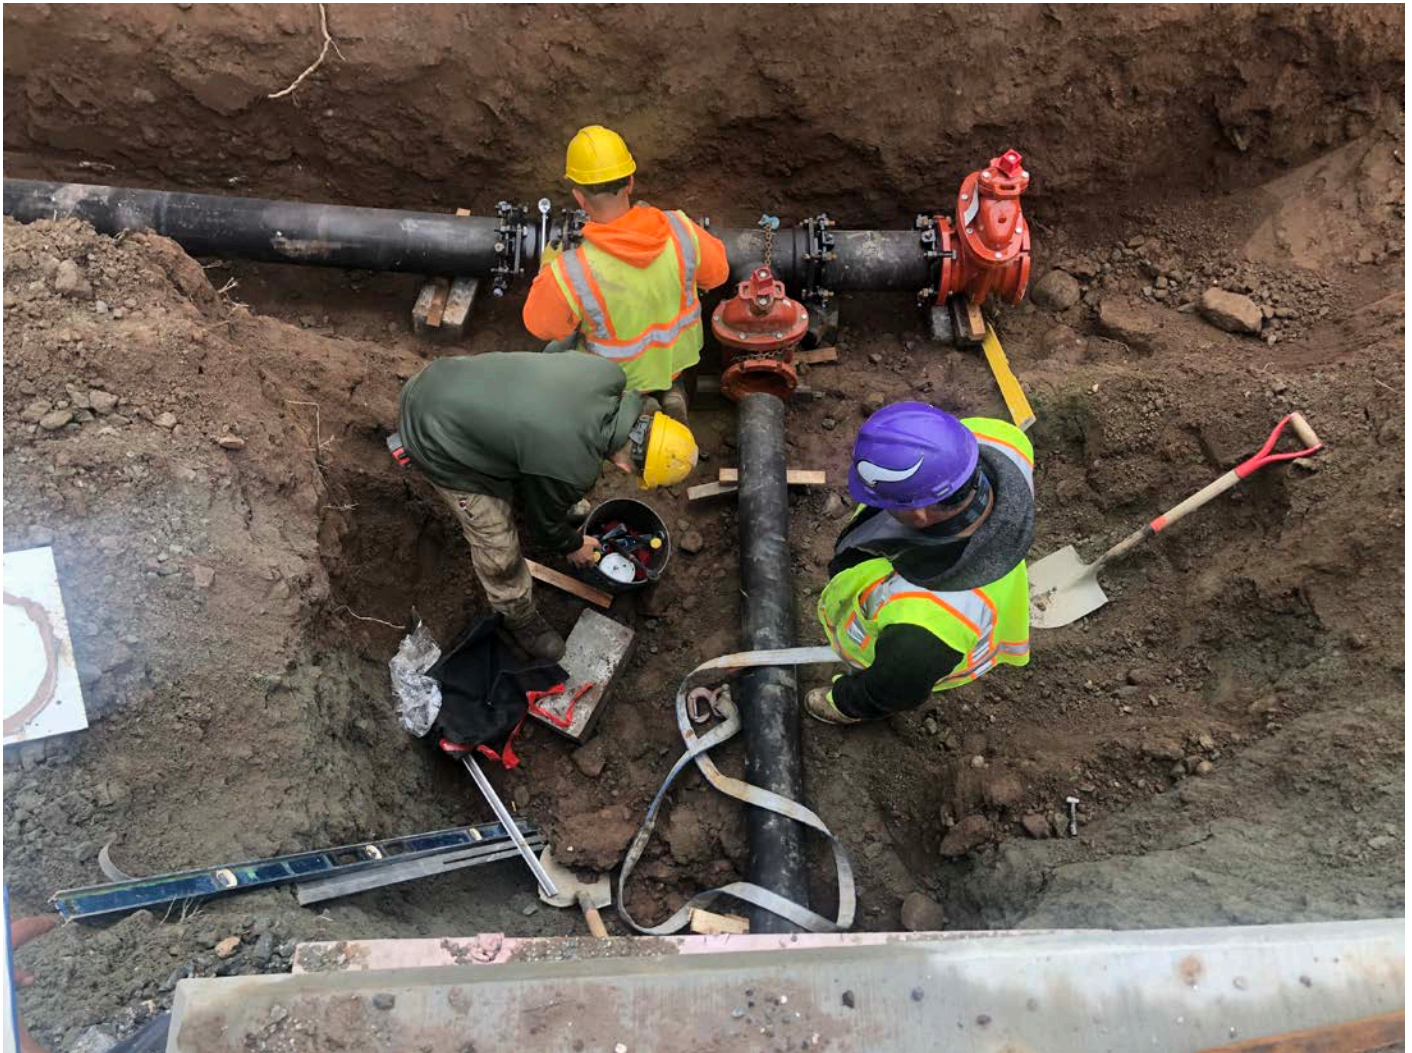
Picture 8: Another view of the 6" DIP that Ludlow placed temporarily between the altitude valve vault and the 8" water tank drain line to assist in the correct placement of the 6" gate valve they attached to the 8"x8"x6" M.J. TEE on the 8" drain line. View to the south.

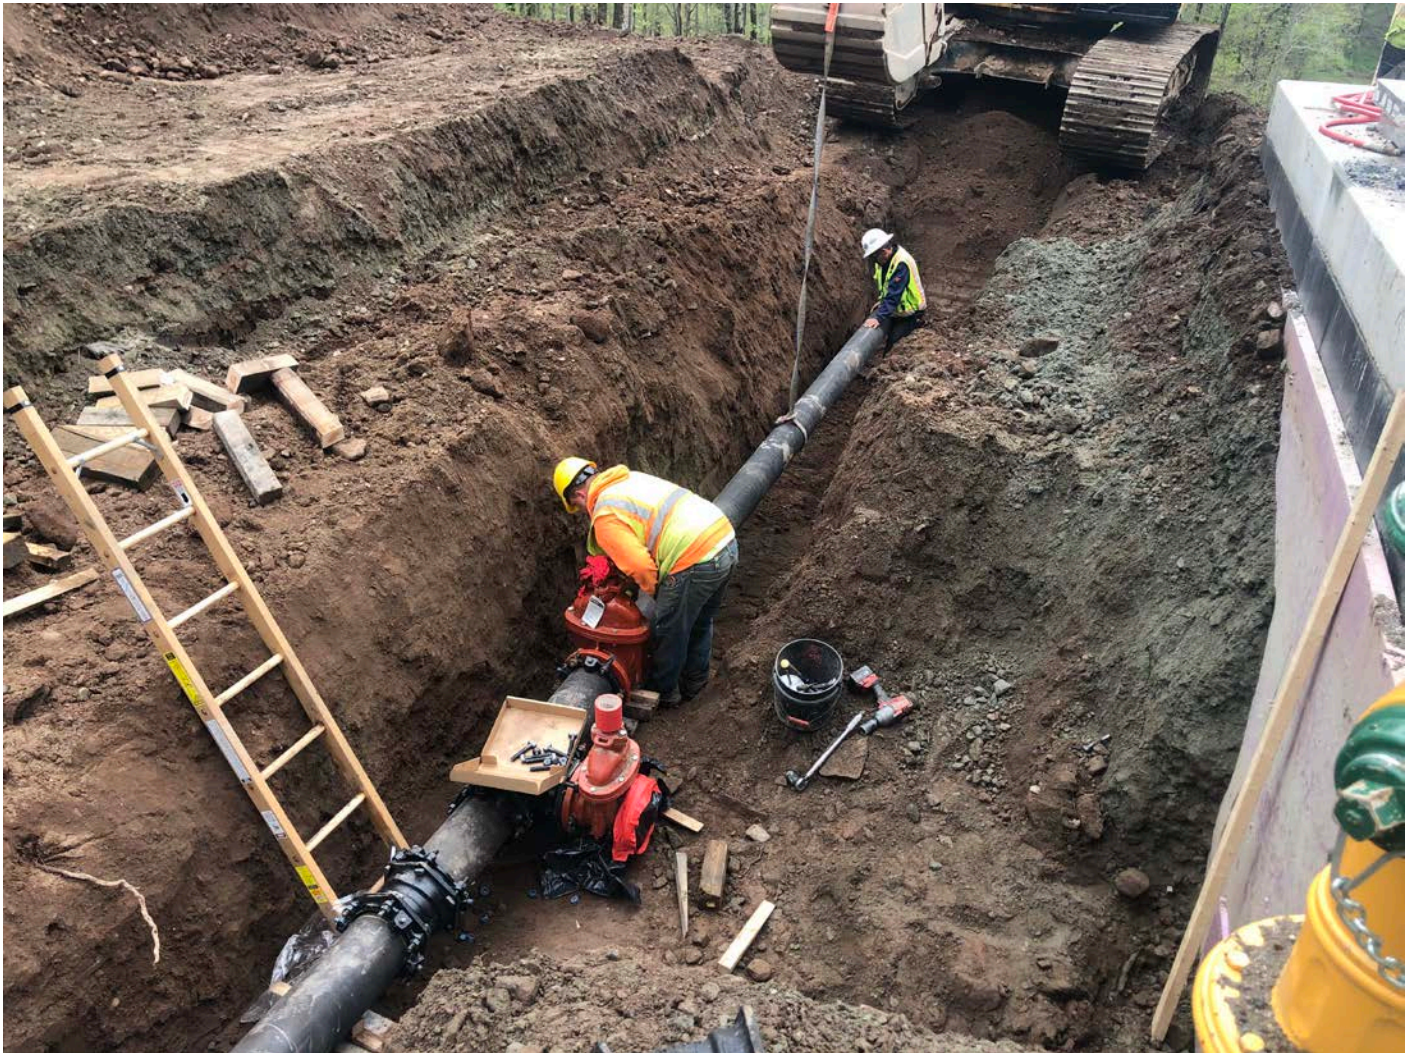
Picture 9: View of 8" water tank drain line located south of the altitude valve vault. Note that Ludlow removed the section of 6" DIP they placed temporarily between the 8" DIP water tank drain line and the altitude valve vault.

1416: Ludlow continues to place 8" pipe on the south side of the altitude vault located east of the Shared Access Driveway in Middletown.
