Daily Report

Project:	Durham Meadows Pipeline Installation	Date:	May 7, 2021
Location:	S. Main Street and the Shared Access Driveway, Middletown	Day of Week:	Friday
Project #:	AECOM: 6061487	Report No:	238
Contractor:	Ludlow Construction	Page:	1 of 9

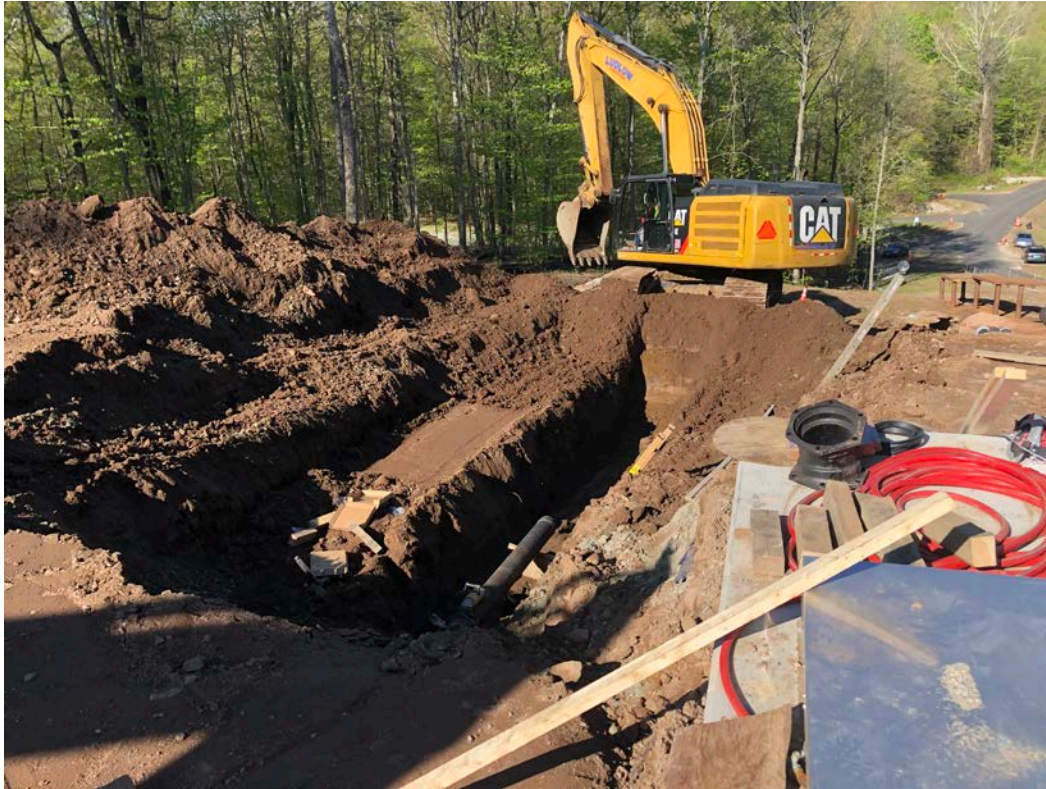
Picture 1: Ludlow in the process of installing 8" DIP for the tank drain between the southwest side of the water tank and the headwall located at ~Station 11+70 in Middletown. View to the west.

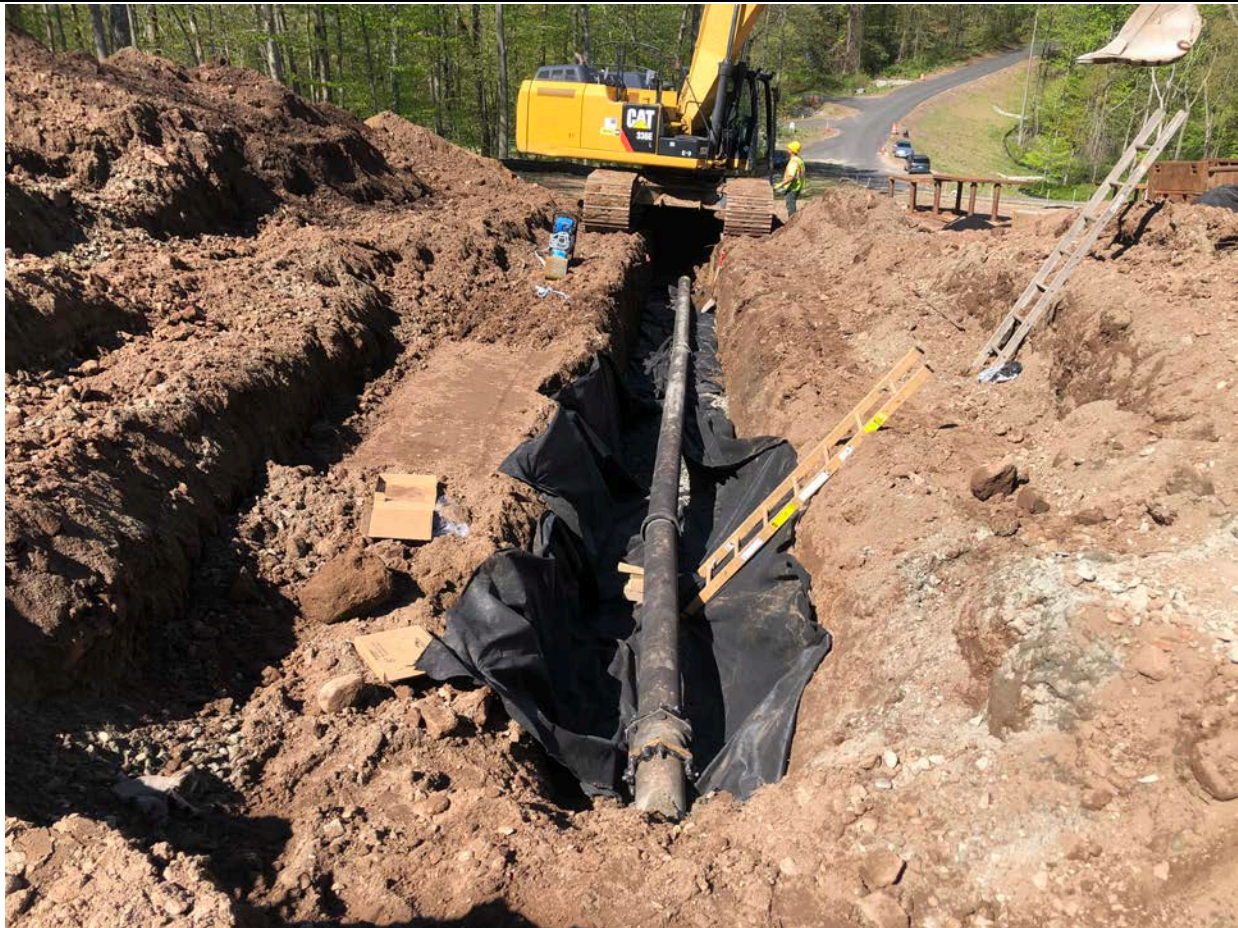
1008: Ludlow continues to place 8" DIP for the drain line that exits the southwest side of the water tank as they move in a western direction towards the catch basin located at ~Station 11+70. The piping is being placed on the following bedding: geofabric placed on native soil, 6" of ¾" gravel on top of the fabric, the same geofabric placed on top of the gravel, and sand placed on top of the fabric. The 8" DIP is then placed on top of the sand.

Picture 2: Geofabric placed over $\frac{3}{4}$ " gravel and another layer of geofabric beneath the 8" DIP that is being installed for the drain between the southwest side of the water tank and the headwall located at ~Station 11+70 in Middletown. View to the west.

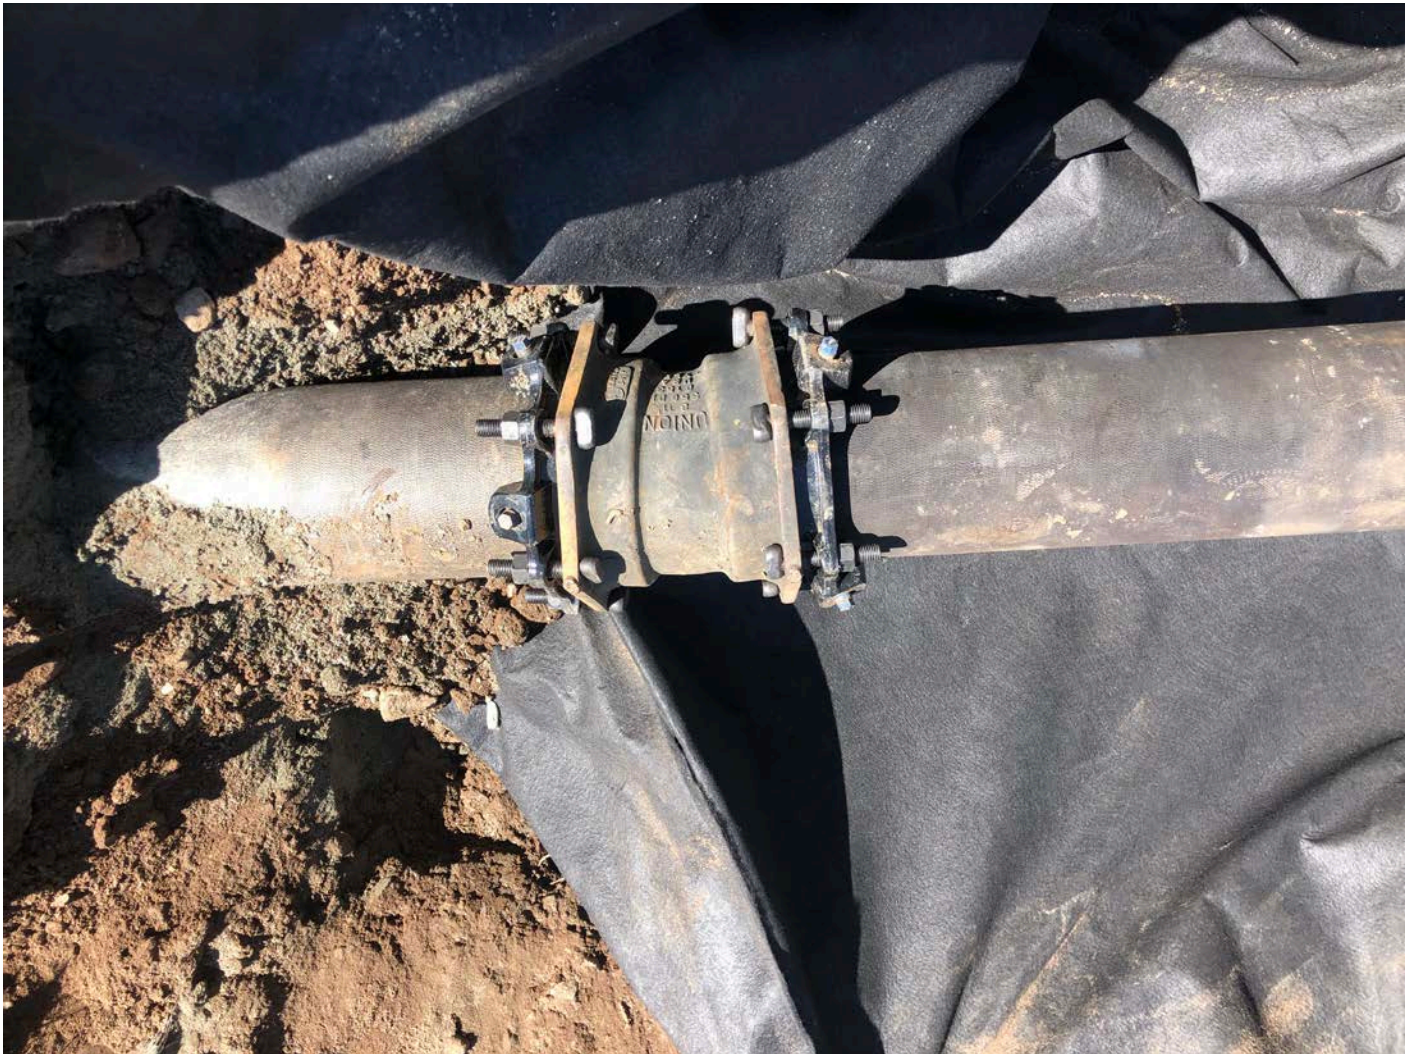
1015: Ludlow has added an 11.25° DIP bend in the string of 8" DIP they are installing to assisting in directing the pipe in a downward direction towards the catch basin located at ~Station 11+70. The slope of the pipe in this area (which is southwest of the altitude vault) pitches downward by 12.88% according to Ludlow. All pipe connections are restrained.

Picture 3: 11.25° DIP bend placed in line with the 8" DIP drain line that Ludlow is installing between the water tank and the headwall located at ~Station 11+70 in Middletown. View to the east.

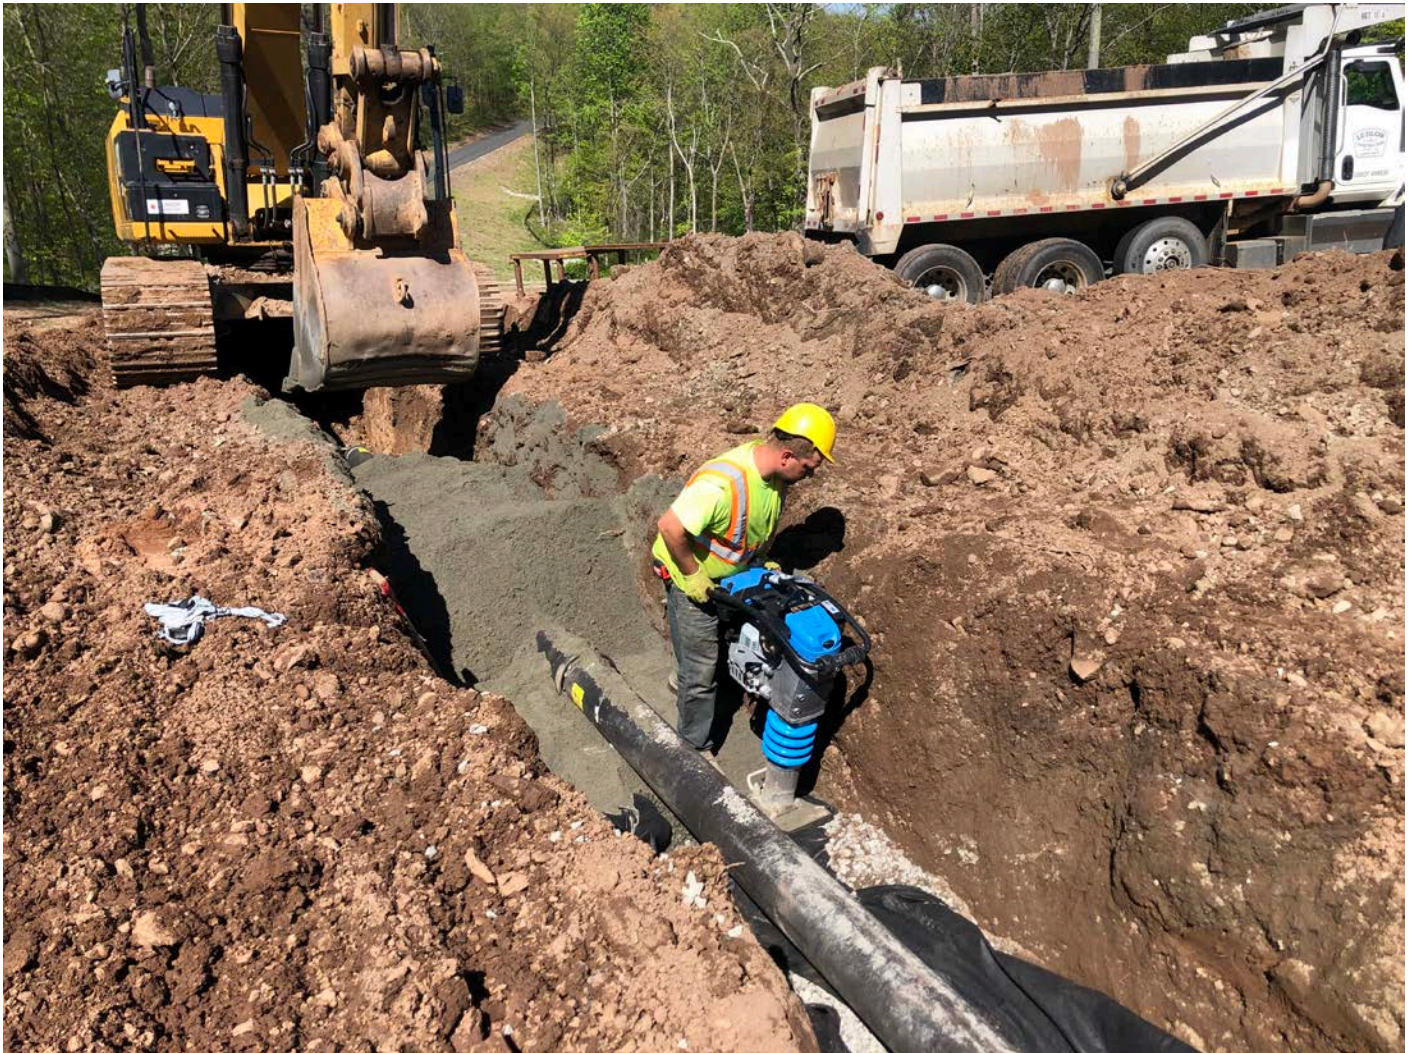
1121: Ludlow is using a jumping jack to compact sand on either side of the 8" drainpipe that exits the water tank on the southwest side and connects to the catch basin located at Station ~11+70.

Picture 4: Ludlow placing and compacting sand on and around the 8” DIP drain line that Ludlow is installing between the water tank and the headwall located at ~Station 11+70 in Middletown. View to the northwest.

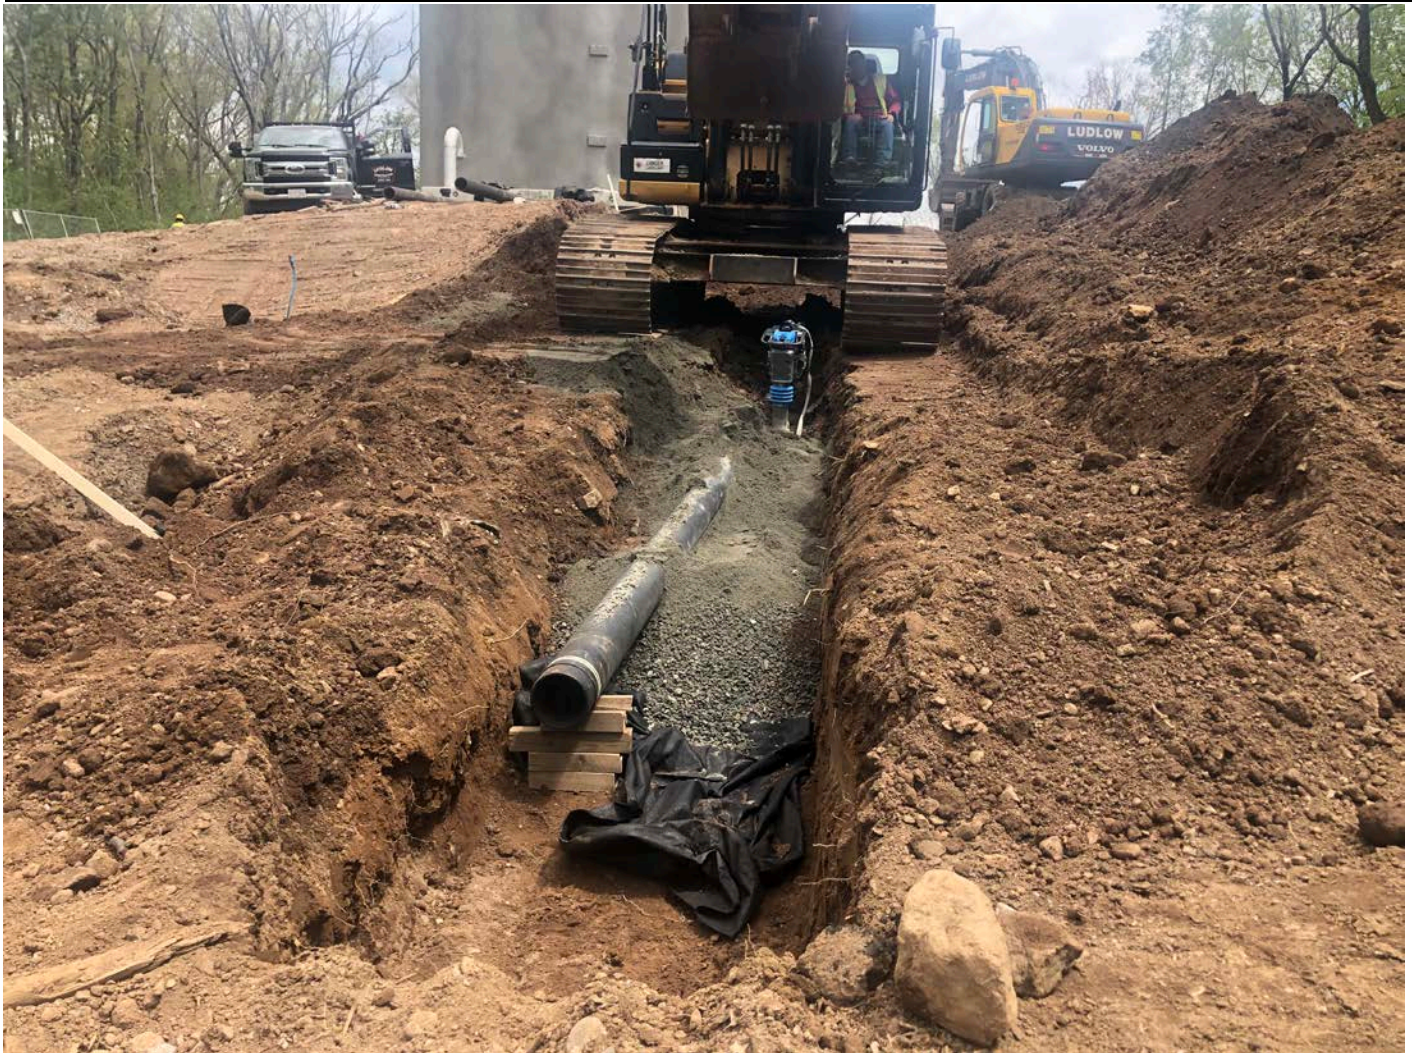
Picture 5: 8" DIP drain line that Ludlow is installing between the water tank and the headwall located at ~Station 11+70 in Middletown. View to the east.

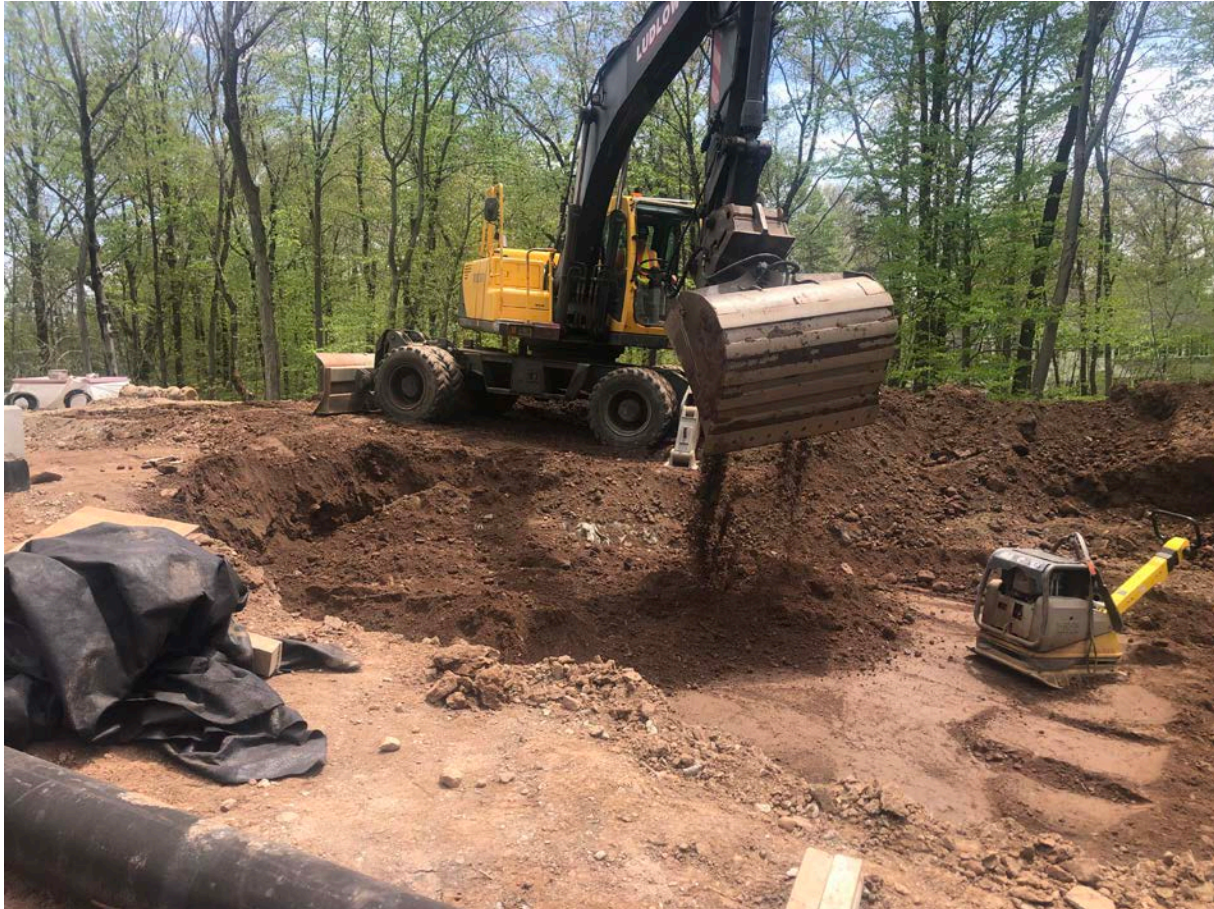
1253: Ludlow continues to place native fill in 1-foot lifts with -5" rock on top 8" DIP drain line they have already installed and are compacting it with a plate compactor.

Picture 6: Ludlow placing native fill over the 8" DIP drain line between the southwest side of the water tank and the headwall located at Station 11+70. Water tank work zone located east of the Shared Access Driveway in Middletown. View to the south.

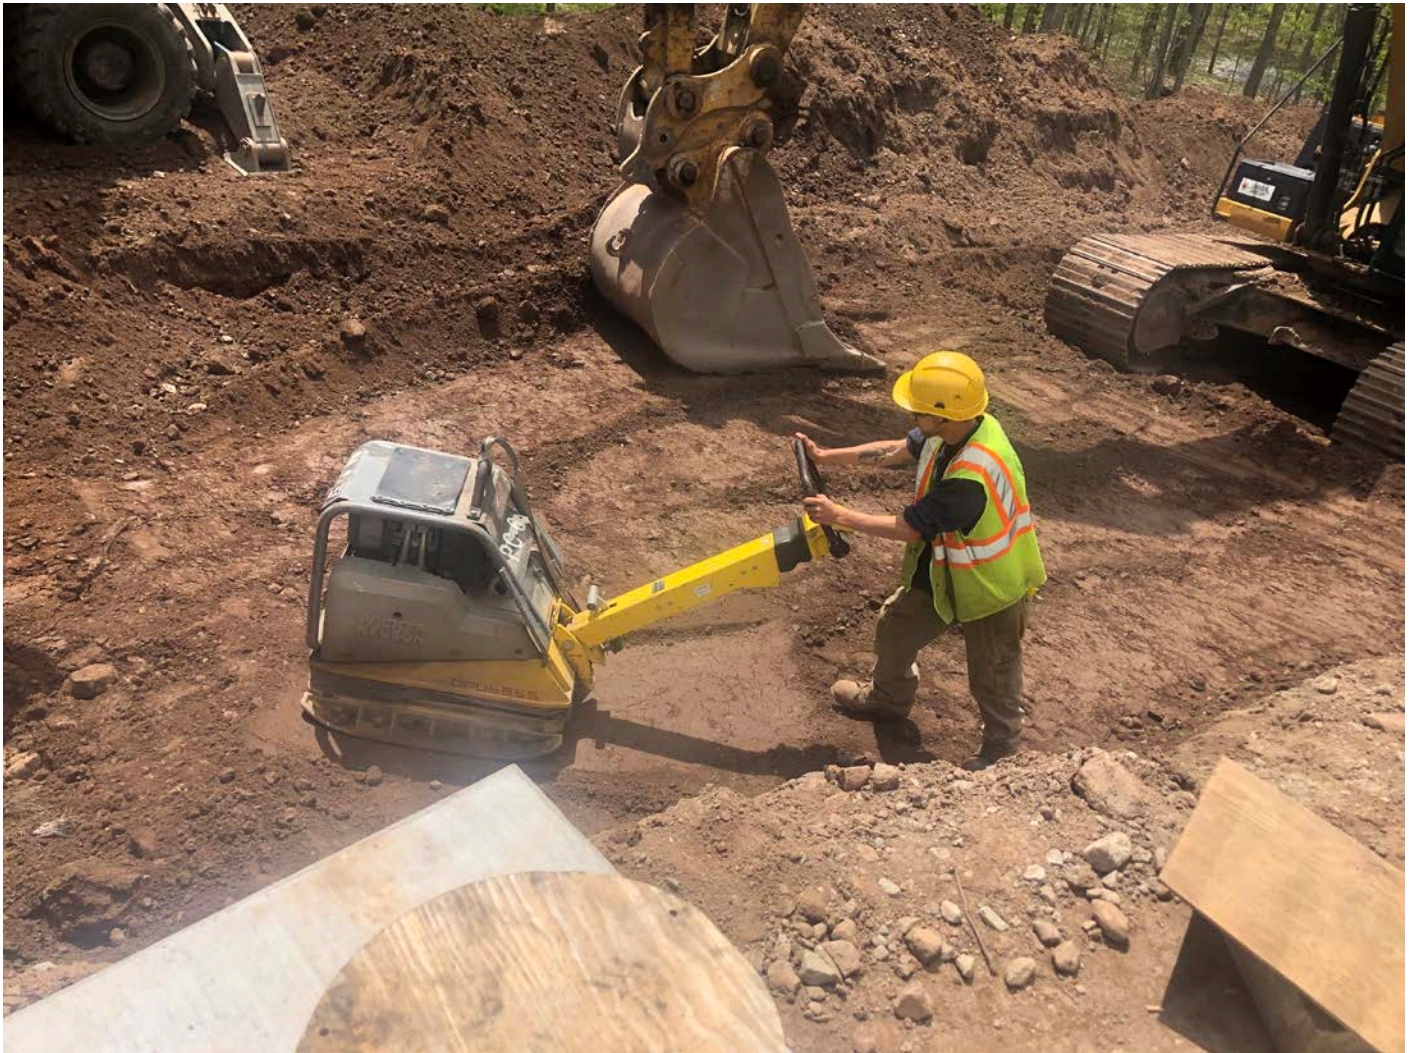
Picture 7: Ludlow compacting native fill over the 8" DIP drain line that runs between the southwest side of the water tank and the catch basin located at Station 11+70. Water tank work zone located east of the Shared Access Driveway in Middletown. View to the southwest.
