## Daily Report

| <b>Project:</b> | Durham Meadows Pipeline Installation | <b>Date:</b> | May 10, 2021 |
| <b>Project #:</b> | AECOM: 6061487 | <b>Report No:</b> | 239 |

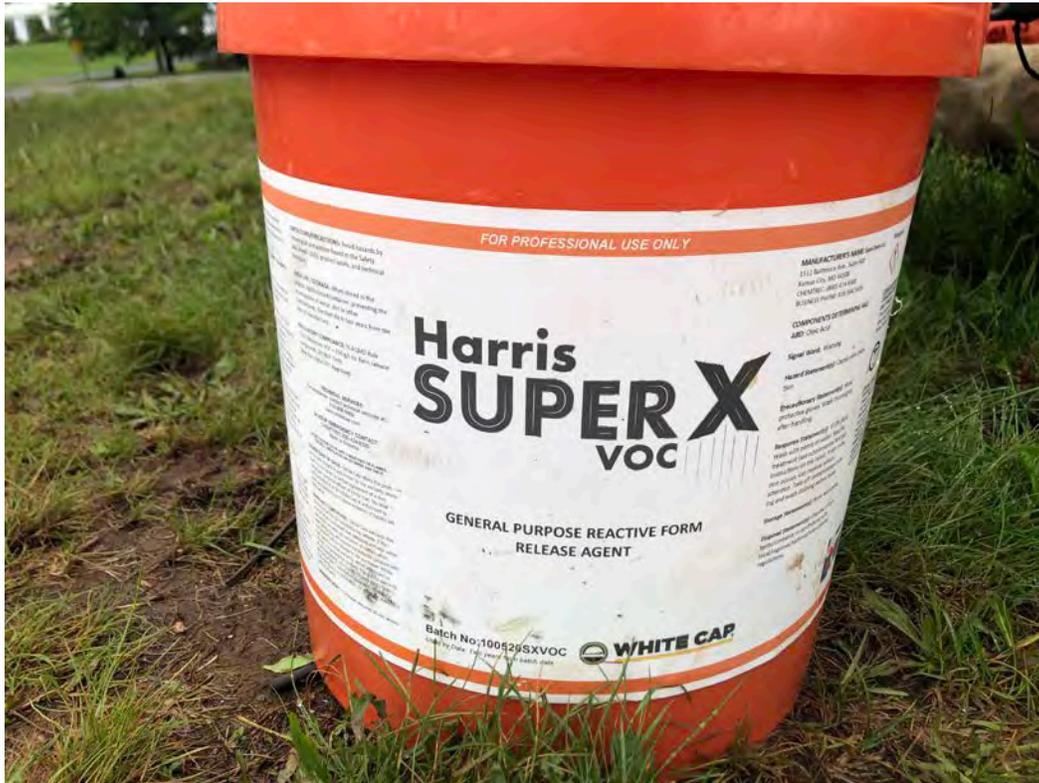
Picture 1: Form release agent that Ludlow applied to the inside of the frost wall concrete forms. Booster station work zone, Station 750+63 South Main Street in Middletown.

0800: Ludlow is staged at the booster station work zone located at Station 750+63 South Main Street in Middletown as they prepare for today's concrete pour. Ludlow has already applied Harris Super X (release compound) to the inside of the concrete forms for the frost wall.

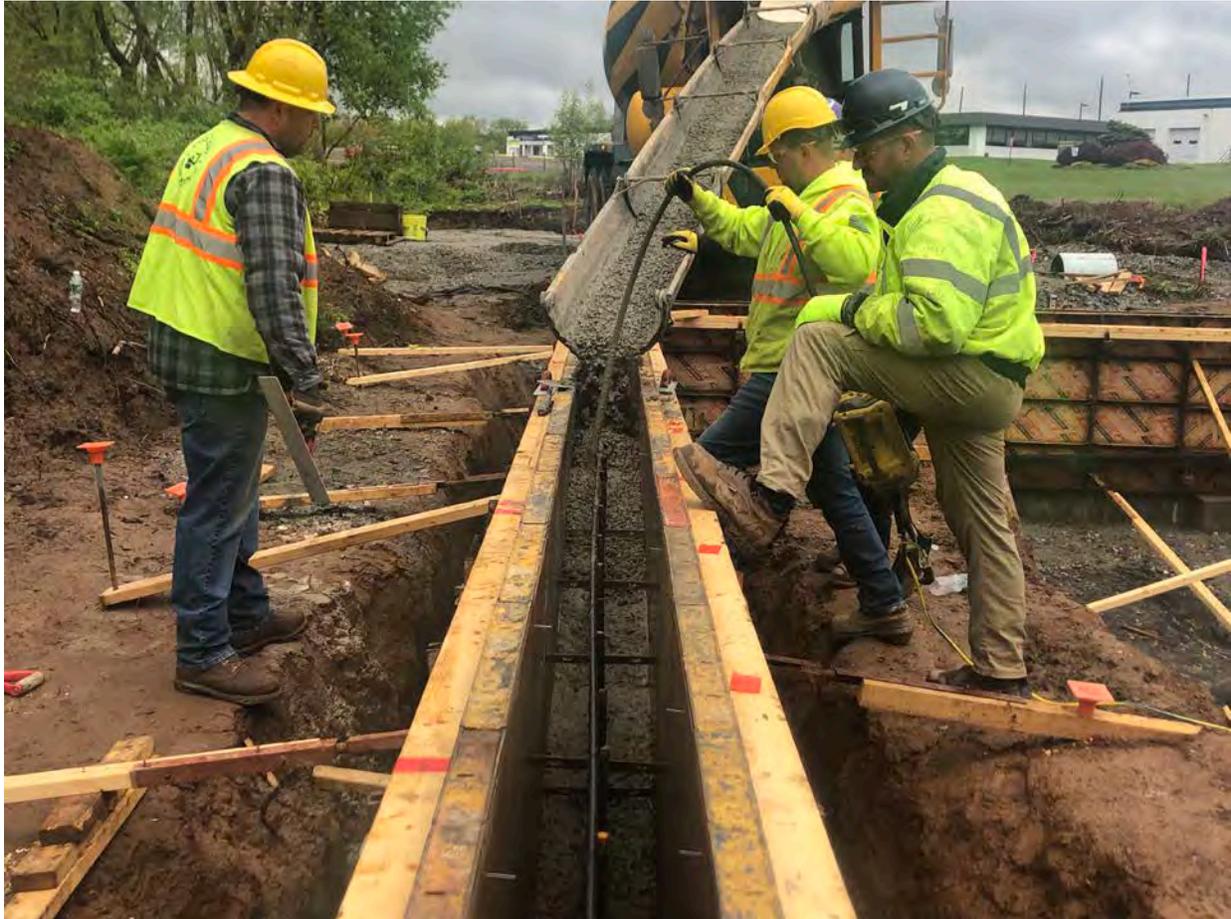
Picture 2: Ludlow vibrating concrete as it is being placed into the frost wall forms by Farmington Ready Mix. Booster station work zone, Station 750+63 South Main Street in Middletown. View to the west.

0909: Farmington Ready Mix starts placing concrete on the south wall of the booster station frost wall. Ludlow is using a vibrator to settle the concrete as it is placed into the forms.

0915: Ludlow starts using a second vibrator as Farmington Ready Mix continues to place concrete into the forms. Proper vibration technique being used.

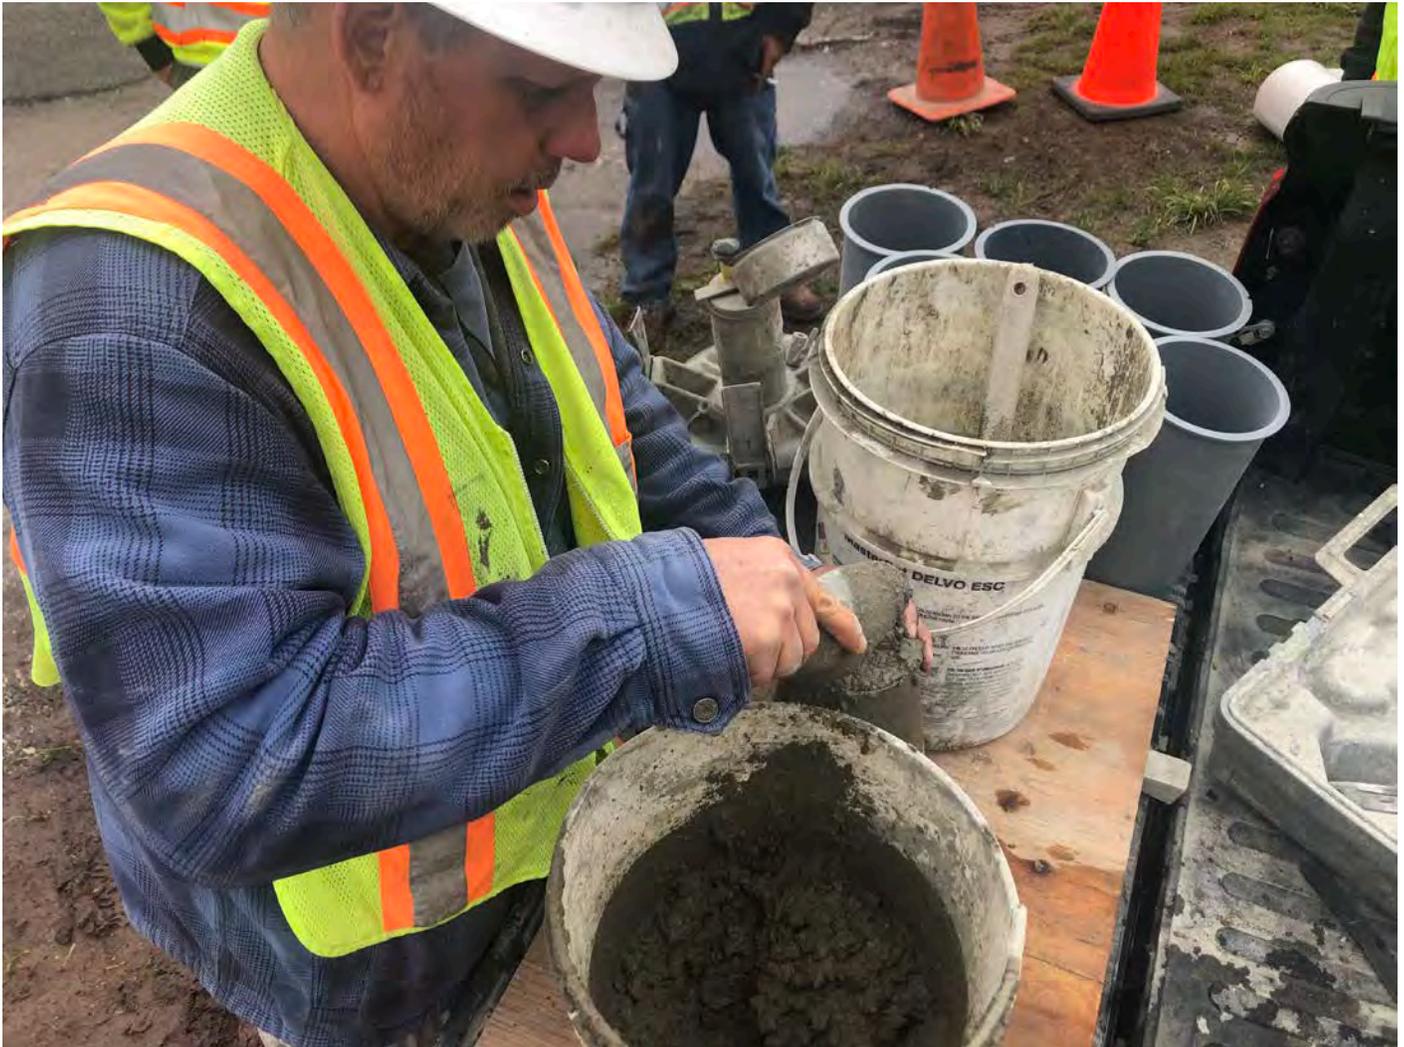
Picture 3: JTC preparing a slump test sample on the first of two loads of concrete brought to the booster station work zone in Middletown.

0924: JTC performs a slump test on the first load of concrete. JTC reports a slump of slightly greater than 6 inches. Farmington Ready Mix truck spins the load of concrete more to tighten up the concrete.

0935: JTC performs another slump test on the first load of concrete and arrives at a slump of 4.25 inches.

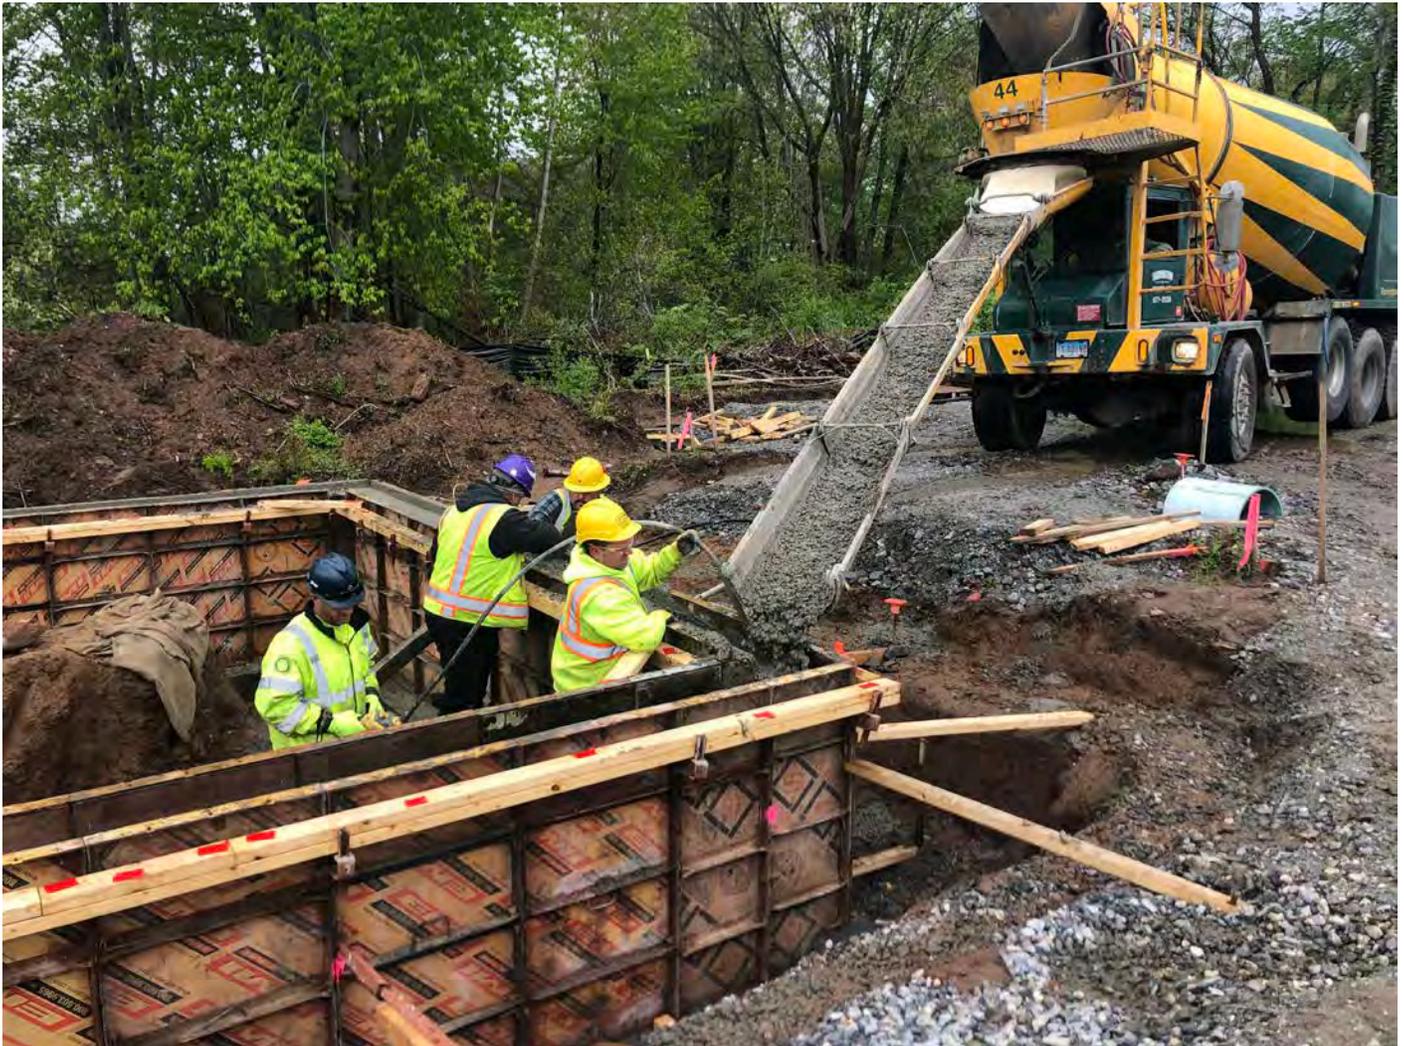
Picture 4: Ludlow vibrating concrete as it is being placed into the frost wall forms by Farmington Ready Mix. Booster station work zone, Station 750+63 South Main Street in Middletown. View to the southwest.

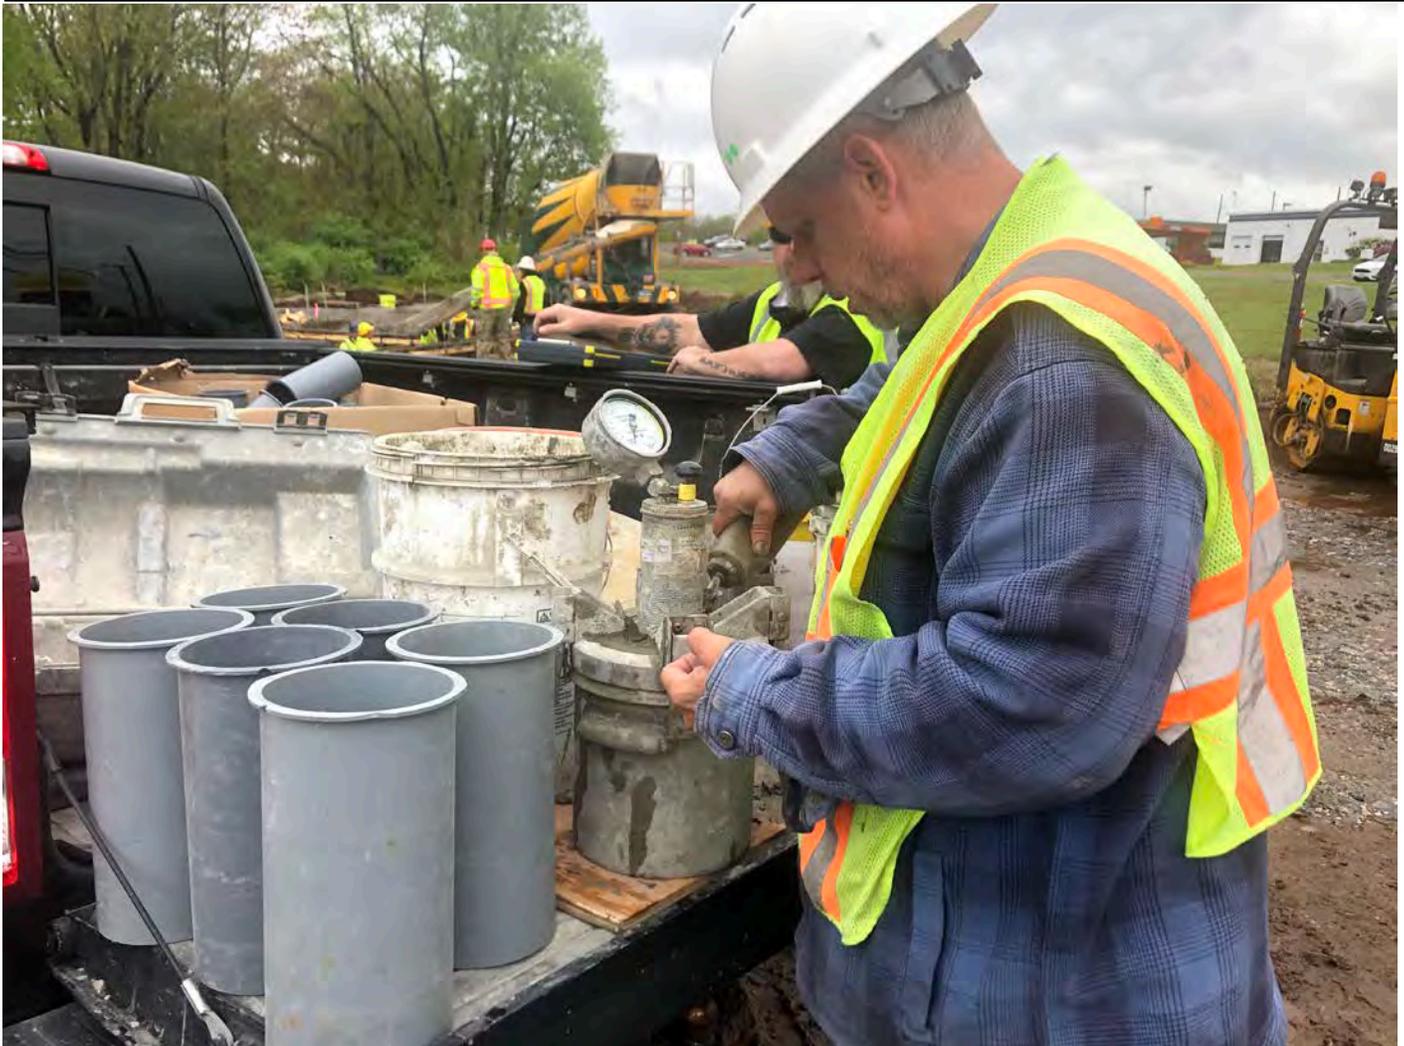
**Picture 5: JTC preparing an air entrainment sample on the first of two loads of concrete brought to the booster station work zone, South Main Street in Middletown.**

0948: JTC performs an air entrainment test on the first load of concrete brought to the site by Farmington Ready Mix. JTC reports an air entrainment value of 5.25%. JTC also collect 6 cylinders of concrete for laboratory testing.

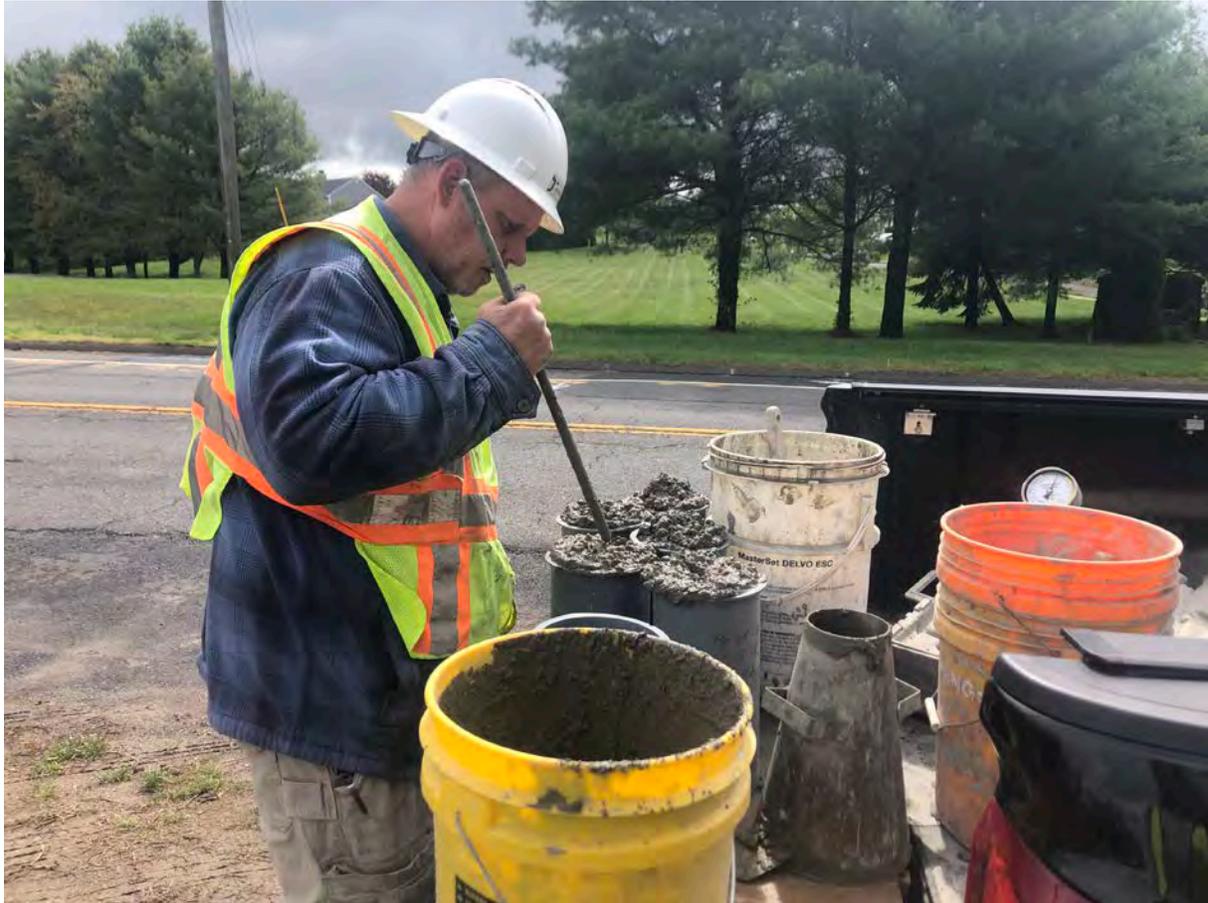
Picture 6: JTC preparing cylinder samples from the first of two loads of concrete brought to the booster station work zone in Middletown.

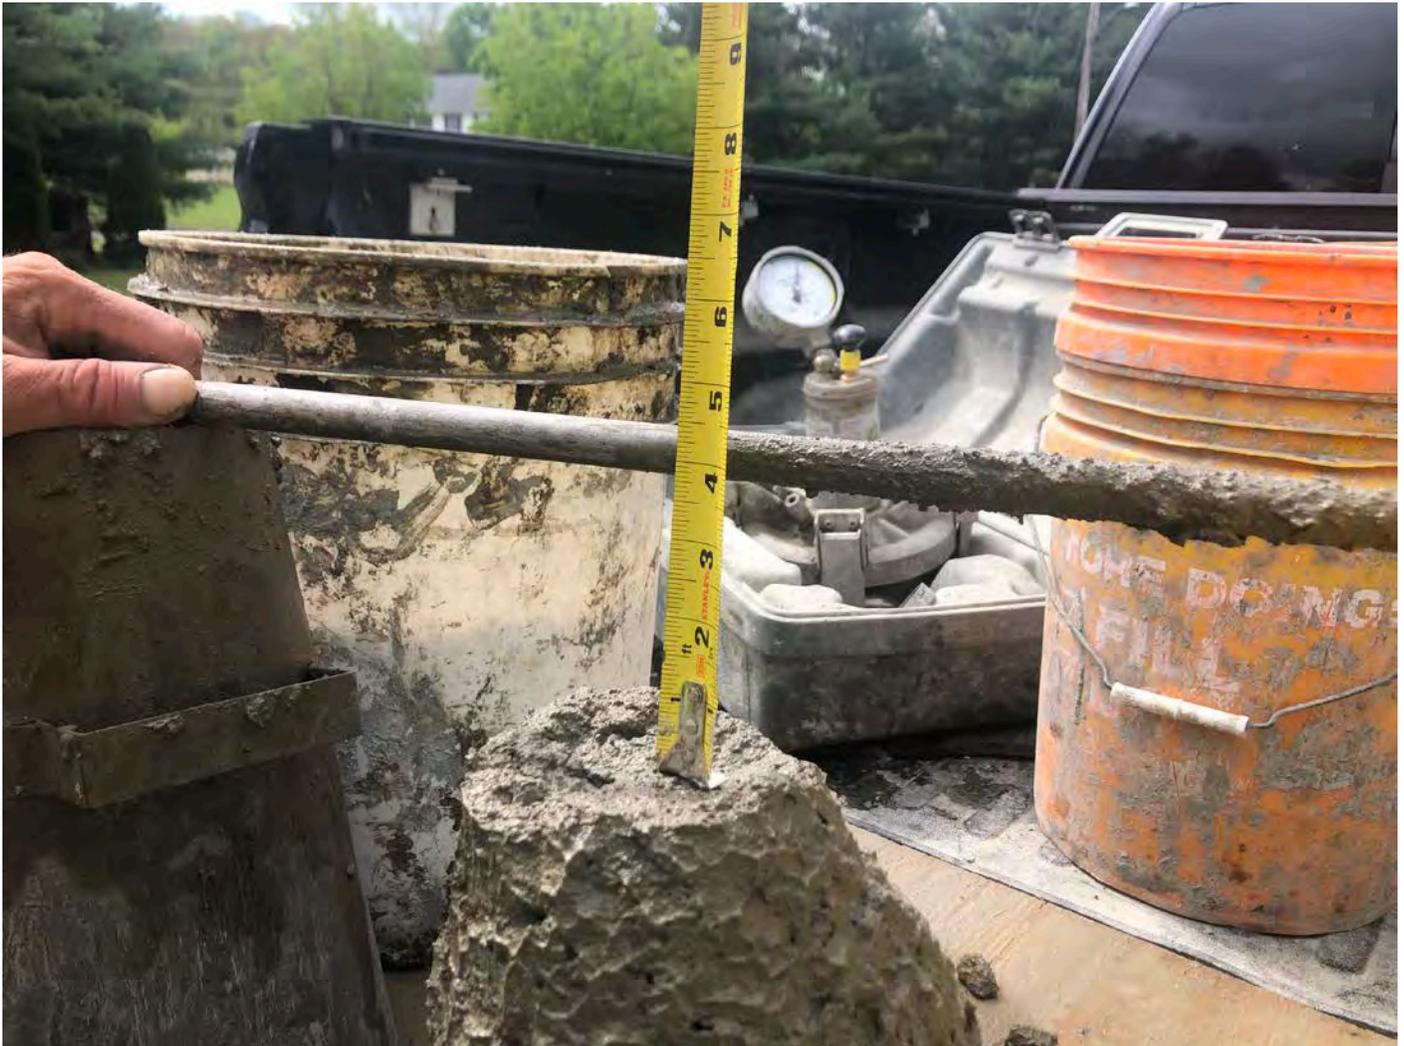
Picture 7: Slump test sample that JTC prepared from the second of two loads of concrete brought to the booster station work zone in Middletown.

1032: JTC performs a slump test on the first load of concrete and arrives at a slump of 3.75".

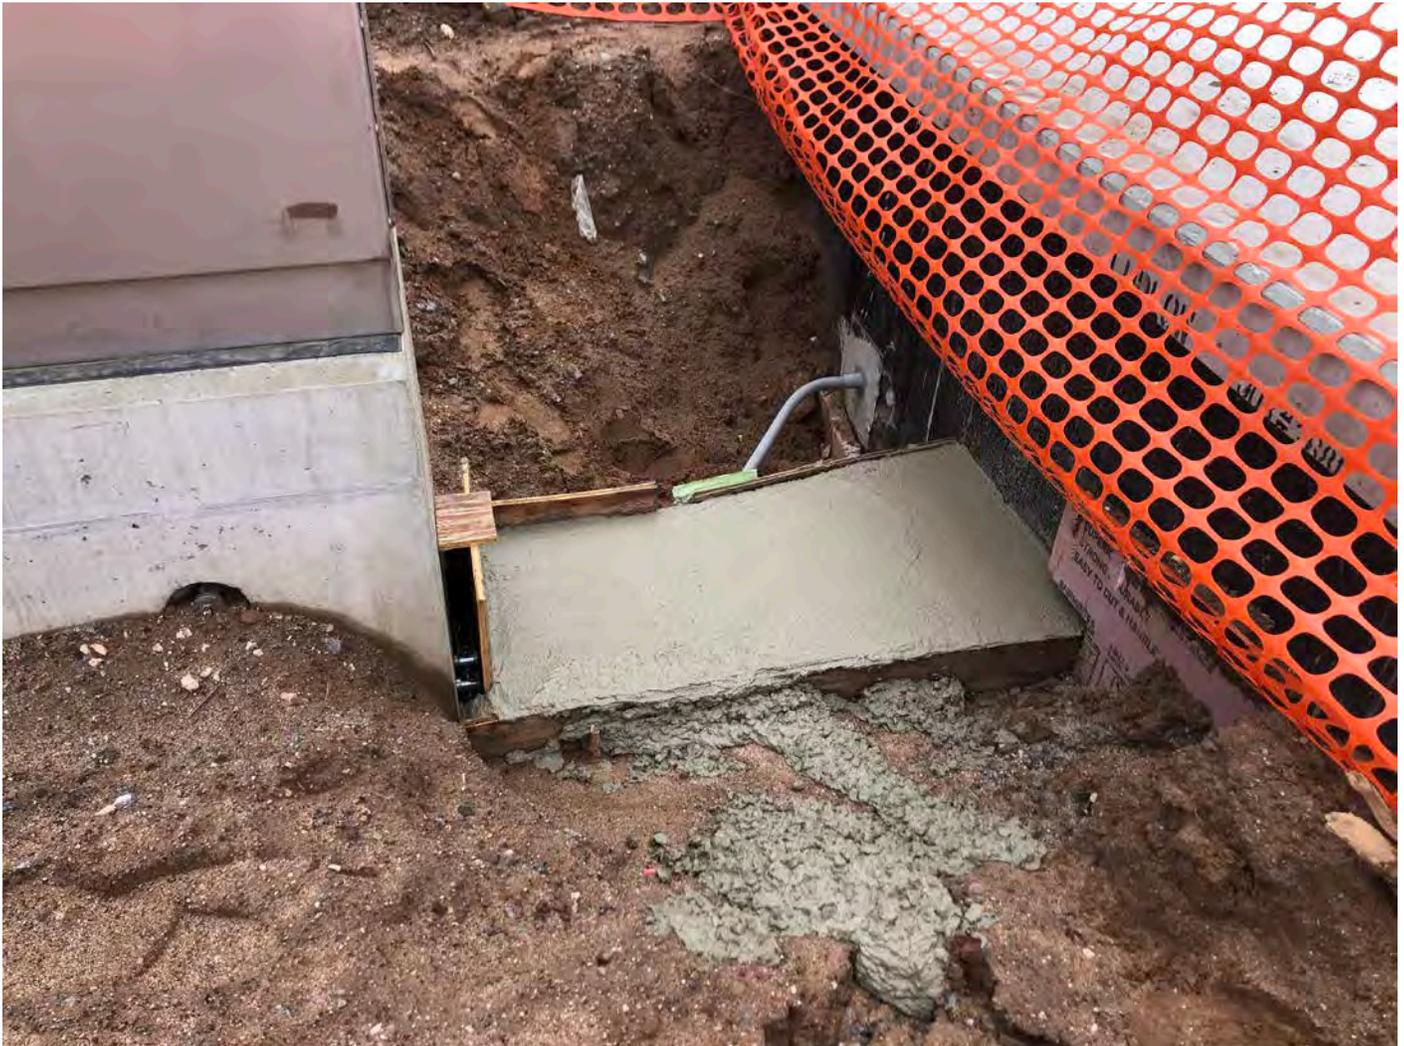
**Picture 8: Concrete placed over the PVC conduits located between the electrical enclosure and the pressure reducing valve vault located at ~Station 161+40 Main Street in Durham. View to the east.**

Ludlow and Farmington Ready Mix placed concrete over the PVC electric conduits at the pressure reducing valve vault located at ~Station 161+40 Main Street in Durham.

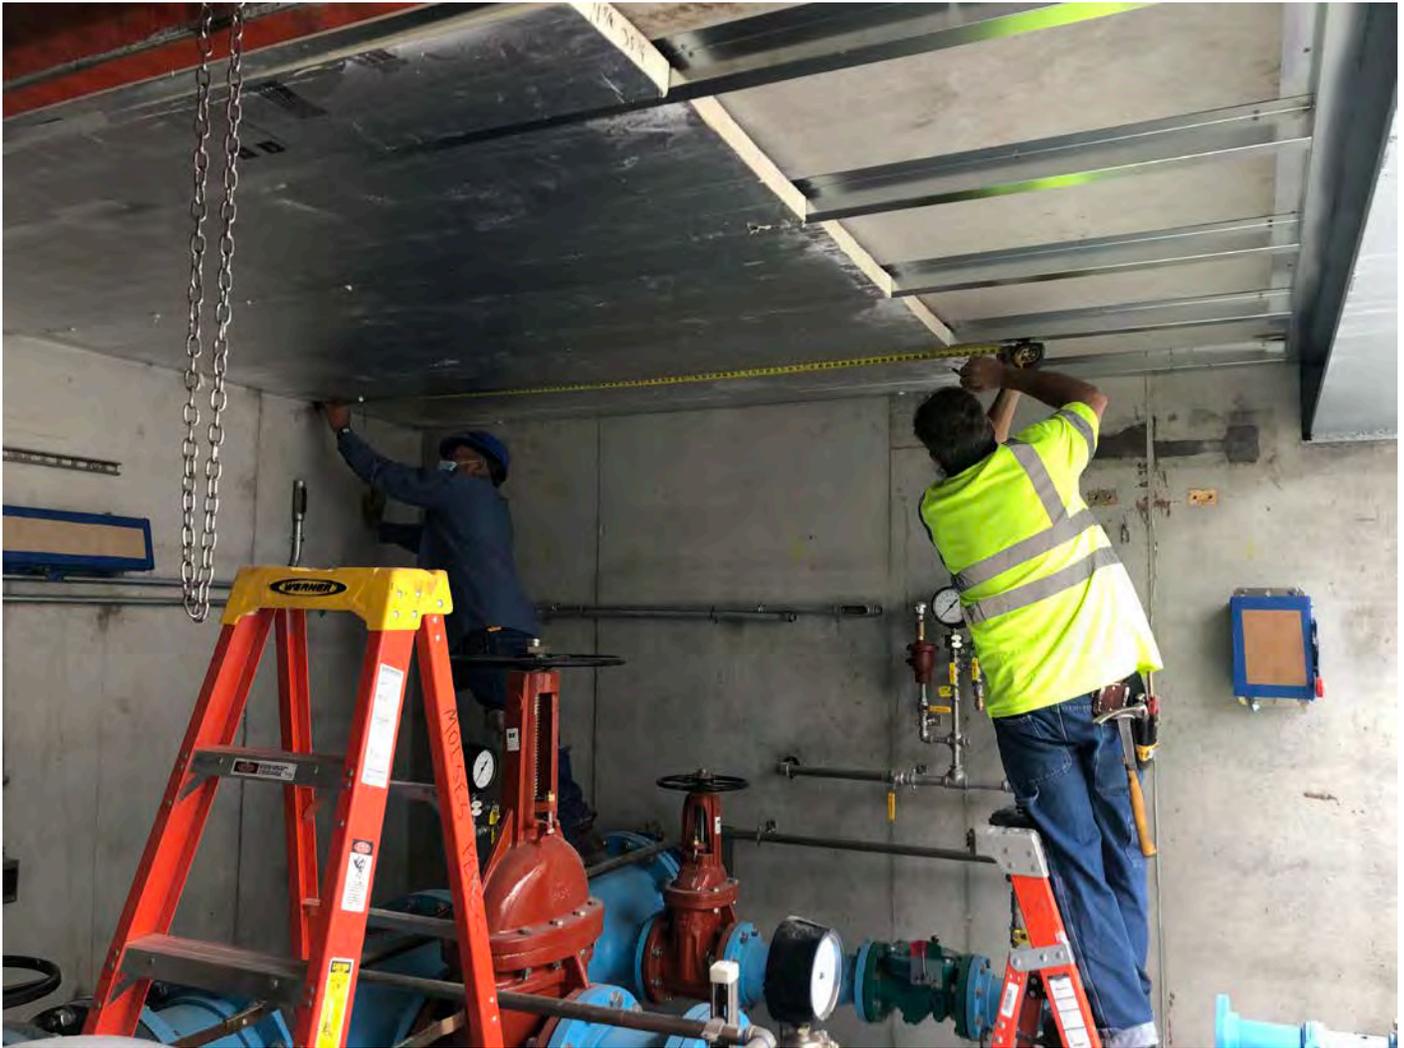
Picture 9: United Concrete installing insulation to the inside of the altitude valve vault located east of the Shared Access Driveway in Middletown. View to the east.

0835: United Concrete has three laborers installing insulation to the inside of the altitude valve vault at the water tank work zone located east of the Shared Access Driveway in Middletown.

1128: Three United Concrete workers continue to place insulation on the inside of the altitude valve vault located east of the Shared Access Driveway in Middletown.

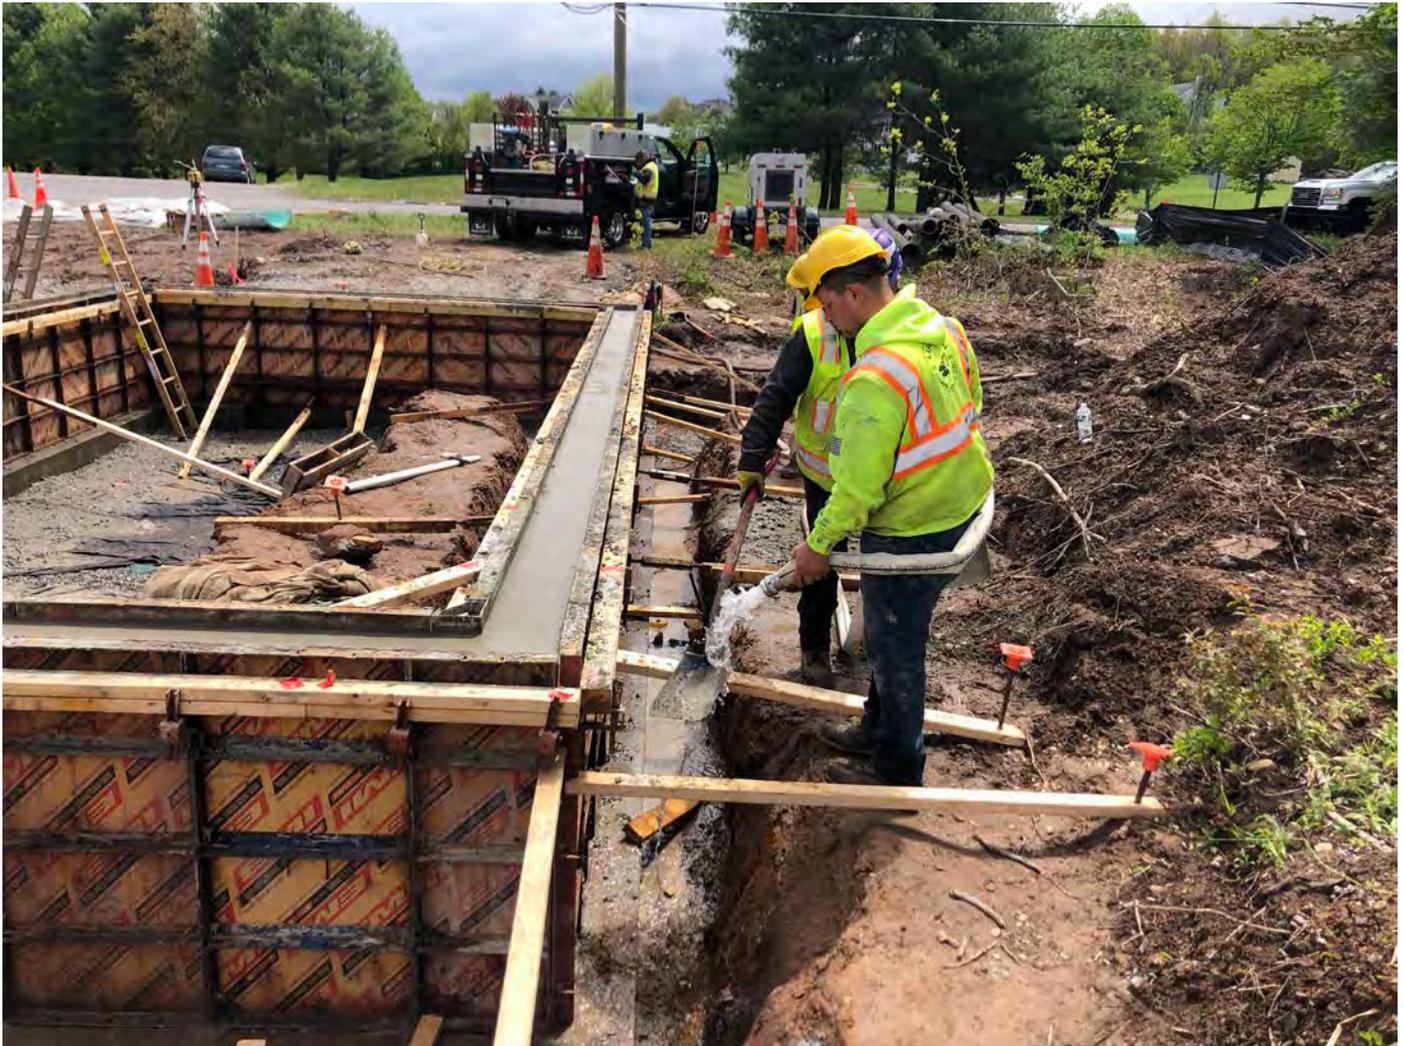
Picture 10: Ludlow washing off the exterior of the concrete forms at the booster station work zone in Middletown. View to the south.

1151: Ludlow is using water to hose off the exterior of the concrete forms and the exterior of the footings at the booster station work zone located at Station 750+63 in Middletown.

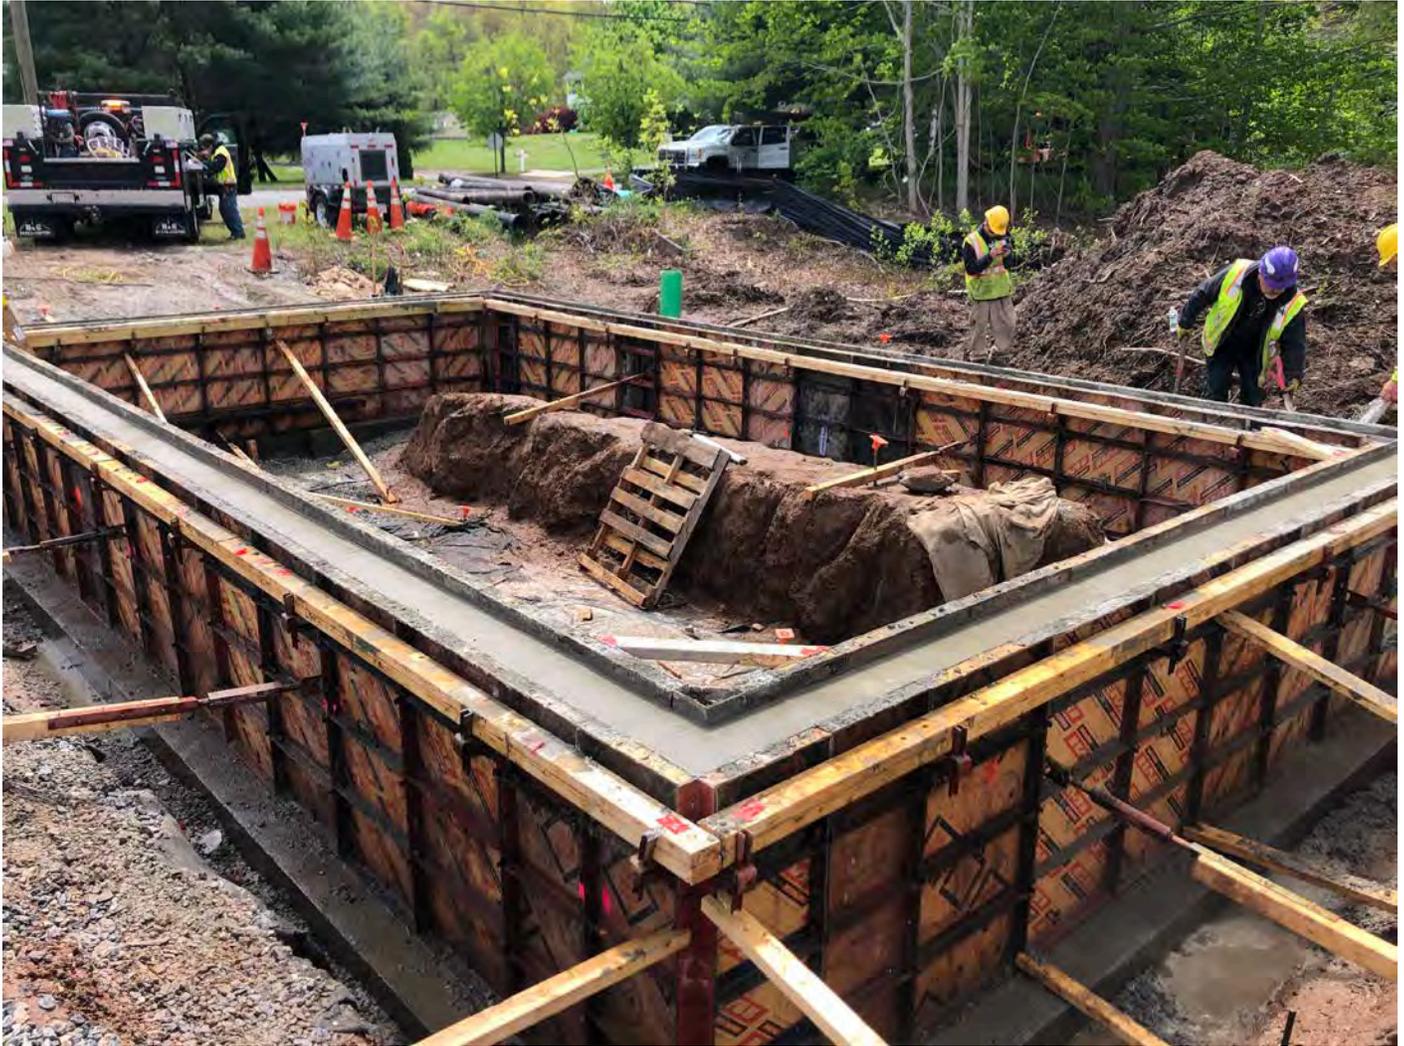
Picture 11: Overview of the frost wall that was placed today at the booster station work zone in Middletown. View to the southeast.

1251: Ludlow is performing finish work on the top of the concrete on the frost wall at the booster station work zone located at Station 750+63 in Middletown. Elevation checks are being performed periodically to make sure the top of the wall is level.
