Daily Report

Project:	Durham Meadows Pipeline Installation	Date:	May 18, 2021
Location:	S. Main Street and the Shared Access Driveway, Middletown	Day of Week:	Tuesday
Project #:	AECOM: 6061487	Report No:	245
Contractor:	Ludlow Construction	Page:	1 of 11

Pipe Connections, Installations, and Other Work

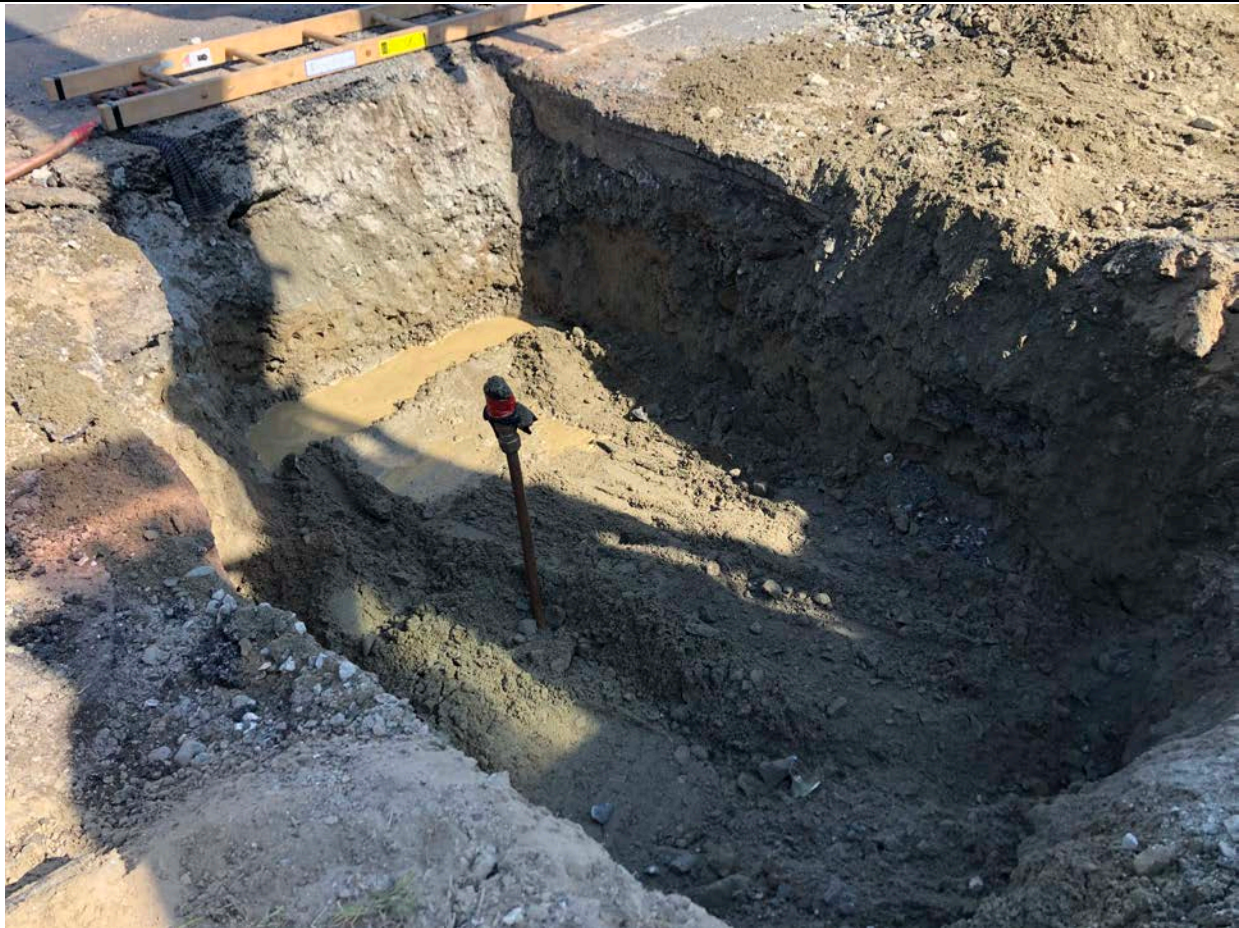
Picture 2: 1" copper blowoff that is attached to a 1" corporation stop that Ludlow installed on 8" DIP at Station 700+00 today. View to the northeast.

0932: Ludlow has finished tapping the 8" DIP at Station 700+00 and have installed a 1" corporation stop with a 1" copper line attached to it for air release and as a potential chlorination point.

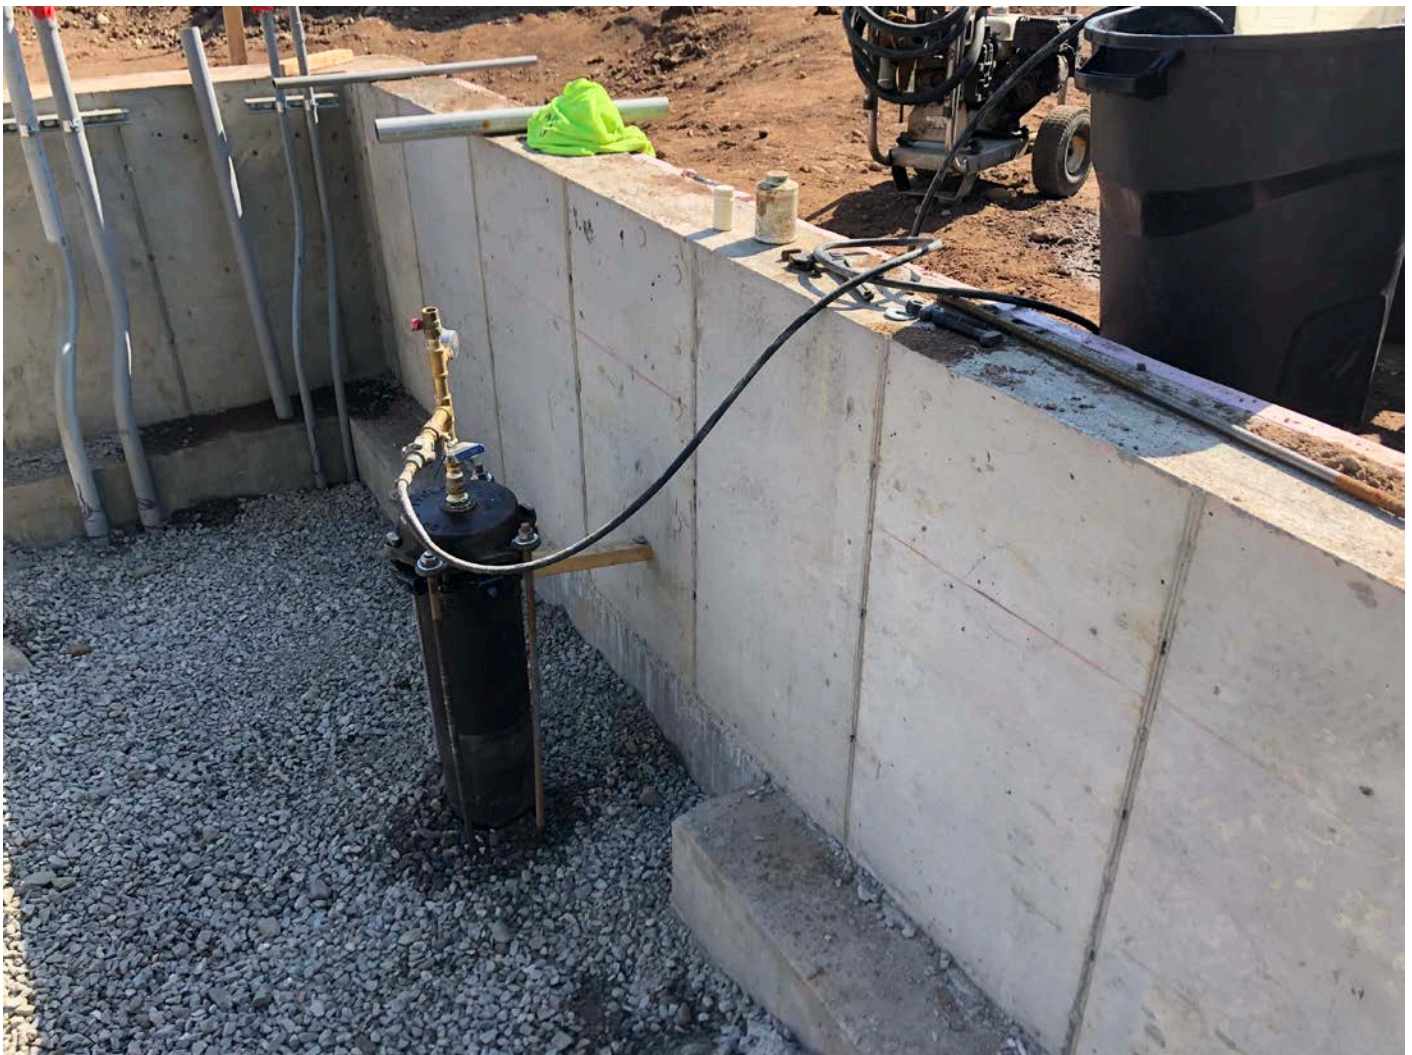
Picture 3: Pressure test setup at the booster station footprint at Station 750+63 in Middletown. View to the northeast.

0816: Ludlow is setting up to start a pressure test of the piping at the booster station work zone. They have attached testing equipment and pressure gauge to the top of the vertical section of 8" DIP located on the east side of the frost wall interior.

1030 Ludlow begins to pressure test 8" DIP at the booster station footprint. The starting pressure is 200 PSI.

1235: Ludlow concludes the pressure test performed on 8" DIP at the booster station work zone. The final pressure is 195 PSI.

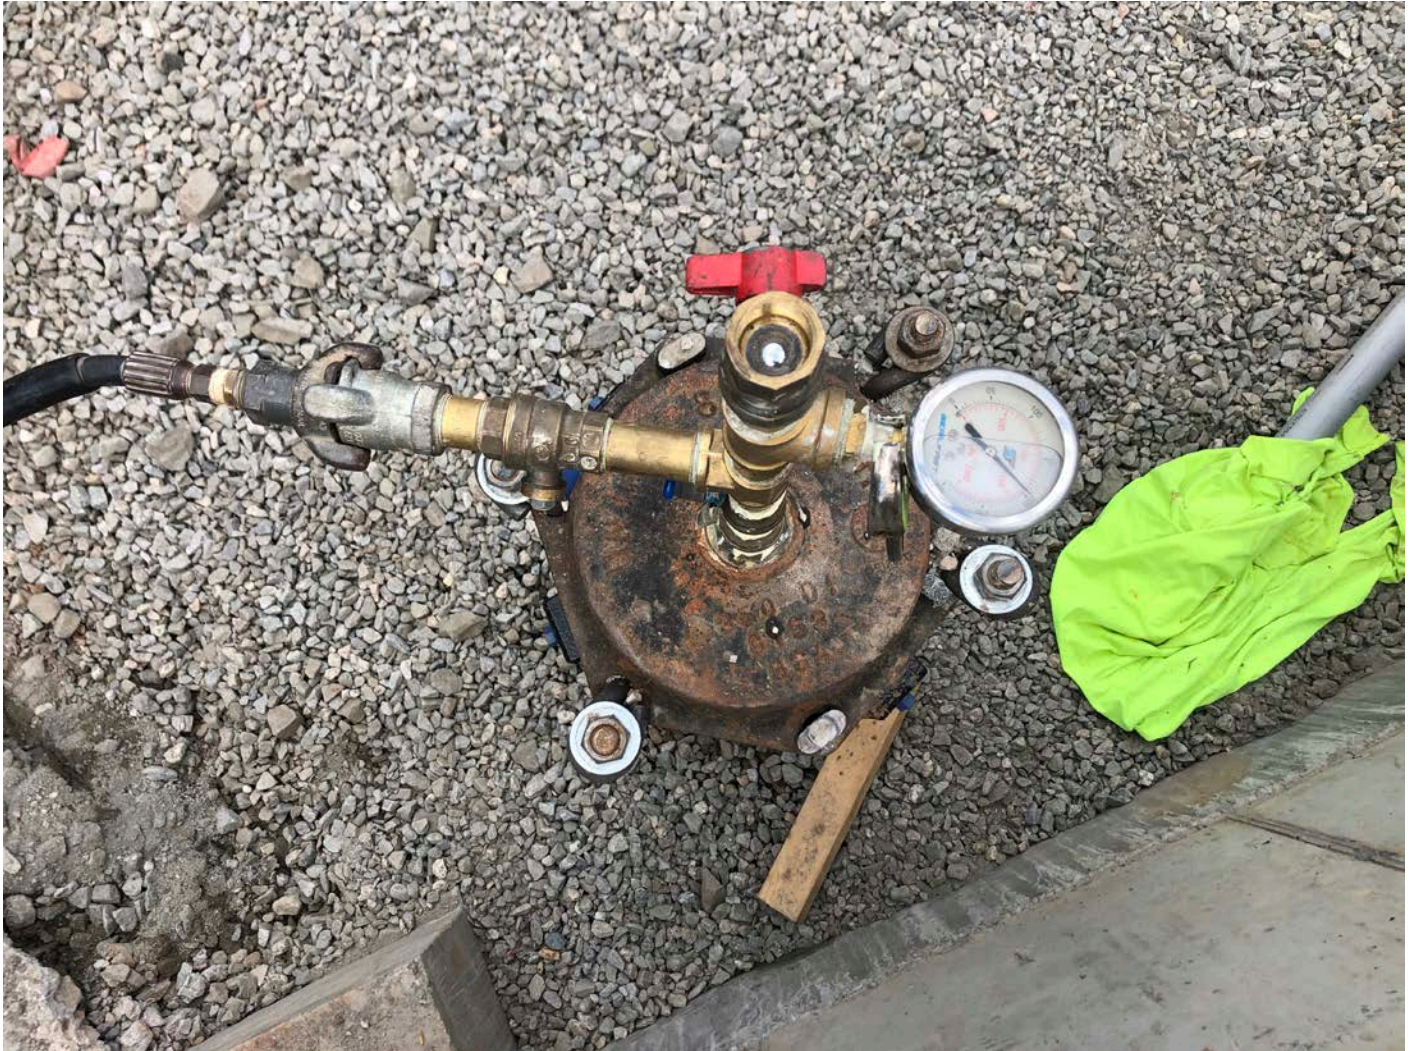
Picture 4: Pressure test setup at the booster station footprint located at Station 750+63 in Middletown, looking down at the pressure gauge. View to the northeast.

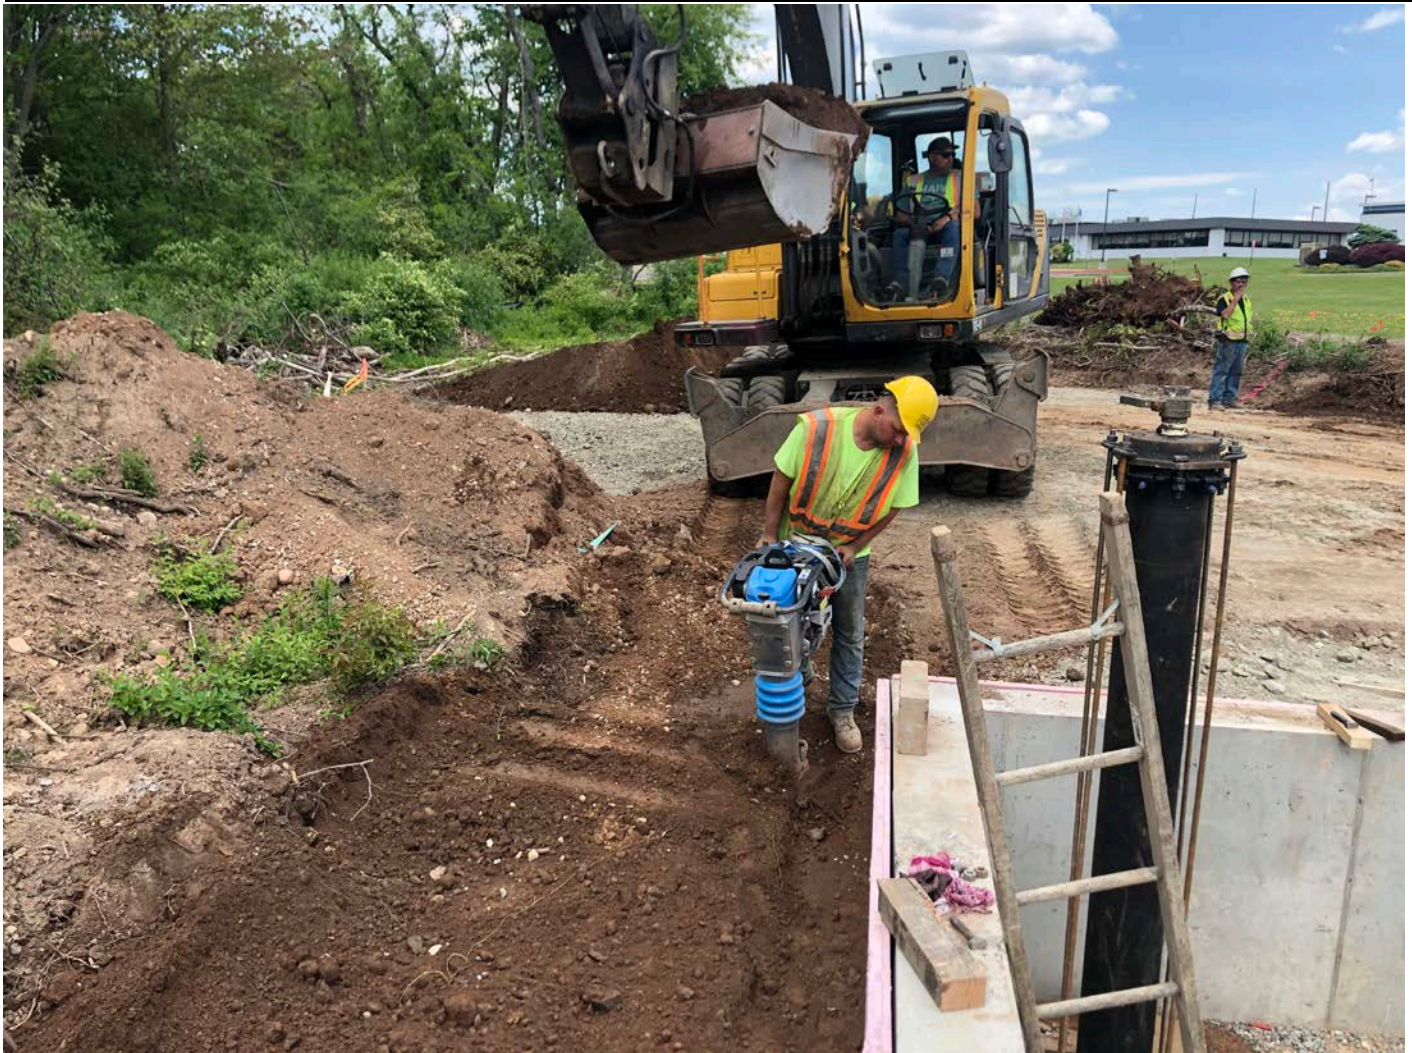
Picture 5: Ludlow compacting fill with a jumping jack along the south side of the booster station frost wall. Station 750+63, Middletown. View to the west.

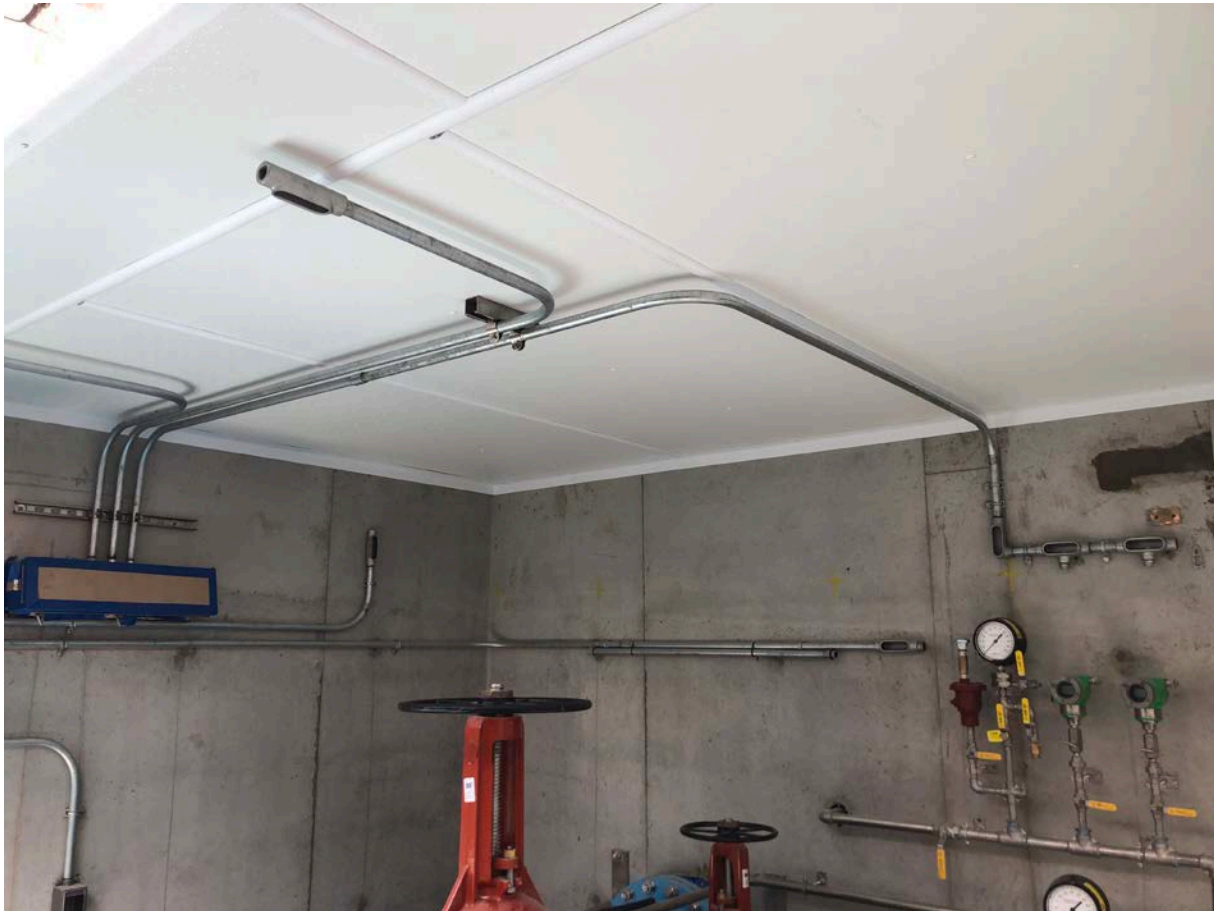
Picture 6: Rigid galvanized steel electrical conduit in the process of being installed by United Concrete at the altitude valve vault located east of the Shared Access Driveway in Middletown.

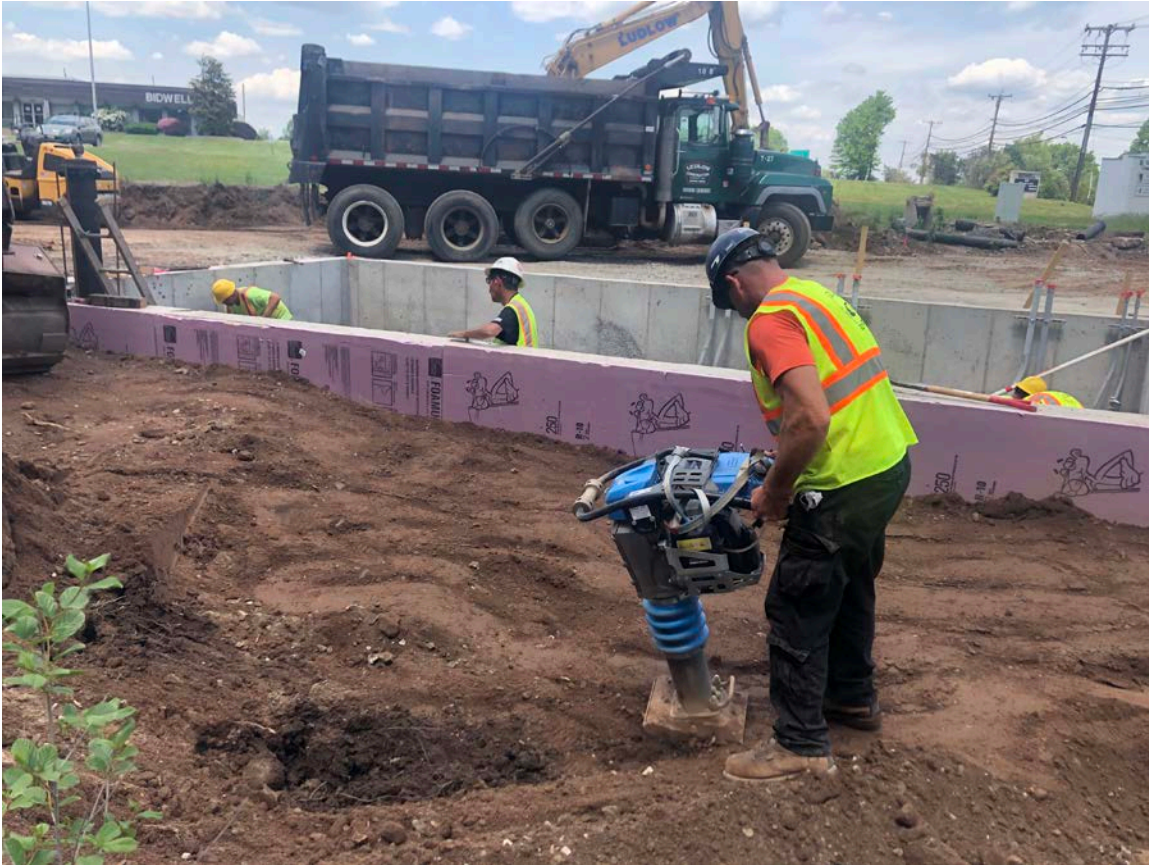
Picture 7: Ludlow compacting fill with a jumping jack south of the booster station footprint. Station 750+63, Middletown. View to the north.

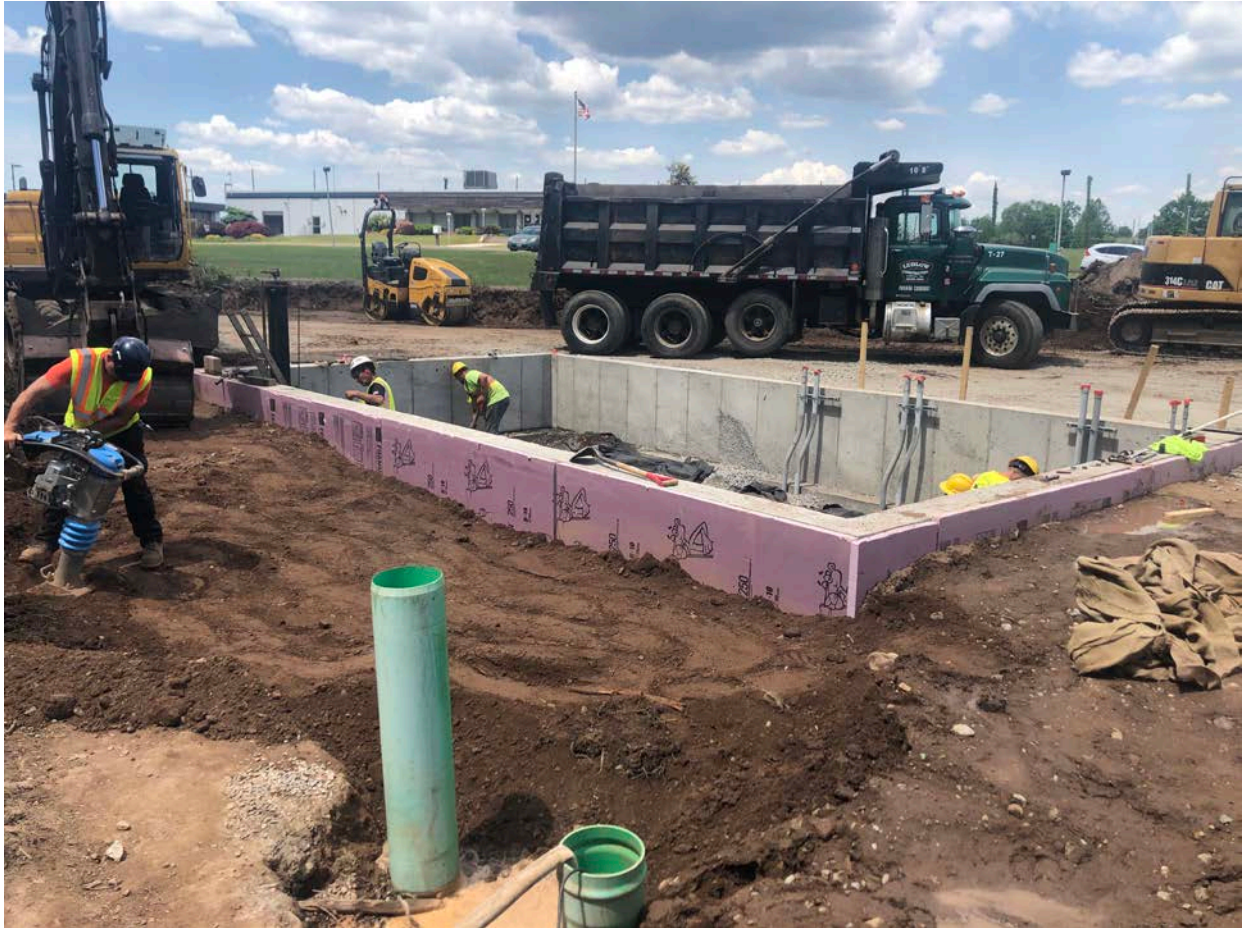
Picture 8: Overview of progress at the booster station footprint located at Station 750+63 in Middletown. View to the north.

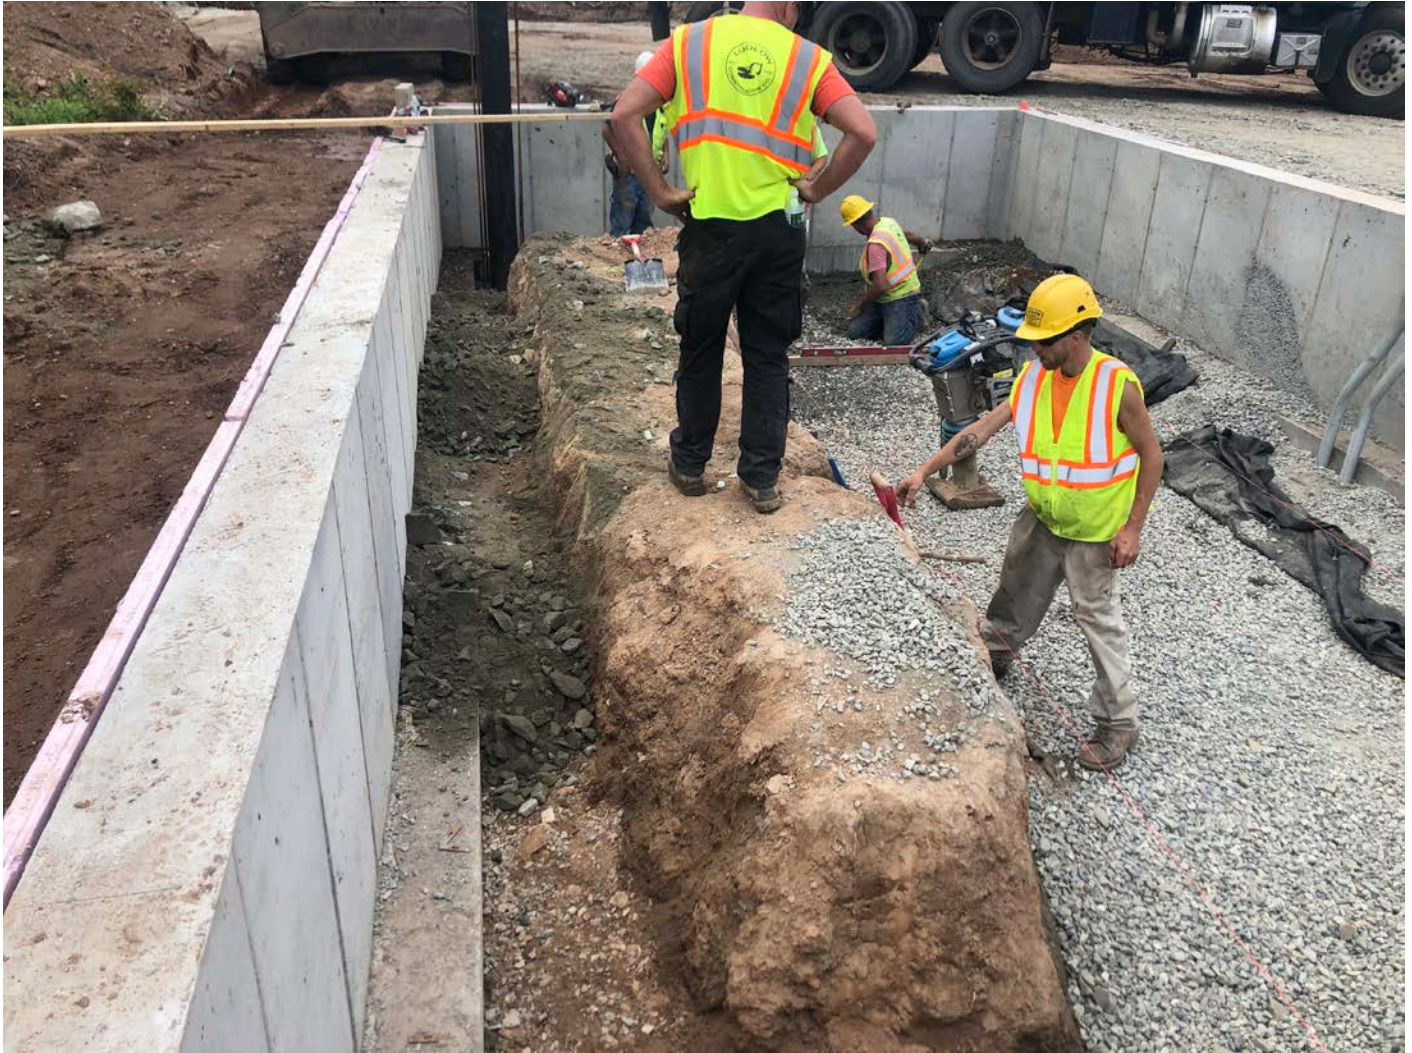
Picture 9: Ludlow in the process of placing backfill on the north side of the southern frost wall at the booster station work zone. View to the west.
