Daily Report

Project:	Durham Meadows Pipeline Installation	Date:	May 19, 2021
Location:	S. Main Street and the Shared Access Driveway, Middletown	Day of Week:	Wednesday
Project #:	AECOM: 6061487	Report No:	246
Contractor:	Ludlow Construction	Page:	1 of 13

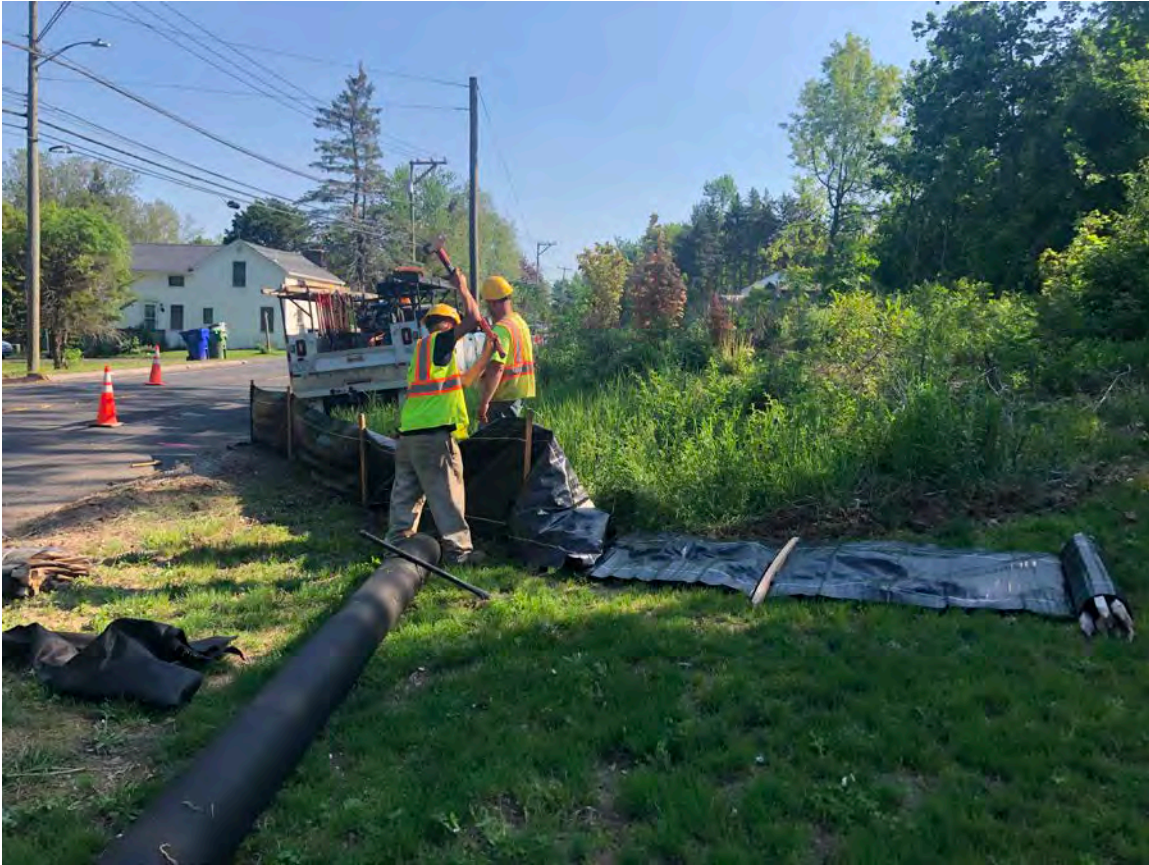
Picture 1: Ludlow installing silt fence at the water meter building work zone located at ~Station 124+80. S. Main Street, Middletown. View to the north.

0842: Ludlow is installing silt fence around the water meter building work zone located at Station ~124+80 in Middletown.

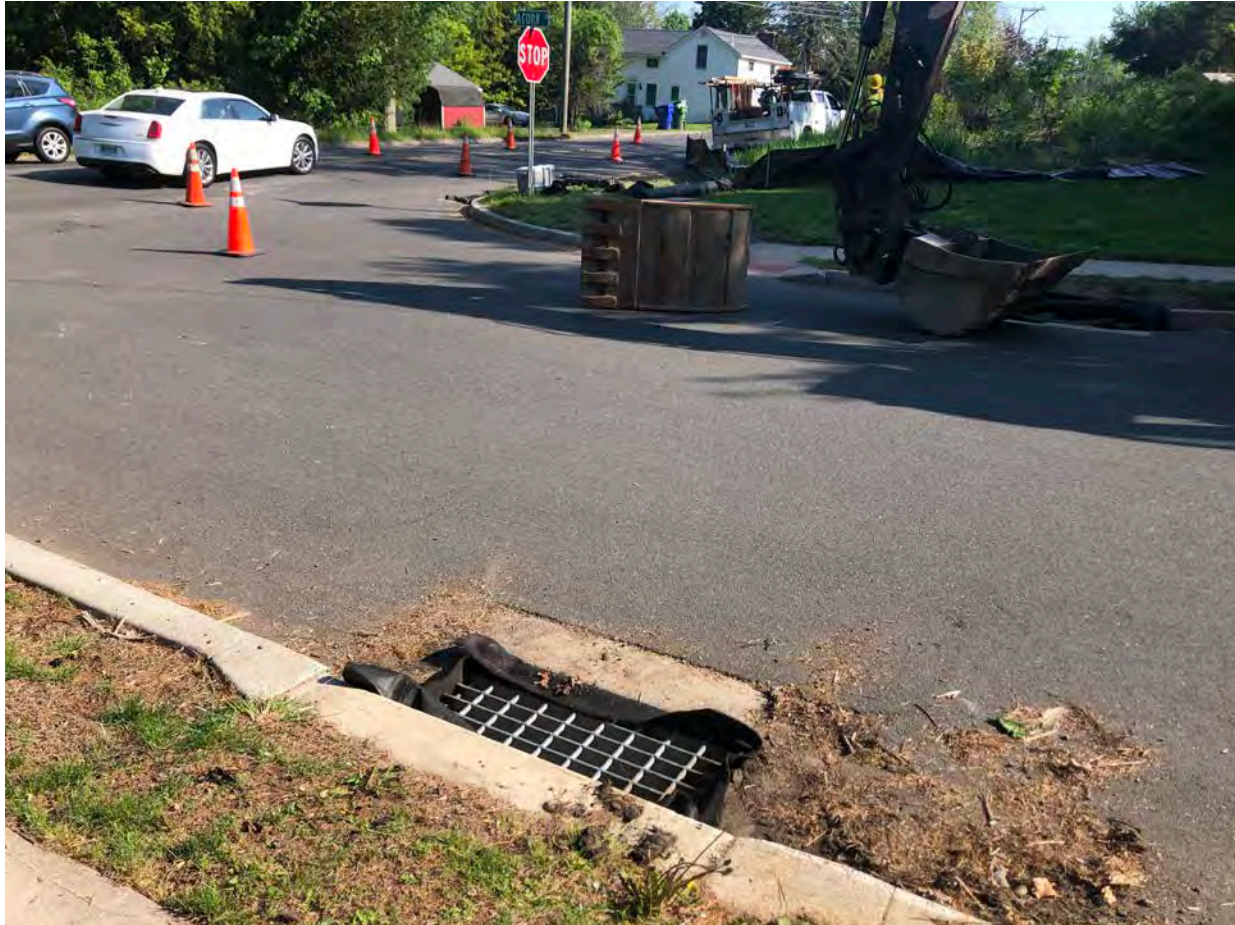
Picture 2: Geofabric placed under a catch basin grate next to the water meter building work zone located at ~Station 124+80. S. Main Street, Middletown. View to the northwest.

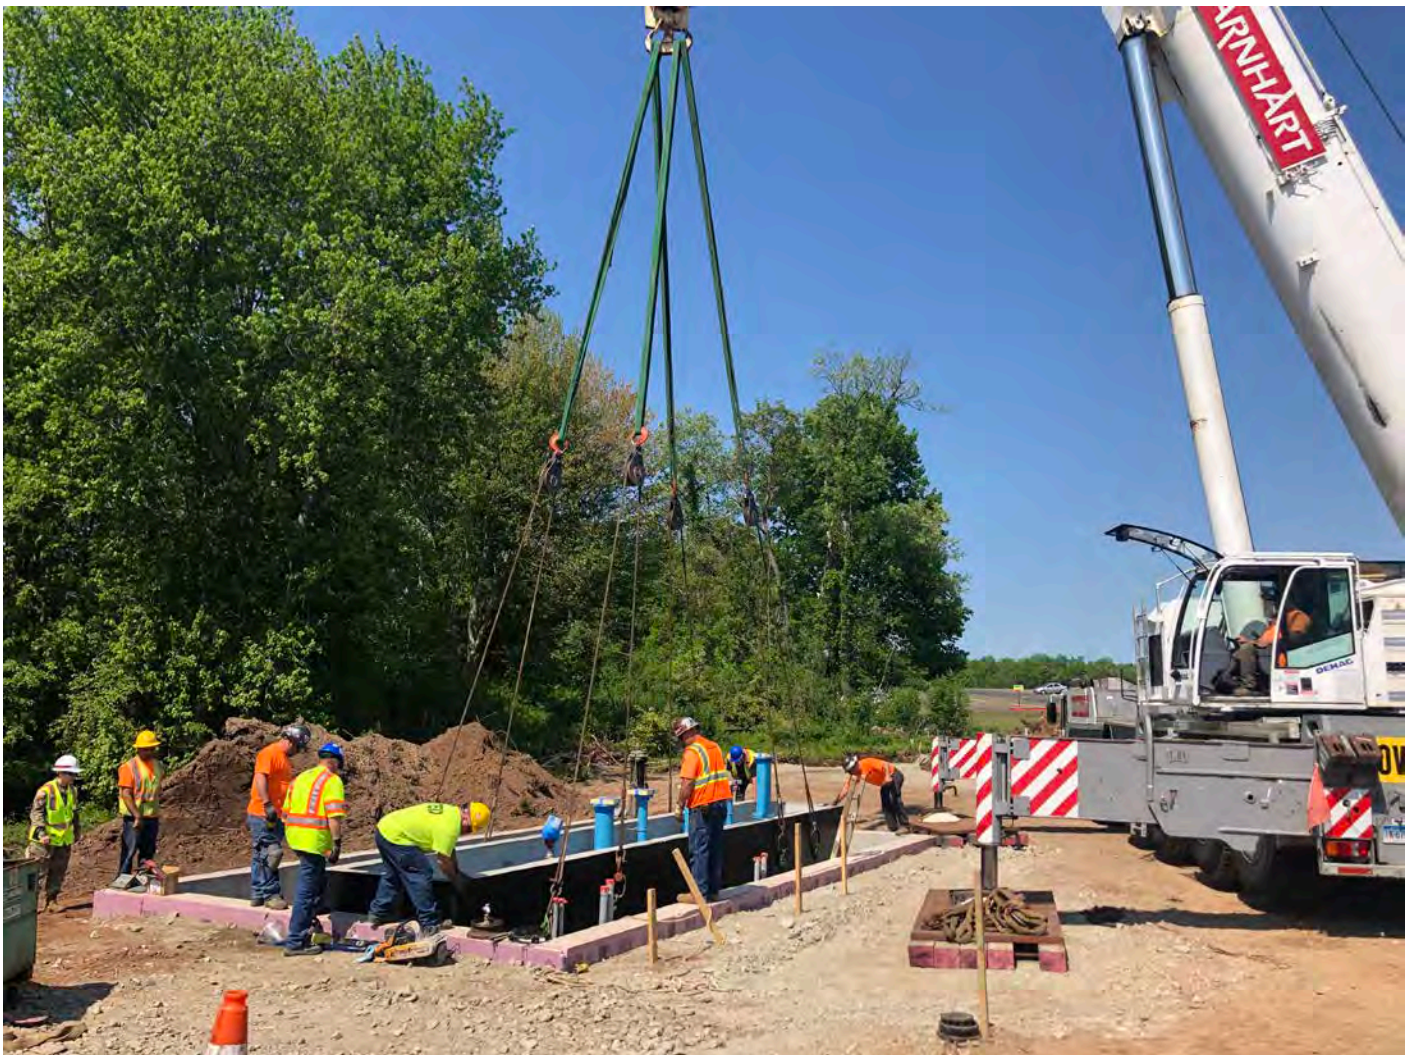
Picture 3: Barnhart lowering the trough into the booster station footprint at Station 750+63 in Middletown. View to the west/southwest.

1031: Barnhart and United Concrete are setting the trough inside of the booster station footprint.

1220: Barnhart has lifted the booster station trough into place for the final time. United Concrete is drilling into the sides of the trough and the frost wall (from the interior) in order to attach brackets that will connect the frost wall to the trough.

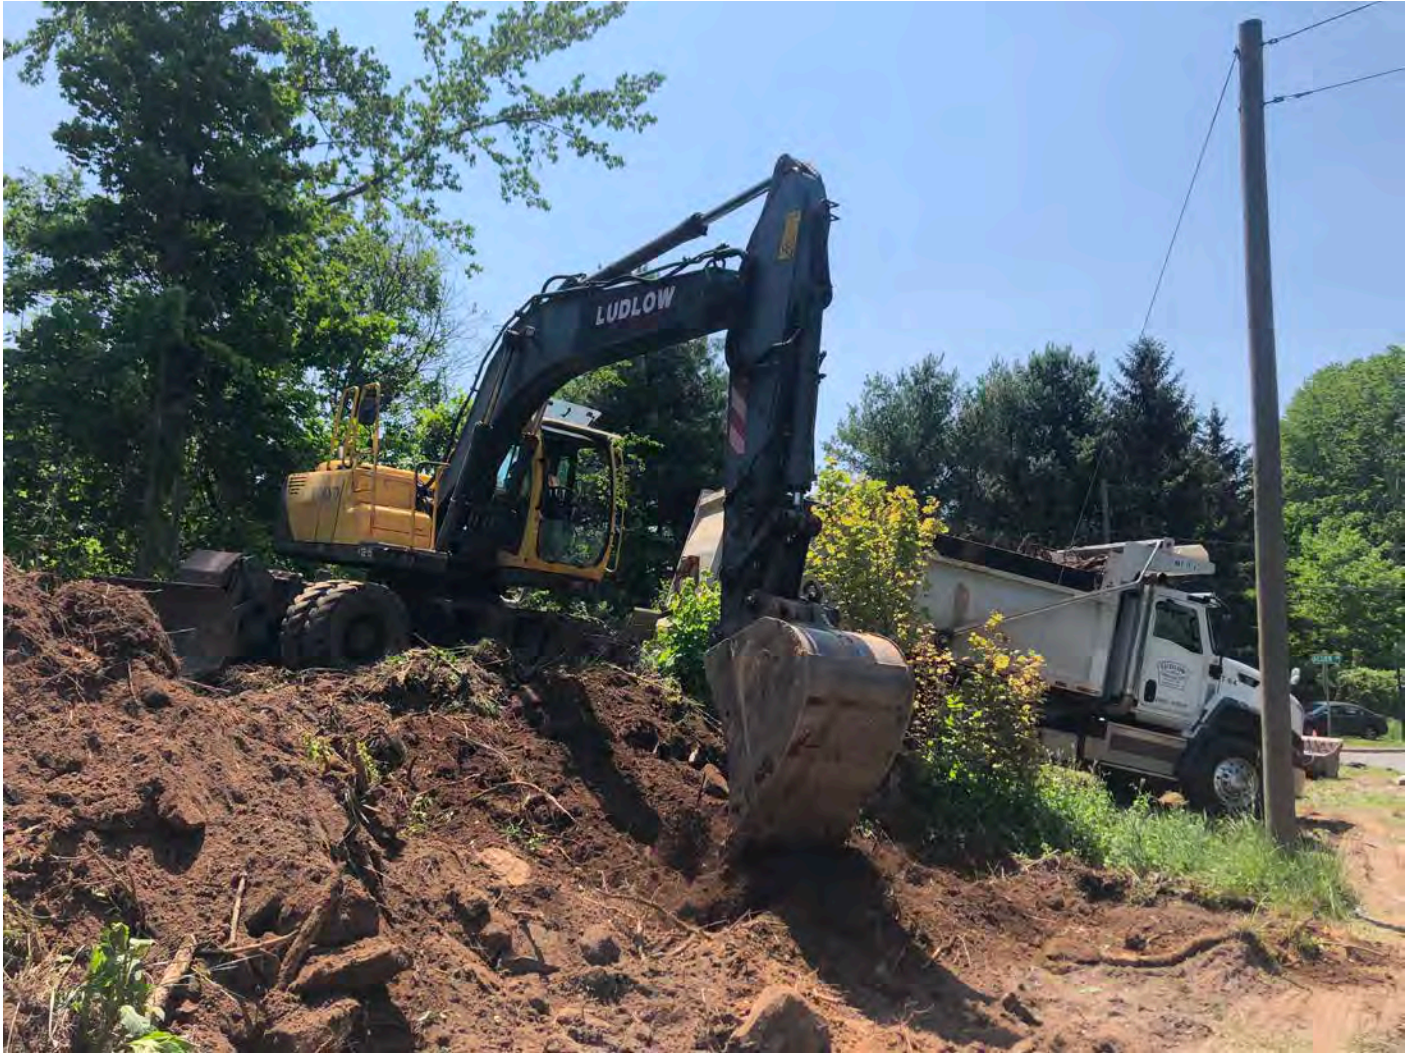
Picture 4: Ludlow clearing and grading at the water meter building work zone located at ~Station 124+80. S. Main Street, Middletown. View to the southeast.

1125: Ludlow has begun clearing and grading the water meter building work zone located at Station ~124+80 in Middletown.

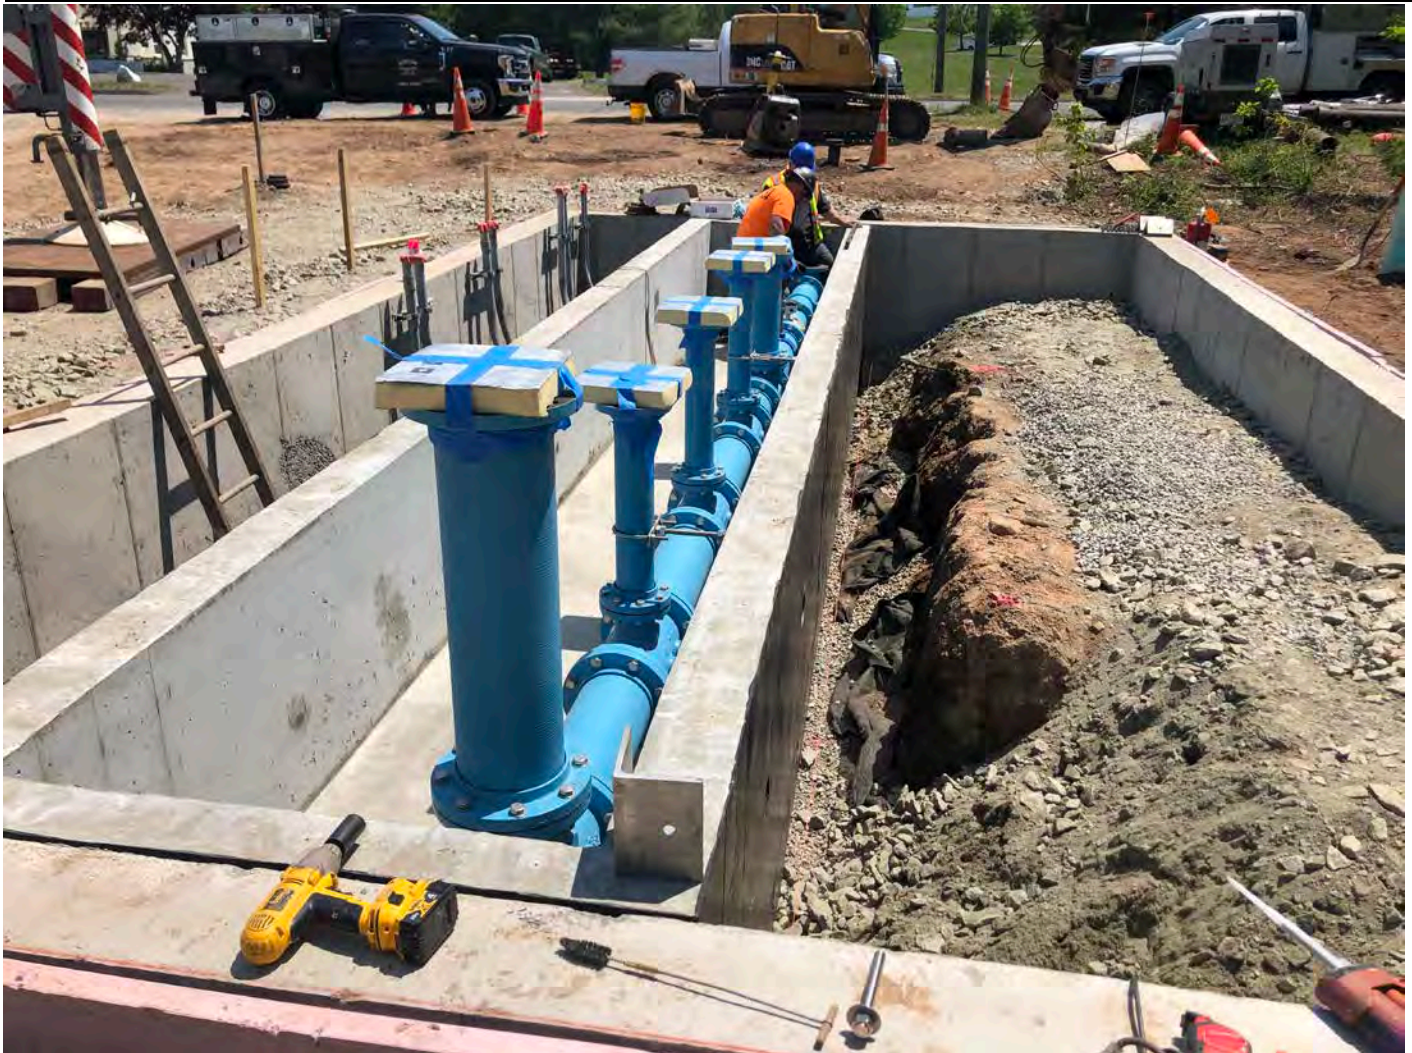
Picture 5: View of the trough after it was placed inside the booster station footprint. Station 750+63, Middletown. View to the east/northeast.

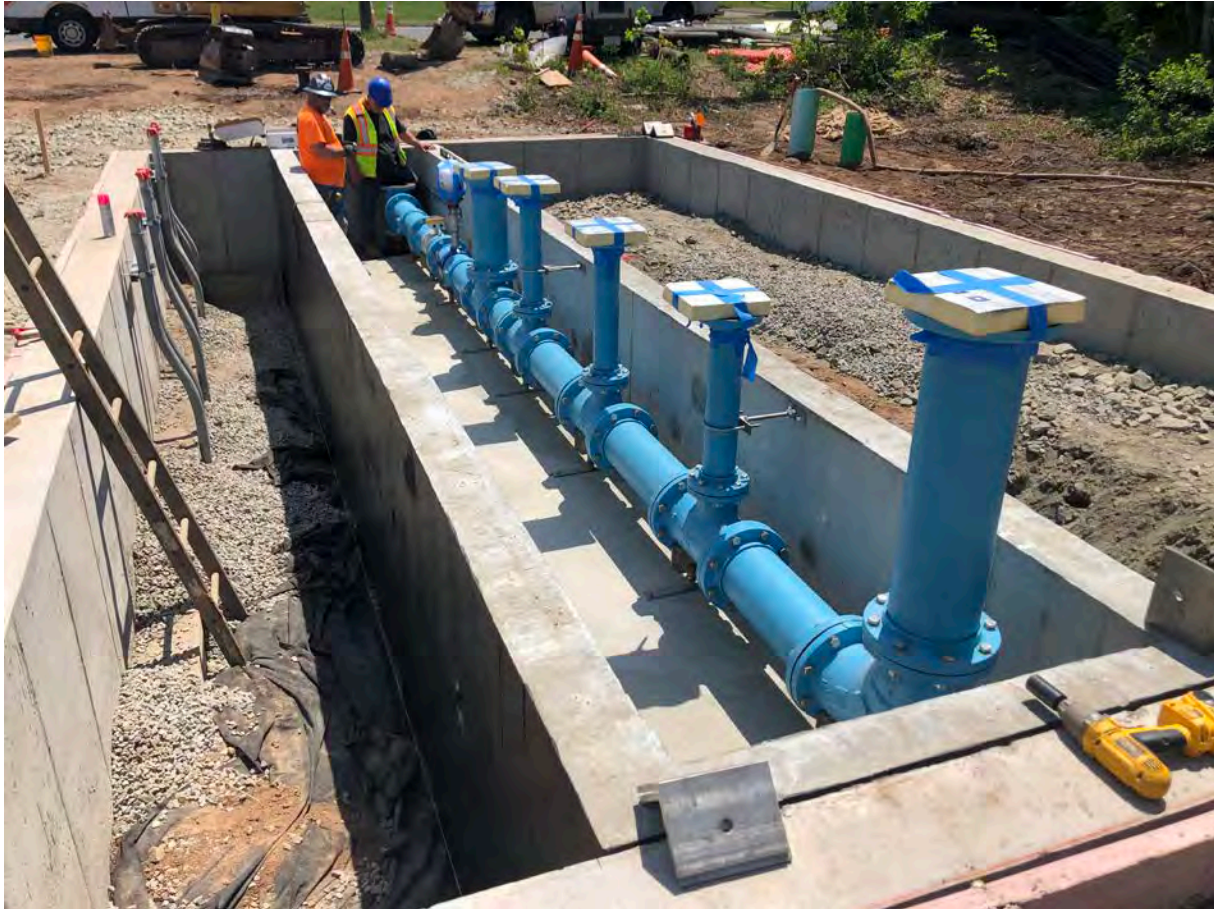
Picture 6: Another view of the trough after placement inside the booster station footprint. Station 750+63, Middletown. View to the east/southeast.

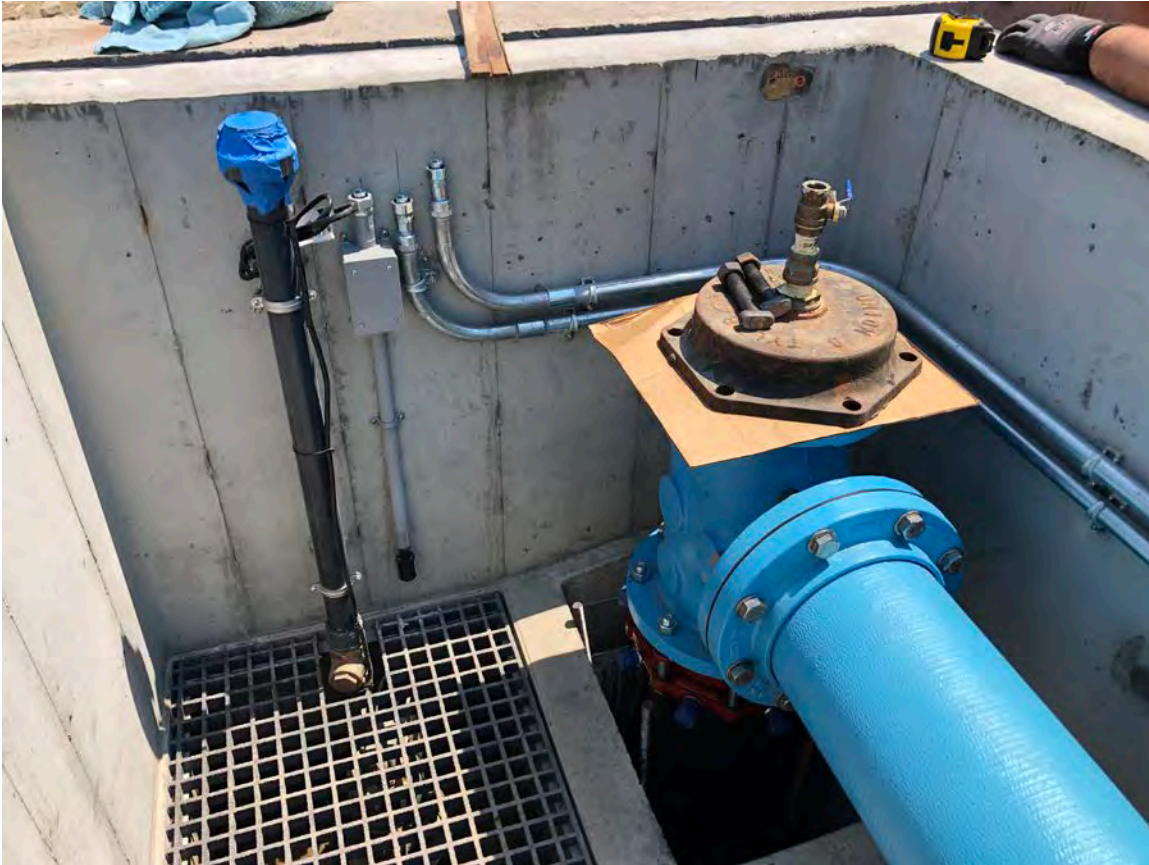
Picture 7: View of where piping that arrived within the trough is connected to the vertical section of 8" DIP located on the interior of the eastern frost wall of the booster station. Station 750+63, Middletown. View to east/southeast.

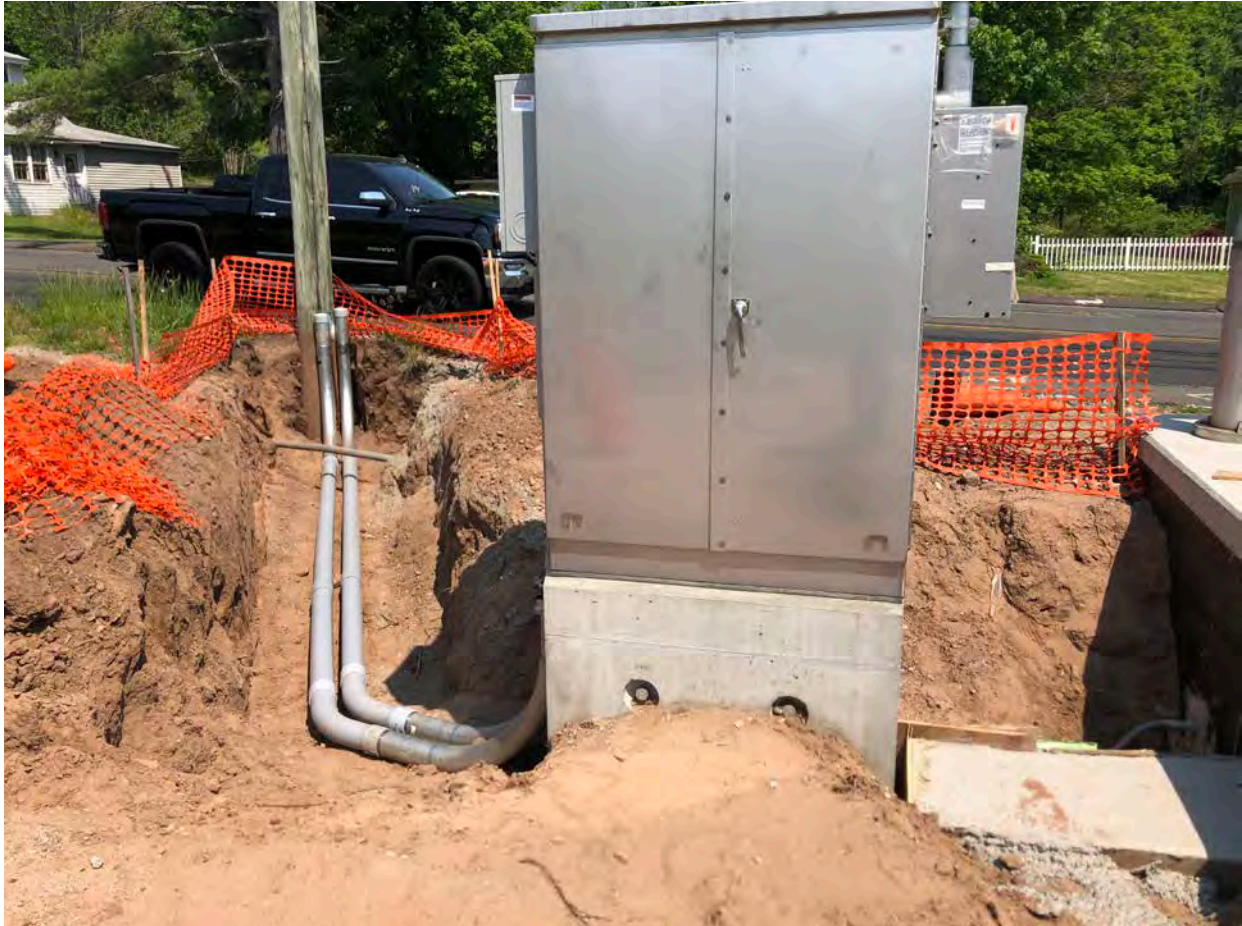
Picture 8: Overview of progress at the pressure reducing vault, where A&R Electric installed PVC conduits with steel sweeps. ~Station 161+40, Main Street, Durham. View to the east.

1504: A&R Electrical finished installing the ground line for the electrical enclosure next to the pressure reducing vault and the conduits between the enclosure and the power sweeps used for the conduit are 4" diameter rigid galvanized steel. The trenches made for the placement of the conduits and the copper ground line have not been backfilled yet. Ludlow is currently placing snow fence around the trench for safety purposes.

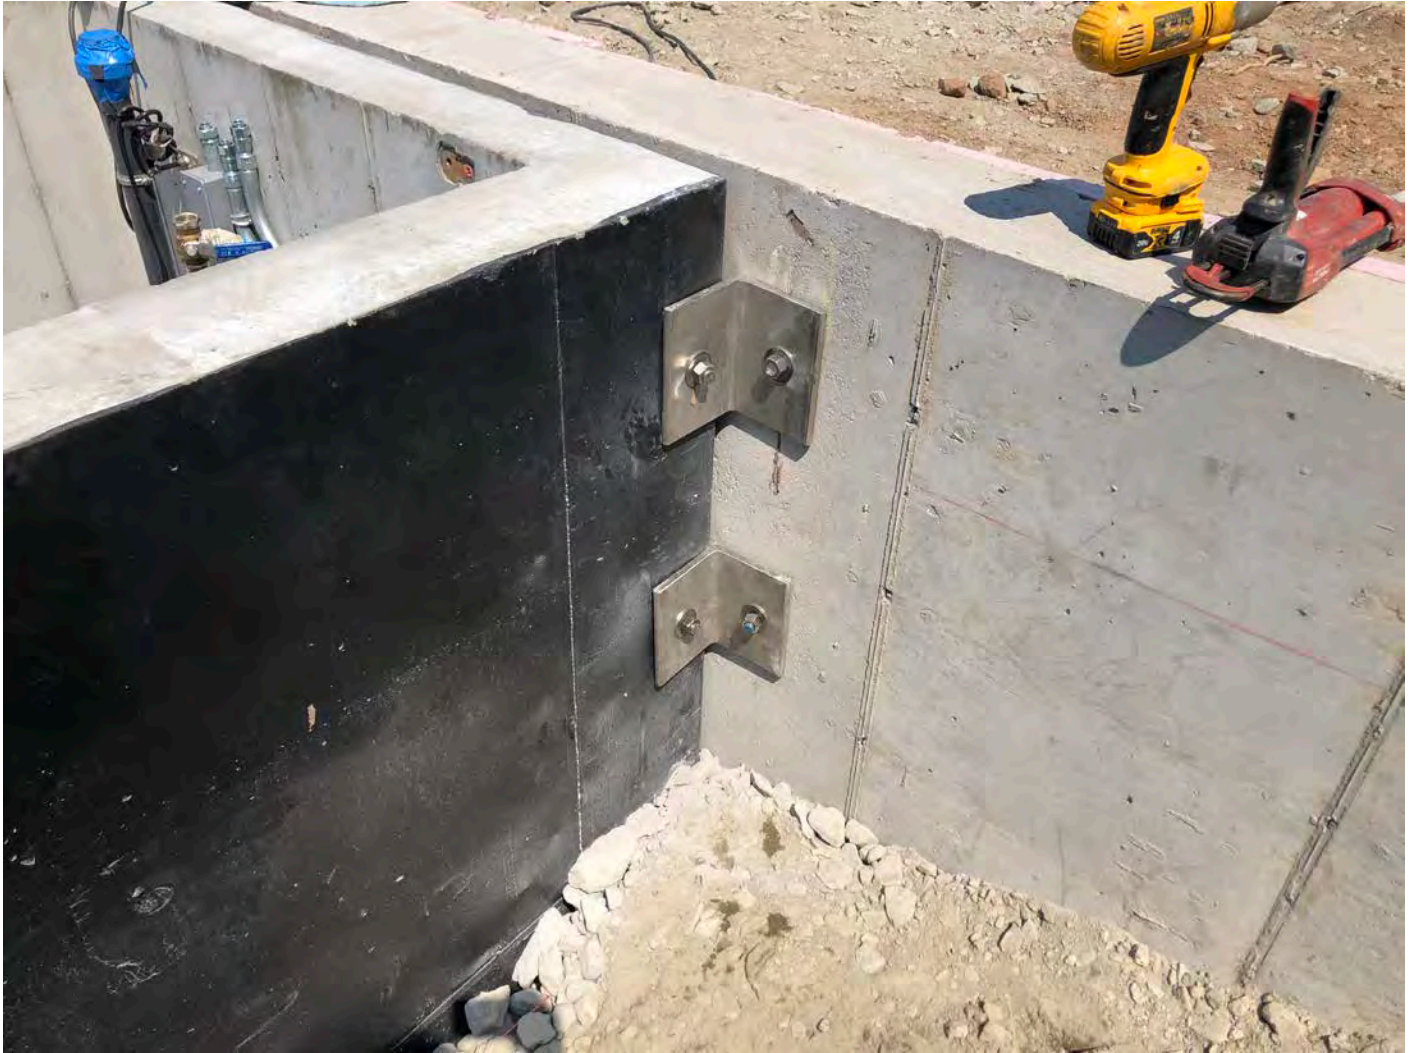
Picture 9: Metal brackets that United Concrete installed that connect the booster station frost wall to the trough they placed today.

1306: United Concrete continues to drill into the sides of the frost wall from the interior in order to attach brackets that will connect the frost wall to the trough.

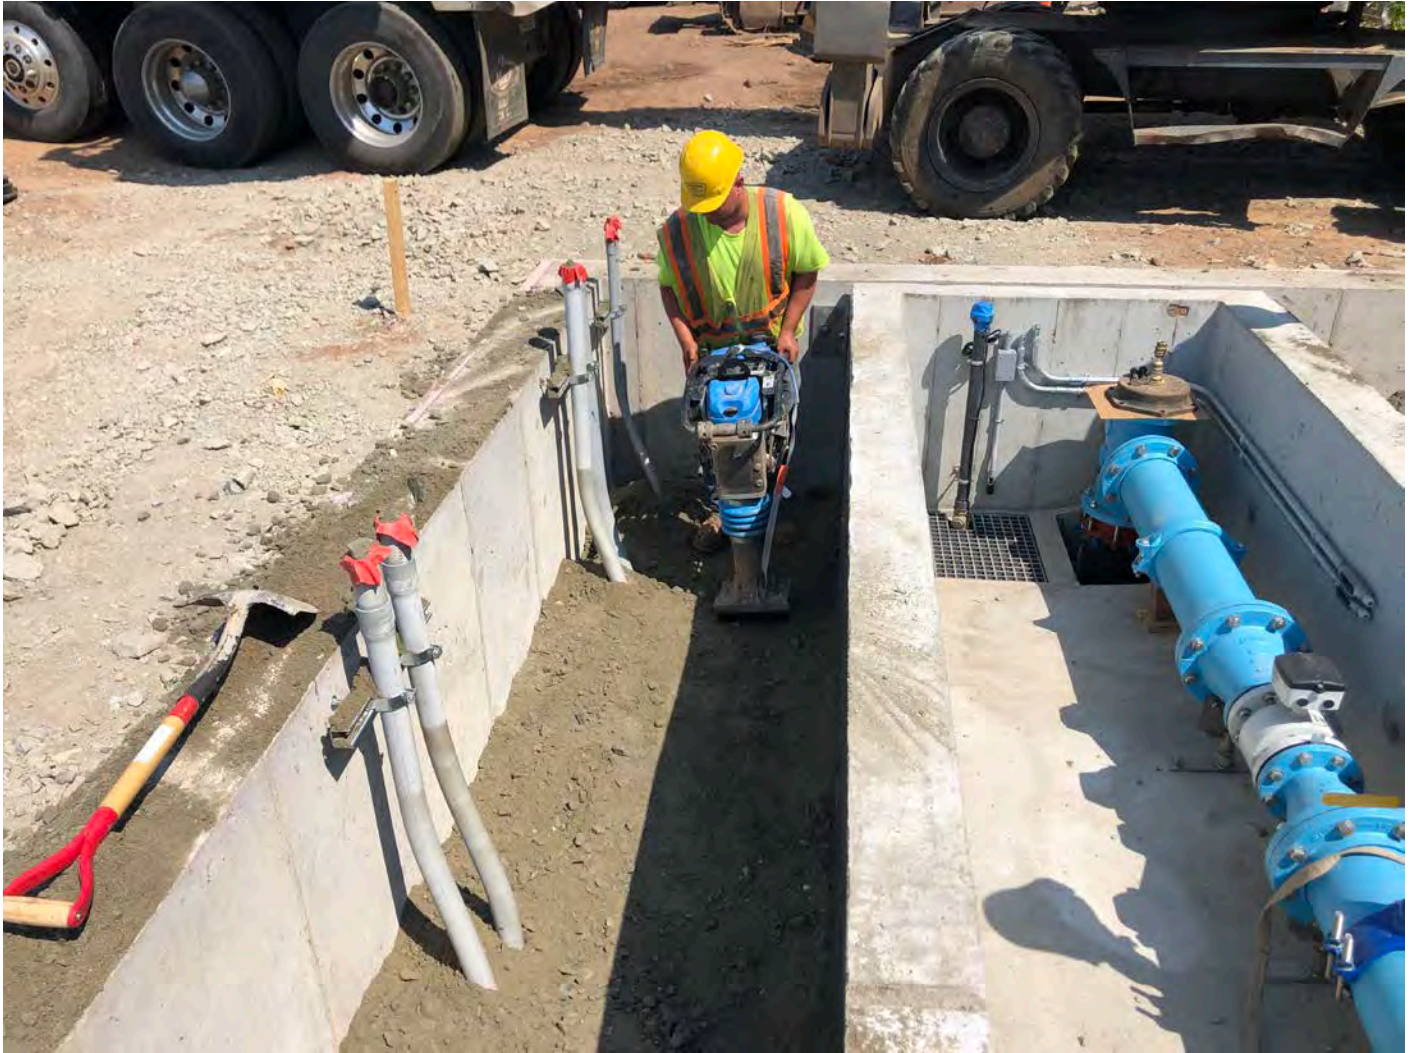
Picture 10: Ludlow compacting fill on the north side of the trough at the booster station footprint. View to the east.

1443: Ludlow begins to place and compact fill on either side of the trough that was placed today at the booster station footprint. Ludlow is filling in 1' lifts and are compacting with a jumping jack.
