## Daily Report

<b>Project:</b>	Durham Meadows Pipeline Installation	<b>Date:</b>	May 21, 2021
<b>Location:</b>	S. Main Street and the Shared Access Driveway, Middletown	<b>Day of Week:</b>	Friday
<b>Project #:</b>	AECOM: 6061487	<b>Report No:</b>	248
<b>Contractor:</b>	Ludlow Construction	<b>Page:</b>	1 of 13

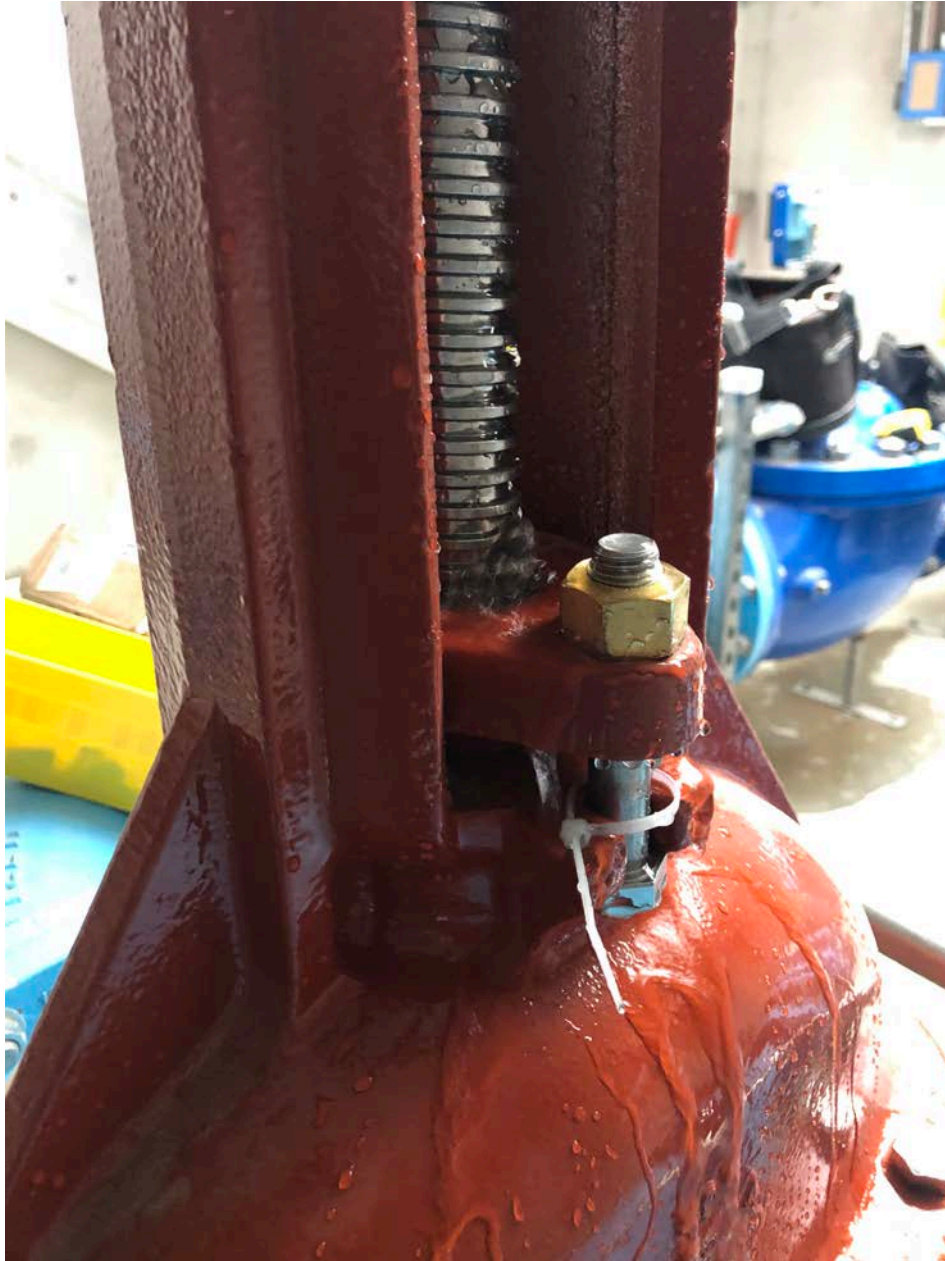
0722: Ludlow is conducting a pressure test at the altitude valve vault. A 12" gate valve inside the vault is leaking water as Ludlow sets up for the test. Ludlow shuts the valve off and ends up not testing the line the valve is on. Instead, Ludlow ends up setting up to test the bypass line located on the north side of the altitude valve vault until the issue with the 12" gate valve inside of the vault has been addressed. United Concrete continues to install electrical conduits on the interior of the altitude valve vault.

Picture 1: 12" gate valve located inside of the altitude valve vault that began to leak when Ludlow was setting up to perform a pressure test.

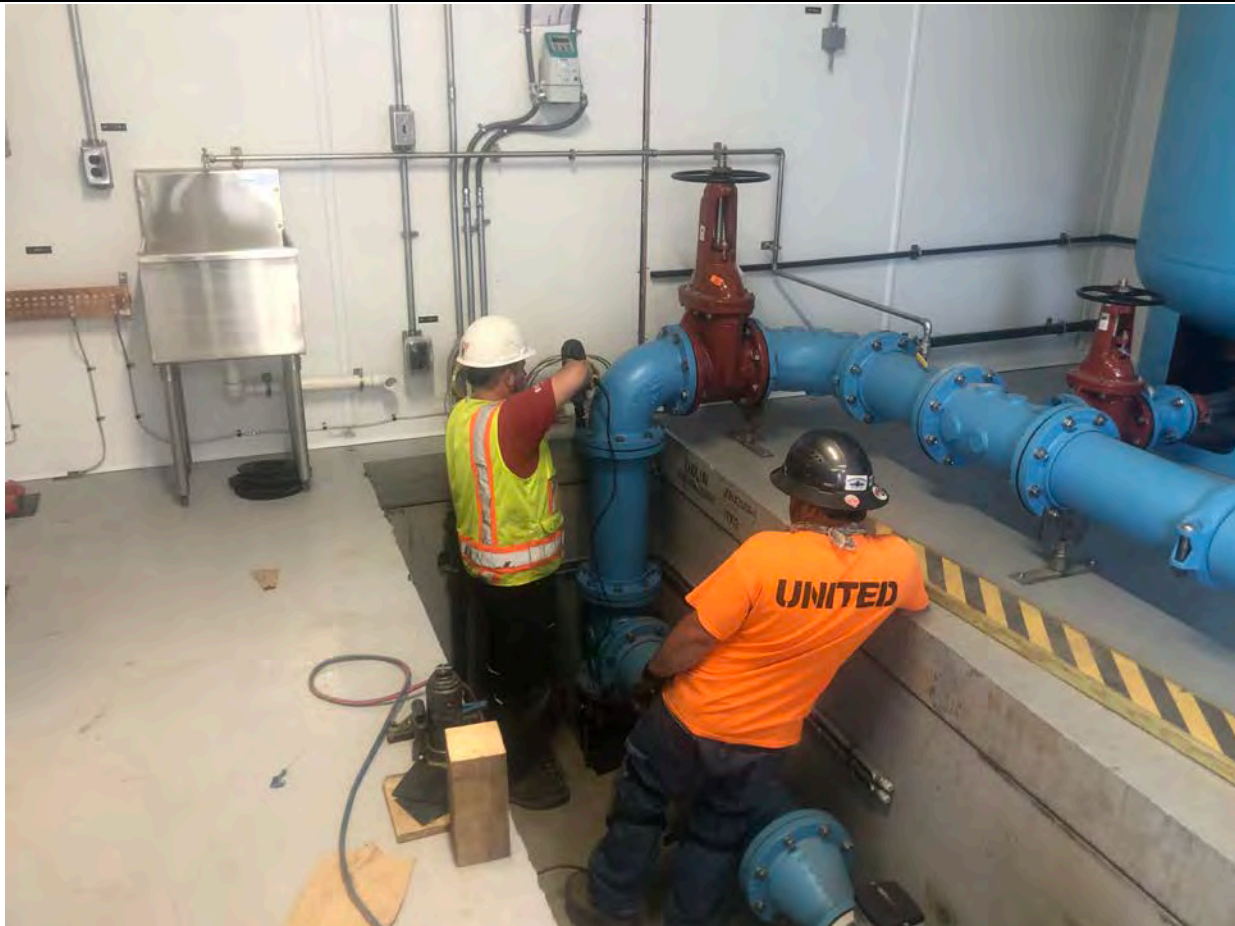
1252: United Concrete is continuing work on the booster station located at Station 750+63 in Middletown. All elbows required to connect the trough piping to the booster station piping have been installed.

Picture 2: United Concrete installing an elbow at the booster station located at Station 750+63.

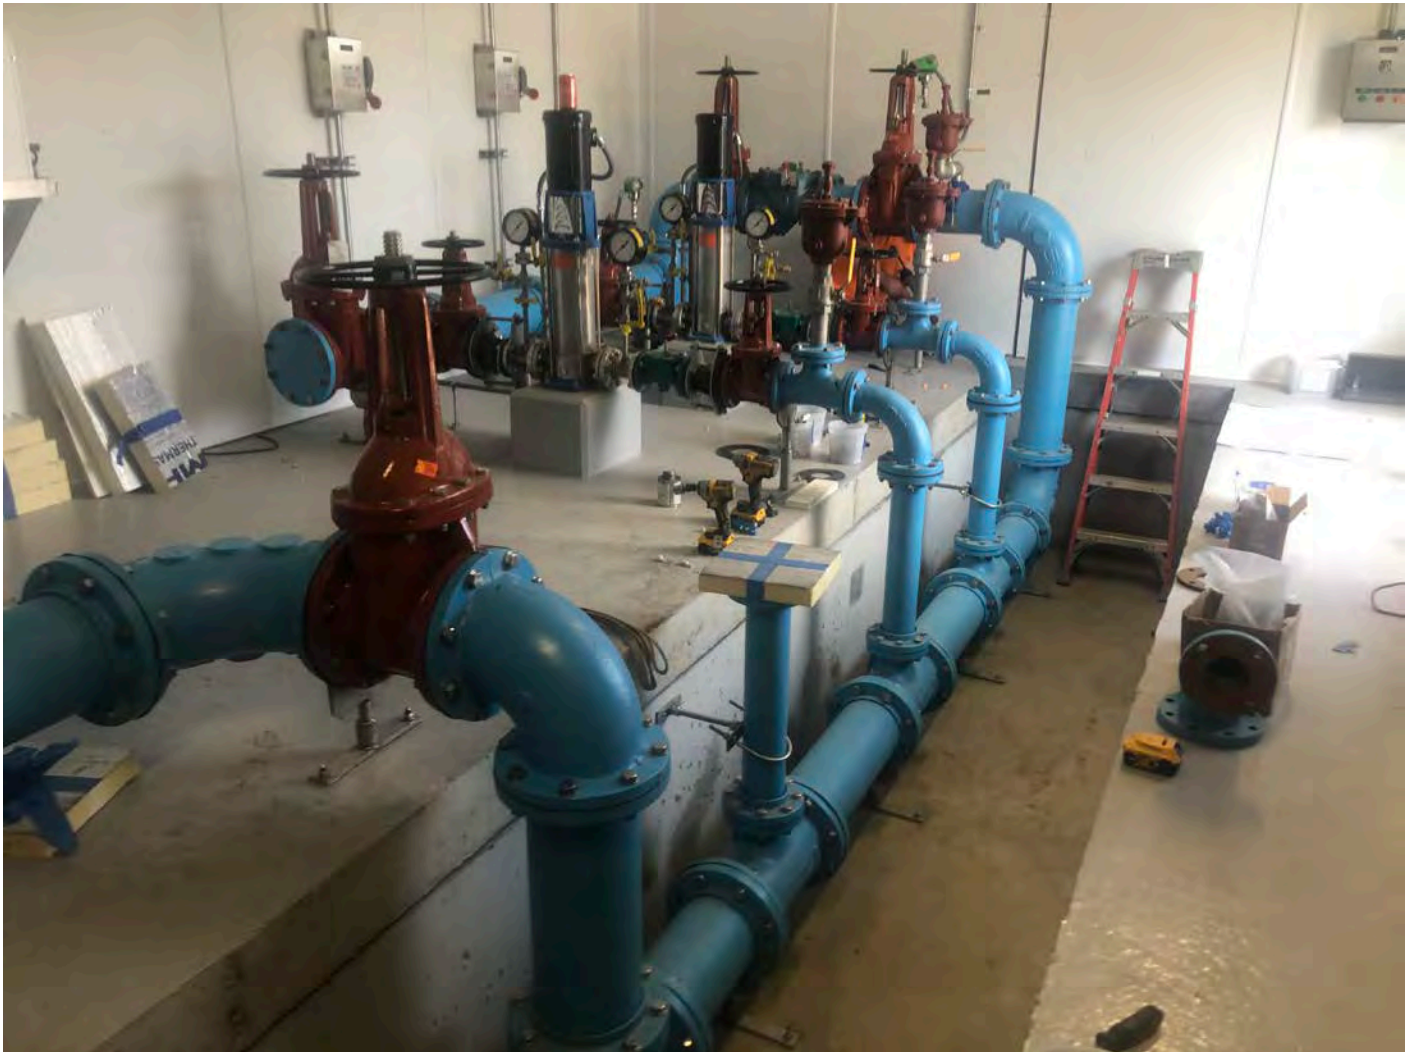
Picture 3: View of the interior of the booster station as United Concrete installs elbows on piping within the trough. View to the east.

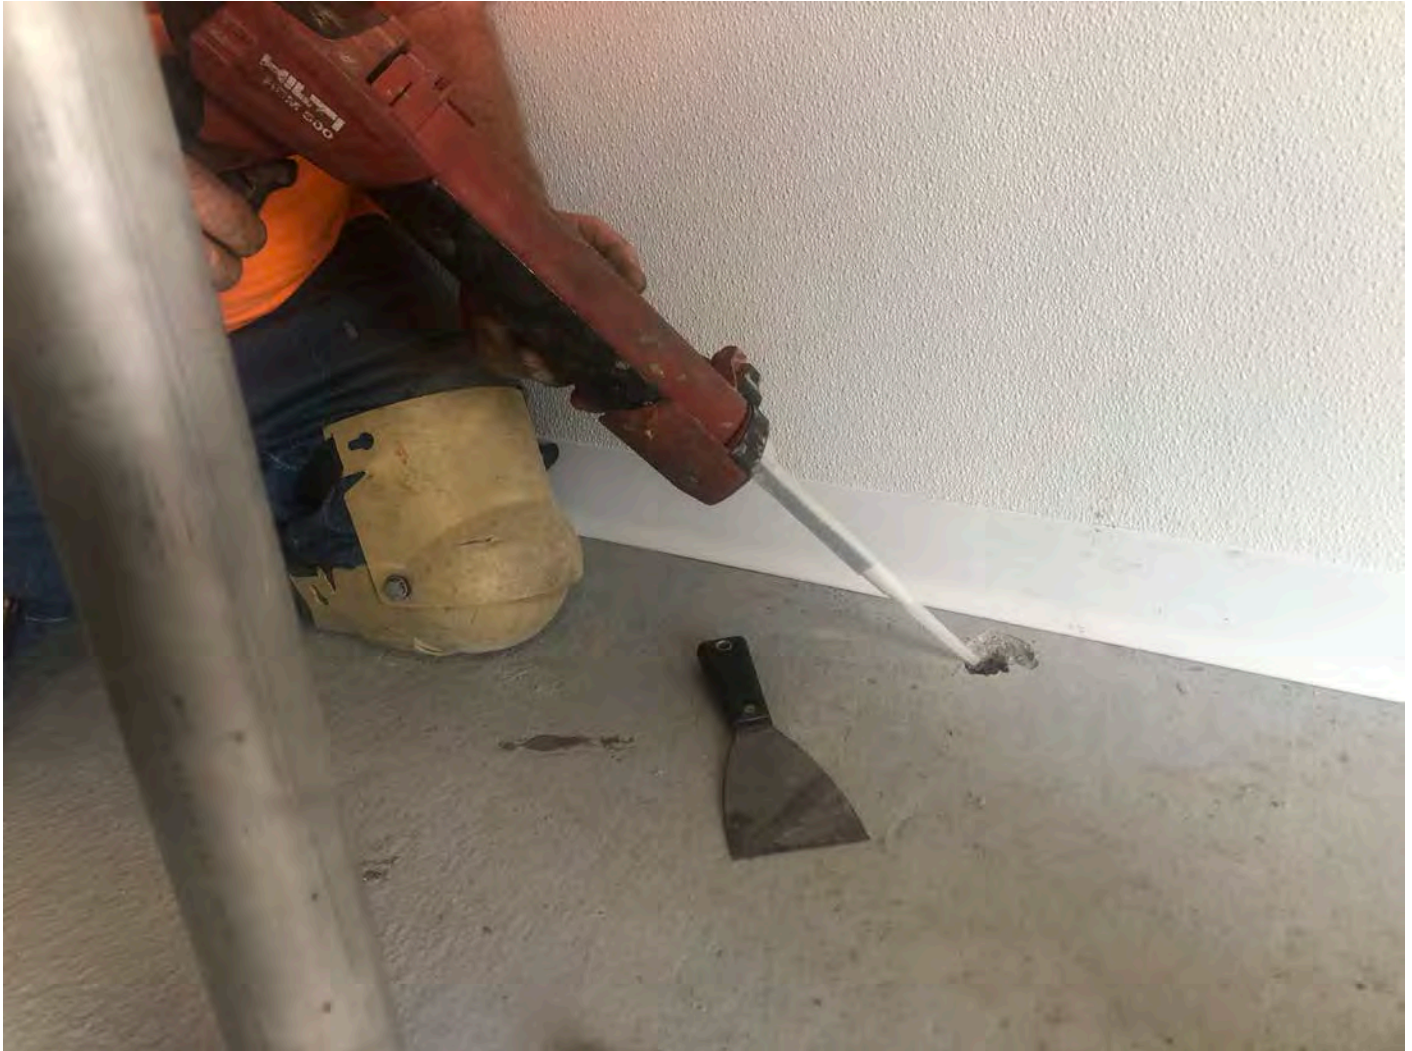
1136: United Concrete is filling holes in the booster station floor with Hilti – HIT HY 200-A (injectable hybrid mortar) where segments of rebar penetrate the floor and go into the top of the frost wall.

Picture 4: United Concrete filling holes in the booster station floor with Hilti – HIT HY 200-A (injectable hybrid mortar) where segments of rebar penetrate the floor and go into the top of the frost wall.

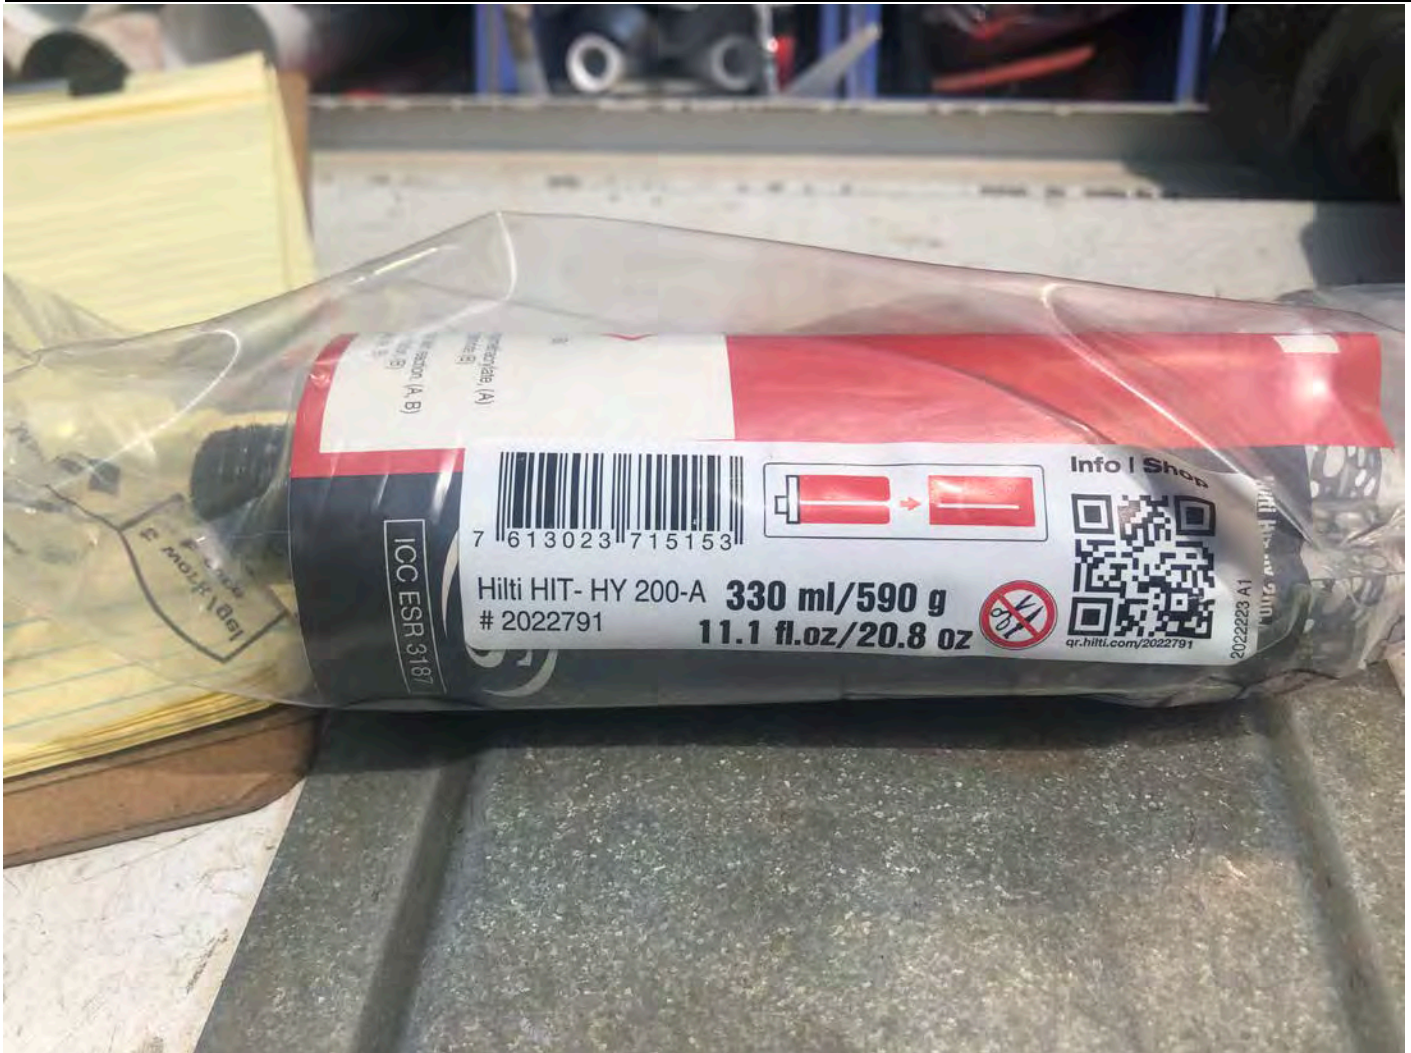
Picture 5: Hilti – HIT HY 200-A injectable hybrid mortar that United concrete is using to cover holes where segments of rebar penetrate the booster station floor and go into the top of the frost wall.

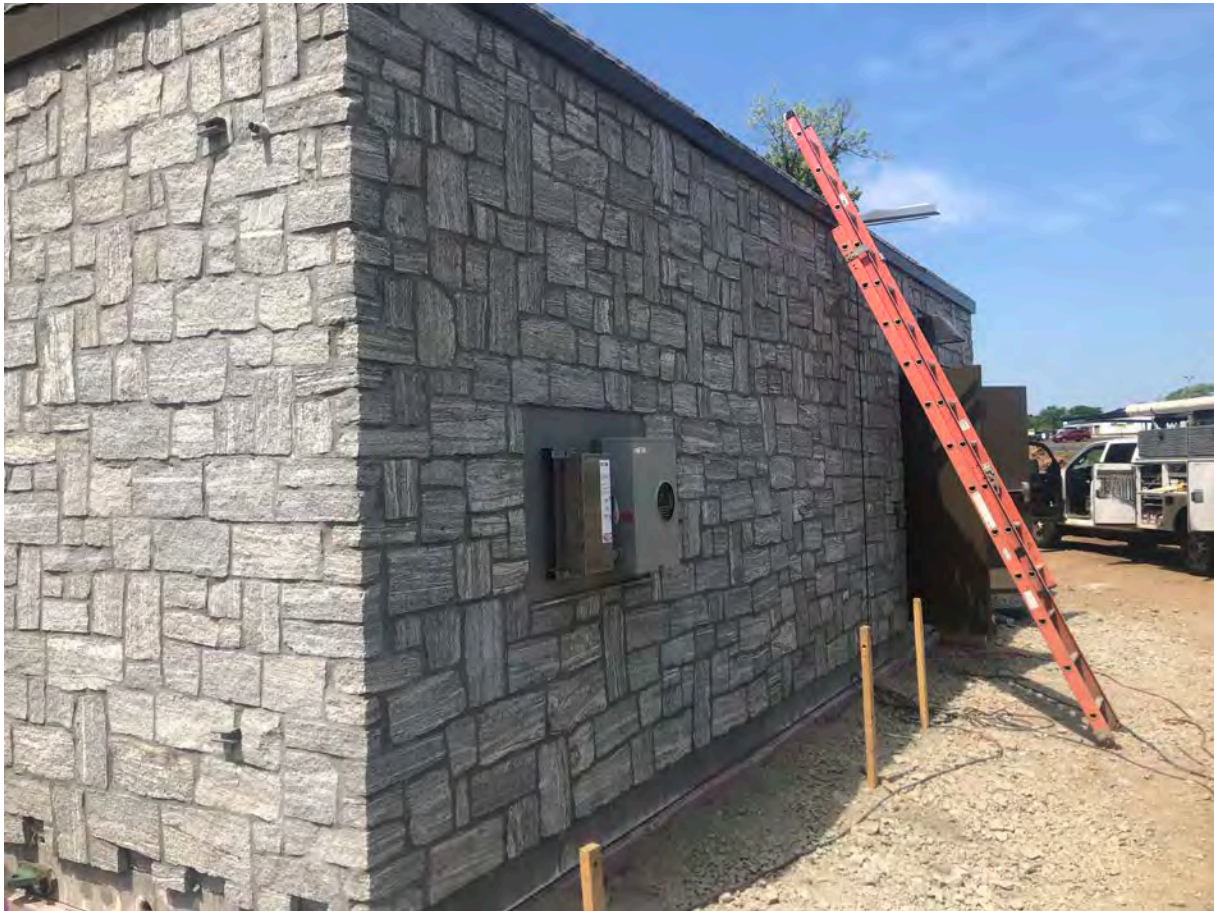
**Picture 6: View of the booster station looking west as United Concrete continues with finish work on the booster station building.**

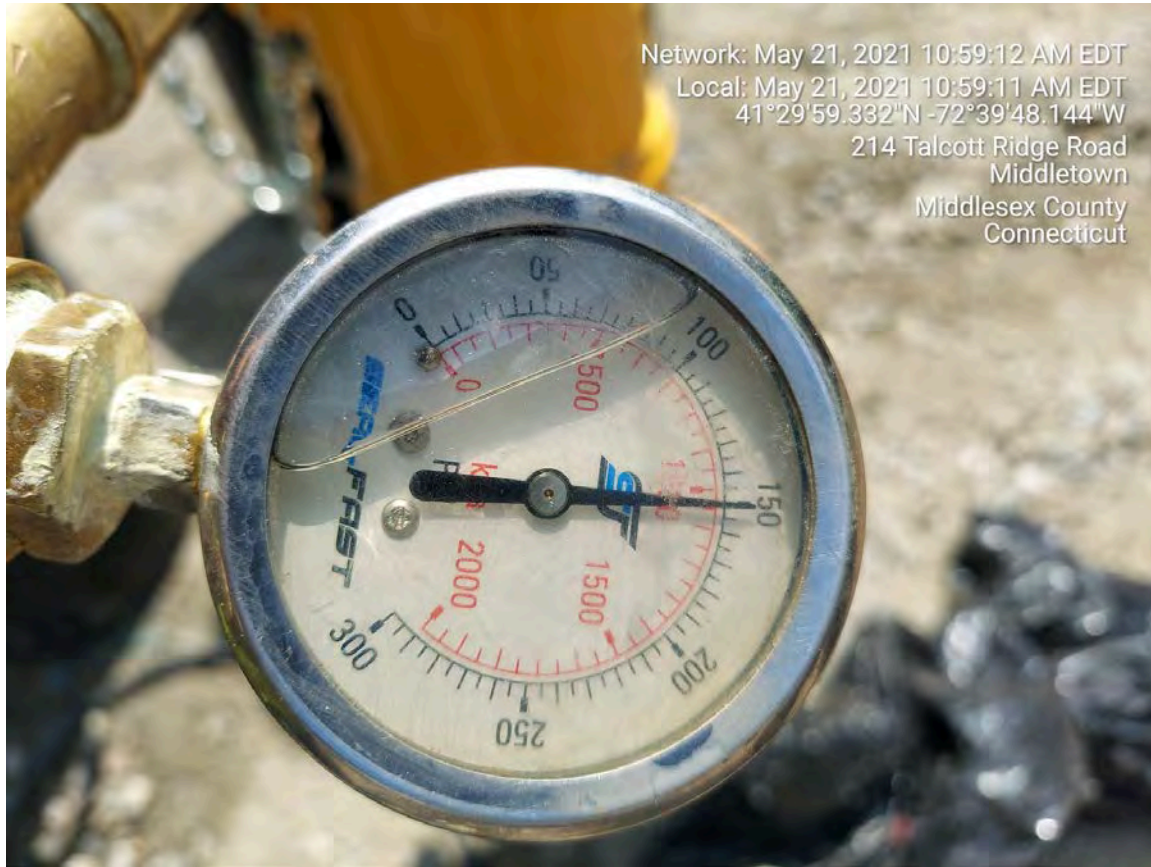
**Picture 7: Starting pressure on the pressure test that Ludlow is running from the water tank located east of the Shared Access Driveway to a valve located on the Talcott Ridge Drive cul-de-sac.**

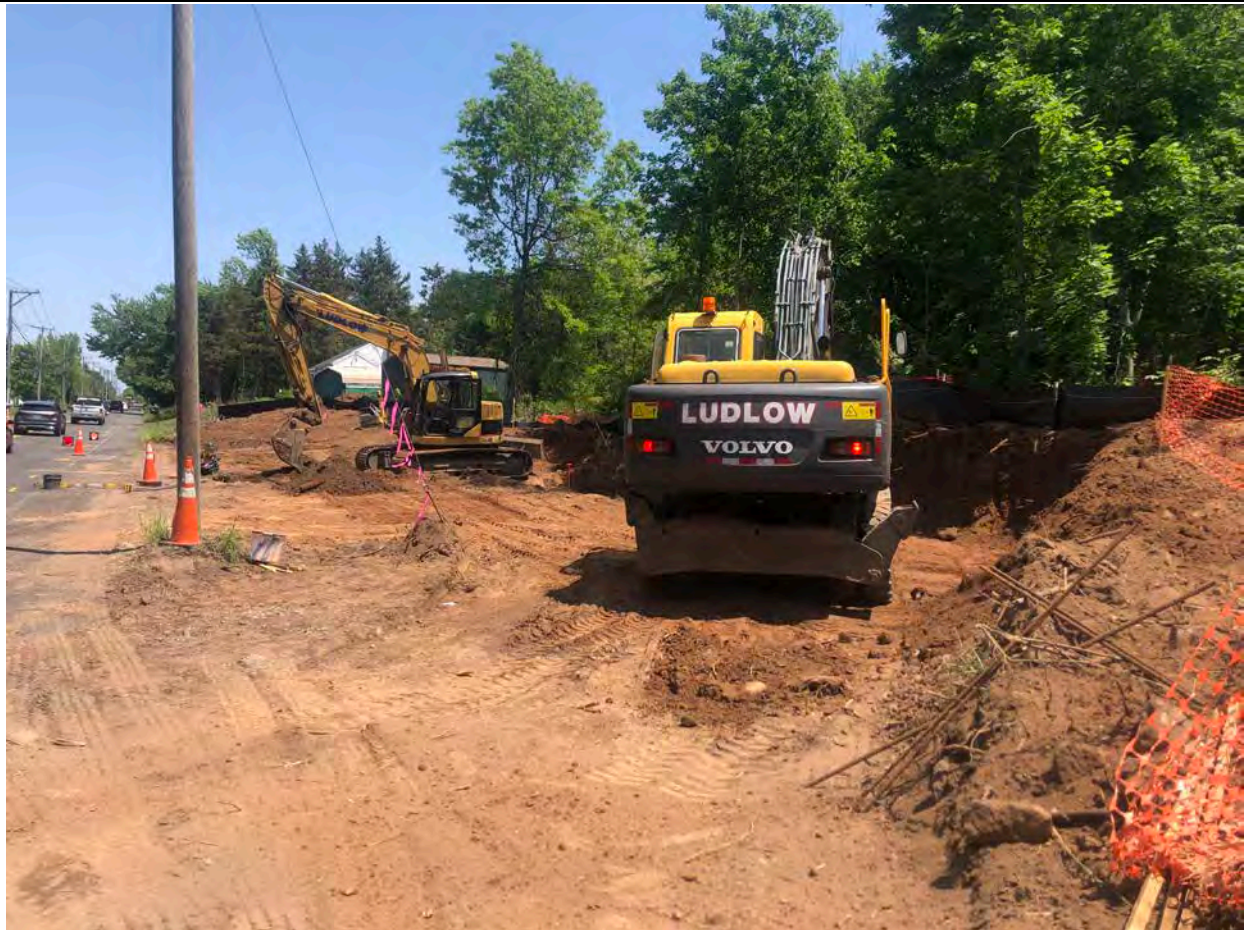
**Picture 8: Ludlow performing earth work activities at the water meter building work zone located at ~Station 124+80 in Middletown. View to the north.**

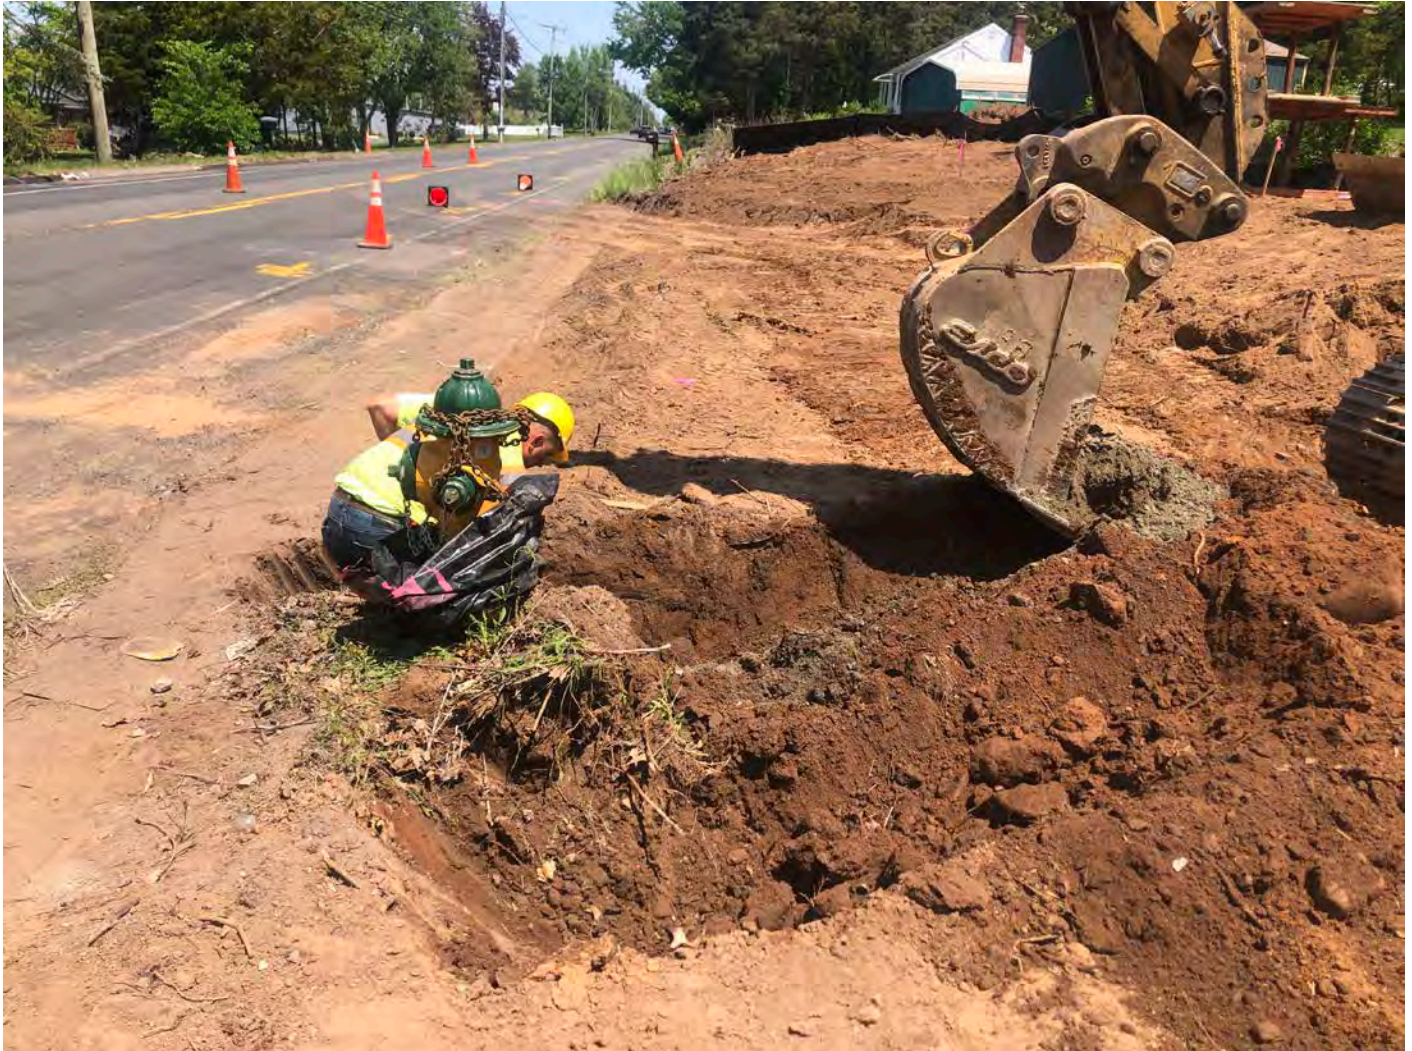
1220: Ludlow in the process of removing the hydrant located on the east side of S. Main street in Middletown at water meter building work zone.

**Picture 9: Ludlow temporarily removing a hydrant at the water meter building work zone located at ~Station 124+80 in Middletown. View to the north.**

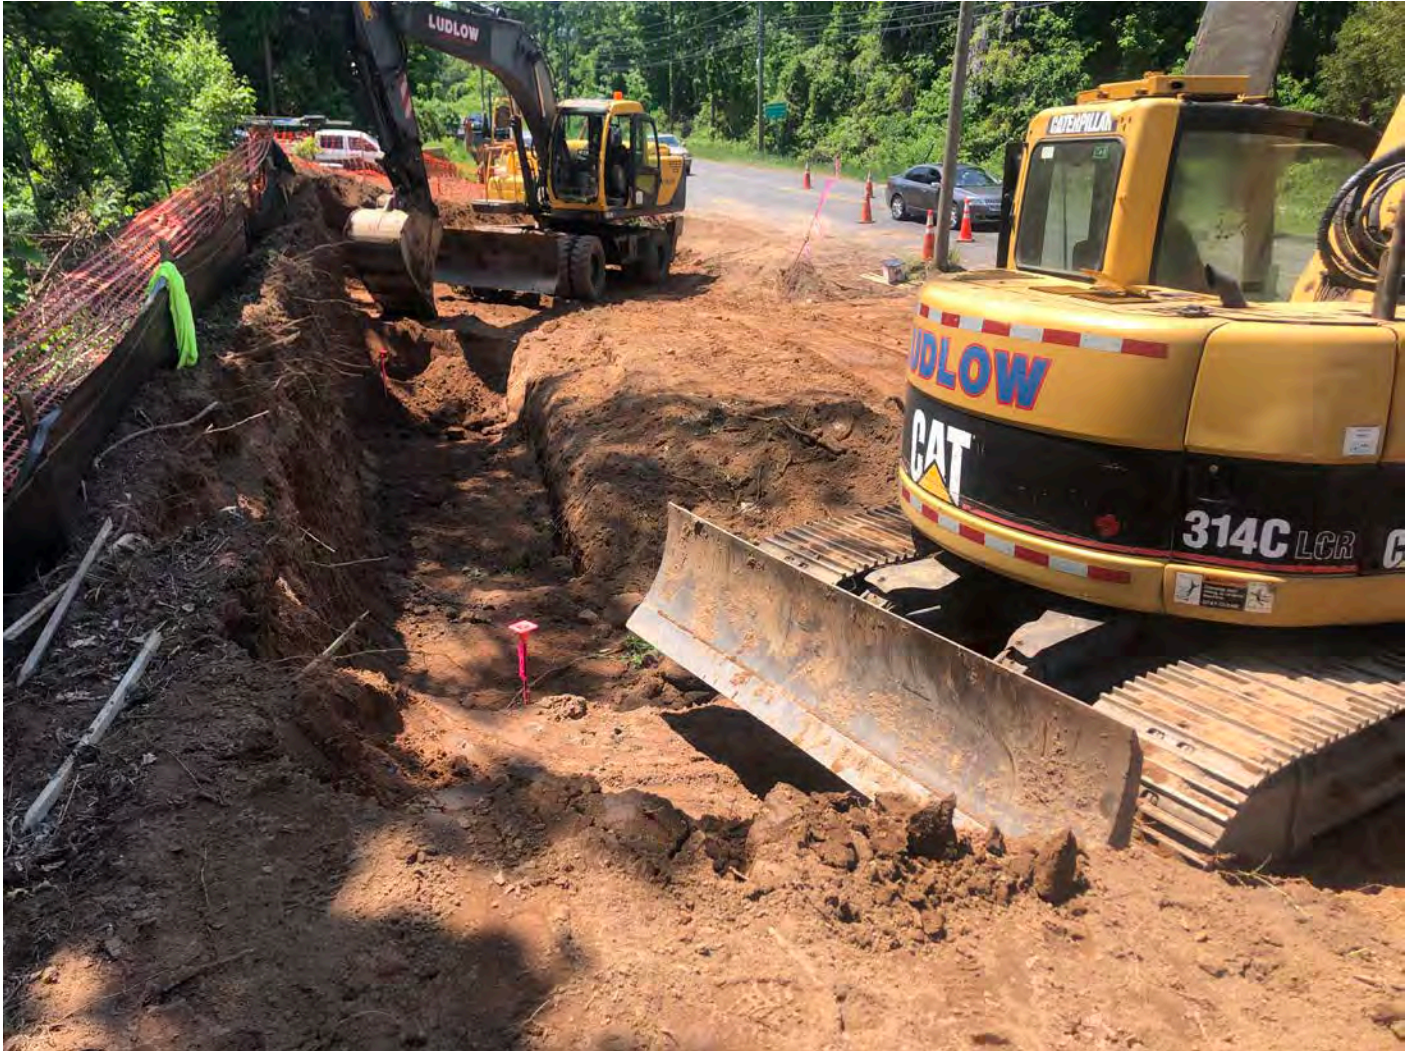
Picture 10: View of progress at the water meter building work zone located at ~Station 124+80 in Middletown. View to the south.

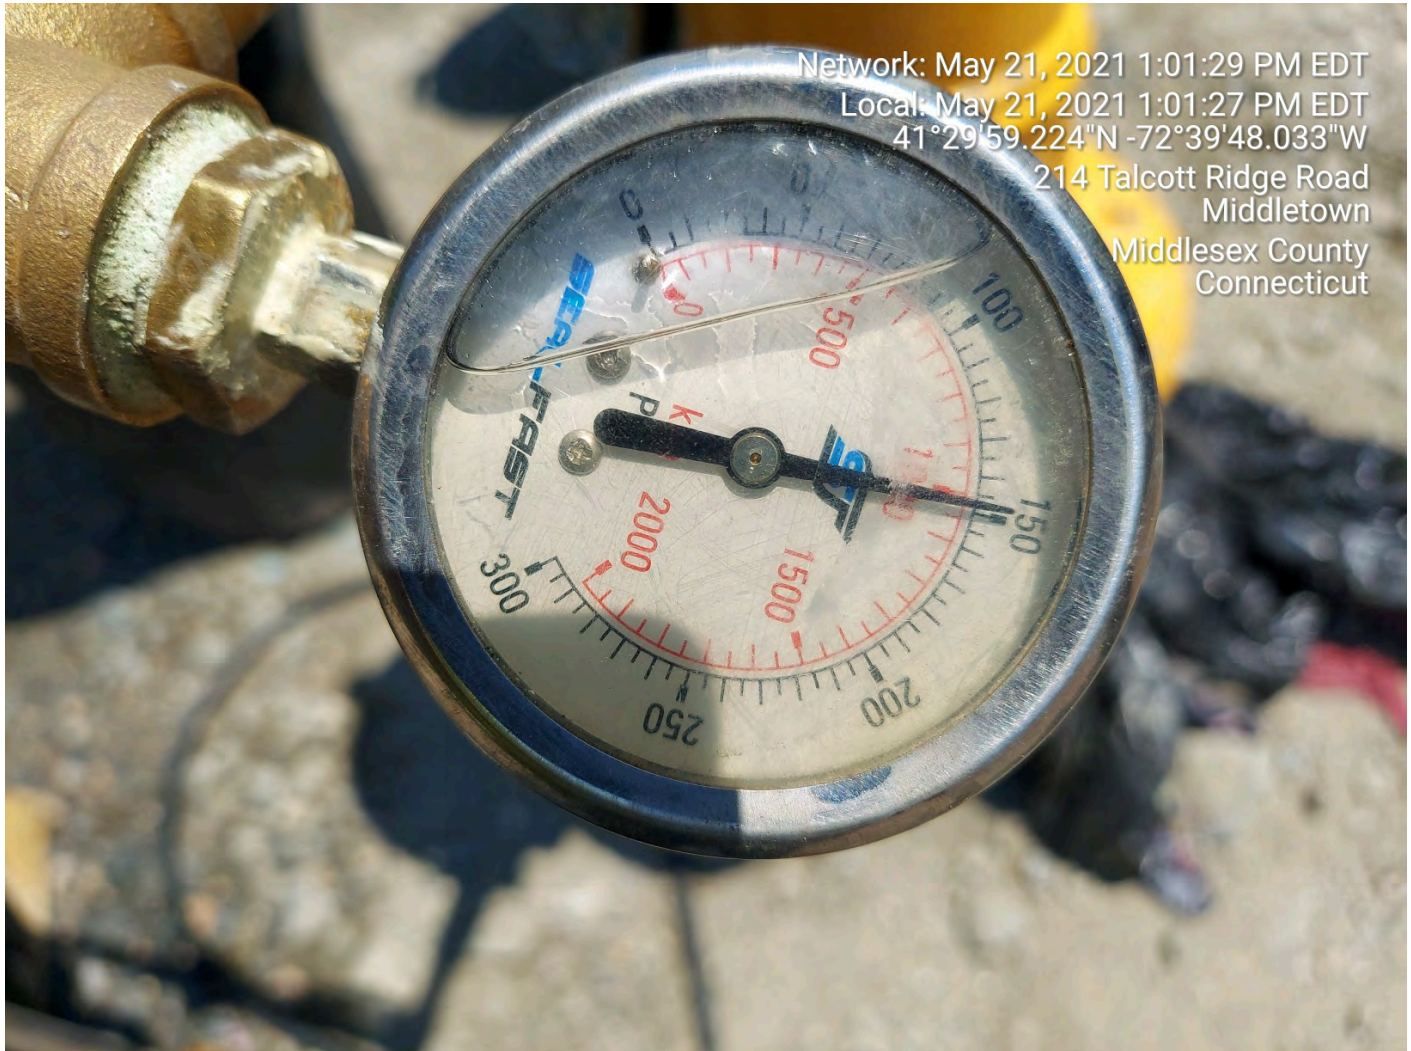
1301: The pressure test that Ludlow performed on the line that runs from the water tank to a valve located on the Talcott Ridge Drive cul-de-sac has been completed. The pressure during the test remained at 150 PSI.

**Picture 11: End pressure on the pressure test that Ludlow is running from the water tank located east of the Shared Access Driveway to a valve located on the Talcott Ridge Drive cul-de-sac.**
