## Daily Report

| <b>Project:</b> | Durham Meadows Pipeline Installation | <b>Date:</b> | May 24, 2021 |
| <b>Project #:</b> | AECOM: 6061487 | <b>Report No:</b> | 249 |
| <b>Contractor:</b> | Ludlow Construction | <b>Page:</b> | 1 of 11 |

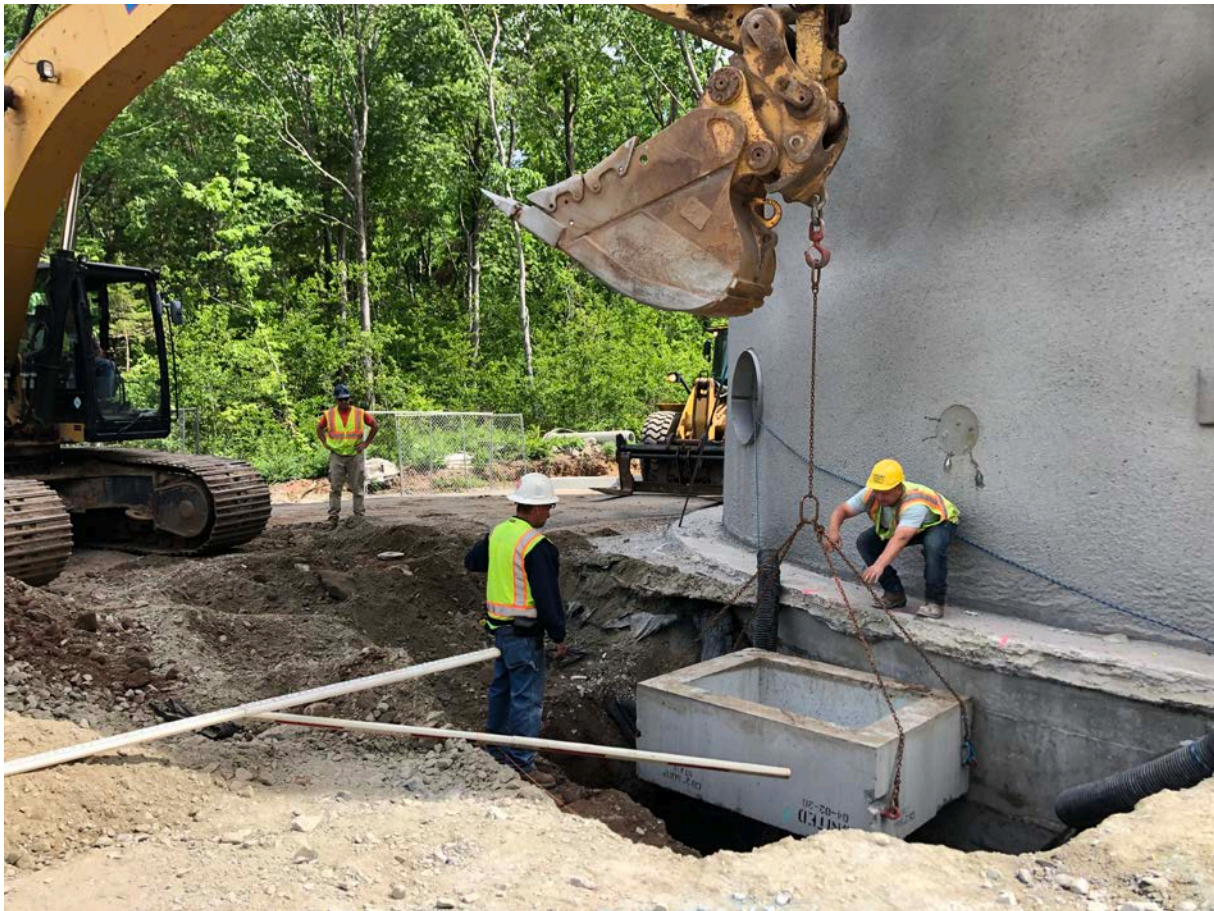
1037: Ludlow has placed the catch basin sump into the excavation located on the west side of the water tank at Station 10+25. Ludlow is currently placing ConSeal tape on the top rim of the catch basin sump.

**Picture 1: Ludlow placing a catch basin sump at Station 10+25 into the excavation located on the west side of the water tank in Middletown. View to the northeast.**

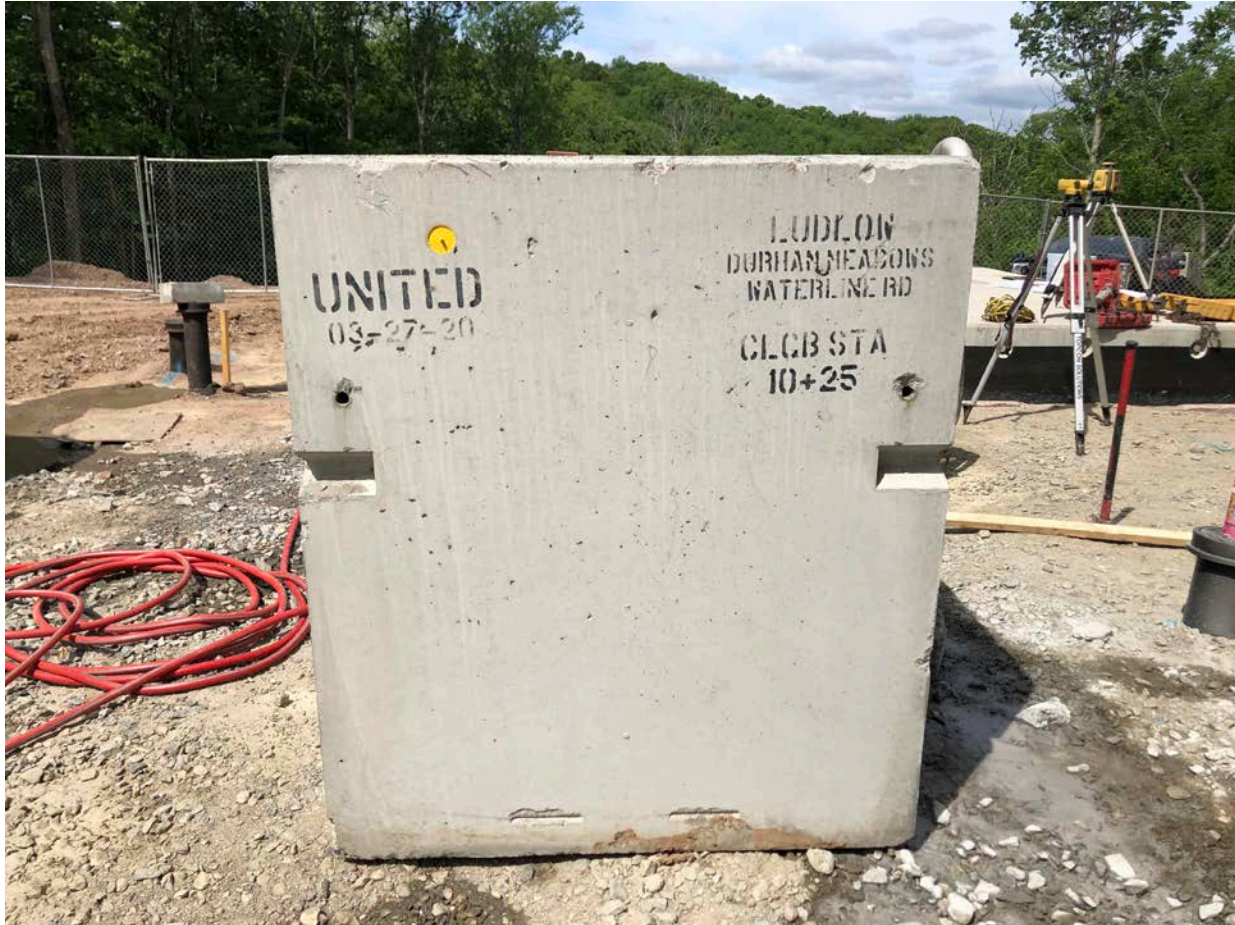
Picture 2: Catch basin that Ludlow is preparing to install Station 10+25 into the excavation located on the west side of the water tank in Middletown.

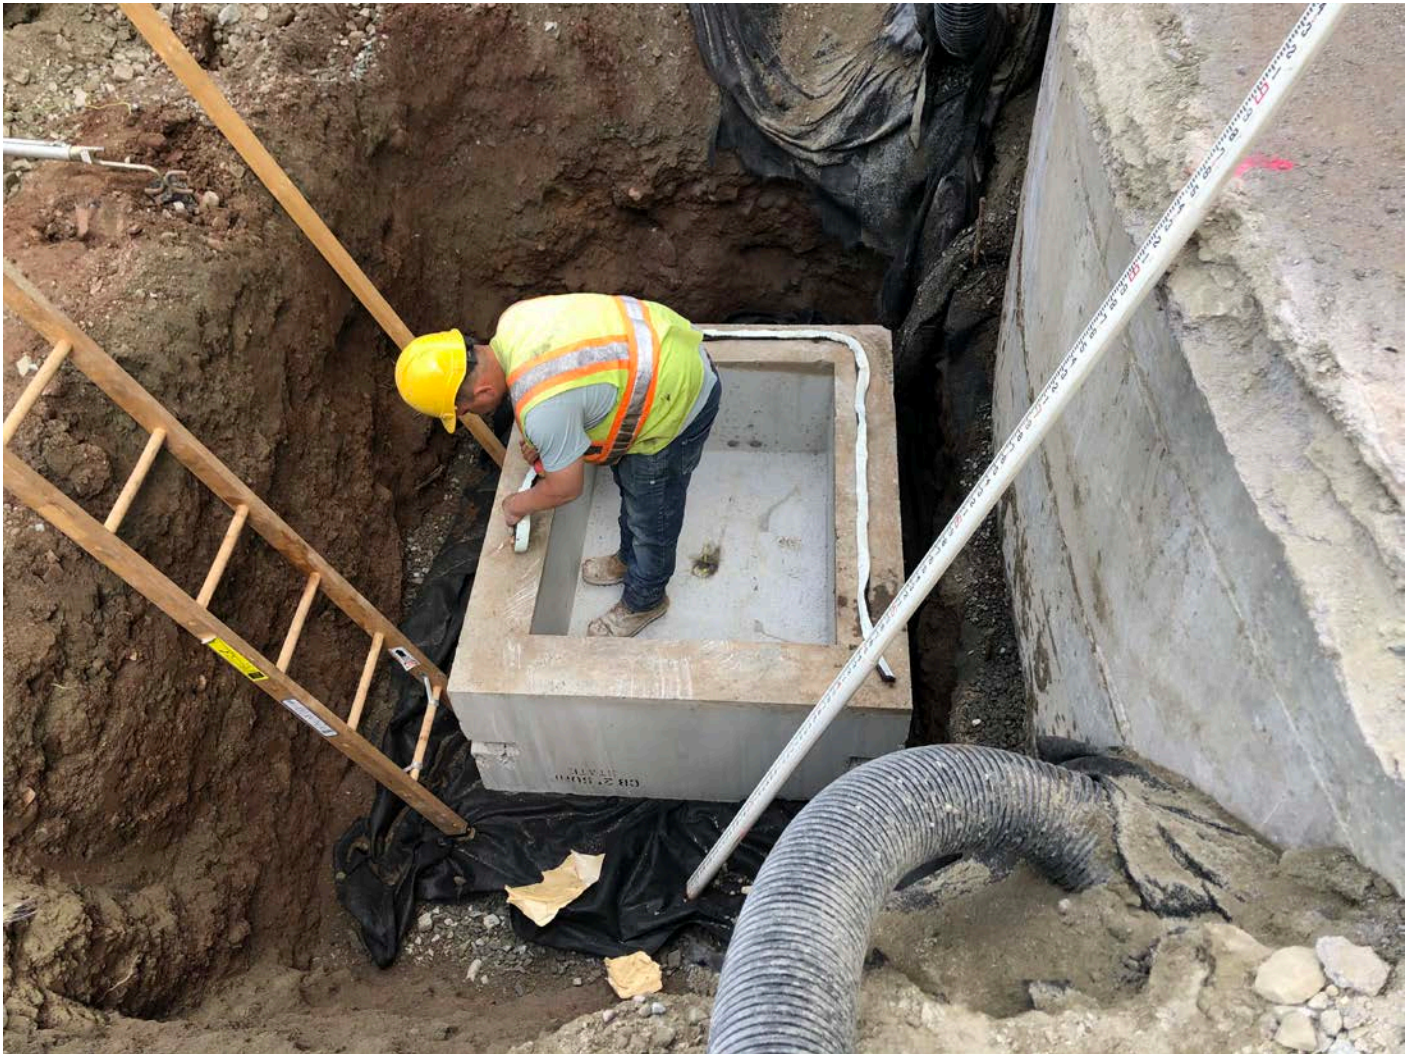
Picture 3: Ludlow applying ConSeal tape on the top rim of the catch basin sump located at Station 10+25 on the west side of the water tank located east of the Shared Access Driveway in Middletown. View to the north.

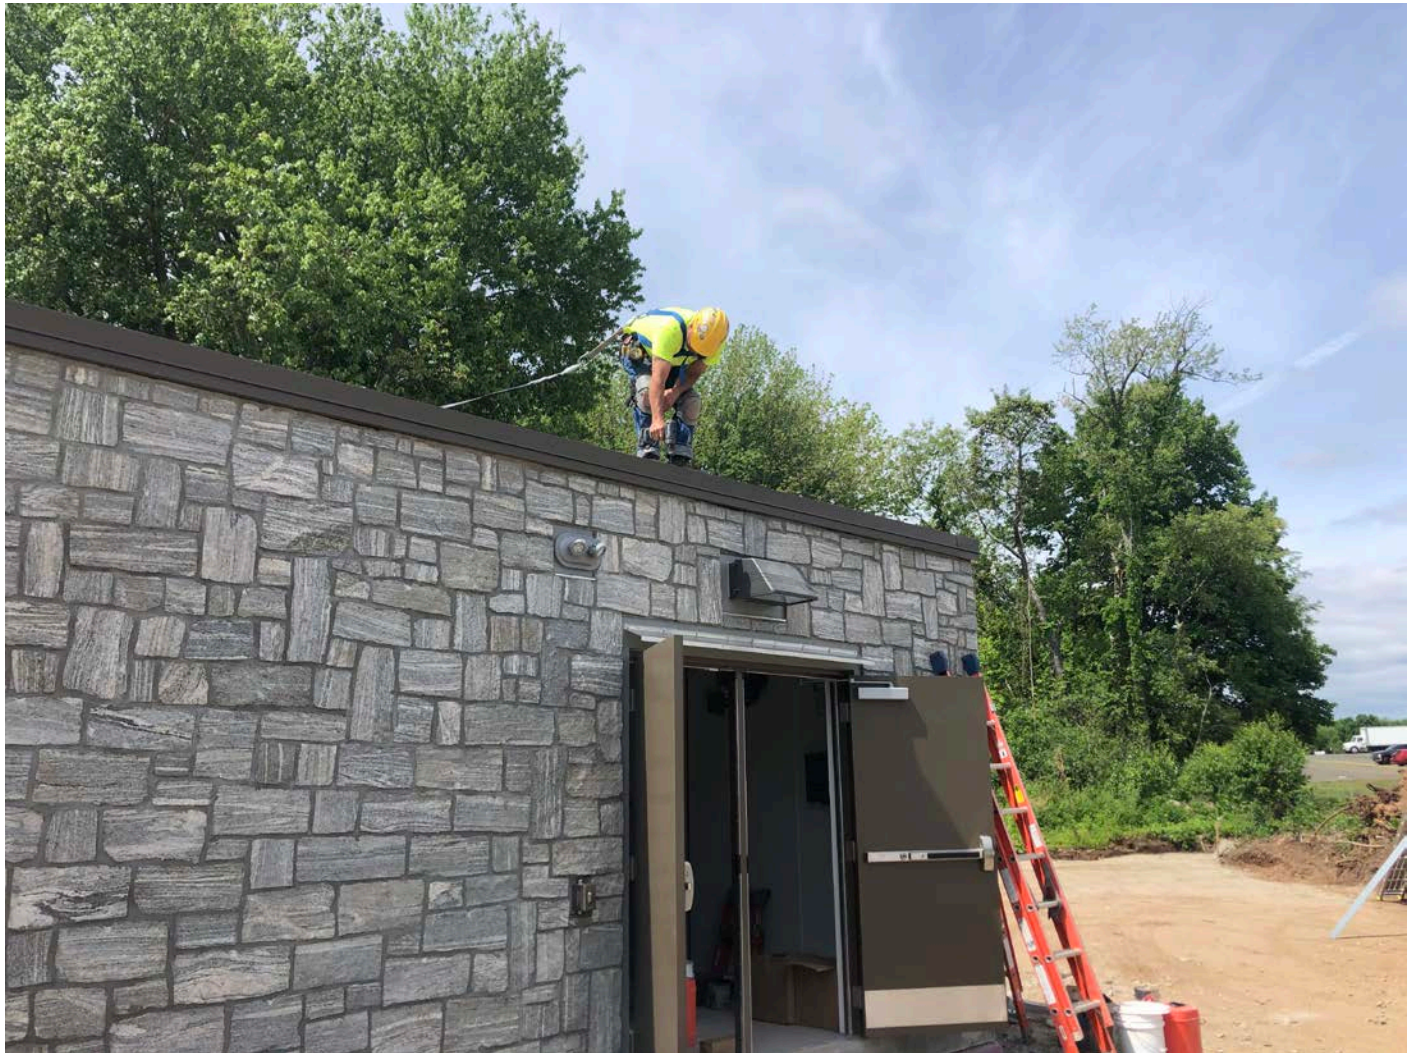
1007: United Concrete continues to work on the booster station installing flashing along the edge of the roof and other finish work.

Picture 4: United Concrete installing flashing on the booster station roof. Station 750+63 in Middletown.

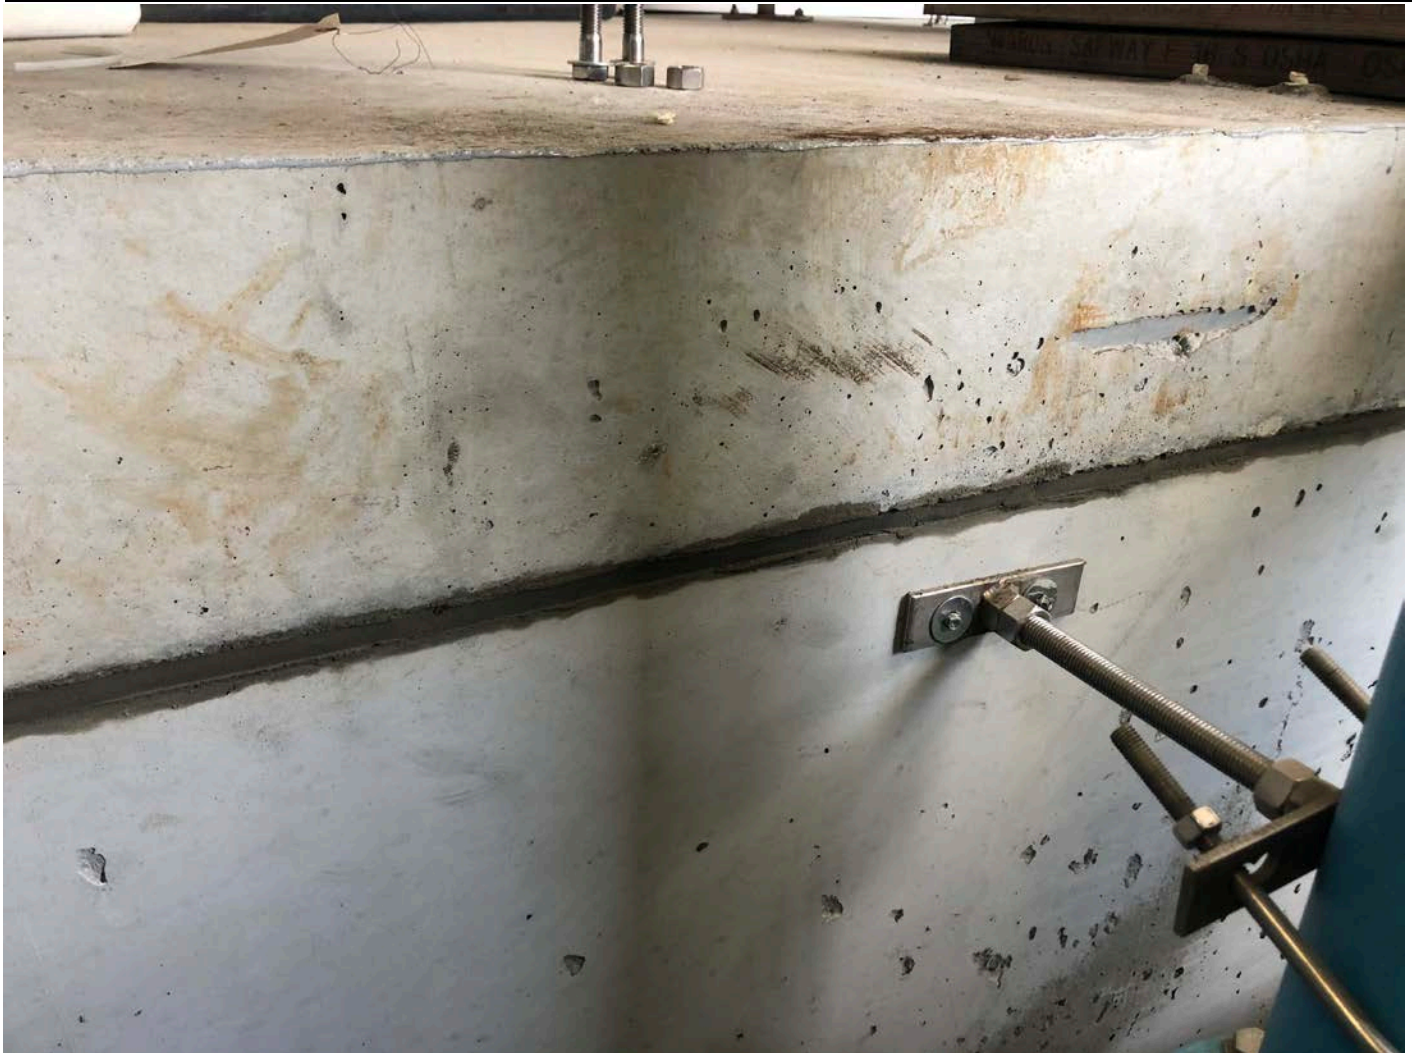
0733: United Concrete is working on attaching flashing to the roof of the booster station and sealing the gap between the top of the trough and the underside of the booster station floor. United Concrete is using Harris Construction grout with some Euclid Chemical Speed plug (rapid-setting hydraulic water stop).

1108: United Concrete continues grouting the seam between the trough and the underside of the booster station floor. United Concrete is also continuing to install flashing on the booster station roof.

Picture 5: The gap between the top of the trough and the underside of the booster station. United Concrete used Harris Construction grout with some Euclid Chemical Speed plug (rapid-setting hydraulic water stop) to fill the gap.

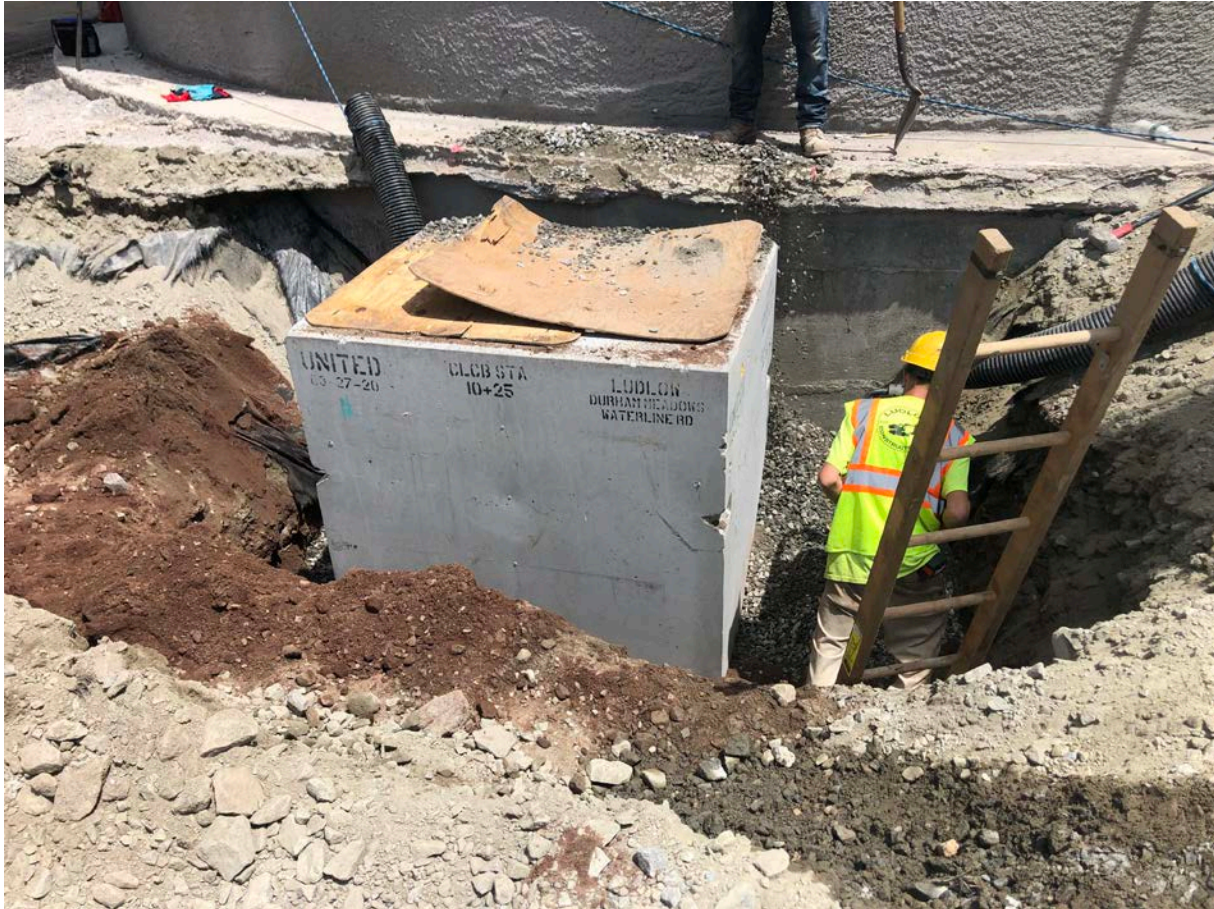
1258: Ludlow has placed the catch basin on top of the sump and is currently compacting three-quarter inch gravel around the bottom/sides of the catch basin. Once that was done, Ludlow continued backfilling and compacting with -5" fill placed in 1' lifts.

Picture 6: Catch basin that has just been placed at Station 10+25 on the west side of the water tank located east of the Shared Access Driveway in Middletown. View to the east.

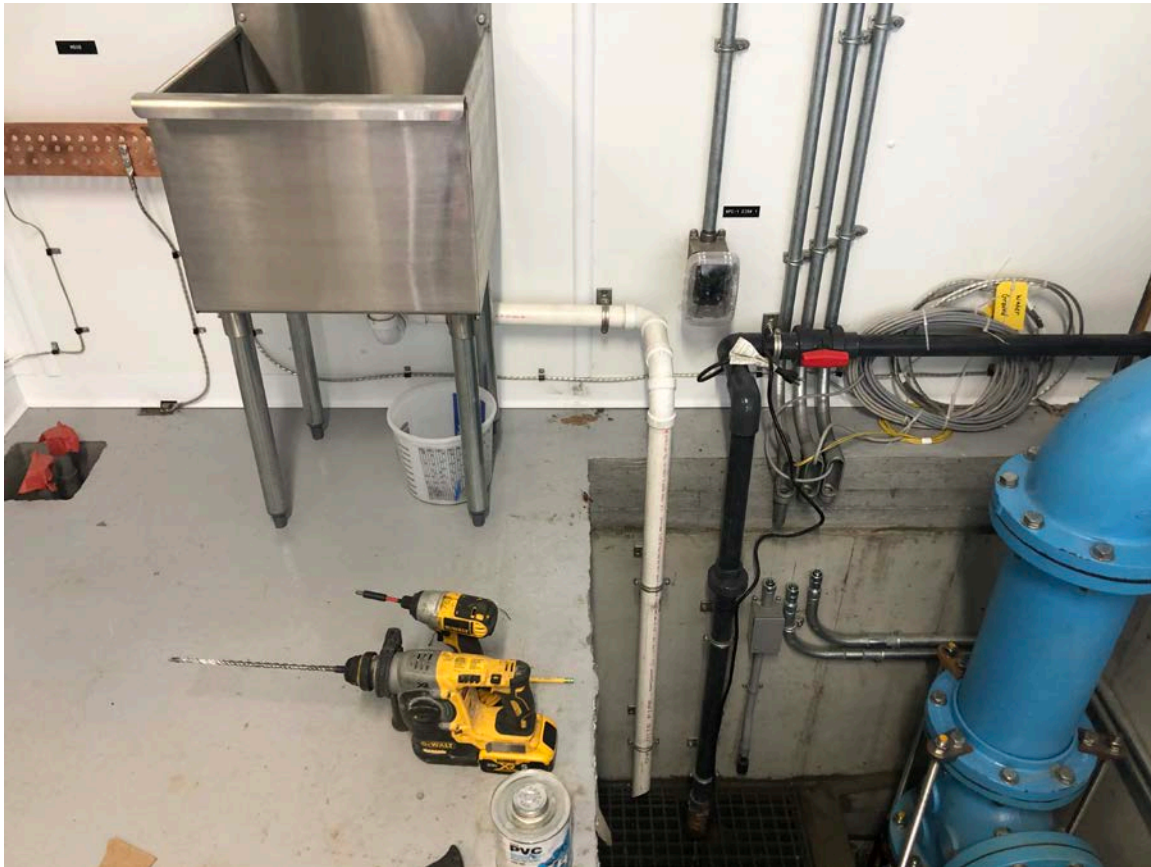
1307: United Concrete has installed PVC pipe for the booster station sink and are finishing the installation of PVC pipe for the sump pump connection. United Concrete continues to fill the gap between the top of the trough and the underside of the booster station floor with grout.

Picture 7: The east side of the booster station interior where United Concrete has installed PVC for the sink drain, and has completed the PVC discharge connection to the sump pump. View to the east.

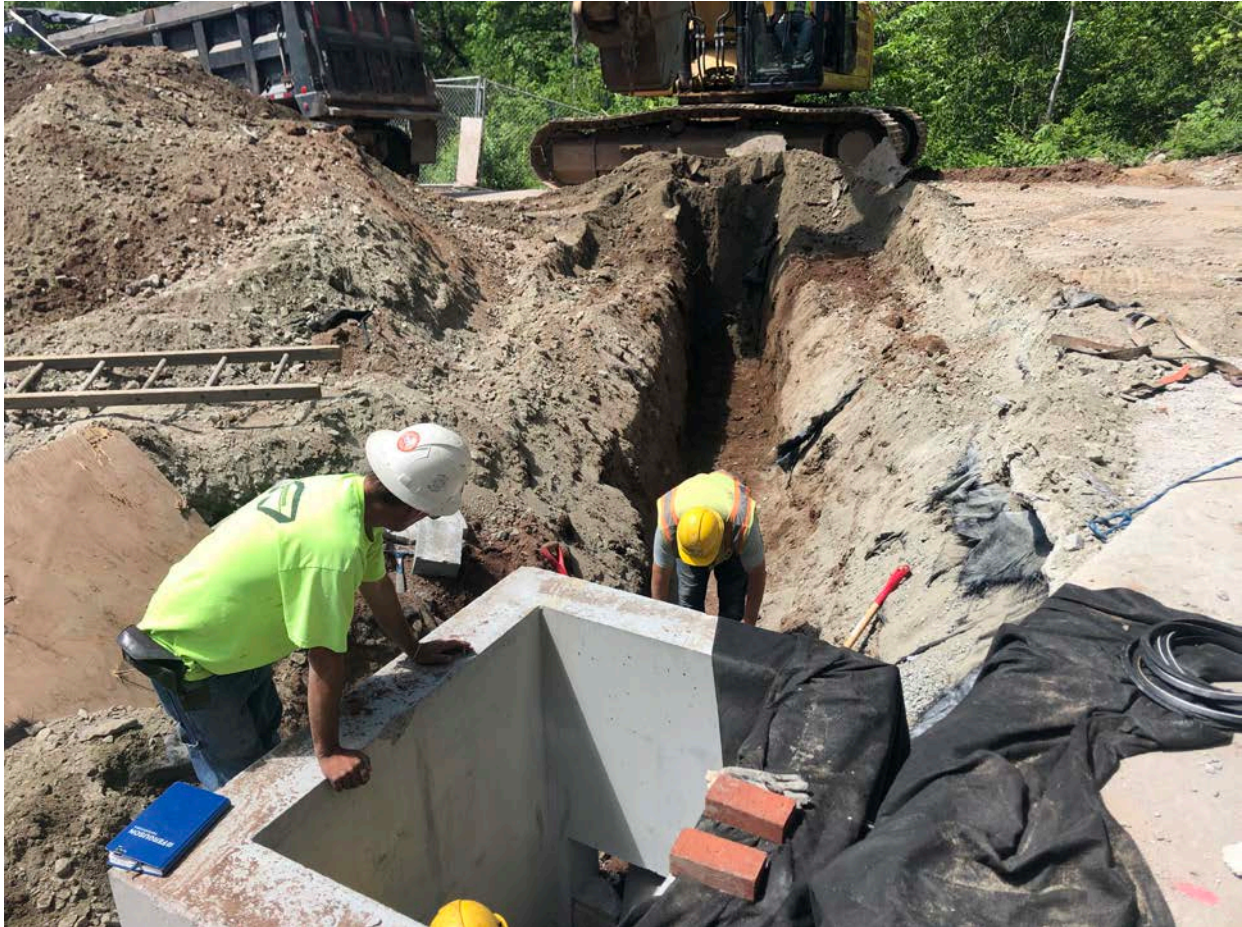
1418: Ludlow is installing 12" RCP between the catch basin at Station 10+25 and the catch basin located approximately 70 feet northwest of the water tank. Sand has been placed beneath the RCP for bedding material.

Picture 8: Ludlow beginning to place 12" RCP from the catch basin located at Station 10+25 to another catch basin located approximately 75' northwest of the water tank (on the north side of the Shared Access Driveway). View to the north.

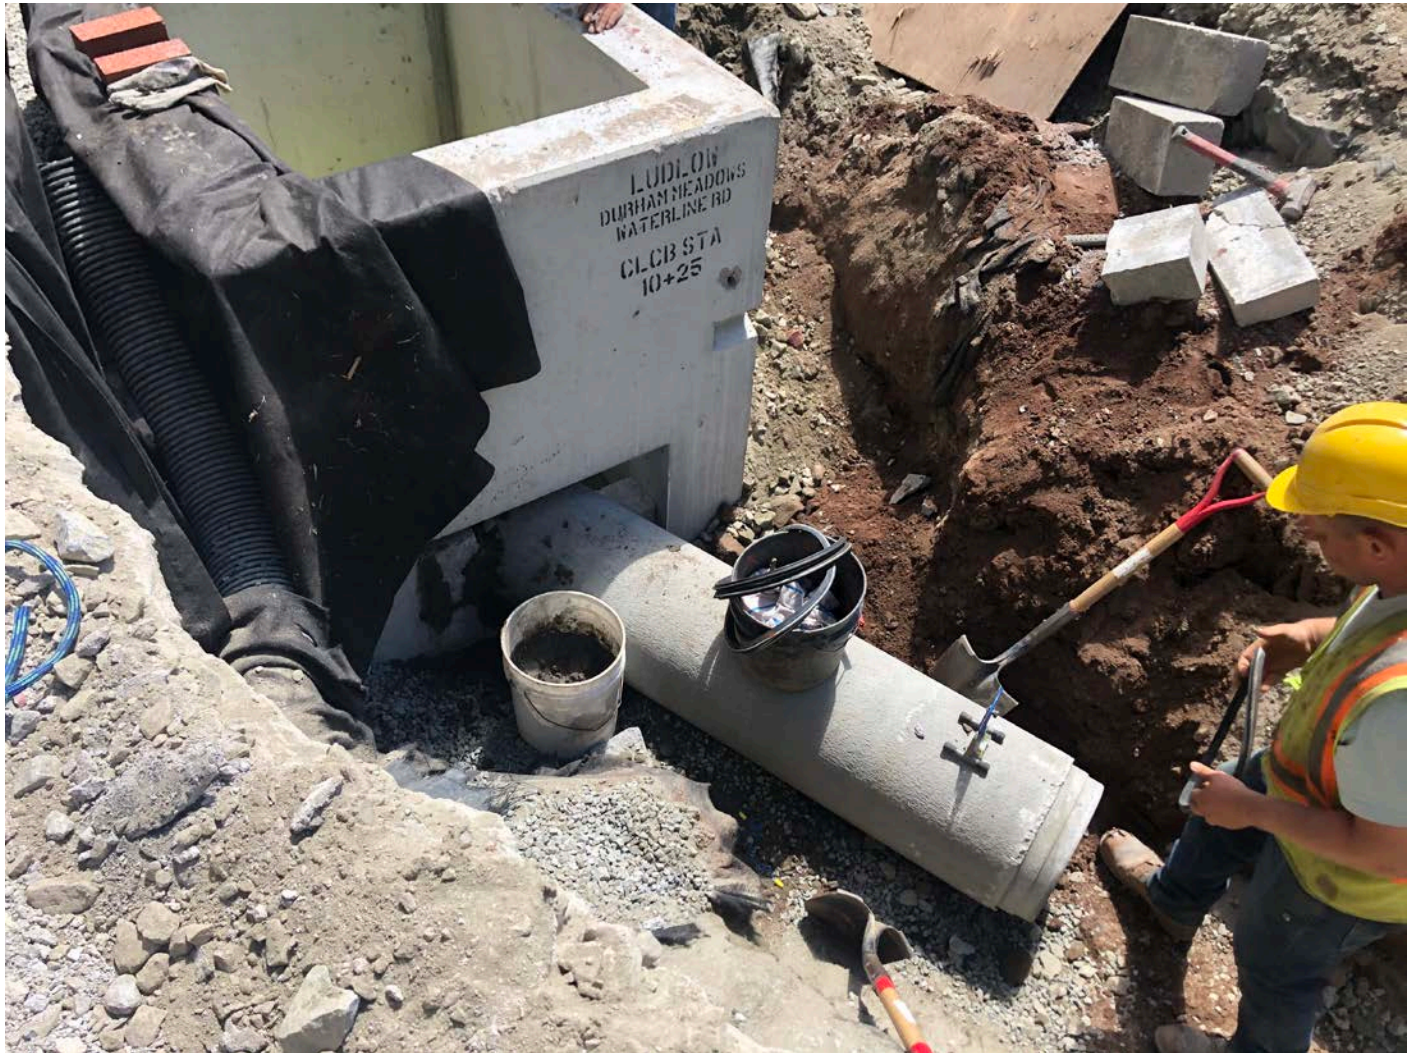
Picture 9: Ludlow placing 12" RCP from the catch basin located at Station 10+25 to another catch basin located approximately 75' northwest of the water tank (on the north side of the Shared Access Driveway). View to the west.
