## Daily Report

<b>Project:</b>	Durham Meadows Pipeline Installation	<b>Date:</b>	May 25, 2021
<b>Location:</b>	S. Main Street and the Shared Access Driveway, Middletown	<b>Day of Week:</b>	Tuesday
<b>Project #:</b>	AECOM: 6061487	<b>Report No:</b>	250
<b>Contractor:</b>	Ludlow Construction	<b>Page:</b>	1 of 13

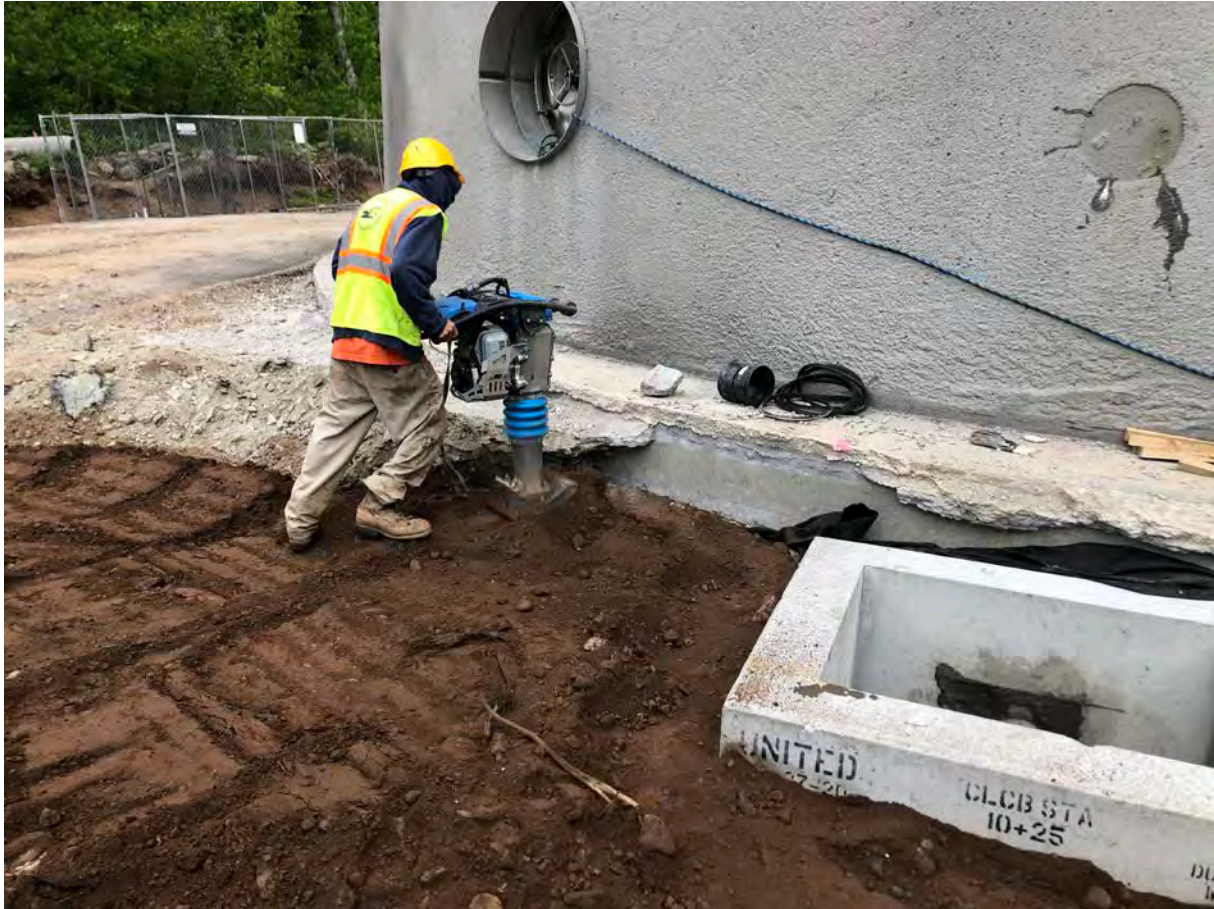
Picture 1: Ludlow compacting fill with a jumping jack on the west side of the water tank in Middletown. View to the northeast.

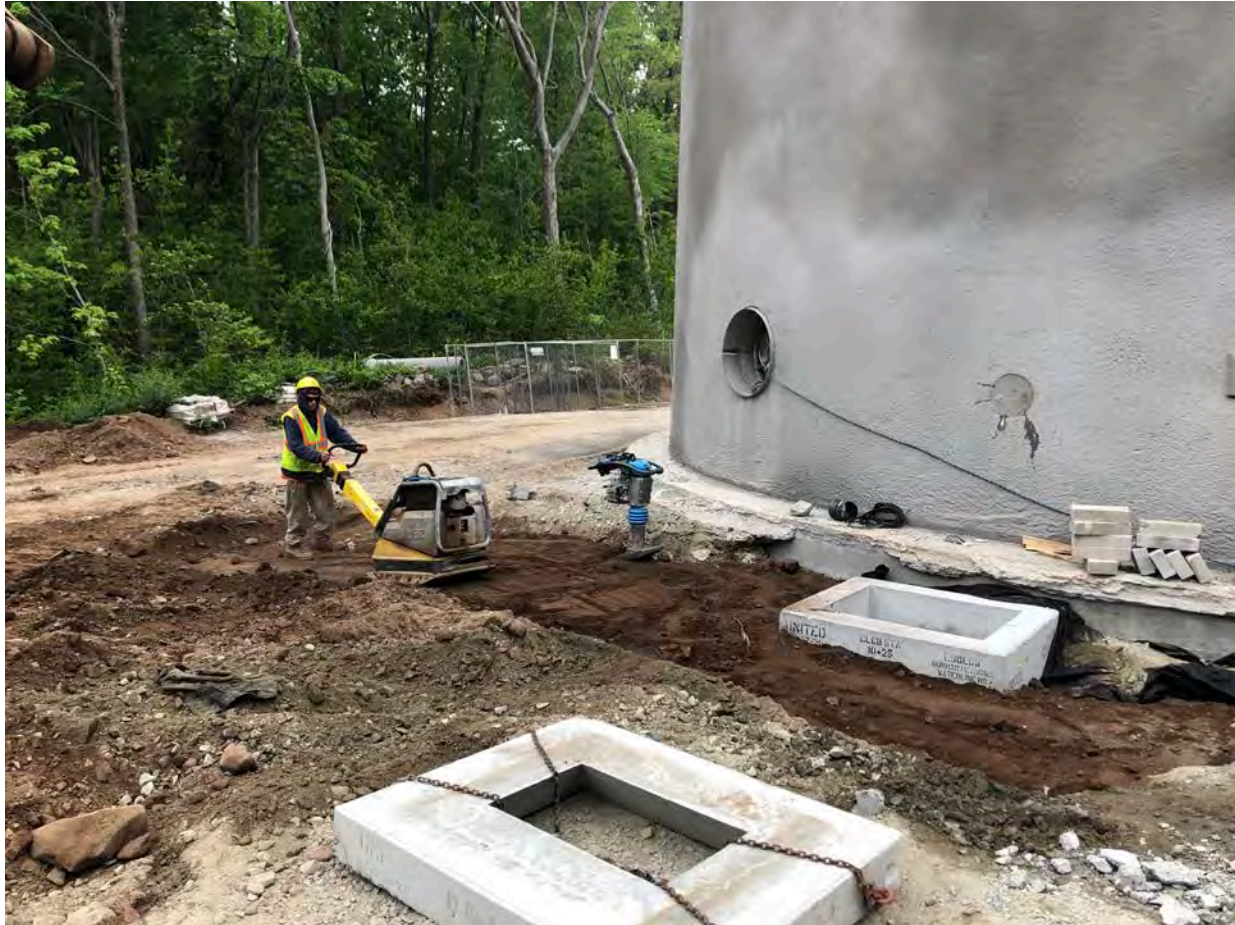
Picture 2: Ludlow compacting fill with a plate compactor on the west side of the water tank in Middletown. View to the northeast.

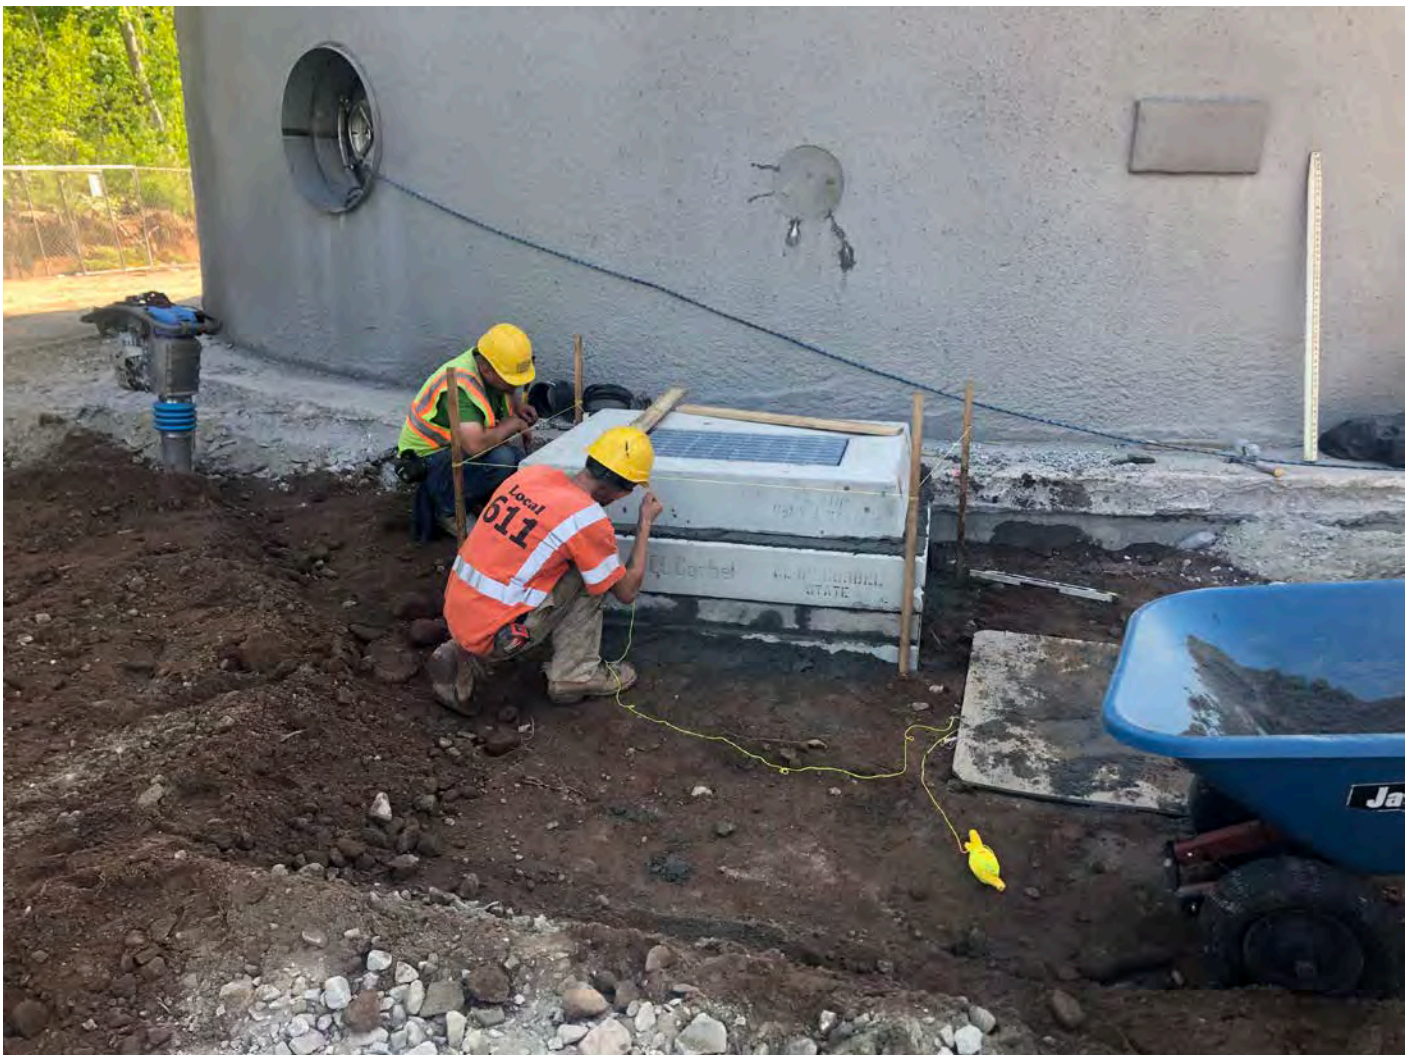
Picture 3: Ludlow applying mortar to the top sections of the catch basin located at Station 10+25 on the west side of the water tank located east of the Shared Access Driveway in Middletown. View to the east.

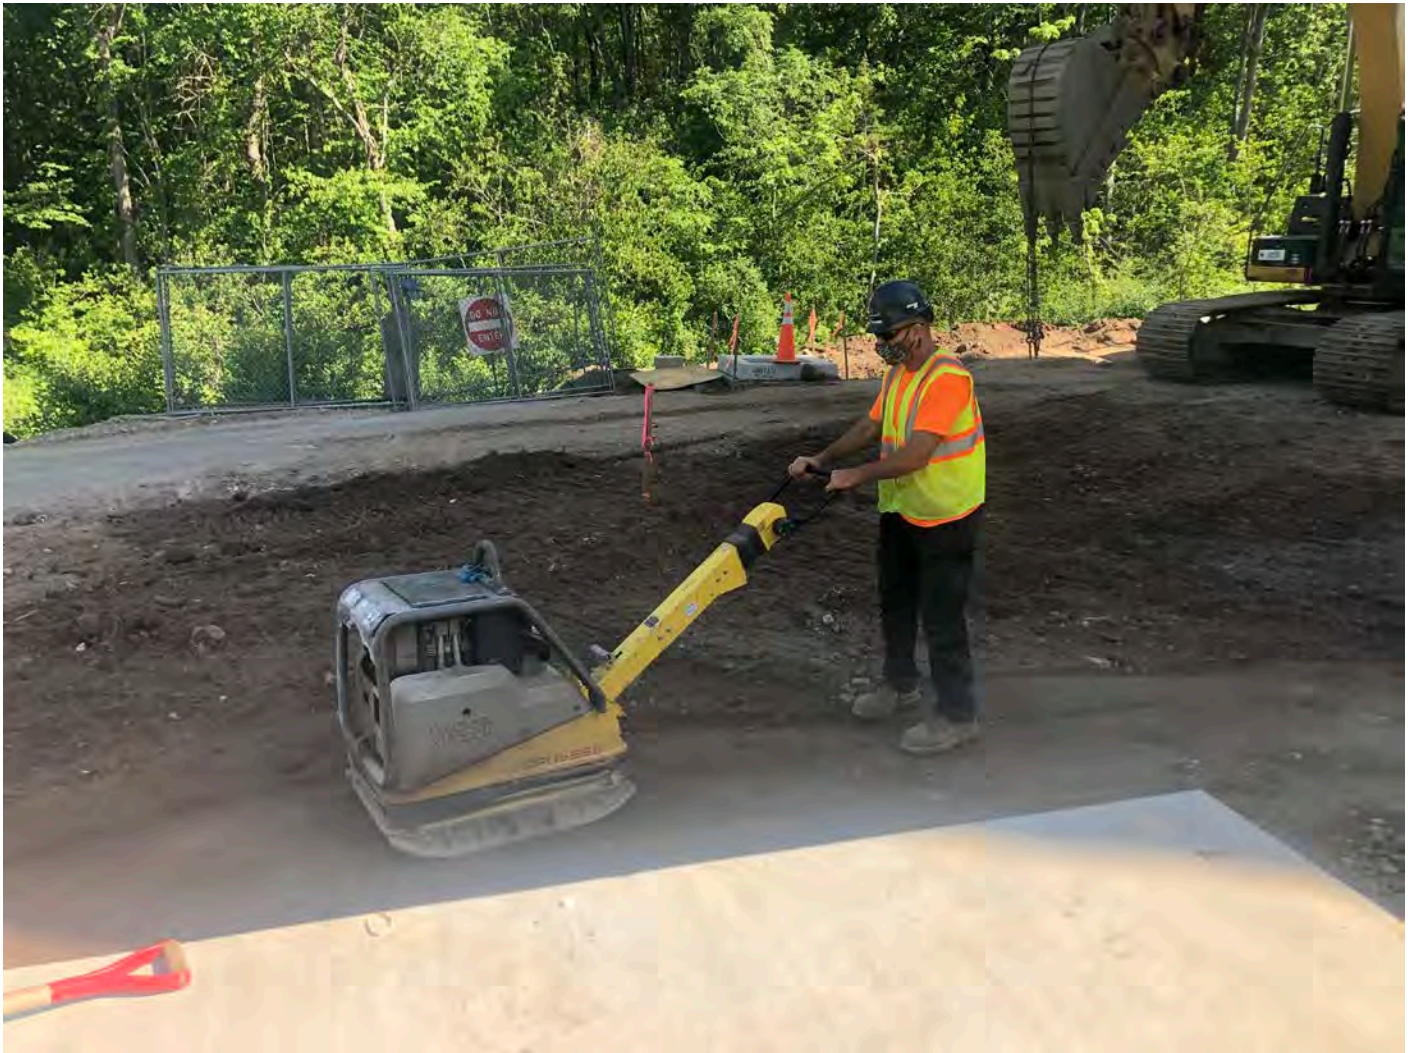
Picture 4: Ludlow compacting fill with a plate compactor on the northwest side of the water tank in Middletown. View to the north.

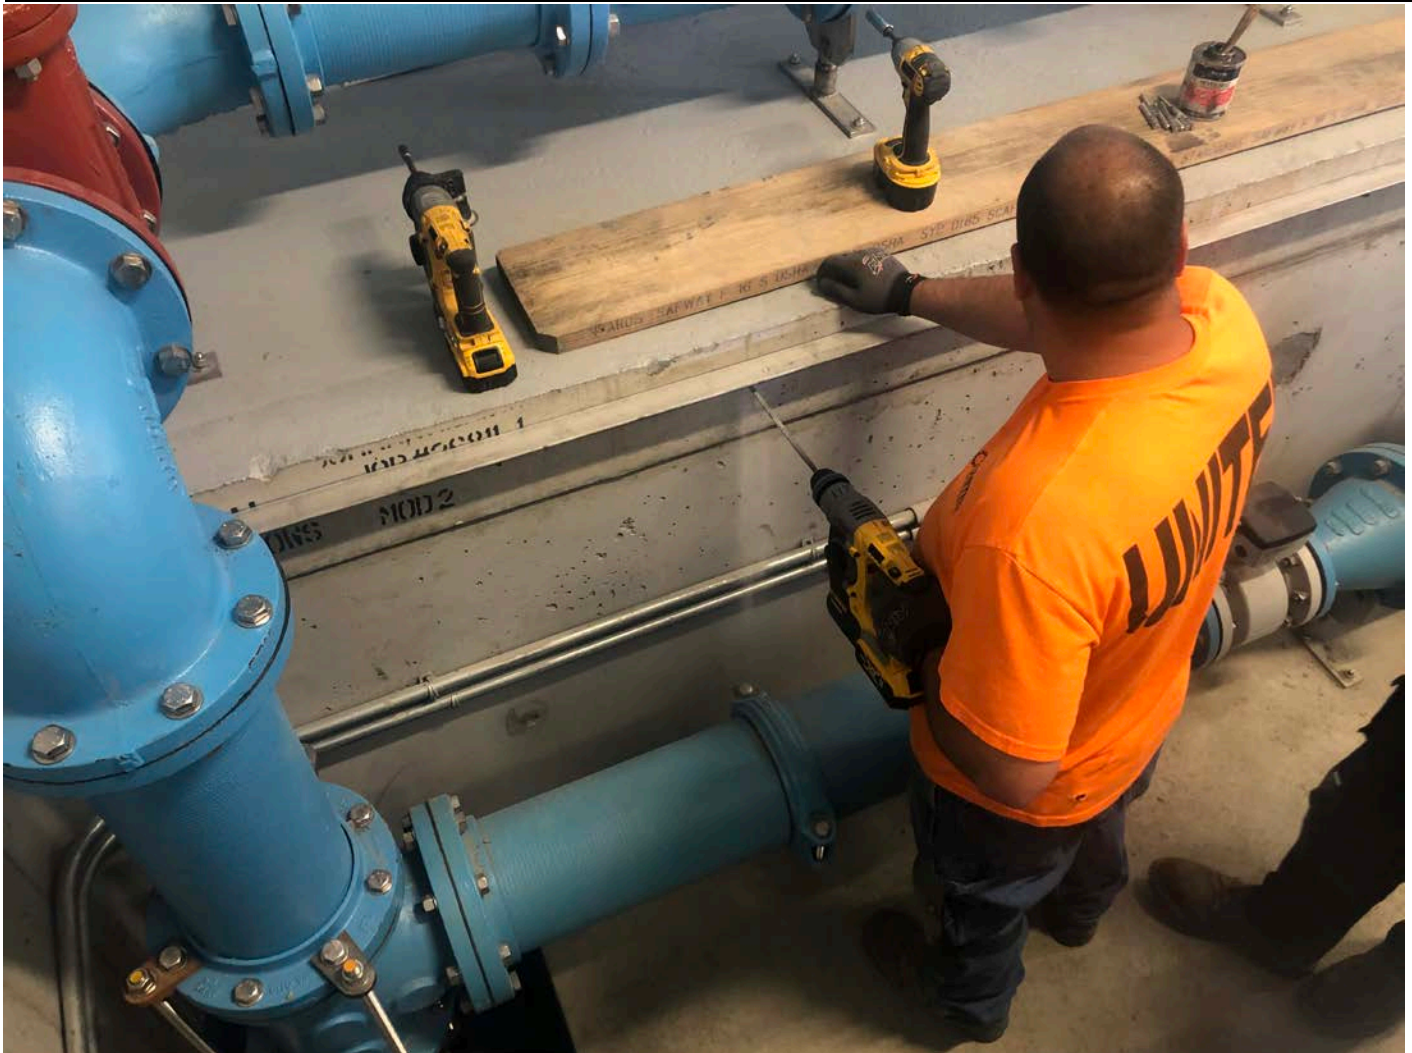
Picture 5: United Concrete installing support bracket for the grating that will sit over the trough in the booster station located at Station 750+63.

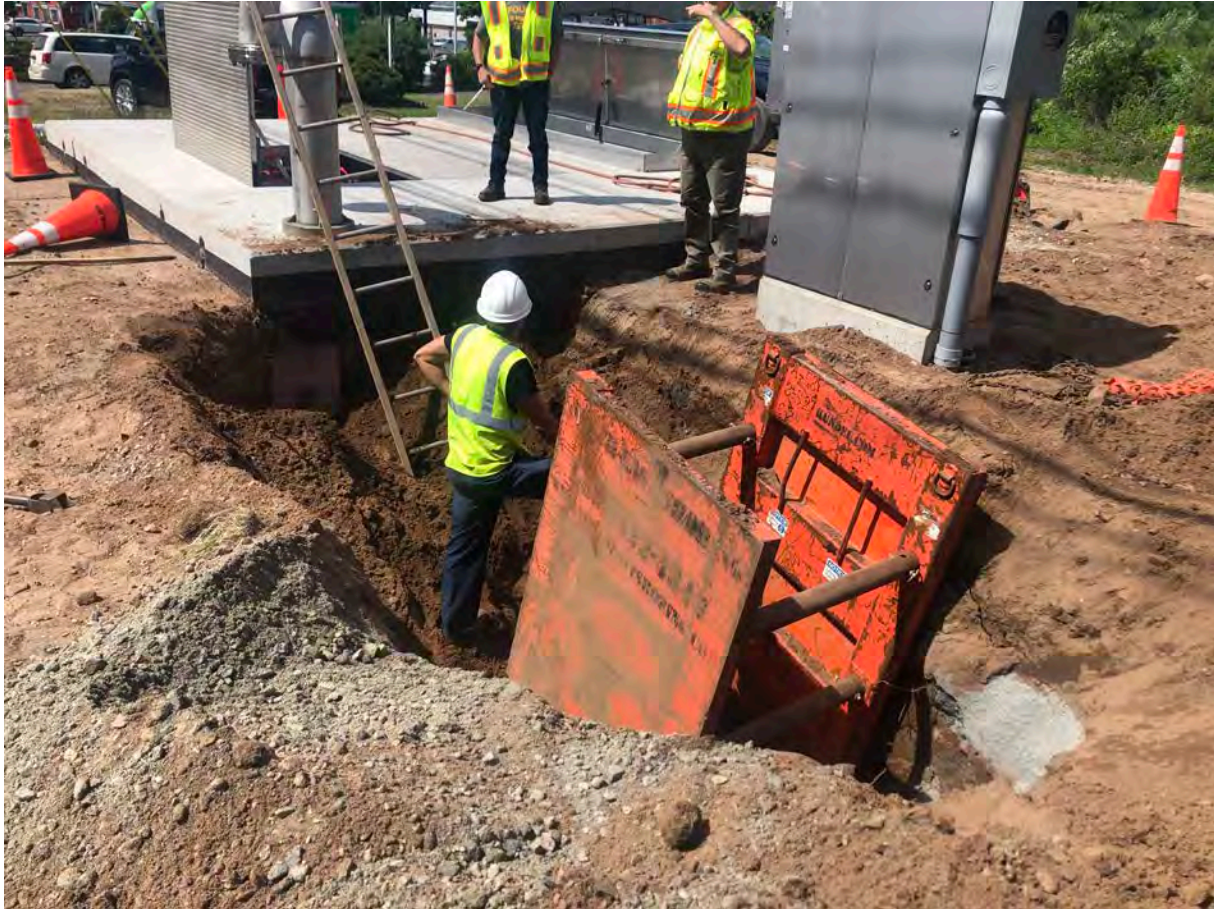
Picture 6: Ludlow excavating on the northeast corner of the pressure reducing valve vault as they attempt to troubleshoot difficulties in conducting a pressure test on the piping associated with the vault. ~Station 161+40, Durham. View to the south.

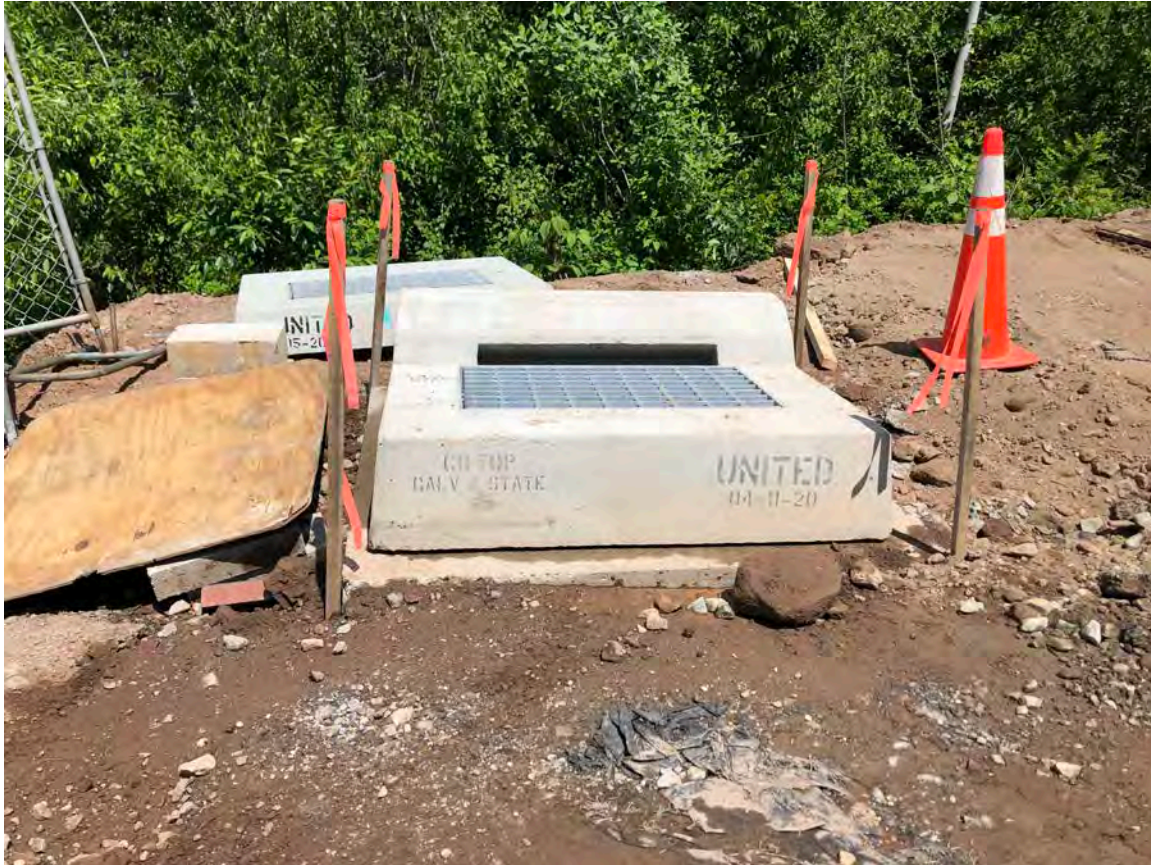
Picture 7: Ludlow changed the top to the catch basin located ~70' northwest of the water tank located east of the Shared Access Driveway in Middletown. View to the north.

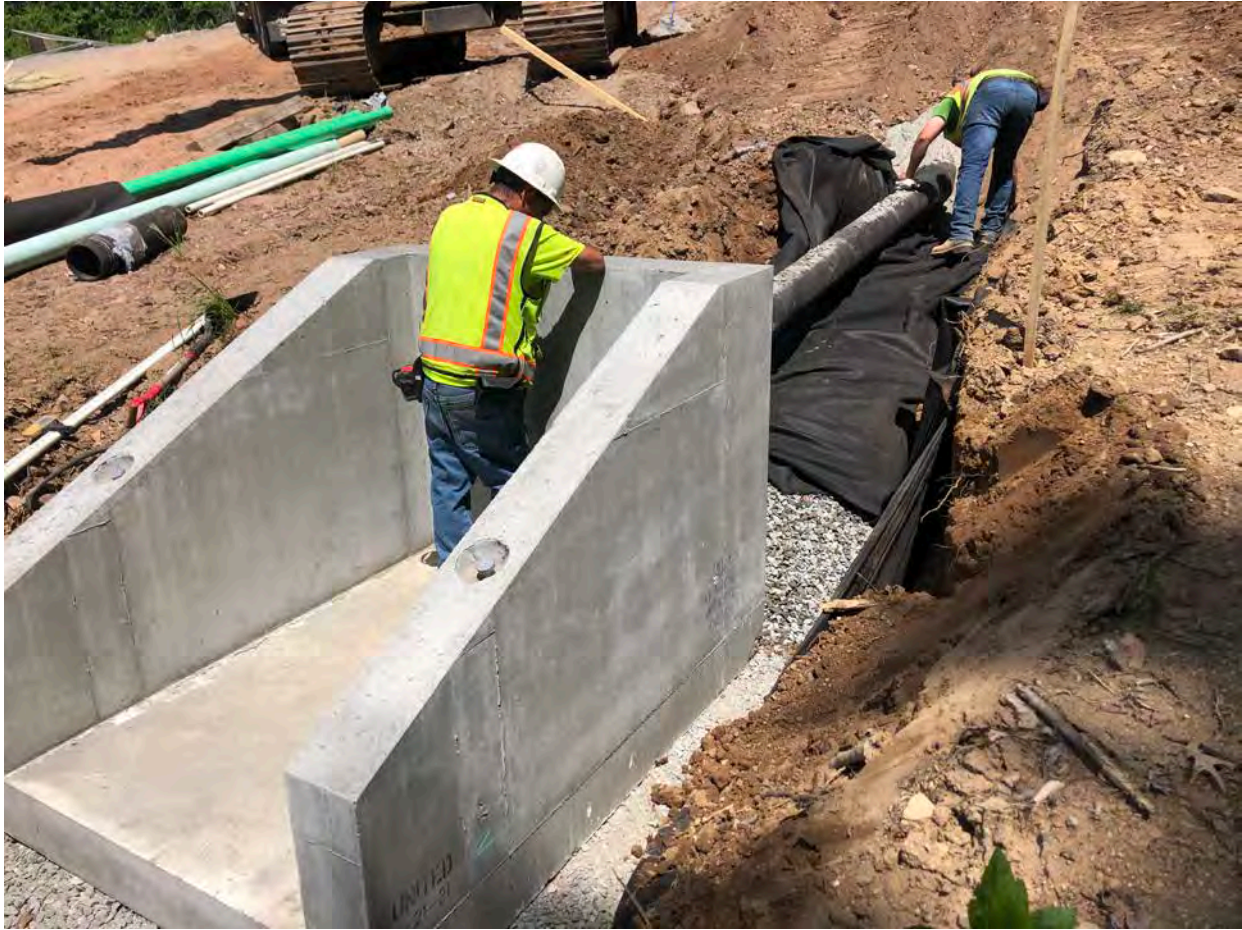
Picture 8: Ludlow in the process of installing 8" DIP to connect to the headwall they just installed at Station 11+50. View to the northeast.

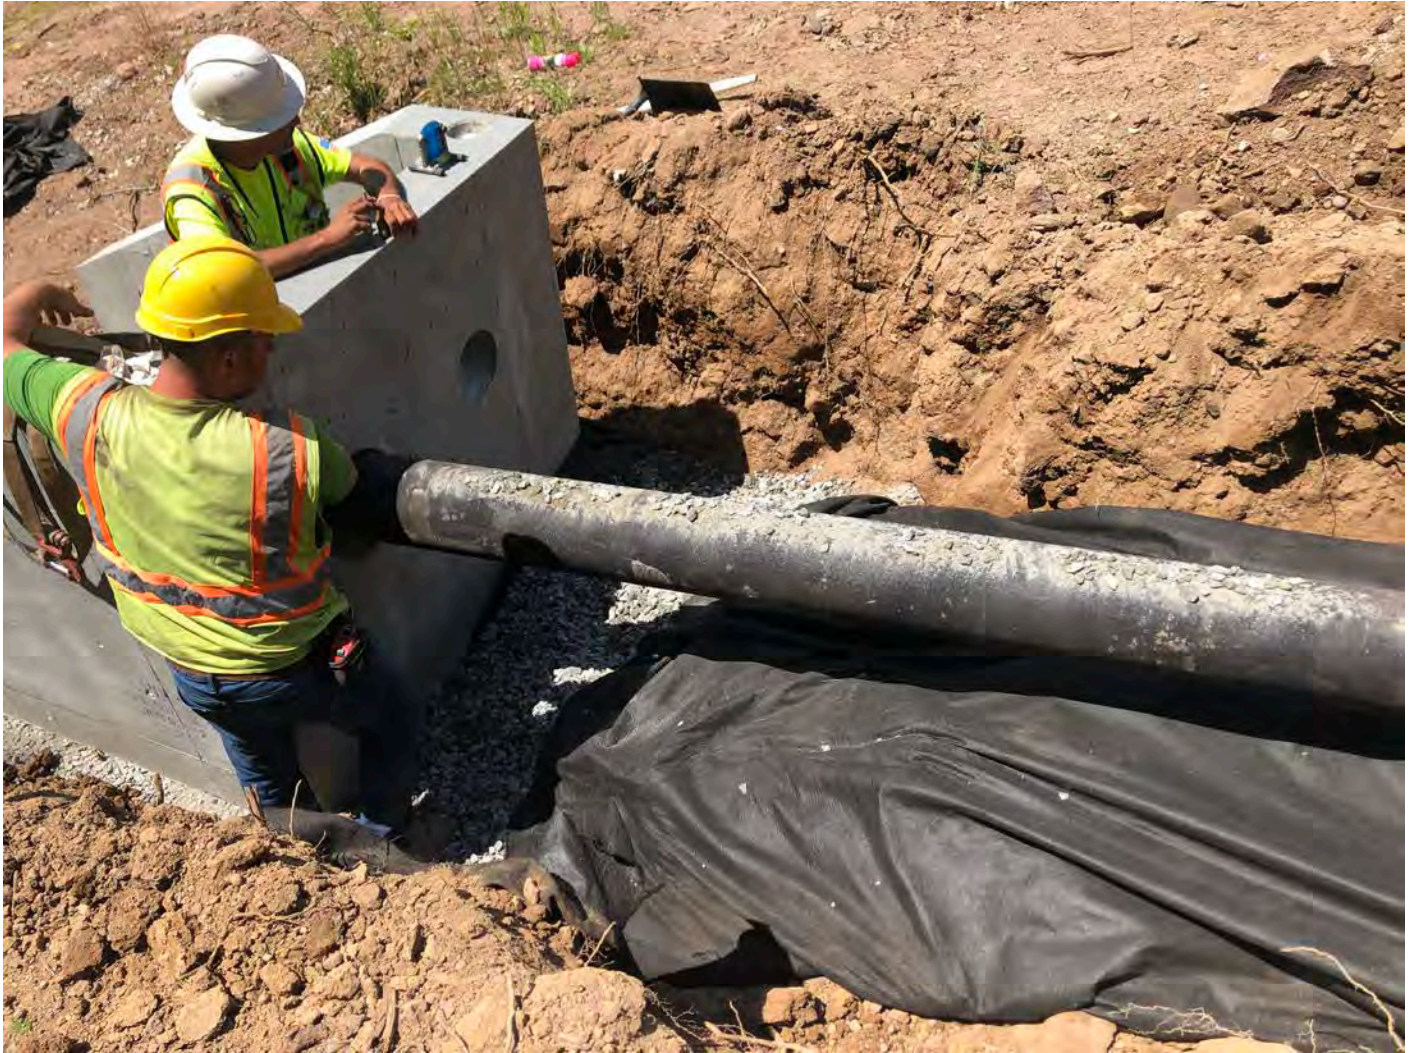
Picture 9: Ludlow in the process of installing 8" DIP to connect to the headwall they just installed at Station 11+50. View to the north.

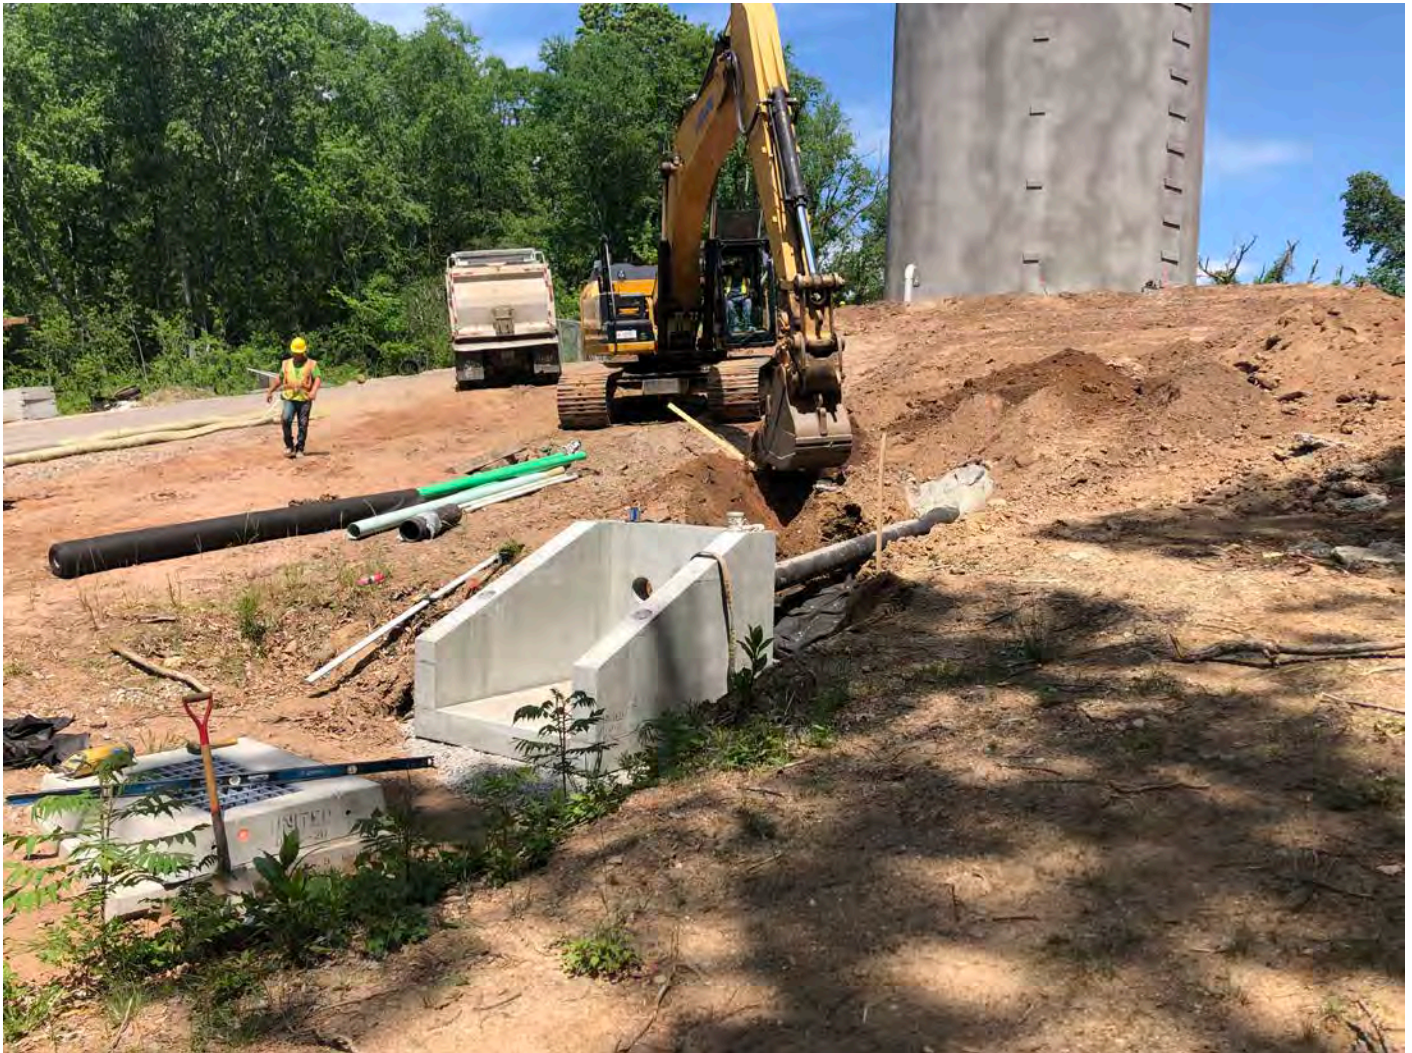
Picture 10: Ludlow excavating to install tank drain pipe to headwall at the water tank site. View to the east.

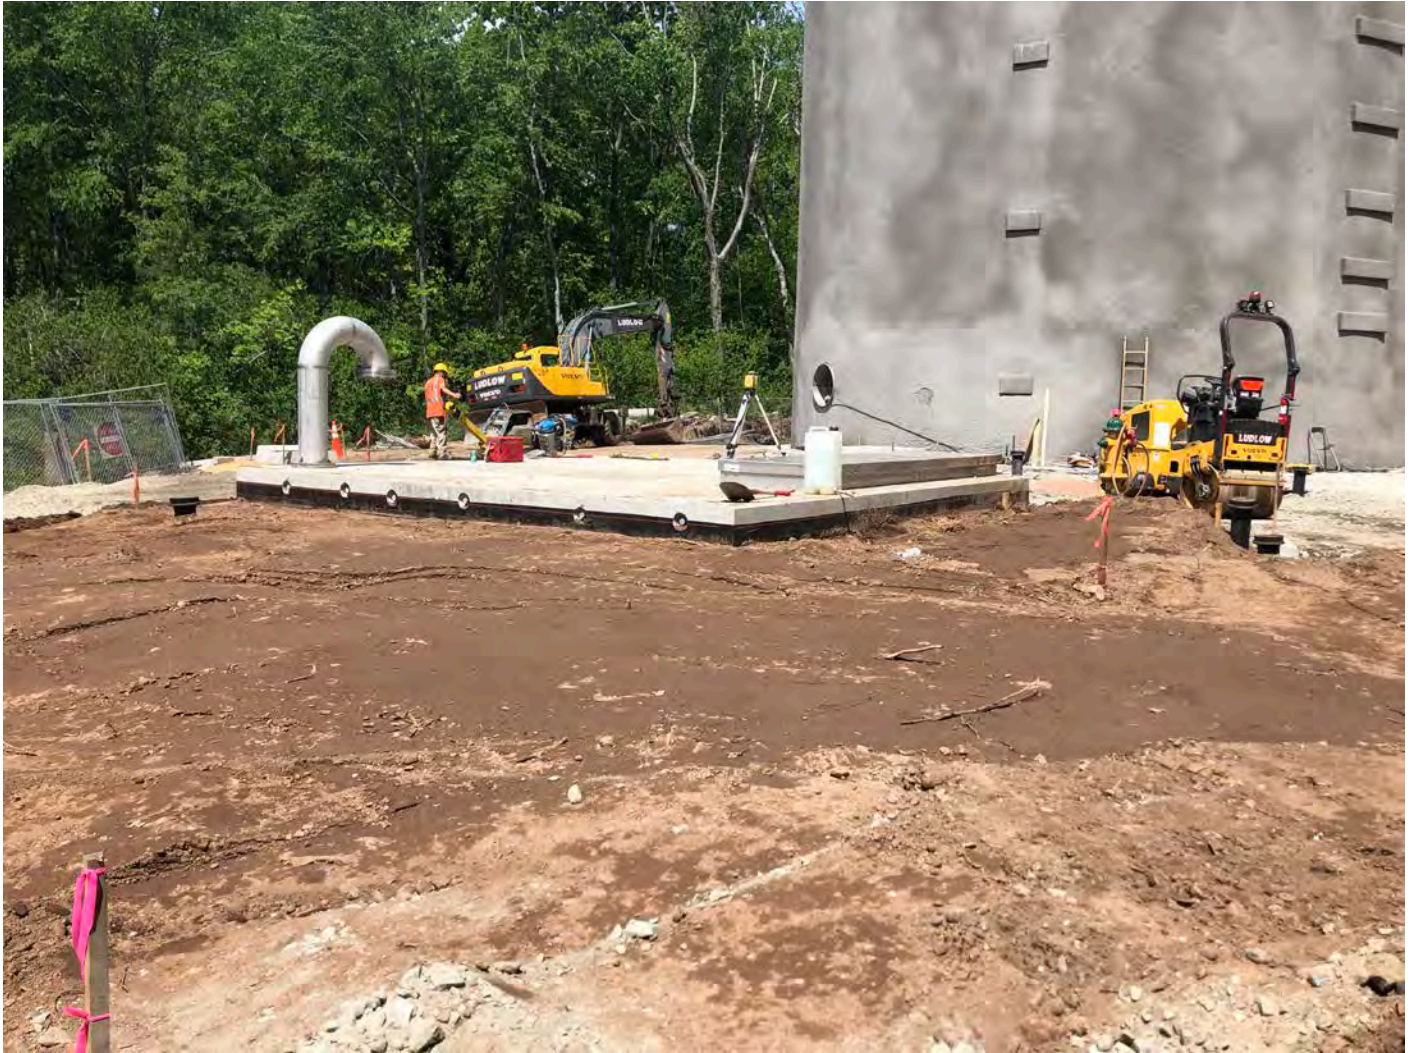
**Picture 11: Ludlow backfilling, grading and compacting around the altitude valve vault west of the water tank. View to the east.**
