Daily Report

Project:	Durham Meadows Pipeline Installation	Date:	June 2, 2021
Location:	S. Main Street, Shared Access Driveway, Middletown	Day of Week:	Wednesday
Project #:	AECOM: 6061487	Report No:	255
Contractor:	Ludlow Construction	Page:	1 of 10

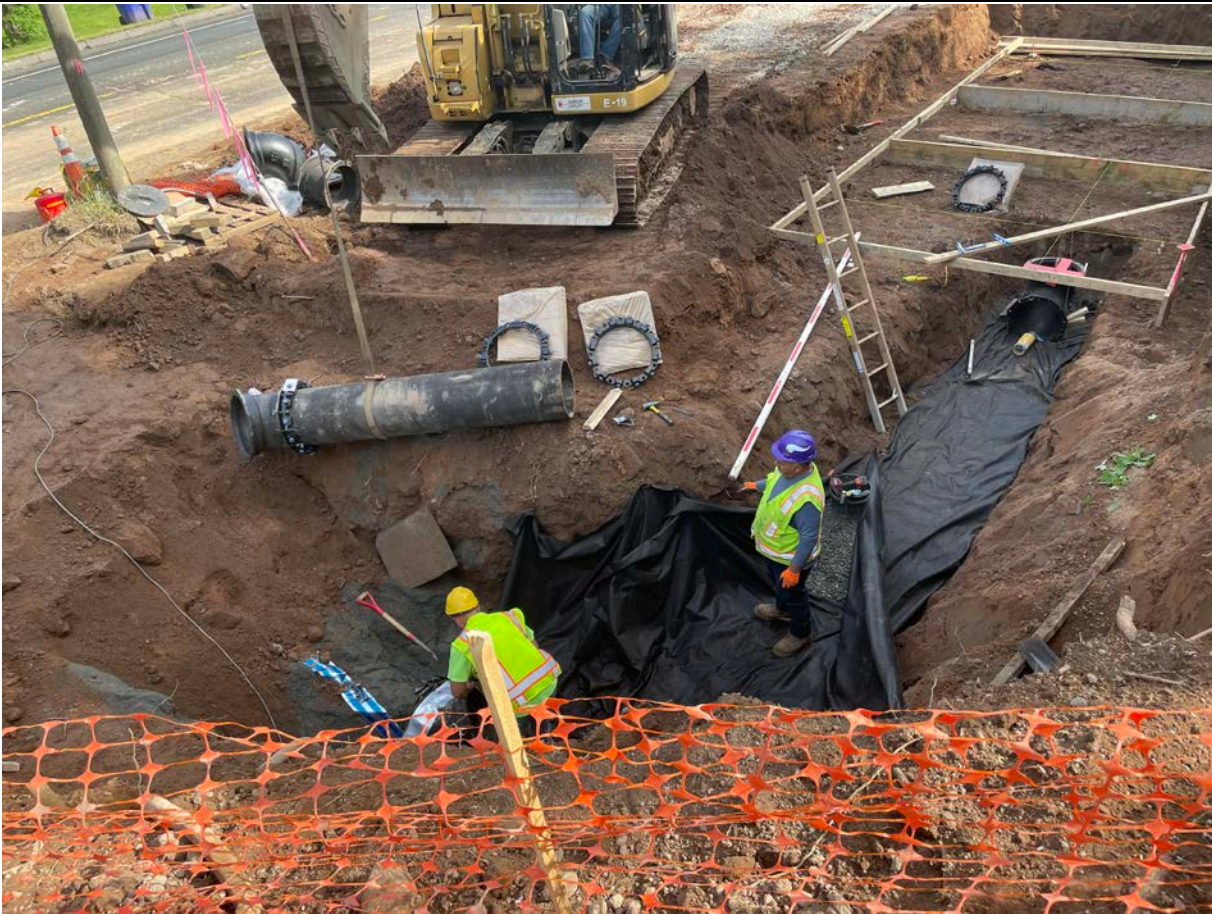
Picture 1: Ludlow in the process of installing 16" DIP close to Station 801+00 at the water meter vault located at ~Station 124+80 on S. Main Street in Middletown. View to the north.

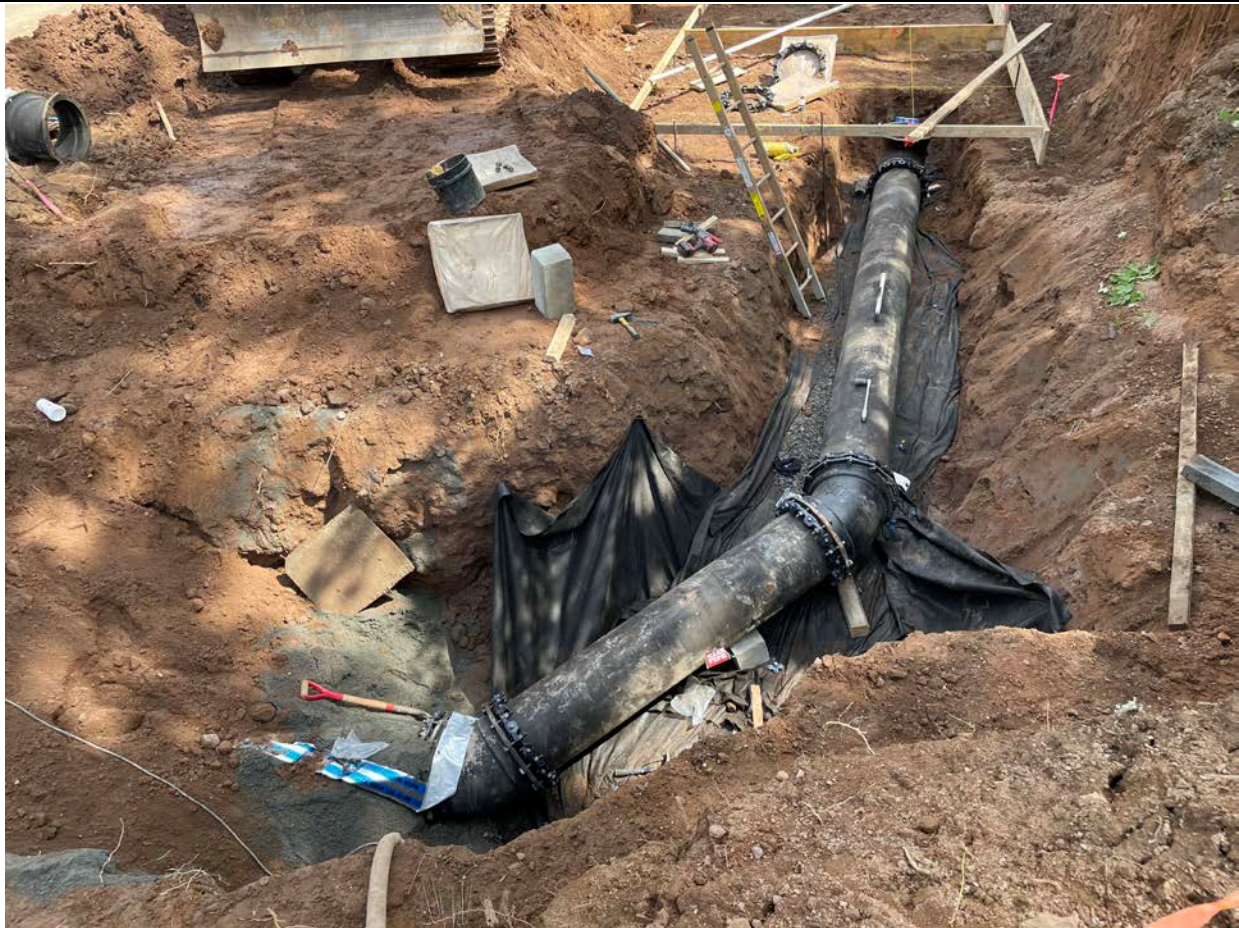
Picture 2: 16" DIP that Ludlow has installed to the south side of the water meter vault footprint. View to the north.

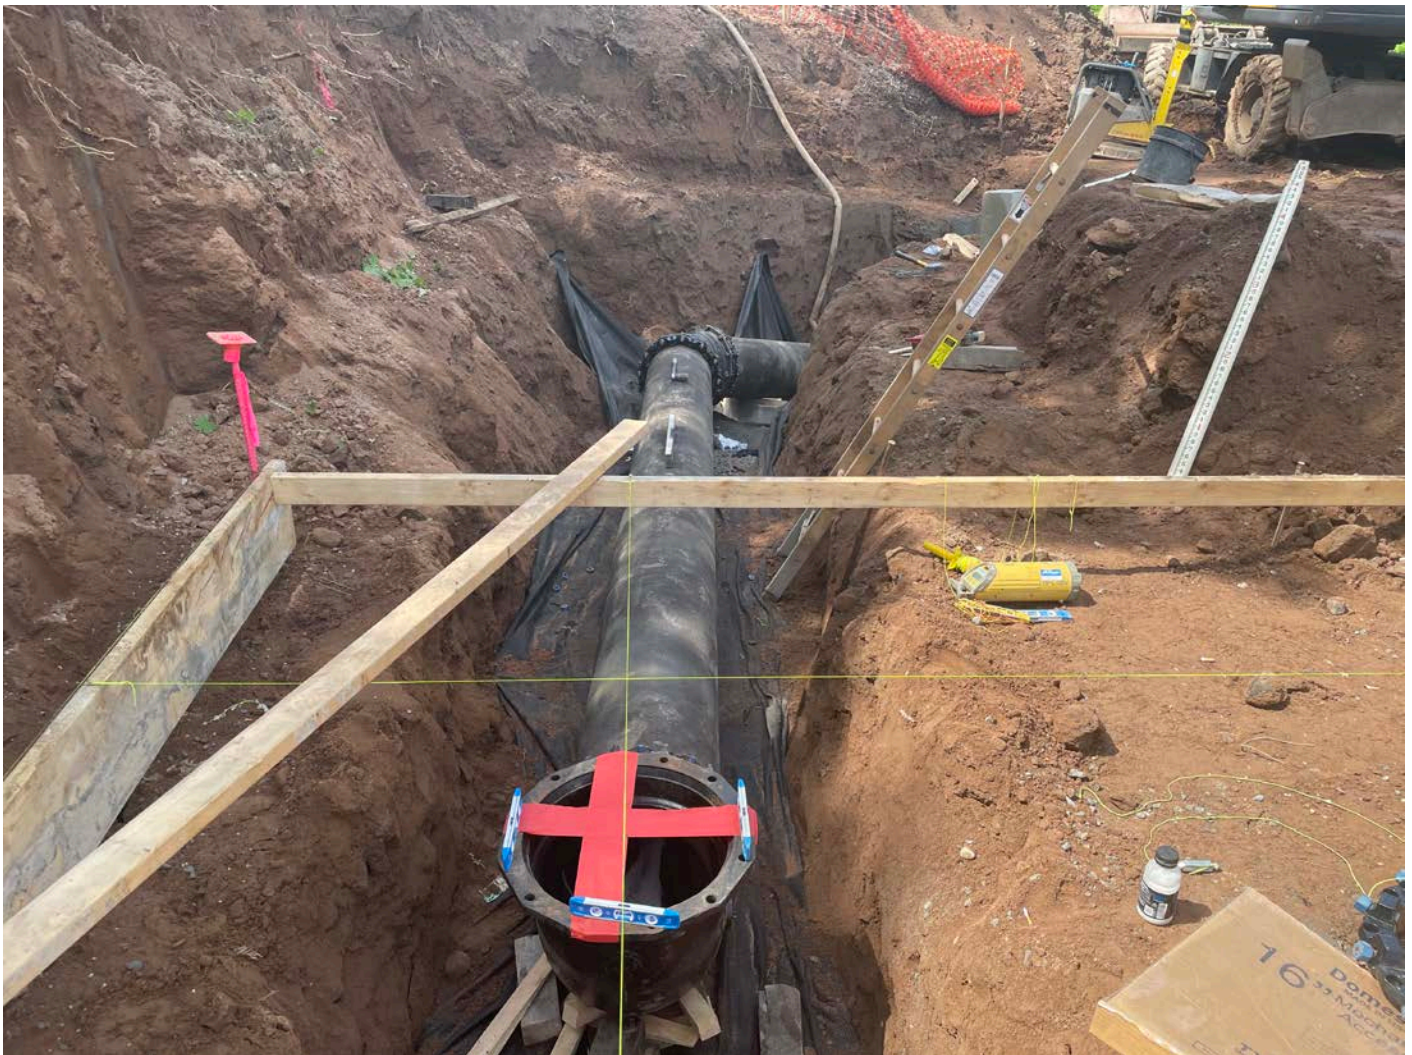
1032: Ludlow is pumping water out of the excavation at the water meter vault work zone at ~Station 801+00. Ludlow has placed a 10" section of 16" DIP with a 45° bend, followed by a ~15" section of DIP with a 90° DIP bend. The 90° bend is oriented to point up, towards the underside of the water meter vault. All connections are restrained with megalug glands

Picture 3: 16" DIP that Ludlow has installed to the south side of the water meter vault footprint. Note the 90° DIP bend that was installed on the north end of the 16" DIP. View to the south.

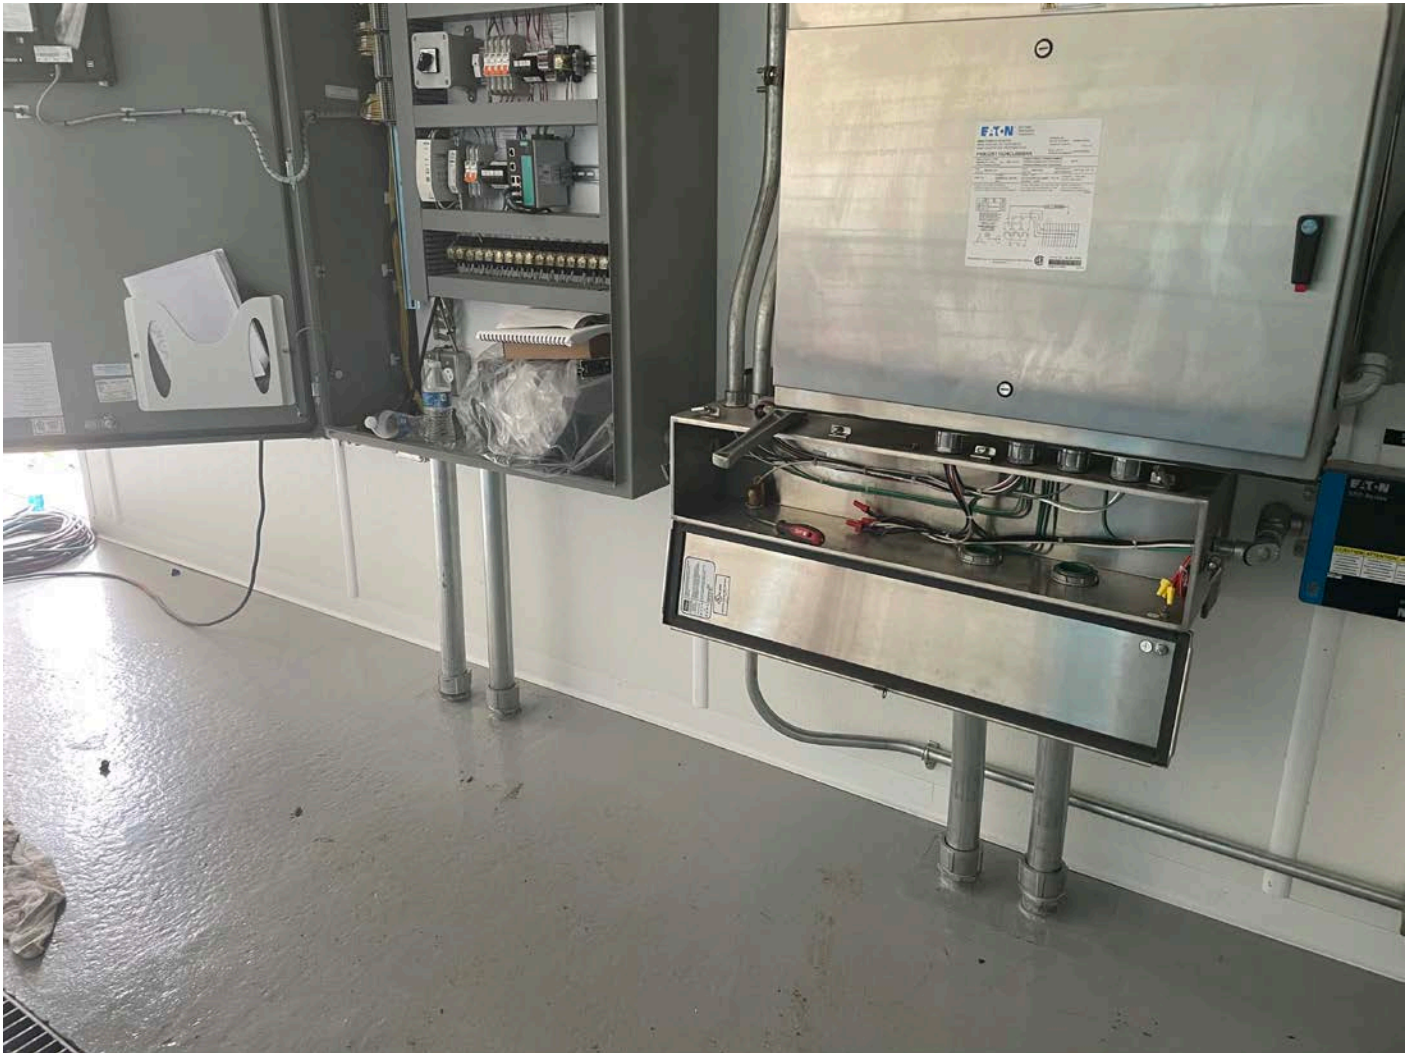
Picture 4: Cabinets on the north wall of the booster station interior where United Concrete has completed the installation of conduits on the underside of the cabinets. View to the northwest.

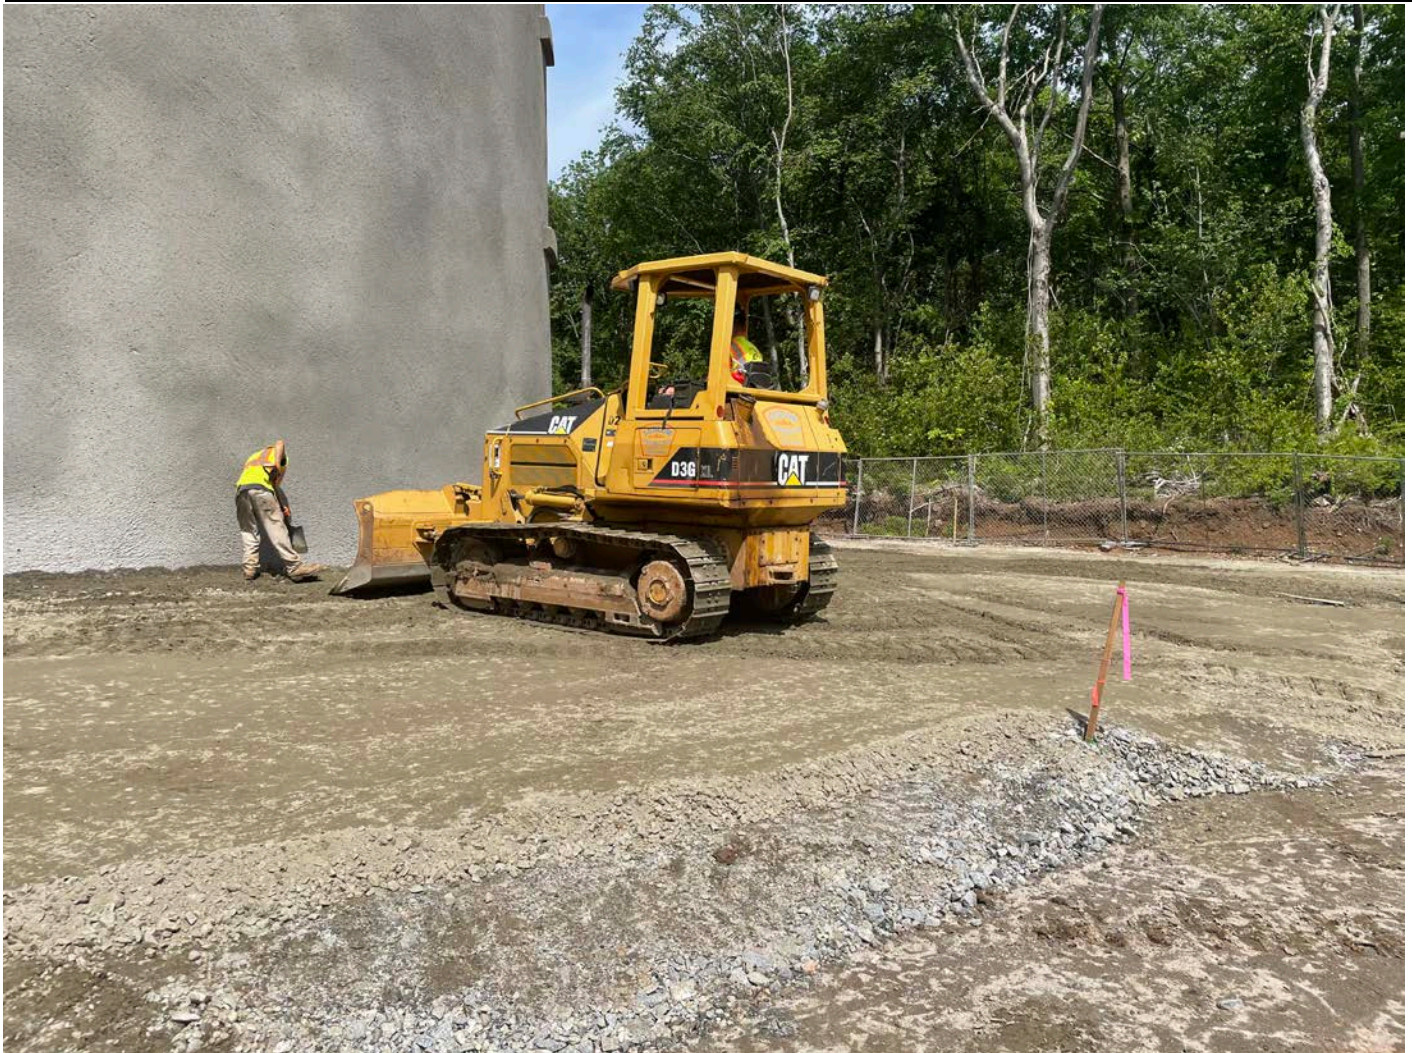
1055: Ludlow continues to place and compact 1.5" gravel on the east and northeast side of the water tank located east of the Shared Access Driveway in Middletown.

Picture 5: Ludlow grading 1.5" gravel they have been placing on the east side of the water tank located east of the Shared Access Driveway in Middletown. View to the northwest.

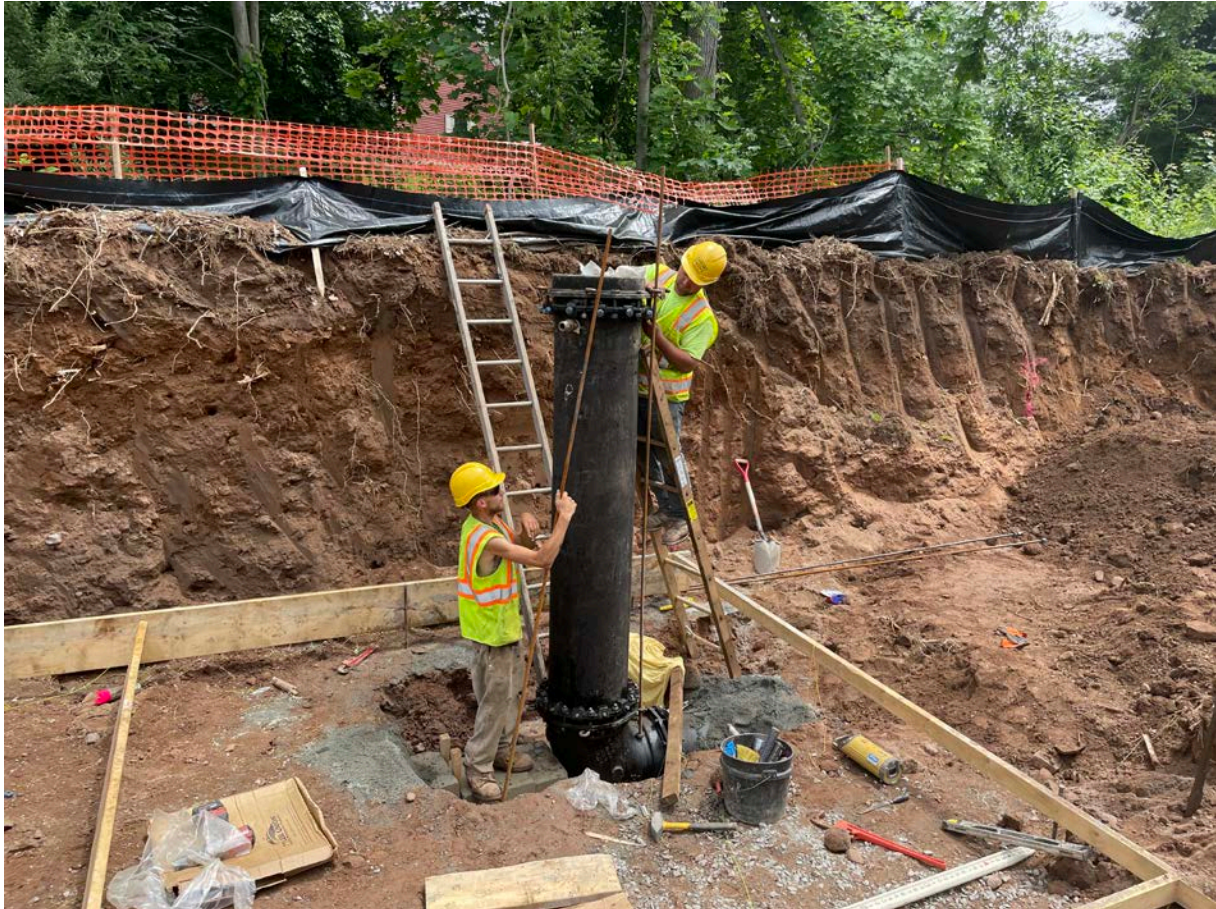
1355: Ludlow is securing the section of 16" DIP they installed vertically on the 90° bend they just installed on the south side of the water meter vault footprint.

Picture 6: Ludlow securing a section of 16" DIP to the top of a 90° DIP bend on the south side of the water meter vault located at Station 124+80. View to the southeast.

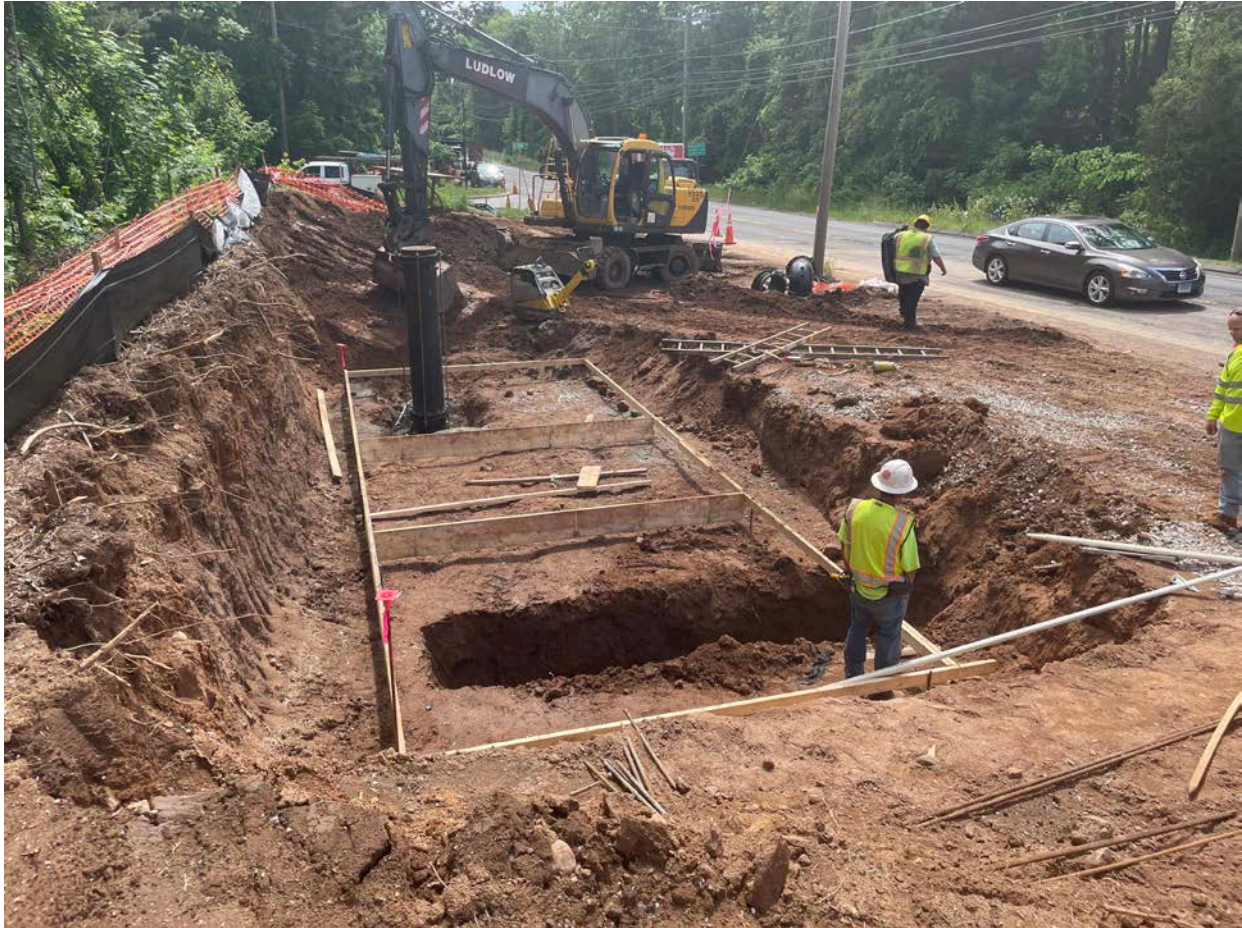
Picture 7: Overview of the water meter vault work zone located at ~Station 124+80. View to the south.

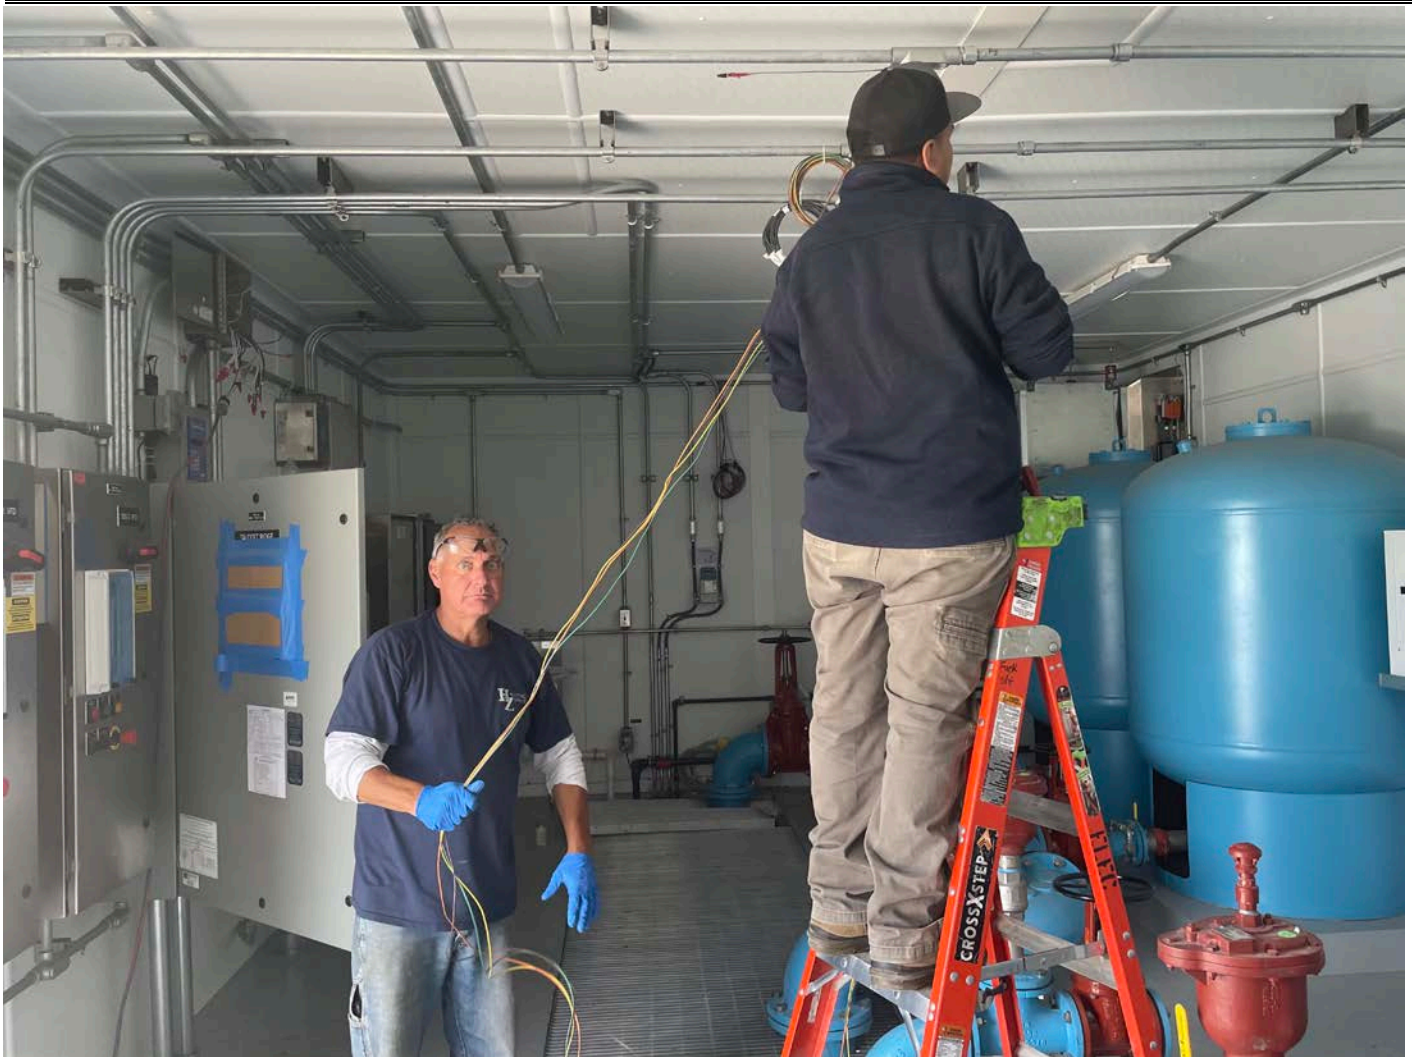
Picture 8: United Concrete installing wiring inside of the booster station located at Station 750+63 on S. Main Street, Middletown. View to the east.
