## Daily Report

<b>Project:</b>	Durham Meadows Pipeline Installation	<b>Date:</b>	June 4, 2021
<b>Location:</b>	S. Main Street and the Shared Access Driveway, Middletown	<b>Day of Week:</b>	Friday
<b>Project #:</b>	AECOM: 6061487	<b>Report No:</b>	257
<b>Contractor:</b>	Ludlow Construction	<b>Page:</b>	1 of 10

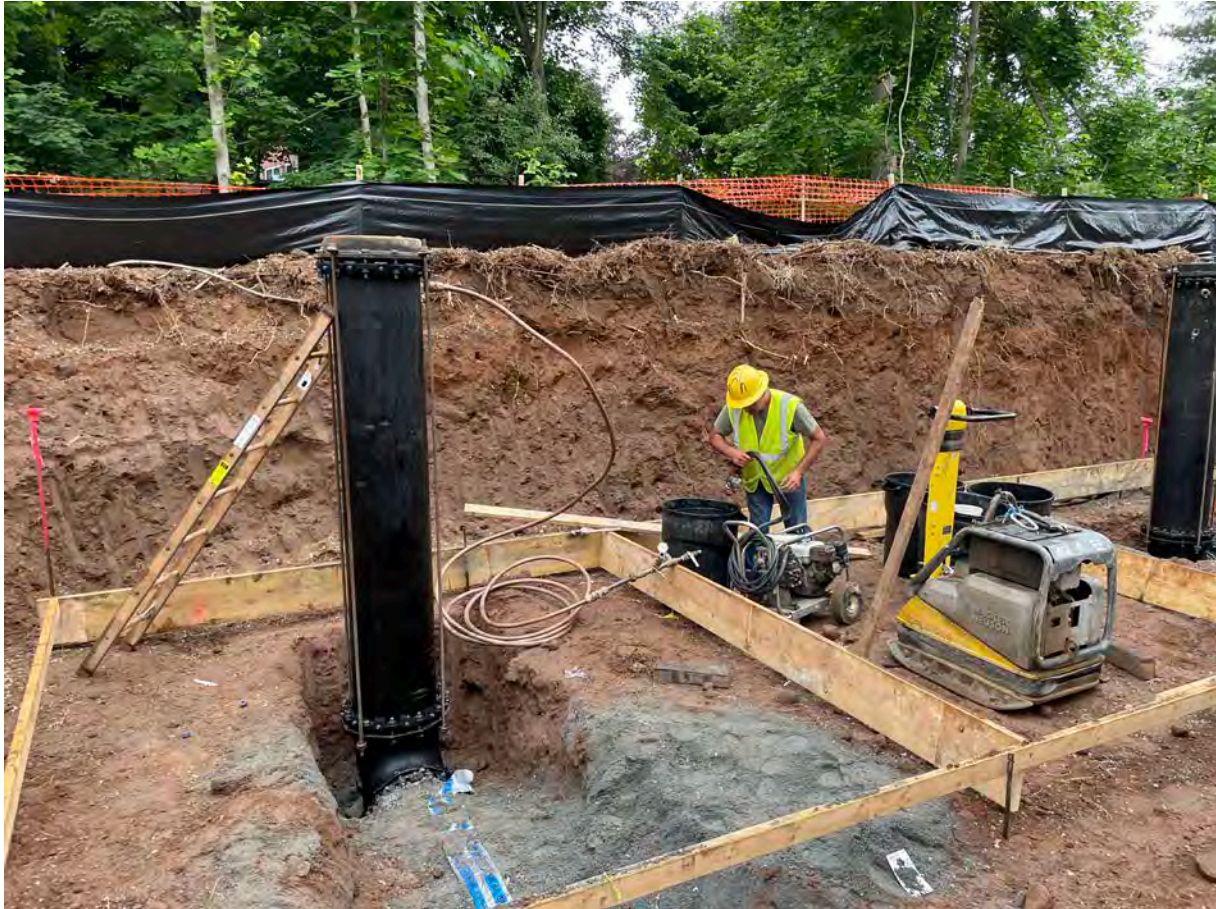
Picture 1: Section of 16" DIP that Ludlow attached to a 90° bend on the north side of the water meter vault footprint yesterday. Ludlow is starting a pressure test from this pipe to where they connected 16" DIP at Station 124+72. View to the southeast.

0747: Ludlow is setting up to pressure test on the 16" DIP they installed yesterday from Station 124+72 to the north side of the water meter vault footprint. Ludlow continues to perform earthwork south of the vault footprint.

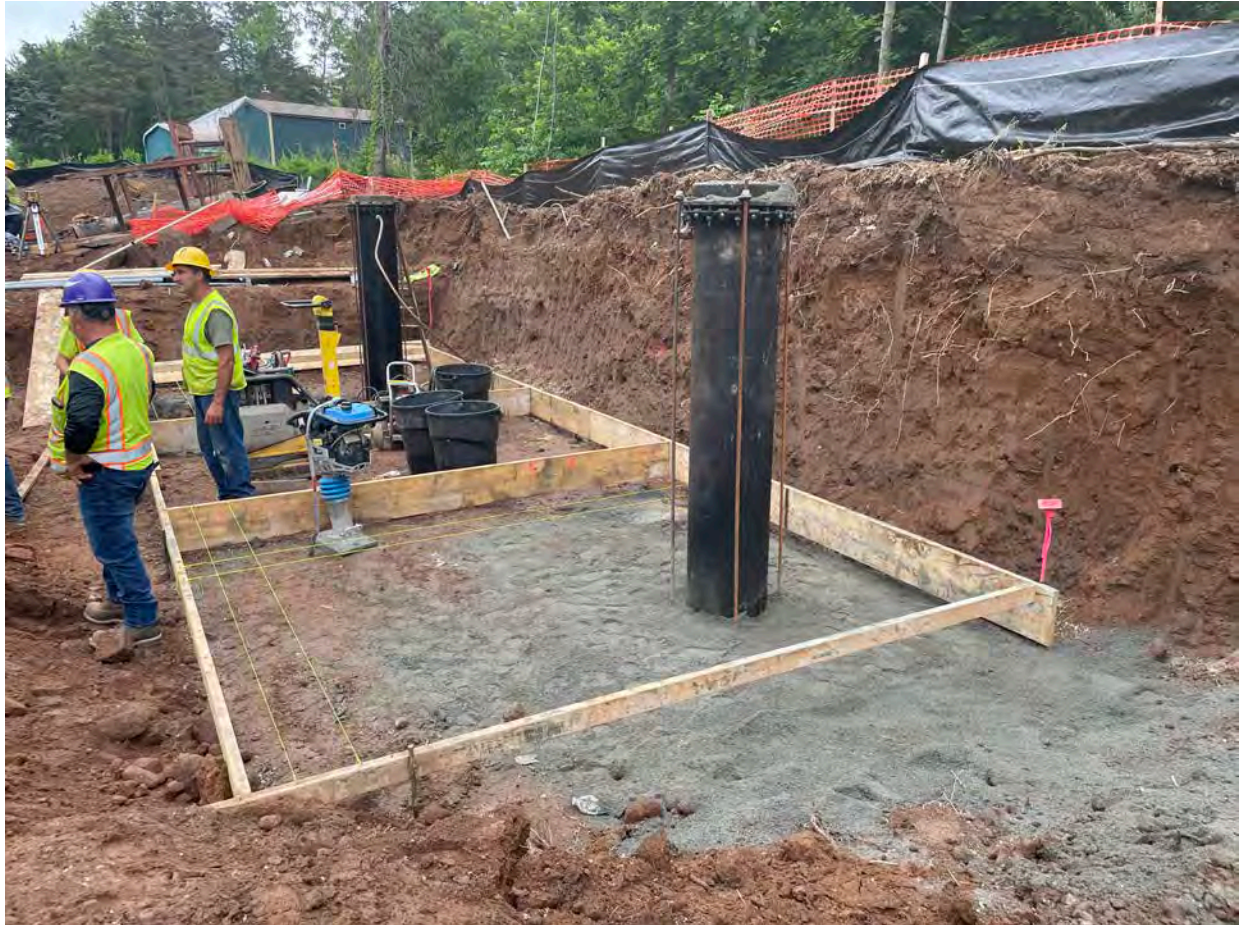
Picture 2: View of the water meter vault footprint and the pressure test that Ludlow is conducting today. View to the north.

0942: Ludlow continues to conduct a pressure test on 16" DIP located on the north side of the water meter vault. Ludlow is also installing additional gray PVC conduits on the west side of the vault footprint.

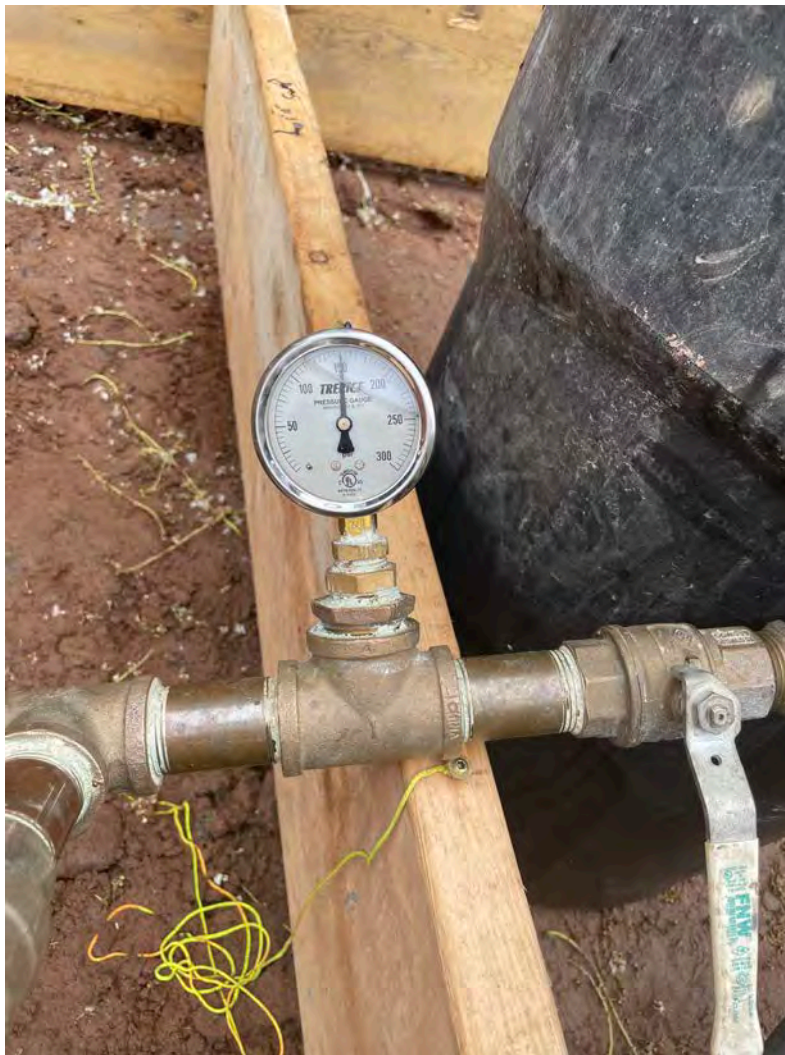
**Picture 3: Starting pressure of 150 PSI on the pressure test that Ludlow is performing today at the water meter vault.**

0920 Ludlow starts to pressure test the 16" DIP located on the north side of the water meter vault footprint. Starting pressure is 150 PSI.

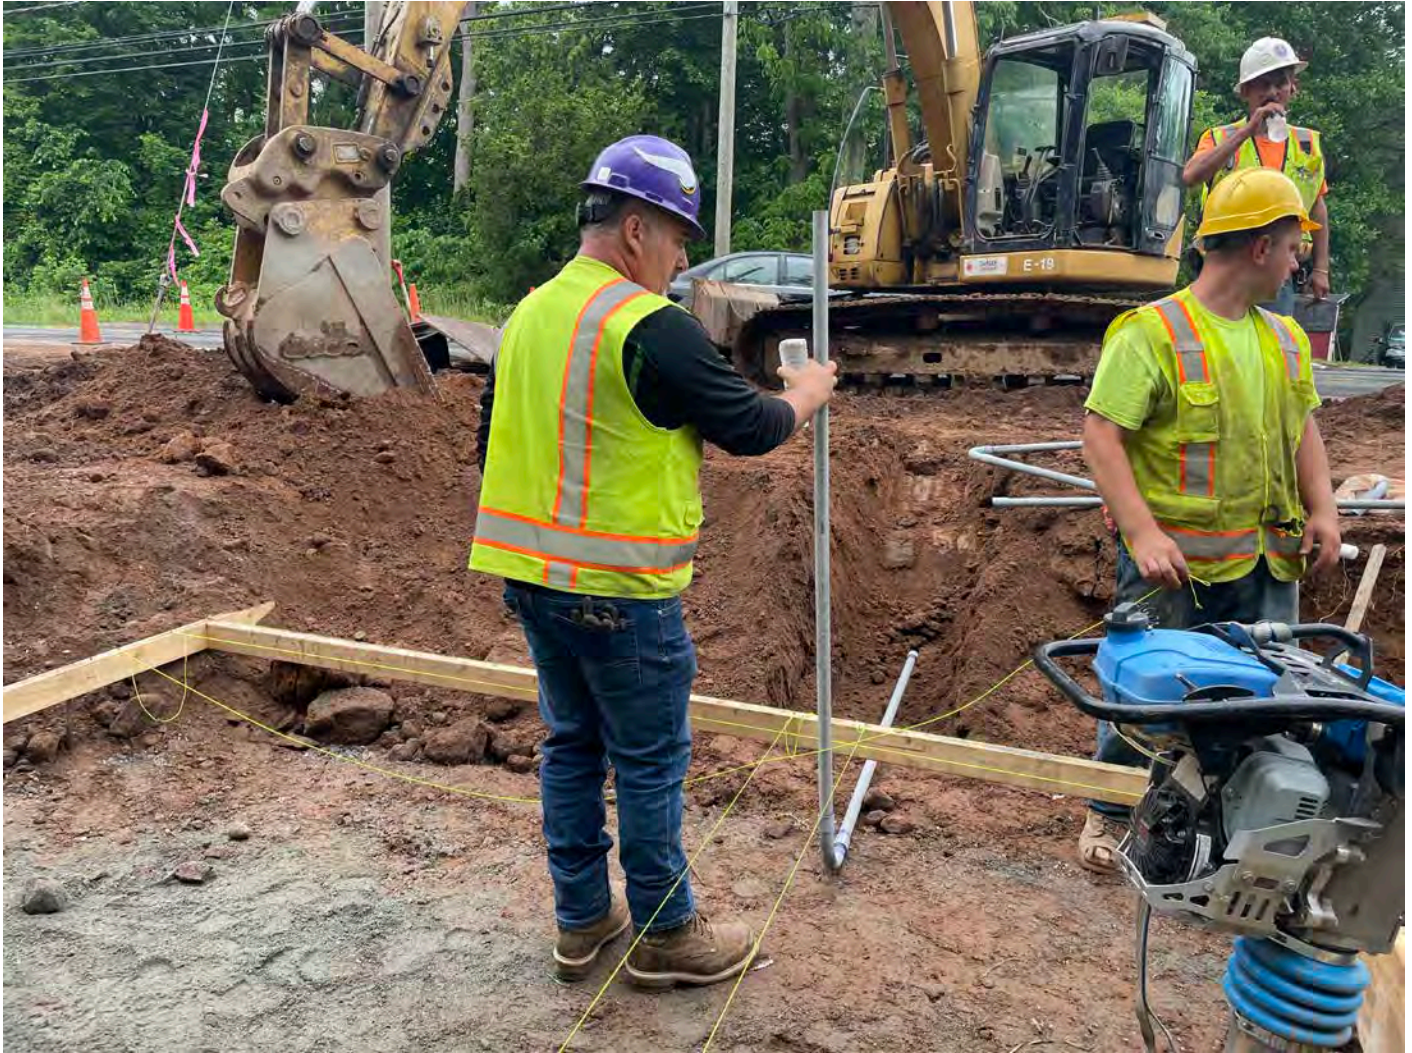
Picture 4: Ludlow installing 1" PVC electrical conduits on the west side of the water meter vault footprint. View to the west.

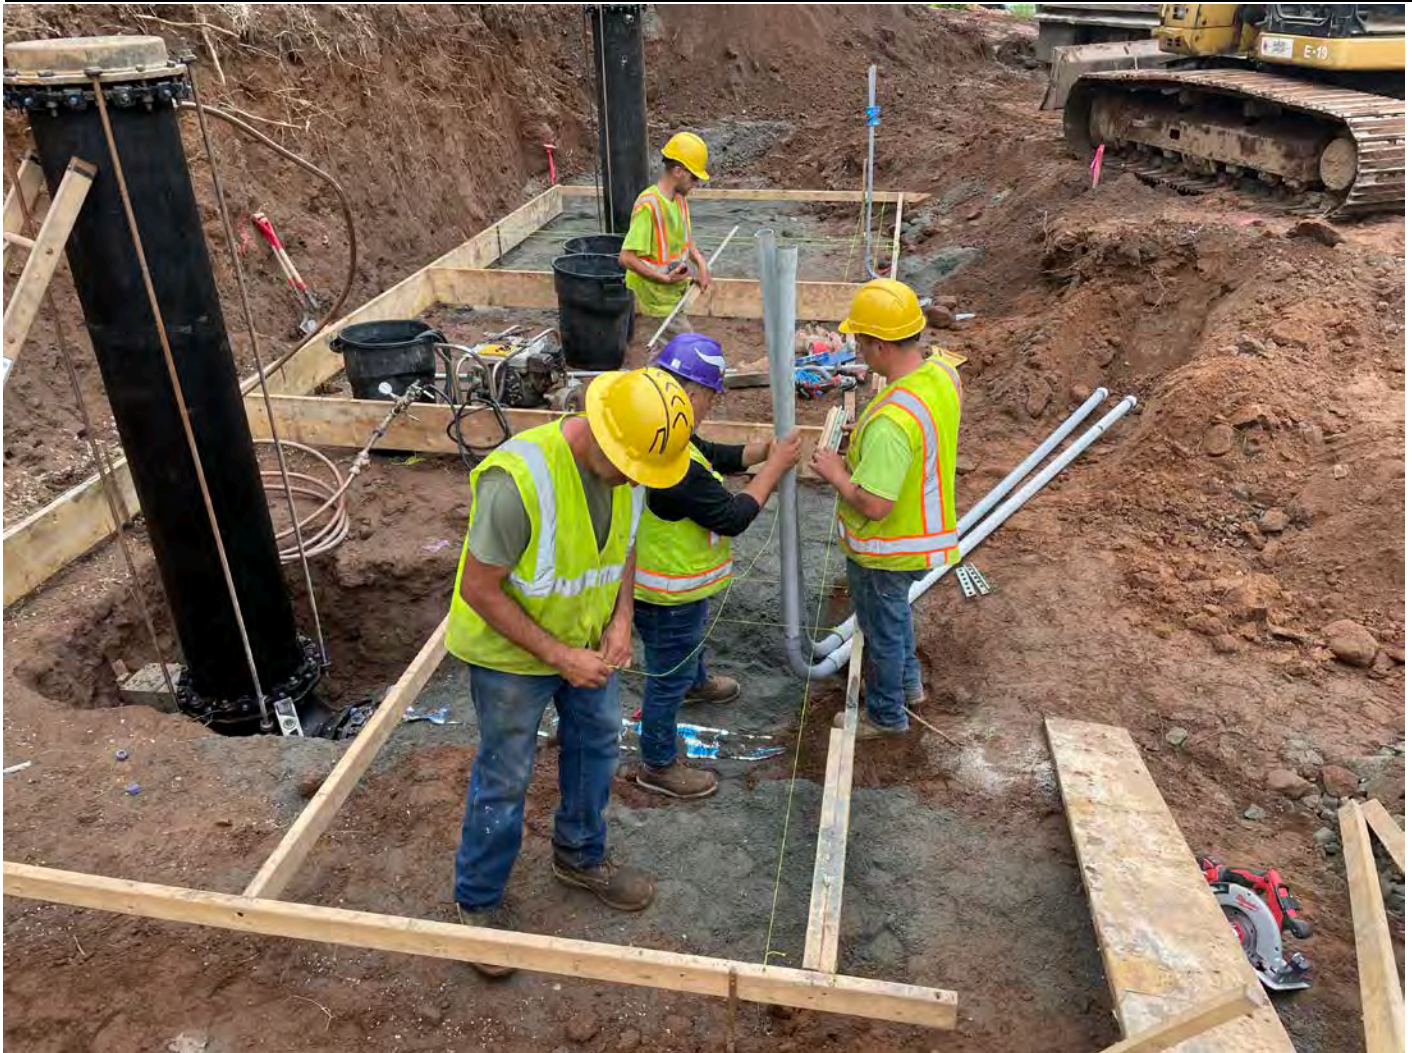
Picture 5: Ludlow installing additional PVC conduits on the west side of the water meter vault footprint. View to the south.

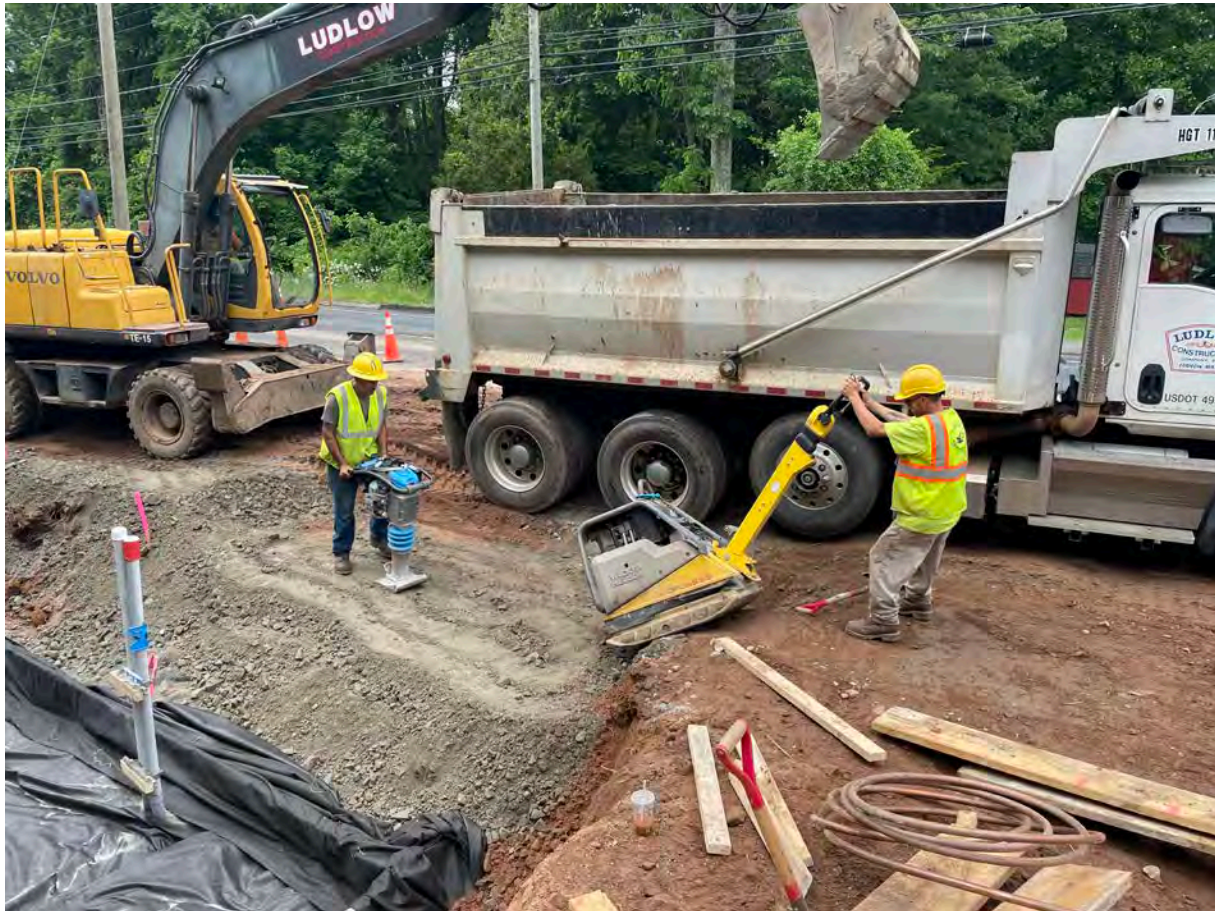
Picture 6: Ludlow compacting gravel over the 16" DIP pipe they installed on the north side of the water meter vault footprint located at ~Station 124+80. View to the southwest.

1254: Ludlow is placing gravel over the 16" DIP that they just installed on the north side of the water meter vault footprint.

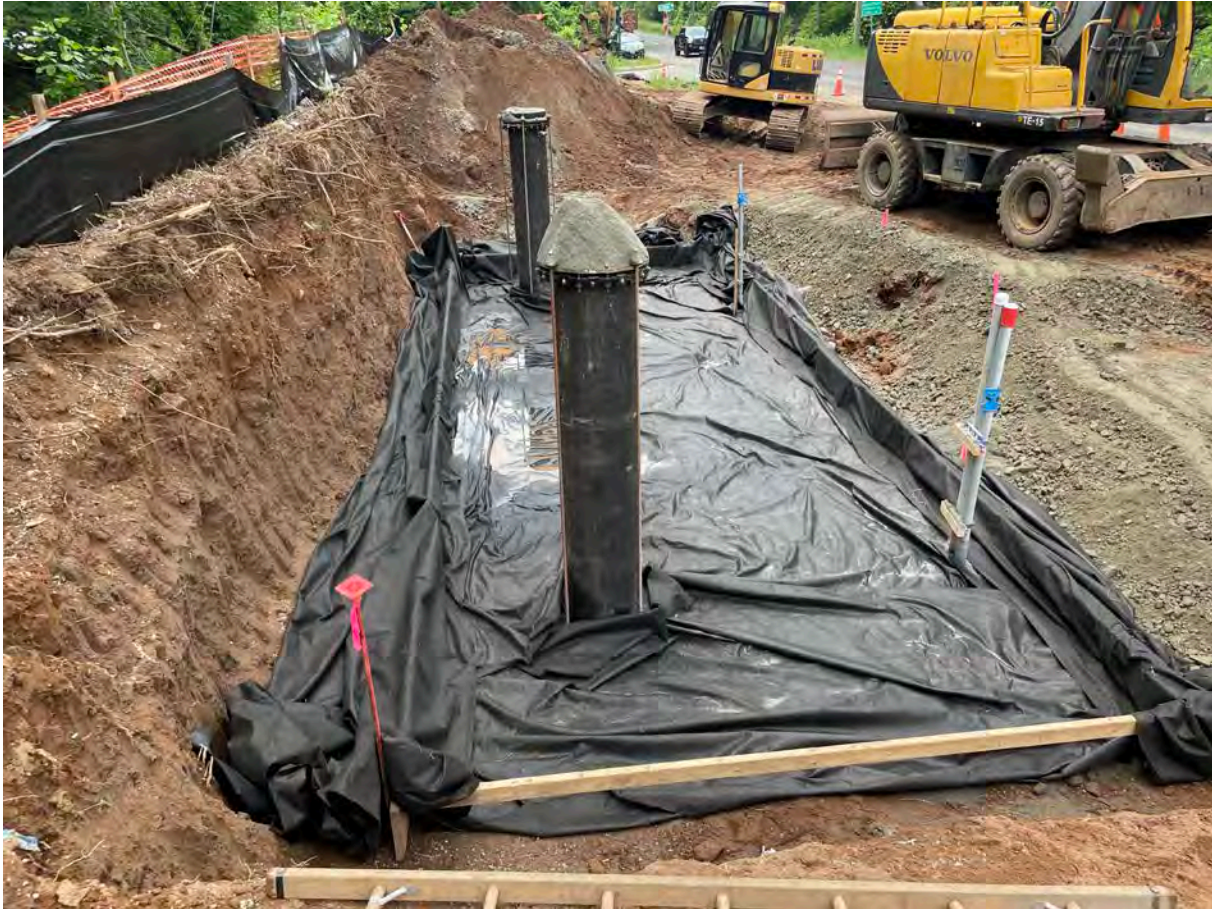
Picture 7: View of the water meter vault footprint, where Ludlow has lined it with geofabric. View to the south.

1233: Ludlow has the footprint of the water meter vault lined with geofabric. They are currently placing and compacting fill on the northwest corner of the footprint.

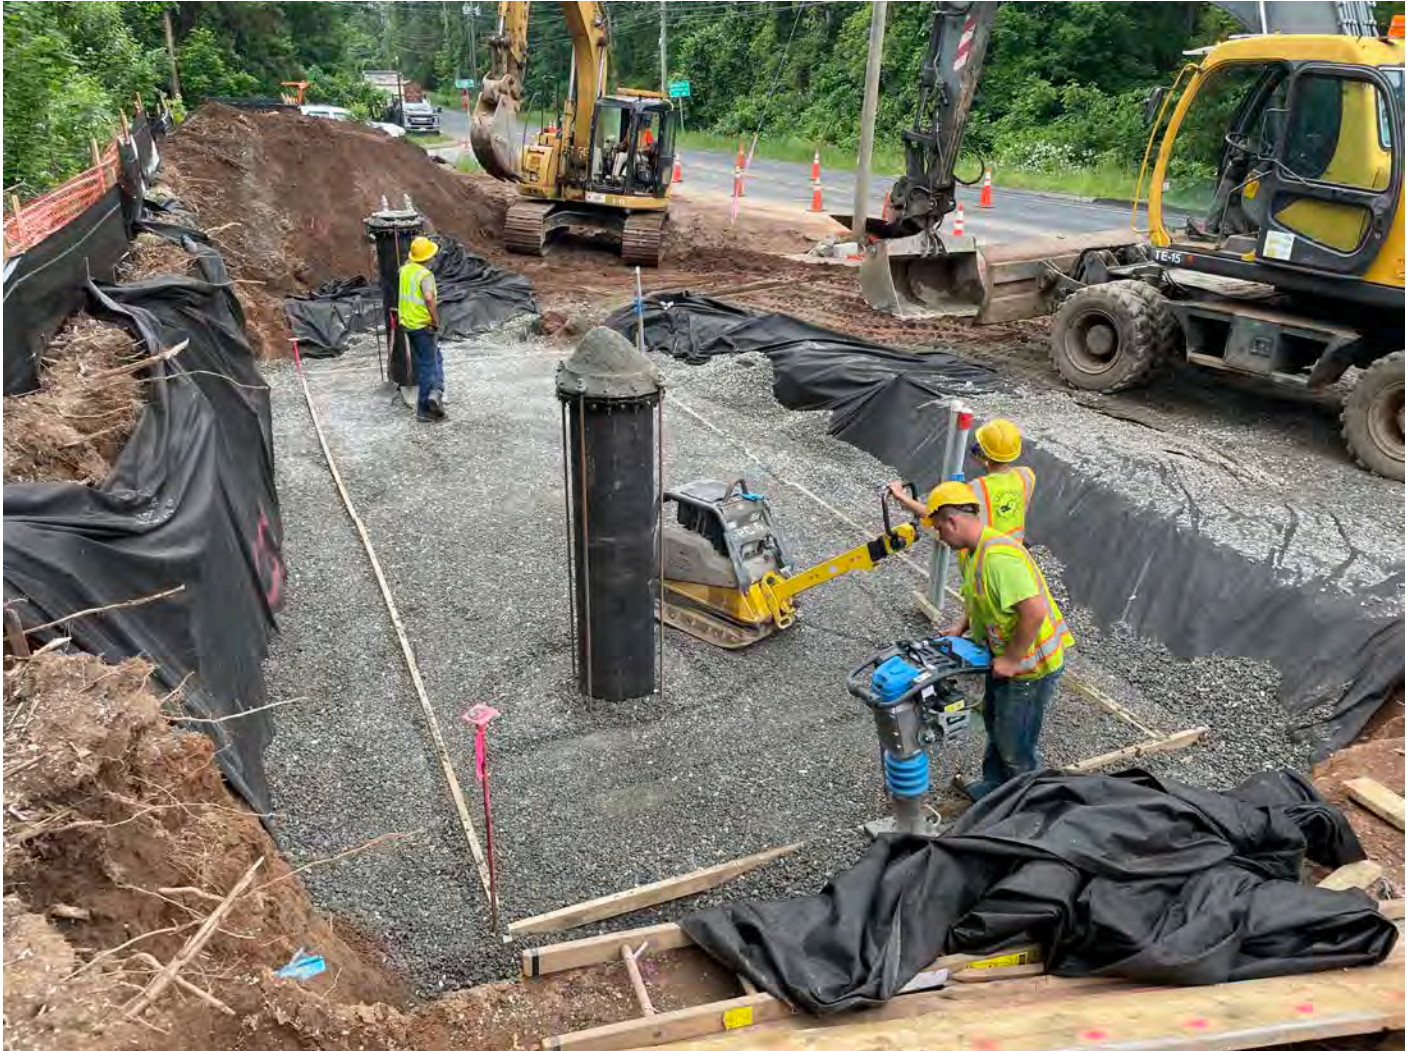
Picture 8: View of the water meter vault footprint where Ludlow placed and compacted 1' of ¾" gravel, and is placing a second 1' lift of gravel. View to the south.

1357: Ludlow is placing and compacting ¾' gravel at the water meter vault footprint. Compaction is being performed with a jumping jack and a plate compactor.
