Daily Report

Project:	Durham Meadows Pipeline Installation	Date:	June 10, 2021
Location:	S. Main Street and the Shared Access Driveway, Middletown	Day of Week:	Thursday
Project #:	AECOM: 6061487	Report No:	261
Contractor:	Ludlow Construction	Page:	1 of 15

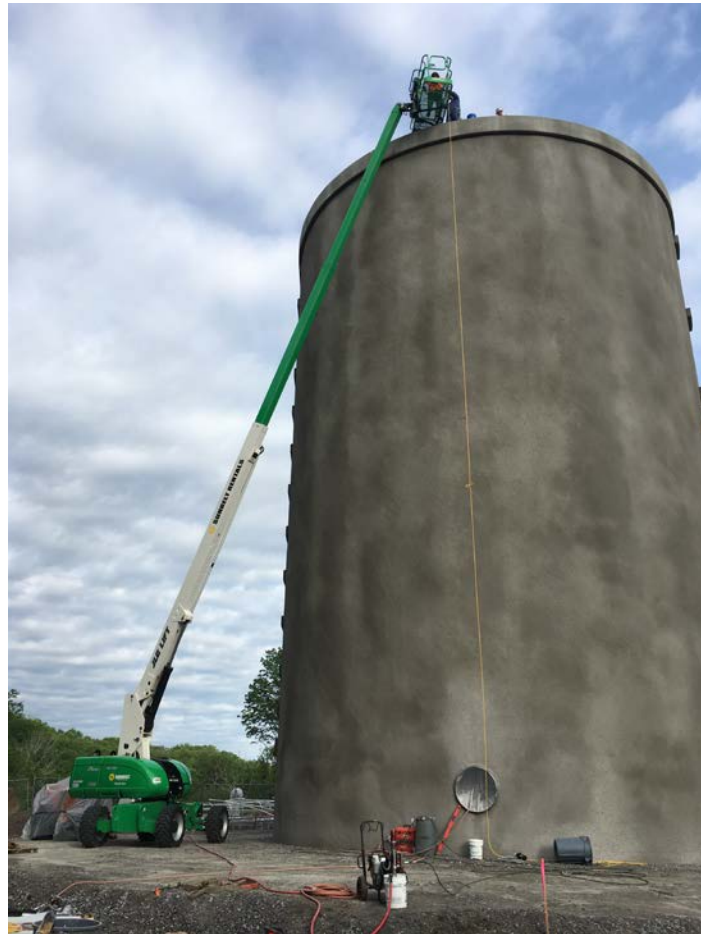
Picture 1: Facing west. Coating underway on the dome.

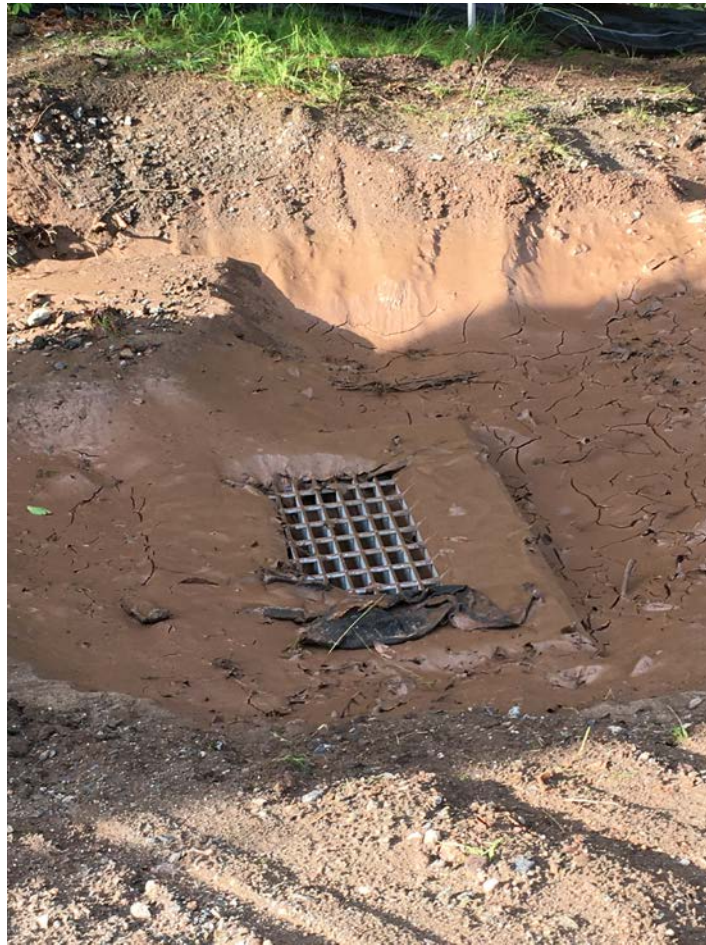
0710: DN Tanks arrived at 0600 hours this morning and began painting the dome of the water tank. Their sub, Keltic Paint, also on site doing the final coat on the ladders. In conversation with Billy (Ludlow) this morning, after severe heavy rains last night, the new catch basin had silted over (due to silt sock in grate, and flooded over carrying the silt (which would have ended up in the drain) out onto the road. The road had to be swept this morning. Billy said he is going to put rip-rap in the basin regardless because the issues will take up more time than the just putting rip-rap in. The slopes off the side of the road do show signs of erosion and will likely continue to erode until the slope is stabilized.

Picture 2: Facing south. View into new catch basin at tank site with silted in and flooded because silt sock plugged.

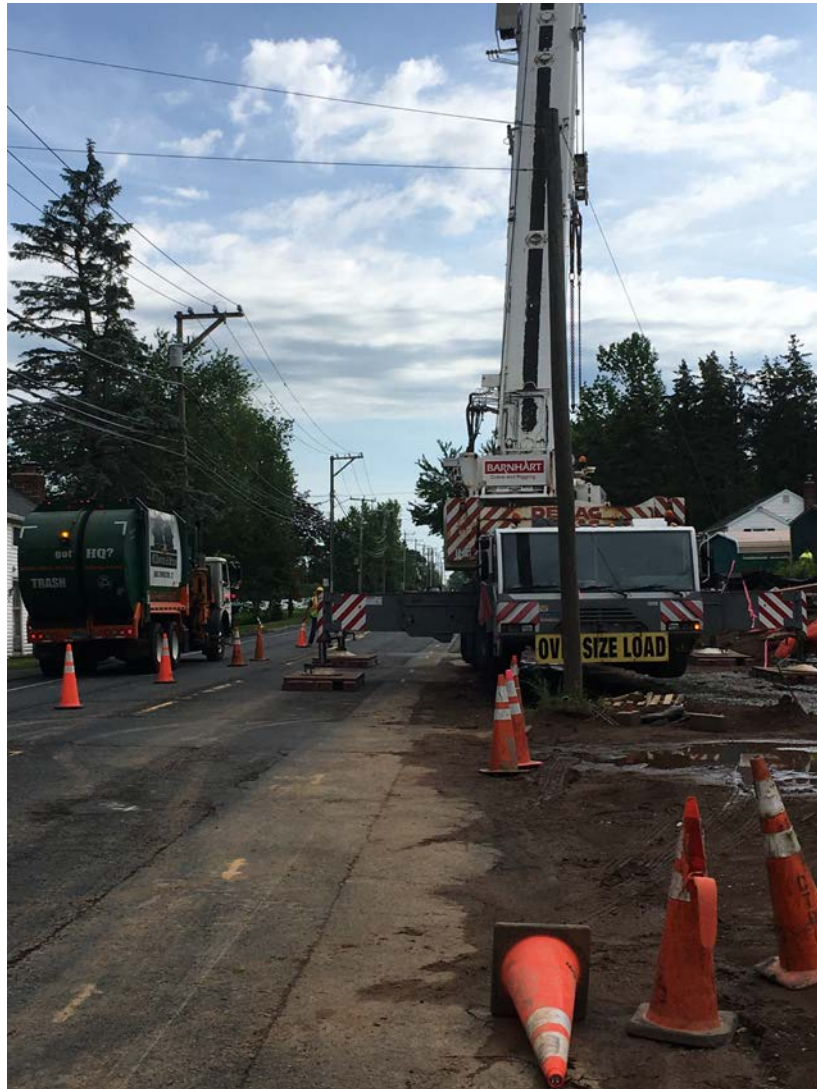
1040: Everything is finally in place and the lift starts. Traffic is stopped during the first part of the pic to allow crane to turn into position. Turns out that the crane was not as wide as stated and sufficient room was available to keep one lane open.

Picture 3: Facing north. Crane with outriggers extended. However back end of crane was slightly over center line hence cone placement. Traffic was able to safely pass.

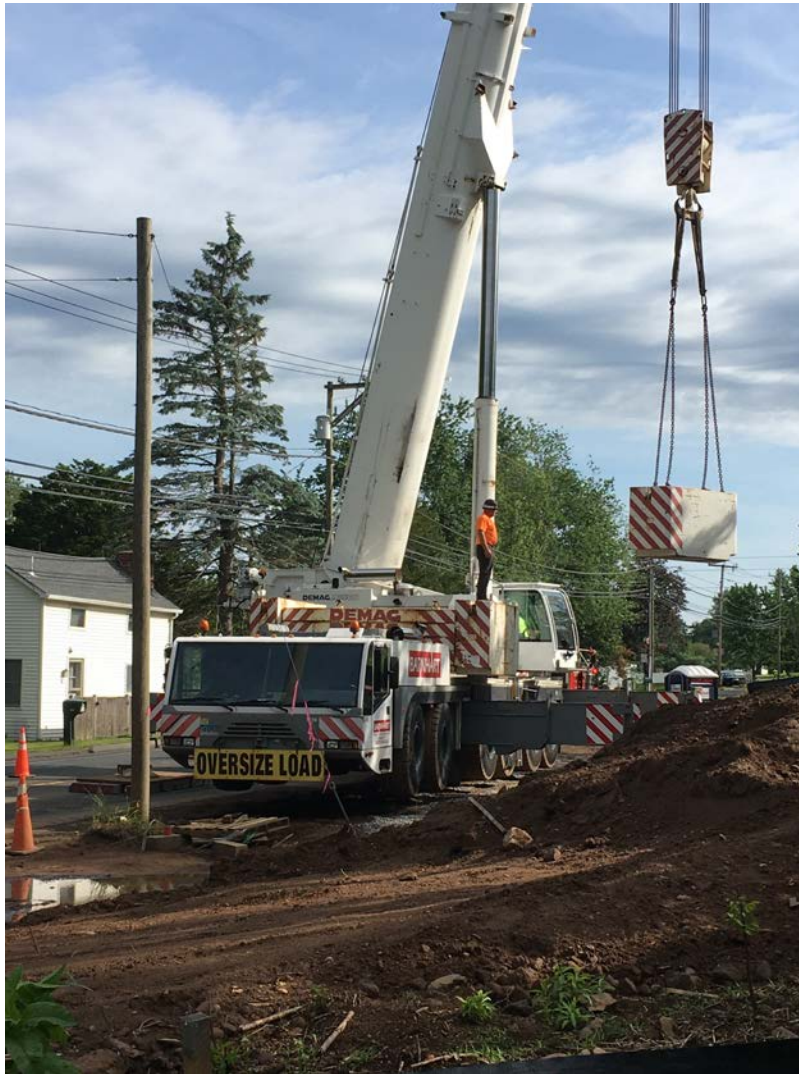
0850: Final set of counterweights added to the crane.

Picture 4: Facing northwest. Loading additional counterweight to crane.

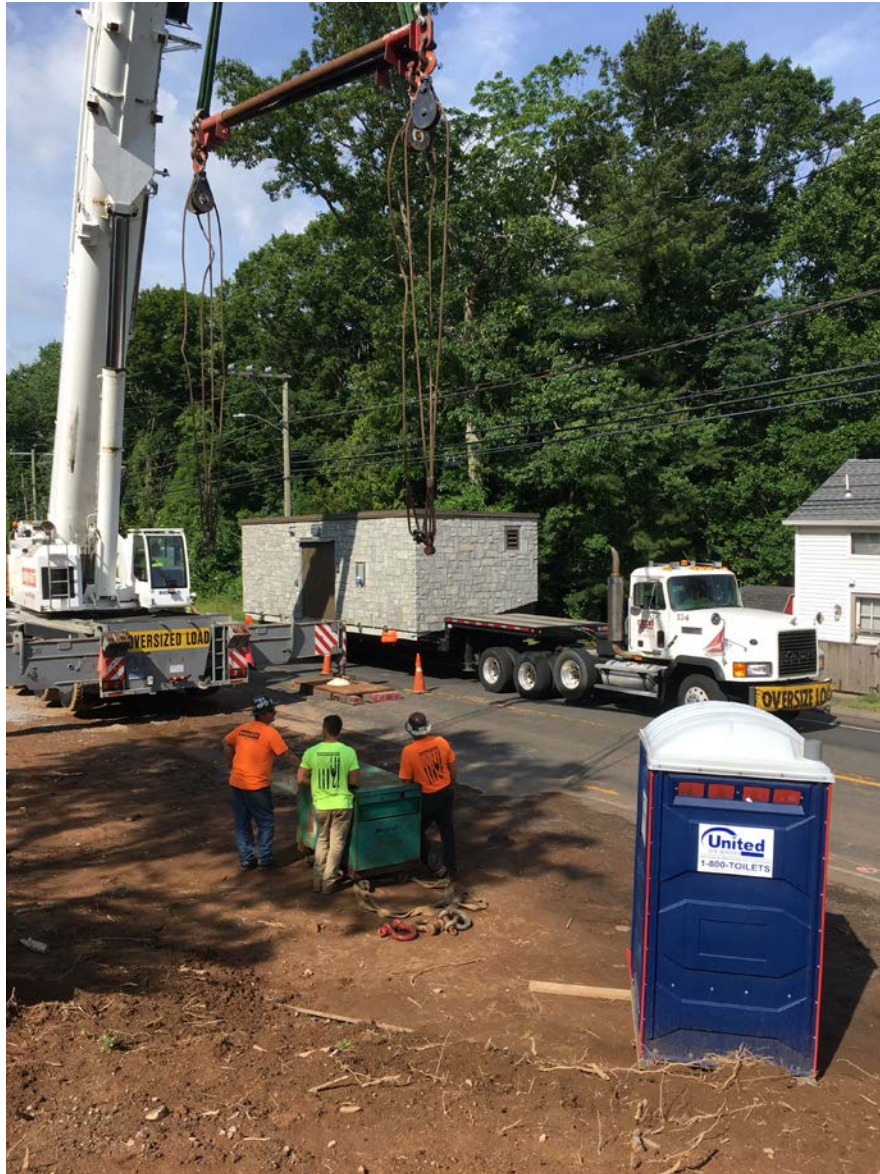
Picture 5: Facing southwest. Meter building arrives on step-deck low-boy trailer.

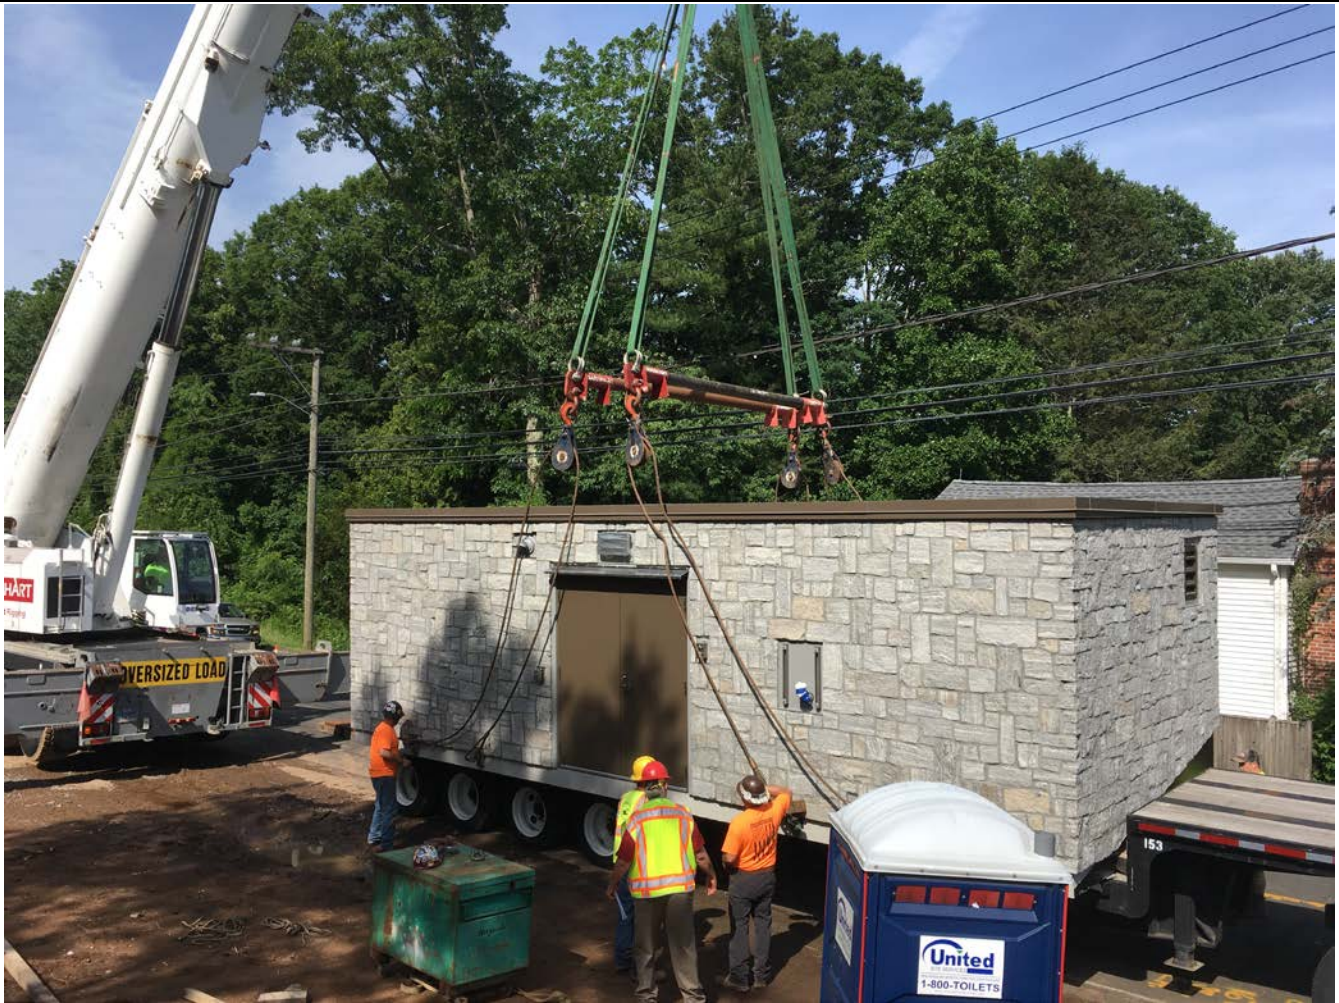
0920: Building arrives on site. Crews work at attaching hoist to the building, but it becomes clear that the spreader bars are not long enough to avoid having the rigging crush the top of the building. Call is made for longer spreader bars. United is cutting piping for final building overlay.

Picture 6: Facing southwest. Setting up rigging. Notice that the spreader bars are too short. Longer bars were brought in so that rigging did not damage top of meter building.

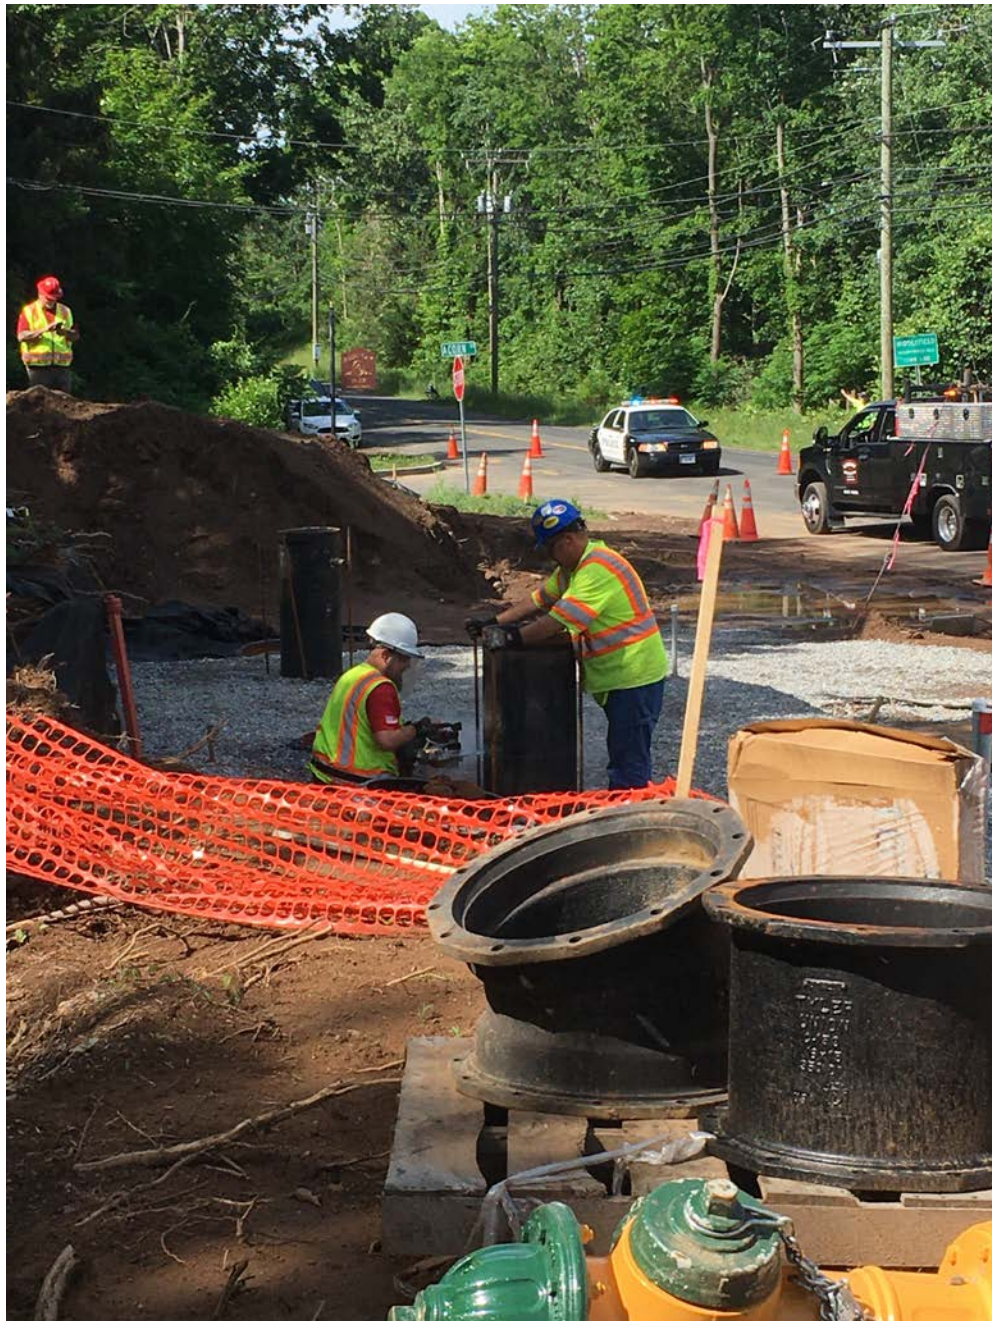
Picture 7: Facing south. United Concrete shortening piping to align with meter house piping.

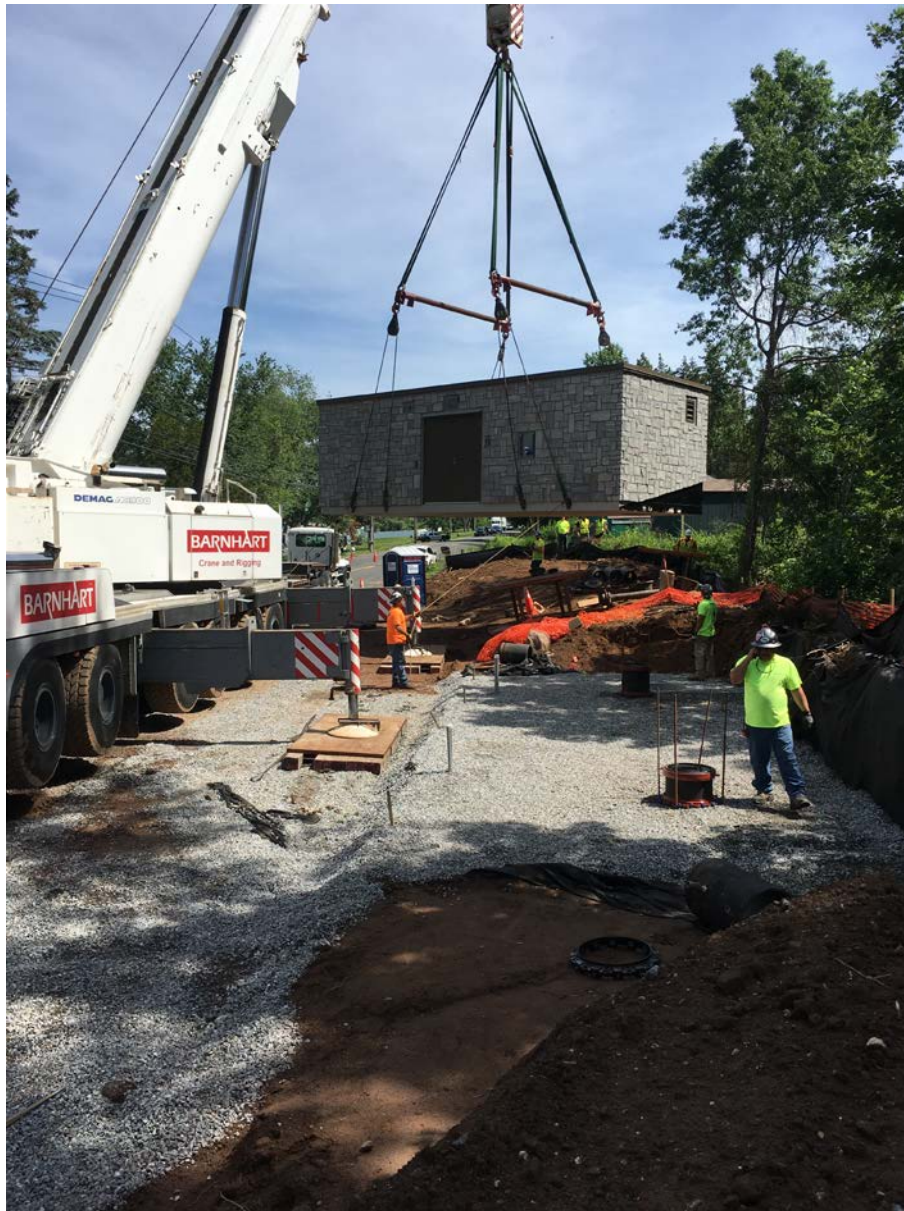
Picture 8: Facing north. Lifting the meter building off the low-boy truck

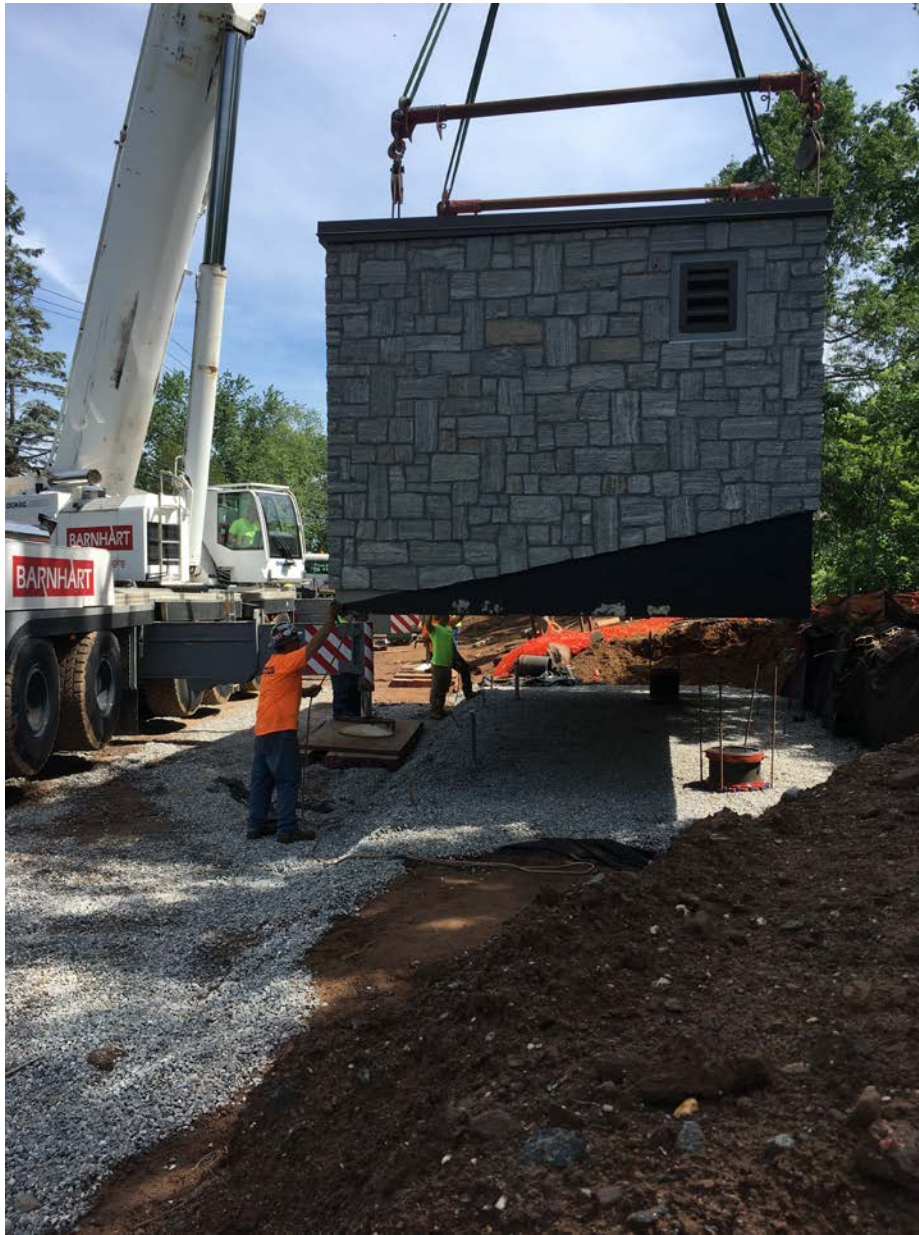
Picture 9: Facing north. Aligning the meter building with piping.

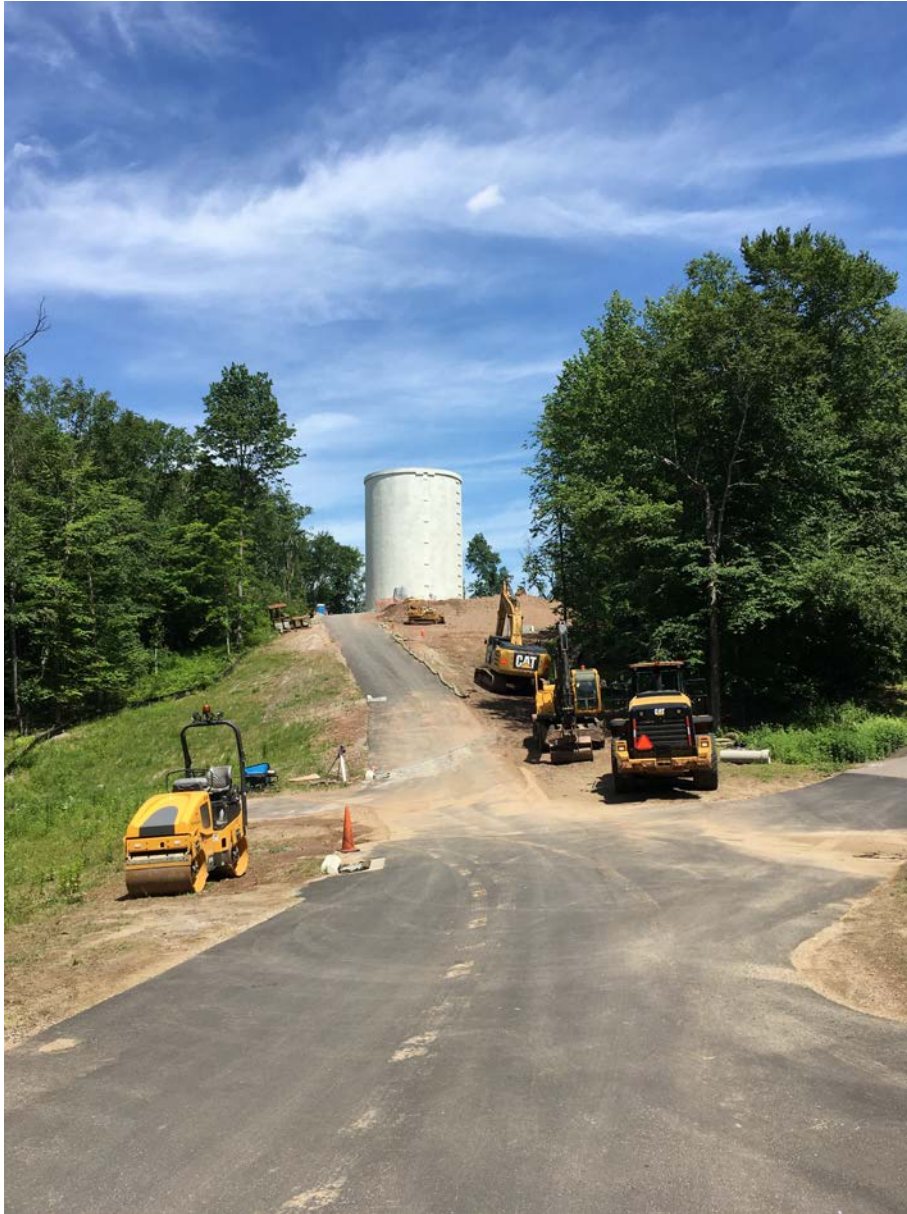
1400: First coat completed on the exterior of the tank. Reportedly it was completed around midday. Ladder materials were also completed. While up at the tank, the neighbor immediately abutting the tank, came up and complained about having the 'yellow-iron' parked at the end of her driveway. Says the view from the house is disrupting and asked if it could be moved by the weekend. AECOM spoke with Ludlow about it. The equipment was being parked there to make room for the painting, Ludlow will see where they can relocate the equipment tomorrow. It appears that 2 of the 3 pieces of equipment are visible plus a smaller roller.

Picture 10: Facing east. View of water tank after first coat of coating. Soil on road is from overnight wash out of new catch basin.

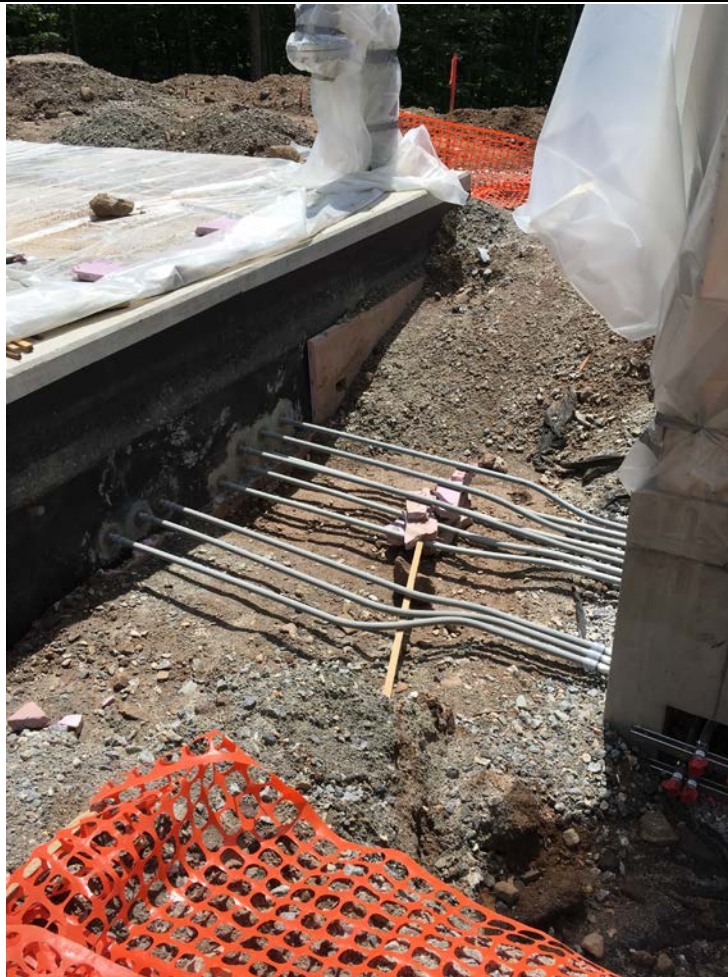
Picture 11: Facing southwest. Completed conduit between altitude valve vault and electrical enclosure up at the water tank site. Note protective plastic over vault and enclosure to protect from tank coating overspray.

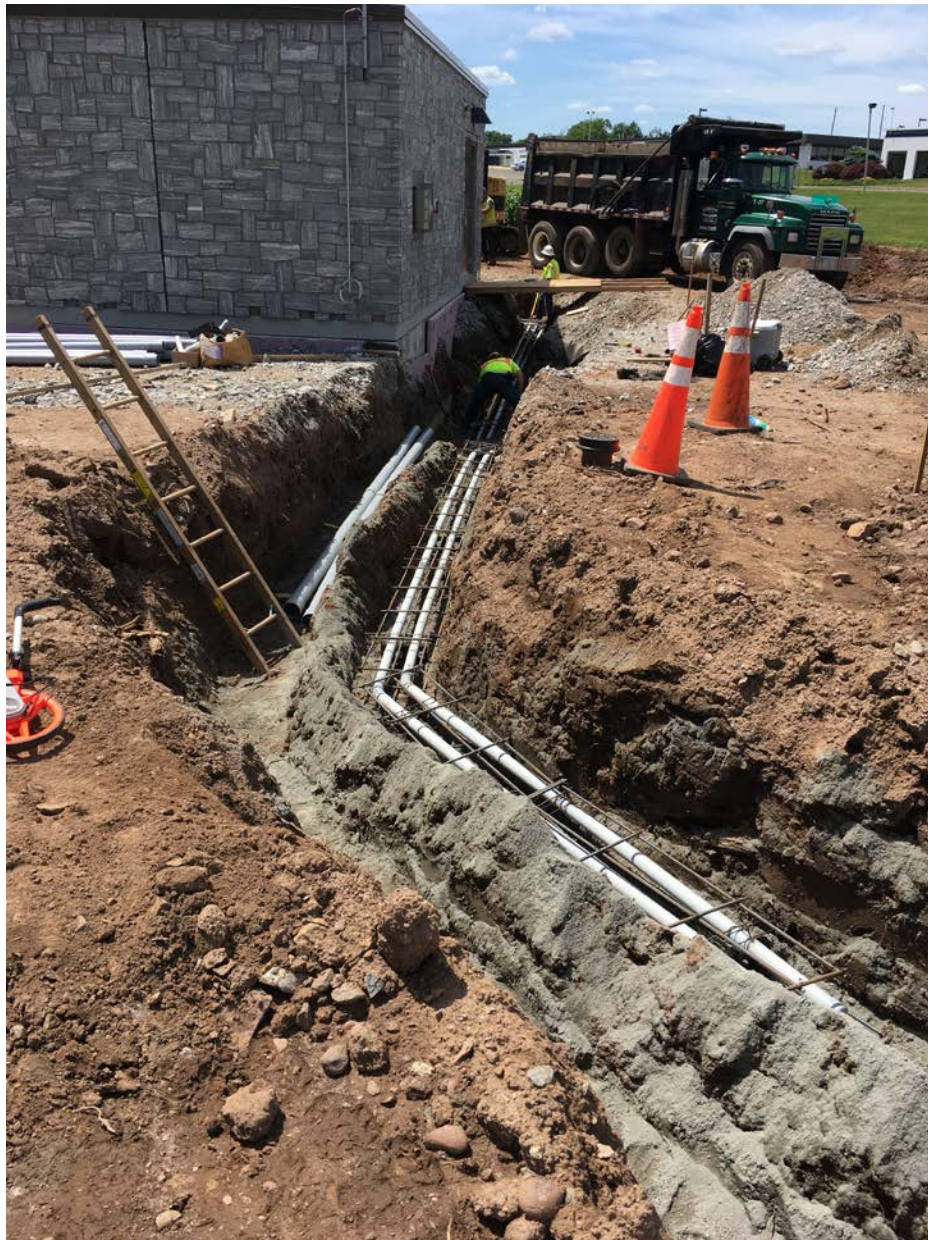
0730: Ludlow re-trenching booster station for conduit. Heavy rains late yesterday washed soil in over the rebar. Rebar was removed and trenches cleaned out and rebar replaced.

Picture 12: Facing west. Conduit from the booster station toward the street.

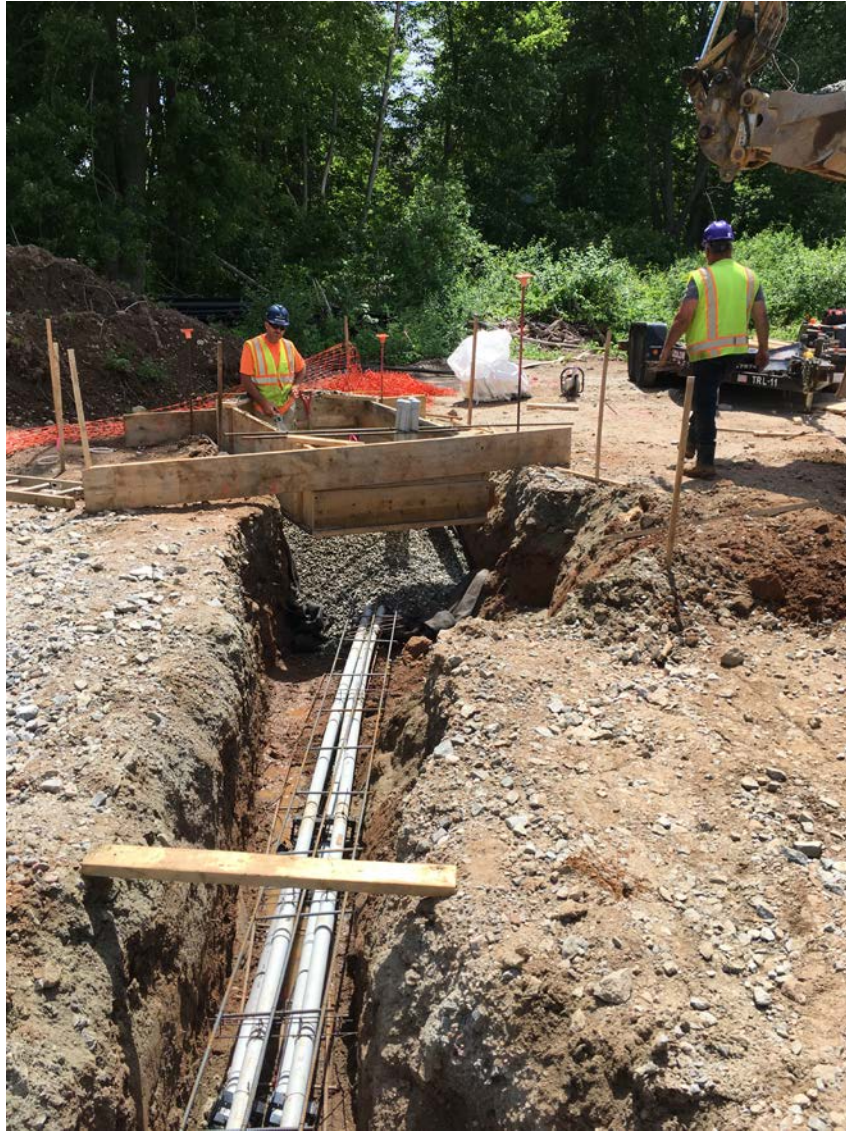
1430: Ludlow has cleaned up the mess made by the rains and has installed the conduit in the trenches, with rebar, and is placing stone under the generator pad form as a sub-base. Ludlow is having a little trouble getting a concrete hauler out this week, so they are hoping for good weather till next week. Currently it sounds like Tuesday for the conduit trenches to be filled and the generator pad placed.

Picture 13: Facing south. Behind booster station this the form for the concrete pad for the generator. The stone base needs to be raised to the bottom of the form prior to concrete pad. Conduit leading to the generator pad in foreground.
