Daily Report

Project:	Durham Meadows Pipeline Installation	Date:	June 14, 2021
Location:	S. Main Street and the Shared Access Driveway, Middletown	Day of Week:	Monday
Project #:	AECOM: 6061487	Report No:	263
Contractor:	Ludlow Construction	Page:	1 of 12

Daily Activities – Booster station, S. Main Street, Middletown

Daily Activities – Water tank work zone, Shared Access Driveway, Middletown

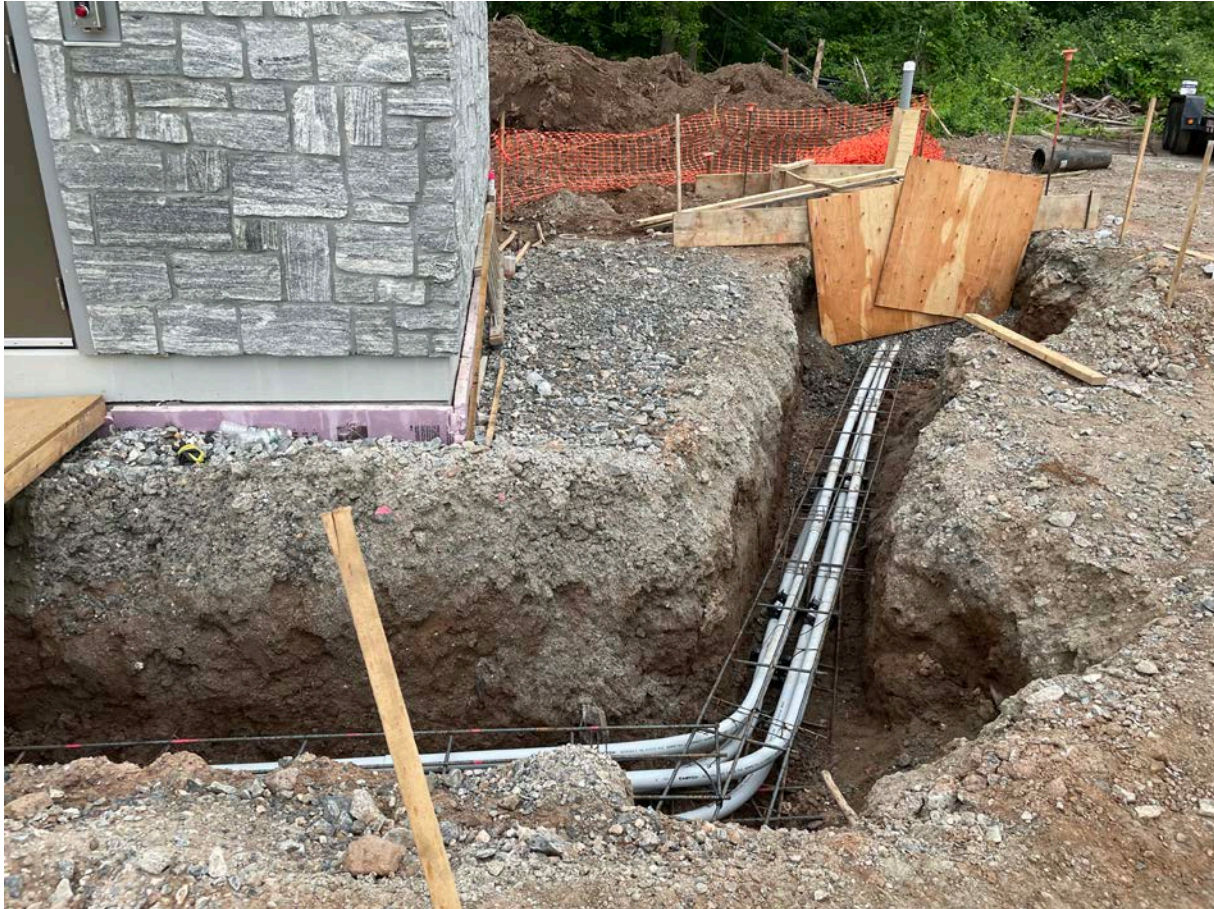
Picture 1: Bank of conduits located on the north and west side of the booster station with rebar in place, ready for the concrete placement today. View to the south.

0930: USACE and AECOM representatives visit the booster station work zone to inspect chairs used for spacing on the PVC conduits and the rebar that was placed over the PVC in the trench located on the north and west side of the booster station.

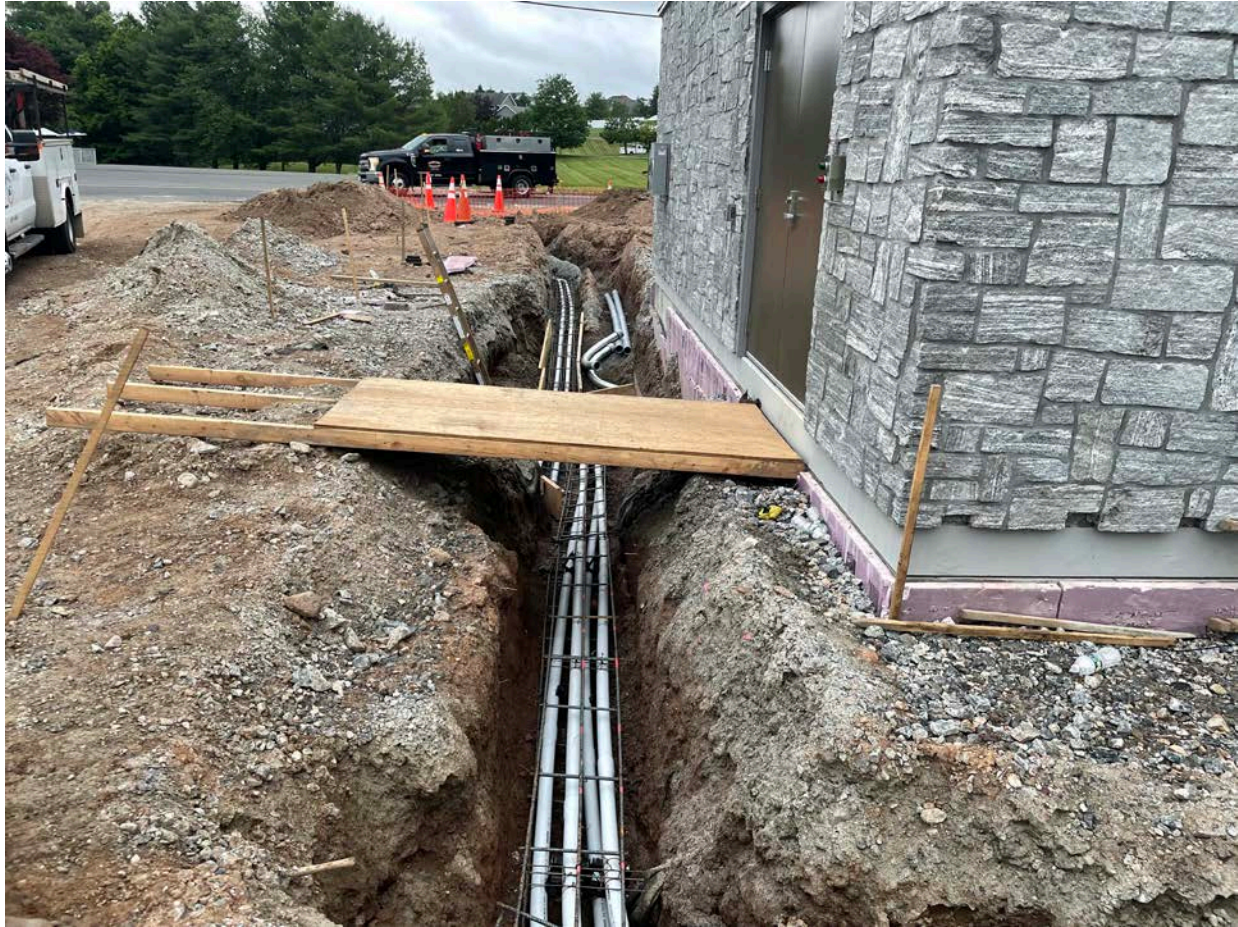
Picture 2: Bank of conduits located on the north of the booster station with rebar in place, ready for the concrete placement today. View to the east.

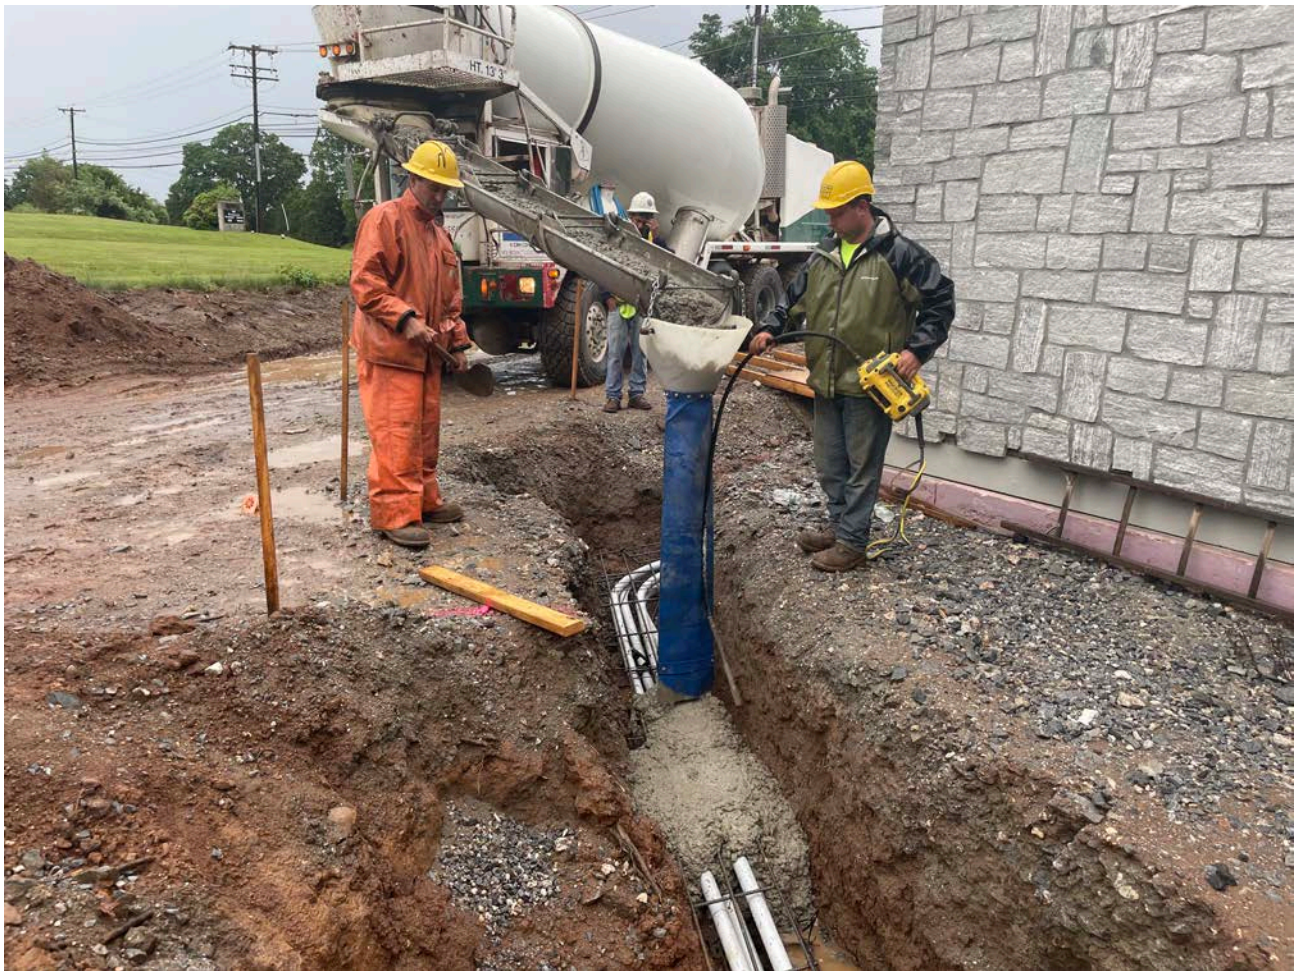
Picture 3: Ludlow and Tilcon placing concrete over the bank of conduits located on the north and west side of the booster station. View to the south.

1146: Tilcon and Ludlow have started to place concrete in the conduit trench located on the north and west sides of the booster station. Ludlow is using a hand-held vibrator to settle the concrete as it is being placed. A moderate amount of rain is currently falling.

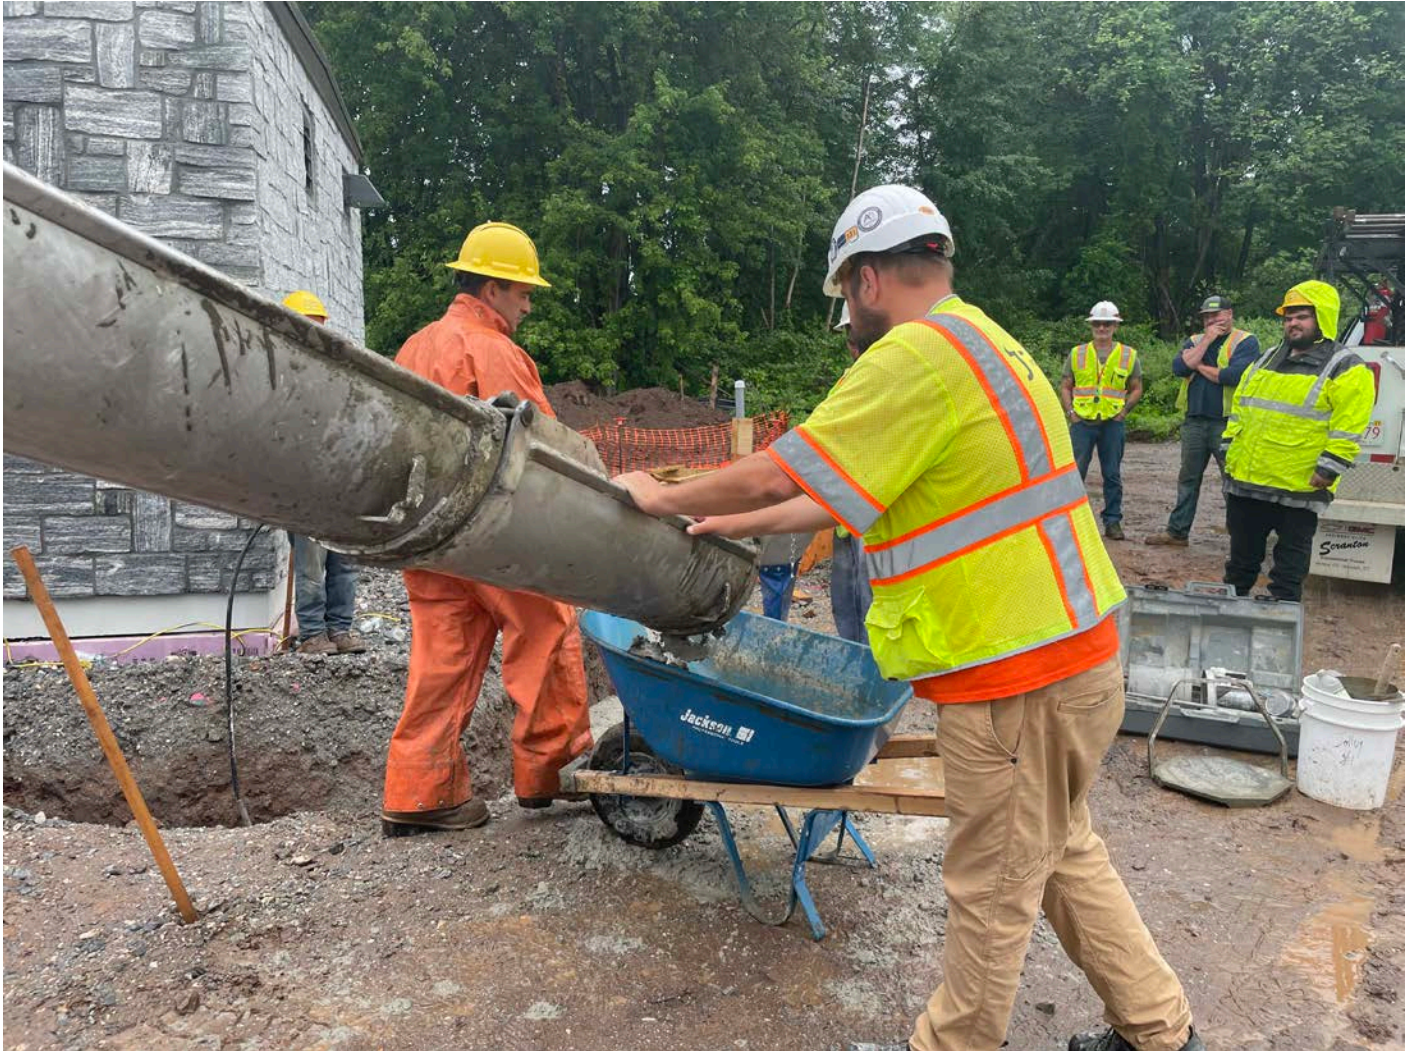
Picture 4: JTC collecting concrete for field and laboratory analysis at the booster station.

1153: JTC is in the process of collecting field data on the concrete that was delivered to the booster station work zone. They report a slump test of 5.5" and an air entrainment value of 5.7%. JTC also collects five concrete cylinder samples for future laboratory analysis.

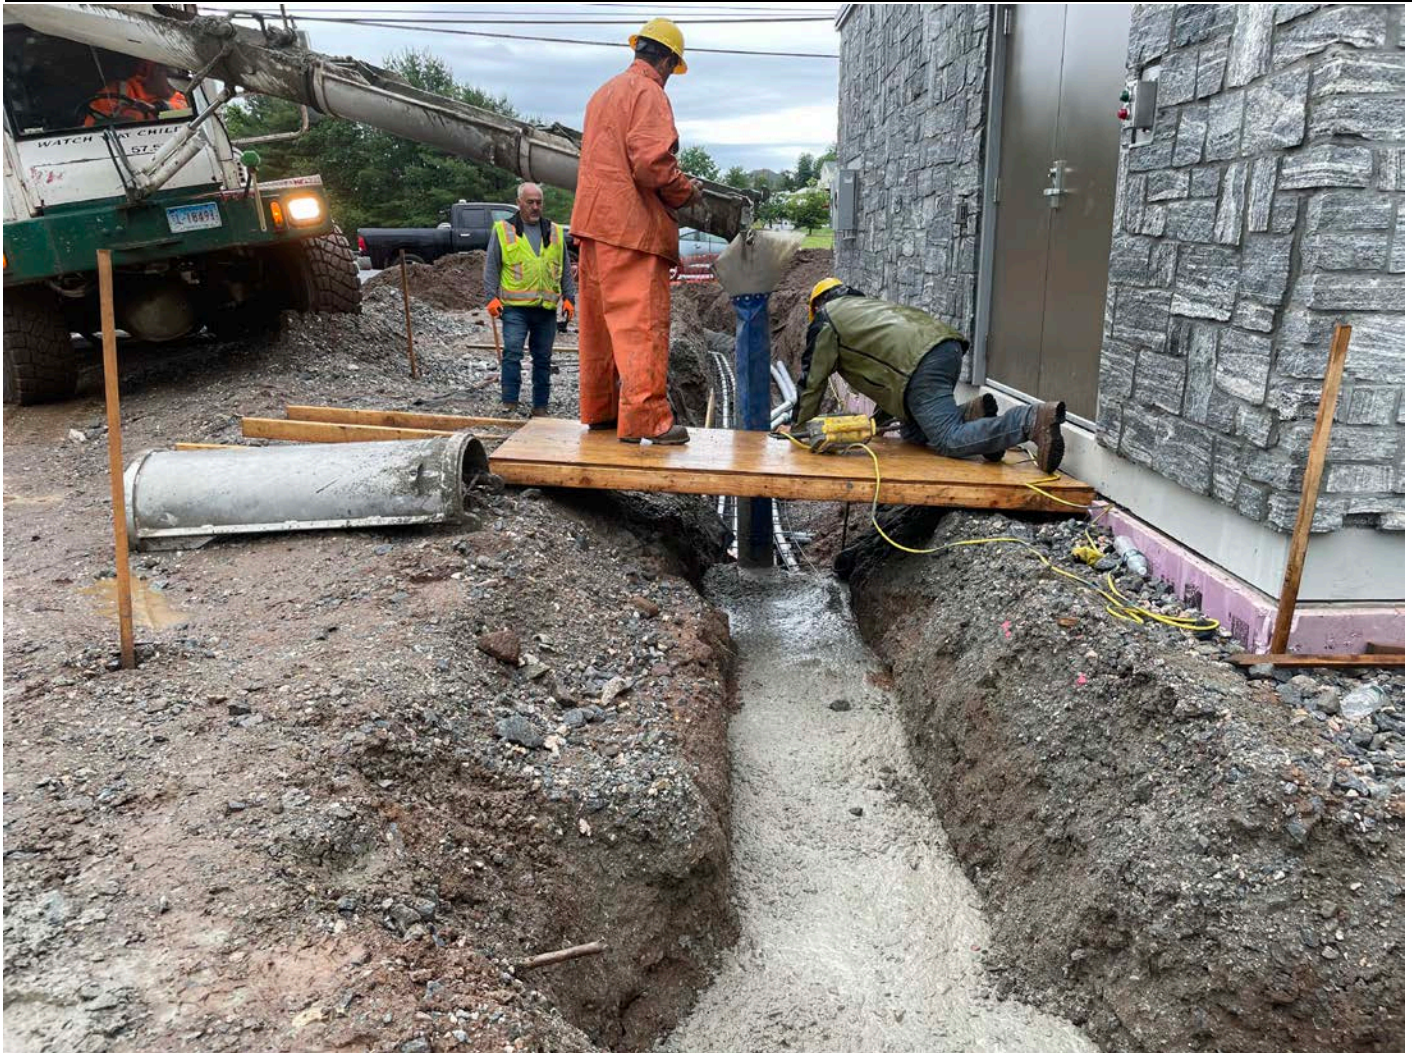
Picture 5: Ludlow and Tilcon placing concrete over the bank of conduits located on the north and west side of the booster station. View to the east.

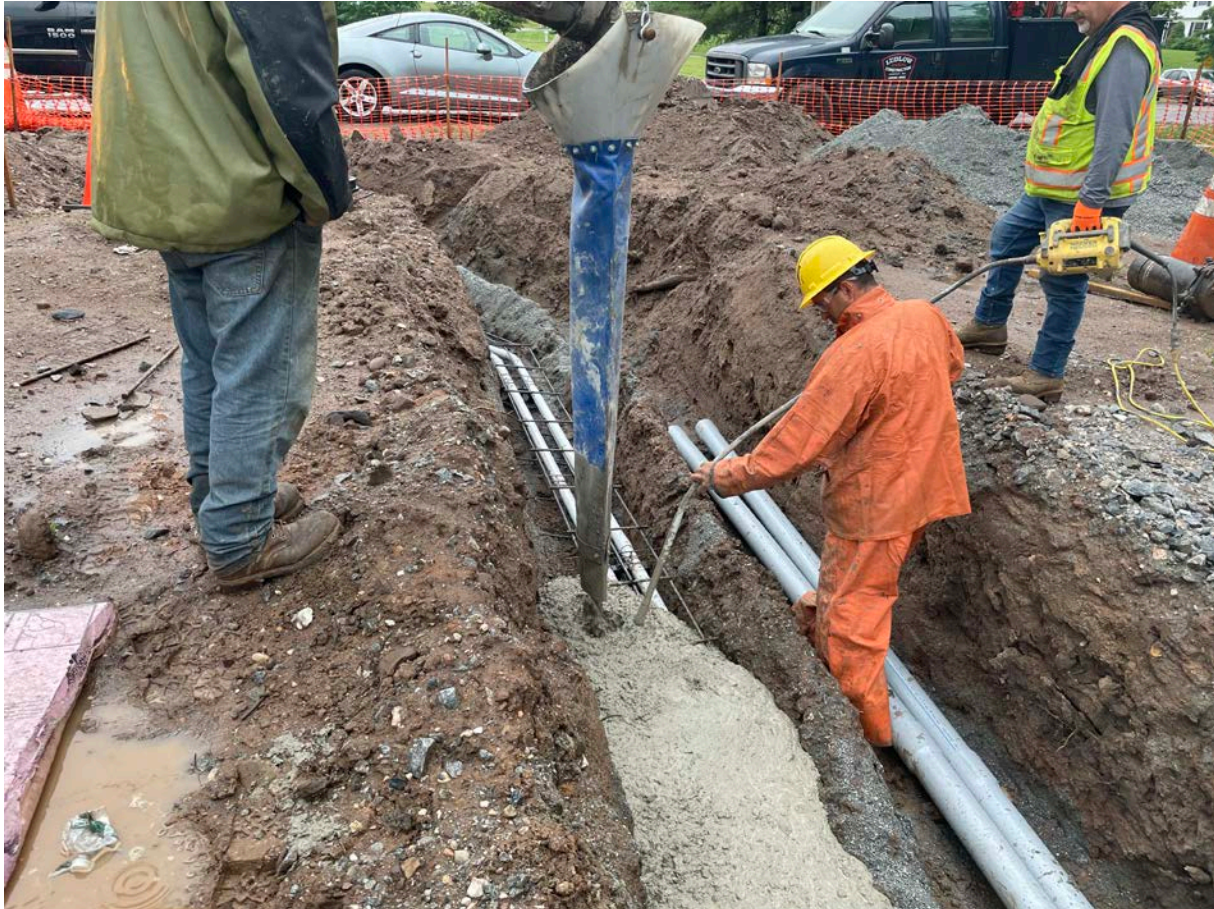
Picture 6: Ludlow and Tilcon placing concrete while Ludlow uses a vibrator to settle the concrete into place over the bank of conduits located on the north and west side of the booster station. View to the east.

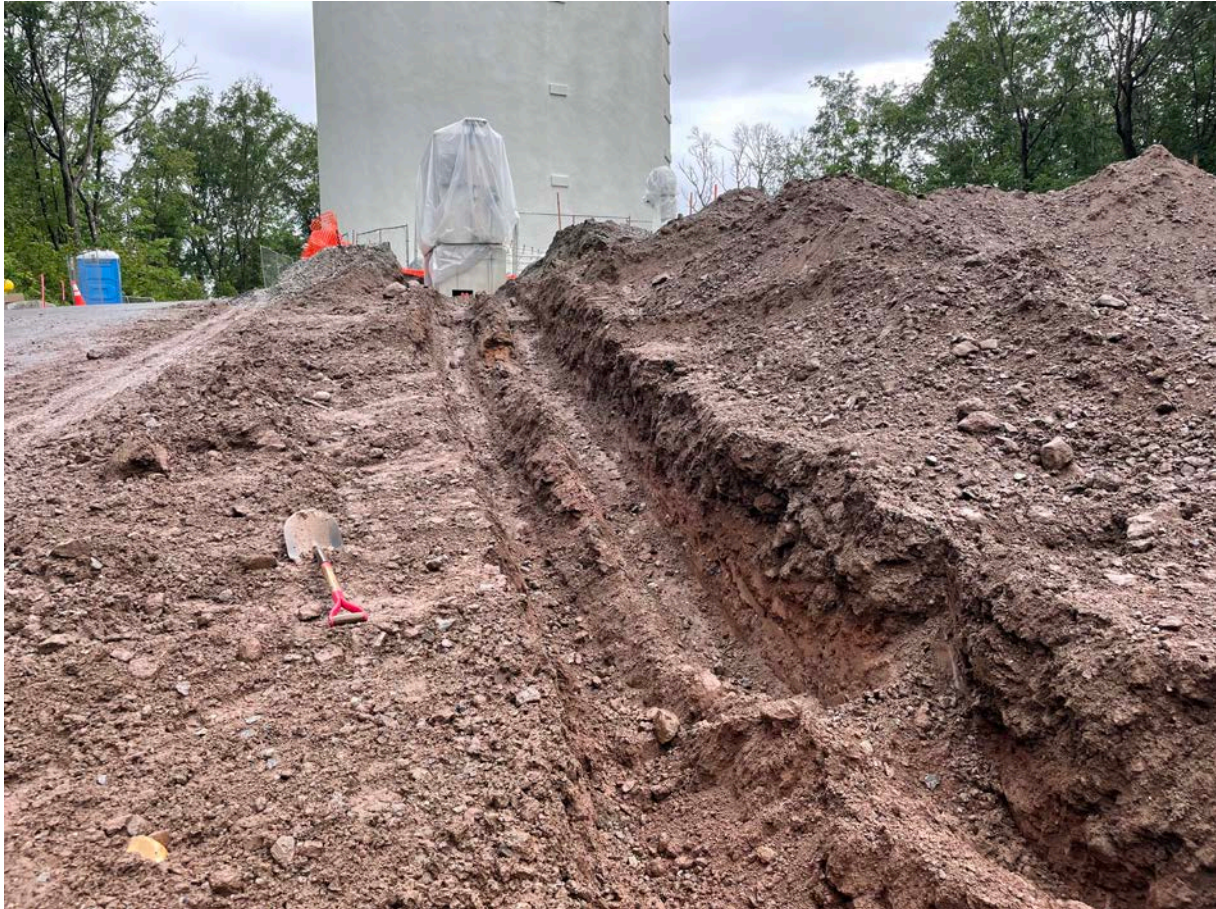
Picture 7: View of the trench that Ludlow has begun to excavate for the installation of 2” and 4” PVC utility conduits on the south side of the Shared Access Driveway. View to the east.

1215: Ludlow has begun to excavate a trench south of the Shared Access Driveway from the electrical enclosure to ~Station 11+60 for the installation of electric lines.

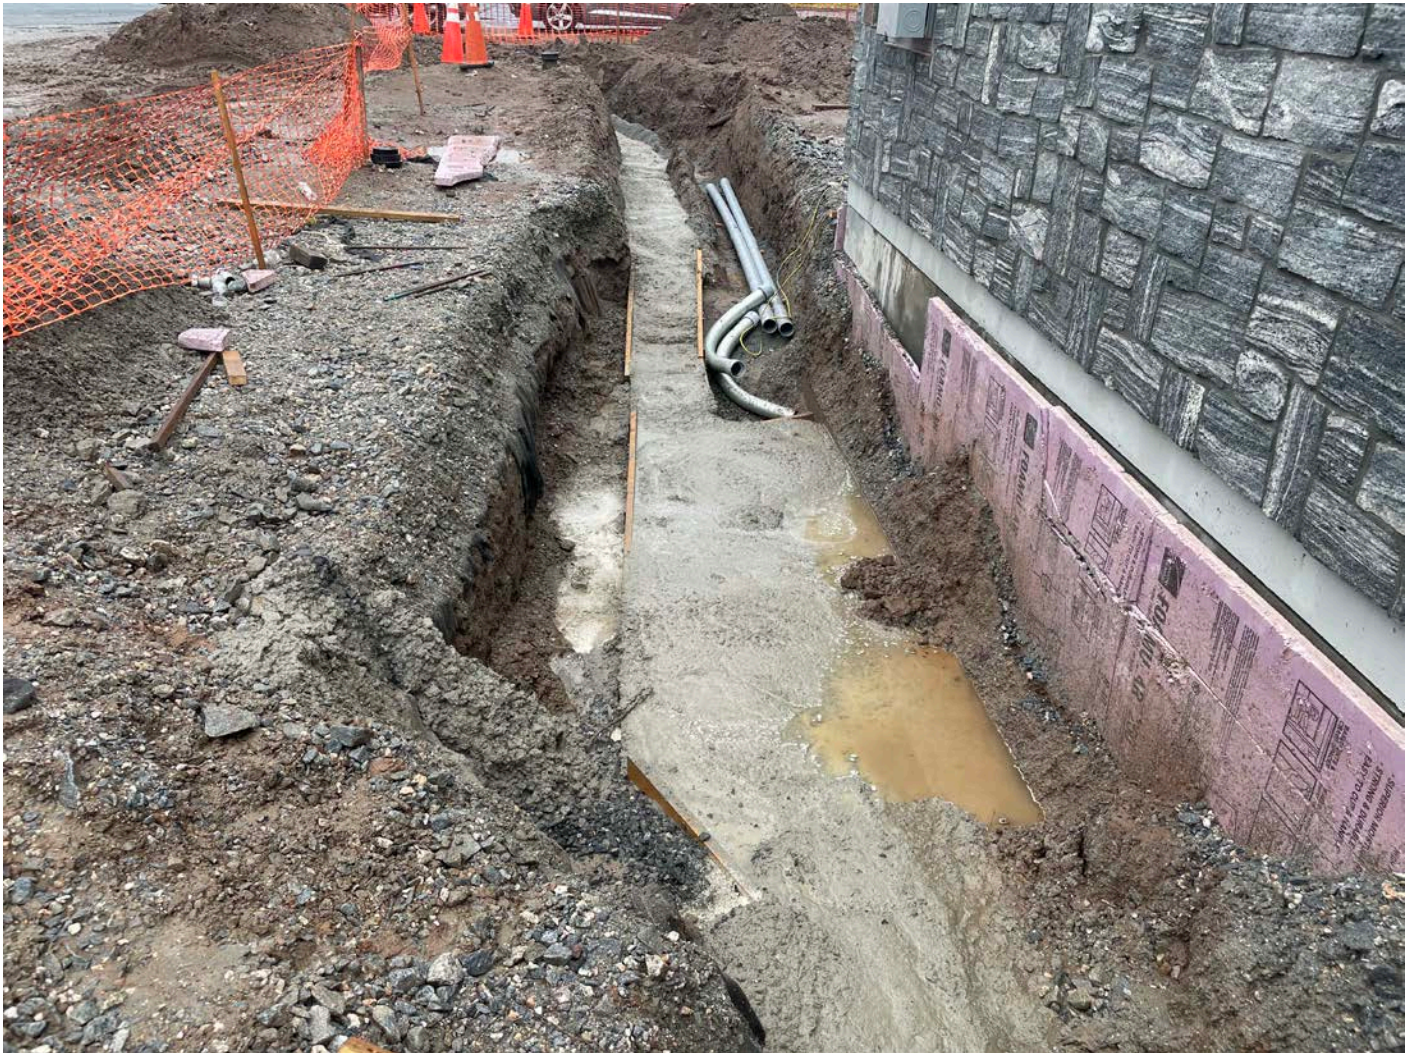
Picture 8: Concrete that Ludlow and Tilcon placed over the bank of conduits located on the north and west side of the booster station after a heavy downpour. View to the east.

1331: A heavy amount of rain is currently falling on the concrete that was placed on at the booster station.

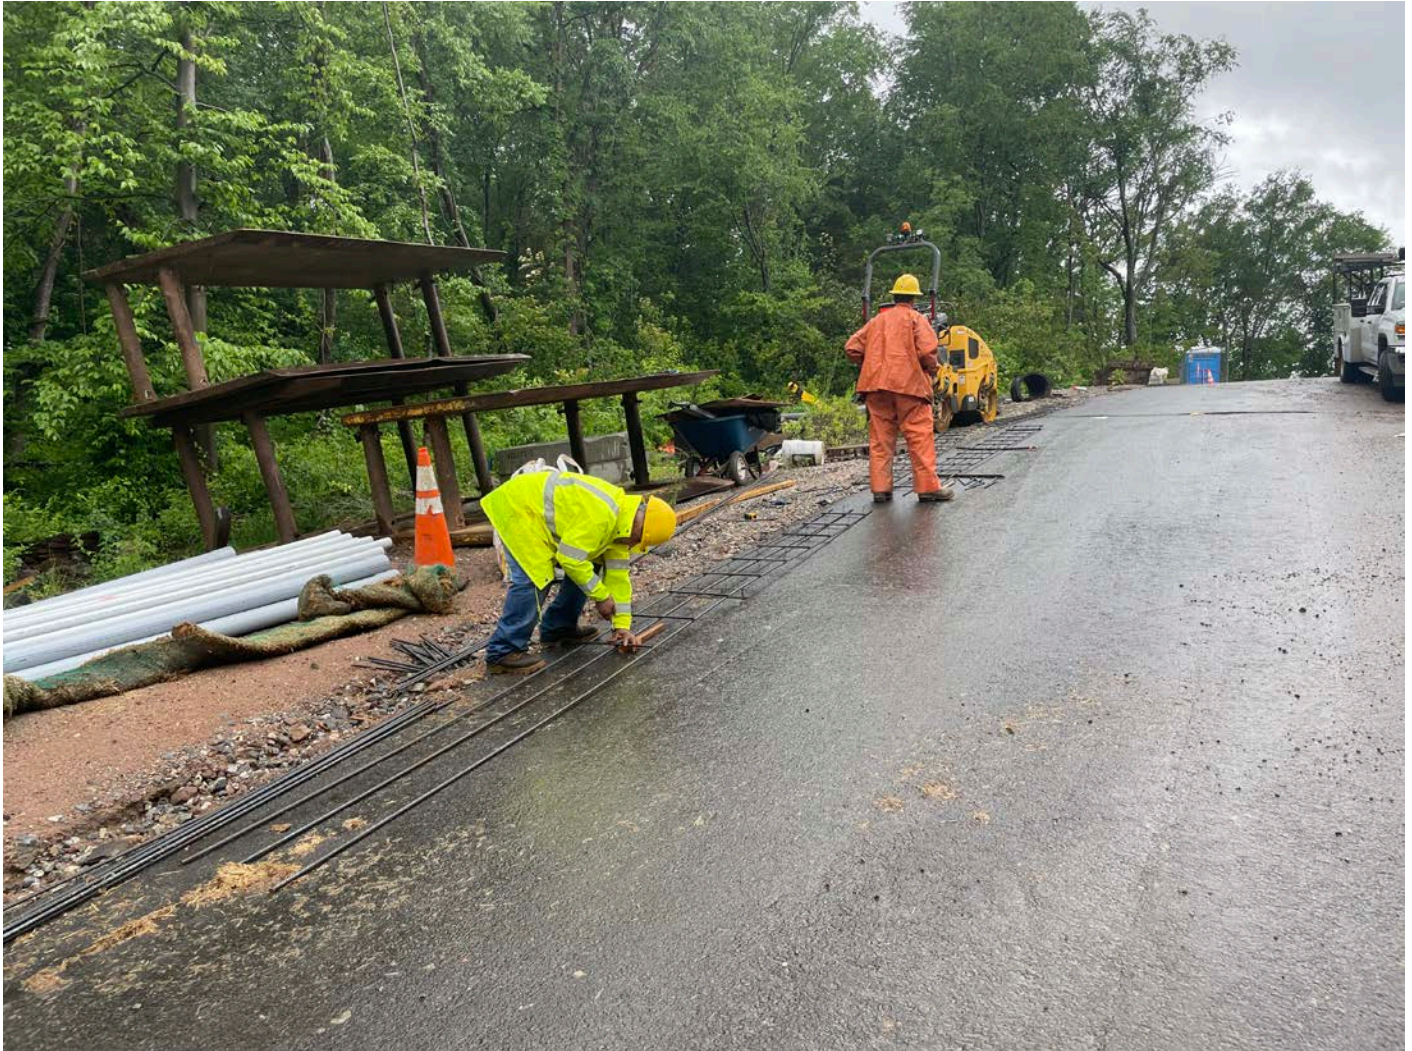
Picture 9: Ludlow connecting sections of rebar together for placement into the utility trench they are excavating on the south side of the Shared Access Driveway in Middletown. View to the east.

0955: Ludlow continues to lay out rebar on the north side of the Shared Access Driveway and has begun to connect sections of the rebar together with wire ties.

1027: Ludlow continues to connect sections of rebar together with wire ties on the north side of the Shared Access Driveway. Heavy rain starts again.

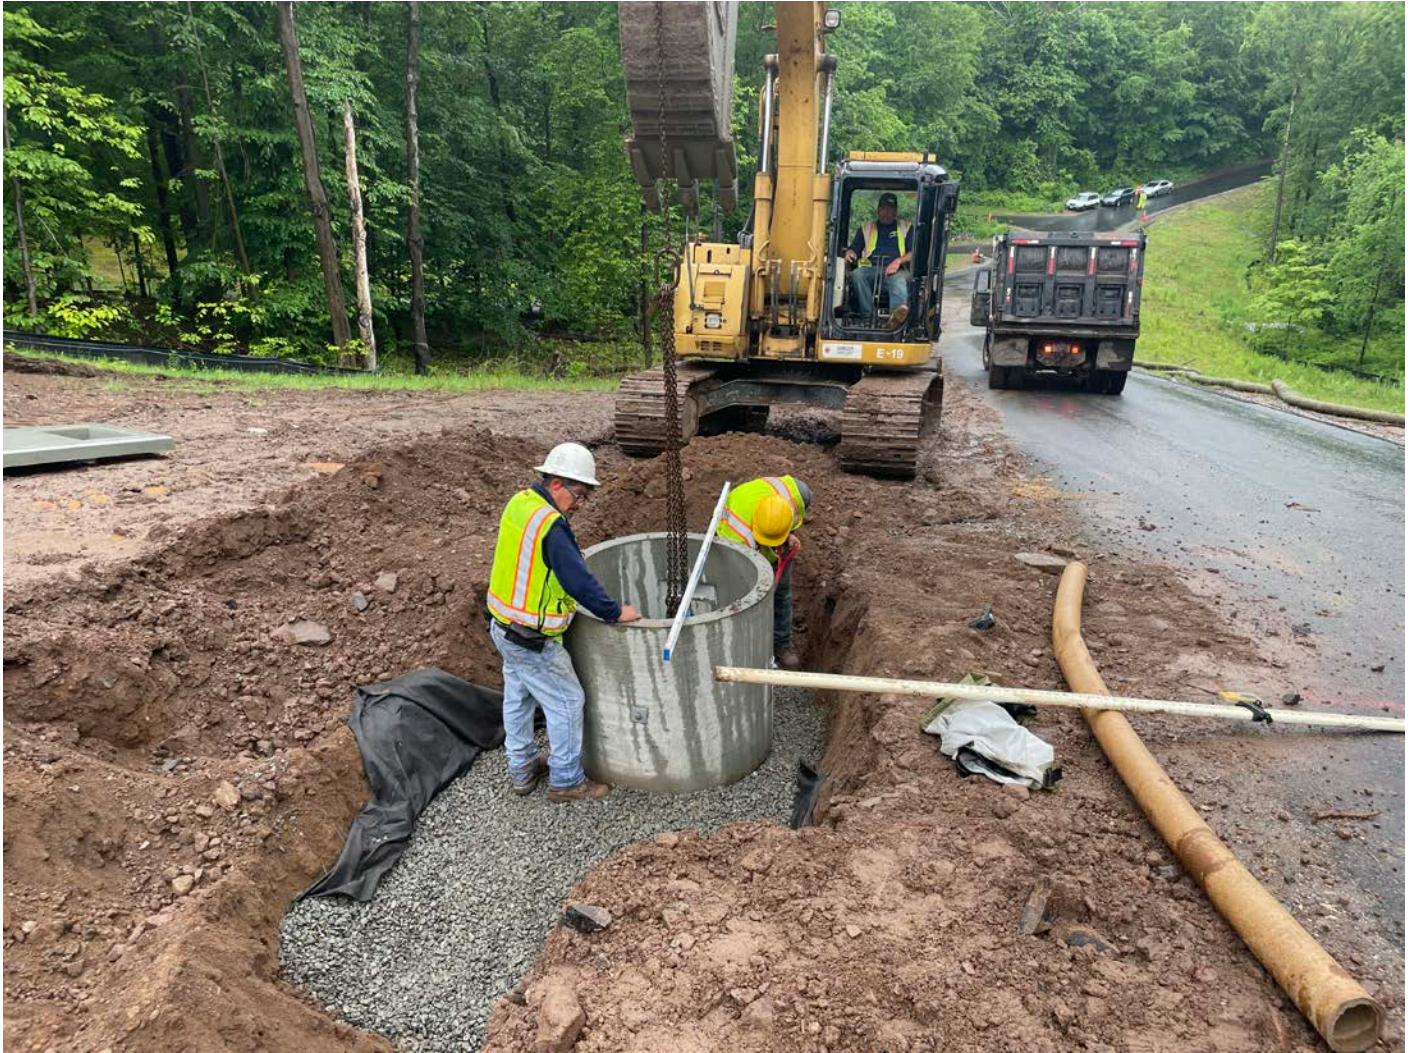
Picture 10: Concrete transformer pad that Ludlow is installing at ~Station 11+60 for the placement of a transformer to the south of the Shared Access Driveway in Middletown. (Note top slab on ground to the left in the photo) View to the west.

1423: Ludlow is installing a concrete transformer pad associated with the electric service being brought up to the electrical enclosure located on the north side of the altitude valve vault. Ludlow continues to connect sections of rebar together with wire ties on the north side of the Shared Access Driveway.
