Daily Report

Project:	Durham Meadows Pipeline Installation	Date:	June 15, 2021
Location:	Shared Access Driveway, Middletown	Day of Week:	Tuesday
Project #:	AECOM: 6061487	Report No:	264
Contractor:	Ludlow Construction	Page:	1 of 12

Daily Activities – Water tank work zone, Shared Access Driveway, Middletown

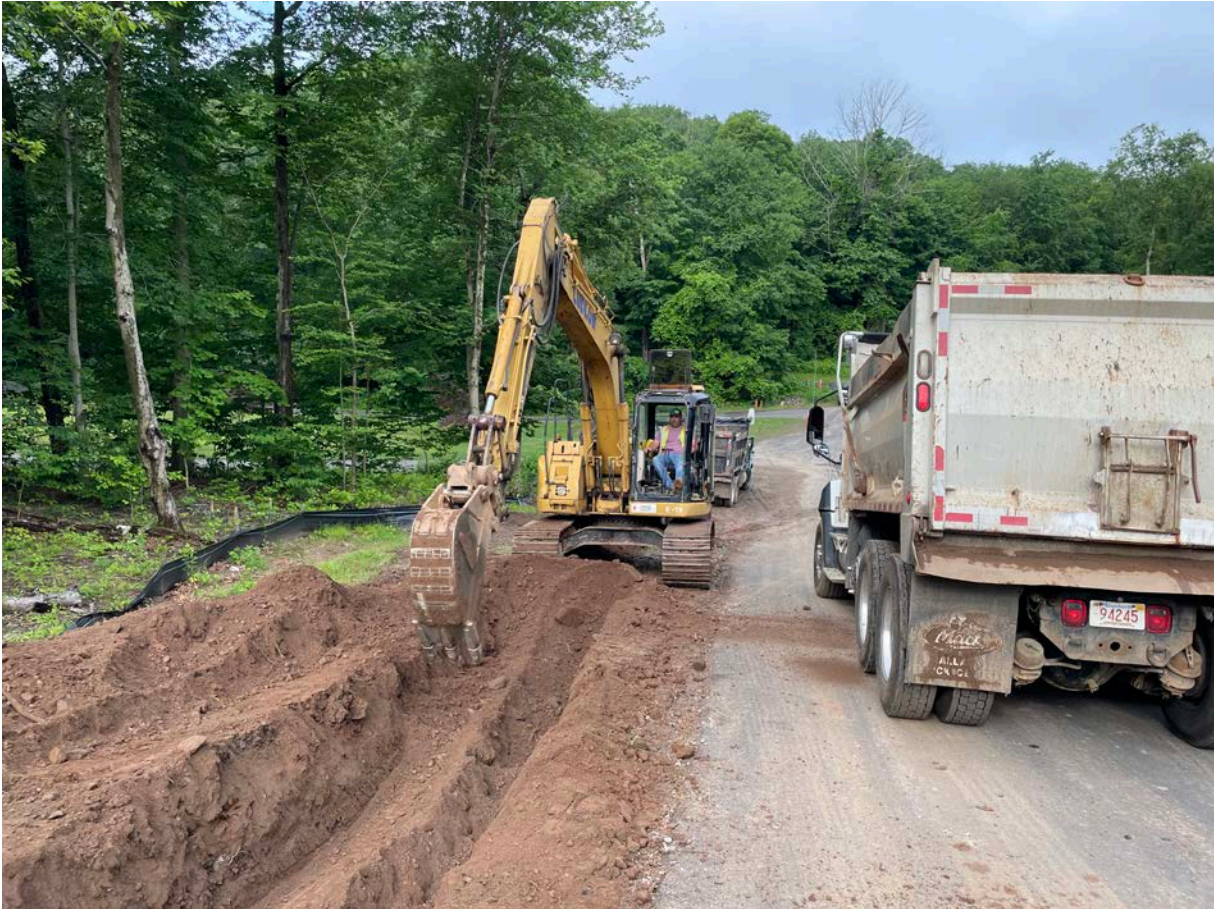
Picture 1: Ludlow excavating a utility trench on the south side of the Shared Access Driveway in Middletown. View to the southwest.

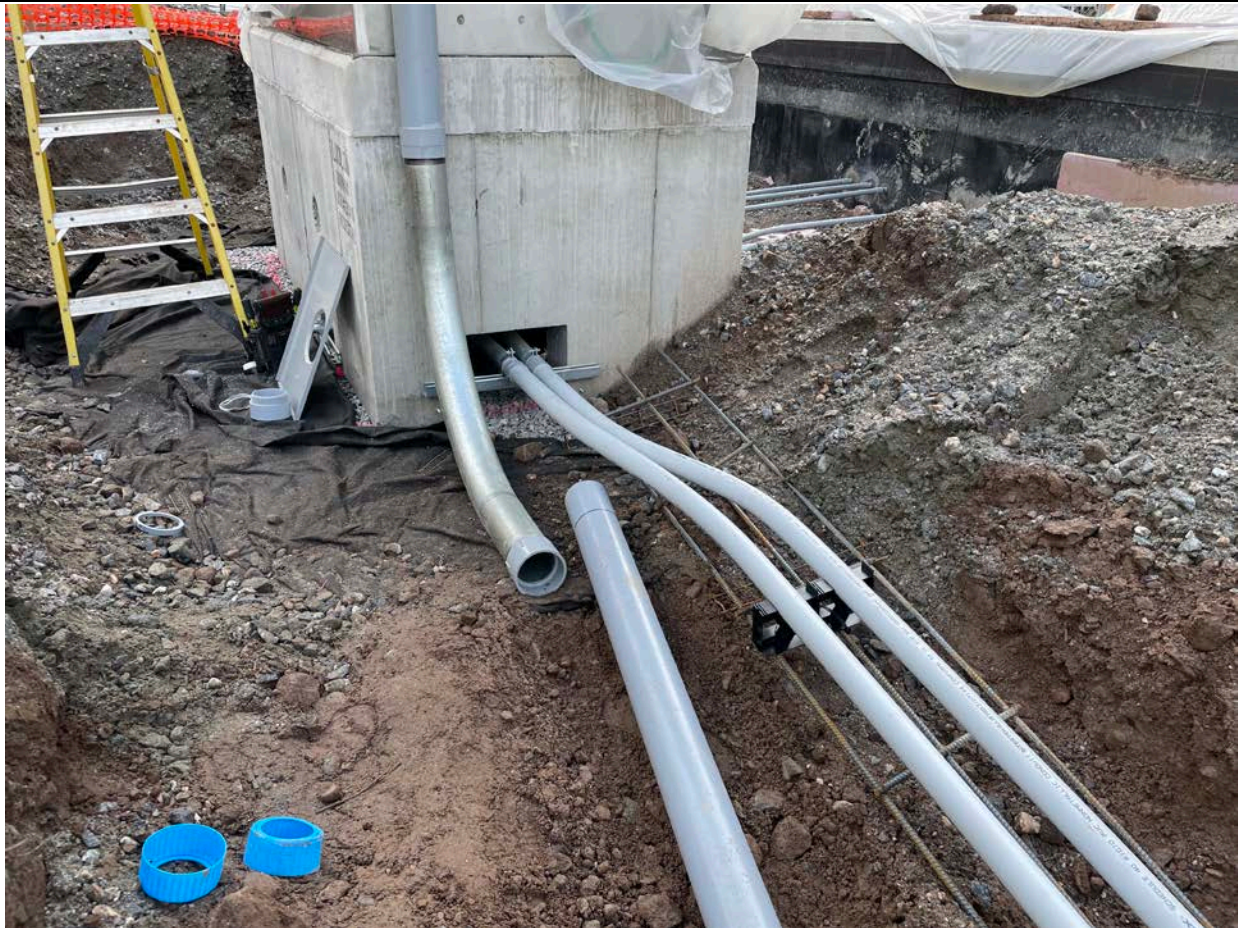
Picture 2: 2" and 4" PVC conduits and the cement vault located at ~Station 11+50 that will house a transformer; all of which are located in the utility trench on the south side of the Shared Access Driveway in Middletown. View to the east.

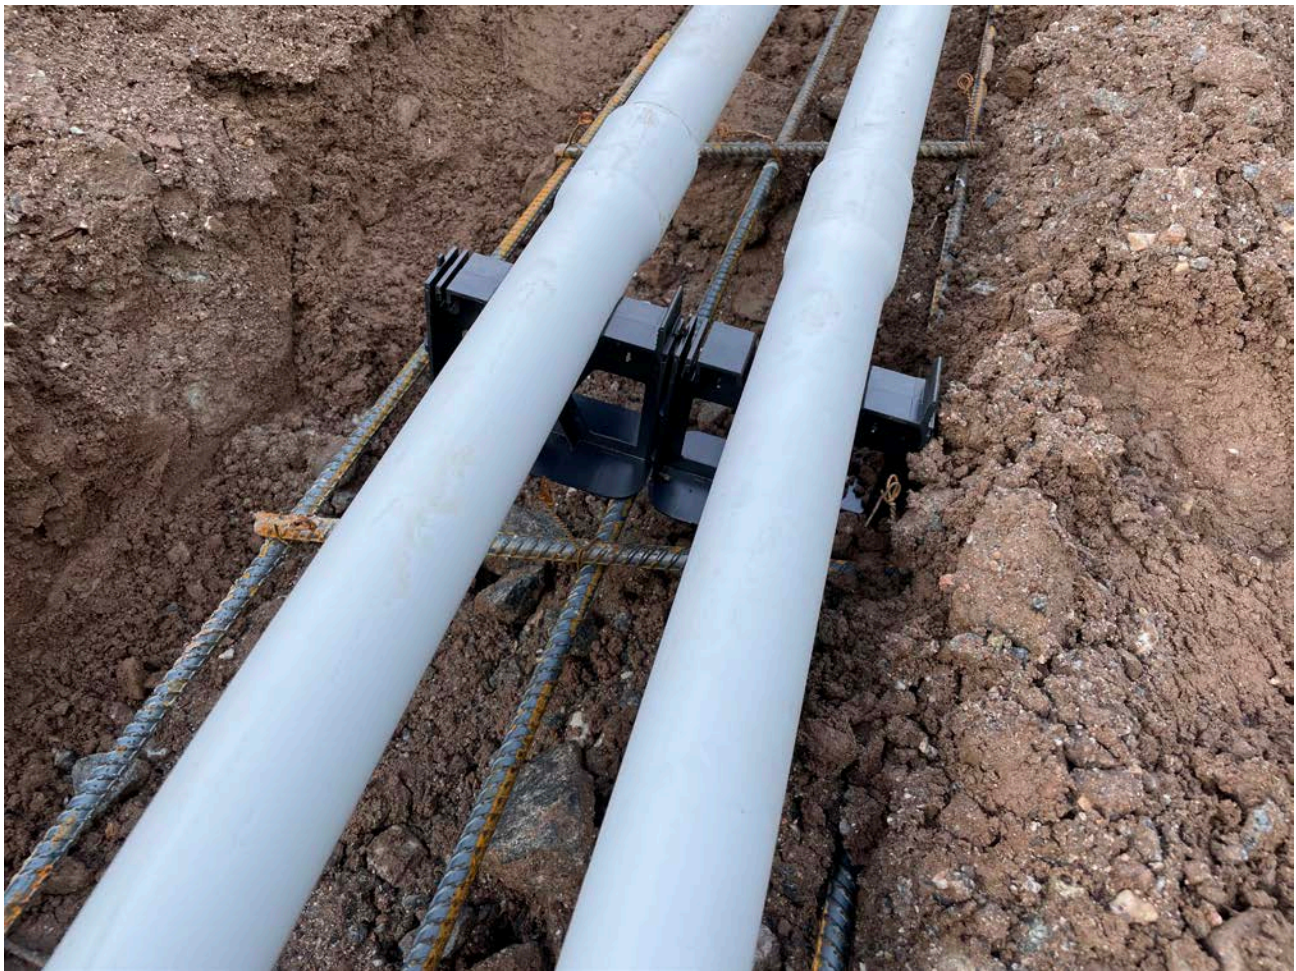
Picture 3: 2" PVC conduit for telephone placed over rebar, with black plastic chairs separating and supporting the PVC, located in the utility trench on the south side of the Shared Access Driveway in Middletown. View to the south.

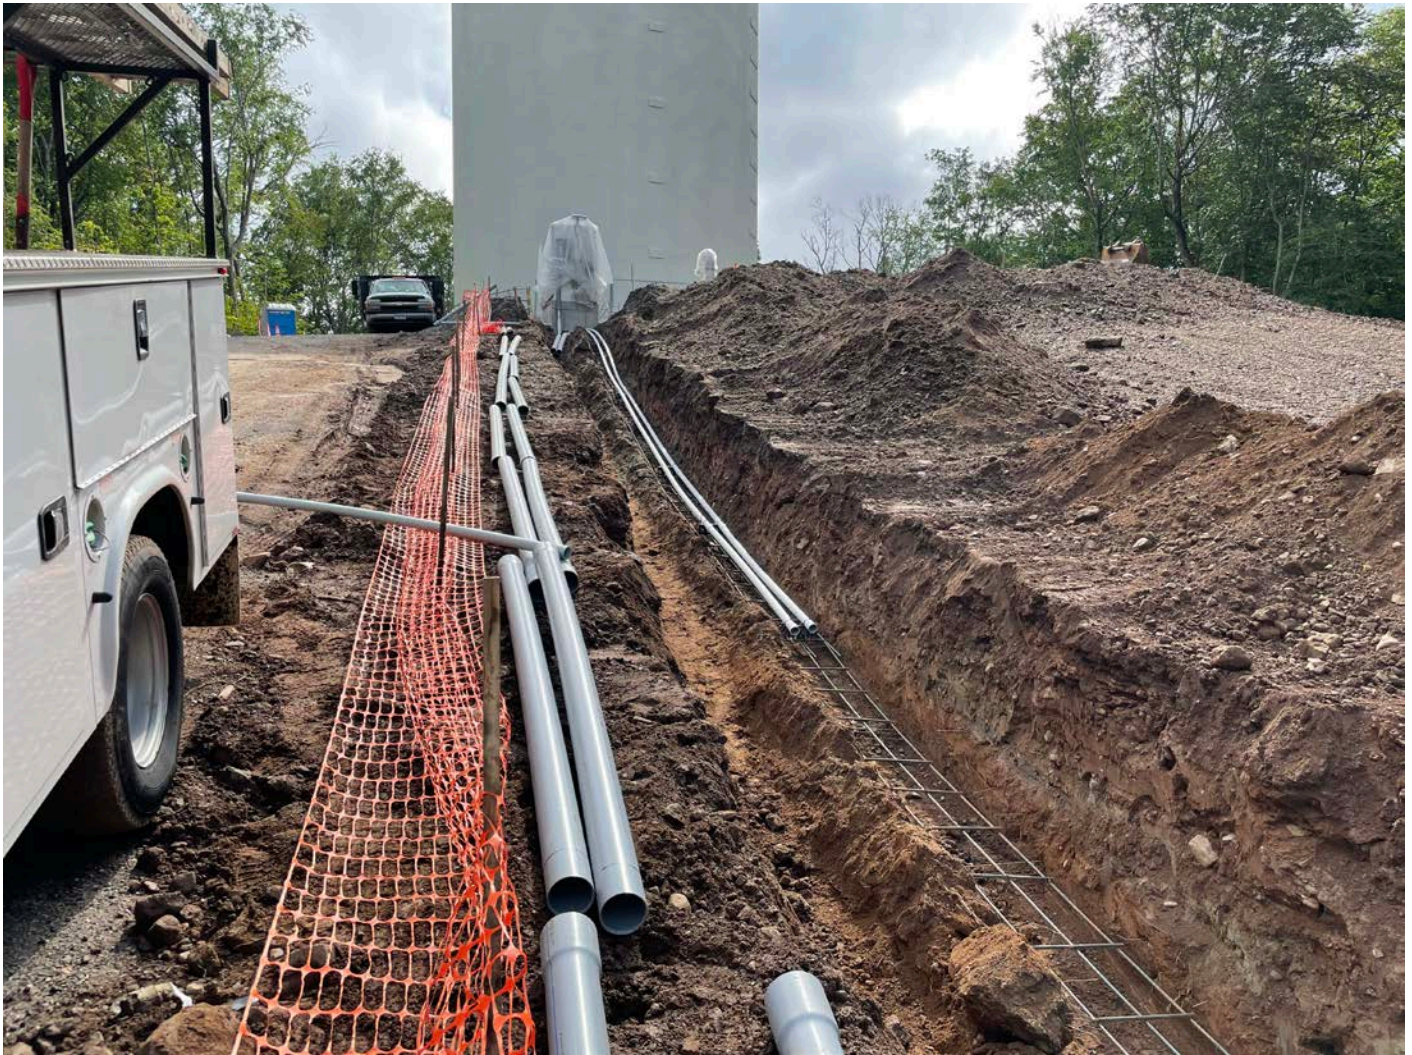
Picture 4: View of PVC conduits that A&R Electric has placed in the utility trench on the south side of the Shared Access Driveway in Middletown. View to the east.

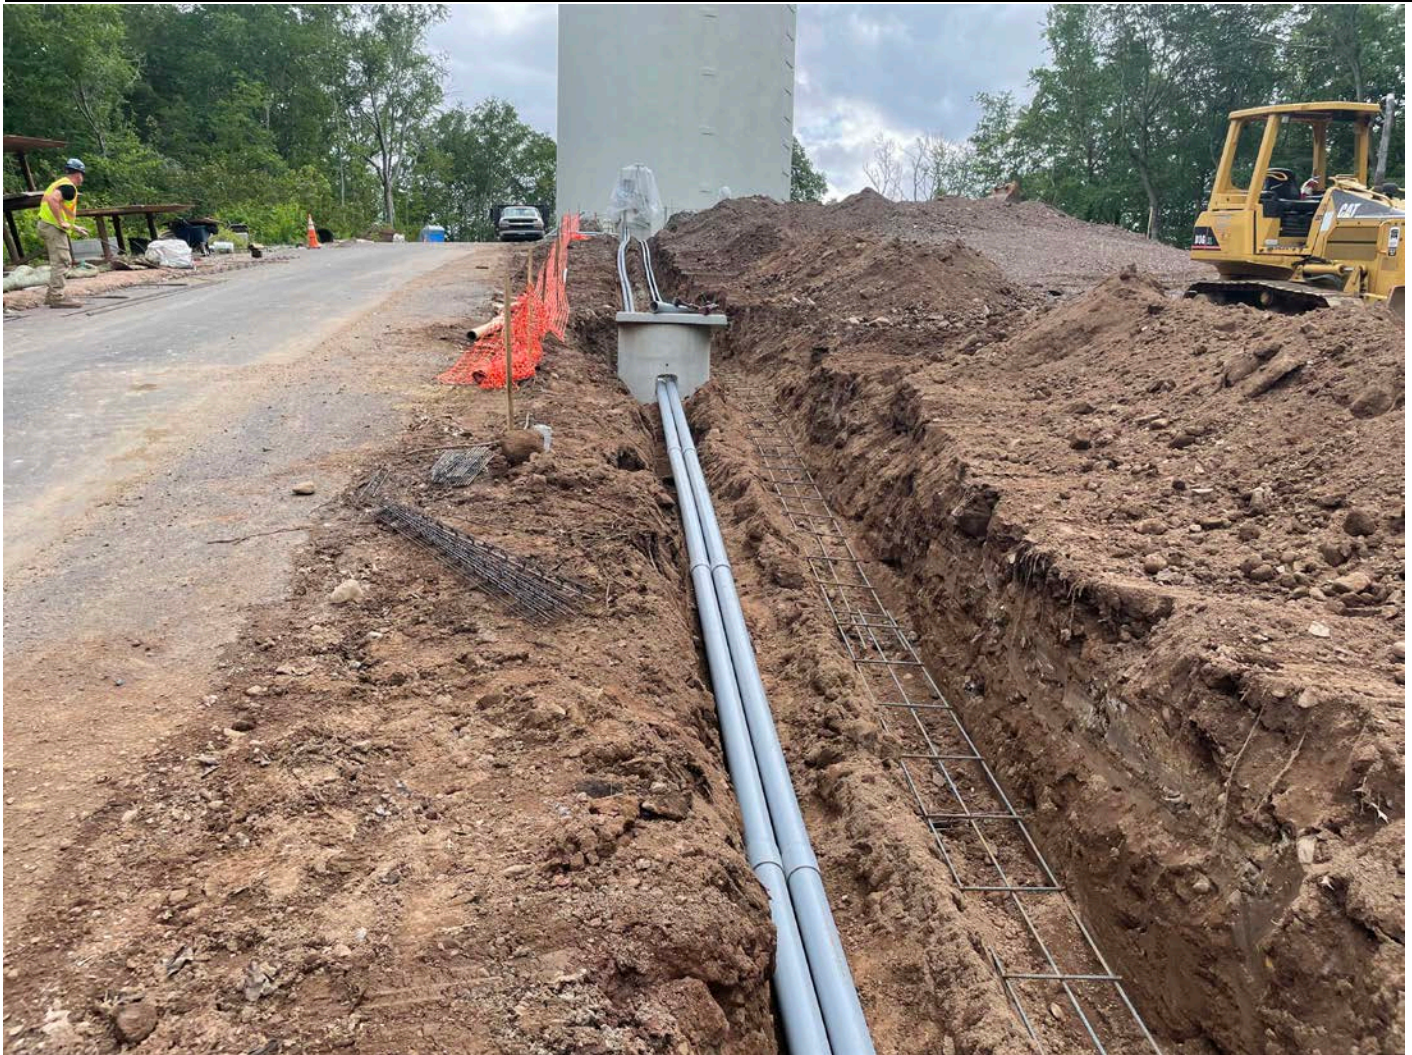
Picture 5: Another view of the PVC conduits and rebar that A&R Electric and Ludlow have placed in the utility trench on the south side of the Shared Access Driveway in Middletown. (Electric power conduits to the left, telephone conduits to the right in this photo) View to the east.

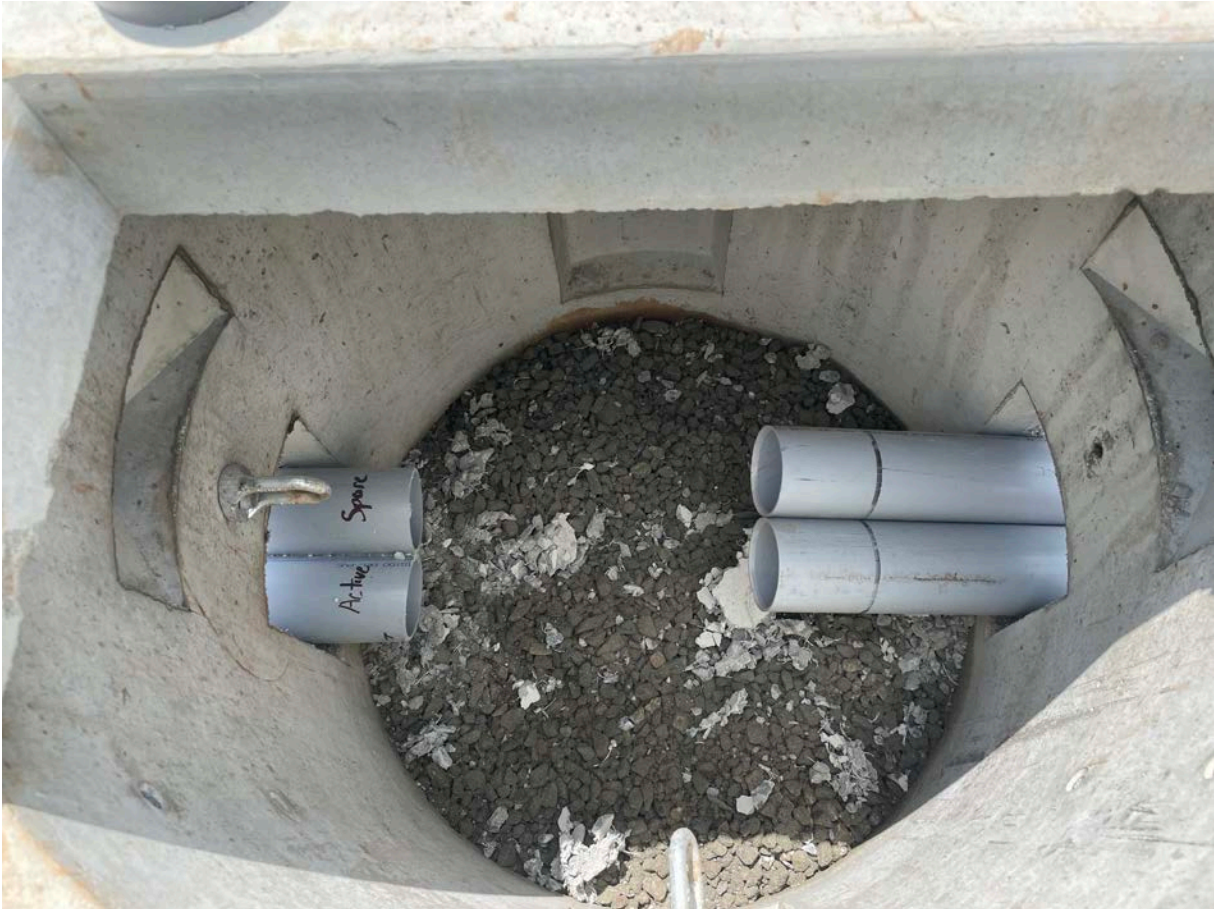
Picture 6: 4" PVC conduit entering and exiting the concrete transformer pad located at ~Station 11+50 that will house a transformer.

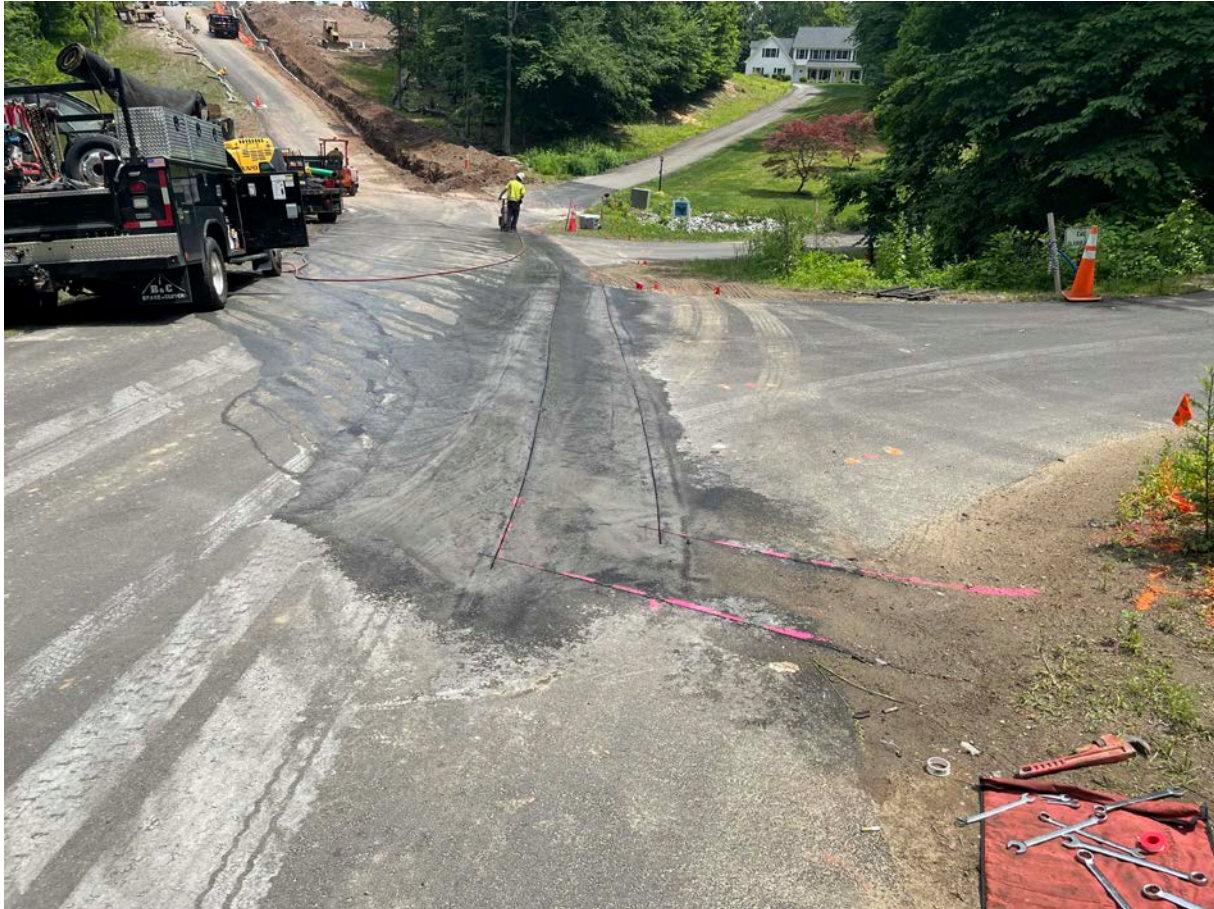
Picture 7: Ludlow saw cutting the footprint for the utility trench in front of the driveways for 214, 216, and 224 Talcott Ridge Drive in Middletown. View to the east.

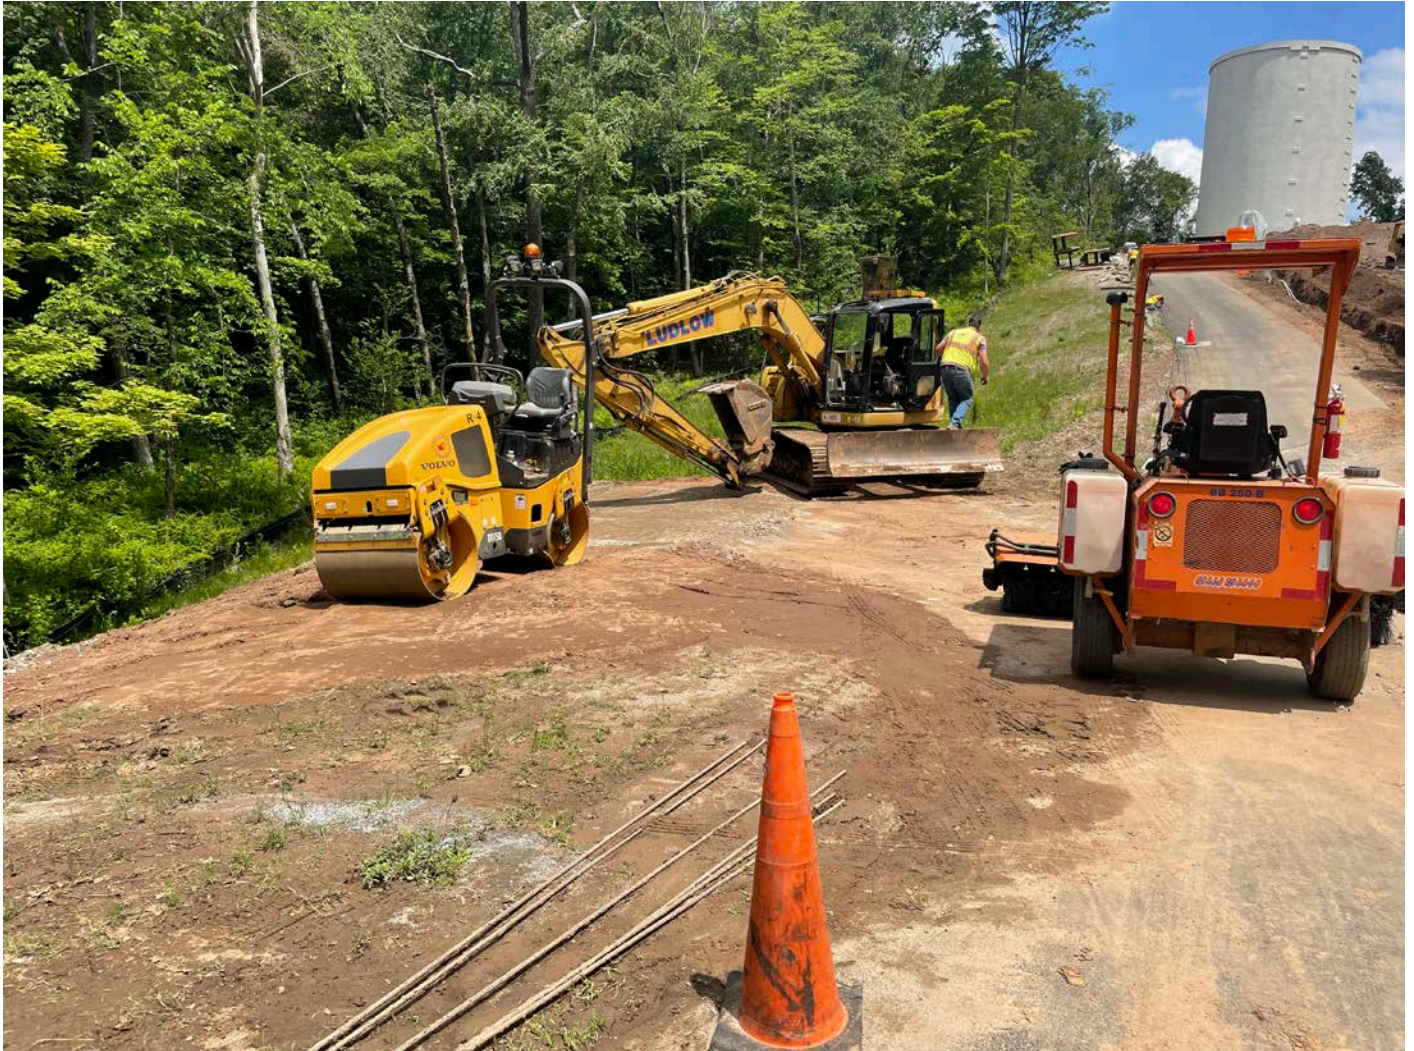
Picture 8: Vehicle turnout located on the north side of the Shared Access Driveway at Station 13+95 where Ludlow is extending it 15' to the north. View to the east.

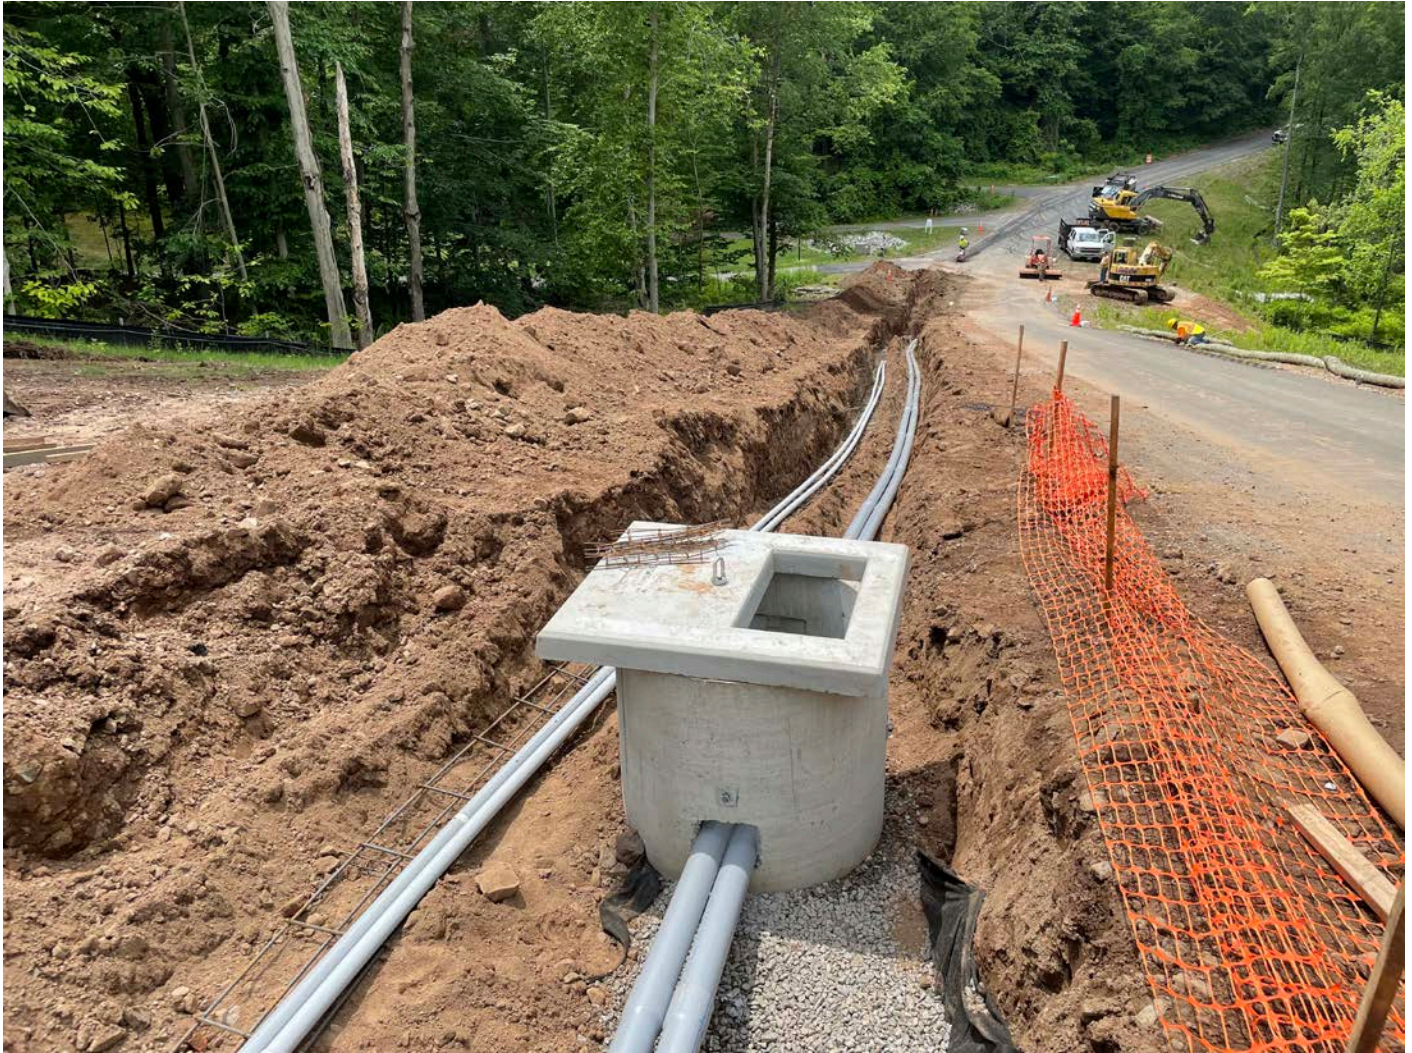
Picture 9: View of progress as A&R Electric place 2" and 4" PVC conduits in the utility trench they are excavating on the south side of the Shared Access Driveway in Middletown. View to the west.

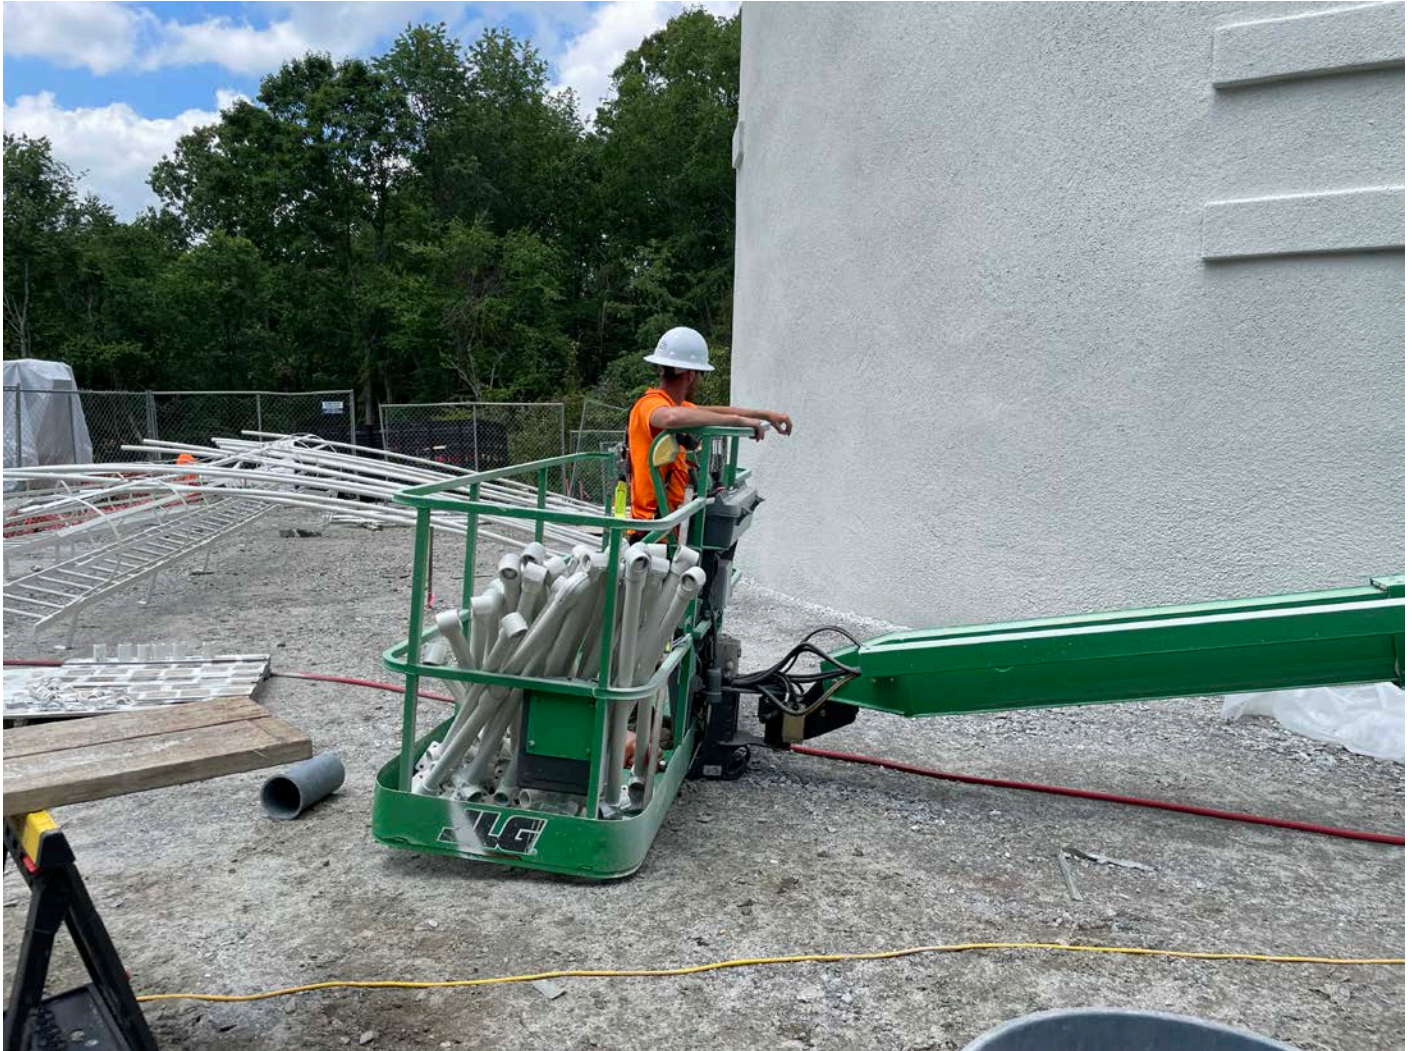
Picture 10: DN Tanks lifting railing components to the top of the water tank for installation.
