Daily Report

Project:	Durham Meadows Pipeline Installation	Date:	June 25, 2021
Location:	Main Street, Durham; S. Main Street and the Shared Access Driveway, Middletown	Day of Week:	Friday
Project #:	AECOM: 6061487	Report No:	272
Contractor:	Ludlow Construction	Page:	1 of 15

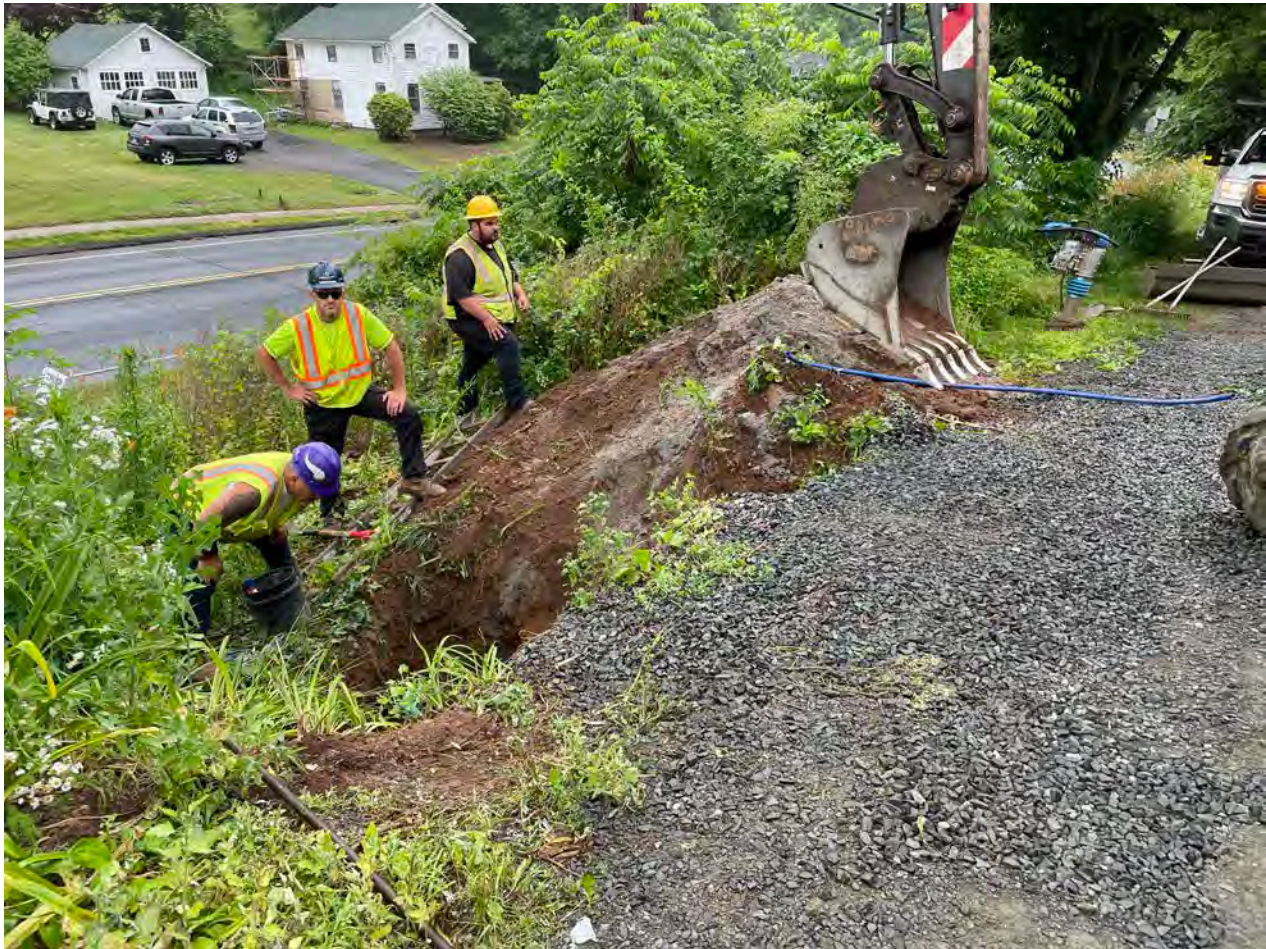
Picture 1: Ludlow excavating at the curb stop for 174 Main Street as the work to connect a section of 1" copper pipe that was previously installed at the residence to the curb stop. View to the southeast.

0734: Ludlow is in the process of connecting the curb stop at 174 Main Street the previous-installed 1" copper water service line. Ludlow used a 3-foot section of 1" copper pipe and another compression fitting to make the connection.

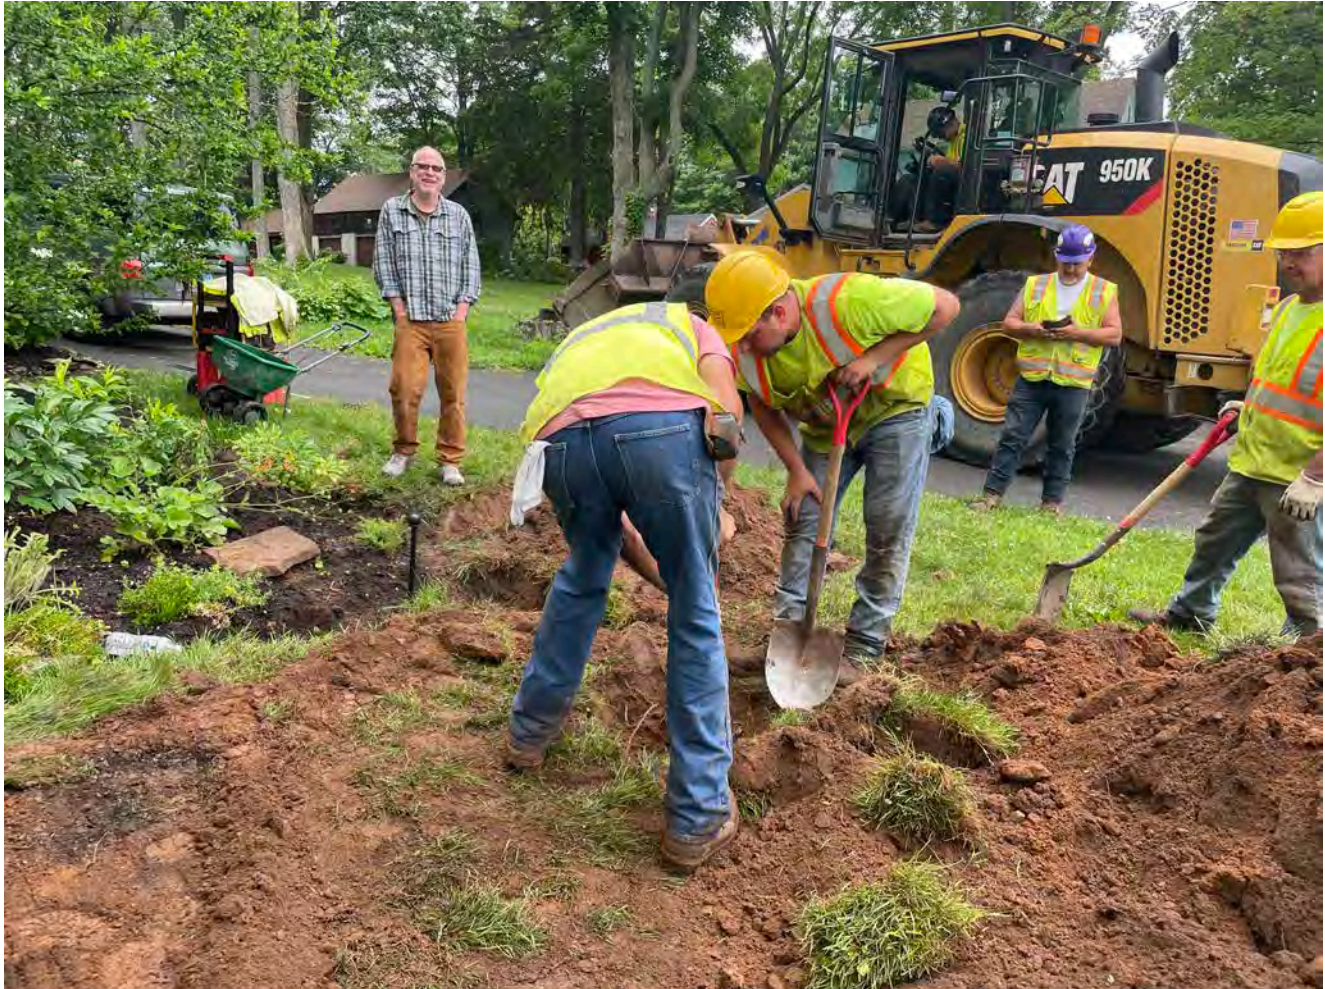
0936: Ludlow is currently hand digging at the northeast corner of the residence at 202 Main Street to daylight the four" PVC pipe that leads from the home's septic tank to the leach field located to the southeast of the house. One section of the pipe that was daylighted appeared to be crushed (prior to Ludlow's work today).

Picture 2: Ludlow hand digging on the northeast corner of the 202 Main Street residence to daylight a 4" PVC line that runs from the home's septic tank to its leach field. View to the northwest.

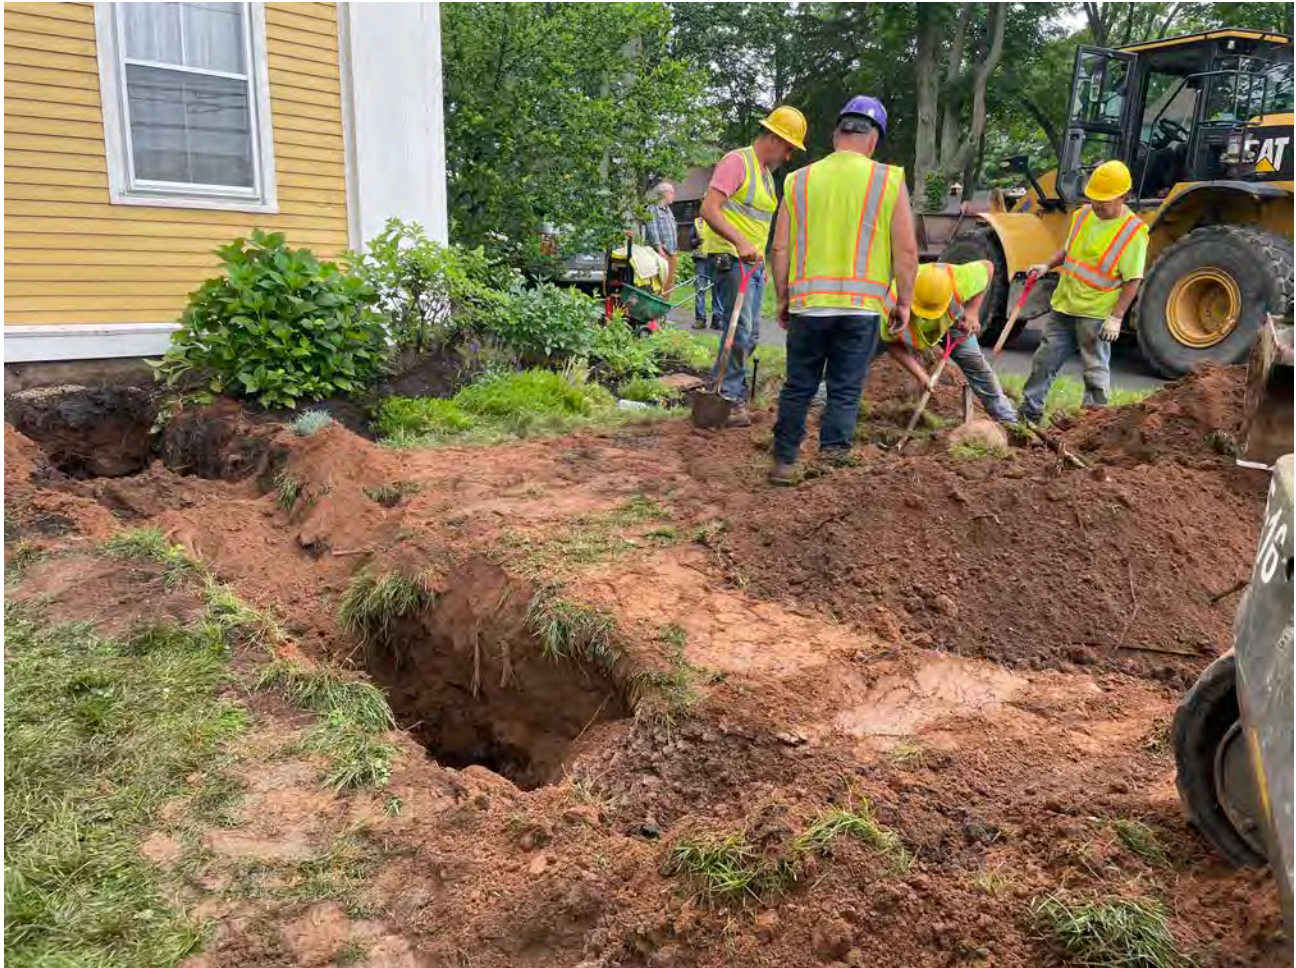
0920: Ludlow started excavating a trench on the northeast corner of the residence at 202 Main Street in Durham for the installation of a 1" copper water service line. Ludlow observes water flooding the trench that they think is associated with the home's septic system. Ludlow backfills the trench and plans to resume the installation of the copper line until a later date when alternate plans are made for the pipe installation. AECOM did not observe materials in the trench excavation that looked like leach field materials.

Picture 3: Ludlow hand digging on the northeast corner of the 202 Main Street residence to daylight a 4" PVC line that runs from the home's septic tank to its leach field. The trench that Ludlow started to excavate to place a 1" copper water service line through the east side of the home's foundation is visible on the left. View to the northwest.

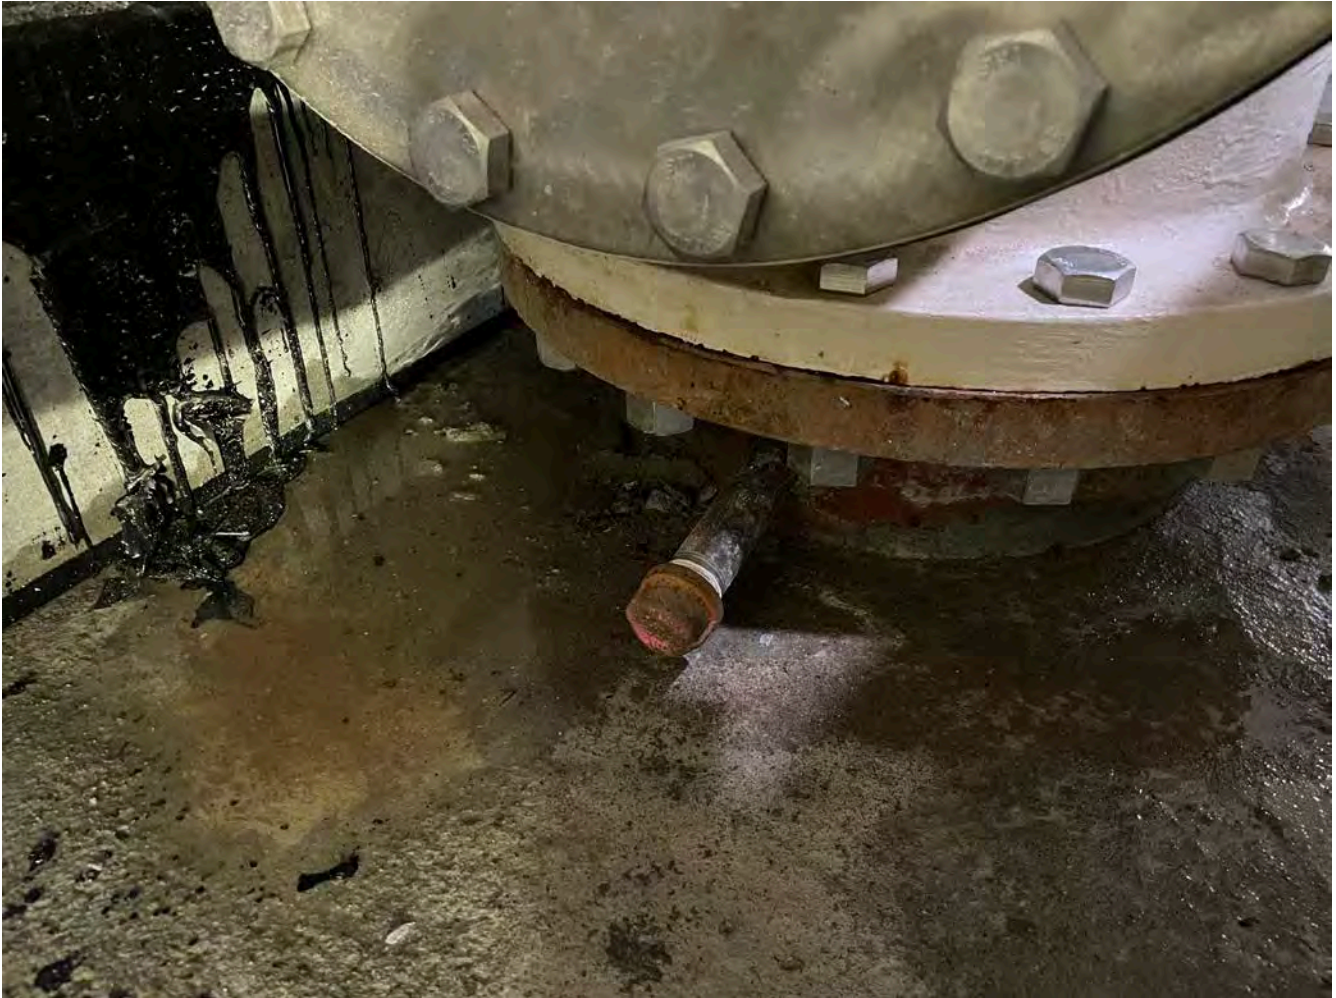
Picture 4: Short pipe nipple located at the base of the inlet pipe of the water tank that Ludlow installed to assist in pressure testing the pipes associated with the water tank. The removal of this nipple and cap is on the punch list of items to be finished at the water tank. View to the southwest.

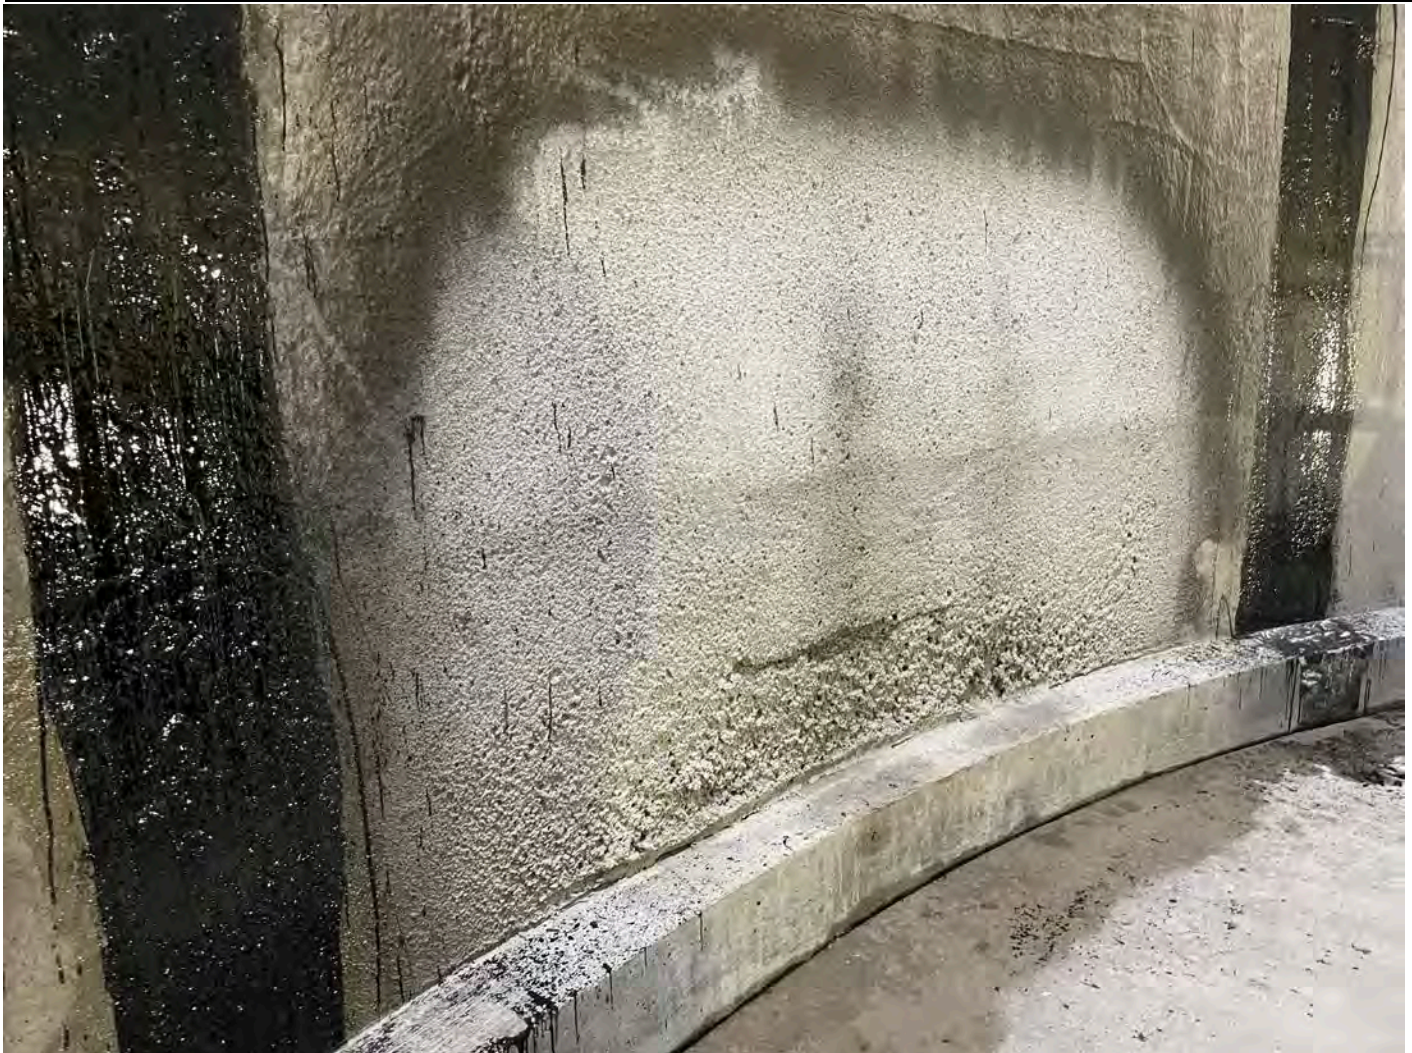
Picture 5: Patched area of the inside of the water tank where a temporary entrance was removed and sealed. Smoothing of the shotcrete surface with additional repair mortar is on the punch list of items to be finished at the water tank. View to the east.

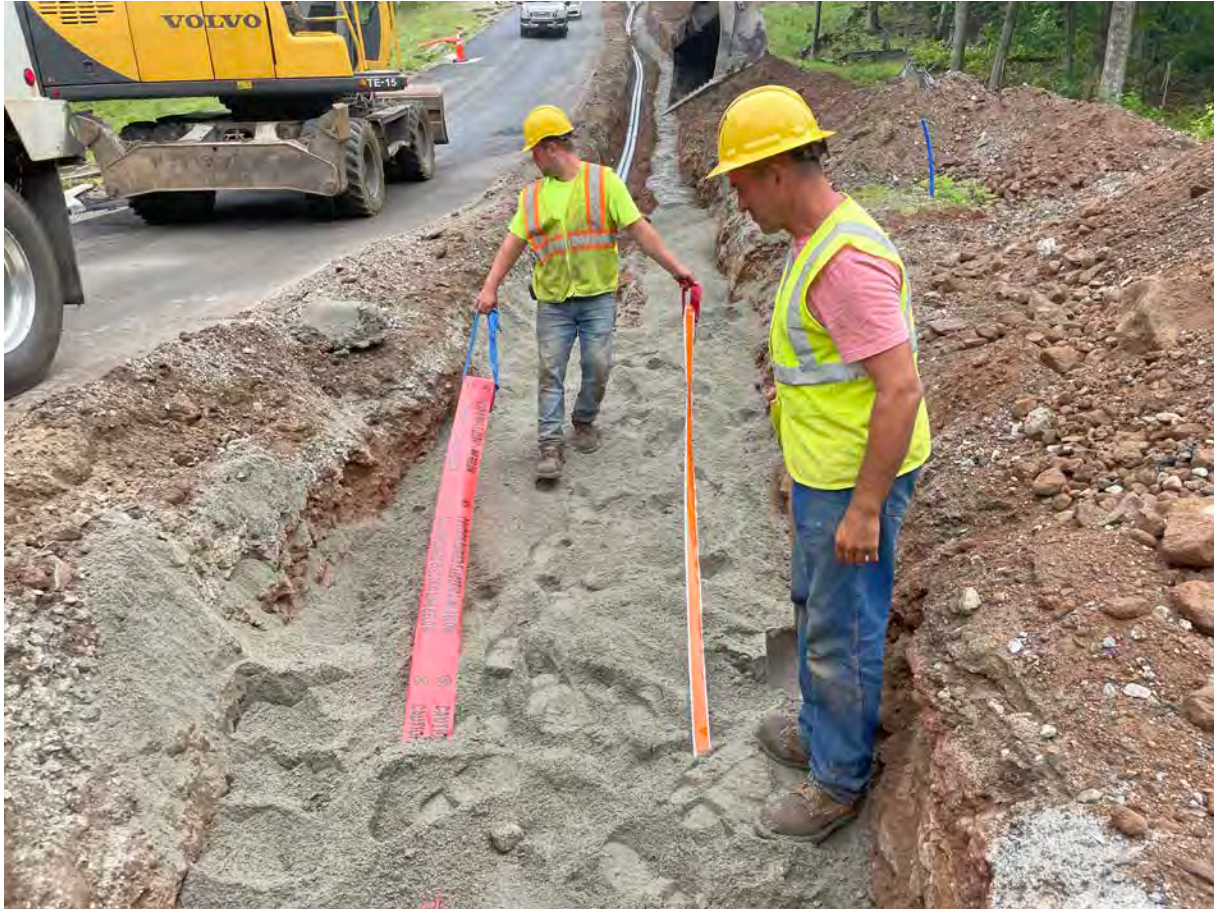
1146: Ludlow begins to backfill over the communication and electric conduits on the south side of the Shared Access Driveway in Middletown. Ludlow is placing sand over the 2" PVC communications conduits (that are encased concrete) and the four-inch PVC electrical conduits. Ludlow is placing the appropriate caution tape on top of both series of conduits.

Picture 6: Ludlow placing caution tape over electrical and communications conduits in the utility trench located south of the Shared Access Road in Middletown. View to the east.

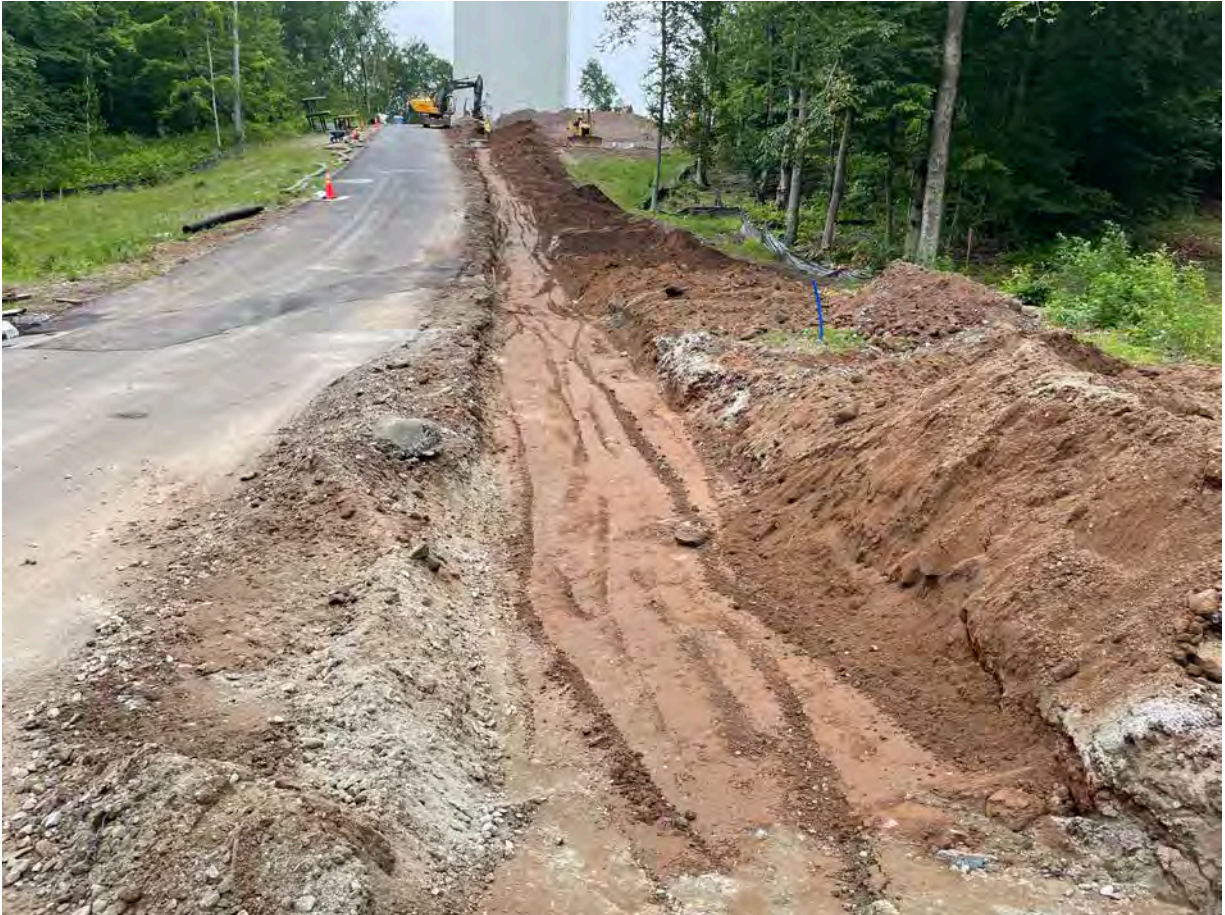
1314: Ludlow has almost finished backfilling the utility trench located south of the Shared Access Driveway. Ludlow is compacting the backfill with compactor roller.

Picture 7: Backfill that Ludlow placed and compacted over electrical and communications conduits in the utility trench located south of the Shared Access Driveway in Middletown. View to the east.

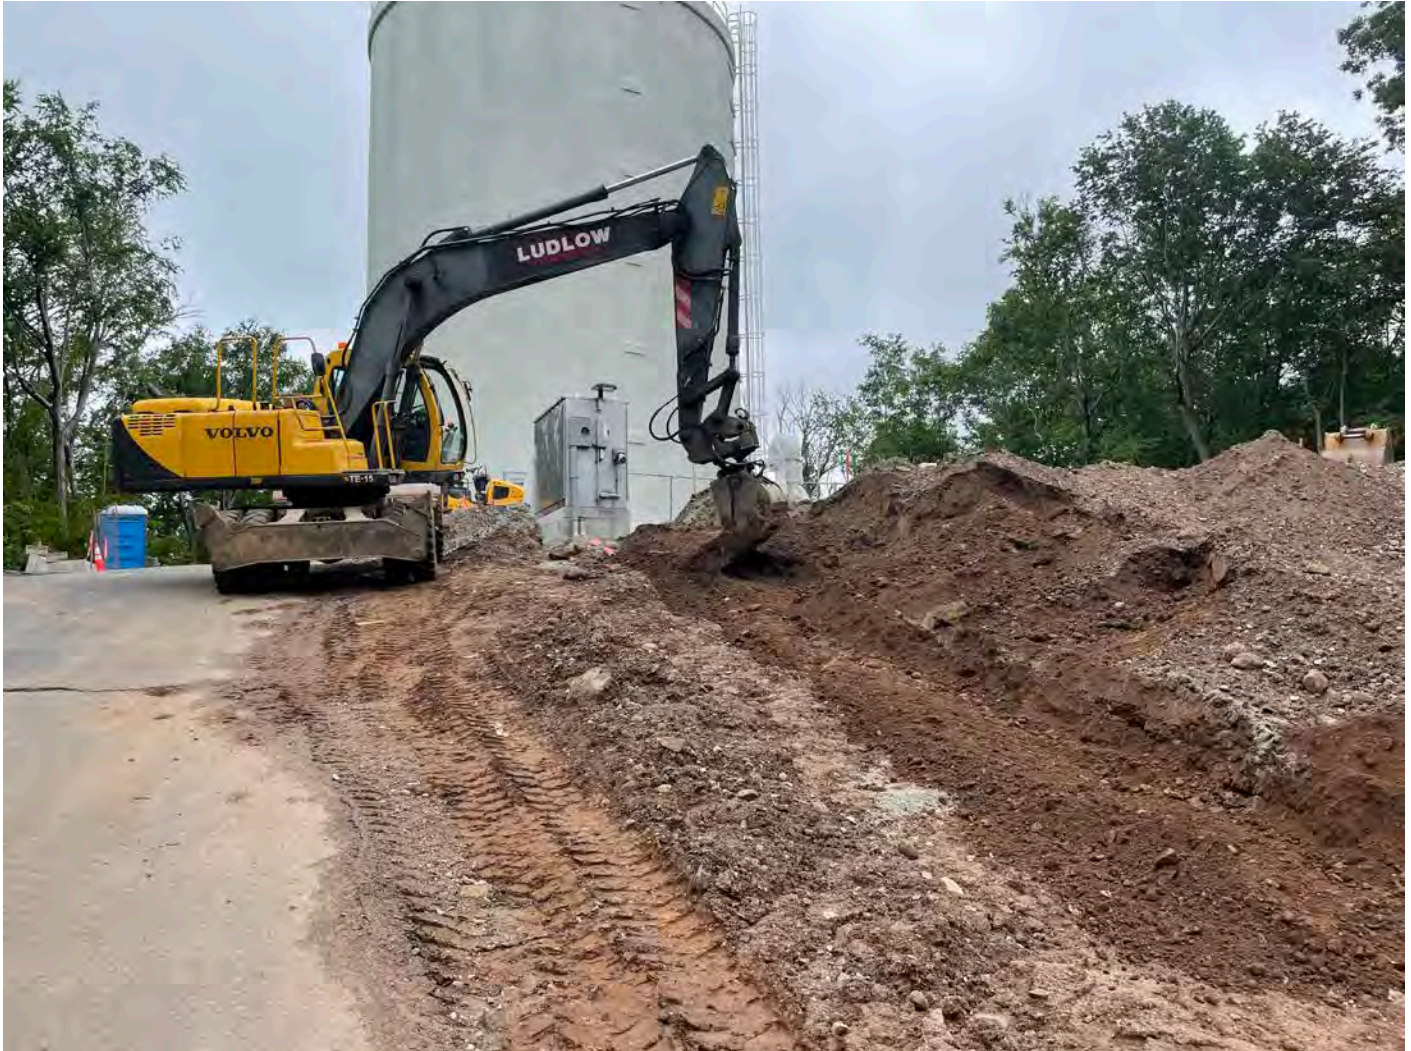
Picture 8: Ludlow placing backfill over electrical and communications conduits in the utility trench located south of the Shared Access Driveway in Middletown. View to the east.

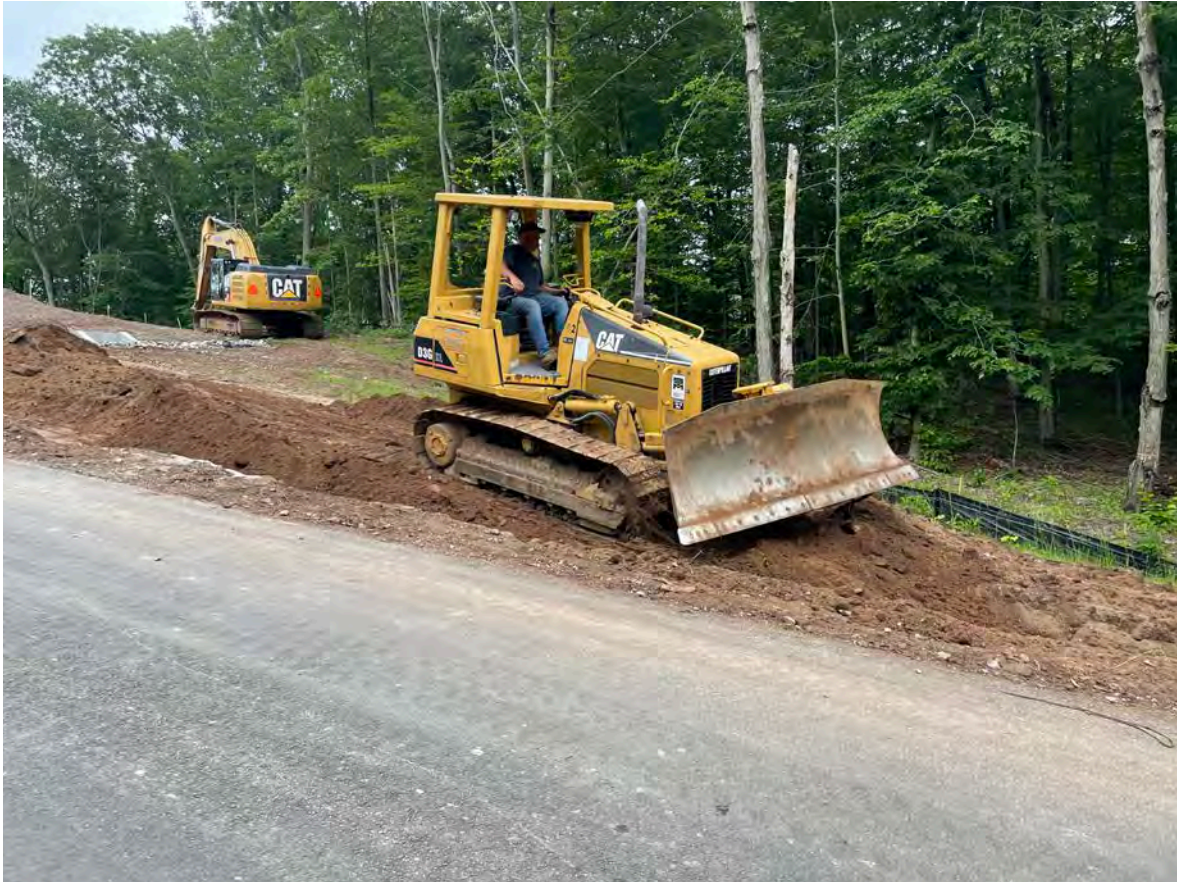
Picture 9: Ludlow grading backfill that they placed over electrical and communications conduits in the utility trench located south of the Shared Access Driveway in Middletown. View to the southeast.

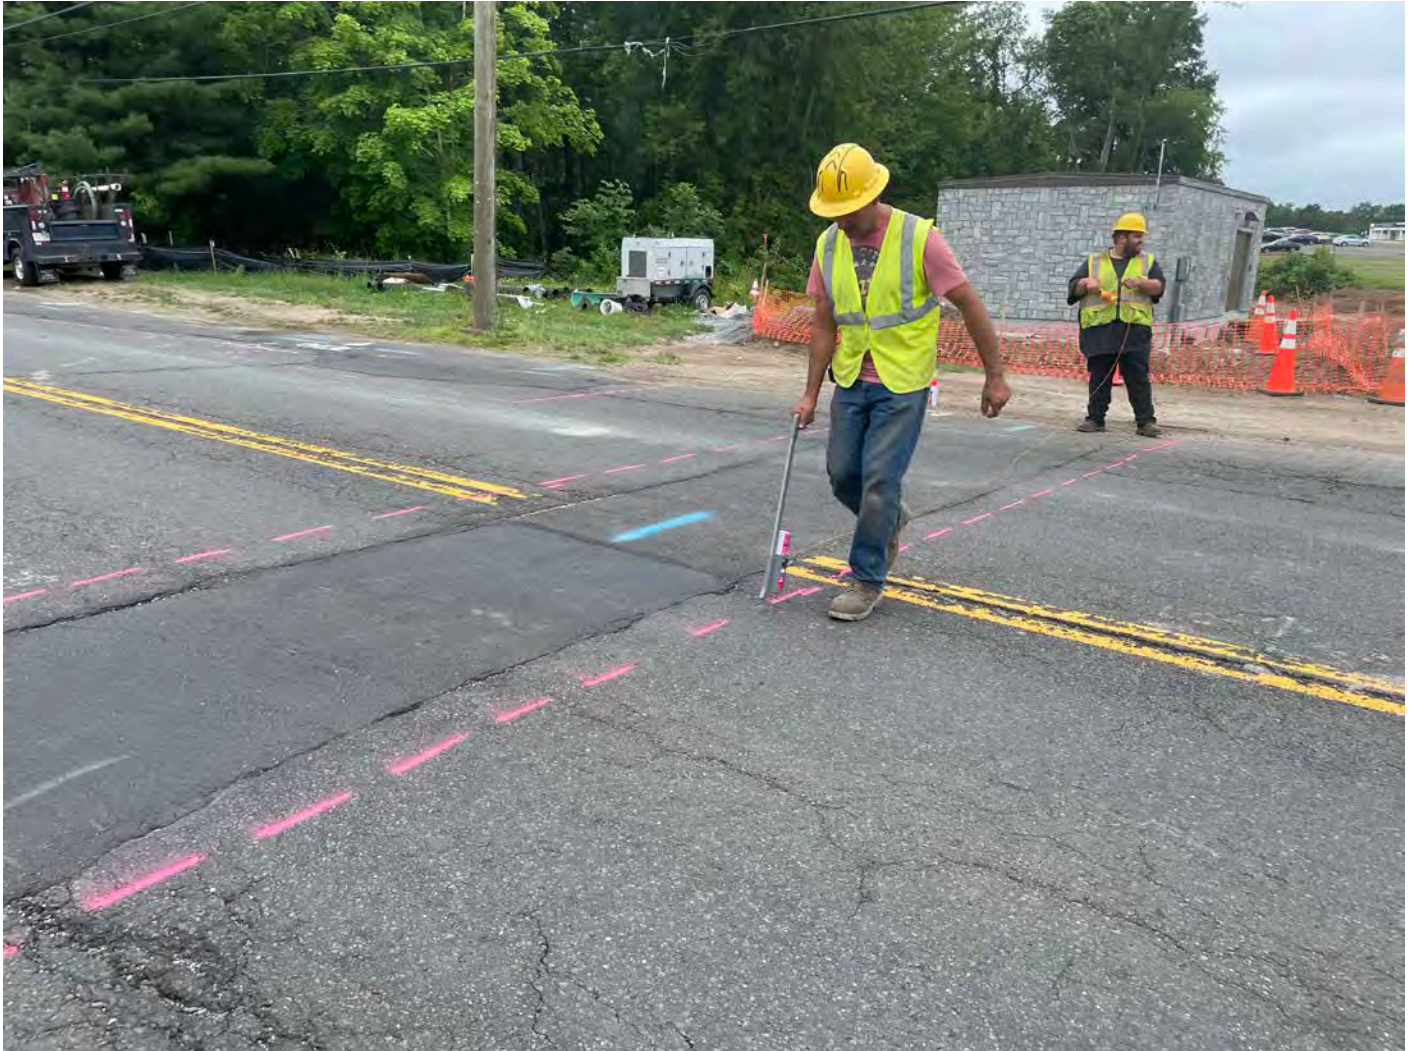
1359: Ludlow marking out pavement overcuts at station 700+00 for the permanent paving activities that are scheduled for next Monday.

Picture 10: Ludlow marking out trench overcuts for permanent paving activities that will be performed on Monday. S. Main Street at ~Station 700+00. View to the east.

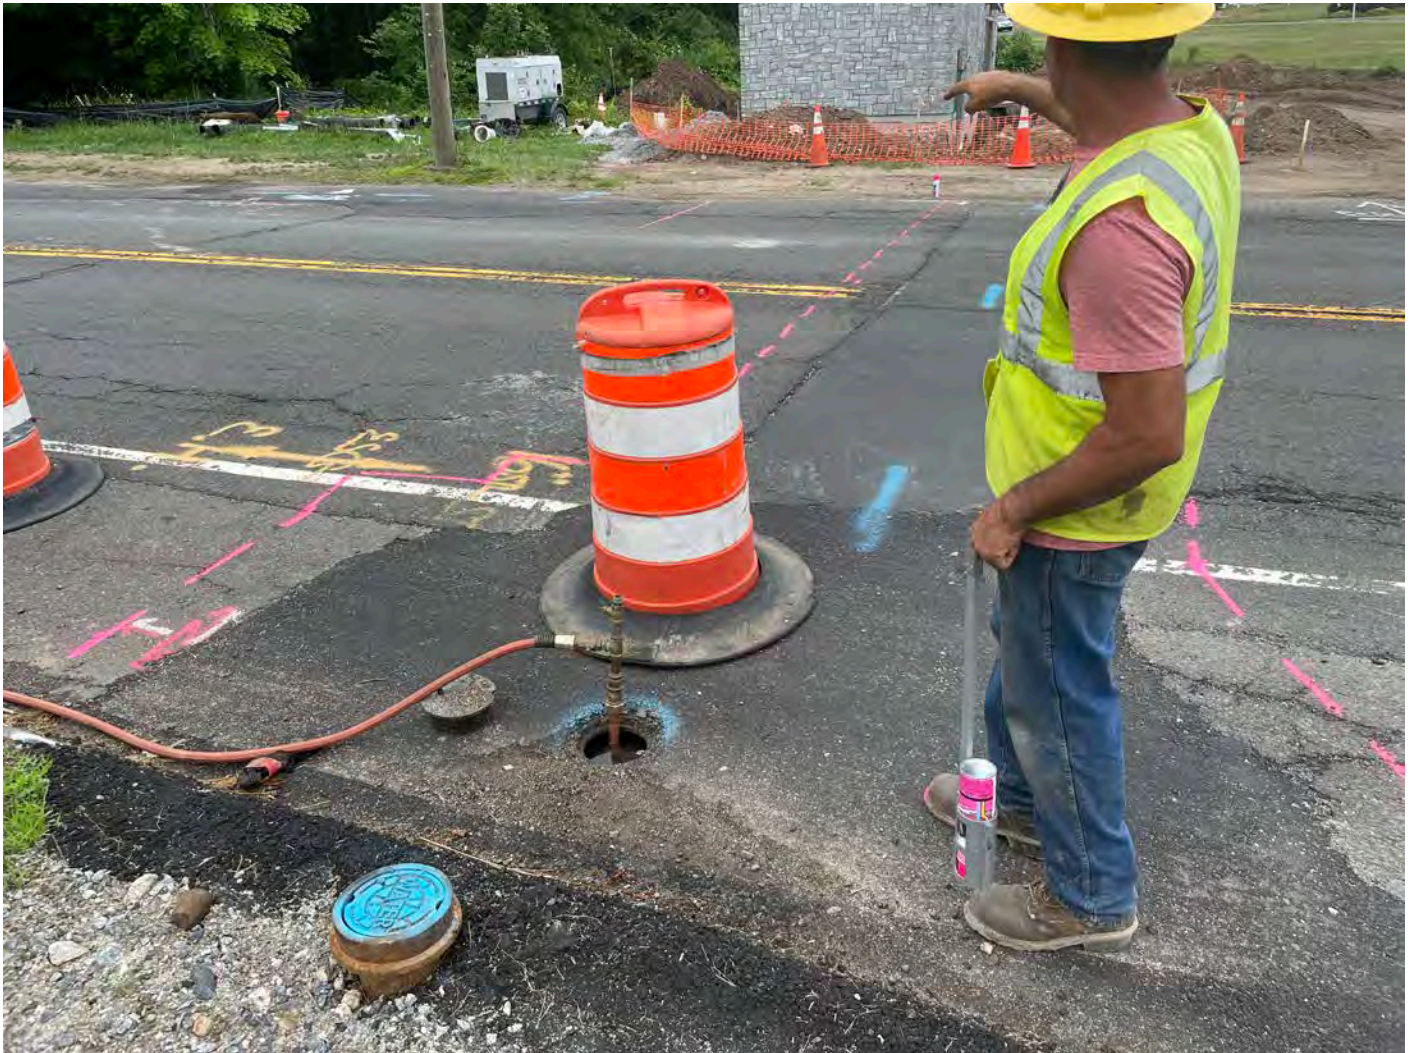
1327: Ludlow is flushing the 8" water line that runs from the intersection of Talcott Ridge Drive and Watch Hill Drive to Station 750+59 and through the booster station.

Picture 11: Ludlow flushing an 8" water line that is located on a portion of Talcott Ridge Drive and on the booster station property. View to the west.

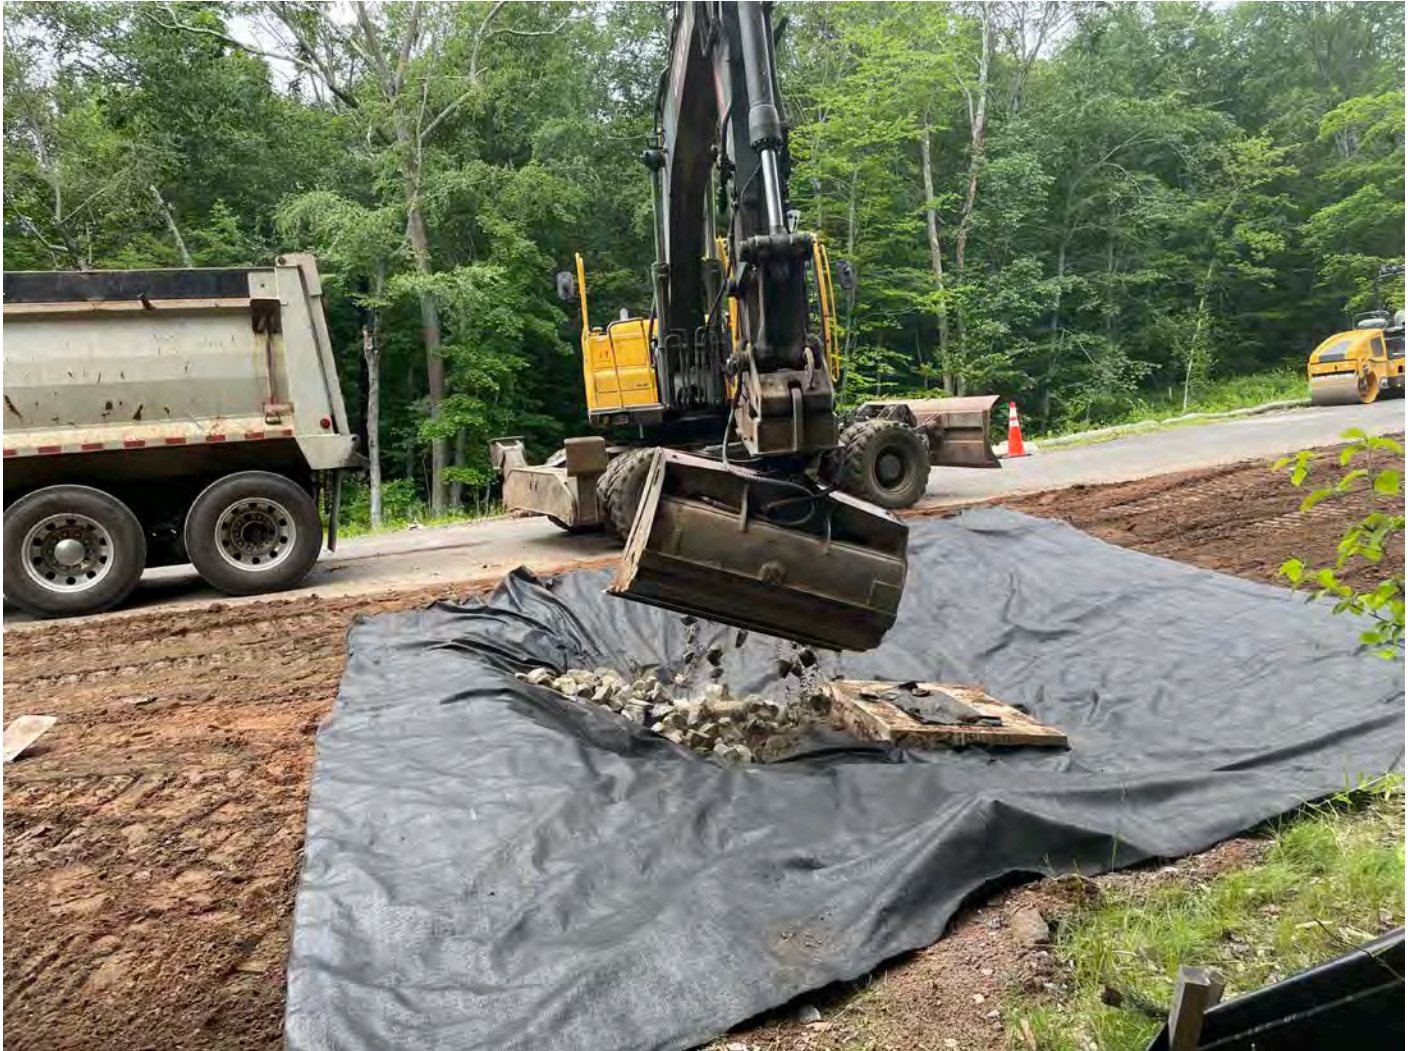
1420: Ludlow is placing rip rap and geofabric around the catch basin located at ~Station 13+20. Ludlow is also grading soil on the south side of the Shared Access Driveway at ~Station 11+50.

Picture 12: Ludlow placing riprap over geofabric that has been placed around a catch basin located south of the Shared Access Driveway at ~Station 13+20. View to the north.
