Daily Report

Project:	Durham Meadows Pipeline Installation	Date:	June 28, 2021
Location:	S. Main Street and the Shared Access Driveway, Middletown	Day of Week:	Monday
Project #:	AECOM: 6061487	Report No:	273
Contractor:	Ludlow Construction	Page:	1 of 12

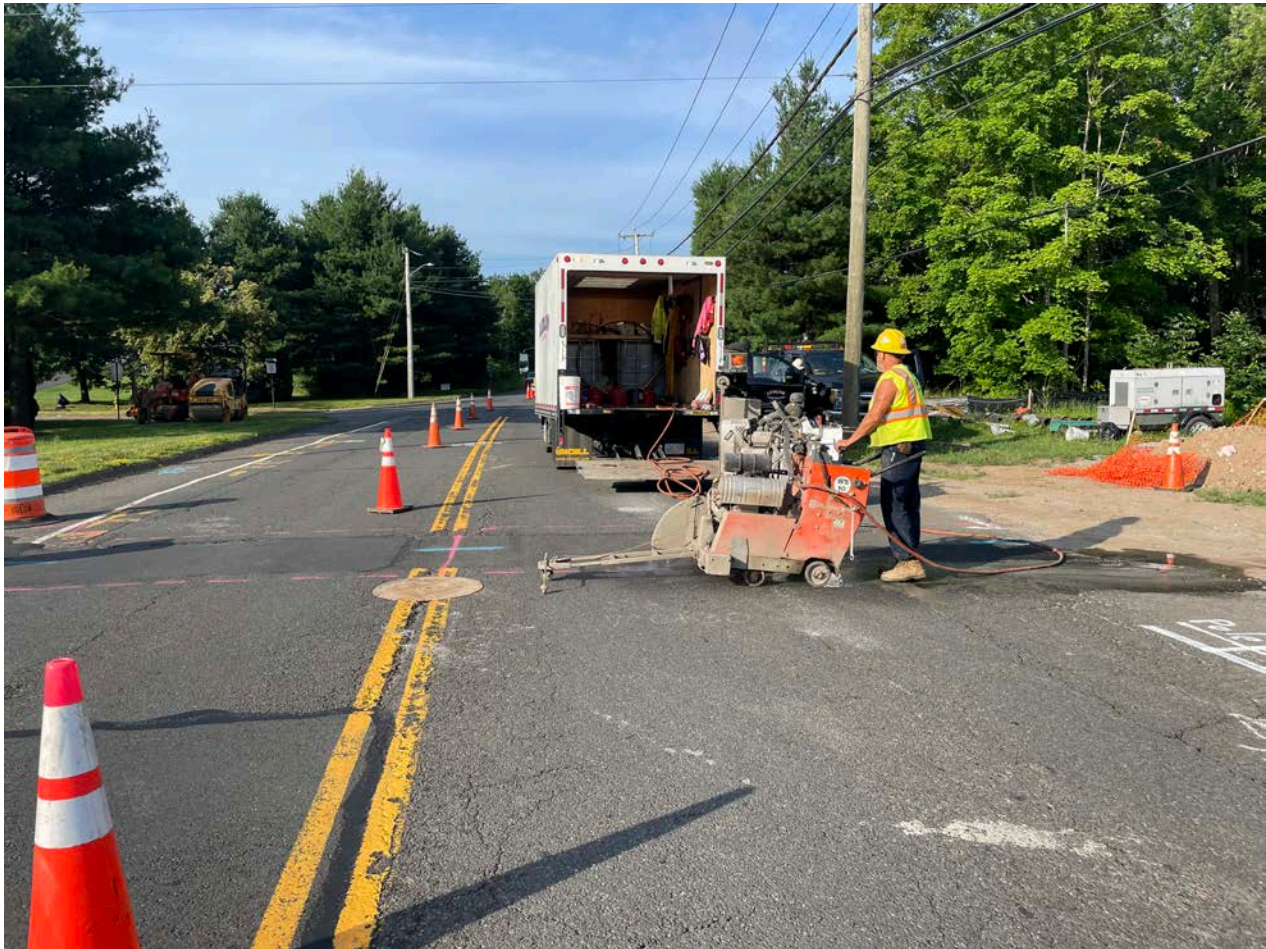
Picture 1: Ludlow saw cutting pavement on trench overcuts as they prepare to place permanent pavement. ~Station 700+00, S. Main Street, Middletown. View to the south.

0850: Ludlow continues to saw cut pavement and are currently working on S. Main Street, immediately east of the booster station. Saw cutting east of the booster station.

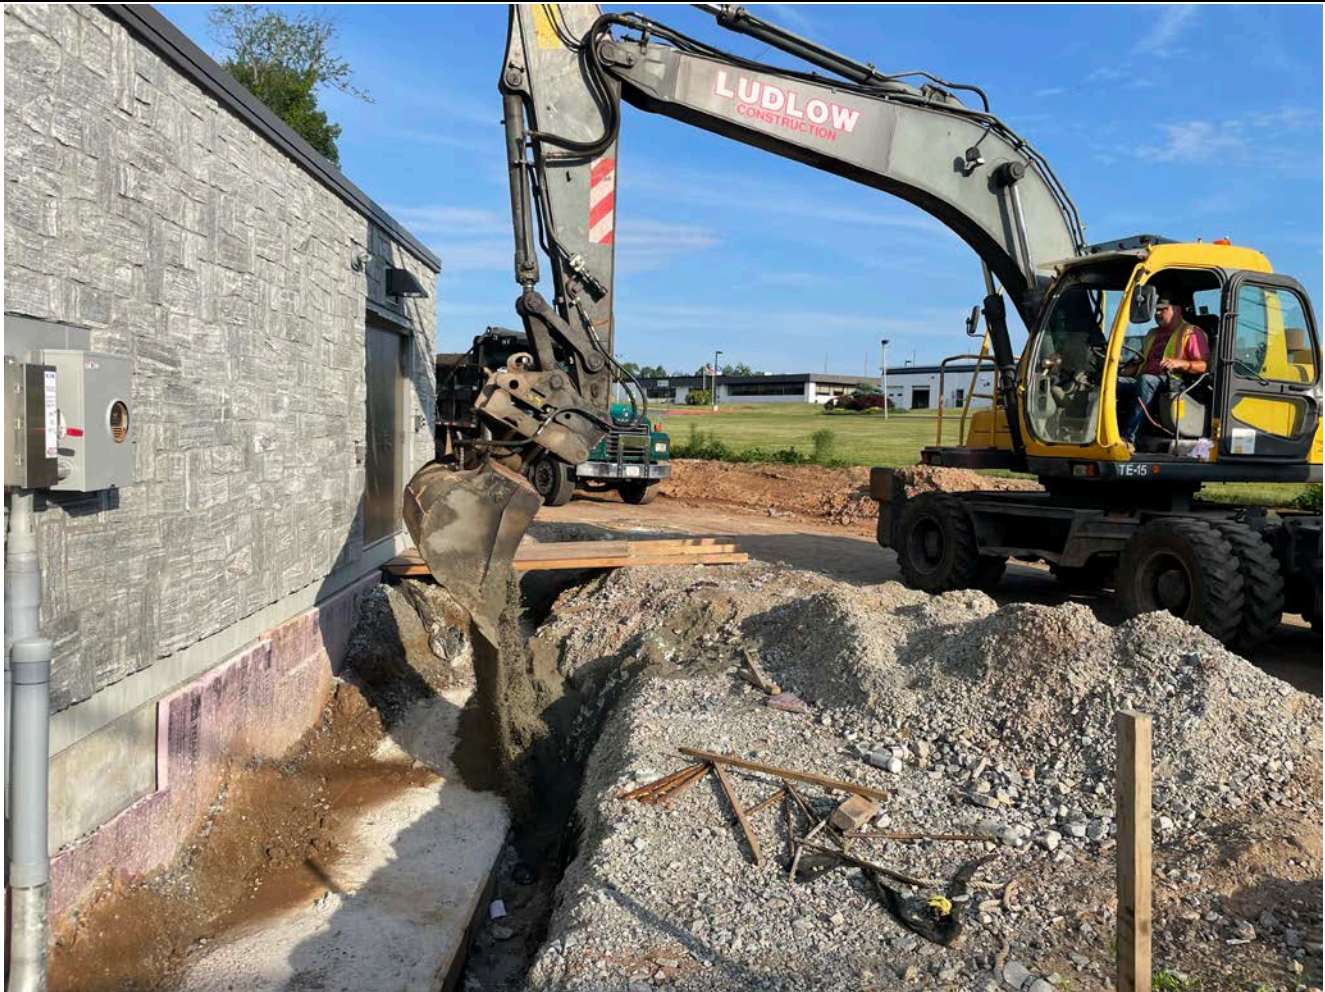
Picture 2: Ludlow placing sand in the utility trench located on the north side of the booster station. View to the west.

0721: Ludlow is saw cutting trench overcuts as part of permanent paving activities at Station 700+00 and moving south in the southbound lane of S. Main Street, Middletown. Ludlow is also backfilling the utility trench located on the north side of the booster station with sand. Ludlow is handling traffic management with one of their own staff, a private flagger, and a police officer from the city of Middletown.

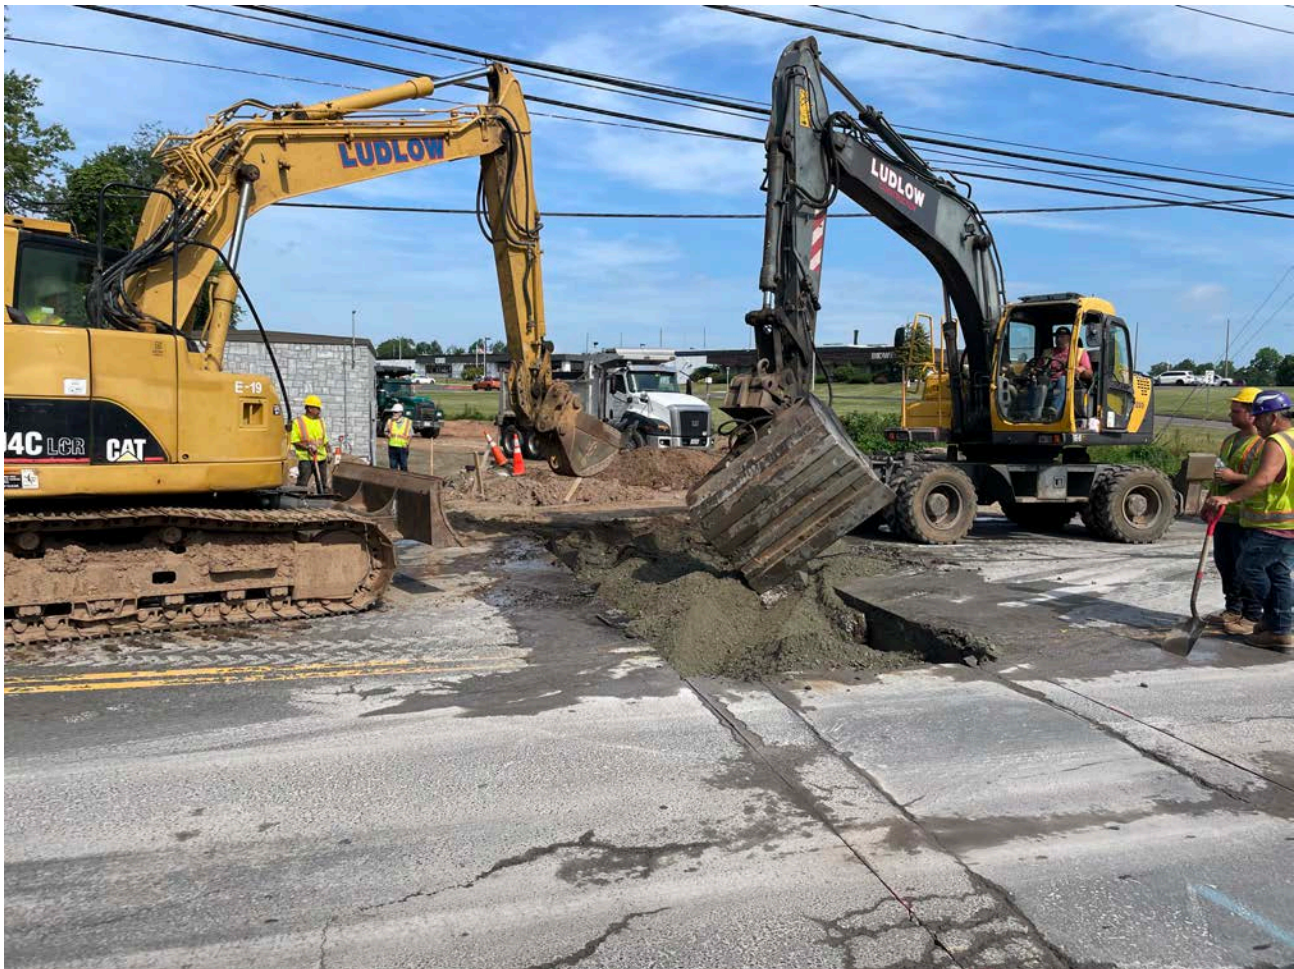
Picture 3: Ludlow excavating asphalt and concrete from trench overcuts on S. Main Street in Middletown near Station 700+00. View to the west.

1030: Ludlow has a portion of the trench overcuts on the southbound lane on S. Main Street excavated of asphalt and concrete, close to Station 700+00.

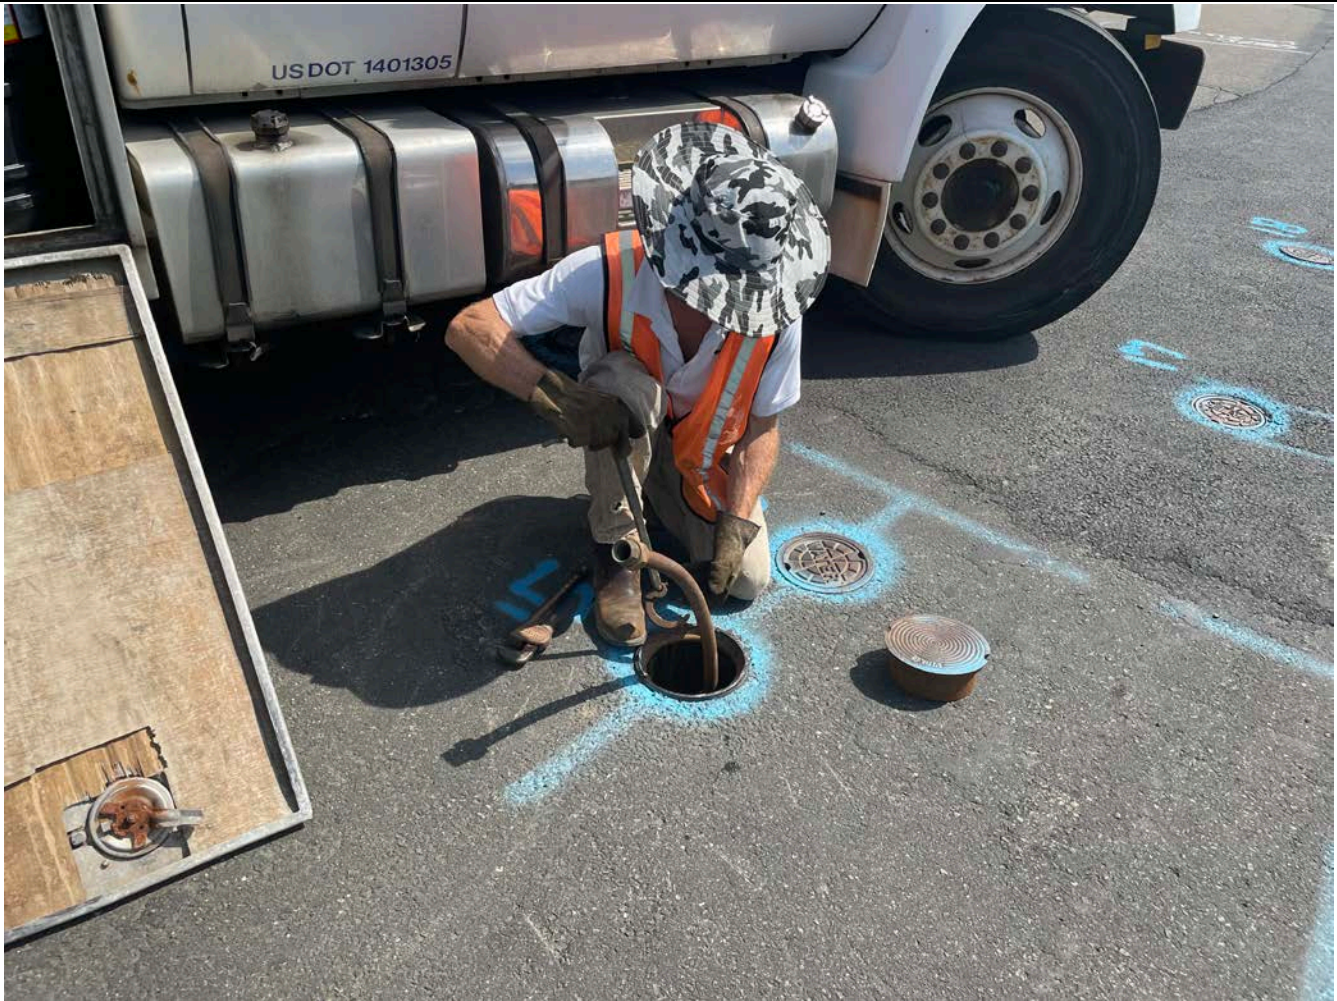
Picture 4: JMS setting up to inject sodium hypochlorite into an 8" DIP water line at the intersection of Talcott Ridge Drive and Watch Hill Drive as part of chlorination activities. View to the southwest.

1017: Ludlow and JMS are setting up to inject sodium hypochlorite into 8" DIP waterline at the intersection of Talcott Ridge Drive and Watch Hill Drive, Middletown. John Ewanowski from the City of Middletown is present to observe the chlorination activities.

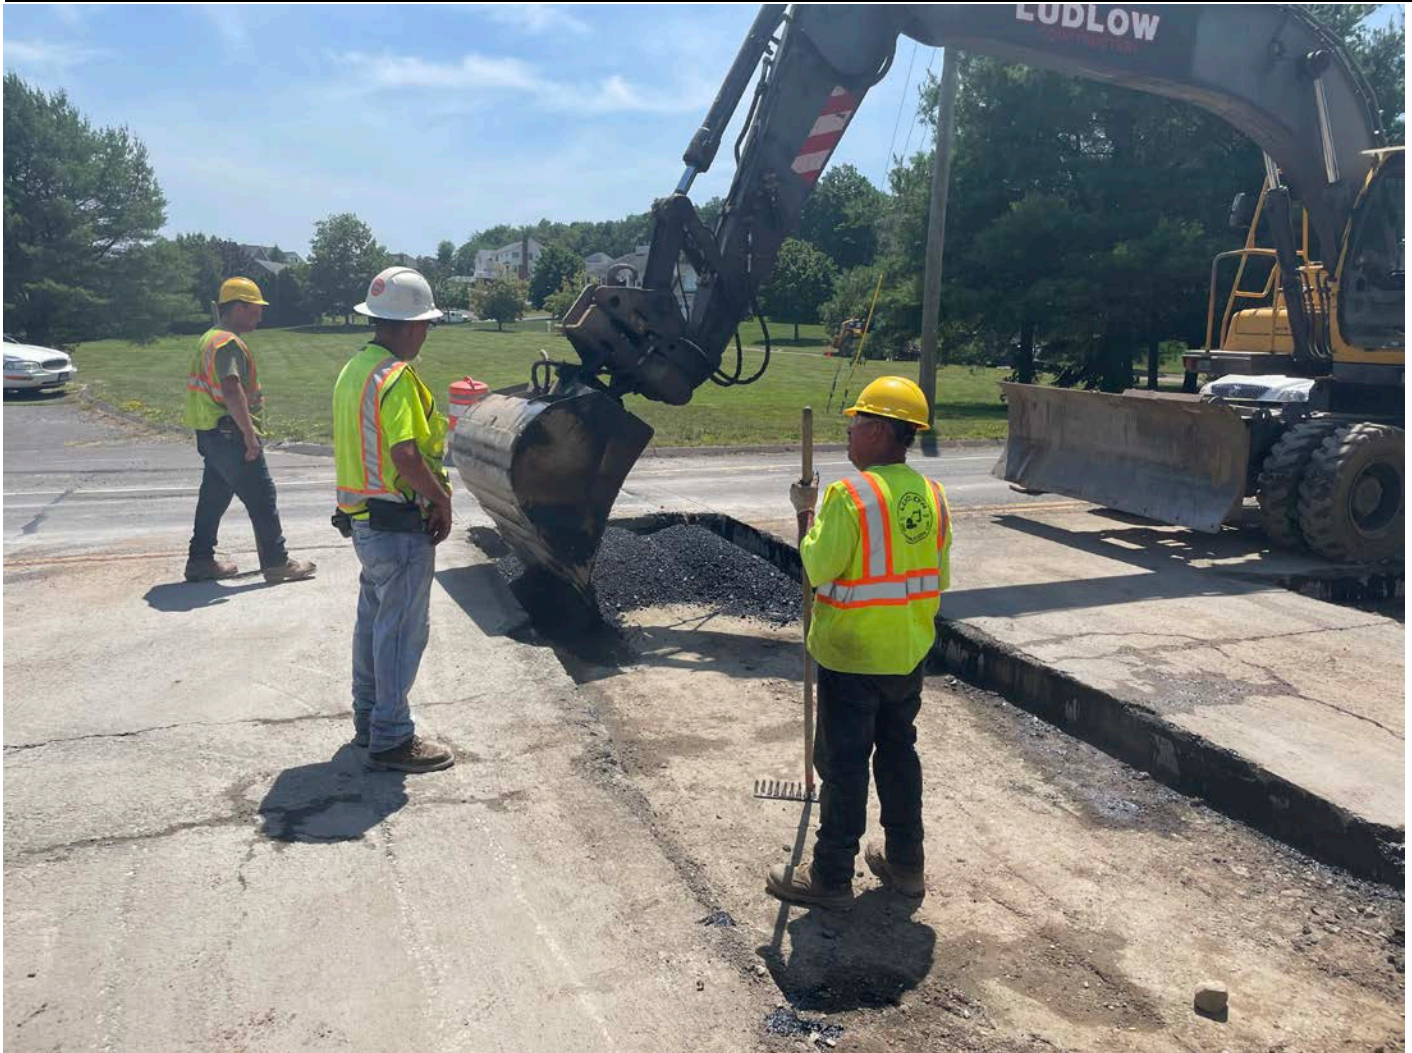
Picture 5: Ludlow placing the first lift of asphalt on trench overcuts on S. Main Street near Station ~700+00 in Middletown. View to the east.

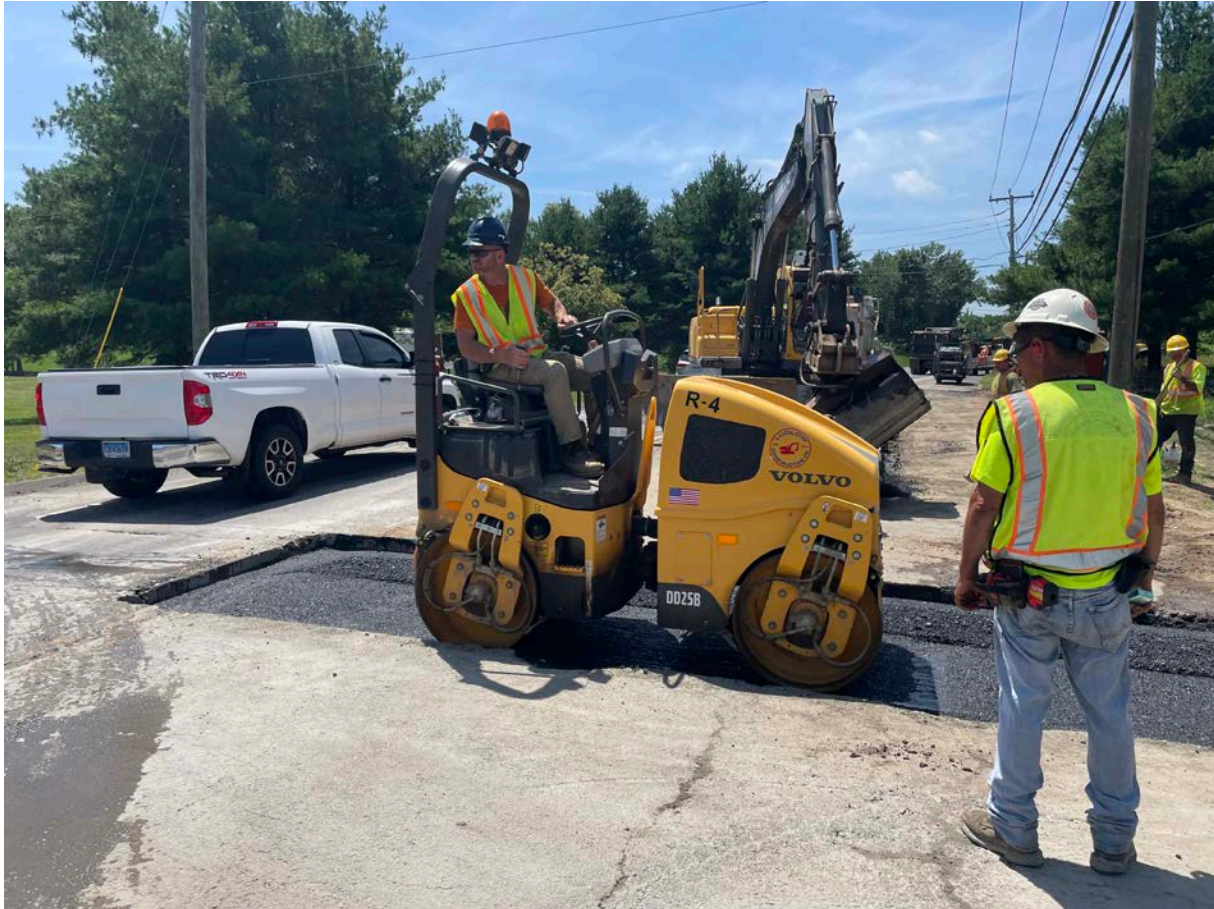
Picture 6: Ludlow rolling asphalt on trench overcuts on S. Main Street as part of permanent paving activities. View to the south.

1403: Ludlow is taking a break from paving due to the heat. They have placed and rolled about half of the second lift of asphalt on the trench overcuts on the southbound lane of S. Main St. in Middletown. JTC has been performing compaction tests at a minimum frequency of one every 25 feet.

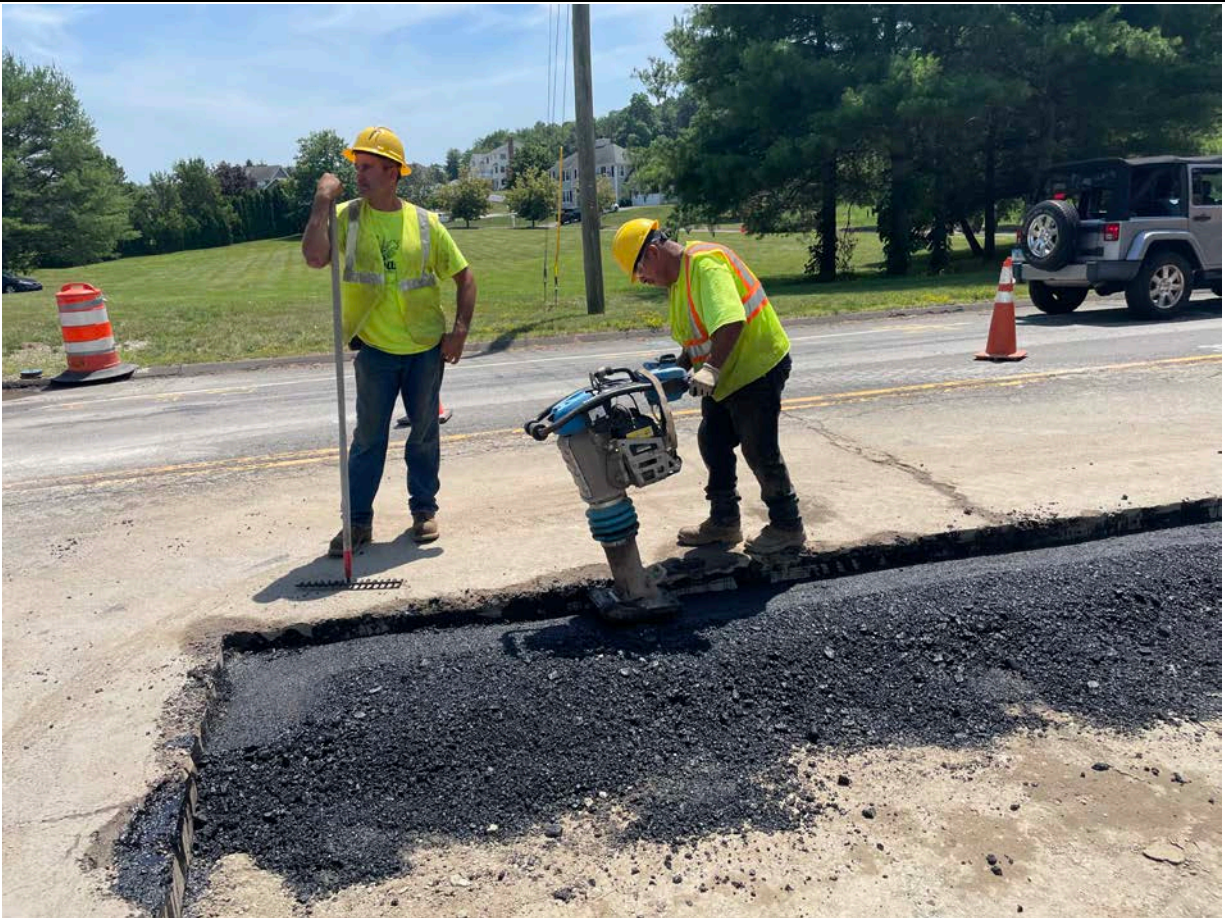
Picture 7: Ludlow using a jumping jack to compact asphalt on trench overcuts on S. Main Street as part of permanent paving activities. View to the east.

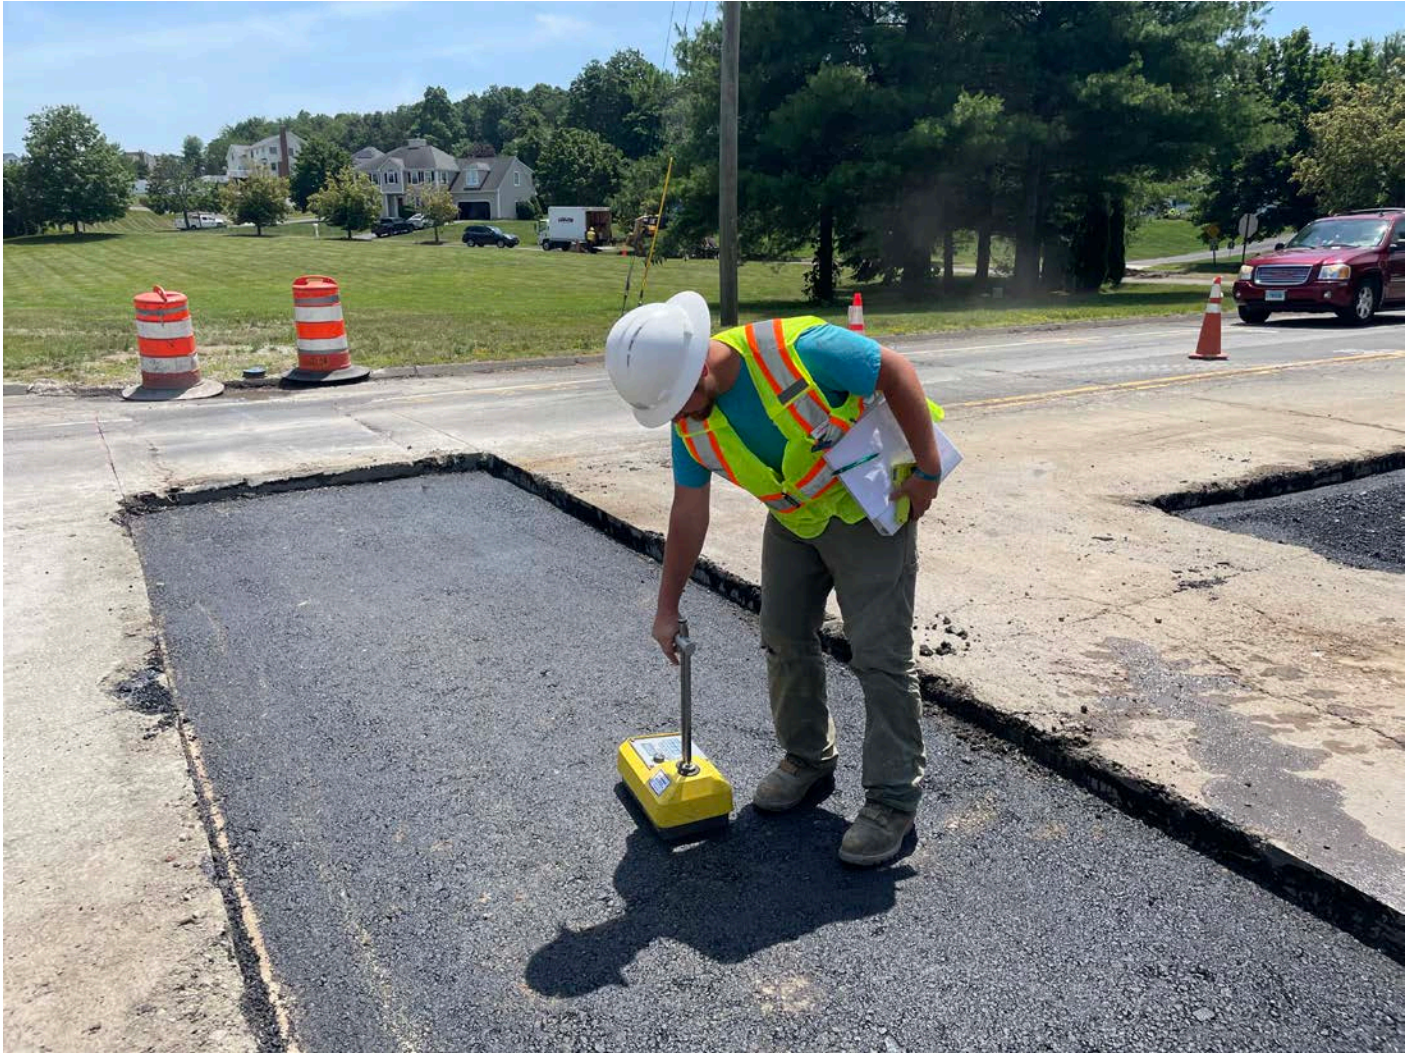
Picture 8: JTC testing compaction on the first lift of asphalt that was placed on the trench overcuts on the southbound lane of S. Main Street, Middletown. View to the east.

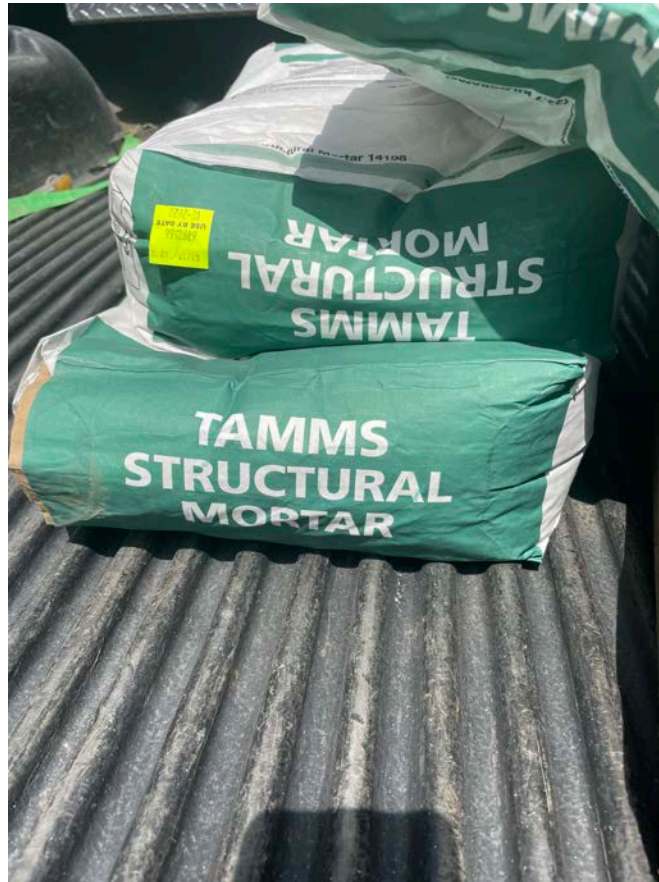
Picture 9: Non-shrinking grout that DN Tanks is using to plug small holes in the water tank roof that were used to run lines into the tank for the lift system.
